## Building Inspection Report

Inspection Date: Thu, 12 Mar 2026

Property Address: 4/34 Barton St, Reservoir VIC 3073,  
Australia

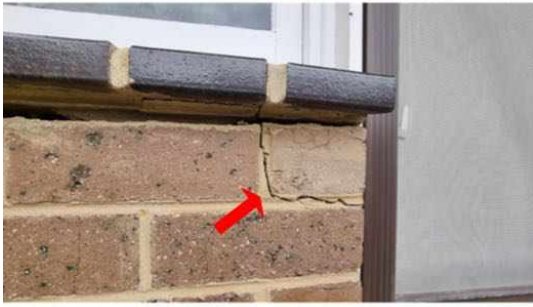
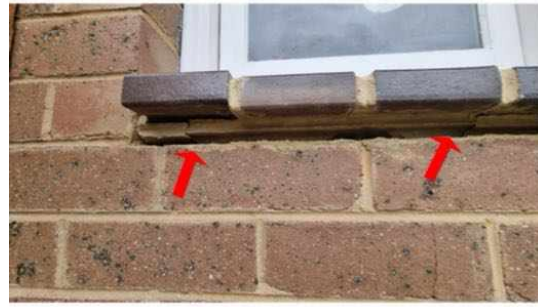
#### Defects 2.01

Building:	Main Building
Location:	All External Areas > All Areas
Finding:	Window brick sill - Cracking (Major Structural Defect)
Information:	At time of inspection, cracking was evident to various areas of the masonry window sills.

A qualified bricklayer should be consulted on how to rectify this defect. If it is found that the cause of cracking is due to foundation movement, a qualified structural engineer should be consulted.

Always contact a building inspector or engineer should cracks widen lengthen or become more numerous, even after repair works have been completed.

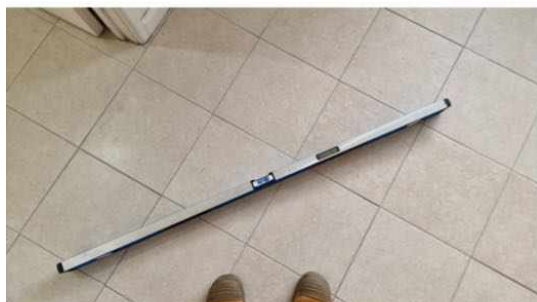
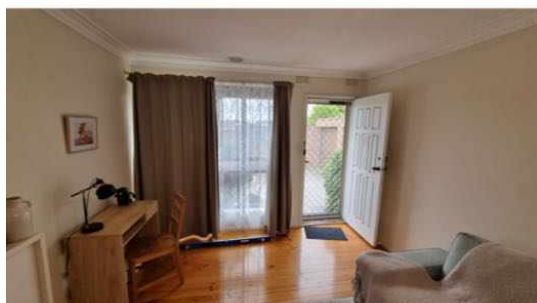
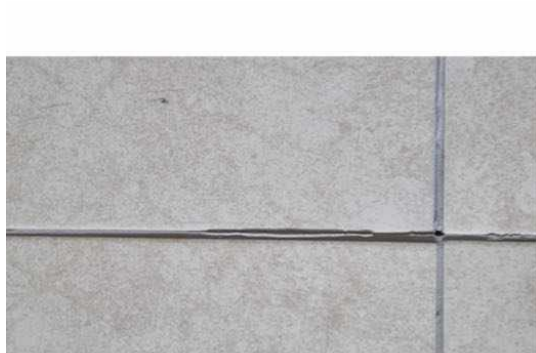
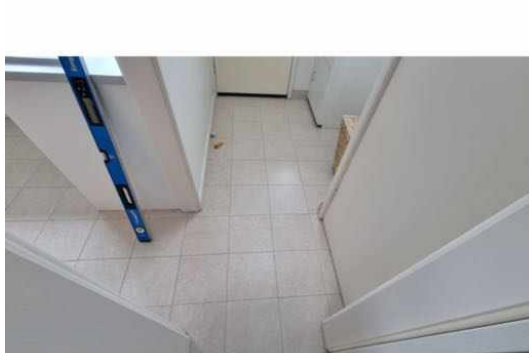
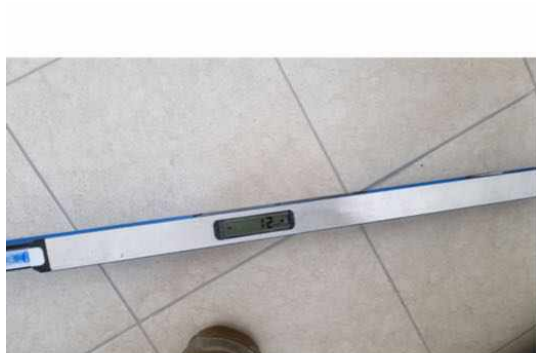
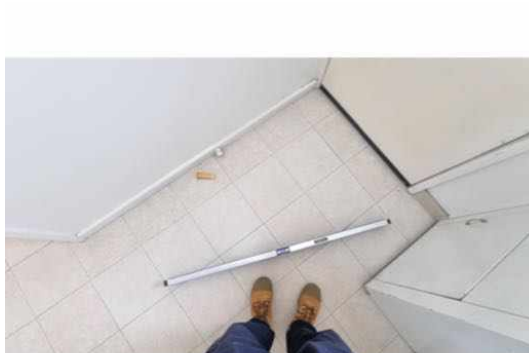
### Defects 3.01

Information: The internal flooring throughout the home is out of level and uneven at time of inspection. Uneven flooring is likely to indicate minor defects such as expected movement of the foundations of the property, but may also indicate subsidence of the associated subfloor stumps.

There were floor areas of the home that were more uneven than others, and it was noticeable when walking across. The kitchen and laundry floor tiles have cracked and when walking across the tiles, you can feel that the support under the tiles is compromised.

It is advised that the flooring be closely monitored to identify any further movement. Where flooring remains relatively unchanged for an extended period of time (i.e. several months), it is likely that this defect has been caused by expected movement of the foundations of the property.

However, where flooring is uneven further, potentially invasive inspection of the subfloor structures and stumps in this area is required. In this case, works to repair are likely to be required, and would be carried out by a registered builder specialising in re-stumping.

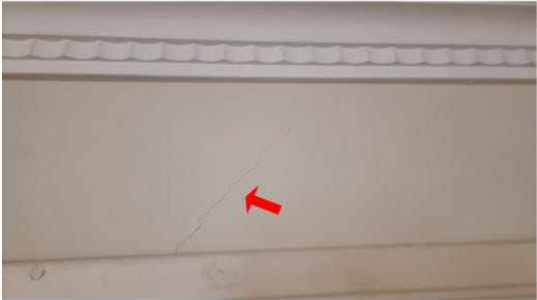
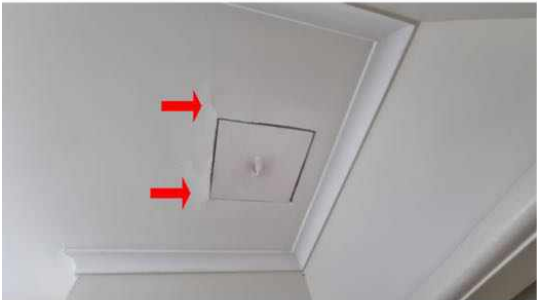
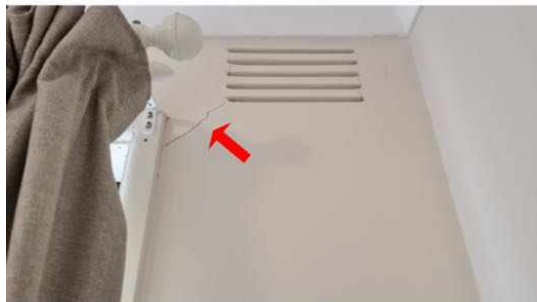
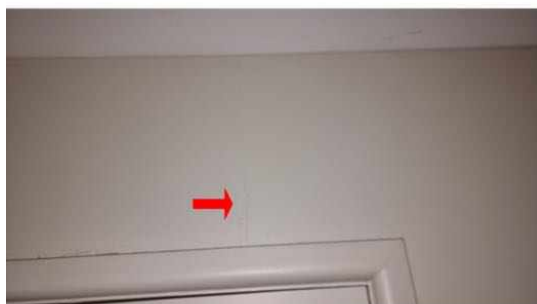
## Defects 3.02

Building:	Main Building
Location:	All Internal Areas > All Areas
Finding:	Cracks in Plaster Wall and Ceiling
Information:	It was found that at the time of the inspection cracks were visible to the walls, window architraves, skirtings and ceiling throughout the home.

In particular of concern are the cracks below and above all window openings and internal openings. These are suspected to be a result of

Movement in the foundations and subfloor structure over a long period of time.

Noticeable cracks may result in minor sticking or jamming of associated doors and windows, which require easement. However, noticeable cracks are easily filled and repaired. A plasterer can be consulted to install an expansion joint at this point to allow for this movement during different weather conditions.

Relevant tradespeople, such as carpenters, painters and plasterers, should be appointed to perform remedial works, as deemed necessary.

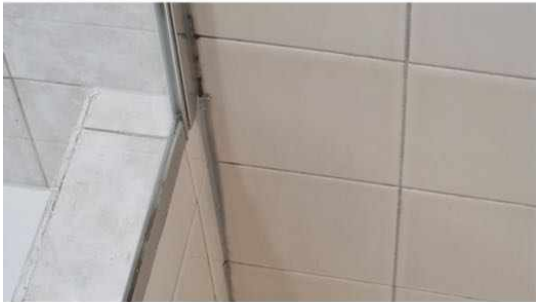
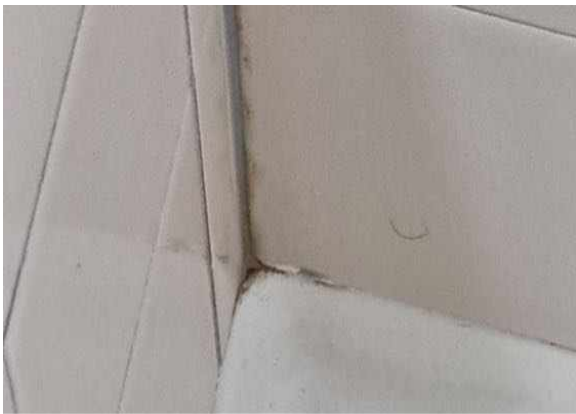
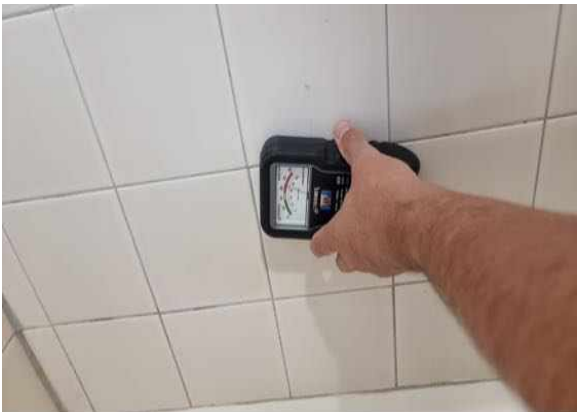
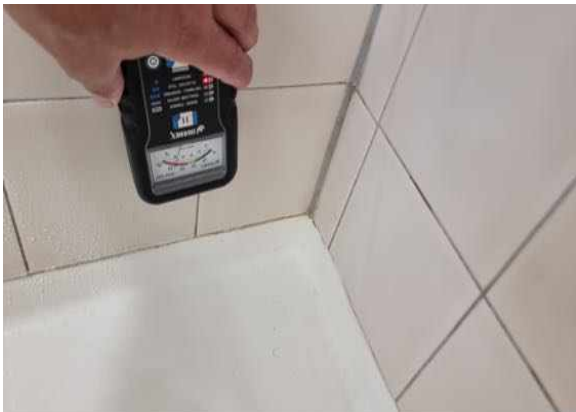
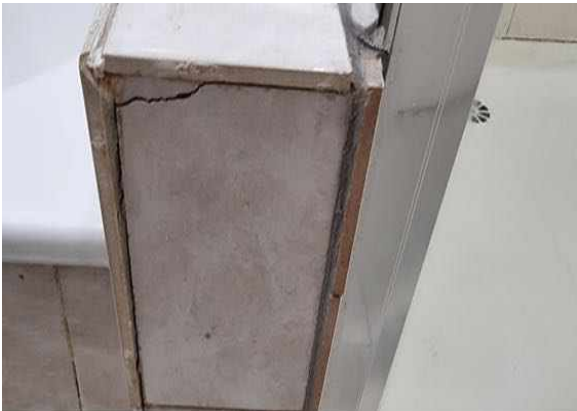
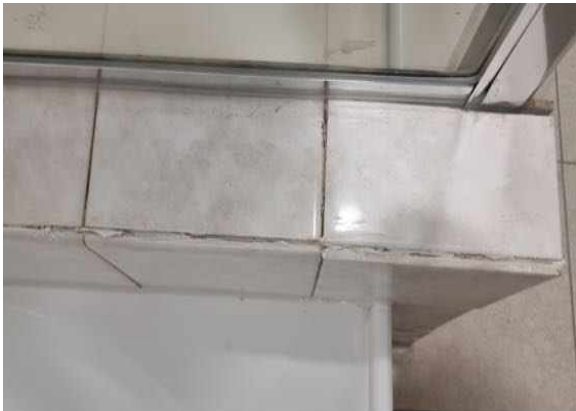
### Defects 3.03

Building:	Main Building
Location:	Bathroom > All Areas
Finding:	Bathroom - Shower leaking and other Minor defects
Information:	At the time of the inspection, the following defects were found,

1. the silicone around parts of the bathroom including shower has deteriorated.
2. Tiles have cracked and coming loose,
3. Grout to tiles have cracked along the wall/floor junction.
4. Moisture detected in shower walls and floor outside shower.

The above defects are generally due to wear and tear over long period of time, and it also is a sign that building elements have moved over time causing numerous defects.

The client should seek further advice from a qualified builder to determine extent of rectification works required.

These works should be done as a matter of priority.

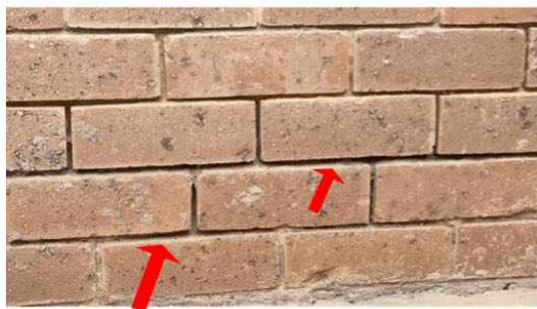
### Defects 3.04

Building:	Main Building
Location:	All External Areas > All Areas
Finding:	Brickwork - Deteriorated mortar
Information:	Mortar, or 'bedding', is the material which fills joints and intersections between bricks in masonry walls and structures.

Upon inspection of the external walls of the home, sections of mortar in the brickwork were identified as having deteriorated, which is generally expected for a property of this age and condition.

Mortar may deteriorate as a result of age of building materials, minor movement of bricks, or frequent exposure to weathering. Mortar should be replaced to ensure that bricks remain in their intended location and to prevent gaps, which would allow water or moisture ingress and secondary damage as a result.

Mortar deterioration can be addressed by a bricklayer where areas of deterioration are localised and easily accessible. Alternatively, appointment of a registered builder is advised, to repoint large areas of decaying mortar. Where secondary structural defects have become evident, consultation with a structural engineer may be required.

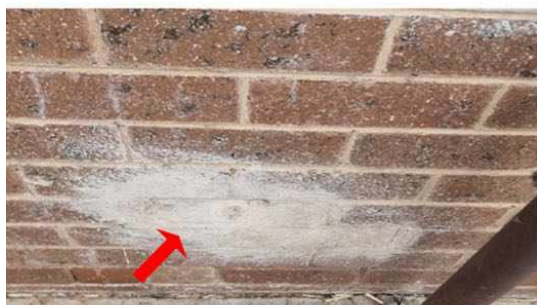
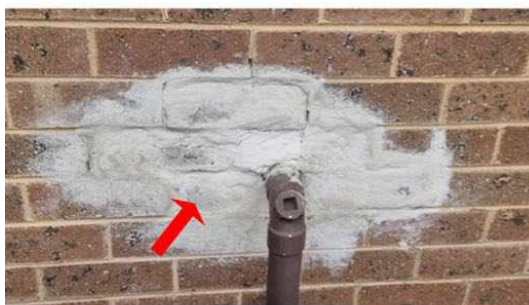
### Defects 3.05

Building:	Main Building
Location:	All External Areas > All Areas
Finding:	Brickwork - Crack Repairs Evident
Information:	At the time of the inspection, there were several crack repairs evident to the external wall brickwork and seems to be done to a substandard level.

Noticeable cracks are a common occurrence in external brickwork and are a likely result of age expected building movement, general expansion, and/or contraction of building materials in different weather conditions.

As crack repairs are evident, always monitor this area and contact a building inspector should cracks re-develop.

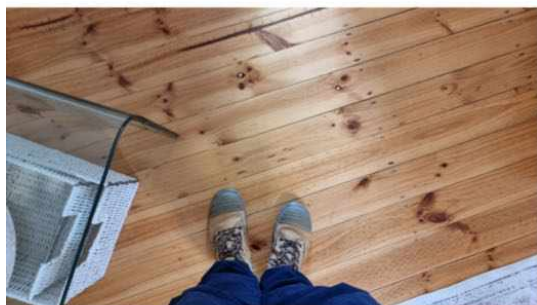
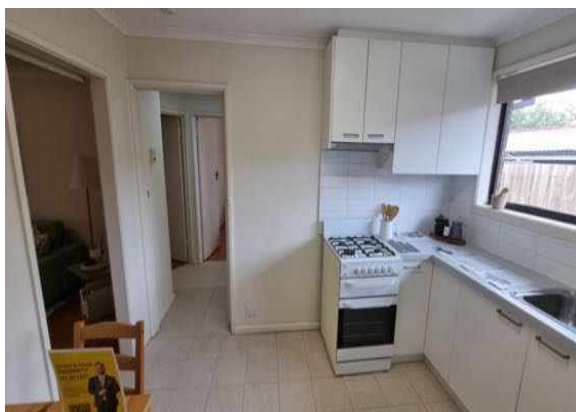
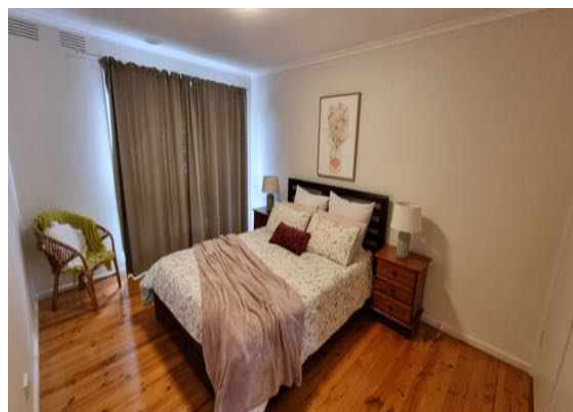
### Defects 3.06

Building:	Main Building
Location:	All Internal Areas > All Areas
Finding:	Floors - bouncy
Information:	The internal flooring throughout the home was identified as being bouncy at the time of inspection.

Bouncy floors generally indicate that the floorboards or the subfloor structures are coming loose from the joists that they are installed on. Bouncy flooring may also be the result of gaps between flooring and stumps or joist structures, which require packing.

Note, some areas of the home indicated more 'bounce' than others.

The client is advised to seek quotations for required repairs from a Registered Builder specialising in re-stumping. The potential resolution may range from packing gaps in subfloor structures through to replacement of subfloors stumps and refixing of flooring.

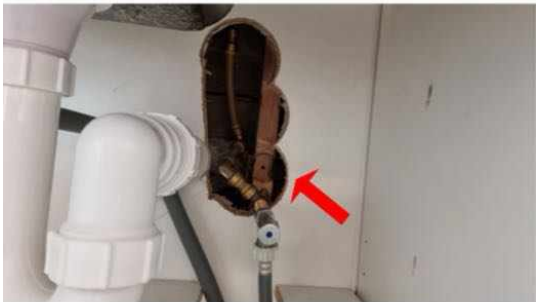
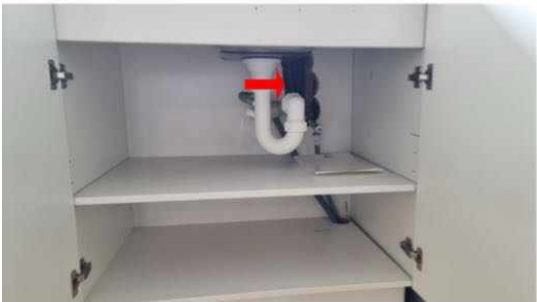
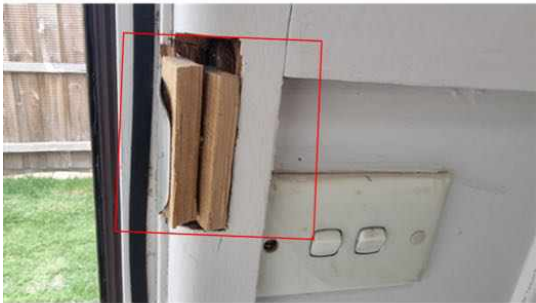
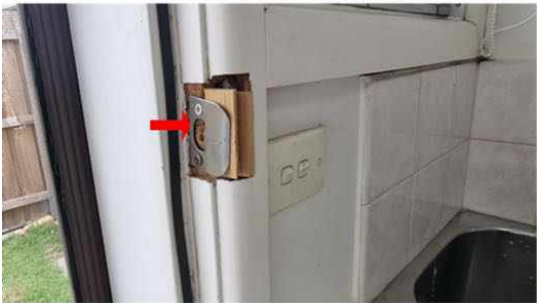
### Defects 3.07

Building:	Main Building
Location:	All Internal Areas > All Areas
Finding:	Incomplete or substandard works
Information:	The works to this area appear to be incomplete or have been completed to a substandard level.

It is highly recommended that the relevant trades such as a qualified carpenter or general handy person be appointed to complete these works and ensure the safety of the area and the longevity of all associated building elements.

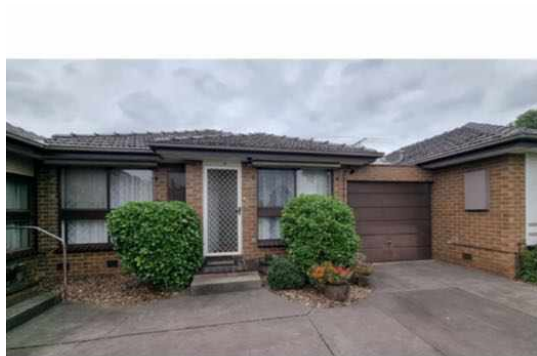
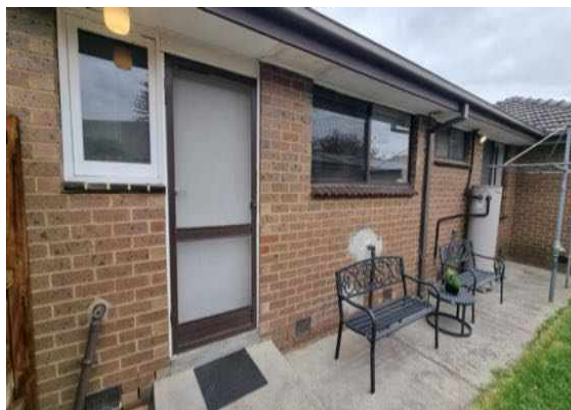
**Defects 3.08**

Building: Main Building  
Location: All External Areas > All Areas  
Finding: Gaps around Window  
Information: At the time of the inspection, we observed gaps around the window frames.

The window is no longer weather-tight, rain penetration and subsequent water damage is therefore likely to ensue. Insulation of the area against external weather conditions will also be compromised.

It is recommended that the above be rectified by a general handyman or sealant expert to prevent any further damage and to restore the window to a fully functional level.

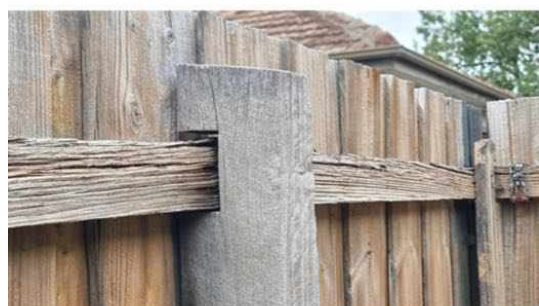
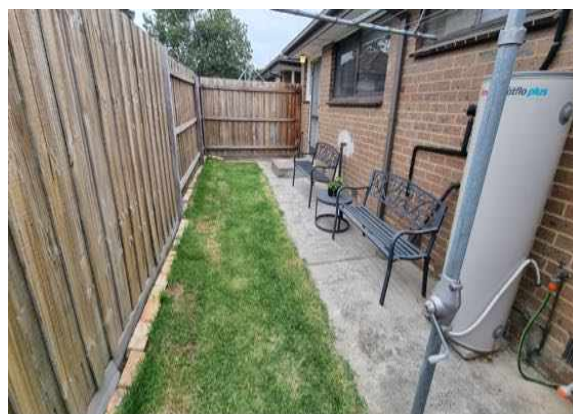
### Defects 3.10

Building: Main Building  
 Location: All External Areas > All Areas  
 Finding: Wood rot - fence  
 Information: This building element shows evidence of wood rot. Wood rot, also known as Fungal Decay, occurs when timbers and other cellulose building materials are exposed to damp conditions on an ongoing basis. This could be the result of exposure to weathering over a prolonged period of time, or the attraction of excessive moisture from other abutting building materials. Contributing factors also include poor air ventilation in the area.

Early intervention and regular maintenance, particularly of exterior timbers, will prolong the useful life of these building elements. Prior to any works being performed, the cause of the moisture that has created the visible wood rot should be identified and addressed in a suitable manner. Replacement of affected timbers may then be a necessary step in protecting surrounding building elements from such deterioration.

A qualified plumber may be appointed to assess the cause of excessive moisture and to provide advice on any remedial works as required. A qualified carpenter or registered builder may also be required to replace affected building materials.

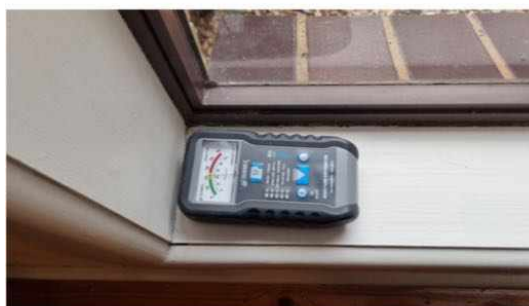
### Defects 3.11

Building: Main Building  
 Location: All Internal Areas > All Areas  
 Finding: Moisture to internal window sill  
 Information: Upon inspection of the windows throughout the home, an elevated level of moisture was detected using a moisture meter to the internal window sill.

Where window flashing is defective, the window is no longer weather-tight, rain penetration and subsequent water damage is therefore likely to ensue. Insulation of the area against external weather conditions will also be compromised.

It is recommended that the suspected defective window sill flashing be replaced by a general handyman or sealant expert to prevent any further damage and to restore the window to a fully functional level as per the window manufacturers specifications.

It is important that the window sill flashing is rectified as soon as possible.

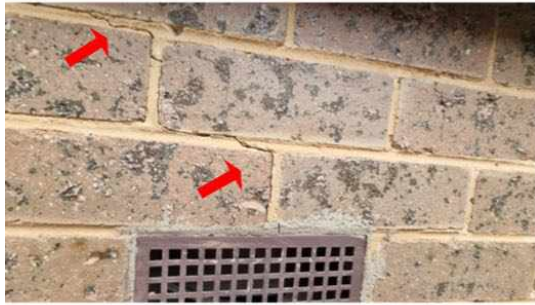
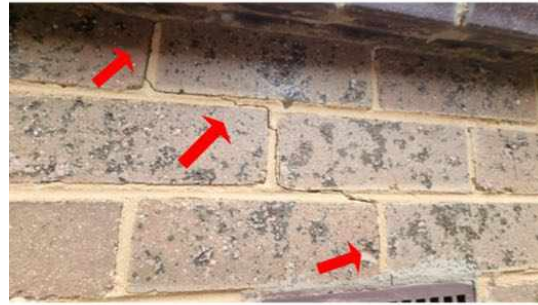
### Defects 3.12

Building:	Main Building
Location:	All External Areas > All Areas
Finding:	Brickwork - Cracking
Information:	At the time of the inspection, minor cracking was identified to the brick wall of the home.

Cracks of this type are likely to have been caused by minor expected movement of building elements, but may also have a structural cause that is more significant. There were also cracks appearing directly above the door where it is suspected that the brick lintel could have moved due to a number of reasons, one of which is movement in the foundations in this section due to soil moisture conditions. We also note, that the external part of the door and wall is not protected from the elements, and the rain over long period of time is suspected to have an affect on the performance of the wall.

A crack of this size may be repaired by extensive filling.

A qualified bricklayer should be contacted immediately to estimate and perform repair and restoration works. Consultation with a structural engineer may be required where structural instability is found to be the underlying cause of the cracking.

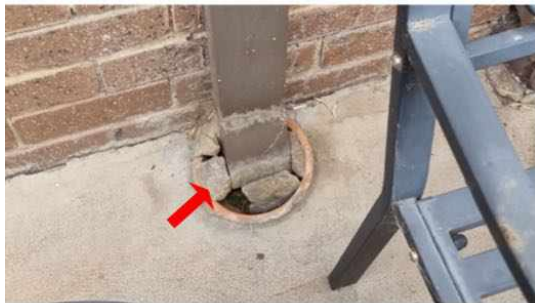
### Defects 3.13

Building:	Main Building
Location:	All External Areas > All Areas
Finding:	Downpipe - Not plumbed properly
Information:	It was observed at the time of the inspection that the downpipe has not been properly connected and seems to be blocked.

It is highly recommended that a qualified plumber be appointed to rectify downpipe installation accordingly. These works will ensure that the area remains dry and free of any secondary defects.

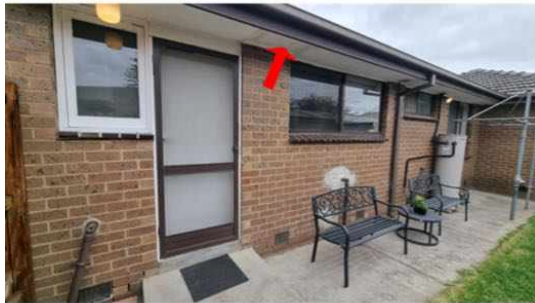
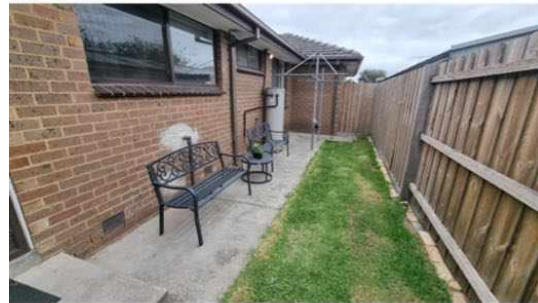
### Defects 3.14

Building:	Main Building
Location:	All External Areas > All Areas
Finding:	Eave lining - Water damaged
Information:	At the time of the inspection, water damage to the eaves lining was observed.

The excessive moisture present is generally an indication that the roof plumbing in this section has failed.

Where water damage is evident to the eave lining, the primary requirement is to identify and rectify the source of the leak.

A roofing plumber should be appointed as soon as possible to identify the leak and perform rectification works as necessary, ensuring the water damage is restricted.

Once the leak is repaired, consultation with relevant tradespeople, including carpenters and painters, is advised. Rectification works may include replacement of eaves lining or minor repainting, depending on the extent of the damage.
