# Building and Timber Pest Inspection Report

Inspection Date: Tue, 10 Feb 2026

Property Address: 39A Nelson Rd, Earlwood NSW 2206,  
Australia

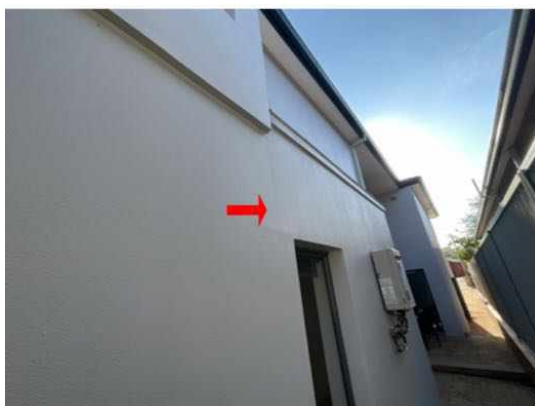
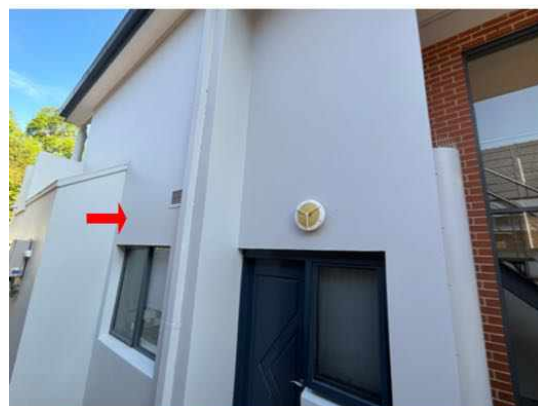
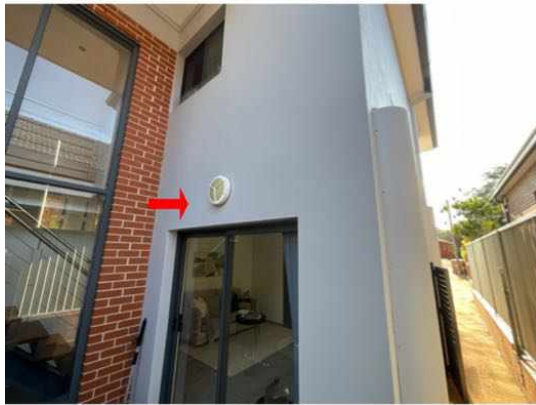
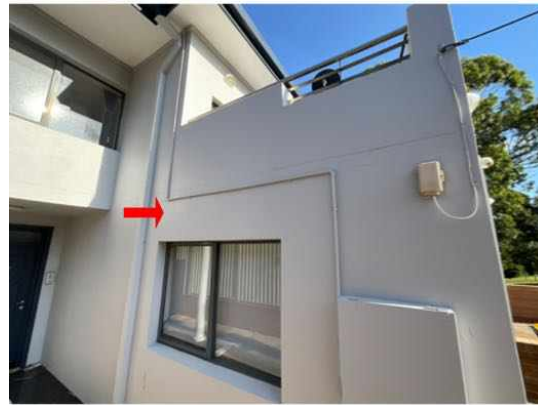
#### Finding 3.01

Building: Main Building  
Location: Exterior walls  
Finding: Weep holes - missing (Bricklayer)  
Information: Weepholes are the gaps left between some bricks in external masonry walls.

I highly recommend that a bricklayer is appointed to see what necessary works are required to install weep holes and to replace damaged render.

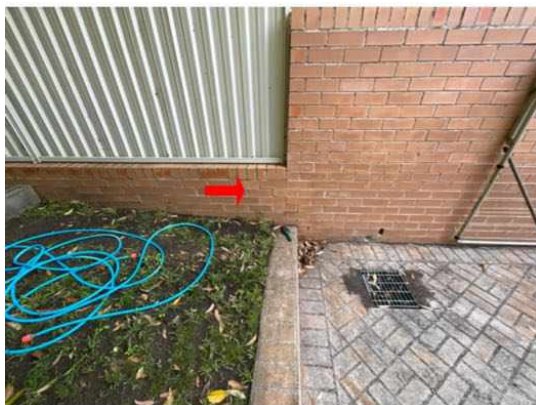
### Finding 3.02

Building:	Yard
Location:	Exterior walls
Finding:	Brickwork - Cracking noticeable
Information:	There were several cracks and or crack repairs evident to external brickwork.

Noticeable cracks are a common occurrence in external brickwork and are a likely result of age expected building movement, general expansion, and/or contraction of building materials in different weather conditions.

It is highly advised that a qualified bricklayer be appointed to provide necessary works to cracked brickwork to prevent any further damage.

Always monitor these cracks and contact a building inspector should cracks widen, lengthen, or become more numerous.

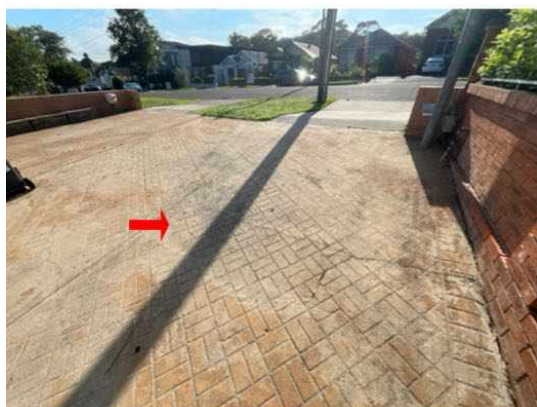
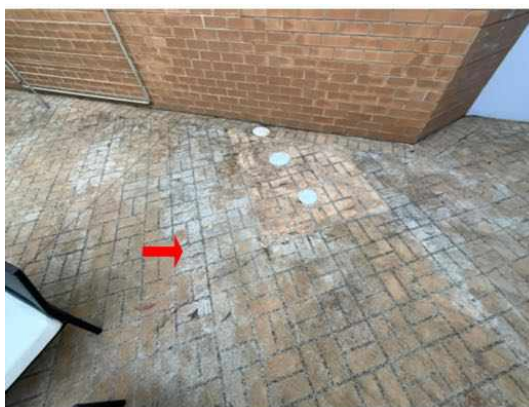
### Finding 3.03

Building:	Yard
Location:	Pathway
Finding:	Cracking - External Concrete Paving Damage Category 1 - Fine (less than 2mm)
Information:	Fine cracks were identified in external concrete paving. Although fine cracks are quite noticeable, they are often only considered to be an appearance defect, and usually do

not indicate any structural damage. To be considered a Category 1 or fine crack, the crack is found to be less than 2mm in width.

Generally the cause of a hairline crack in existing concrete paving such as driveways and pathways is indicative of the expansion and contraction of the concrete. Such causes are generally due to environmental factors, such as moisture levels, weather conditions, root systems of nearby trees or the soil types on which they are laid.

Fine cracks may also be due to poor original installation of the concrete. Factors such as poor compaction of the sub surface and/or inadequate reinforcing of the slab may create cracking and other secondary defects.

Monitoring of all cracking should be conducted frequently. Always contact a building inspector should cracks widen, lengthen, or become more numerous.

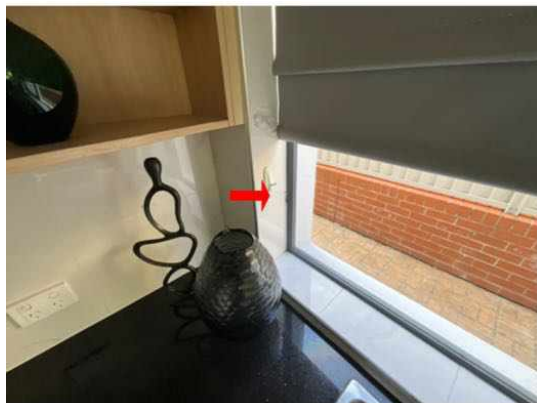
### Finding 3.04

Building:	Main Building
Location:	Kitchen
Finding:	Tile - Cracked or damaged
Information:	Cracking was evident to the tiling in this area at the time of inspection.

I recommend appointing a tiling contractor to see what necessary works are required to replace any damaged tiles.

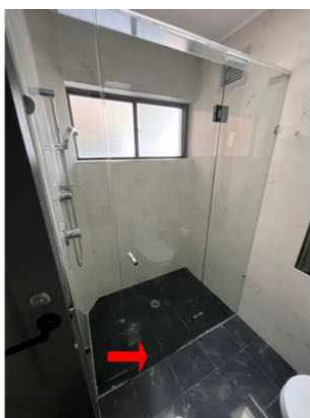
### Finding 3.05

Building:	Main Building
Location:	Ensuite
Finding:	Glass Door - Binding/jamming
Information:	Binding and/or jamming of this door is evident during standard operation. This defect inhibits the functionality of the affected door as well as creating potential for secondary defects to associated building elements, such as damage to the floor covering.

For minor causes, a qualified carpenter or general handyperson should be appointed to perform minor rectification works at client discretion.

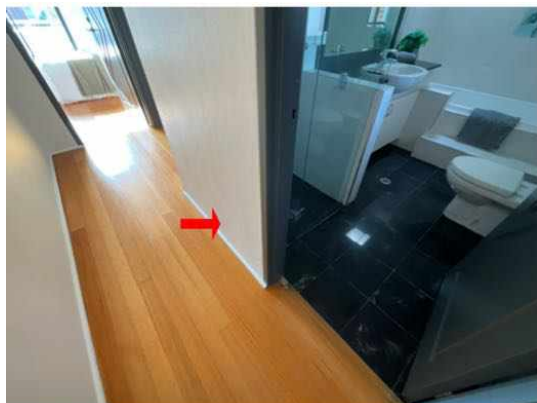
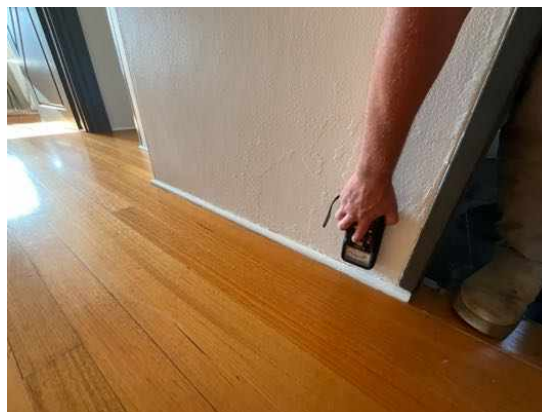
### Finding 3.06

Building:	Main Building
Location:	Bathroom
Finding:	Painted surface - Bubbling
Information:	Sections of paint in this area was found to have bubbled and deteriorated. Paint bubbling is generally an indication of excessive moisture in the area past or present.

Although there was no moisture detected in the wall due to this being the wall that backs onto the shower I would recommend monitoring this area as the waterproofing membrane may have failed in this area.

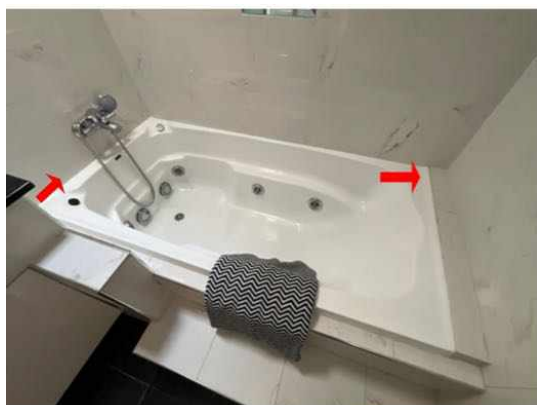
### Finding 3.07

Building:	Main Building
Location:	Bathroom
Finding:	Sealant and grouting - Missing or damaged
Information:	It was noted on inspection that sealant or grout is degraded to the tiled areas.

Different materials and floor areas move at different rates, generally causing cracking to grout or sealant at this point. A flexible sealant is required to allow for expected expansion and contraction, while keeping the joint water tight and protective of all associated building materials.

Flexible and mould resistant materials should be applied to affected areas to prevent any subsequent water damage that is likely to occur. Regular maintenance and replacement of damage or missing or damaged sealant and grout is highly recommended to the wet areas, as this is a regular wear and tear defect. Sealant and grouting in areas that come into regular contact with water should be maintained for the long term care of your property.

A sealant specialist or tiling contractor should be appointed to complete these works.

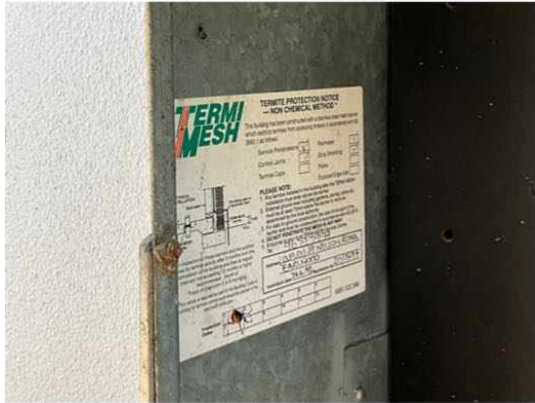
Building: Main Building  
 Location: All Areas  
 Finding: Evidence of a previous termite management system was identified  
 Information: There are a number of factors which indicate the presence of a previously installed or applied termite barrier. The most common are a durable notice (to the inside of your meter box) observable physical barriers installed to building perimeter and in ground reticulation systems.

Where a Termite Management System has been identified you should refer to the type

of barrier date of installation warranty conditions and any documentation provided by a builder or past owner. Consult the company who installed the barrier to confirm whether the system is still under warranty.
