Building and Timber Pest Inspection Report

Inspection Date: Wed, 28 Jan 2026

Property Address: 65 Gipps St, Kiama NSW 2533, Australia

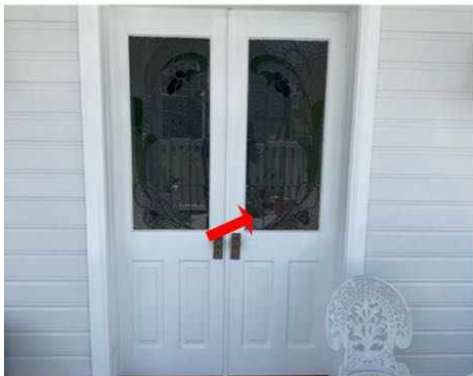
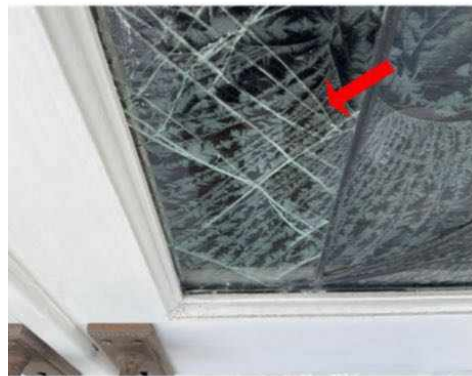
Building:	Building 1
Location:	Exterior front doors
Finding:	Windows - Cracked
Information:	Cracks were identified in the windows in these areas. Cracking in windows is generally the result of impact damage, and is likely to develop further when left unmanaged.

The likelihood of this windowpane further cracking and shattering is increased exponentially, providing a safety hazard in the area. The cracked window also impairs the weather tightness of the building, creating potential for minor water leaks.

A qualified glazier is required to repair the windows. Depending on the extent of the cracking, replacement of the window may be required. Please be advised that any persons coming into contact with the cracked window should do so with due caution to avoid any personal injury that may ensue.

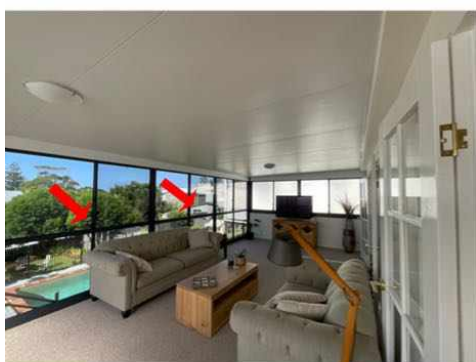
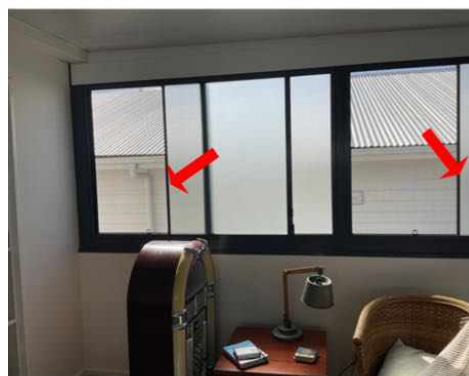
Finding 1.02

Building:	Building 1
Location:	Pictured upstairs windows
Finding:	Window opening restrictors missing.
Information:	The Building Code of Australia rules require all openable windows (where the internal floor is more than 2m above the ground outside) in residential rooms to be fitted with a suitable screen or restrictor. Windows located 1.7m above the floor level do not require protection.

Window restrictors are required where people who are vulnerable to the risk of falling have access to windows. This means all windows above ground level which do not have another fall prevention safety measure in place, such as a balcony or balustrade should have a restrictor.

These need to be added urgently for the safety of all persons.

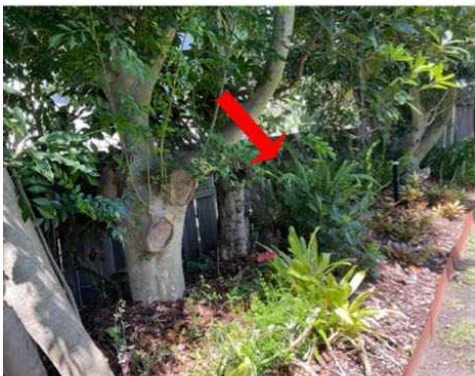
Building:	Building 1
Location:	Pictured fences
Finding:	Fences damaged - loose & leaning
Information:	Evidence of damage to the pictured fences was identified at the time of the inspection. The likely cause of both fences leaning and the front fence loose is not enough concrete used in the post footings. If left unmanaged this fence may deteriorate further.

It is suggest a fencing contractor be engaged for rectification when convenient.

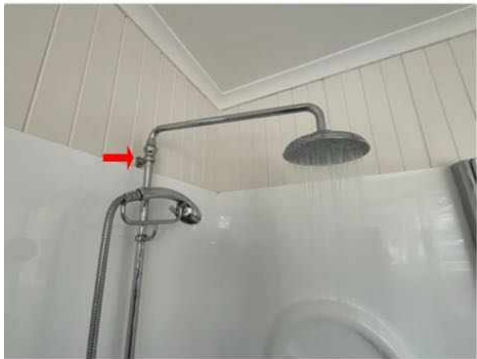
Finding 3.03

Building: Building 1
 Location: Bathroom
 Finding: Water leak into shower - Active
 Information: A water leak was found in the shower rail. Regardless of the location, even minor leaks that are left unmanaged can lead to damage of associated building elements and result in the need for replacement of building materials.

A licensed plumber can repair the leak in the near future.

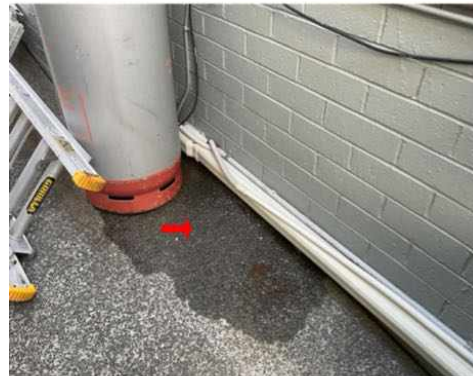
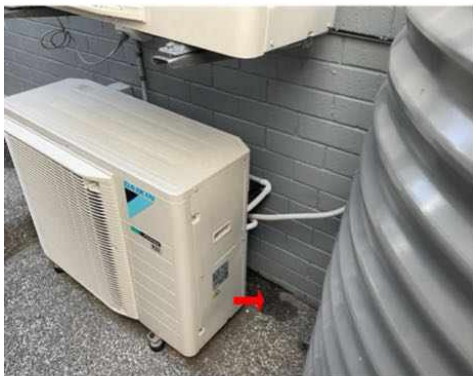
Finding 3.04

Building:	Building 1
Location:	Walls
Finding:	Site drainage - Inadequate
Information:	The site drainage in this area was found to be inadequate at the time of inspection, creating potential for subsequent water damage to associated building elements.

These air conditioner overflows run against the house walls.

It is important that water does not lie against the base of walls; surrounding paths and ground levels should be sloped to drain water away from walls. Downpipes should not discharge stormwater onto lower walls or plinths. Stormwater should be carried away by large, regularly cleaned drains. Ground levels may need to be lowered to expose a buried DPC.

Where site drainage is inadequate, installation of an Agricultural (Aggie) Drain may be required. A qualified plumber should be appointed to further inspect the property and perform any remedial works as necessary. Secondary defects are likely to occur if left unmanaged.

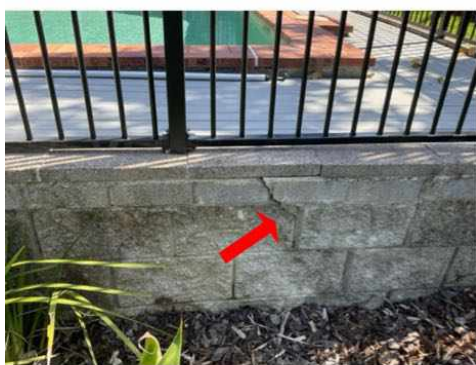
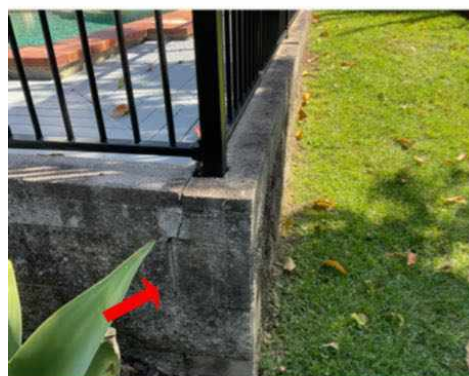
Finding 3.05

Building:	Building 1
Location:	Exterior rear pool wall

Finding:	Step cracking to brickwork (minor)
Information:	<p>Step cracking was identified to the brickwork in this area at the time of inspection. Step cracking, which is similar to other forms of cracking, has a variety of possible causes. However, the most common is the subsidence of adjacent footings.</p> <p>Step cracking is a relatively common defect, and is most likely to occur adjacent to windows, doors and other openings. Mortar failure in the gaps between affected bricks indicates the stresses and tensions affecting the wall.</p> <p>This minor step cracking can be used as a warning sign to address factors causing stress to the wall, which can include the effect of surrounding trees, water leaks, soil erosion, or even the presence of reactive soils in the surrounding area.</p>

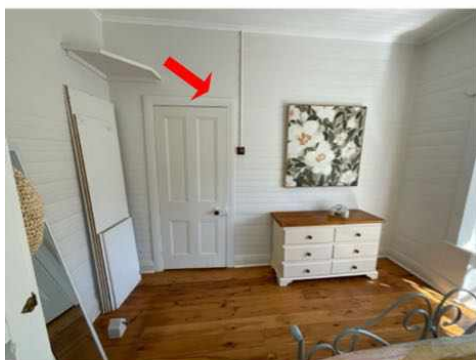
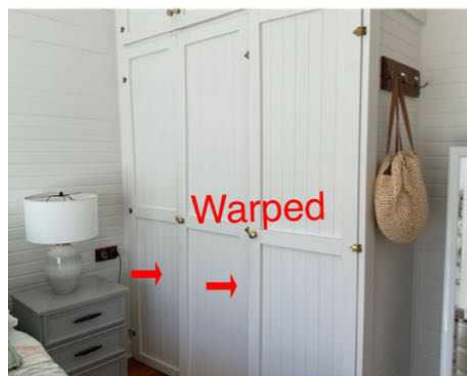
Finding 3.06

Building:	Building 1
Location:	Front Bedroom
Finding:	Doors - Binding & warped
Information:	<p>Binding and/or jamming of this door and warping of some cupboard doors is evident during standard operation. This defect inhibits the functionality of the affected door as well as creating potential for secondary defects to associated building elements, such as damage to the floor covering.</p>

A door that binds to flooring or to the associated door frame may have several causes, ranging from minor defects, such as poor installation of the door or deteriorated hinges, through to major structural issues, such as damage to subfloor areas. For minor causes like this, a qualified carpenter or general handyperson should be appointed to perform minor rectification works at client discretion.

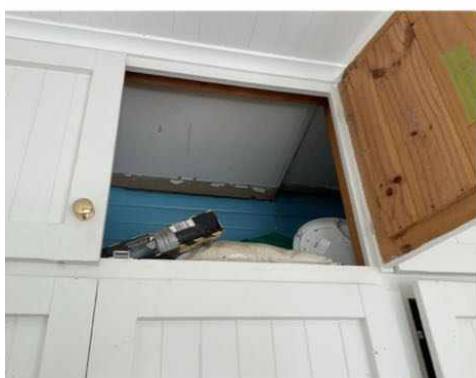
Finding 3.07

Building:	Building 1
Location:	Front bedroom
Finding:	Ceiling - Sagging inside cupboard
Information:	Sections of the ceiling were found to be sagging at the time of inspection. Sagging to the fixed ceiling structure generally indicates that the building materials have swollen, due to contact with water, or that fixings (e.g. nails or glue) have become loose and require reattachment.

Where minor sagging is evident, comparatively minor works, such as re-gluing of ceiling sheets, may be required. Such works may be performed by relevant tradespeople, such as plasterers and painters.

The appropriate action should be taken by the client as soon as possible to refix this ceiling to ensure that any potential further damage is limited.

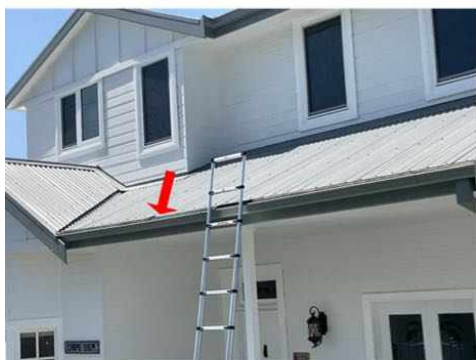
Finding 3.10

Building:	Building 1
Location:	Roof exterior Front
Finding:	Gutter - Insufficient fall
Information:	There is an insufficient fall in the verandah gutter, which means that the angle of this gutter is inadequate for rainwater to drain away. This may result in pooling of water in the area. This gutter should be checked in a high rainfall event for water pooling. Adjustment by a roofing contractor is required as soon as possible to prevent any damage to this area.

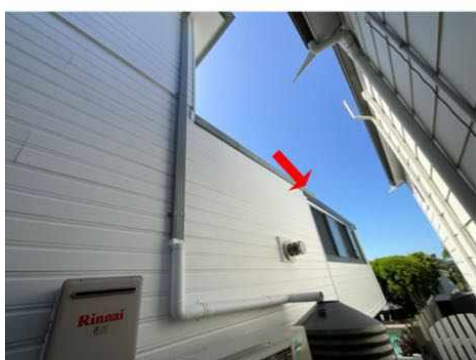
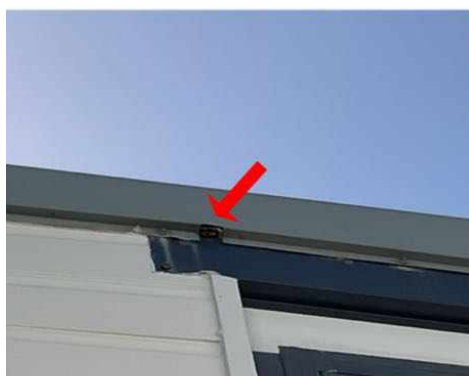
Finding 3.11

Building:	Building 1
Location:	Exterior walls
Finding:	Sealant (external) - missing
Information:	It was noted on inspection that areas of external sealant was missing to small areas of the external walls.

Flexible sealants should be applied to these affected areas to prevent any subsequent water damage that is likely to occur.

A sealant specialist or skilled handy person should be appointed to complete these works as soon as possible

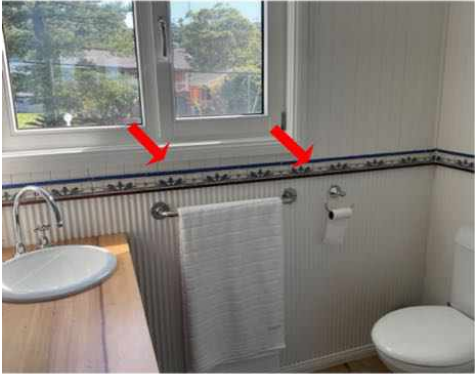
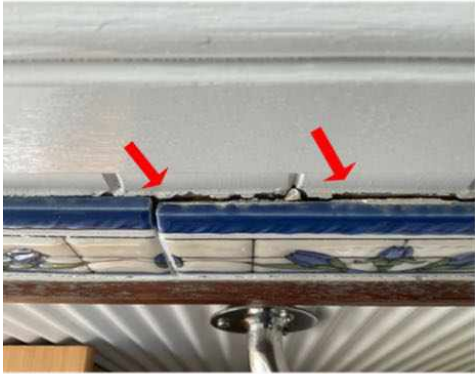
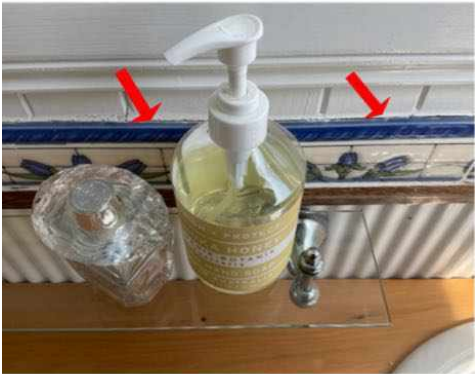
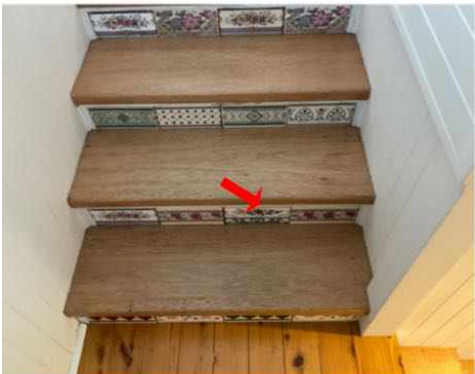
Finding 3.12

Building:	Building 1
Location:	Bathroom, stairs
Finding:	Tiles loose or cracked
Information:	Cracked and loose tiles was evident in these pictured areas at the time of inspection. It is suspected that this cracking has occurred as a result of minor settlement or impact

damage. Cracked tiles throughout the household detract from the overall appearance of the affected areas. In wet areas of kitchens and bathrooms, it can lead to water damage of adjoining walls and floors.

Replacement of cracked tiles and reglueing loose tiles is recommended as soon as possible. A tiling contractor may be appointed to perform these works. Where cracks become more numerous, contact a licensed building inspector for further investigation.

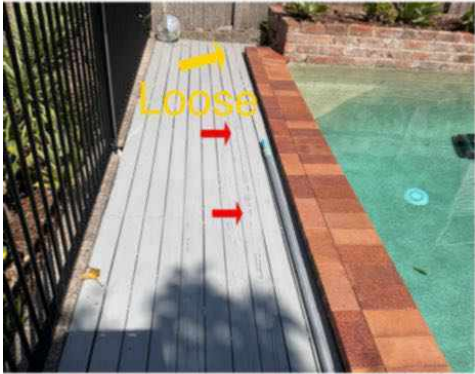
Finding 3.13

Building: Building 1
Location: Pictured areas

Finding: Wood rot
Information: The reardecking and kitchen window shows evidence of wood rot. Wood rot, also known as Fungal Decay, occurs when timbers and other cellulose building materials are exposed to damp conditions on an ongoing basis. This could be the result of exposure to weathering over a prolonged period of time, or the attraction of excessive moisture from other abutting building materials.

Early intervention and regular maintenance, particularly of exterior timbers, will prolong the useful life of these building elements. Prior to any works being performed, the cause of the moisture that has created the visible wood rot should be identified and addressed in a suitable manner. Replacement of affected timbers may then be a necessary step in protecting surrounding building elements from such deterioration.

A qualified carpenter or registered builder may also be required to replace affected building materials.

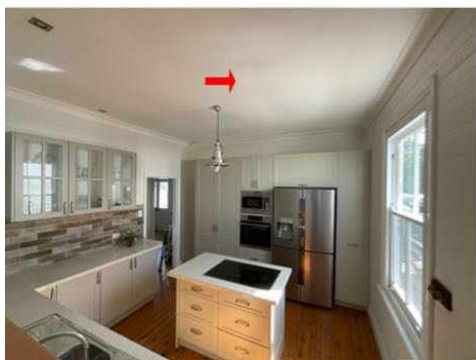
Finding 3.14

Building:	Building 1
Location:	Kitchen
Finding:	Rangehood or exhaust missing
Information:	No rangehood was installed in the kitchen. This may lead to a build-up of grease and grime in the surrounding area. It is therefore preferable that a range hood be installed to vent into the external environment. A licensed plumber should be appointed as soon as possible to provide further consultation on the scope of these works and to provide quotations for any necessary works.

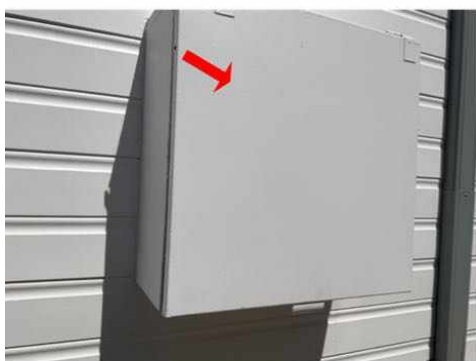
Building:	Building 1
Location:	Meter Box
Finding:	Termite Management System - no evidence of a chemical installation
Information:	The application of a post-construction chemical termite barrier is highly recommended for all properties. Such barriers are highly effective in preventing termite attack on any timber building elements throughout the property.

A durable notice should be placed in the switchboard unit to indicate current termite barriers. At the time of inspection, no durable notice was evident and it appeared as though no chemical termite management system has been installed, with no evidence to suggest preventative works taking place since the property was built.

The client may consider gaining further advice from a pest controller as to the costs and procedures involved with a 'chemical' application. It is recommended that obtaining such advice be a short-term priority.

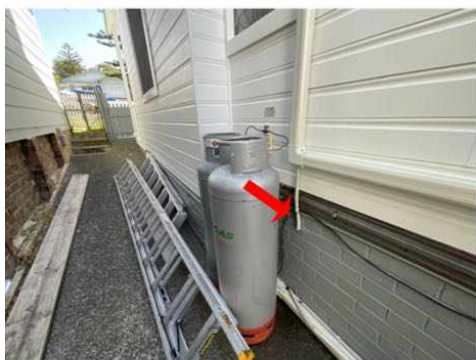
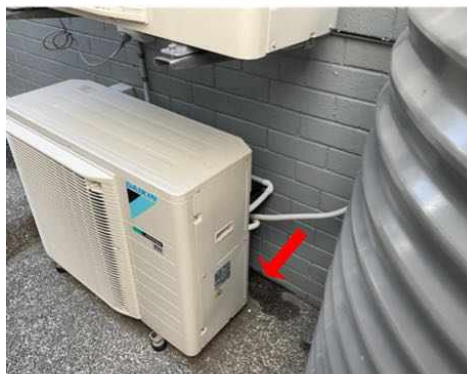
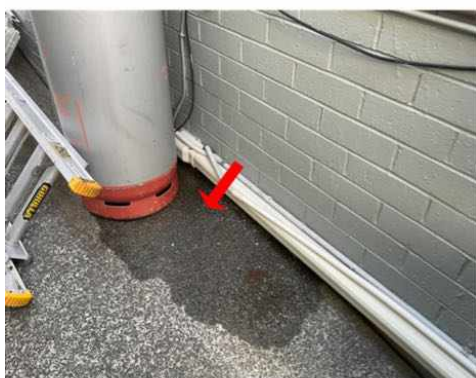
Finding 6.02

Building:	Building 1
Location:	External right wall areas
Finding:	Overflows - Not plumbed for drainage
Information:	The pictured overflow pipes are not plumbed or connected to suitable drainage, which has resulted in the surrounding area becoming excessively damp.

These damp conditions can lead to secondary defects such as rot, rust or corrosion of associated building elements, the formation of fungal decay, or even the creation of potential slip hazards. When coupled with poor site drainage, pooling of water may also attract termite activity to this area. It is highly recommended that a qualified plumber be appointed to install adequate drainage to these areas. These works will ensure that the area remains dry and free of any secondary defects.

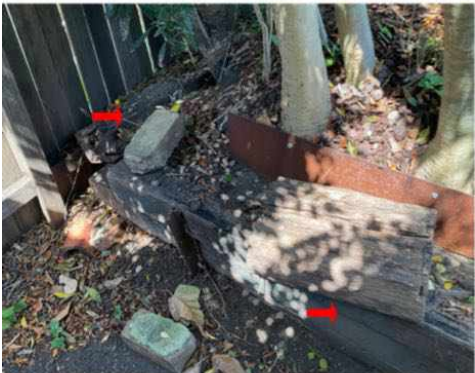
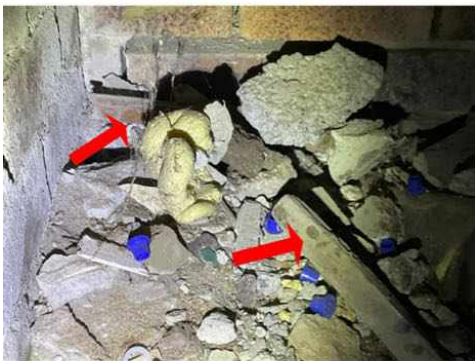
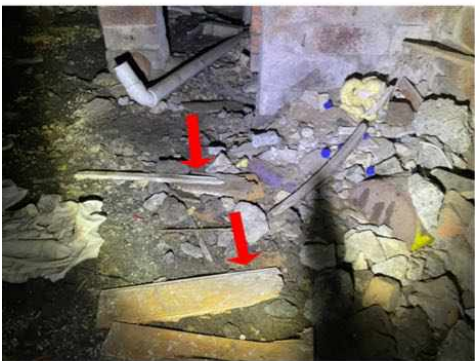
Finding 6.03

Building:	Building 1
Location:	Rear yard and subfloor
Finding:	Timber in contact with the ground
Information:	Any timbers in direct ground contact provide opportunity for concealed termite entry and are likely to be subject to premature rot and decay as the soil retains moisture or damp conditions against the timbers.

Removal of all waste timber that is in direct contact with ground is highly advised. This timber is promoting mould and wood rot and is very attractive to termites.

Frequent pest inspections are advised to readily identify any termite activity in these areas.

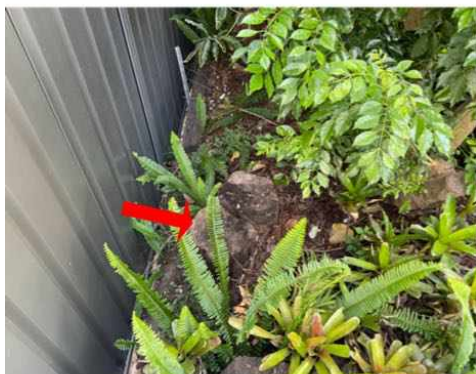
Finding 6.04

Building: Building 1
Location: Pictured yard area
Finding: Tree stumps - left in ground
Information: Tree stumps left in ground provide opportunity for termite attack as they are likely to be subject to rot and decay providing an attractive food source. Treatment and/or Removal of the stump is highly recommended. A pest controller and tree removalist should be engaged to perform such works.

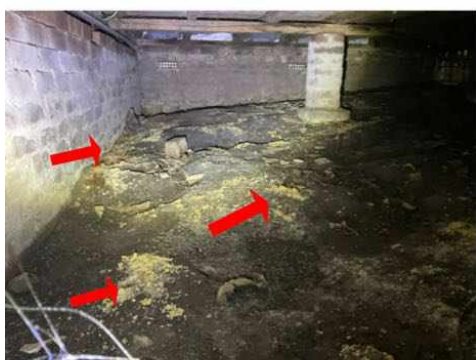
Finding 6.05

Building: Building 1
Location: Subfloor
Finding: Mould - Present in subfloor
Information: Where evidence of mould growth was noted, there may be environmental, biological or health issues associated with the report. A specialist inspection by a suitably qualified environmental health inspector is warranted, where mould is extensive or where any queries regarding air quality spores or other related issues apply.

Subfloor mould is generally caused by moisture ingress, lack of external drainage, lack of adequate ventilation and subfloor debris present. These issues need rectification

Generally, the client is advised to ensure that the general environment is free of moisture and humidity to aid in the prevention of mould formation and development.

to stop mould development. Any mould found during the inspection should be cleaned immediately by a cleaning contractor or the homeowner as applicable.

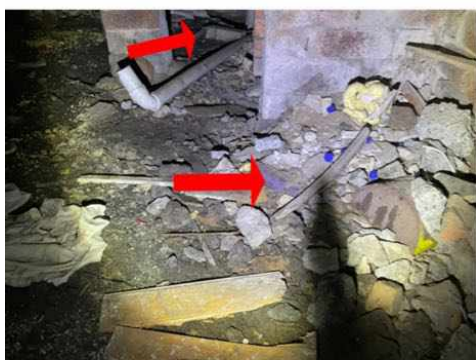
Building:	Building 1
Location:	Subfloor
Finding:	Subfloor - Debris
Information:	An array of debris was found in the subfloor area at the time of inspection. Debris in this area restricts subfloor ventilation and creates potential for concealed pest entry. Stored timbers and other materials may also make the area susceptible to termite activity and wood rot.

A clear and empty subfloor will be better ventilated and easier to maintain in a dry condition. The removal of any timber debris is vital in minimising the risk of termite or wood borer activity.

Debris in the subfloor should be removed as soon as possible. Depending on the location and amount of debris and stored items, the homeowner may elect to undertake this task. Alternatively there are a large number of rubbish removal subcontractors that could undertake these works.
