Building and Timber Pest Inspection Report

Inspection Date: Mon, 16 Feb 2026

Property Address: 7 Birdwood St, Corowa NSW 2646,
Australia

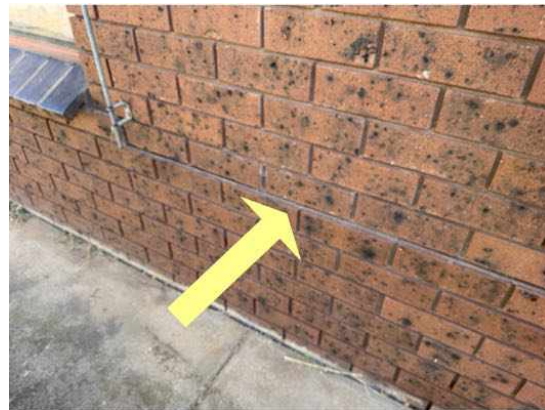
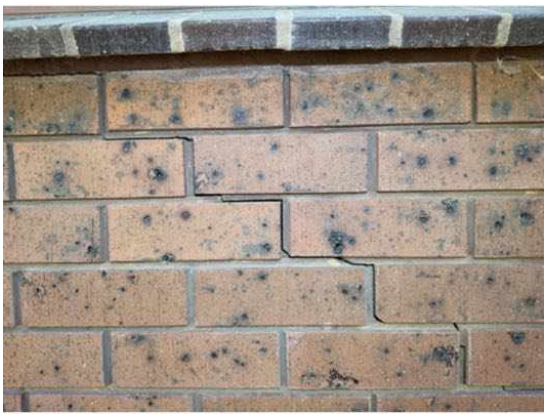
Finding 3.01

Building: Main Building
Location: All External Areas
Finding: Brickwork - Step cracking, Movement
Information: Step cracking & evidence of movement was identified to areas of the brickwork at the time of inspection. Step cracking, has a variety of possible causes. However, the most common is movement of adjacent footings.

The client should closely monitor the cracking & movement. Should the step cracking, lengthen, widen or become more numerous, the client should engage a structural engineer promptly, to provide further advice.

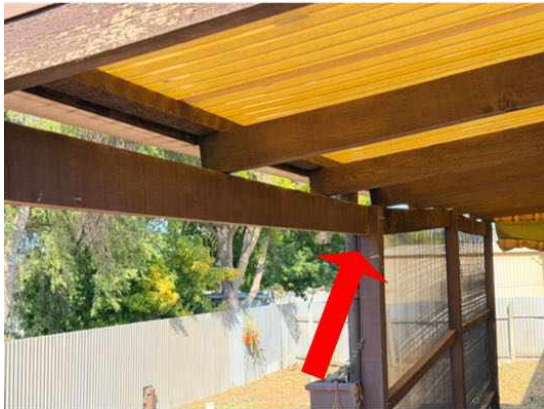
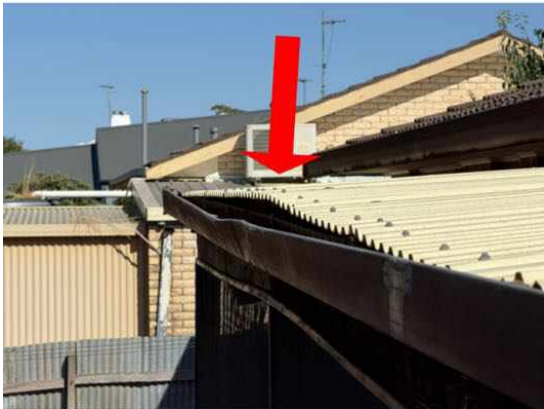
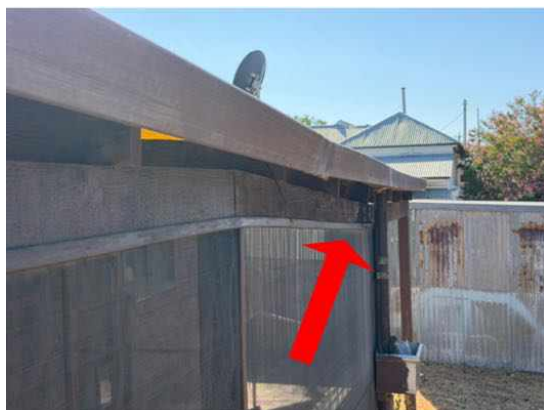
Finding 3.02

Building: Main Building
 Location: Patio Framing
 Finding: Sagging Patio Framing
 Information: It appears that a section of the patio framing is sagging and uneven. It appears this has caused the roof sheets to be higher than the guttering, potentially allowing stormwater runoff and bypass the gutters. Recommend engaging a registered builder in the short term to provide remedial works where necessary, to ensure the structure is even & secure.

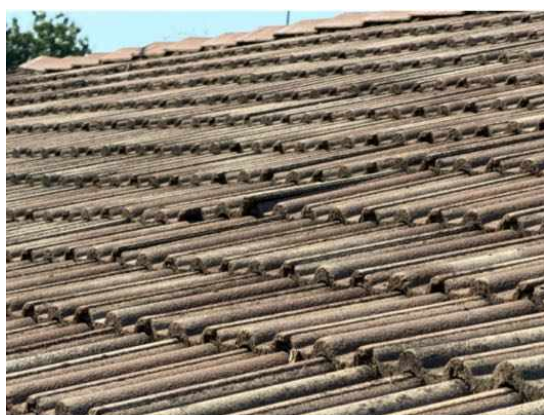
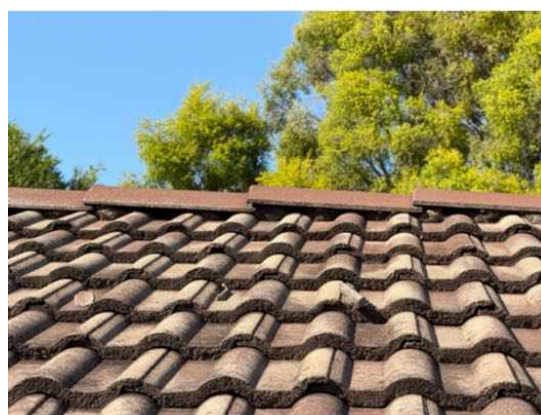
Finding 3.03

Building:	Main Building
Location:	Roof Exterior
Finding:	Roof Exterior - Cracking
Information:	Areas of cracking and missing tile pointing were identified to the roof exterior. Some lifted roof tiles were also noted. While weathering of the roof exterior is consistent with the age of the property, maintenance works are advised.

Where left unmanaged, deteriorating and damaged roof tiles are likely to lead to secondary defects, including water leaks.

Recommend consulting with a licensed roofing contractor in the short term, to provide further advice on maintenance works needed.

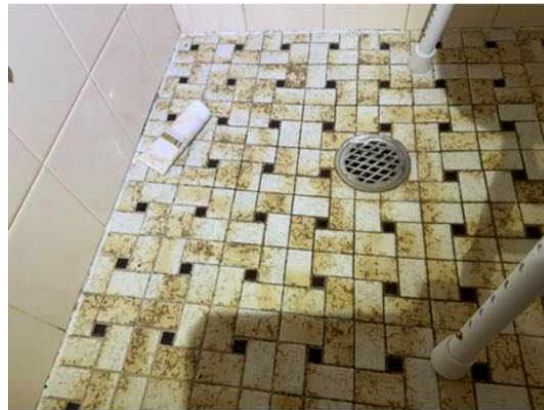
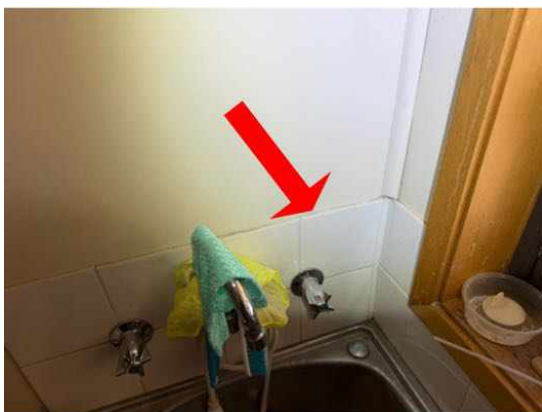
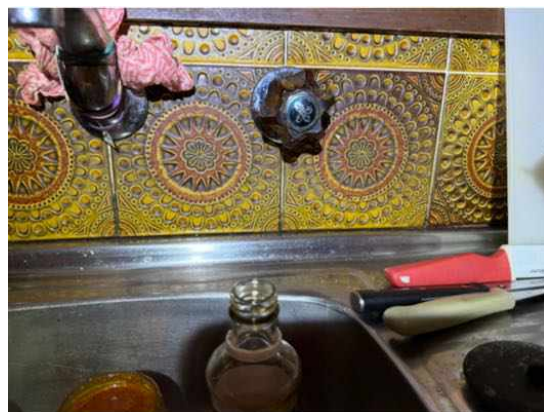
Finding 3.04

Building:	Main Building
Location:	Tiled Areas
Finding:	Sealant / grouting - deteriorated or missing & Cracked / Loose Tiles
Information:	It appears that the sealant and grout has deteriorated in some tiled areas, a common defect in buildings of a similar age. Areas of cracked & loose tiles were also noted, which can allow for moisture ingress behind the tiles, if neglected.

Sealant and grouting in areas that come into regular contact with water should be maintained for the long term care of your property.

Recommend engaging a licensed tiling contractor in the short term, to provide maintenance works where necessary.

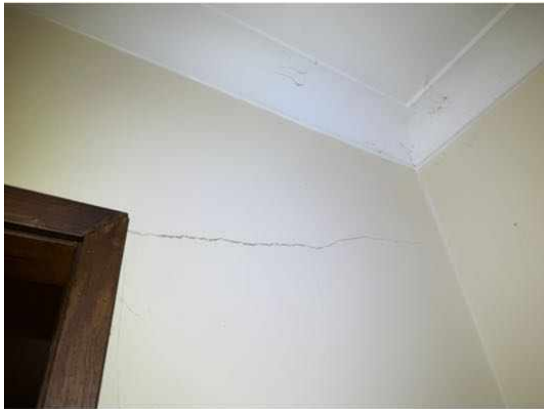
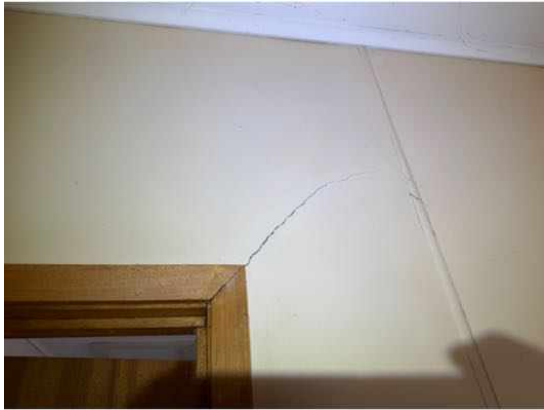
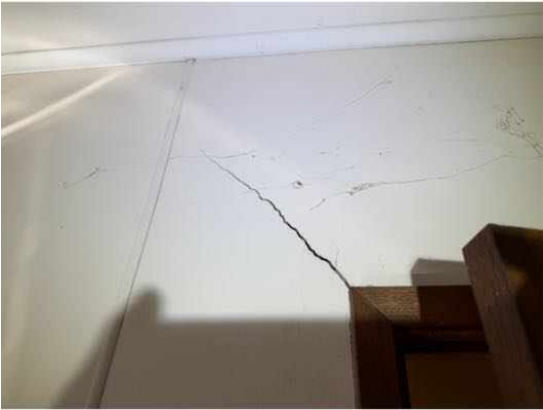
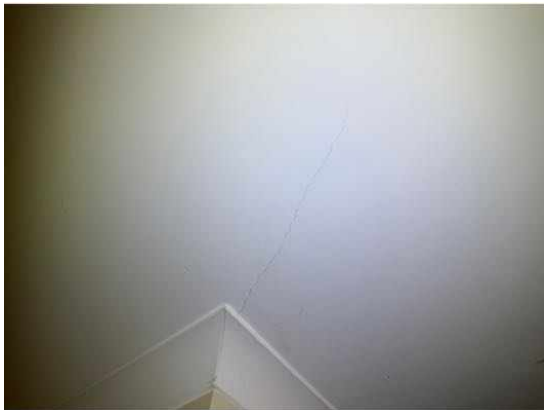
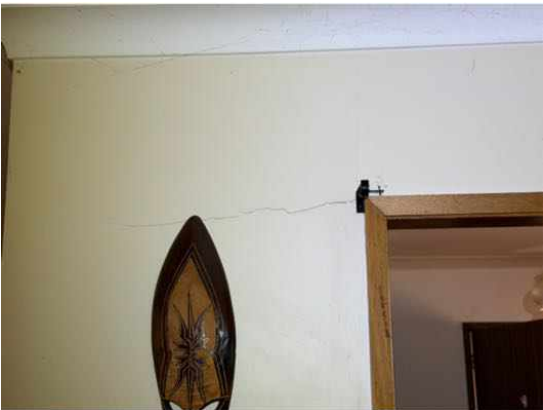
Finding 3.05

Building: Main Building
Location: All Internal Areas
Finding: Plaster - Cracking
Information: There appears to be several areas of cracking throughout the wall linings, indicating

movement of the building. The client should closely monitor these areas. Should cracking widen, lengthen, or become more numerous, the client should consult with a structural engineer promptly, for further advice & remedial works.

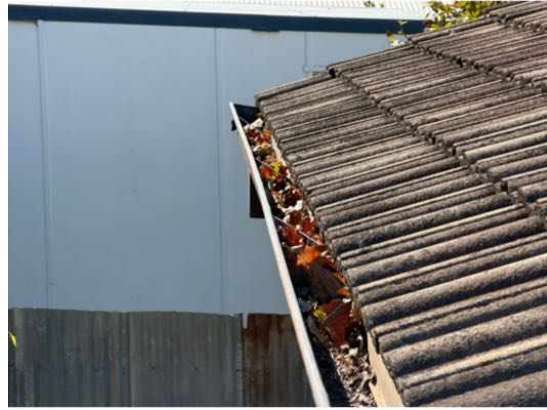
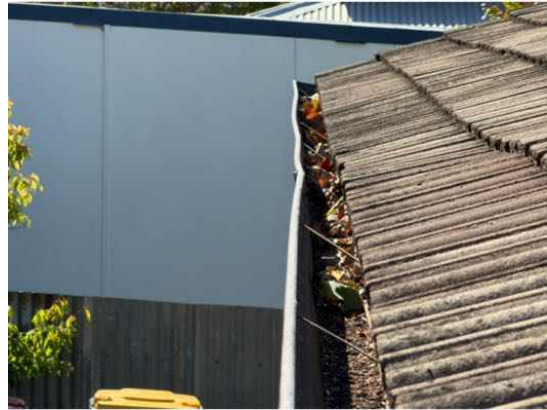
Finding 3.06

Building: Main Building
Location: Gutters
Finding: Debris in Gutters
Information: It appears that there is some debris in the gutters. Accumulation of debris can lead to blockages of the gutters & water overflows, if neglected.

Recommend engaging a general handyman to remove all debris from the gutters promptly to prevent overflows & blockages.

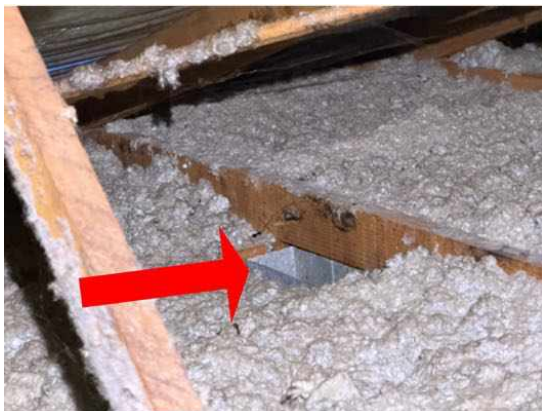
Finding 3.07

Building:	Main Building
Location:	Roof Void
Finding:	Range-hood - disconnected
Information:	It appears that the range-hood ducting was disconnected in the roof void. This defect inhibits the functionality of the affected system, and is likely to lead to moisture build up in the area if neglected. Consultation with a licensed electrician is advised at clients convenience, to reconnect the ductwork and redirect it to the external environment.

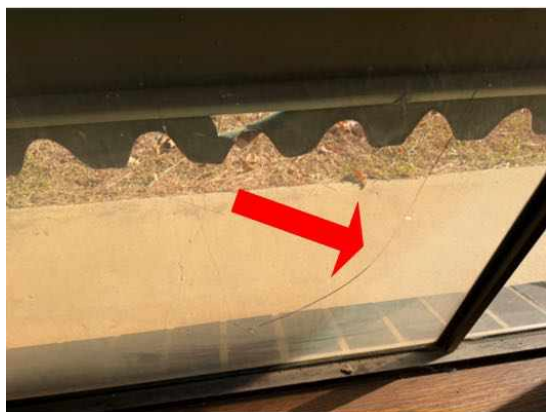
Finding 3.08

Building:	Main Building
Location:	Front Bedroom
Finding:	Window - Cracked
Information:	Minor cracking was evident at but not limited to, the front bedroom window at the time of inspection. Further impact may lead to additional cracking.

It is advised that the client monitor the condition of the window. Should further cracking occur, a qualified glazier should be engaged to replace the window

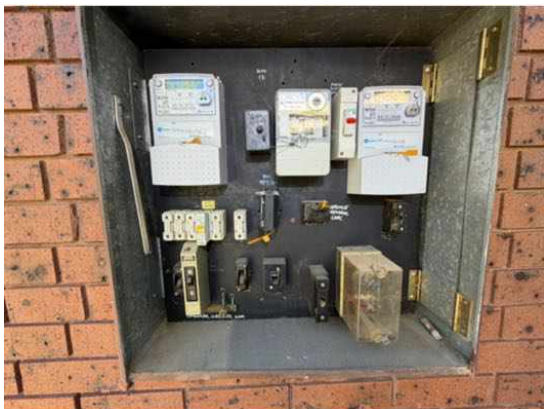
Finding 6.01

Building:	Main Building
Location:	Switchboard
Finding:	Termite Management System - no evidence of a chemical installation
Information:	The application of a termite barrier is strongly recommended, as it appears no termite management system has been installed, with no evidence or durable notice to suggest works taking place. Generally, a durable notice is placed in the meter box to indicate current termite barriers.

Such barriers are highly effective in preventing termite attack on the building and therefore should be installed.

Recommend seeking further advice from a licensed pest controller.

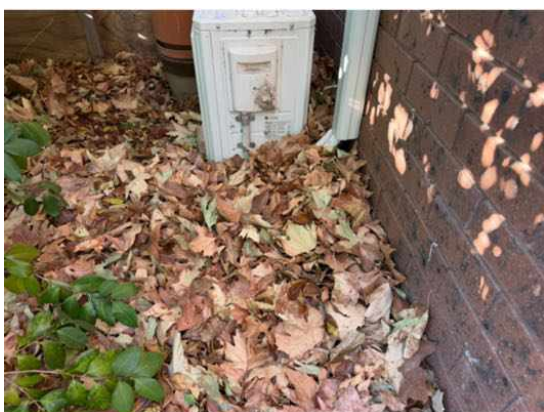
Finding 6.02

Building:	Main Building
Location:	All external areas
Finding:	Potential Water pooling - against property
Information:	Potential areas of water pooling around the perimeter of the property were identified. Where insufficient site drainage is present, water pooling is likely to occur, and can create areas conducive to timber pests. Recommend consulting with a licensed plumber and/or landscaping contractor to provide further advice.

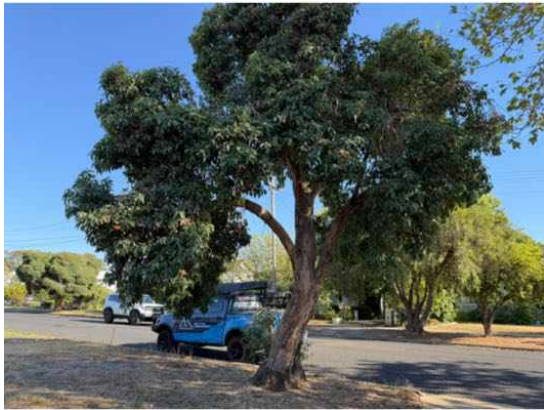
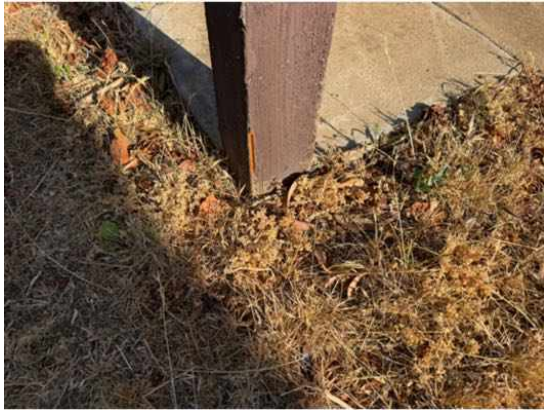
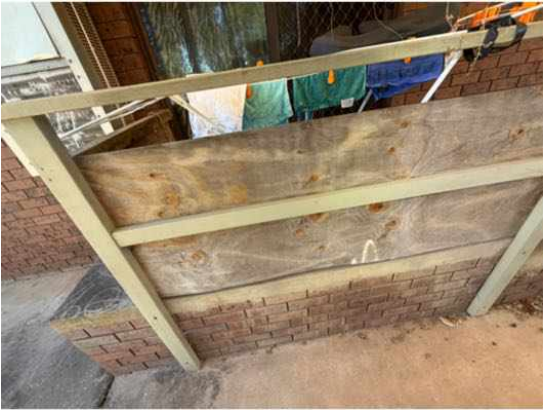
Finding 6.04

Building: Main Building
Location: All External Areas
Finding: Timber in direct ground contact & trees - conducive to termites
Information: Where timber materials are in direct contact with the ground and consequently moisture, they become conducive to termite activity. The timber debris, posts in contact with the ground, and trees surrounding the building create an environment conducive to termite activity.

Where feasible, any timbers in direct contact with the ground should be removed and

any trees in close proximity to the building should be removed or test drilled (inspected) at least annually to reduce the risk of termite infestation & detect any early signs of termite activity.

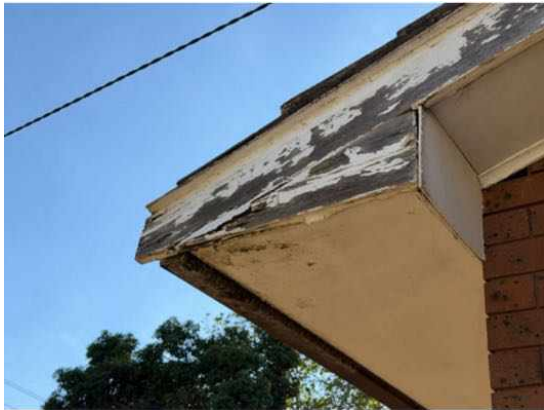
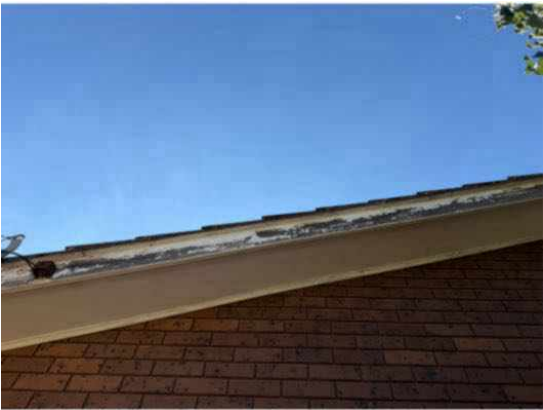
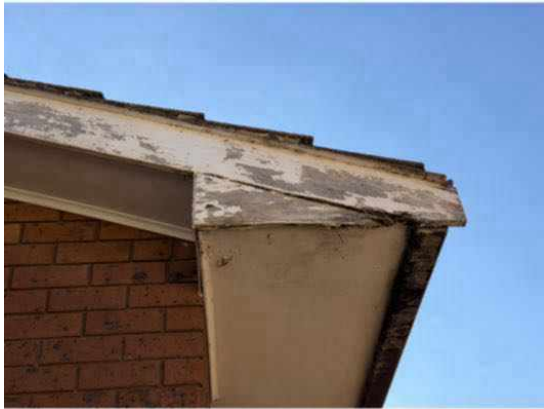
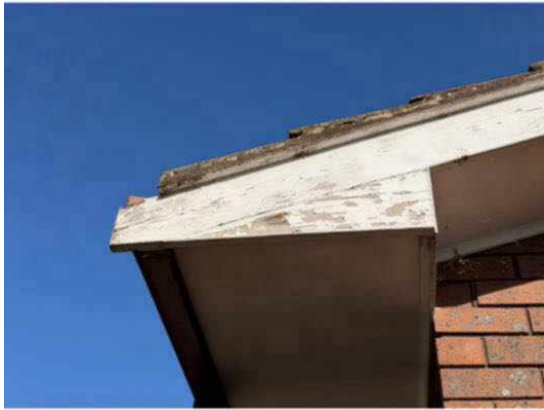
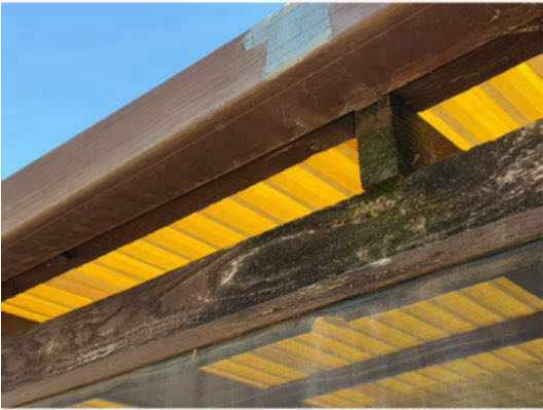
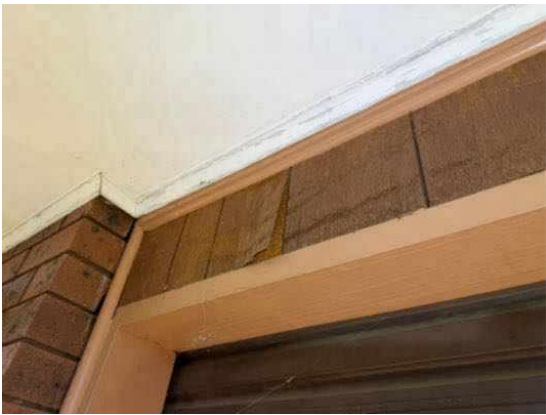
Finding 7.01

Building:	Main Building
Location:	Patio Framing, Posts, Fascias, External Trims, Window frames
Finding:	Fungal decay, weathering

Information: Areas of fungal decay (wood rot) were identified at but not limited the Patio framing, patio posts, fascias, external trims & window frames.

For areas of fungal decay, the client can engage a licensed carpenter at their discretion to replace affected materials.

For areas of general weathering, it is advised the client engage a licensed painter to apply protective sealant or coating to areas of weathered external timbers.

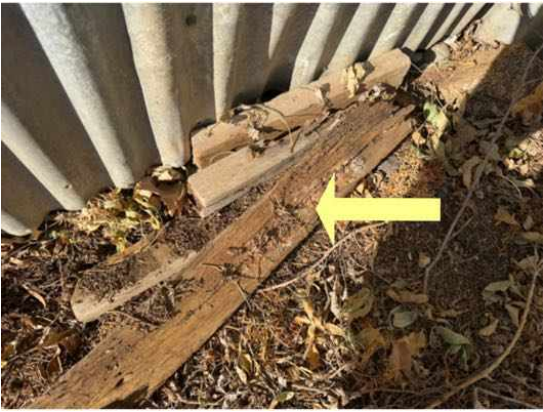
Finding 8.01

Building: Main Building
Location: Tree, Timber Debris
Finding: Evidence of wood borer damage identified (powder-post)
Information: Evidence of previous Lyctus Borer (powder-post beetle) damage was identified at but not limited to a front tree & timber debris. As no live wood borer activity was identified treatment is not required.

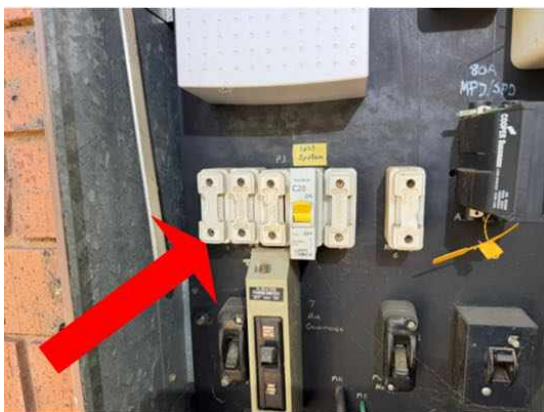
Building:	Main Building
Location:	Switchboard
Finding:	Electrical switchboard - Old ceramic fuses
Information:	It was noted that the electrical switchboard has old ceramic fuses in place. It is noted for the clients consideration that a switchboard upgrade may be required. Recommend consulting with a licensed electrician to provide further advice.

Old ceramic fuses identified in the switchboard. Recommend consulting with a licensed electrician to provide further advice.

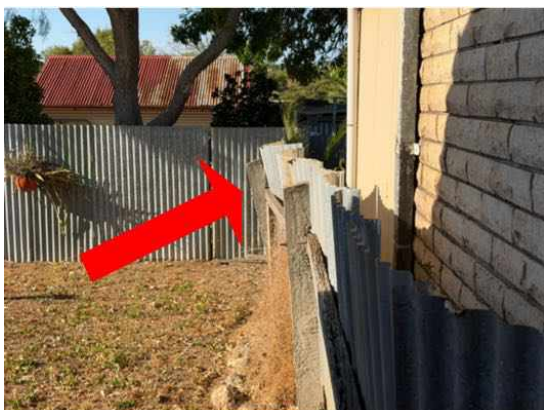
Building: Main Building
 Location: Fencing
 Finding: Fencing - Leaning
 Information: It was noted at the time of inspection that sections of the fencing appeared to be leaning and may require additional support or reinforcement.

The client could engage a licensed fencing contractor at their discretion, to provide remedial works where necessary.

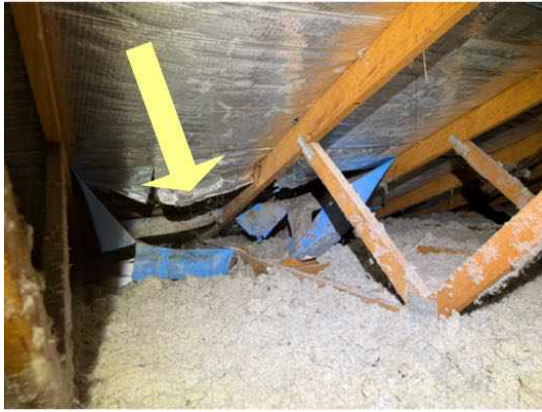
Building: Main Building
 Location: Roof Void
 Finding: Sarking - Damaged
 Information: The sarking appears to be damaged/deteriorated in areas of the roof void. Sarking is a laminated aluminium foil applied to the interior of the roof covering, which assists in insulating the property and acts as a vapour-barrier to the roof void.

Where sarking is damaged, there is potential for moisture ingress from condensation or leaking roof tiles.

Recommend engaging a roofing contractor at clients discretion, to provide further

advice.

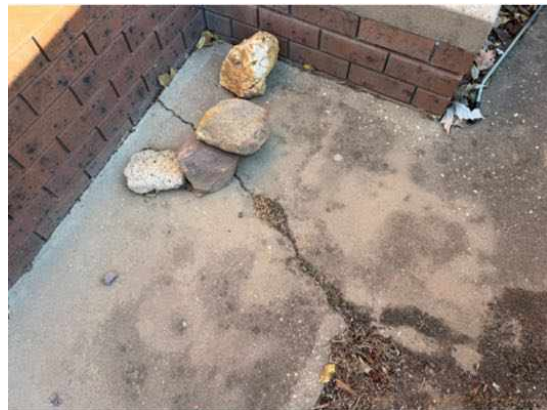
Building: Main Building
Location: Pavement, Garage Slab
Finding: Cracking - Pavement & Footpath
Information: It was noted there is cracking in areas of the pavement and driveway. Cracks in the pavement are a common occurrence in houses of a similar age.

Recommend that the client monitor the cracking. A licensed concreter can be engaged at clients discretion, should cracks widen, lengthen, or become more numerous.

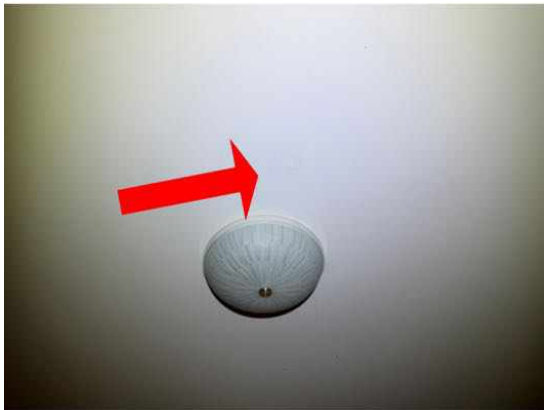
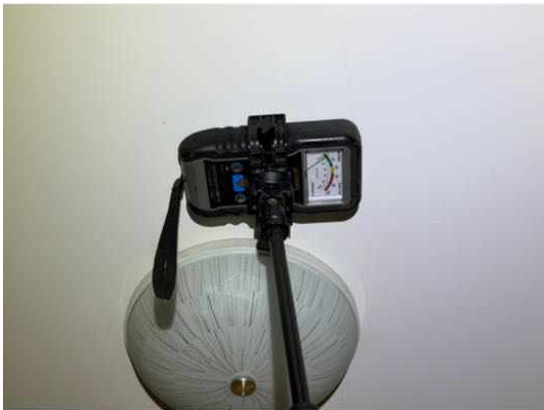
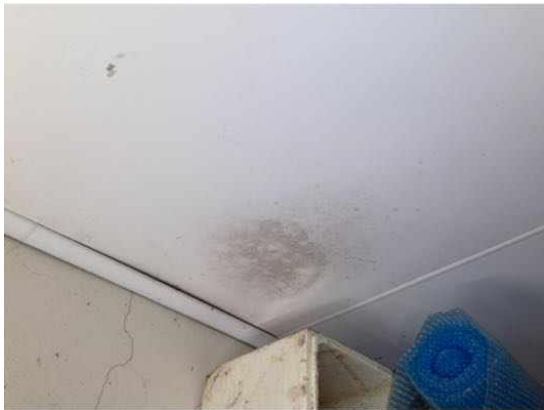
Building: Main Building
Location: Garage, Front Bedroom
Finding: Water Staining Present
Information: It appears that water staining was present at but not limited to, the front bedroom ceiling and garage ceiling. Potential causes of leaking include deteriorated roof cladding or damaged plumbing fittings and fixtures. No high moisture was evident to the bedroom ceiling at the time of inspection.

Recommend that the client monitor the areas and engage a licensed roof plumber promptly, should the leak persist or return.

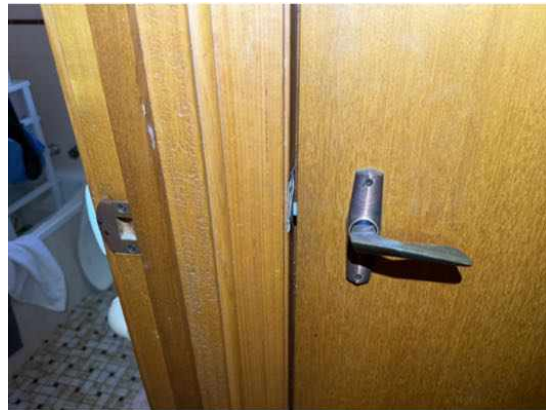
Building: Main Building
Location: Internal doors
Finding: Door - Binding/jamming
Information: It was noted at the time of inspection that some internal doors were binding against the door jamb & not shutting properly.

A qualified carpenter or general handyman can be engaged to perform minor rectification works at clients discretion.
