Building and Timber Pest Inspection Report

Inspection Date: Mon, 9 Mar 2026

Property Address: 1/35 Sandy Beach Rd, Korora NSW 2450, Australia

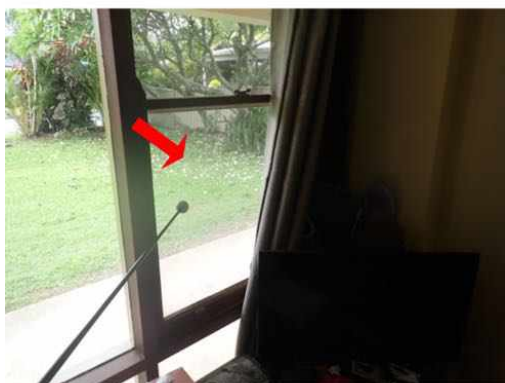
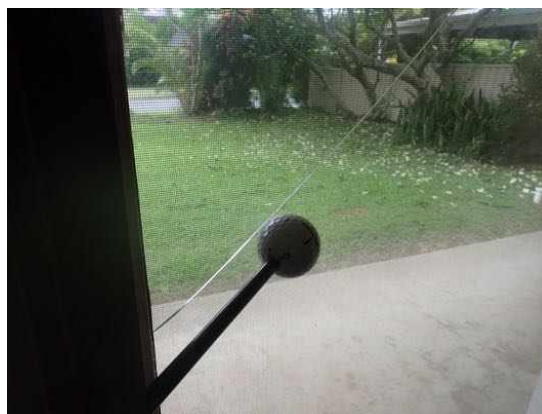
Finding 1.01

Building:	Main Building
Location:	Bedroom
Finding:	Cracked Bedroom Window Glass Pane
Information:	A crack was identified in a bedroom window glass pane at the time of inspection. Cracked glass can occur due to impact, movement of the window frame, or general deterioration and may worsen over time if not replaced. Damaged glazing can also reduce the safety and weather resistance of the window. It is recommended that a qualified glazier replace the damaged glass pane as required to restore the window to a safe and functional condition. Repairs should be carried out as soon as possible.

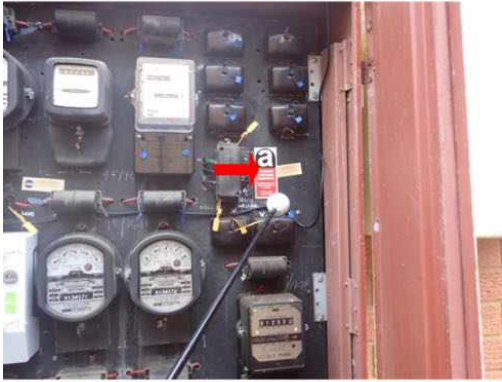
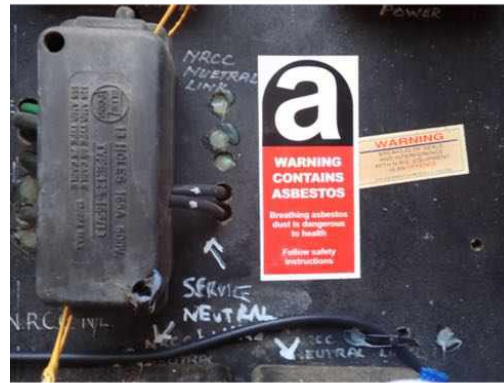
Finding 1.02

Building:	Main Building
Location:	Wall left hand side
Finding:	Asbestos Caution Sticker Identified Within Electrical Meter Box
Information:	Asbestos Caution Sticker Identified Within Electrical Meter Box

An asbestos caution sticker was identified within the electrical meter box at the time of inspection. The presence of this sticker may indicate that asbestos-containing materials are present within or associated with the electrical meter backing board. Disturbance of asbestos-containing materials can present health risks if fibres become airborne. It should be noted that asbestos detection and identification is outside the scope of this inspection. It is recommended that the area be treated with caution and that any works involving the meter box or surrounding materials be carried out by a suitably qualified electrician and, if required, a licensed asbestos professional. Further investigation should be carried out as deemed necessary before any disturbance of the materials.

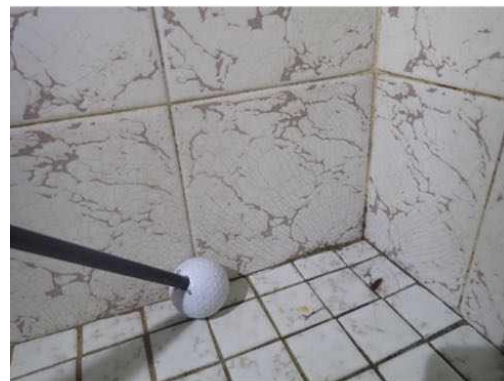
Finding 2.01

Finding: Hairline Cracks to Multiple Wall Tiles in Shower Area

Information: Multiple wall tiles in the shower area were identified as having hairline cracks at the time of inspection. This condition is likely due to the age of the tiles and the type of tile material. Cracking to tiles in wet areas may allow moisture to penetrate behind the tiled surface which can lead to further deterioration if not addressed. It is recommended that a qualified tiler assess the affected tiles and carry out repairs or replacement as required to maintain the integrity of the tiled surface. Repairs should be carried out as deemed necessary.

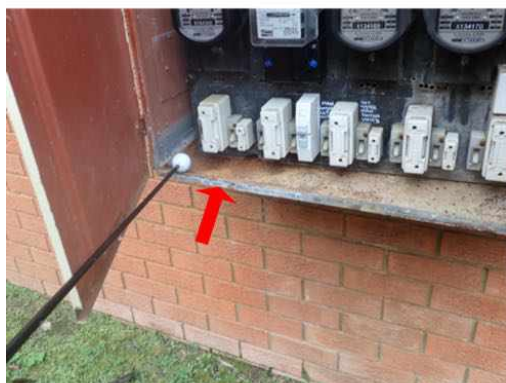
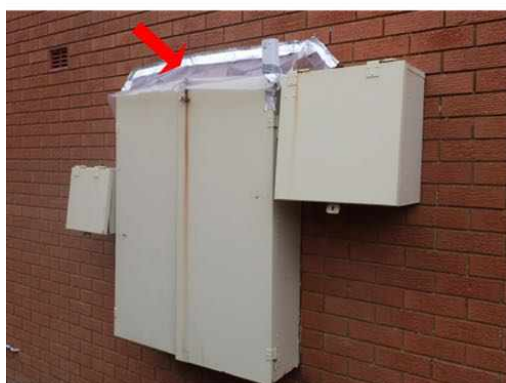
Finding 2.02

Finding: Rust to Electrical Meter Box

Information: Rust was identified to the electrical meter box at the time of inspection. Corrosion to

metal electrical enclosures can occur over time due to exposure to weather and moisture and may worsen if not addressed. Continued deterioration may affect the durability of the enclosure and its ability to protect the electrical components inside. It is recommended that a qualified electrician assess the meter box and carry out repairs, treatment, or replacement as required to maintain the integrity of the enclosure. Repairs should be carried out as deemed necessary.

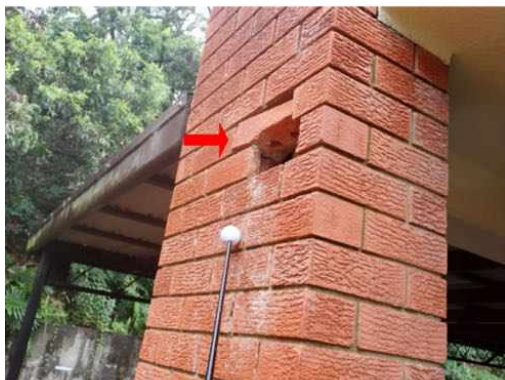
Finding 2.03

Building:	Main Building
Location:	Rear left hand column
Finding:	Brick Removed from Rear Right-Hand Side Column
Information:	A brick was observed to have been removed from the rear right-hand side column at the time of inspection. The brick may have been removed to allow access to plumbing pipework within the column. Missing masonry elements may allow moisture, pests, or debris to enter the cavity if left unsealed. It is recommended that a qualified bricklayer or builder assess the affected area and reinstate the brick or provide an appropriate repair as required to maintain the integrity of the column. Repairs should be carried out as deemed necessary.

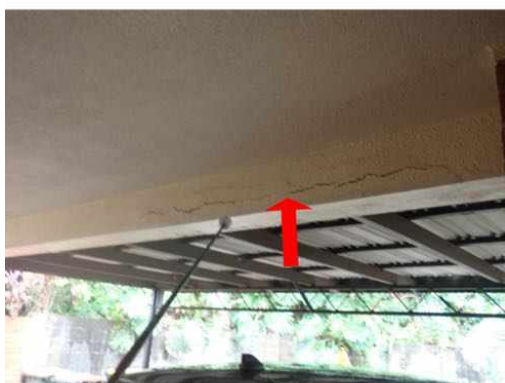
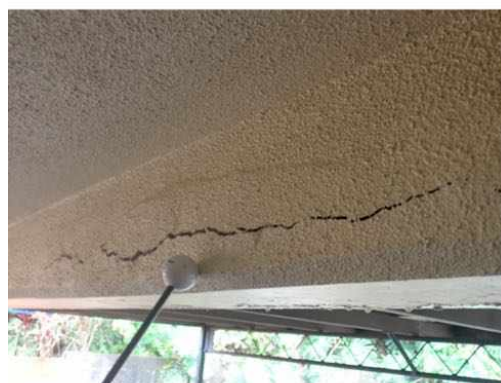
Finding 2.04

Building:	Main Building
Location:	Rear of building above carport
Finding:	Large Structural Crack to Concrete Beam at Edge of Carport
Information:	A large structural crack was identified to the concrete beam at the edge of the carport at the time of inspection. Cracking of this nature may indicate structural movement or deterioration of the concrete element and may affect the structural integrity of the beam if not addressed. The full extent and cause of the cracking could not be determined during the visual inspection. It is recommended that a qualified structural engineer or suitably experienced builder assess the affected beam and provide recommendations for repair or further investigation as required. Rectification works should be carried out as deemed necessary.

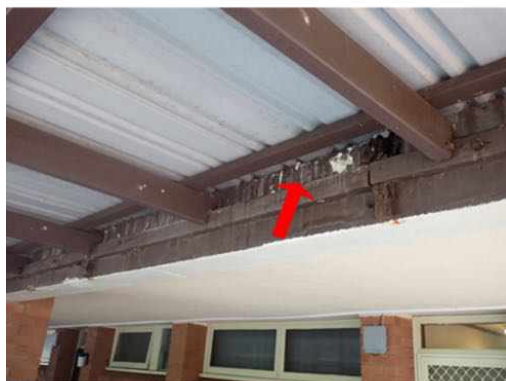
Finding 2.05

Building:	Main Building
Location:	Carport roof
Finding:	Water Leak Where Carport Roof Meets Concrete Deck Above
Information:	Leaking was identified where the carport roof meets the concrete deck to the unit above at the time of inspection. Water ingress at roof and deck junctions can occur due to deteriorated sealants, poor flashing installation, or defects in the roof connection and may lead to ongoing moisture damage if not addressed. The full

extent and source of the leak could not be determined during the visual inspection. It is recommended that a qualified builder or roofer assess the affected junction and carry out repairs as required to prevent further leaking. Repairs should be carried out as deemed necessary.

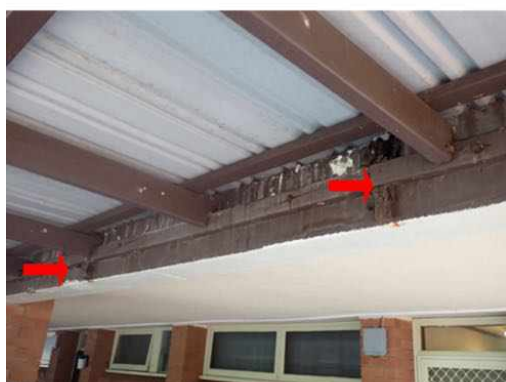
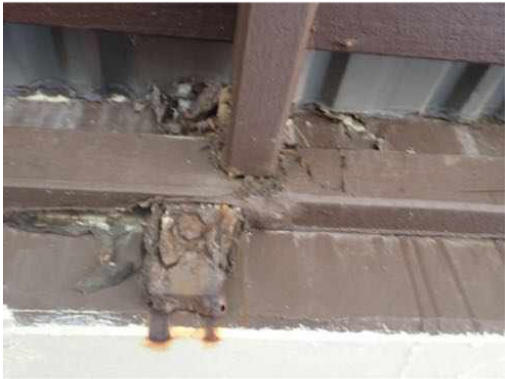
Finding 2.06

Building:	Main Building
Location:	Carport roof
Finding:	Rust to Metal Fixings Where Carport Roof Meets Structure
Information:	Rust was identified to the metal fixings where the carport roof meets the structure at the time of inspection. Corrosion to metal fixings can occur over time due to exposure to weather and moisture and may lead to loosening or deterioration of the roof connection if left unaddressed. It is recommended that a qualified roofer or suitably experienced handyman assess the affected fixings and carry out replacement or treatment as required to maintain the integrity of the roof connection. Repairs should be carried out as deemed necessary.

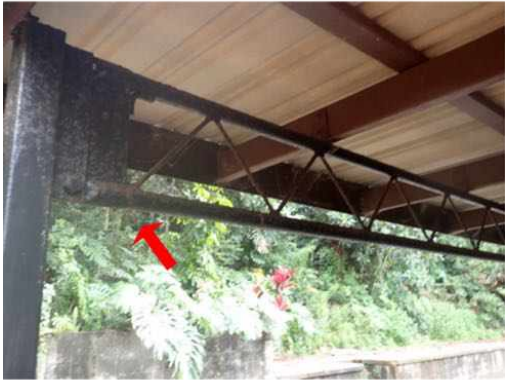
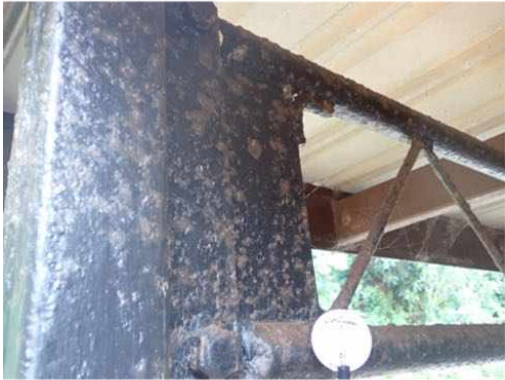
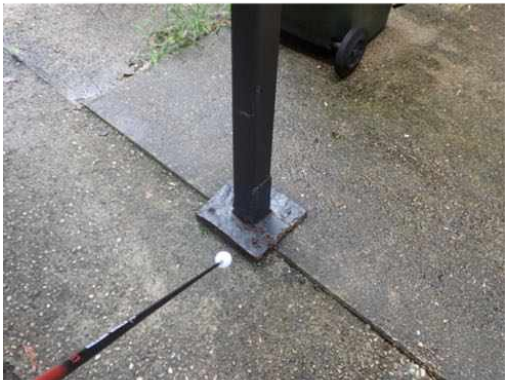
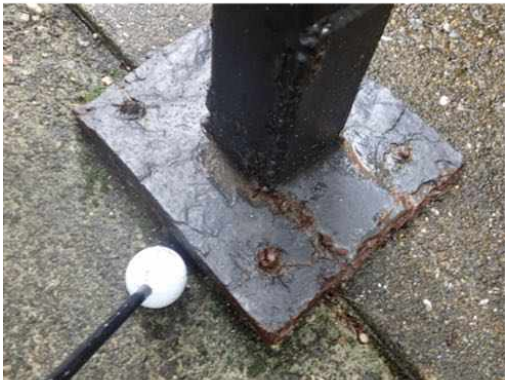
Finding 2.07

Building: Main Building
Location: Carport
Finding: Rust to Carport Roof Structure
Information: Rust was identified to the carport roof structure at the time of inspection. Corrosion to metal structural components can occur over time due to exposure to weather and moisture and may worsen if not addressed. Continued deterioration may affect the durability of the structure. It is recommended that a qualified builder, metal contractor, or suitably experienced handyman assess the affected areas and carry out cleaning, treatment, or replacement of the rusted components as required to prevent further deterioration. Repairs should be carried out as deemed necessary.

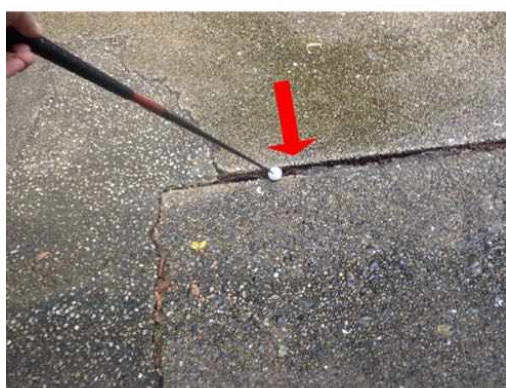
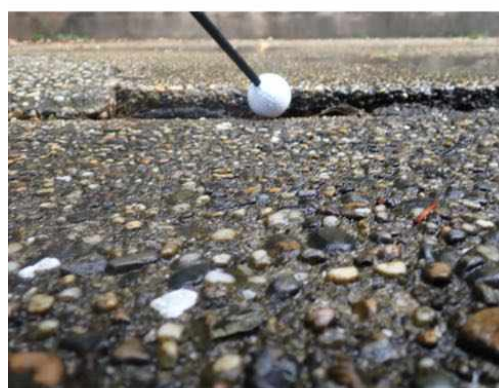
Finding 2.08

Building:	Main Building
Location:	Carport
Finding:	Step in Carport Concrete Slab
Information:	A step was identified in the carport concrete slab at the time of inspection. Changes in level within concrete slabs can occur due to ground movement, settlement, or deterioration over time and is a common defect with concrete of this age. Uneven concrete surfaces may present a trip hazard and may worsen if movement continues. It is recommended that a qualified concreter or suitably experienced builder assess the affected area and carry out repairs as required. Repairs should be carried out as deemed necessary.

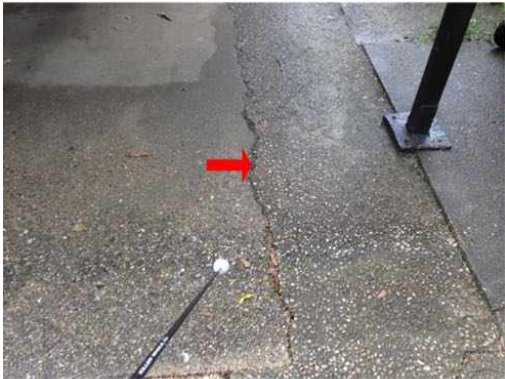
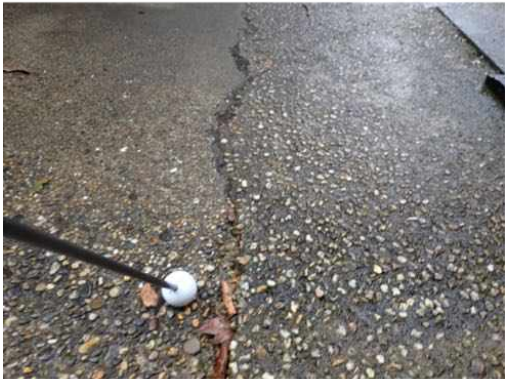
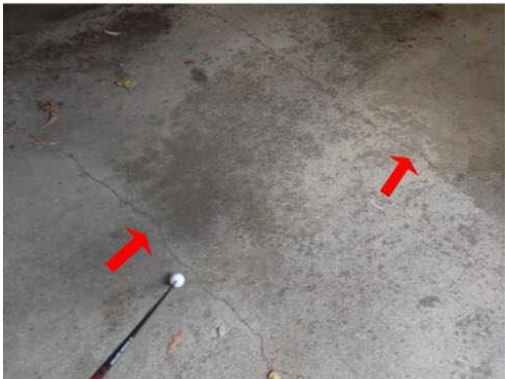
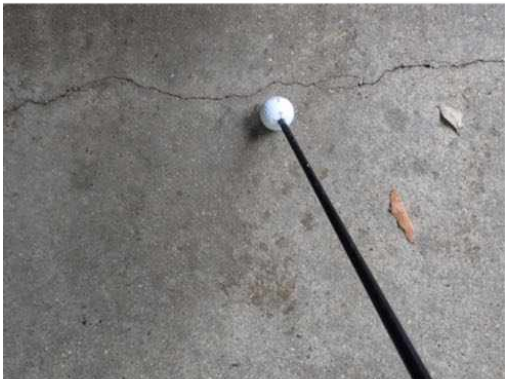
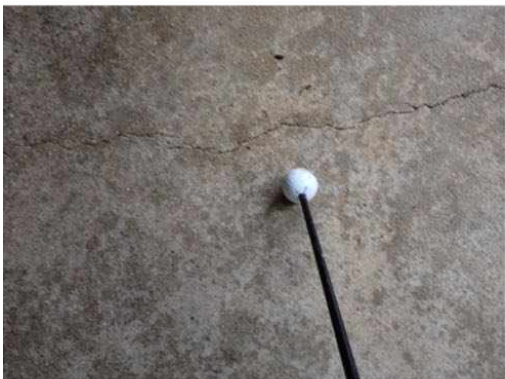
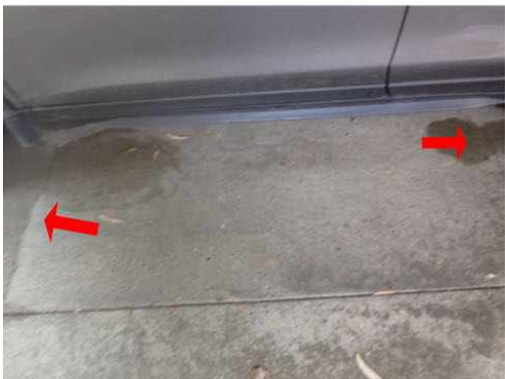
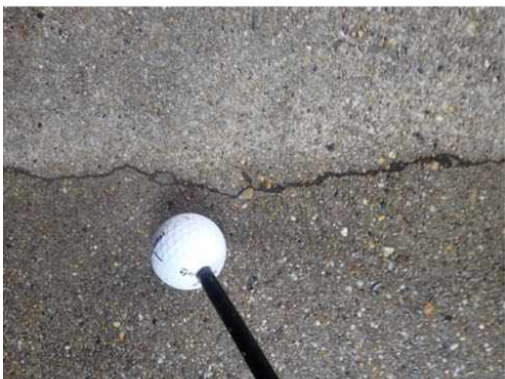
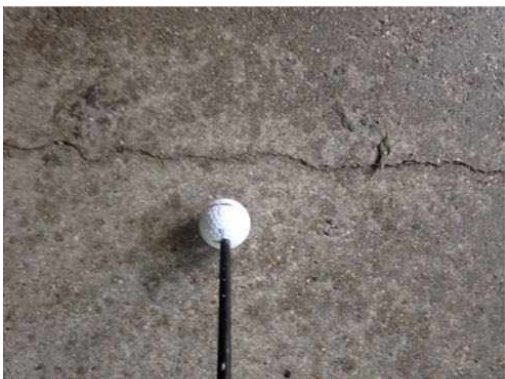
Finding 2.09

Building:	Main Building
Location:	Carport
Finding:	Major and Minor Cracks to Carport Concrete Slab
Information:	Major and minor cracks were identified to the carport concrete slab at the time of inspection. Cracking in concrete slabs can occur due to ground movement, settlement, shrinkage of the concrete, or ageing of the slab and is a common defect with concrete of this age. Larger cracks may allow moisture ingress and may worsen over time if movement continues. It is recommended that a qualified concreter or suitably experienced builder assess the affected slab and carry out repairs as required. Repairs should be carried out as deemed necessary.

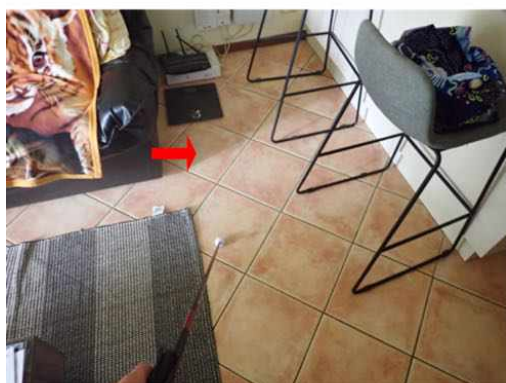
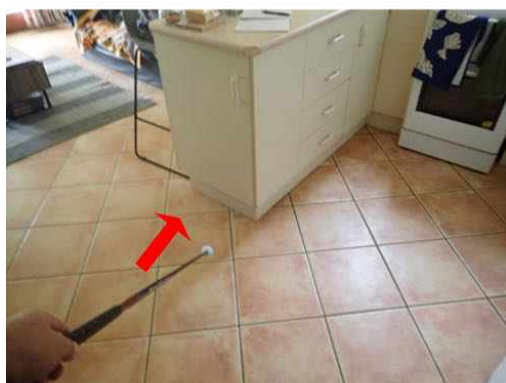
Finding 3.01

Building: Main Building
Location: Kitchen and entry hall.
Finding: Drummy Floor Tiles to Kitchen and Hallway
Information: Drummy floor tiles were identified around the kitchen breakfast bench and in the hallway near the bathroom at the time of inspection. In the same hallway area, missing grout and a loose tile were also observed. Drummy or loose tiles may indicate poor adhesion or movement in the substrate and may worsen over time if not addressed. Missing grout can allow moisture and debris to penetrate beneath the tiles which may contribute to further deterioration. This is a common defect with properties of this age and construction type. It is recommended that a qualified tiler assess the affected areas and carry out repairs, re-grouting, or replacement of tiles as required to prevent further deterioration. Repairs should be carried out as deemed necessary.

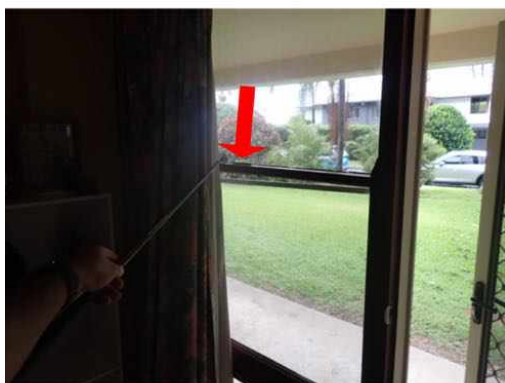
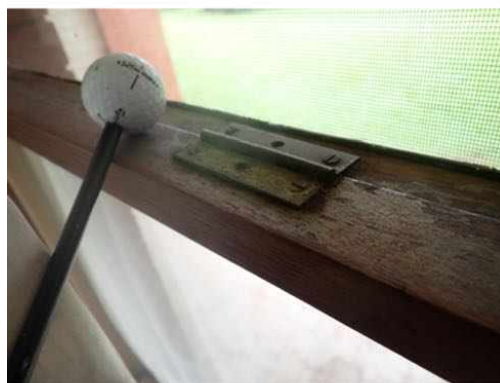
Finding 3.02

Building:	Main Building
Location:	Living room
Finding:	Living Room Window Screwed Shut Near Entry Door
Information:	The living room window located to the right-hand side of the entry door was observed to be screwed shut at the time of inspection. Windows that are fixed shut may indicate previous operational issues, damage, or attempts to restrict movement of the window. This condition prevents normal operation and may restrict ventilation. It is recommended that a qualified carpenter or suitably experienced handyman assess the window and carry out repairs or adjustments as required to restore normal operation if desired. Repairs should be carried out as deemed necessary.

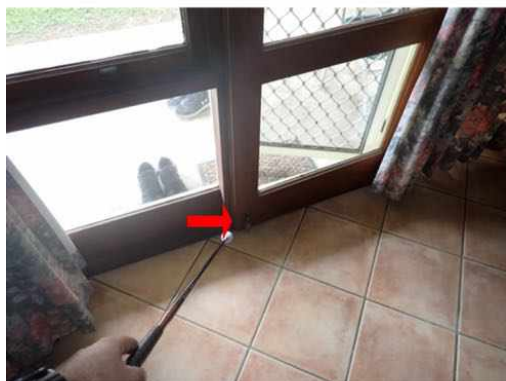
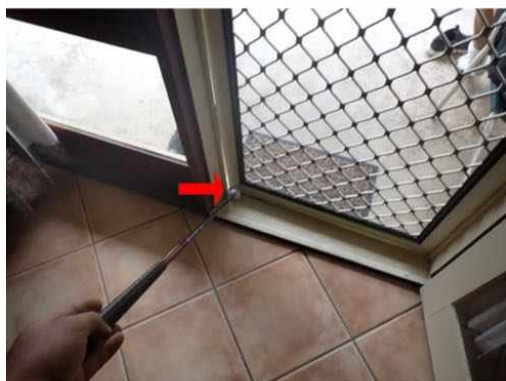
Finding 3.03

Building:	Main Building
Location:	Living room
Finding:	Entry Security Door and Timber Door Catching on Door Sill
Information:	The entry security door and timber entry door were observed to be catching on the door sill during normal operation at the time of inspection. Doors catching on the sill may be caused by minor movement in the building, door misalignment, swelling of timber components, or general wear over time. Continued use in this condition may lead to further wear or damage to the door or sill. It is recommended that a qualified

carpenter or suitably experienced handyman assess the doors and carry out adjustments or repairs as required to ensure smooth operation. Repairs should be carried out as deemed necessary.

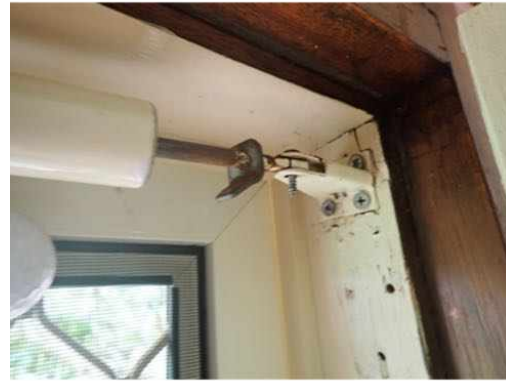
Finding 3.04

Building:	Main Building
Location:	Front and rear security doors
Finding:	Front Security Door Closer in Poor Condition and Rear Closer Missing
Information:	The automatic door closer to the front security door was found to be in poor condition at the time of inspection, and the door closer to the rear security door was missing. Door closers assist in ensuring doors close properly and remain secure. Missing or deteriorated closers may prevent the doors from functioning as intended. It is recommended that a suitably experienced handyman repair or replace the defective and missing door closers to ensure the doors operate correctly. Repairs should be carried out as deemed necessary.

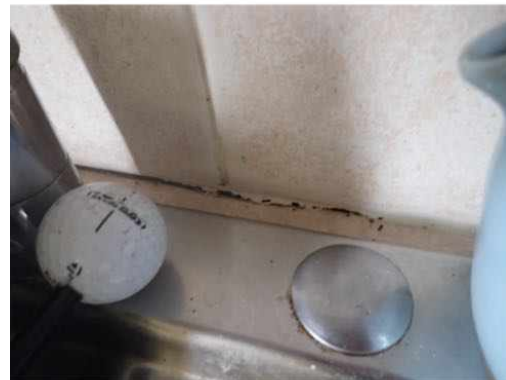
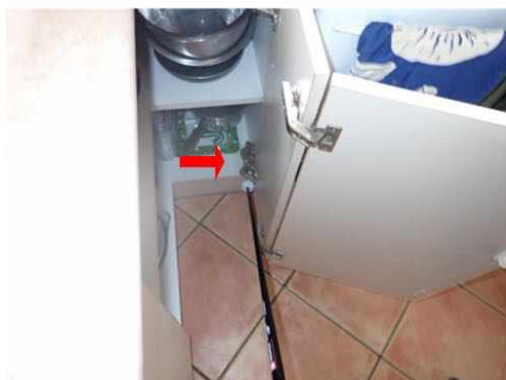
Finding 3.05

Finding: Kitchen in Fair Condition for Age with Minor Maintenance Required

Information: The kitchen was found to be in fair condition for the age of the property at the time of inspection. Minor defects observed included deteriorated silicone around the splash back and cabinet hinges requiring adjustment. These conditions are typical maintenance items and may occur over time due to normal use and ageing of materials. It is recommended that a suitably experienced handyman carry out re-sealing of the splash back and adjust the cabinet hinges as required to maintain the condition and functionality of the kitchen. Repairs and maintenance should be carried out as deemed necessary.

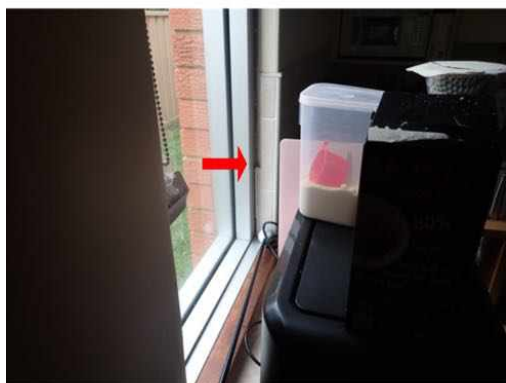
Finding 3.06

Building:	Main Building
Location:	Kitchen
Finding:	Poor Tile Work Around Replaced Kitchen Window
Information:	Poor tile work was identified around the replaced kitchen window at the time of inspection. The tiles in this area appeared to be poorly finished which may affect the durability and appearance of the tiled surface. This condition may be due to previous alterations or poor workmanship during installation. It is recommended that a qualified tiler assess the affected area and carry out repairs or re-tiling as required to achieve a proper finish and help prevent further deterioration. Repairs should be carried out as deemed necessary.

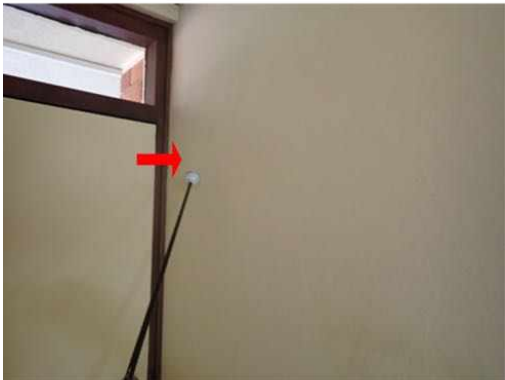
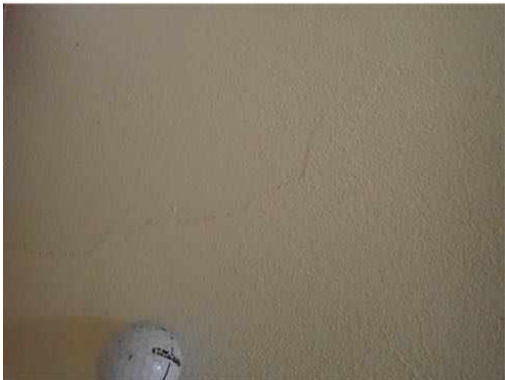
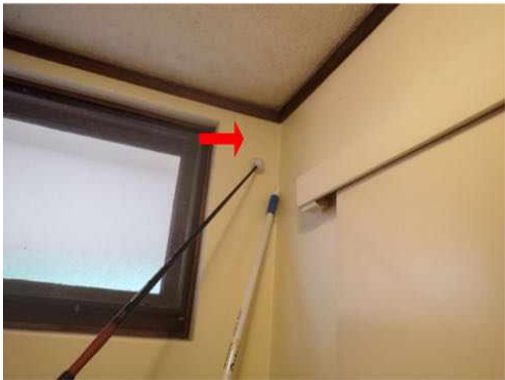
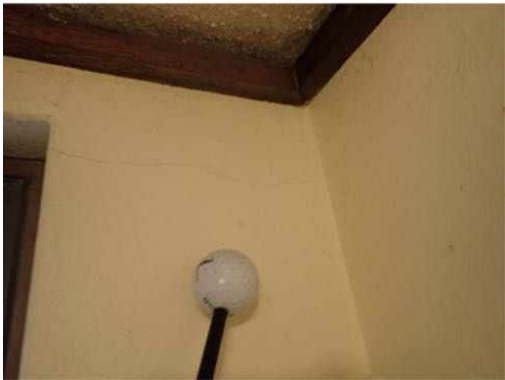
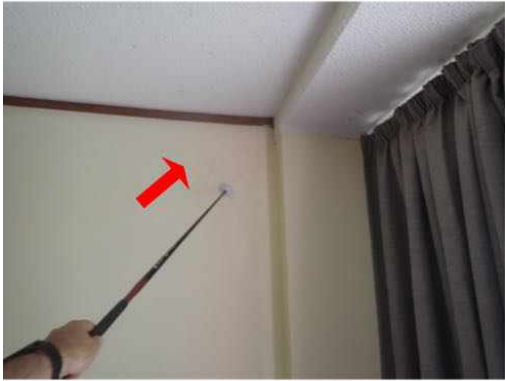
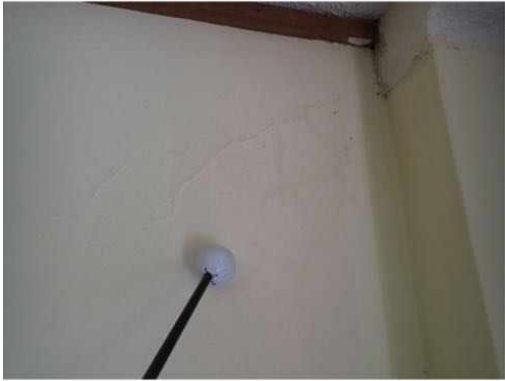
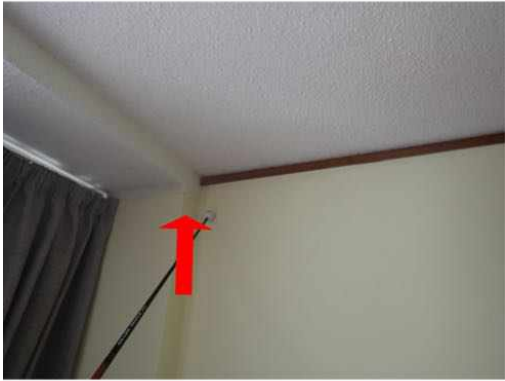
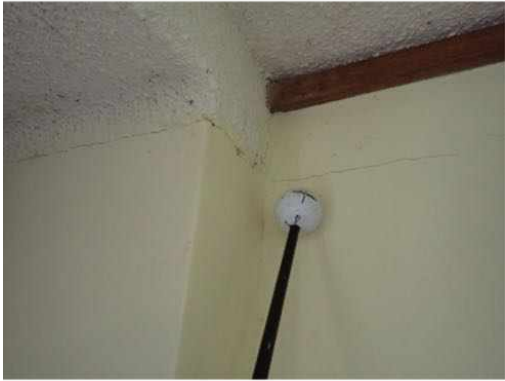
Finding 3.07

Building:	Main Building
Location:	Bedroom, bathroom and living room
Finding:	Minor Cracks in Internal Render
Information:	Minor cracks were identified in the internal rendered wall surfaces at the time of inspection. Cracking of this nature is commonly associated with minor building movement, shrinkage of materials, or general ageing of the building and is typical in properties of this age and construction type. It is recommended that a qualified plasterer or suitably experienced handyman carry out repairs to the affected areas as

required. Repairs should be carried out as deemed necessary.

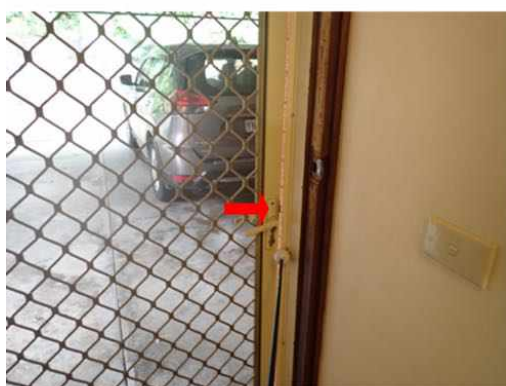
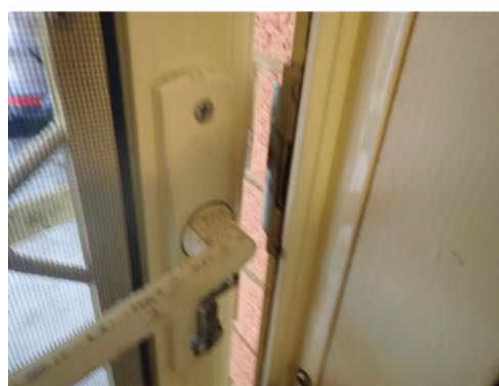
Finding 3.08

Building:	Main Building
Location:	Rear security door
Finding:	Rear Security Door Lock Catching on Door Jamb
Information:	The lock to the rear security door was observed to be catching on the door jamb during normal operation at the time of inspection. This condition may be due to minor misalignment of the door or strike plate, general wear, or movement in the door frame. Continued use in this condition may lead to further wear of the locking components. It is recommended that a suitably experienced handyman adjust or repair the door and lock components as required to ensure smooth operation. Repairs should be carried out as deemed necessary.

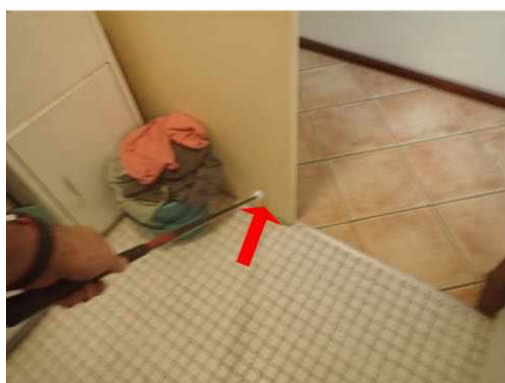
Finding 3.11

Building:	Main Building
Location:	Bathroom
Finding:	Bathroom Sliding Door Difficult to Operate
Information:	The bathroom sliding door was found to be difficult to operate during normal use at the time of inspection. Difficulty operating sliding doors can be caused by worn rollers, misalignment, debris in the track, or general wear over time. It is recommended that a qualified carpenter or suitably experienced handyman inspect the door and carry out adjustments, repairs, or replacement of worn components as required to ensure smooth operation. Repairs should be carried out as deemed necessary.

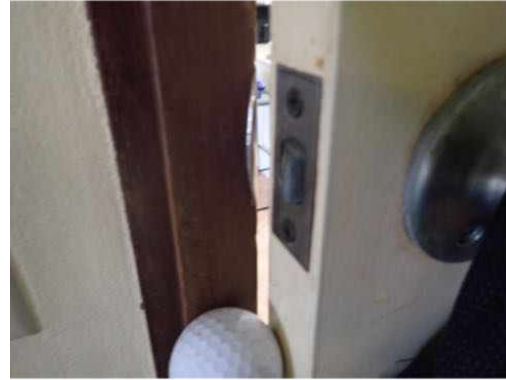
Finding 3.13

Building: Main Building
Location: Bedrooms
Finding: Bedroom Doors Catching on Door Jambs
Information: The bedroom doors were observed to be catching on the door jambs during normal operation at the time of inspection. Doors catching on jambs can be caused by minor movement in the building, door misalignment, swelling of timber components, or general wear over time. Continued use in this condition may lead to further wear or damage to the doors or jambs. It is recommended that a qualified carpenter or suitably experienced handyman adjust or repair the doors as required to ensure smooth operation. Repairs should be carried out as deemed necessary.

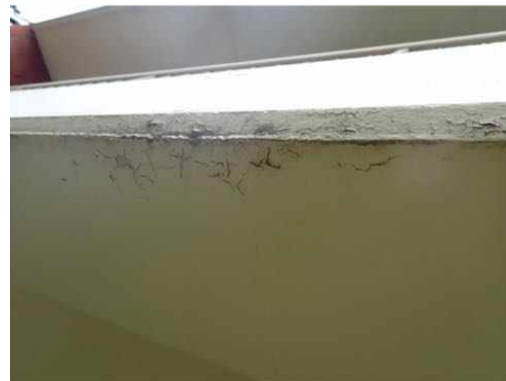
Finding 3.14

Building:	Main Building
Location:	Concrete above front porch area
Finding:	Flaking Paint to Concrete Above Front Porch Area
Information:	The paint finish to the concrete above the front porch area was observed to be starting to flake at the time of inspection. Flaking paint can occur due to ageing of the coating, moisture exposure, or deterioration of the painted surface over time. Continued deterioration may lead to further loss of the protective coating. It is recommended that a qualified painter prepare the surface and reapply an appropriate paint coating as required to prevent further deterioration. Repairs should be carried out as deemed necessary.

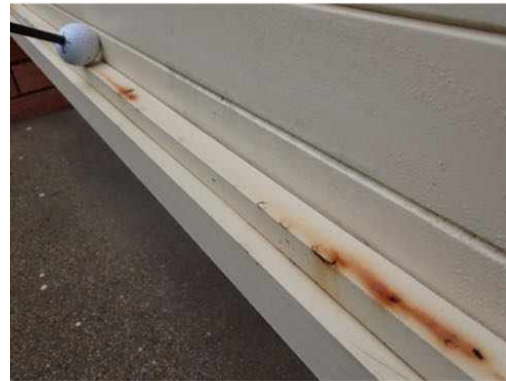
Finding 3.15

Building:	Main Building
Location:	Screen to left hand side of front porch area.
Finding:	Rusted Nails to Timber Trims Around Front Porch Privacy Screen
Information:	Rusted nails were identified to the timber trims around the front porch area privacy screen at the time of inspection. Corrosion to fixings can occur over time due to exposure to weather and moisture and may lead to loosening of the trims if deterioration continues. It is recommended that a qualified carpenter or suitably

experienced handyman replace the rusted fixings and re-secure the timber trims as required to maintain the stability of the privacy screen. Repairs should be carried out as deemed necessary.

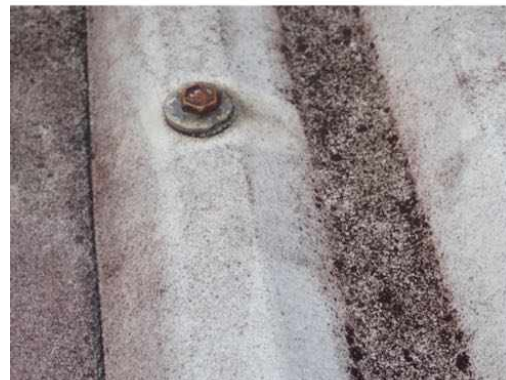
Finding 3.16

Finding: Rusted Screw Heads to Carport Roof Cladding

Information: Multiple rusted screw heads were identified to the carport roof cladding at the time of inspection. Corrosion to roof fixings can occur over time due to exposure to weather and moisture and may lead to deterioration of the fixings if not addressed. Continued corrosion may reduce the effectiveness of the roof cladding fixings and may contribute to leaks if deterioration continues. It is recommended that a qualified roofer or suitably experienced handyman replace the rusted fixings as required to maintain the integrity of the roof cladding. Repairs should be carried out as deemed necessary.

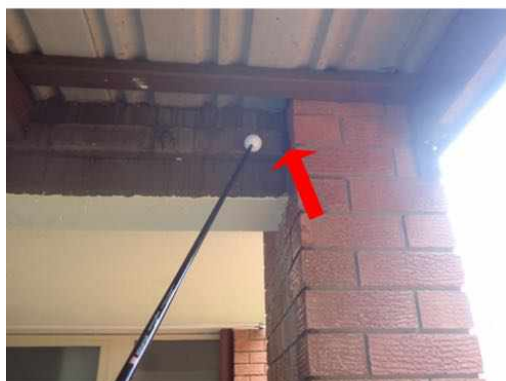
Finding 7.01

Building:	Main Building
Location:	Carport roof
Finding:	Wood Rot to Carport Timber Where It Meets Concrete Deck Above
Information:	Wood rot was identified to the carport timber where it meets the concrete deck above at the time of inspection. Deterioration of timber elements in this location is commonly associated with prolonged moisture exposure and may lead to further deterioration if not addressed. Continued decay may reduce the strength and durability of the affected timber components. It is recommended that a qualified carpenter or builder assess the affected timber and carry out repairs or replacement as required to prevent further deterioration. Repairs should be carried out as deemed necessary.

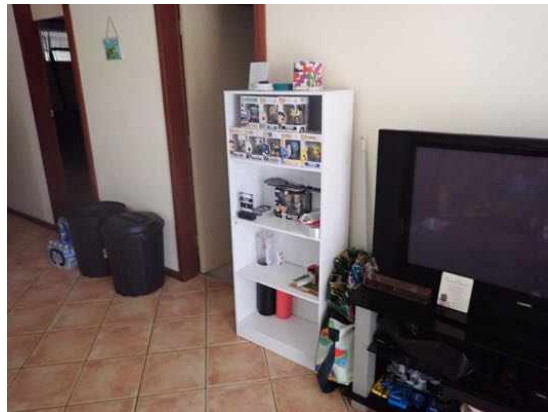
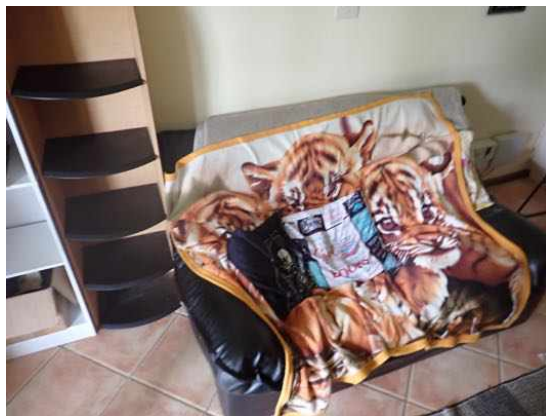
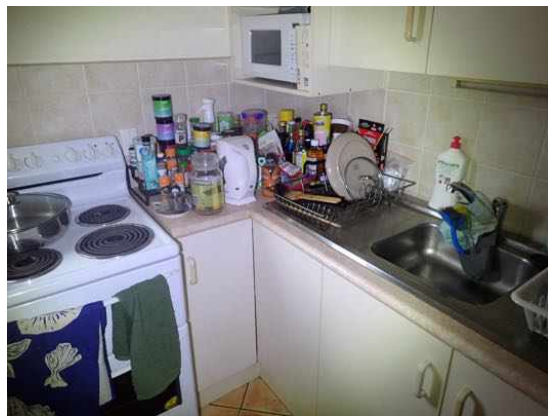
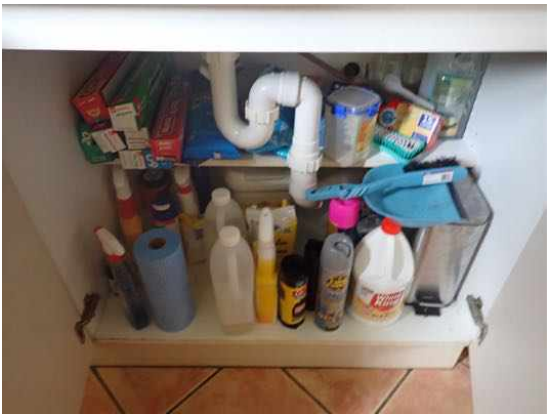
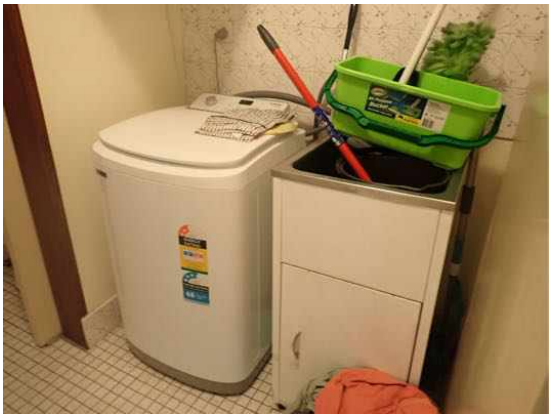
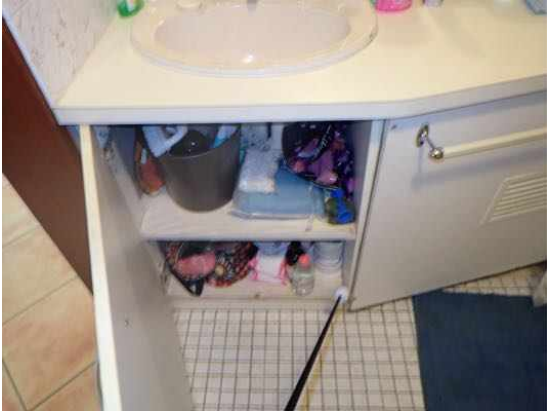
Noted Item

Building: Main Building
Location: All Areas
Finding: Additional Photos - Obstructions and Limitations
Information: These photographs are an indication of the obstructions and limitations which impeded full inspection of the area at the time of inspection. These obstructions can hide an array of defects and should be removed to allow full inspection to be carried out. A re-inspection is recommended once the areas are made accessible.
