Building and Timber Pest Inspection Report

Inspection Date: Wed, 4 Mar 2026

Property Address: 5A Innes Rd, Windsor Gardens SA 5087,
Australia

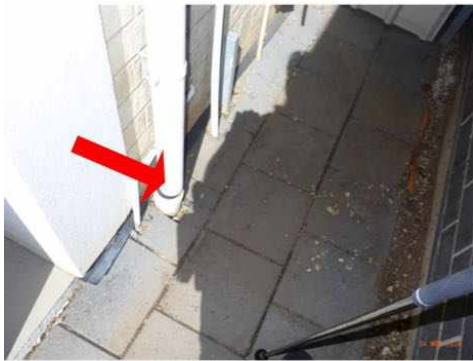
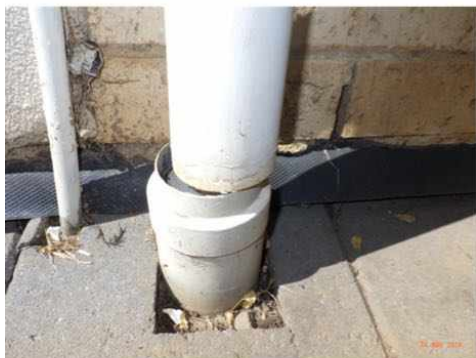
Finding 2.01

Building: Building 1
Location: Yard - Front
Finding: Stormwater drain - damaged/ leaking
Information: The roof plumbing is not adequately connected to stormwater drainage on the site with separation evident to a downpipe. Due to this damage the area could be prone to moisture related defects ranging from deterioration of pavements to damage of adjacent building elements.

Where roof plumbing doesn't drain adequately, the area at the base perimeter can become excessively damp, potentially creating an environment that is susceptible to rust and corrosion of surrounding building elements, as well as attracting termites and other pests.

It is highly recommended that a plumber be appointed to further inspect the area and to install adequate drainage equipment where necessary.

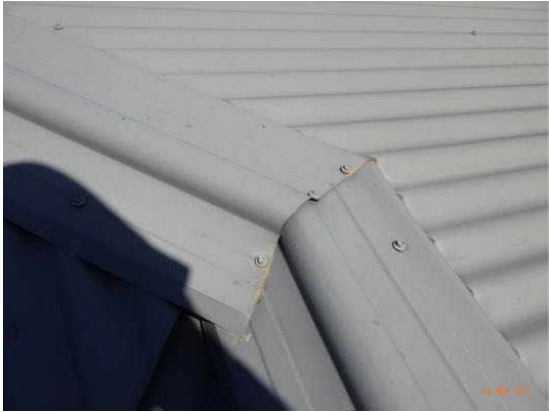
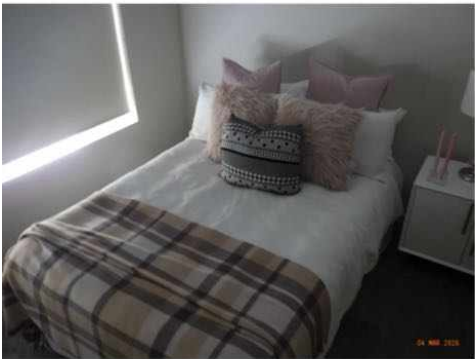
Finding 2.03

Building:	Building 1
Location:	Roof Exterior
Finding:	Water leaks evident to roofing
Information:	It appears that water leaks were evident to a section of the roof at the time of inspection high moisture staining evident to bedroom two.

While Access in the area was not possible due to air-conditioning ductwork the point where the leak appears to be occurring is at a junction in the ridge capping which requires further investigation and repair. .

High moisture and damage to the ceiling is evident while repairs also appear to have been carried out indicating that they leak may not have been addressed properly prior to repairs being carried out.

If the issue is not addressed further damage to all building elements is likely and as such immediate repair is recommended.

Moisture around timber elements also creates an environment that is highly conducive to termite activity.

A licensed roof plumber should be appointed immediately to address the roof leak issues to prevent further moisture damage in the future. Following this a licensed painting contractor should make repairs to the ceiling. Insulation may need to be removed to to ensure no mould exists in the area.

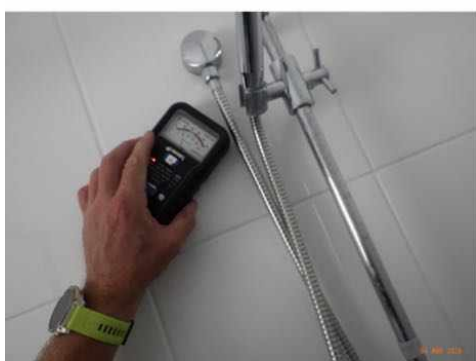
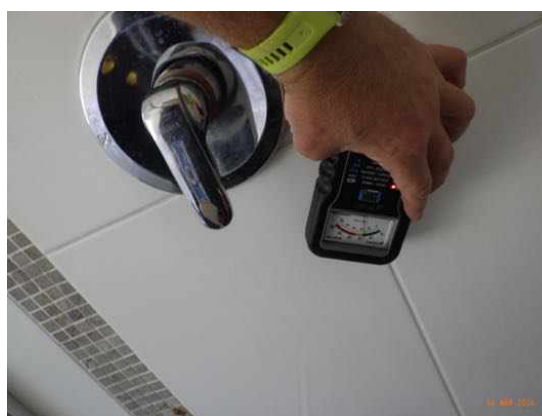
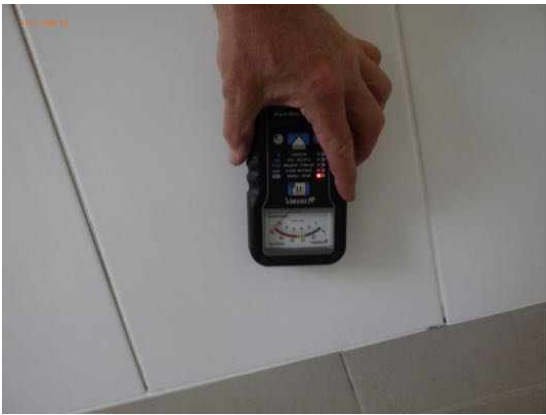
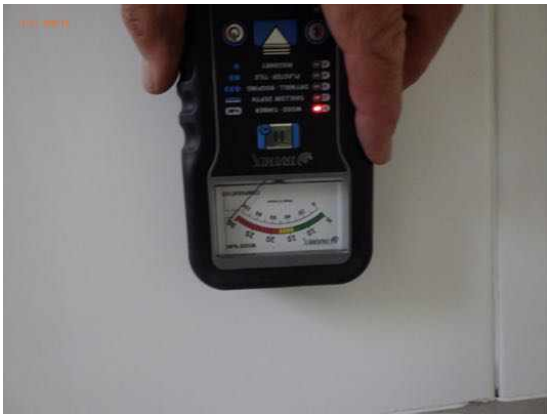
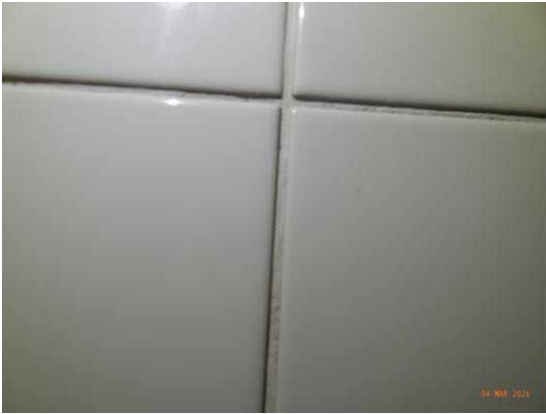
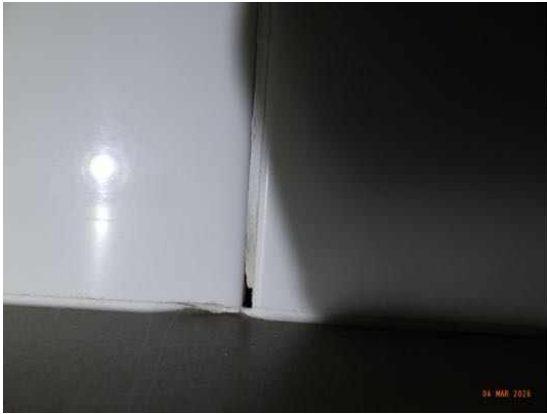
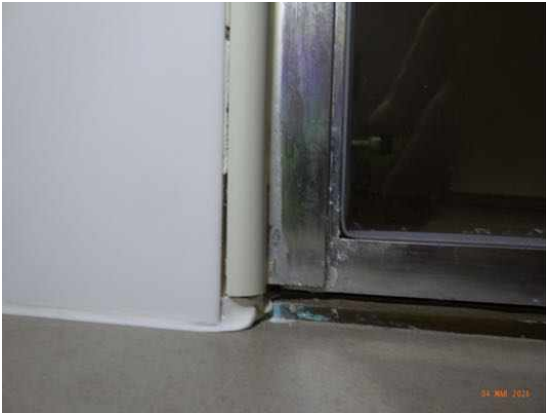
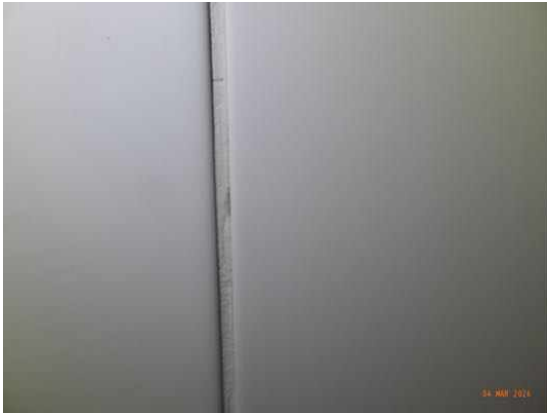
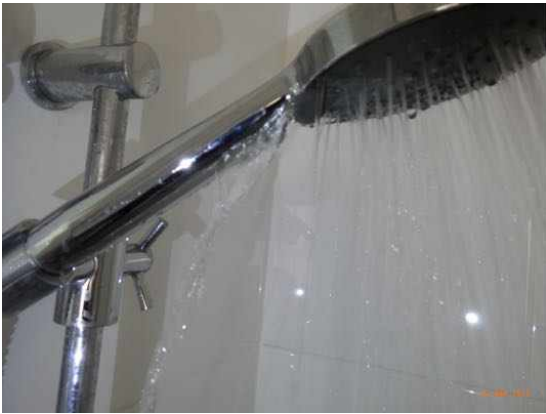
Building: Building 1
Location: Bathroom
Finding: Shower - Damp
Information: Damp is evident to the lower 300mm of wall to the shower alcove.

This defect is quite common, and is suspected to have been caused by moisture permeating through the tiling, grouting and or sealant in this area, which shows evidence of deterioration. The showerhead is leaking heavily on the wall also which is a likely contributing factor.

Leaking pipes within the adjoining wall is also a possible cause however it seems unlikely in this instance as there was no high readings around the taps nor transferring to the other side of the wall.

Unmanaged damp in the shower recess is likely to facilitate the formation and development of mould and fungi growth, decaying associated building materials and compromising their structural integrity. High moisture around timber elements also creates an environment that is conducive to termite activity. Further investigation would likely uncover currently concealed defects.

Consultation with a qualified plumber or bathroom specialist is advised immediately to identify the cause of damp and to perform remedial works as required.

Always ensure that sealant and grout is in good condition to prevent any moisture issues occurring in the future.

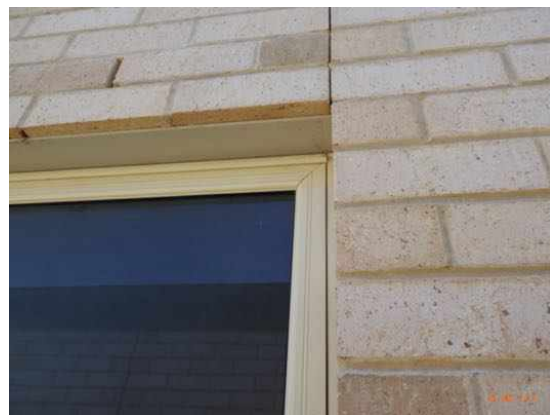
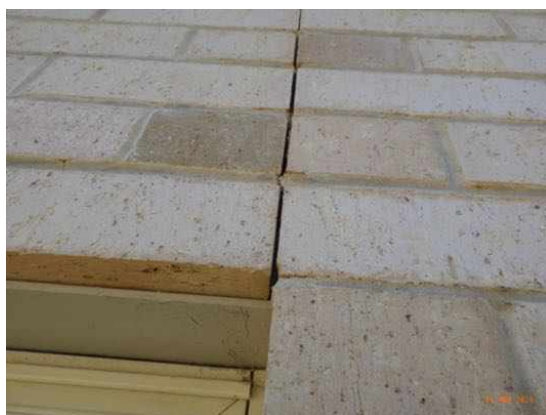
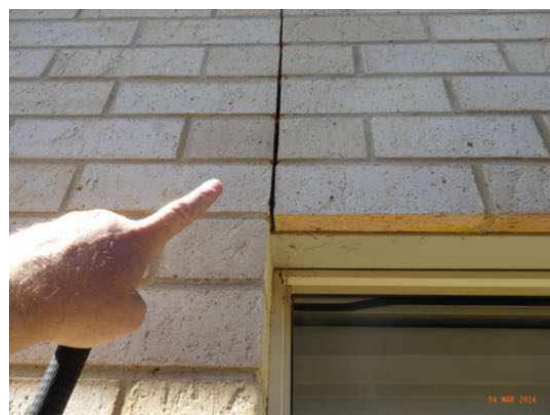
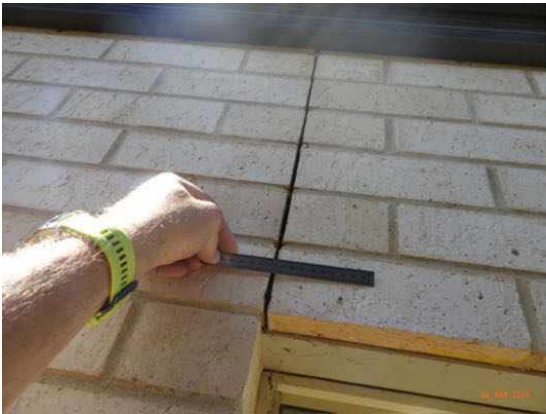
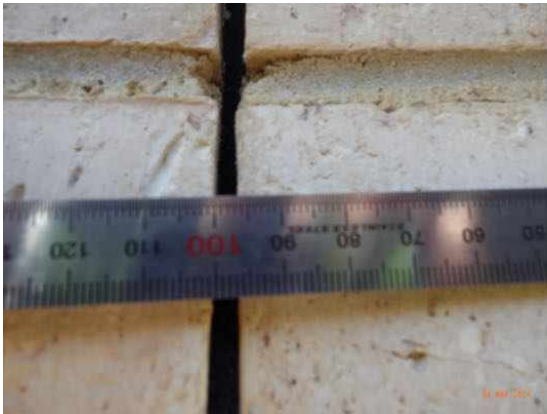
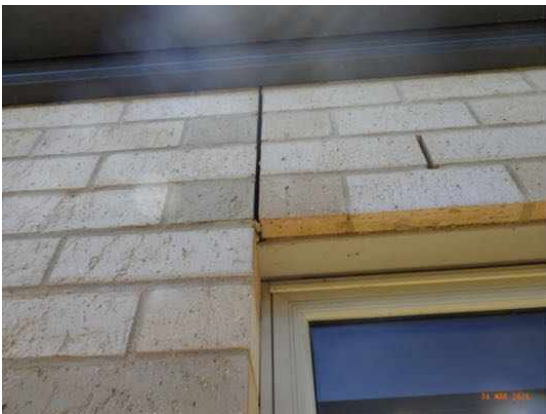
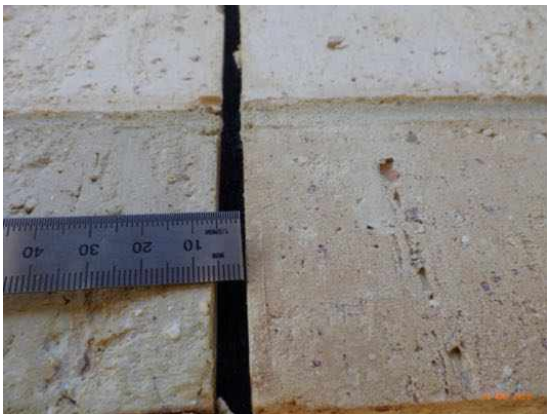
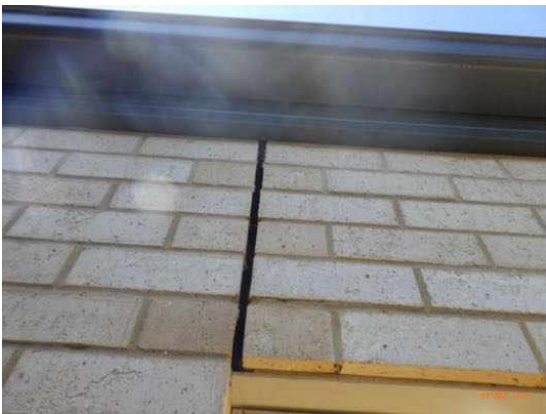
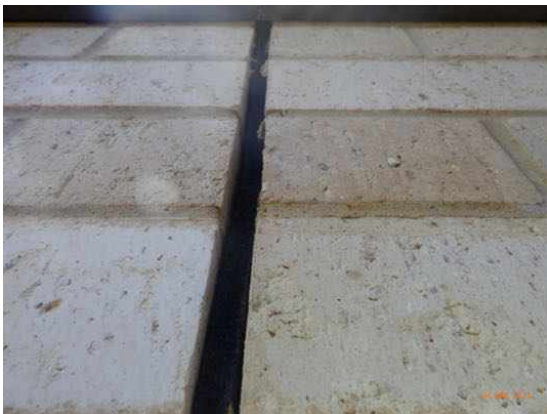
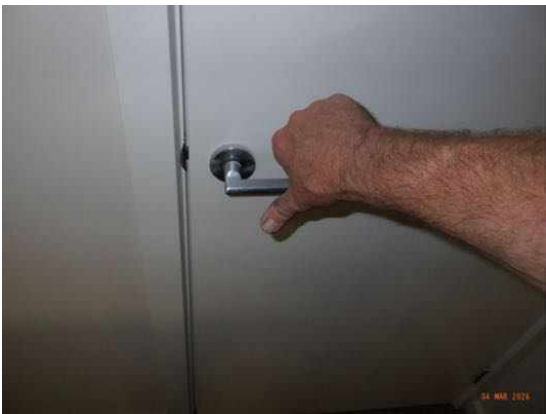
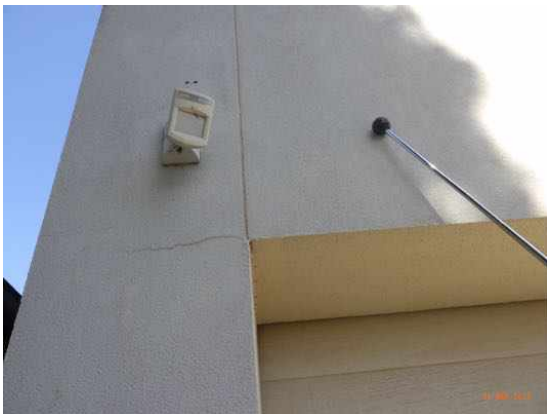
Finding 3.01

Building: Building 1
 Location: Exterior walls
 Finding: Brickwork - Articulation joint compressed, Subsidence
 Information: There were indications of footing movement around windows and doors at the centre of the dwelling on the perimeter walls at the time of inspection. No cracking was evident to the internal walls to these areas.

Other minor cracking is evident to external brickwork.

Movement of this nature can cause cracks in associated building elements along with the requirement to adjust doors over time due to seasonal movement. Pressure could also cause issues with windows and glazing and as such close monitoring of the movement is warranted.

Monitoring the areas is recommended and should any further cracking, or movement become evident then A structural engineer should be appointed immediately to inspect and nominate a scope of works required for rectification.

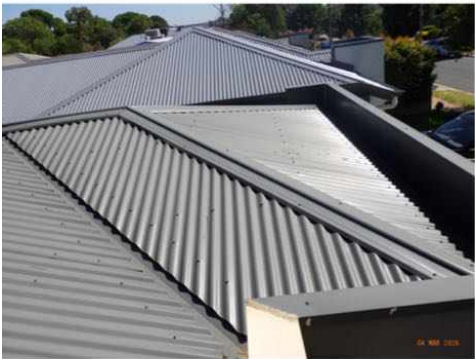
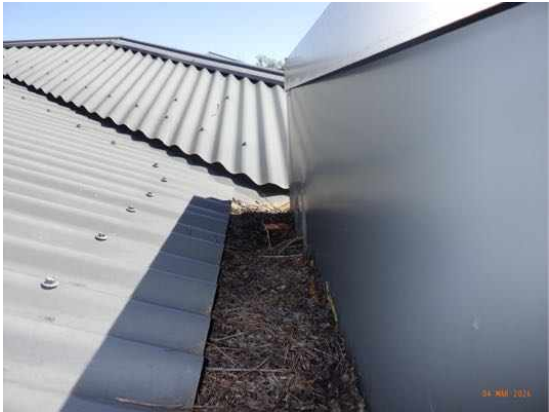
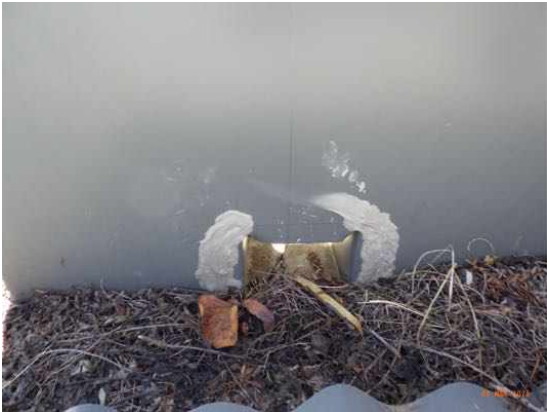
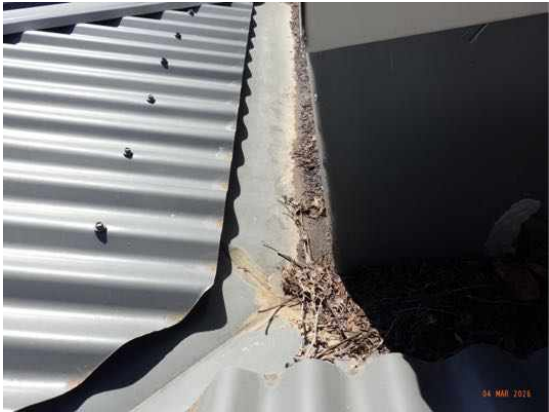
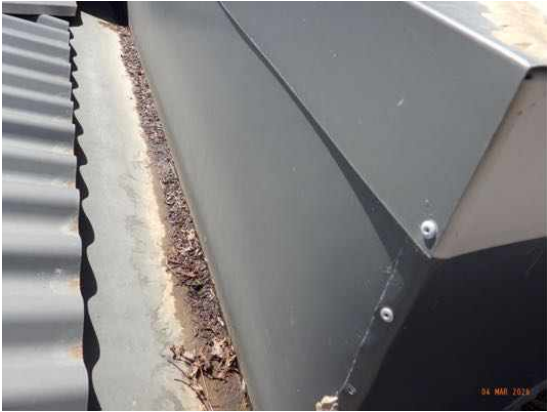
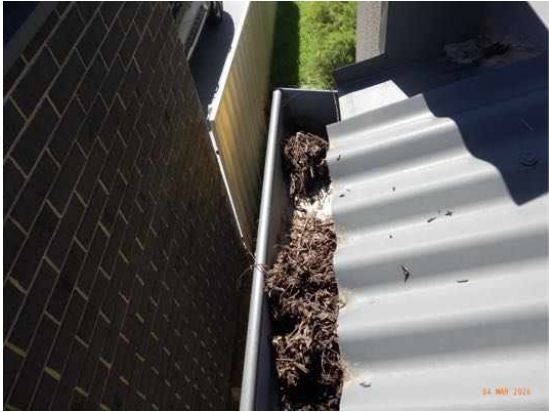
Finding 3.02

Blocked gutters are likely to lead to high levels of moisture in the affected areas. Such

moisture will not only cause rust and decay of the associated building materials, but can also provide conditions that are conducive to termite and timber pest activity. Blockages in gutters should therefore be removed immediately to ensure dry conditions are maintained.

Consult a Licensed Plumber for further specific advice on remedial works that may be required. In the interim, it is highly advised that blocked gutters be removed by the homeowner or a general handyperson as a matter of urgency.

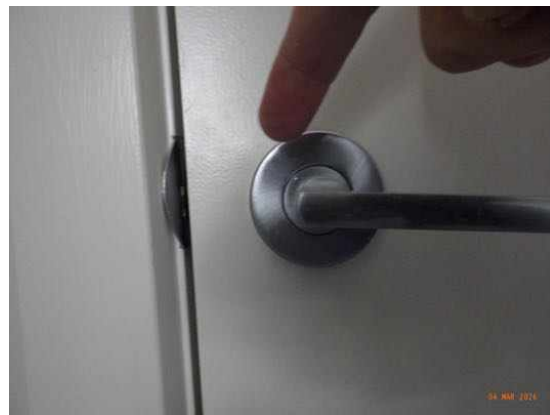
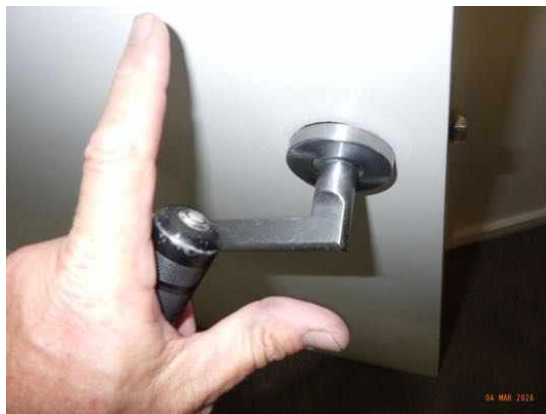
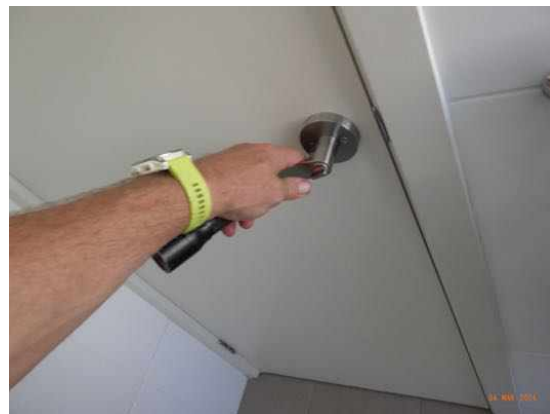
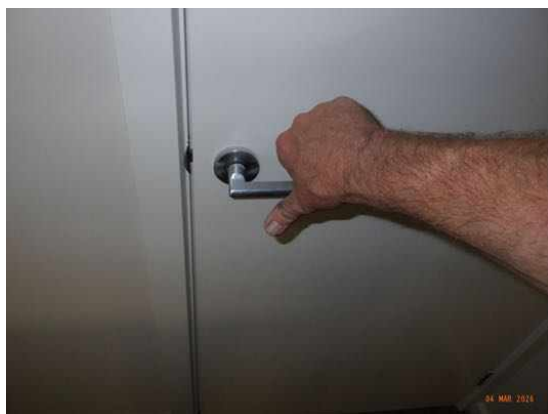
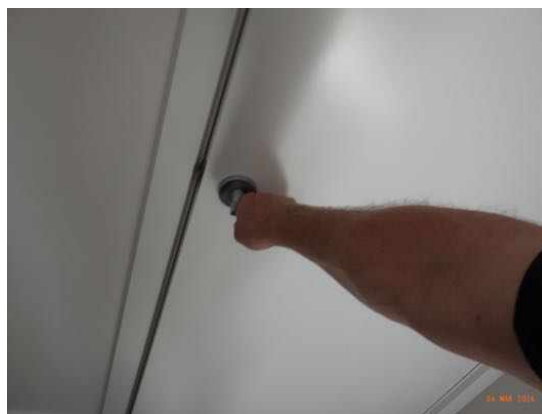
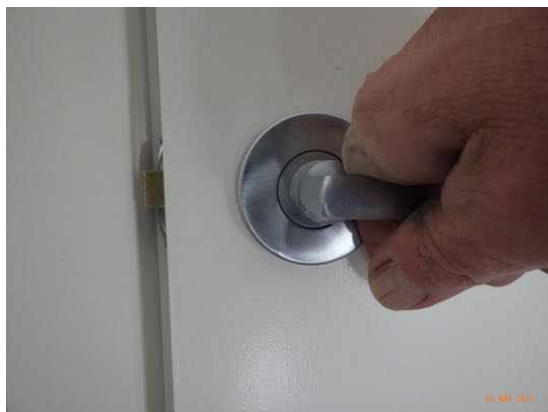
Finding 3.03

Building: Building 1
Location: All Internal Areas
Finding: Several Doors - Striker plate misaligned
Information: The striker plate to several doors appears to have become misaligned and has consequently resulted in the door's operation being compromised.

This is a common defect and is expected in a property of this age, whether being due to substandard installation or general deterioration of the door hardware and or seasonal changes. As movement has been noted to the property this is a likely contributing factor to the doors not striking and rubbing on floor coverings.

Readjustment of the striker plates is recommended at client discretion. Works such as these can be completed by a general handyman or qualified carpenter.

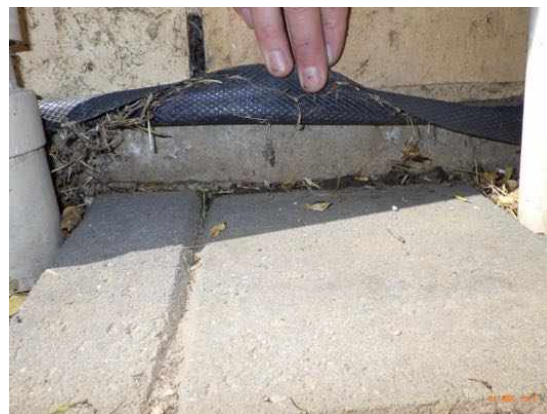
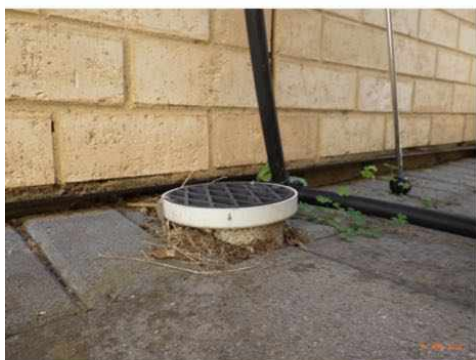
If the slab edge is not properly exposed there is a high risk of concealed termite attack which your inspector will likely not be able to see. Sometimes, in order to determine the type of slab, a suitably qualified person such as an architect or builder may be required to consult construction plans.

Where the slab edge cannot be properly inspected, it is highly recommended that termite or timber pest inspections be carried out every 6-12 months to aid protection of the property against infestation and termite treatment advice is followed closely.

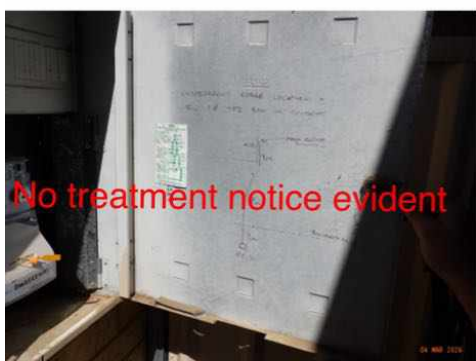
Finding 6.02

Building:	Building 1
Location:	All Areas
Finding:	Termite Management System - no evidence of a chemical installation
Information:	The application of a post-construction chemical termite barrier is highly recommended for all properties, particularly if live termite activity has been found on the site previously. Such barriers are highly effective in preventing termite attack on any timber building elements throughout the property.

At the time of inspection, it appeared as though no termite management system has been installed, with no evidence to suggest preventative works taking place.

The client may consider gaining further advice from a pest controller as to the costs and procedures involved with this application. It is recommended that obtaining such advice be a short-term priority.

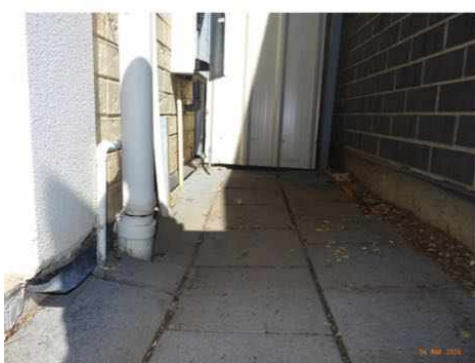
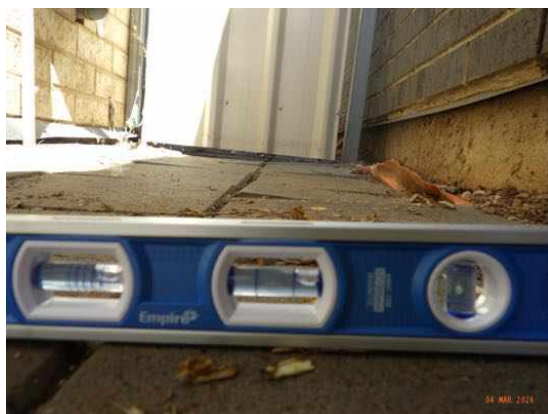
Finding 6.03

Building:	Building 1
Location:	Yard - Side

Information: The perimeter paving or ground levels were found to have an inadequate slope away from the adjoining building structure, creating potential for water pooling in this area.

This standard ensures that excessive moisture does not pool around the base of building structures, which creates potential for water and structural damage, as well as making the area susceptible to termite and timber pest activity.

Where paving or ground levels do not have adequate fall, a licensed paving contractor should be appointed to install or remove and re-level pavement.

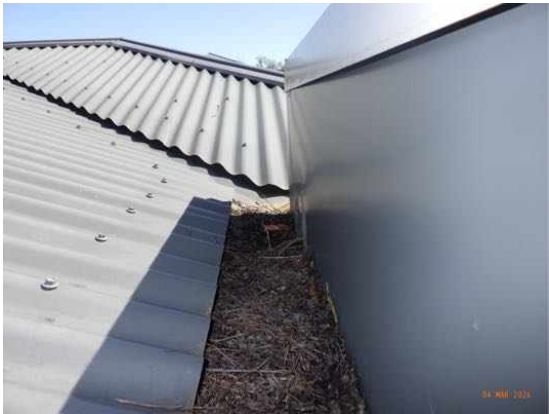
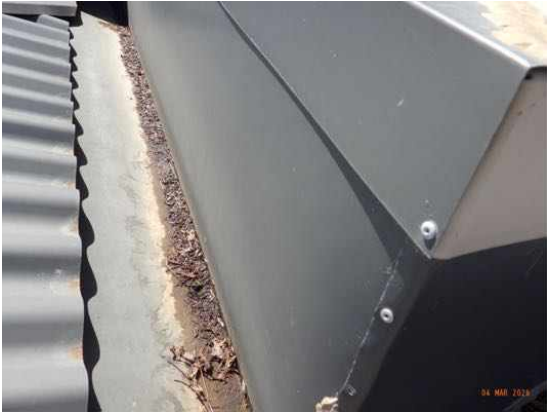
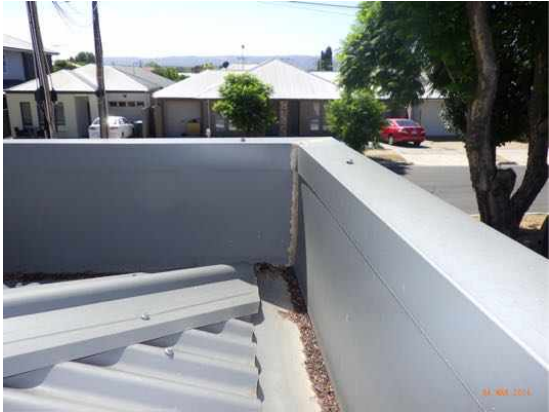
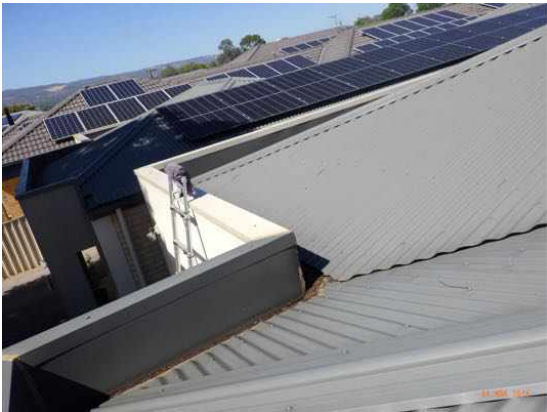
Building: Building 1
 Location: Roof Exterior
 Finding: Box gutters non compliant pre purchase.
 Information: It was noted that compliance issues exist with the box gutter system on the roof, main issues being

- V gutters installed instead of box gutters.
- Non compliant outlet size
- Non compliant overflow to rainheads
- Gutter changing direction
- Some areas have inadequate fall

Monitoring the areas recommended and should issues arise then a licensed roofer should be appointed to give advice quotation and make repairs to ensure no leaks in the future.

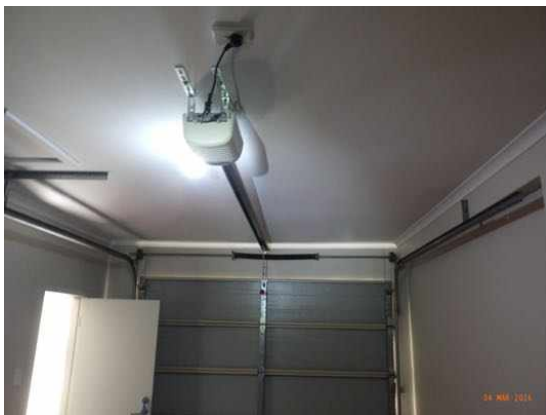
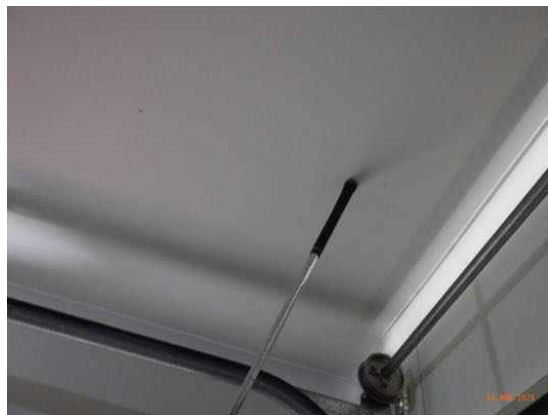
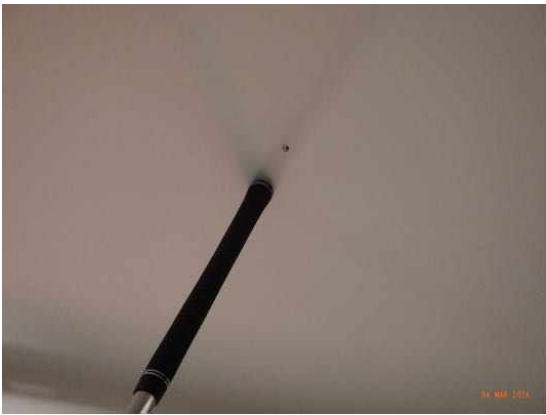
Information: A very common defect found in garages is that the ceiling can sag over time, due to their lack of insulation and or their susceptibility to moisture. Condensation builds up in the roof and rests on the plasterboard softening it somewhat which makes it more likely to sag and release from its fixing points. Moisture evaporating from cars can also contribute to this issue.

Therefore we recommend that you insulate your garage and also apply a good coat of washable paint to the ceiling of the garage to prevent any moisture entering the plasterboard and creating issues in the future.

A licensed building insulation installer and licensed painting contractor could be appointed to carry out these works at the discretion of the client.

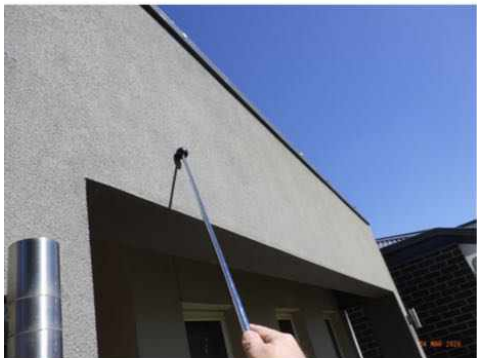
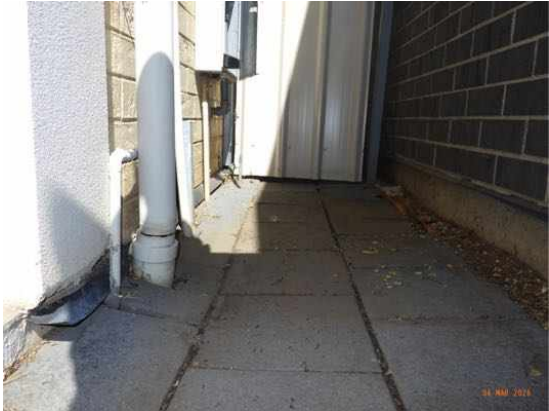
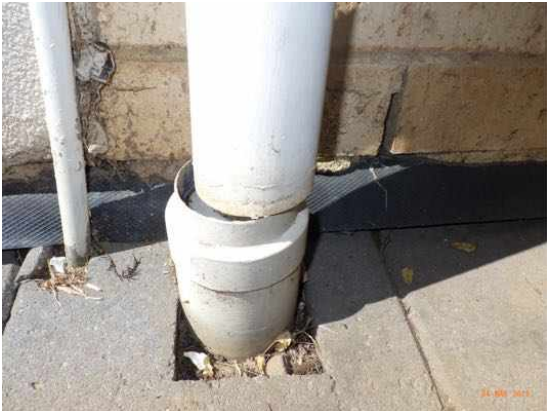
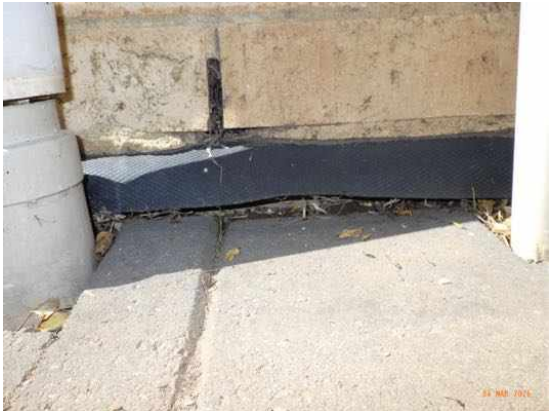
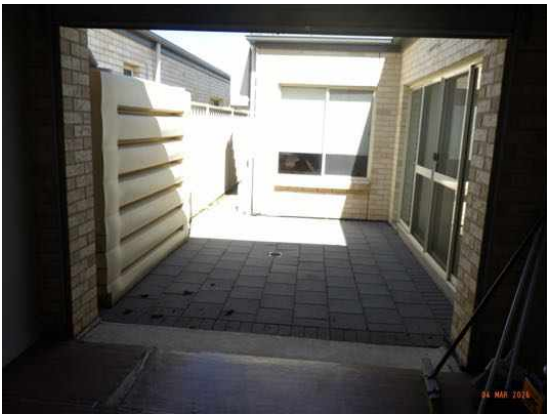
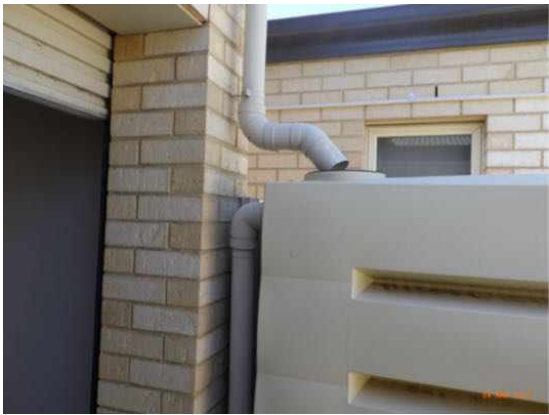
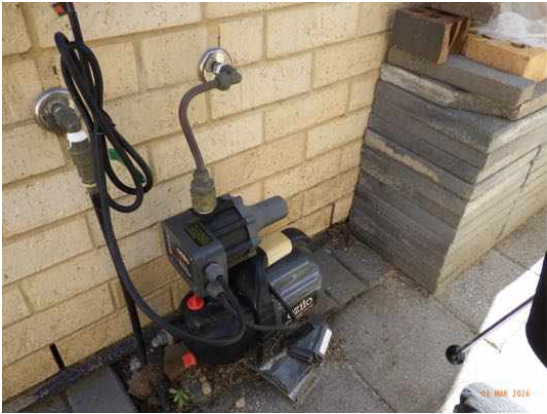
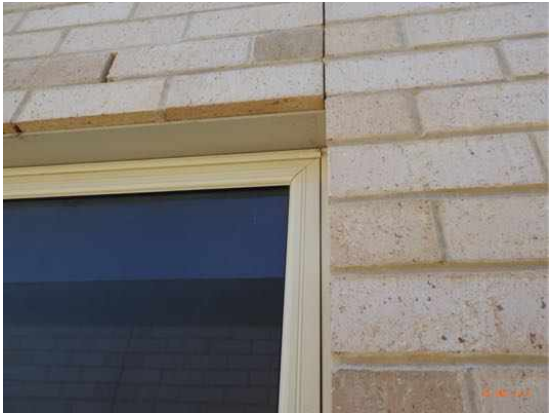
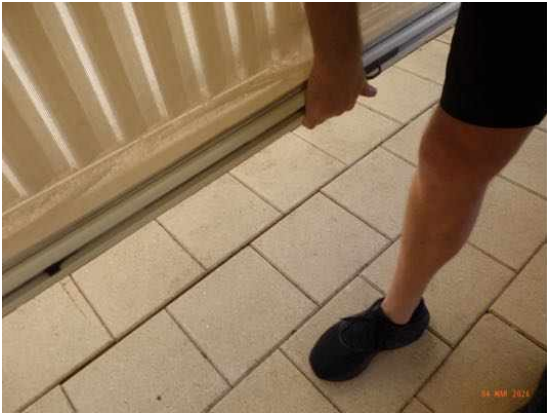
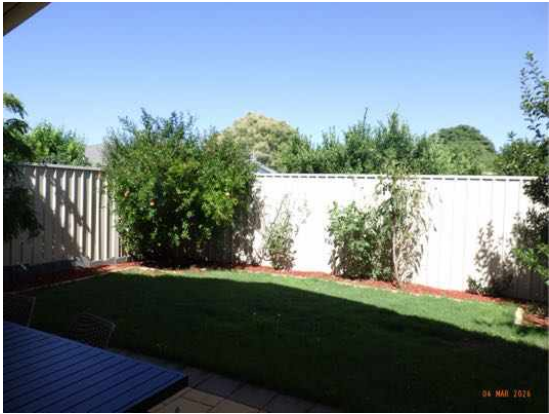
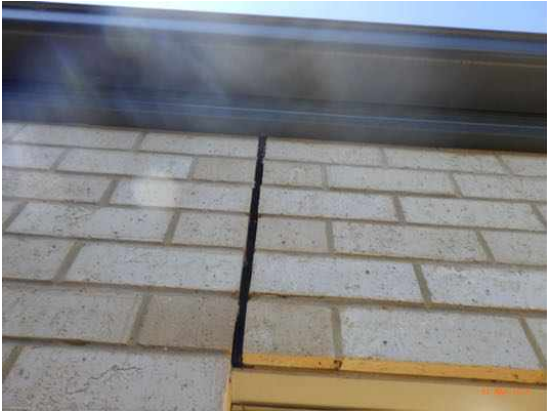
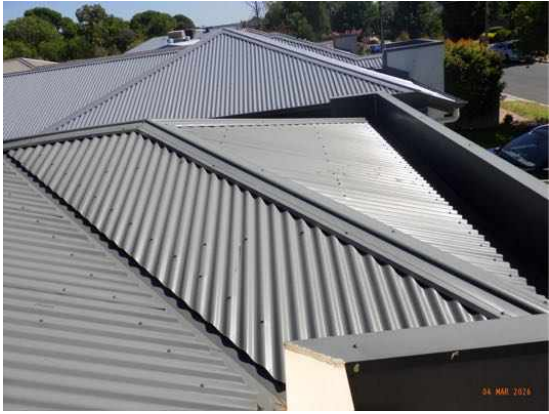
Building: Building 1
Location: All Areas
Finding: Additional Photos - Obstructions and Limitations
Information:

These photographs are an indication of the obstructions and limitations which impeded full inspection of the property at the time of inspection. These obstructions can hide an array of defects and should be removed to allow full inspection to be carried out.
