Building and Timber Pest Inspection Report

Inspection Date: Tue, 31 Mar 2026

Property Address: 195 Willigobung Rd, Willigobung NSW
2653, Australia

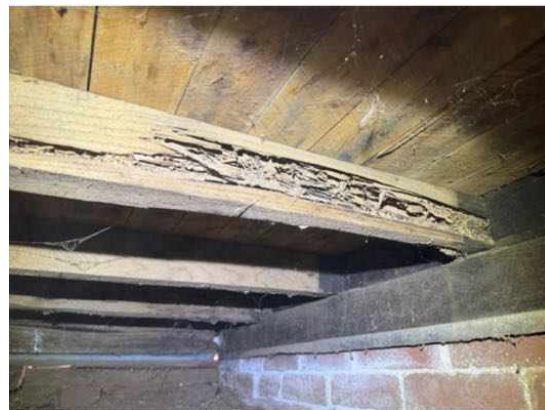
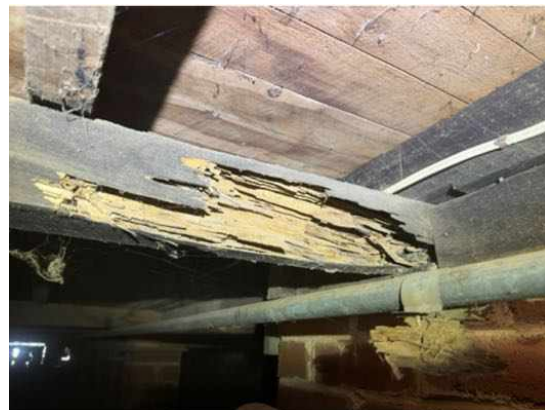
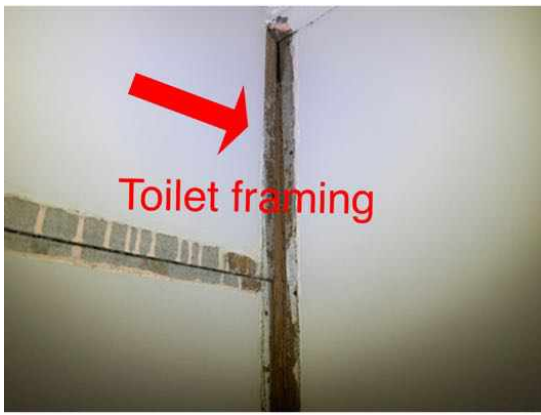
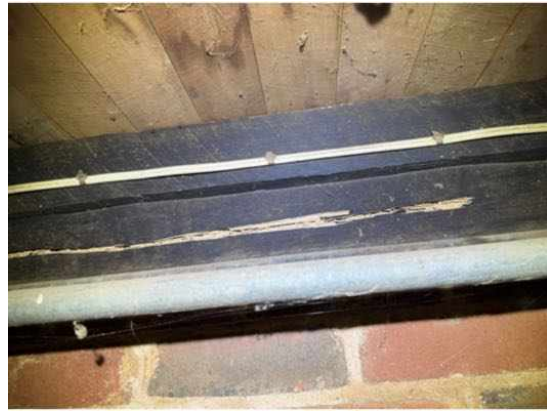
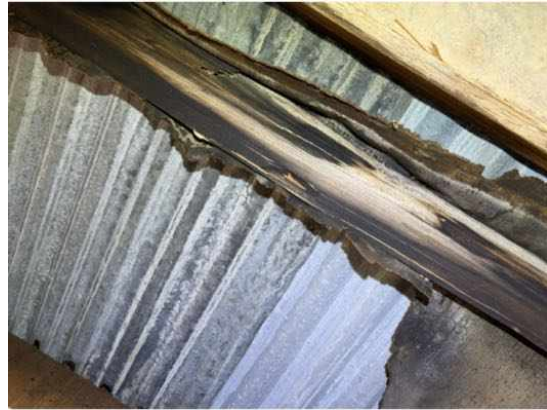
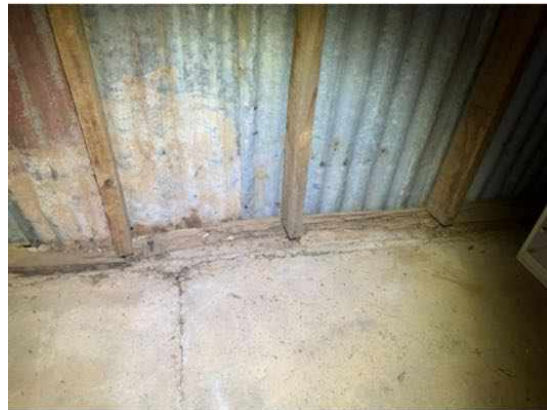
Finding 2.01

Building: Main Building
Location: Subfloor framing, Shed Framing & Beams
Finding: Evidence of termite damage - Subfloor & Shed Framing
Information: Termite damage was identified throughout some structural members in the subfloor area, toilet wall framing & the shed framing & beams. This affects the structural integrity of the building & shed and therefore should not be neglected. A more invasive inspection is recommended to identify the extend of the damage.

A registered builder should be engaged promptly, to conduct a more invasive inspection & replace all damaged structural building materials. A more invasive inspection may reveal secondary building defects.

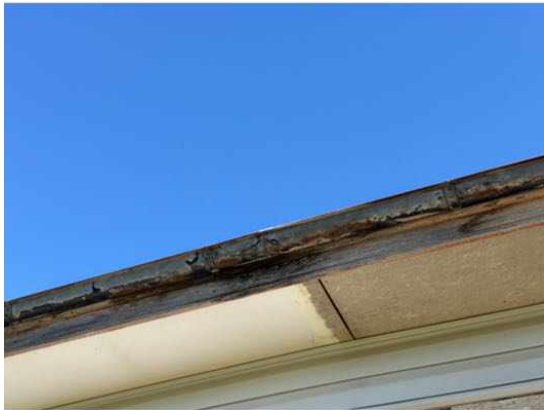
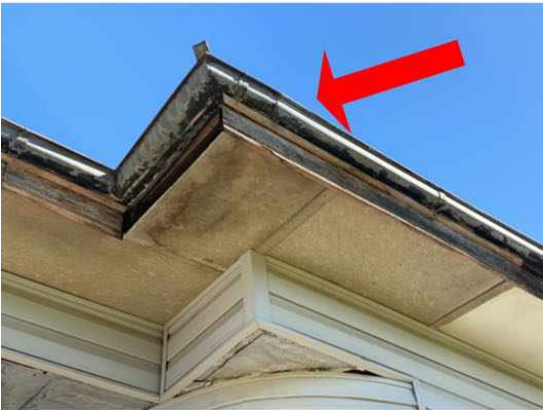
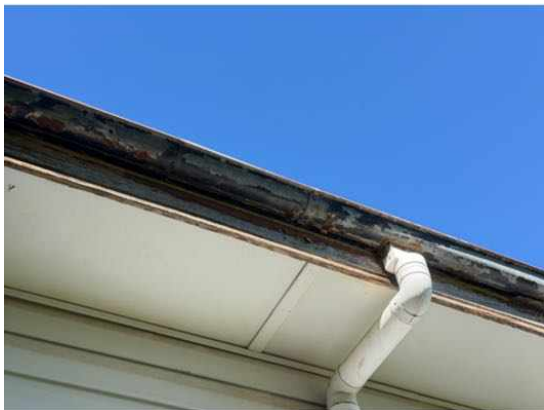
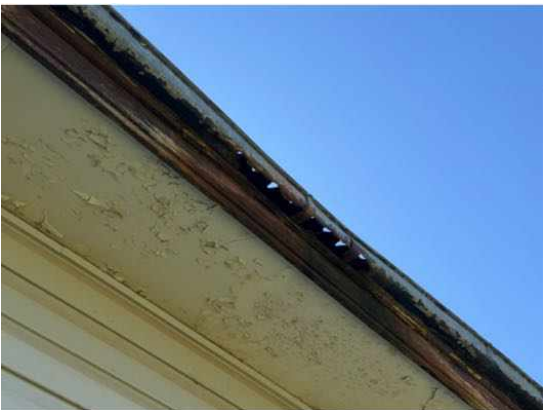
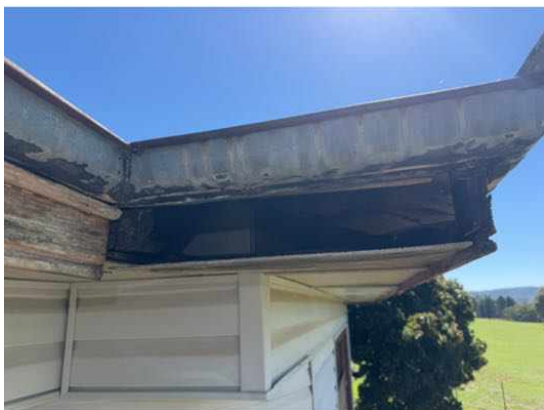
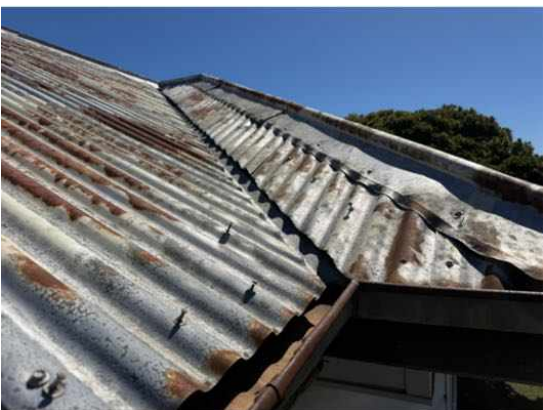
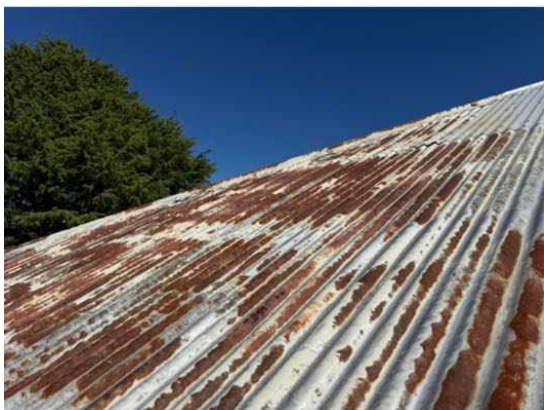
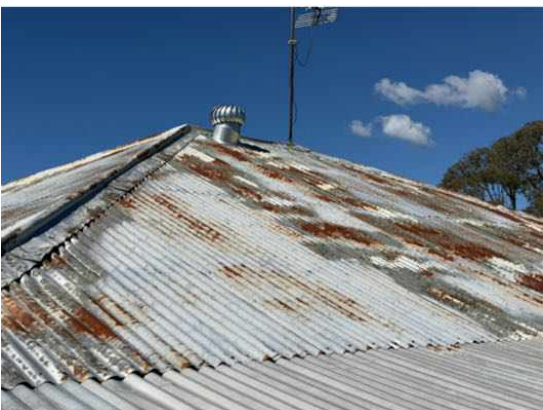
Finding 2.02

Building:	Main Building
Location:	Roof sheeting, gutters
Finding:	Roof plumbing & Roof sheeting - Rusted & Loose
Information:	It appears that extensive rust and deterioration is present to gutters and roof sheeting. Areas of loose roof sheeting & screws were also noted. It appears this has led to leaking of the roof exterior, & the development of holes in the gutters.

A licensed roof plumber & roofing contractor is required promptly, to provide further advice on replacement works needed to prevent further leaking & the development of secondary building defects.

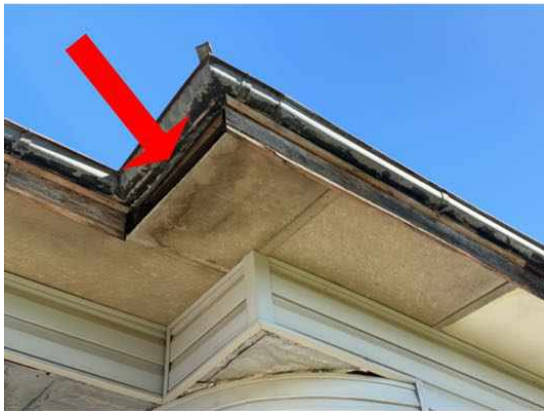
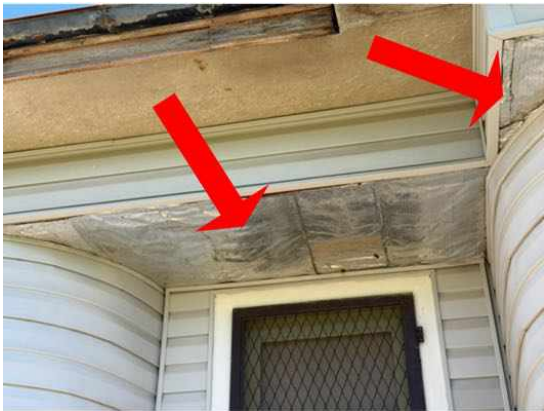
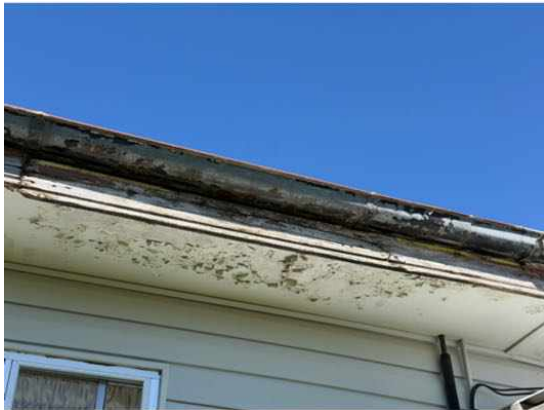
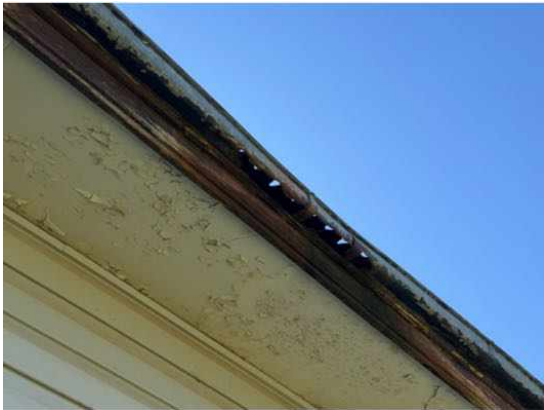
Finding 3.03

Finding: Eaves - Water Staining & Unsealed / Unfinished

Information: It appears that water staining is present throughout areas of the external eaves. This defect has likely been caused by leaking of associated roof plumbing. It appears some eaves were missing at the front of the building & should be installed.

Recommend engaging a licensed roof plumber to provide remedial works to associated roof plumbing, and a licensed carpenter to install eaves where needed.

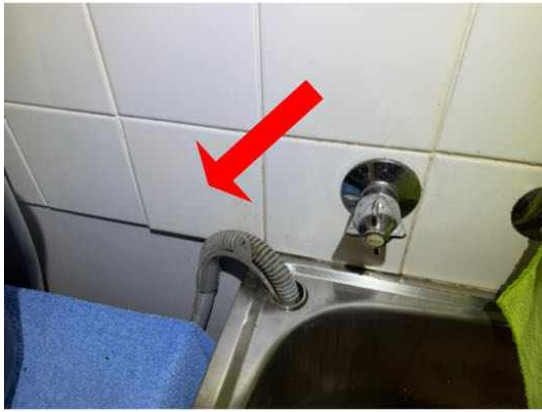
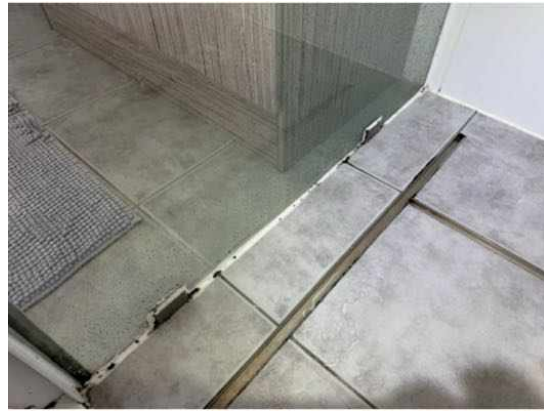
Finding 3.04

Building: Main Building
Location: Tiled Areas
Finding: Sealant / grouting - deteriorated or missing & Drummy / Cracked Tiles
Information: It appears that the sealant and grout has deteriorated in some tiled areas, a common defect in buildings of a similar age. Areas of cracked & drummy tiles were also noted, which can allow for moisture ingress behind the tiles, if neglected.

Recommend engaging a licensed tiling contractor in the short term, to provide maintenance works where necessary.

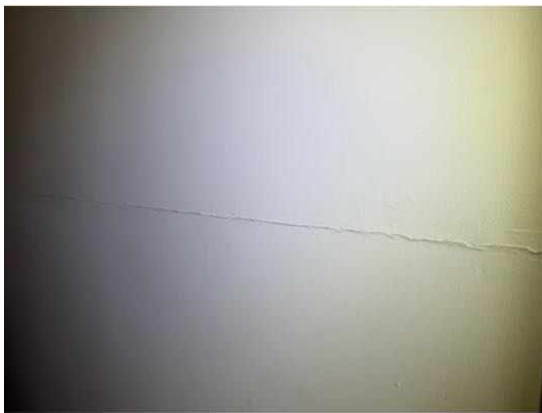
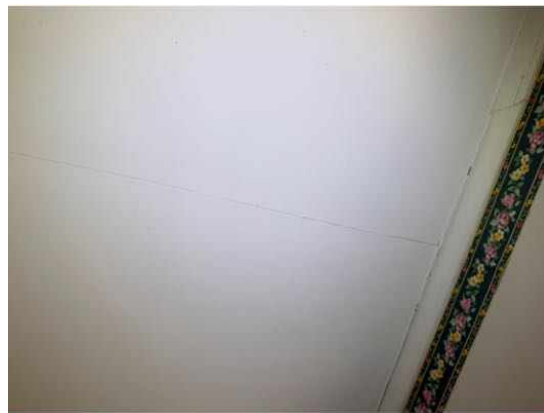
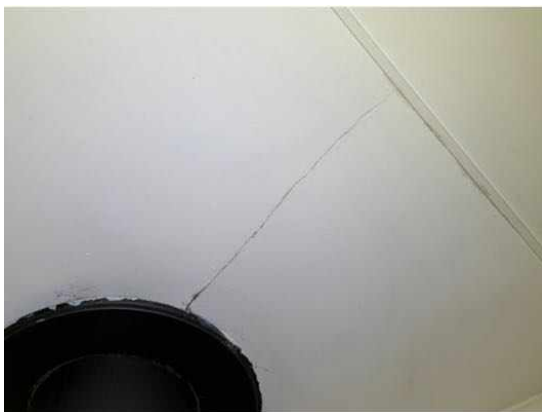
Finding 3.05

Finding: Plaster - Cracking

Information: There appears to be cracking in some areas of the ceiling and wall linings throughout the building. Cracking of this type is common in buildings of a similar age. It is advised that the client monitor these areas.

Should cracking widen, lengthen, or become more numerous, the client should consult with a structural engineer promptly, for further evaluation.

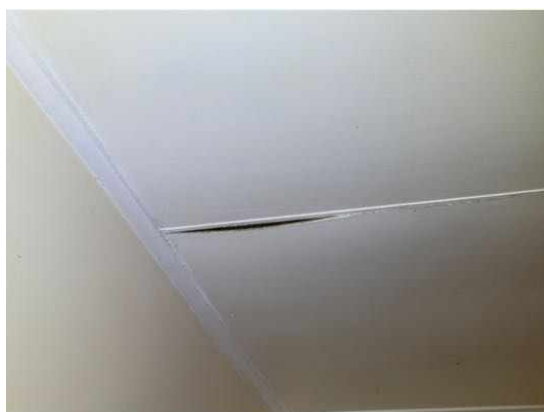
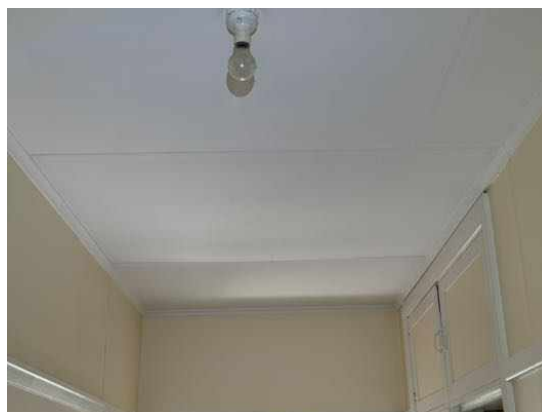
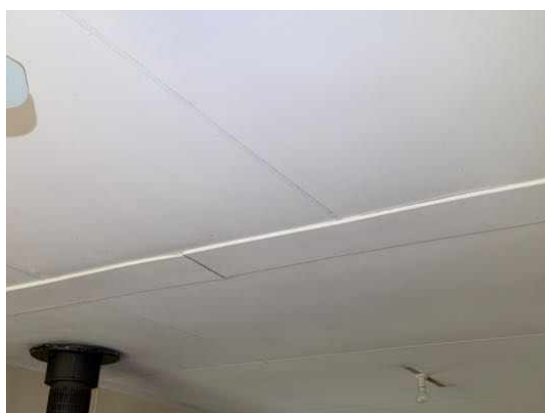
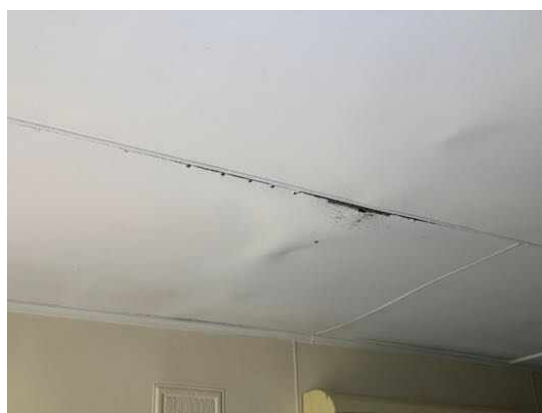
Finding 3.06

Building:	Main Building
Location:	Lounge Room, Hallway
Finding:	Ceiling - Sagging
Information:	Sections of the ceilings at but not limited to, the hallway & lounge room were found to be sagging. Causes of ceiling sagging include fixings (e.g. nails or glue) that have become loose and require re-fixing or associated leaking.
	Recommend engaging a licensed plasterer / carpenter at clients discretion to provide remedial works where necessary.

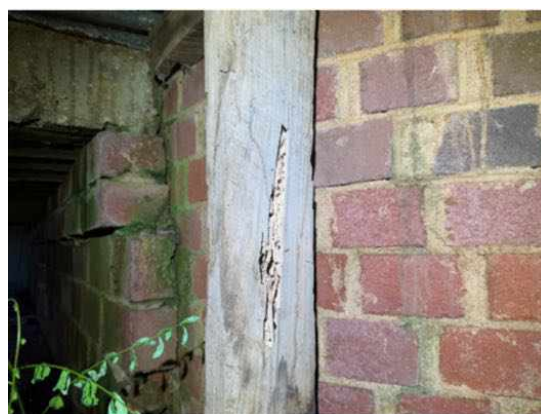
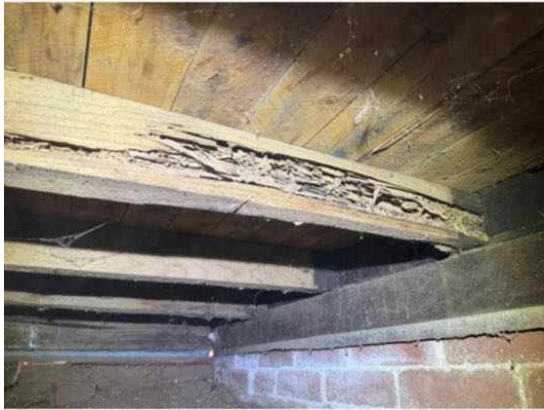
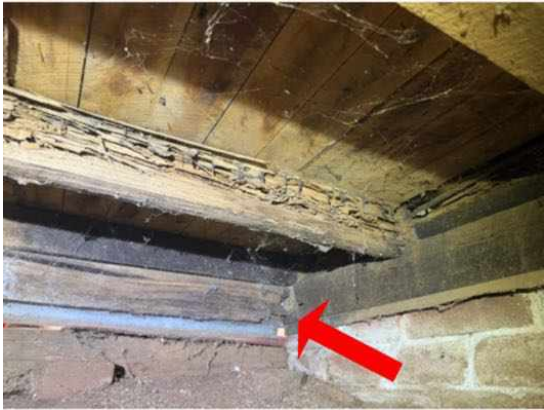
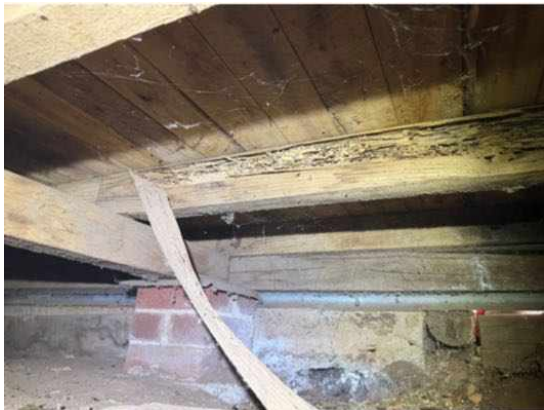
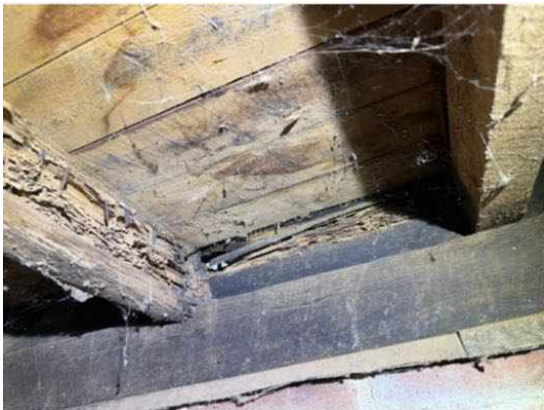
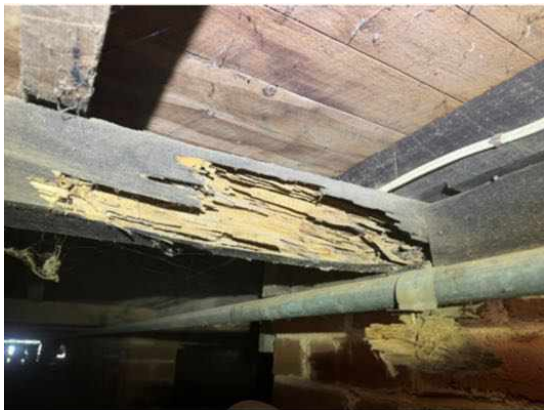
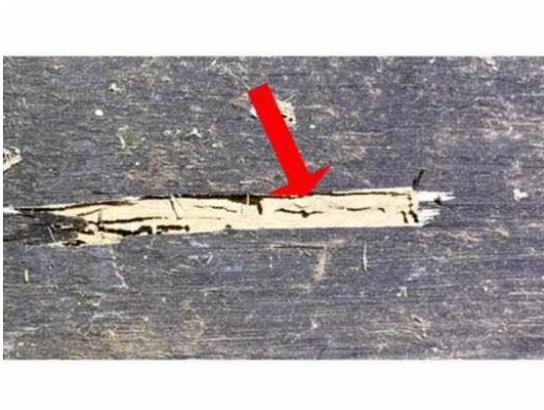
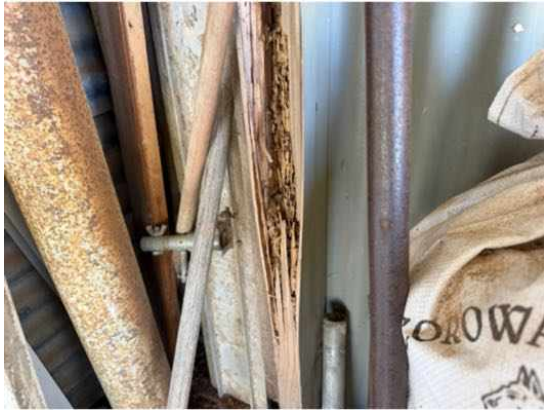
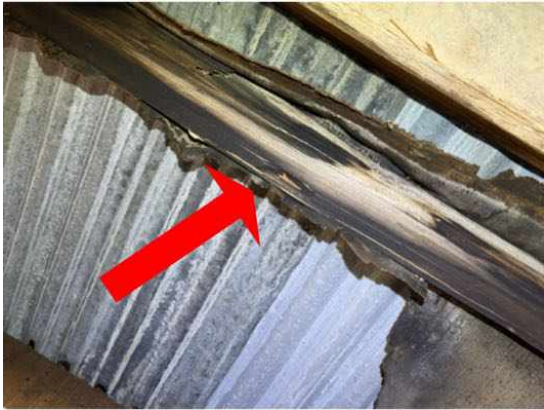
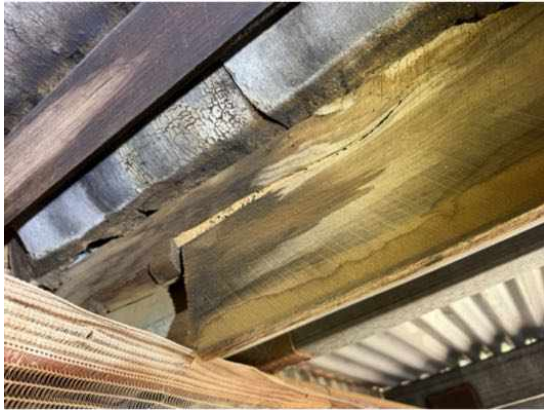
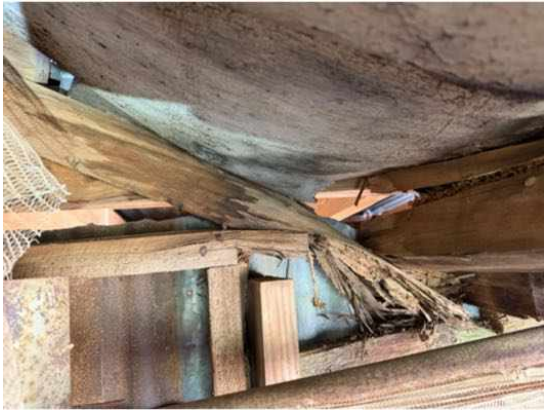
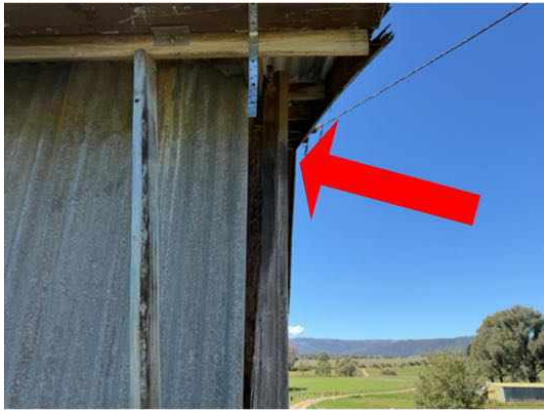
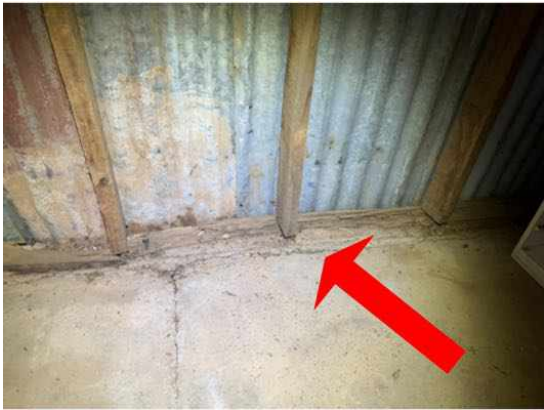
Finding 5.01

Building:	Main Building
Location:	Subfloor, Shed Framing, Toilet framing, Trees
Finding:	Evidence of termite workings & damage
Information:	Termite damage & workings were identified at, but not limited to, some subfloor timbers, areas of the shed framing, toilet wall framing and trees. For areas where structural damage has occurred (shed framing, subfloor framing, toilet wall framing) a registered builder should be engaged promptly to replace affected materials.

The client should engage a licensed pest controller promptly, to provide further advice regarding installation of a termite treatment. A more invasive inspection is also recommended to identify the extent of the damage. 6 monthly ongoing termite inspections, conducted by a qualified termite inspector, are also recommended

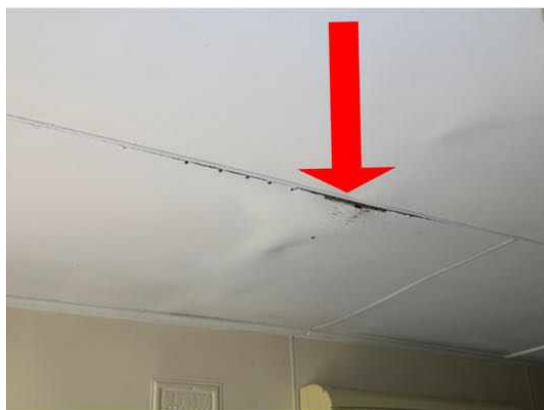
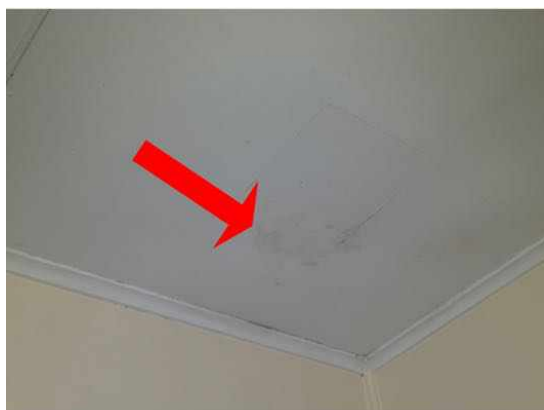
Finding 6.02

Building:	Main Building
Location:	Lounge Room Ceiling
Finding:	Ceiling Leaks
Information:	High moisture was identified at, but not limited to areas of the lounge room ceiling, which is suspected to be caused by the deterioration of the roof exterior. This creates an environment conducive to termite activity. Recommend engaging a licensed roof plumber or roofing contractor promptly to provide remedial works where necessary.

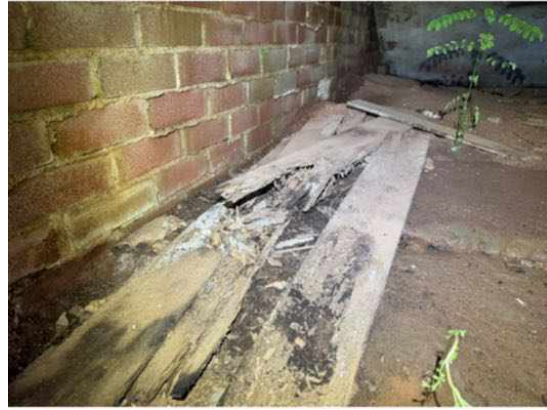
Finding 6.03

Building:	Main Building
Location:	All External Areas
Finding:	Timber in direct ground contact & trees - conducive to termites
Information:	Where timber materials are in direct contact with the ground and consequently moisture, they become conducive to termite activity. The tree stumps, shed framing, timber debris in the subfloor, and trees surrounding the building create an environment conducive to termite infestation.

Where feasible, any timbers in direct contact with the ground should be removed and any trees in close proximity to the building should be removed or test drilled (inspected) at least annually to reduce the risk of termite infestation & detect any early signs of termite activity.

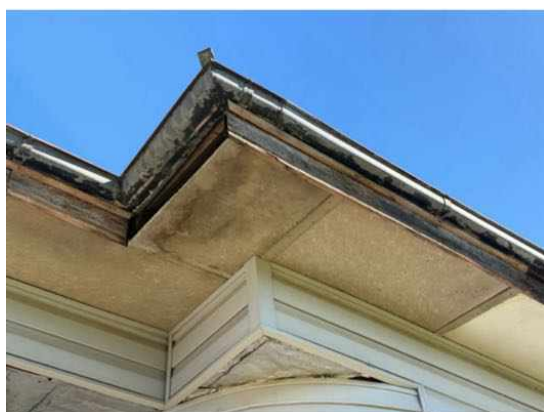
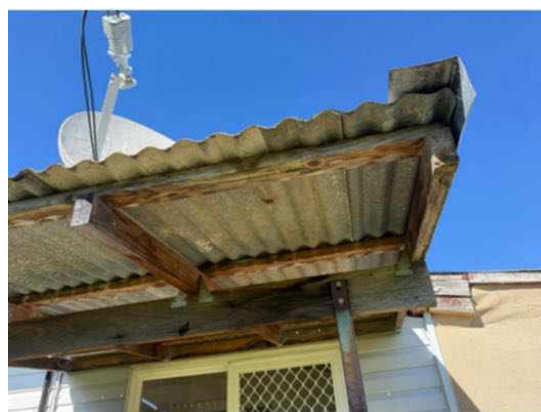
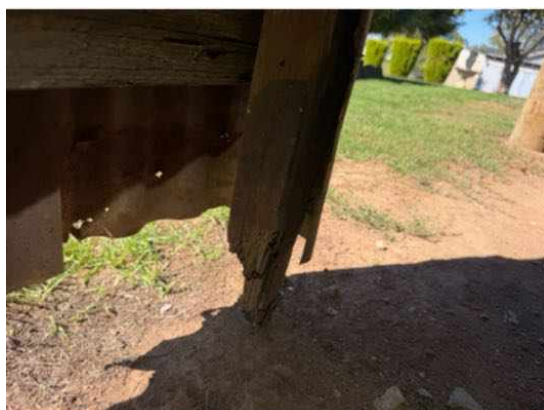
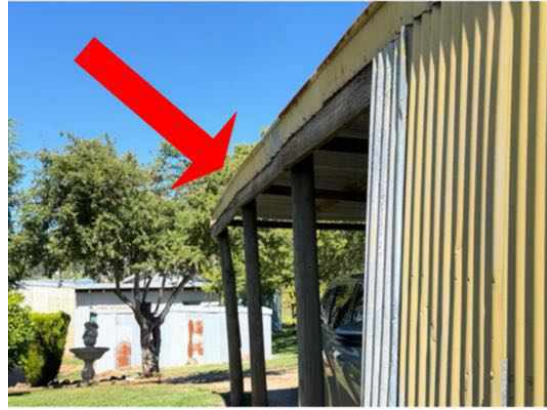
Finding 7.01

Building:	Main Building
Location:	Subfloor, shed frames, window frames, fascia's, beams
Finding:	Fungal decay & weathering
Information:	Areas of fungal decay (wood rot) & weathering were identified at but not limited to some subfloor timbers, shed framing & posts, window frames, fascia's, and the patio beam.

For areas where structural timbers are affected by wood rot (patio beam, shed posts, subfloor timbers) a registered builder should be engaged promptly to replace affected materials where necessary.

For areas where fungal decay is superficial, the client can engage a licensed carpenter at their discretion to replace affected materials. For areas of general weathering, it is advised the client engage a licensed painter to apply protective sealant or coating to areas of weathered external timbers.

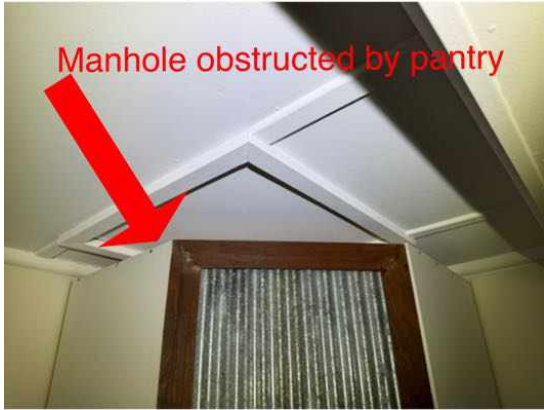
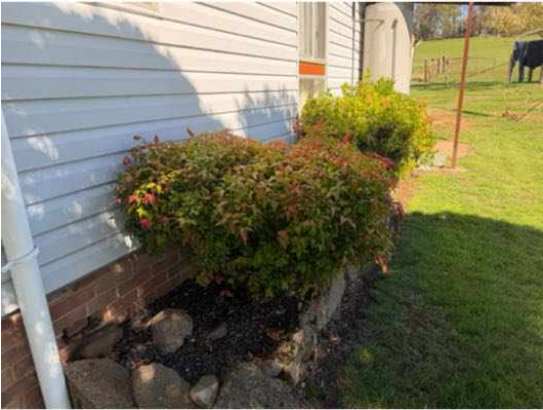
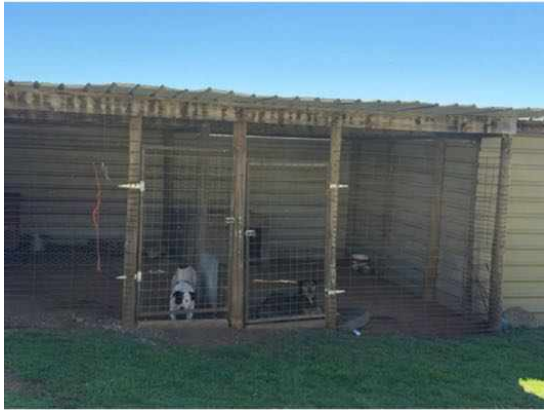
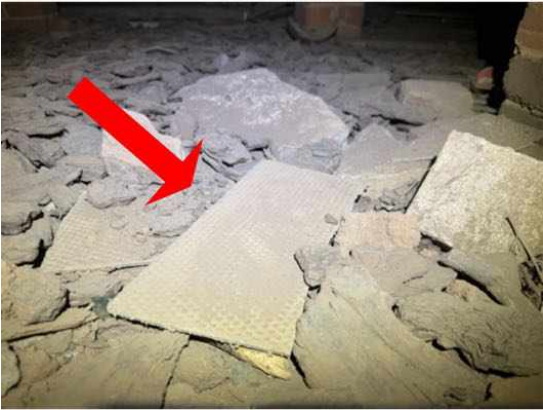
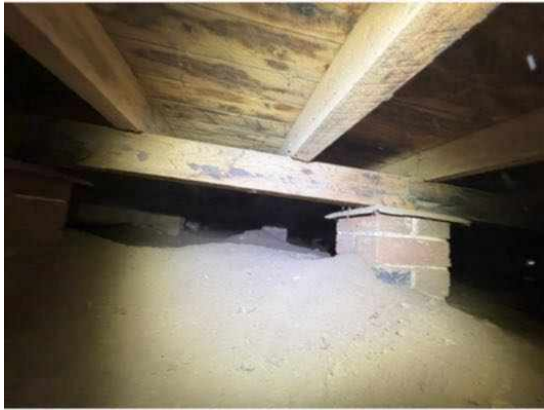
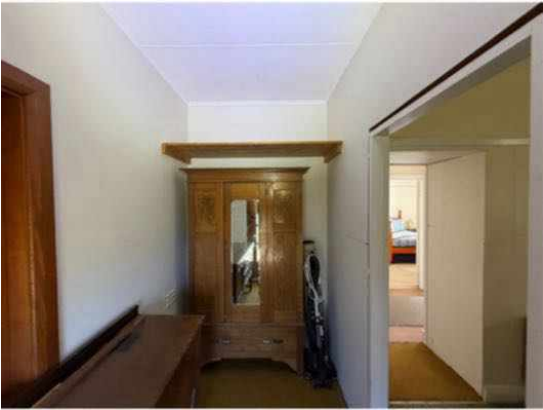
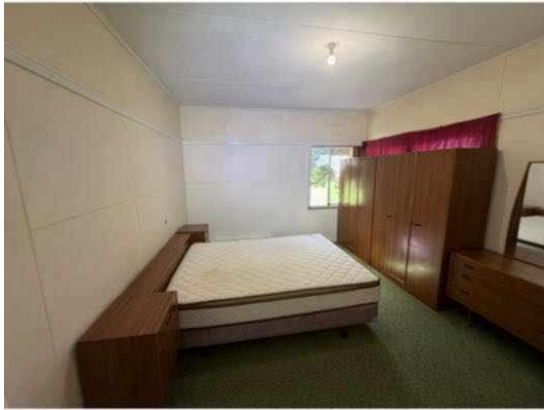
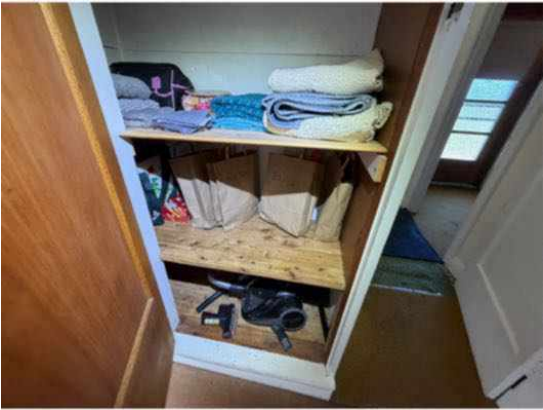
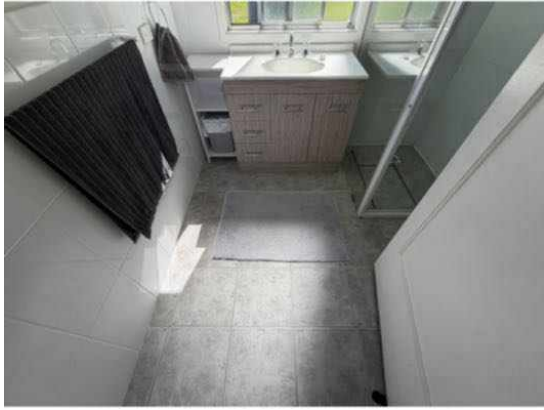
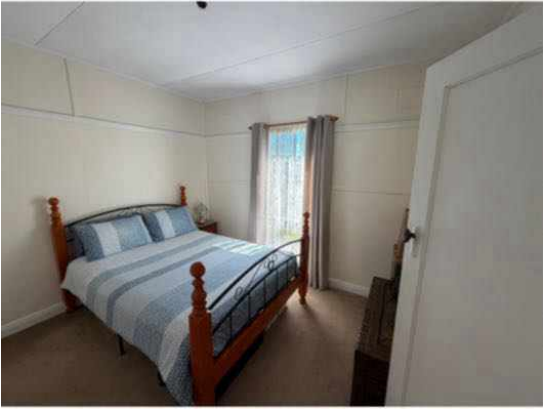
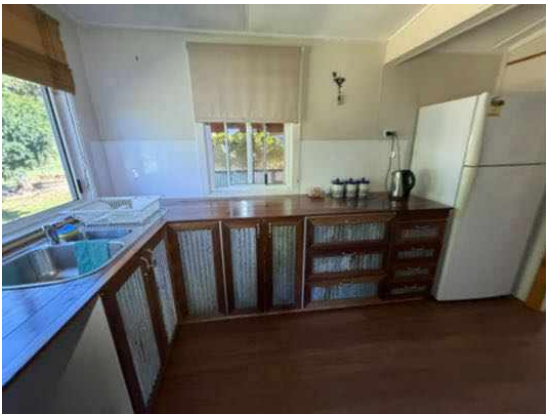
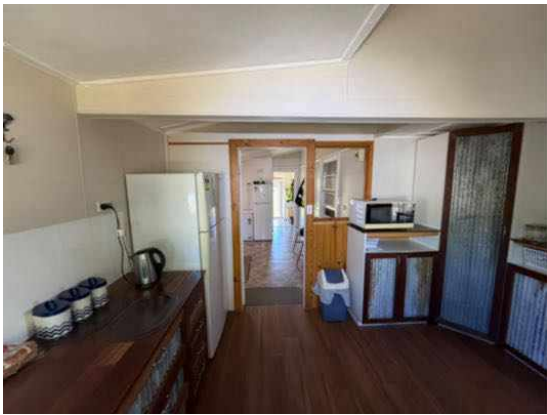
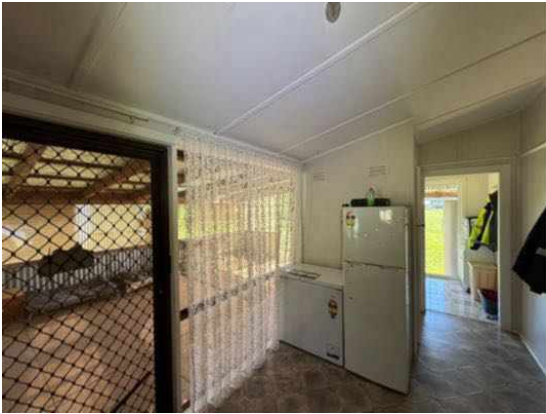
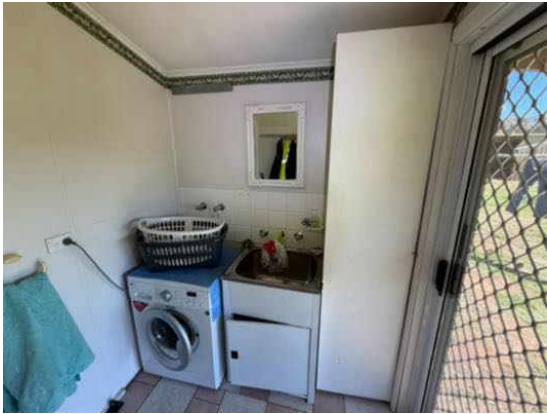
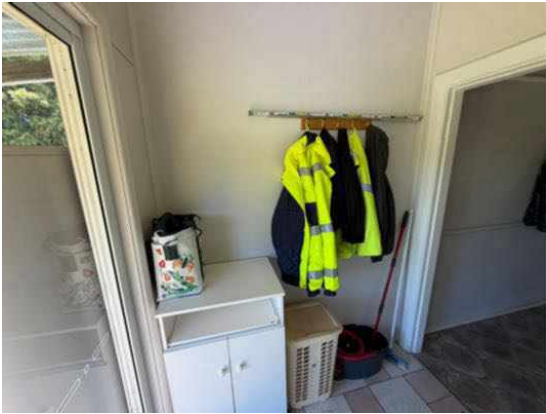
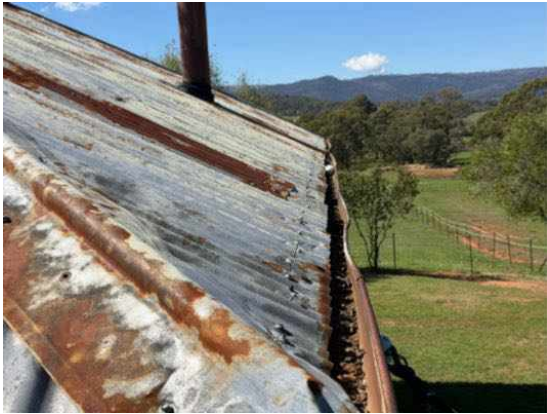
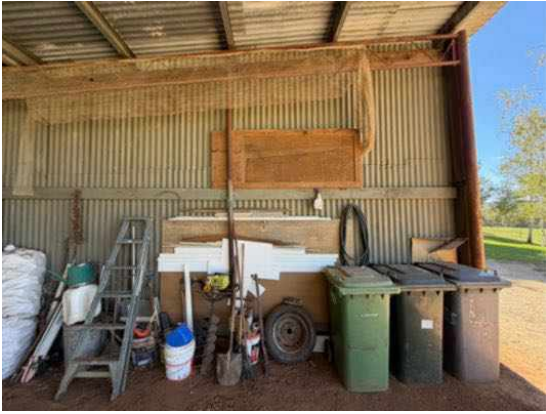
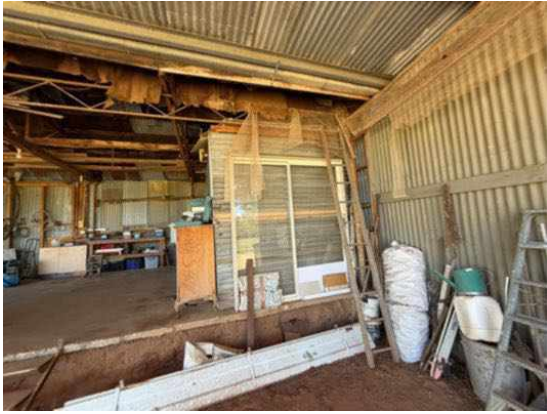
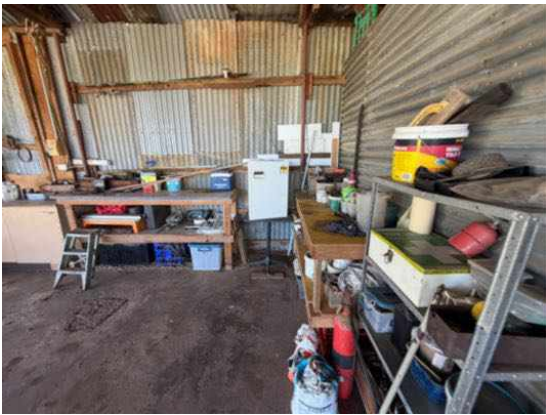
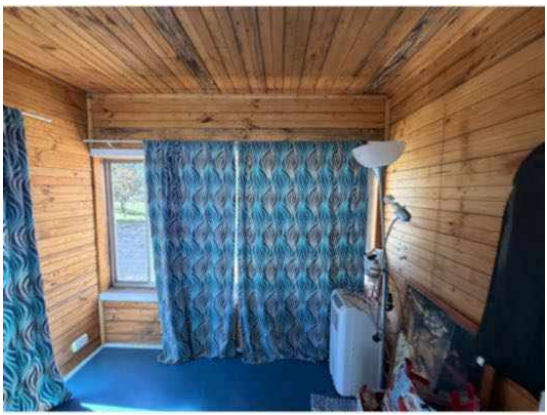
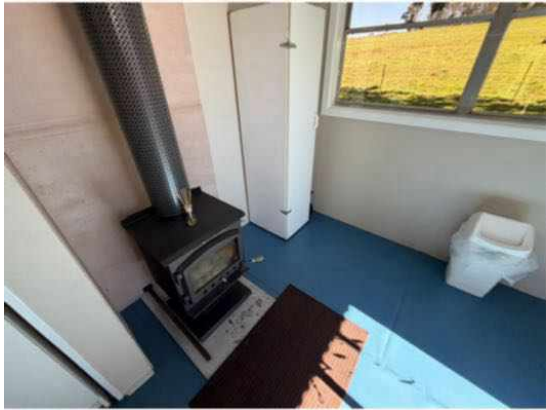
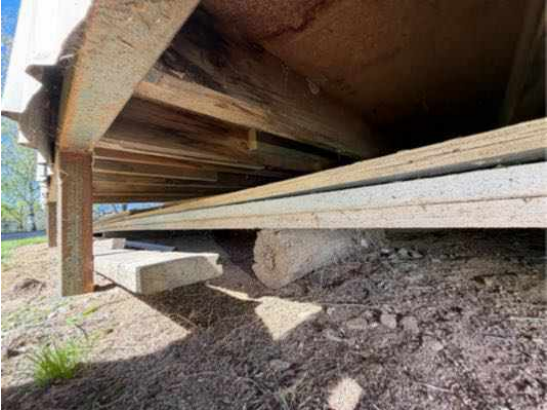
Building: Main Building
Location: All Areas
Finding: Additional Photos - Obstructions and Limitations
Information: These photographs are an indication of the obstructions and limitations which impeded full inspection of the property at the time of inspection. These obstructions can hide an array of defects and should be removed to allow full inspection to be carried out. A re-inspection is recommended once the areas are made accessible.

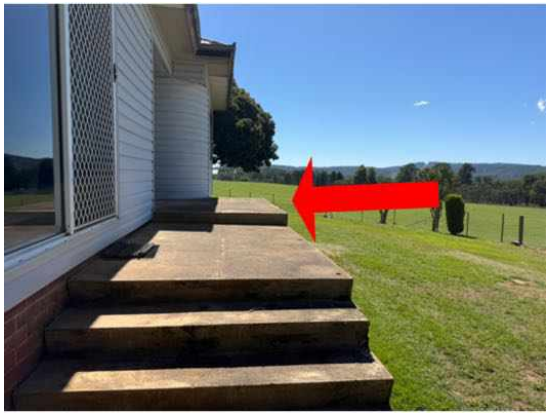
Building: Main Building
 Location: Patio
 Finding: No Handrails
 Information: It is noted for your information that there are no handrails to the front porch. Recommend engaging a registered builder in the short term, to install a secure balustrade around the perimeter of the porch, to avoid creating an environment which is unsafe.
