Building Inspection Report

Inspection Date: Wed, 4 Feb 2026

Property Address: 541 Glynburn Rd, Hazelwood Park SA 5066,
Australia

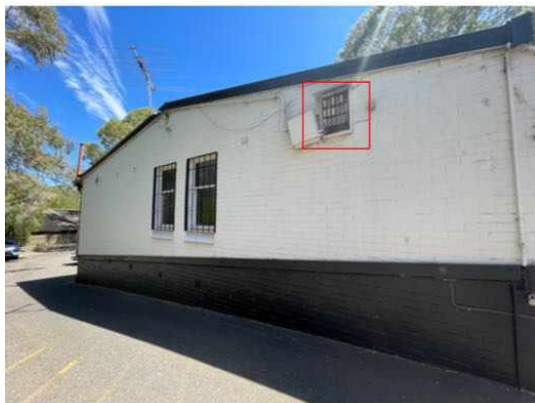
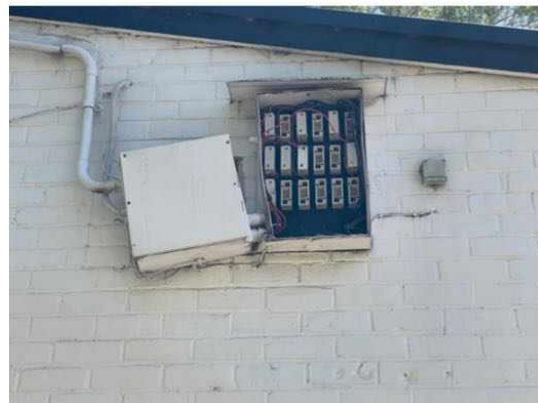
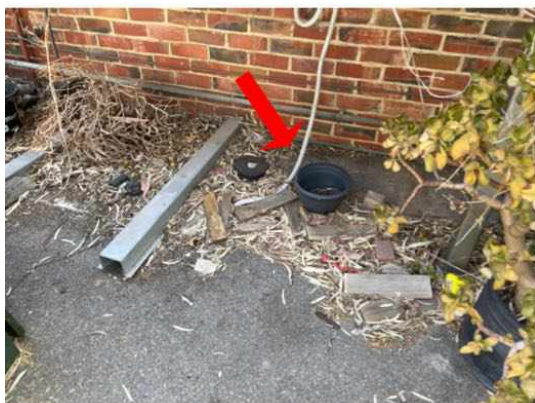
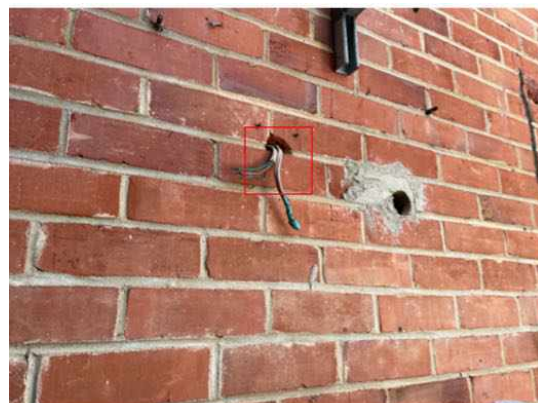
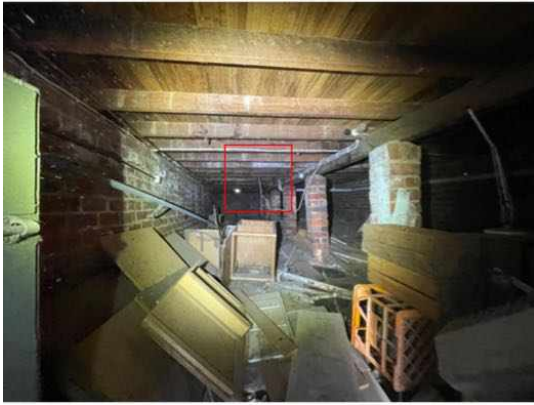
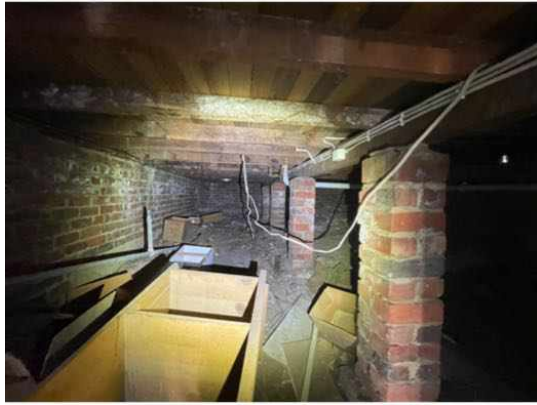
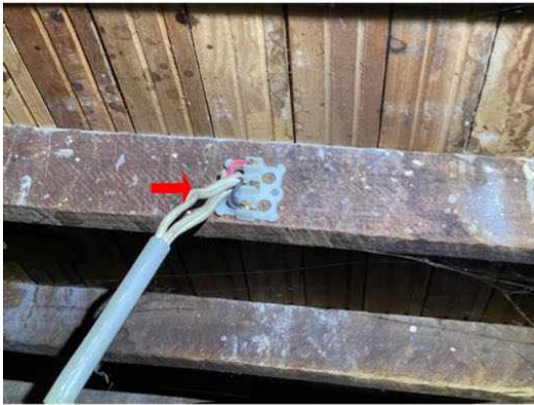
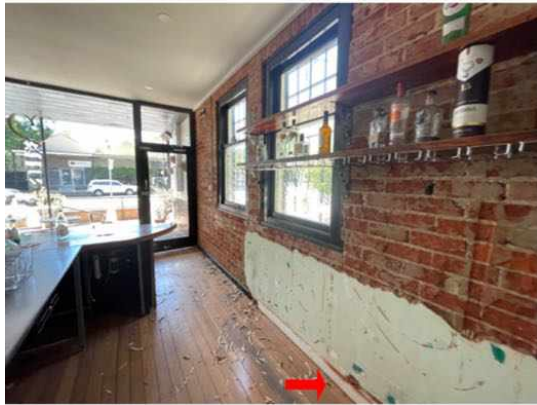
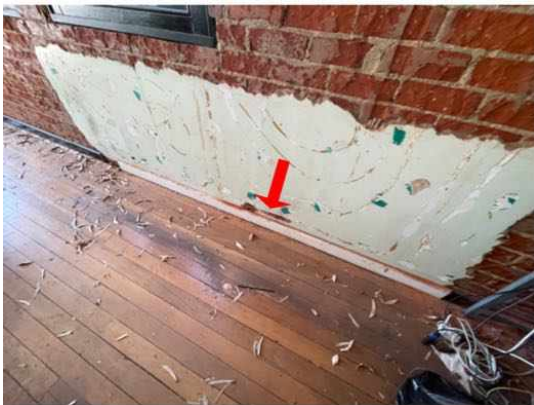
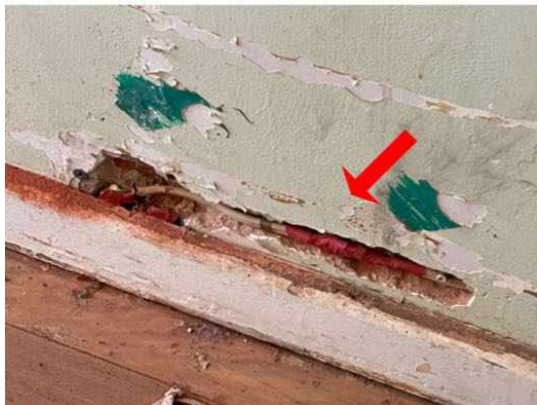
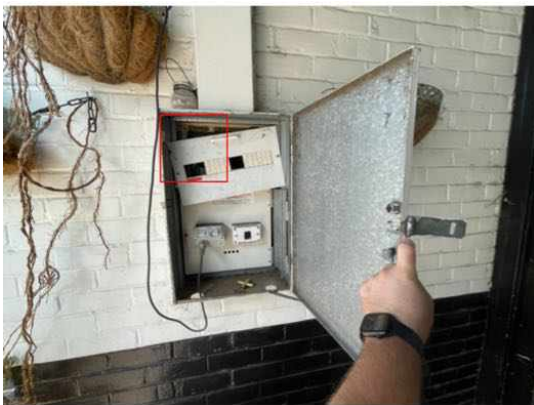
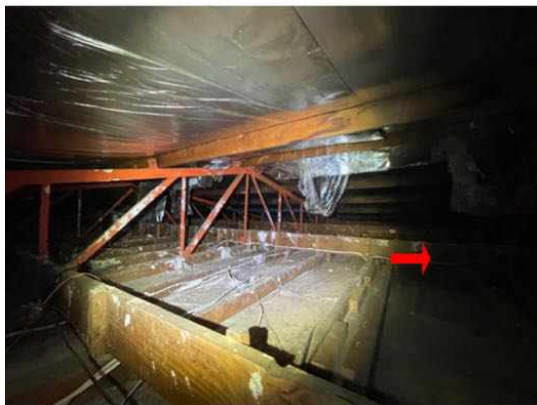
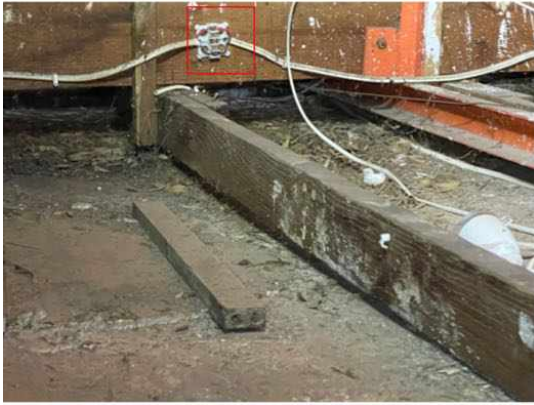
Defects 1.01

Building:	Main Building
Location:	All Areas
Finding:	Electrical Defects
Information:	Multiple damaged, deteriorated and or poorly installed areas of electrical equipment were identified at the time of inspection.

Several unprotected junction boxes were evident to the subfloor and roof void, uncapped cables protruding from walls where older equipment appears to have been removed, and damage to switchboards. (It was not determined at the time of inspection as to whether these switchboards are in use currently).

Damaged or poorly installed electrical equipment creates a risk for electric shock, and is thus deemed a safety hazard. Appointment of a licensed electrician is highly advised to provide additional information on the risks of the defects listed and carry out repairs. Such works should be carried out as a matter of urgency.

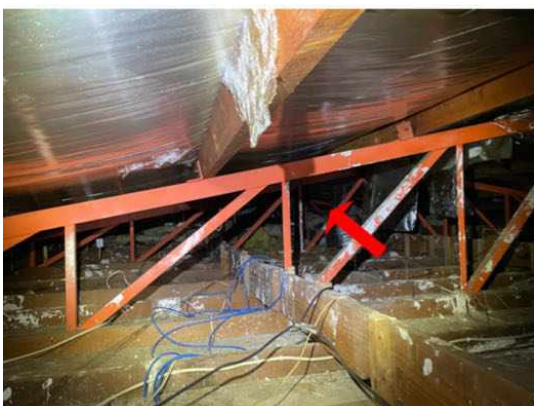
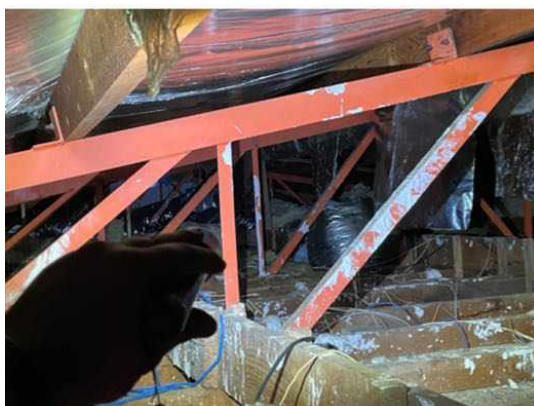
Defects 1.02

Building:	Main Building
Location:	Roof Void
Finding:	No Fire Wall in Place
Information:	It is suspected that no fire-rated wall was in place between this property and the adjoining tenancy at the time of inspection.

In older properties, such measures may not have been required at the time of construction. However, the absence of a fire separation wall poses a potential safety risk in the event of a fire.

Reporting on compliance and fire compliance is generally outside the scope of this report. This suspected defect is highlighted as a caution only, however, it is recommended that a licensed builder or fire safety professional be consulted to assess the area and advise on possible upgrades to improve fire protection.

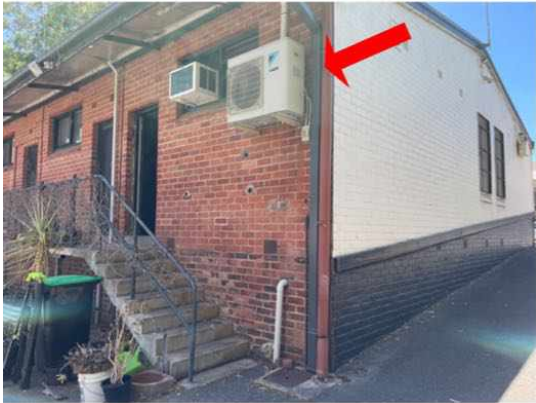
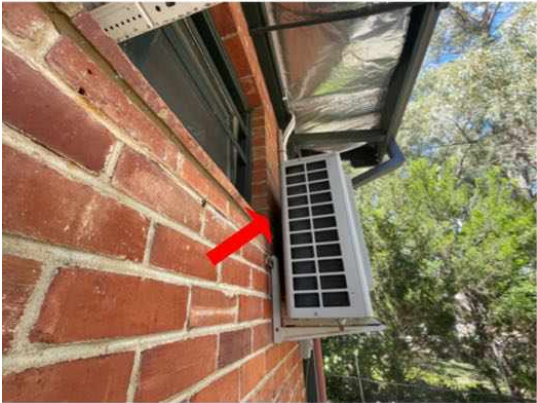
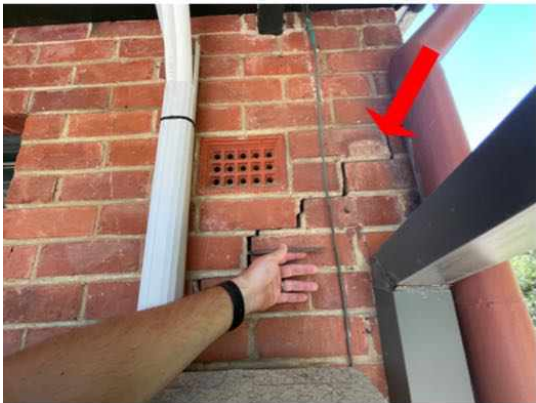
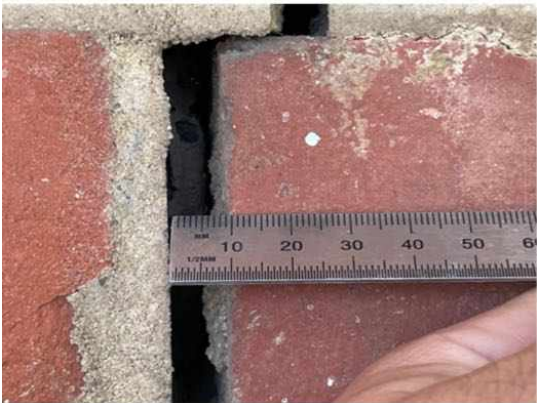
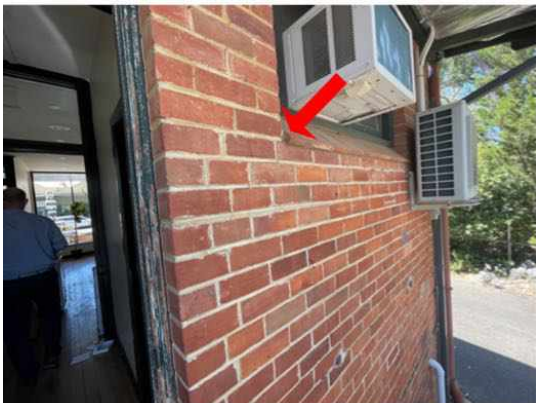
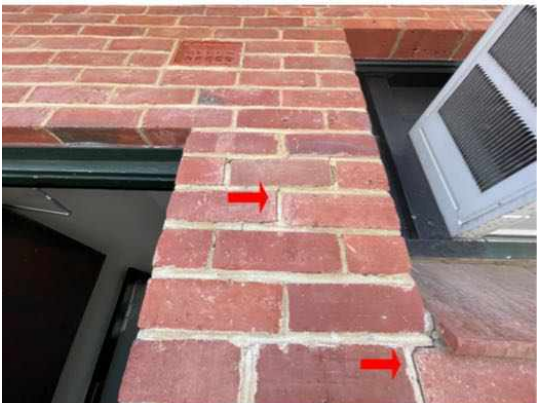
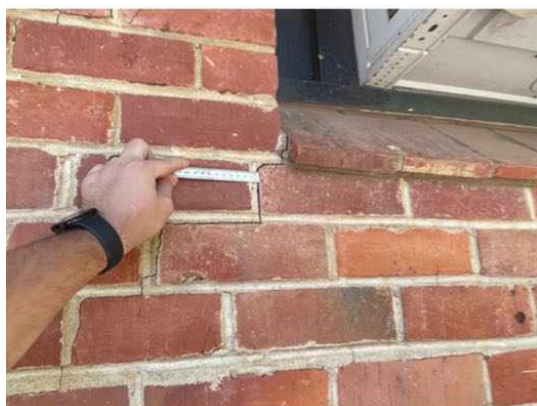
Defects 2.02

Building:	Main Building
Location:	Rear corner
Finding:	Brickwork - Step cracking
Information:	Step cracking was identified to the brickwork to the rear corner of the building at the time of inspection. Step cracking, which is similar to other forms of cracking, has a variety of possible causes. However, the most common is the subsidence of adjacent footings.

This cracking measures approximately 10mm in width and appears to spread from the corner of the building (behind the air conditioning unit) to the rear entry door frame.

Step cracking is a relatively common defect, and is most likely to occur adjacent to windows, doors and other openings. Mortar failure in the gaps between affected bricks indicates the stresses and tensions affecting the wall.

The presence of large established trees nearby to the building are a likely factor in this case.

Where step cracking is extensive or severe, the client is advised to consult a structural engineer. Minor step cracking can be used as a warning sign to address factors causing stress to the wall, which can include the effect of surrounding trees, water leaks, soil erosion, or even the presence of reactive soils in the surrounding area.

Monitoring of all cracking should be conducted frequently. Always contact a building inspector should cracks widen, lengthen, or become more numerous. Additionally, your building inspector should also be contacted if associated building elements such as doors and windows become more difficult to operate over time.

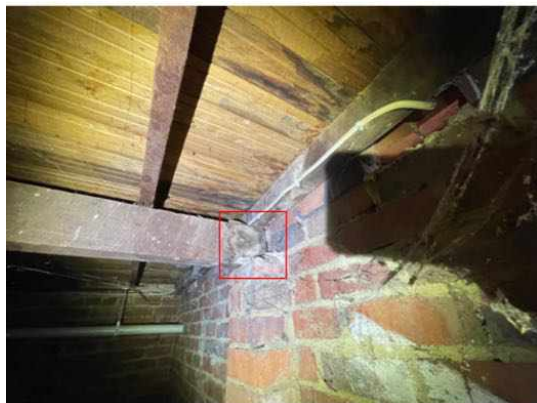
Defects 2.03

Building:	Main Building
Location:	Subfloor
Finding:	Subfloor structure - Wood rot
Information:	The subfloor has areas of wood rot (fungal decay) to the structure towards the rear of the accessible subfloor area. It is suspected that this defect may have developed as a result of damp conditions in the subfloor over time.

Damp conditions cause the timbers to fail, resulting in the subfloor structures failing to bear the load (or weight) of the building as originally intended. Without repairs and maintenance, including potential replacement of affected elements, it is likely that serious structural faults will result, as well as an array of minor defects.

The presence of wood rot to the subfloor structure is also conducive to termite infestation. As timber stumps are in direct contact with the ground, concealed termite is made possible. Such entry is made easier if the timbers become non-durable due to even slight wood rot.

Where wood rot is present to any structural timber, rectification or replacement of the affected timber building element is required. The adequate timeframe for such works are dependent on the severity of the rot. Where rot has developed to become widespread, replacement of sections of the subfloor structure may be required. Consultation with a structural engineer or registered builder specialising in re-stumping is highly advised as soon as possible.

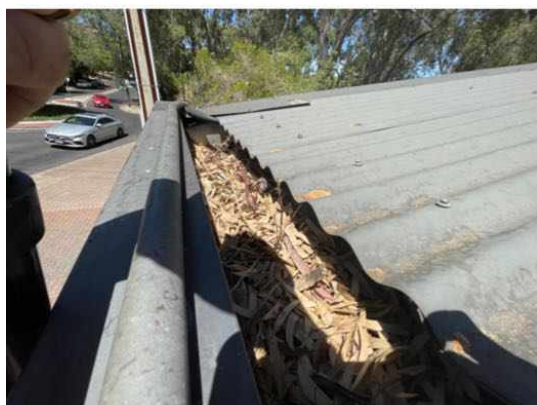
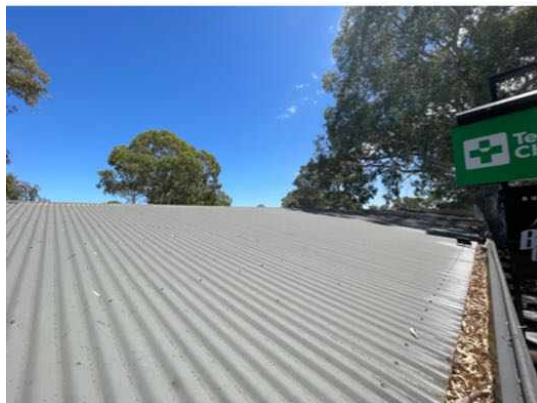
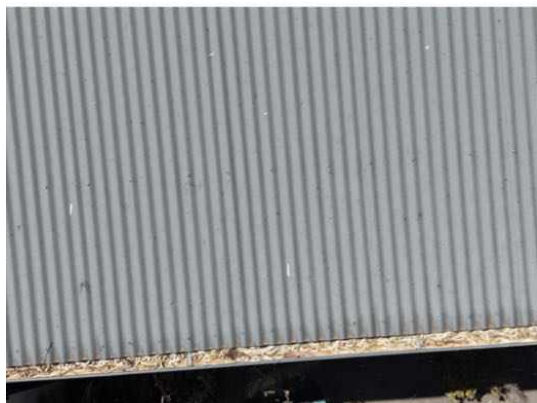
Defects 2.04

Building:	Main Building
Location:	Roof Exterior
Finding:	Gutters - Blocked
Information:	Significant degrees of debris build up was identified throughout the guttering at the time of inspection.

Blocked gutters and drainage is likely to lead to flooding, as well as high levels of moisture in the affected areas. Such moisture will not only cause rust and decay of the associated building materials, but can also provide conditions that are conducive to termite and timber pest activity. Blockages in gutters should therefore be removed immediately to ensure dry conditions are maintained.

Consult a Licensed Plumber for further specific advice on remedial works that may be required. In the interim, it is highly advised that blocked gutters and drainage be removed by a general handyperson as a matter of urgency.

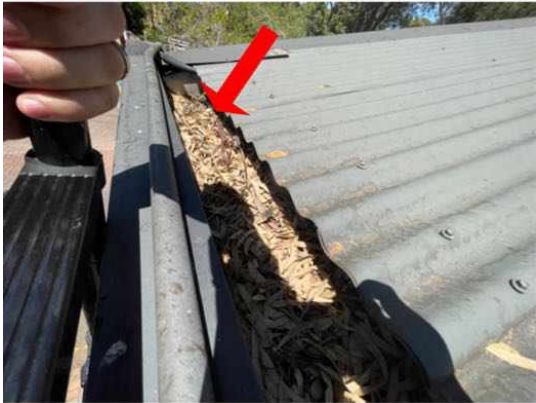
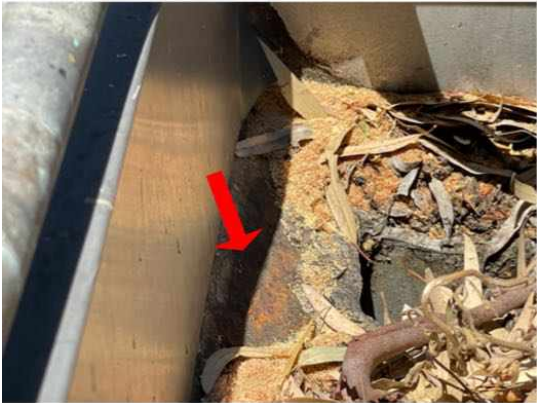
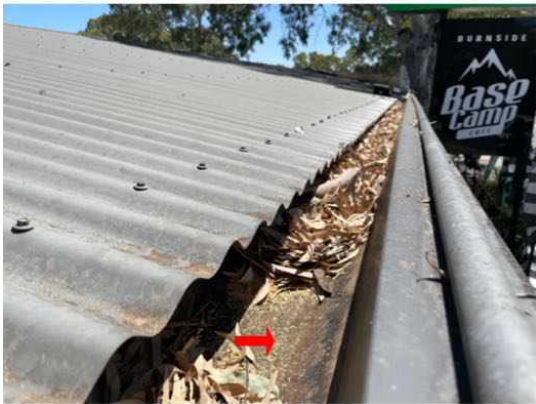
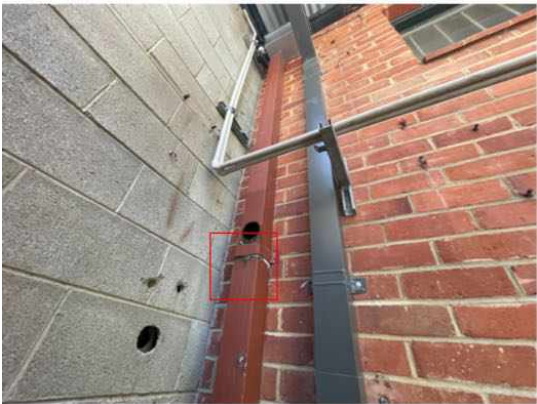
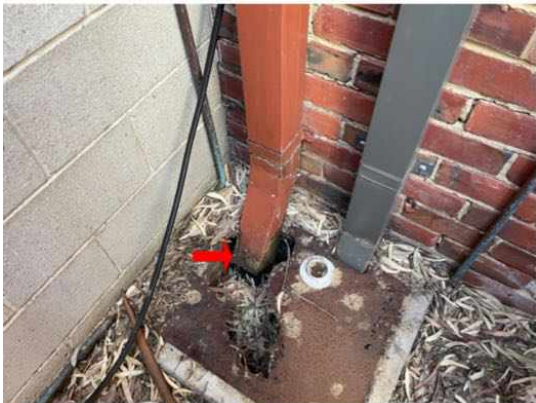
Defects 2.05

Building:	Main Building
Location:	Roof Exterior
Finding:	Roof plumbing - Rusted or corroded
Information:	The roof plumbing has areas of rust and corrosion, the extent of the damages could not be observed at the time of inspection due to significant debris build up throughout the guttering. It is suspected that this has been caused by blockages, resulting in pooling or standing water, that have prematurely rusted elements of the roof plumbing. Age is also a likely contributing factor.

Rusted roof plumbing will generally develop holes and leaks that can affect other building elements with poor drainage of storm water. Poorly drained roof areas will also lead to damp conditions surrounding the base perimeter of the building which, if left unmanaged, can lead to a range of secondary building defects.

It is advised to clean the gutters, assess the extent of the damages and treat the damaged areas as necessary. Should leaking develop and or further deterioration occur, repair and/or replacement of any significantly rusted elements of roof plumbing is required in order to reinstate the roof drainage system to a fully operational level. To further maintain these areas, gutters should be cleaned frequently, allowing the avoidance of any partial blockages.

A licensed plumber or specialist roof restoration company should be appointed to

undertake these works. It is advised that such works be completed as soon as possible to prevent any further damage and deterioration.

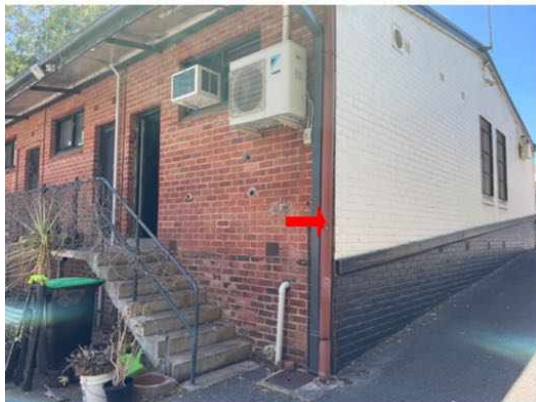
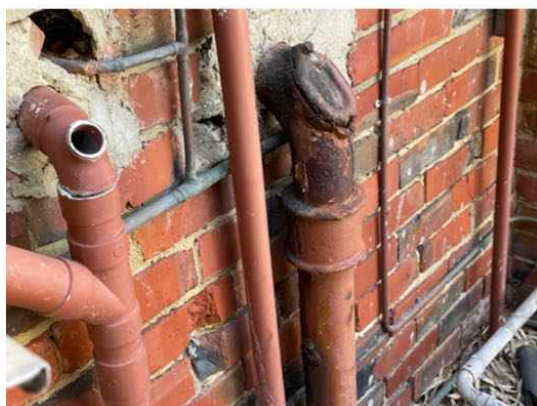
Defects 3.01

some older metal pipe work showing rust and deterioration.

The client should be aware that older buildings may have aged or outdated plumbing systems. Aged plumbing may be more prone to break down, deterioration and defects that affect the functionality of the plumbing system.

Where aged plumbing deteriorates, this can lead to cracks, holes and leaks in the plumbing that can affect other building elements due to poor drainage of waste water or storm water. Poorly drained areas will also lead to damp conditions surrounding the base perimeter of the building which, if left unmanaged, can lead to a range of secondary building defect as well as being conducive to termites.

A licensed plumber should be appointed as soon as possible to perform further inspection to the buildings internal and underground plumbing structures to assess for damages and potential weak points.

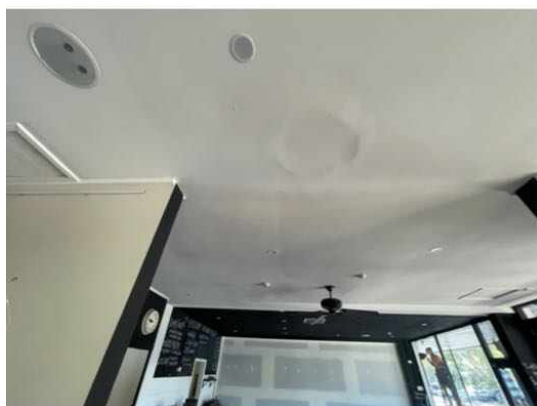
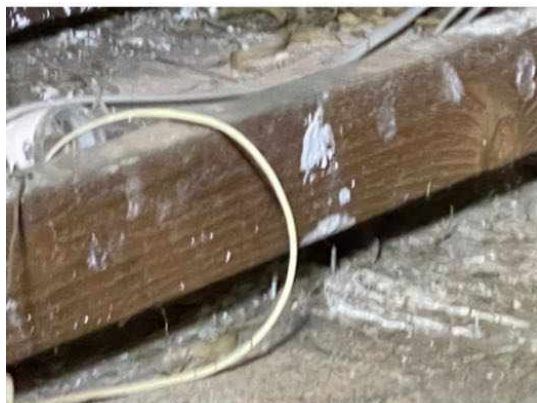
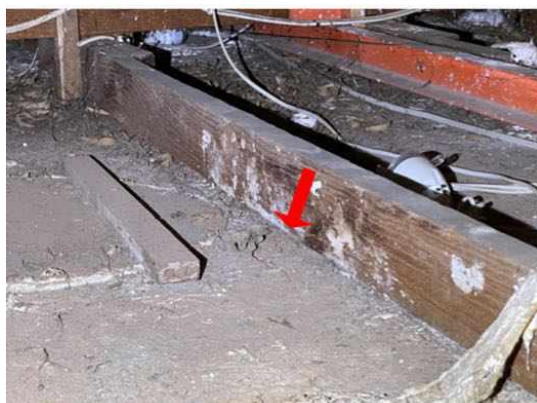
Defects 3.02

Information: Ceilings were found to be sagging throughout the building at the time of inspection. This was most notable to the main dining/bar area, however most ceilings showed some form of sagging to varying degrees. Sagging to the fixed ceiling structure generally indicates that the building materials have swollen, due to contact with water, or that fixings (e.g. nails or glue) have become loose and require reattachment.

The roof space could not be fully accessed due to access restrictions, further invasive inspection is recommended to assess the area. Further inspection and remedial works may reveal currently hidden defects.

Where minor sagging is evident, comparatively minor works, such as re-gluing of ceiling sheets, may be required. Such works may be performed by relevant tradespeople, such as plasterers and painters. Where excessive moisture has caused the roofing structure to swell and sag, the source of the water leak should primarily be identified prior to any remedial works being performed.

This level of sag requires immediate attention, to prevent further deterioration. A licenced builder should be appointed immediately to address the issue and the contributing factors.

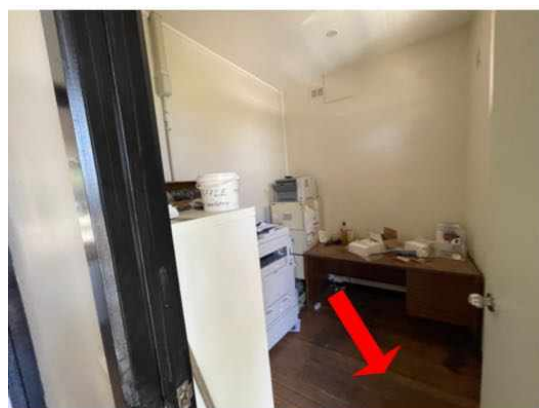
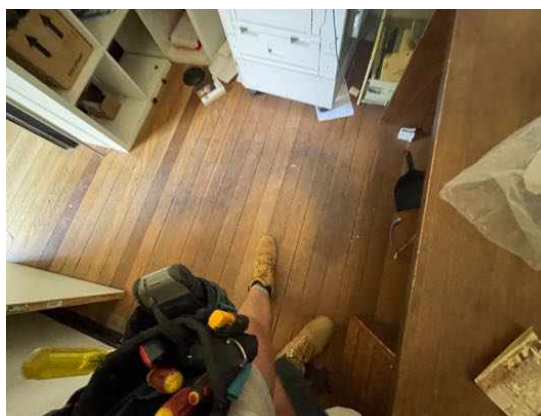
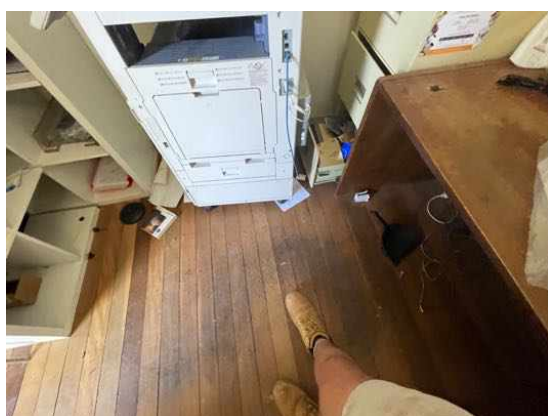
Defects 3.03

Building:	Main Building
Location:	All Internal Areas
Finding:	Floors - noisy/bouncy
Information:	The internal flooring in several areas, but particularly to the rear office area, were identified as being noisy or bouncy at the time of inspection. A noisy/bouncy floor surface generally presents as a discernible change in level as they are walked across, in noisy or creaking flooring, or in consequent movement of surrounding furniture and fixtures.

Noisy/bouncy floors generally indicate that the floorboards or the subfloor structures are coming loose from the joists that they are installed on. Noisy/bouncy flooring may

Some areas of the internal flooring also shows a minor discrepancy in level. Uneven flooring is likely to indicate minor defects such as expected movement of the foundations of the property, but may also indicate subsidence of the associated subfloor stumps.

As this defect only appears minor at this stage, it is advised that the flooring be closely monitored to identify any further movement. Where flooring remains relatively unchanged for an extended period of time (i.e. several months), it is likely that this defect has been caused by expected movement of the foundations of the property.

However, where flooring is uneven further, potentially invasive inspection of the subfloor structures and stumps in this area is required. In this case, works to repair are likely to be required, and would be carried out by a registered builder. The potential resolution may range from packing gaps in subfloor structures through to replacement of subfloors stumps and refixing of flooring.

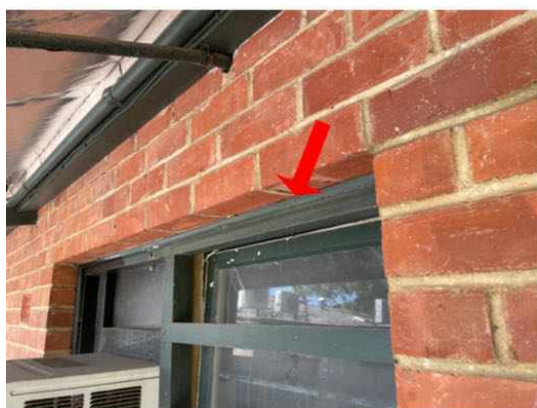
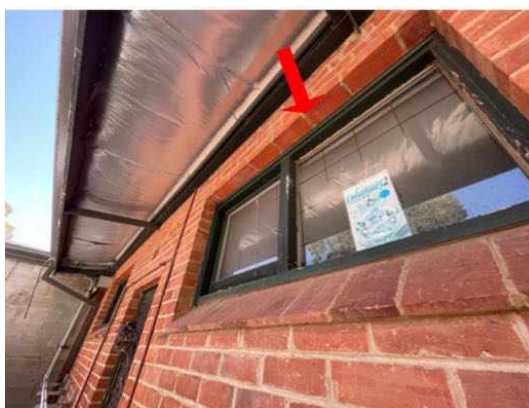
Defects 3.04

Finding: Lintels - missing (suspected)

Information: It was suspected at the time of inspection that a lintel is missing over the rear windows. Lintels are generally used to support brickwork over openings in the wall. Without a steel lintel in place the brickwork may be relying on the window frames for support, which is likely not within the design use of the timber frame.

Secondary damage can develop to associated building elements as a result of missing lintels, which may impede on the integrity and strength of the structure.

A registered builder should be appointed to assess the area and where necessary, install a lintel and perform any necessary repair works in the short term.

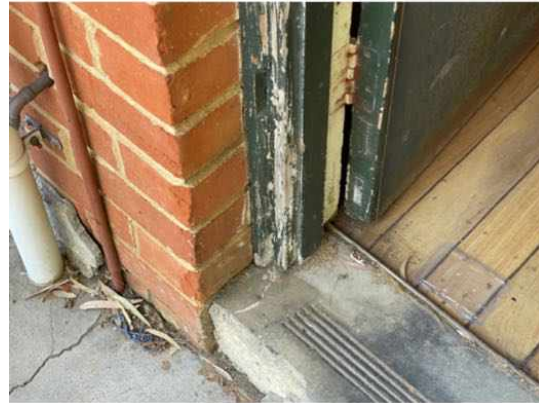
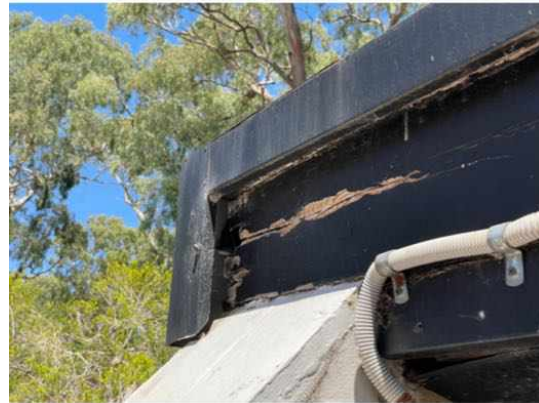
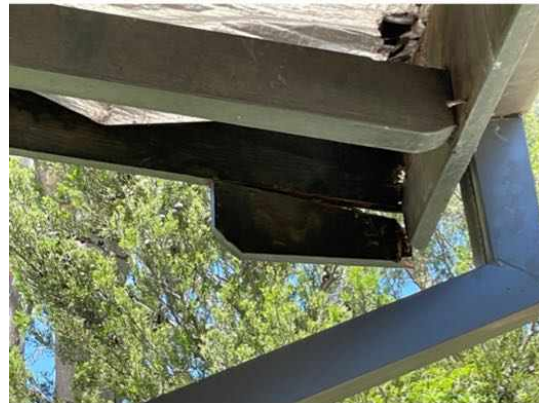
Defects 3.05

Finding: Wood Rot

Information: Several building elements around the property show evidence varying levels of wood rot, including to Fascias, veranda posts and timber trimmings.

Wood rot, also known as Fungal Decay, occurs when timbers and other cellulose building materials are exposed to damp conditions on an ongoing basis. This could be the result of exposure to weathering over a prolonged period of time, or the attraction of excessive moisture from other abutting building materials. Contributing factors also include poor air ventilation in the area.

Wood rot is often associated with general damp problems and is evidenced by a 'musty' smell or mould and mildew occurring on surfaces. If left unmanaged, damp conditions can lead to further health problems and the decay of timbers will continue.

Early intervention and regular maintenance, particularly of exterior timbers, will prolong the useful life of these building elements. Prior to any works being performed, the cause of the moisture that has created the visible wood rot should be identified and addressed in a suitable manner. Replacement of affected timbers may then be a necessary step in protecting surrounding building elements from such deterioration.

A qualified plumber may be appointed to assess the cause of excessive moisture and to provide advice on any remedial works as required. A qualified carpenter or registered builder may also be required to replace affected building materials.

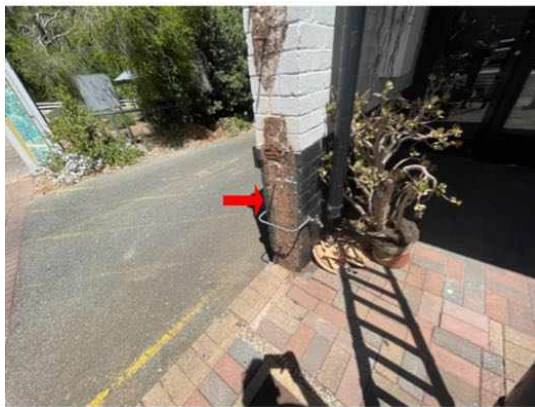
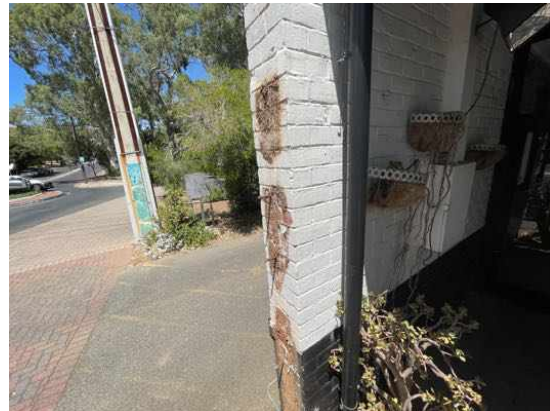
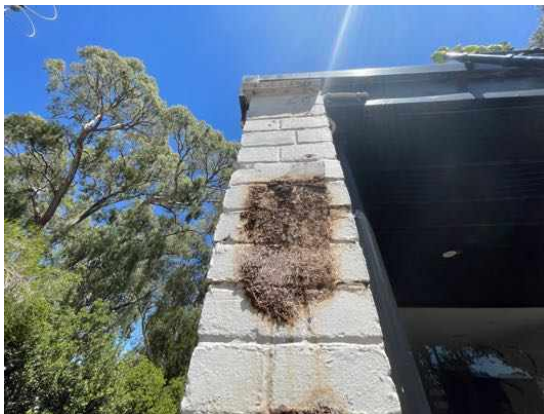
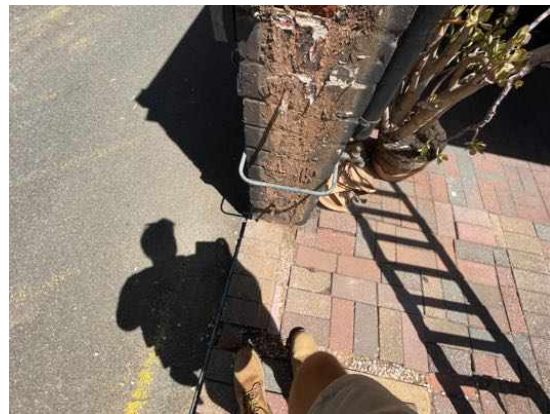
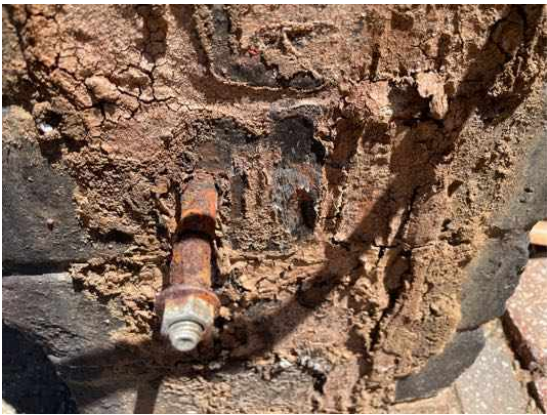
Defects 3.06

Building:	Main Building
Location:	Front elevation
Finding:	Damage Consistent With Termite / Timber Pest Activity
Information:	Damage consistent with that of termite / timber pest activity was present on the property.

Mud buildup consistent with termite activity was evident to the front of the brick wall beside the driveway at the time of inspection. It is suspected that termite damaged timber may have been removed from this area and left the mud in place.

Damage from termites or timber pests can be more serious and extensive than what may be visible to the naked eye. It should be noted that where termite activity occurs in close proximity to the building the risk of termite activity within the main building becomes greatly increased, particularly where inspection is obstructed, or in inaccessible areas such as the subfloor and parts of the roof. Further inspection of external and internal areas is required in order to fully identify the extent of termite / timber pest activity and will likely require works of an intrusive nature.

Reporting on termite activity is outside the scope of this report and it is strongly recommended that further inspection be conducted as soon as possible by a qualified pest inspector in order to prevent any further damage that may ensue. The installation of a proper termite protection system is recommended to prevent termite infestation and possible damage to the property.
