Building and Timber Pest Inspection Report

Inspection Date: Sat, 14 Mar 2026

Property Address: 1/22 Chiswick Rd, Greenacre NSW 2190, Australia

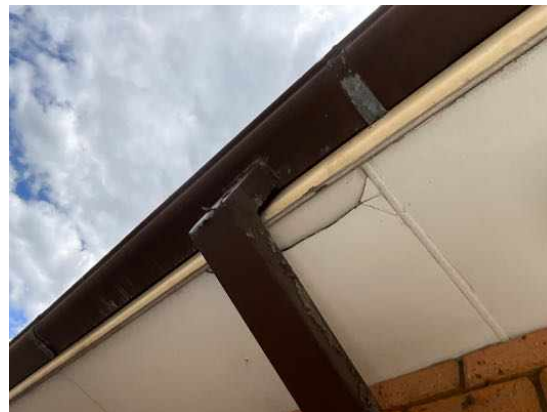
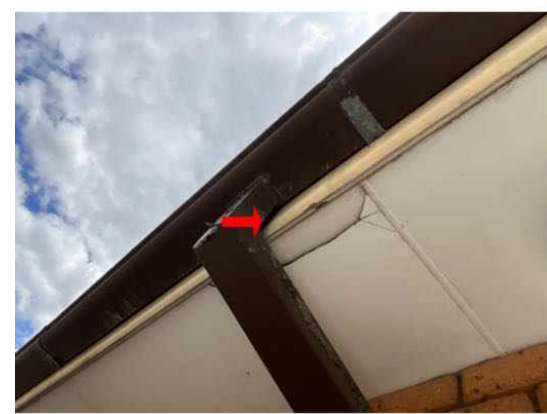
Building:	Main Building
Location:	All Areas
Finding:	Asbestos - Suspected ACM Identified on Site
Information:	Reporting on Asbestos is outside the Scope of this Report. This suspected defect is highlighted as a caution only. We suspect, based on our experience in the building industry, that there is a higher risk of the identified building element containing asbestos.

As Asbestos Reporting is outside the scope of this report, we advise that you consider a separate Asbestos Inspection and Condition Audit, which can include the taking of samples for definitive confirmation of the presence of Asbestos.

In the interim, the client is advised to act with caution, especially when considering any damage to building materials general wear and tear renovations extensions demolition and general maintenance activities due to the suspected presence of Asbestos.

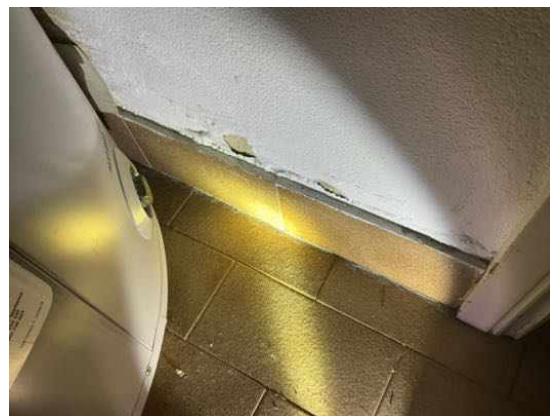
Building: Main Building
 Location: Laundry
 Finding: Water damage

Information: The area has sustained water damage resulting in potential structural issues. This damage compromises both the aesthetic and functional aspects.

1 **Plumber:** If the water damage is due to plumbing issues, a plumber can fix leaks and ensure there are no further water-related problems.

2 **General Contractor:** If the damage is extensive and affects the surrounding area, a general contractor can coordinate the repair work, including any related structural or cosmetic repairs.

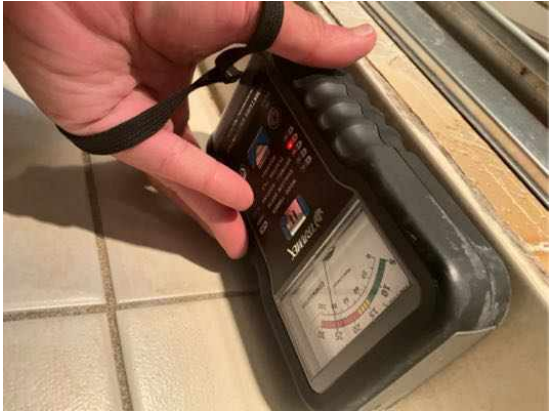
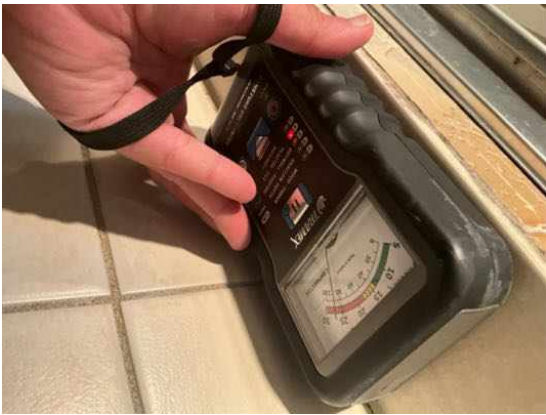
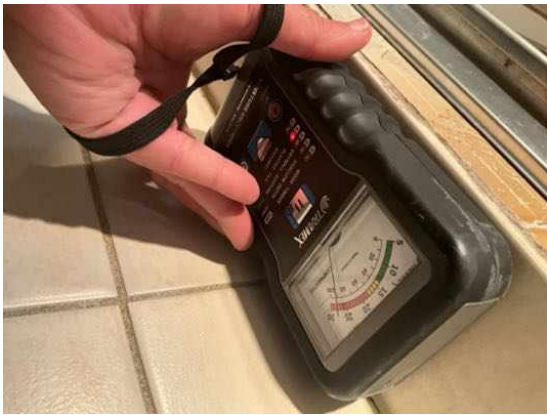
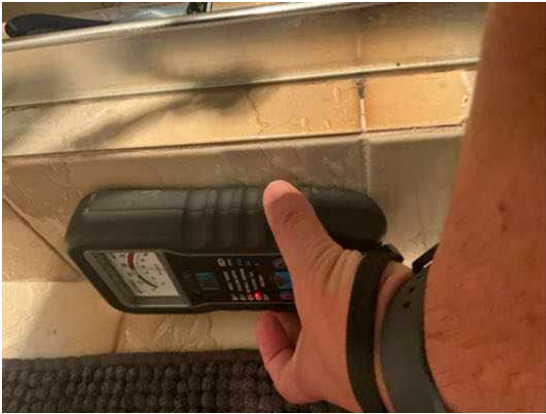
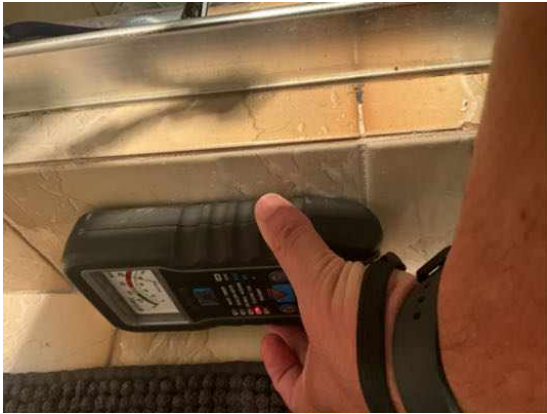
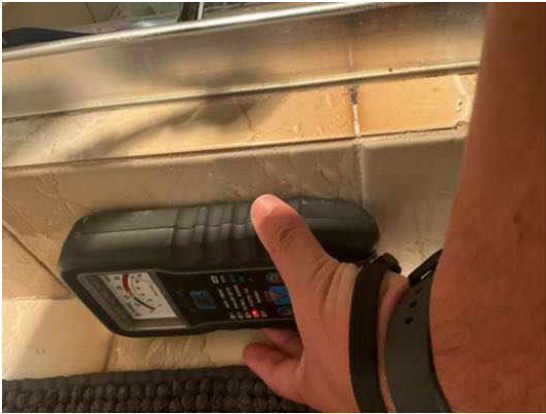
Finding 2.02

Building:	Main Building
Location:	Bathroom
Finding:	Evidence of excessive moisture was present at the time of inspection
Information:	Excessive moisture is present behind the bathroom tiles, indicating a potential water leakage issue within the wall.

The prolonged presence of moisture can lead to mold growth, deteriorate the structure, and create an environment conducive to health hazards. Additionally, it may compromise the adhesive holding the tiles, leading to their detachment.

A licensed plumber or a qualified contractor specializing in water damage remediation should investigate the source of the moisture, fix any leaks, and address the damage. Additionally, replacing affected tiles and ensuring proper waterproofing are crucial to preventing future issues.

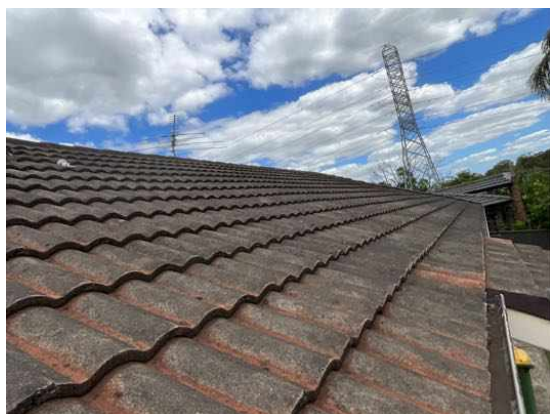
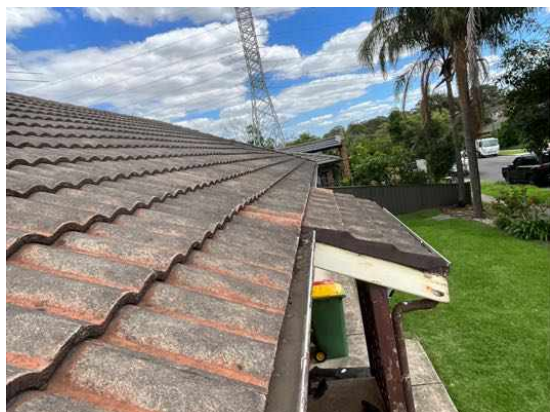
Finding 3.01

Building: Main Building
Location: All Areas
Finding: Roof Weathered
Information: Upon inspection of the exterior roofing, the majority of roof was not in a fair condition. While weathering of the roof is consistent with the age of the property, maintenance works are required.

Isolated areas of mortar have come loose in the valleys and minor cracking is also present. Re-pointing and re-sealing the may be considered as an interim solution by the client to help preserve and extend the life span of the tiles.

Where left unmanaged, deteriorating roof are likely to lead to a number of secondary defects, including minor water leaks and weather exposure to internal roofing structures.

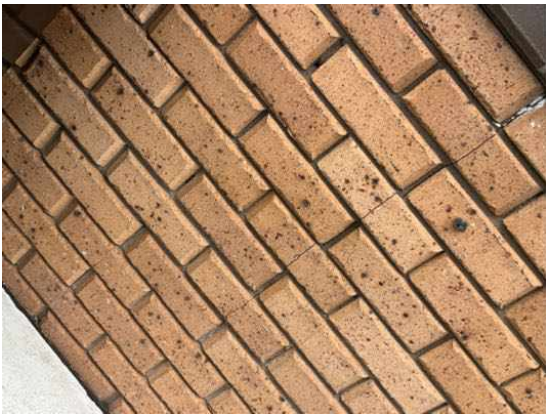
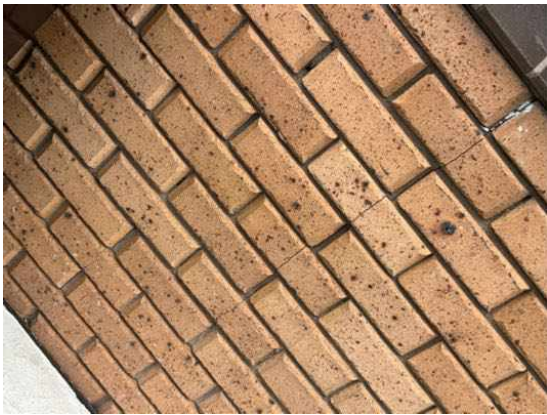
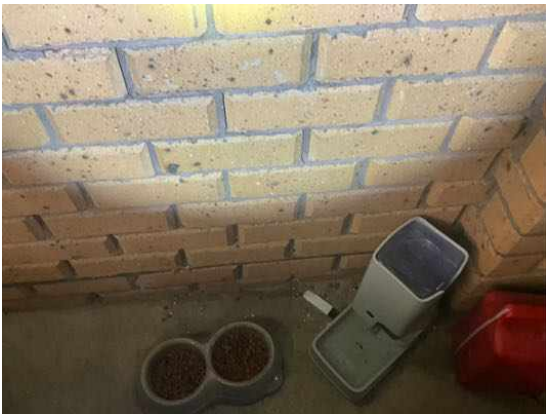
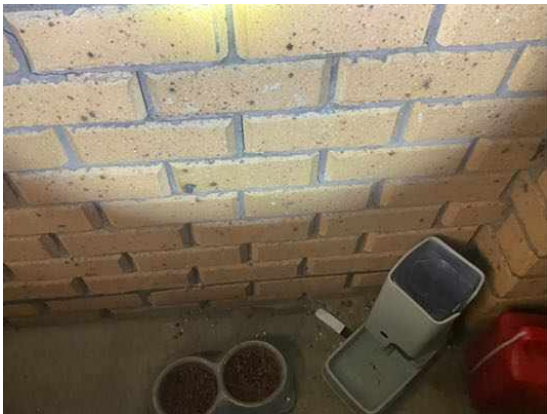
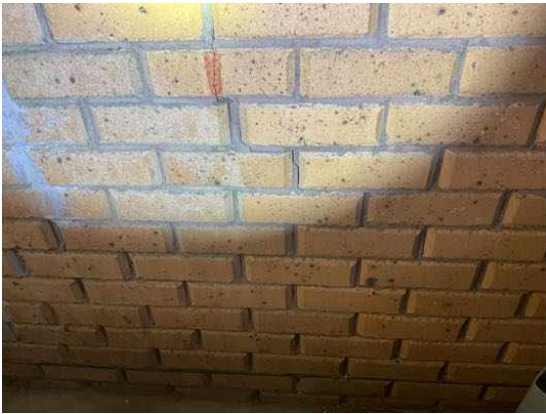
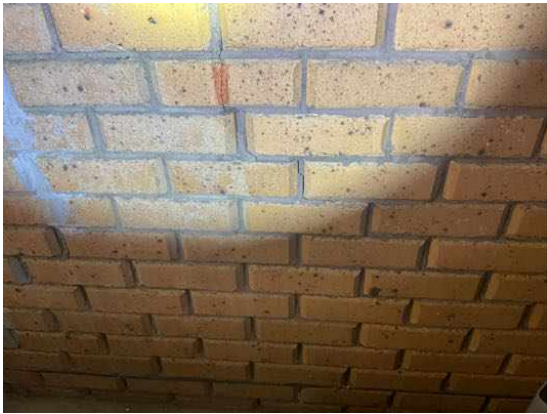
Finding: Brickwork - Cracking [Fine]

Although fine cracks are quite noticeable, they are often only considered to be an appearance defect and usually do not indicate any structural damage. Generally, the cause of a fine crack is indicative of a separation between brickwork and mortar throughout the structure, but single bricks may also show cracks of this nature.

Cracking of this nature can generally be repaired with minor filling and should be conducted by a qualified bricklayer.

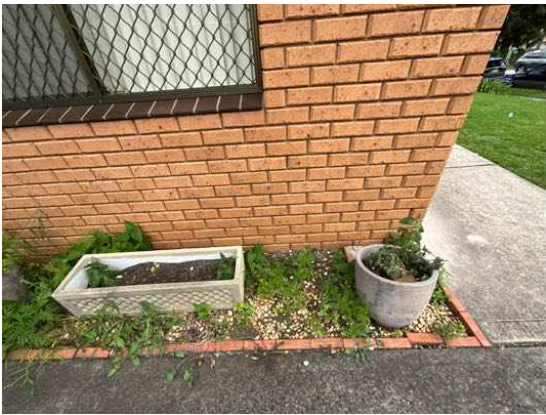
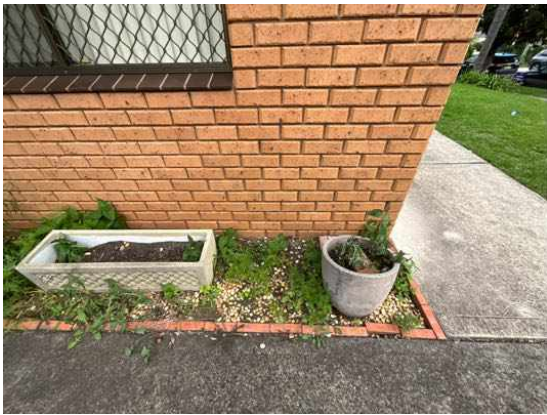
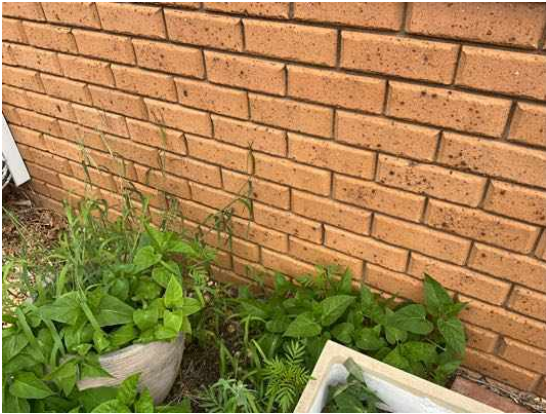
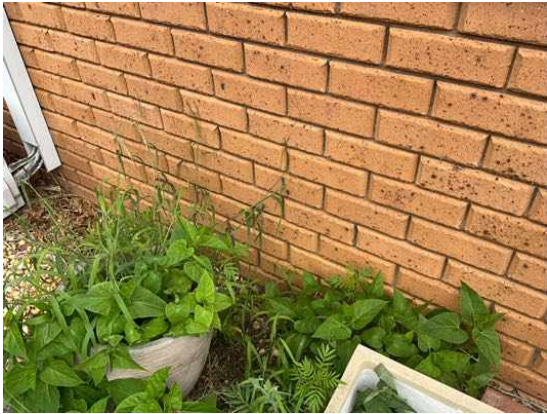
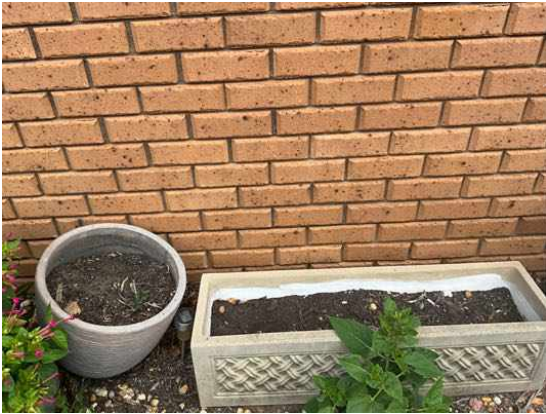
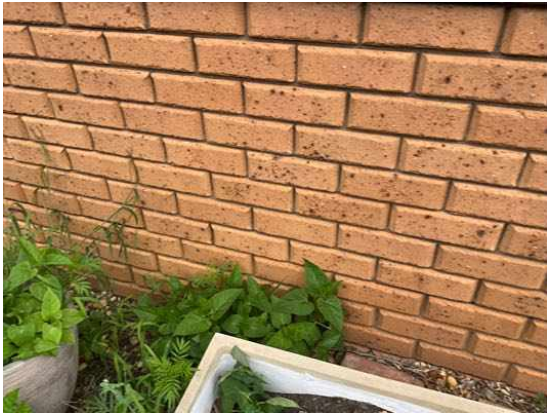
Finding: Weep holes - Missing

1. Moisture Accumulation: Without weepholes, moisture can accumulate within the wall cavity, leading to dampness and potential water damage to the building structure.

A qualified bricklayer or masonry contractor should be contacted to assess and install the missing weepholes. They will:

- Drill or create gaps in the appropriate locations of the masonry wall to ensure effective drainage and ventilation.
- Ensure compliance with the Australian Standard AS 3700 (Masonry Structures) and the National Construction Code (NCC) requirements for weephole placement and spacing.
- Inspect the wall cavity for any existing moisture damage and recommend additional repairs if necessary.

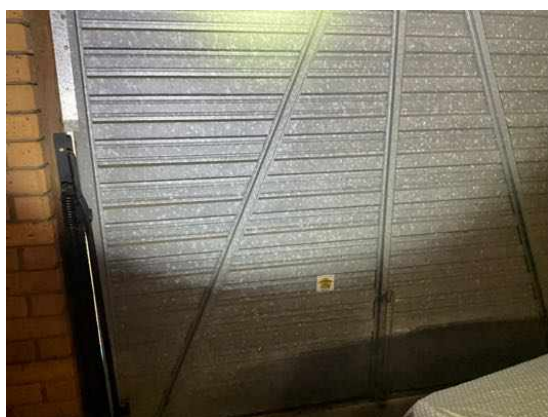
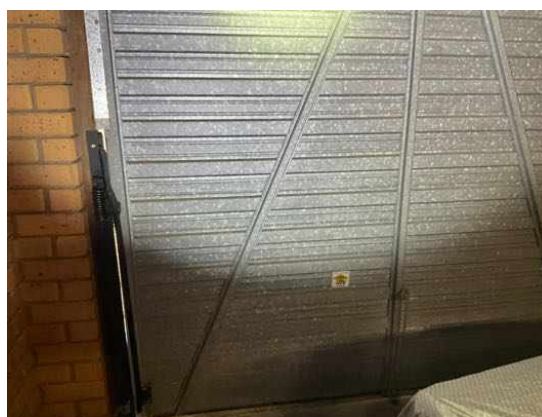
Building:	Main Building
Location:	Garage
Finding:	Garage door not operational
Information:	The garage door is not operational and fails to open or close properly.

pose safety hazards, and restrict access to the garage space.

****Recommended Action:**** A professional garage door technician should be hired to diagnose and repair the malfunction, ensuring the door operates smoothly and safely.

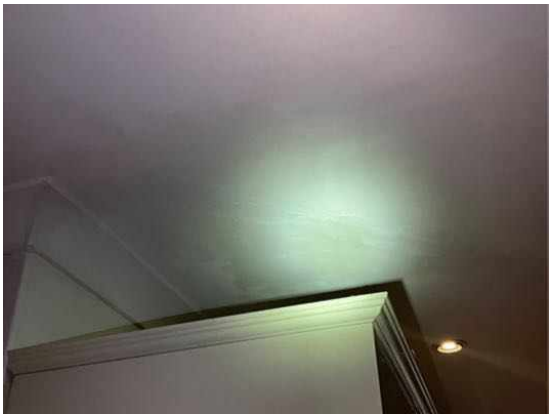
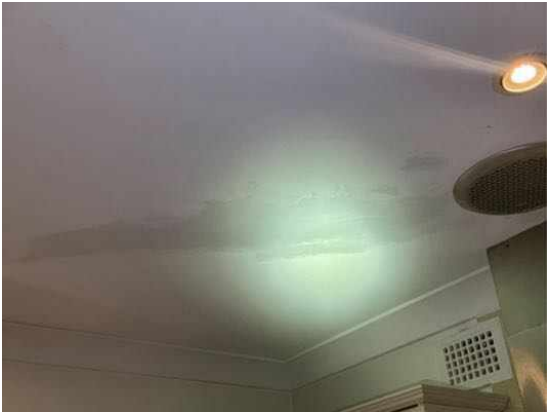
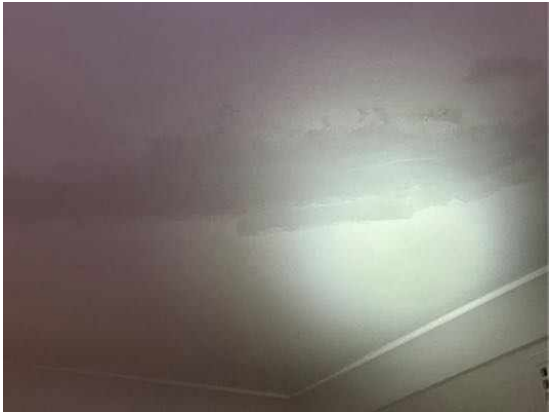
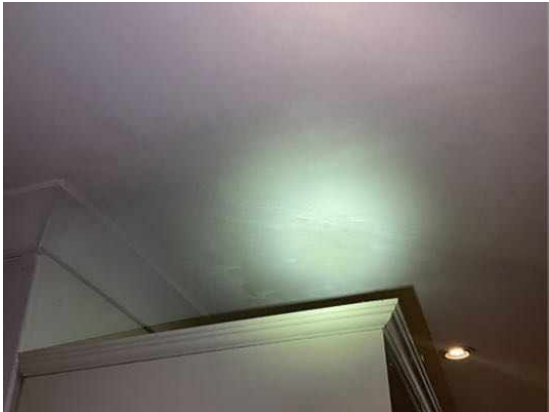
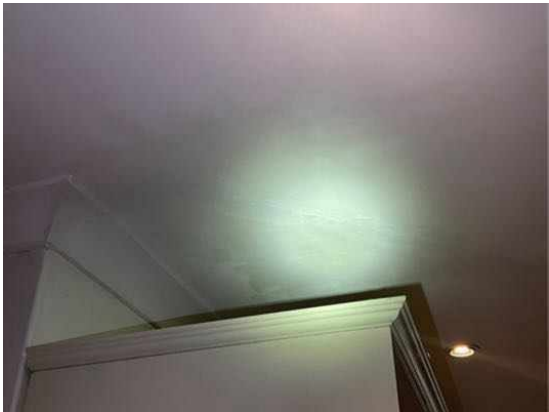
Finding 3.08

Building:	Main Building
Location:	All Areas
Finding:	Poor workmanship
Information:	The structure exhibits signs of poor workmanship, evident in various aspects of construction and finishing.

Risk: Poor workmanship poses a range of risks, including compromised structural integrity, potential safety hazards, and a decreased lifespan of the structure. It may also lead to aesthetic and functional issues.

Resolution: A qualified contractor or construction professional should be consulted to assess and address the poor workmanship. They can implement corrective measures to ensure structural soundness, safety, and overall quality of the construction.

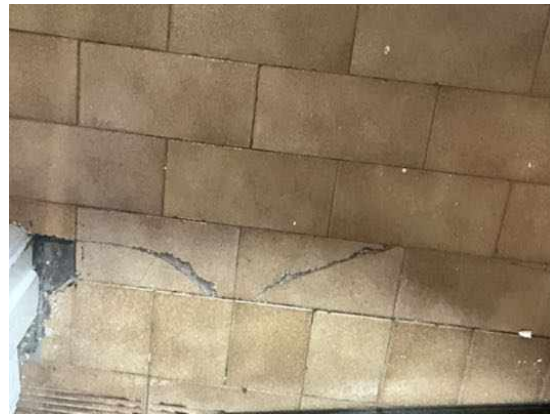
Finding 3.09

Building: Main Building
 Location: Laundry
 Finding: Tile - Floor Tile Damaged
 Information: A floor tile is visibly damaged, showing a chipped/broken section on the surface.

The damaged tile presents a trip hazard, may lead to cuts if stepped on barefoot, and can allow moisture ingress into the substrate, which may cause further deterioration or loosening of adjacent tiles. It also affects the overall appearance of the floor.

A licensed tiler should be engaged to remove the damaged tile and install a matching replacement. If spare tiles are unavailable, additional remedial work may be required to blend the repair with surrounding finishes.

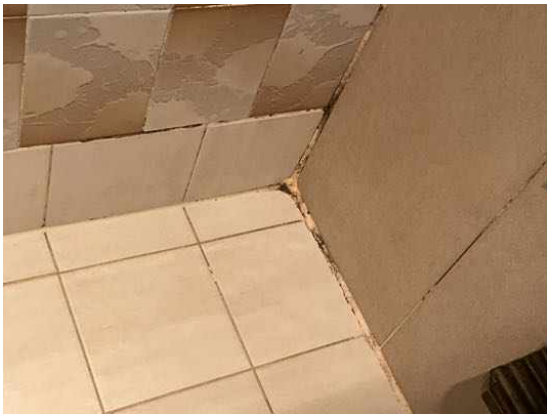
Building:	Main Building
Location:	Bathroom
Finding:	Sealant and grouting - Missing or damaged
Information:	It was noted on inspection that sealant or grout is degraded to the tiled shower alcove and or other areas of the bathroom.

Different materials and floor areas move at different rates, generally causing cracking to grout or sealant at this point. A flexible sealant is required to allow for expected expansion and contraction, while keeping the joint water tight and protective of all associated building materials.

There appears to be excessive mould to the sealant and grout which will likely require scraping out and replacement.

Flexible and mould resistant materials should be applied to affected areas to prevent any subsequent water damage that is likely to occur. Regular maintenance and replacement of damage or missing or damaged sealant and grout is highly recommended to the wet areas, as this is a regular wear and tear defect. Sealant and grouting in areas that come into regular contact with water should be maintained for the long term care of your property.

A sealant specialist or tiling contractor should be appointed to complete these works as soon as possible

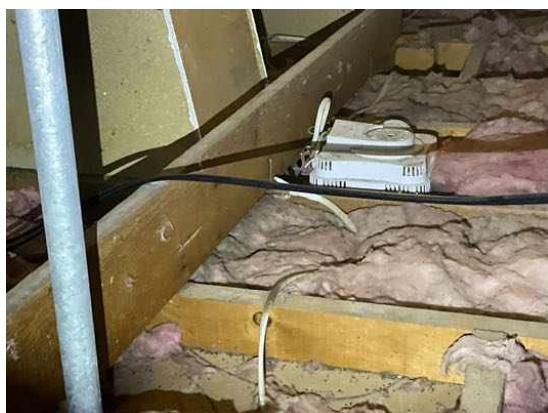
Finding 3.13

Building: Main Building
Location: Roof Void
Finding: Exhaust fan not vented out
Information: The exhaust fan located within the roof void is not appropriately ducted to the external atmosphere and is currently discharging moist air directly into the roof space. This is considered a defect under AS 4349.1, as it does not meet the minimum standard of residential building performance expected under normal residential building practices.

This condition may lead to excessive condensation within the roof void, increasing the risk of mould growth, deterioration of insulation, timber decay, and overall reduced durability of building elements. It may also result in poor indoor air quality, potentially affecting occupant health.

It is recommended that the exhaust fan be modified by a licensed HVAC contractor or qualified builder, ensuring it is properly ducted to discharge externally in accordance with manufacturer specifications, the National Construction Code (NCC), and applicable Australian Standards.

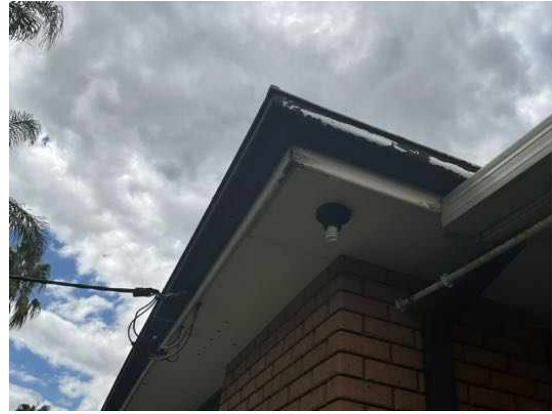
Finding 7.01

Building:	Main Building
Location:	All Areas
Finding:	Wood rot
Information:	This building element shows evidence of wood rot. Wood rot, also known as Fungal Decay, occurs when timbers and other cellulose building materials are exposed to damp conditions on an ongoing basis. This could be the result of exposure to weathering over a prolonged period of time, or the attraction of excessive moisture from other abutting building materials. Contributing factors also include poor air ventilation in the area.

A qualified plumber may be appointed to assess the cause of excessive moisture and to provide advice on any remedial works as required. A qualified carpenter or registered builder may also be required to replace affected building materials.
