Building Inspection Report

Inspection Date: Thu, 8 Jan 2026

Property Address: 632 Beachmere Rd, Beachmere QLD 4510,
Australia

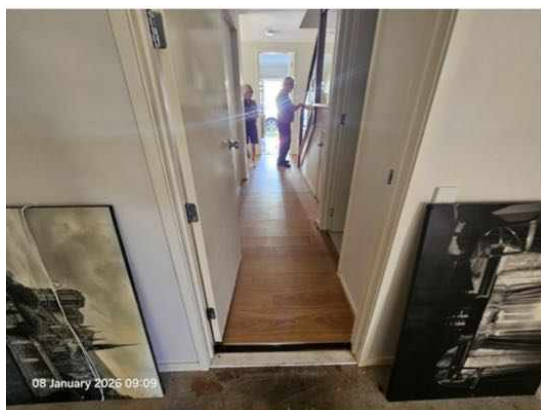
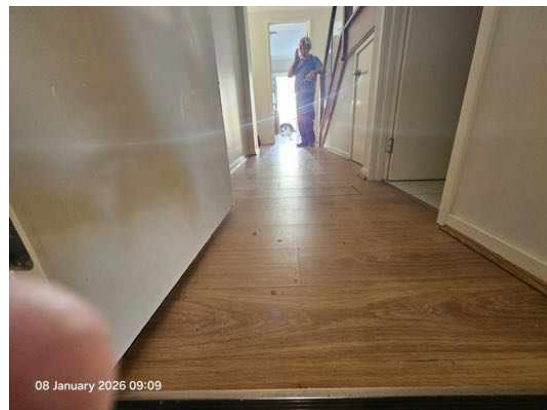
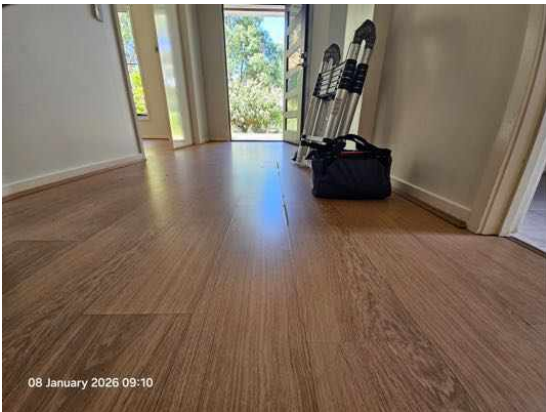
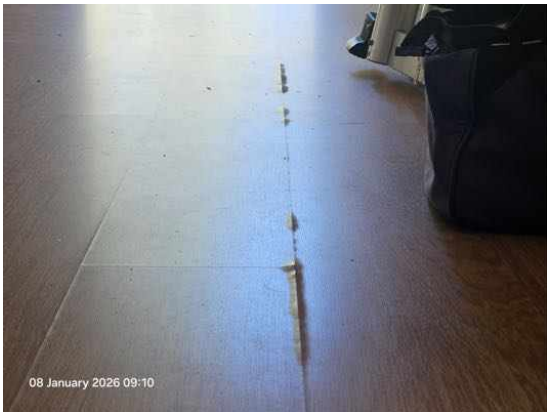
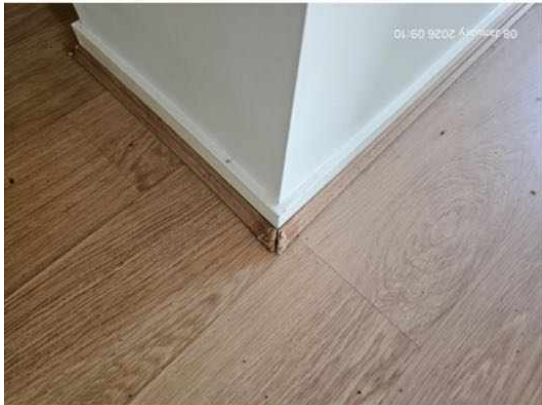
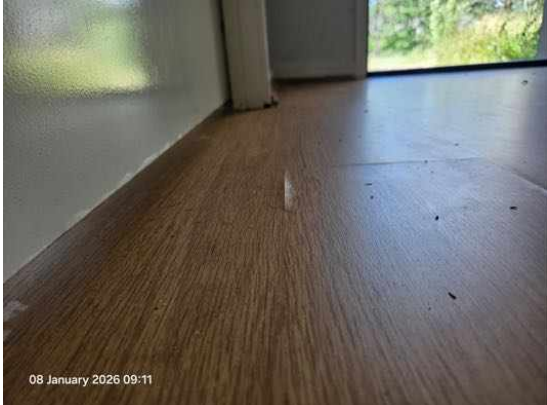
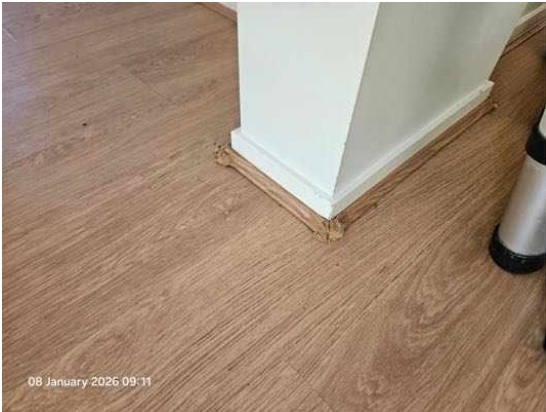
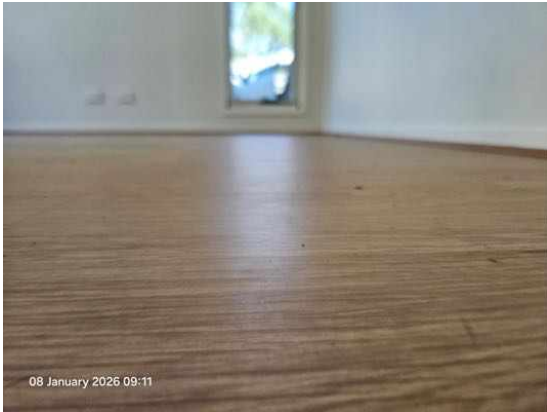
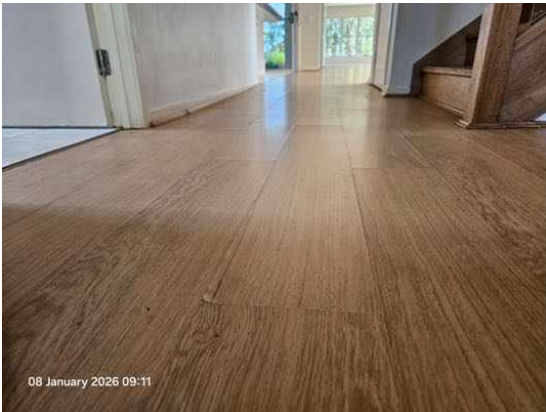
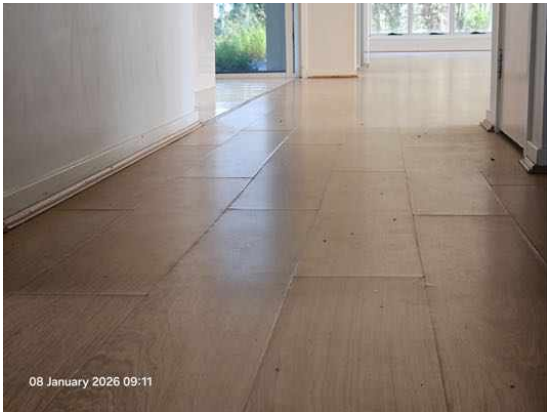
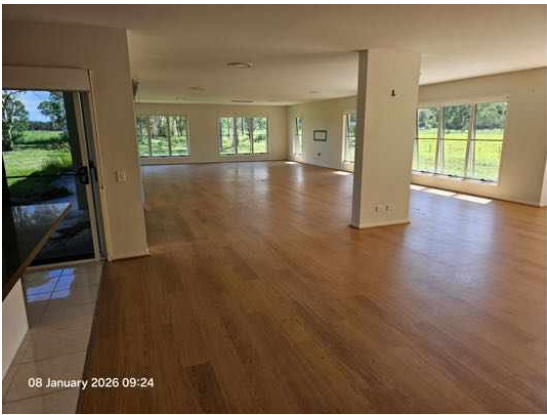
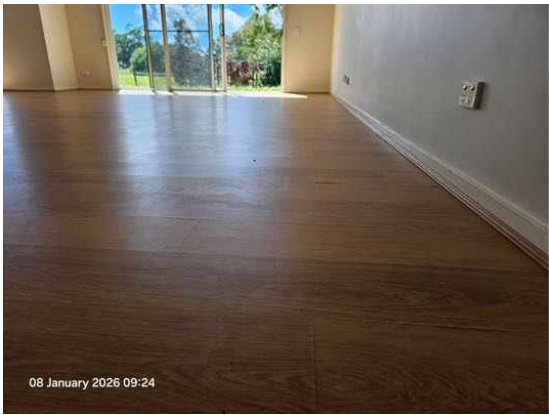
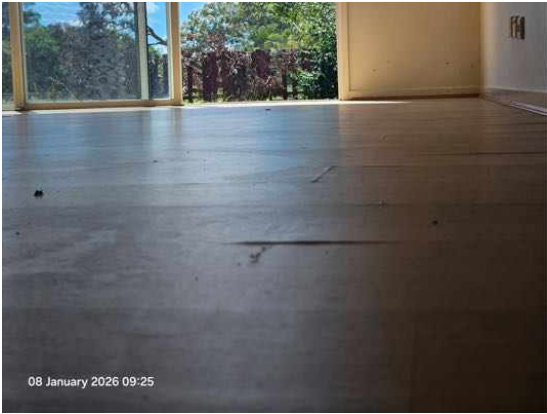
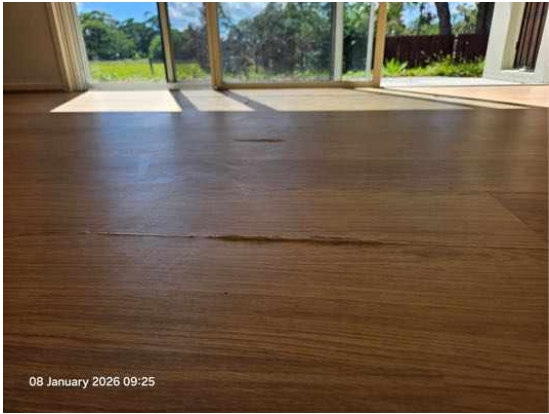
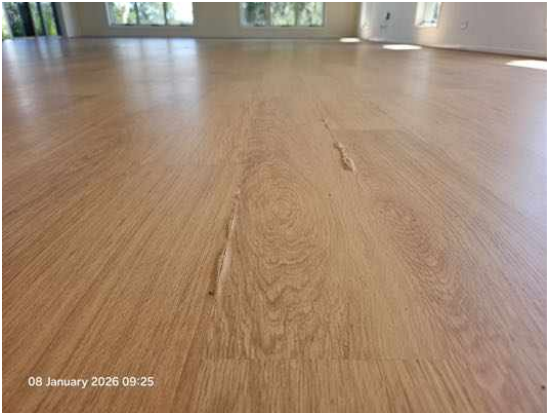
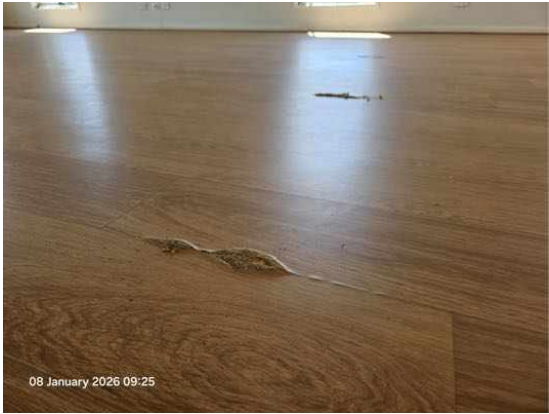
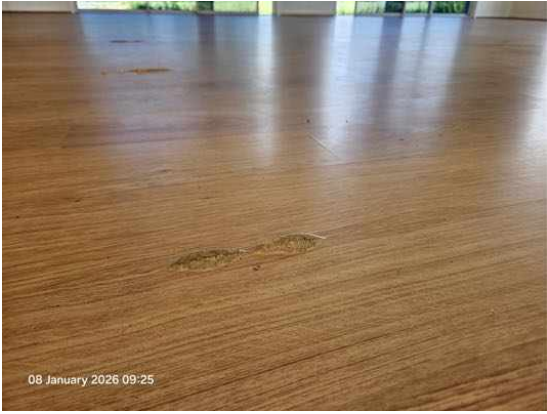
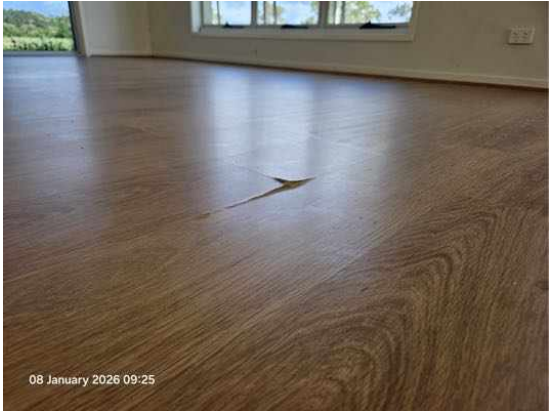
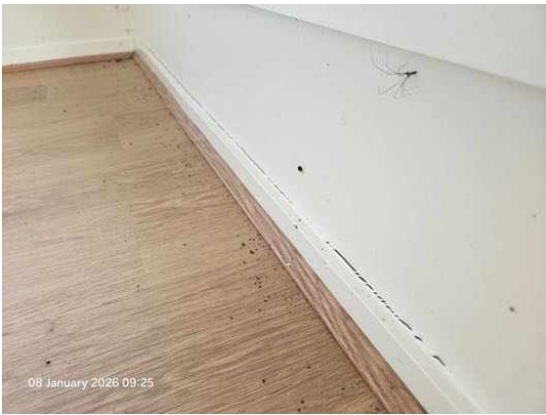
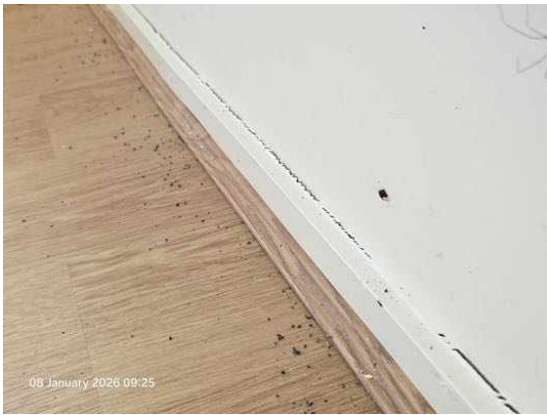
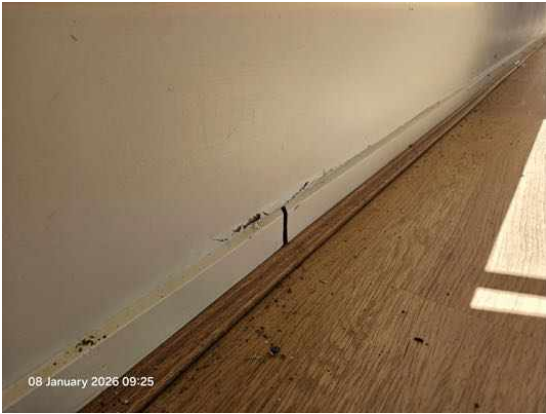
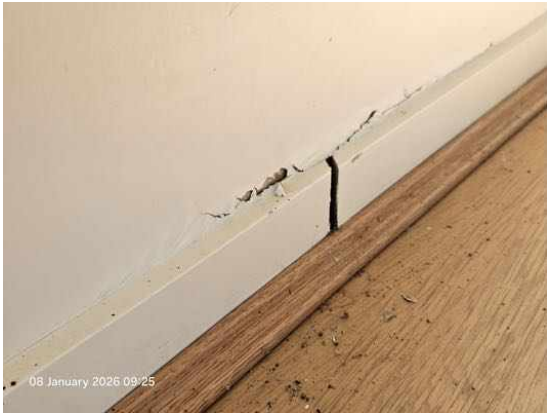
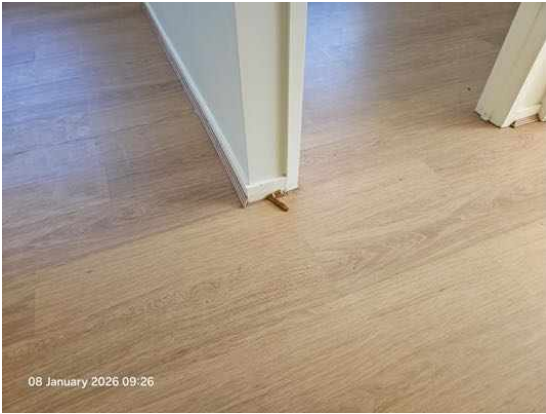
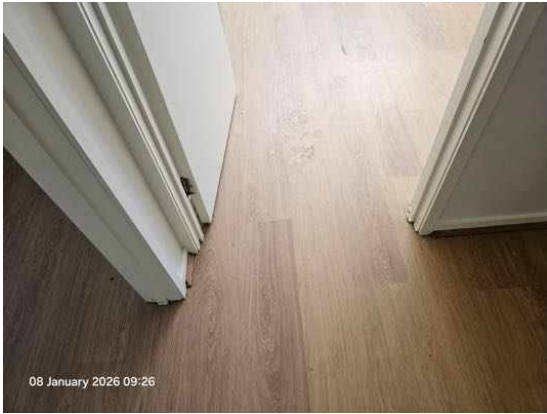
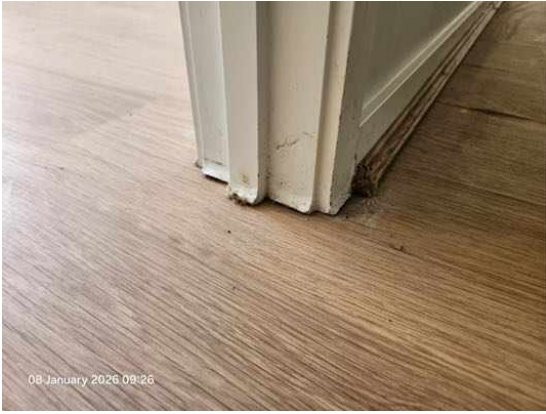
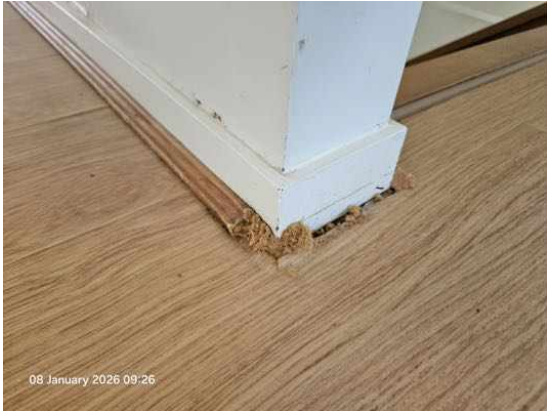
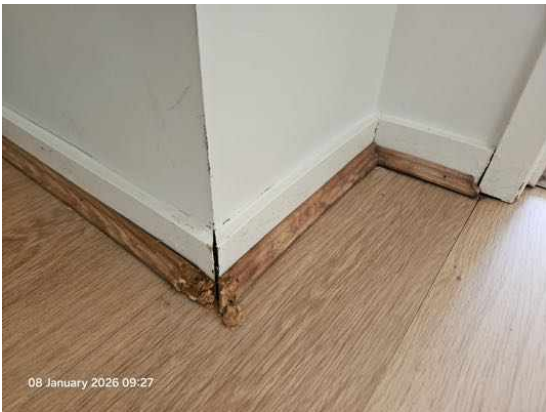
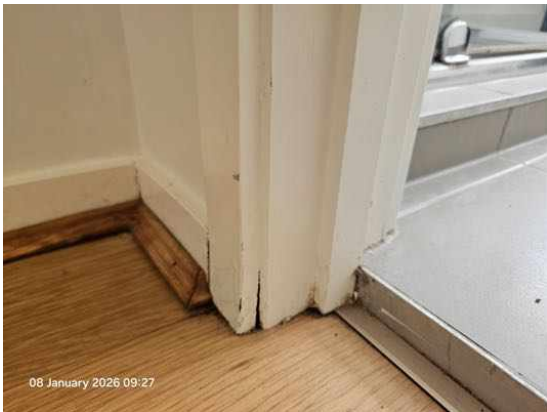
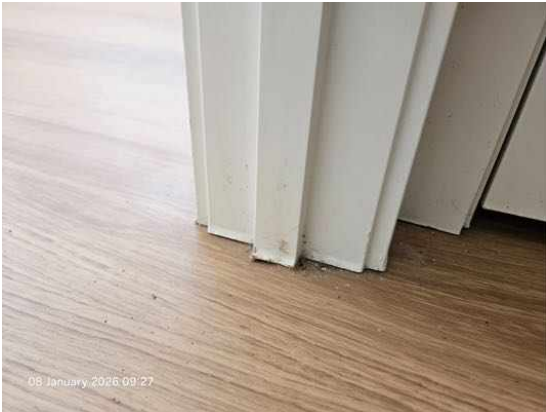
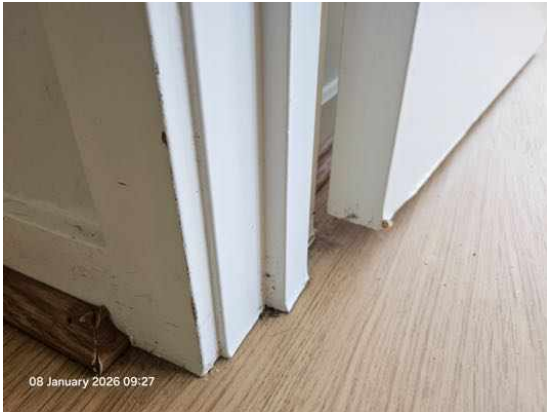
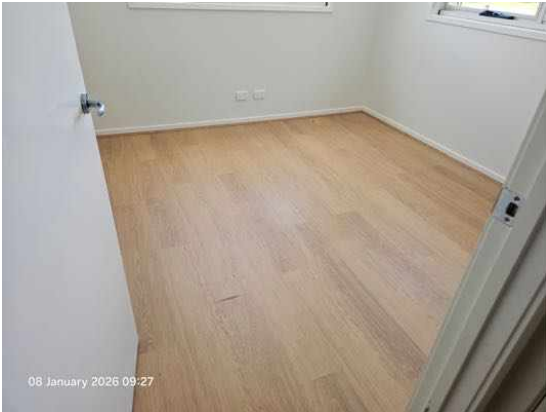
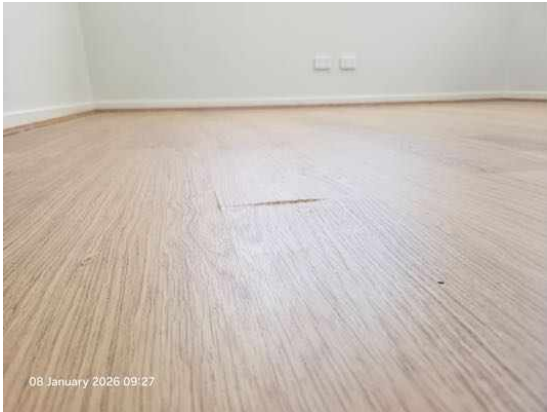
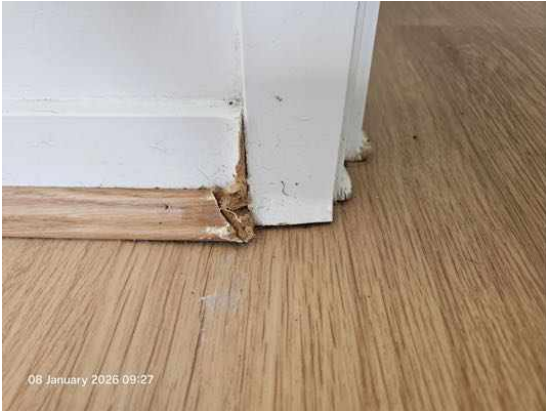
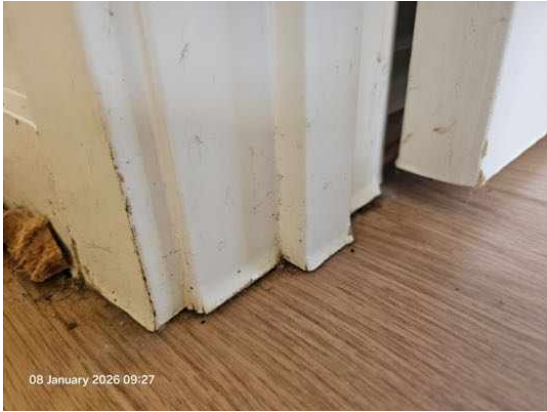
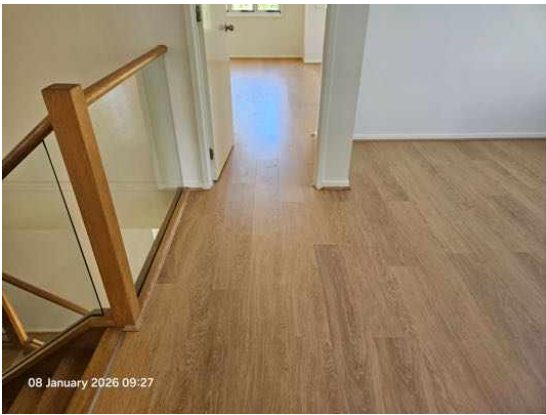
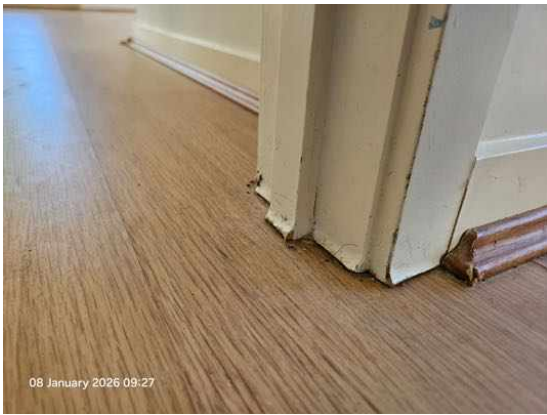
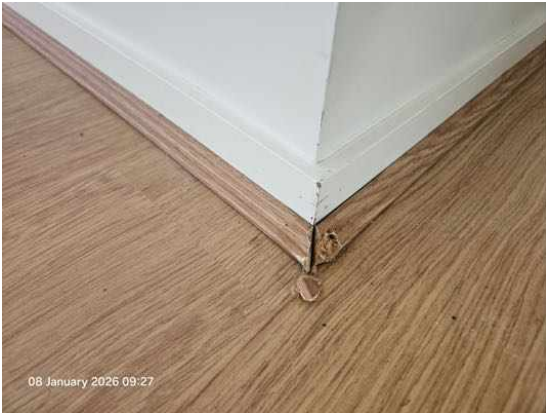
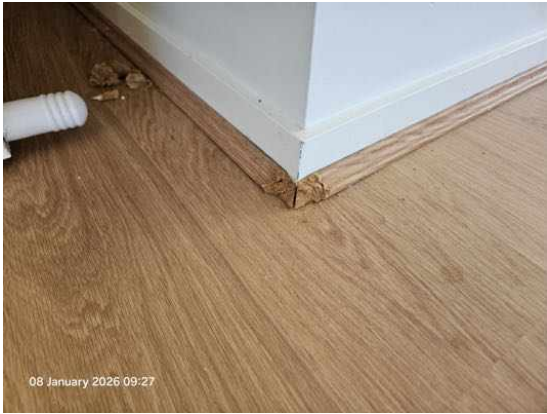
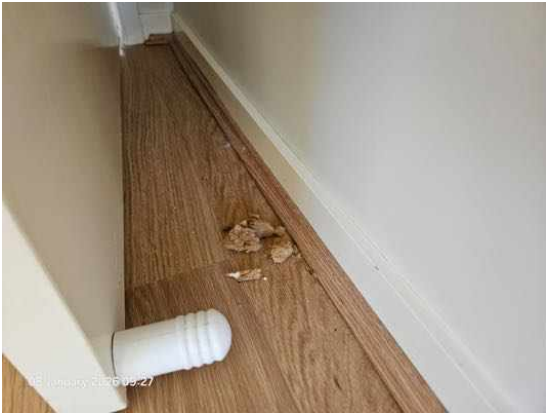
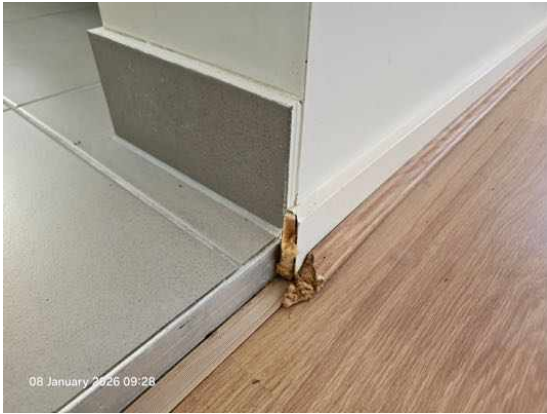
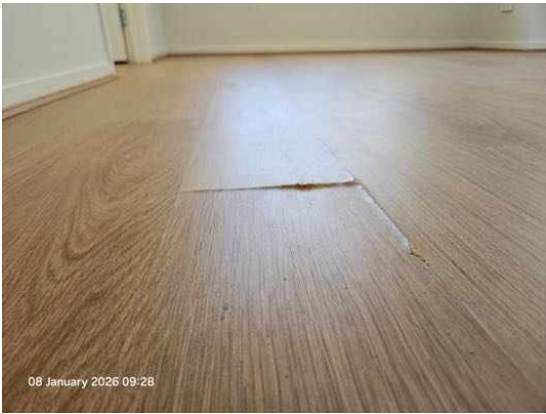
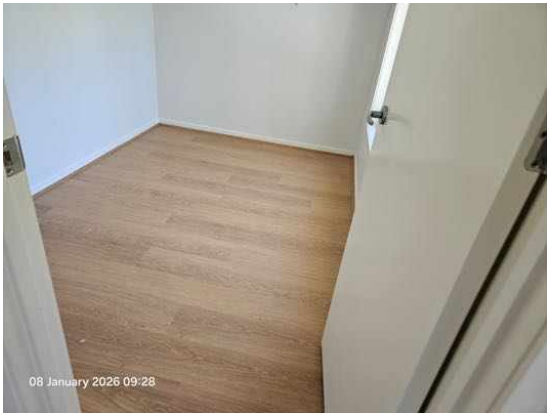
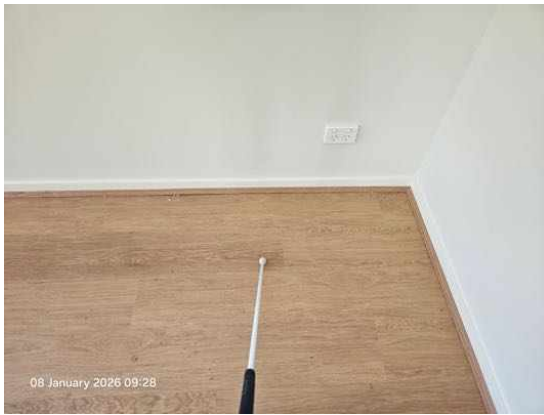
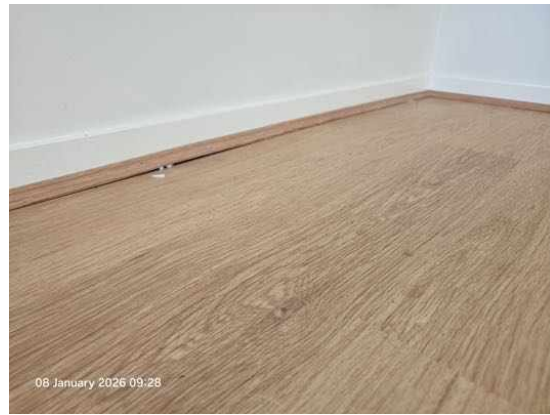
Defects 2.01

Building: Main Building
Location: All Internal Areas
Finding: Floating floor - swelling
Information: During the inspection the floating floor surfaces throughout the property had observable swelling and damage consistent with exposure to moisture.

The observable damage is more severe on the ground floor; however, there is deterioration on the upper floor. Given the wide spread coverage of the damage and deterioration of the flooring and the swelling noted in door jambs and some joinery, the conclusion has been reached that there has been some form of flooding. Minor peaking may be attributed to environmental moisture absorption; however, other factors make this assumption unlikely.

Seen in the photos and noted throughout the floor surfaces are areas of severe swelling and lipping at board joins. The scotia trims are also severely deteriorated, swelling and breaking down at mitres and joins. This is consistent on both floor levels.

This assessment of the flooring has determined that the most effective repair proposal would be replacement of the product. A suitably qualified flooring tradesperson or licensed carpenter person could be engaged to provide a proposal for the replacement of the floor covering.

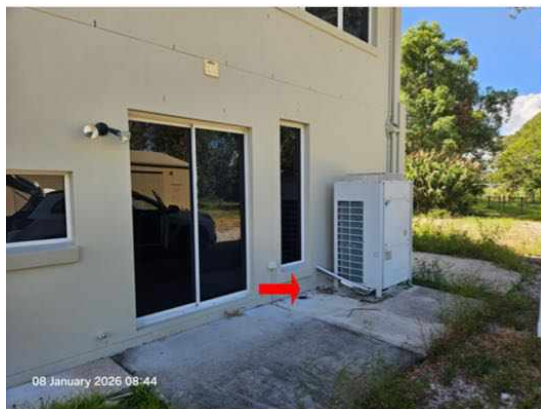
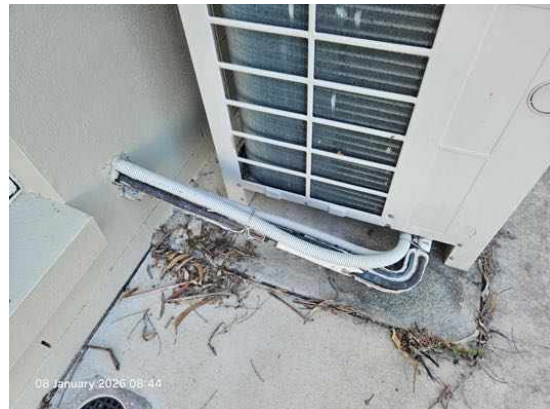
Defects 3.01

Building:	Main Building
Location:	Left side
Finding:	Air conditioner pipes
Information:	On the day of inspection it was noted the the lagging of the air conditioner coolant pipes has worn away and is exposed to the elements. Air conditioning is out of scope for the report and is noted as an information statement only.

The client could engage an air conditioning technician to provide any required repairs.

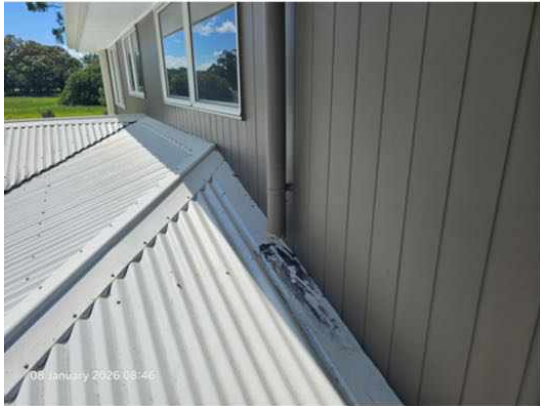
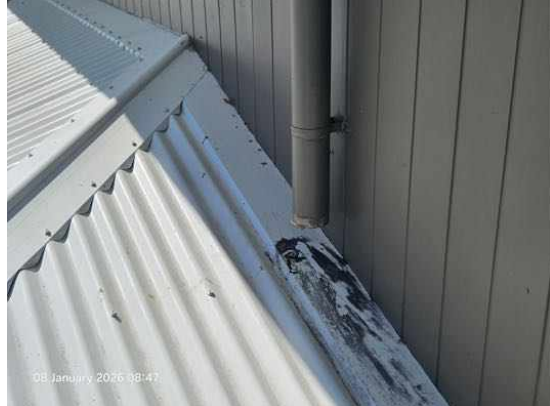
Defects 3.02

Building:	Main Building
Location:	Rear
Finding:	Downpipe spitter / spreader - missing
Information:	On the day of inspection it was noted that the downpipe of the rear upper roof ejects directly on to the lower roof surface over the flashing. A spitter / spreader was previously fitted here; however, was missing on the day of inspection. These are required to distribute water on to the lower roof surface over an increased area and to

direct water way from flashings, cladding and wall surfaces.

A licensed plumber could be engaged to carry out this work.

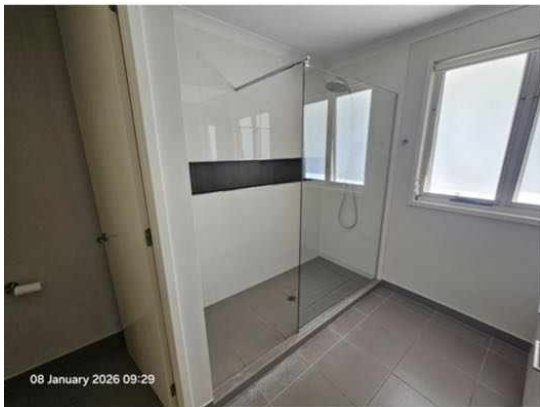
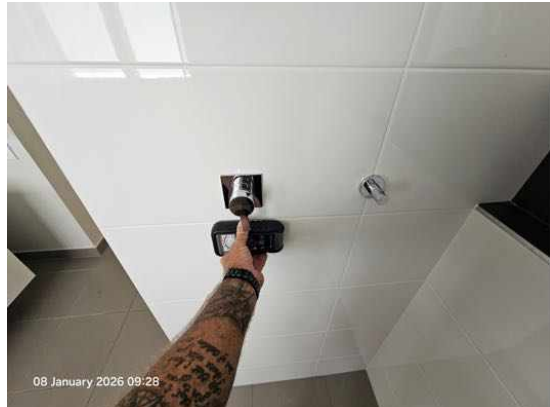
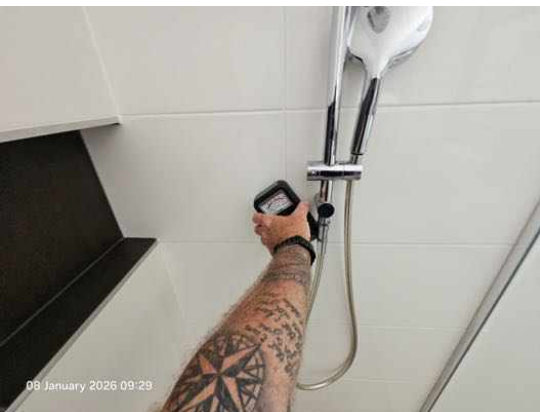
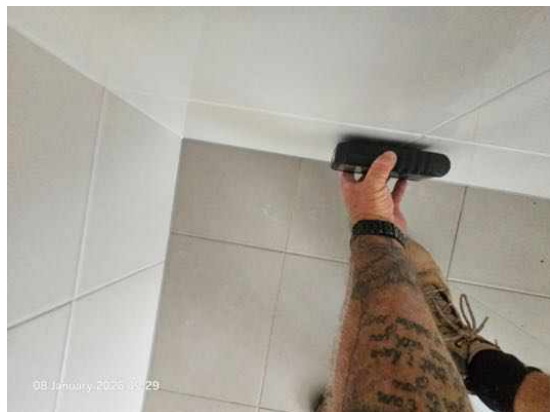
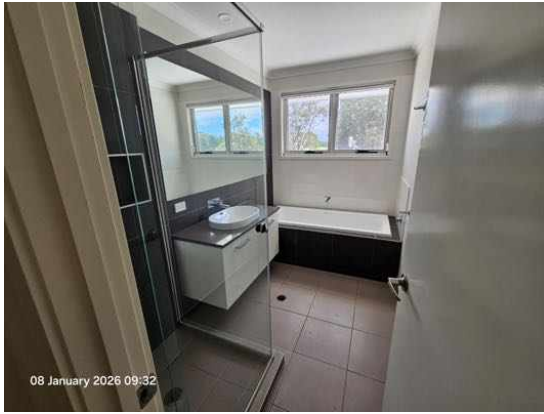
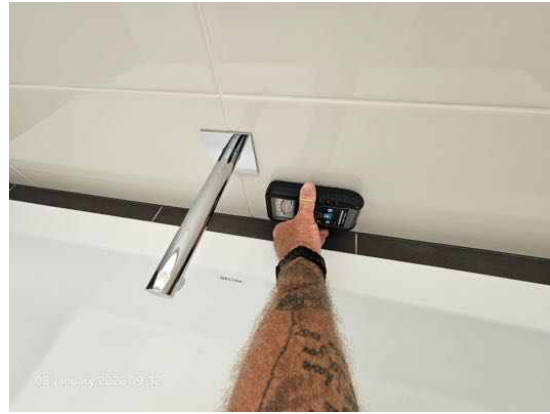
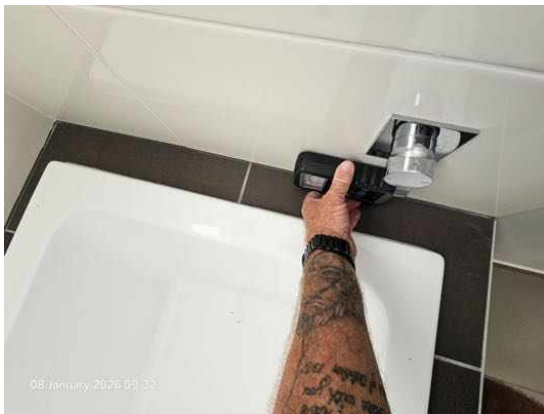
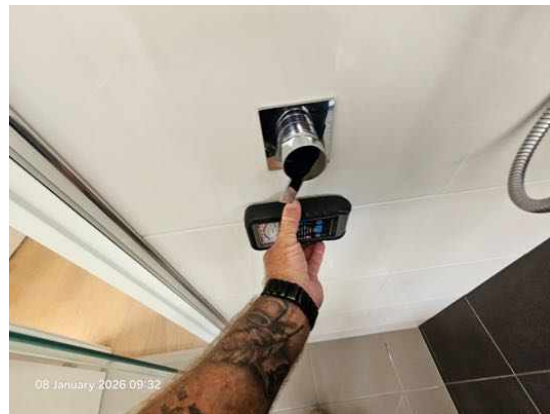
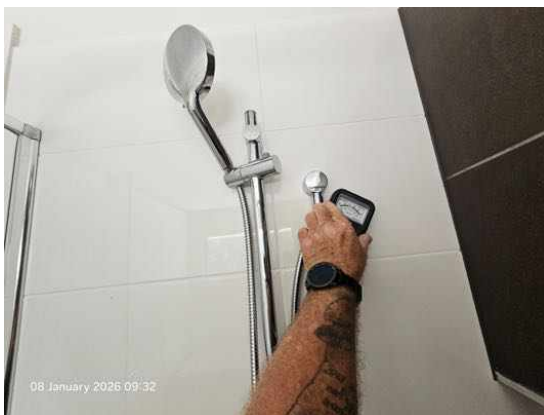
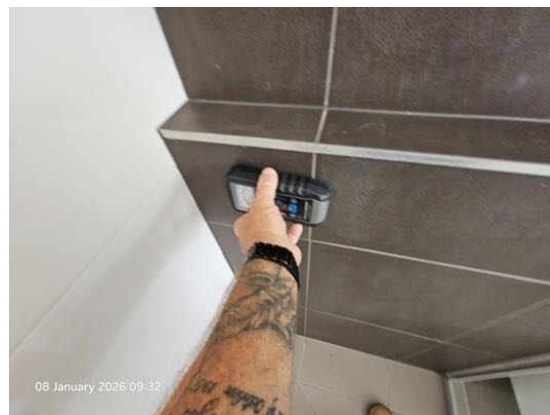
Defects 3.03

Building: Main Building
Location: Bathroom, ensuite
Finding: No moisture detected in bathroom / ensuite
Information: On the day of inspection the showers in the bathroom/s and ensuite are measure for moisture using a "Tramex" moisture meter. During this inspection no moisture was detected in these areas and the tiled / sheeted surfaces appear to be in good order.

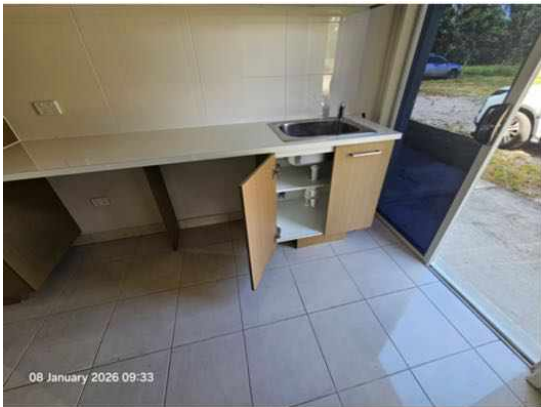
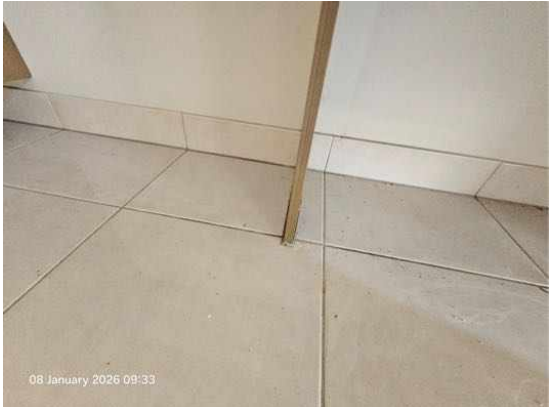
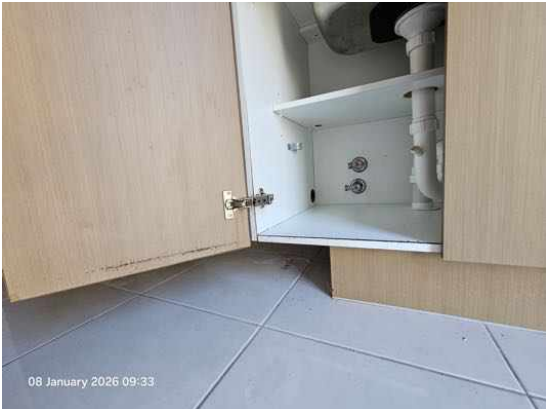
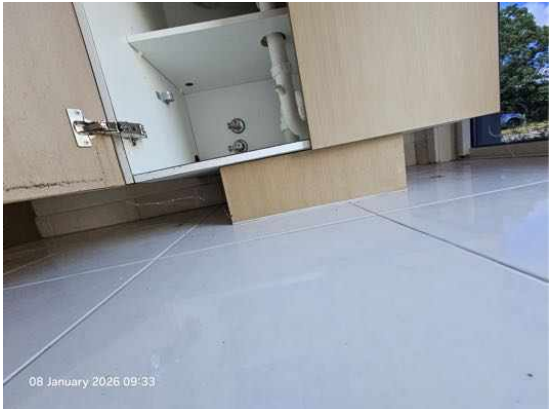
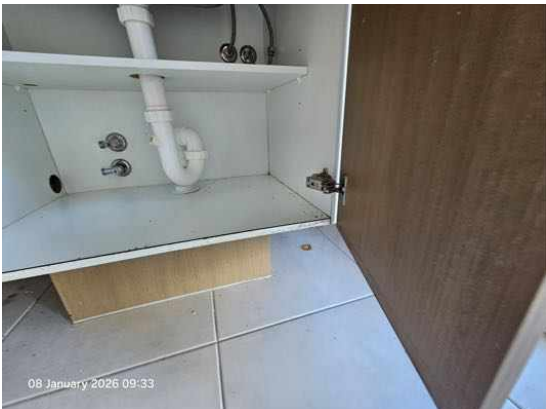
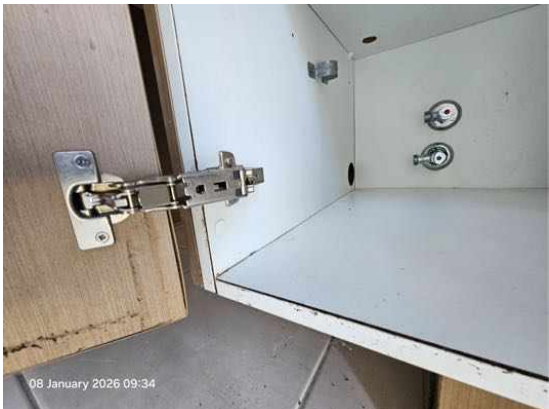
Defects 3.04

Building:	Main Building
Location:	Laundry
Finding:	Moisture damage to cabinets - laundry
Information:	During the inspection moisture damage was observed in the cabinetry components of the laundry cupboard. This damage is wide spread and consistent with a flood or severe / long term leak in the plumbing of the cabinet.

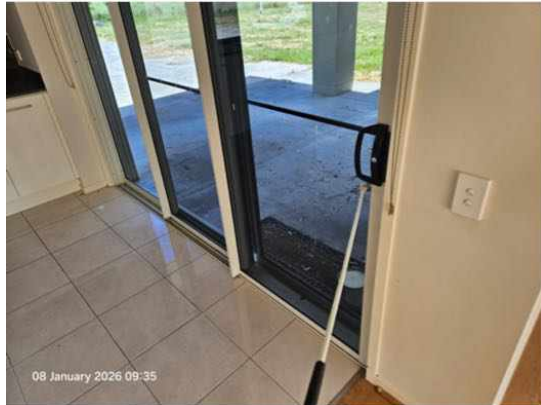
Defects 3.05

Building: Main Building
Location: Kitchen
Finding: Glass sliding door - heavy to slide
Information: The glass sliding door of the family room was difficult to operate and heavy to slide at the time of the inspection.

Doors are a vital part of the building designed to provide access and ventilation to and from the exterior of the building area and should be at a fully operational level to ensure user comfort. Restricted function of the window may also pose as a potential safety hazard if required for emergency egress from the building.

Generally, factors such as general age of the building element and a lack of maintenance are the usual causes for this type of defect.

Replacement of door hardware may be required, as well as minor repairs and cleaning. A licensed glazier or general handy person will be required to repair the door.

It should be noted, many of the doors and windows showed signs of lack of use and will require servicing. It is recommended that a service person be engaged to assess and repair the aluminium joinery accordingly.
