# Building and Timber Pest Inspection Report

Inspection Date: Fri, 6 Mar 2026

Property Address: 11 President St, Croydon Park NSW 2133,  
Australia

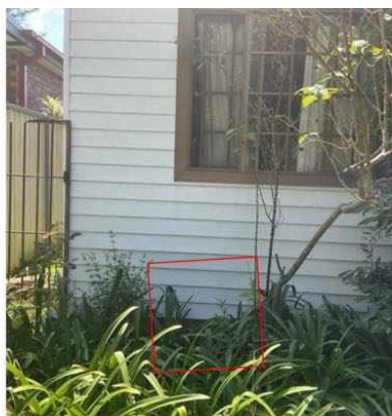
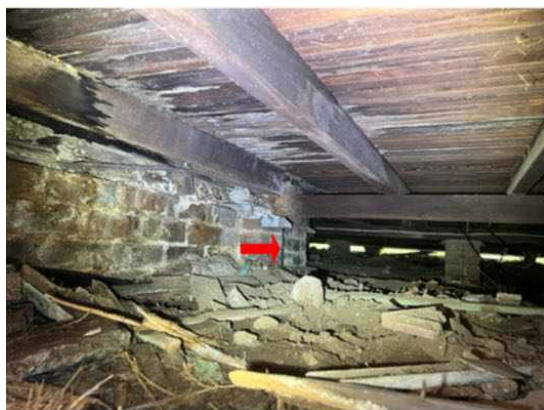
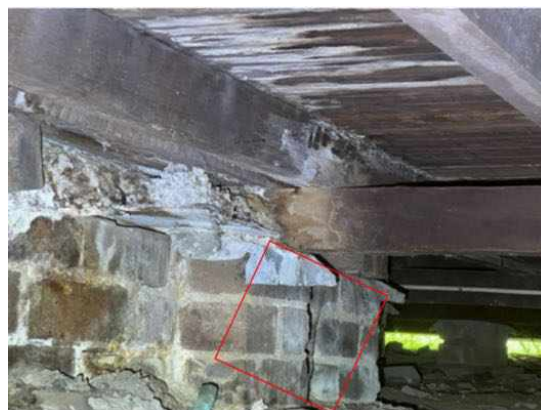
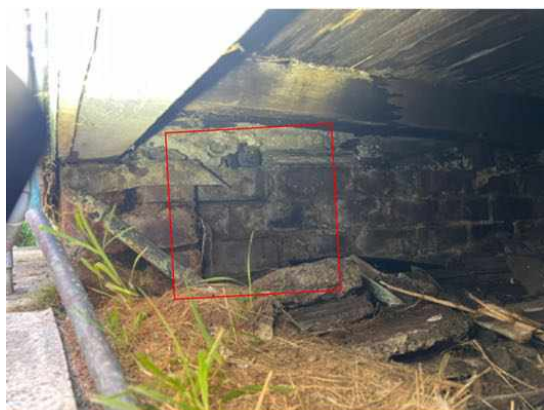
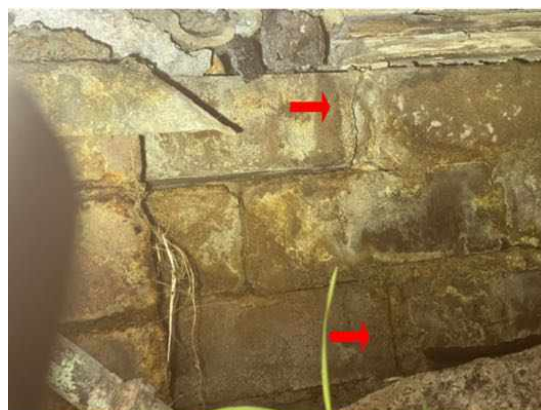
Building: Main Building  
Location: All External Areas and subfloor  
Finding: Brickwork - Cracking noticeable  
Information: There were several cracks and or crack repairs evident to external brickwork.

Noticeable cracks are a common occurrence in external brickwork and are a likely result of age expected building movement, general expansion, and/or contraction of building materials in different weather conditions. Noticeable cracks in brickwork may develop if left unattended, with potential for necessitating major remedial works or replacement of the brickwork.

It is highly advised that a qualified bricklayer be appointed to provide necessary works to cracked brickwork to prevent any further damage. Such works should be conducted as soon as possible.

Always monitor these cracks and contact a building inspector should cracks widen, lengthen, or become more numerous.

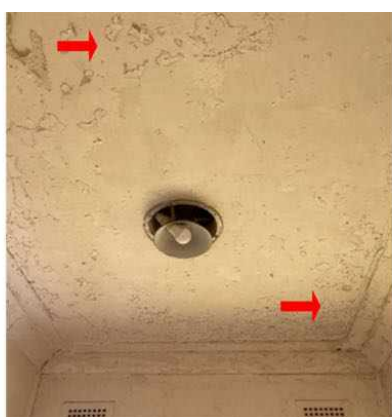
Building:	Main Building
Location:	All Internal Areas
Finding:	Mould - Present - Ceilings in poor condition with holes and sagging
Information:	Where evidence of mould growth was noted, there may be environmental, biological or health issues associated with the report. A specialist inspection by a suitably qualified environmental health inspector is warranted, where mould is extensive or where any queries regarding air quality spores or other related issues apply.

Generally, the client is advised to ensure that the general environment is free of moisture and humidity to aid in the prevention of mould formation and development. Any mould found during the inspection should be cleaned immediately by a cleaning contractor or the homeowner as applicable.

Please note that severely affected building elements may require replacement by a registered builder or qualified carpenter.

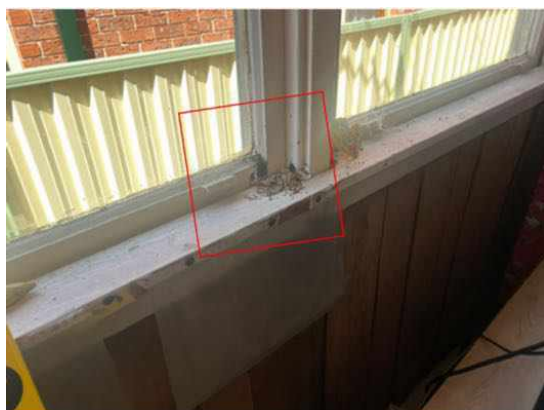
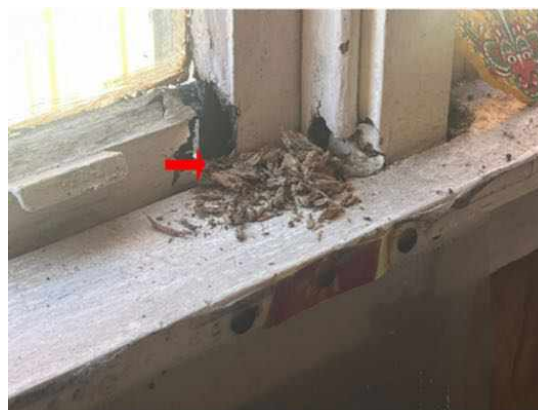
Building:	Main Building
Location:	All External Areas
Finding:	Wood rot to some areas (Also refer to D 3.1 & 6.1)
Information:	This building element shows evidence of wood rot. Wood rot, also known as Fungal Decay, occurs when timbers and other cellulose building materials are exposed to damp conditions on an ongoing basis. This could be the result of exposure to weathering over a prolonged period of time, or the attraction of excessive moisture from other abutting building materials. Contributing factors also include poor air ventilation in the area.

Wood rot is often associated with general damp problems and is evidenced by a

'musty' smell or mould and mildew occurring on surfaces. If left unmanaged, damp conditions can lead to further health problems and the decay of timbers will continue.

Early intervention and regular maintenance, particularly of exterior timbers, will prolong the useful life of these building elements. Prior to any works being performed, the cause of the moisture that has created the visible wood rot should be identified and addressed in a suitable manner. Replacement of affected timbers may then be a necessary step in protecting surrounding building elements from such deterioration.

A qualified plumber may be appointed to assess the cause of excessive moisture and to provide advice on any remedial works as required. A qualified carpenter or registered builder may also be required to replace affected building materials.

Even though Liverpool termite activity was not visible. A further invasive inspection by a licensed termite technician its also highly recommended to eliminate possibility of potential termite activity.

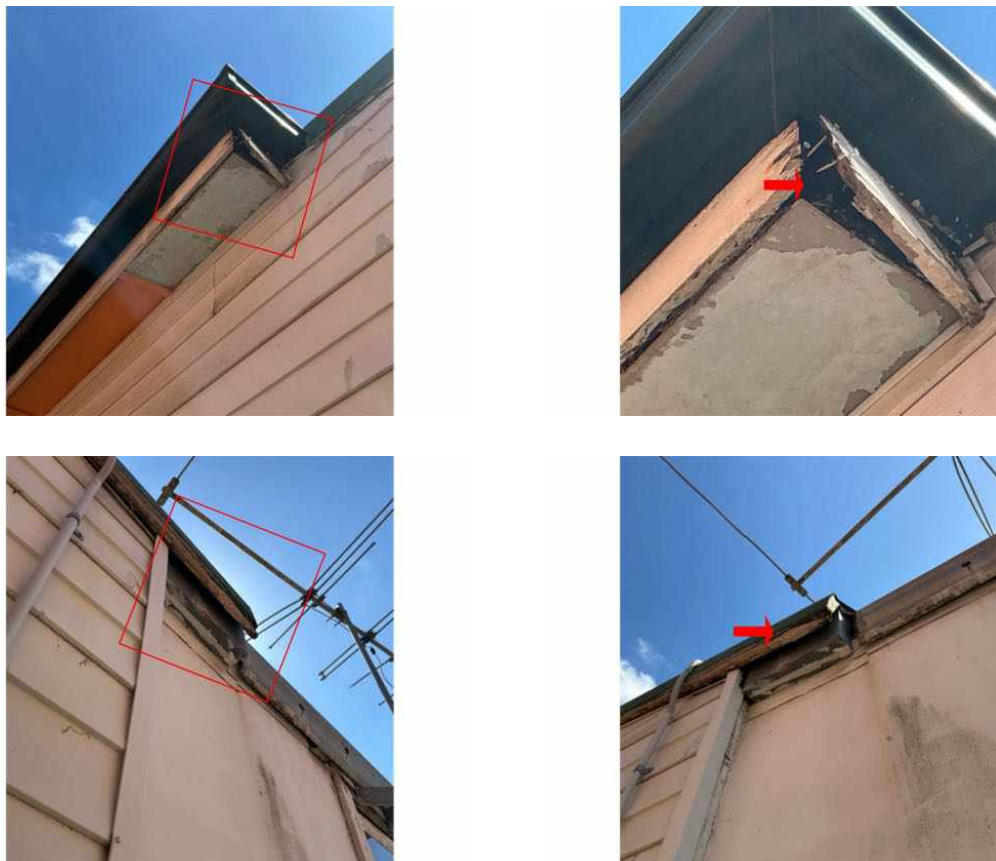
### Finding 3.01

Building:	Main Building
Location:	All External Areas
Finding:	Fascias - Wood rot (Also refer to D 6.1)
Information:	Wood rot was found to be affecting fascias and barges in this area, evidenced by the presence of mould on the surface in some areas. Wood rot, also known as Fungal Decay, occurs when timbers and other cellulose building materials are exposed to damp conditions on an ongoing basis.

It is likely that this wood rot has developed as a result of faults in the roof plumbing, creating excessive moisture in this areas. Frequent exposure to rain and other weather conditions also make fascias and barges susceptible to accelerated deterioration.

Early intervention and regular maintenance will prolong the useful life of these building elements. Prior to any works being performed, the cause of the moisture that has created the visible wood rot should be identified and addressed in a suitable manner.

It is advised that a roof plumber be appointed to inspect all roof plumbing and subsequently identify the cause of the wood rot. Replacement of affected fascias and barges may then be a necessary step in protecting surrounding building elements from

A qualified plumber may be appointed to assess the cause of excessive moisture and to provide advice on any remedial works as required. A qualified carpenter or registered builder may also be required to replace affected building materials.

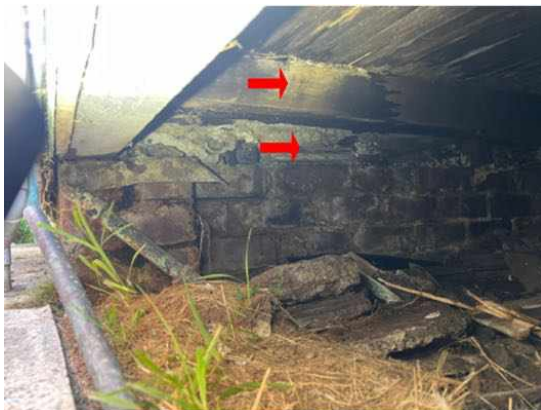
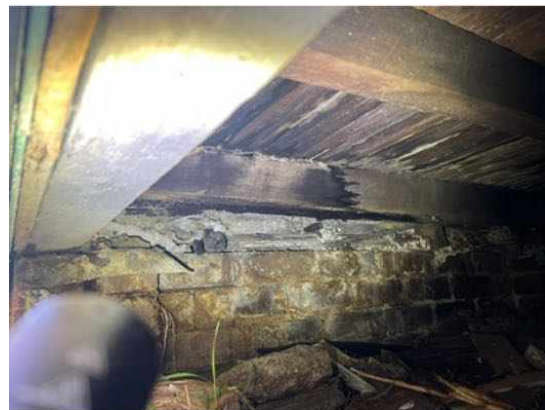
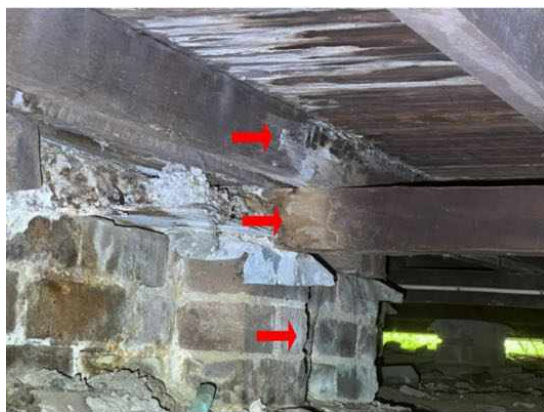
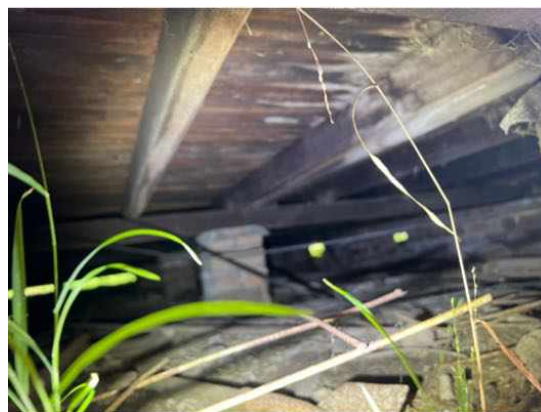
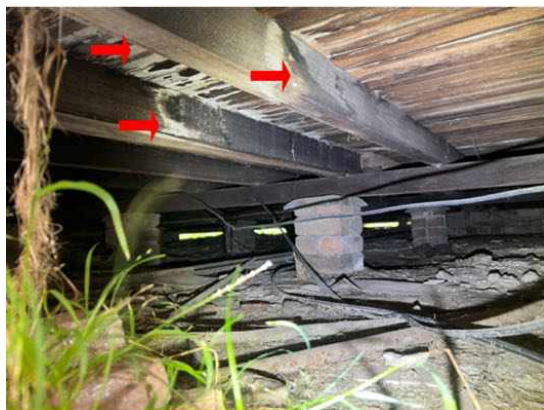
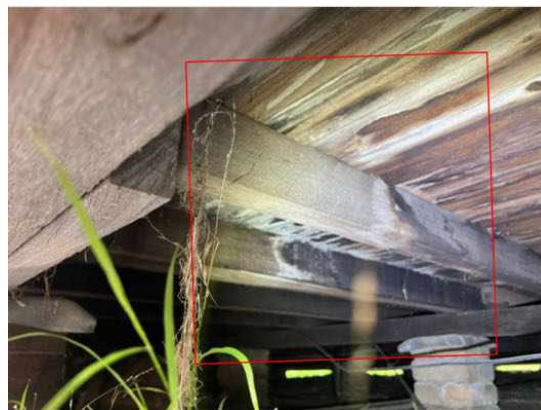
Finding: Subfloor Timber Staining – Moderate Condition

Information: Subfloor was only inspected from outside limited viewing space, Discolouration and surface fungal growth were noted on several subfloor timbers, likely due to historic moisture exposure. Although not classified as a major defect, ongoing monitoring is recommended, and a licensed plumber should be engaged to check for any slow leaks or past water ingress contributing to staining.

Although no visible signs of termites was evident at the time of inspection however due to presence of conducive conditions a further invasive inspection by a licensed termite specialist is recommended in the areas where access was limited due to obstructions and limited or no crawl space.

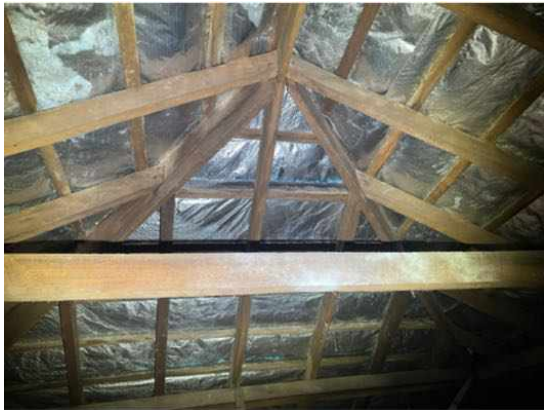
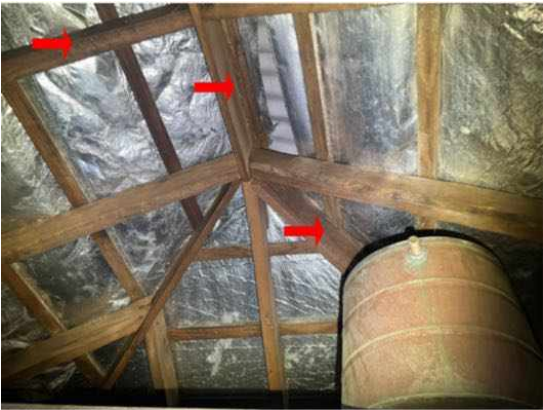
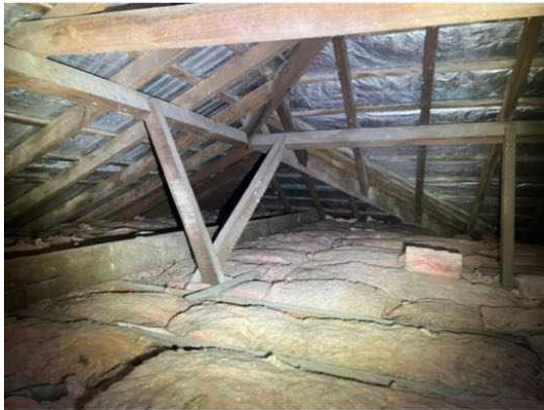
**Finding 3.08**

Building: Main Building  
Location: Roof Void  
Finding: Aged Timber and moisture staining – Roof Void  
Information: Visible decay was noted to some areas , consistent with age-related shrinkage and general weathering. The affected areas also exhibited localised surface darkening, which may indicate past moisture exposure. These conditions appear typical for a dwelling of this age and construction, but ongoing monitoring is recommended. A licensed builder or licensed carpenter should be consulted if there is further deterioration or leaks. A further invasive inspection by a licensed timber pest technician is highly recommended to check for concealed termite activity

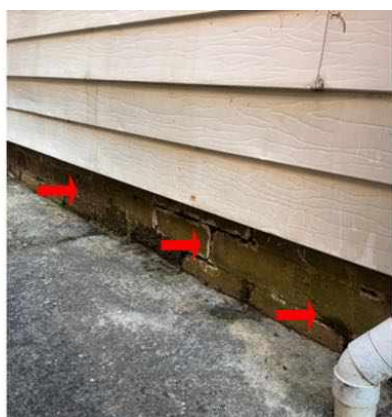
Mortar may deteriorate as a result of age of building materials, minor movement of bricks, or frequent exposure to weathering. Mortar should be replaced to ensure that bricks remain in their intended location and to prevent gaps, which would allow water or moisture ingress and secondary damage as a result.

Mortar deterioration can be addressed by a bricklayer where areas of deterioration are localised and easily accessible. Alternatively, appointment of a registered builder is advised, to repoint large areas of decaying mortar. Where secondary structural defects have become evident, consultation with a structural engineer may be required.

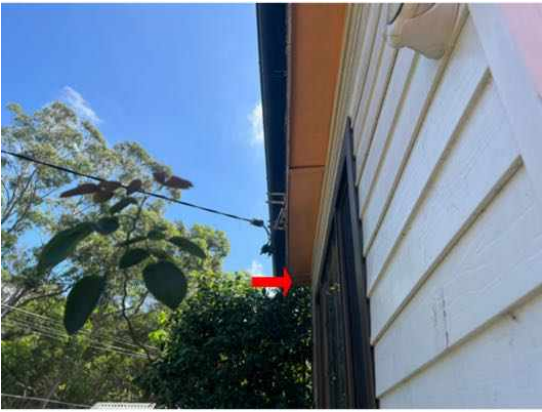
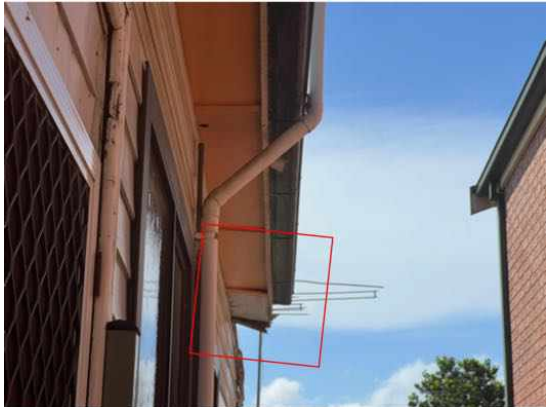
### Finding 3.14

Building: Main Building  
 Location: All External Areas  
 Finding: Building element - Damaged- Trim and weatherboards damaged , eaves damaged  
 Information: Breakage occurs generally when the building materials have either aged and decayed, or as a result of damage (accidental or deliberate).

Repair and/or replacement of broken elements is advised to ensure that additional secondary defects do not arise as a consequence. Such works are necessary, as all building elements play a key role in the operation and function of the overall structure and its performance.

A relevant tradesperson should be appointed to repair or replace the affected building element prior to any subsequent damage being caused.

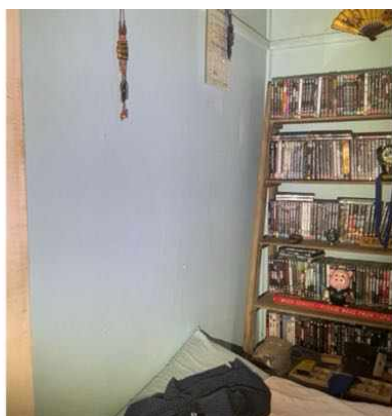
Incomplete paint finishes should be sanded back, filled, leveled and painted, as applicable. Where inadequate or missing paint protection has led to the deterioration of the associated building element, repair and/or replacement of this building element may be required.

A painting contractor should be appointed as soon as possible to perform necessary works to aid the appearance of the affected area and to ensure the area is protected against further deterioration. Alternatively, the homeowner following manufacturer instructions may perform these works.

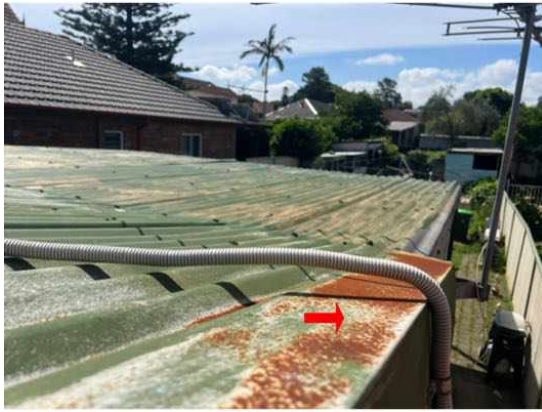
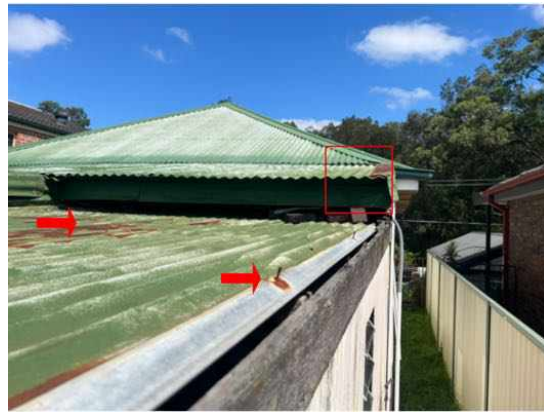
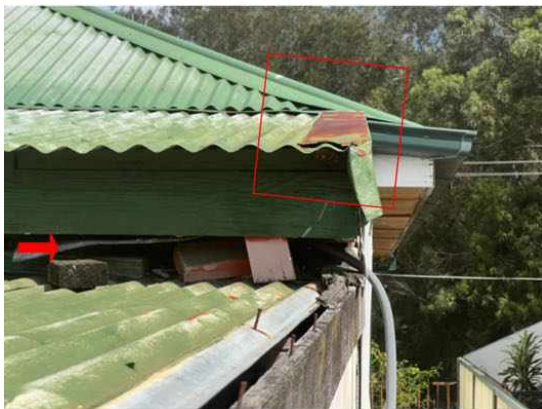
Where possible, the use of galvanized (treated) metals or aluminium coated metals aid in rust prevention, as does regular general maintenance. Rust formation can be controlled with coatings, such as paint, that isolate the iron from the environment.

Rusting and corrosion should be managed by ideally removing or limiting the affected surface from exposure to moisture. A registered builder may be appointed to replace any building elements that have been severely affected by rust or water damage.

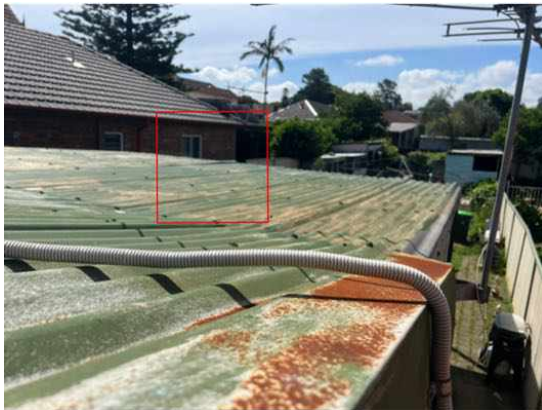
### Finding 3.23

Building:	Main Building
Location:	Roof Exterior
Finding:	Building element - Damaged - roof sheeting lifting to some areas
Information:	Breakage occurs generally when the building materials have either aged and decayed, or as a result of damage (accidental or deliberate).

Repair and/or replacement of broken elements is advised to ensure that additional secondary defects do not arise as a consequence. Such works are necessary, as all building elements play a key role in the operation and function of the overall structure and its performance.

A relevant tradesperson should be appointed to repair or replace the affected building element prior to any subsequent damage being caused.

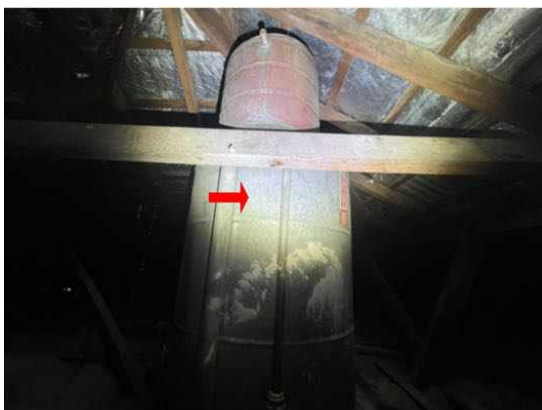
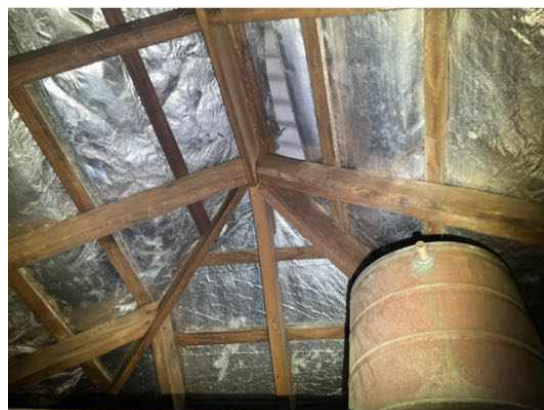
### Finding 3.24

Building:	Main Building
Location:	Roof Void
Finding:	Gravity-Fed HWS - Disconnected
Information:	It was noted at the time of inspection that a disconnected gravity-fed hot water system (HWS) remains in this area.

Despite this plumbing structure being unused, it is likely to be storing residual water, and is therefore susceptible to rust and corrosion. If allowed to continue, rust and corrosion is likely to lead to damage to adjoining building elements, and may also make the area susceptible to termite or timber pest activity.

While it is a costly exercise to remove the disused gravity-fed HWS, it is advisable in the short-term future to prevent any further damage to the area. Further consultation with a licensed plumber is required to gain further advice on removal of the structure.

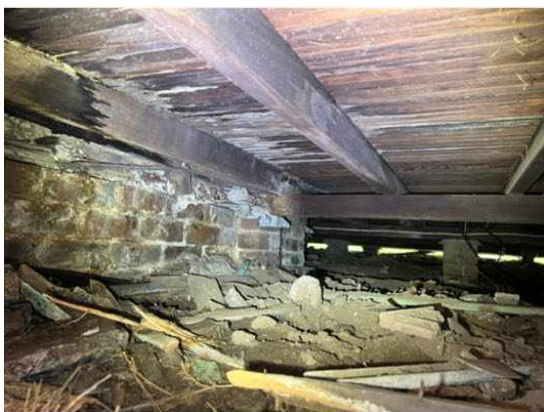
### Finding 3.26

Building:	Main Building
Location:	Subfloor
Finding:	Subfloor ventilation - Inadequate
Information:	Adequate subfloor ventilation aids in preventing excessive moisture wood rot and termite activity by ensuring a dry subfloor environment.

A registered builder should be appointed as soon as possible to perform these works as necessary.
