Building and Timber Pest Inspection Report

Inspection Date: Tue, 3 Mar 2026

Property Address: 31 Debrincat Avenue, North St Marys, NSW
2760

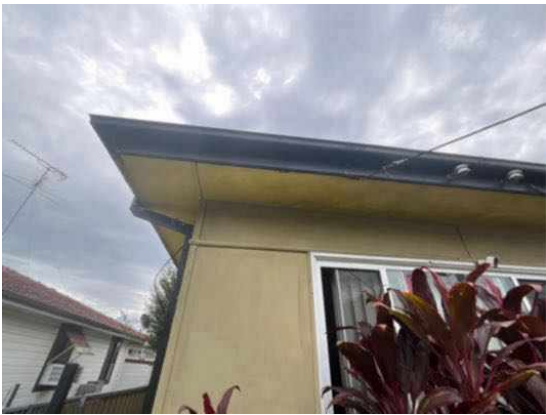
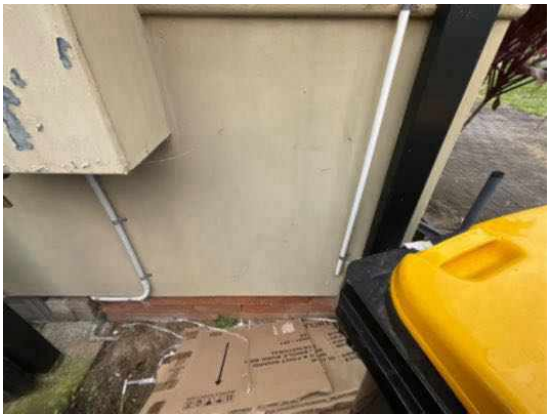
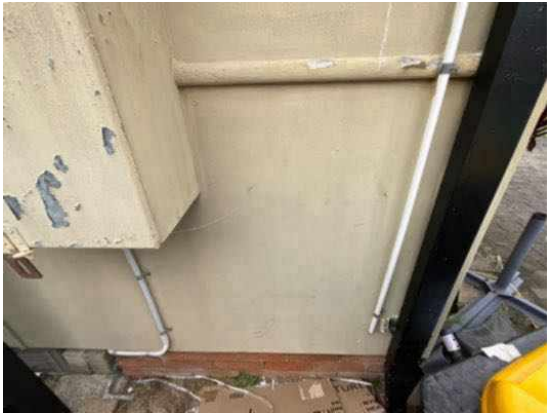
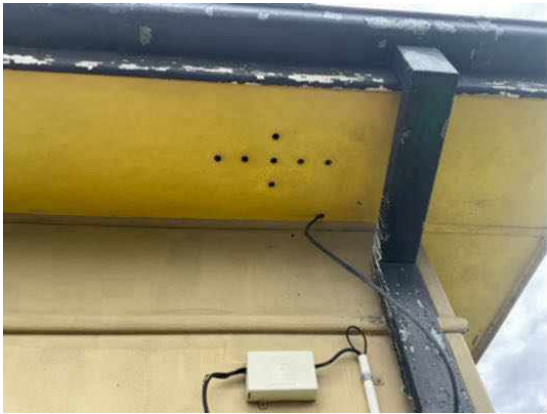
Building:	Main Building
Location:	All Areas
Finding:	Asbestos - Suspected ACM Identified on Site
Information:	Reporting on Asbestos is outside the Scope of this Report. This suspected defect is highlighted as a caution only. We suspect, based on our experience in the building industry, that there is a higher risk of the identified building element containing asbestos.

As Asbestos Reporting is outside the scope of this report, we advise that you consider a separate Asbestos Inspection and Condition Audit, which can include the taking of samples for definitive confirmation of the presence of Asbestos.

In the interim, the client is advised to act with caution, especially when considering any damage to building materials general wear and tear renovations extensions demolition and general maintenance activities due to the suspected presence of Asbestos.

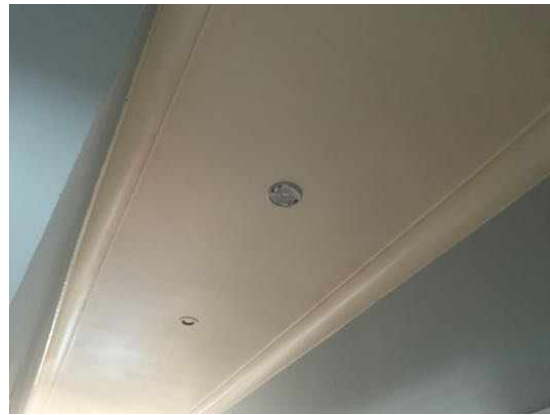
Please note that this defect is highlighted as a caution only. We suspect, based on our experience in the building industry, that the absence of smoke detectors, or their poor condition, should be addressed as a matter of urgency to improve occupant safety.

Always ensure sufficient working and suitable smoke detectors are installed prior to occupying any building. Additionally, it is advised that all smoke detectors be tested by the homeowner on a monthly basis.

Please refer to AS3786 and state based legislation, which may also apply.

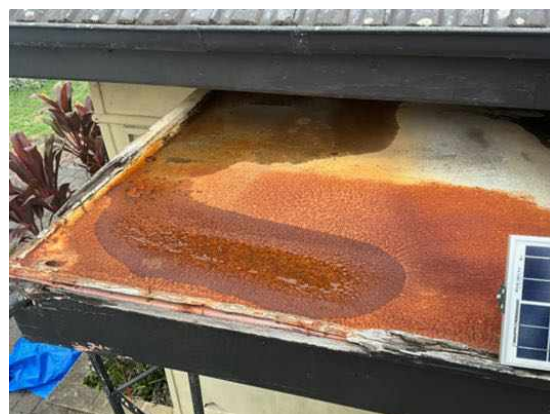
Finding 2.01

Building:	Main Building
Location:	All Areas
Finding:	Roof Weathered
Information:	Upon inspection of the exterior roofing, the majority of roof was not in a fair condition. While weathering of the roof is consistent with the age of the property, maintenance works are required.

Isolated areas of mortar have come loose in the valleys and minor cracking is also present. Re-pointing and re-sealing the may be considered as an interim solution by the client to help preserve and extend the life span of the tiles.

Where left unmanaged, deteriorating roof are likely to lead to a number of secondary defects, including minor water leaks and weather exposure to internal roofing structures.

Consultation with a roofing contractor is highly advised to gain advice on cost of remedial works that may be required in the short to medium term. Remedial works are likely to increase the longevity of the exterior roofing structure.

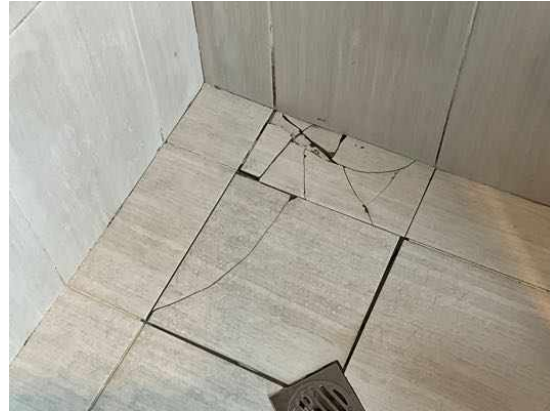
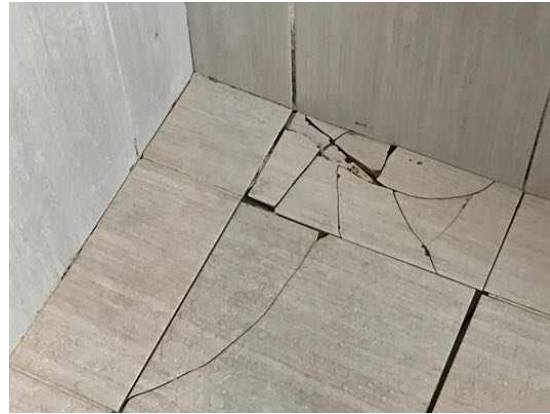
Finding: Tiles - shower Cracked floor tile

Information: A floor tile within the shower area is severely cracked, showing multiple fracture lines extending from the centre. This indicates either substrate movement, inadequate tile bed support, or impact damage. The defect compromises the waterproofing integrity of the wet area.

Cracked tiles in wet areas allow water penetration beneath the surface, potentially causing damage to the waterproof membrane, tile adhesive failure, and water seepage to adjoining areas. If left unrepaired, it may result in mould growth and structural moisture damage.

Engage a licensed tiler to remove and replace the damaged tile(s). The underlying substrate and waterproof membrane should be inspected and repaired if damaged, in accordance with AS 3740 Waterproofing of domestic wet areas.

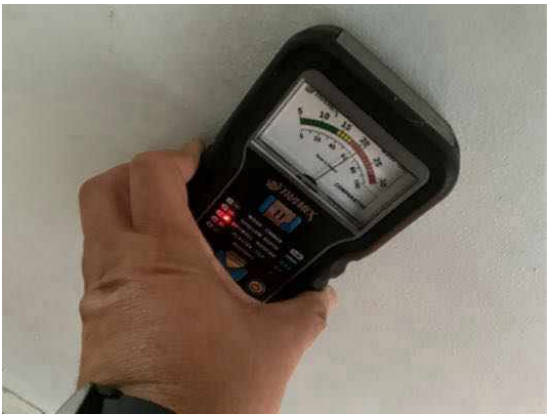
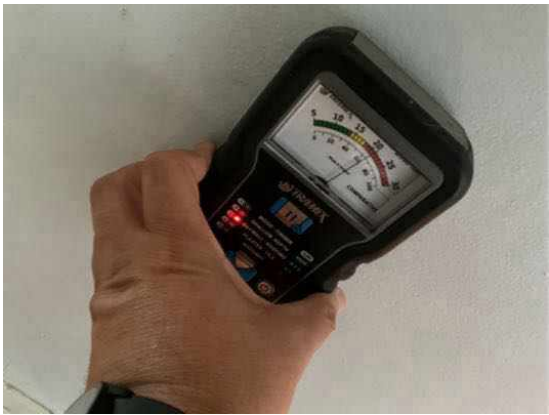
Finding 2.04

Building:	Main Building
Location:	Bathroom
Finding:	Evidence of excessive moisture was present at the time of inspection
Information:	Excessive moisture is present behind the bathroom tiles, indicating a potential water leakage issue within the wall.

The prolonged presence of moisture can lead to mold growth, deteriorate the structure, and create an environment conducive to health hazards. Additionally, it may compromise the adhesive holding the tiles, leading to their detachment.

A licensed plumber or a qualified contractor specializing in water damage remediation should investigate the source of the moisture, fix any leaks, and address the damage. Additionally, replacing affected tiles and ensuring proper waterproofing are crucial to preventing future issues.

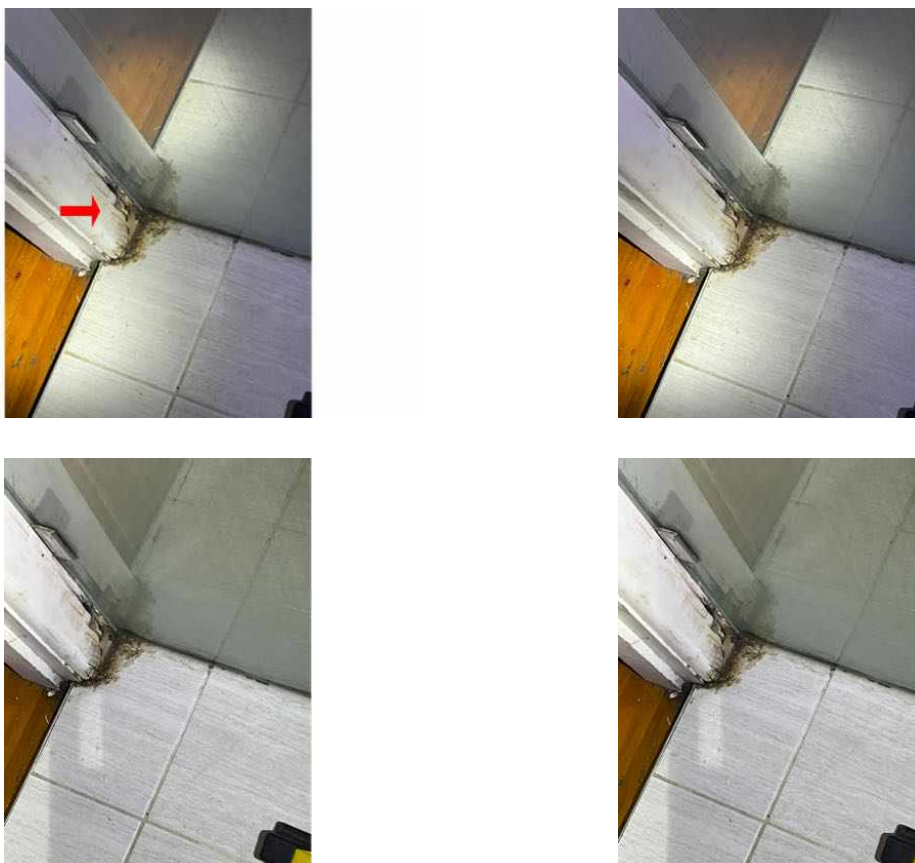
Finding 2.05

Finding: Water damage

Information: The door in the shower area has sustained water damage, resulting in swelling and discoloration of the wood, as well as potential structural issues. This damage compromises both the aesthetic and functional aspects of the vanity."

1. ****Carpenter or Woodworker:**** They can assess and repair the damage to the vanity, potentially replacing any irreparable parts.
2. ****Plumber:**** If the water damage is due to plumbing issues, a plumber can fix leaks and ensure there are no further water-related problems.
3. ****General Contractor:**** If the damage is extensive and affects the surrounding area, a general contractor can coordinate the repair work, including both the vanity and any related structural or cosmetic repairs.

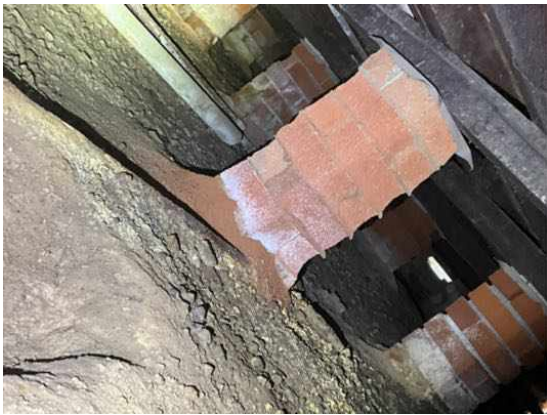
Finding 2.06

Building:	Main Building
Location:	Subfloor
Finding:	Subfloor Piers - Unstable or deteriorated
Information:	Piers to the subfloor structure are unstable, indicating that their structural integrity has been affected. The cause of this instability is likely to be movement by which piers deteriorate at a rapid rate.

The piers are suspected to be failing in their structural purpose, which is likely to lead to a range of major and minor defects. Further (potentially major) damage to the piers and structure may be imminent if left unattended.

Appointment of a Registered Builder specialising in re-stumping is required immediately to assess the condition of the stumps and provide advice on remedial works. This defect should not be left unmanaged.

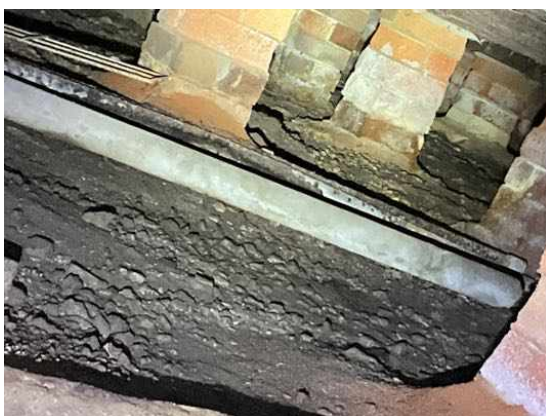
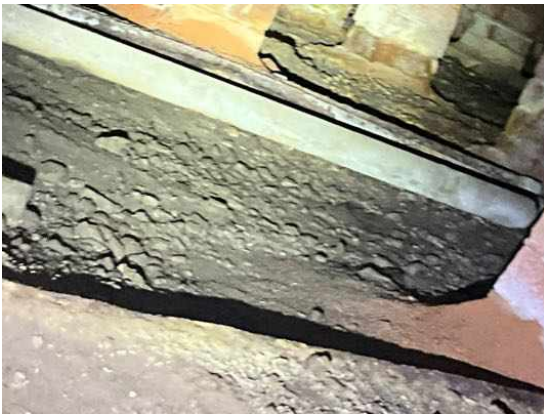
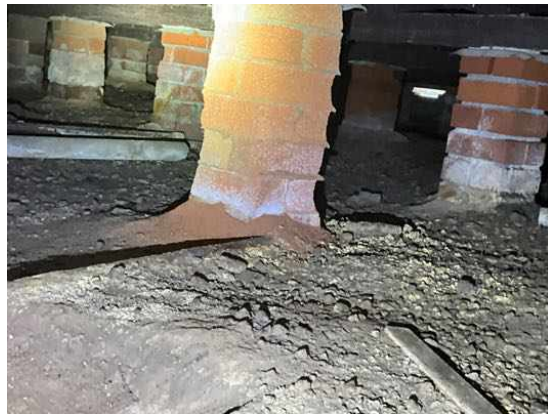
Building:	Main Building
Location:	Subfloor
Finding:	Subfloor - Site drainage - Inadequate
Information:	The site exhibits poor drainage under the subfloor, leading to several critical issues. Water accumulates and does not properly drain away from the subfloor area, creating a hazardous condition.
Problem:	1. Frequent water pooling and stagnation under the subfloor.

2. Risk of subfloor structural damage due to prolonged moisture exposure.
3. Potential for mold and mildew growth, compromising indoor air quality and a potential of Termite attack.
4. Safety hazard for occupants due to slippery surfaces and potential electrical hazards.

The poor site drainage under the subfloor poses a significant safety risk to the occupants, as it can lead to structural damage and health hazards.

This issue requires immediate attention and rectification. A licensed and experienced plumber or licensed builder specialising in drainage and foundation work should be engaged to assess the problem and implement necessary drainage solutions, such as improved grading, installation of drainage systems, and moisture barrier enhancements. Regular maintenance and inspections should also be scheduled to prevent future occurrences. Water damage and secondary defects are likely to occur if left unmanaged.

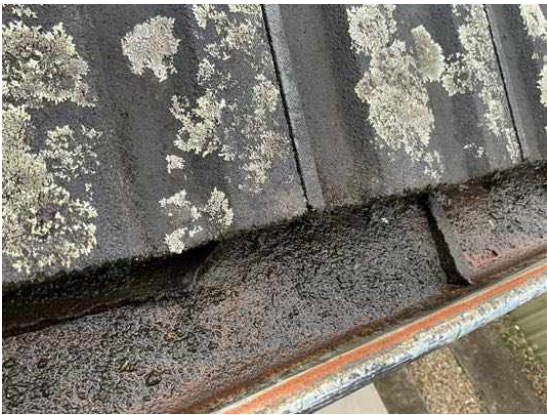
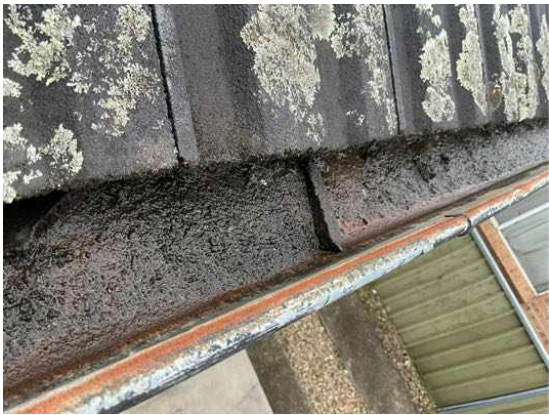
Building: Main Building
Location: All Areas
Finding: Blocked Gutters
Information: Blocked gutters , observed vegetation grown in the gutter , advised gutter to be cleaned.

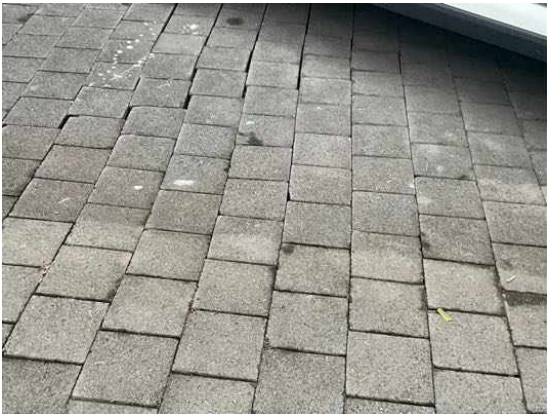
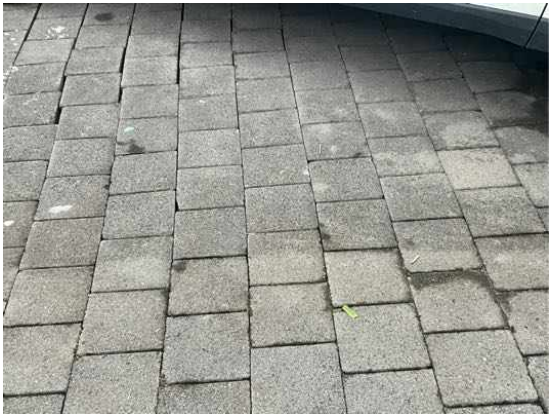
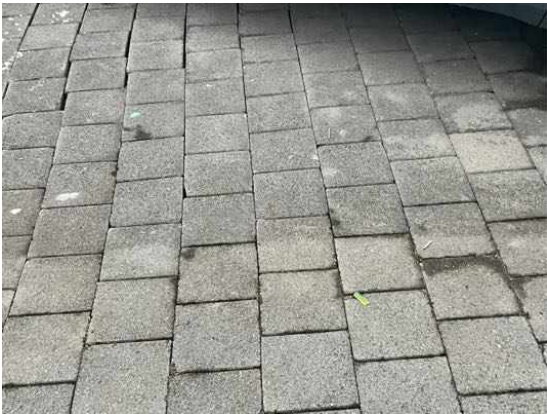
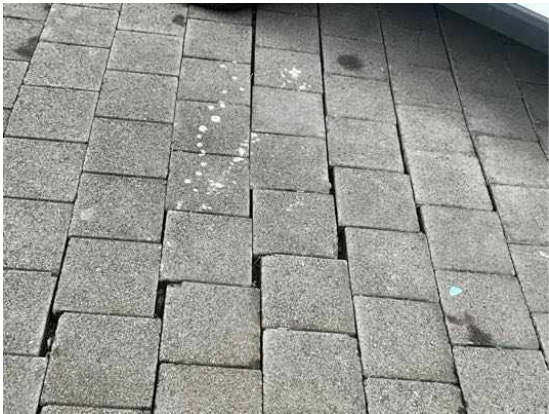
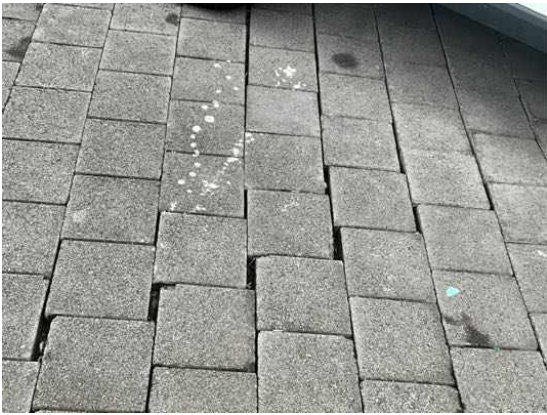
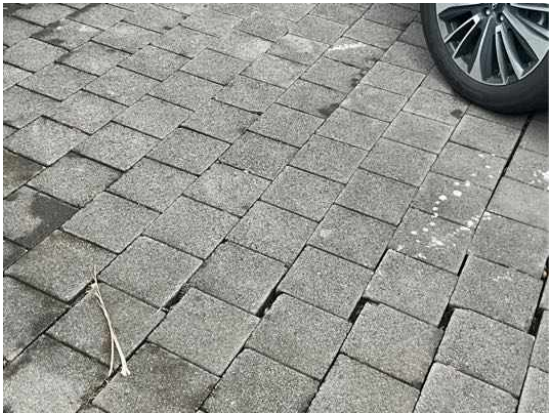
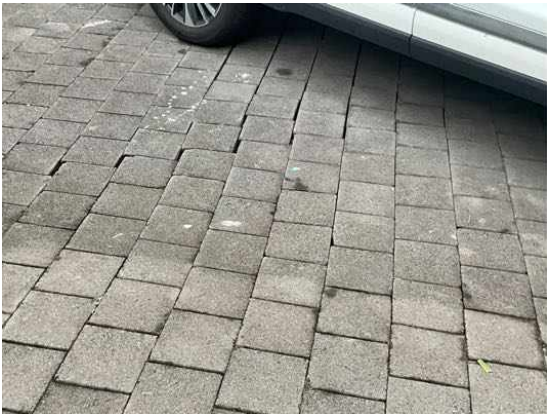
Finding 3.03

Building: Main Building
 Location: All Areas
 Finding: Pavers uneven and displaced
 Information: Cracked, uneven, and displaced pavers were observed. Several pavers appear loose, misaligned, or deteriorated.

Risk:
 The uneven surface poses a significant trip hazard for pedestrians and may impact the usability of the driveway. Displacement and cracking can worsen over time due to vehicle traffic, poor subbase compaction, or water ingress. Wall cracking may lead to moisture entry or structural wear if left untreated.

- Recommendation:
- A qualified paving contractor should be engaged to lift, relevel, and relay the affected pavers with proper bedding and compaction.
 - A licensed builder or bricklayer should repair and seal the masonry wall crack around the pipe to prevent further water ingress and deterioration.
 - Drainage should also be checked to ensure water is not contributing to the issue.

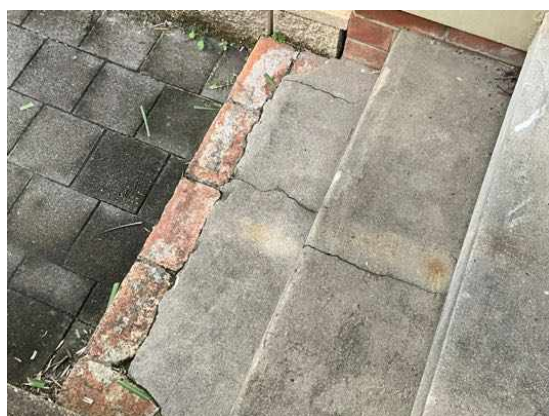
Finding 3.04

Building:	Main Building
Location:	All Areas
Finding:	Brickwork - Cracking [Fine]
Information:	Although fine cracks are quite noticeable, they are often only considered to be an appearance defect and usually do not indicate any structural damage. Generally, the cause of a fine crack is indicative of a separation between brickwork and mortar throughout the structure, but single bricks may also show cracks of this nature.

Cracking of this nature can generally be repaired with minor filling and should be conducted by a qualified bricklayer.

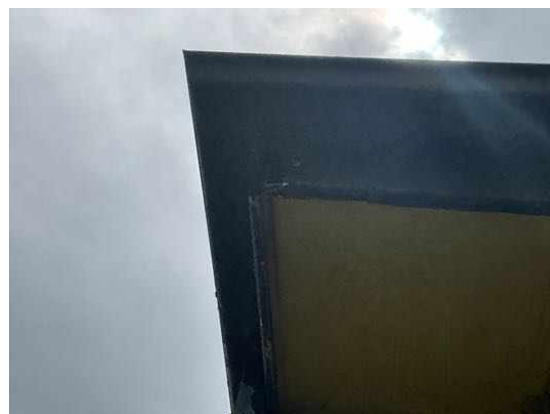
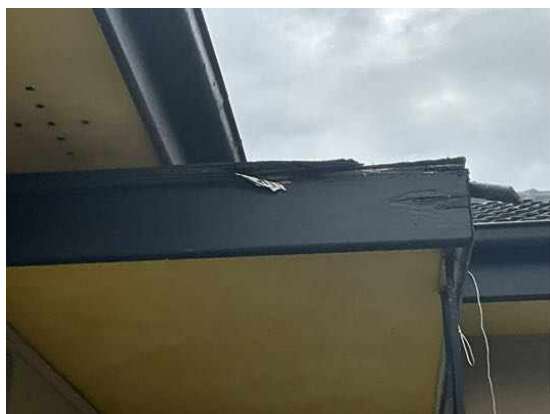
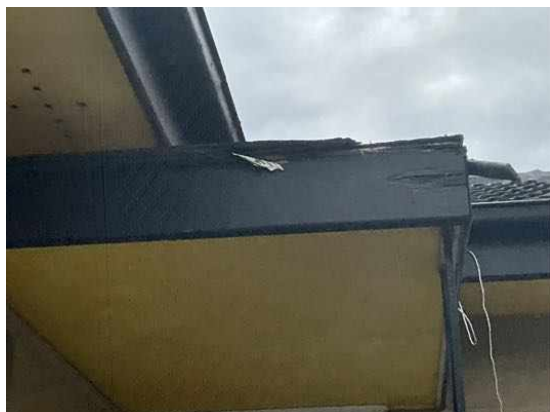
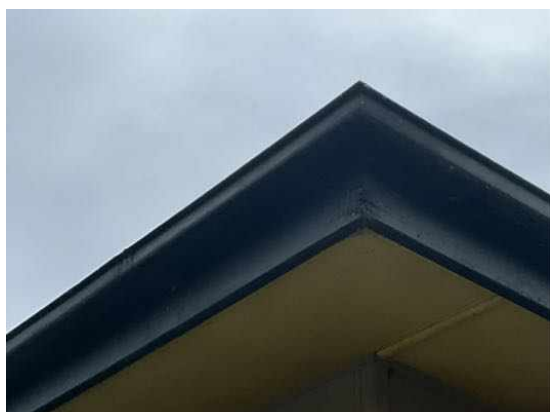
Finding 3.05

Building:	Main Building
Location:	All Areas
Finding:	Fascias - Wood rot
Information:	Wood rot was found to be affecting fascias and barges in this area, evidenced by the presence of mould on the surface in some areas. Wood rot, also known as Fungal Decay, occurs when timbers and other cellulose building materials are exposed to damp conditions on an ongoing basis.

It is likely that this wood rot has developed as a result of faults in the roof plumbing, creating excessive moisture in this areas. Frequent exposure to rain and other weather conditions also make fascias and barges susceptible to accelerated deterioration.

It is advised that a roof plumber be appointed to inspect all roof plumbing and subsequently identify the cause of the wood rot. Replacement of affected fascias and barges may then be a necessary step in protecting surrounding building elements from such deterioration.

A qualified plumber may be appointed to assess the cause of excessive moisture and to provide advice on any remedial works as required. A qualified carpenter or registered builder may also be required to replace affected building materials.

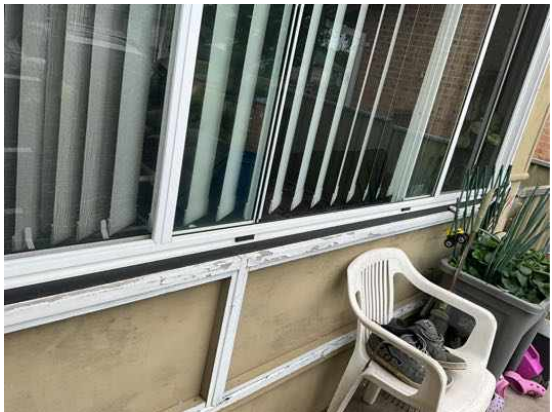
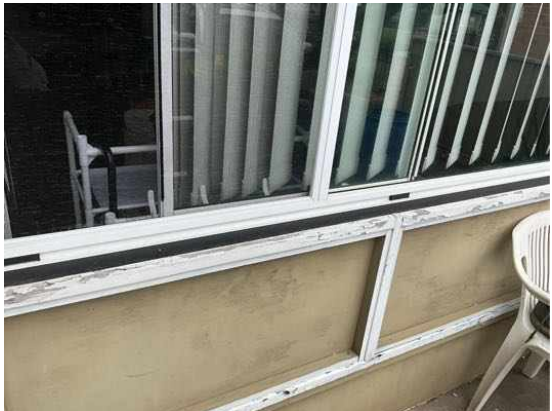
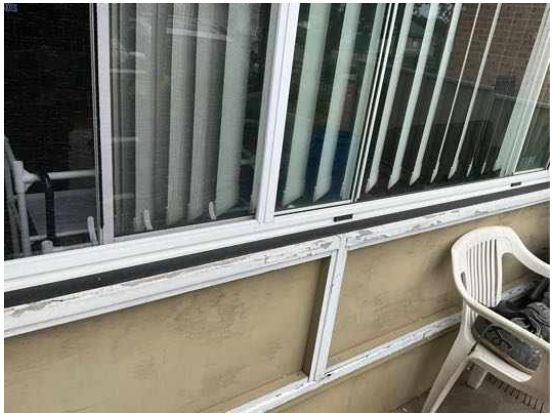
Finding 3.06

Building:	Main Building
Location:	All Areas
Finding:	Timber - exposed to weather
Information:	External timbers that are frequently exposed to harsh weather conditions require adequate protection in order to maintain their condition. Where timbers have not been painted or treated adequately, general deterioration is likely to occur at an accelerated rate.

If left unattended, replacement of these timbers is likely to be necessary in the short-term future. Adequate treatment of these timbers is required as soon as possible by a painting contractor or general handyman.

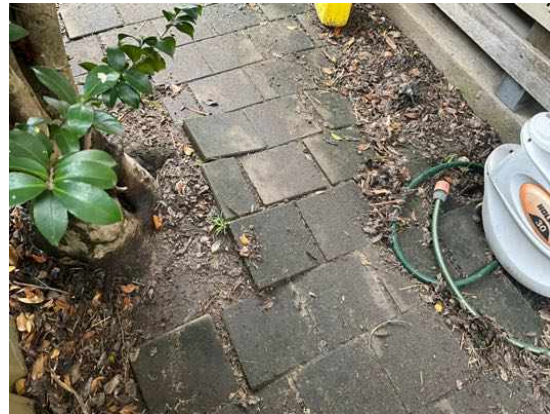
Finding 3.08

Building:	Main Building
Location:	Yard - Side
Finding:	Tree roots have uplifted & displaced the pavers
Information:	Tree roots have uplifted and displaced the pavers along the side walkway, creating an uneven surface and trip hazard. Movement appears ongoing and may impact drainage and adjacent structures. Visual inspection only as per AS 4349.1. Recommend further assessment by an arborist and rectification by a qualified paving contractor.

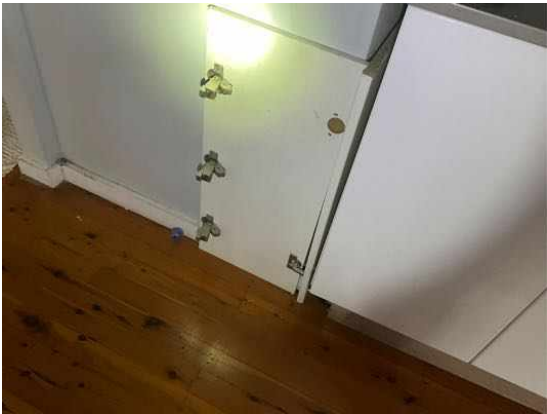
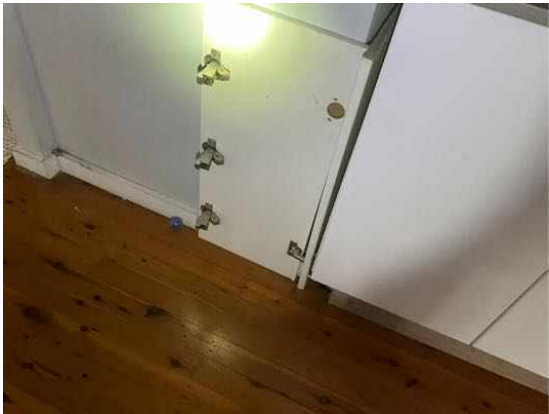
Finding 3.10

Building: Main Building
Location: Kitchen
Finding: Damaged cabinetry
Information: A damaged cabinetry poses a risk of functional issues, reduced aesthetics, and potential further deterioration if left unaddressed.

Seeking assistance from a skilled carpenter or cabinet repair specialist is advisable to assess and repair the damaged cabinet door, ensuring proper restoration and maintaining the functionality and appearance of the cabinetry.

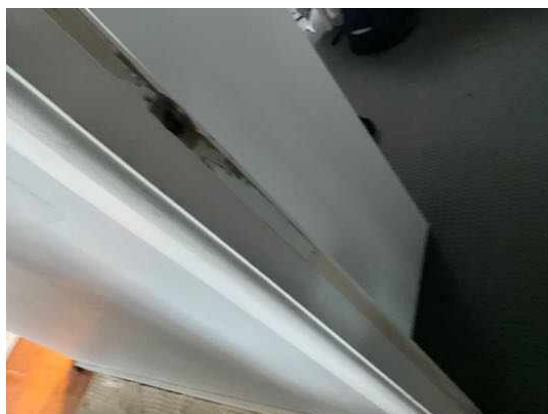
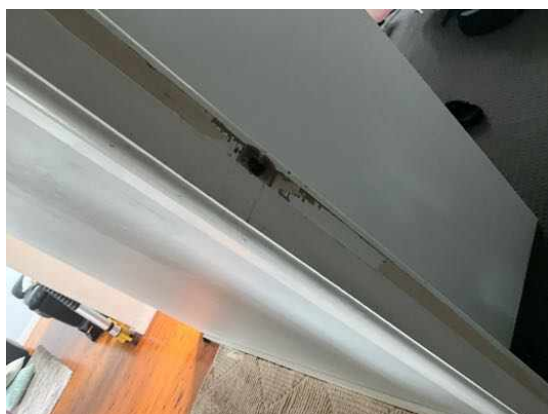
Finding 3.11

Building:	Main Building
Location:	All Areas
Finding:	Paint surface - Scratches
Information:	Scratches have been identified on the paint surface, detracting from the overall appearance and quality of the painted surface.

A qualified painter should address the issue promptly to repair the scratched paint. Depending on the severity of the scratches, repair options may include sanding, priming, and repainting the affected area to restore the integrity and appearance of the paint surface.

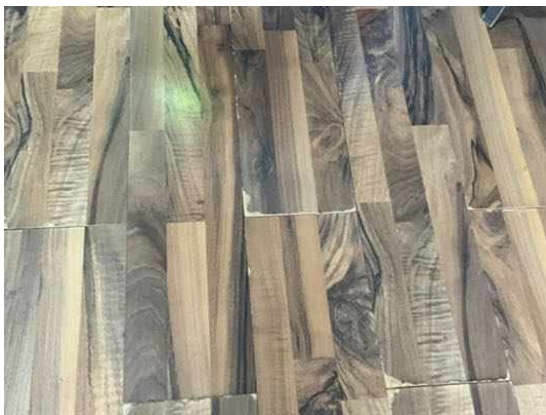
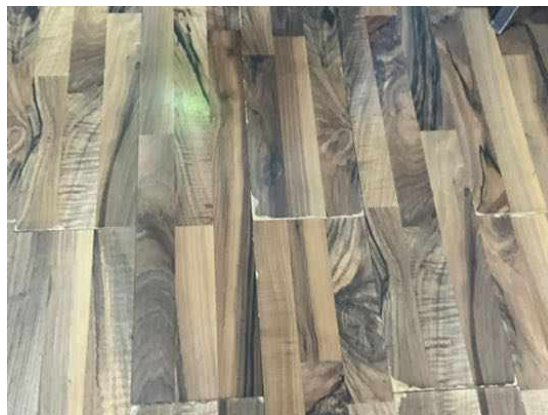
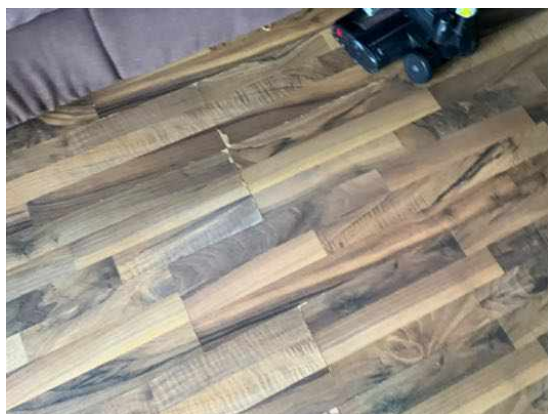
Finding 3.12

Building:	Main Building
Location:	All Areas
Finding:	Timber Floor Damage
Information:	The timber floor in the property displays visible signs of damage, including scratches, dents, or warping. This defect compromises the aesthetic appeal of the flooring and raises concerns about the long-term durability and structural integrity of the timber.

Timely intervention by a qualified professional is essential to restore the timber floor's appearance, functionality, and longevity. Regular maintenance practices contribute to preserving the quality of the flooring over time.

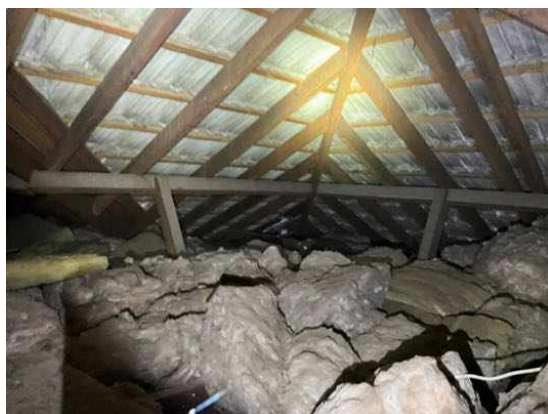
Finding 3.13

Building:	Main Building
Location:	Roof Void
Finding:	Sarking - Missing
Information:	Sarking is missing under the roof sheeting. Sarking acts as an insulator that helps with noise reduction and protects against water penetration. Sarking plays a key role in the operation and function of the overall roofing structure and its performance.

Sarking may be retrospectively fitted by a registered builder at the discretion of the client.

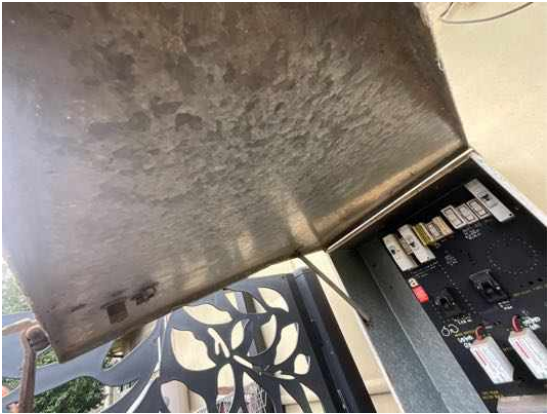
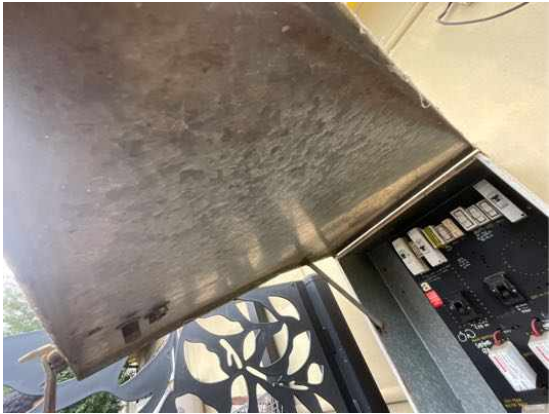
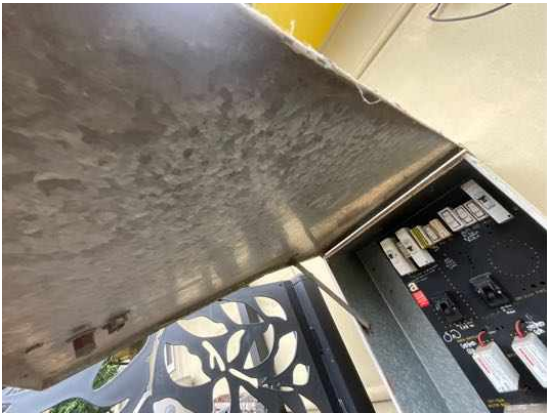
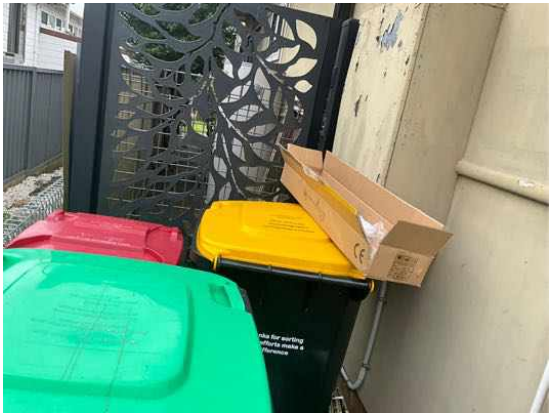
A durable notice was not placed in the switchboard unit to indicate current termite barriers is legible at the time of inspection.

Client must seek further information from the vendor or real estate agent if the conditions of termite management systems were maintained.

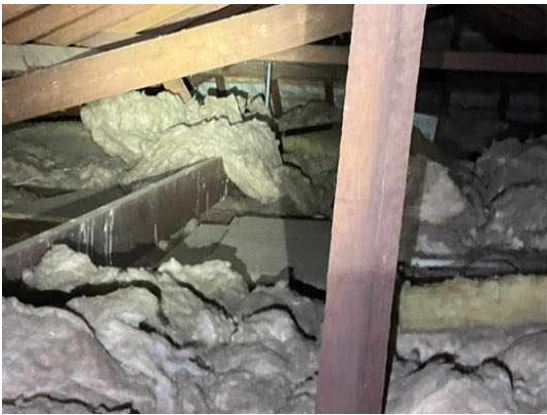
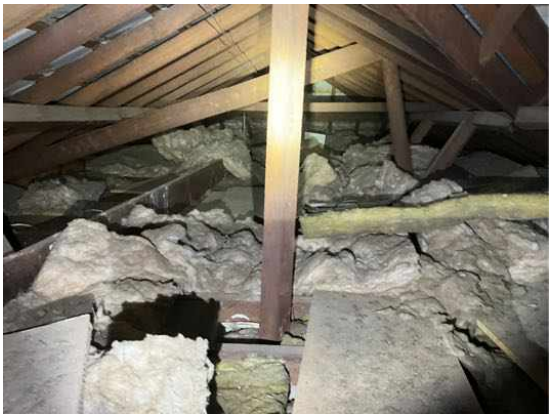
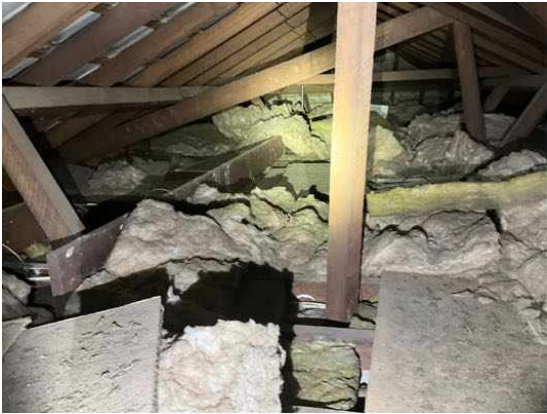
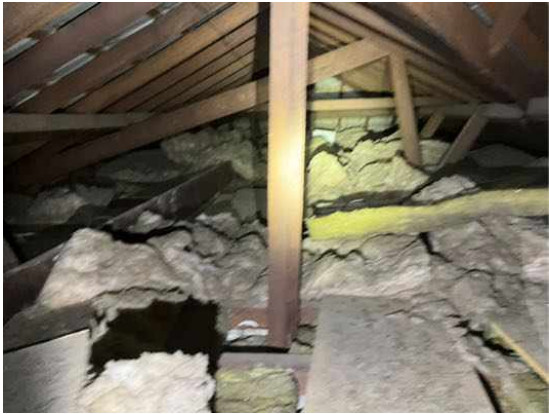
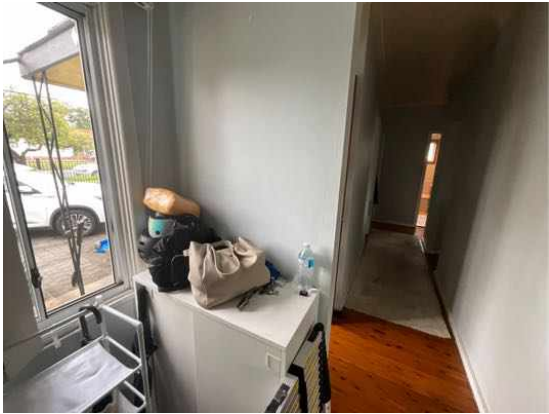
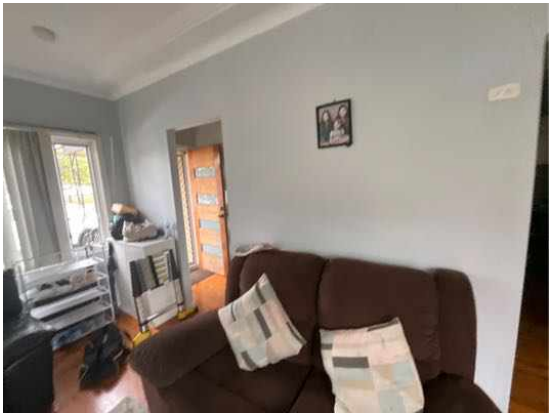
Building:	Main Building
Location:	All Areas
Finding:	Additional Photos - Obstructions and Limitations
Information:	These photographs are an indication of the obstructions and limitations which impeded full inspection of the property at the time of inspection. These obstructions can hide an array of defects and should be removed to allow full inspection to be carried out. A re-inspection is recommended once the areas are made accessible.
