Building and Timber Pest Inspection Report

Inspection Date: Tue, 27 Jan 2026

Property Address: 5-1a Edward St, Mordialloc VIC 3195,
Australia

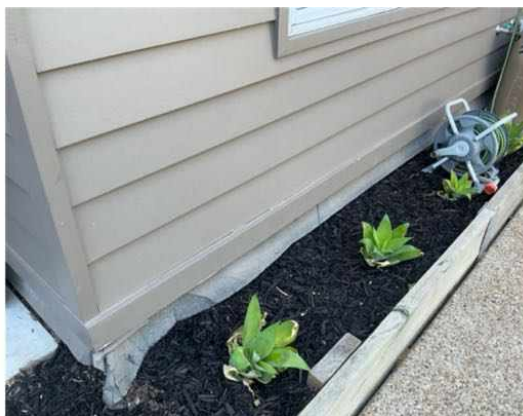
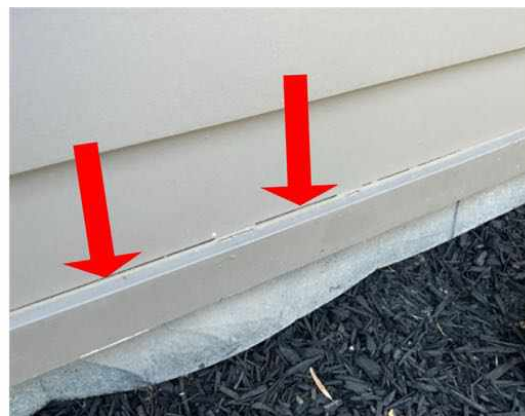
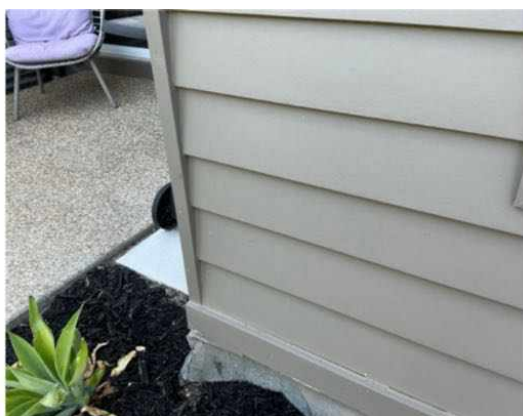
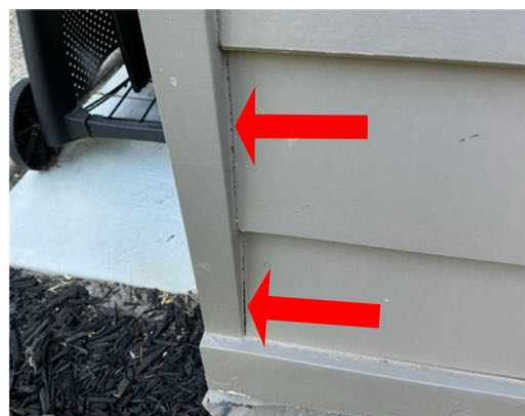
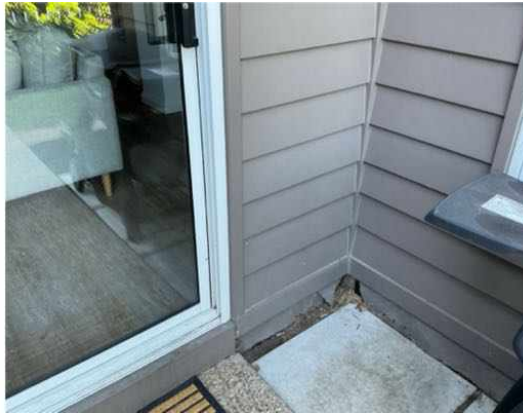
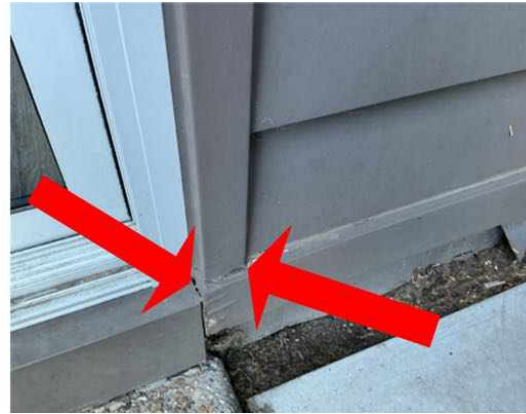
Finding 3.01

Building: Main Building
Location: Exterior walls - rear
Finding: A few gaps to the exterior walls
Information: A few gaps were noticed to some of the rear exterior walls to the building. These gaps can let in water, drafts, and pests. Overtime moisture ingress may cause damage to internal walls, mould growth, or structural issues. Gaps also reduce the energy efficiency of the property. Recommend engaging a caulker/painter to seal gaps to reduce the risk of pest/water penetration to the building at the owners discretion.

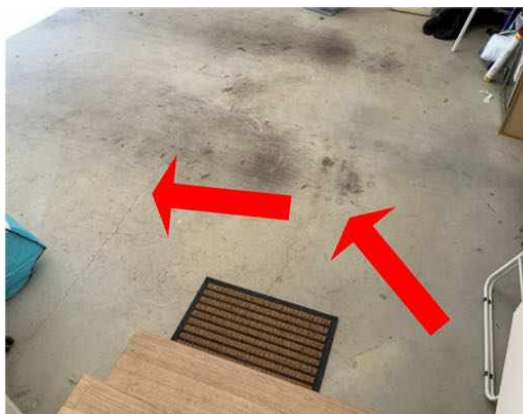
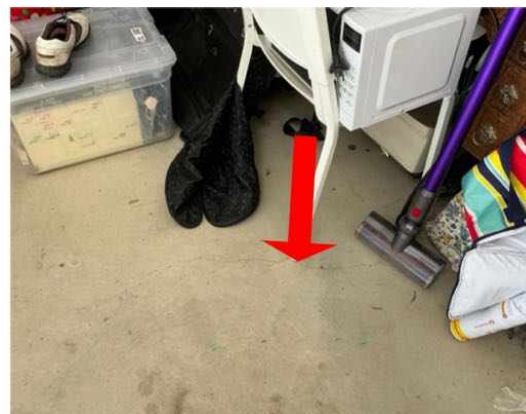
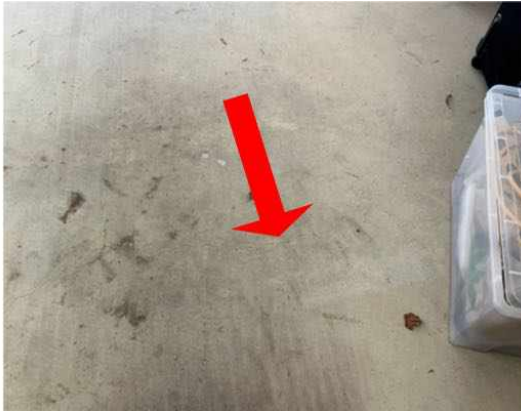
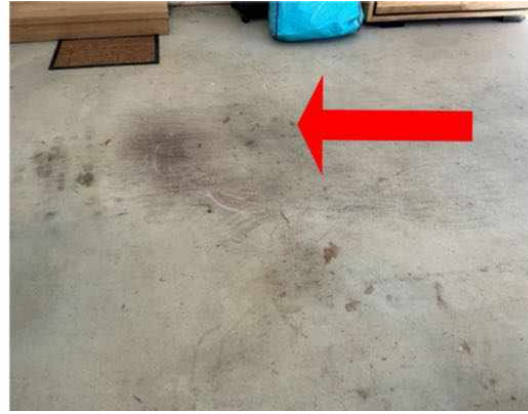
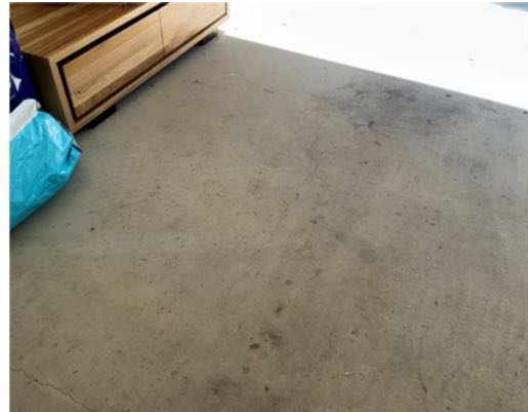
Finding 3.02

Location: Garage

Finding: Garage Cracking - Concrete Paving Damage Category 1 - Fine (less than 2mm)

Information: Fine cracks were identified in the garage concrete paving. Although fine cracks are quite noticeable, they are often only considered to be an appearance defect, and usually do not indicate any structural damage. To be considered a Category 1 or fine crack, the crack is found to be less than 2mm in width.

Generally the cause of a hairline crack in existing concrete paving such as driveways and pathways is indicative of the expansion and contraction of the concrete. Such causes are generally due to environmental factors, such as moisture levels, weather conditions, root systems of nearby trees or the soil types on which they are laid.

Fine cracks may also be due to poor original installation of the concrete. Factors such as poor compaction of the sub surface and/or inadequate reinforcing of the slab may create cracking and other secondary defects.

Monitoring of all cracking should be conducted frequently. Always contact a building inspector should cracks widen, lengthen, or become more numerous.

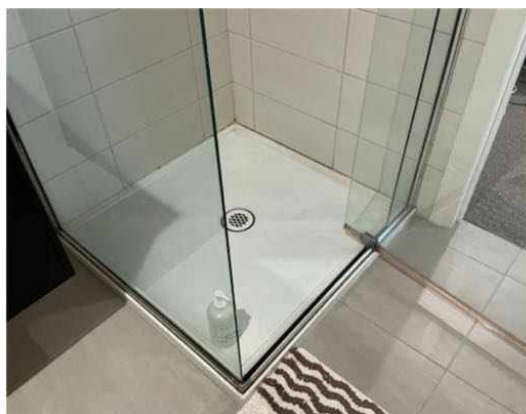
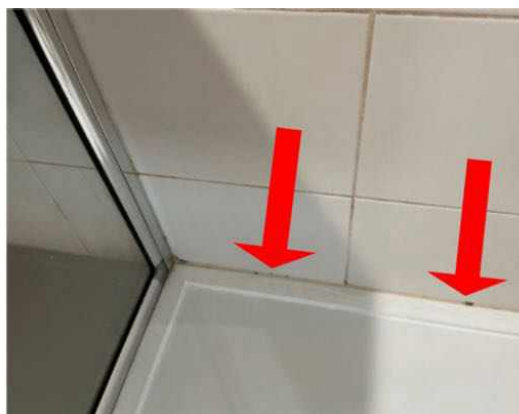
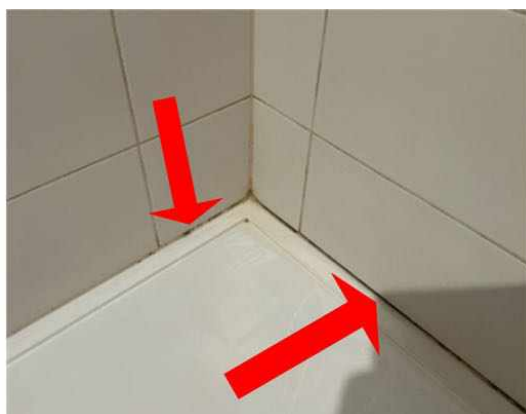
Finding 3.03

Building: Main Building
 Location: Bathroom
 Finding: Bathroom Sealant and grouting - Missing or damaged
 Information: It was noted on inspection that sealant or grout is degraded to the tiled shower alcove and or other areas of the bathroom.

Different materials and floor areas move at different rates, generally causing cracking to grout or sealant at this point. A flexible sealant is required to allow for expected expansion and contraction, while keeping the joint water tight and protective of all associated building materials.

Flexible and mould resistant materials should be applied to affected areas to prevent any subsequent water damage that is likely to occur. Regular maintenance and replacement of damage or missing or damaged sealant and grout is highly recommended to the wet areas, as this is a regular wear and tear defect. Sealant and grouting in areas that come into regular contact with water should be maintained for the long term care of your property.

A sealant specialist or tiling contractor should be appointed to complete these works as soon as possible

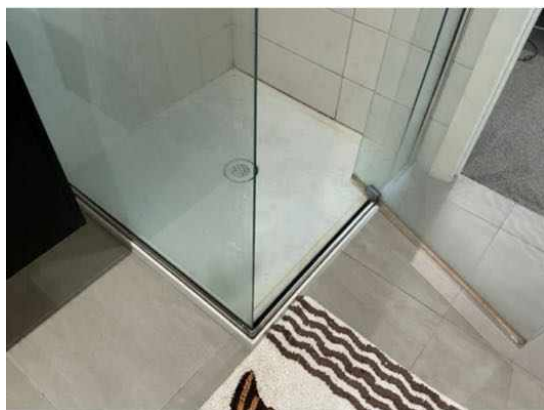
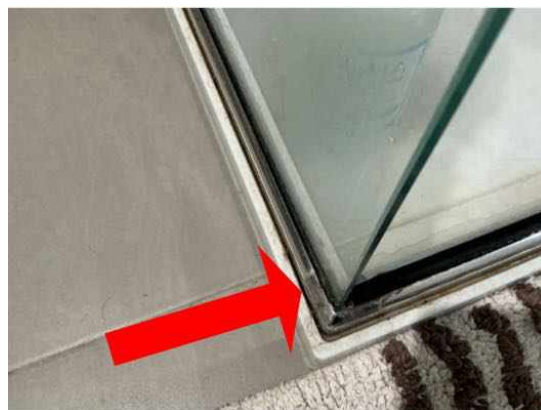
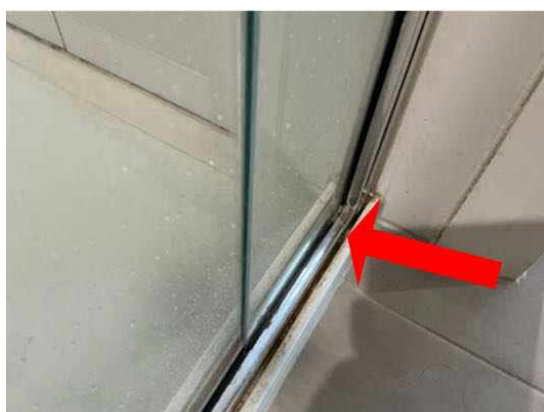
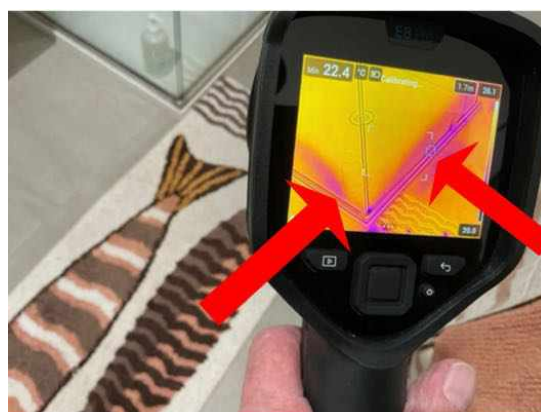
Finding 3.04

Building:	Main Building
Location:	Bathroom
Finding:	Shower screen - Leaking bathroom
Information:	Leaking was evident to the shower screen in the bathroom at the time of inspection. It is suspected that the leaking has occurred as a result of deteriorated or missing caulking to the shower and/or the shower being slow to drain.

Leaking from the shower where left unattended, is likely to lead to water damage to adjoining flooring and walls. Such damage can lead to water damage and necessitate extensive remedial works being required. Active water leaks may also create an environment that is susceptible to the formation and development of mould.

Recommend engaging a plumber to investigate and rectify the slow drainage to the shower.

Appointment of a caulking contractor is required after the plumber has rectified the slow drainage, to repair or replace the caulking to the shower area. Such works should be performed as soon as possible to ensure that no further damage occurs.

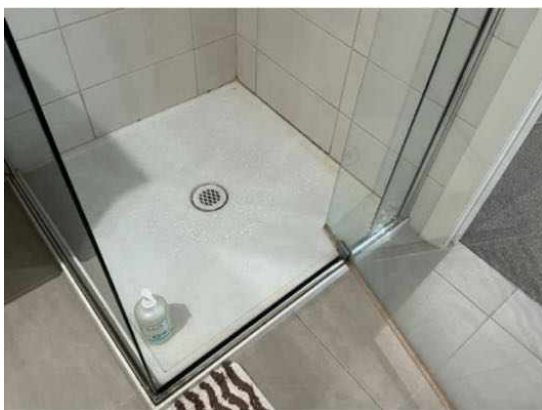
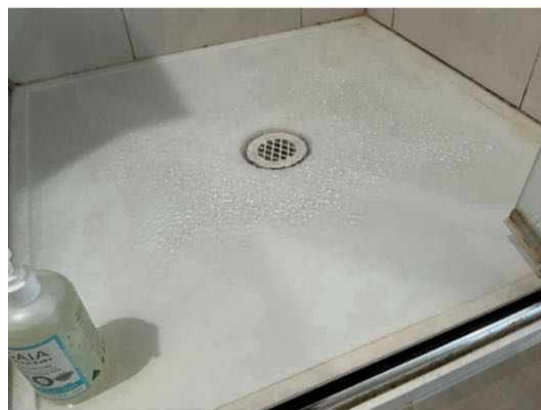
Finding 3.05

Building:	Main Building
Location:	Bathroom
Finding:	Shower slow to drain
Information:	On inspection of the shower it was observed to drain slowly, resulting in a build up of water within the shower base causing water to leak through the shower screen. Recommend engaging a plumber to investigate and rectify the cause of the slow drainage and overflow leaking through the shower screen as a matter of urgency to reduce the risk of further deterioration.

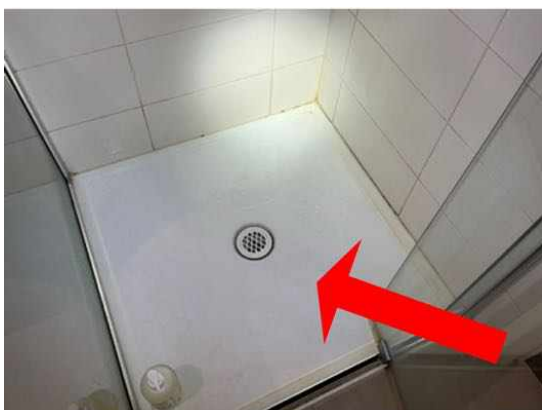
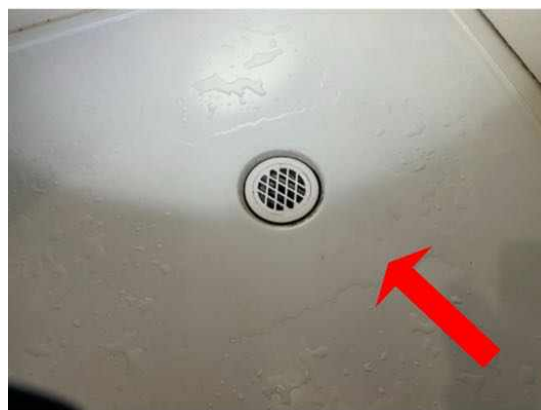
Finding 3.06

Building:	Main Building
Location:	Bathroom
Finding:	Shower base- Water pooling
Information:	Evidence of water pooling around the floor waste in the bathroom shower recess was noticed at the time of inspection. It is suspected that this excessive moisture is attributed to insufficient fall in the shower base.

This pooling is minor overall but is still considered unsatisfactory, as standard practices would not permit this situation to occur. Pooling water around floor wastes can create a slip hazard in extreme cases and create conditions that are conducive to termites and mould growth over time. Where left unmanaged, the degradation of sealant and grouting is also likely to occur, possibly necessitating further repair works. Recommend engaging a tiler and plumber to rectify to reduce the risk of further deterioration as soon as possible.

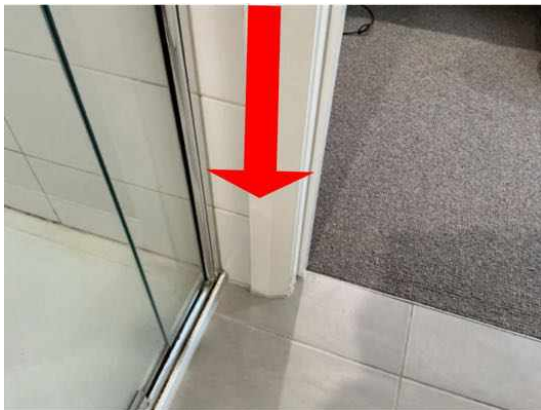
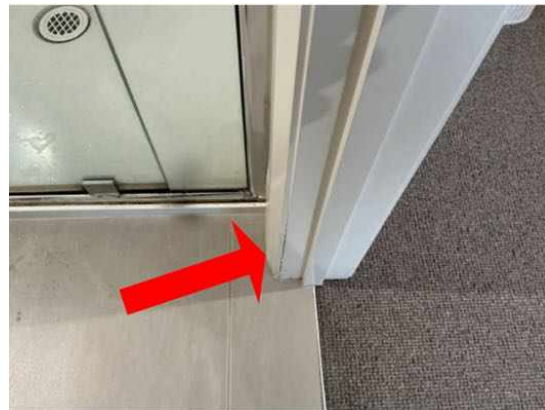
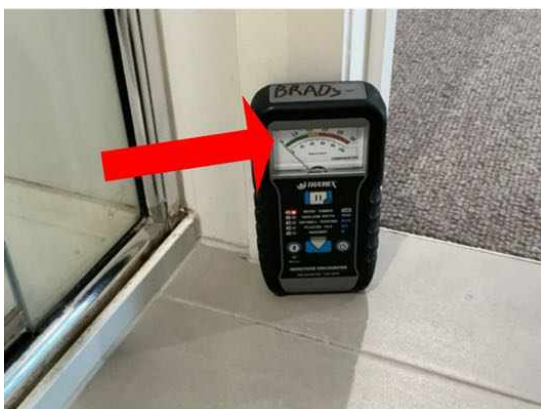
Finding 3.07

Building:	Main Building
Location:	Bathroom
Finding:	Swollen architraves
Information:	A water damaged/swollen architrave was noticed to the bathroom but tested dry with

a moisture meter. It is suspected this has been caused by the leaking shower screen. Swollen building elements generally indicate that the building materials have been affected by excessive moisture over a prolonged period of time, and have swollen as a result. The formation and development of mould/fungi or mildew is also a likely consequence of excessive moisture, which may pose major respiratory issues for occupants, particularly the elderly, the very young and those with existing illnesses and could be potential health safety hazards. In these cases an appropriately qualified inspector/tester should also be contacted for advice and/or technical assistance.

The structural integrity of swollen building elements can not be guaranteed, and further damage is likely to develop if left unmanaged. Excessive moisture is likely to lead to the development of secondary damage to any associated building elements, which may necessitate major reparation works if prolonged.

Rectification of the cause of the water leak should be addressed prior to any remedial works to the swollen building elements. A licensed builder /plumber should be appointed immediately to identify the cause of the leak and provide advice on remedial works as necessary, Repair and/or replacement of swollen building elements should be conducted as soon as possible by a registered builder or qualified carpenter.

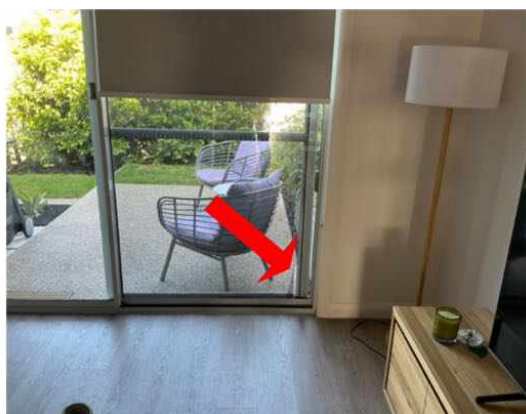
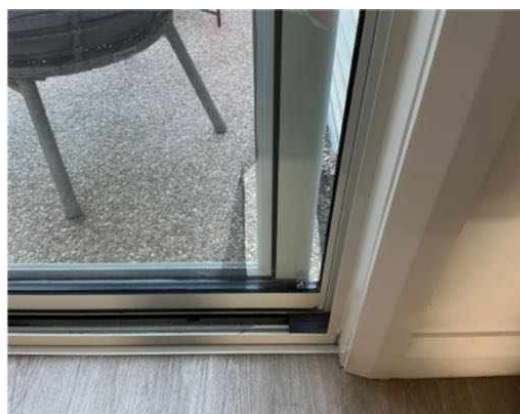
Finding 3.08

Building: Main Building
Location: Living Room

Finding: Flyscreen damaged
 Information: The living room flyscreen was found to be damaged at the time of inspection. This can happen overtime with deterioration in harsh weather conditions or accidental impact damage.

Where not replaced, damaged flyscreens allow pest and insect ingress into the adjoining room/s. It is advised that all damaged flyscreens be replaced in order to ensure the full function of all building structures.

A general handyman may be appointed to replace flyscreens at the discretion of the client.

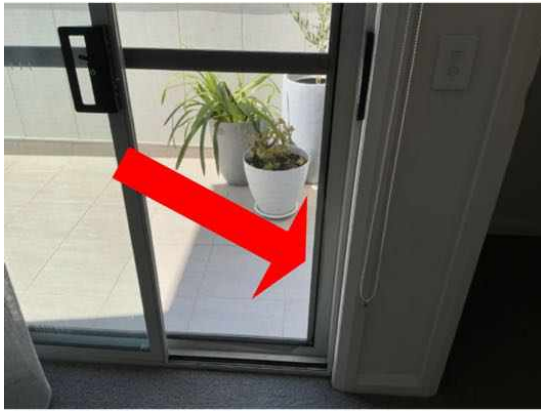
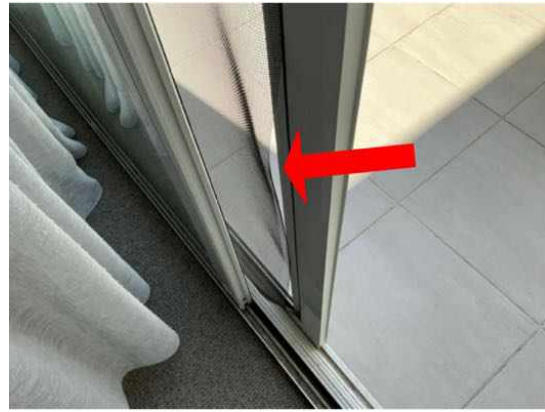
Finding 3.09

Building: Main Building
 Location: Bedroom - Master
 Finding: Flyscreen damaged
 Information: The master bedroom flyscreen was found to be damaged at the time of inspection. This can happen overtime with deterioration in harsh weather conditions or accidental impact damage.

Where not replaced, damaged flyscreens allow pest and insect ingress into the adjoining room/s. It is advised that all damaged flyscreens be replaced in order to ensure the full function of all building structures.

A general handyman may be appointed to replace flyscreens at the discretion of the client.

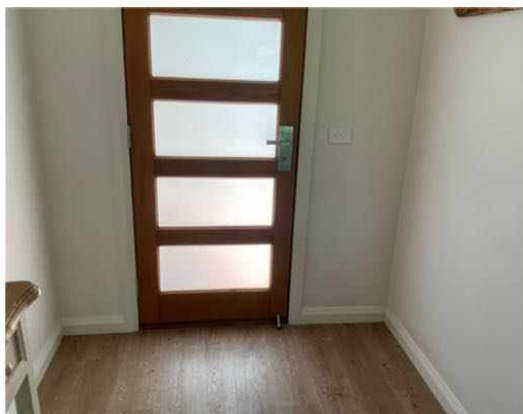
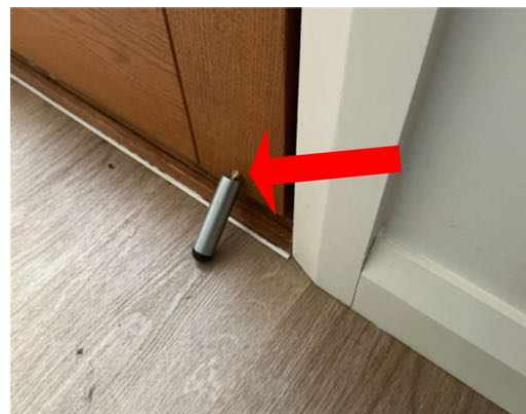
Finding 3.10

Building:	Main Building
Location:	Entry
Finding:	Door stop - inadequate
Information:	The front door stop is inadequate to stop the door handle from damaging the wall. Although some building elements may seem irrelevant or unnecessary, all building elements play a key role in the operation and function of the overall structure and its performance.

Re-installation or replacement of the door stop is advised as soon as possible to prevent any subsequent damage to the door or associated structures. A general handyman may be appointed to perform these works at client discretion.

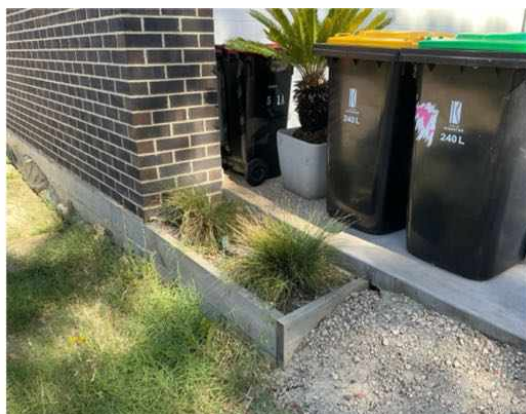
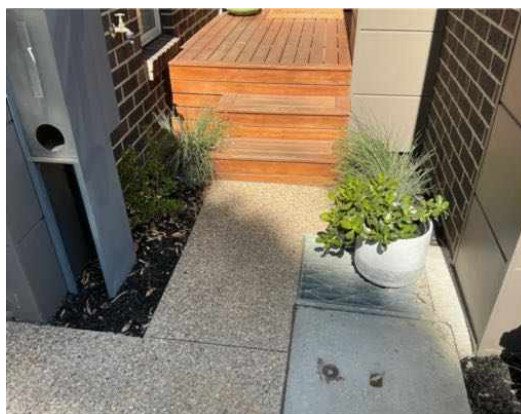
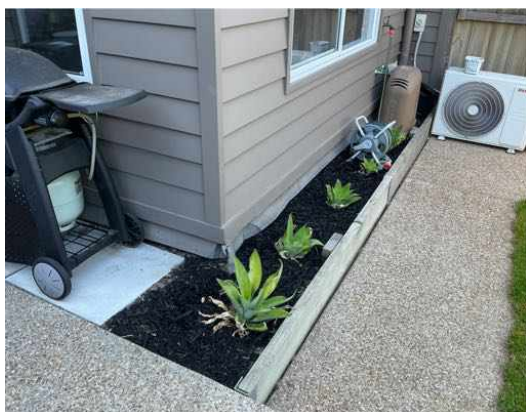
Building:	Main Building
Location:	Yards
Finding:	Garden Beds Conditions Conducive to Termites
Information:	Garden beds were found to be evident in close proximity to the building. Garden beds immediately adjacent to the perimeter of the building block the visual inspection of these areas, providing a concealed termite entry point.

These garden beds can include untreated timber, and with a combination of moisture from watering hosing can make conditions conducive to termite activity and termite ingress.

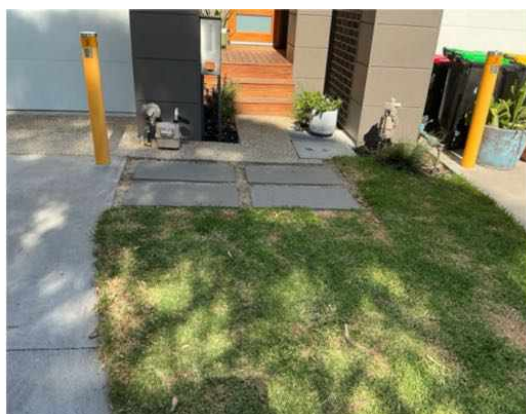
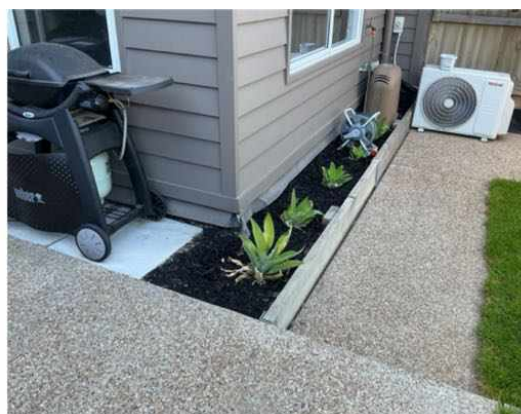
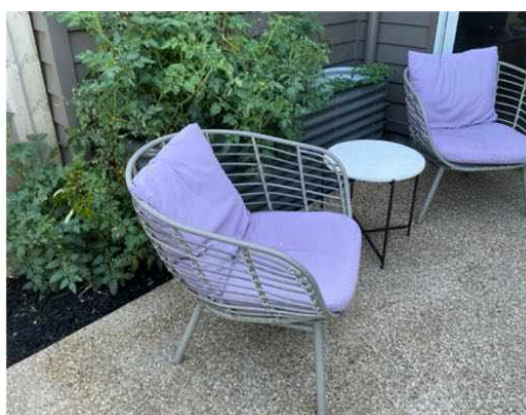
Finding 6.02

Building:	Main Building
Location:	Yards
Finding:	Site drainage - poor/inadequate
Information:	The site drainage to parts of the yards was found to be inadequate at the time of inspection, creating potential for subsequent water damage to associated building elements. Excessive moisture will attract termites.

It is important that water does not lie against the base of walls; surrounding paths and ground levels should be sloped to drain water away from walls. Downpipes should not discharge stormwater onto lower walls or plinths. Stormwater should be carried away by large, regularly cleaned drains. Ground levels may need to be lowered to expose a buried DPC.

Where site drainage is inadequate, installation of an Agricultural (Aggie) Drain may be required. A qualified plumber should be appointed to further inspect the property and perform any remedial works as necessary. Water damage and secondary defects are likely to occur if left unmanaged.

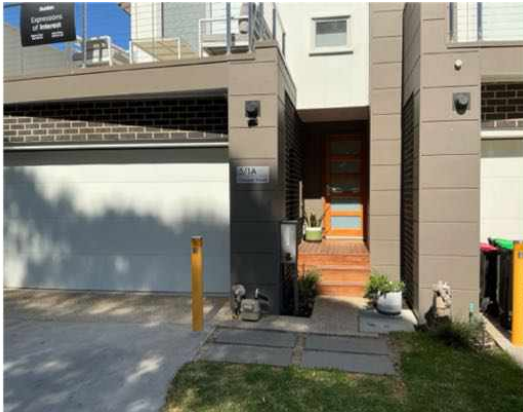
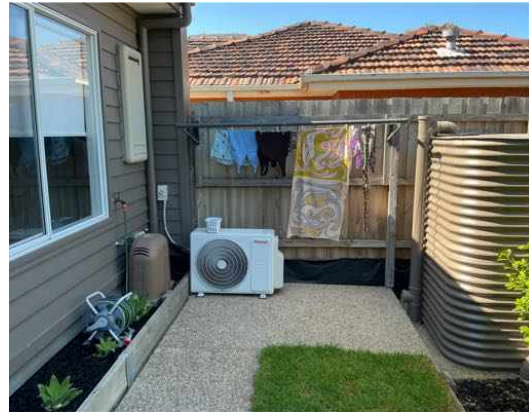
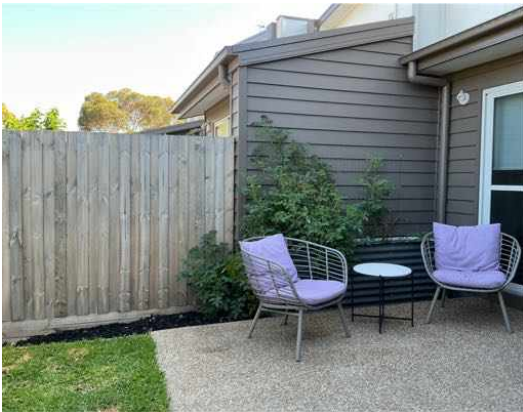
Finding 6.03

Building:	Main Building
Location:	Various parts of the building
Finding:	Bridging attachments to buildings
Information:	Bridging occurs when items against a building provide a concealed entry point for termites into the building or by passing around a termite management system.

service conduits and the like provide the opportunity for concealed entry.

Building attachments of this nature need to be frequently inspected for termite activity by a qualified inspector.

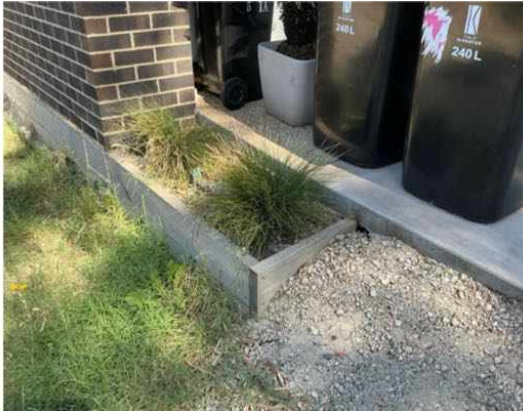
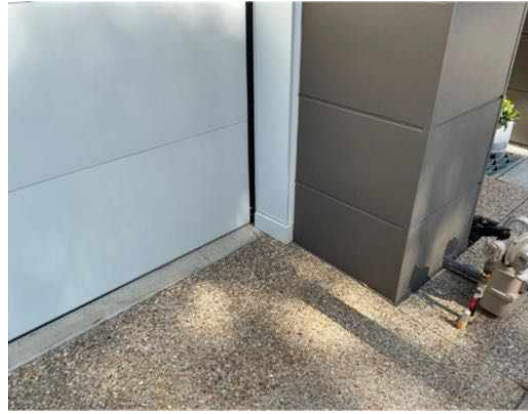
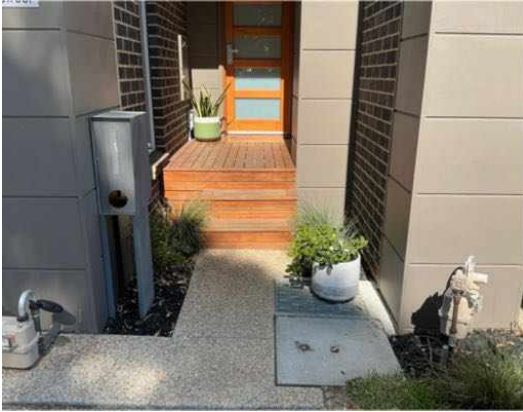
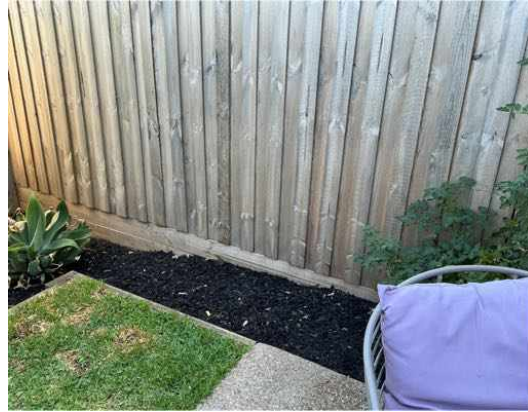
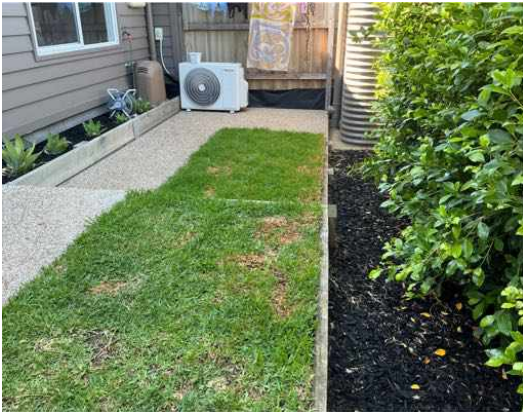
Finding 6.04

Building:	Main Building
Location:	Various parts of the building
Finding:	In ground contact
Information:	Any timbers in direct ground contact provide opportunity for concealed termite entry and are likely to be subject to premature rot and decay as the soil retains moisture or damp conditions against the timbers.

Remove untreated timber that is in direct contact with external grounds. Consider replacement with more durable materials i.e. treated timber or non timber elements. Frequent pest inspections are advised to readily identify any termite activity in these areas.

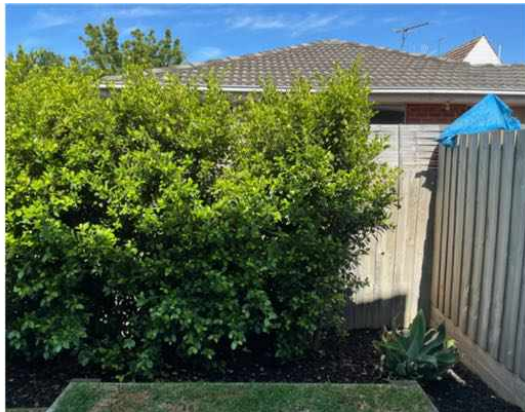
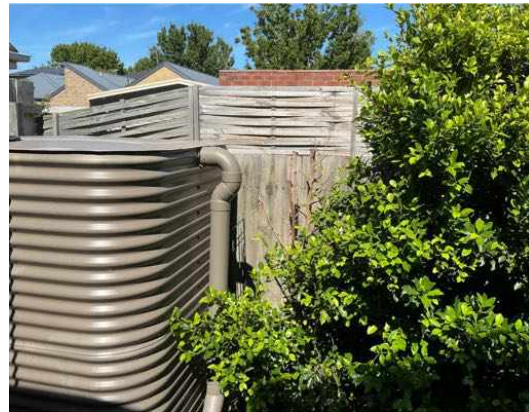
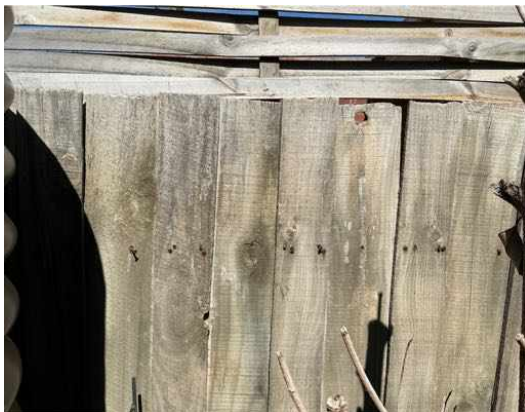
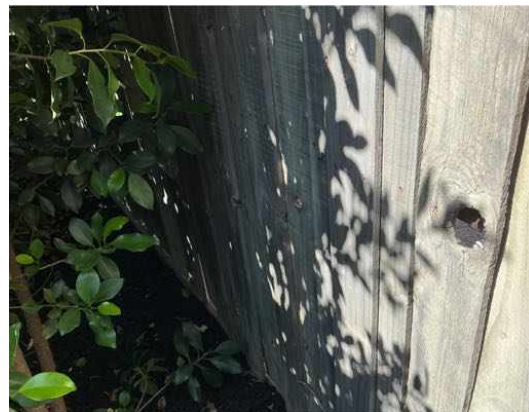
Finding 7.01

Building:	Main Building
Location:	Yard - Back
Finding:	Fencing - wood rot-fungal decay
Information:	It was noted at the time of inspection that sections of the fencing to the rear of the property have deteriorated and have fungal decay/wood rot present. Typically fencing deteriorates due to age and or wear, rot and or rust which is generally expected for a structure of this age, due to prolonged exposure to weather conditions. Sometimes

inadequate installation or maintenance can be to blame.

If left unattended, it is likely that further damage will occur. It is suspected that repair of several elements of the fencing may be required however replacement may be a consideration of the client also.

A licensed fencing contractor should be appointed to provide further advice and perform rectification works as necessary.
