Building and Timber Pest Inspection Report

Inspection Date: Wed, 25 Feb 2026

Property Address: 170 Boronia Rd, Greenacre NSW 2190,
Australia

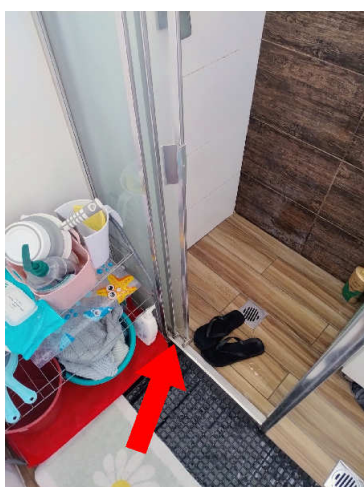
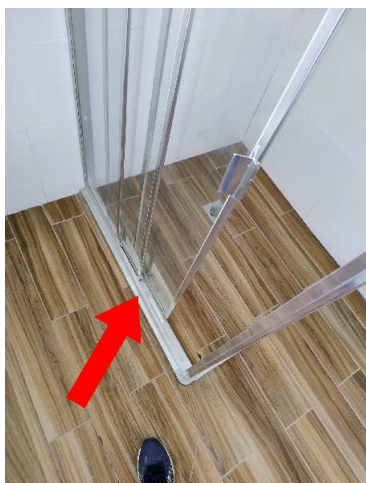
Finding: Shower door - not fixed at bottom - Safety hazard - Main BLD and Granny

Information: A significant gap was identified between the shower door and framing in both shower area of Main building and Granny unit. Which can be seen because of misalignment of door fixings or poor workmanship at first place. This can lead to safety hazard for the person using the area as the glass door can become loose from the fixings.

Where large gaps to the head or foot of door frames appear, it may indicative of a variety of defects, ranging from uneven framework, sagging hinges or uneven flooring.

A qualified carpenter should be appointed to perform remedial works to restore the door to a fully secured position on priority level.

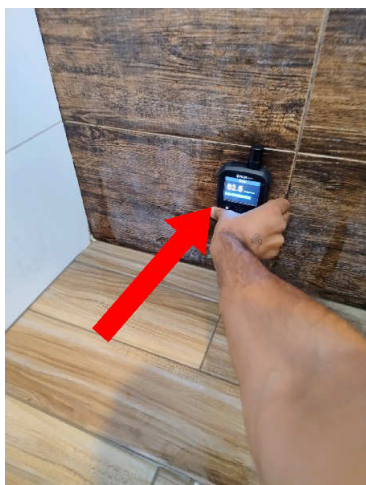
Finding 2.01

Finding: Evidence of Excessive moisture - identified - Major Defect

Information: Evidence of excessive moisture recorded by moisture meter in the shower wall of the bathroom.

Excessive moisture can attract termites and produce conditions that promote fungal growth and wood decay.

Excessive moisture is generally caused by deteriorated, inadequate or missing roof drainage, leaking plumbing pipes or fixtures, poorly plumbed HWS overflows or condenser units and poor site drainage.

Prior to any remedial works being performed a qualified plumber should be appointed to further inspect the property and to identify the cause of the excessive moisture. Works to remove affected building elements may then be necessary and should be performed by an appropriate tradesperson.

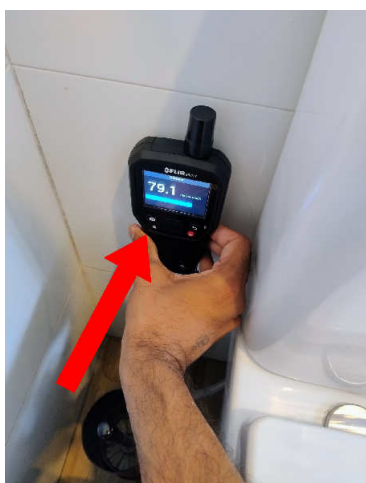
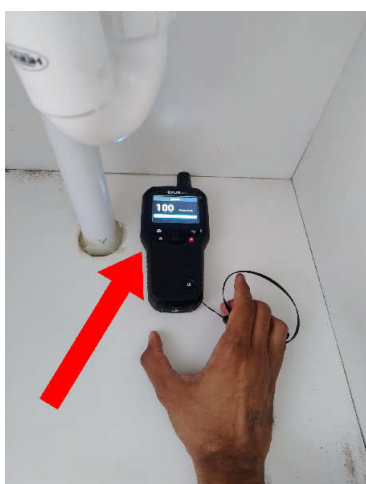
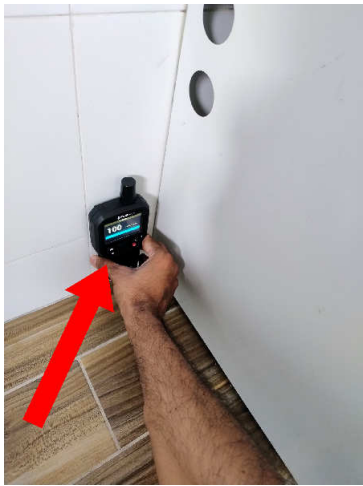
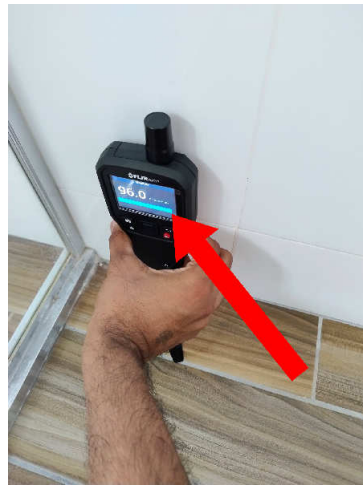
Finding 2.02

Building: Granny-Flat
Location: Bathroom walls and other areas
Finding: Evidence of Excessive moisture - identified in bathroom

Evidence of excessive moisture recorded by moisture meter at multiple locations in Bathroom and shower area walls at the time of inspection in granny flat. Excessive moisture can attract termites and produce conditions that promote fungal growth and wood decay.

Excessive moisture is generally caused by deteriorated, inadequate or missing roof drainage, leaking plumbing pipes or fixtures, poorly plumbed HWS overflows or condenser units and poor site drainage.

Prior to any remedial works being performed a qualified plumber should be appointed to further inspect the property and to identify the cause of the excessive moisture. Works to remove affected building elements may then be necessary and should be performed by an appropriate tradesperson as soon as possible.

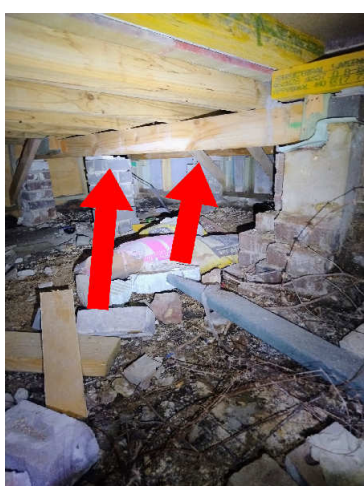
Finding 2.03

Information: Upon inspection of the subfloor area, it was noted that there is a Gap between structural timber and the brick piers at number of location in subfloor structures.

The absence of adequate subfloor stability indicates non-compliance with contemporary building practices and is likely to result in numerous minor defects, such as uneven and noisy floors. Over time, insufficient subfloor structures are likely to result in structural deterioration, as the structures do not have the capacity to bear the weight of the building.

The client is advised to seek quotations for required repairs as the potential resolution may range from packing gaps in subfloor structures through to replacement of subfloors stumps and refixing of flooring. Consultation with a registered builder specialising in re-stumping is advised immediately.

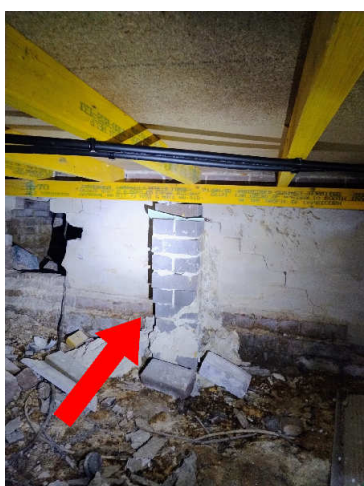
Finding 2.04

Finding: Subfloor stumps - Unstable or deteriorated

Information: Stumps to the subfloor structure was observed unstable at the time of inspection, indicating that their structural integrity has been affected. The cause of this instability is likely to be movement or extensive wood rot, both of which may deteriorate stumps at a rapid rate.

The stumps are suspected to be failing in their structural purpose, which is likely to lead to a range of major and minor defects. Further (potentially major) damage to the stumps and structure may be imminent if left unattended.

Appointment of a Registered Builder specialising in re-stumping is required immediately to assess the condition of the stumps and provide advice on remedial works. This defect should not be left unmanaged.

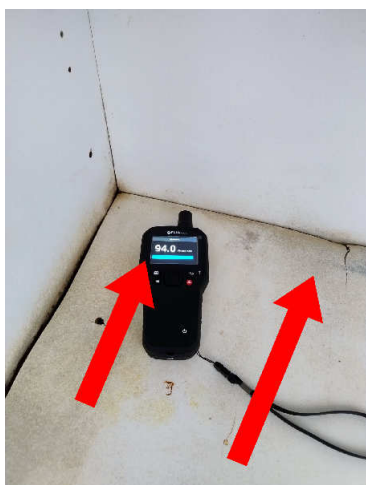
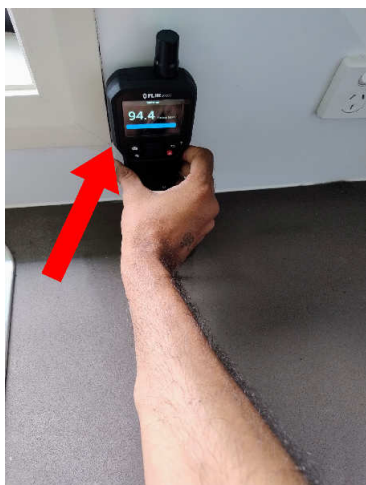
Finding 2.05

Finding: Kitchen joinery - Swollen and high moisture reading - Major defect

Kitchen joinery below wash basin was observed to be swollen, has mould impressions and recorded higher reading at the time of inspection. Swollen building elements generally indicate that the building materials have been affected by excessive moisture over a prolonged period of time, and have swollen as a result. The formation and development of mould/fungi or mildew is also a likely consequence of excessive moisture, which may pose major respiratory issues for occupants, particularly the elderly, the very young and those with existing illnesses and could be potential health safety hazards. In these cases an appropriately qualified inspector/tester should also be contacted for advice and/or technical assistance.

The structural integrity of swollen building elements can not be guaranteed, and further damage is likely to develop if left unmanaged. Excessive moisture is likely to lead to the development of secondary damage to any associated building elements, which may necessitate major reparation works if prolonged.

Rectification of the cause of the water leak should be addressed prior to any remedial works to the swollen building elements. A licensed plumber should be appointed immediately to identify the cause of the leak and provide advice on remedial works as necessary, Repair and/or replacement of swollen building elements should be conducted as a matter of urgency by a registered builder or qualified carpenter.

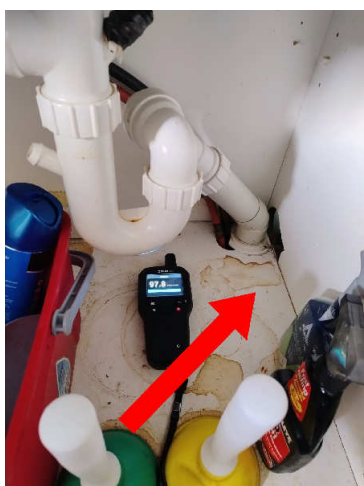
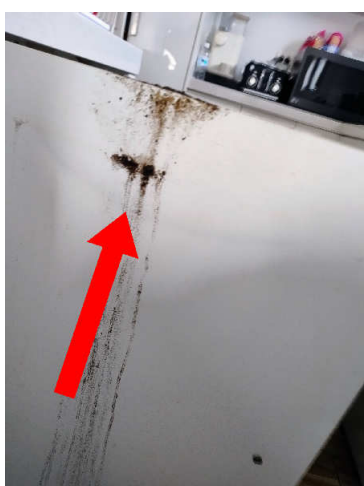
Finding 3.01

Building: Main Building
Location: Kitchen
Finding: Joinery Damage - Water stained and deteriorated

Water staining and deterioration of bolts and connections to joinery in kitchen area was evident at the time of inspection. Water staining and rusting indicates that surfaces have been exposed to excessive moisture over time. The minerals and other elements in the water lead to staining, which may graduate to corrosion and deterioration if left unmanaged.

While mostly an appearance defect, water staining can be indicative of more serious defects, which may be currently concealed by interior ceilings.

Where water staining is active, a licensed plumber must be consulted to identify the cause of the staining and to provide advice on any repair work that may be required. Replacement of any damaged structures is advised.

Conversely, where water staining is old and inactive, affected building materials may be repaired or replaced at client discretion.

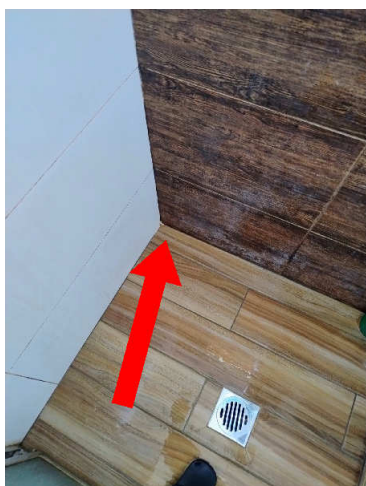
**Finding 3.02**

Finding: Sealant and Grouting - Damaged or Detoriorated

Information: It was noted on inspection that sealant or grout is degraded to the tiled shower alcove and or other areas of the bathroom.

Different materials and floor areas move at different rates, generally causing cracking to grout or sealant at this point. A flexible sealant is required to allow for expected expansion and contraction, while keeping the joint water tight and protective of all associated building materials.

There mould to the sealant and grout which will likely require scraping out and replacement.

This can lead to water ingress into the shower base and creates conducive condition to termite activity. If left unmanaged can cause further deterioration to building elements.

Flexible and mould resistant materials should be applied to affected areas to prevent any subsequent water damage that is likely to occur. Regular maintenance and replacement of damage or missing or damaged sealant and grout is highly recommended to the wet areas, as this is a regular wear and tear defect. Sealant and grouting in areas that come into regular contact with water should be maintained for the long term care of your property.

Qualified trade person or plumber must be appointed for rectification on priority.

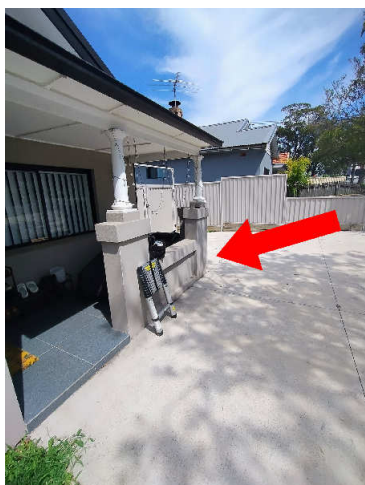
Finding 3.03

Finding: Site drainage - Inadequate

Information: The site drainage in front area was found to be inadequate at the time of inspection, creating potential for subsequent water damage to associated building elements.

It is important that water does not lie against the base of walls; surrounding paths and ground levels should be sloped to drain water away from walls. Downpipes should not discharge stormwater onto lower walls or plinths. Stormwater should be carried away by large, regularly cleaned drains. Ground levels may need to be lowered to expose a buried DPC.

Where site drainage is inadequate, installation of an Agricultural (Aggie) Drain may be required. A qualified plumber should be appointed to further inspect the property and perform any remedial works as necessary. Water damage and secondary defects are likely to occur if left unmanaged.

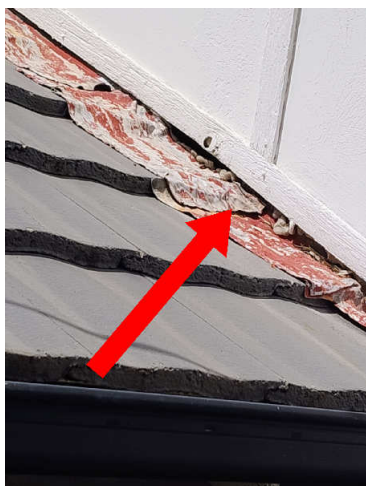
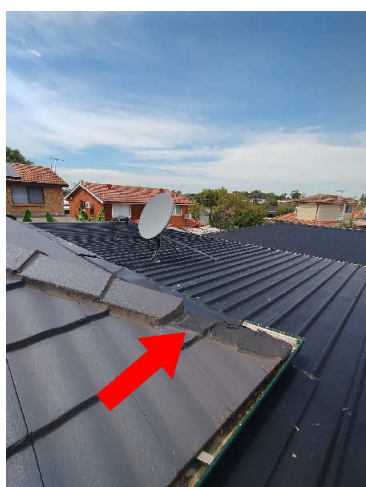
Finding 3.04

Upon inspection of the exterior roofing, the some of roof tiles were considered to be in a fair condition also roof exterior seems to be sagging at ridge. While weathering of the tiles is consistent with the age of the property, maintenance works are required.

Isolated areas of mortar have come loose in the valleys and minor cracking is also present. Re-pointing and re-sealing the may be considered as an interim solution by the client to help preserve and extend the life span of the tiles.

Where left unmanaged, deteriorating roof tiles are likely to lead to a number of secondary defects, including minor water leaks and weather exposure to internal roofing structures.

Consultation with a roofing contractor is highly advised to gain advice on cost of remedial works that may be required in the short to medium term. Remedial works are likely to increase the longevity of the exterior roofing structure.

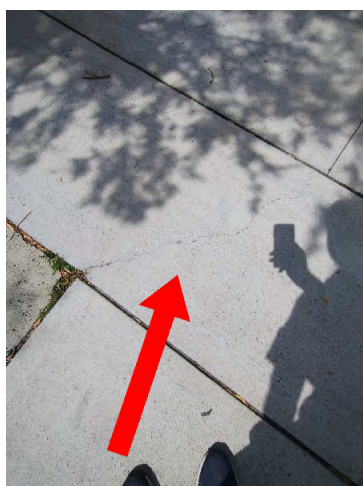
Finding: Crack in concrete slab - Category 2

Information: A crack coded as Category 2 was identified in the driveway slab at the time of inspection. A Category 2 crack is described as a distinct crack, with the slab being noticeably curved or changed in level.

To be considered Category 2, the approximate width of the crack is less than 2.0mm, or a change in offset of less than 15mm when a 3m straight edge is placed over the defect.

Category 2 cracks to slabs should be monitored for a period of 12 months. At the end of the monitoring period, cracks rated greater than Category 2 are considered defects that require rectification.

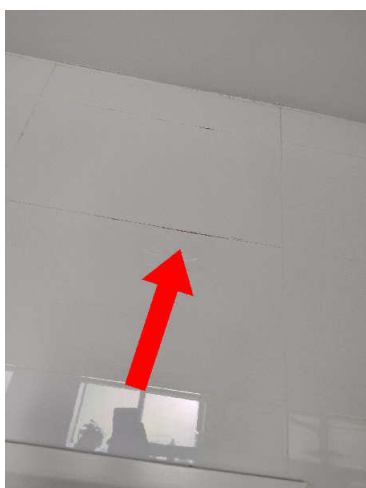
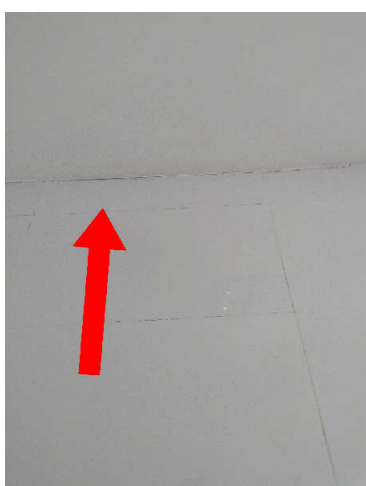
Finding 3.08

Building: Main Building
 Location: Bathroom
 Finding: Tiles grouting - Cracked and damaged

A tiling contractor should be appointed to ensure that no further water damage occurs. The re-application of silicone and grouting throughout remaining tile work is also advised, to further protect the area against water penetration.

Where water penetration has led to water damage, appointment of a relevant tradesperson may be required to repair damaged building elements.

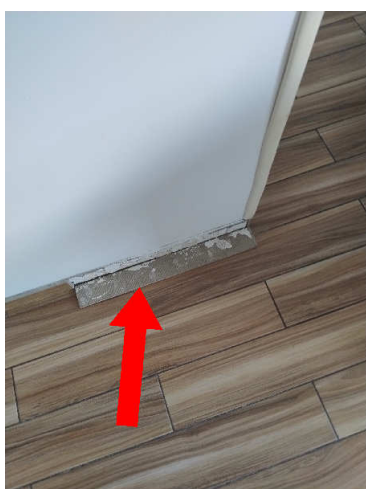
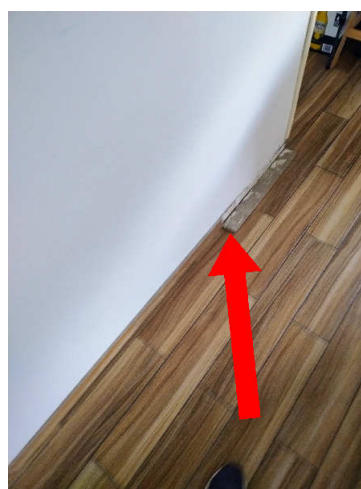
Finding 3.10

If left unmanaged, water ingress into adjoining areas may have major implications, and may potentially necessitate works to other building elements in the long-term future.

It is highly recommended that a tiling contractor be appointed to complete these minor works as soon as possible to prevent such damage from occurring.

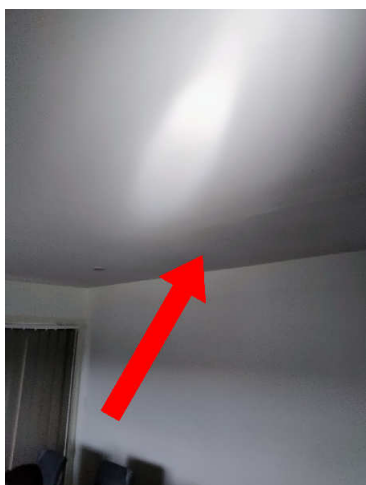
Finding 3.11

Building: Main Building
Location: Dining Room
Finding: Ceiling - Sagging

The appropriate action should be taken by the client as soon as possible to ensure that any potential further damage is limited.

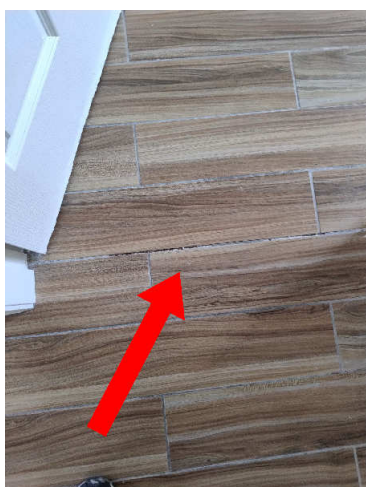
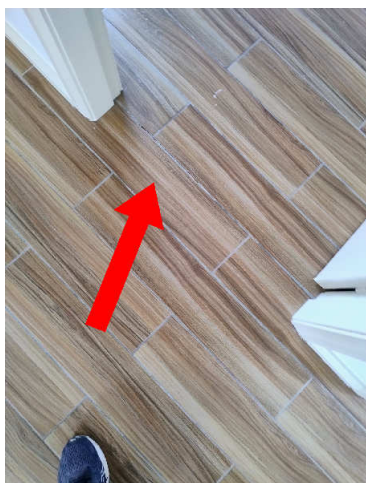
Cracked tiles throughout the household detract from the overall appearance of the affected areas however it is unlikely to create or lead to any secondary defects.

While not considered a matter of urgency, replacement of cracked floor tiles is recommended at the clients discretion. A tiling contractor may be appointed to perform these works. Where cracks become more numerous, contact a licensed building inspector for further investigation.

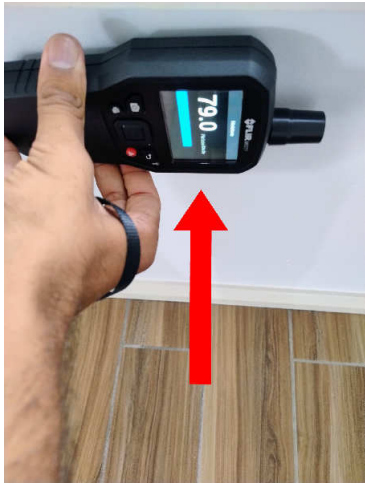
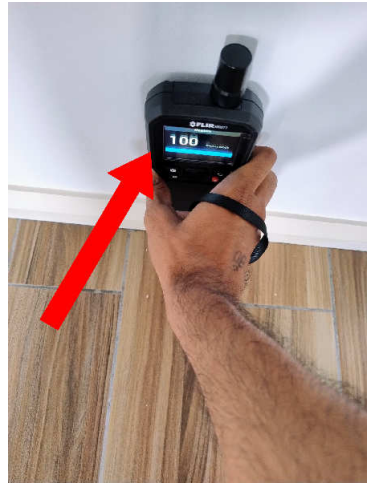
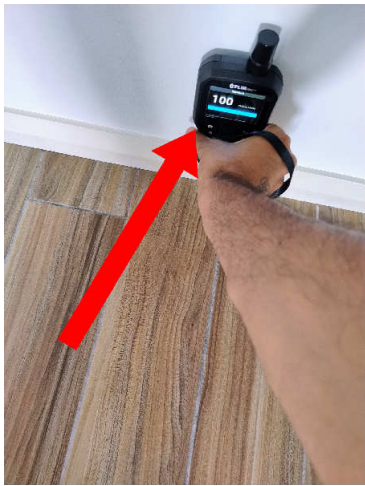
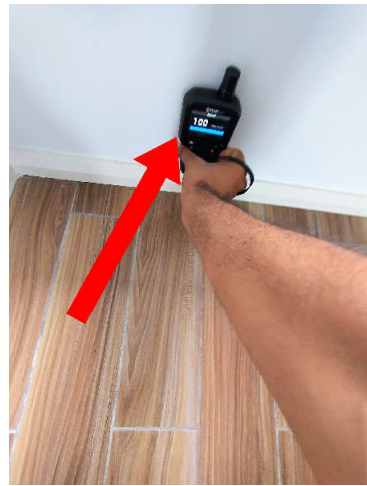
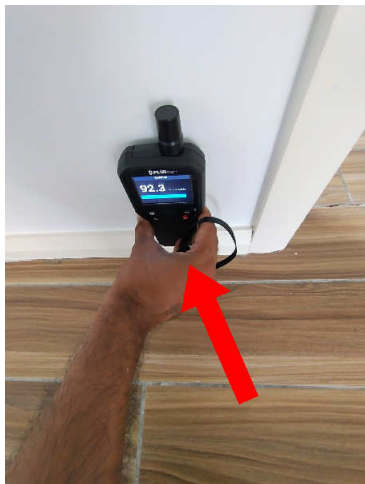
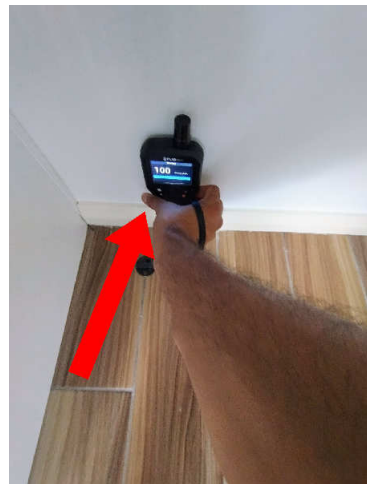
Finding 3.14

Building:	Granny-Flat
Location:	Living Room
Finding:	Evidence of Excessive moisture - identified
Information:	<p>Evidence of excessive moisture recorded by moisture meter in the bathroom walls at the time of inspection.</p> <p>Excessive moisture can attract termites and produce conditions that promote fungal growth and wood decay.</p> <p>Excessive moisture is generally caused by deteriorated, inadequate or missing roof drainage, leaking plumbing pipes or fixtures, poorly plumbed HWS overflows or condenser units and poor site drainage.</p> <p>If mould growth has been found there may be environmental biological or health issues involved. In these cases an appropriately qualified inspector should also be contacted.</p> <p>Prior to any remedial works being performed a qualified plumber should be appointed to further inspect the property and to identify the cause of the excessive moisture. Works to remove affected building elements may then be necessary and should be performed by an appropriate tradesperson.</p>

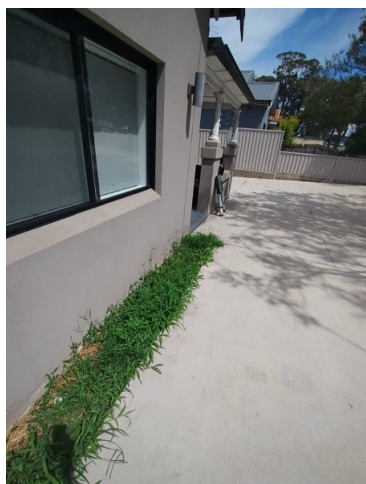
Finding 6.05

Information: Garden beds were found to be evident in the front area. These garden beds can include untreated timber, and with a combination of moisture from watering hosing can make conditions conducive to termite activity and termite ingress.

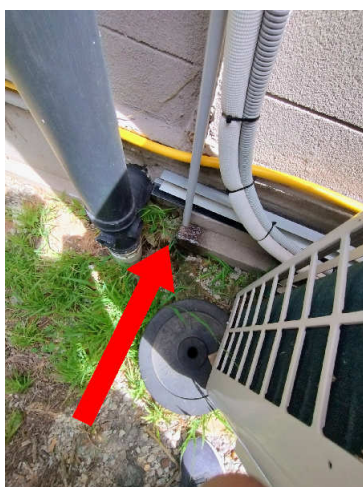
Finding 6.06

When coupled with poor site drainage, pooling of water may also attract termite activity to this area. It is highly recommended that a qualified plumber be appointed to install adequate drainage to the overflow. These works will ensure that the area remains dry and free of any secondary defects.

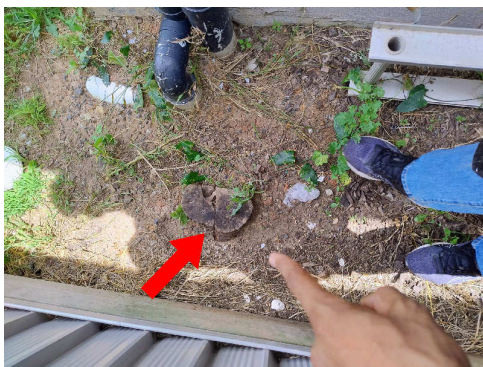
**Finding 6.13**

Building: Granny-Flat
Location: Rear Elevation

All tree stumps should be removed where possible, frequent pest inspections are advised to readily identify any termite activity in these areas.

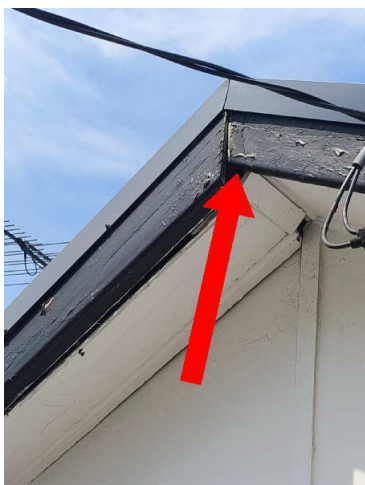
In this case although the affected timber element is in a decaying state the extent of any visible damage appears to be localised to a specific area and is yet to spread to other parts of the building element or affect adjoining structures. The fungal decay is therefore likely to be of a relatively superficial nature with minimal impact on the structural integrity or tensile strength of the timber element.

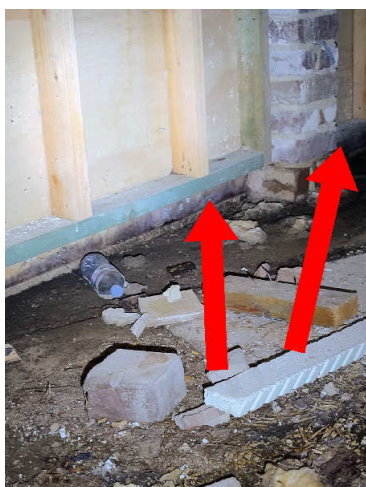
Finding 7.02

Building: Main Building
Location: Subfloor
Finding: Subfloor structure - Wood rot

Where wood rot is present to any structural timber, rectification or replacement of the affected timber building element is required. The adequate timeframe for such works are dependent on the severity of the rot. Where rot has developed to become widespread, replacement of sections of the subfloor structure may be required. Consultation with a structural engineer or registered builder specialising in re-stumping is highly advised as soon as possible.
