Building and Timber Pest Inspection Report

Inspection Date: Thu, 19 Feb 2026

Property Address: 2/29 Dunmore St, Croydon Park NSW 2133, Australia

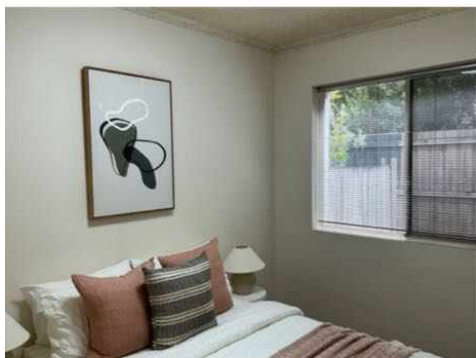
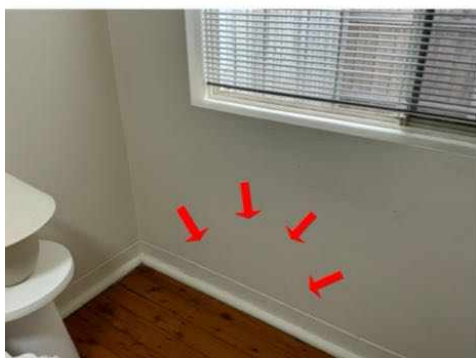
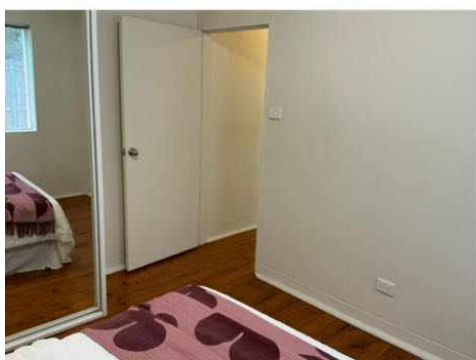
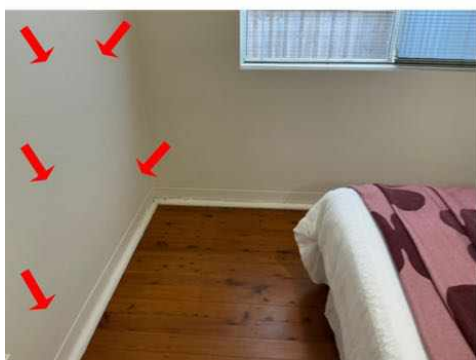
Building: Main Building
Location: Both bedrooms
Finding: Excessive Moisture Identified.
Information: Excessive moisture can attract termites and produce conditions that promote fungal growth and wood decay.

Excessive moisture is generally caused by deteriorated, inadequate or missing roof drainage, leaking plumbing pipes or fixtures, poorly plumbed HWS overflows or condenser units and poor site drainage.

If mould growth has been found there may be environmental biological or health issues involved. In these cases an appropriately qualified inspector should also be contacted.

Prior to any remedial works being performed a qualified plumber should be appointed to further inspect the property and to identify the cause of the excessive moisture. Works to remove affected building elements may then be necessary and should be performed by an appropriate tradesperson.

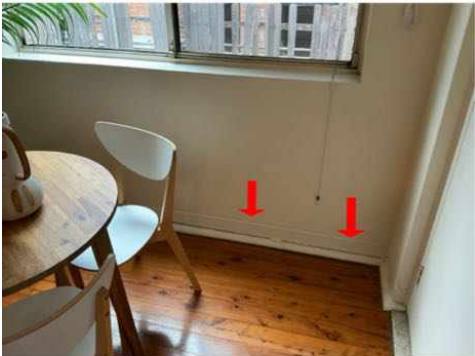
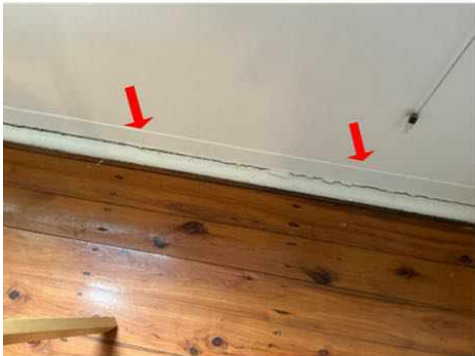
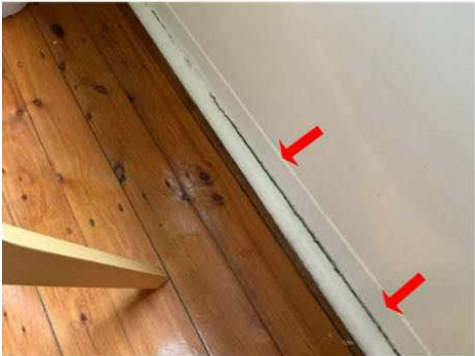
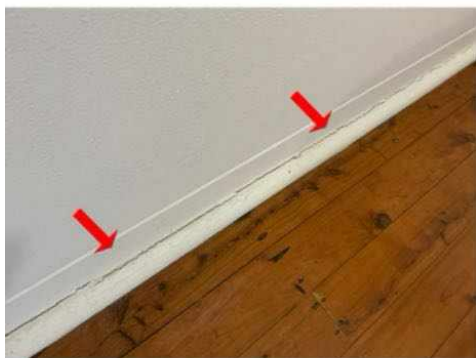
Finding 3.02

Building:	Main Building
Location:	Lounge, hall, bedrooms
Finding:	Paint finish - Substandard- skirting boards
Information:	The paint finish in this area was found to have been completed to a substandard level. Substandard painting is generally classified as an appearance defect. However, the substandard appearance may also be indicative of poor surface preparation and substandard workmanship.

If this applies, further areas of poor and incomplete finishes could develop over time. Furthermore, substandard paint finishes in areas exposed to moisture, e.g. external areas or wet areas, could lead to deterioration of underlying building materials.

Substandard paint finishes should be sanded back, filled, leveled and repainted, as applicable. Where inadequate paint protection has led to the deterioration of the associated building element, repair and/or replacement of this building element may be required.

A painting contractor should be appointed as soon as possible to perform necessary works to aid the appearance of the affected area and to ensure that the area is protected against further deterioration. Alternatively, the homeowner following manufacturer instructions may be able to provide this service.

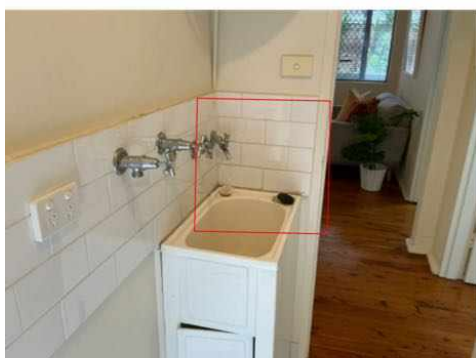
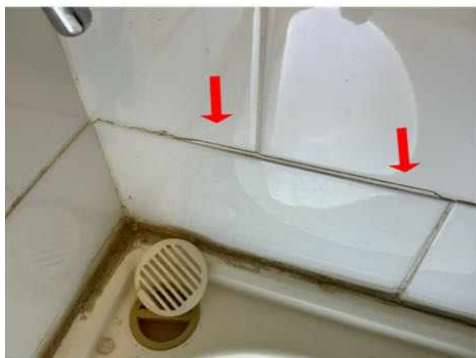
Finding 3.03

Building:	Main Building
Location:	Laundry
Finding:	Tiles - Drummy
Information:	Drummy tiled areas were identified at the time of inspection. The term 'drummy' refers to tiles that have become detached from their fixing, despite otherwise being in relatively good condition. Such defects are generally caused by physical or moisture damage to the area. Drummy tiled areas may also be a direct result of poor workmanship during the construction process.

Tiled areas may swell and shrink with changes in air humidity if the area has sustained moisture damage. Any exposure to moisture is capable of causing tiled areas to become drummy and/or cracked over a prolonged period of time. Drummy tiled areas generally require removal and replacement of affected tiles, with adequate sealant and grouting.

Specialist trades are available for these types of services. A registered builder may be required to undertake works if damage is extensive or if secondary building defects have resulted. Otherwise, it is advised that a tiling contractor be appointed to perform works as necessary. Immediate action is recommended to ensure that no further damage is sustained in the affected area.

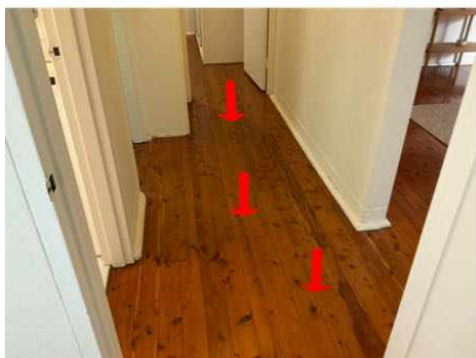
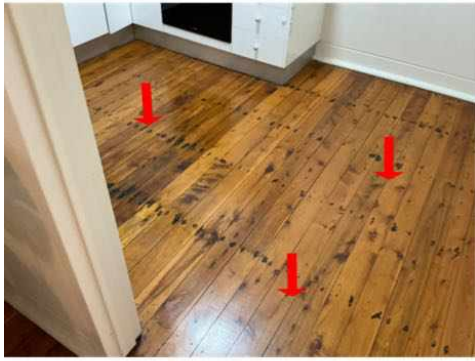
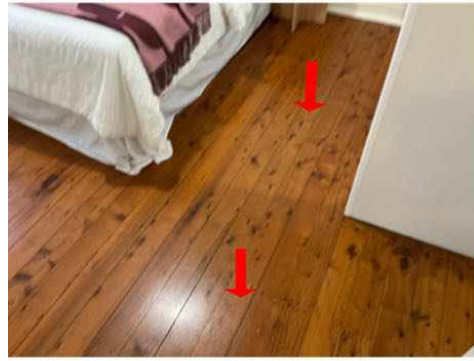
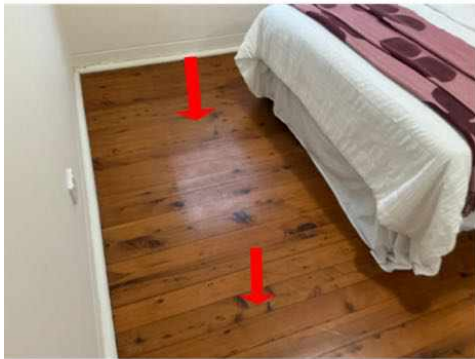
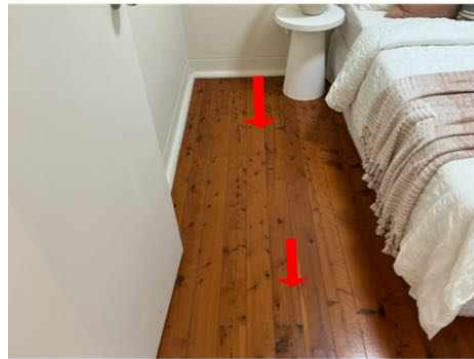
Finding 3.04

Building:	Main Building
Location:	All areas- lounge room, kitchen, hallway, bedrooms
Finding:	Floors - bouncy
Information:	The internal flooring in this area was identified as being bouncy at the time of inspection. A bouncy floor surface generally presents as a discernible change in level as they are walked across, in noisy or creaking flooring, or in consequent movement of surrounding furniture and fixtures.

Bouncy floors generally indicate that the floorboards or the subfloor structures are coming loose from the joists that they are installed on. Bouncy flooring may also be the result of gaps between flooring and stumps or joist structures, which require packing.

The client is advised to seek quotations for required repairs from a Registered Builder specialising in re-stumping. The potential resolution may range from packing gaps in subfloor structures through to replacement of subfloors stumps and refixing of flooring.

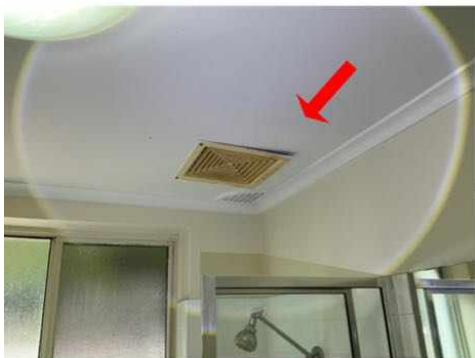
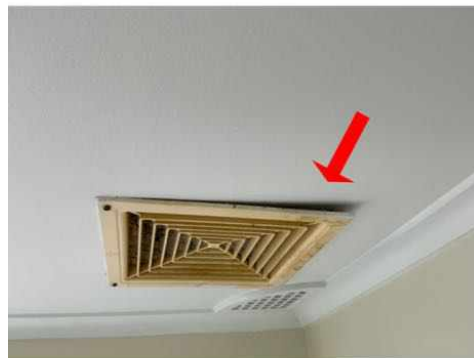
Finding 3.05

Building:	Main Building
Location:	Bathroom
Finding:	Fitting or fixture - Loose- exhaust fan in bathroom
Information:	The fitting in this area is loose and requires adjustment to tighten.

If left unmanaged, the fitting may further deteriorate, causing potential for the development of other minor secondary defects.

A relevant tradesperson should be appointed to perform these rectification works at discretion of the client.

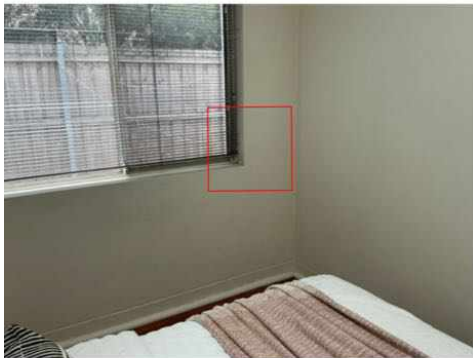
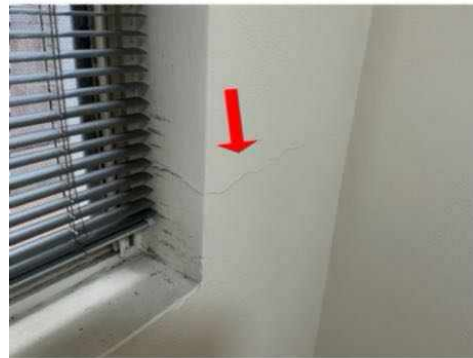
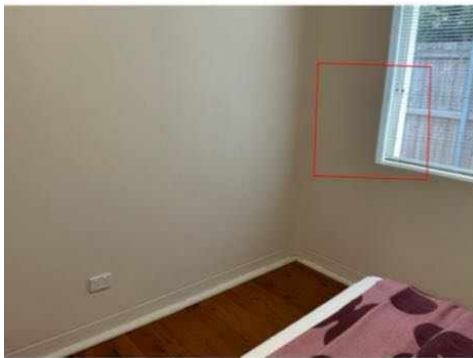
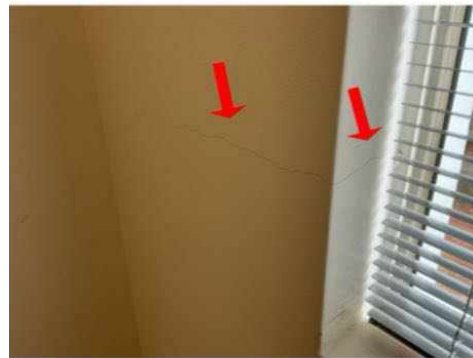
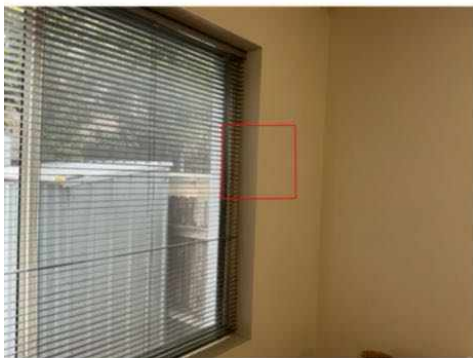
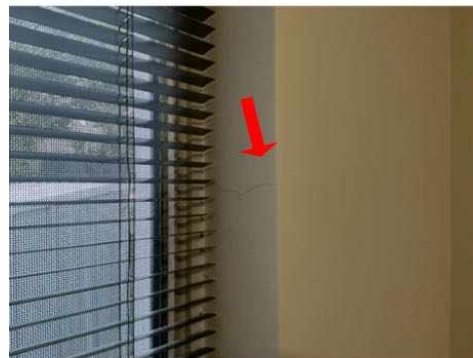
Finding 3.06

Building: Main Building
Location: Both bedrooms
Finding: Cracks to internal render - Category 1
Information: It has been observed that cracking to internal rendered surfaces has occurred. The degree of damage falls within Category 1, described as fine cracks that do not need repair and which are less than 1.0mm in width limit.

Damage of this category is not considered a defect for rectification. Always contact your building inspector should cracks widen, lengthen, or become more numerous.

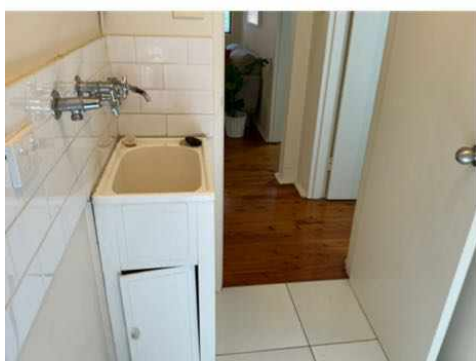
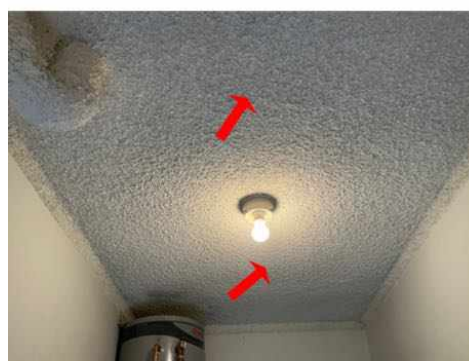
Finding 3.07

Building:	Main Building
Location:	Laundry
Finding:	Exhaust fan - Missing
Information:	An exhaust fan has not been installed in this area. Missing exhaust fans may lead to the development of more significant defects such as moisture damage to surrounding building materials from inadequate ventilation. Inadequate ventilation in internal areas creates an environment that is conducive to the formation and development of mould and other respiratory hazards. It is highly advised that a licensed electrician be appointed to retrospectively install an exhaust fan. Failure to perform works to aid the ventilation of the area may lead to the development of these secondary defects.

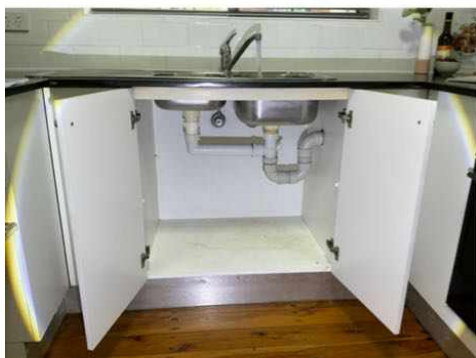
Building:	Main Building
Location:	Meter box & under kitchen sink
Finding:	Termite Management System - no evidence of a chemical installation
Information:	The application of a post-construction chemical termite barrier is highly recommended for all properties, particularly if live termite activity has been found on the site previously. Such barriers are highly effective in preventing termite attack on any timber building elements throughout the property.

A durable notice should be placed in the switchboard unit to indicate current termite barriers. At the time of inspection, it appeared as though no termite management system has been installed, with no evidence to suggest preventative works taking place.

The client may consider gaining further advice from a pest controller as to the costs and procedures involved with this application. It is recommended that obtaining such advice be a short-term priority.

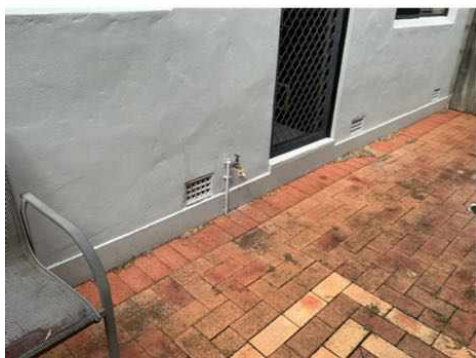
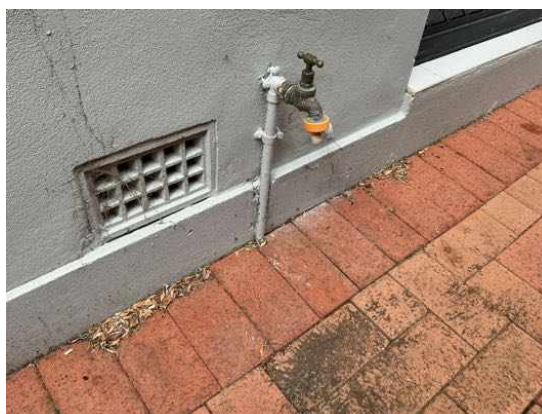
Finding 6.02

Building:	Main Building
Location:	Rear courtyard
Finding:	Overflow - Not plumbed for drainage (Excessive Moisture)
Information:	The overflow is not plumbed or connected to suitable drainage, which has resulted in the surrounding area becoming excessively damp. These damp conditions can lead to secondary defects such as rot, rust or corrosion of associated building elements, the formation of fungal decay, or even the creation of potential slip hazards.

When coupled with poor site drainage, pooling of water may also attract termite activity to this area. It is highly recommended that a qualified plumber be appointed to install adequate drainage to the overflow. These works will ensure that the area remains dry and free of any secondary defects.

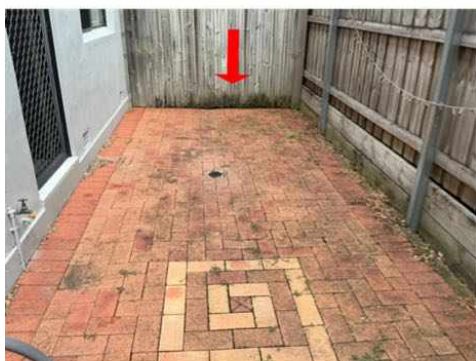
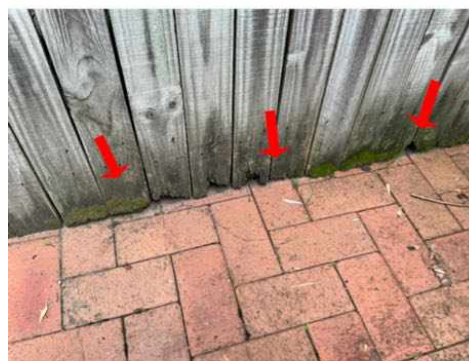
Finding 6.03

Building:	Main Building
Location:	Courtyard- fence
Finding:	Wood rot
Information:	This building element shows evidence of wood rot. Wood rot, also known as Fungal Decay, occurs when timbers and other cellulose building materials are exposed to damp conditions on an ongoing basis. This could be the result of exposure to weathering over a prolonged period of time, or the attraction of excessive moisture from other abutting building materials. Contributing factors also include poor air ventilation in the area.

Wood rot is often associated with general damp problems and is evidenced by a 'musty' smell or mould and mildew occurring on surfaces. If left unmanaged, damp conditions can lead to further health problems and the decay of timbers will continue.

Early intervention and regular maintenance, particularly of exterior timbers, will prolong the useful life of these building elements. Prior to any works being performed, the cause of the moisture that has created the visible wood rot should be identified and addressed in a suitable manner. Replacement of affected timbers may then be a necessary step in protecting surrounding building elements from such deterioration.

A qualified plumber may be appointed to assess the cause of excessive moisture and to provide advice on any remedial works as required. A qualified carpenter or registered builder may also be required to replace affected building materials.

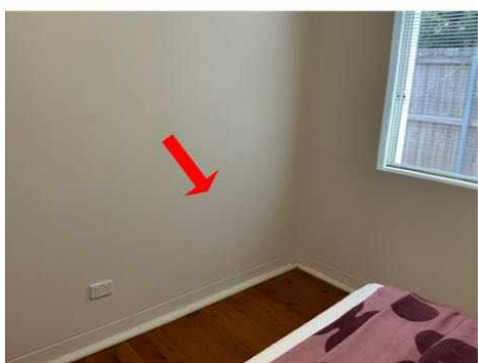
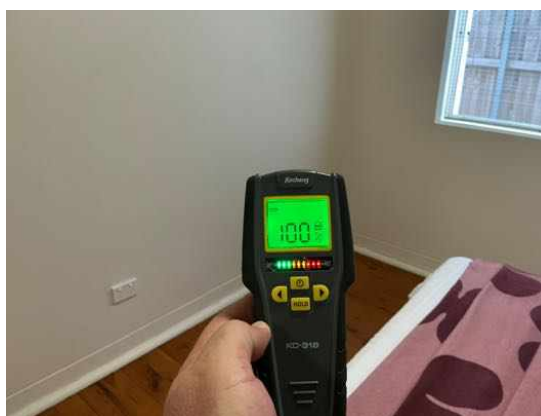
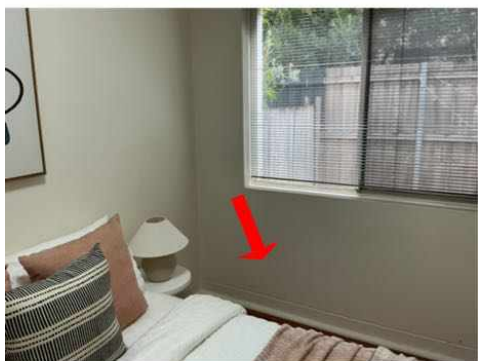
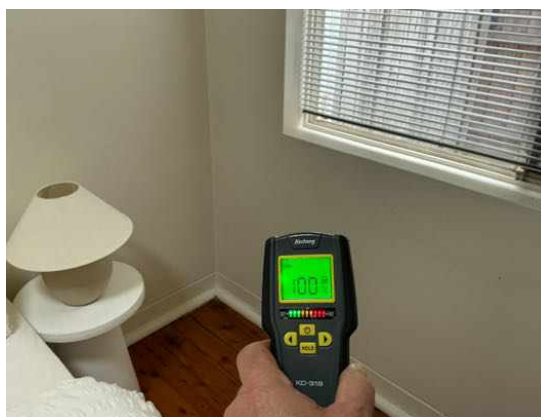
Finding 6.04

Building:	Main Building
Location:	All Areas
Finding:	Excessive moisture - identified
Information:	Excessive moisture can attract termites and produce conditions that promote fungal growth and wood decay.

Excessive moisture is generally caused by deteriorated, inadequate or missing roof drainage, leaking plumbing pipes or fixtures, poorly plumbed HWS overflows or condenser units and poor site drainage.

If mould growth has been found there may be environmental biological or health issues involved. In these cases an appropriately qualified inspector should also be contacted.

Prior to any remedial works being performed a qualified plumber should be appointed to further inspect the property and to identify the cause of the excessive moisture. Works to remove affected building elements may then be necessary and should be performed by an appropriate tradesperson.

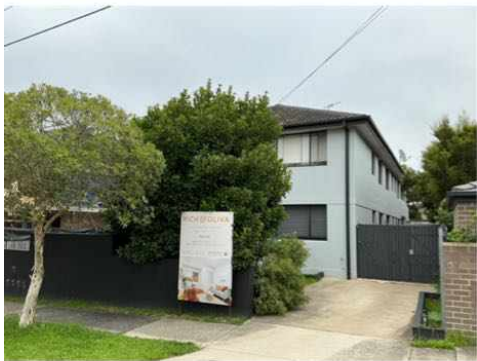
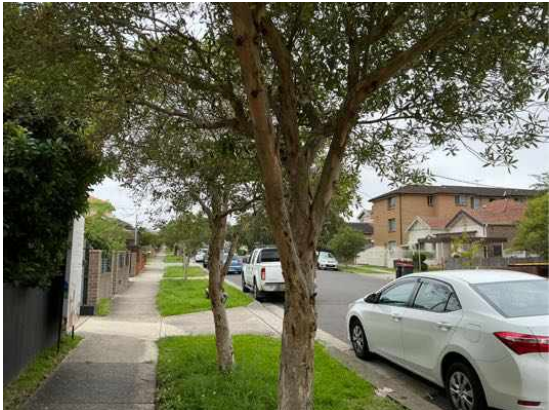
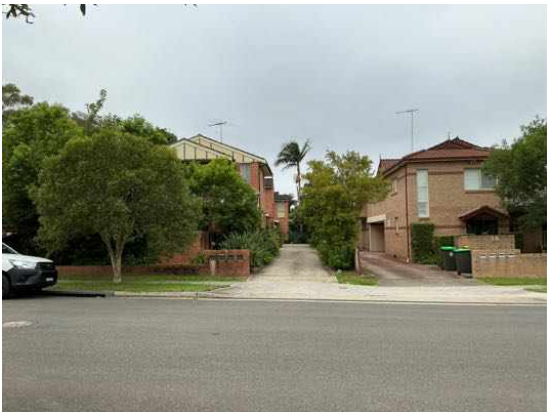
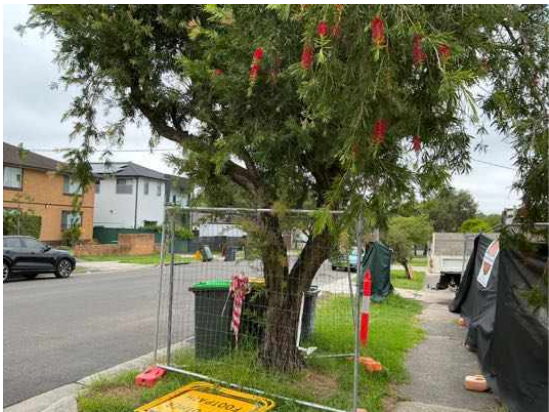
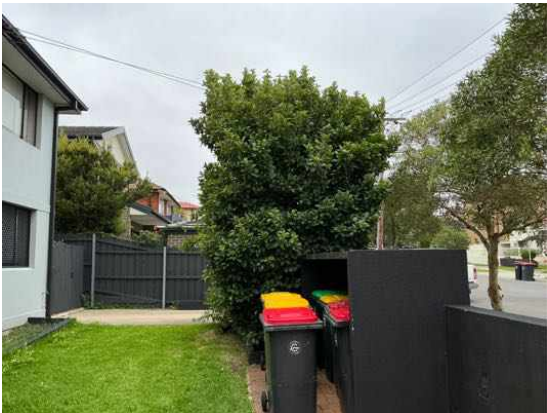
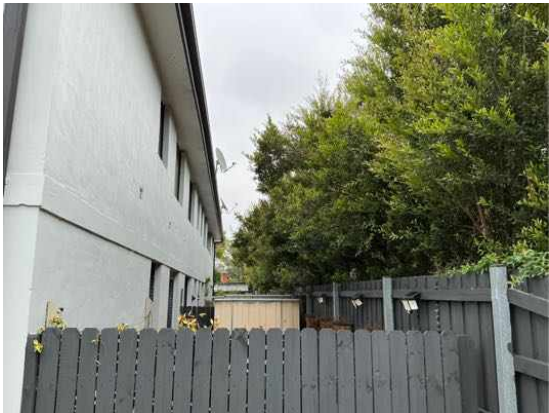
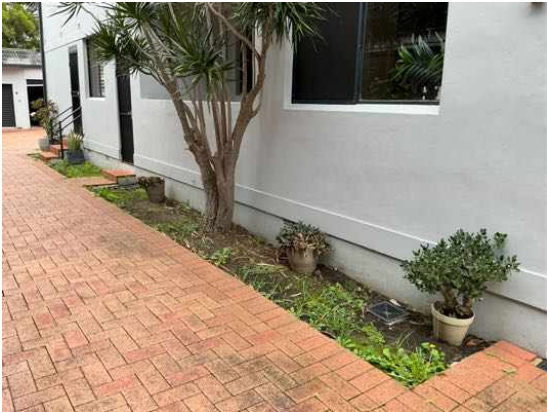
Finding 6.05

Building:	Main Building
Location:	All Areas
Finding:	Trees to be inspected within the property.
Information:	Trees can be conducive to termite activity and nesting. Trees over 100mm on the property, should be drilled and tested for termite activity.

Regular inspections every 6-12 months- or advised by the termite management system installer.
