# Building and Timber Pest Inspection Report

Inspection Date: Thu, 22 Jan 2026

Property Address: 129 & 129A Maple Rd, North St Marys NSW  
2760, Australia

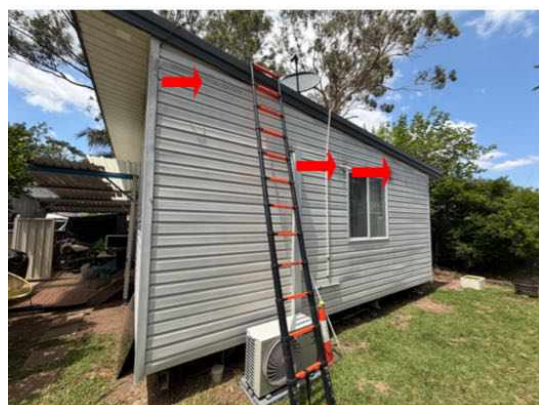
Building:	Main Building
Location:	Granny flat - left side
Finding:	Mould - Present
Information:	Where evidence of mould growth was noted, there may be environmental, biological or health issues associated with the report. A specialist inspection by a suitably qualified environmental health inspector is warranted, where mould is extensive or where any queries regarding air quality spores or other related issues apply.

Generally, the client is advised to ensure that the general environment is free of moisture and humidity to aid in the prevention of mould formation and development. Any mould found during the inspection should be cleaned immediately by a cleaning contractor or the homeowner as applicable.

Please note that severely affected building elements may require replacement by a registered builder or qualified carpenter.

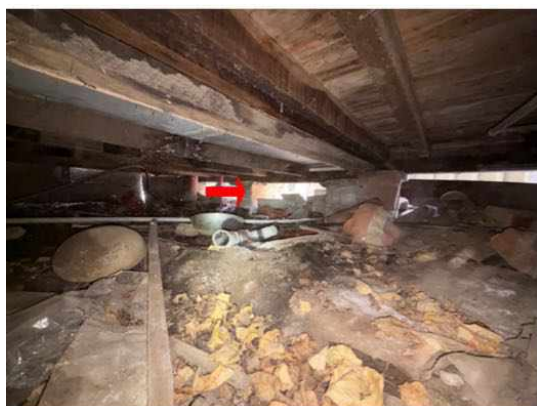
Building:	Main Building
Location:	Laundry
Finding:	Piers -- Leaning (major)
Information:	A pier to the subfloor under the laundry is not supporting the suspended structure adequately, indicating that its structural integrity has been affected. The cause of this instability is likely to be caused by movement / subsidence of the pier due to moisture and inadequate site drainage. Other piers were noted with slight movement, which currently require regular monitoring.

Inadequate support is likely to lead to a range of other secondary major and minor defects and hence immediate rectification to the pier is required by a licensed builder. Monitoring and when required improving site drainage is recommended to avoid further movement / subsidence of the affected piers.

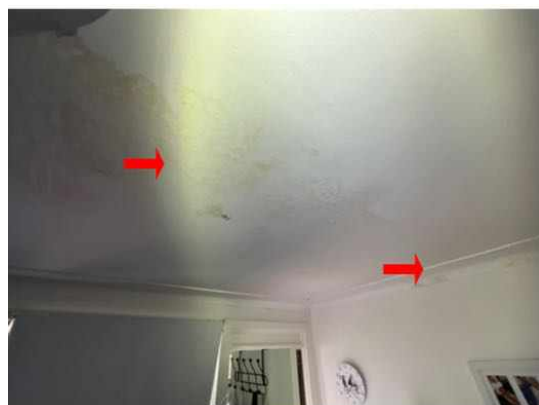
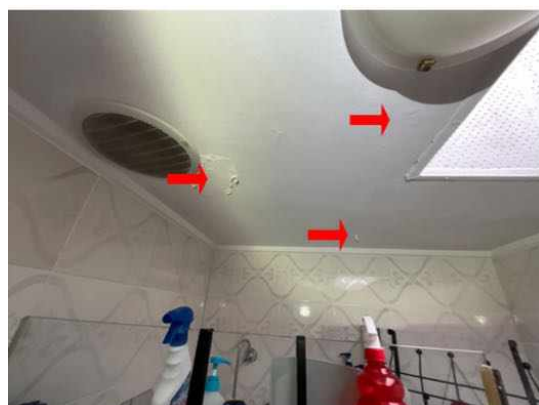
## Finding 2.02

Building:	Main Building
Location:	Multiple areas
Finding:	Ceiling - Water damaged
Information:	Water damage to the ceiling lining is generally an indication of excessive moisture being present in the roof void, usually via a leak to the roof covering.

Where water damage is evident to the ceiling, the primary requirement is to identify and rectify the source of the leak. A roof restoration specialist should be appointed as soon as possible to identify the leak and perform rectification works as necessary, ensuring the water damage is restricted.

Once the leak is repaired, consultation with relevant tradespeople, including plasterers and painters, is advised. Rectification works may include replacement of ceiling lining or minor repainting, depending on the extent of the damage.

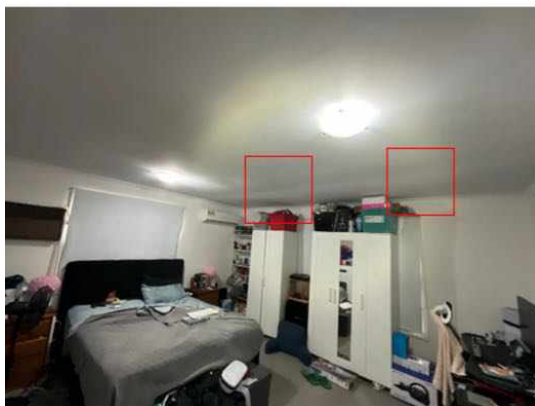
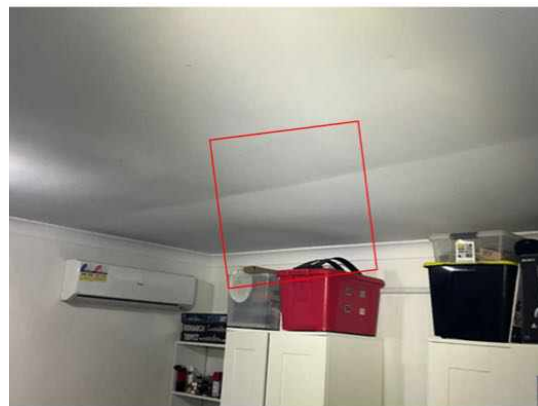
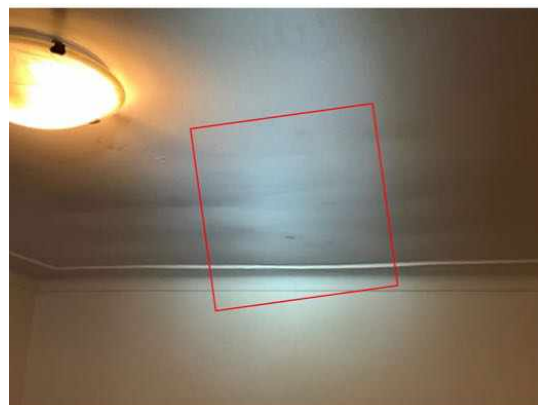
Information: Sections of the ceiling were found to be sagging at the time of inspection. Sagging to the fixed ceiling structure generally indicates that the building materials have swollen, due to contact with water, or that fixings (e.g. nails or glue) have become loose and require reattachment.

Where minor sagging is evident, comparatively minor works, such as re-gluing of ceiling sheets, may be required. Such works may be performed by relevant tradespeople, such as plasterers and painters. Where excessive moisture has caused the roofing structure to swell and sag, the source of the water leak should primarily be identified prior to any remedial works being performed.

The appropriate action should be taken by the client as soon as possible to ensure that any potential further damage is limited.

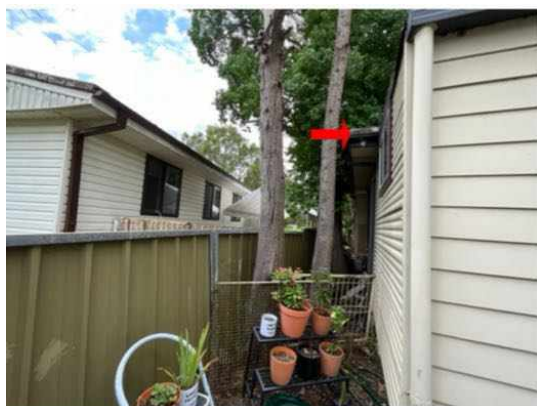
Where roof plumbing doesn't drain adequately, the area at the base perimeter can become excessively damp, potentially creating an environment that is susceptible to rust and corrosion of surrounding building elements, as well as attracting termites and other pests.

It is highly recommended that a plumber be appointed to further inspect the area and to install adequate drainage equipment where necessary.

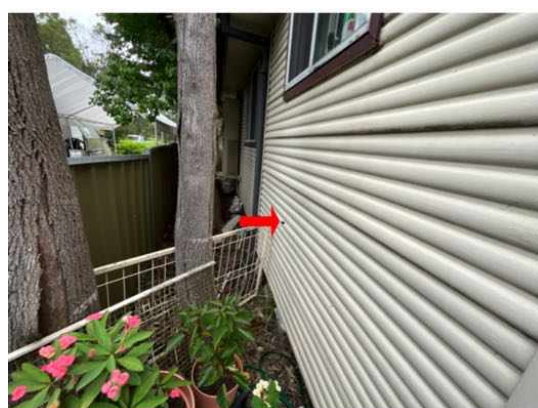
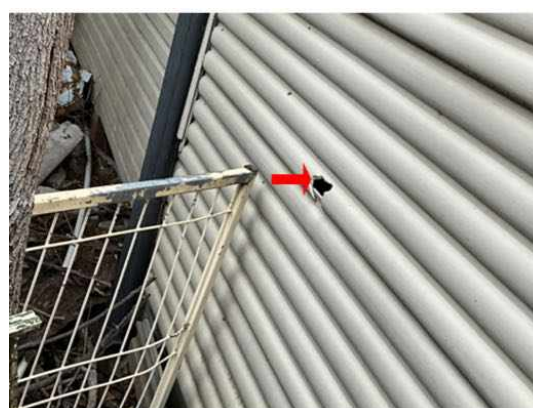
Whether intentional or not, gaps and holes to external surfaces are susceptible to insect and vermin ingress, as well as allowing water penetration to the cavity wall. As such, associated building elements are likely to deteriorate at an accelerated rate, and major implications are expected if holes around the pipework are left unmanaged.

All excessive holes, gaps or cracks should be adequately filled by a suitable sealant or trimmings as soon as possible to prevent any further damage. Such works may be conducted by a general handyperson or licensed carpenter.

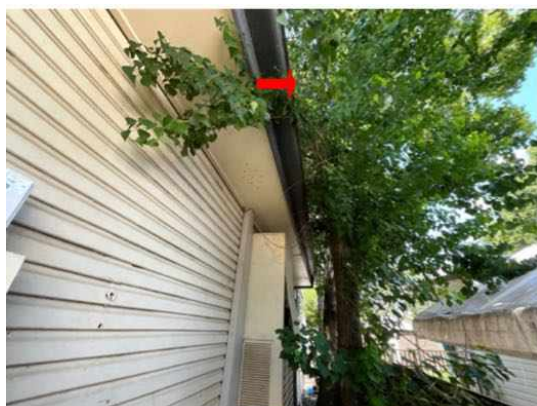
Gutters are a critical part of the building's management of storm water and rain. It is therefore important that they be kept clear to prevent secondary damage to associated building elements, including exterior and interior walls, ceiling linings and any adjoining building elements. Where gutters are blocked, pooling of rainwater is likely to occur, fast-tracking rust and corrosion of the roof plumbing elements.

It is highly advised that all overhanging tree branches be removed as soon as possible to prevent any further damage. Repair and/or replacement of sections of damaged guttering may also be required where the extent of the damage necessitates.

Such works should be performed by the homeowner; however, appointment of a landscape contractor or an arborist may be required. Consultation with a licensed roof plumber is required where guttering has been damaged.

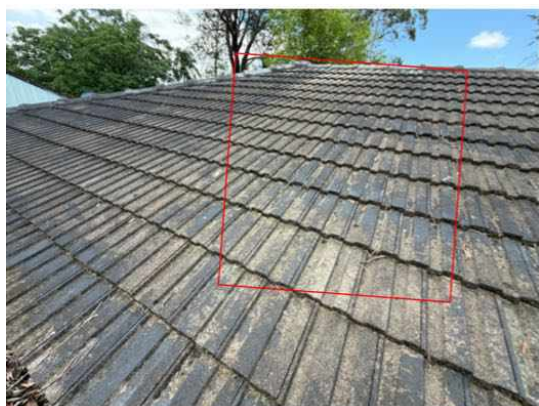
### Finding 3.10

Upon inspection of the exterior roofing, the majority of roof tiles were considered to be in a fair condition. While weathering of the tiles is consistent with the age of the property, maintenance works are required.

Isolated areas of mortar have come loose and minor cracking is also present. Re-pointing and re-sealing the may be considered as an interim solution by the client to help preserve and extend the life span of the tiles.

Where left unmanaged, deteriorating roof tiles are likely to lead to a number of secondary defects, including minor water leaks and weather exposure to internal roofing structures.

Consultation with a licensed roofing contractor is highly advised to gain advice on cost of remedial works that may be required in the short to medium term. Remedial works are likely to increase the longevity of the exterior roofing structure.

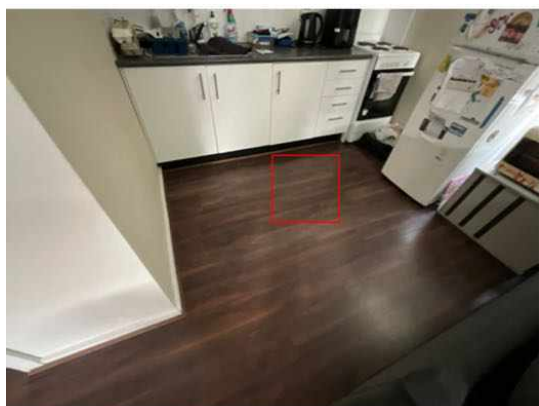
### Finding 3.11

Building: Main Building  
 Location: Granny kitchen  
 Finding: Building element - Swollen  
 Information: Swollen building elements generally indicate that the building materials have been affected by excessive moisture over a prolonged period of time, and have swollen as a result.

Repair and/or replacement of swollen building elements may be conducted by a licensed carpenter.

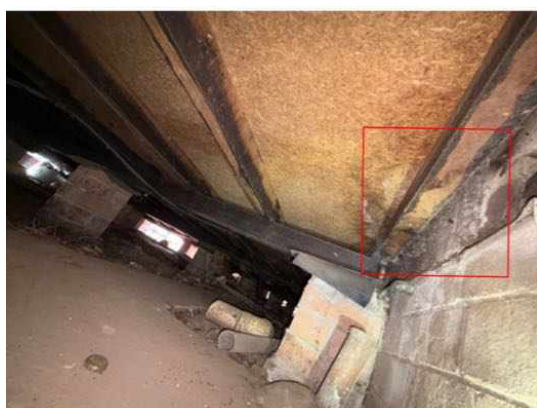
Building:	Main Building
Location:	Bathroom
Finding:	Subfloor members — Water staining
Information:	There is evidence of water staining to the subfloor members under the bathroom.

This water staining indicates that surfaces have been exposed to excessive moisture over time, potentially due to water leak. The minerals and other elements in the water lead to staining, which may graduate to corrosion and deterioration if left unmanaged.

A licensed plumber must be appointed immediately for further assessment and to confirm whether any active leaks are affecting the area or not and also that the waterproofing membrane is in serviceable condition.

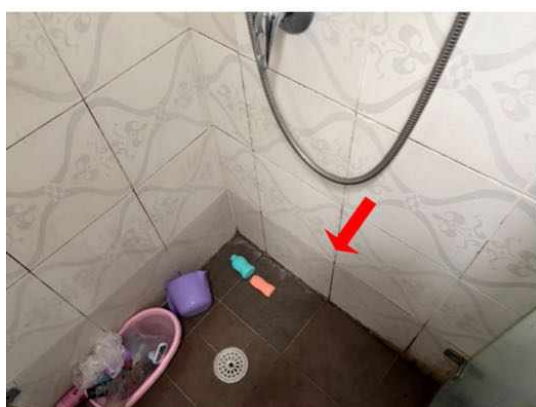
### Finding 3.14

Building:	Main Building
Location:	Bathroom

Finding: Shower damp - Sealant and grout  
 Information: Damp is evident to the lower 400mm of wall to the shower alcove. This defect is quite common, and is suspected to have been caused by moisture permeating or leaching through the grouting and sealant in this area, which shows evidence of deterioration. Leaking pipes within the wall is also a possible cause however this seems unlikely in this instance as there is no moisture build up around the taps or transferring to the other side of the wall. There appears to be no sealant around the tap spindles which may be a small contributing factor.

Consultation with a bathroom sealant specialist is advised immediately to identify the cause of damp and to perform remedial works as required.

Always ensure that sealant and grout is in good condition to prevent any moisture issues occurring in the future.

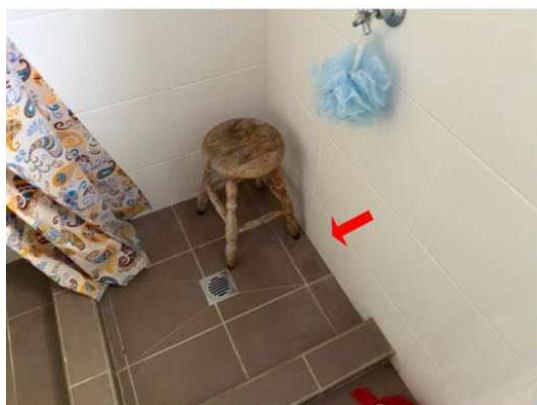
### Finding 3.15

Building: Main Building  
 Location: Granny bathroom  
 Finding: Shower damp - Monitor

Always ensure that sealant and grout is in good condition to prevent any moisture issues occurring in the future.

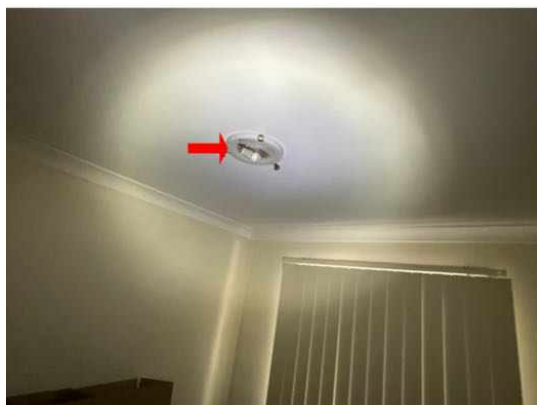
### Finding 3.16

Building: Main Building  
Location: Granny bed 2

Finding:	Light cover - Missing (Cosmetic)
Information:	The light cover in this area was found to be missing at the time of inspection. Breakage occurs generally when the building materials have aged and decayed, but may also be indicative of impact damage to the building element (accidental or deliberate). This is mainly a cosmetic defect which can be replaced by the home owner.

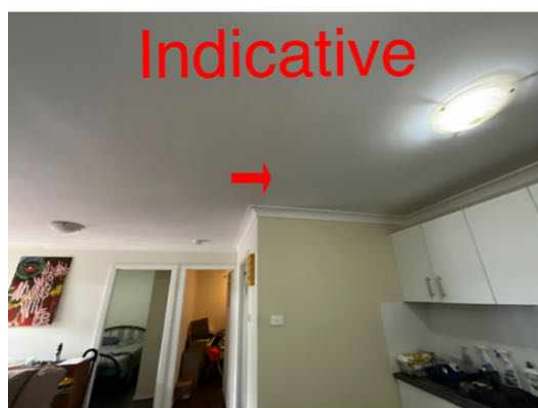
### Finding 3.17

Building:	Main Building
Location:	Multiple areas
Finding:	Cracking - Damage Category 1 - Fine (up to 1mm)
Information:	Although fine cracks are quite noticeable, they are often only considered to be an appearance defect, and usually do not indicate any structural damage. Generally, the cause of a fine crack is indicative of a separation between building materials and finishes (e.g. paint, plaster, etc.) along joins.

Cracking of this nature can generally be repaired with minor sanding, filling and/or repainting. Such works should be performed by a qualified painter or a general handyman.

Monitoring of all cracking should be conducted frequently. Always contact a building inspector should cracks widen, lengthen, or become more numerous.

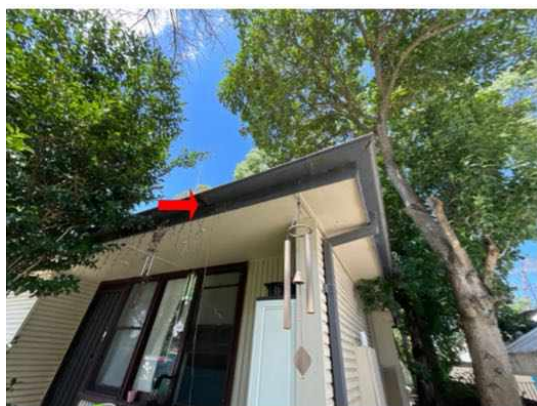
### Finding 6.02

Building:	Main Building
Location:	Multiple areas of roof plumbing
Finding:	Water leak - External
Information:	Water leaks were found to be present to exterior plumbing work. Leaks are generally caused by deterioration of the plumbing elements over time, due to exposure to weather conditions, but may have also been caused by minor impact damage.

It is highly advised that a licensed plumber be appointed to rectify any water leaks that may be present. Areas of repair and replacement of plumbing fittings and fixtures may be required and, as such, a quotation should be sought.

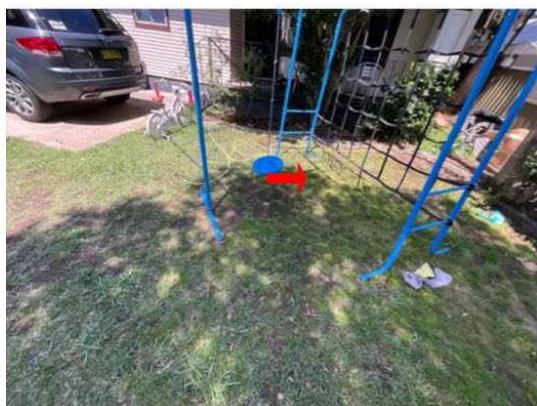
### Finding 6.03

Building:	Main Building
Location:	Yard
Finding:	Site drainage— Inadequate
Information:	The site drainage in this area was found to be inadequate at the time of inspection, creating potential for subsequent water damage to associated building elements. This is additionally conducive to termite activity.

Where site drainage is inadequate, installation of an Agricultural (Aggie) Drain may be required. A licensed plumber should be appointed to further inspect the property and perform any remedial works as necessary. Water damage and secondary defects are likely to occur if left unmanaged.

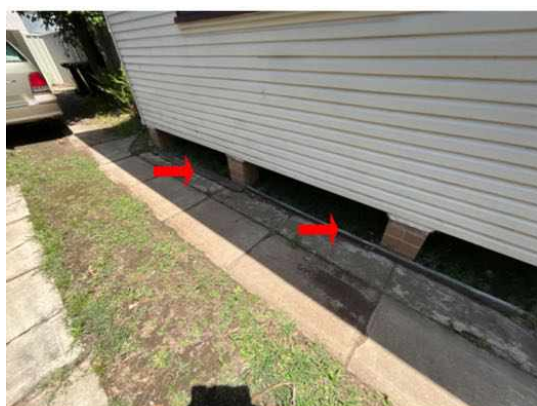
### Finding 6.08

Building:	Main Building
Location:	Fencing & Landscaping
Finding:	Building materials in direct ground contact - conducive to termites
Information:	Where timber elements are in direct contact with the ground and consequently moisture or dampness they become conducive to termite activity. Whether timber is used as a building element part of a fencing structure or stored as an unused item they can provide an environment that is attractive to termite infestation.

The removal of any such materials that may be conducive to termite activity should be removed as soon as possible to minimise the risk of termite attack.

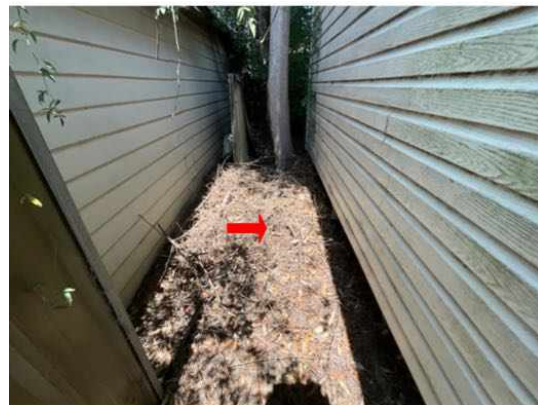
### Finding 6.11

Building:	Main Building
Location:	Garden beds
Finding:	Garden Beds
Information:	Garden beds were found to be evident in the garden area. These garden beds can include untreated timber, and with a combination of moisture from watering or hosing can make conditions conducive to termite activity and termite ingress.

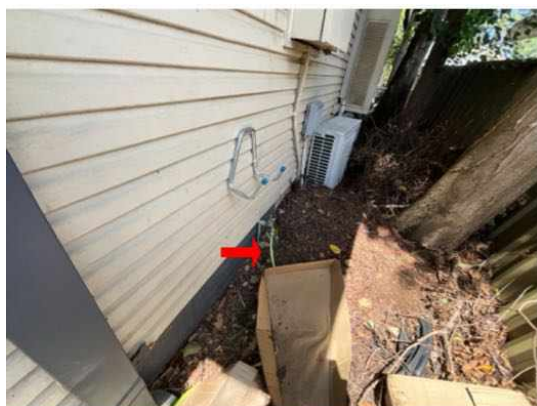
### Finding 6.12

Building:	Main Building
Location:	External tap
Finding:	Tap - No drain
Information:	The external tap in this area was noted to have no drain at the time of inspection.  This keeps the surrounding surfaces damp while using the tap, which becomes conducive to termite activity.  A licensed plumber must be appointed to ensure an appropriate drain is installed.

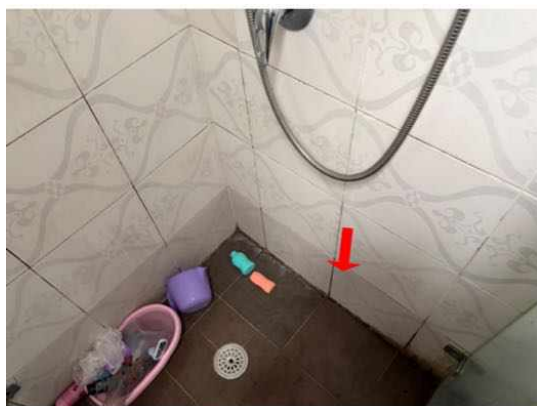
### Finding 6.13

Building:	Main Building
Location:	Bathroom
Finding:	Shower damp - Sealant and grout
Information:	Damp is evident to the lower 400mm of wall to the shower alcove. This defect is quite common, and is suspected to have been caused by moisture permeating or leaching through the grouting and sealant in this area, which shows evidence of deterioration. Leaking pipes within the wall is also a possible cause however this seems unlikely in this instance as there is no moisture build up around the taps or transferring to the other side of the wall. There appears to be no sealant around the tap spindles which may be a small contributing factor.

Always ensure that sealant and grout is in good condition to prevent any moisture issues occurring in the future.
