Building and Timber Pest Inspection Report

Inspection Date: Tue, 17 Mar 2026

Property Address: 18 Cabinda Dr, Keysborough VIC 3173,
Australia

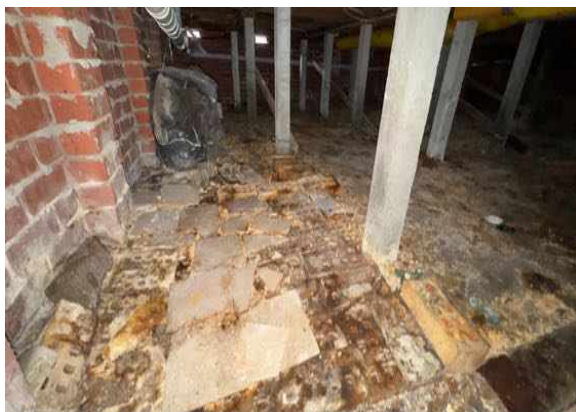
Building:	Main Building
Location:	Subfloor
Finding:	Sub Floor - Suspected Mould
Information:	Suspected mould growth was observed in the subfloor in this area.

This has likely occurred due to water ingress, poor ventilation, and persistent damp conditions. Mould can damage building materials, reduce indoor air quality, and pose health risks to occupants.

A registered builder or mould remediation specialist is required to inspect the subfloor, identify the source of moisture, and remediate the mould. Works may include removal of affected materials and treatment of surfaces. This should be rectified immediately to prevent further damage and health risks.

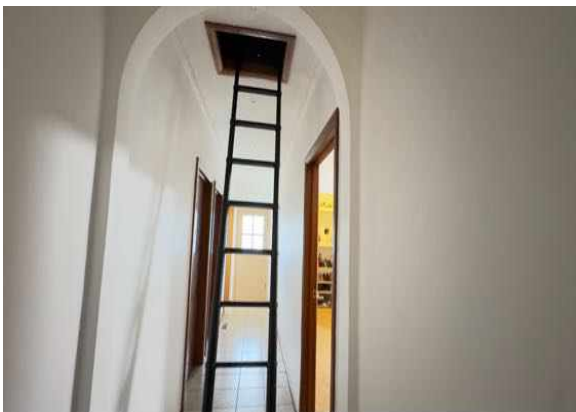
Building:	Main Building
Location:	Roof Void
Finding:	Roof Void - Electrical - Downlight Fittings - No Cover
Information:	Downlight fittings within the roof space were observed to not have covers. This is an unsafe condition, as combustible materials in close proximity to light fittings can increase the risk of overheating and fire.

This condition may have resulted from poor insulation installation.

A licensed electrician should be engaged immediately to assess the downlight installation. The fitting should be made safe, which may include installing an appropriate fire-rated downlight cover or replacing the fitting to ensure safe operation and reduce fire risk.

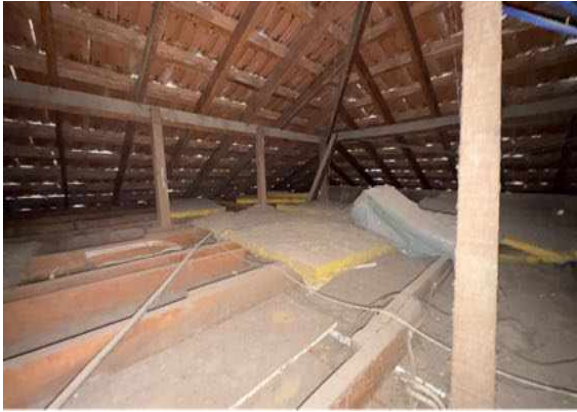
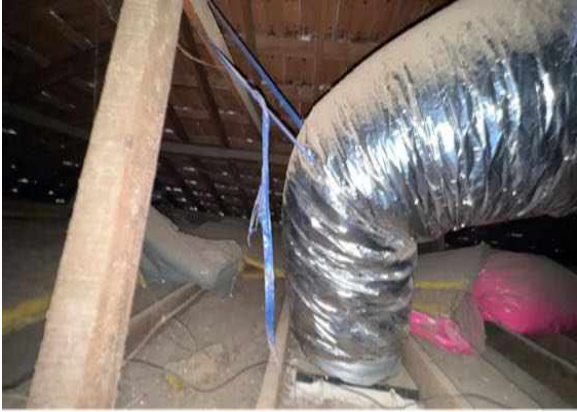
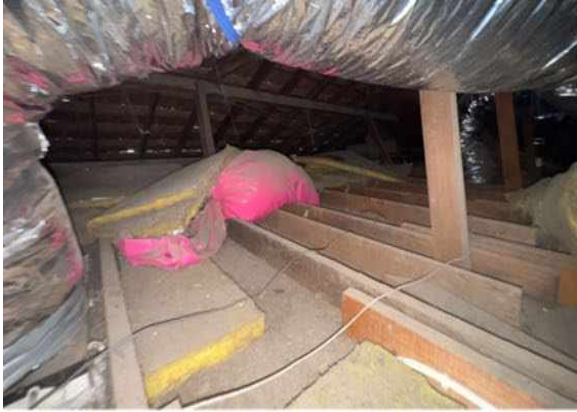
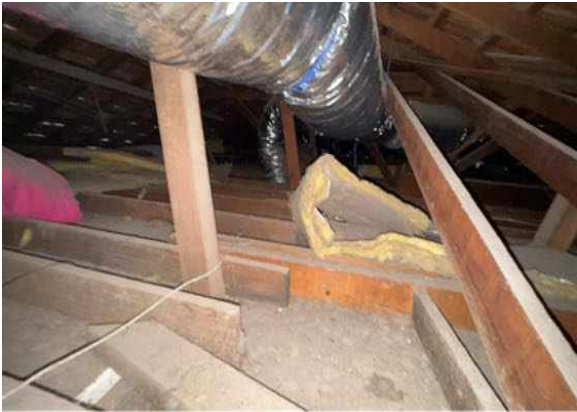
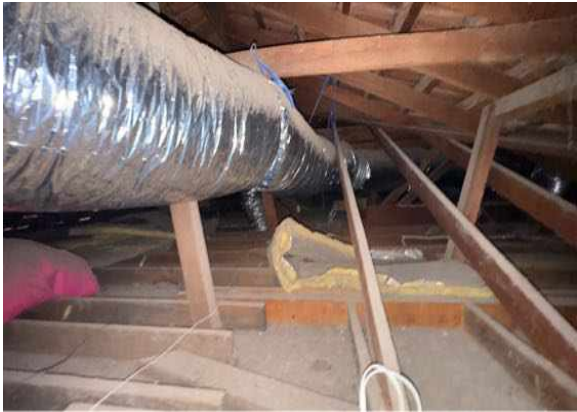
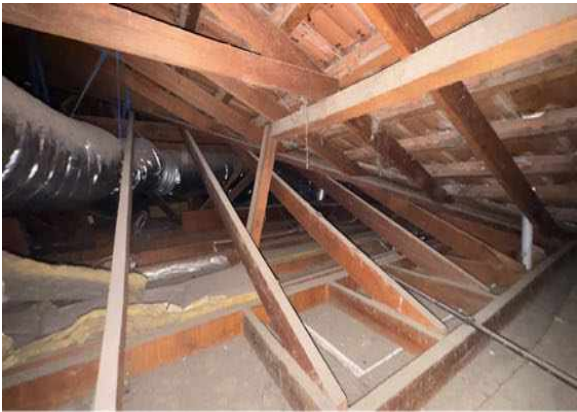
Finding 3.07

Building:	Main Building
Location:	Roof Void >
Finding:	Roof Void - Inadequate Insulation Installation
Information:	Insulation in the roof void was found to be unevenly installed, with gaps, inconsistent coverage, and some displaced sections. This reduces its effectiveness in maintaining thermal efficiency.

The issue may result from poor workmanship during installation or movement of insulation after installation. If not corrected, the reduced insulation can increase heating and cooling costs and may create cold spots that lead to localized condensation or moisture issues.

A qualified insulation installer should be engaged promptly to assess the roof void and reposition or add insulation as needed to ensure full, even coverage without compression. Regular monitoring is recommended to maintain thermal performance.

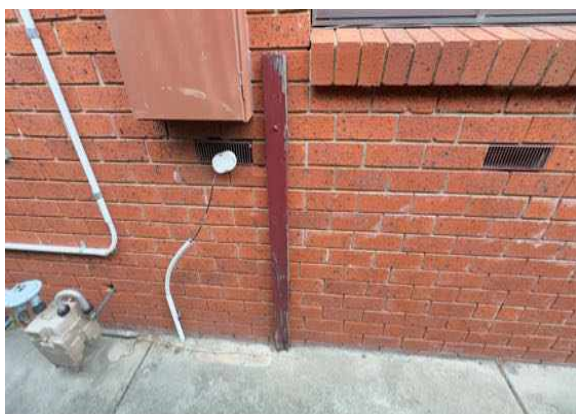
Building:	Main Building
Location:	All External Areas
Finding:	External Timber - Timber Rot
Information:	Timber elements including wall claddings, timber rails & posts, landscaping timbers, and other external timber surfaces were inspected and show signs of rot, decay and fungal attack in these areas. Softening, discoloration, splitting, and moisture penetration indicate ongoing timber degradation.

This is likely caused by prolonged moisture exposure, inadequate protective coatings or maintenance, direct contact with soil or water, or poor detailing that traps water or limits ventilation.

If left unaddressed, the affected timber may lose structural integrity, leading to progressive decay, potential collapse of walls, decks, or landscaping features, mould growth, and reduced durability and appearance of the building exterior.

A registered builder or timber specialist should inspect the affected areas immediately to determine the extent of damage. Damaged timbers should be repaired or replaced, protective treatments applied, and drainage or detailing corrected to prevent recurrence. Ongoing monitoring and urgent remedial action are required to prevent further deterioration.

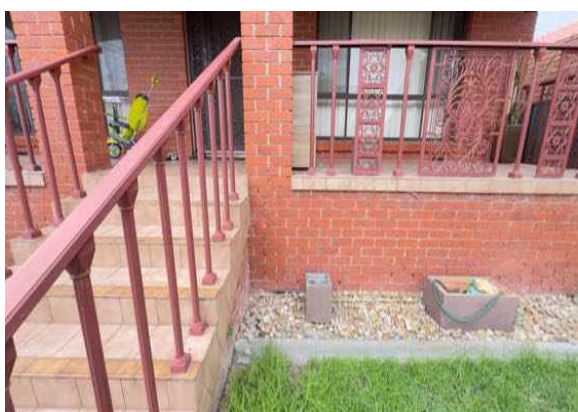
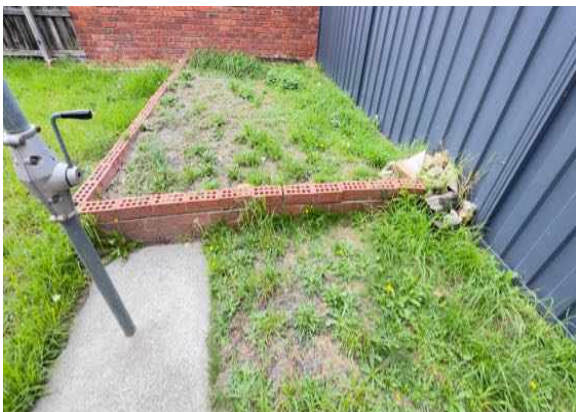
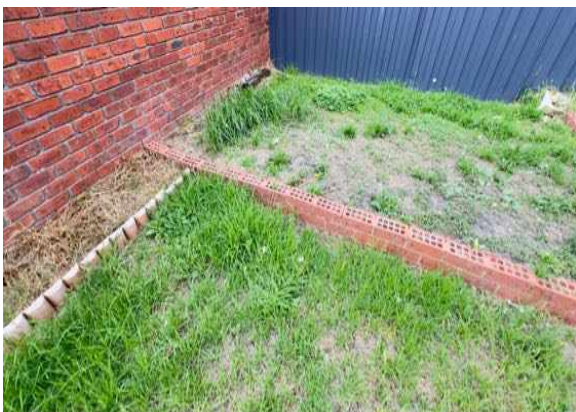
Finding 3.10

Building: Main Building
Location: All External Areas >
Finding: Brickwork - Minor Cracking
Information: Minor cracking was observed in the brickwork in this area. Hairline cracks are commonly cosmetic in nature; however, the presence of wider or stepped cracks, displaced bricks, or delaminated render may indicate structural movement or water ingress.

Possible contributing factors include normal thermal expansion and contraction, minor foundation settlement, structural movement, moisture penetration, impact damage, or workmanship-related issues.

*Note: No elevated moisture levels were detected at the time of inspection.

The brickwork in this area should be monitored, and if cracks widen or additional movement occurs, a structural engineer should be engaged immediately to assess the condition and advise on any required remedial works. Cosmetic hairline cracking can be repaired by a registered builder or qualified bricklayer to improve appearance and maintain weatherproofing.

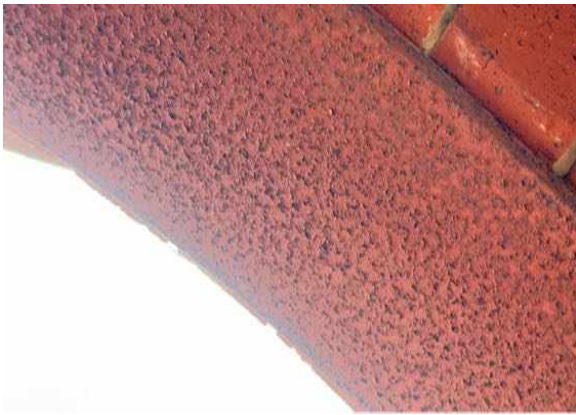
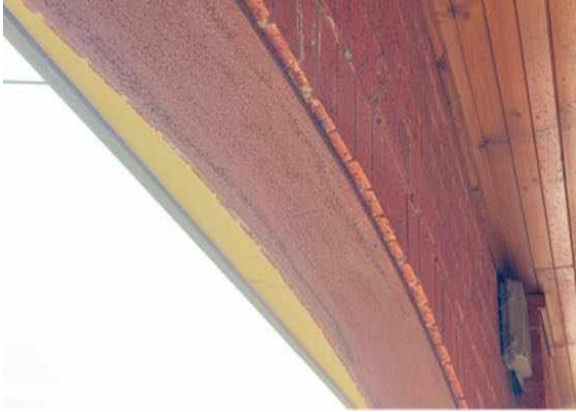
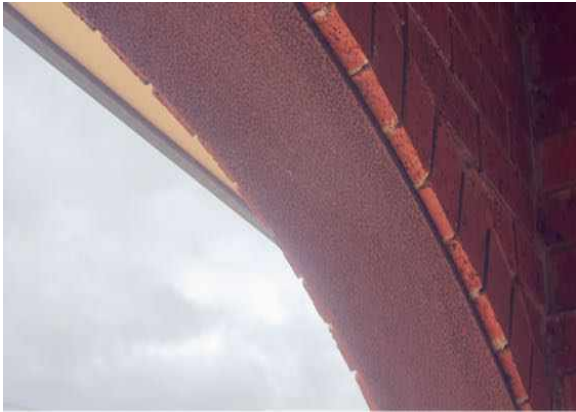
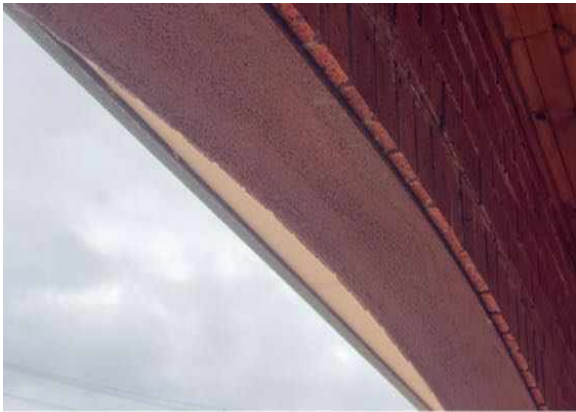
Finding 3.11

Building:	Main Building
Location:	All External Areas >
Finding:	Building element - Rusted or corroded
Information:	This building element shows evidence of rusting and corrosion, which is likely to have developed as a result of excessive exposure to moisture and or inadequate coatings.

As surface rust provides no protection to the underlying iron, the deteriorating condition is likely to worsen if not addressed in the short-term future.

Where possible, the use of galvanized (treated) metals or aluminium coated metals aid in rust prevention, as does regular general maintenance. Rust formation can be controlled with coatings, such as paint, that isolate the iron from the environment.

Rusting and corrosion should be managed by ideally removing or limiting the affected surface from exposure to moisture. A registered builder may be appointed to replace any building elements that have been severely affected by rust or water damage.

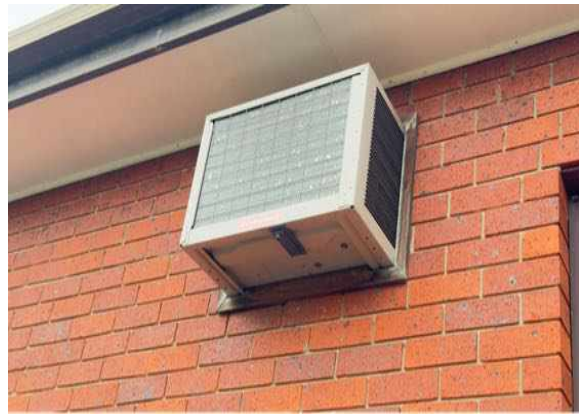
When condensate is not properly directed to a stormwater outlet, water can accumulate around the building or air conditioning unit, creating damp conditions that may lead to secondary defects such as timber rot, corrosion of nearby metal components, mould growth, or slippery surfaces. Prolonged pooling of water may also attract termites and contribute to long-term deterioration of surrounding building elements.

A qualified HVAC technician or licensed plumber should be engaged immediately to connect the condensate drain to a suitable stormwater outlet. Prompt rectification will ensure proper drainage, protect the building fabric, and reduce potential health and safety risks.

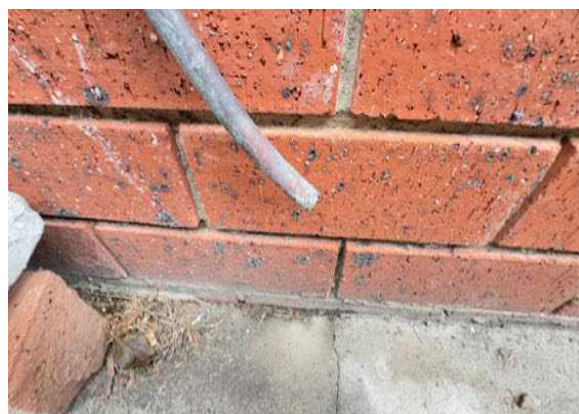
Finding 3.14

Building:	Main Building
Location:	All External Areas >
Finding:	HWS - (T&P) Valve Not Connected To Storm Water
Information:	The Hot Water System (HWS) Temperature & Pressure Relief (T&P) valve discharge pipe was observed to be disconnected from stormwater drainage.

When not properly connected, discharged water can create damp conditions around the HWS, potentially leading to secondary defects such as timber rot, corrosion of nearby metal components, mould growth, or slip hazards. Prolonged exposure to moisture in this area may also attract termite activity and contribute to long-term deterioration of surrounding building elements.

A licensed plumber should be engaged immediately to connect the T&P discharge pipe to a suitable stormwater outlet or floor waste. Prompt rectification will ensure safe operation of the HWS, protect surrounding structures, and reduce potential health and safety risks.

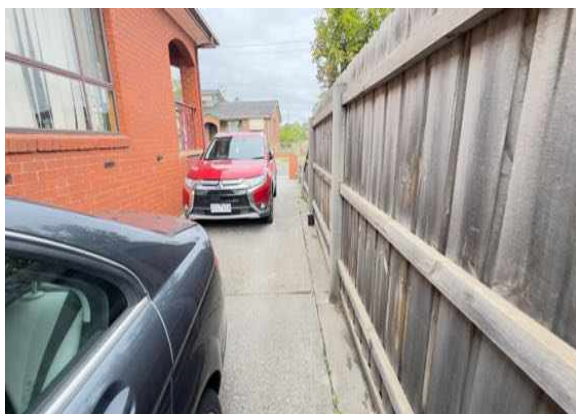
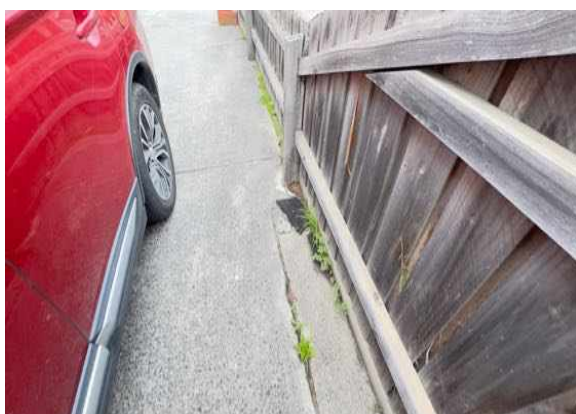
Finding 3.15

Building:	Main Building
Location:	Fencing All Areas

When practical, a qualified carpenter or fencing specialist should be engaged to repair or replace affected sections, and a qualified painter should be engaged to restore protective finishes. Prompt rectification will maintain structural performance, improve appearance, and extend the lifespan of the fencing.

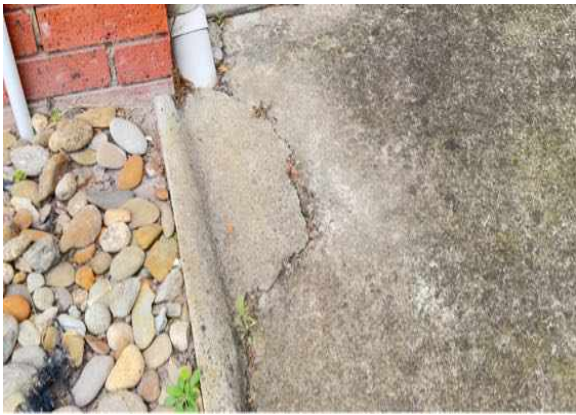
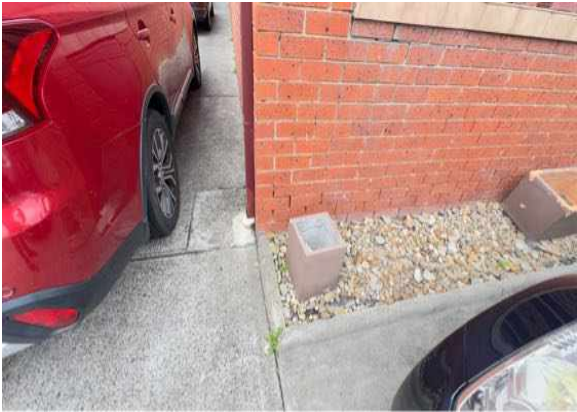
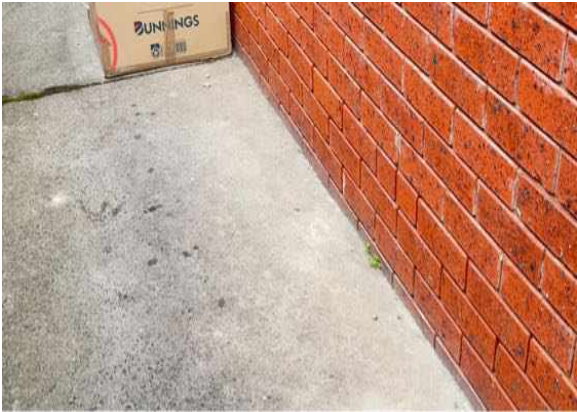
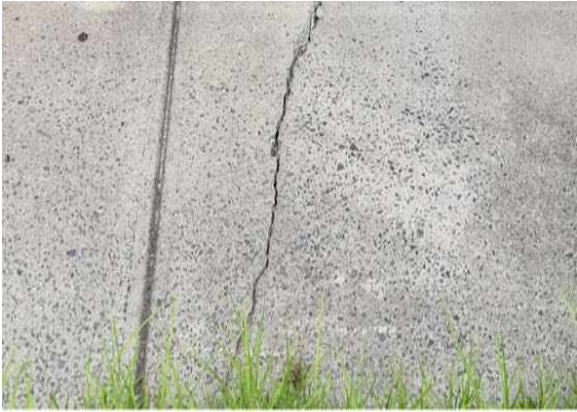
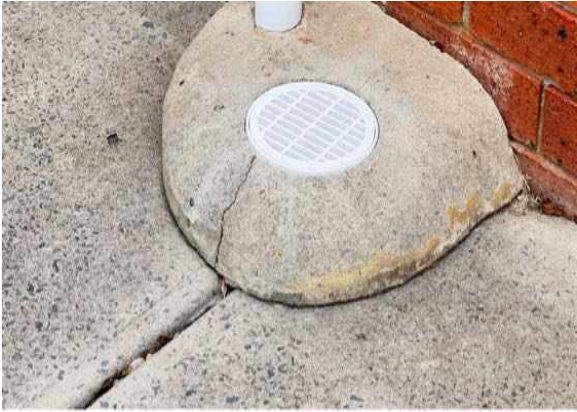
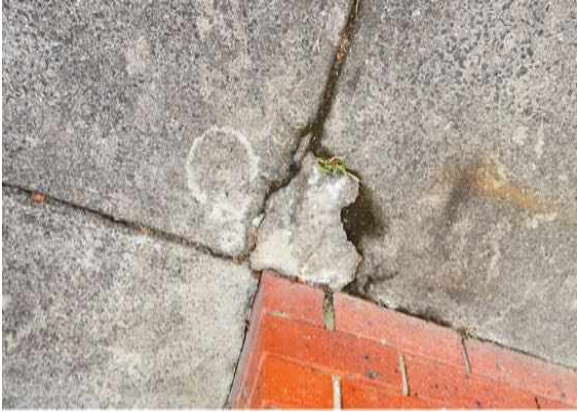
Finding 3.16

Building:	Main Building
Location:	All External Areas >
Finding:	Paving - Minor Cracking
Information:	The external paved areas were visually inspected. Minor cracking, uneven surfaces, and general wear were observed in this area. These defects do not currently affect structural safety but may reduce durability, appearance, and safe pedestrian access.

This may be caused by age-related deterioration of concrete, pavers, or other materials, soil movement or settlement beneath paved surfaces, tree root intrusion or erosion, or inadequate original installation or sub-base compaction.

A qualified landscaper should be engaged as soon as possible to repair or resurface sections as required. Rectification will restore even surfaces, reduce trip hazards, and improve the serviceability and appearance of the paved areas.

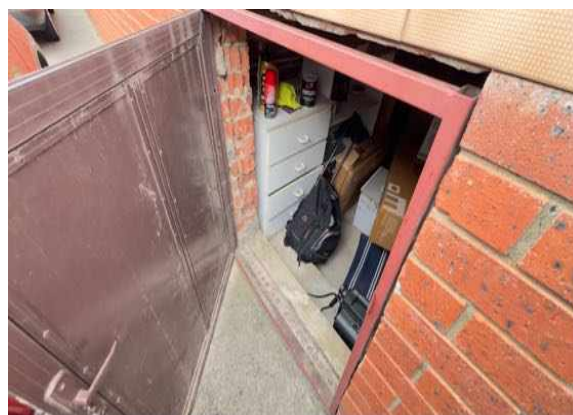
This has likely occurred due to accumulation of materials over time or inadequate cleaning. Excess items can conceal defects, restrict inspections and maintenance, increase pest activity, and create fire or safety hazards.

This observation is provided for information only. When practical, a competent handyman should be engaged to remove all rubbish and clear access to ensure safe inspection, maintenance, and ongoing monitoring of the subfloor.

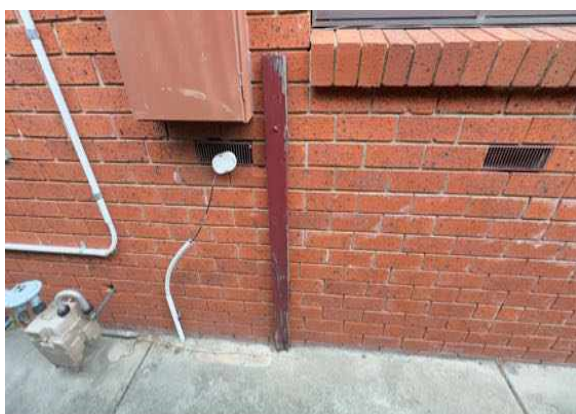
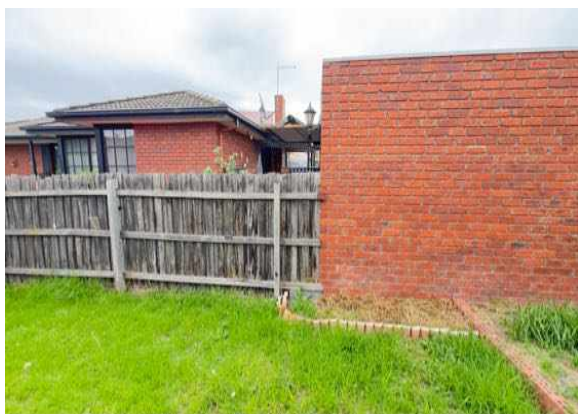
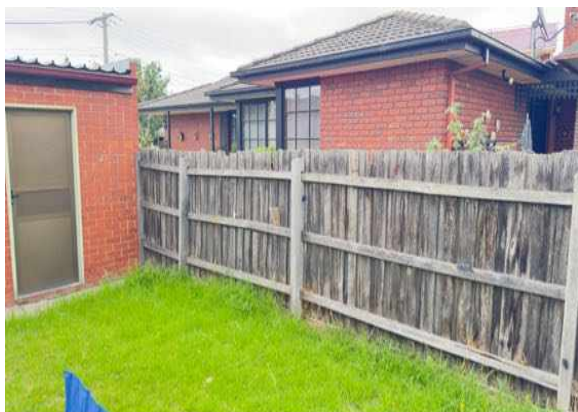
If left unaddressed, the affected timber may lose structural integrity, leading to progressive decay, potential collapse of walls, decks, or landscaping features, mould growth, and reduced durability and appearance of the building exterior.

A registered builder or timber specialist should inspect the affected areas immediately to determine the extent of damage. Damaged timbers should be repaired or replaced, protective treatments applied, and drainage or detailing corrected to prevent recurrence. Ongoing monitoring and urgent remedial action are required to prevent further deterioration.
