Building and Timber Pest Inspection Report

Inspection Date: Wed, 14 Jan 2026

Property Address: 10 Warwick Cl, Blaxland NSW 2774,
Australia

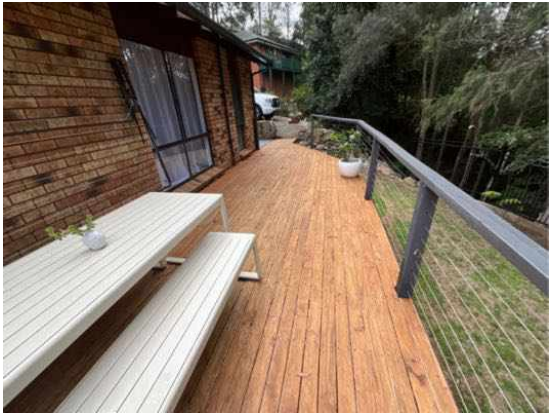
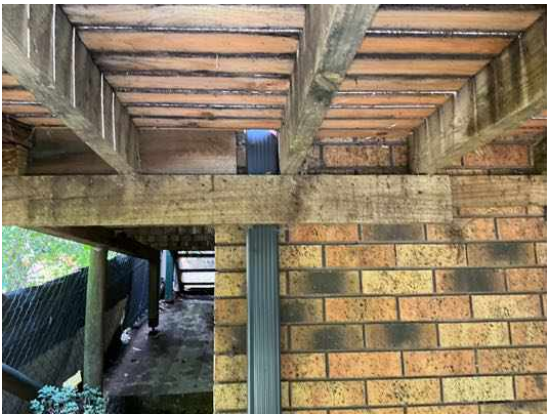
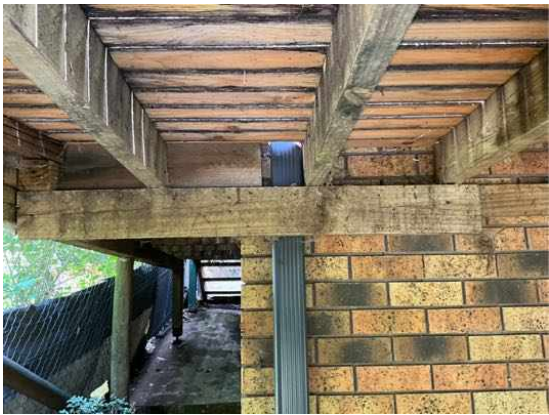
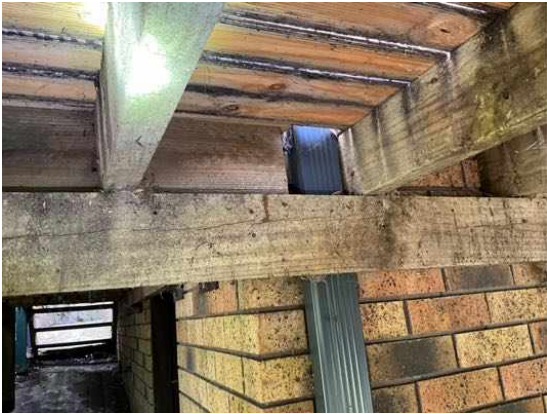
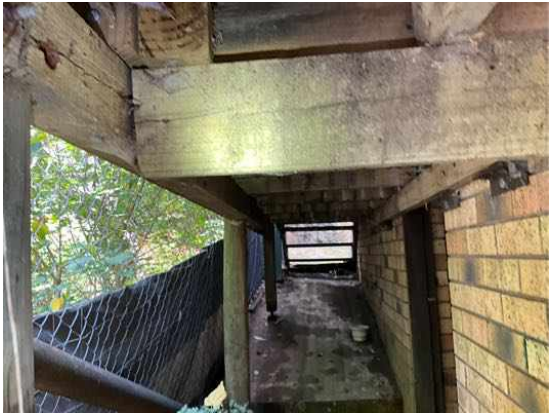
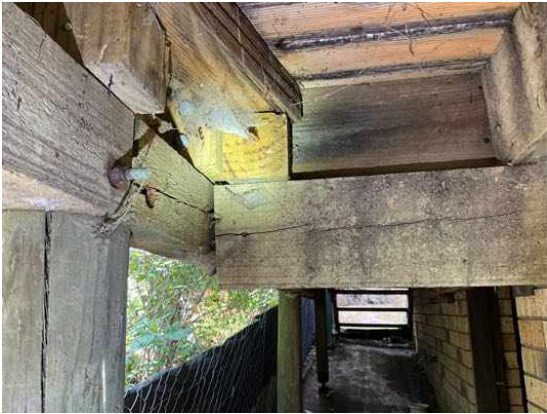
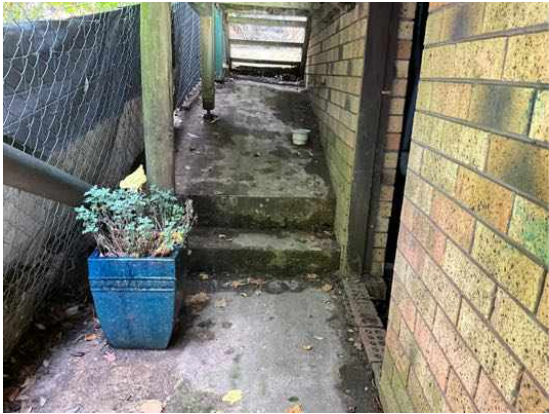
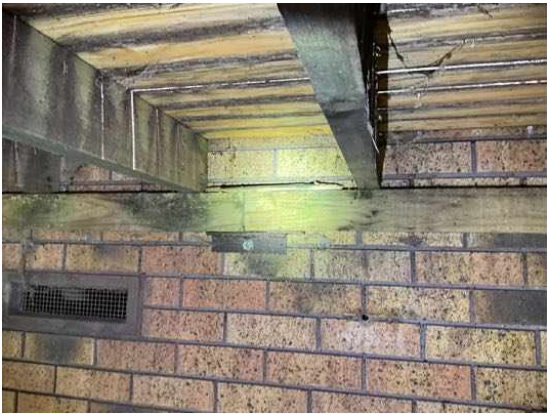
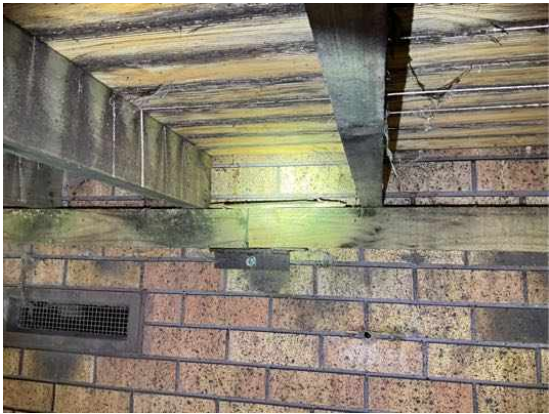
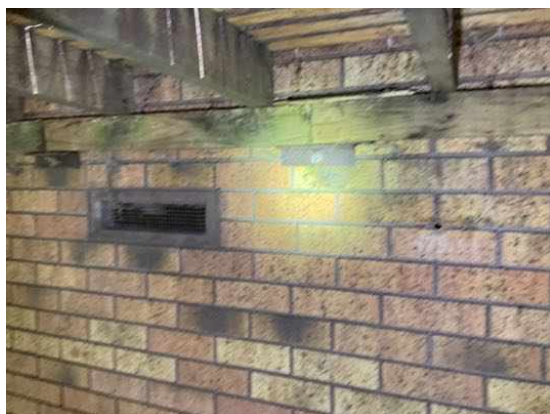
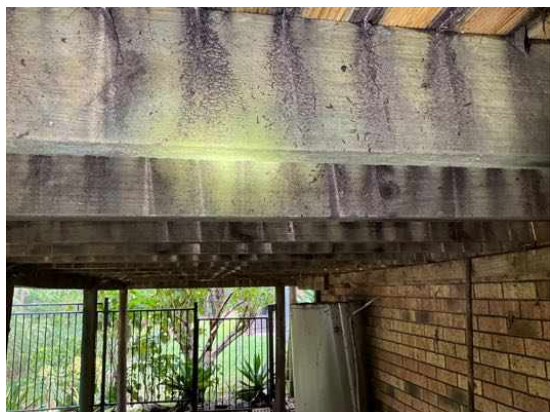
External timber structures are also constantly exposed to weather deteriorates in an exhilarate manner, ongoing assessments are required.

It is highly recommended that a structural engineer further, assess the external timber balcony or a deck to inform the client of its load capacity.

Regular maintenance inspections by competent practitioners is needed.

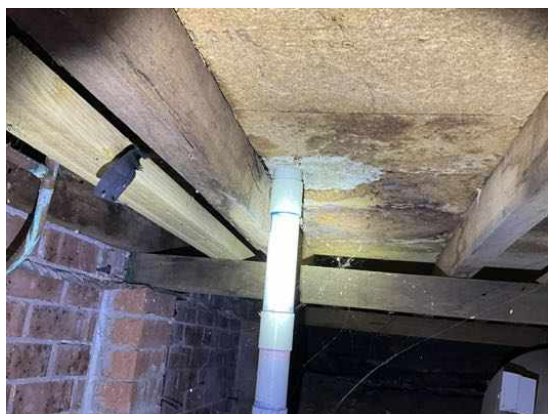
Finding 2.01

Building:	Main Building
Location:	Subfloor
Finding:	Subfloor- leaking plumbing fittings
Information:	Evidence of leaking plumbing fittings was observed within the subfloor area. Moisture staining and timber deterioration suggest prolonged water exposure from faulty pipe joints or fixtures.
Risk:	<ul style="list-style-type: none"> • Structural damage to timber framing and flooring due to continuous moisture exposure. • Mould growth and decay, posing potential health risks and further degradation of building materials. • Pest attraction, as damp environments are conducive to termites and other pests. • Non-compliance with plumbing standards and risk of escalation if not addressed promptly.

- A licensed plumber should be engaged to identify the exact source of leakage, repair or replace faulty fittings, and confirm watertight integrity. A builder may also be required to assess and rectify any structural damage.

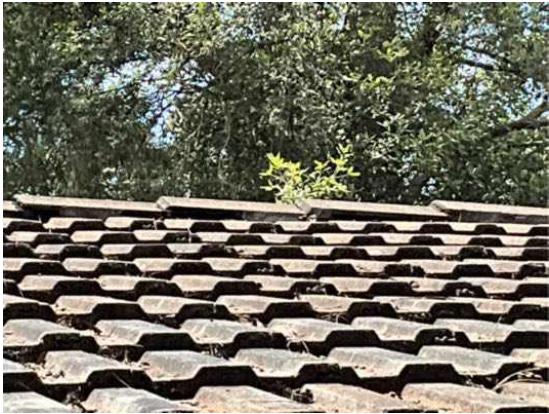
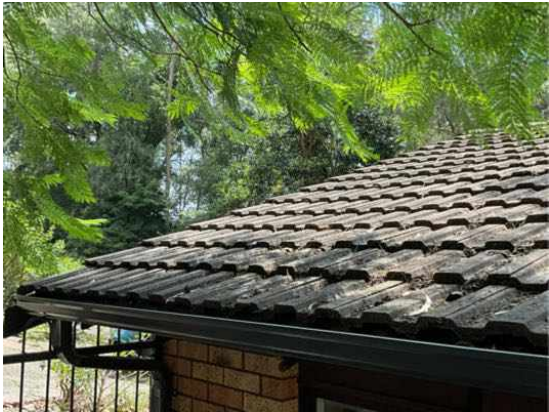
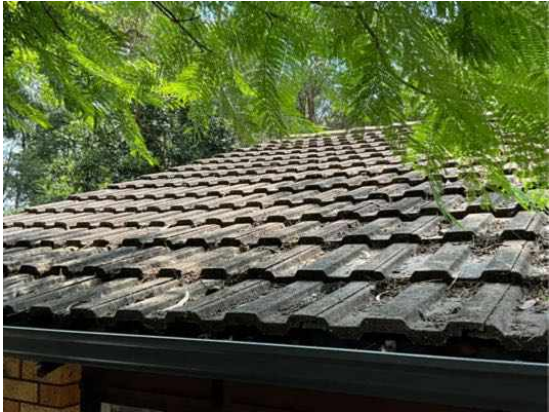
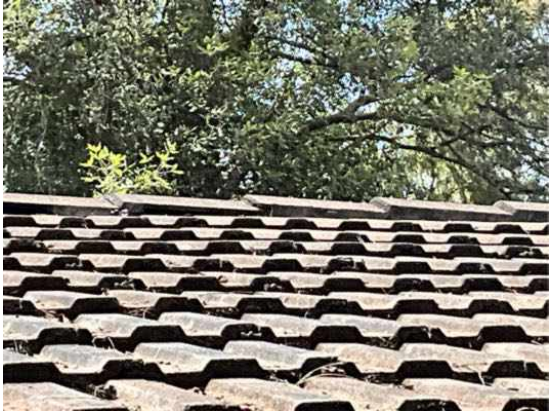
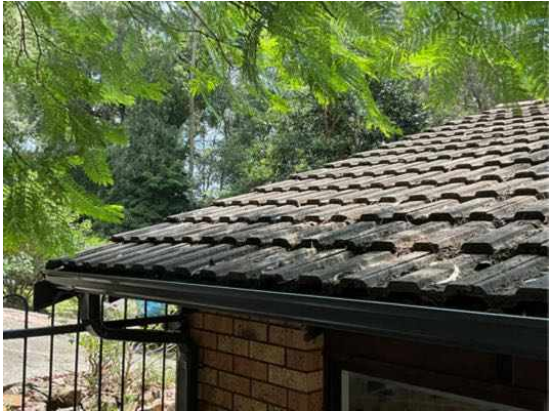
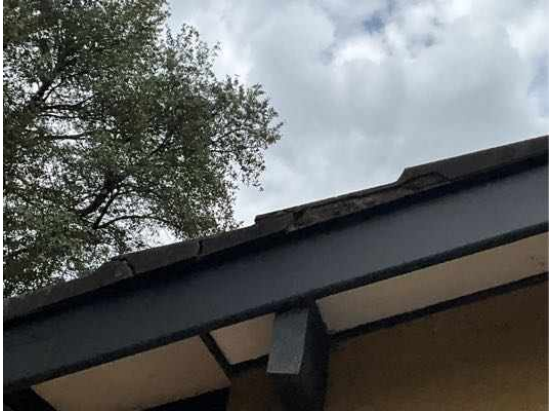
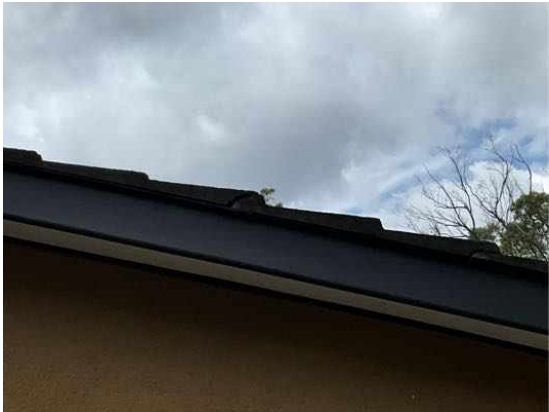
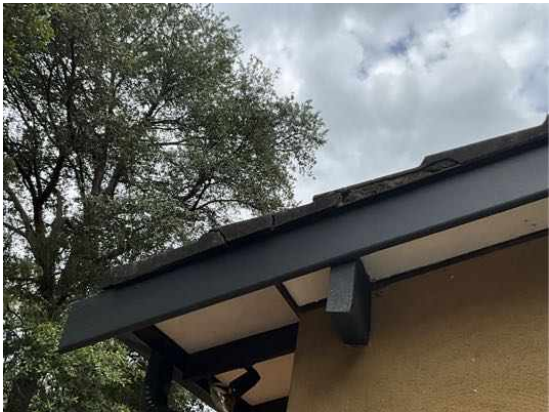
Finding 3.01

Building:	Main Building
Location:	All Areas
Finding:	Roof Weathered
Information:	Upon inspection of the exterior roofing, the majority of roof was not in a fair condition. While weathering of the roof is consistent with the age of the property, maintenance works are required.

Isolated areas of mortar have come loose in the valleys and minor cracking is also present. Re-pointing and re-sealing the may be considered as an interim solution by the client to help preserve and extend the life span of the tiles.

Where left unmanaged, deteriorating roof are likely to lead to a number of secondary defects, including minor water leaks and weather exposure to internal roofing structures.

Consultation with a roofing contractor is highly advised to gain advice on cost of remedial works that may be required in the short to medium term. Remedial works are likely to increase the longevity of the exterior roofing structure.

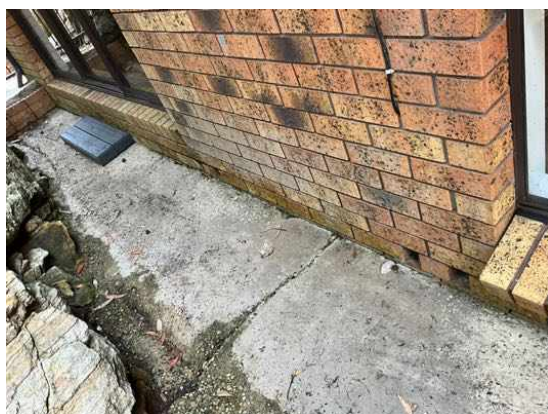
Building: Main Building
Location: All Areas
Finding: Perimeter Paving - Insufficient Fall
Information: The perimeter paving or ground levels were found to have an inadequate slope away from the adjoining building structure, creating potential for water pooling in this area.

Perimeter paving is required to fall from the building by a minimum of 25mm in the first metre and bare ground should fall away from the house by 50mm in the first meter. This standard ensures that excessive moisture does not pool around the base of building structures, which creates potential for water and structural damage, as well as making the area susceptible to termite and timber pest activity.

Where paving or ground levels do not have adequate fall, a licensed paving contractor should be appointed to install or remove and re-level pavement.

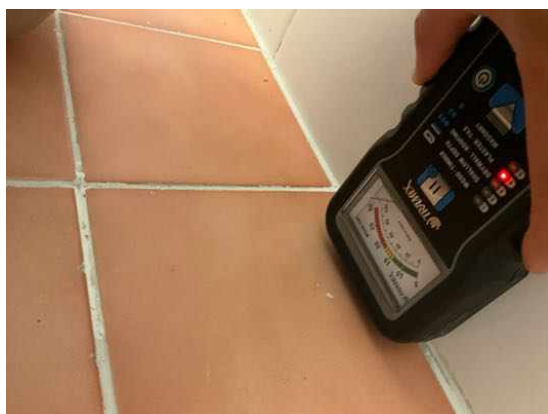
Building:	Main Building
Location:	Ensuite
Finding:	Shower - Damp
Information:	Damp is evident to the lower 300mm of wall to the shower alcove. This defect is quite common, and is suspected to have been caused by moisture permeating through the grouting in this area, which shows evidence of deterioration. Leaking pipes within the adjoining wall is also a possible cause.

Damp (or structural damp) refers to the presence of unwanted moisture in the structure of a building, either as the result of intrusion from outside, or condensation from within the structure. In the shower area, internal water leaks or other sources of excessive moisture are generally the cause of damp.

Unmanaged damp in the shower recess is likely to facilitate the formation and development of mould and fungi growth, decaying associated building materials and compromising their structural integrity. It is important to address damp conditions, as the World Health Organisation notes that excess moisture leads - on almost all indoor materials - to growth of microbes such as moulds, fungi and bacteria, which subsequently emit spores and other matter into the indoor air. Exposure to these contaminants is associated with a wide range of respiratory and other health-related problems.

Consultation with a qualified plumber or bathroom specialist is advised immediately to identify the cause of damp and to perform remedial works as required. Where excessive mould growth is present, further inspection by a specialist environmental health inspector should also be considered.

Always ensure that sealant and grout is in good condition to prevent any moisture issues occurring in the future.

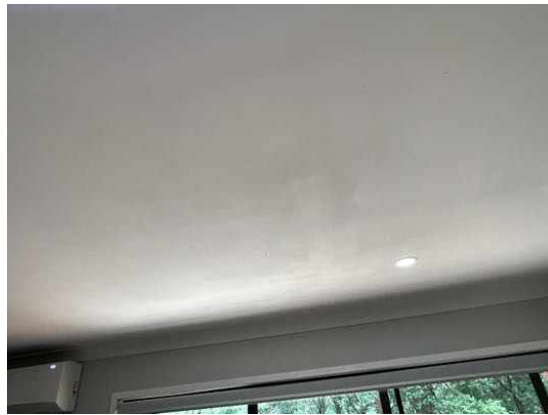
Building:	Main Building
Location:	All Areas
Finding:	Paint - Substandard
Information:	Areas were identified where the surface finish of the painting is substandard and this is considered a defect.

Any irregularity in the surface which is visible from a normal viewing position is considered a defect. Marks may also be a result of fault by other tradespeople throughout the construction process.

Defective surface finish of paintwork is marked with an arrow to the below photos in the following locations.

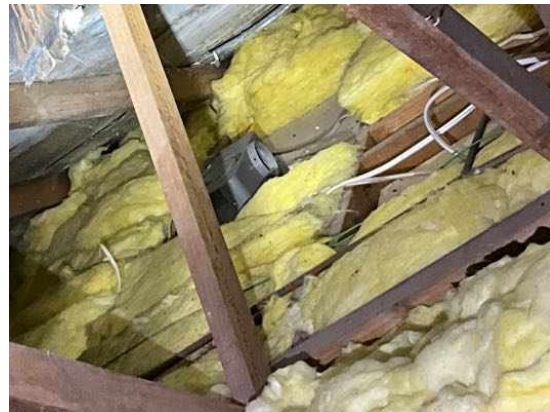
Finding 3.20

Building:	Main Building
Location:	Roof Void
Finding:	Exhaust fan not vented out
Information:	The exhaust fan located within the roof void is not appropriately ducted to the external atmosphere and is currently discharging moist air directly into the roof space. This is considered a defect under AS 4349.1, as it does not meet the minimum standard of residential building performance expected under normal residential building practices.
Risk Implication:	This condition may lead to excessive condensation within the roof void, increasing the

It is recommended that the exhaust fan be modified by a licensed HVAC contractor or qualified builder, ensuring it is properly ducted to discharge externally in accordance with manufacturer specifications, the National Construction Code (NCC), and applicable Australian Standards.

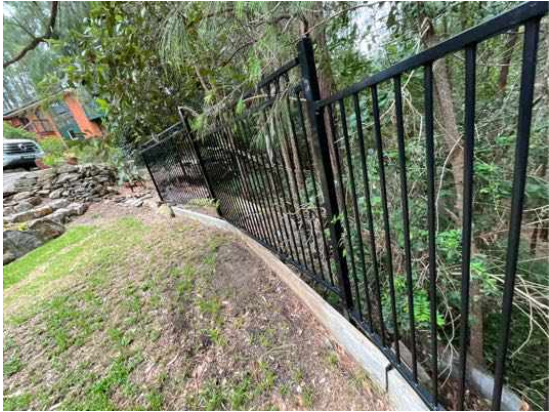
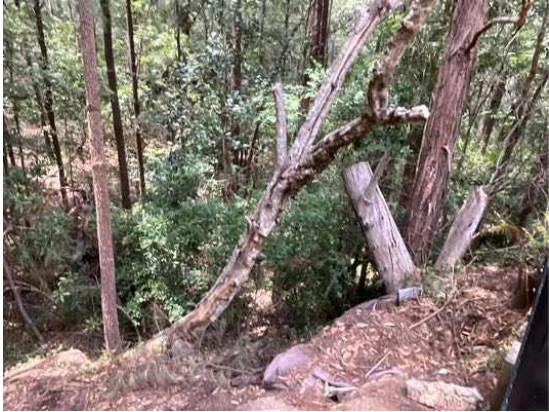
Finding 6.01

Building:	Main Building
Location:	All Areas
Finding:	Dense vegetation around a property can increase the risk of termite infestation
Information:	The presence of dense vegetation around a property can increase the risk of termite infestation, as it provides a conducive environment for them. To address this, consider maintaining a clear space between the vegetation and your home. If you suspect a termite issue, it's advisable to consult with a licensed pest control professional for inspection and treatment.

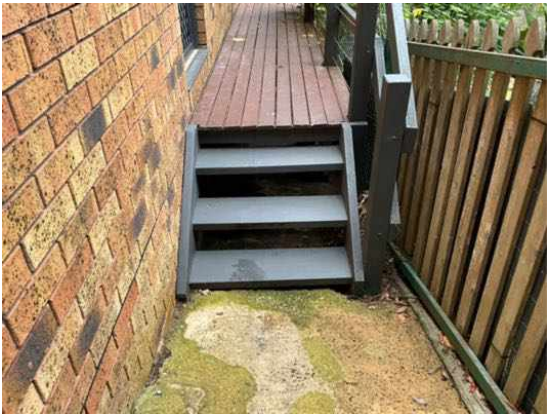
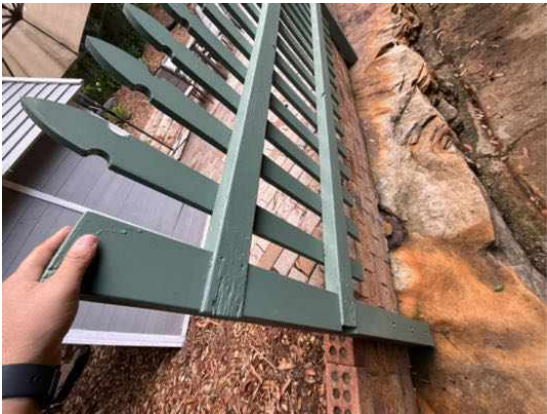
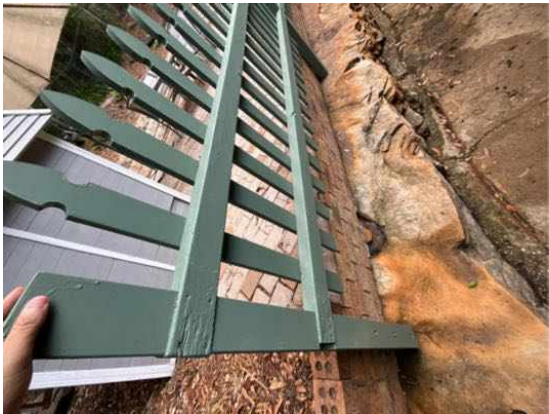
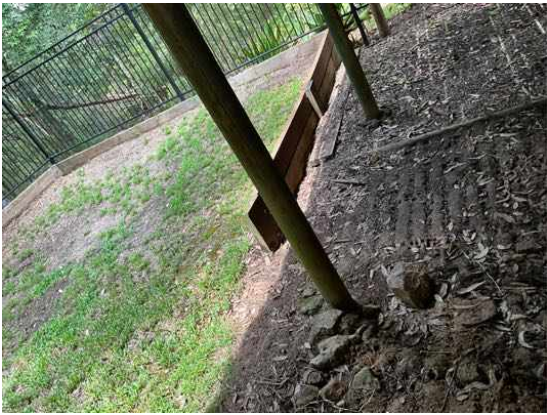
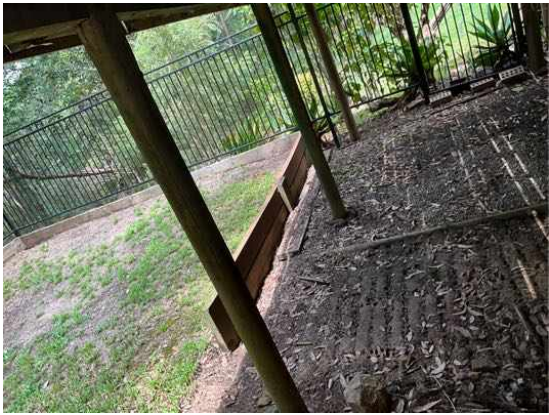
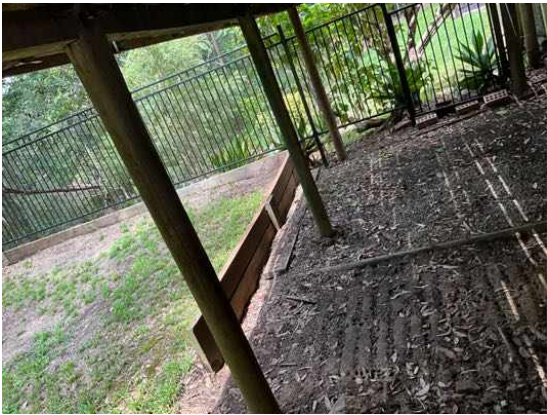
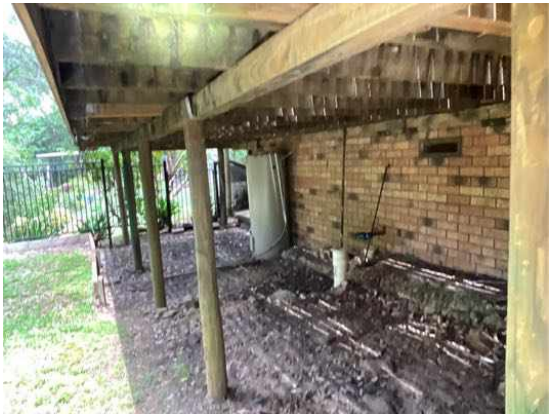
Finding 6.02

Building: Main Building
 Location: All Areas
 Finding: Timber on ground / conducive conditions to termite damage
 Information: Timber on the ground is indeed conducive to termite damage. Termites are known to thrive in moist environments, and wood in contact with soil or moisture is more susceptible to infestation.

To prevent this, it's important to keep timber elevated and away from direct ground contact. Regular inspections and proper termite control measures are also essential to protect your wooden structures from termite damage.

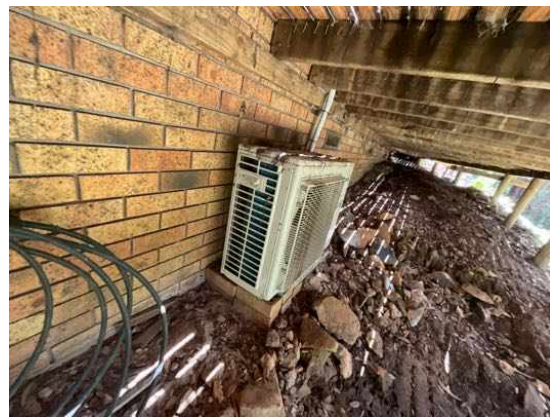
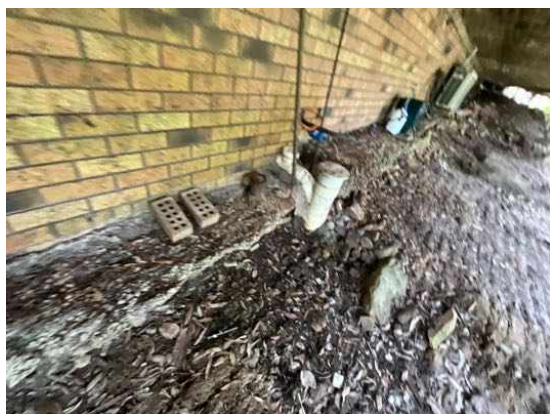
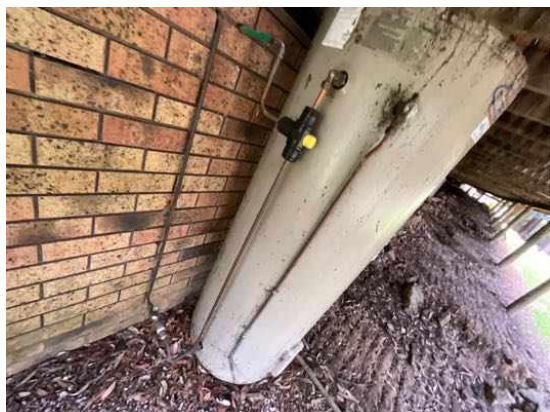
Finding 6.03

Building: Main Building
Location: Under Deck
Finding: Bridging or Obstruction Conducive environment for Termites
Information: Bridging of termite barriers occurs when termites bridge (usually by building a mud tunnel) a termite barrier or inspection inspection zone or where termites have a passage, allowing them to bridge the barrier.

Where bridging has occurred full inspection is prevented and termites may enter a property in a concealed or undetected manner.

Recommended moving obstructions away from the external walls for further and future inspections.

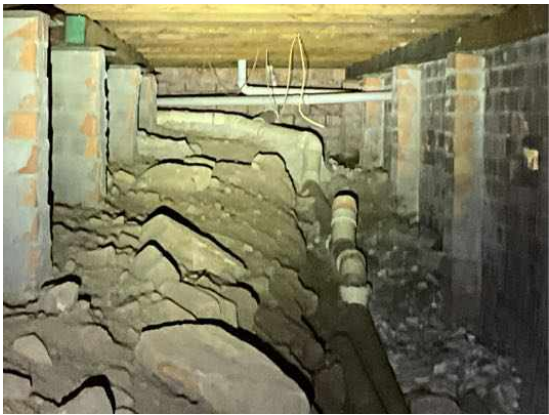
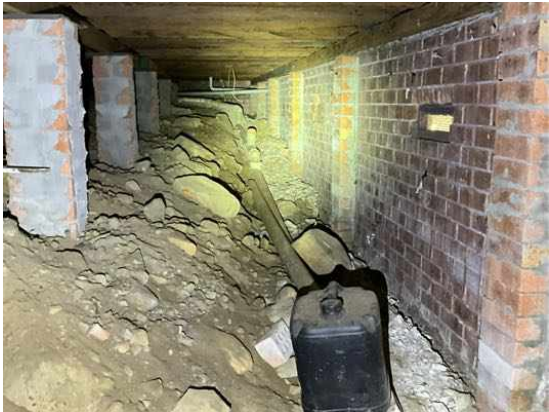
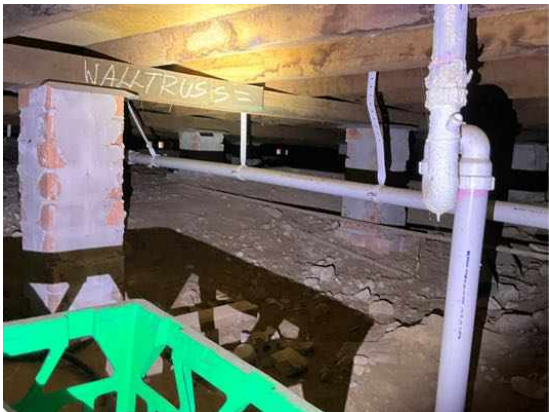
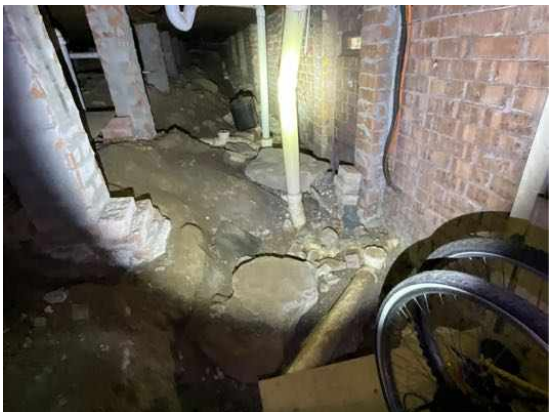
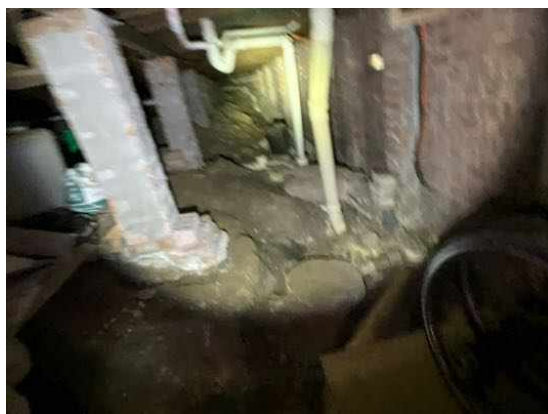
Risk: The combination of poor ventilation, inadequate drainage, water stains significantly increases the risk of timber pest infestations. Termites are attracted to moist environments and can thrive in subfloors with high humidity levels and water damage. The lack of proper ventilation and drainage exacerbates moisture retention, providing an ideal habitat for timber pests to establish colonies and cause extensive damage to the subfloor structure. Additionally, water stains indicate previous or ongoing moisture issues, which further attract timber pests and contribute to the deterioration of timber materials.

A licensed pest control professional specializing in timber pest management should be consulted to assess the extent of the infestation and develop a comprehensive treatment plan. They can implement strategies to eliminate existing timber pests, such as termites and prevent future infestations by addressing underlying moisture issues. Additionally, a qualified plumber or builder may be needed to improve subfloor ventilation, enhance site drainage, repair water-damaged areas. Regular inspections and maintenance are essential to ensure ongoing protection against timber pests and maintain the structural integrity of the subfloor.

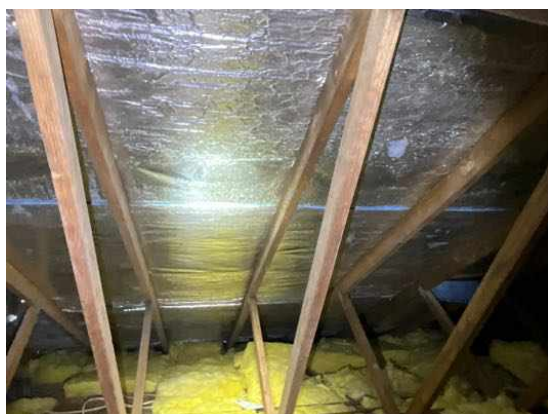
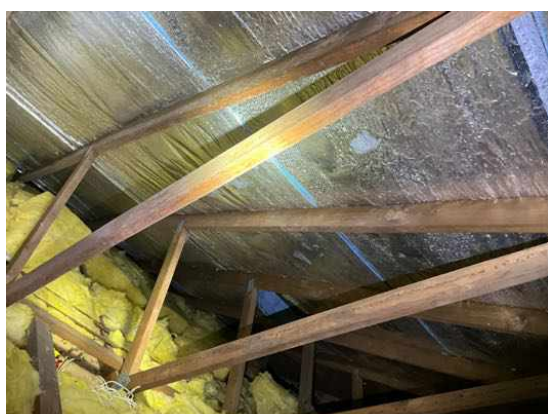
Finding 6.10

Building:	Main Building
Location:	Roof Void
Finding:	Roof void exhibits conspicuous signs of excessive moisture
Information:	The roof void exhibits conspicuous signs of excessive moisture, evident through water staining within the sarking material.

Risk in Terms of Timber Pest: The excessive moisture within the roof void poses a significant risk for timber pests such as termites, as it creates an ideal environment for infestation and proliferation. The damp conditions promote wood decay, making the structure susceptible to damage by these pests.

A qualified roofing contractor and a professional pest control service specialized in timber pest management should be engaged to rectify the issue. They can assess the extent of moisture damage, address any underlying structural issues, and implement effective solutions to mitigate the risk of timber pest infestation.

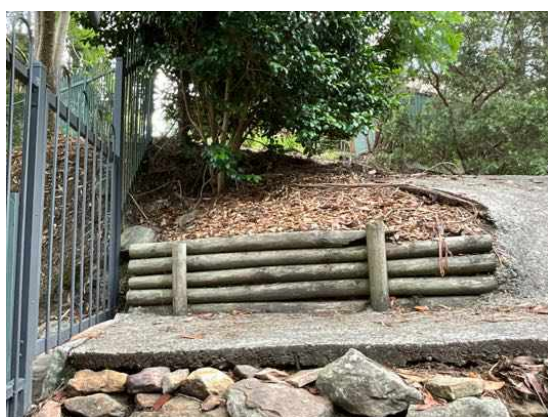
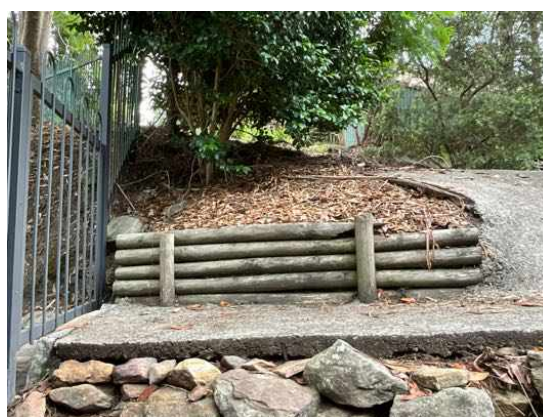
Finding 7.01

Early intervention and regular maintenance, particularly of exterior timbers, will prolong the useful life of these building elements. Prior to any works being performed, the cause of the moisture that has created the visible wood rot should be identified and addressed in a suitable manner. Replacement of affected timbers may then be a necessary step in protecting surrounding building elements from such deterioration.

A qualified plumber may be appointed to assess the cause of excessive moisture and to provide advice on any remedial works as required. A qualified carpenter or registered builder may also be required to replace affected building materials.
