Building Inspection Report

Inspection Date: Tue, 17 Feb 2026

Property Address: 13/54-55 Park Avenue, Kingswood NSW
2747

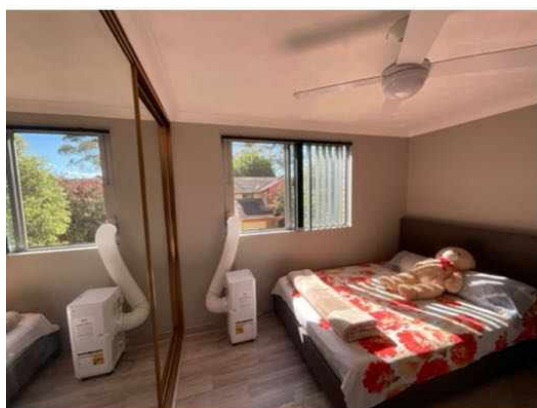
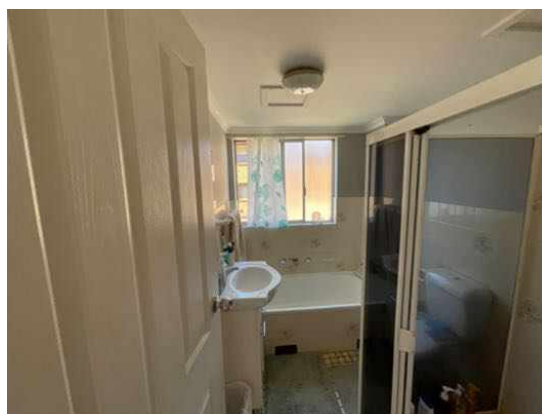
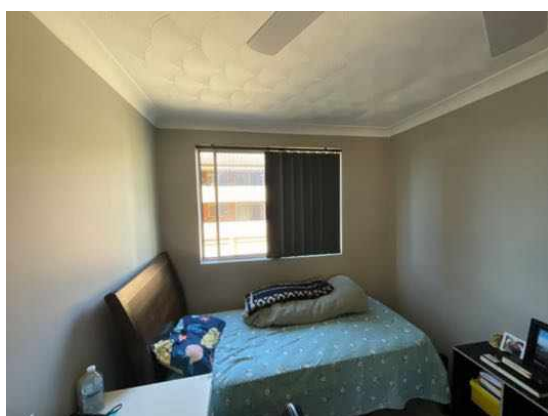
Defects 1.01

Building: Main Building
 Location: All Areas
 Finding: Safety Hazard – Missing / Non-Compliant Window Restriction Devices (Apartment Building)

It was noted at the time of inspection that window restriction devices were either missing, inoperative, or not installed to the affected windows within the apartment. This comment is raised as a cautionary safety item.

Given that this is an apartment building, responsibility for installation and compliance may fall under strata management depending on whether the windows are classified as common property or part of the lot. Failure to address this issue may expose the owners corporation and/or lot owner to safety and liability risks.

It is strongly recommended that compliant window restriction devices or approved safety screens be installed to affected windows in accordance with the National Construction Code and relevant state-based safety requirements for openable windows in residential buildings.

A qualified window specialist or licensed contractor should be engaged to assess all applicable windows and install compliant restrictors as required. The strata manager or owners corporation should be consulted to clarify responsibility and coordinate rectification where the windows form part of common property.

Prompt action is advised to mitigate the identified fall risk and ensure occupant safety.

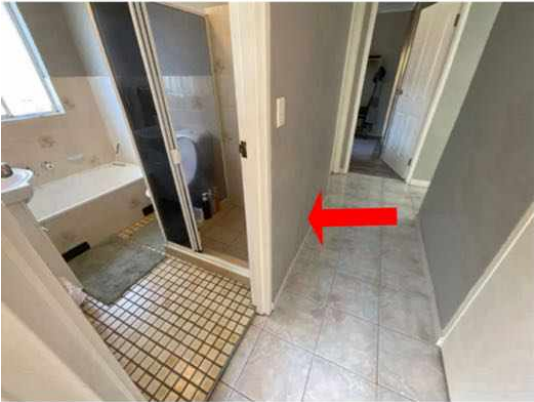
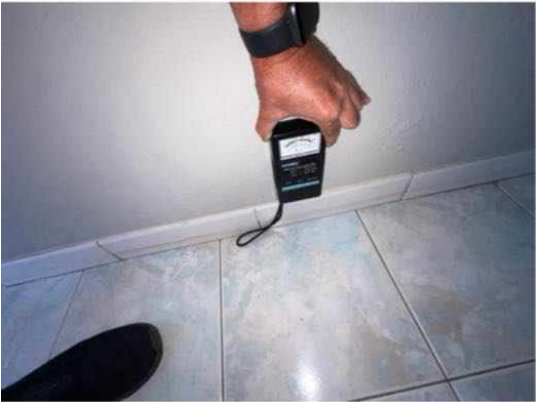
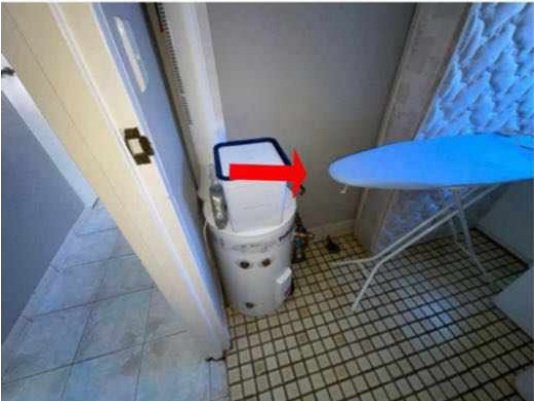
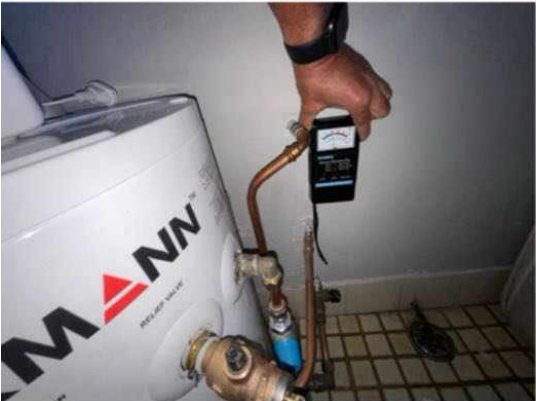
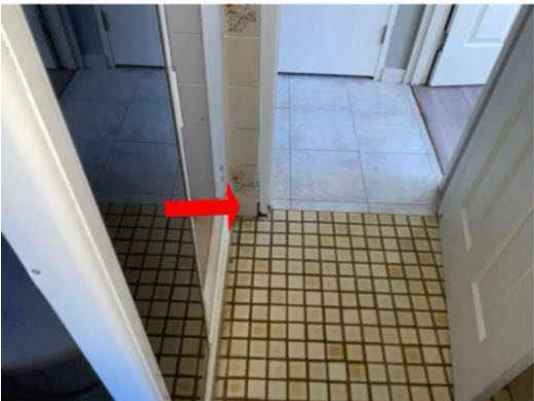
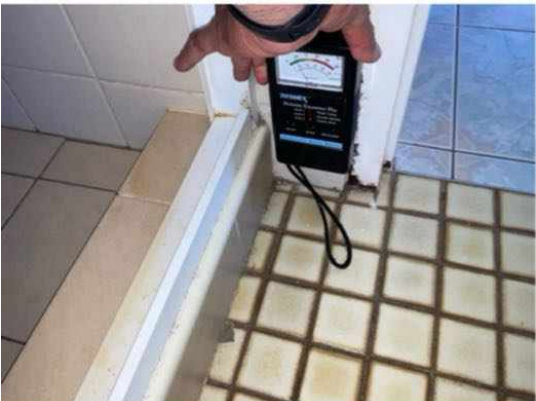
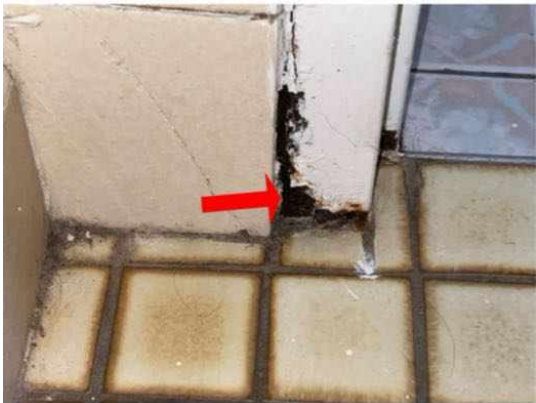
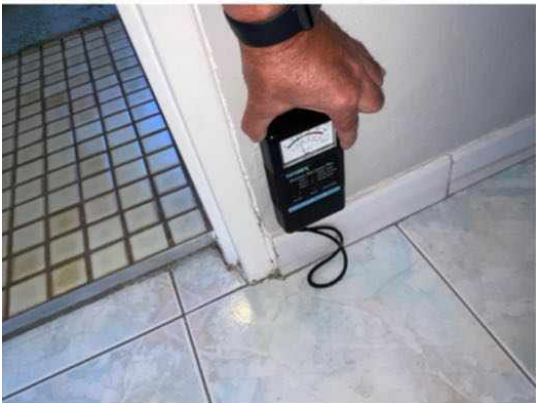
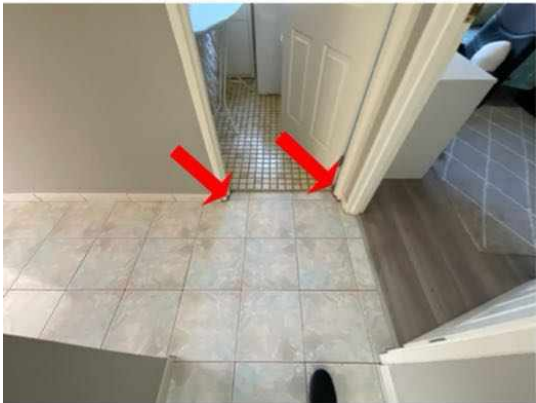
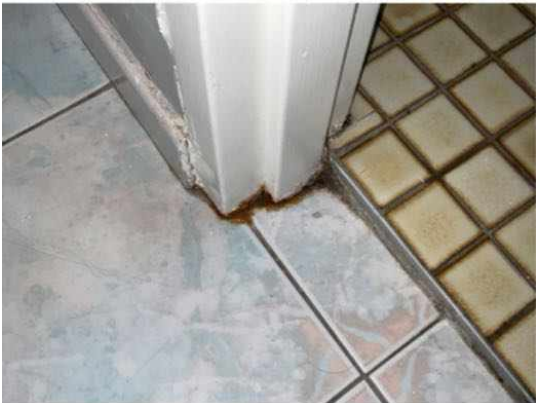
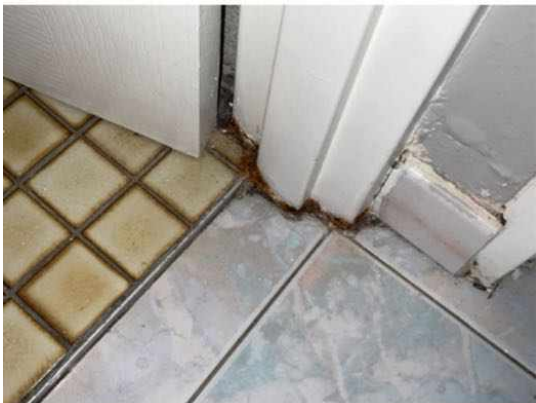
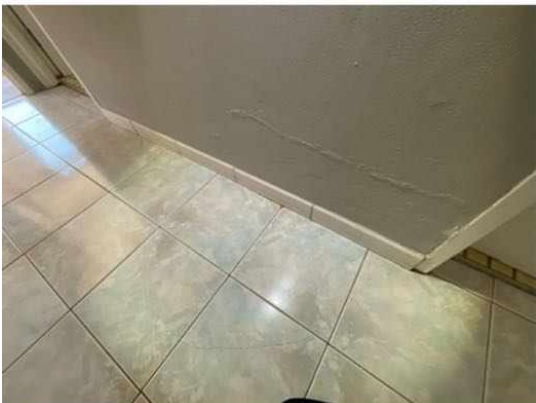
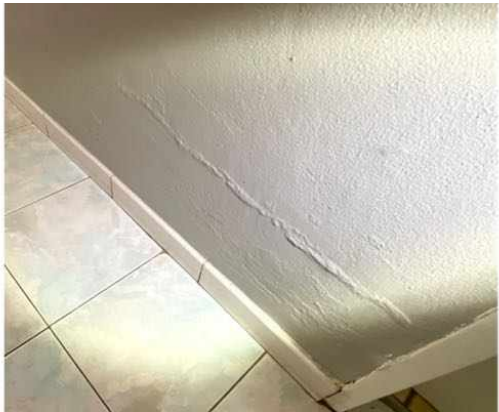
Defects 2.01

Building: Main Building
 Location: Bathroom
 Finding: Major Defect – Moisture Ingress and Associated Damage (Bathroom / Laundry / Adjoining Areas)
 Information: Observation:

Evidence of previous patching and render damage was noted to the masonry wall behind the hallway shower, visible under directional lighting. Elevated moisture readings were recorded at the base of this wall at the time of inspection.

Additional elevated moisture readings were obtained behind the shower wall in the adjoining laundry area, particularly around the hot water system (HWS) and associated plumbing penetrations. The timber floating floor to the adjoining bedroom exhibited minor visual indicators consistent with past or present water penetration.

Corrosion and rust perforation were observed to the lower sections of the bathroom

metal door frame, with early-stage corrosion forming to the laundry door frame. These conditions are consistent with prolonged exposure to moisture.

The combination of elevated moisture readings, render deterioration, corrosion to metal door frames, and water-related impact to adjoining finishes indicates an ongoing or recurrent moisture source. Likely causes include failure or deterioration of the shower waterproofing membrane and/or minor concealed plumbing leaks within wall cavities servicing the bathroom and laundry areas.

Given the presence of confirmed elevated moisture readings and associated material deterioration, this condition is considered a major defect due to the risk of ongoing structural and material damage if left unresolved.

If plumbing defects are ruled out, a licensed waterproofing specialist should assess the integrity of the shower waterproofing membrane in accordance with the requirements of the National Construction Code (including AS 3740 – Waterproofing of Domestic Wet Areas).

Rectification works may involve plumbing repairs, repairs of failed waterproofing

membranes.

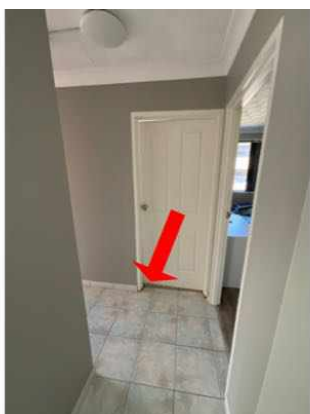
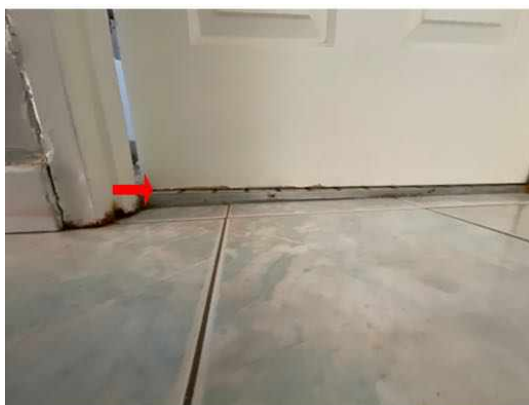
Defects 3.01

Building: Main Building
Location: Laundry
Finding: Door - Binding on floor or carpet (insufficient clearance)...
Information: During standard operation, it was observed that one or more doors are binding or rubbing against the floor covering due to insufficient clearance between the bottom edge of the door and the finished floor level. This condition impedes smooth operation of the door and is classified as a defect.

- **Functionality:** The affected door(s) do not open or close freely, which compromises intended use and occupant convenience.
- **Wear and Damage:** Continued rubbing may cause damage to the floor covering, such as scuffing, tearing, or indentation (particularly on carpet, vinyl, or timber surfaces).
- **Door Damage:** The bottom edge of the door may also suffer wear, swelling (if unsealed), or delamination over time.
- **Compliance:** Doors are expected to operate without obstruction in accordance with good building practice and the tolerances outlined in Guide to Standards and Tolerances.

The bottom edge of the affected door(s) should be planed or trimmed to provide sufficient and uniform clearance above the floor surface. Following adjustment, the exposed edge must be appropriately sealed to prevent future moisture ingress or material degradation. All works should be carried out by a qualified tradesperson in accordance with manufacturer recommendations and industry standards.

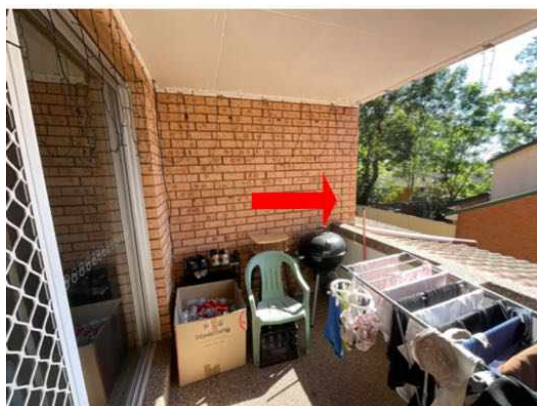
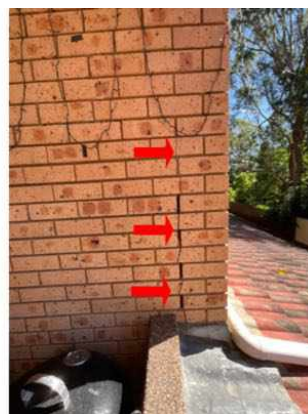
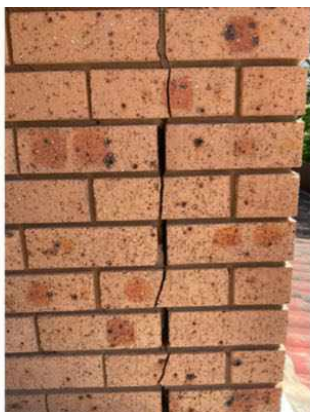
Defects 3.02

Building:	Main Building
Location:	External Wall
Finding:	Brickwork - Cracking Moderate.
Information:	Observation:

Cracking was noted in the external brickwork and appeared to be moderate at the time of inspection.

Vertical cracking may indicate thermal movement, while other patterns could suggest more localised stress within the wall.

- Cracks of this nature may progress or widen if underlying movement continues
- There is potential for remedial works or brickwork replacement in the future
- Moisture ingress may also occur through open cracks, leading to deterioration of internal elements if not addressed

- Although cracking appears moderate and non-structural at this stage, it is recommended that the area be monitored
- For a more detailed assessment, consultation with a qualified Structural Engineer is advised to determine if movement is ongoing and whether any remedial action is necessary

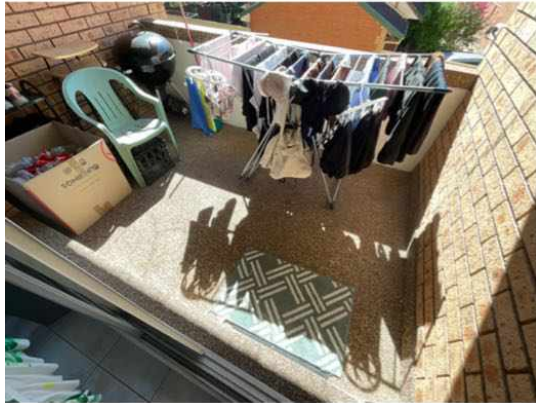
Defects 3.03

Building:	Main Building
Location:	Balcony
Finding:	Observation – Substandard Balcony Drainage
Information:	During the inspection, the floor drainage to the enclosed balcony area was assessed and found to be substandard. The balcony is fully enclosed, effectively creating a vessel-like space in which water cannot freely escape. No primary floor waste was visible to facilitate effective water removal. It is possible that stored items, mats etc. may be concealing a floor waste, and further investigation is advised to confirm whether one exists.

Additionally, no overflow pipes or alternative drainage provisions were observed along the masonry external balustrade walls. In the absence of adequate drainage, water may accumulate and pool on the balcony floor. This can present a slip hazard and due to current floor level differences, may also increase the risk of moisture ingress into adjoining internal living areas.

- Floor waste may be covered by mats, recommend further investigation to confirm

- At the client's discretion, this matter may be referred to the Owners Corporation should issues arise, as balcony drainage design and performance may fall under strata responsibility depending on the registered strata plan.

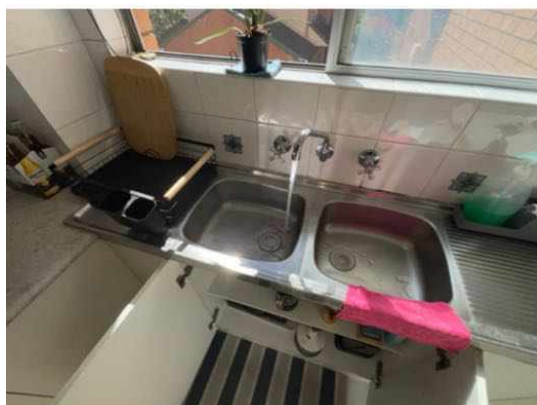
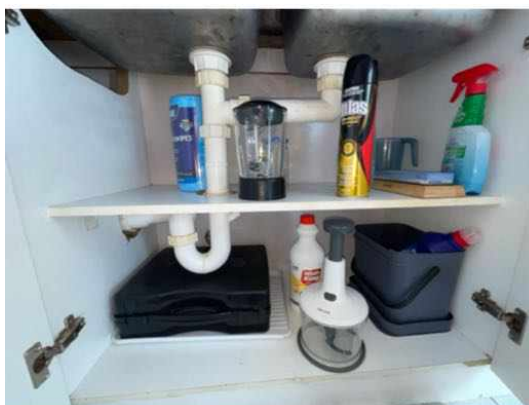
Building: Main Building
Location: Kitchen
Finding: Kitchen Sink – Overall Condition & Recommendations.
Information: Observations:

- The kitchen sink tap(s) were water tested at the time of inspection, with no evidence of leaks or blockages observed in the visible plumbing or drainage.
- No significant water damage was observed to the cabinetry/unit
- Stored items under the sink obstructed access, limiting a full inspection of the plumbing and internal cabinetry.

- Further monitoring and testing are recommended once the tap(s) are in constant use, to identify any drainage issues or signs of slow leaks not evident during the limited inspection.
- For long-term property care, it is advised that sealant and grouting in water-exposed areas be regularly inspected and maintained.
- It is recommended that the stored items beneath the sink be removed to allow for a full re-inspection of the plumbing and cabinetry, ensuring no concealed defects are present.

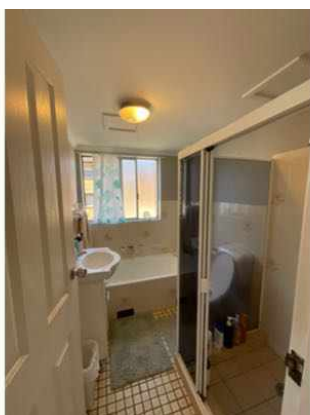
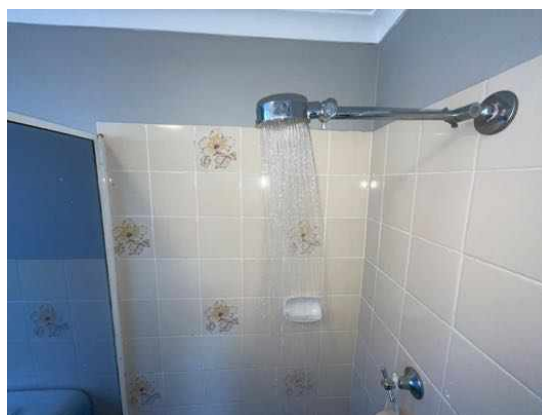
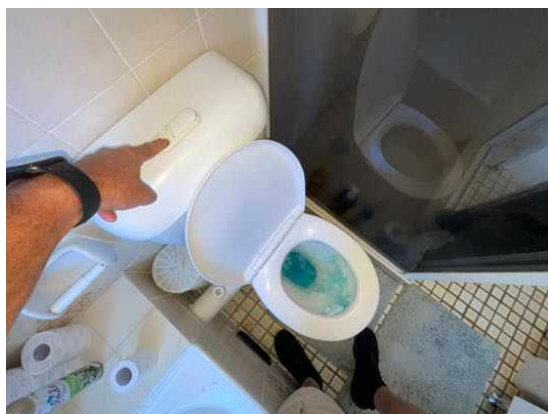
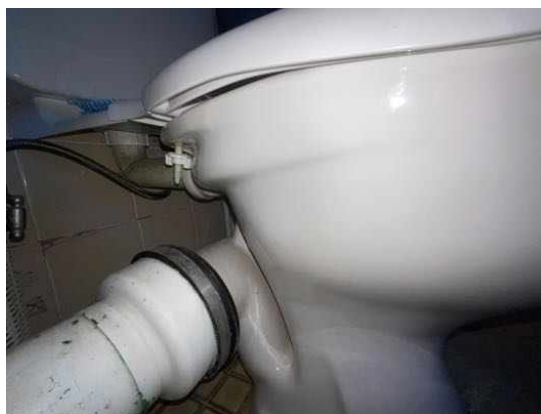
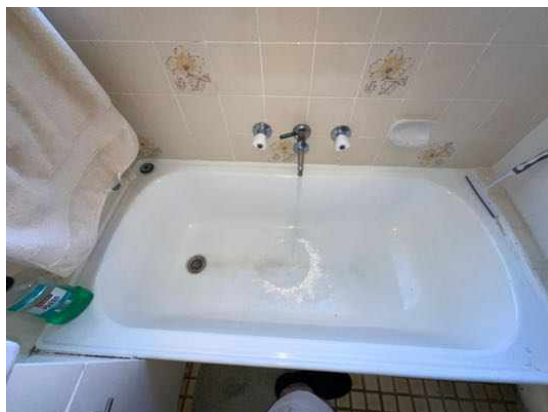
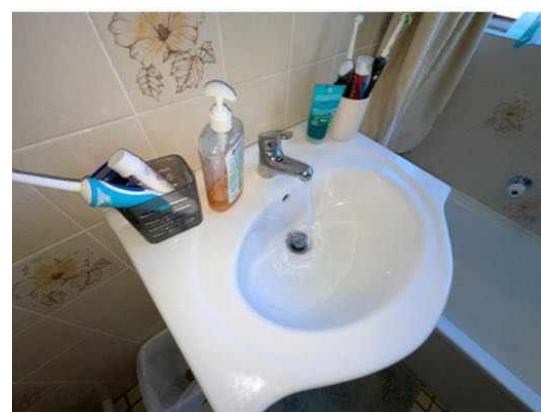
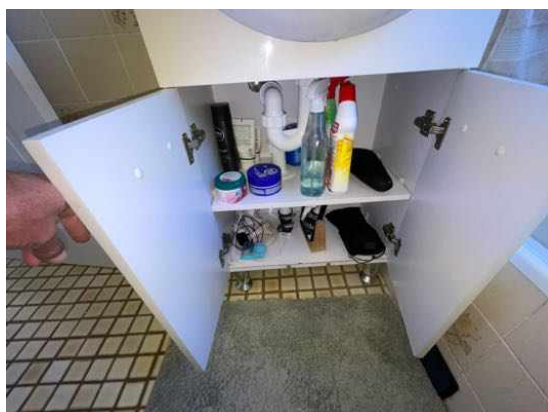
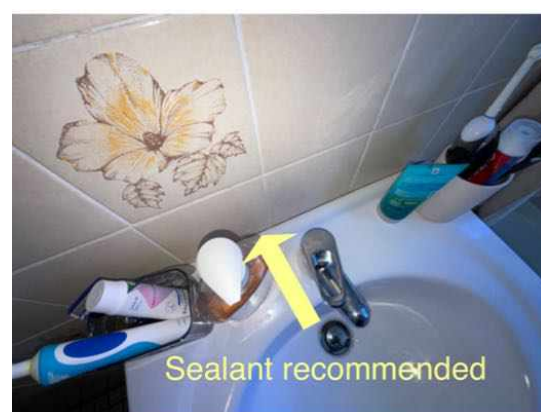
Building: Main Building
Location: Bathroom
Finding: Wet Areas - Bathroom(s) - Overall Condition & Recommendations.
Information: Overall Condition & Recommendations

- Floor waste was found to be clear and free of blockages at the time of inspection. Further monitoring is advised after consistent use to identify any drainage issues or buildup requiring cleaning.

- No elevated moisture readings were detected around the tap fittings
- Sealing of grout and tiles is recommended to prevent moisture buildup and mould growth in damp areas such as showers.

- Moisture readings (as documented in the report) suggest some retained moisture in the shower walls. Further investigation by a qualified plumber or waterproofing specialist is advised to confirm any underlying issues.

- The condition of grout average with some areas potentially requiring maintenance or replacement.
- Grout in wall and/or floor junctions may crack and deteriorate over time. It is recommended to remove any rigid grout from junctions and replace with flexible, mould-resistant sealant in accordance with best building practices.

- Mould growth was noted in some areas of grout/sealant. Cleaning or, if necessary, replacing affected grout or sealant is recommended to maintain hygiene and waterproofing integrity.

- Flood testing of the shower recess is recommended. This may reveal inadequacies in the waterproofing or shower screens, which could lead to water damage in surrounding areas.
