# Building and Timber Pest Inspection Report

Inspection Date: Mon, 30 Mar 2026

Property Address: 212/20 Hilly St, Mortlake NSW 2137,  
Australia

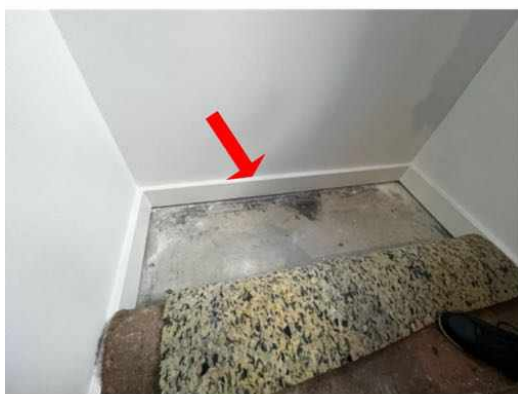
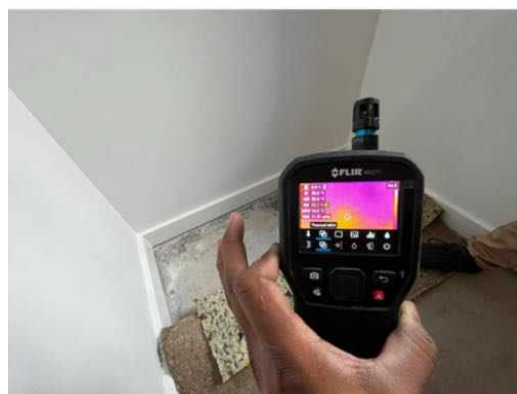
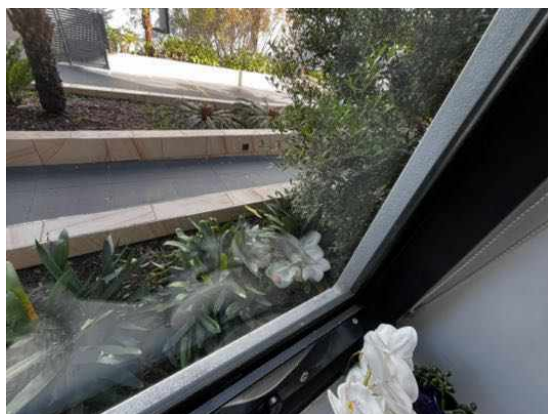
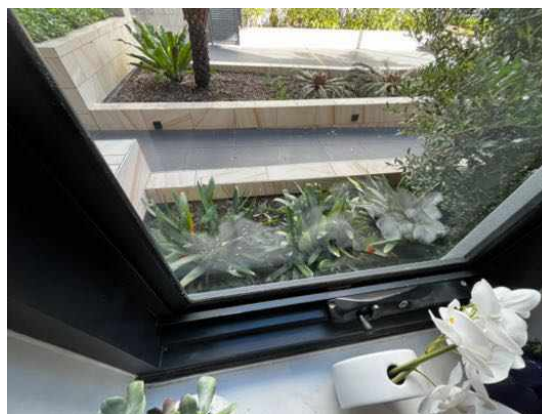
Building: Main Building  
Location: Bedroom >  
Finding: Evidence of Previous water leakage was present at the time of inspection  
Information: Evidence of Previous Water Leak was found during Inspection in the walls below the window area in the second bedroom. Missing roof drainage, leaking plumbing pipes or fixtures, poorly plumbed HWS overflows or condenser units and poor site drainage / Landscaping water disposal, Excessive Moisture may generally be the causes of the leakage. It is highly recommended that all plumbing and drainage fixtures and fittings be maintained regularly in order to prevent excessive moisture being present in the external / internal property.

Upon Inspection the carpet was taken apart to attend to the leak/ detect the leak and was mentioned that the leak had been fixed and the carpet would be replaced by Wooden floors.

Request the buyer to verify on the same and do due delegalance from the strata.

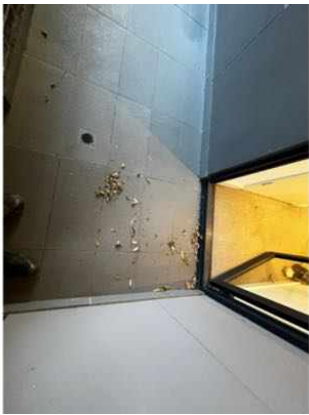
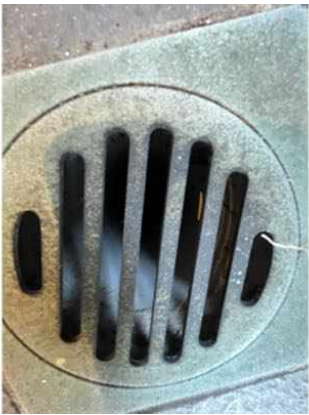
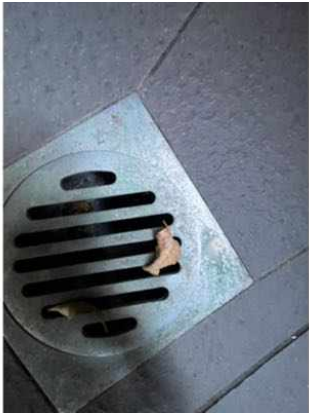
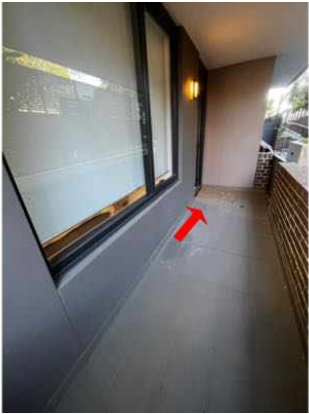
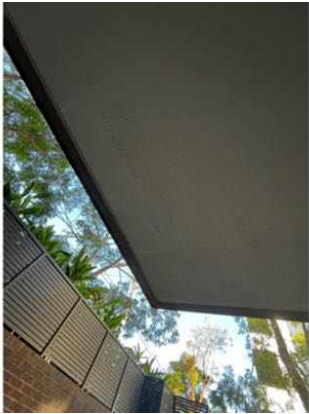
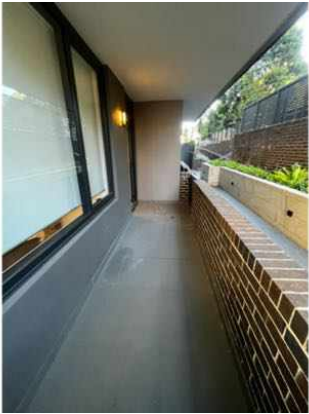
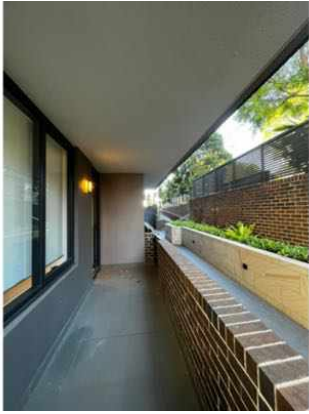
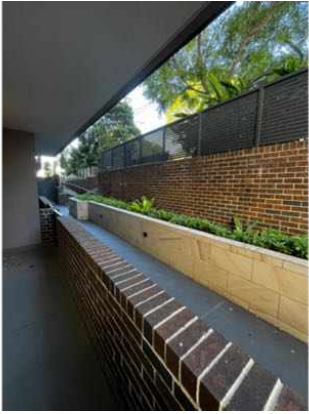
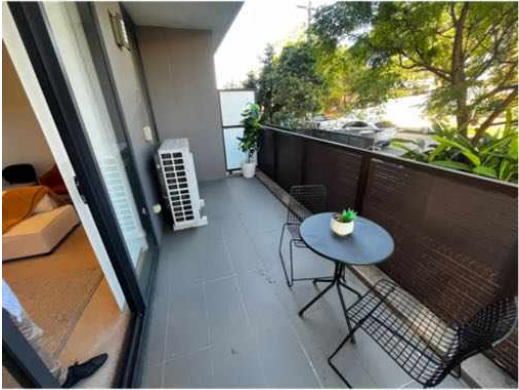
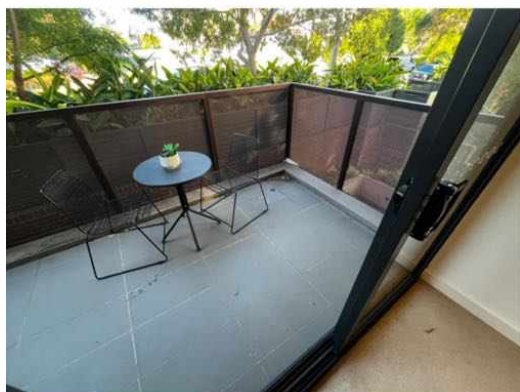
Building:	Main Building
Location:	Balcony upstairs and Downstairs
Finding:	Balcony - Floor
Information:	Upon Inspection The gradients of the Balcony floor levels are checked and found to be ok with a fall towards the floor trap.

The area being exposed to different weather is also a Cause for the grout/ silicone to dry up. Regular maintenance and replacement of damage or missing or damaged sealant and grout is highly recommended to the wet areas, as this is a regular wear and tear defect. Sealant and grouting in areas that come into regular contact with water should be maintained for the long term care of your property.

Suggest to always keep the area clear of rubbish and leaves, for the free flow of water/ rainwater to go through the downpipes.

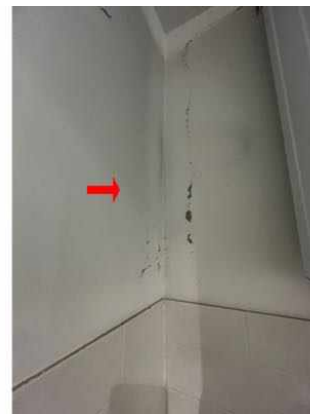
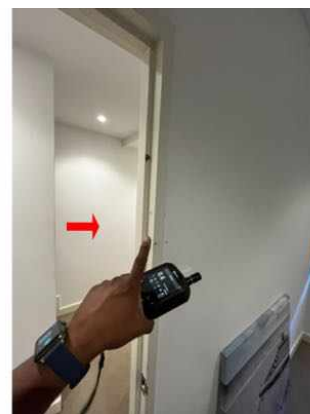
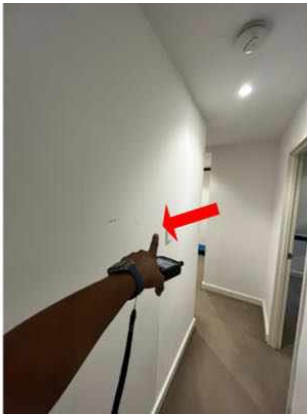
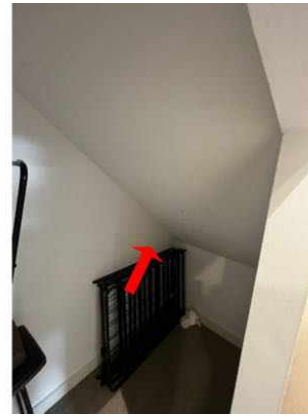
Finding 3.03

Building: Main Building  
Location: All Internal Areas  
Finding: Paint finish - Incomplete  
Information: The paint finish in some areas were identified as being incomplete/ substandard/ cracks at the time of inspection. I have attached a cluster of photos taken in various rooms where the defect was visible. There may be hidden defects/ smudges/blemish in the wall and ceiling areas as they were being covered by a number stored items and furniture present at the time of inspection.

Whilst incomplete or missing paint finish is generally an appearance defect, it can also lead to the development of secondary building defects over time. Incomplete areas of paint finish expose the area to moisture, potentially accelerating the deterioration of underlying building materials.

Incomplete paint finishes should be sanded back, filled, leveled and painted, as applicable. Where inadequate or missing paint protection has led to the deterioration of the associated building element, repair and/or replacement of this building element may be required.

A painting contractor should be appointed as soon as possible to perform necessary works to aid the appearance of the affected area and to ensure the area is protected against further deterioration. Alternatively, the homeowner following manufacturer instructions may perform these works.

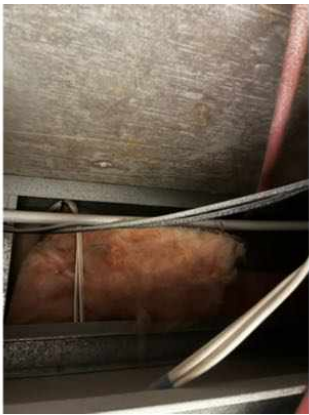
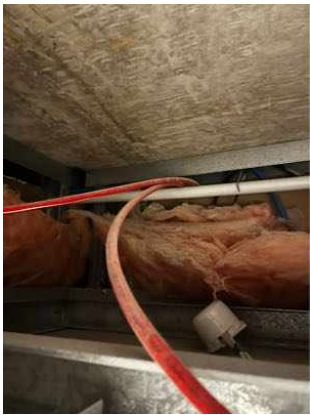
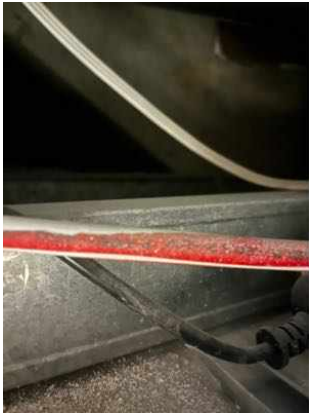
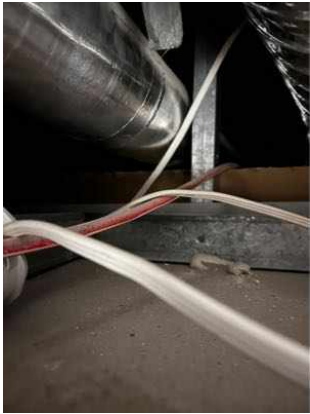
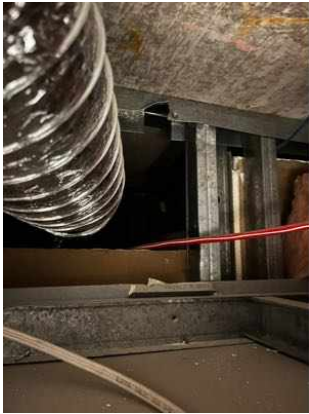
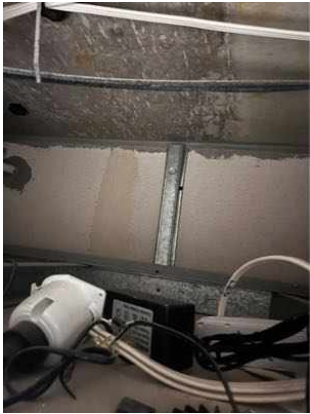
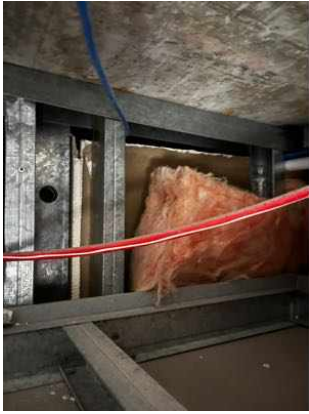
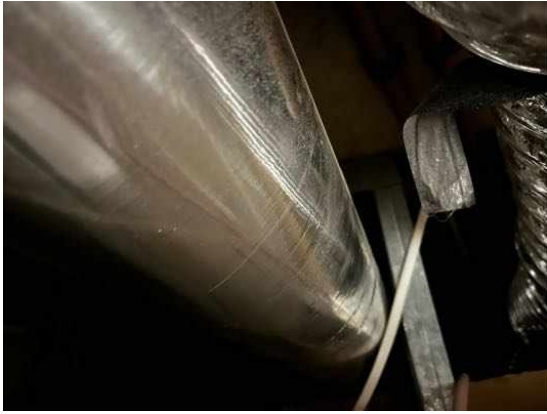
Building: Main Building  
Location: Roof Void  
Finding: Roof - No Access  
Information: Limited access to the roof void was present due to facts including but not limited to access hatch size or placement, Its a Flat roof and no access on inspection.

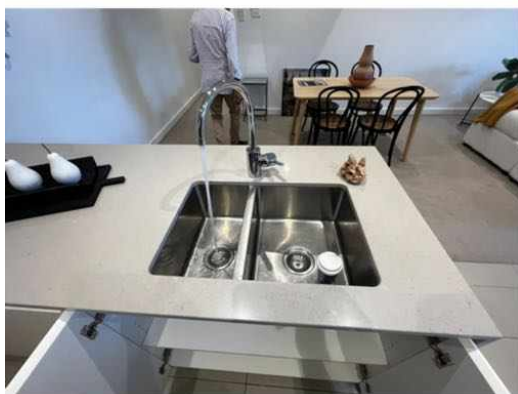
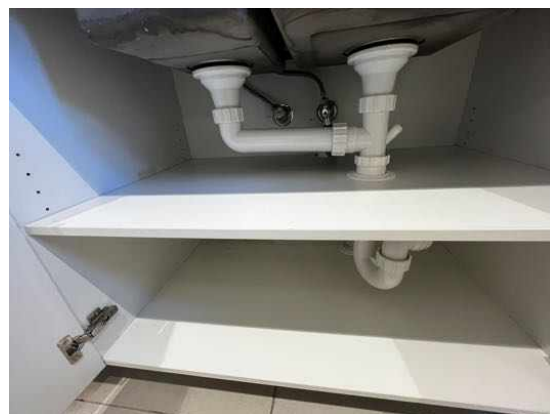
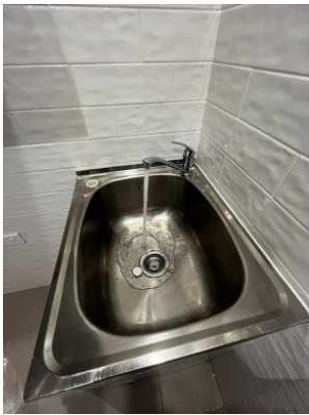
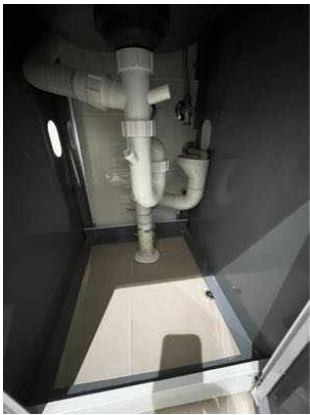
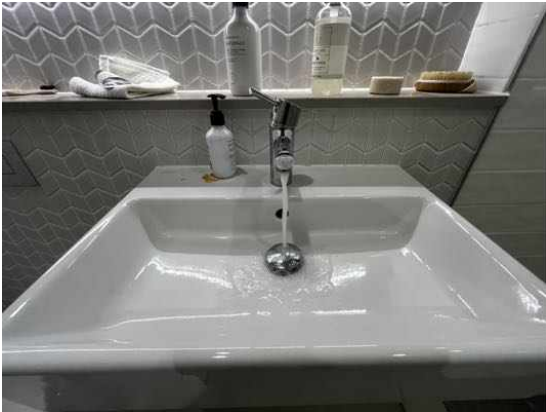
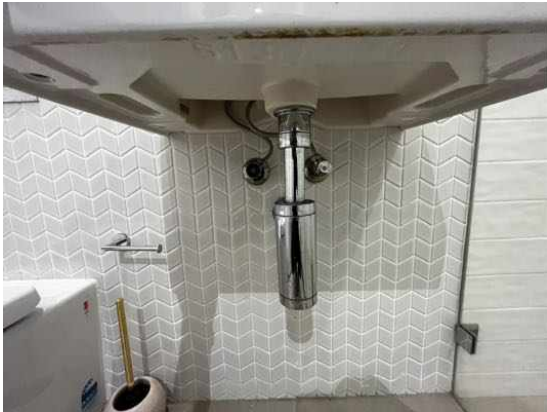
Building: Main Building  
 Location: Kitchen/ Laundry/ Ensuite/ Bathroom  
 Finding: Cabinetry Plumbing - Kitchen/ Laundry/Ensuite  
 Information: All cupboards where sinks and basins with drainage plumbing were inspected and no evidence of leaks were present at the time of inspection.

For your information only no remedial works are required at the time of inspection.
