# Building and Timber Pest Inspection Report

Inspection Date: Tue, 31 Mar 2026

Property Address: 17 De Boos St, Euroa VIC 3666, Australia

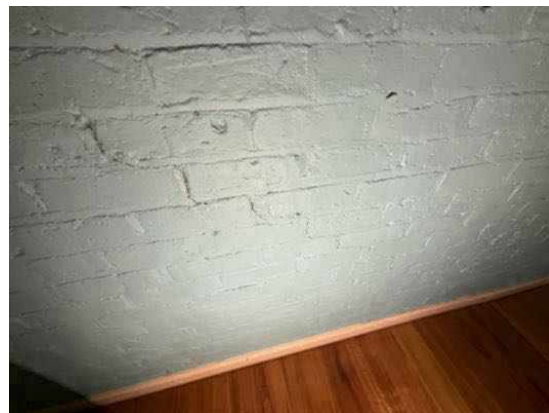
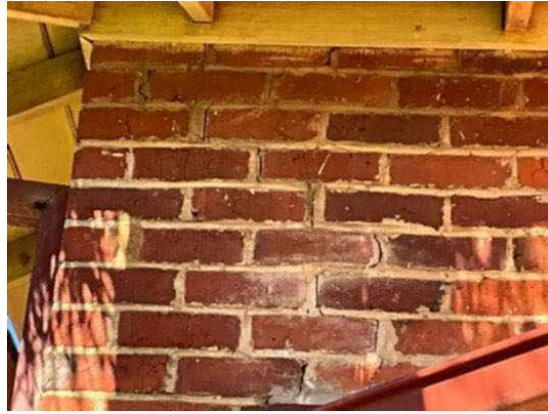
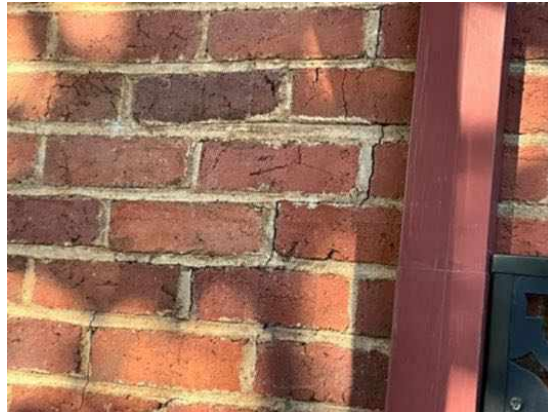
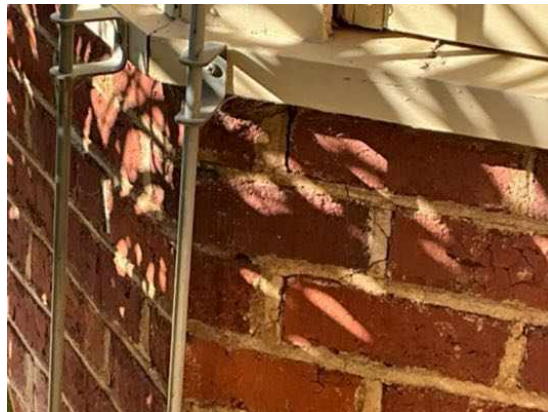
Building: Building 1  
Location: Bedroom 3, front wall  
Finding: Brickwork - Step cracking  
Information: Step cracking was identified to the brickwork in this area at the time of inspection. Step cracking, which is similar to other forms of cracking, has a variety of possible causes. However, the most common is the subsidence of adjacent footings.

Step cracking is a relatively common defect, and is most likely to occur adjacent to windows, doors and other openings. Mortar failure in the gaps between affected bricks indicates the stresses and tensions affecting the wall.

Internal cracking should be considered as part of this defect.

Where step cracking is extensive or severe, the client is advised to consult a structural engineer. Minor step cracking can be used as a warning sign to address factors causing stress to the wall, which can include the effect of surrounding trees, water leaks, soil erosion, or even the presence of reactive soils in the surrounding area.

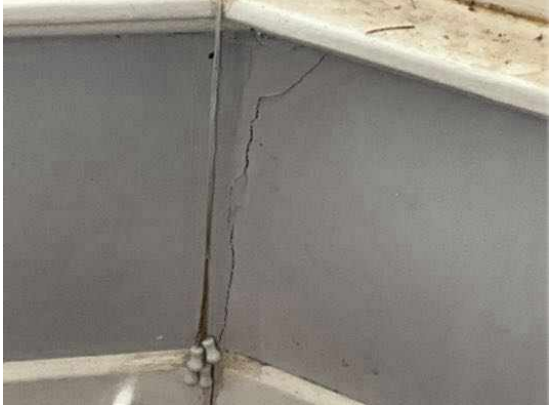
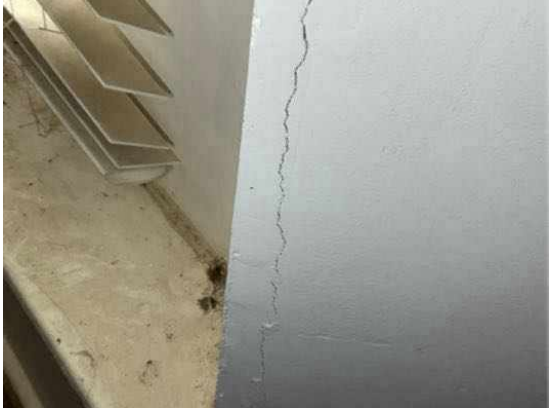
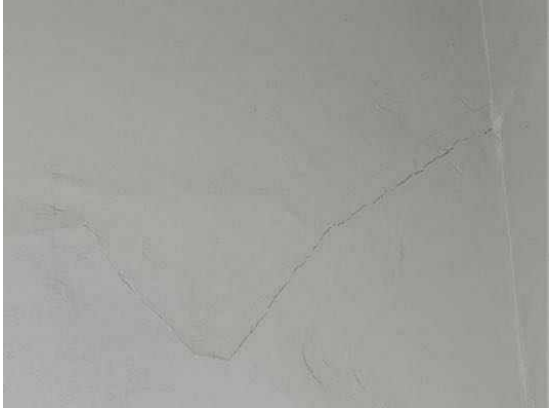
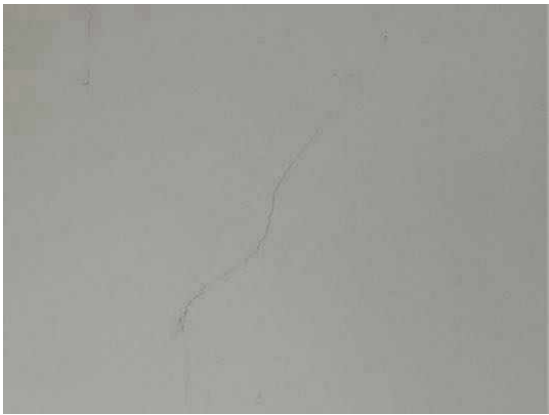
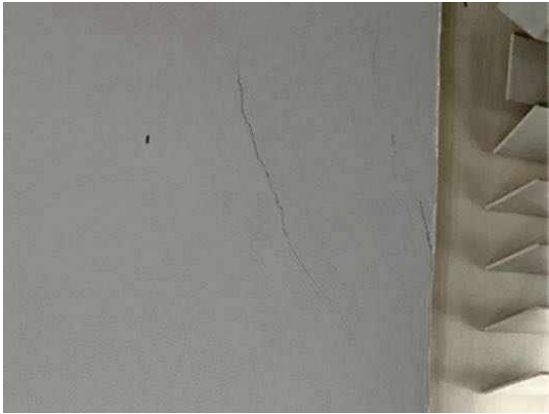
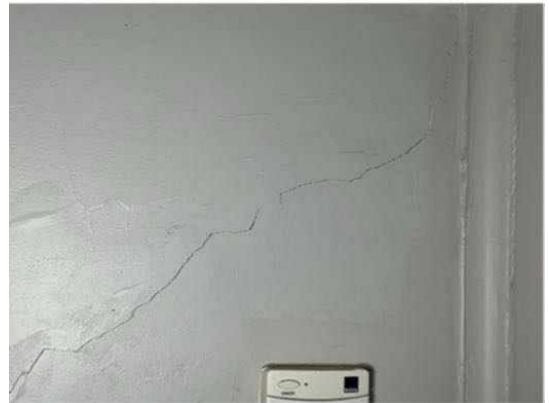
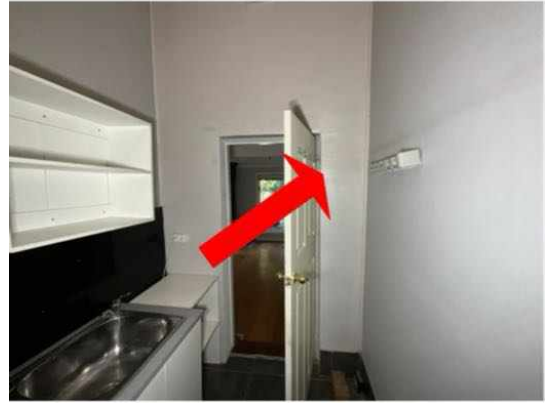
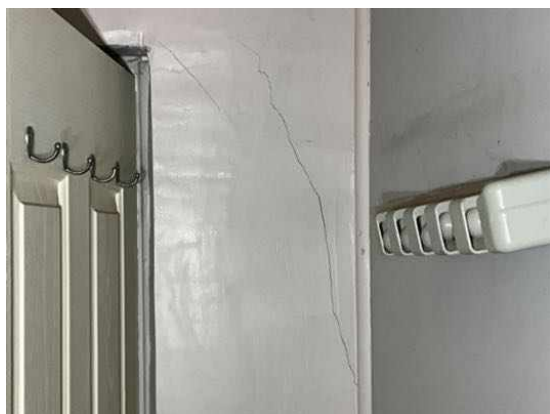
### Finding 3.02

Building: Building 1  
 Location: Living Room, laundry  
 Finding: Cracks to internal render  
 Information: It has been observed that cracking to internal rendered surfaces has occurred. The degree of damage falls within Category 2, described as noticeable cracks which are easily filled. Cracking of this size are generally less than 5mm in width.

Category 2 damage is required to be monitored for a period of 12 months. After the monitoring period, a crack rated at Category 2 or above is considered a defect requiring rectification.

The cracking internally is reflected in external cracking in the brickwork. These defects should be considered together.

Always contact a registered builder or structural engineer should cracks widen, lengthen, or become more numerous.

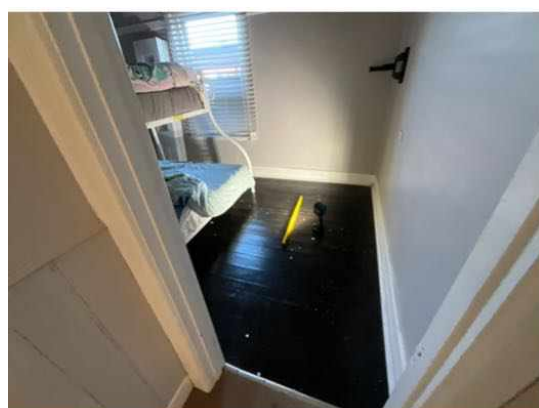
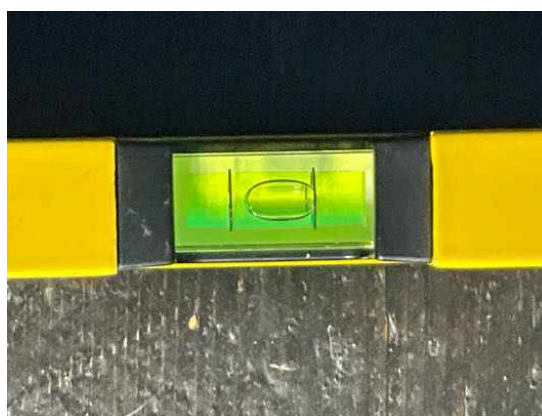
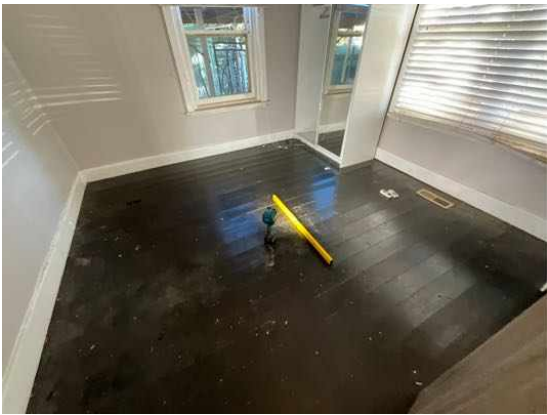
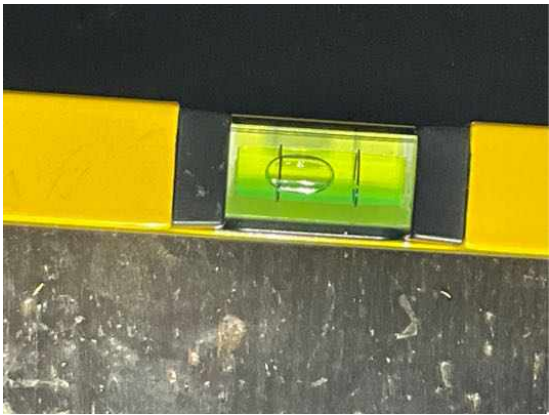
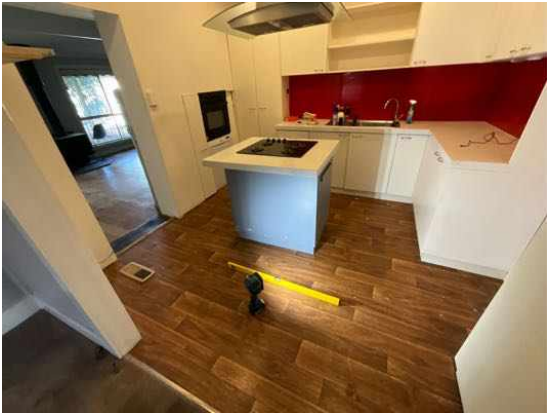
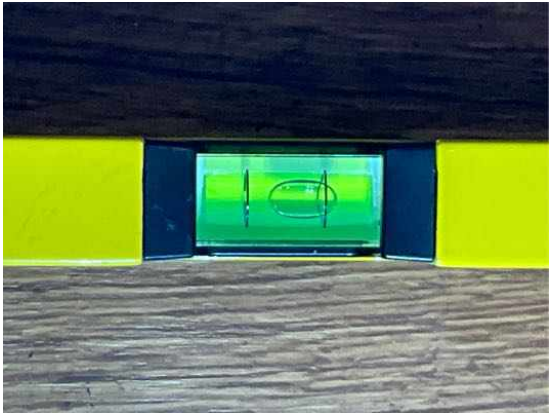
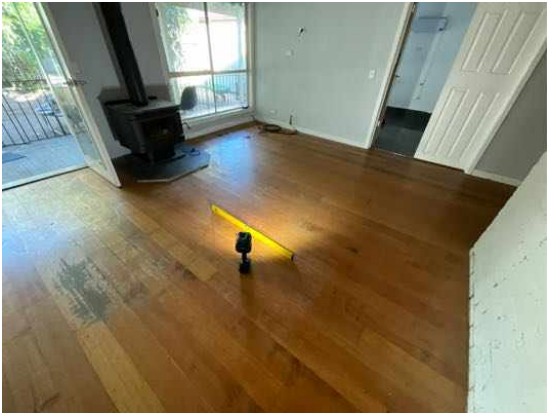
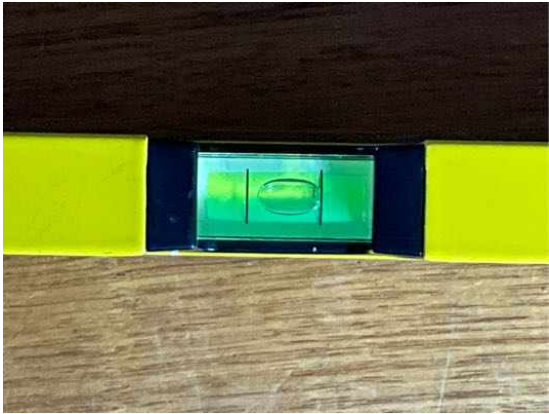
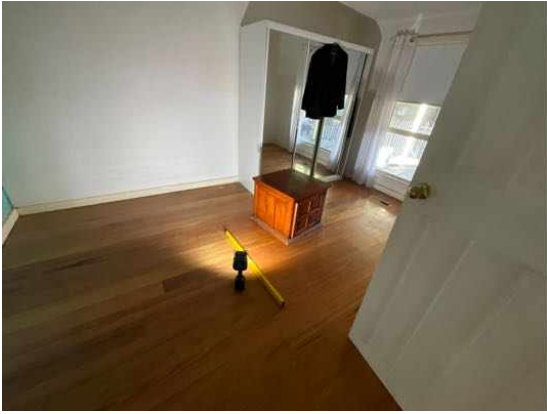
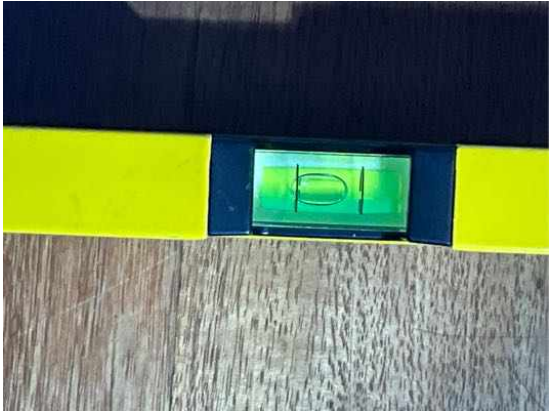
### Finding 3.03

Building:	Building 1
Location:	All Internal Areas
Finding:	Flooring - Uneven
Information:	The internal flooring in this area is out of level and uneven. Uneven flooring is likely to indicate minor defects such as expected movement of the foundations of the property, but may also indicate subsidence of the associated subfloor stumps.

It is advised that the flooring be closely monitored to identify any further movement. Where flooring remains relatively unchanged for an extended period of time (i.e. several months), it is likely that this defect has been caused by expected movement of the foundations of the property.

However, where flooring is uneven further, potentially invasive inspection of the subfloor structures and stumps in this area is required. In this case, works to repair are likely to be required, and would be carried out by a registered builder specialising in re-stumping.

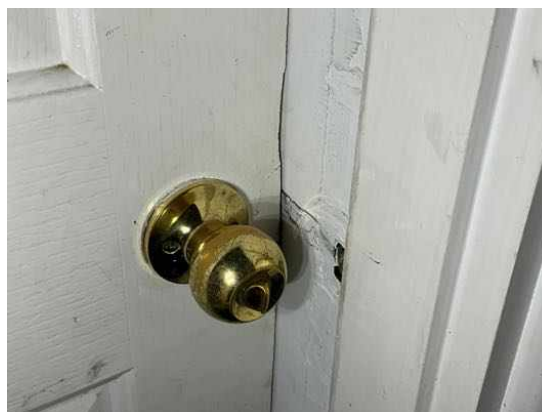
Finding 3.04

Building: Building 1  
 Location: Laundry  
 Finding: Door- Binding/jamming  
 Information: Binding and/or jamming of this door is evident during standard operation. This defect inhibits the functionality of the affected door as well as creating potential for secondary defects to associated building elements, such as damage to the floor covering.

A door that binds to flooring or to the associated door frame may have several causes, ranging from minor defects, such as poor installation of the door or deteriorated hinges, through to major structural issues, such as damage to subfloor structures.

A qualified carpenter or general handyperson should be appointed to perform minor rectification works at client discretion.

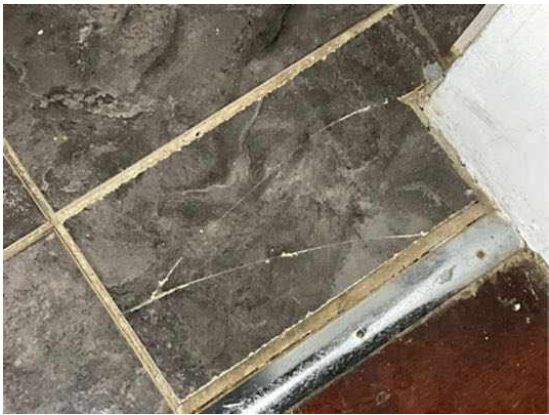
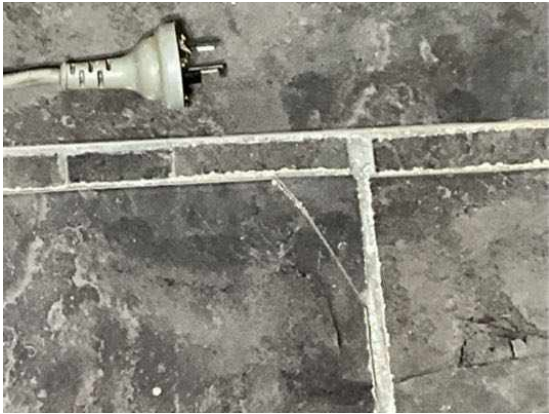
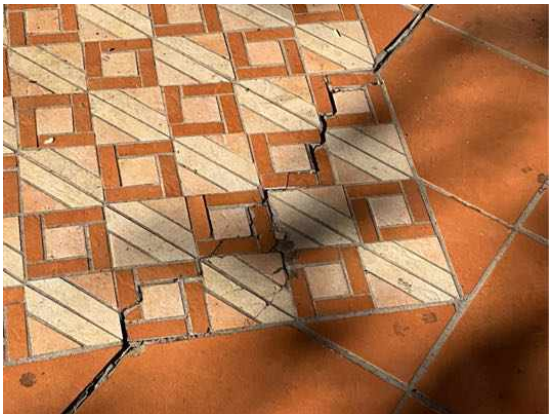
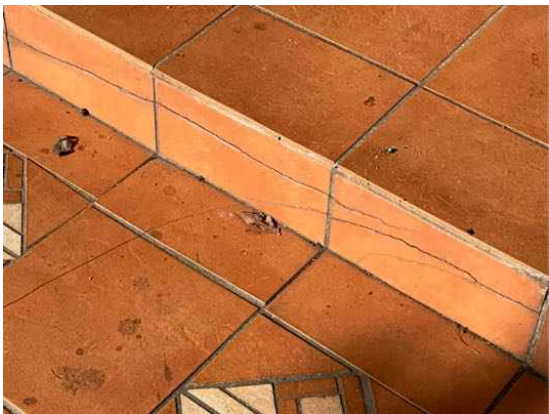
### Finding 3.05

Building: Building 1  
 Location: Laundry, entry  
 Finding: Cracked floor tiles  
 Information: Cracking in the floor tiles was evident in this area at the time of inspection. It is suspected that this cracking has occurred as a result of minor settlement or impact damage.

Cracked tiles throughout the household detract from the overall appearance of the affected areas however it is unlikely to create or lead to any secondary defects.

In the case of the entry area, the structure under the tiles will also have cracking.

While not considered a matter of urgency, replacement of cracked floor tiles is recommended at the clients discretion. A tiling contractor may be appointed to perform these works. Where cracks become more numerous, contact a licensed building inspector for further investigation.

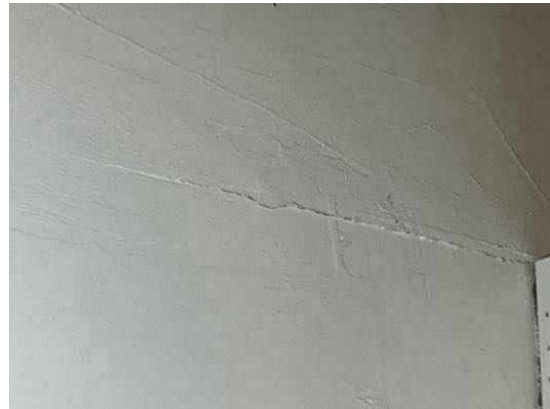
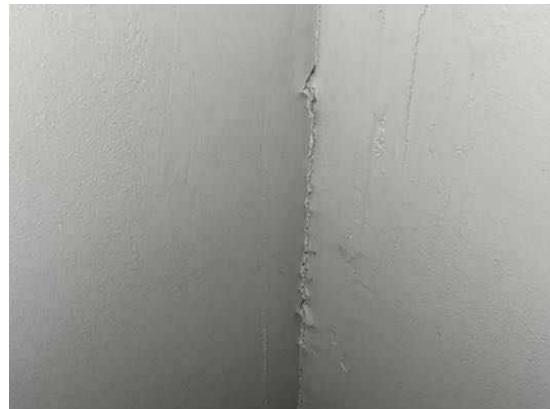
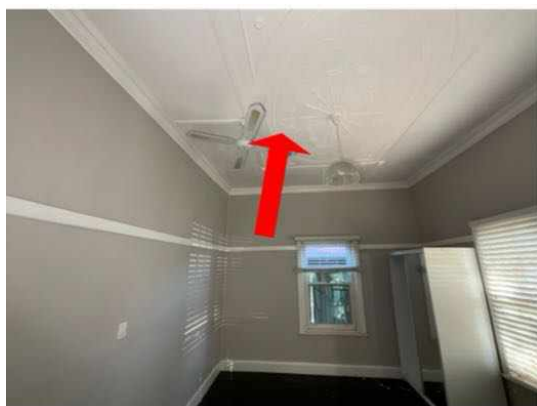
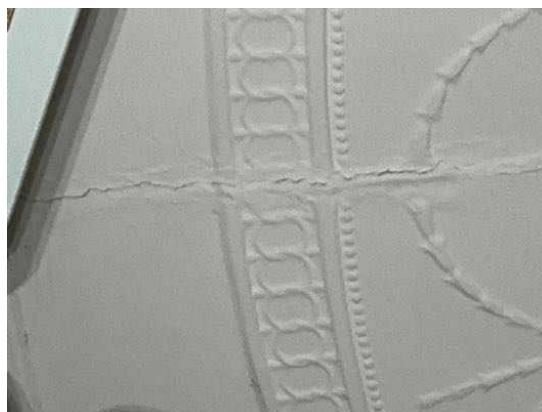
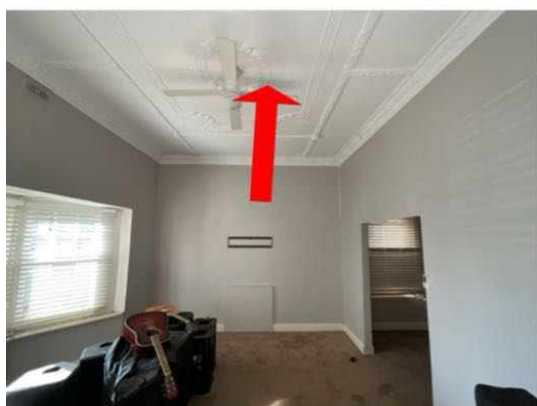
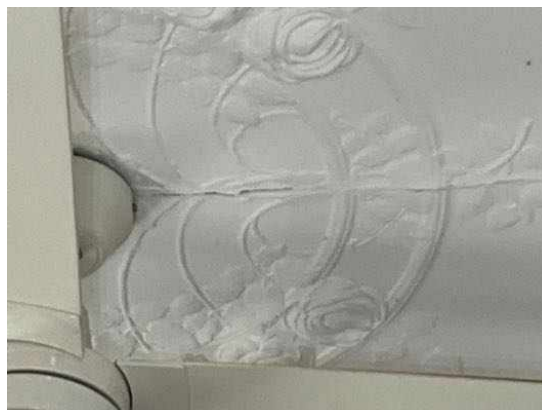
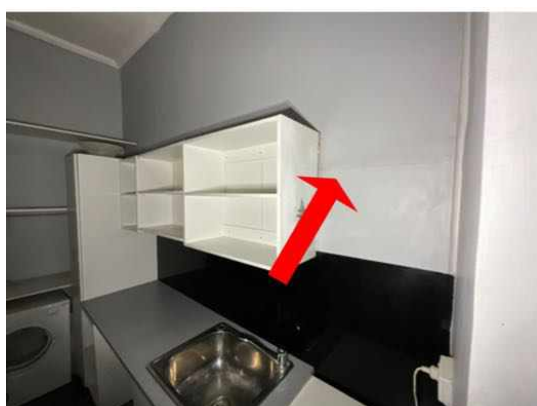
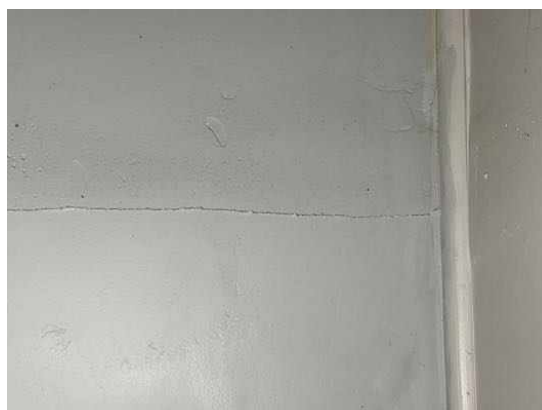
Finding 3.06

Building: Building 1  
Location: Kitchen, bed 1,3, living, laundry  
Finding: Cracking - Damage Category 1 - Fine (up to 1mm)  
Information: Although fine cracks are quite noticeable, they are often only considered to be an appearance defect, and usually do not indicate any structural damage. Generally, the cause of a fine crack is indicative of a separation between building materials and finishes (e.g. paint, plaster, etc.) along joints.

Cracking of this nature can generally be repaired with minor sanding, filling and/or repainting. Such works should be performed by a qualified painter or a general handyman.

Monitoring of all cracking should be conducted frequently. Always contact a building inspector should cracks widen, lengthen, or become more numerous.

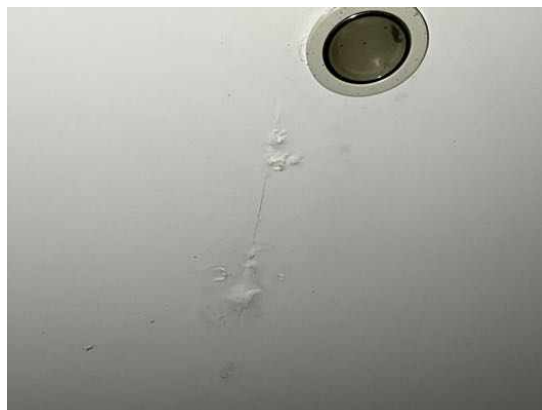
### Finding 3.07

Building:	Building 1
Location:	Family Room
Finding:	Ceiling - Water damaged
Information:	Water damage to the ceiling lining is generally an indication of excessive moisture being present in the roof void, usually via a leak to the roof covering.

Where water damage is evident to the ceiling, the primary requirement is to identify and rectify the source of the leak. A roofing plumber should be appointed as soon as possible to identify the leak and perform rectification works as necessary, ensuring the water damage is restricted.

Once the leak is repaired, consultation with relevant tradespeople, including plasterers and painters, is advised. Rectification works may include replacement of ceiling lining or minor repainting, depending on the extent of the damage.

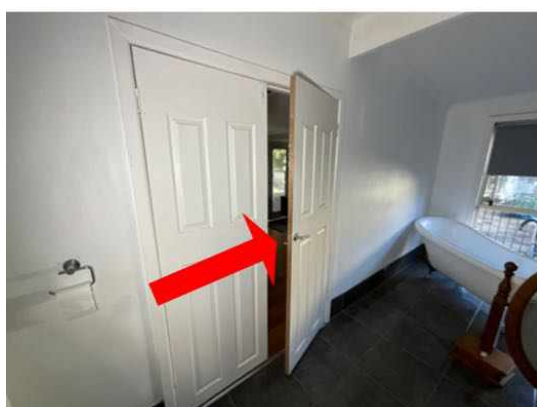
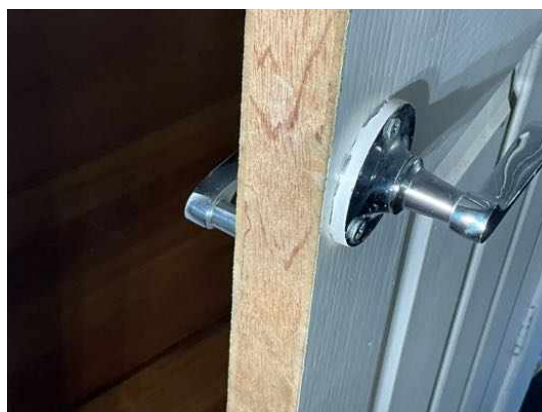
### Finding 3.08

Building: Building 1  
 Location: Bathroom  
 Finding: Door handle- Not latching  
 Information: It was noted that the door in this area was not latching during operation at the time of inspection.

It is suspected that this defect has occurred due to minor issues with the associated hinges. Such damage is identified as general wear and tear, which is expected for building elements of this age.

A qualified carpenter or general handyperson may be appointed to perform rectification works as necessary, at client discretion.

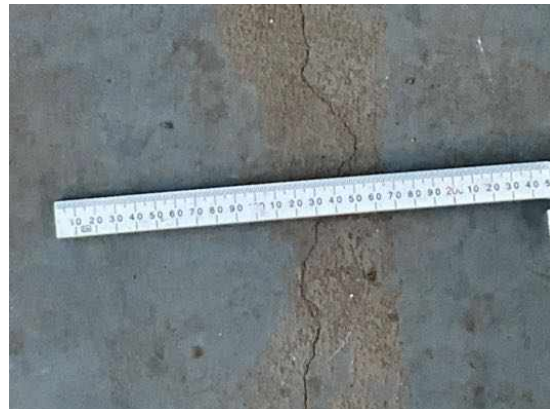
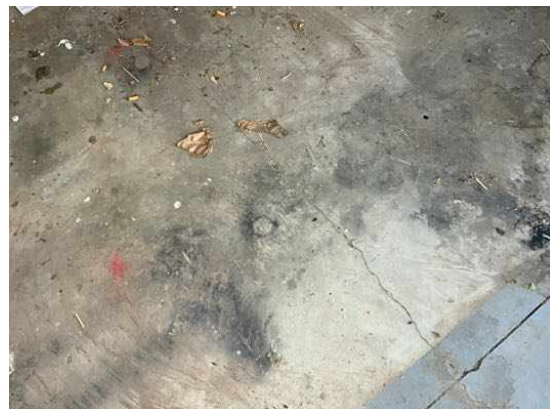
### Finding 3.09

Building: Building 1  
 Location: Carport, garage

Finding: Cracking - External Concrete Paving Damage Category 1 - Fine (less than 2mm)  
 Information: Fine cracks were identified in external concrete paving. Although fine cracks are quite noticeable, they are often only considered to be an appearance defect, and usually do not indicate any structural damage. To be considered a Category 1 or fine crack, the crack is found to be less than 2mm in width.

Generally the cause of a hairline crack in existing concrete paving such as driveways and pathways is indicative of the expansion and contraction of the concrete. Such causes are generally due to environmental factors, such as moisture levels, weather conditions, root systems of nearby trees or the soil types on which they are laid.

Fine cracks may also be due to poor original installation of the concrete. Factors such as poor compaction of the sub surface and/or inadequate reinforcing of the slab may create cracking and other secondary defects.

Monitoring of all cracking should be conducted frequently. Always contact a building inspector should cracks widen, lengthen, or become more numerous.

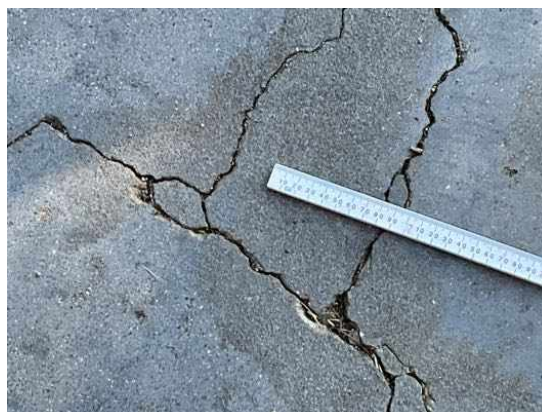
### Finding 3.10

Building: Building 1  
 Location: Driveway  
 Finding: Cracking - External Concrete Paving Damage Category 3 - Wide Cracks (2mm - 4mm)

Information: Wide cracks were identified in external concrete paving. Wide cracks are significant and are likely to lead to the development of safety hazards and secondary defects if left unmanaged.

General age and expected deterioration of the paved areas is a common cause of this type of cracking. However, expansion and contraction of the slab may also have occurred due to environmental factors. Such factors include variable moisture and weather conditions, the presence of trees and their roots having a settling or lifting affect on the soil, or the effect of load bearing, e.g. heavy vehicles over a sustained period of time.

Cracking to this degree may also be due to poor original installation of the concrete. Factors such as poor compaction of the sub surface and/or inadequate reinforcing of the slab may create cracking and other secondary defects. Wide cracks may also have a more significant structural cause, such as subsidence of soils.

Where the crack is located adjacent to structural elements of the building, the advice of a Structural Engineer is advisable before undertaking repairs. Significant repair and likely replacement of the concrete paving is probable.

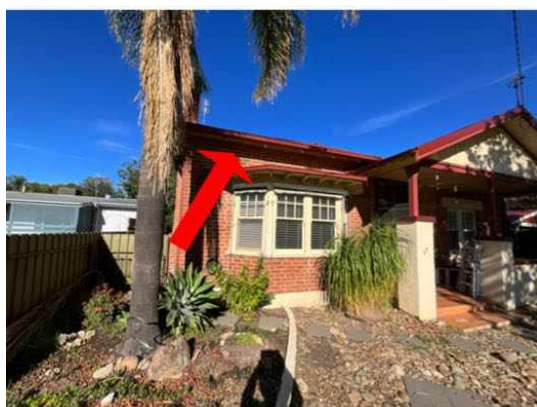
Blocked gutters are likely to lead to high levels of moisture in the affected areas. Such moisture will not only cause rust and decay of the associated building materials, but can also provide conditions that are conducive to termite and timber pest activity. Blockages in gutters should therefore be removed immediately to ensure dry conditions are maintained.

Consult a Licensed Plumber for further specific advice on remedial works that may be required. In the interim, it is highly advised that blocked gutters be removed by the homeowner or a general handyperson as a matter of urgency.

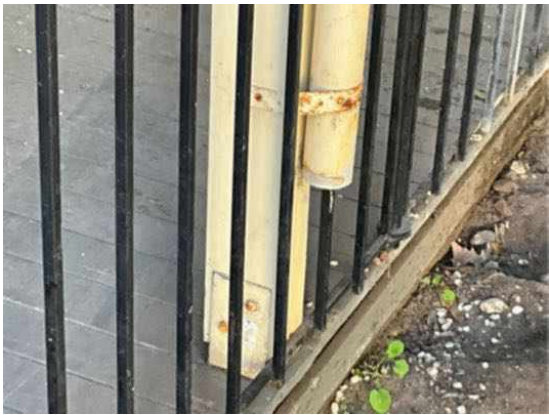
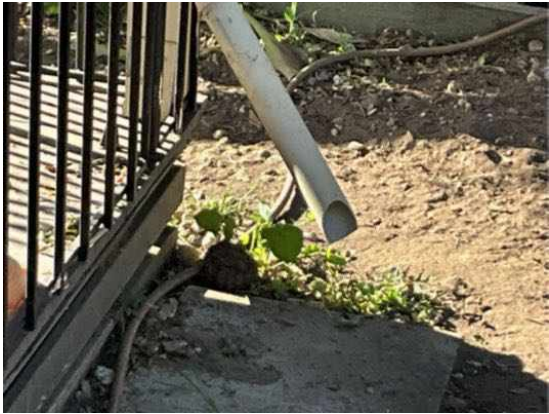
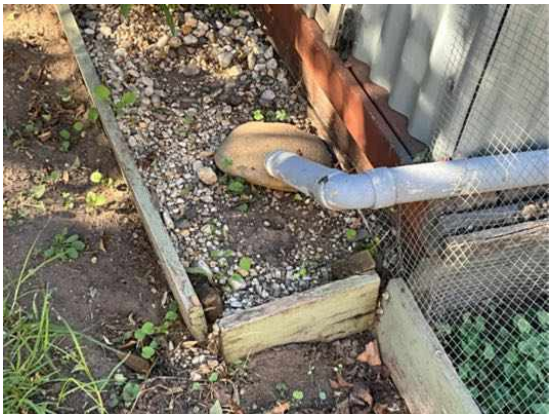
## Finding 6.02

Building: Building 1  
 Location: Yard - Back  
 Finding: Stormwater drain - Not connected  
 Information: The roof plumbing is not adequately connected to stormwater drainage on the site. This disconnection negatively impacts the functional capacity of the roof plumbing.

Where roof plumbing doesn't drain adequately, the area at the base perimeter can become excessively damp, potentially creating an environment that is susceptible to rust and corrosion of surrounding building elements, as well as attracting termites and other pests.

It is highly recommended that a plumber be appointed to further inspect the area and to install adequate drainage equipment where necessary.

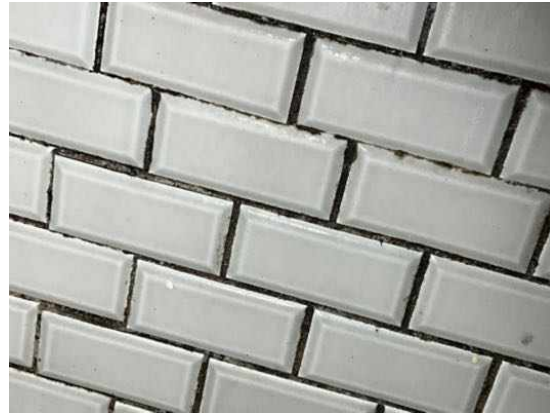
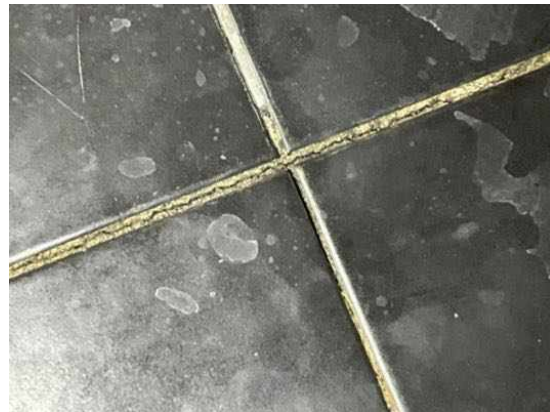
**Finding 6.03**

Building: Building 1  
Location: Bathroom  
Finding: Inadequate sealant or Grout  
Information: This area has a lack of effective Sealant or Grout. This is allowing the ingress of water to the structure inside the wall.

The presence of water encourages Termite attack, Mould and Fungal Decay.

A Tiler or General Handy person must be contacted as soon as possible to effect repairs and prevent further deterioration.

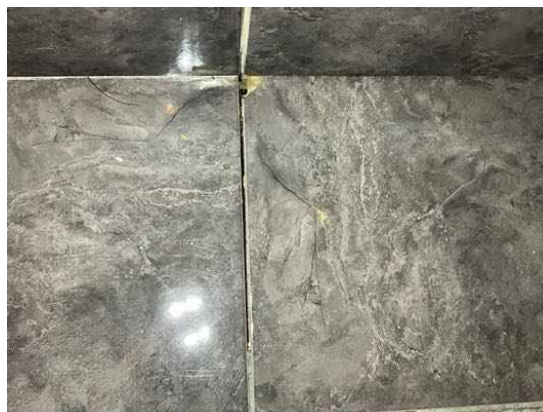
### Finding 6.04

Building:	Building 1
Location:	Laundry
Finding:	Inadequate sealant or Grout
Information:	This area has a lack of effective Sealant or Grout. This is allowing the ingress of water to the structure inside the wall.

The presence of water encourages Termite attack, Mould and Fungal Decay.

A Tiler or General Handy person must be contacted as soon as possible to effect repairs and prevent further deterioration.

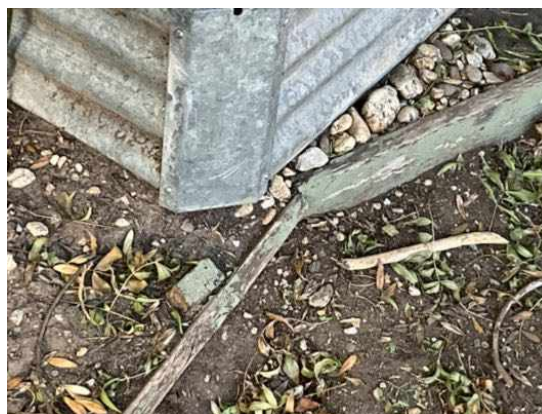
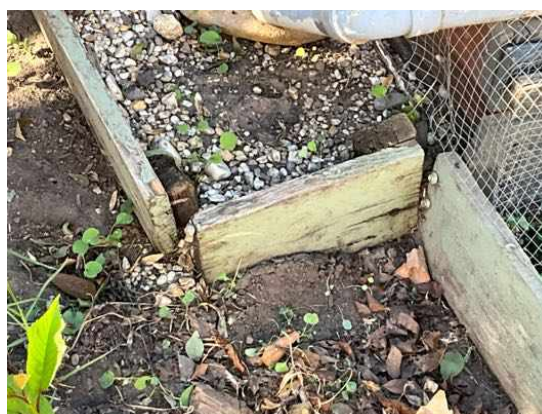
Building: Building 1  
 Location: Yard - Back  
 Finding: Untreated or non-durable timbers in a hazardous environment  
 Information: To reduce the risk of timber pest attack it is essential that timber used in a hazardous environment (e.g. in direct contact with the ground or frequently exposed to damp

conditions) is of sufficient durability and/or is adequately preservative treated.

Untreated timbers in direct contact with the ground are likely to develop severe wood rot and/or fungal decay if left unattended creating attraction for subterranean termites to infest the timbers from surrounding areas.

If untreated or non-durable timbers are found to be in a hazardous environment it is highly advised that replacement of these building elements be performed as soon as possible to aid the protection of the property against termite / timber pest attack.

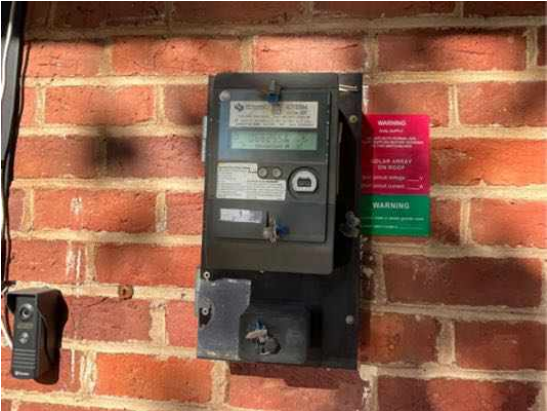
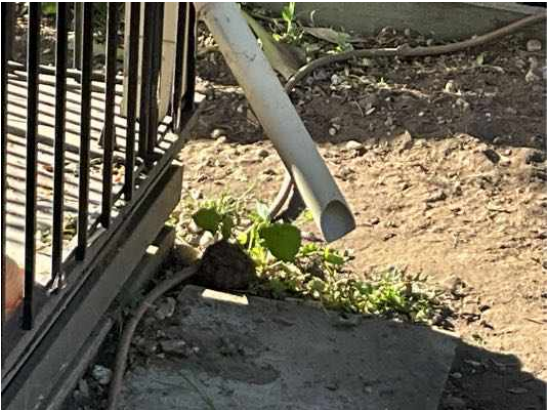
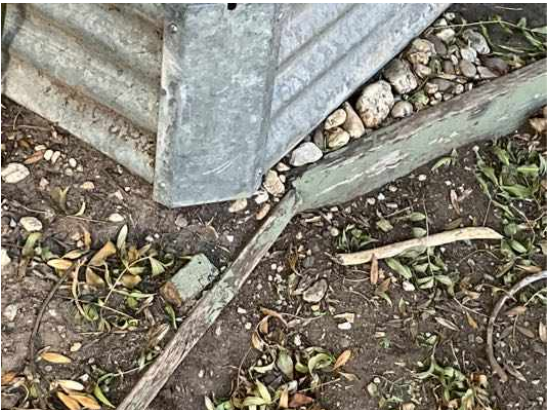
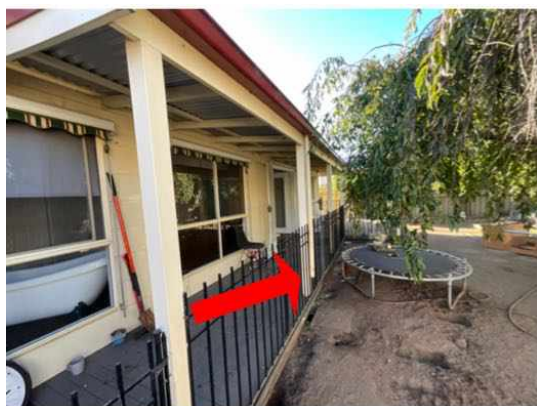
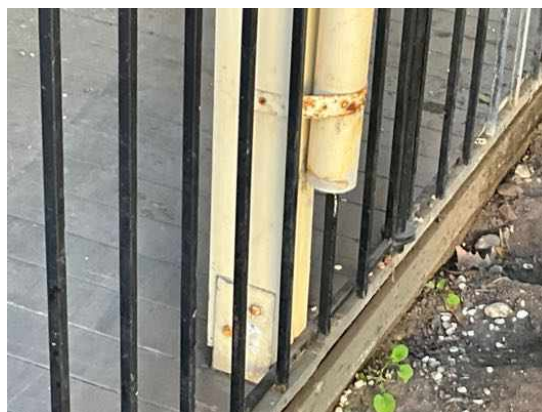
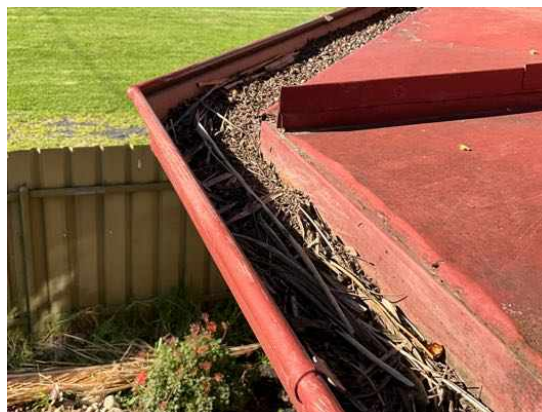
### Finding 6.07

Building:	Building 1
Location:	All External Areas
Finding:	Termite Management System - no evidence of a chemical installation
Information:	The application of a post-construction chemical termite barrier is highly recommended for all properties, particularly if live termite activity has been found on the site previously. Such barriers are highly effective in preventing termite attack on any timber building elements throughout the property.

A durable notice should be placed in the switchboard unit to indicate current termite barriers. At the time of inspection, it appeared as though no termite management system has been installed, with no evidence to suggest preventative works taking place.

The client may consider gaining further advice from a pest controller as to the costs and procedures involved with this application. It is recommended that obtaining such advice be a short-term priority.

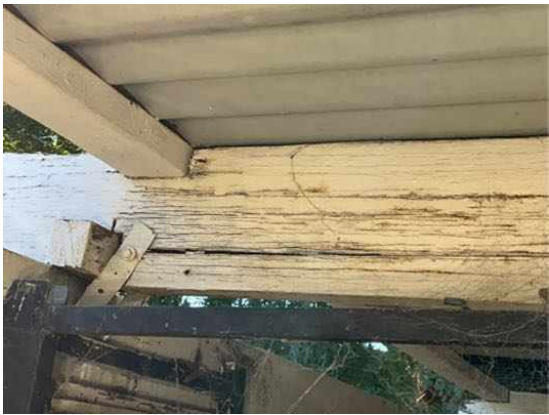
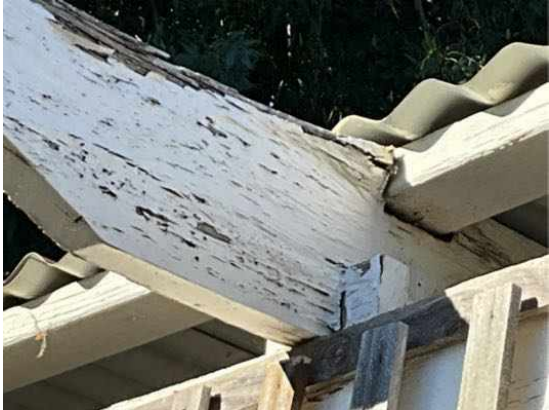
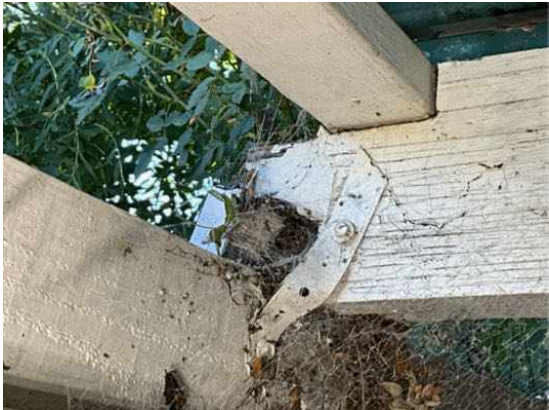
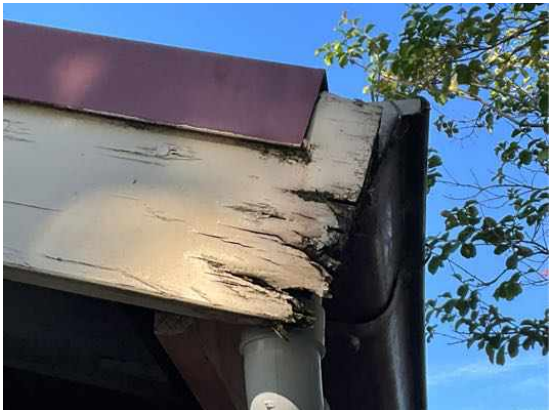
### Finding 7.01

Building:	Building 1
Location:	Alfresco, carport
Finding:	Fungal decay - present (localised)
Information:	Fungal decay also known as wood decay or wood rot generally refers to the deterioration of timber elements when in contact with excessive levels of moisture for a prolonged period of time.

The development of fungal decay is accelerated by temperatures in the range of 5degreeC to 40degreeC as well as the presence of oxygen. Generally fungal decay develops on timber elements that are in use in an external environment which are exposed to rain penetration.

In this case although the affected timber element is in a decaying state the extent of any visible damage appears to be localised to a specific area and is yet to spread to other parts of the building element or affect adjoining structures. The fungal decay is therefore likely to be of a relatively superficial nature with minimal impact on the structural integrity or tensile strength of the timber element.

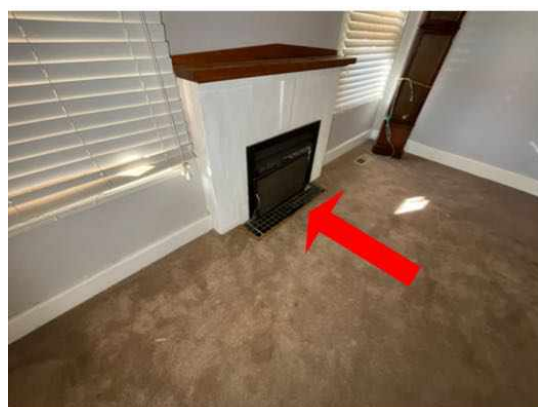
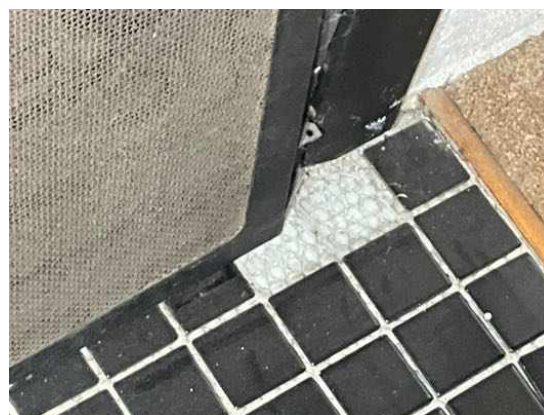
Building: Building 1  
 Location: Living Room  
 Finding: Tiles - Drummy  
 Information: Drummy tiled areas were identified at the time of inspection. The term 'drummy' refers to tiles that have become detached from their fixing, despite otherwise being in relatively good condition. Such defects are generally caused by physical or moisture damage to the area. Drummy tiled areas may also be a direct result of poor workmanship during the construction process.

Tiled areas may swell and shrink with changes in air humidity if the area has sustained moisture damage. Any exposure to moisture is capable of causing tiled areas to become drummy and/or cracked over a prolonged period of time. Drummy tiled areas generally require removal and replacement of affected tiles, with adequate sealant and grouting.

Specialist trades are available for these types of services. A registered builder may be required to undertake works if damage is extensive or if secondary building defects have resulted. Otherwise, it is advised that a tiling contractor be appointed to perform works as necessary. Immediate action is recommended to ensure that no further damage is sustained in the affected area.

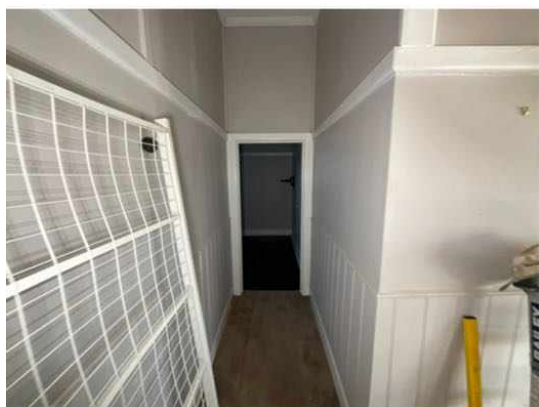
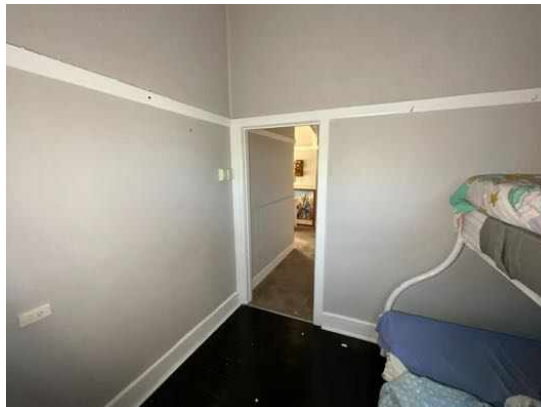
Building: Building 1  
 Location: Bedroom 2  
 Finding: Door- Missing  
 Information: During the visual inspection it was found that the door in this area is missing. The door may have been removed for practical reasons by a resident. No spare door was

readily apparent.

A Door specialist or Handy person should be appointed at the Owner's discretion to replace the door and restore the area to it's original function.

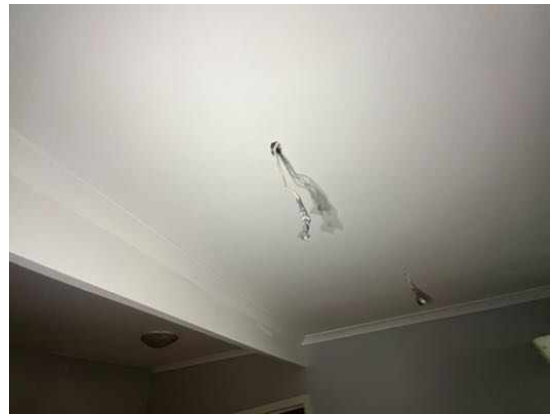
Building: Building 1  
 Location: Family Room  
 Finding: Plumbing and Electrical  
 Information: Some installations appear of poor quality. A plumber should be contacted at client discretion, to improve the installation and prevent further deterioration.

It is highly recommended that the client makes immediate arranges to have the gas appliances checked by a licensed gas plumber to ensure that the appliances are working safely and efficiently.

We recommend all other installations be checked also.

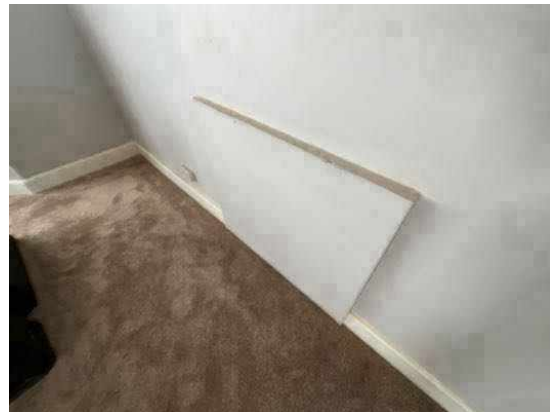
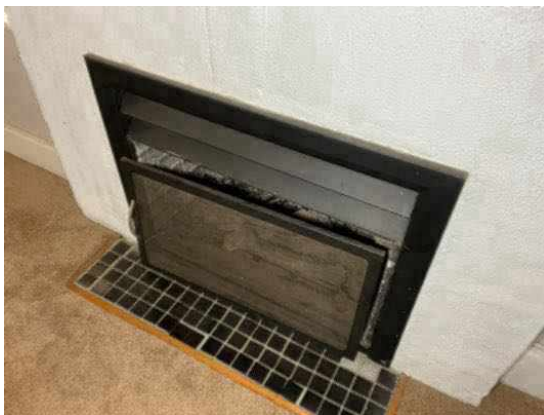
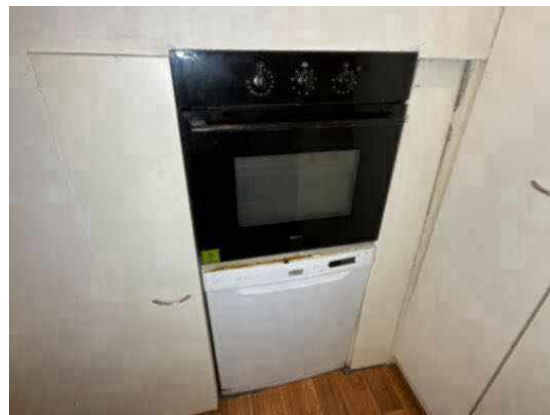
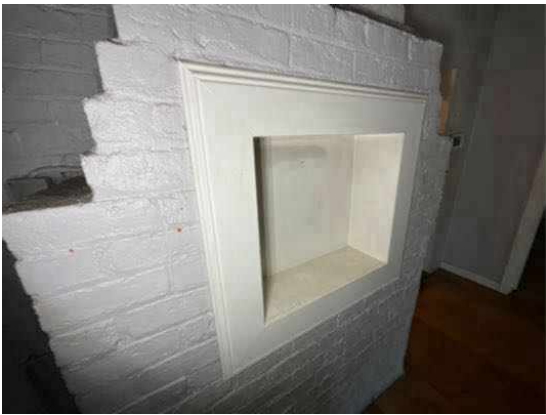
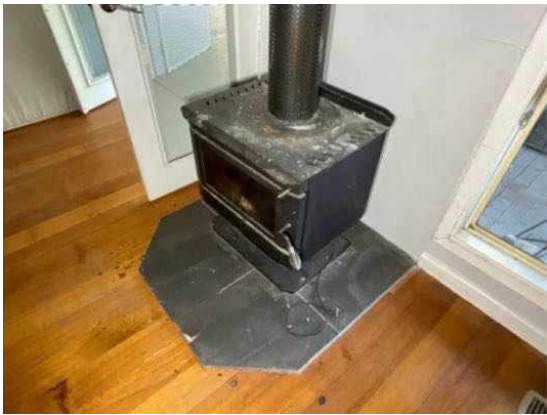
Building: Building 1  
 Location: All Areas  
 Finding: Additional Photos - Obstructions and Limitations  
 Information: These photographs are an indication of the obstructions and limitations which impeded full inspection of the property at the time of inspection. These obstructions can hide an array of defects and should be removed to allow full inspection to be carried out. A re-inspection is recommended once the areas are made accessible.
