# Building and Timber Pest Inspection Report

Inspection Date: Wed, 18 Feb 2026

Property Address: 27 Minories St, Port Adelaide SA 5015,  
Australia

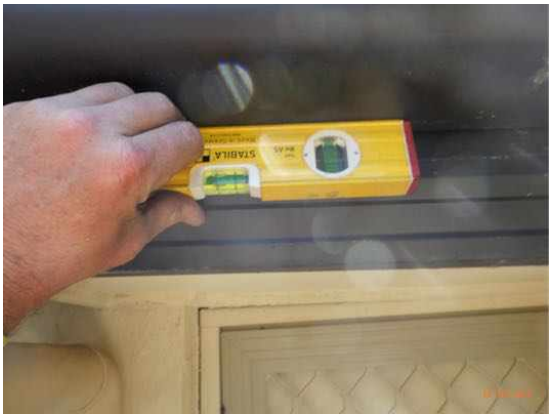
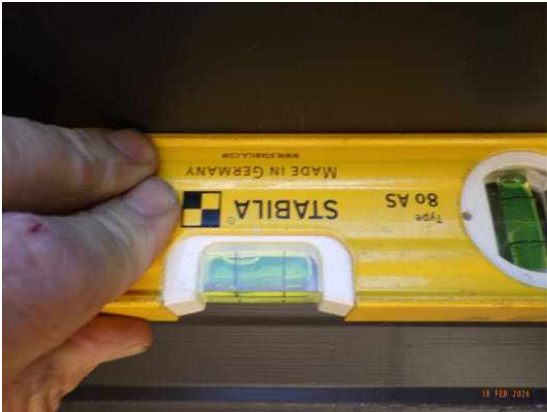
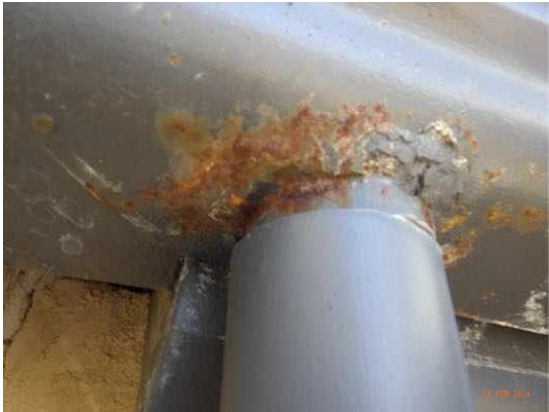
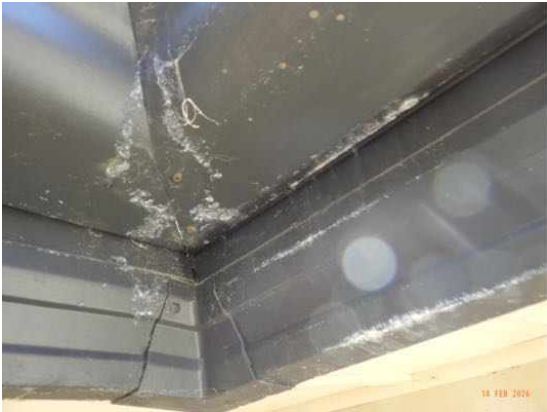
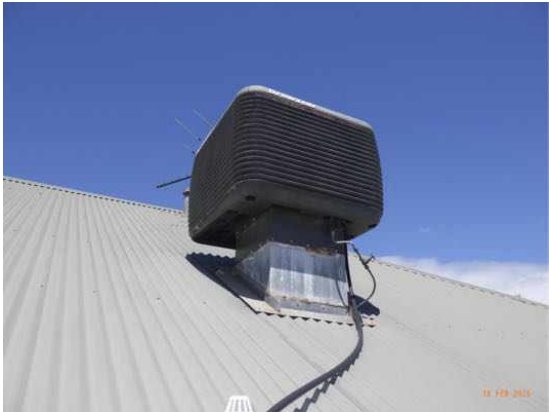
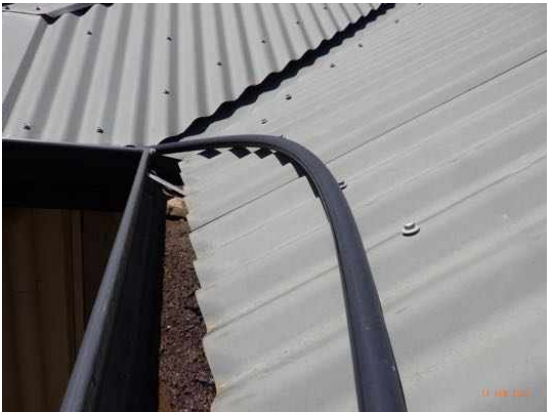
Building:	Building 1
Location:	Roof Exterior
Finding:	Roof plumbing - Rusted or corroded
Information:	The roof plumbing has areas of rust and corrosion. It is suspected that this has been caused by incorrect fall to the gutter and the proximity of the air-conditioner drainage pipe to the area, that have prematurely rusted elements of the roof plumbing.

Rusted roof plumbing will generally develop holes and leaks that can affect other building elements with poor drainage of storm water.

Poorly drained roof areas will also lead to damp conditions surrounding the base perimeter of the building which, if left unmanaged, can lead to a range of secondary building defects.

Repair and/or replacement of rusted roof plumbing is highly required in order to reinstate the roof drainage system to a fully operational level.

To further maintain these areas, gutters should be cleaned frequently, allowing the avoidance of any partial blockages.

A licensed plumber or specialist roof restoration company should be appointed to undertake these works. It is advised that such works be completed as soon as possible to prevent any further damage and deterioration.

Clear gutters and repair rusted section

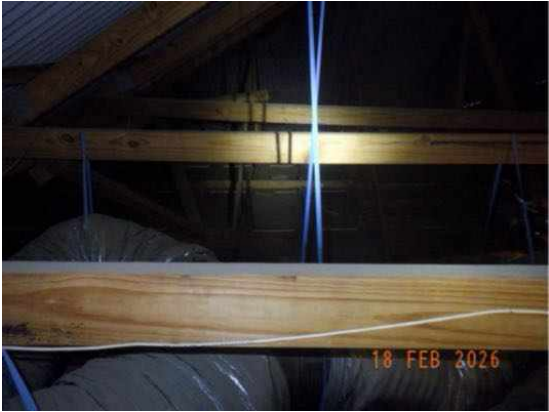
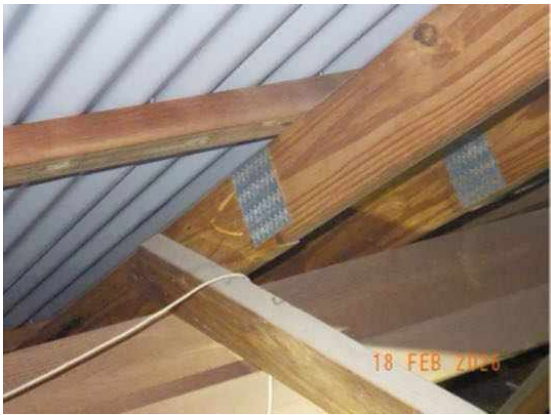
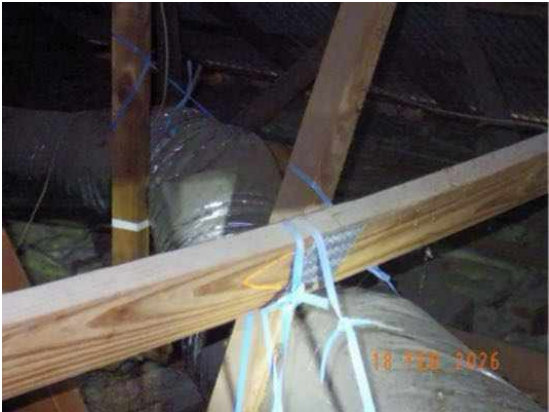
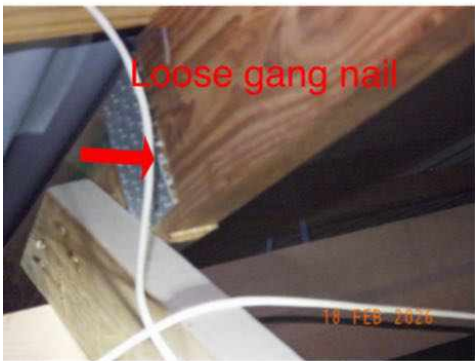
Finding 2.03

Building: Building 1  
Location: Roof Void  
Finding: Roof structure - Collar ties loose/ deteriorated  
Information: Upon inspection of the roofing structure, it was noted that a collar tie has become dislodged from their original fixings bracing and requires bolting in position.

There was also one gang nail that was noted to be backing out and as such all should be checked and repairs carried out.

These collar ties are very long due to the large span and reasonable high pitch and as such they should be braced in the centre and bolted at the ends to prevent further sag and degradation. Additional loads from the AC installation is a small contributing factor also.

Damage to roofing members can create secondary defects, ranging from sagging of the roof to degradation of ceiling linings.

A licensed carpenter should be appointed immediately to install bolts to collar ties and provide further remedial works to ensure no further movement in the future. As these are a structural element advice key be required from a structural engineer. Any loose gang nails should be repaired at the same time.

Repair collar ties and gang nails in the roof void

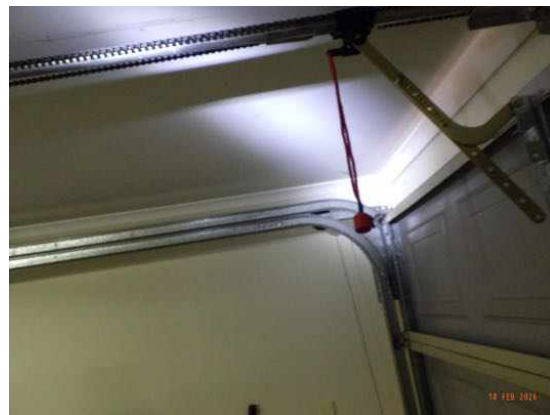
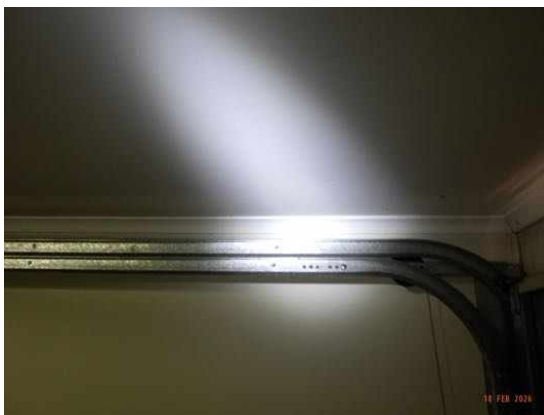
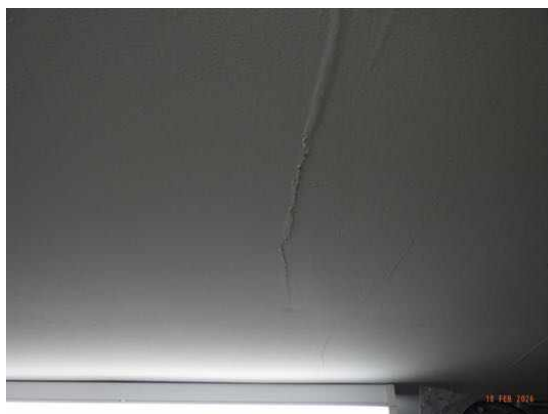
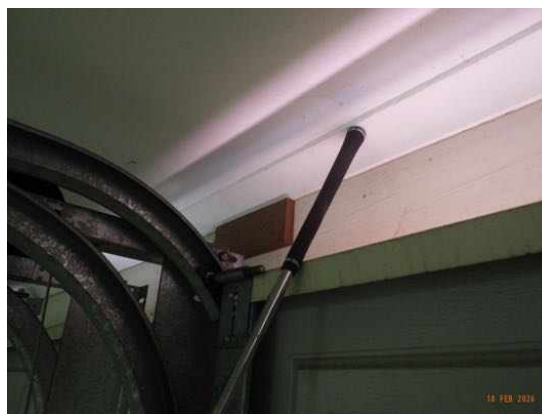
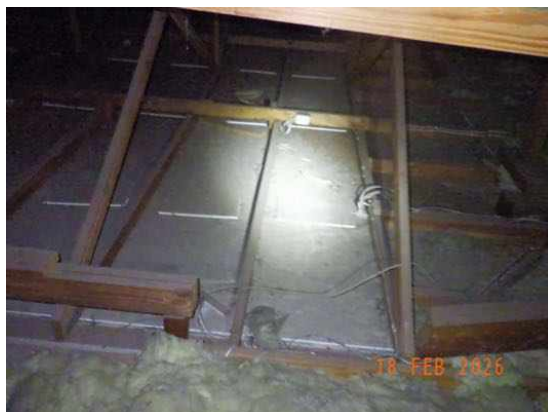
**Finding 3.01**

Building:	Building 1
Location:	Carport
Finding:	Ceiling sagging - Garage (minor)
Information:	Sections of the garage ceiling were found to be sagging and cracking at the time of inspection. Sagging to the fixed ceiling structure generally indicates that the building materials have swollen, due to contact with water, or that fixings (e.g. nails or glue) have become loose and require reattachment.

This is a very common defect in garages due to their lack of insulation, vibration from automatic doors and or their susceptibility to moisture.

Such works may be performed by relevant tradespeople, such as carpenters, plasterers and painters along with repairing the cracks.

It is recommended to insulate the area also to prevent further damage in the future.

Minor repairs to garage ceiling

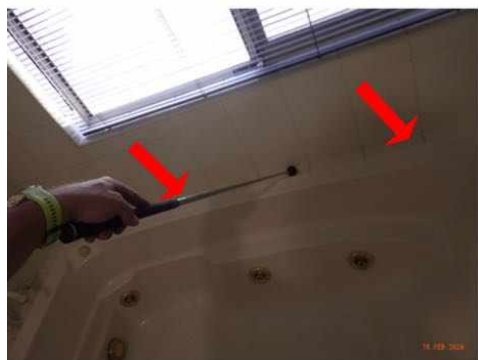
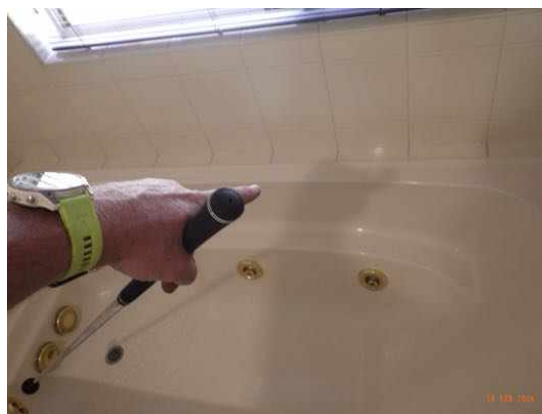
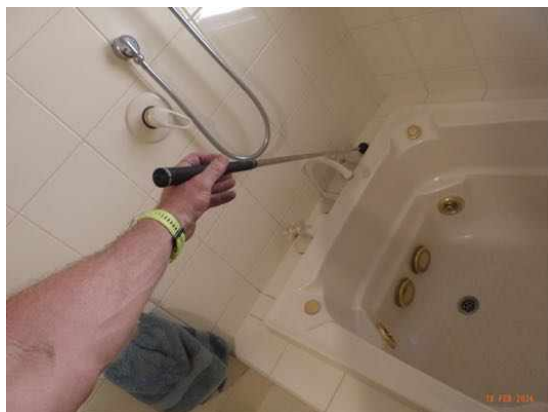
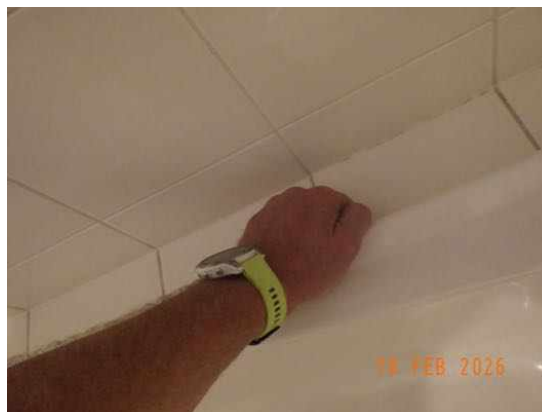
### Finding 3.02

Building:	Building 1
Location:	Bathroom
Finding:	Tiles - Drummy
Information:	Drummy tiles were identified to the bath surround at the time of inspection.

The term 'drummy' refers to tiles that have become detached from their fixing, despite otherwise being in relatively good condition, or sometimes they get laid onto dust during the building process and never really form a good bond. Such defects are generally caused by physical or moisture damage to the area or poor workmanship during the building process.

As no damage to tiles or grout was evident at the time of inspection further monitoring is recommended and should deterioration to the tiles become evident a licensed tiling contractor should be appointed to required repairs at the discretion of the client.

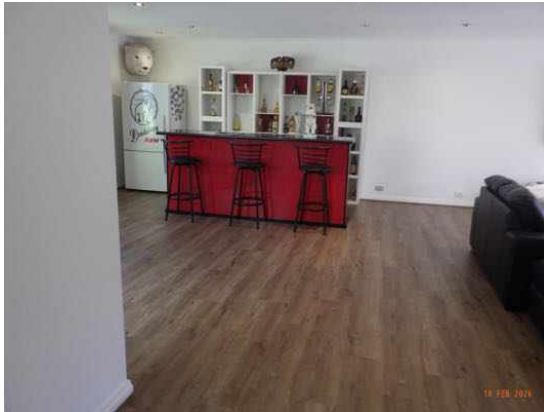
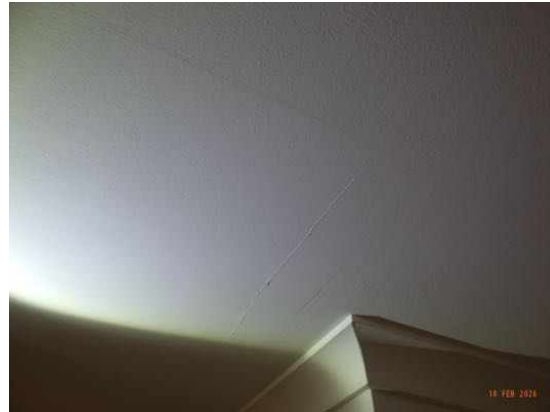
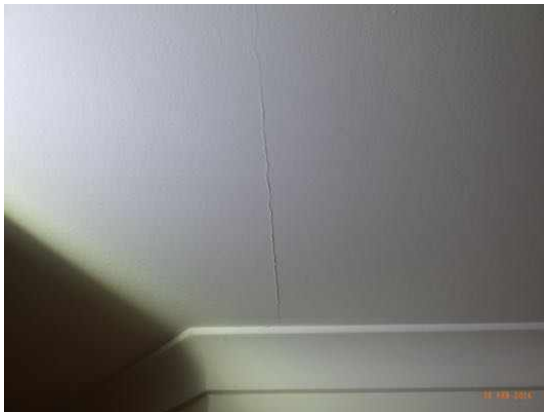
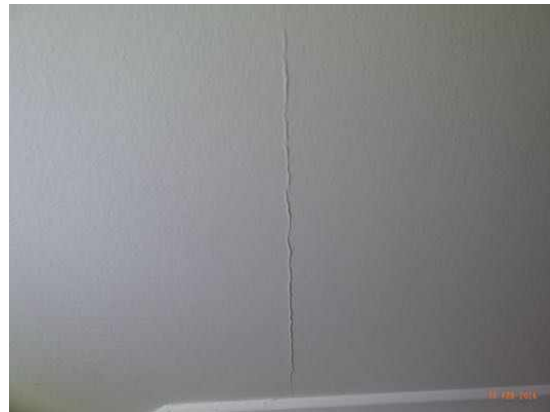
### Finding 3.03

Building:	Building 1
Location:	All Internal Areas
Finding:	Cracking - Damage Category 1 - Fine (up to 1mm)
Information:	There were fine cracks evident to the walls and ceilings throughout the dwelling at the time of inspection.

Although fine cracks are quite noticeable, they are often only considered to be an appearance defect, and usually do not indicate any structural damage. Generally, the cause of a fine crack is indicative of a separation between building materials and finishes (e.g. paint, plaster, etc.) along joints.

Cracking of this nature can generally be repaired with minor sanding, filling and/or repainting. Such works should be performed by a qualified painter or a general handyman.

Monitoring of all cracking should be conducted frequently. Always contact a building inspector should cracks widen, lengthen, or become more numerous.

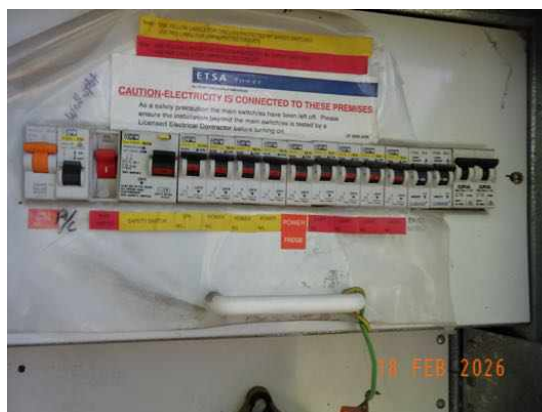
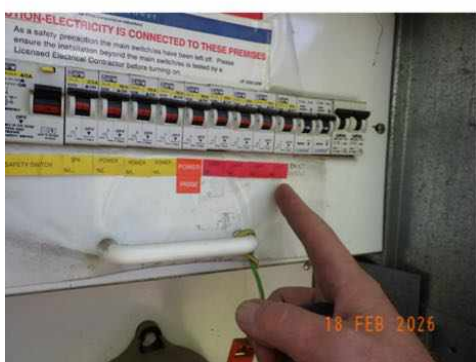
### Finding 3.04

Building:	Building 1
Location:	All Areas
Finding:	Minor defects present
Information:	Minor defects were evident throughout the dwelling at the time of inspection, which are consistent with normal wear and tear and considered appropriate for a property of this age.

These defects are typical of ongoing material ageing, settlement, and general use over time, and include, but are not limited to:

- Gate latch damaged

- Electrical labels are coming loose. Relabelling recommended.

While these defects are not considered structurally significant at present, they should be addressed as part of routine and ongoing property maintenance to prevent further deterioration. Repairs and maintenance works should be carried out by appropriately licensed and qualified tradespeople to ensure the continued serviceability and longevity of the dwelling.

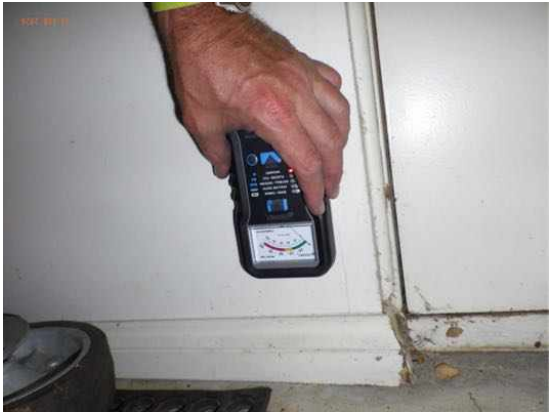
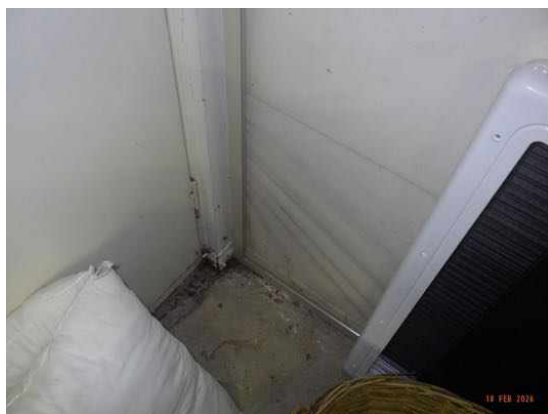
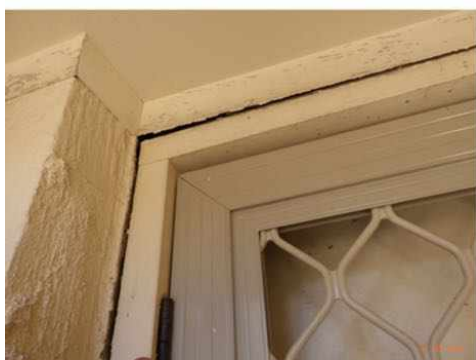
### Finding 6.02

Building: Building 1  
 Location: All Areas  
 Finding: Damp or wet - leak  
 Information: There was damage to the timber skirting evident to the sides of the garage side entry door at the time of inspection.

It appears that moisture is entering through poor seals to this door and as such repair is required.

Damp or wet conditions are generally a direct result of an active leak.. Dry conditions should be maintained to prevent secondary building defects from developing.

If left unattended damp or wet conditions may have many consequences including the development of fungal decay and/or wood rot as well as providing an environment that may be conducive to termite or timber pest attack. Further invasive investigation will likely uncover currently concealed defects.

A qualified carpenter should be appointed immediately to identify the cause of the excessive moisture and make repairs in order to prevent further damage.

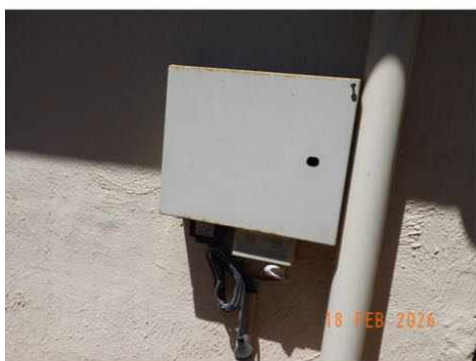
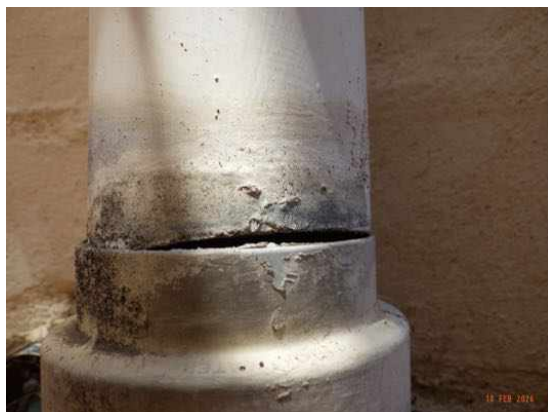
Building:	Building 1
Location:	All External Areas
Finding:	Stormwater drain - damaged/ leaking
Information:	The roof plumbing is not adequately connected to stormwater drainage on the site with damaged evident to several downpipes. Due to this damage the area could be prone to moisture related defects ranging from deterioration of pavements to damage of adjacent building elements.

Where roof plumbing doesn't drain adequately, the area at the base perimeter can become excessively damp, potentially creating an environment that is susceptible to rust and corrosion of surrounding building elements, as well as attracting termites and other pests.

It is highly recommended that a plumber be appointed to further inspect the area and to install adequate drainage equipment where necessary.

Repair any leaking stormwater pipes

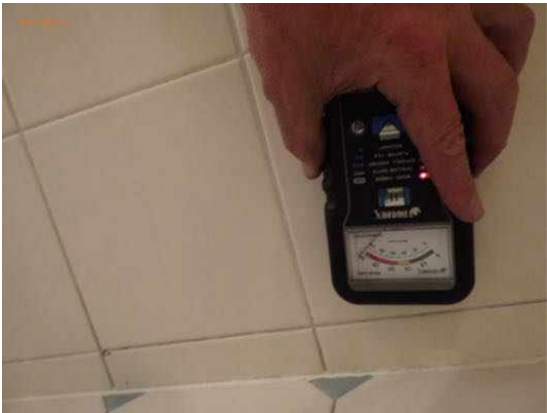
### Finding 6.05

Building:	Building 1
Location:	Ensuite - Master
Finding:	Shower damp - Sealant and grout
Information:	Damp is evident to sections of the lower wall to the shower alcove of the ensuite shower alcove.

This defect is quite common, and is suspected to have been caused by moisture permeating or leaching through the tiling, grouting and sealant in this area, which shows evidence of deterioration.

There were no high moisture readings around the taps no were there high readings transferring to the other side of the wall.

Unmanaged damp in the shower recess is likely to facilitate the formation and development of mould and fungi growth, decaying associated building materials and compromising their structural integrity of associated elements.

Consultation with a bathroom sealant specialist is advised immediately to make repairs to the shower alcove.

Always ensure that sealant and grout is in good condition to prevent any moisture issues occurring in the future.

Repair sealant and grout to bathroom

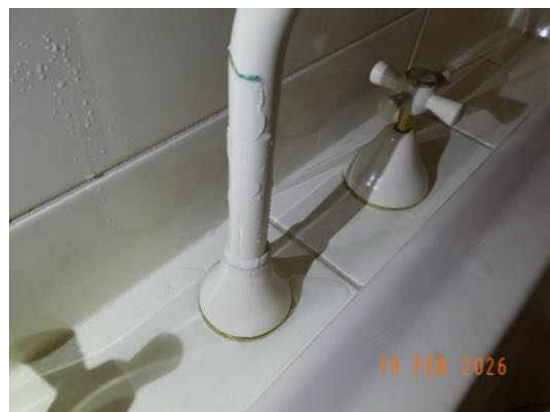
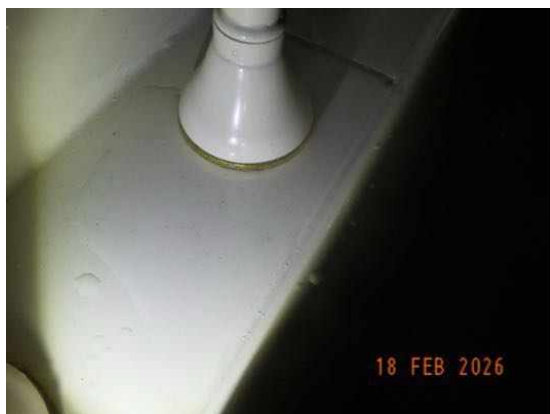
### Finding 6.06

Building:	Building 1
Location:	Bathroom
Finding:	Bath - Leaking
Information:	At the time of inspection, the bath tap showed evidence of leaking during operation likely due to general old age and corrosion as it is leaking out of the spout.

Although common, water leaks can be detrimental to surrounding building elements. Rust, corrosion, decay and water damage are all potential outcomes of a water leak that is left unattended, which are then likely to develop into more serious defects and may necessitate major repair works.

Additionally, water leaks may significantly increase the termite risk to the dwelling.

It is highly advised that water leak be addressed by a licensed plumber as soon as possible. Use of the leaking bath should be minimised until such time as the spout is replaced. .

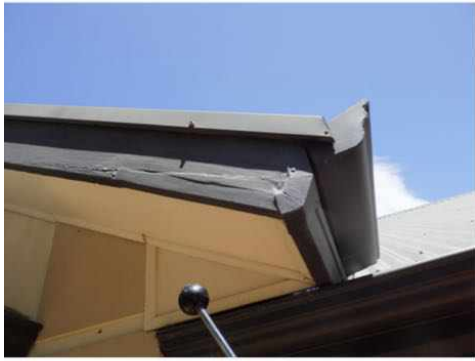
### Finding 7.01

Building:	Building 1
Location:	All External Areas
Finding:	Fascias - Wood rot
Information:	Wood rot was found to be affecting the front barge to the roof, evidenced by the presence of deterioration on the surface. Wood rot, also known as Fungal Decay, occurs when timbers and other cellulose building materials are exposed to damp conditions on an ongoing basis.

It appears that the rot has been repaired however closely monitoring the area to ensure no gutter leak exists is recommended.

It is likely that this wood rot has developed as a result of faults in the roof plumbing, creating excessive moisture in this areas.

Frequent exposure to rain and other weather conditions also make fascias and barges susceptible to accelerated deterioration.

It is advised to monitor the area and should a leak be present then a roof plumber be appointed to inspect all roof plumbing and subsequently identify the cause of the wood rot.

Replacement of affected fascias and barges may then be a necessary step in protecting surrounding building elements from such deterioration and would be carried out by a qualified carpenter.

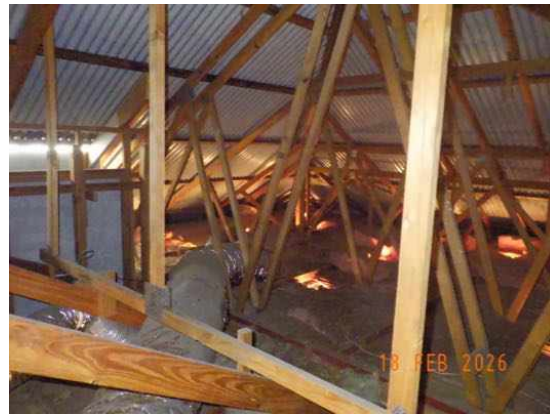
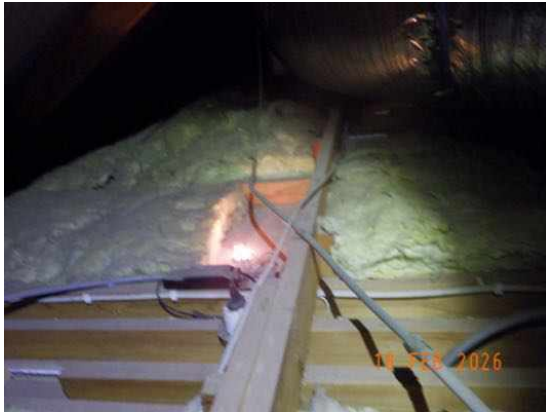
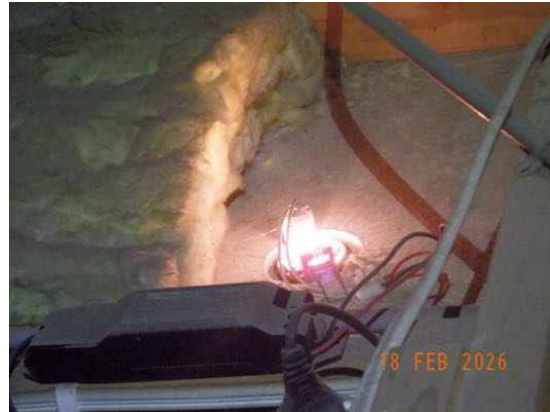
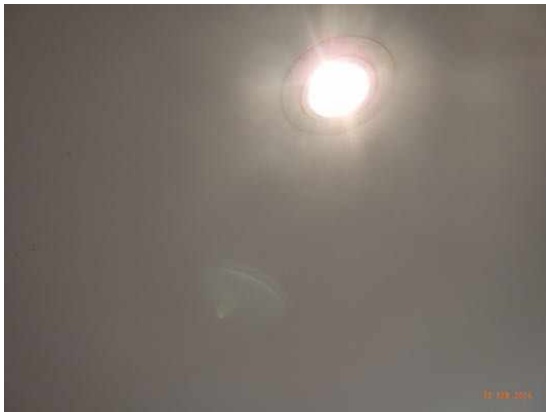
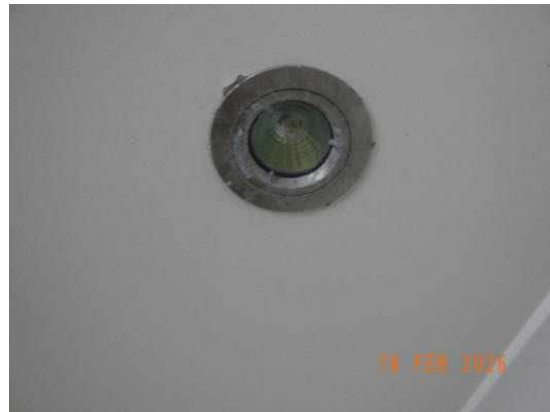
Building:	Building 1
Location:	Roof Void
Finding:	Down-lights, Halogen no protective covers
Information:	There were several lights that appear to be halogen down lights noted throughout the property.

Replace down-lights

Alternatively the lights could be swapped for LED equivalents which burn cooler and use considerably less power.

A qualified electrician should be appointed to provide further advice and quotation for replacement immediately.
