Building and Timber Pest Inspection Report

Inspection Date: Thu, 12 Feb 2026

Property Address: 70 Lochinvar Parade, Carlingford NSW
2118, Australia

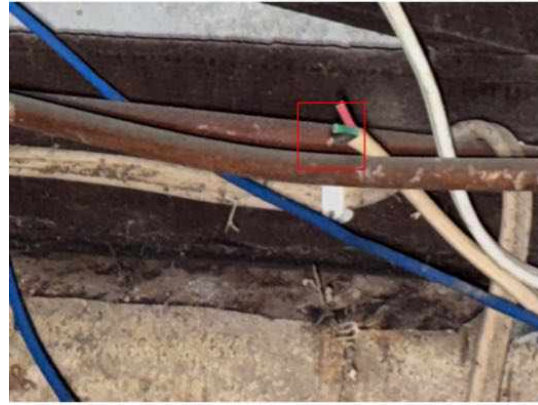
Building: Main Building
Location: Subfloor
Finding: Electrical wiring - Exposed/Messy
Information: Instances of exposed wiring, messy wiring, not in junction boxes or unprotected with electrical tape was identified in this area at the time of inspection.

We highly recommend that a licensed electrician be engaged to check this area and make safe all exposed wiring before any further inspections or works are carried out.

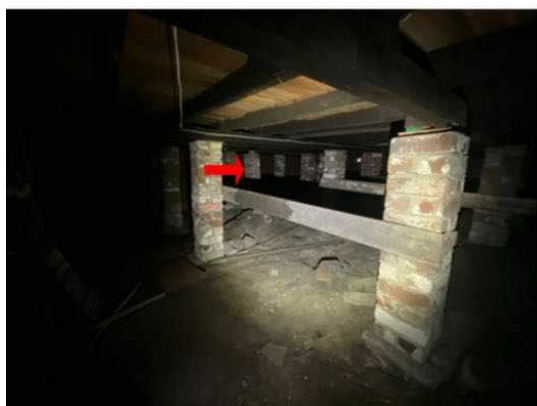
Building:	Main Building
Location:	Subfloor
Finding:	Piers -- Leaning (major)
Information:	Some piers to the subfloor are not supporting the suspended structure adequately, indicating that their structural integrity have been affected. The cause of this instability is likely to be caused by movement / subsidence of the pier due to moisture and inadequate site drainage.

Inadequate support is likely to lead to a range of other secondary major and minor defects and hence immediate rectification to these piers are required by a licensed builder. Monitoring and when required improving site drainage is recommended to avoid further movement / subsidence of the affected piers.

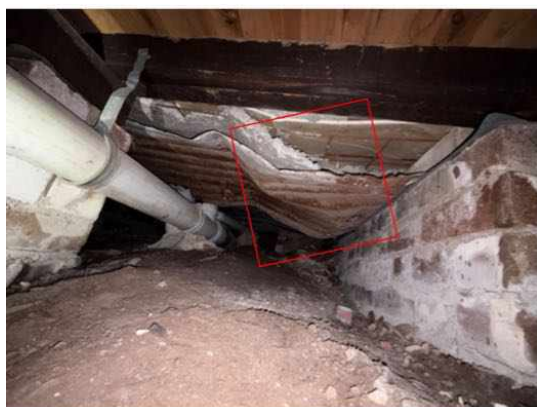
Works that have not been completed to a satisfactory level create potential for the development of building defects and may impede on the safety and integrity of the overall structure.

It is highly recommended that the relevant trades be appointed to complete these works and ensure the safety of the area and the longevity of all associated building elements.

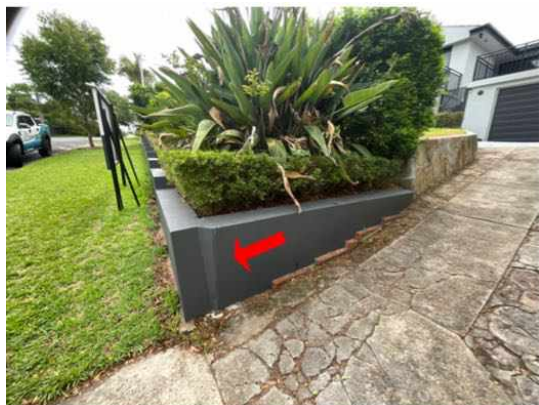
Building: Main Building
 Location: Retaining Walls
 Finding: Retaining wall — Cracking
 Information:

Cracking on retaining walls were identified in these areas. Generally, defective retaining walls are caused by poor original design or material use. However, deteriorated retaining walls may also be a result of substandard construction, poor site drainage or unmanaged stormwater flows.

AS4349.1-2007 requires all retaining walls in excess of 700mm to be inspected by a licensed and practicing structural engineer.

The structural engineer may draft a scope of works for a licensed trade to carry out rectifications.

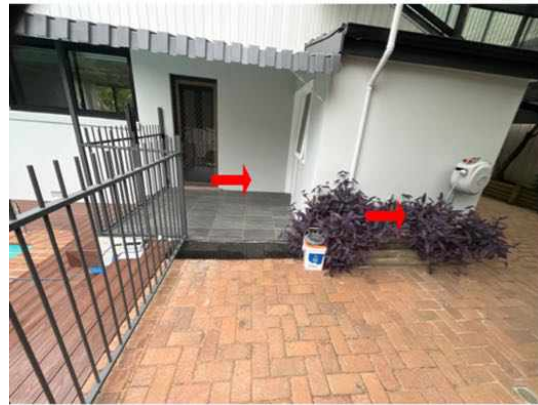
Building:	Main Building
Location:	Walls - Right & Rear
Finding:	Air vents - Blocked or inadequate
Information:	It was noted at the time of inspection that the subfloor area lacks adequate ventilation. The cause of this inadequate ventilation is the state of the air vents to the subfloor area. Where air vents are insufficient in number or are blocked, either fully or partially, subfloor ventilation is decreased.

A well ventilated subfloor aids in maintaining dry conditions, preventing secondary damage such as wood rot and pest activity, as well as preventing the development of mould/fungi and mildew (which can lead to major respiratory issues or safety hazards for occupants, particularly the elderly, the very young and those with existing illnesses).

All air vents should be cleared of blockages to promote adequate air flow to the area. Where ventilation is still insufficient, retrospective installation of air vents may be required. Appointment of a registered builder may be required to perform these works as necessary.

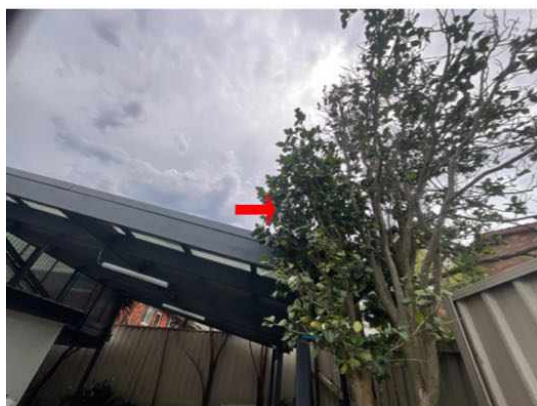
Gutters are a critical part of the building's management of storm water and rain. It is therefore important that they be kept clear to prevent secondary damage to associated building elements, including exterior and interior walls, ceiling linings and any adjoining building elements. Where gutters are blocked, pooling of rainwater is likely to occur, fast-tracking rust and corrosion of the roof plumbing elements.

It is highly advised that all overhanging tree branches be removed as soon as possible to prevent any further damage. Repair and/or replacement of sections of damaged guttering may also be required where the extent of the damage necessitates.

Such works should be performed by the homeowner; however, appointment of a landscape contractor or an arborist may be required. Consultation with a licensed roof plumber is required where guttering has been damaged.

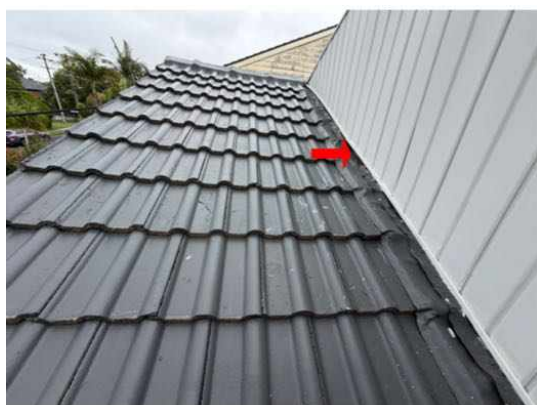
Building:	Main Building
Location:	Roof Exterior
Finding:	Roof flashing (acceptable) - Non-standard
Information:

The roof flashing that has been installed does not appear to comply with current building practice. However the flashing appears to be in an acceptable condition and is fulfilling its purpose in ensuring the roof covering is weather-tight.

Whilst retrospective fixing is not required if flashing begins to come loose from its fixing or deteriorates as evidenced by roof leaks a licensed roofing plumber should be appointed immediately to replace the building element.

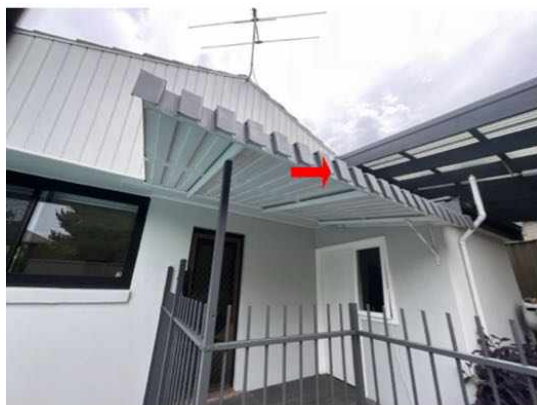
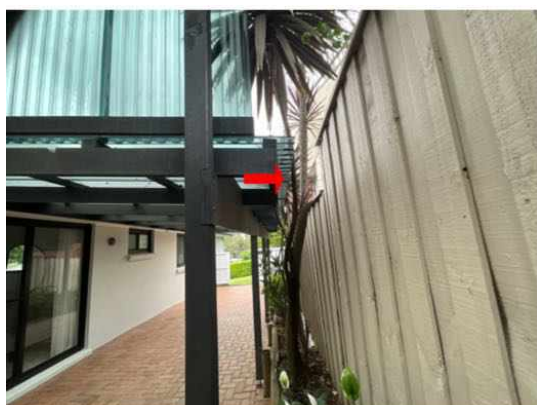
Building:	Main Building
Location:	Alfresco
Finding:	Roof plumbing - Missing
Information:	Some sections of the roof are not adequately drained via gutters and downpipes. Gutters and downpipes that are not installed adequately are likely to result in excessively damp conditions against the exterior surfaces and around the base perimeter of the building.

Excessive moisture creates an environment which accelerates the deterioration of building elements in the area, as well as being conducive to termite and pest infestation. Such an environment is likely to necessitate repair and/or replacement of building elements, which are prone to sustaining wood rot, rust or corrosion.

A roofing plumber should be appointed as soon as possible to install relevant roof plumbing materials. Depending on the extent of the damage, repair and/or replacement of damaged building elements may be required.

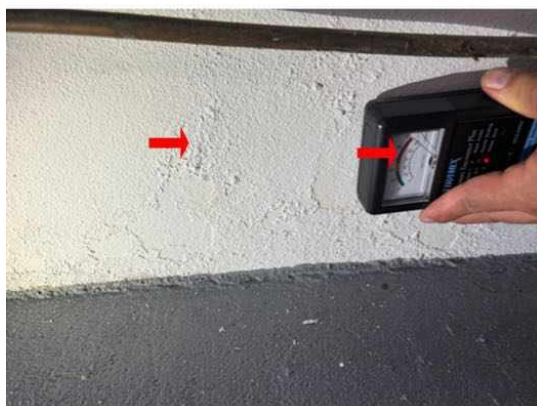
Building:	Main Building
Location:	Garage
Finding:	Exterior walls - Lateral damp
Information:	Lateral penetrating damp refers to the sideways movement of moisture, predominantly from the surrounding ground, which tends to affect basement walls and other earth-retaining walls. The implications of unmanaged damp range from mould fungi growth, wood rot and decaying building materials, to finishes including lifting, bubbling, peeling and staining of paint, plaster and wallpaper.

It is important to address damp conditions as the World Health Organisation notes that excess moisture leads - on almost all indoor materials - to the growth of microbes such as moulds, fungi and bacteria, which subsequently emit spores and other matter into the indoor air. Exposure to these contaminants is associated with a wide range of respiratory and other health-related problems. Additionally, the development of damp in timber building elements also provides an environment that is conducive to termite / timber pest attack.

Immediate consultation with a licensed plumber is advised to address the cause of the damp and to perform remedial works as necessary.

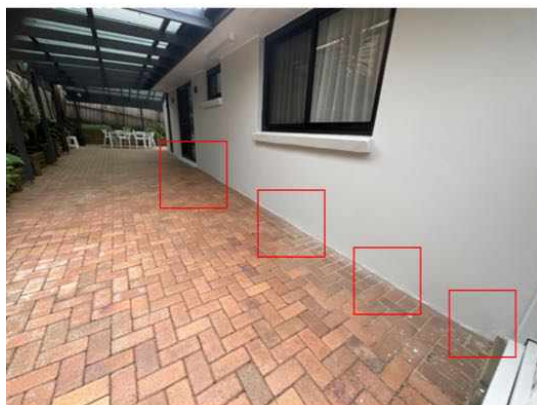
Damp proof course (DPC) is a barrier of impervious material built into a wall or pier to prevent moisture from moving to any part of the building. Where external ground levels are built up over this barrier ingress is provided for moisture from the exterior grounds into the base brickwork or other building material and allowed to rise.

Such conditions attract termites into these damp areas which is likely to lead to infestation if left untreated.

While retrospective fitting of DPC is considered to be impractical works are required in order to prevent the extraction of moisture from the external environment into exterior brickwork or wall materials. Landscaping or re-paving of external grounds may be considered by the client. Regular annual inspections are strongly advised.

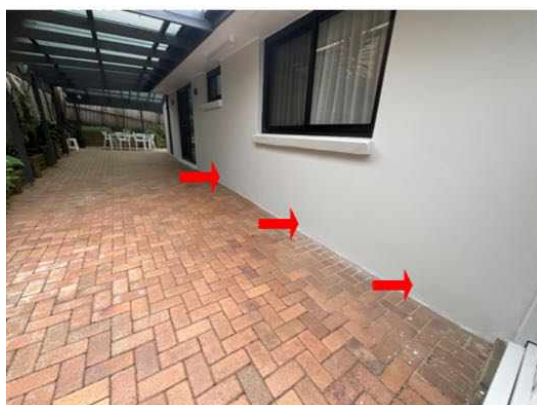
Building:	Main Building
Location:	Walls - Right & Rear
Finding:	Air vents - Blocked or inadequate
Information:	It was noted at the time of inspection that the subfloor area lacks adequate ventilation. The cause of this inadequate ventilation is the state of the air vents to the subfloor area. Where air vents are insufficient in number or are blocked, either fully or partially, subfloor ventilation is decreased.

A well ventilated subfloor aids in maintaining dry conditions, preventing secondary damage such as wood rot and pest activity, as well as preventing the development of mould/fungi and mildew (which can lead to major respiratory issues or safety hazards for occupants, particularly the elderly, the very young and those with existing illnesses).

All air vents should be cleared of blockages to promote adequate air flow to the area. Where ventilation is still insufficient, retrospective installation of air vents may be required. Appointment of a registered builder may be required to perform these works as necessary.

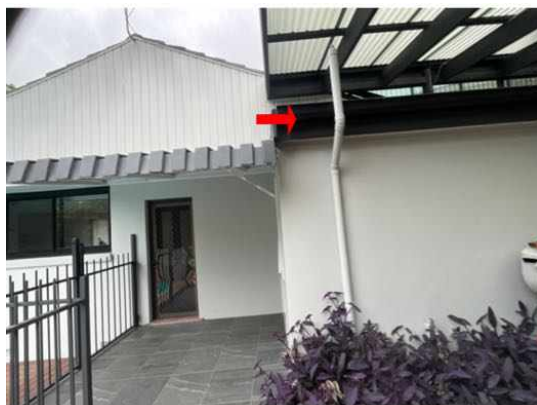
Building:	Main Building
Location:	Rear Elevation
Finding:	Stormwater drain - Not connected
Information:	The roof plumbing is not adequately connected to stormwater drainage on the site. This disconnection negatively impacts the functional capacity of the roof plumbing.

Where roof plumbing doesn't drain adequately, the area at the base perimeter can become excessively damp, potentially creating an environment that is susceptible to rust and corrosion of surrounding building elements, as well as attracting termites and other pests.

It is highly recommended that a plumber be appointed to further inspect the area and

to install adequate drainage equipment where necessary.

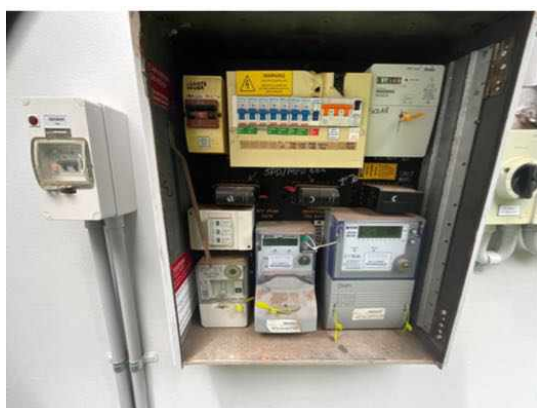
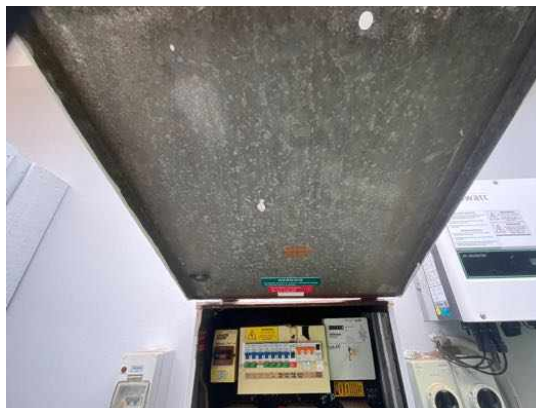
Building:	Main Building
Location:	Meterbox
Finding:	Termite Management System - no evidence of installation
Information:	The application of a post-construction chemical termite barrier is highly recommended for all properties, particularly if live termite activity has been found on the site previously. Such barriers are highly effective in preventing termite attack on any timber building elements throughout the property.

The client may consider gaining further advice from a pest controller as to the costs and procedures involved with this application. It is recommended that obtaining such advice be a short-term priority.

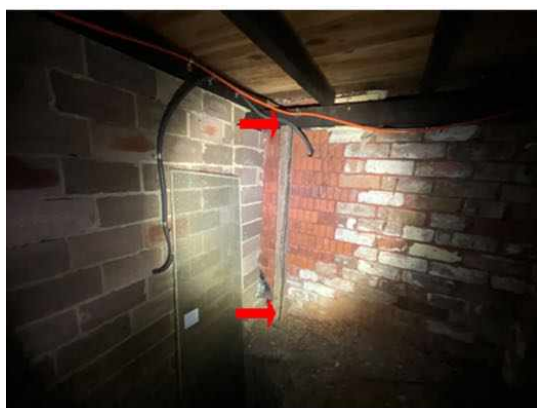
Building:	Main Building
Location:	Subfloor
Finding:	Bridging of termite barrier
Information:	Bridging of termite barriers occurs when termites bridge (usually by building a mud tunnel) a termite barrier or inspection zone or where termites have a passage allowing them to bridge the barrier.

Generally this takes the form of finished ground levels external paving or concrete being retrospectively installed above the damp course level the adjacent internal floor level or weep and ventilation holes.

Where bridging has occurred full inspection is prevented and termites may enter a property in a concealed or undetectable manner.

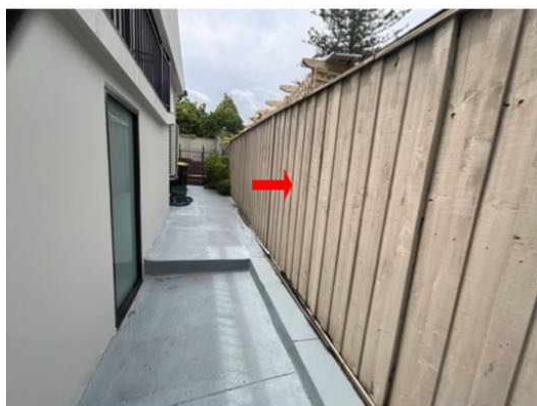
Building:	Main Building
Location:	Fencing & Landscaping
Finding:	Building materials in direct ground contact - conducive to termites
Information:	Where timber elements are in direct contact with the ground and consequently moisture or dampness they become conducive to termite activity. Whether timber is used as a building element part of a fencing structure or stored as an unused item they can provide an environment that is attractive to termite infestation.

The removal of any such materials that may be conducive to termite activity should be removed as soon as possible to minimise the risk of termite attack.

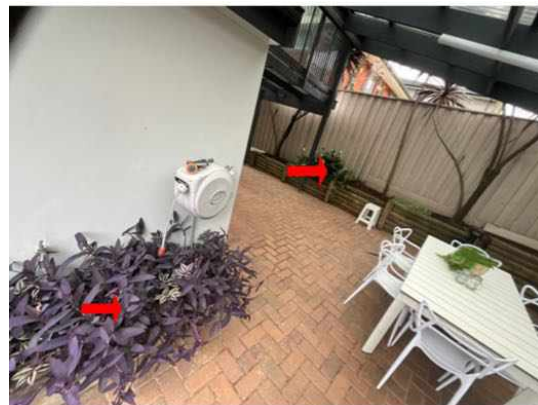
Building:	Main Building
Location:	Garden beds
Finding:	Garden Beds
Information:	Garden beds were found to be evident in the garden area. These garden beds can include untreated timber, and with a combination of moisture from watering or hosing can make conditions conducive to termite activity and termite ingress.

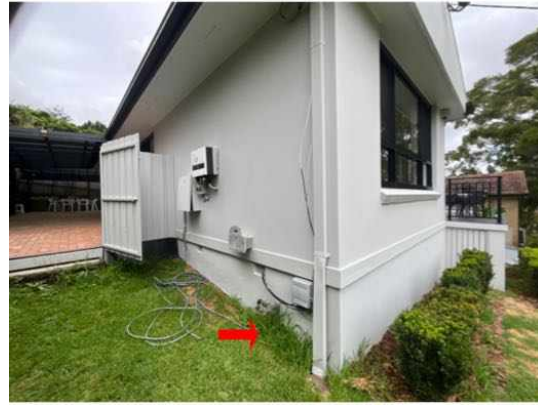
Building:	Main Building
Location:	External tap
Finding:	Tap - No drain
Information:	<p>The external tap in this area was noted to have no drain at the time of inspection.</p> <p>This keeps the surrounding surfaces damp while using the tap, which becomes conducive to termite activity.</p> <p>A licensed plumber must be appointed to ensure an appropriate drain is installed.</p>
