Building and Timber Pest Inspection Report

Inspection Date: Tue, 7 Apr 2026

Property Address: 134 West St, Casino NSW 2470, Australia

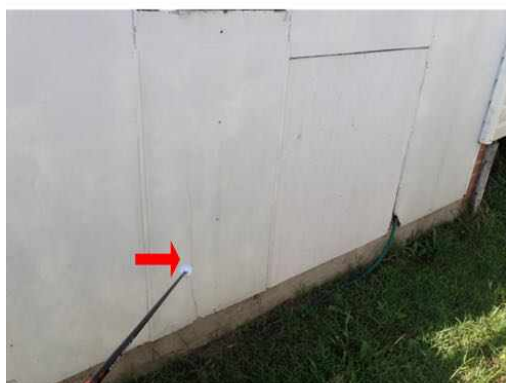
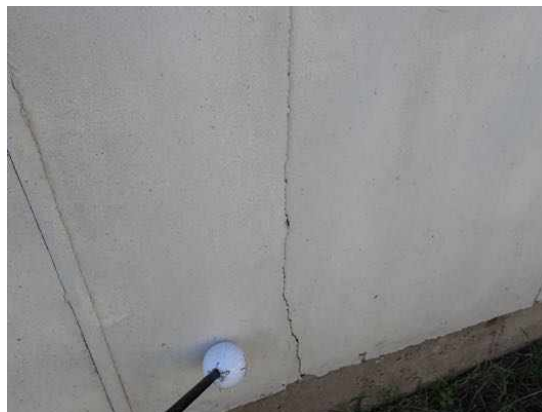
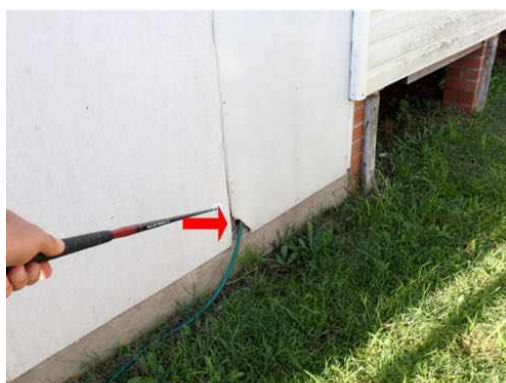
Finding 1.01

Building:	Main Building
Location:	Left hand elevation
Finding:	Damaged External Cladding Suspected To Contain Asbestos
Information:	External cladding suspected to contain asbestos has been identified as damaged. This may be due to age-related deterioration, impact damage, or previous works. Disturbance of asbestos-containing materials can pose a health risk if fibres become airborne. It is recommended that a licensed asbestos professional assess the material, confirm its composition, and carry out any necessary repairs or removal in accordance with relevant regulations. Repairs should be undertaken in a controlled manner to minimise risk.

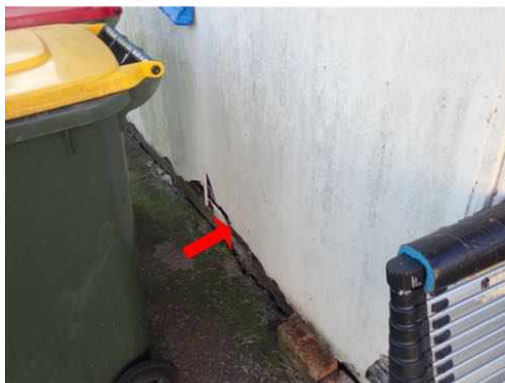
Finding 1.02

Building:	Garage
Location:	External cladding
Finding:	Damaged External Cladding Suspected To Contain Asbestos

Information: External cladding suspected to contain asbestos has been identified as damaged. This may be due to age-related deterioration, impact damage, or previous works. Disturbance of asbestos-containing materials can pose a health risk if fibres become airborne. It is recommended that a licensed asbestos professional assess the material, confirm its composition, and carry out any necessary repairs or removal in accordance with relevant regulations. Repairs should be undertaken in a controlled manner to minimise risk.

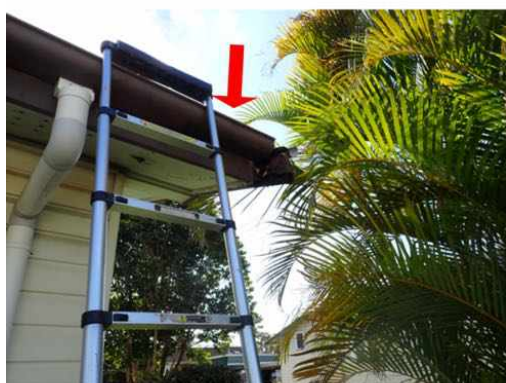
Finding 2.02

Building:	Main Building
Location:	Gutter front right hand side of roof
Finding:	Rust To Front Right Hand Side Gutter
Information:	Significant rust has been identified to the front right-hand side gutter. This is typically associated with advanced age-related deterioration, prolonged moisture exposure, and failure of protective coatings. The condition indicates the guttering is likely compromised and may leak or fail, leading to uncontrolled water discharge and potential damage to adjacent building elements. It is recommended that a licensed plumber replace the affected gutter sections to ensure proper drainage and prevent further deterioration.

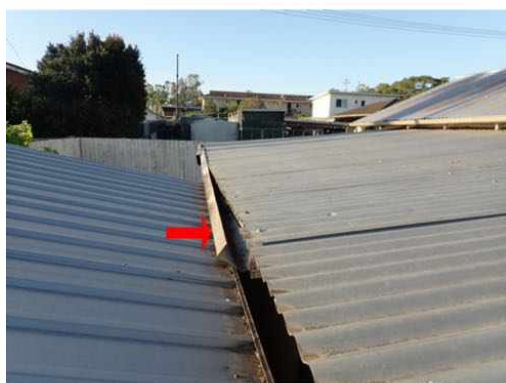
Finding 2.03

Building:	Garage
Location:	Roof
Finding:	Missing Gutter To Garage Roof
Information:	A gutter is missing to the garage roof. This may be due to removal, damage, or incomplete installation. The absence of a gutter can result in uncontrolled water discharge, potentially leading to water ingress, erosion, or damage to adjacent building elements. It is recommended that a licensed plumber or suitably experienced handyman install an appropriate gutter system to manage roof water effectively. Repairs can be carried out at the owner's discretion.

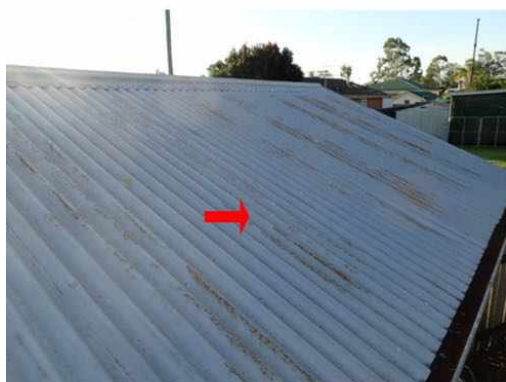
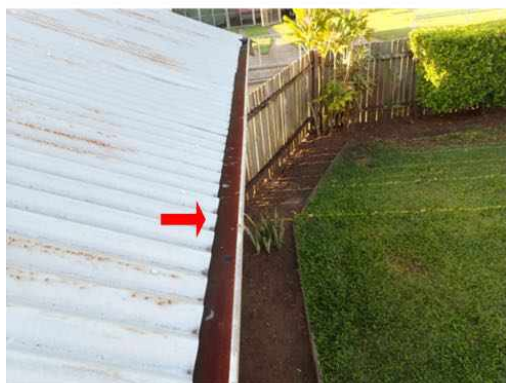
Finding 2.04

Building:	Garage
Location:	Roof
Finding:	Rust To Garage Roof Cladding And Guttering
Information:	Rust has been identified to the garage roof cladding and guttering. This is typically associated with age-related deterioration, prolonged weather exposure, and breakdown of protective coatings. If left untreated, corrosion may progress and lead to leaks or failure of the affected components. It is recommended that a licensed roofer or suitably experienced handyman treat or replace the affected sections and ensure the roof and drainage system are functioning correctly. Repairs can be carried out at the owner's discretion.

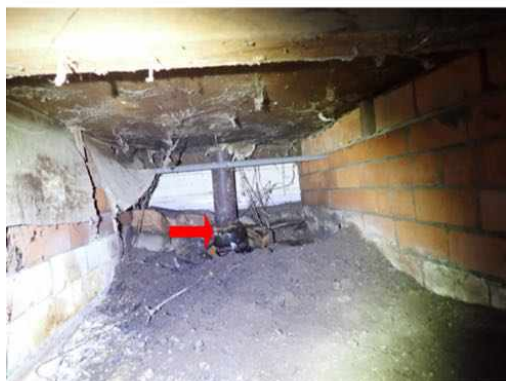
Finding 2.05

Building:	Main Building
Location:	Subfloor
Finding:	Leaking Plumbing To Subfloor Below Toilet
Information:	Plumbing has been identified as leaking within the subfloor below the toilet. This is typically associated with failed seals, pipe deterioration, or connection issues. Ongoing leakage may lead to moisture build-up, deterioration of surrounding building materials, and conditions conducive to termite activity if left unaddressed. It is recommended

that a licensed plumber locate and repair the source of the leak and ensure the area is adequately dried. Prompt repairs are strongly recommended to prevent further damage.

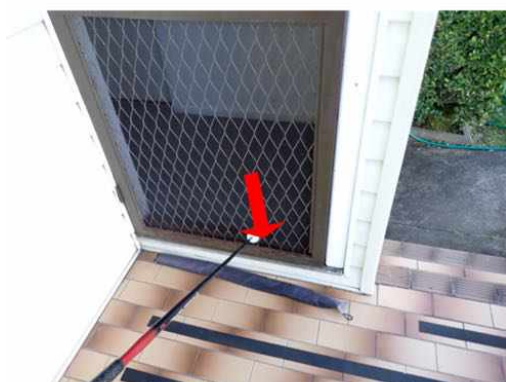
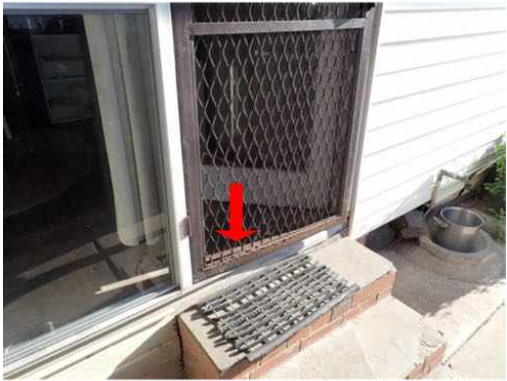
Finding 3.01

Building:	Main Building
Location:	Front and rear entry doors
Finding:	Rust To Bottom Of Front And Rear Security Doors
Information:	Rust has been identified to the bottom sections of the front and rear security doors. This is typically associated with age-related deterioration, moisture exposure, and breakdown of protective coatings. If left untreated, corrosion may worsen and lead to further deterioration of the door frames. It is recommended that a painter, metal fabricator, or suitably experienced handyman treat the affected areas, remove corrosion, and apply protective coatings, or replace components as required. Repairs can be carried out at the owner's discretion.

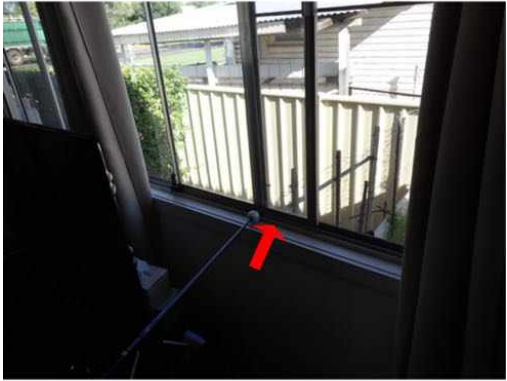
Finding 3.02

Building: Main Building
Location: All windows
Finding: Sliding Windows Require General Maintenance
Information: All sliding windows throughout the main building were operational at the time of inspection, however general maintenance is required. This is typically associated with age-related deterioration and is considered a common defect. Ongoing wear may affect ease of operation over time if not maintained. It is recommended that a carpenter or suitably experienced handyman service the windows, including cleaning tracks, lubricating moving parts, and adjusting components as required. Maintenance can be carried out at the owner’s discretion.

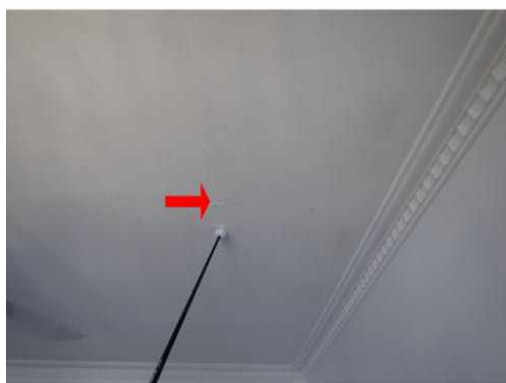
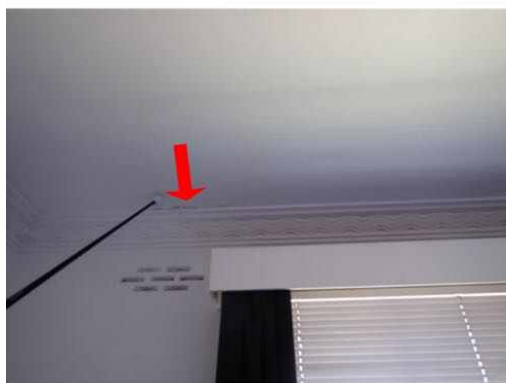
Finding 3.04

Building:	Main Building
Location:	Ceilings
Finding:	Flaking Paint To Ceilings At Isolated Locations
Information:	Paintwork is flaking to ceiling areas at several isolated locations. This is typically associated with age-related deterioration, moisture exposure, or inadequate surface preparation during previous painting works. Continued deterioration may result in further paint loss and potential exposure of underlying surfaces. It is recommended that a painter or suitably experienced handyman prepare the affected areas and repaint as required. Repairs can be carried out at the owner's discretion.

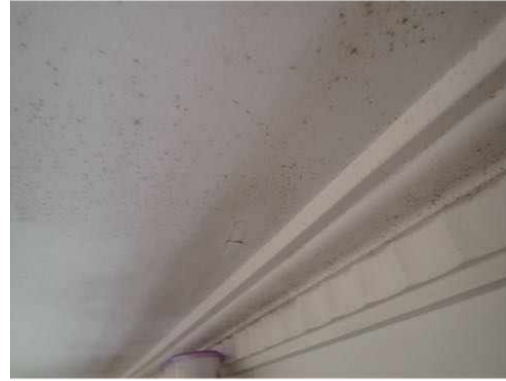
Finding 3.05

Building:	Main Building
Location:	Bedrooms and living room
Finding:	Minor Mould Spots To Bedroom And Living Room Ceilings (Southern Corner)
Information:	Small mould spots have been identified to the ceilings of the bedrooms and living room, predominantly to the southern corner. No elevated moisture readings were detected at the time of inspection using a moisture meter. This condition is typically associated with condensation, limited ventilation, or cooler internal surface temperatures rather than active moisture ingress. If left unaddressed, mould growth

may increase and affect indoor air quality and surface finishes. It is recommended that a suitably experienced handyman or cleaning specialist treat and remove the mould, and that ventilation to affected areas be improved where possible. Repairs and maintenance can be carried out at the owner's discretion.

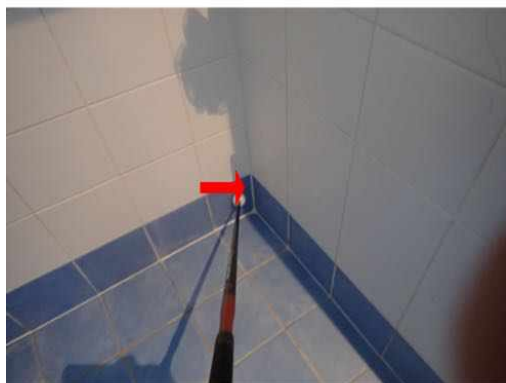
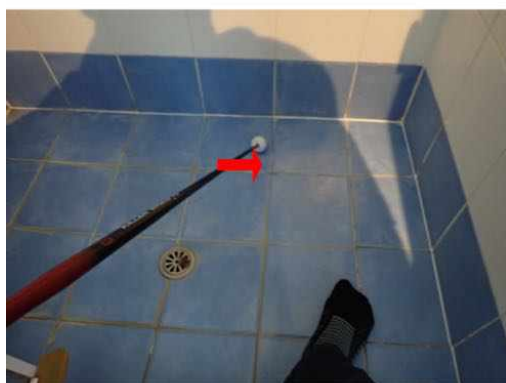
Finding: Deteriorated Grout And Silicone To Shower Area

Information: Deterioration of grout and silicone has been identified to the shower area. This is typically associated with age-related wear, moisture exposure, and breakdown of sealants over time. Defective grout and silicone may allow water ingress into surrounding building materials, potentially leading to further deterioration if left unaddressed. It is recommended that a tiler or suitably experienced handyman remove and replace the affected grout and silicone to ensure a watertight seal. Repairs can be carried out at the owner's discretion.

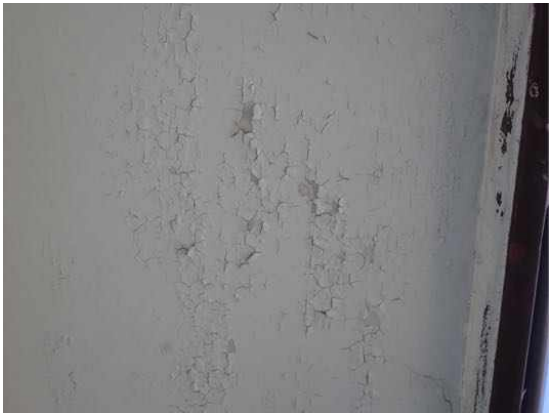
Finding 3.11

Building: Main Building
Location: Eaves and fascia boards
Finding: Deteriorated And Flaking Paint To Fascia Boards And Eaves
Information: Deteriorated and flaking paint has been identified to the fascia boards and eaves. This is typically associated with age-related wear, weather exposure, and breakdown of protective coatings. If left unaddressed, exposed timber may be susceptible to moisture ingress and further deterioration. It is recommended that a painter or suitably experienced handyman prepare the surfaces and repaint to provide adequate protection. Repairs can be carried out at the owner’s discretion.

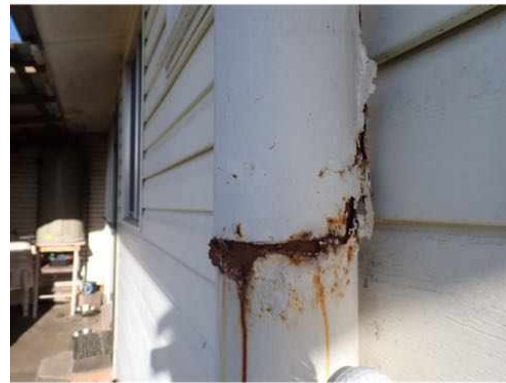
Finding 3.13

Building:	Main Building
Location:	Right hand side elevation
Finding:	Rusted Plumbing Vent Pipe
Information:	The plumbing ventilation pipe has been identified as rusted. This is typically associated with age-related deterioration, weather exposure, and breakdown of protective coatings. If left untreated, corrosion may progress and lead to failure of the pipe. It is recommended that a licensed plumber replace or repair the affected pipe and apply appropriate protective measures. Repairs can be carried out at the owner's discretion.

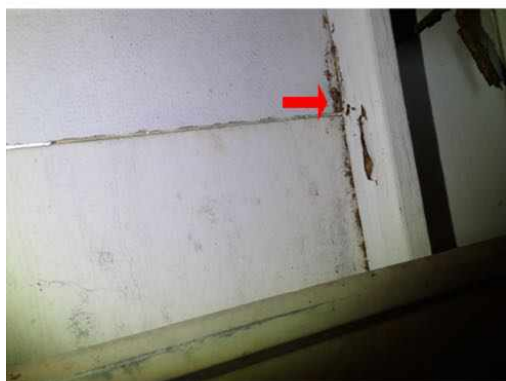
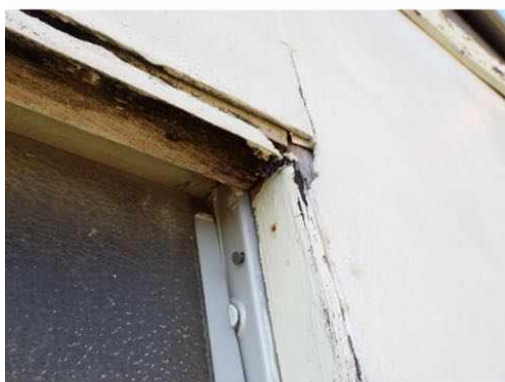
Finding 5.01

Building:	Main Building
Location:	Rear covered area
Finding:	Termite Damage To Framework And Window At Rear Covered Area
Information:	Termite damage has been identified to the framework and window within the rear covered area. This is typically associated with previous or ongoing termite activity. Damaged timber may continue to deteriorate over time if left unaddressed. It is recommended that a licensed builder or suitably experienced handyman repair or replace the affected timber and ensure the area is reinstated appropriately. It is also recommended that a licensed timber pest controller be engaged to assess for active infestation and implement appropriate treatment measures. Prompt action is strongly recommended to prevent further damage.

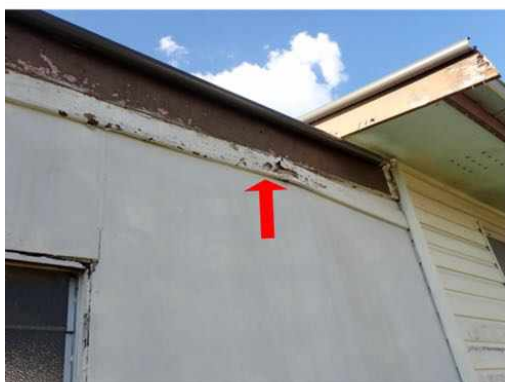
Building: Main Building
 Location: Fascia boards
 Finding: Wood Rot To Fascia Boards At Multiple Locations
 Information: Wood rot has been identified to the fascia boards at multiple locations. This is typically associated with prolonged moisture exposure and breakdown of protective coatings. Timber in this condition may continue to deteriorate and is conducive to termite attack if left unaddressed. It is recommended that a carpenter or suitably experienced handyman repair or replace the affected timber and apply appropriate protective finishes to prevent recurrence. Repairs can be carried out at the owner’s discretion.

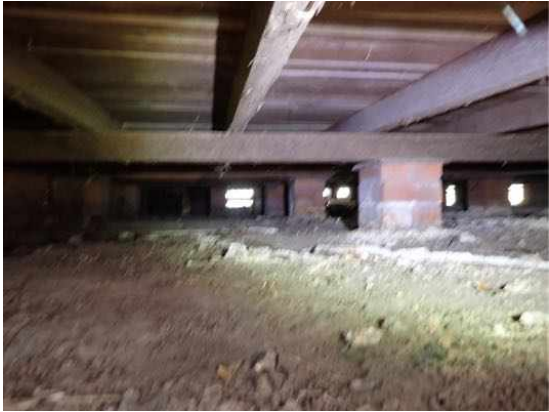
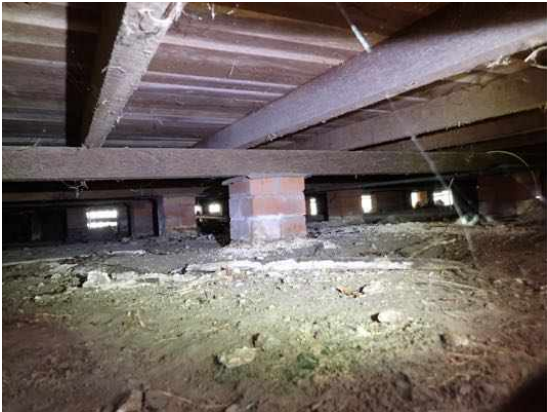
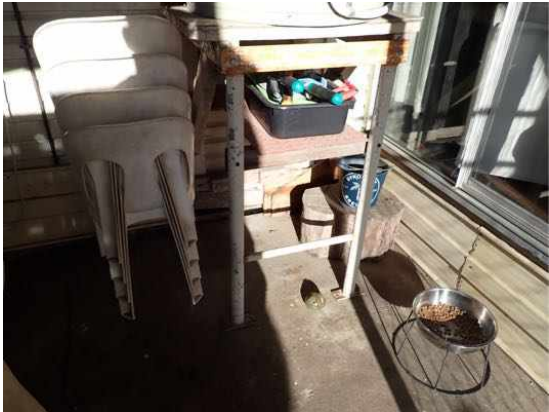
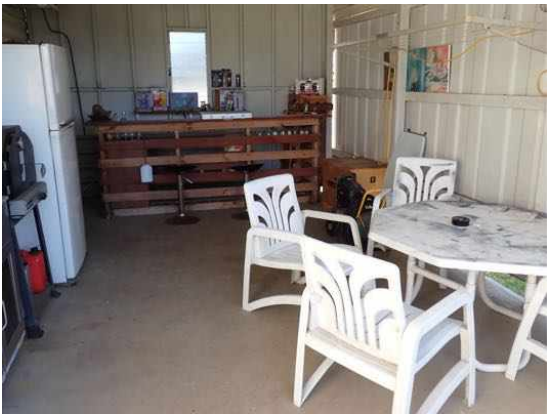
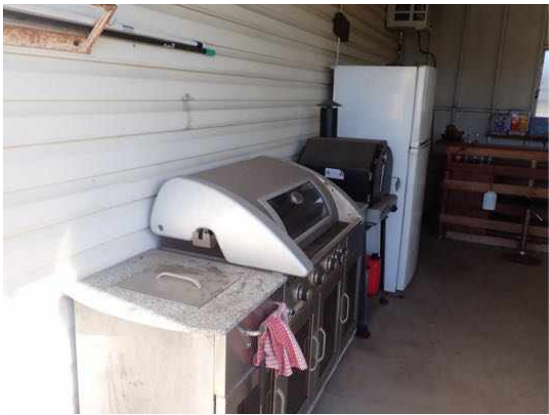
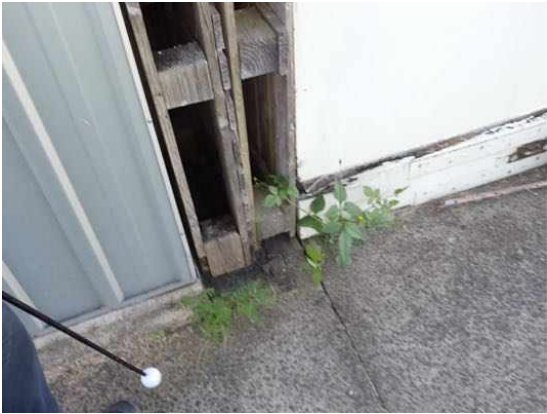
Noted Item

Building: Main Building
 Location: All Areas
 Finding: Additional Photos - Obstructions and Limitations
 Information: These photographs are an indication of the obstructions and limitations which

impeded full inspection of the area at the time of inspection. These obstructions can hide an array of defects and should be removed to allow full inspection to be carried out. A re-inspection is recommended once the areas are made accessible.

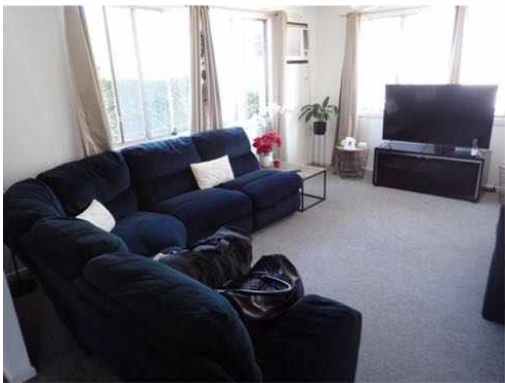
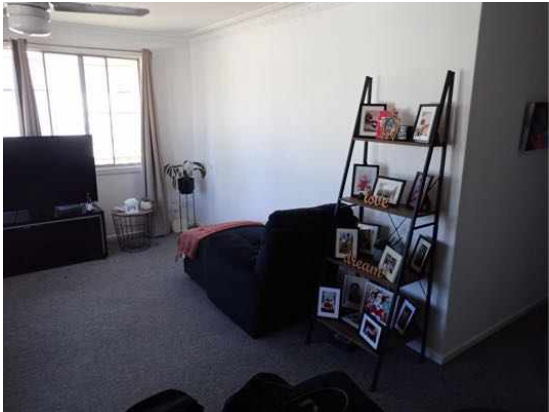
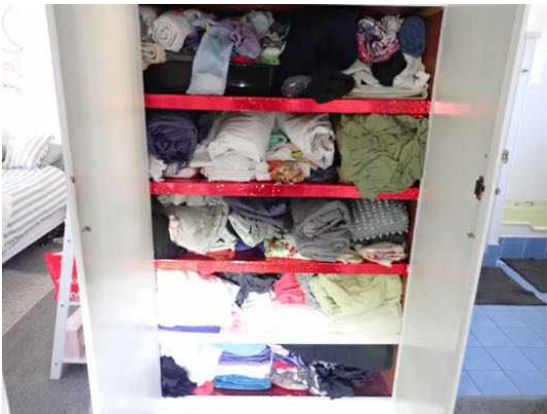
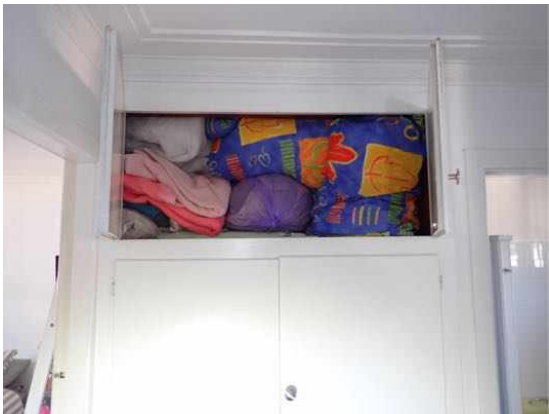
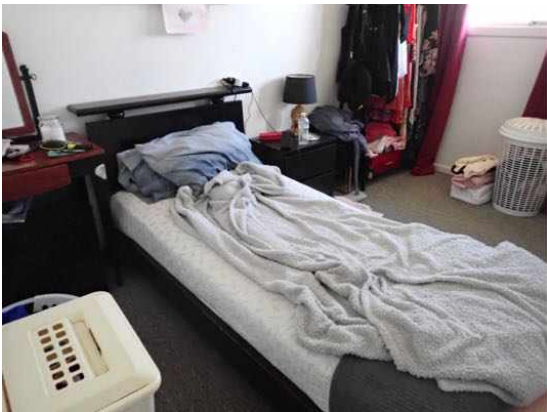
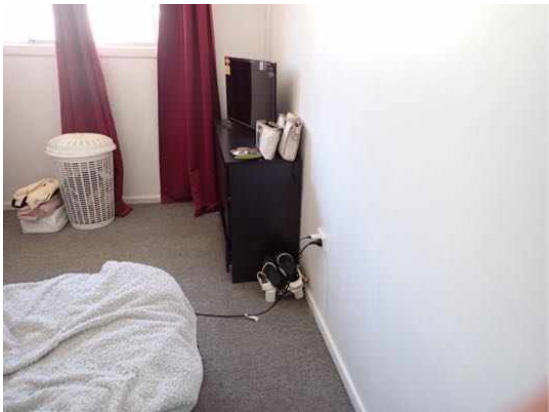
Noted Item

Building: Main Building
Location: All Areas
Finding: Additional Photos - Obstructions and Limitations
Information: These photographs are an indication of the obstructions and limitations which impeded full inspection of the area at the time of inspection. These obstructions can hide an array of defects and should be removed to allow full inspection to be carried out. A re-inspection is recommended once the areas are made accessible.

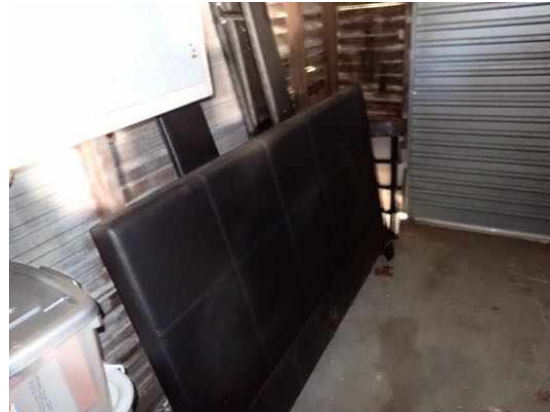
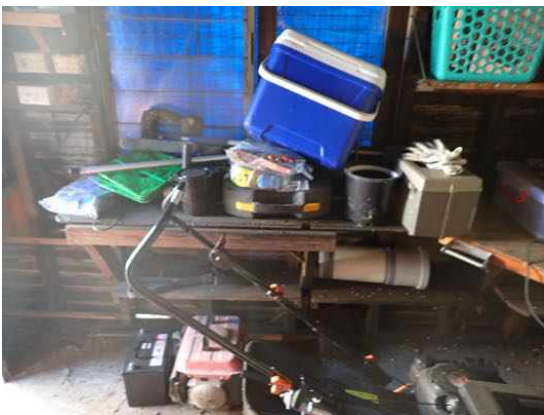
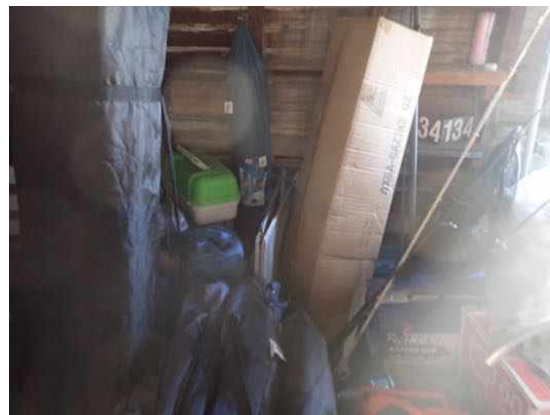
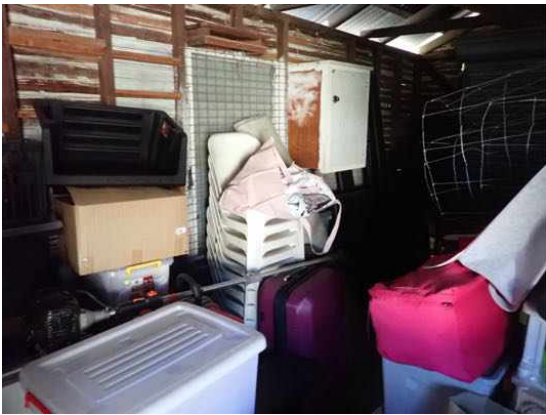
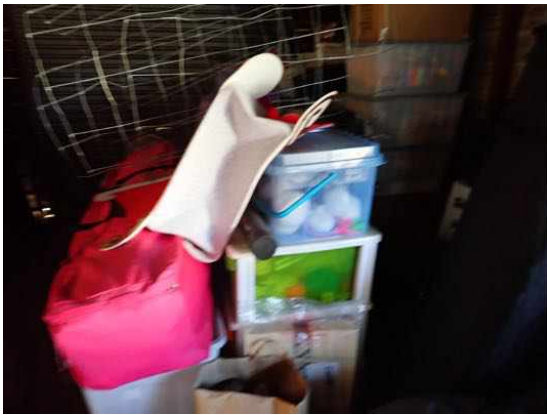
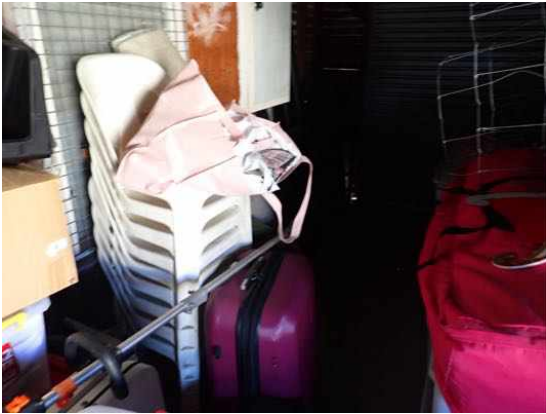
Noted Item

Building: Garage
 Location: All Areas
 Finding: Additional Photos - Obstructions and Limitations
 Information: These photographs are an indication of the obstructions and limitations which impeded full inspection of the area at the time of inspection. These obstructions can hide an array of defects and should be removed to allow full inspection to be carried out. A re-inspection is recommended once the areas are made accessible.
