# Building and Timber Pest Inspection Report

Inspection Date: Wed, 18 Feb 2026

Property Address: 40 Oriole Street, Glenmore Park NSW 2745

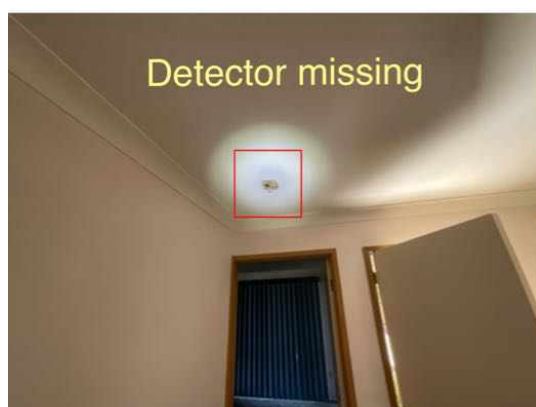
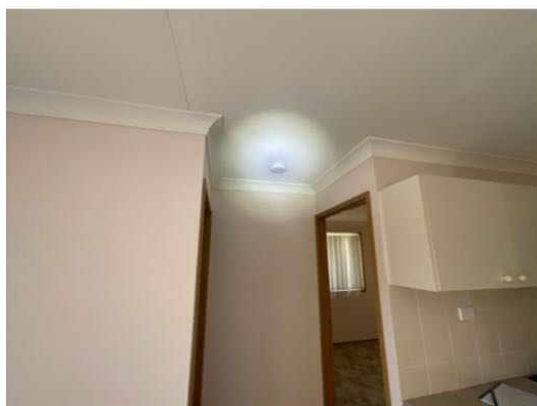
To ensure compliance and safety, further inspection and/or advisory services from a qualified specialist are recommended. These services can confirm the sufficiency, type, location, and functionality of all smoke detection devices within the property.

- All smoke detectors be tested monthly by the homeowner.
- All systems comply with the requirements of AS 3786 and any applicable state-based legislation.

Failure to comply with these requirements may pose a serious risk to occupant safety.

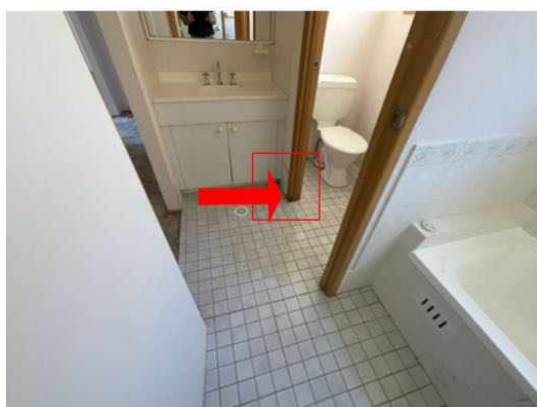
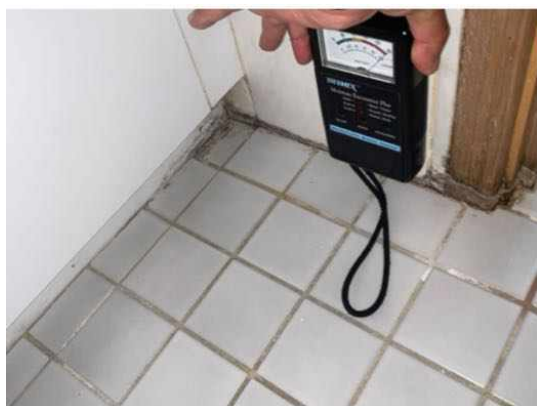
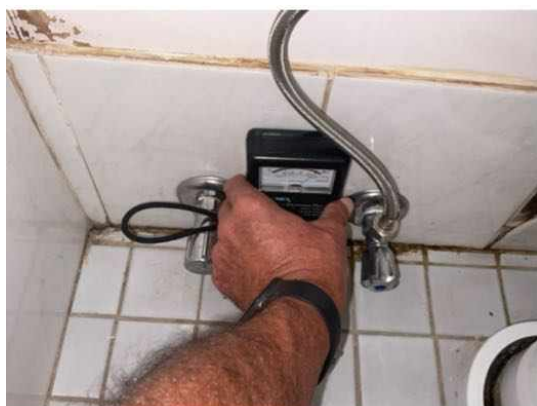
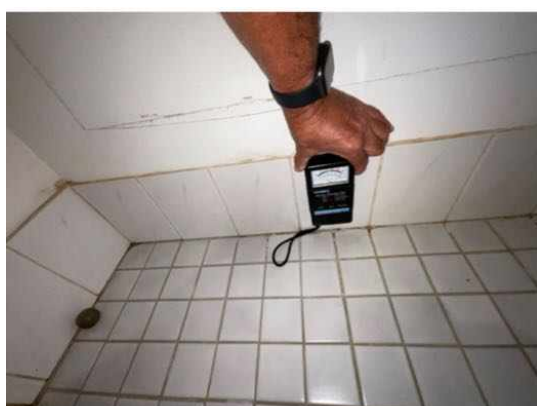
### Finding 2.01

Building:	Main Building
Location:	Bathroom
Finding:	Major Defect – Moisture Ingress and Associated Deterioration (Toilet & Adjacent Areas)
Information:	Observation:

Elevated moisture readings were recorded to the lower wall linings and skirting tiles within the toilet and adjacent vanity area at the time of inspection. The skirting wall tiles were noted to be loose and drummy in sections, consistent with prolonged moisture exposure and loss of adhesive bond. Visible signs of moisture staining and mould-like growth were observed to the base/kickboard of the vanity cabinetry.

Minor fungal decay/early-stage timber rot was identified to the lower section of the toilet door frame, indicating sustained damp conditions. In the adjoining laundry area, a substantial section of plasterboard behind the toilet has previously been cut out and replaced or partially removed, which is suggestive of prior leak rectification works. However, the extent, cause, and adequacy of these repairs could not be confirmed at the time of inspection.

Despite apparent previous works, moisture readings remain elevated in the affected skirting and lower wall areas, indicating that the moisture source may still be active or that materials have not fully dried.

The presence of loose tiles, decayed timber, and active moisture readings indicates that this issue is more than cosmetic and requires further investigation. Without rectification, continued deterioration and increased repair costs are likely.

This matter should be treated as a major defect requiring prompt investigation and rectification. It is recommended that:

- A licensed plumber be engaged to undertake leak detection testing to identify and rectify the moisture source (e.g., plumbing penetrations, waterproofing failure, concealed pipework, or drainage issues).
- A qualified builder assess the extent of internal damage and carry out necessary repairs, including replacement of affected wall linings, tiles, door frame sections, and cabinetry components as required.
- Damaged or moisture-affected materials be removed and the area allowed to fully dry prior to reinstatement works.
- Mould remediation be undertaken where required in accordance with appropriate standards.

Further clarification should be obtained from the current owner/vendor regarding the nature and scope of previous repair works and whether any warranties or documentation are available.

Ongoing monitoring is advised following rectification to confirm that moisture levels return to normal and that the issue has been fully resolved.

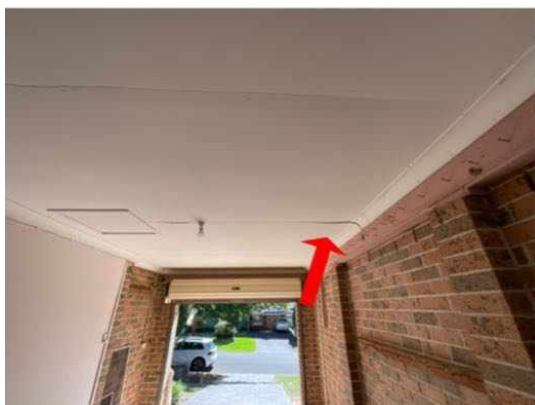
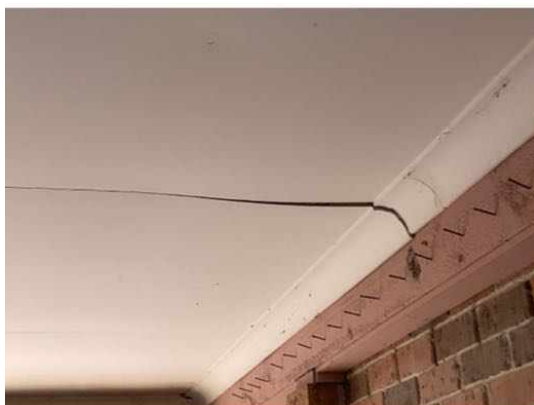
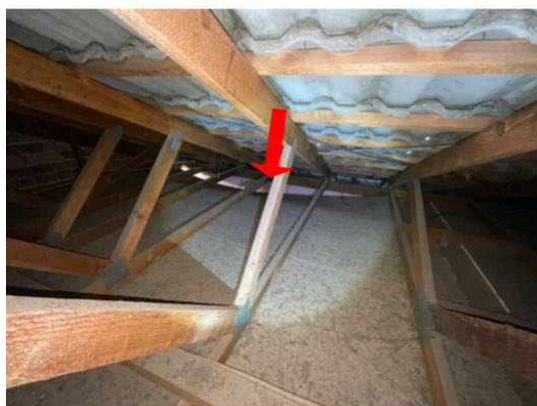
## Finding 2.02

Building:	Main Building
Location:	Garage
Finding:	Ceiling lining - Localised Ceiling Sagging (Garage Area).
Information:	During the inspection, isolated sections of ceiling lining were found to be sagging or detached, particularly near the rear garage doorway. This type of defect is commonly observed in garage areas and is typically attributed to general wear over time.

- Age-related deterioration of ceiling fixings (e.g. nails, screws, or adhesive/glue)

- Moisture exposure or humidity-related expansion, often exacerbated by incorrect or low-grade paint coatings that fail to protect the ceiling surface adequately

While the defect is currently considered minor to moderate and does not appear to compromise the structural integrity of the ceiling, it may worsen over time if left untreated and impedes on the roller door. Early signs such as sagging may eventually lead to detachment of ceiling sheets or visible cracking along joins or edges.

Repairs may involve re-gluing and re-fixing the ceiling sheets to the joists, a task generally undertaken by qualified plasterers or general interior trades. In some cases, repainting with moisture-resistant coatings may also be appropriate, particularly in garages where humidity levels can fluctuate.

It is recommended that buyers allow for maintenance or minor repair costs in the medium to long term and engage a relevant trade professional to assess and carry out works as needed. Timely intervention will help prevent further deterioration and maintain the visual and functional condition of the ceiling.

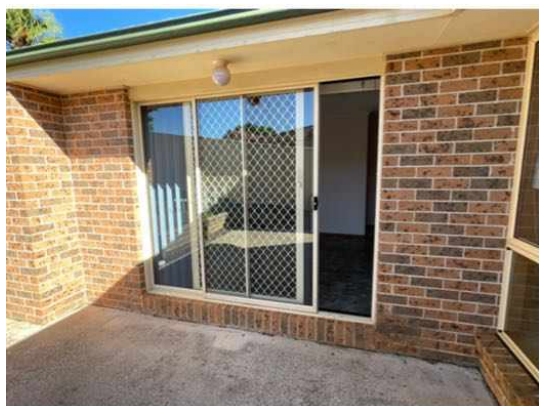
### Finding 3.01

At the time of inspection, the sliding door was jammed and difficult to operate. The door did not slide smoothly within its track, indicating impaired operation. This condition is commonly associated with factors such as general age-related wear, lack of routine maintenance, contamination of the track with dirt or debris, or deterioration and misalignment of the door rollers and associated hardware.

A sliding door that is difficult to operate does not function as intended and may worsen over time if left unaddressed. Continued use in this condition may place additional stress on door hardware, potentially leading to further wear, failure of rollers, or damage to the track and door frame. In some cases, restricted operation may also pose a minor safety concern, particularly in emergency egress situations.

It is recommended that the sliding door be further assessed and repaired to restore proper operation. Cleaning of the track, adjustment of the door alignment, and repair or replacement of worn or damaged rollers and hardware may be required. For minor causes, a suitably qualified carpenter or competent general handyperson should be able to carry out the necessary maintenance and adjustments. If significant wear or damage is identified, more extensive repairs or replacement of components may be necessary.

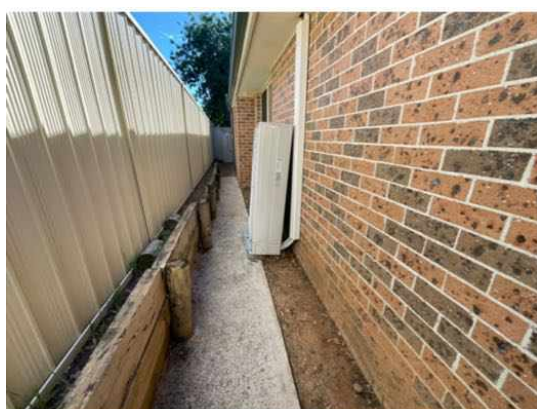
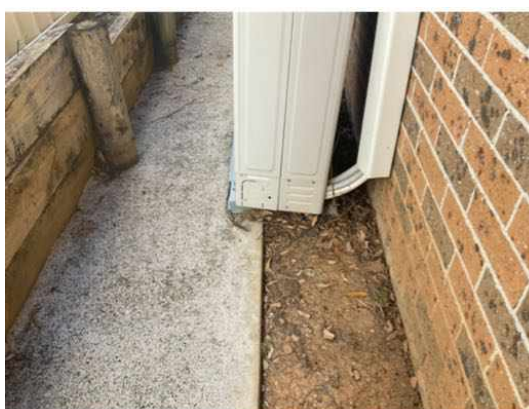
### Finding 3.02

Building:	Main Building
Location:	Exterior walls - right side
Finding:	External – Air Conditioning Condenser Unit
Information:	Observation:

The external air conditioning condenser unit was observed to be leaning and not adequately supported on its concrete pad at the time of inspection.

Only the front portion of the unit was bearing on the concrete base, with the rear section inadequately supported. The unit is currently leaning toward the building structure. This condition indicates that the supporting pad may be undersized, out of level, or subject to ground movement/subsidence.

- Increased vibration and operational noise
- Stress on refrigerant pipework and electrical connections
- Premature mechanical wear or component failure
- Potential water drainage issues from the condensate system
- Further movement or instability over time

If left unrectified, continued settlement or instability may lead to damage to the unit, associated services, or adjacent building elements.

Engage a suitably licensed air conditioning contractor to assess the installation and reinstate the unit so that it is fully supported on a stable, level, and appropriately sized concrete base.

Rectification may involve re-levelling or replacing the existing pad, ensuring adequate ground compaction beneath, and confirming that pipework and electrical connections have not been compromised.

Prompt rectification is advised to prevent further movement and to maintain the serviceability and longevity of the system.

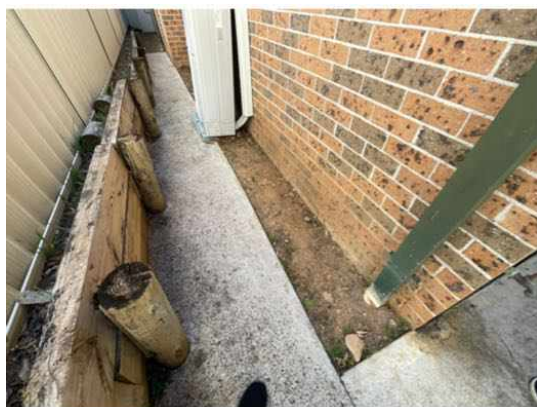
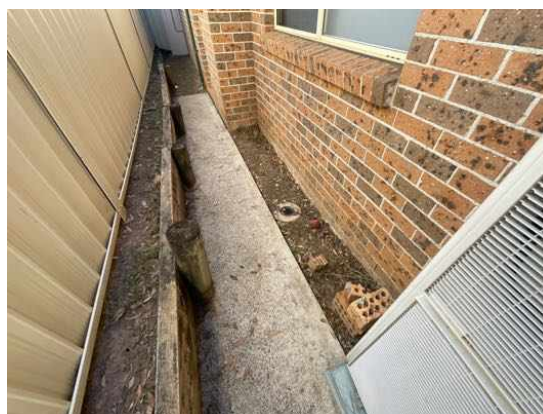
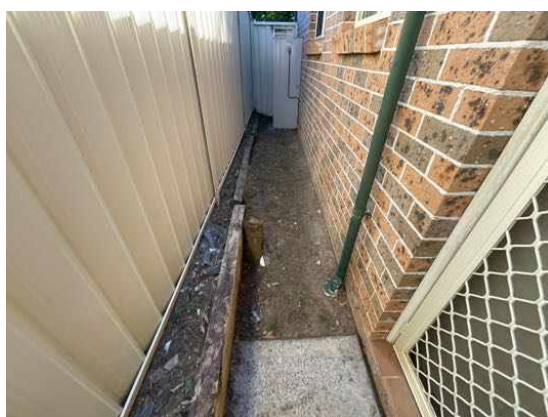
**Finding 3.03**

Building:	Main Building
Location:	Exterior walls - right side
Finding:	Site/Yard drainage - Inadequate.
Information:	Defect / Observation – Inadequate Site Drainage

At the time of inspection, site drainage in this area was found to be inadequate, allowing water to pool against the base of the external walls.

Poor surface drainage can lead to moisture ingress and deterioration of materials at the base of walls, slab edge dampness, or foundation movement. Prolonged exposure to standing water may cause rising damp, efflorescence, or corrosion of embedded steel components. These conditions can lead to secondary structural or moisture-related defects if not rectified.

To prevent moisture-related damage, ground levels around the dwelling should:

- Provide a minimum 50 mm clearance between finished ground level and the bottom of cladding or wall weep holes (minimum 75 mm where paved and 100 mm where unpaved).
- Be graded to achieve a minimum fall of 1:20 (50 mm over 1 m) away from the building for at least 1 m.

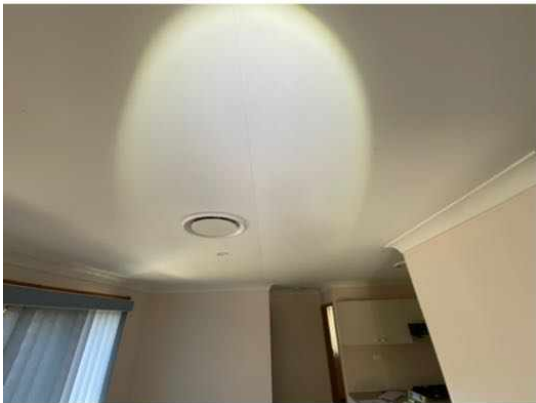
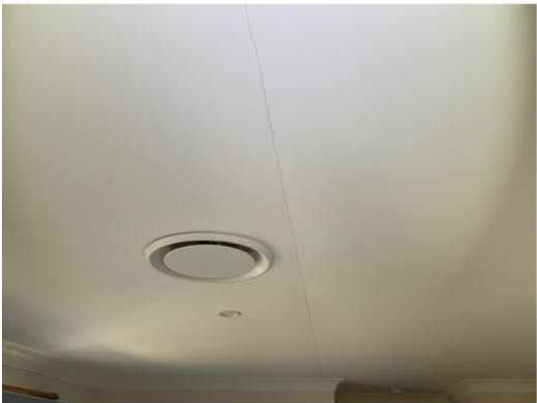
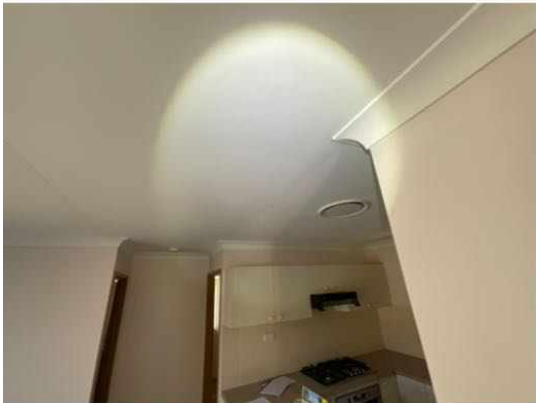
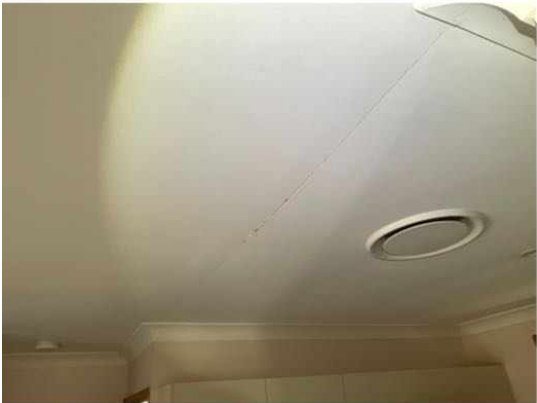
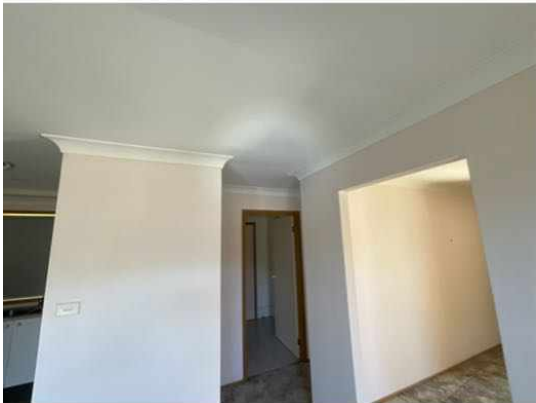
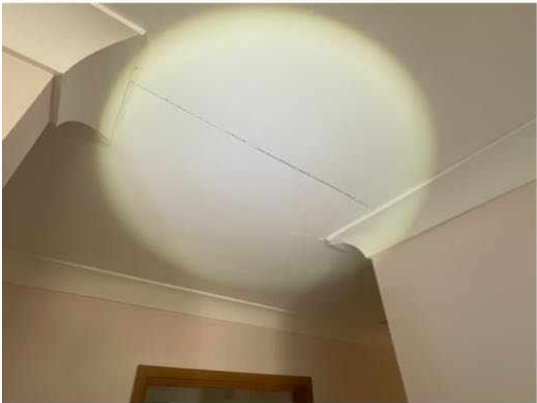
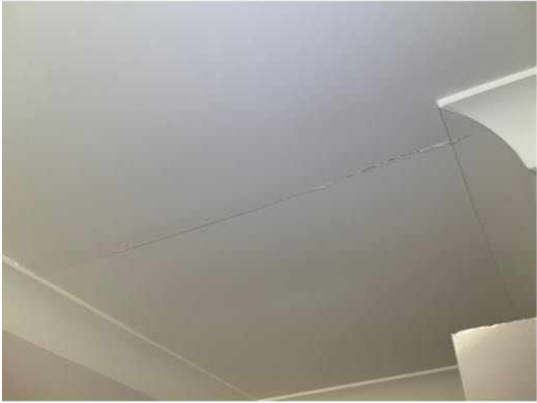
## Finding 3.04

Building: Main Building  
Location: Dining / Kitchen / Hallway / Bathroom  
Finding: Ceiling Cracking – Non-Structural Movement.  
Information: Observation:

- Cracking was noted in the ceiling at this location(s). This is a common occurrence in buildings of similar age and construction, typically caused by:
  - Minor separation of building materials due to seasonal moisture fluctuations
  - Shrinkage during the timber drying process
  - Natural settlement of the building over time

- The observed cracking appears to be fine and cosmetic in nature at the time of inspection.
- These cracks are typically considered appearance defects and are not believed to impact the structural integrity of the building.
- However, should further evidence arise during a more detailed or invasive inspection, it may suggest underlying structural issues that require further assessment.

- Cracks of this nature can generally be repaired with standard cosmetic maintenance, including:
  - Filling, sanding, and repainting of affected areas
  - Installing a ceiling expansion joint to accommodate future movement and reduce the likelihood of recurrence
- These works may be carried out at the client's discretion by a qualified plasterer, painter, or handyman.

- Not all areas of the roof void were accessible at the time of inspection. A further inspection of the roof void—particularly in the vicinity of the ceiling cracks—is recommended to rule out any concealed structural issues.

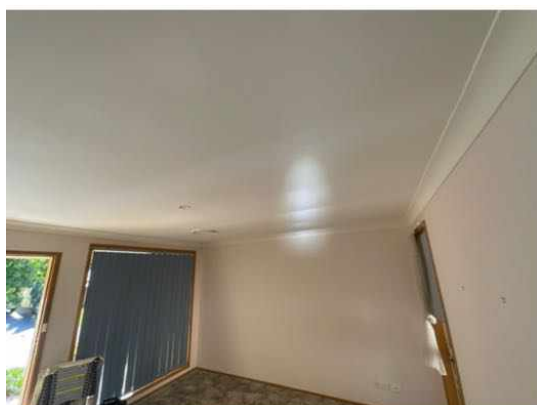
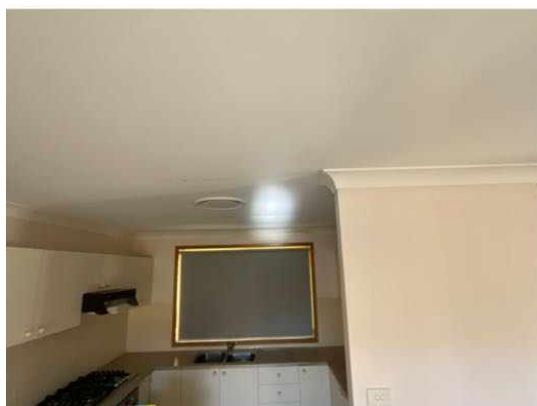
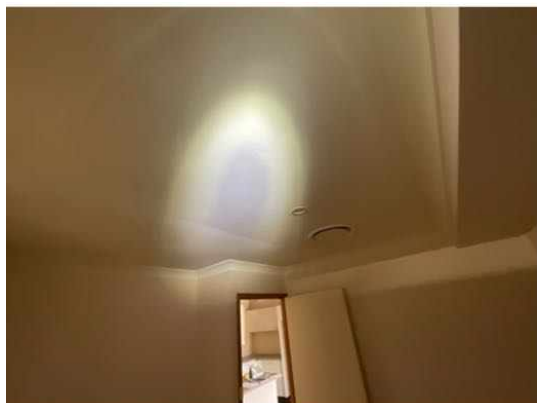
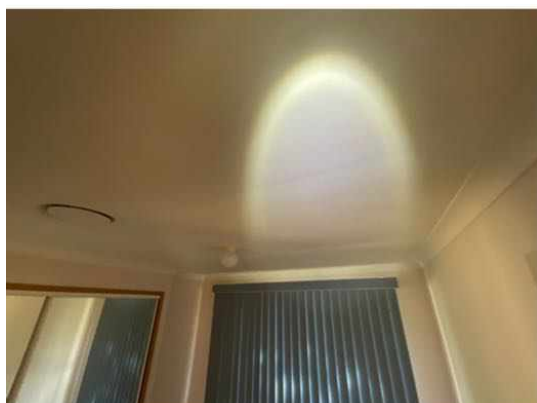
Finding 3.05

Building: Main Building  
Location: All Internal Areas  
Finding: Ceiling Linings – Uneven or Sagging Surfaces.  
Information: Observation:

Uneven sagging ceiling linings were observed in various areas throughout the property. At the time of inspection, the condition appeared to be minor and cosmetic in nature.

This is a common occurrence in homes of similar age and construction, often caused by the gradual deterioration or loosening of original fixings, such as nails, screws, or adhesives used to secure ceiling sheets.

- Remedial works may be recommended to improve appearance and prevent further sagging. These may include:

Further investigating Structural roofing elements

- Re-gluing or re-adhering the ceiling sheeting
- Re-securing sheets using appropriate modern fixings
- These works can be carried out by a qualified plasterer or painter,
- Ongoing monitoring is advised to detect any worsening of the condition or further movement over time.

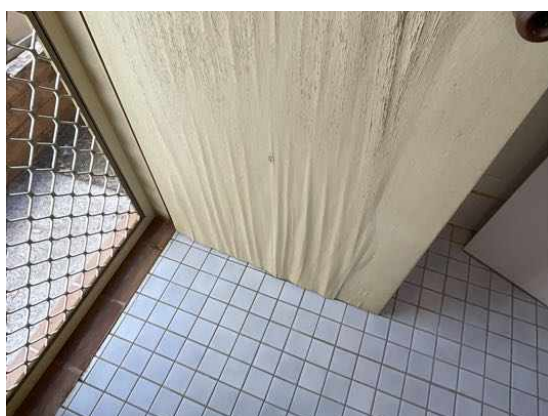
### Finding 3.06

Finding: Door(s) - Damaged.

Information: During the inspection, damage was noted to one of the doors within the property. The damage appears consistent with general wear and tear, likely resulting from prolonged use and a lack of regular maintenance. Common signs of deterioration include surface scratches, swelling at the base (possibly from moisture exposure), minor cracking, or delamination of the door finish or veneer.

The observed condition does not currently prevent the door from operating, but if left unattended, the defect may worsen over time. Continued exposure to moisture,

changes in humidity, or mechanical stress can accelerate deterioration, potentially leading to functional issues such as difficulty opening or closing the door, further material breakdown, or aesthetic decline.

This type of defect is typical in aging doors and does not indicate a structural issue with the building itself. However, it reflects a need for general upkeep.

Repairs are considered minor and non-urgent, and may be undertaken at the client's discretion. A qualified carpenter or experienced handyman can carry out remedial work, which may include:

- Sanding or filling superficial surface damage
- Resealing or repainting to protect against moisture
- Adjusting or rehangng the door if alignment is affected
- Replacing the door if damage is beyond economical repair

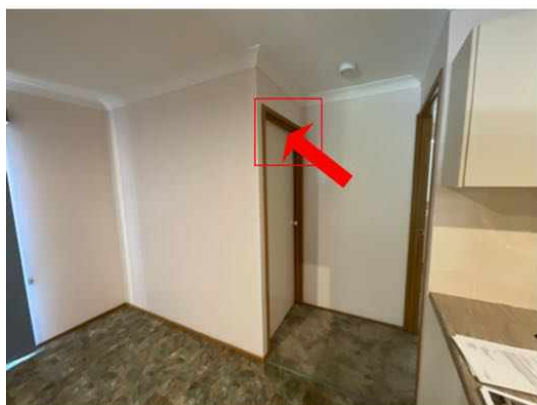
### Finding 3.07

Building: Main Building  
Location: Kitchen  
Finding: Ceiling - Water stained.  
Information: Observation:

Water staining was noted to ceiling linings in the inspected area(s) at the time of the inspection. These stains present as discoloured or patchy areas and may suggest a history of moisture ingress, most commonly associated with roof leaks or plumbing issues.

- If the issue appears to be related to major structural movement, it is recommended that a registered builder with experience in re-stumping or subfloor repairs be engaged to assess the extent of the movement and provide a quotation for necessary remedial works.
- Where the issue is minor in nature, a qualified carpenter or general handyperson may be appointed to carry out corrective works at the client's discretion.

Prompt assessment and remediation are advised to prevent further deterioration or related damage.

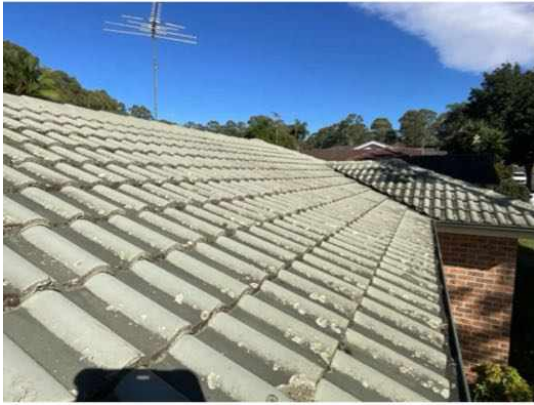
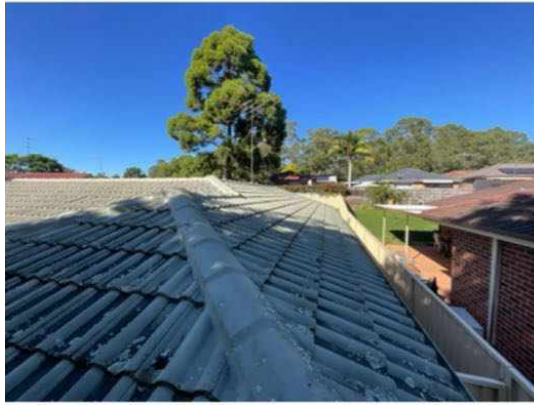
Building:	Main Building
Location:	Roof Exterior
Finding:	Roof Tiles – General Condition.
Information:	Condition Overview:

Based on the limited visual inspection, the roof and guttering system appears to be in a generally serviceable condition. A further investigation by a roofing specialist to ensure the integrity of non-visible areas.

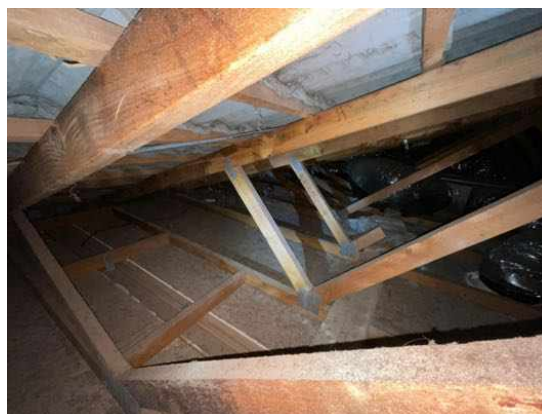
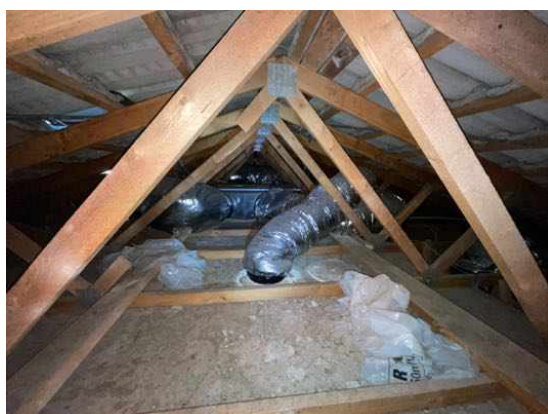
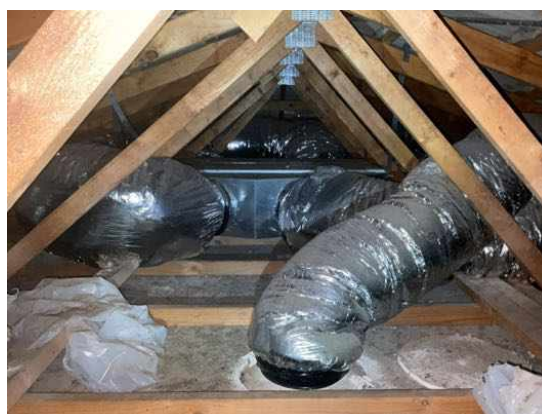
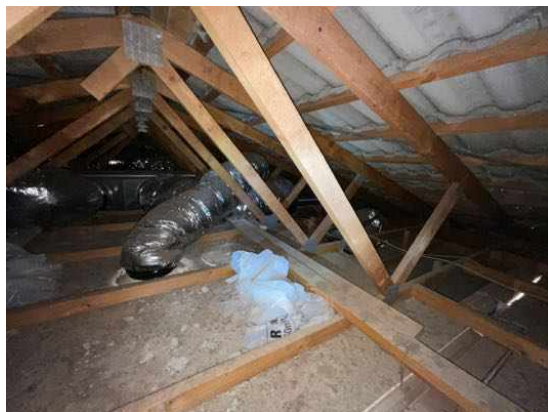
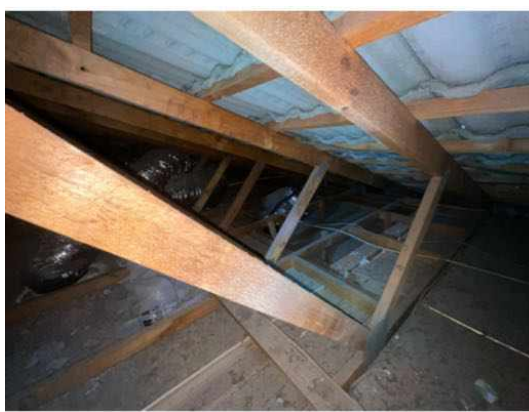
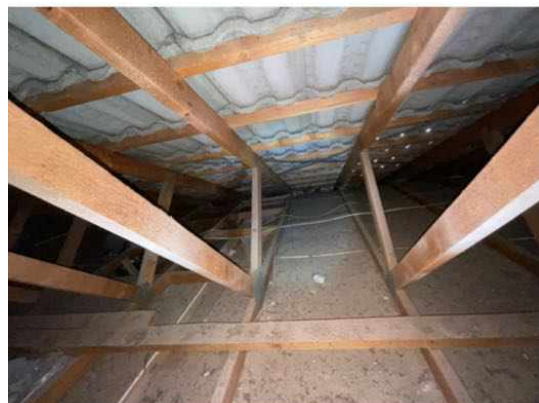
Building: Main Building  
Location: Roof Void  
Finding: Roof Void – Limited Accessibility..  
Information: Observation:

Installation of an additional manhole is recommended to facilitate a re-inspection and enable a more thorough assessment of the roof void in the future. This will help ensure that all structural elements and concealed areas are properly evaluated.

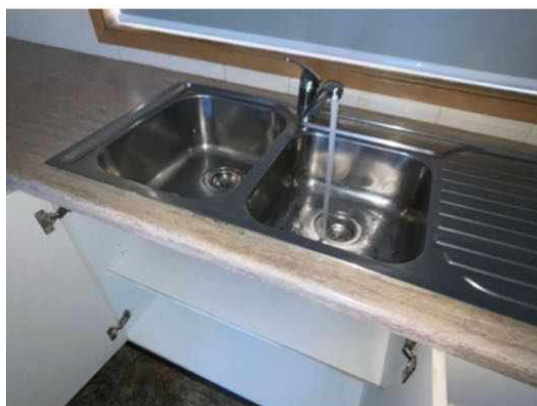
Building: Main Building  
 Location: Kitchen  
 Finding: Kitchen Sink – Overall Condition & Recommendations.  
 Information: Observations:

- Further monitoring and testing are recommended once the tap(s) are in constant use, to identify any drainage issues or signs of slow leaks not evident during the limited inspection.
- For long-term property care, it is advised that sealant and grouting in water-exposed areas be regularly inspected and maintained.

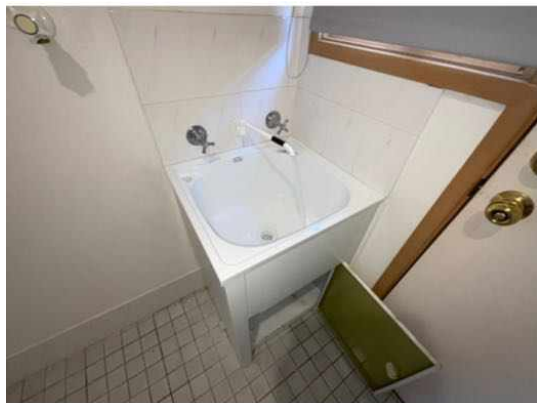
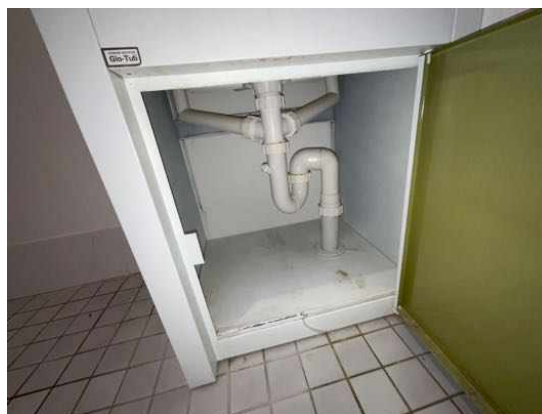
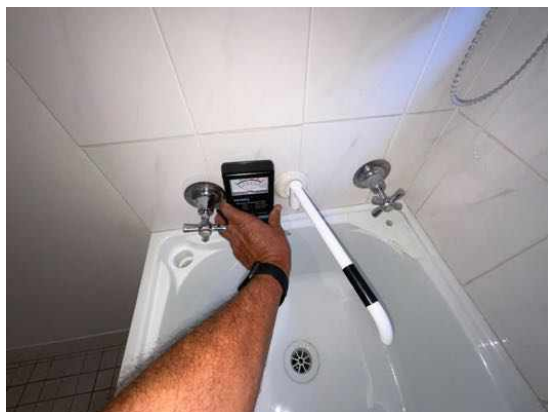
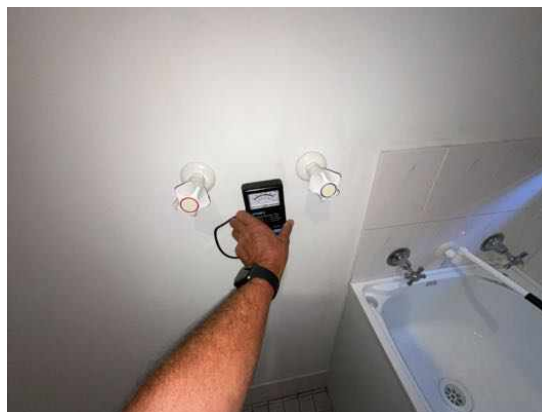
Building: Main Building  
 Location: Laundry  
 Finding: Laundry - Taps/Plumbing/Drainage.  
 Information: Observation: Laundry Tub – Taps, Plumbing, and Cabinetry

- Further monitoring or testing is recommended once the taps are placed into regular use, to ensure no leaks develop over time and that the drainage system continues to perform adequately.
- Flexible and mould-resistant sealant should be applied to junctions between the basin and the wall to prevent water ingress that may lead to damage.
- Regular maintenance and prompt replacement of missing or deteriorated sealant is highly recommended, as this is a common wear-and-tear issue.
- Sealant and grouting in wet areas should be maintained as part of the long-term care and upkeep of the property.
- Where required, a sealant specialist or qualified tiling contractor should be appointed to carry out remedial sealing works.

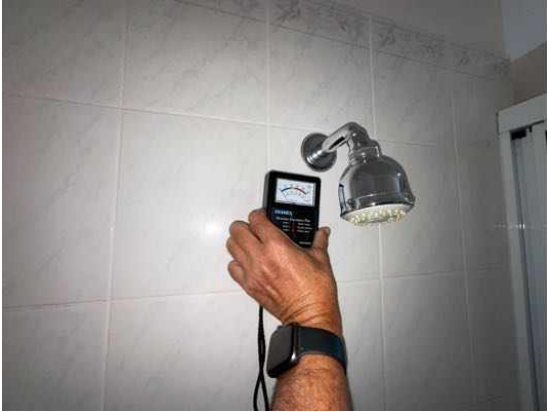
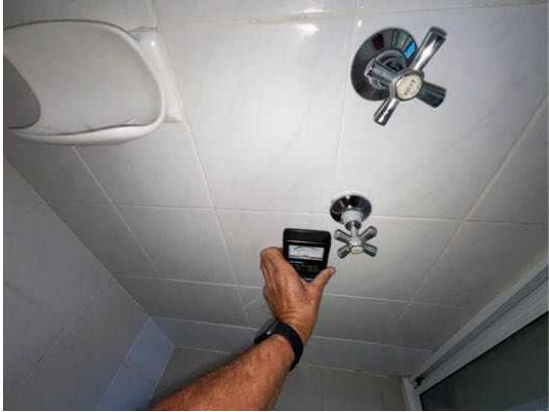
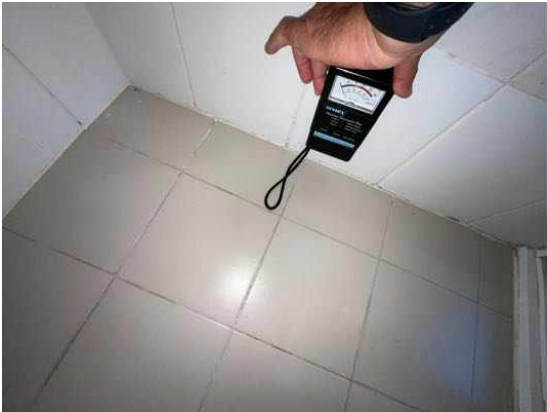
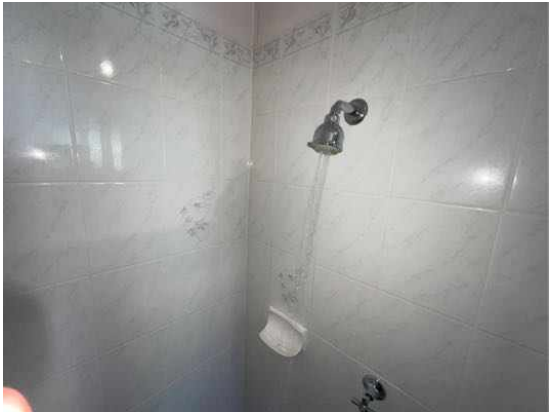
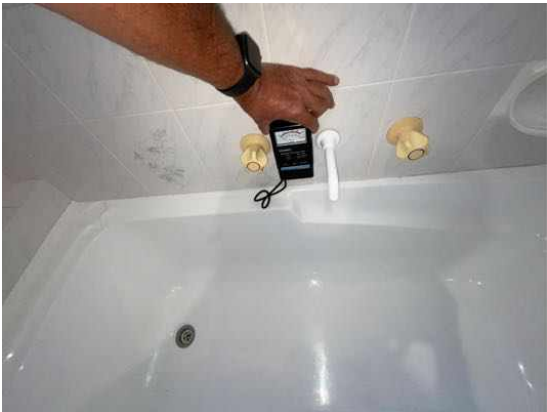
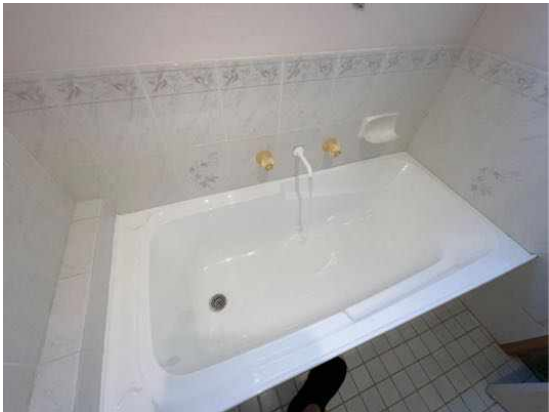
Building: Main Building  
 Location: Bathroom  
 Finding: Wet Areas - Bathroom(s) - Overall Condition & Recommendations.  
 Information: Overall Condition & Recommendations

It is not possible under the visual inspection criteria of a standard pre-purchase report to categorically determine if leaks are present. If a more detailed or accurate assessment is required, a special-purpose inspection should be undertaken.

Alternatively, the assumption should be made that leakage may occur, particularly where historical or environmental conditions are conducive. The visual nature of this inspection cannot detect issues concealed behind wall/floor linings or cabinetry, and invasive investigation may be necessary to confirm the true condition of adjacent or hidden structures.
