Building and Timber Pest Inspection Report

Inspection Date: Wed, 4 Mar 2026

Property Address: 4 Mortimer St, Minto NSW 2566, Australia

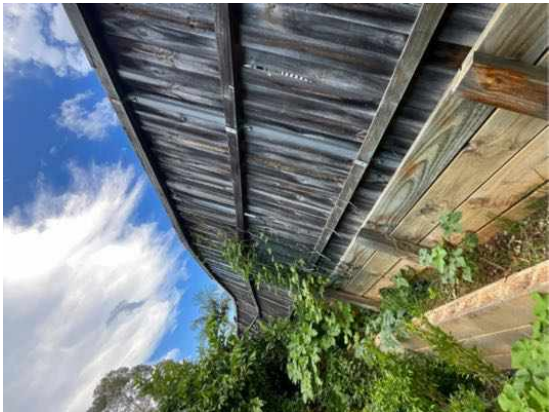
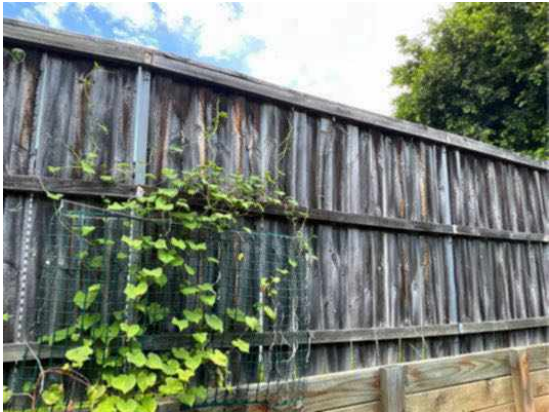
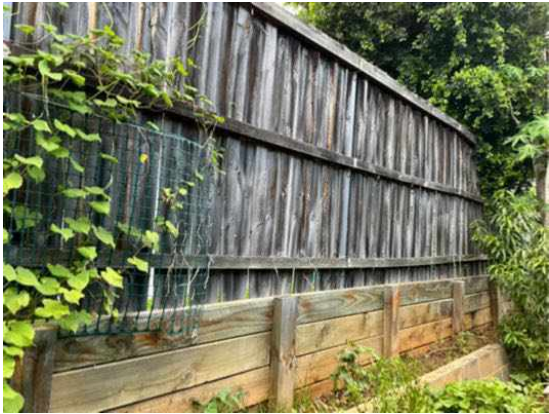
This is classified as a major structural defect under AS 4349.1-2007, as it affects the stability and load-bearing capacity of the retaining wall. There is a risk of collapse, posing a hazard to nearby structures, occupants, and vegetation. Failure of the wall may also result in soil displacement and drainage issues.

- Inspection: A qualified structural engineer should conduct a detailed assessment to determine the cause and extent of movement.
- Repair: Rectification work should be performed by a licensed builder or landscaper with experience in retaining structures, following engineering specifications.
- Prevention: Ensure proper drainage, footing depth, and wall anchorage in the rebuild to prevent recurrence.

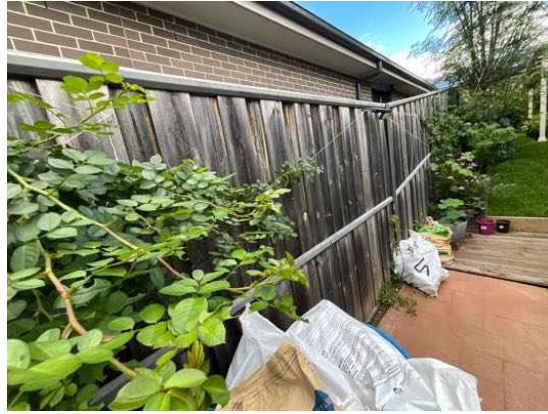
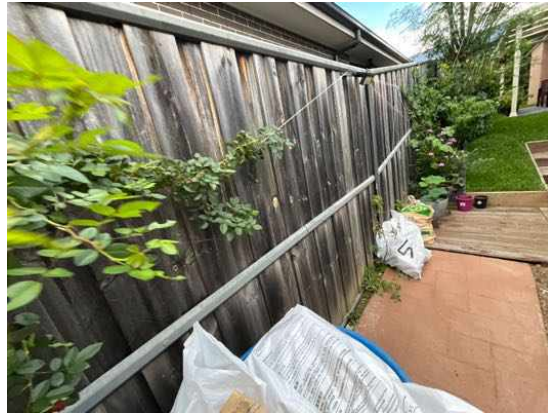
Finding 3.01

Building: Main Building
Location: All Areas
Finding: Detoriated fence
Information: The fence along the property boundary has deteriorated significantly, showing signs of rot, rust, and structural weakness. Several sections are leaning or have become detached, compromising the integrity of the fence and its ability to perform its intended function.

The deteriorated fence poses multiple risks:

1. **Safety Hazard:** The unstable fence may collapse, posing a risk of injury to residents, visitors, and passersby.
2. **Security Concern:** The compromised fence may allow unauthorized access to the property, increasing the risk of theft, vandalism, or trespassing.
3. **Property Damage:** Falling sections of the fence could damage nearby structures, plants, or other property features.

- **Licensed Fencing Contractor:** A professional fencing contractor should be hired to assess the extent of the damage and either repair or replace the deteriorated sections.
- **Handyman Services:** For minor repairs, a qualified handyman could be engaged to reinforce or repair specific sections of the fence.
- **Landscaper (if the fence is part of a larger garden feature):** If the fence is integrated into the landscape design, a landscaper with experience in fencing could be involved in the repair or replacement process.

It's important to ensure that whoever is hired is experienced and qualified to ensure the fence is restored to a safe and functional condition, compliant with local regulations.

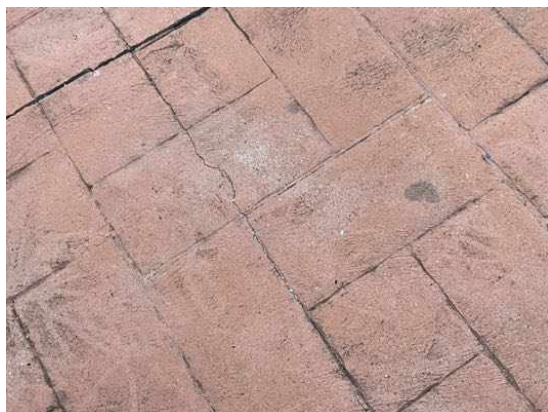
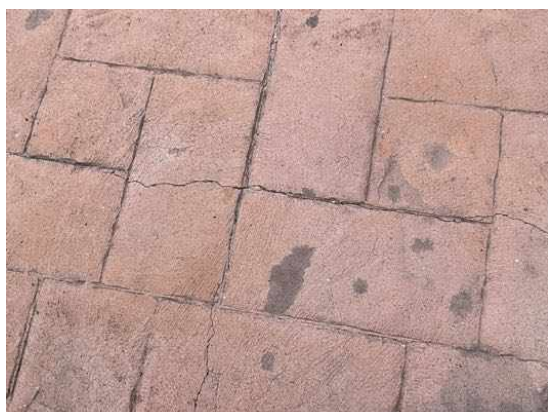
Finding 3.02

Building:	Main Building
Location:	All Areas
Finding:	Crack in concrete slab - Category 0
Information:	A crack coded as Category 0 was identified in the slab. A Category 0 crack is described as a hairline crack, representing insignificant movement of slab from level.

The approximate width of the crack to be considered Category 0 is 0.3mm, or change in offset of less than 8mm when a 3m straight edge is placed over the defect.

No rectification is required at this time. However, all cracking should be monitored over a 12 month period to identify any further damage in the area.

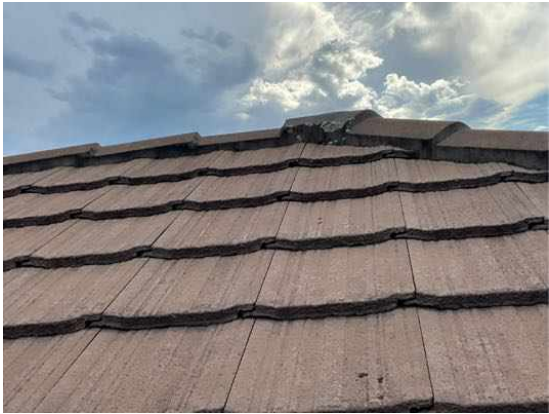
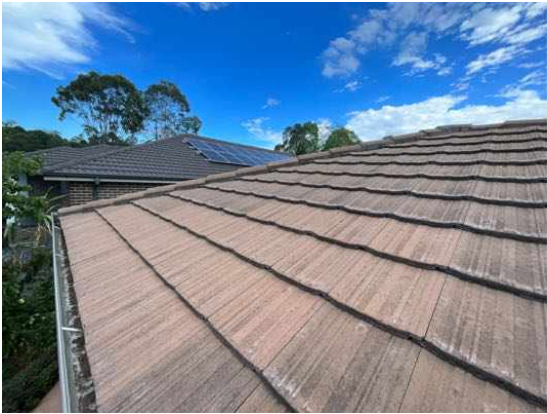
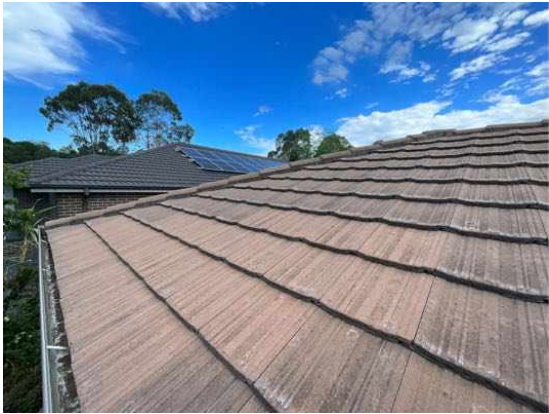
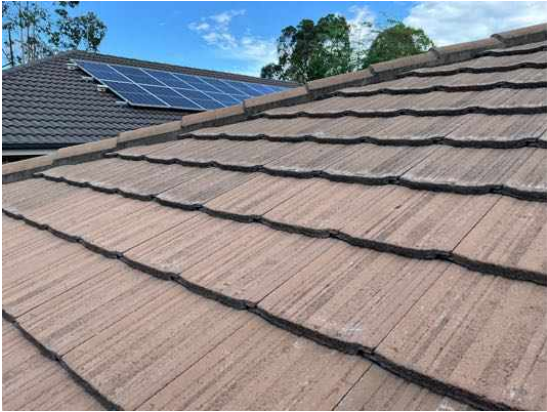
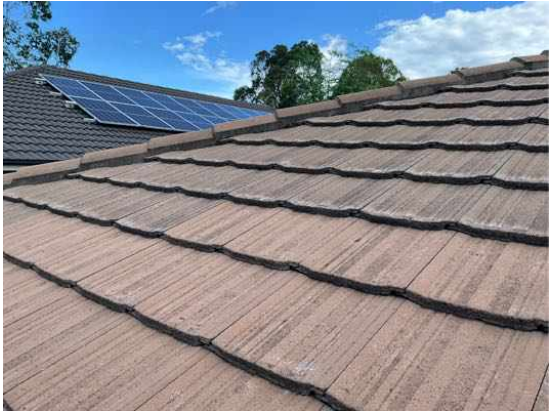
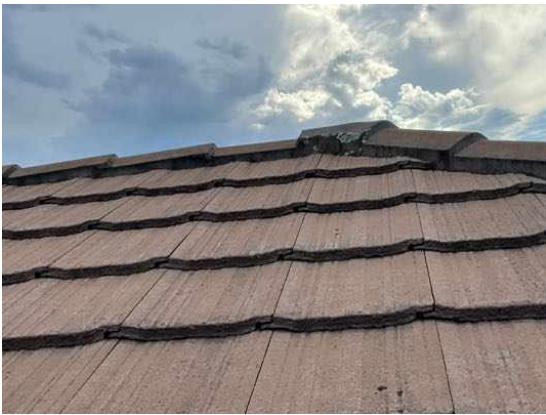
Finding 3.03

Information: Inspection of the roof revealed widespread weathering to the tiled roof surface. The tiles show loss of surface finish, colour fading, and age-related deterioration typical of older roof coverings. Although no significant cracking was noted, weathering can lead to increased porosity, reduced water-shedding capability, and a higher risk of future cracking or displacement during adverse weather conditions.

A licensed roofer should be engaged to undertake a closer inspection, carry out routine maintenance, and replace any tiles that may be compromised. Ongoing

monitoring is recommended due to the age and condition of the roof covering.

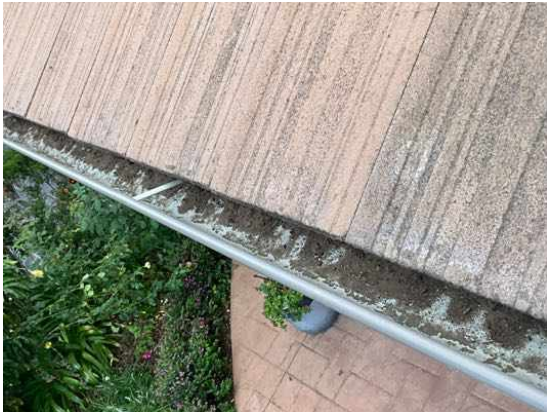
Finding 3.04

Building: Main Building
Location: All Areas
Finding: Blocked Gutters
Information: Blocked gutters , advised gutter to be cleaned.

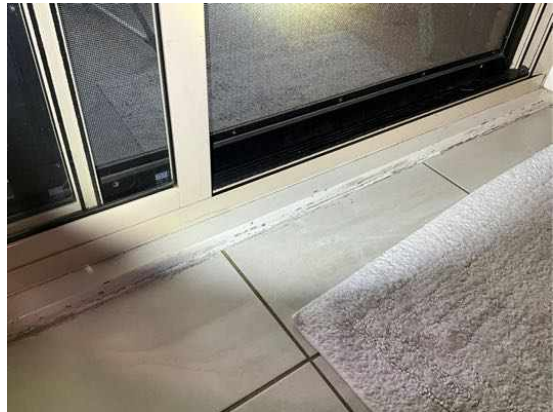
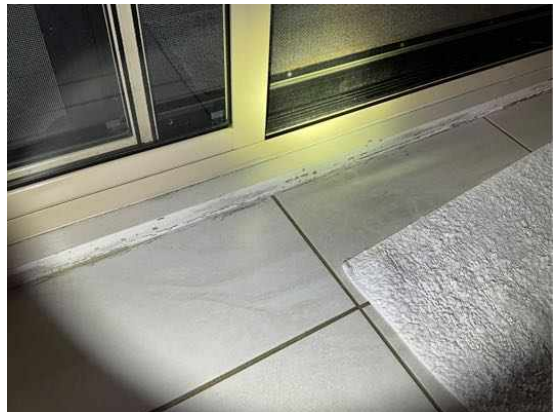
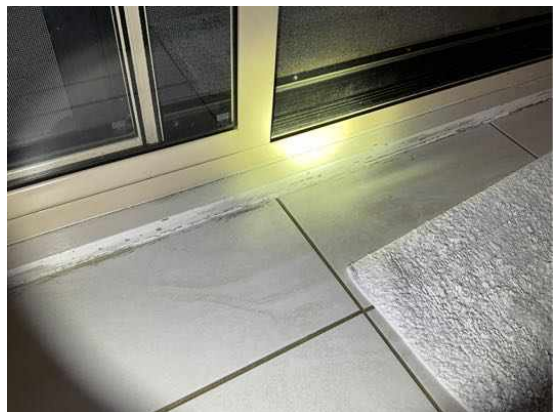
Finding 3.05

Building: Main Building
Location: Dining Room
Finding: Paint surface deteriorated

Information: Sections of the paint in this area was found to have bubble and deteriorated. Paint bubbling is generally an indication of excessive moisture in the area that is currently hidden by the painted surface.

The presence of excessive moisture can have major implications on associated building elements if left unattended. While only seemingly minor at this stage, the damage cannot be determined due to the paint, obstructing any further inspection of the damage.

It is highly advised that the affected paint to be cleaned to allow a further, more invasive inspection by a licensed builder/painter. Failure to act on this defect may necessitate major works in the future.

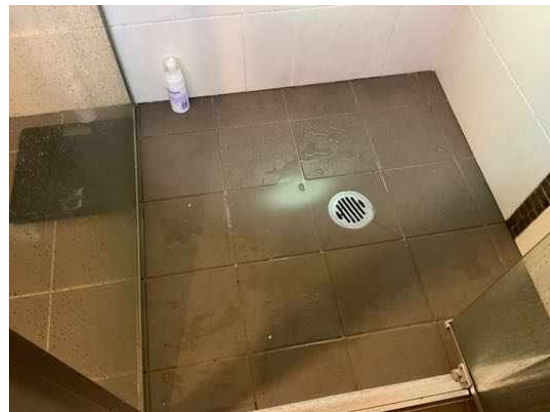
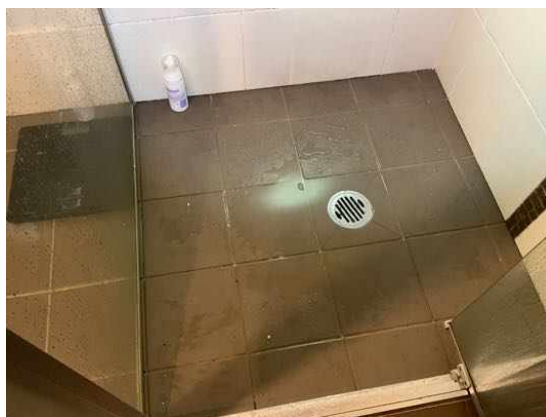
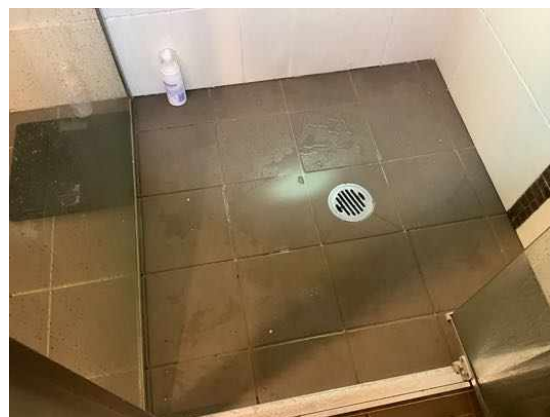
Building: Main Building
 Location: Ensuite
 Finding: Shower base - Water pooling
 Information: Evidence of water pooling around the floor waste in the shower recess was noticed at the time of inspection. It is suspected that this excessive moisture is attributed to insufficient fall in the shower floor tiles.

This pooling is minor overall but is still considered unsatisfactory, as standard tiling practices would not permit this situation to occur. Pooling water around floor wastes can create a slip hazard in extreme cases and create conditions that are conducive to mould growth over time. Where left unmanaged, the degradation of sealant and grouting is also likely to occur, possibly necessitating further repair works.

Remedial works may involve some sections of tiling and flooring repair and replacement. A tiling contractor or bathroom specialist should be appointed to provide further advice on reparation options and to perform works as necessary.

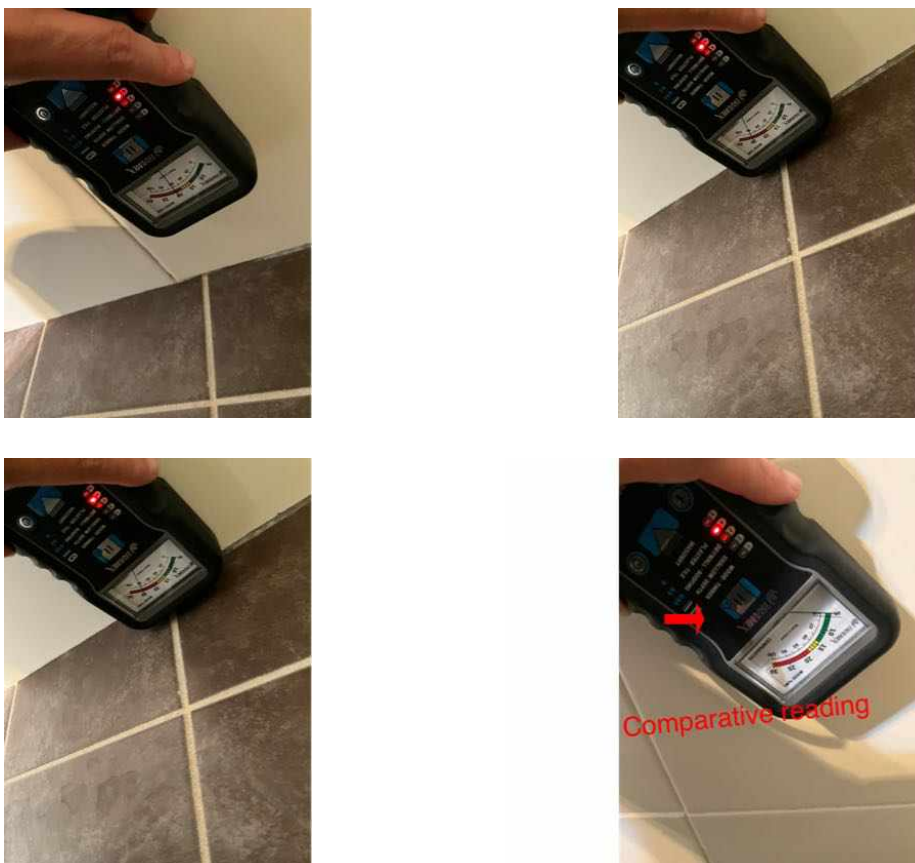
Finding 3.09

Building: Main Building
 Location: Bathroom
 Finding: Shower - Damp
 Information: Damp is evident to the lower 300mm of wall to the shower alcove. This defect is quite

common, and is suspected to have been caused by moisture permeating through the grouting in this area, which shows evidence of deterioration. Leaking pipes within the adjoining wall is also a possible cause.

Unmanaged damp in the shower recess is likely to facilitate the formation and development of mould and fungi growth, decaying associated building materials and compromising their structural integrity. It is important to address damp conditions, as the World Health Organisation notes that excess moisture leads - on almost all indoor materials - to growth of microbes such as moulds, fungi and bacteria, which subsequently emit spores and other matter into the indoor air. Exposure to these contaminants is associated with a wide range of respiratory and other health-related problems.

Consultation with a qualified plumber or bathroom specialist is advised immediately to identify the cause of damp and to perform remedial works as required. Where excessive mould growth is present, further inspection by a specialist environmental health inspector should also be considered.

Always ensure that sealant and grout is in good condition to prevent any moisture issues occurring in the future.

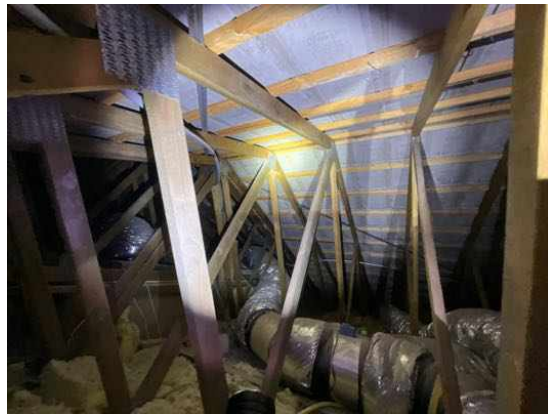
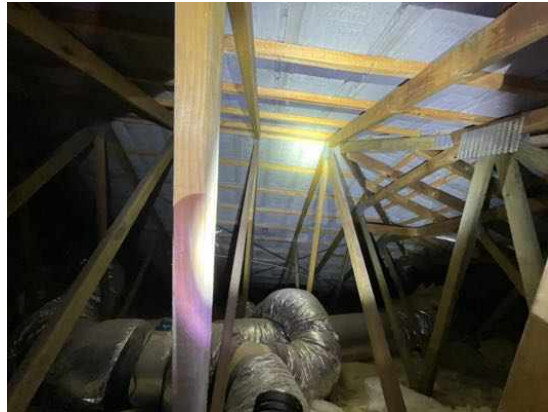
Finding 3.10

Building:	Main Building
Location:	Roof Void
Finding:	Sarking - Missing
Information:	Sarking is missing under the roof sheeting. Sarking acts as an insulator that helps with noise reduction and protects against water penetration. Sarking plays a key role in the operation and function of the overall roofing structure and its performance.

Although not a requirement at the time of construction, replacement of any missing building element is advisable (although this can be quite expensive to do after the time of construction). Where sarking is missing, regular inspections of the roof tiles for cracking and potential moisture penetration is required.

Sarking may be retrospectively fitted by a registered builder at the discretion of the client.

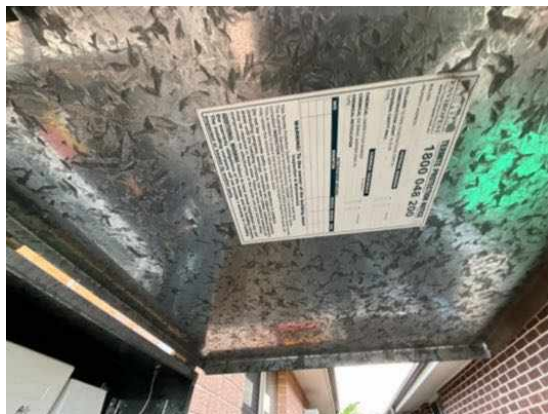
Building: Main Building
 Location: Exterior walls - right side
 Finding: No Evidence of Termite Management System - Durable notice / Legible Sticker
 Information: The application of a pre & post-construction chemical termite barrier is highly recommended for all properties. Such barriers are highly effective in preventing termite attack on any timber building elements throughout the property.

Client must seek further information from the vendor or real estate agent if the conditions of termite management systems were maintained.

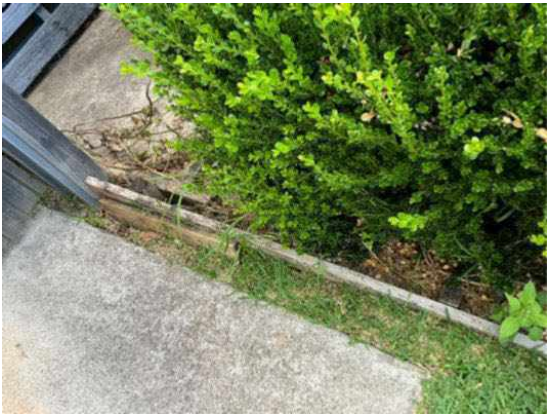
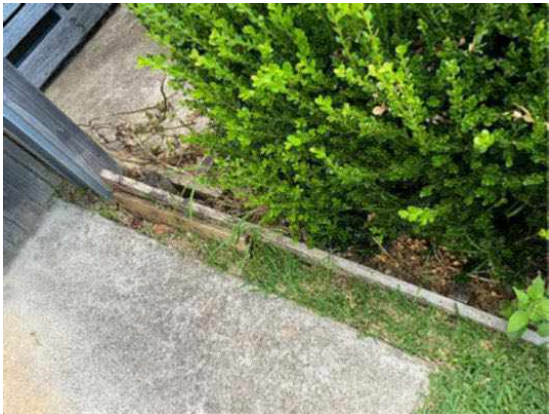
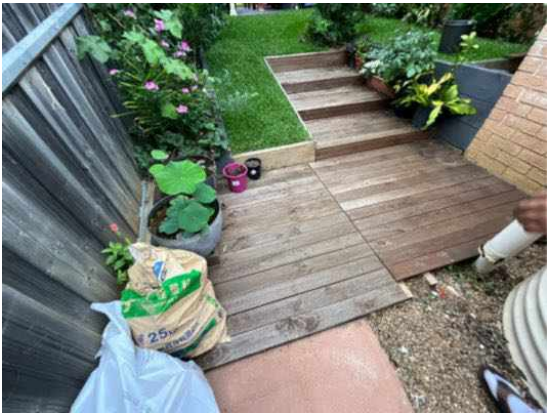
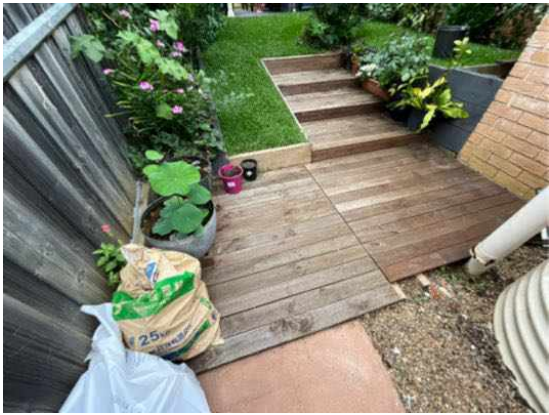
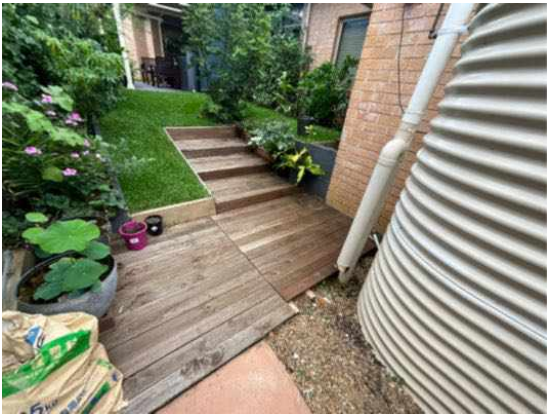
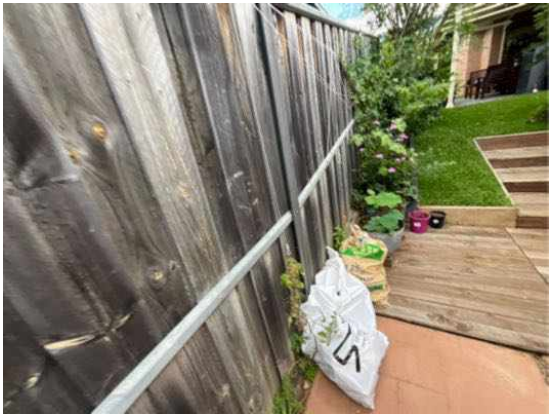
Finding 6.04

Building: Main Building
Location: All Areas
Finding: Timber on ground / conducive conditions to termite damage
Information: Timber on the ground is indeed conducive to termite damage. Termites are known to thrive in moist environments, and wood in contact with soil or moisture is more susceptible to infestation.

To prevent this, it's important to keep timber elevated and away from direct ground contact. Regular inspections and proper termite control measures are also essential to protect your wooden structures from termite damage.

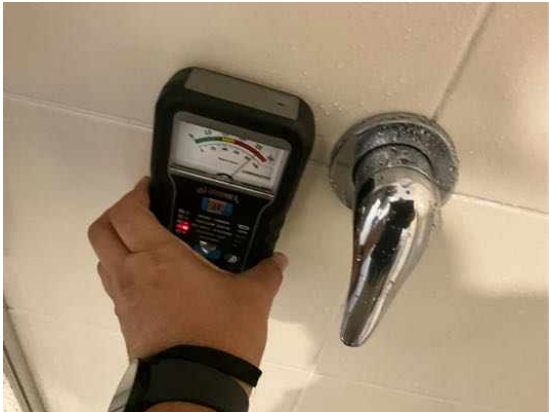
Finding 6.07

Building:	Main Building
Location:	Ensuite
Finding:	Excessive moisture - Conducive to Timber pest
Information:	Excessive moisture can attract termites and produce conditions that promote fungal growth and wood decay.

Excessive moisture is generally caused by deteriorated inadequate or missing roof drainage leaking plumbing pipes or fixtures poorly plumbed HWS overflows or condenser units and poor site drainage.

Prior to any remedial works being performed a qualified plumber should be appointed to further inspect the property and to identify the cause of the excessive moisture. Works to remove affected building elements may then be necessary and should be performed by an appropriate tradesperson.

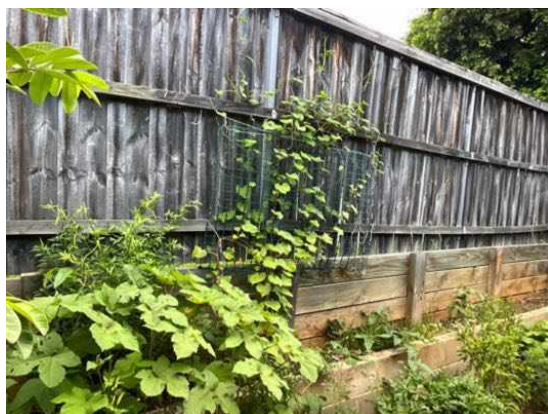
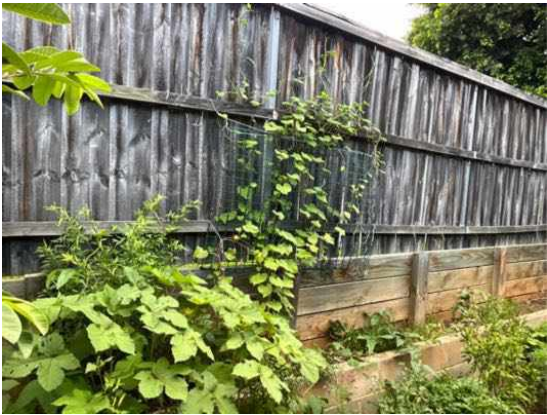
Building:	Main Building
Location:	All Areas
Finding:	Wood rot
Information:	This building element shows evidence of wood rot. Wood rot, also known as Fungal Decay, occurs when timbers and other cellulose building materials are exposed to damp conditions on an ongoing basis. This could be the result of exposure to weathering over a prolonged period of time, or the attraction of excessive moisture from other abutting building materials. Contributing factors also include poor air ventilation in the area.

Wood rot is often associated with general damp problems and is evidenced by a 'musty' smell or mould and mildew occurring on surfaces. If left unmanaged, damp conditions can lead to further health problems and the decay of timbers will continue.

Early intervention and regular maintenance, particularly of exterior timbers, will prolong the useful life of these building elements. Prior to any works being performed, the cause of the moisture that has created the visible wood rot should be identified and addressed in a suitable manner. Replacement of affected timbers may then be a necessary step in protecting surrounding building elements from such deterioration.

A qualified plumber may be appointed to assess the cause of excessive moisture and to provide advice on any remedial works as required. A qualified carpenter or registered builder may also be required to replace affected building materials.
