Building and Timber Pest Inspection Report VR

Inspection Date: Fri, 20 Feb 2026

Property Address: 11 Lucy St, Ashfield NSW 2131, Australia

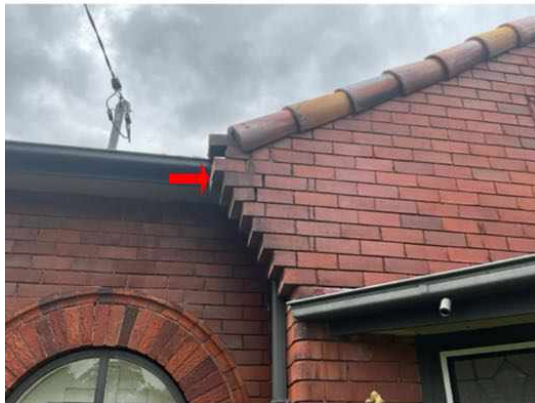
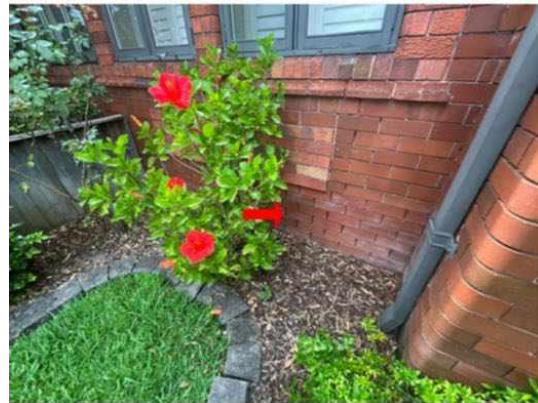
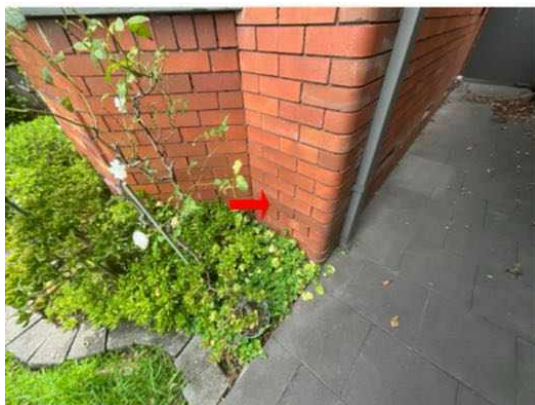
Finding 3.01

Building: Main Building

Location: Exterior walls

Finding: Brickwork - Deteriorated mortar

Information: Mortar, or 'bedding', is the material which fills joins and intersections between bricks in masonry walls and structures. Sections of mortar in this brickwork were identified as having deteriorated.

Mortar deterioration can be addressed by a bricklayer.

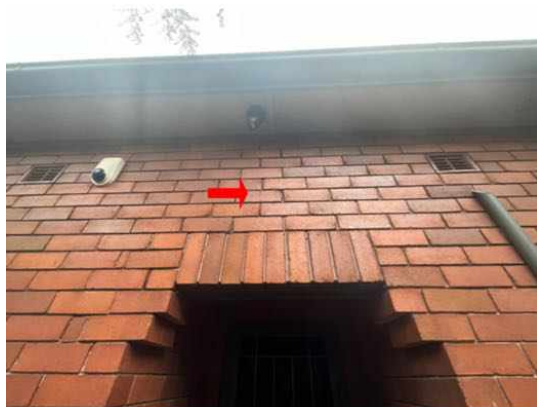
Finding 3.02

Building:	Main Building
Location:	Exterior walls
Finding:	Brickwork - Cracking noticeable
Information:	There were several cracks and or crack repairs evident to external brickwork.

Noticeable cracks are a common occurrence in external brickwork and are a likely result of age expected building movement, general expansion, and/or contraction of building materials in different weather conditions.

It is highly advised that a qualified bricklayer be appointed to provide necessary works to cracked brickwork to prevent any further damage.

Always monitor these cracks and contact a building inspector should cracks widen, lengthen, or become more numerous.

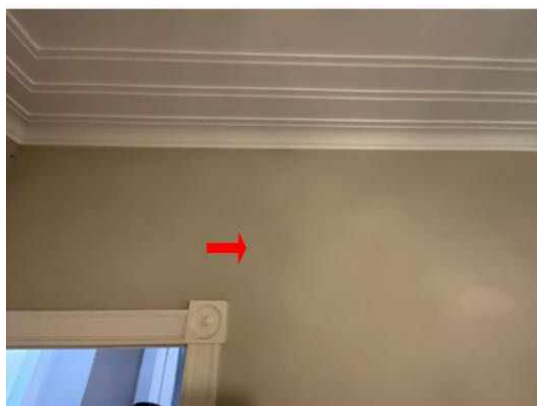
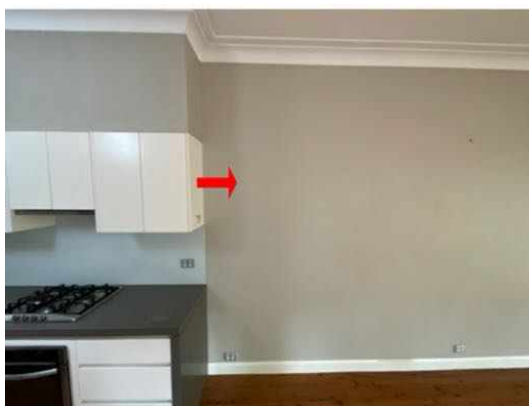
Finding 3.03

Building:	Main Building
Location:	Internal Areas
Finding:	Cracking - Damage Category 2 - Noticeable (up to 5mm)
Information:	Noticeable cracks are a common occurrence as a result of many primary defects. Such causes may include age, general wear and tear, expected building movement, general expansion/contraction of building materials in different weather conditions, and/or minor failings in the installation or application of building materials.

I recommend monitoring and if further cracking is evident appoint a bricklayer to see what works are required.

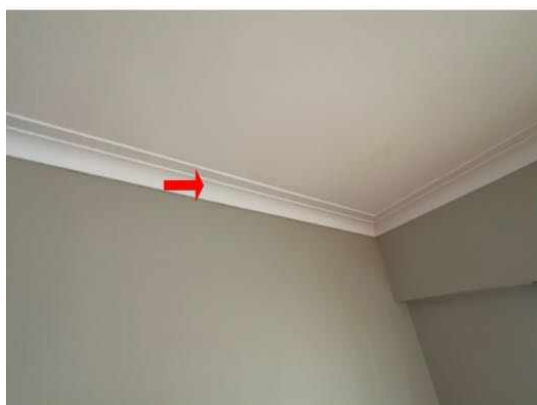
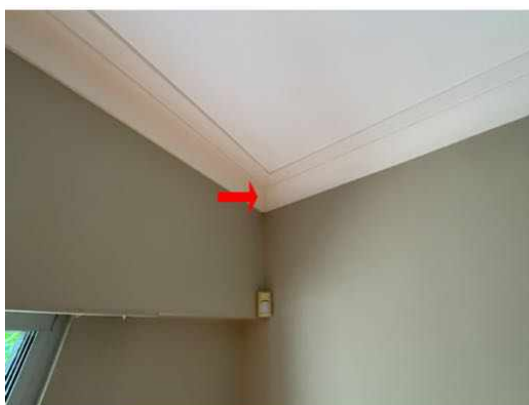
Finding 3.04

Building:	Main Building
Location:	Internal Areas
Finding:	Cracking - Damage Category 1 - Fine (up to 1mm)
Information:	Although fine cracks are quite noticeable, they are often only considered to be an appearance defect, and usually do not indicate any structural damage. Generally, the cause of a fine crack is indicative of a separation between building materials and finishes (e.g. paint, plaster, etc.) along joins.

Cracking of this nature can generally be repaired with minor sanding, filling and/or repainting. Such works should be performed by a qualified painter or a general handyman.

Monitoring of all cracking should be conducted frequently. Always contact a building inspector should cracks widen, lengthen, or become more numerous.

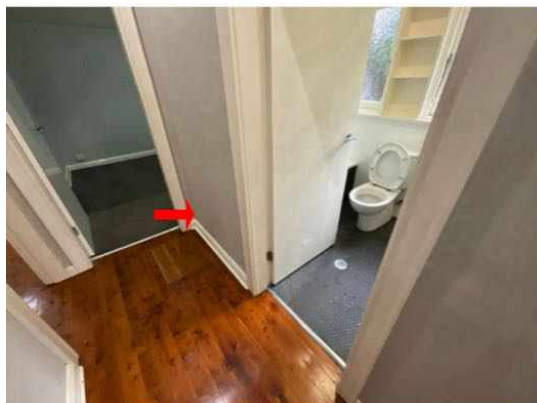
Finding 3.05

Building:	Main Building
Location:	Bathroom
Finding:	Moisture Detected to Wall Backing onto Shower
Information:	Moisture was detected in the wall that backs onto the bathroom shower area.

The presence of moisture may indicate a potential waterproofing failure or plumbing leak within the shower area. Ongoing dampness may lead to deterioration of wall linings, framing, and finishes if not addressed.

Further investigation by a licensed plumber or waterproofing contractor is recommended to determine the source of moisture and carry out necessary rectification works.

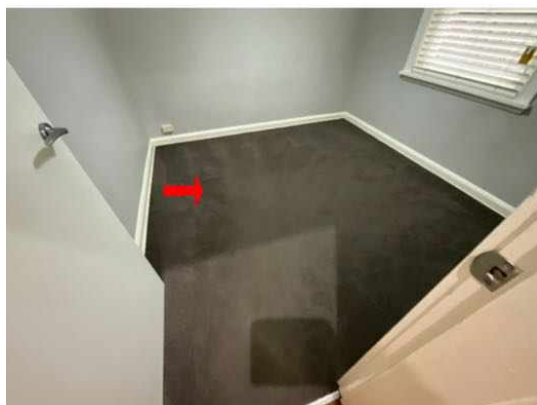
Finding 3.06

Building: Main Building

Location: Bedroom

Finding: Floors - bouncy

Information: The internal flooring in this area was identified as being bouncy at the time of inspection. A bouncy floor surface generally presents as a discernible change in level as they are walked across, in noisy or creaking flooring, or in consequent movement of surrounding furniture and fixtures.

Bouncy floors generally indicate that the floorboards or the subfloor structures are coming loose from the joists that they are installed on. Bouncy flooring may also be the result of gaps between flooring and joist structures, which require packing.

The client is advised to seek quotations for required repairs from a Registered Builder.

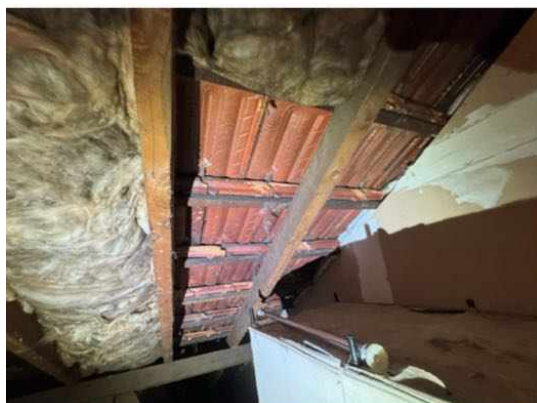
Finding 3.07

Building:	Main Building
Location:	Roof Void
Finding:	Roof Tiles - Weathered
Information:	Upon inspection of the interior roofing, sections of the tiles were beginning to deteriorate. While deteriorating of the tiles is consistent with the age of the property, replacement of the roof tiles may need to be carried out to prevent future defects to the property.

Where left unmanaged, deteriorating roof tiles may lead to a number of secondary defects, including minor water leaks and weather exposure to internal roofing structures.

Further consultation with a roofing contractor is highly advised to gain advice of remedial works that may be required.

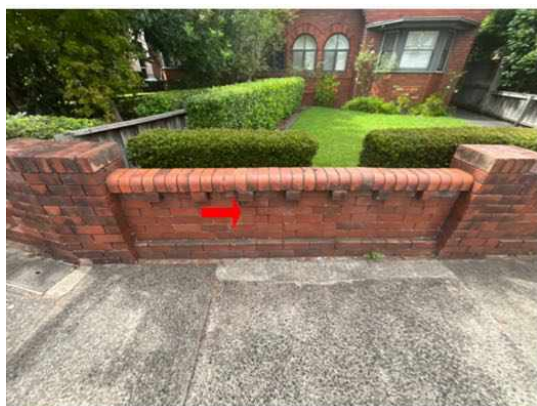
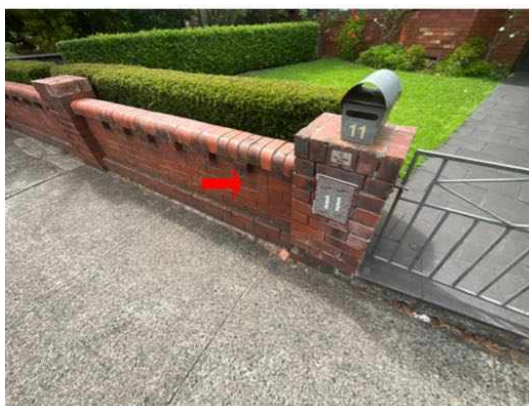
Finding 3.08

Building:	Yard
Location:	Exterior walls
Finding:	Brickwork - Deteriorated mortar
Information:	Mortar, or 'bedding', is the material which fills joins and intersections between bricks in masonry walls and structures. Sections of mortar in this brickwork were identified as having deteriorated.

Mortar deterioration can be addressed by a bricklayer.

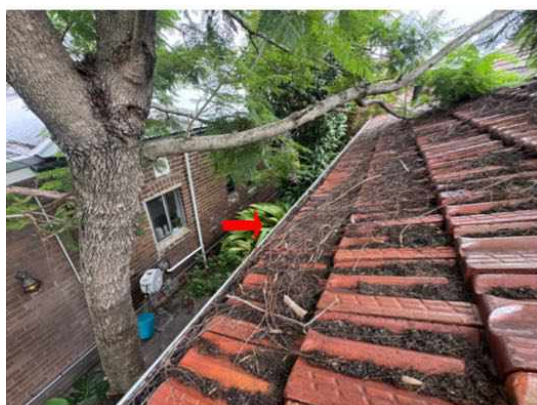
Finding 3.09

Building: Main Building

Location: Roof Exterior

Finding: Gutters - Blocked

Information: Roof plumbing structures, such as guttering and downpipes, should be free of all debris to prevent blockages. Blockages of the guttering and downpipes will lead to pooling and accumulated water overflows, which is likely to subsequently flood eaves and exterior walls.

Blocked gutters are likely to lead to high levels of moisture in the affected areas. Such moisture will not only cause rust and decay of the associated building materials, but can also provide conditions that are conducive to termite and timber pest activity. Blockages in gutters should therefore be removed to ensure dry conditions are maintained.

Consult a Licensed Plumber for further specific advice on remedial works that may be required. In the interim, it is highly advised that blocked gutters be removed by the homeowner or a general handyperson as a matter of urgency.

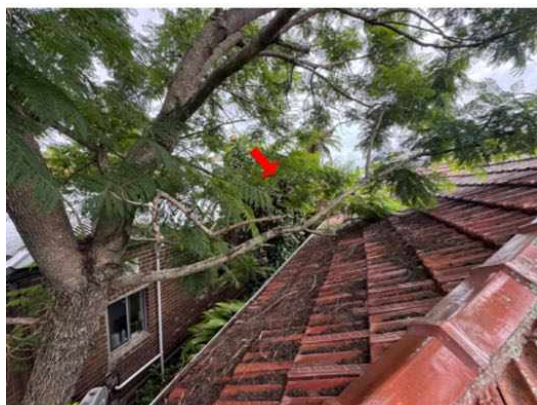
Finding 3.10

Building: Main Building

Location: Roof Exterior

Finding: Trees - Overhanging and filling gutters
 Information: Overhanging trees often result in excessive amounts of leaf debris accumulating in gutters.

Gutters are a critical part of the building's management of storm water and rain. It is therefore important that they be kept clear to prevent secondary damage to associated building elements, including exterior and interior walls, ceiling linings and any adjoining building elements. Where gutters are blocked, pooling of rainwater is likely to occur, fast-tracking rust and corrosion of the roof plumbing elements.

It is highly advised that all overhanging tree branches be removed as soon as possible to prevent any further damage. Repair and/or replacement of sections of damaged guttering may also be required where the extent of the damage necessitates.

Such works should be performed by the homeowner; however, appointment of a landscape contractor or an arborist may be required. Consultation with a licensed roof plumber is required where guttering has been damaged.

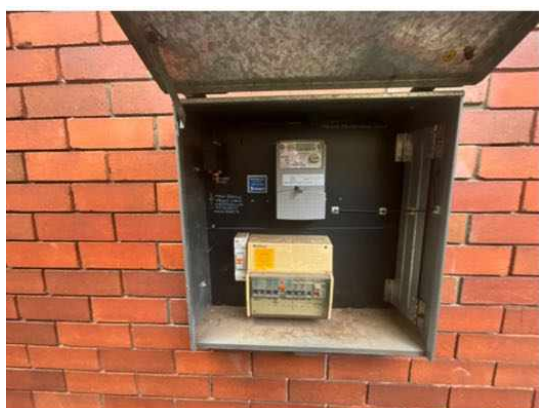
Finding 6.01

Building: Main Building
 Location: All Areas
 Finding: Termite Management System - no evidence of a chemical installation

Information: The application of a post-construction chemical termite barrier is highly recommended for all properties, particularly if live termite activity has been found on the site previously. Such barriers are highly effective in preventing termite attack on any timber building elements throughout the property.

A durable notice should be placed in the switchboard unit to indicate current termite barriers. At the time of inspection, it appeared as though no termite management system has been installed, with no evidence to suggest preventative works taking place.

The client may consider gaining further advice from a pest controller as to the costs and procedures involved with this application. It is recommended that obtaining such advice be a short-term priority.

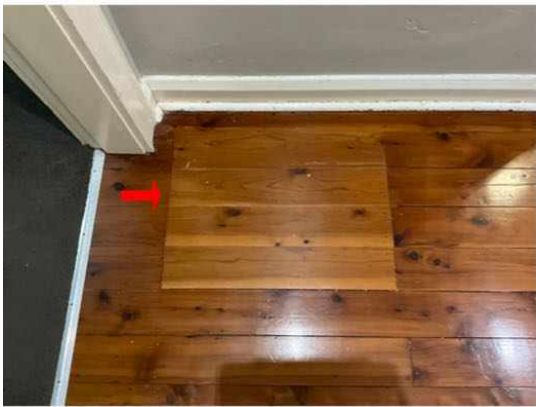
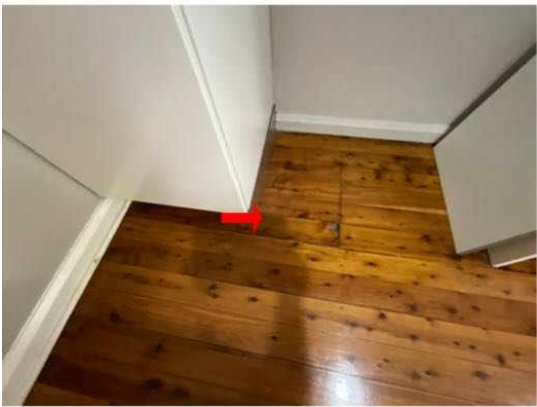
Building: Main Building
Location: Subfloor
Finding: Additional Photos - Obstructions and Limitations
Information: These photographs are an indication of the obstructions and limitations which impeded full inspection of the property at the time of inspection. These obstructions can hide an array of defects and should be removed to allow full inspection to be carried out. A re-inspection is recommended once the areas are made accessible.
