# Building and Timber Pest Inspection Report

Inspection Date: Wed, 25 Mar 2026

Property Address: 21/12-18 Lane Cove Rd, Ryde NSW 2112, Australia

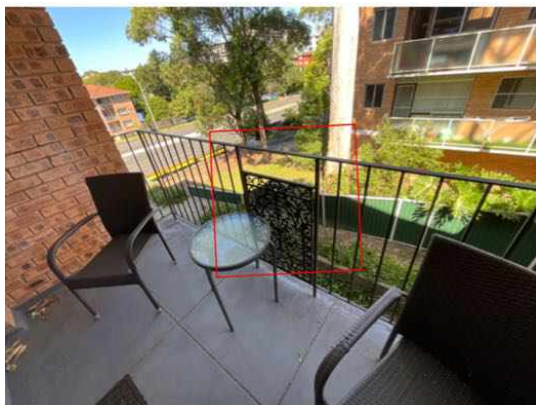
#### Finding 1.01

Building:	Main Building
Location:	Balcony
Finding:	Balustrade - Suspected Non-Compliance
Information:	The gaps between the balustrade cladding were found to be greater than the present building regulation requirement of 125mm.

This defect creates a potential safety hazard and should be rectified as soon as possible to ensure the safety of the area and to meet present building standards and regulations.

The balcony balustrade was found to be non-compliant, requiring immediate rectifications by a licensed builder.

A licensed builder should be contacted to discuss possible rectification solutions.

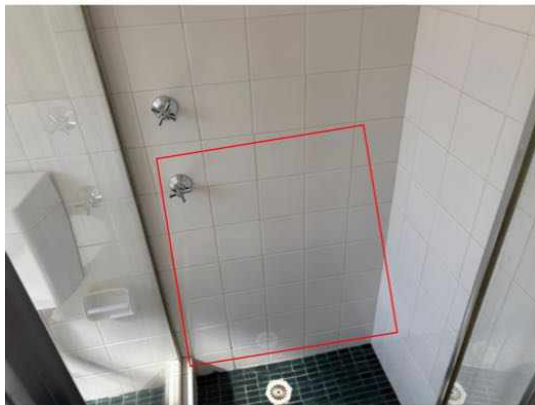
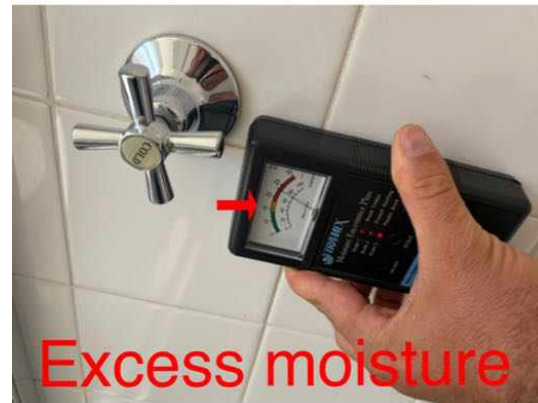
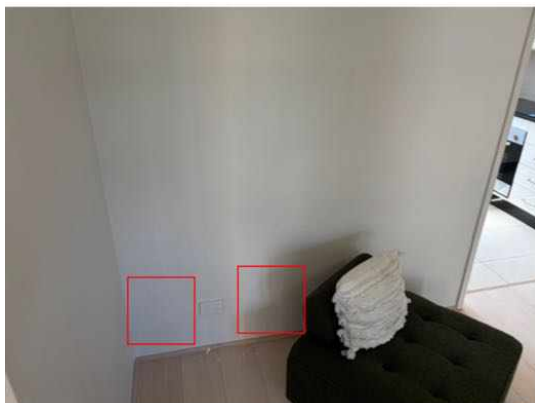
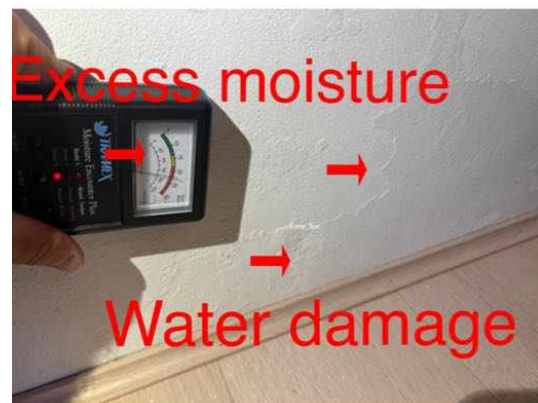
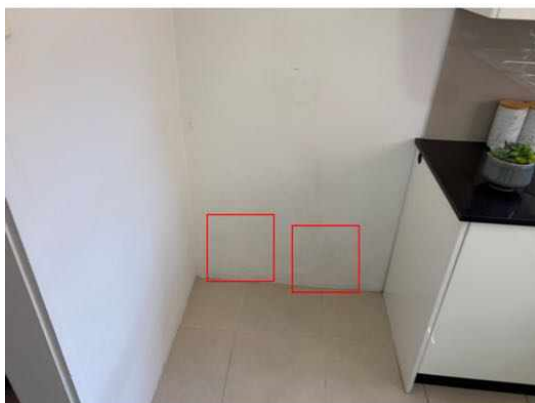
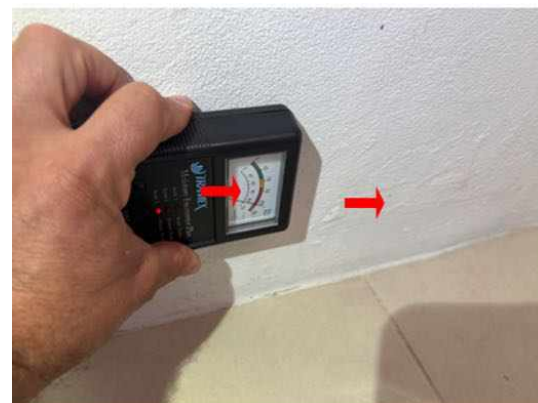
#### Finding 2.01

Building:	Main Building
Location:	Bathroom
Finding:	Water leak suspected - Internal
Information:	A water leak is suspected in this area at the time of inspection. Internal water leaks can

be detrimental to surrounding building elements; their potential causes include damage to plumbing fittings and fixtures, through to water damage and deterioration of associated building elements.

Rust, corrosion, decay and water damage are potential outcomes where a minor water leak is left unattended. More serious defects may also result, such as electrical hazards, or water damage to structural building elements.

Excess moisture was also identified to the ensuite shower, but also to the surfaces behind the shower. Water damages were also evident, indicative of an internal water leak. A bathroom specialist must be appointed urgently for further assessment and rectifications.

In extreme cases, structural damage may develop due to a prolonged water leak. A bathroom specialist must be appointed urgently for assessment and rectification.

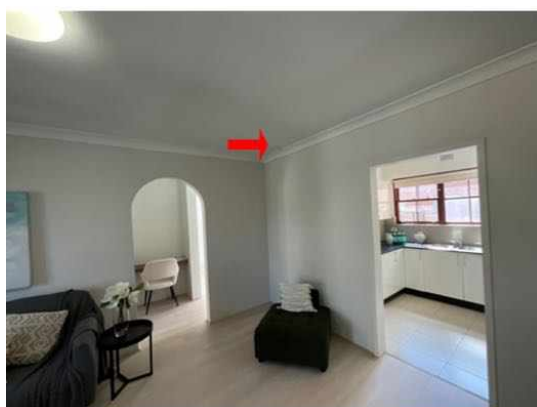
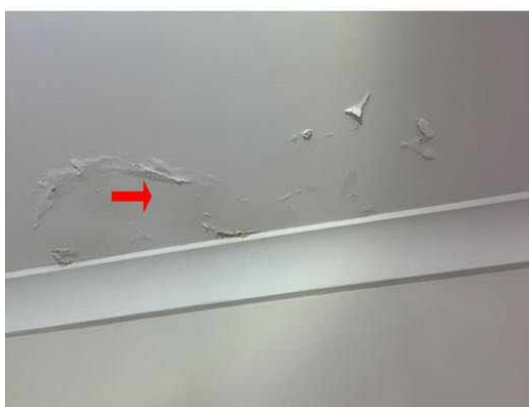
## Finding 2.02

Building: Main Building  
 Location: Lounge Room  
 Finding: Water Damage  
 Information: Water damage is generally an indication of excessive moisture being present, usually via a leak. It is suspected that the shower to the unit above is leaking.

Water damages were also identified to the loungeroom ceiling. It is suspected that the shower to the unit above is also leaking. A bathroom specialist must be appointed immediately for this work.

Where water damage is evident, the primary requirement is to identify and rectify the source of the leak. A bathroom specialist should be appointed as soon as possible to identify the leak and perform rectification works as necessary, ensuring the water damage is restricted.

Once the leak is repaired, consultation with relevant tradespeople, including carpenters, plasterers and painters, is advised.

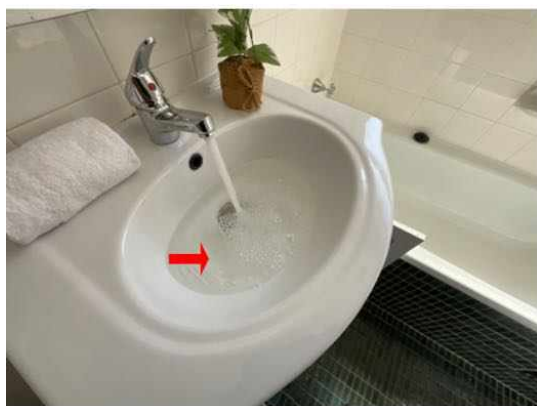
### Finding 3.01

Building: Main Building  
 Location: Bathroom  
 Finding: Sink/basin - slow draining  
 Information:

The sink/basin drain appeared to be partially blocked at the time of inspection. Blockages here are usually caused by hair and other debris. If left unmanaged, a lack of general maintenance may lead to the development of more significant defects, such as water damage to surrounding building materials.

A licensed plumber should be appointed to remove the blockage at the client discretion.

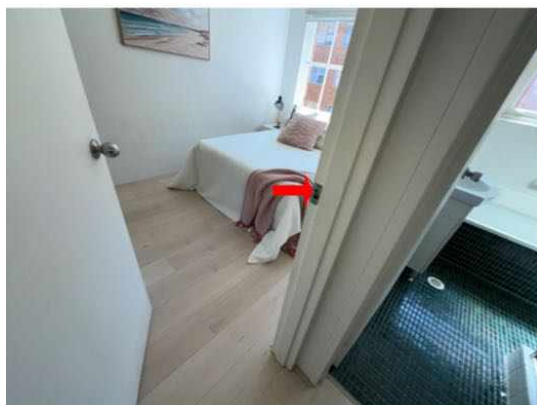
### Finding 3.02

Finding: Door - Striker plate misaligned

Information: The striker plate to this door appears to have become misaligned and has consequently resulted in the door's operation being compromised.

This is a common defect and is expected in a property of this age, whether being due to substandard installation or general deterioration of the door hardware.

Readjustment of the striker plate is recommended at client discretion. Works such as these can be completed by a general handyman or qualified carpenter.

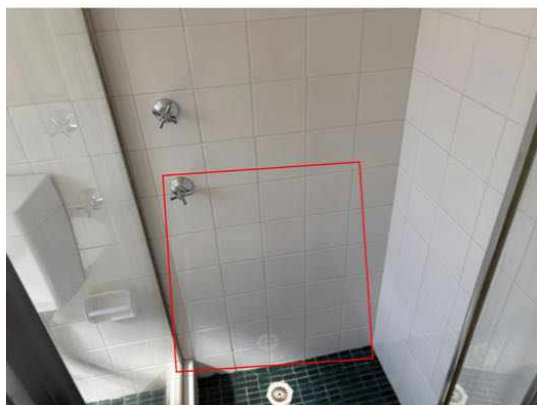
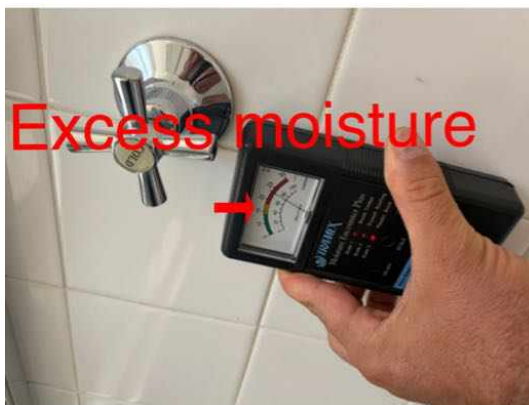
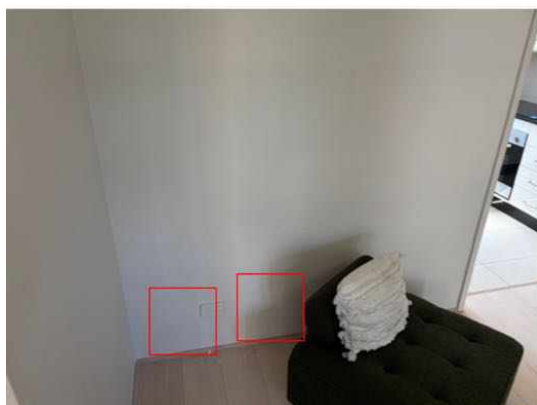
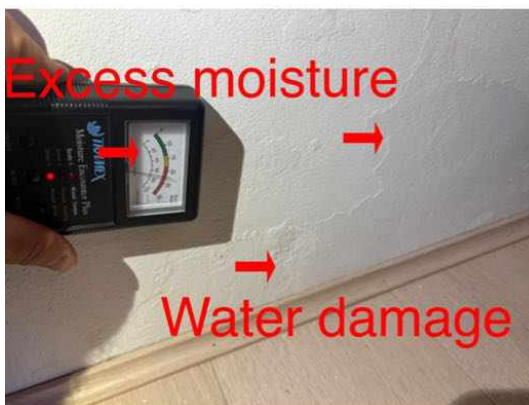
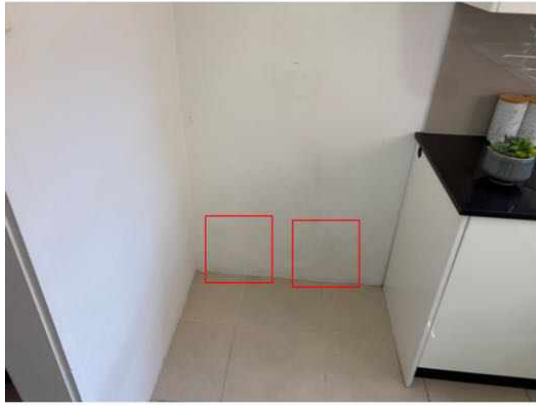
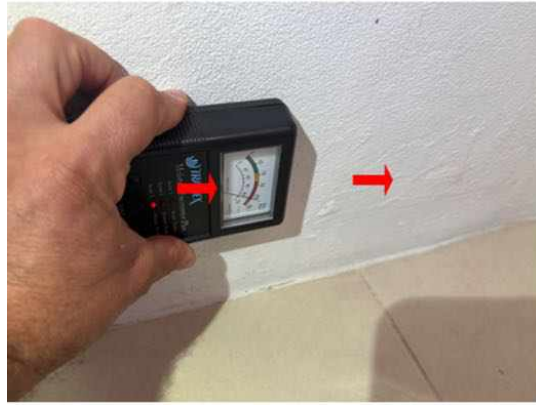
### Finding 6.01

Building: Main Building  
 Location: Bathroom  
 Finding: Water leak suspected - Internal  
 Information: A water leak is suspected in this area at the time of inspection. Internal water leaks can be detrimental to surrounding building elements; their potential causes include damage to plumbing fittings and fixtures, through to water damage and deterioration of associated building elements.

Rust, corrosion, decay and water damage are potential outcomes where a minor water leak is left unattended. More serious defects may also result, such as electrical hazards, or water damage to structural building elements.

In extreme cases, structural damage may develop due to a prolonged water leak. A bathroom specialist must be appointed urgently for assessment and rectification.

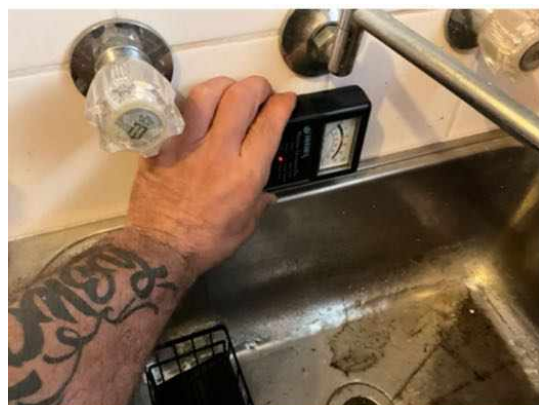
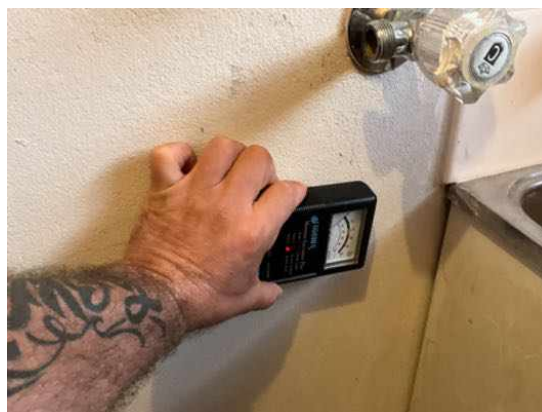
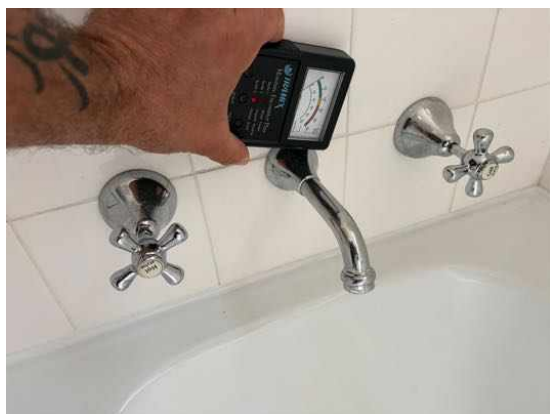
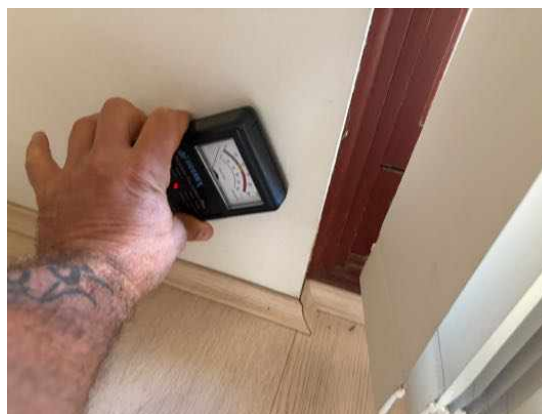
Building: Main Building  
 Location: All Areas  
 Finding: Moisture metre  
 Information: During the inspection the property was checked for moisture using a moisture metre.

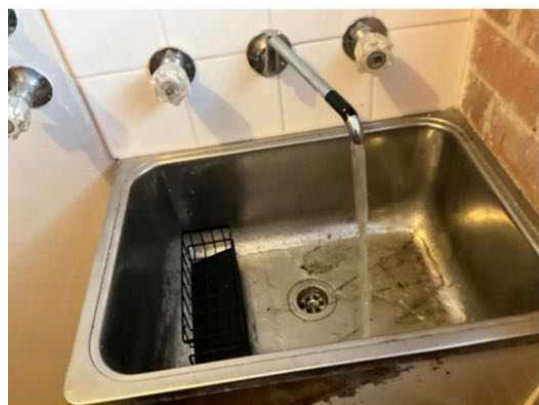
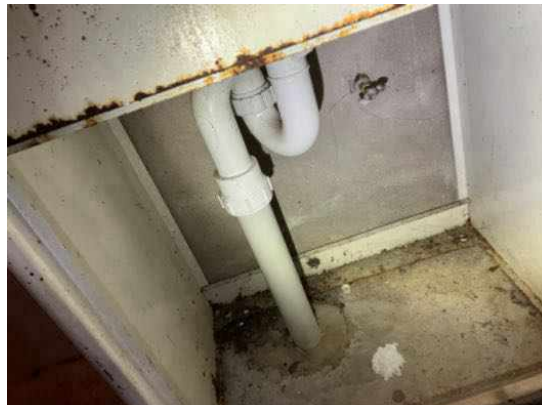
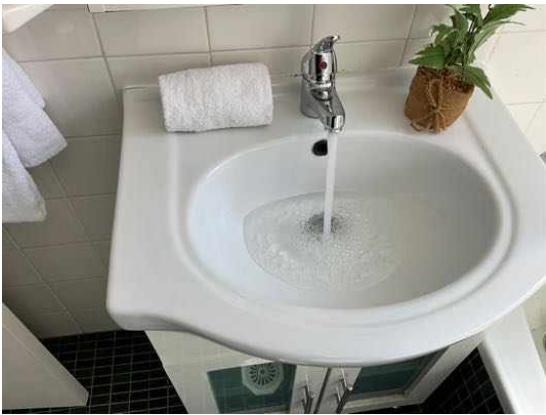
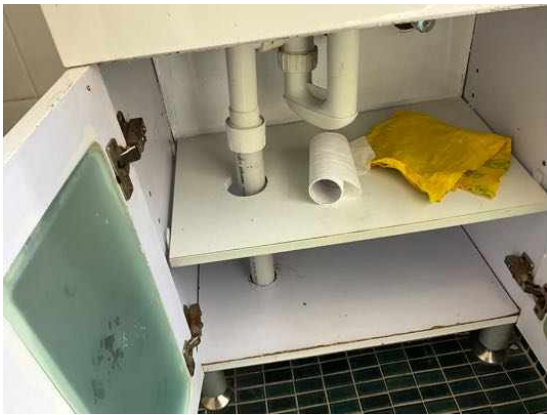
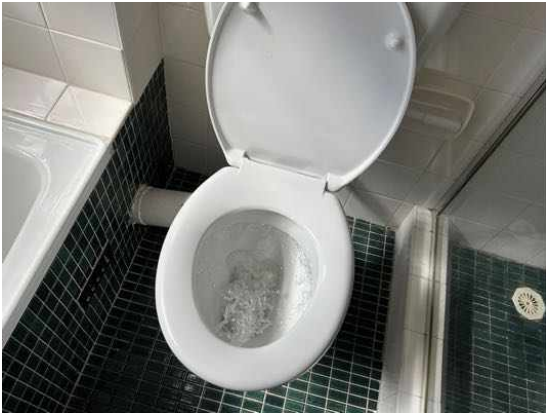
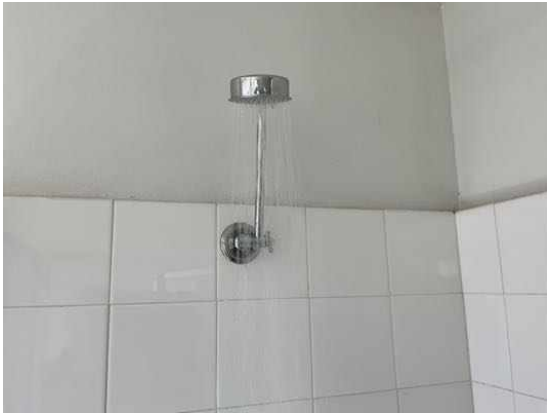
All taps, mixers and toilets were tested for operation, except for those obstructed. The waterproofing to the shower recess was assessed by checking the walls in and around the shower recess for varying moisture content. There were no significant variations across the tested areas. No sign of recent water damage was evident upon a visual inspection of the surrounding walls, where the visual nature of the inspection was possible.

Consequently, there is no conclusive evidence of any current shower recess leakage other than those which may have already been mentioned earlier in this report. It is reasonable to assume the shower waterproofing is sound. Note that if the shower is not used, or has not been used for some time, moisture readings would not vary significantly and this can lead to erroneous results. It is not possible under the visual inspection criteria (under which a prepurchase inspection is carried out) to categorically determine if there are leaks. If a more accurate assessment is required, a special purpose inspection should be requested. Alternatively, the assumption should be made that the shower may leak.
