Timber Pest Inspection Report

Inspection Date: Thu, 26 Mar 2026

Property Address: 4 Timble Cl Wollert

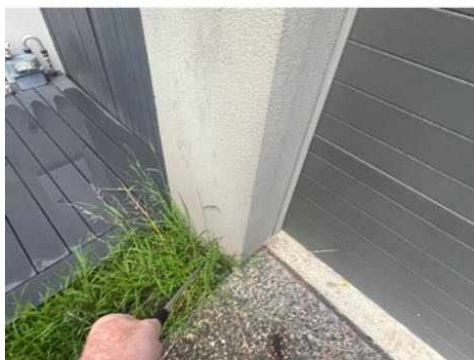
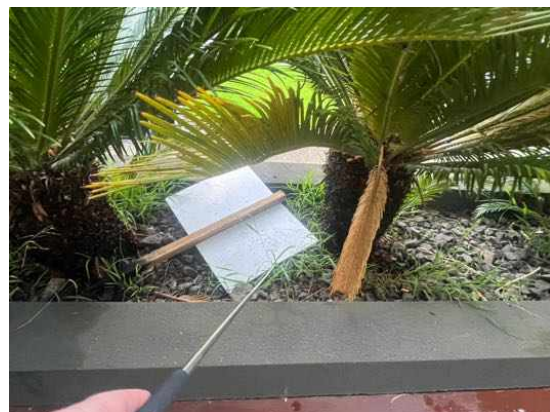
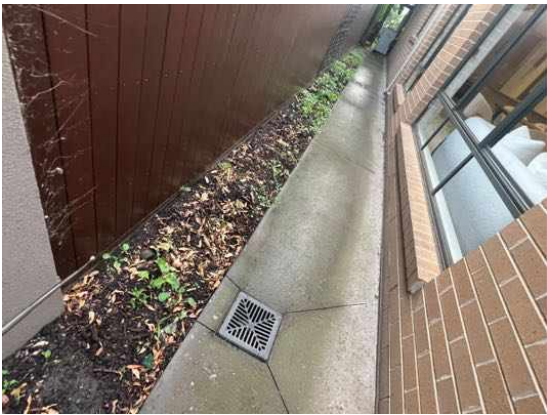
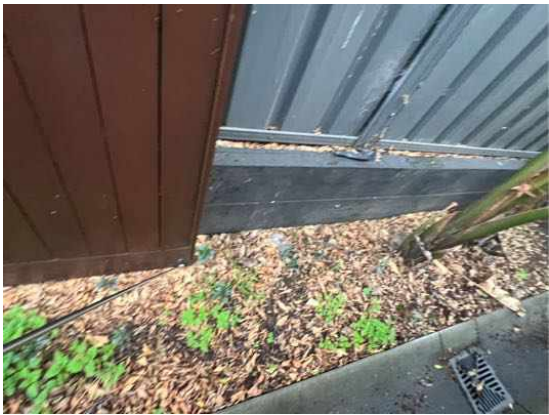
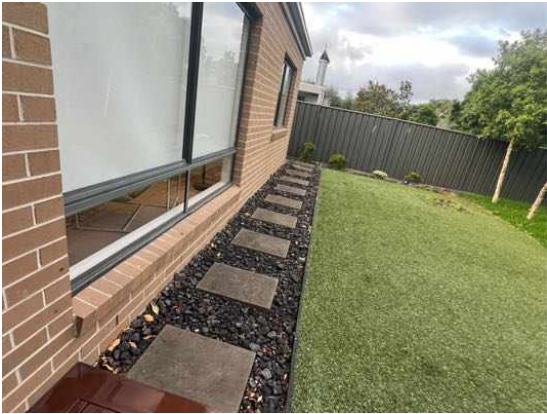
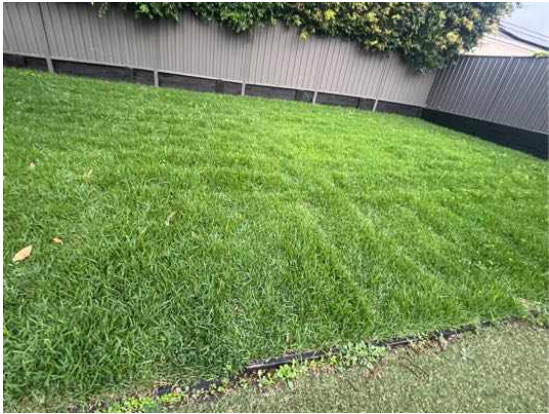
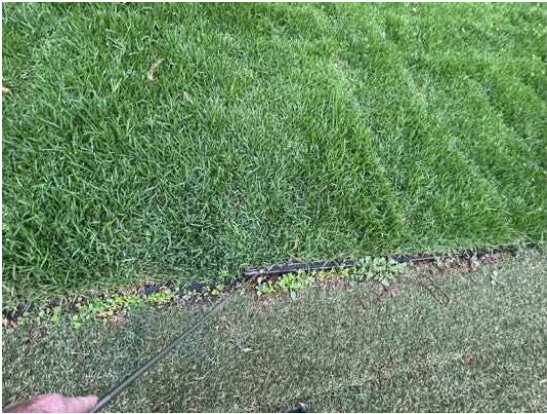
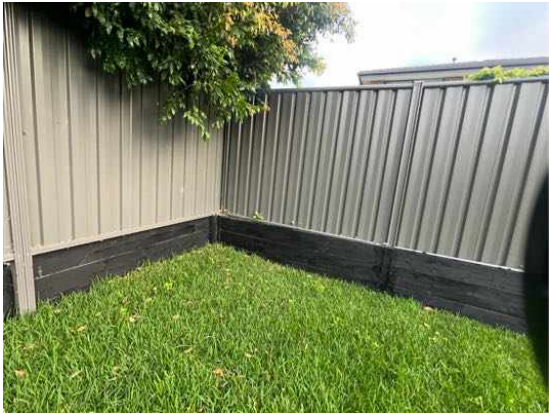
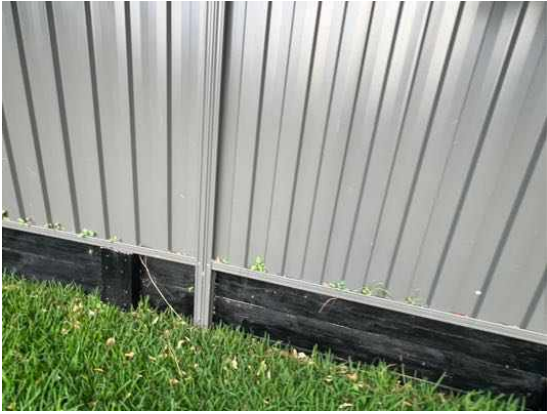
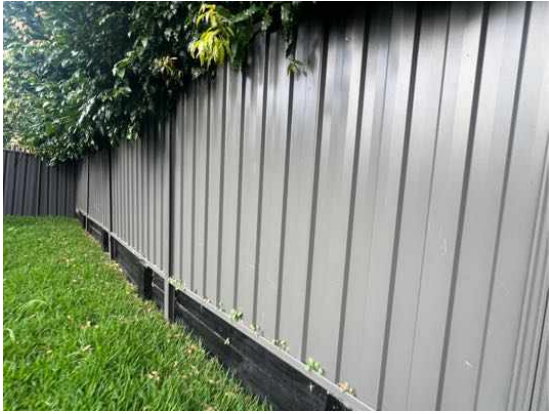
Termite and Timber Pest 4.01

Building:	Main Building
Location:	All Areas > All Areas
Finding:	Building materials in direct ground contact - conducive to termites
Information:	Where timber elements are in direct contact with the ground and consequently moisture or dampness they become conducive to termite activity. Whether timber is used as a building element part of a fencing structure or stored as an unused item they can provide an environment that is attractive to termite infestation.

When met with excessive moisture timber begins to decay and develop wood rot. Any timbers that are in direct contact with external grounds especially if left untreated or non-durable also provide ingress for subterranean termites into that particular element.

The removal of any such materials that may be conducive to termite activity should be removed as soon as possible to minimise the risk of termite attack.

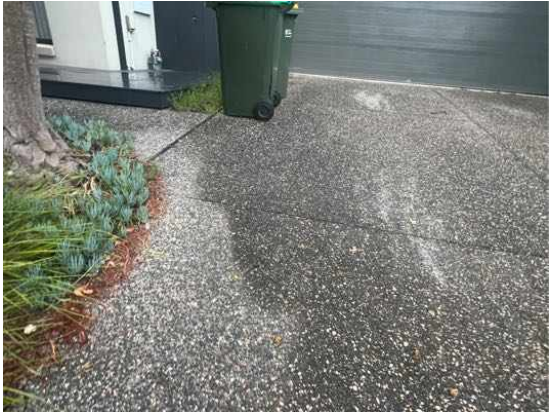
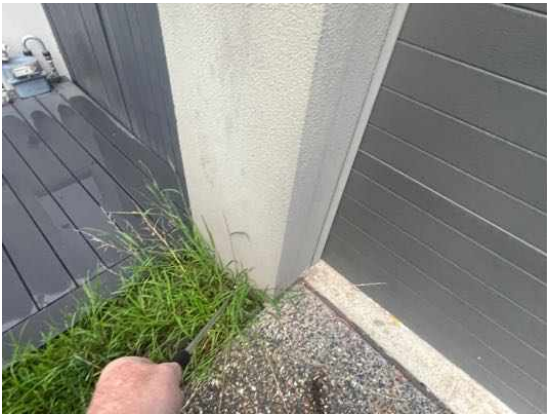
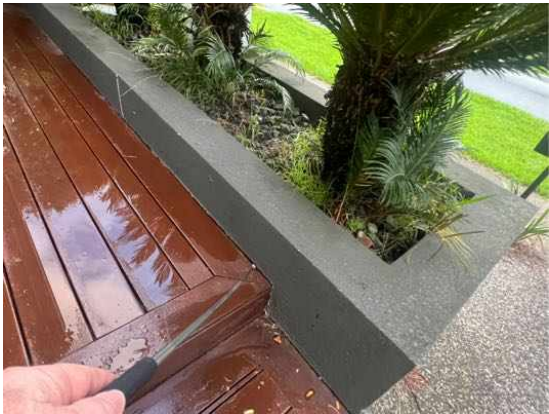
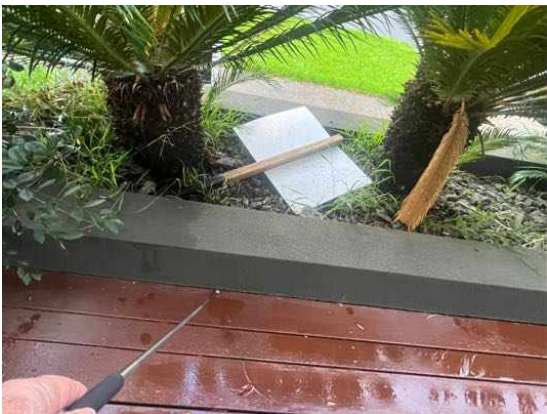
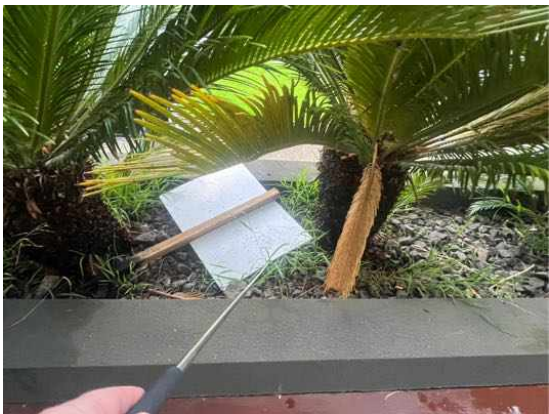
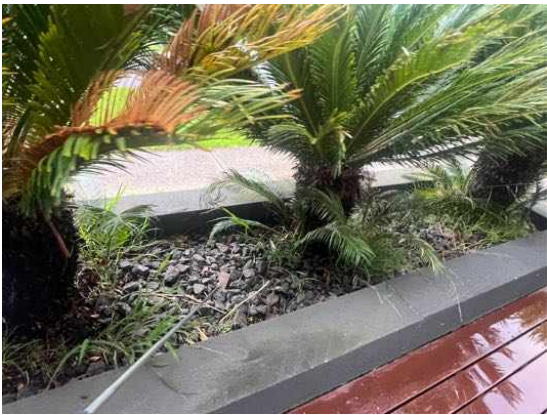
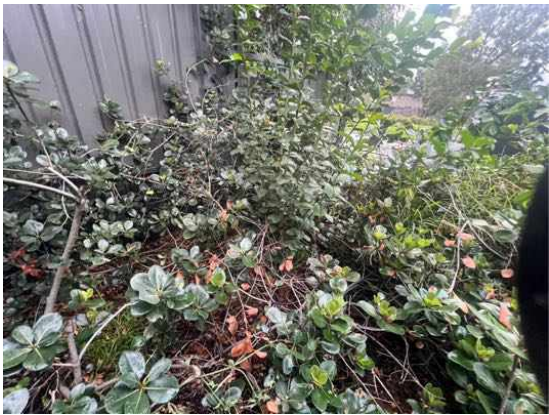
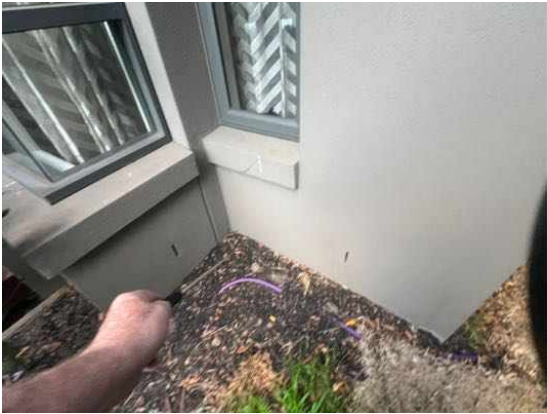
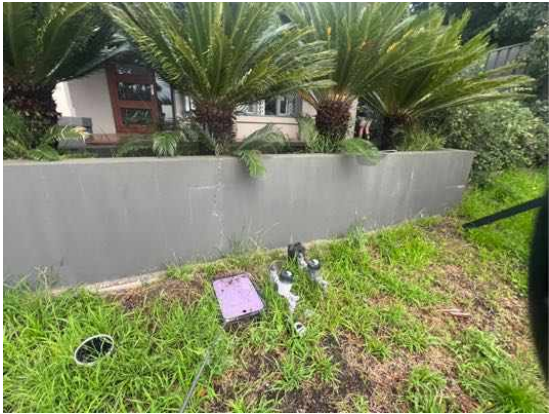
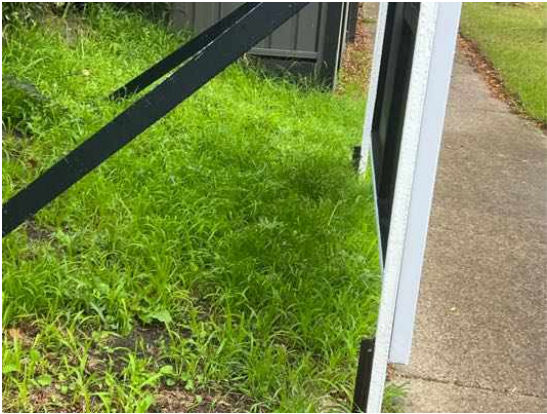
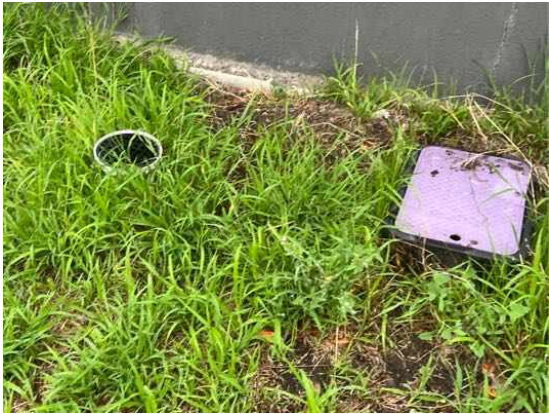
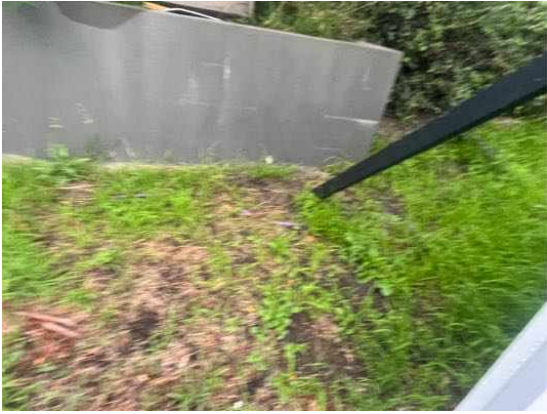
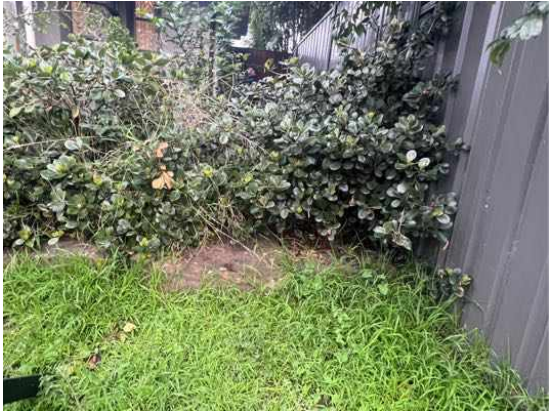
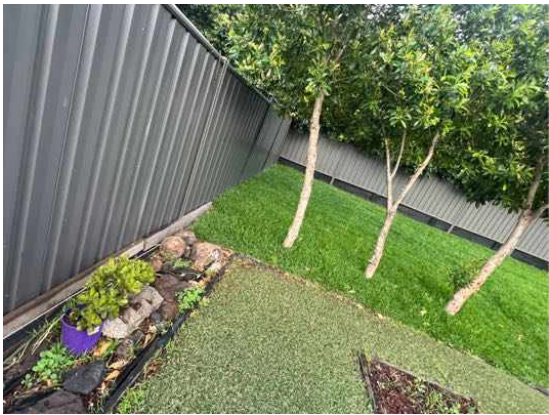
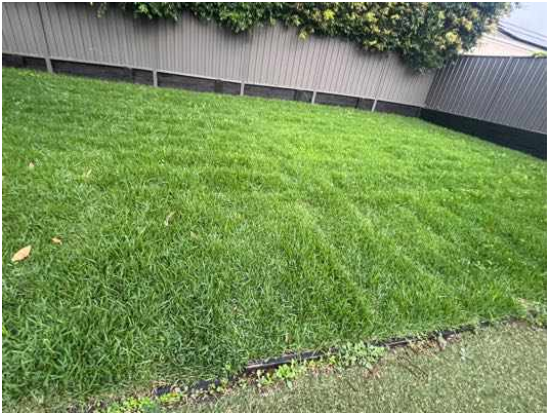
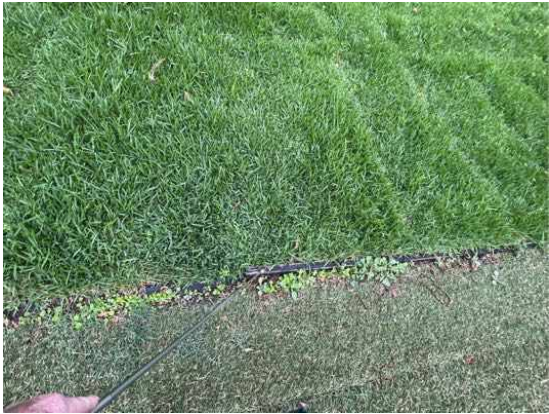
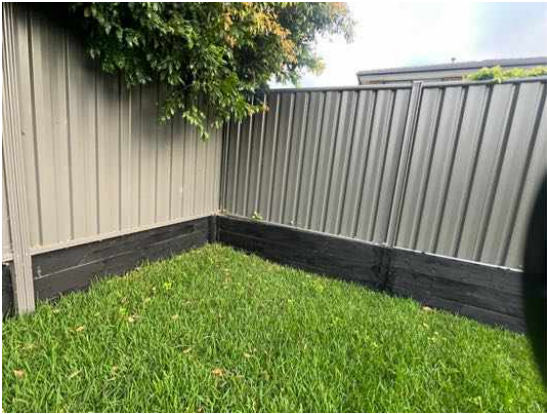
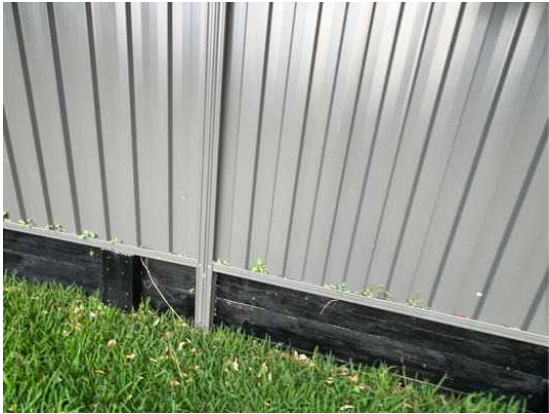
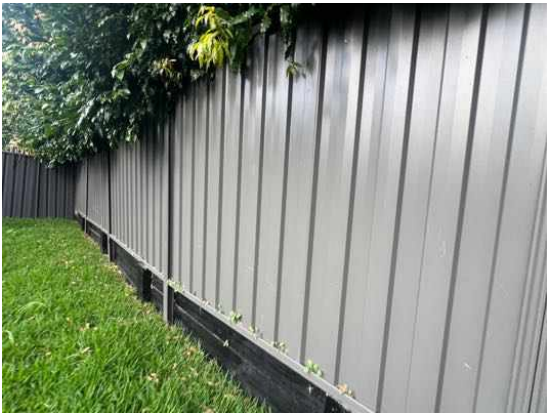
Termite and Timber Pest 4.02

Building: Yard
Location: All Areas > All Areas
Finding: Garden Beds - Conditions Conducive to Termites
Information: Garden beds were found to be evident in the garden area. These garden beds can include untreated timber, and with a combination of moisture from watering hosing can make conditions conducive to termite activity and termite ingress.

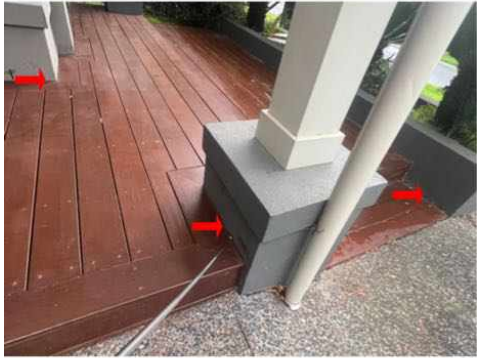
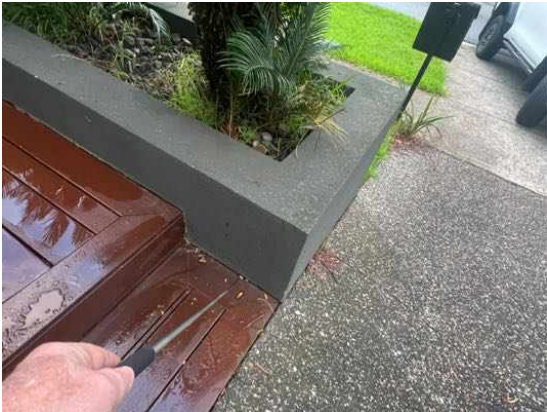
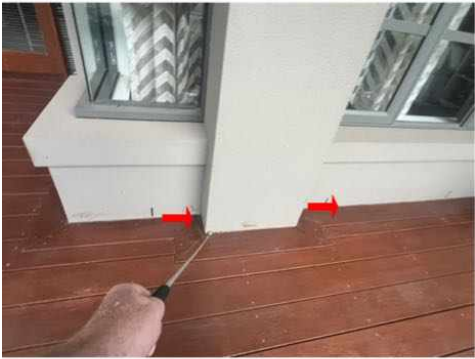
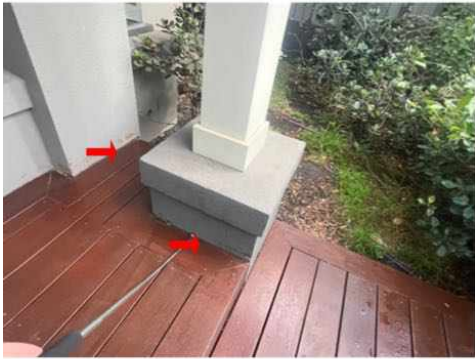
Termite and Timber Pest 4.03

Building: Main Building
Location: All Areas > Front Left
Finding: Pest -Attachments to buildings-structures-EG steps, verandahs, porches, carports, trellises, decks-down pipes-
Information: 5.4.3 Attachments to buildings Attachments to buildings such as downpipes and service pipes mounted on external walls shall have a nominal gap, which provides clear and uninterrupted visual inspection across the inspection zone. Structures such as steps, verandahs, porches, access ramps, carports, trellises, decks, hot- water systems, air-conditioners, or similar, which are not provided with a termite management system in accordance with AS 3660.1, shall be separated from the building by gap of at least 25 mm, to allow clear and uninterrupted visual inspection across the inspection zone.

NOTE: In some cases where there is zero boundary clearance or where existing structures are covered by heritage protections or cannot be practicably modified to conform with this clause,then conformance with this Standard may not be possible.

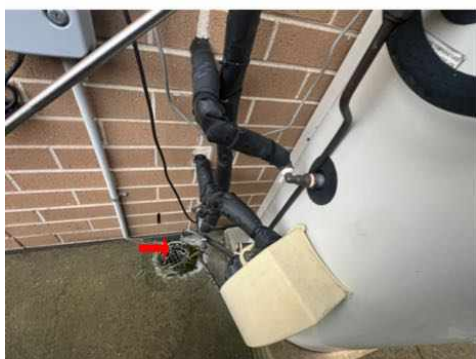
Termite and Timber Pest 4.07

Building: Main Building
Location: Exterior walls - left side > Front
Finding: HWS Overflow - Not Connected
Information: The Hot Water System (HWS) overflow was found to be disconnected from storm water drainage and is creating excessive moisture in the surrounding area.

These damp conditions can lead to secondary defects such as rot, rust or corrosion of associated building elements, the formation of fungal decay, or even the creation of potential slip hazards. When coupled with poor site drainage, pooling of water may also attract termite activity to this area.

It is highly recommended that a licensed plumber be appointed to connect the HWS overflow in order to prevent such an environment from being created. These minor works should be carried out as soon as possible.

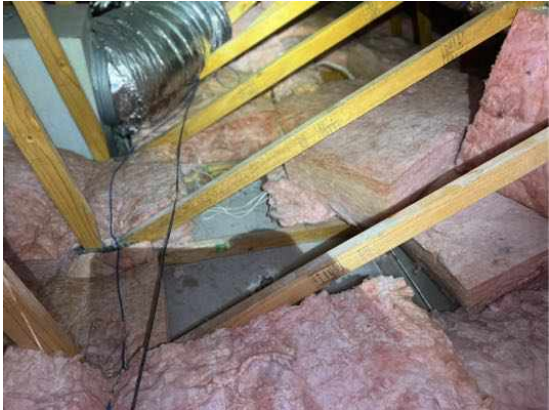
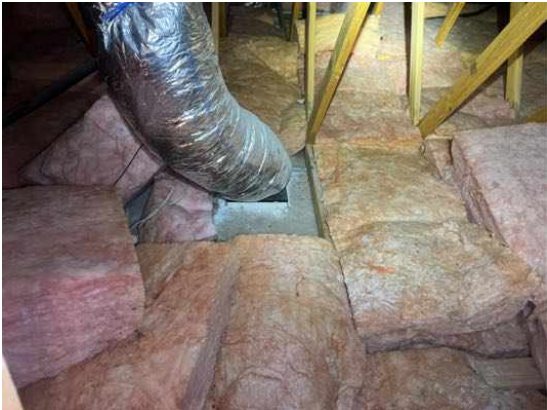
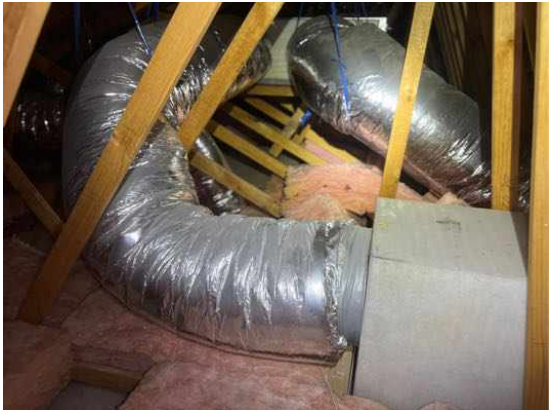
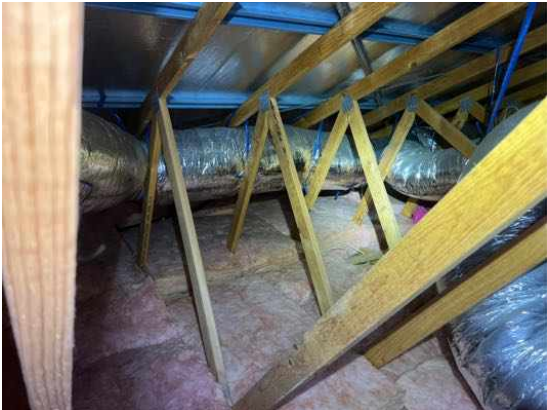
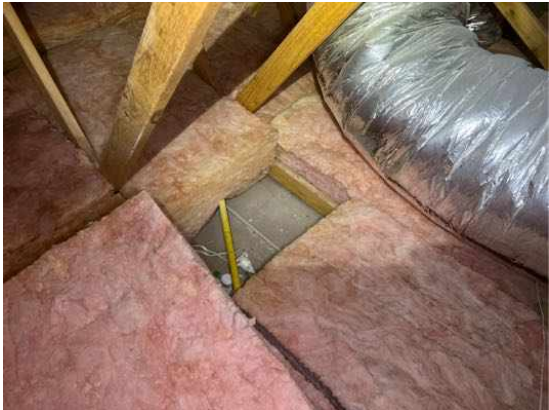
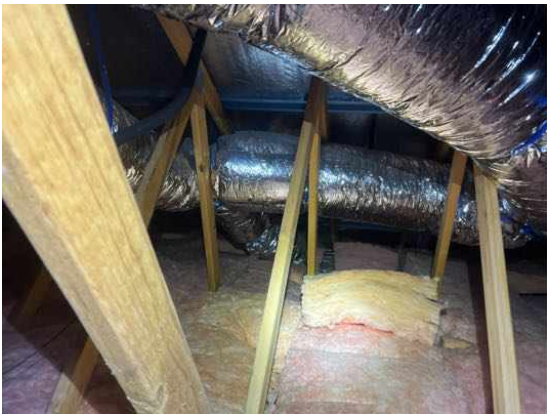
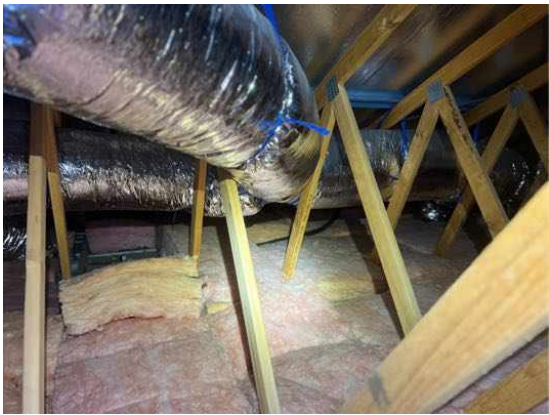
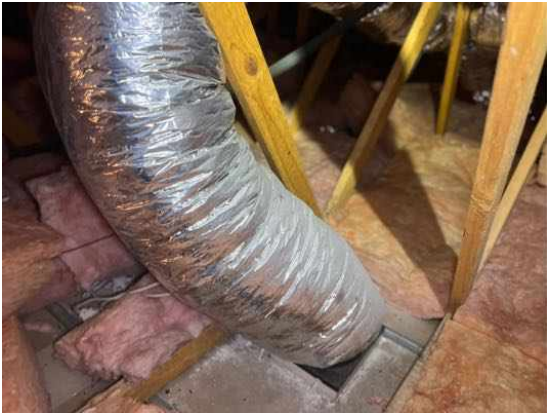
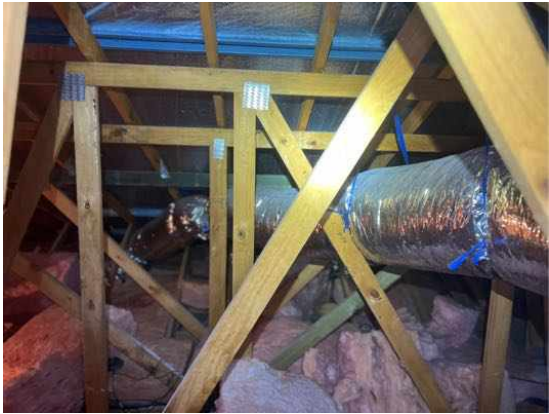
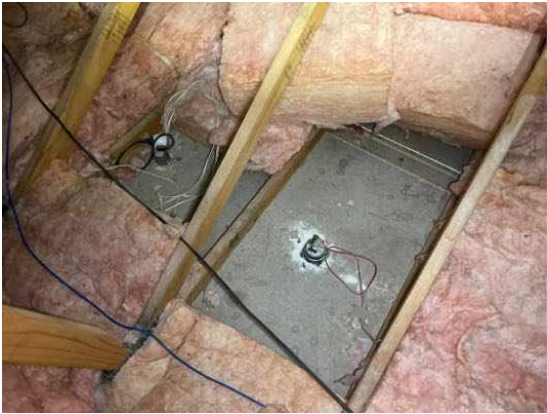
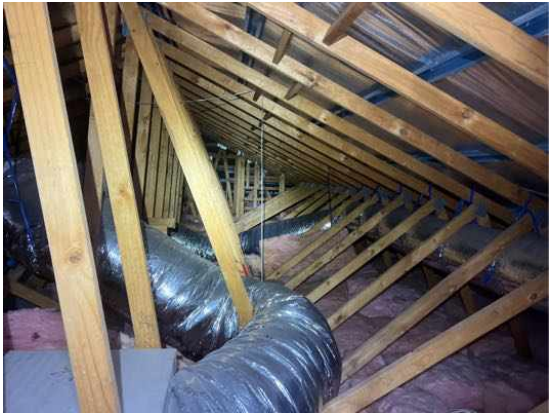
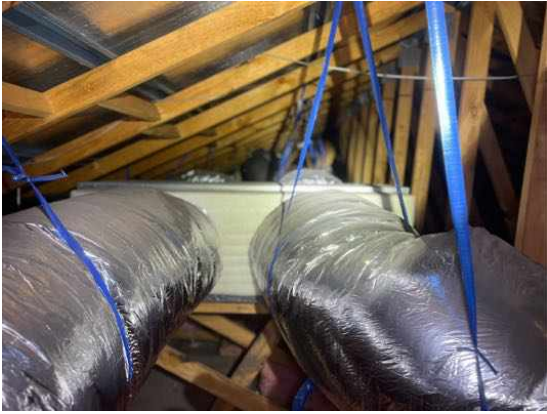
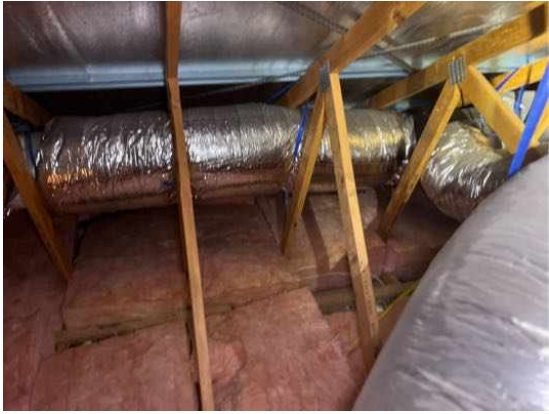
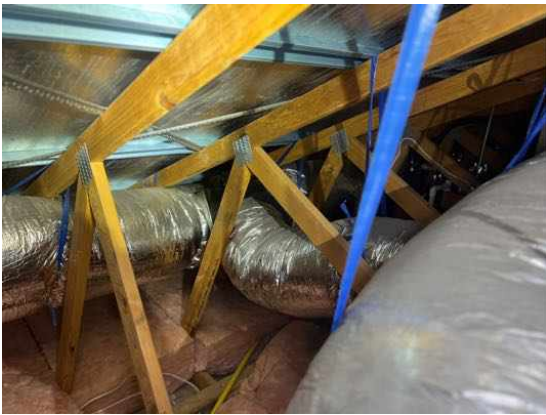
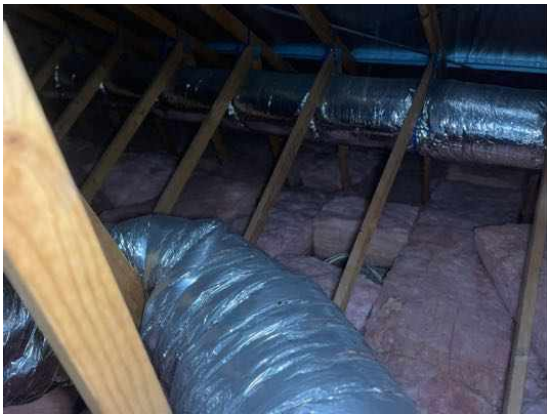
Termite and Timber Pest 4.09

Building: Main Building
 Location: All Areas > Front, All Areas
 Finding: Pest -Obstructions & Limitations-roof void-
 Information:

These photographs are an indication of the obstructions and limitations which impeded full inspection of the property at the time of inspection. These obstructions can hide an array of defects and should be removed to allow full inspection to be carried out. A re-inspection is recommended once the areas are made accessible.

The roof void contains a large area obstructed by insulation.

It is neither feasible or practical to remove all the insulation, therefore the risk of hidden termite timber pest activity cannot be ruled out.

Inspection of areas around the wet areas was limited and over 75% of the roof void could not be inspected.

Therefore, It is critical that before proceeding further, an inspection and possibly a treatment or advice regarding a treatment, be sourced form a Licenced Termite Timber Pest Controller.

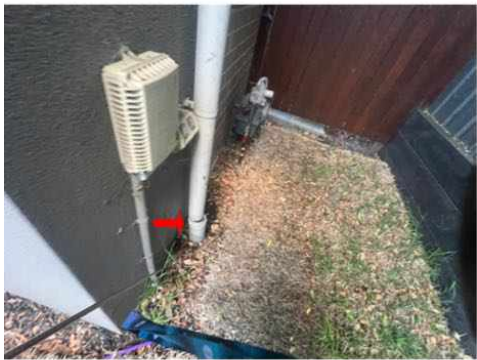
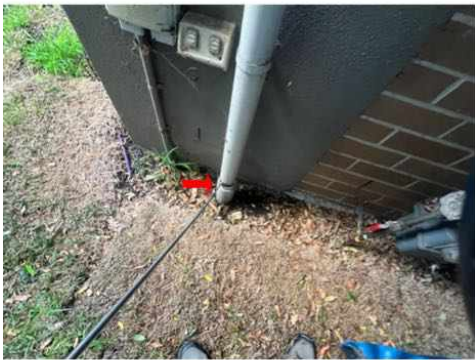
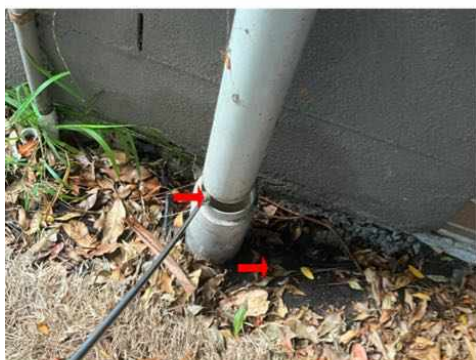
Termite and Timber Pest 4.10

Building: Main Building
 Location: Yard - Front > Front Right
 Finding: Damp or wet - leak-down pipe-damaged
 Information: Damp or wet conditions are generally a direct result of poor drainage an active leak or poor ventilation (or a combination of the three). Dry conditions should be maintained to prevent secondary building defects from developing.

If left unattended damp or wet conditions may have many consequences including the development of fungal decay and/or wood rot as well as providing an environment that may be conducive to termite or timber pest attack.

A qualified plumber should be appointed immediately to identify the cause of the excessive moisture in order to prevent further damage. The water leak should be resolved prior to any repairs of the damaged area which may require localised replacement of building materials and refinishing..

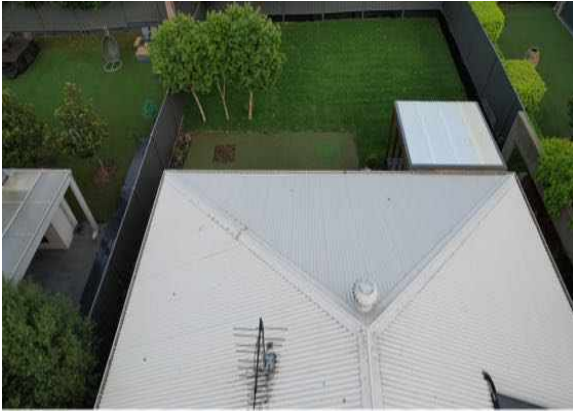
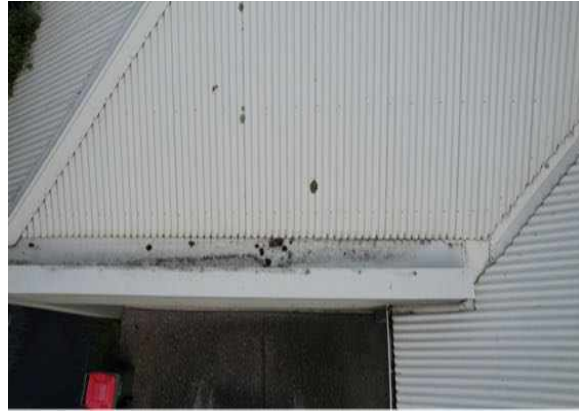
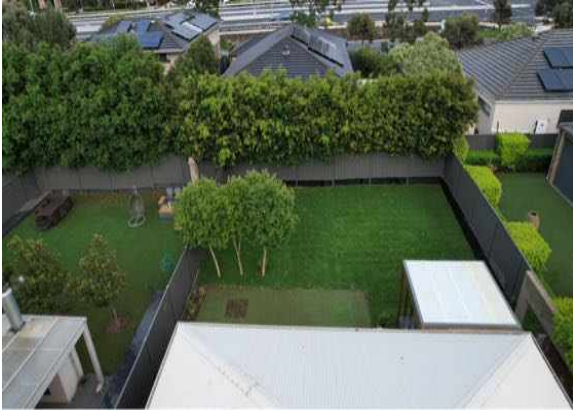
Termite and Timber Pest 4.11

Building:	Main Building
Location:	All Areas > All Areas
Finding:	Gutters - Blocked
Information:	Roof plumbing structures, such as guttering and downpipes, should be free of all debris to prevent blockages. Blockages of the guttering and downpipes will lead to pooling and accumulated water overflows, which is likely to subsequently flood eaves and exterior walls.

Blocked gutters are likely to lead to high levels of moisture in the affected areas. Such moisture will not only cause rust and decay of the associated building materials, but can also provide conditions that are conducive to termite and timber pest activity. Blockages in gutters should therefore be removed immediately to ensure dry conditions are maintained.

Consult a Licensed Plumber for further specific advice on remedial works that may be required. In the interim, it is highly advised that blocked gutters be removed by the homeowner or a general handyperson as a matter of urgency.

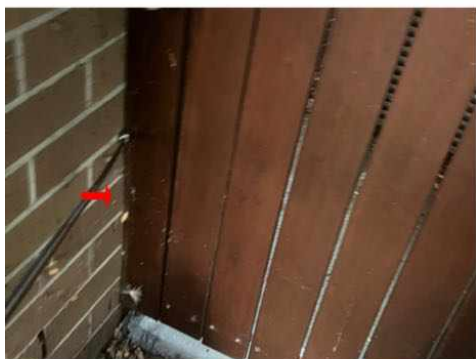
Termite and Timber Pest 4.12

Building:	Main Building
Location:	Yard - Side > All Areas, Front
Finding:	Pest - Attachments to buildings-structures-EG steps, verandahs, porches, carports, trellises, decks-down pipes-
Information:	5.4.3 Attachments to buildings Attachments to buildings such as downpipes and service pipes mounted on external walls shall have a nominal gap, which provides clear and uninterrupted visual inspection across the inspection zone. Structures such as steps, verandahs, porches, access ramps, carports, trellises, decks, hot- water systems, air-conditioners, or similar, which are not provided with a termite management system in accordance with AS 3660.1, shall be separated from the

building by gap of at least 25 mm, to allow clear and uninterrupted visual inspection across the inspection zone.

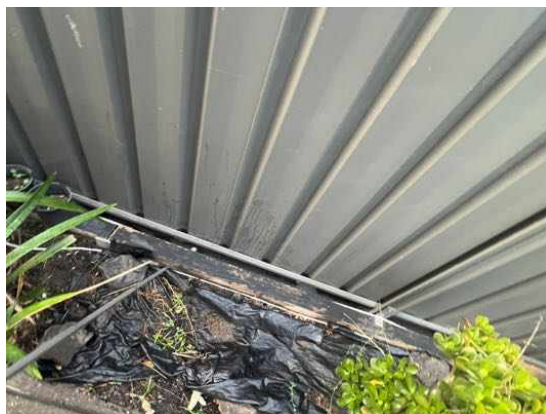
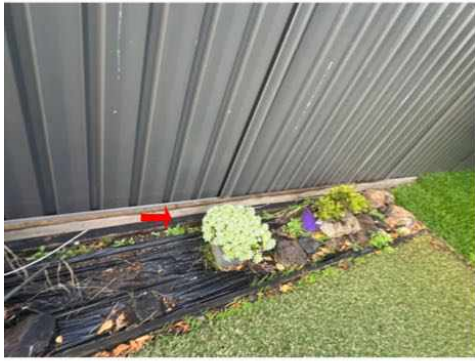
Termite and Timber Pest 7.01

Building:	Main Building
Location:	Exterior walls - left side > Rear
Finding:	Fungal decay - present (localised)-to door frame
Information:	Fungal decay also known as wood decay or wood rot generally refers to the deterioration of timber elements when in contact with excessive levels of moisture for a prolonged period of time.

The development of fungal decay is accelerated by temperatures in the range of 5degreeC to 40degreeC as well as the presence of oxygen. Generally fungal decay develops on timber elements that are in use in an external environment which are exposed to rain penetration.

In this case although the affected timber element is in a decaying state the extent of any visible damage appears to be localised to a specific area and is yet to spread to other parts of the building element or affect adjoining structures. The fungal decay is therefore likely to be of a relatively superficial nature with minimal impact on the structural integrity or tensile strength of the timber element.

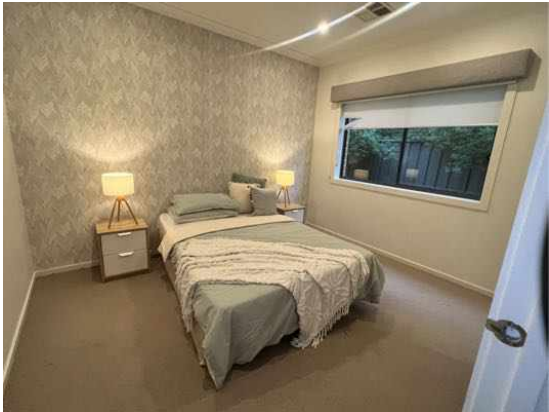
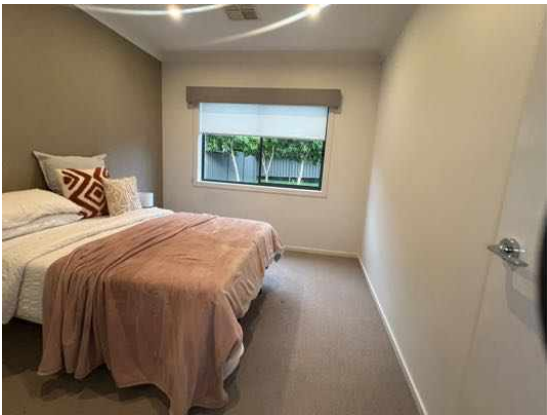
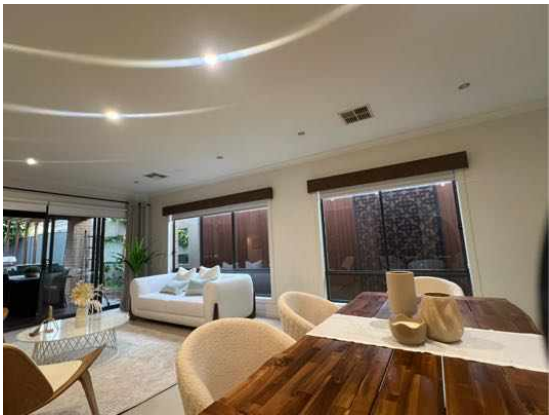
Noted Item

Building: Main Building
 Location: All Areas > All Areas
 Finding: Additional Photos - Obstructions and Limitations
 Information: These photographs are an indication of the obstructions and limitations which impeded full inspection of the property at the time of inspection. These obstructions can hide an array of defects and should be removed to allow full inspection to be carried out. A re-inspection is recommended once the areas are made accessible.
