Building Inspection Report

Inspection Date: Wed, 8 Apr 2026

Property Address: 18 Flemington Pkwy, Box Hill NSW 2765,
Australia

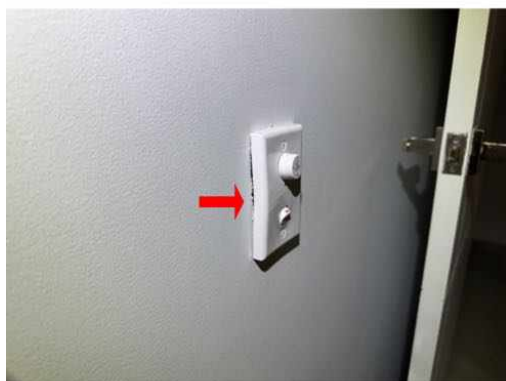
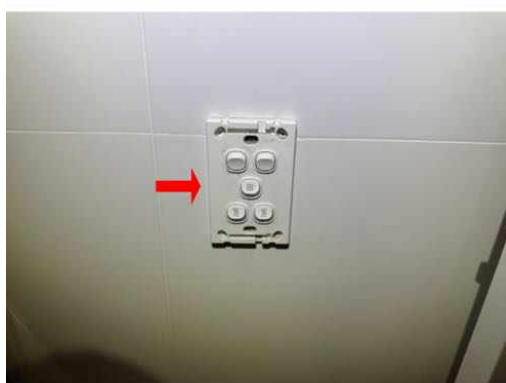
Defects 1.01

Building:	Main Building
Location:	All Areas > All Areas
Finding:	Electrical fittings: Deteriorated damage.
Information:	The electrical fitting in this area was found to be showing signs of deterioration at the time of inspection.

Left unmanaged, the fitting is unlikely to cause further damage to surrounding building elements. However, the broken fitting may create a safety hazard if there is potential contact with persons in the area.

Repair and/or replacement of the broken fitting is advised. A Licensed electrician should be appointed to repair/replace the fitting immediately.

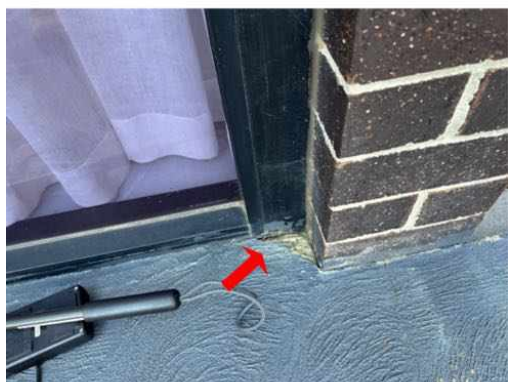
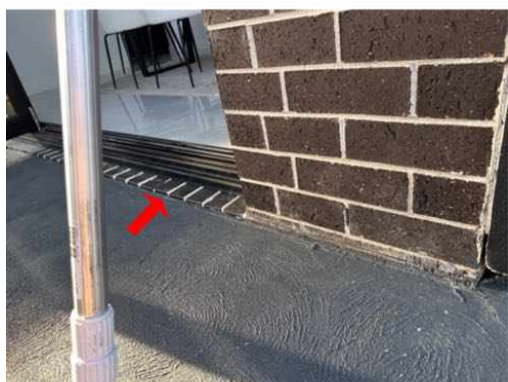
Defects 2.01

Building:	Main Building
Location:	Exterior walls - rear > Rear Left
Finding:	Perimeter Paving - Insufficient weather proofing.
Information:	The perimeter paving or ground levels were found to have an inadequate weather proofing from the adjoining building structure, creating potential for water pooling in this area.

Perimeter paving is required to fall from the building by a minimum of 25mm in the first metre and bare ground should fall away from the house by 50mm in the first meter. This standard ensures that excessive moisture does not pool around the base of building structures, which creates potential for water and structural damage, as well as making the area susceptible to termite and timber pest activity.

Where paving or ground levels do not have adequate fall, a licensed paving contractor should be appointed to install or remove and re-level pavement.

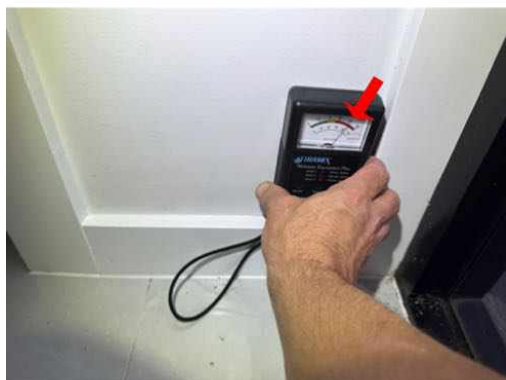
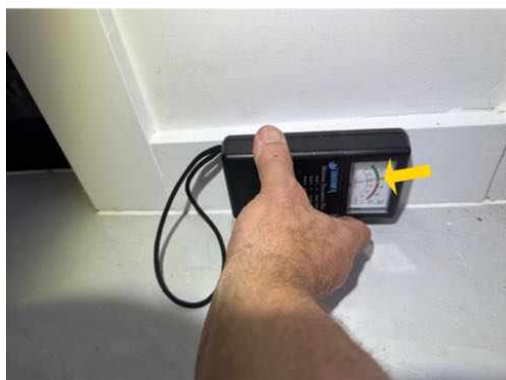
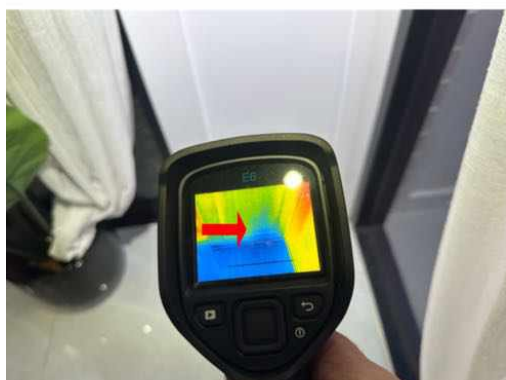
Defects 2.02

Building:	Main Building
Location:	Living Room > Rear Left
Finding:	Damp
Information:	Damp (or structural damp) refers to the presence of unwanted moisture in the structure of a building, either as the result of intrusion from outside, or condensation

from within the structure. Generally, structural damp is caused by rain penetration, rising damp, and leaks from plumbing pipes.

Unmanaged damp facilitates the formation and development of mould, fungi growth and wood rot, decaying associated building materials and compromising their structural integrity. Damage to finishes is also likely to occur, including lifting, bubbling, peeling and staining of paint, plaster and wallpaper.

A moisture meter was used on all accessible walls during the inspection and a limited amount of excessive moisture was detected to living room wall on the lower rear left wall, possibly due to the exterior concrete height to the internal floor height with no barrier between the two.

Consultation with a qualified plumber is advised immediately to identify the cause of damp and perform remedial works as required. Where excessive mould growth is present, further inspection by a specialist environmental health inspector should also be considered.

All areas with high moisture should be investigated by way of an invasive inspection by either a plumber and/or pest controller. High moisture levels also increase the likelihood of termite attack and may also be conducive to borer activity, wood decay, mould and deterioration of the building elements.

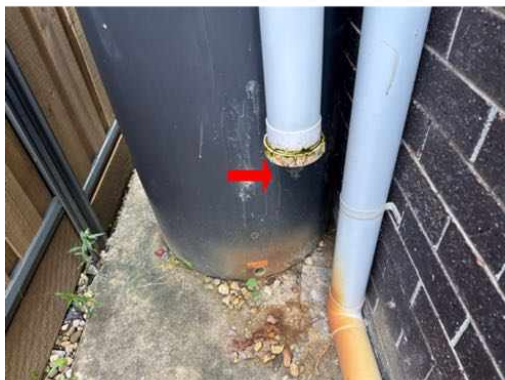
Defects 3.01

Building:	Main Building
Location:	Exterior walls - left side > Front Left
Finding:	Rain Water Tank: first flush not connected.
Information:	The first flush overflow was found to be disconnected from storm water drainage and is creating excessive moisture in the surrounding area.

Such leaking creates an environment which is conducive to an array of defects, including water damage to associated building elements and the attraction of termite or timber pest infestation.

It is highly recommended that a licensed plumber be appointed to connect the first flush overflow in order to prevent such an environment from being created. These minor works should be carried out as soon as possible.

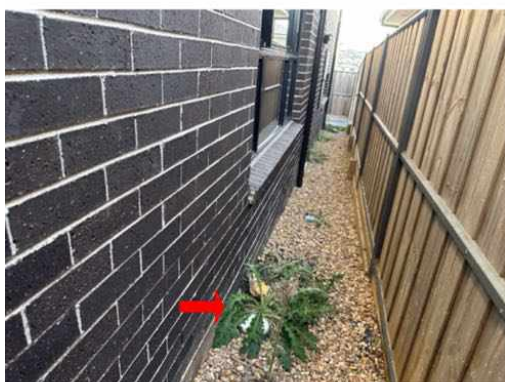
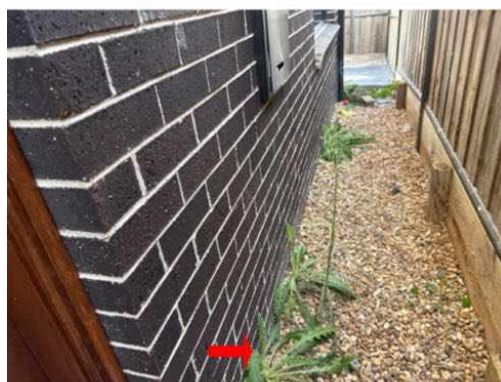
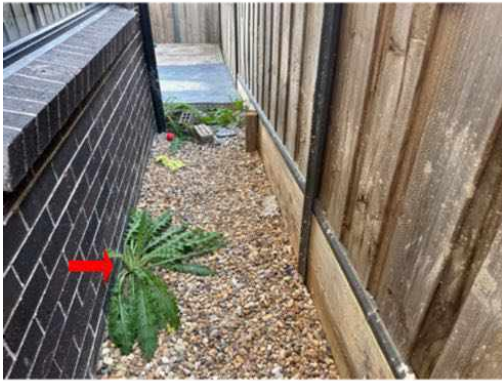
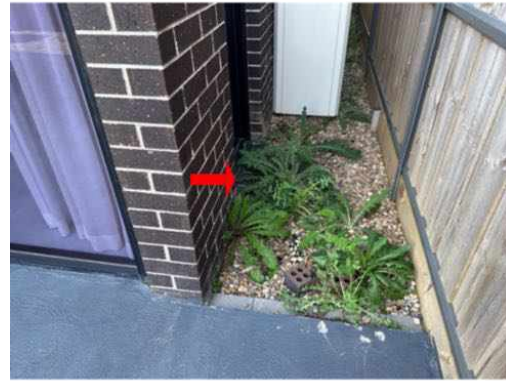
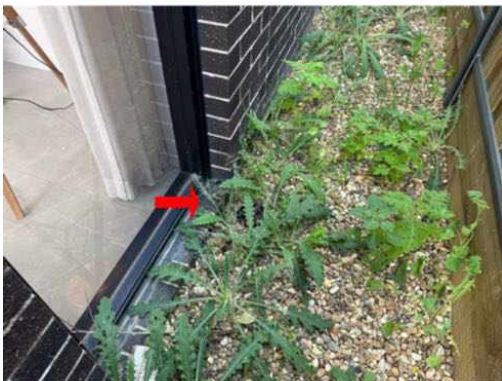
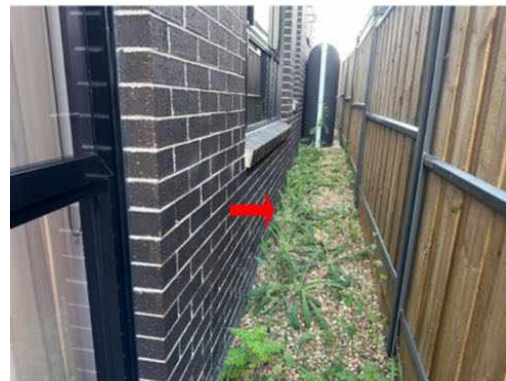
Defects 3.02

Building: Main Building
 Location: All Areas > All Areas
 Finding: Bridging - Vegetation
 Information: Where vegetation obstructs inspection of building elements, also known as bridging as it provides a bridging point for the access of termites, full inspection can not be achieved. Consequently moisture or dampness may be present and the areas becomes conducive to termite activity. Plants against or very close to buildings provide cover, shade and can provide an environment that is attractive to termite infestation.

The removal and replanting of species that do not provide "cover" or cutting back of existing vegetation will assist greatly in preventing Bridging from occurring.

The removal of any such materials that may be conducive to termite activity should be carried out as soon as possible and arrange re inspection to minimize the risk of termite attack.

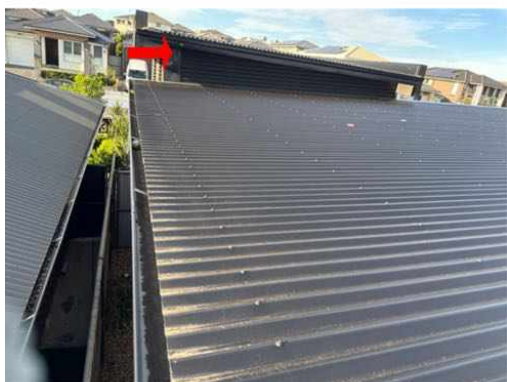
Defects 3.03

Building:	Main Building
Location:	All Areas > Level 2, Veranda
Finding:	Roof plumbing - Missing
Information:	Some sections of the roof are not adequately drained via gutters and downpipes. Gutters and downpipes that are not installed adequately are likely to result in excessively damp conditions against the exterior surfaces and around the base perimeter of the building.

Excessive moisture creates an environment which accelerates the deterioration of building elements in the area, as well as being conducive to termite and pest infestation. Such an environment is likely to necessitate repair and/or replacement of building elements, which are prone to sustaining wood rot, rust or corrosion.

A roofing plumber should be appointed as soon as possible to install relevant roof plumbing materials. Depending on the extent of the damage, repair and/or replacement of damaged building elements may be required.

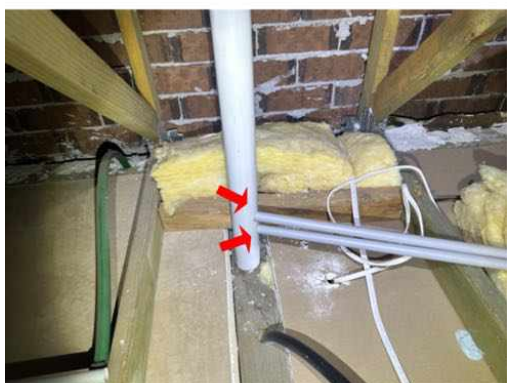
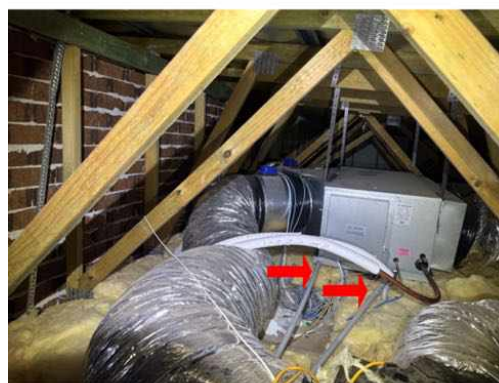
Defects 3.04

Building:	Main Building
Location:	Roof Void > Centre Left
Finding:	Air conditioning condensation pipework.
Information:	<p>At the time of inspection the air condition condensation pipework appeared not to be installed correctly to the sewer vent pipework. The condensation and drip tray pipe have been installed directly into the vent pipe by drilling holes into the sewer vent pipe and poked into the vent pipe with no sealer. This may allow odour or gases from the sewer pipe to escape into the roof void via the unsealed joints or travel up the condensation pipe to the HVAC condenser.</p> <p>There should be a "S" trap or "P" trap installed to the vent pipe to create a water barrier to prevent this from occurring.</p> <p>A licensed plumber should be engaged immediately to perform rectification works to prevent any potential damage to the property or HVAC.</p>

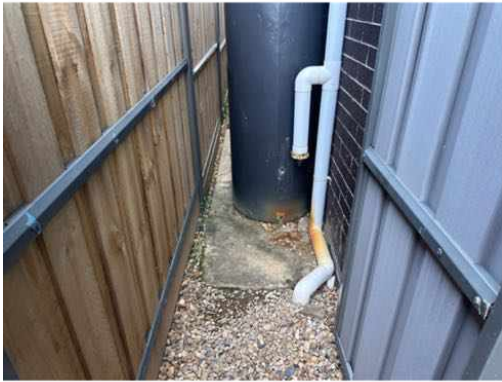
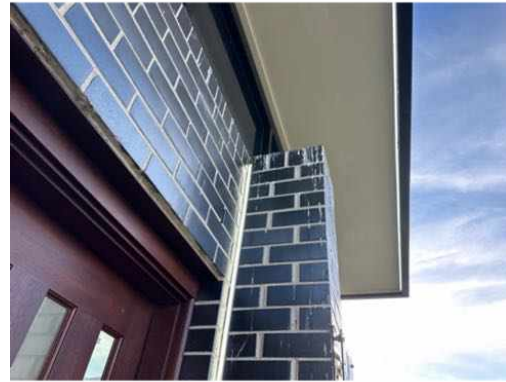
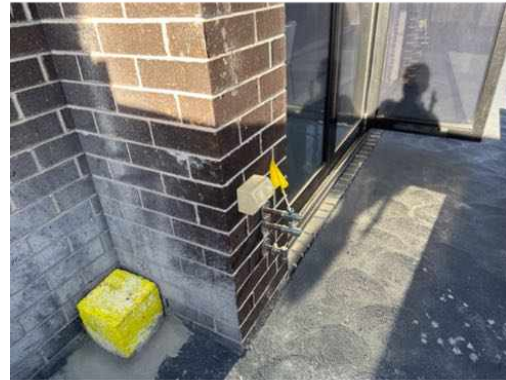
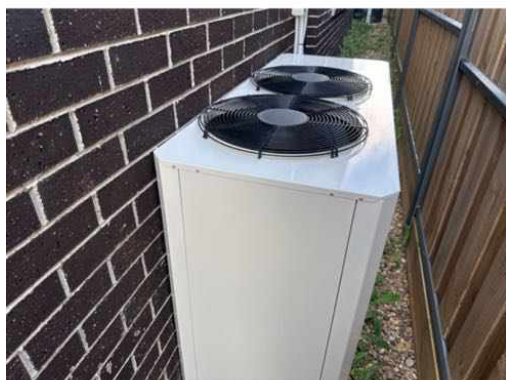
Building: Main Building
Location: All Areas > All Areas
Finding: Additional Photos - Obstructions and Limitations
Information: These photographs are an indication of the obstructions and limitations which impeded full inspection of the property at the time of inspection. These obstructions can hide an array of defects and should be removed to allow full inspection to be carried out. A re-inspection is recommended once the areas are made accessible.

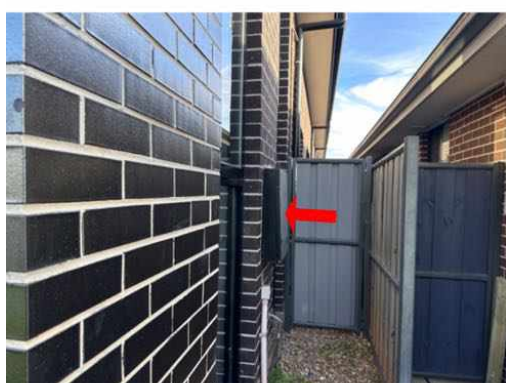
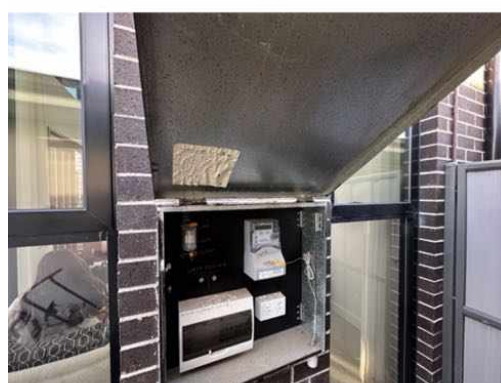
Building: Main Building
 Location: Electrical circuit box > Front Right
 Finding: Termite Management System - no evidence of a chemical installation
 Information: The application of a post-construction chemical termite barrier is highly recommended for all properties, particularly if live termite activity has been found on the site previously. Such barriers are highly effective in preventing termite attack on any timber building elements throughout the property.

A durable notice should be placed in the switchboard unit to indicate current termite barriers. At the time of inspection, it appeared as though no termite management system has been installed, with no evidence to suggest preventative works taking place.

The client may consider gaining further advice from a pest controller as to the costs and procedures involved with this application. It is recommended that obtaining such advice be a short-term priority.

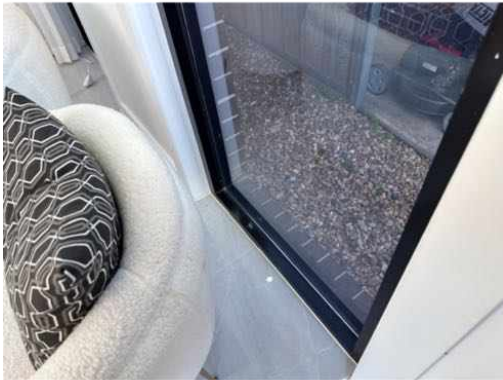
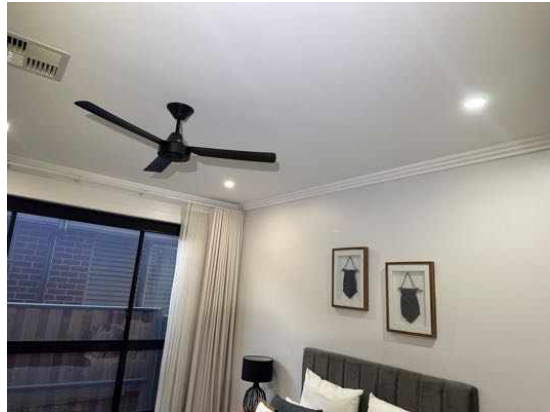
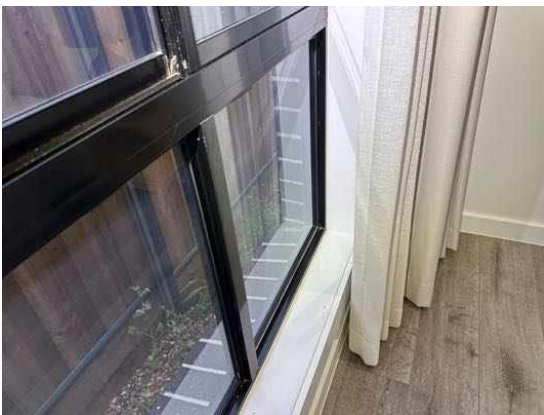
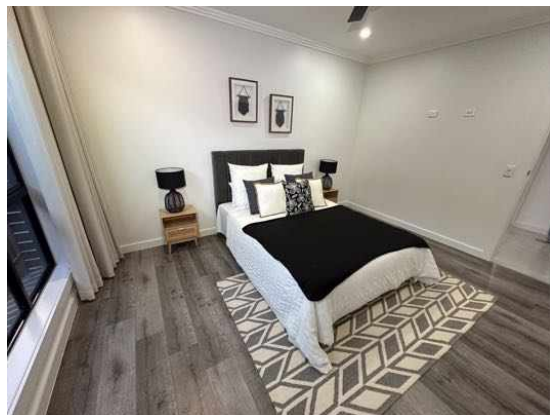
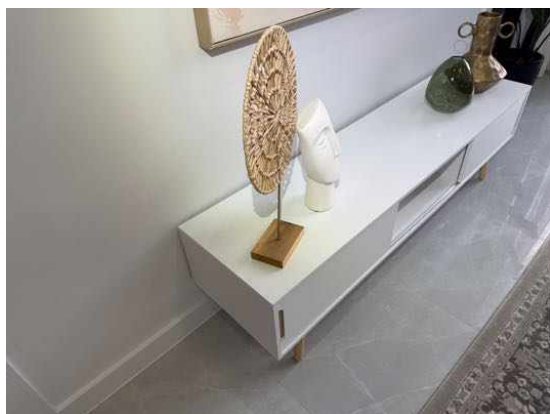
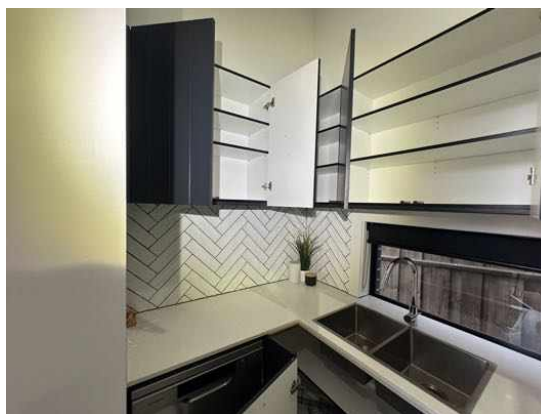
Building: Main Building
Location: All Areas > All Areas
Finding: Additional Photos - Obstructions and Limitations
Information: These photographs are an indication of the obstructions and limitations which impeded full inspection of the property at the time of inspection. These obstructions can hide an array of defects and should be removed to allow full inspection to be carried out. A re-inspection is recommended once the areas are made accessible.

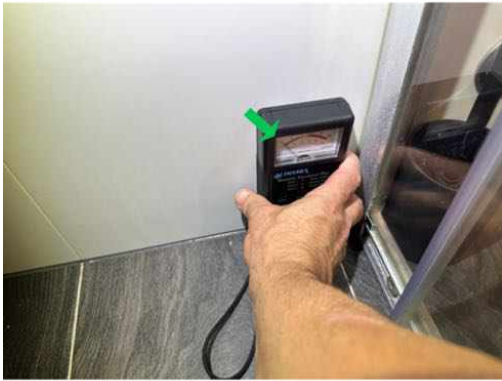
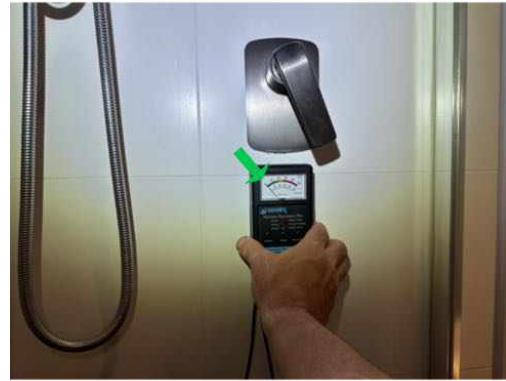
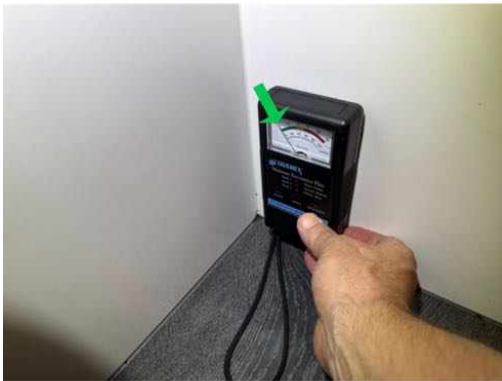
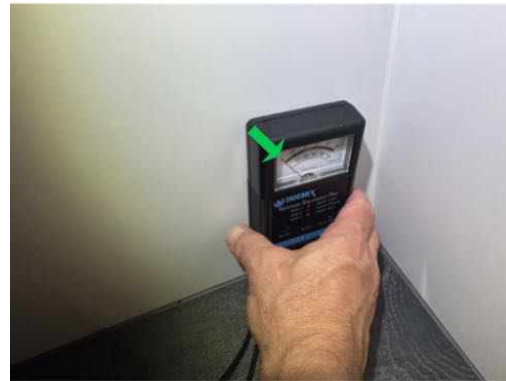
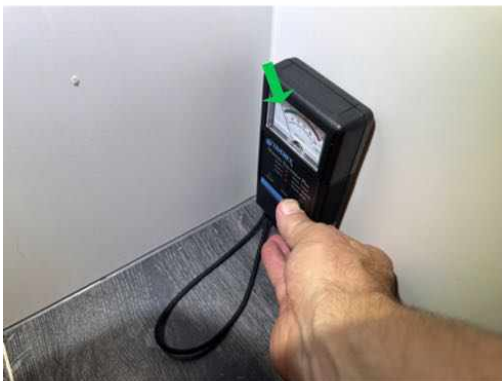
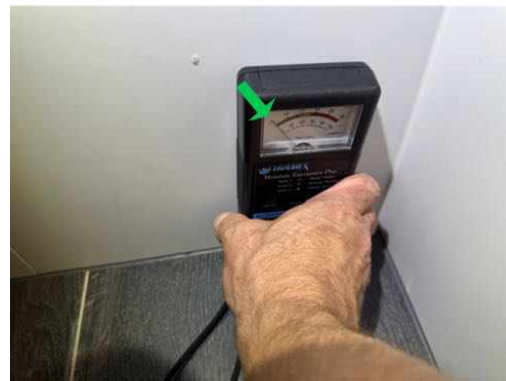
Building: Main Building
 Location: Ensuite - Master > Centre Left
 Finding: Moisture Meter used: No Moisture Detected.
 Information: Moisture meter was used during the inspection and no excessive moisture was detected to accessible walls inside the shower recess at the time of inspection.

The grout and tiles in this area appear to be in good condition at the time of inspection

Monitoring the area is advised and if any visual signs of excessive moisture appear (peeling paint, mould) then consultation with a qualified plumber or bathroom specialist would be advised to identify the cause of damp and to perform remedial works as required.

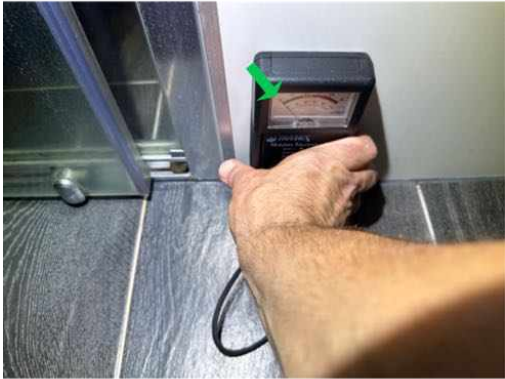
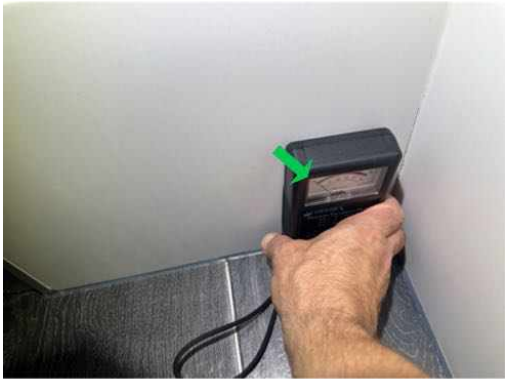
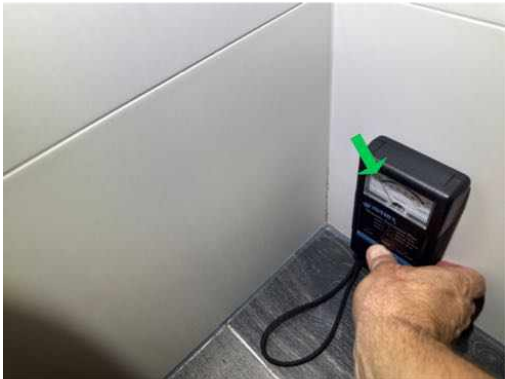
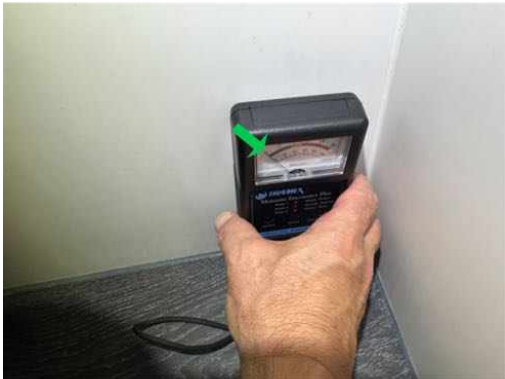
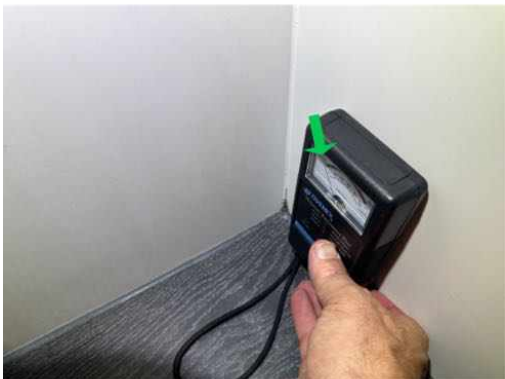
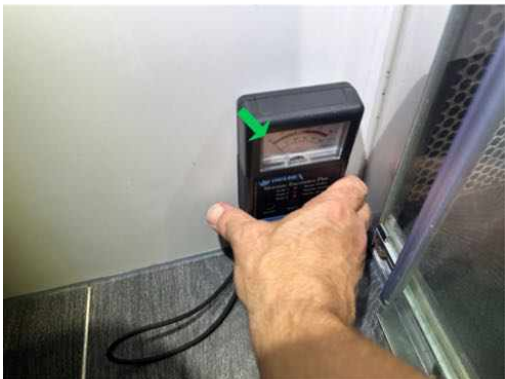
Building: Main Building
 Location: Bathroom > Centre Right
 Finding: Moisture Meter used: No Moisture Detected.
 Information: Moisture meter was used during the inspection and no excessive moisture was detected to accessible walls inside the shower recess at the time of inspection.

The grout and tiles in this area appear to be in good condition at the time of inspection

Monitoring the area is advised and if any visual signs of excessive moisture appear (peeling paint, mould) then consultation with a qualified plumber or bathroom specialist would be advised to identify the cause of damp and to perform remedial works as required.

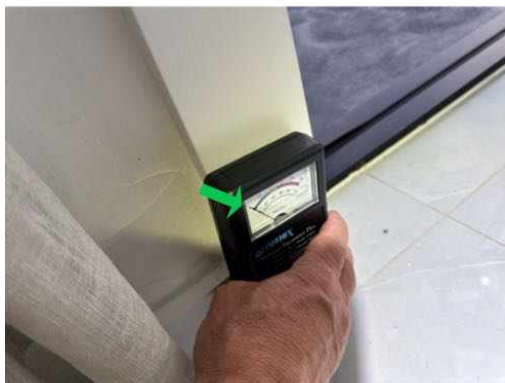
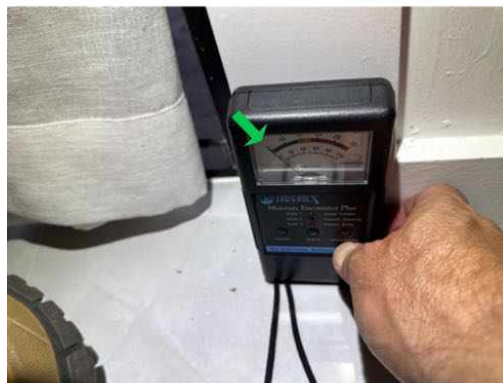
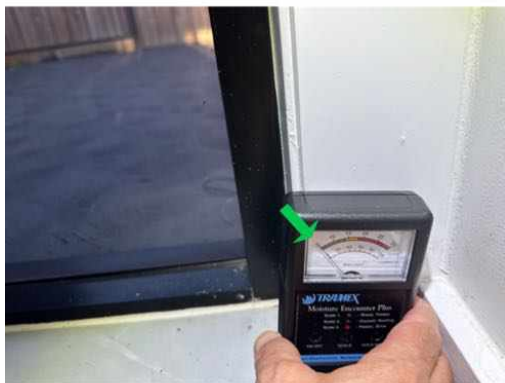
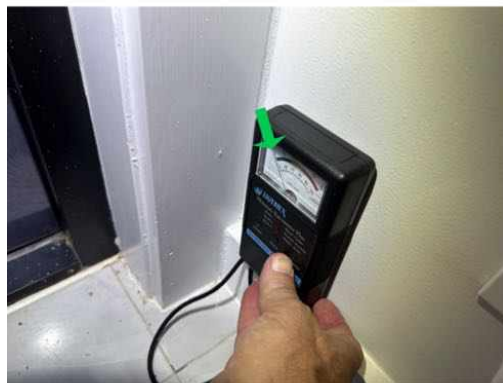
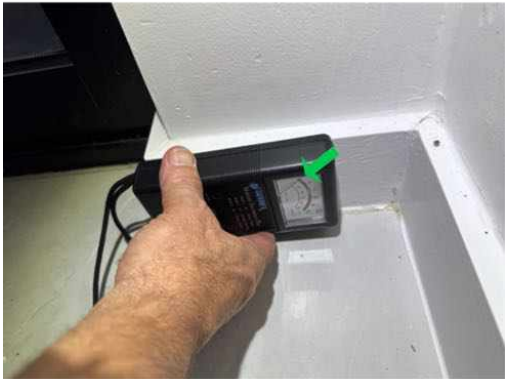
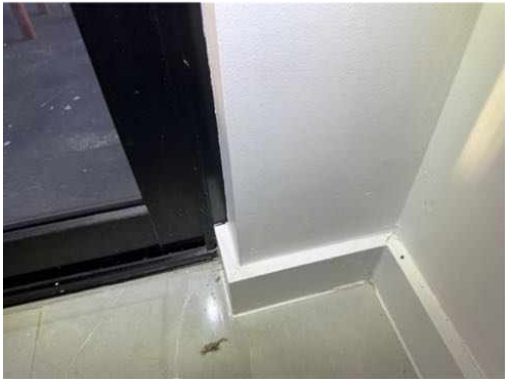
Finding: Moisture Meter used: No Moisture Detected.
Information: Moisture meter was used during the inspection and no excessive moisture was detected to accessible walls inside the property at the time of inspection.

Monitoring the area is advised and if any visual signs of excessive moisture appear (peeling paint, mould) then consultation with a qualified plumber, builder, or damp proof specialist would be advised to identify the cause of damp and to perform remedial works as required

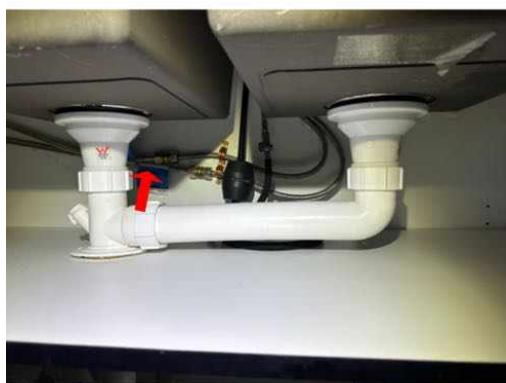
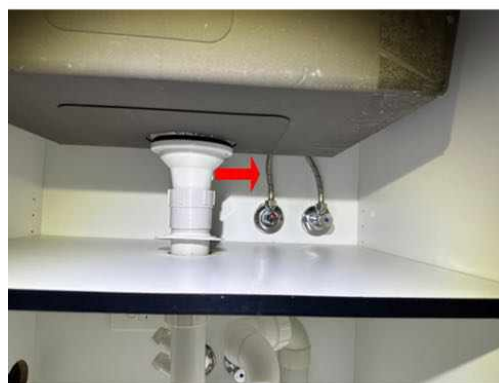
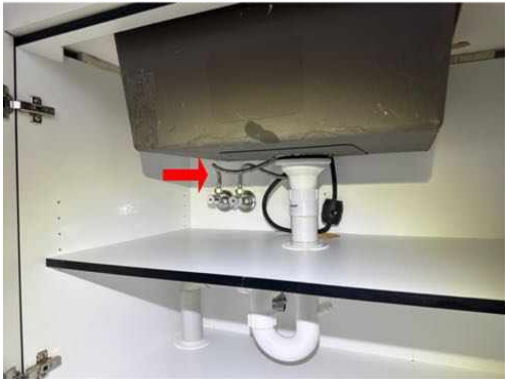
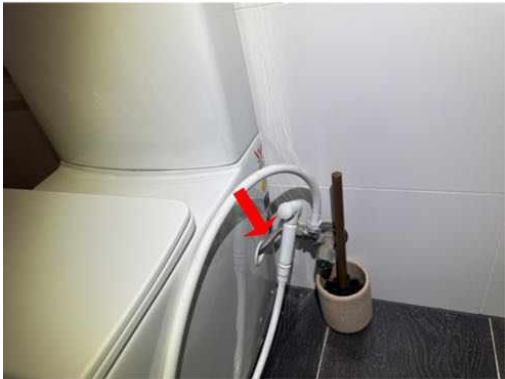
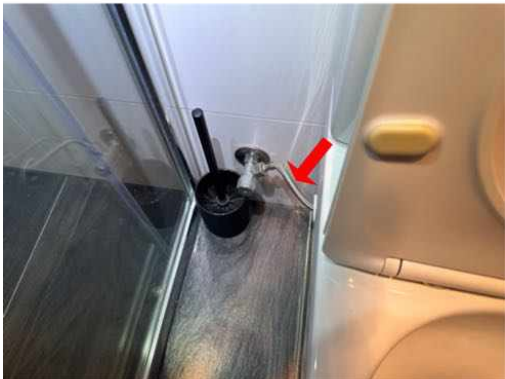
Building: Main Building
Location: All Areas > All Areas
Finding: Pipe: Flexible Braided pipes.
Information: Braided Stainless Steel Flexi connector hose are popular in modern home fit outs because they can be bent into shape. They started to be installed in the early two thousands and their use is now extremely widespread in contemporary construction and renovations.

Flexible braided hoses accounted for more than one in five water damage claims lodged by Australian households according to research released by general insurer IAG.

It is recommended that the Flexi pipes to be replaced at the owners discretion to avoid an “escape water incident” which may lead to water damage to other building elements in the home.

This work can be undertaken by a licensed plumber, general handy person at the owners discretion.

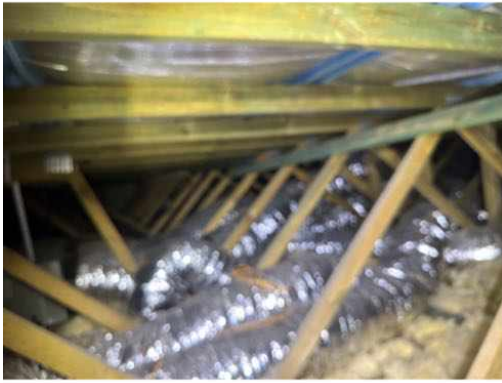
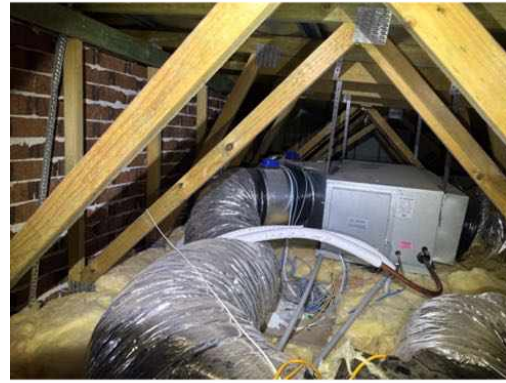
Building: Main Building
Location: Roof Void > All Areas
Finding: Roof void: limited access.
Information: Limited access to the roof void was present due to facts including but not limited to access hatch size or placement, insulation for this reason inspection to the roof void was minimal and a range of defect's from minor to major may not be visible at the time of inspection.

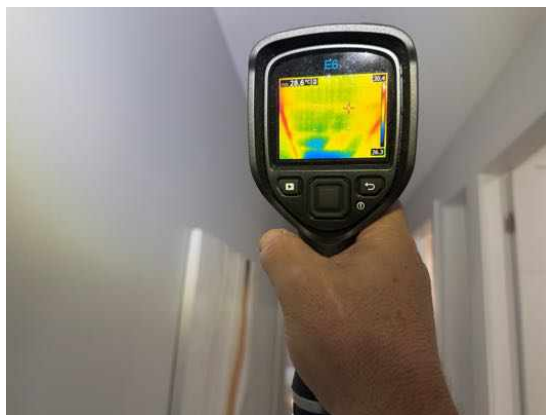
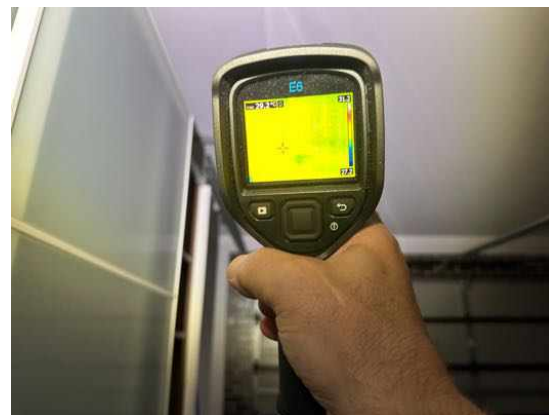
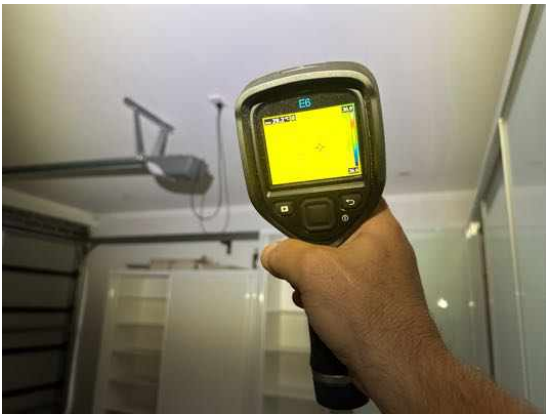
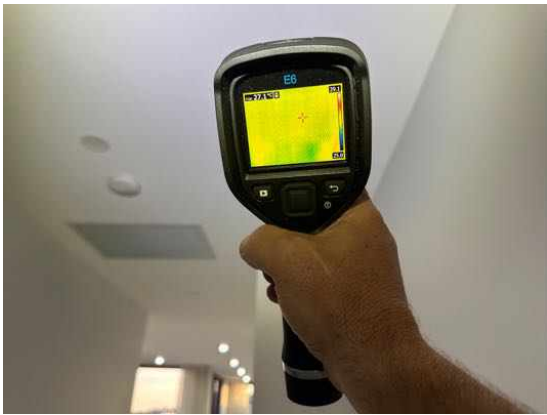
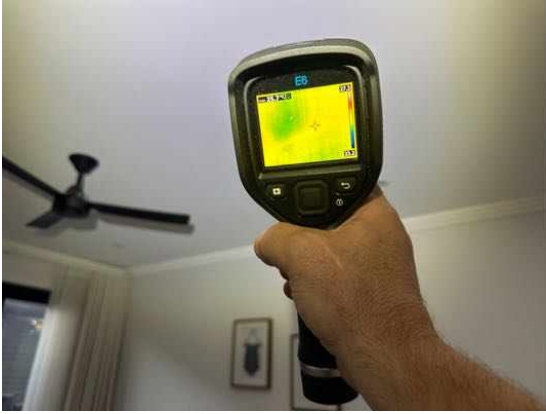
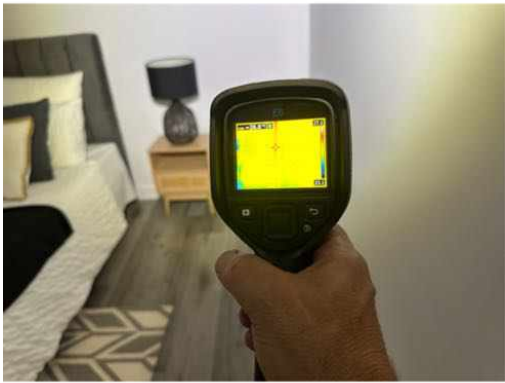
Building: Main Building
 Location: All Areas > All Areas
 Finding: Thermal imaging: No excessive moisture presentation.
 Information: At the time of inspection there appeared to be no excessive moisture presentation in this area.
