Building and Timber Pest Inspection Report

Inspection Date: Wed, 11 Mar 2026

Property Address: 6 Chippers Glade Blacktown NSW 2148

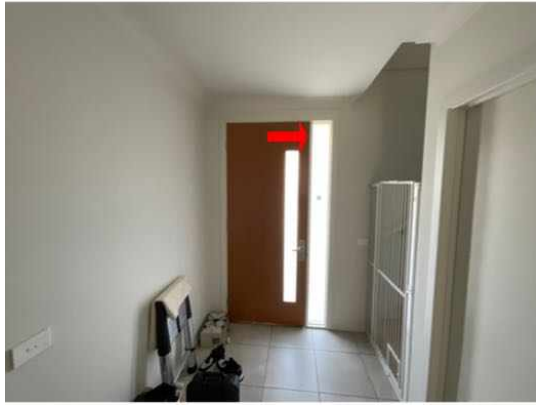
Building:	Main Building
Location:	Entry
Finding:	Door - Binding and/or Jamming.
Information:	Functional Defect Identified

Binding and/or jamming of this door was observed during standard operation and appeared to be rubbing or binding. This issue impairs the normal functionality of the door and may lead to secondary damage to adjacent building elements, such as scuffing or tearing of floor coverings, or stress to door hardware and framing.

- Poor door installation
- Worn, damaged, or misaligned hinges

- This issue is minor in nature, a qualified carpenter or general handyperson may be appointed to carry out corrective works at the client's discretion.

Prompt assessment and remediation are advised to prevent further deterioration or related damage.

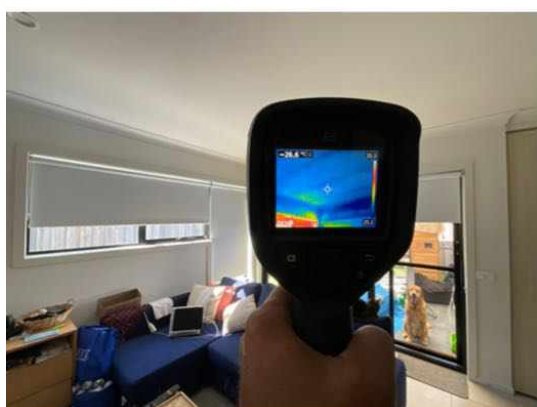
Termites release heat in the form of carbon dioxide and build mud tubes with high moisture content, which can create irregular heat patterns on surfaces such as walls, ceilings, and floors.

At the time of the inspection, no abnormalities indicating live termite activity were observed. However, it's important to note that various factors—such as obstructions, ambient temperature, and wall material/thickness—can impact the accuracy of thermal readings. In cases where surfaces are visually restricted or obstructed, a comprehensive thermal scan may not always be feasible.

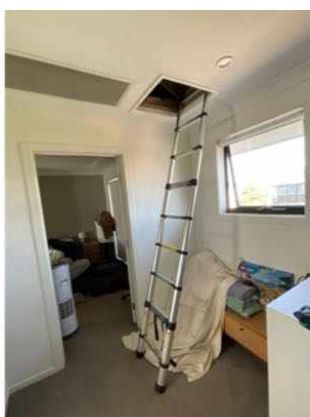
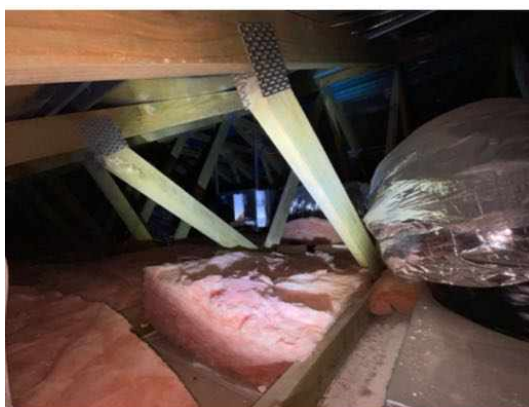
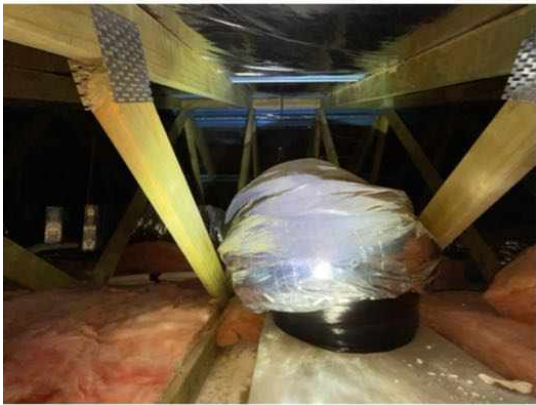
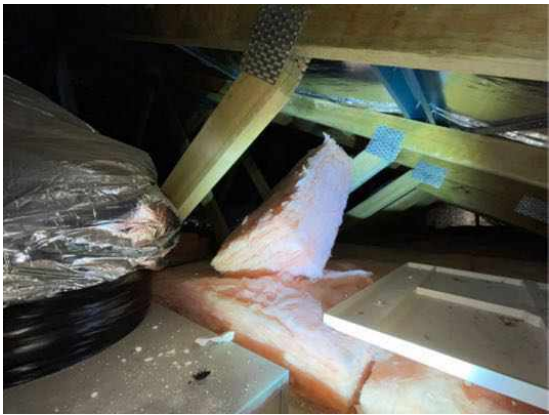
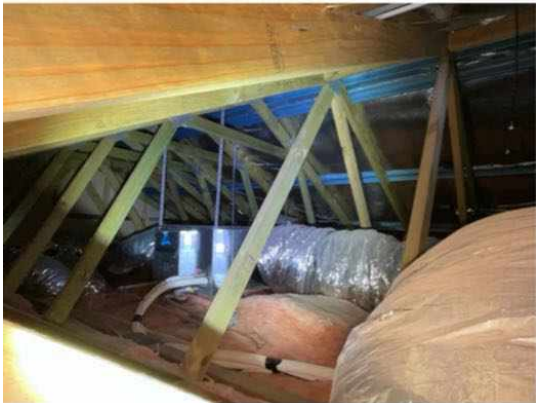
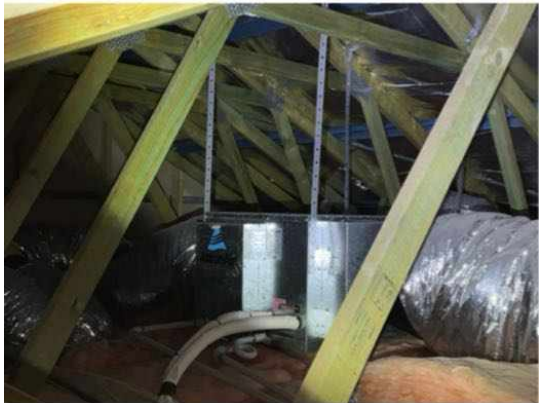
Building:	Main Building
Location:	Roof Void
Finding:	Roof Void – Limited Accessibility..

A full inspection of the roof space is not achievable unless all obstructions—including insulation and restricted access points—are removed, and full, safe access is provided. Termite activity or timber pest damage may go undetected in concealed or inaccessible areas.

Installation of an additional manhole is recommended to facilitate a re-inspection and enable a more thorough assessment of the roof void in the future. This will help ensure that all structural elements and concealed areas are properly evaluated.

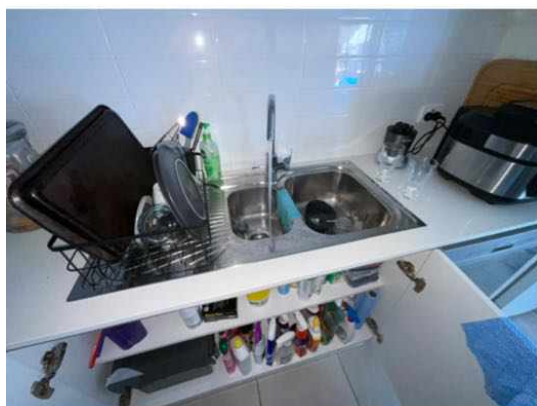
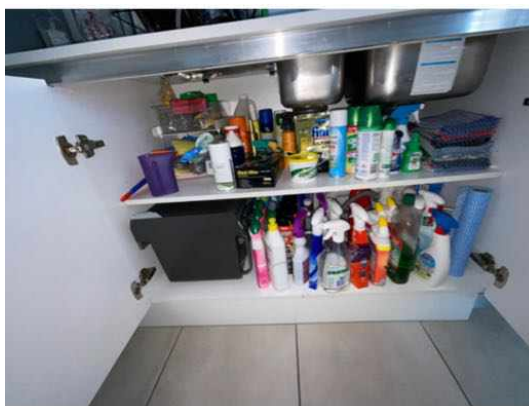
Building: Main Building
 Location: Kitchen
 Finding: Kitchen Sink – Overall Condition & Recommendations.
 Information: Observations:

- The kitchen sink tap(s) were water tested at the time of inspection, with no evidence of leaks or blockages observed in the visible plumbing or drainage.
- No significant water damage was observed to the cabinetry/unit
- Stored items under the sink obstructed access, limiting a full inspection of the plumbing and internal cabinetry.

- Further monitoring and testing are recommended once the tap(s) are in constant use, to identify any drainage issues or signs of slow leaks not evident during the limited inspection.
- For long-term property care, it is advised that sealant and grouting in water-exposed areas be regularly inspected and maintained.
- It is recommended that the stored items beneath the sink be removed to allow for a full re-inspection of the plumbing and cabinetry, ensuring no concealed defects are present.

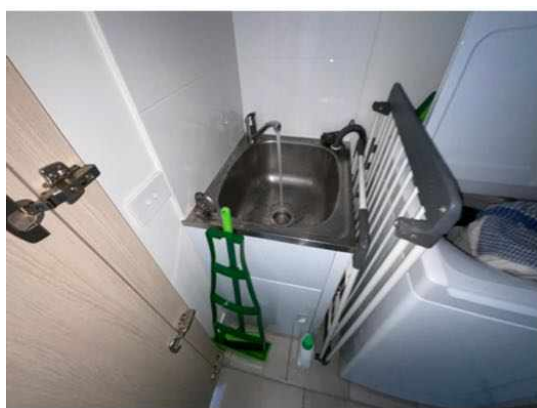
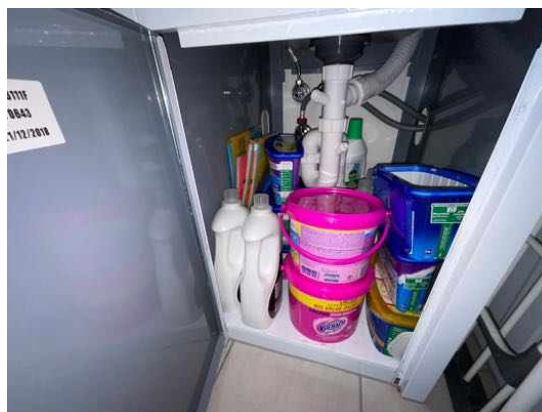
Building: Main Building
 Location: Laundry
 Finding: Laundry - Taps/Plumbing/Drainage.
 Information: Observation: Laundry Tub – Taps, Plumbing, and Cabinetry

- The taps to the laundry tub were water tested and inspected, with no evidence of plumbing or drainage leaks observed at the time of inspection.
- No visible signs of water damage, rust, or corrosion were noted to the cabinetry or surrounding unit during the inspection.

- Further monitoring or testing is recommended once the taps are placed into regular use, to ensure no leaks develop over time and that the drainage system continues to perform adequately.
- Sealant and grouting in wet areas should be maintained as part of the long-term care and upkeep of the property.

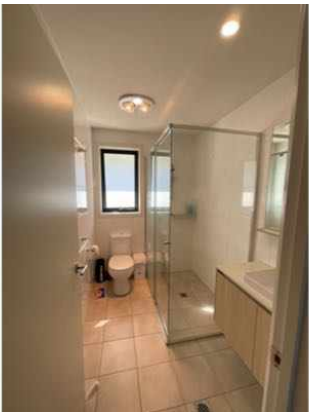
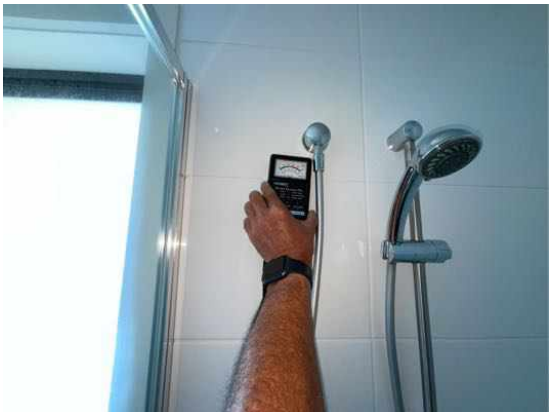
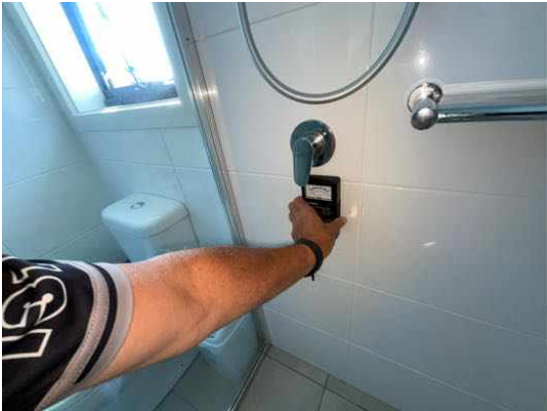
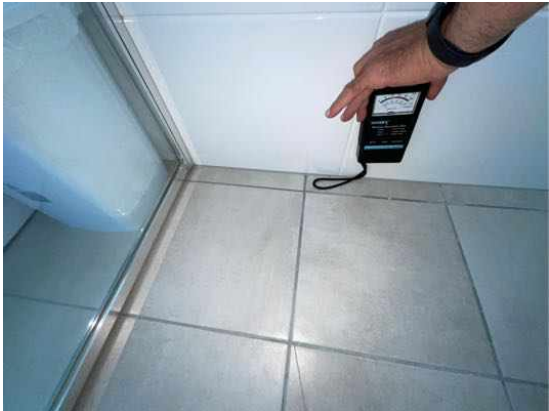
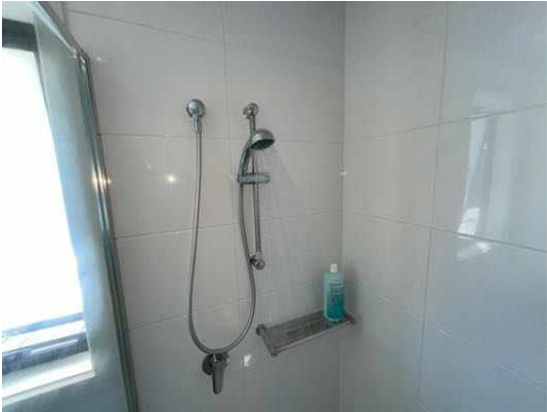
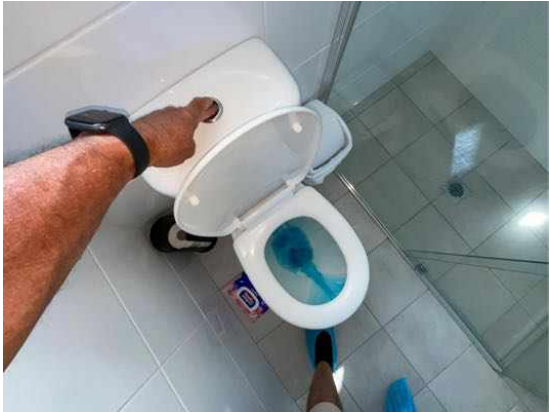
Building: Main Building
 Location: Bathroom
 Finding: Wet Areas - Bathroom(s) - Overall Condition & Recommendations.
 Information: Overall Condition & Recommendations

- Water appeared to flow freely towards the floor waste during testing of the shower taps. However, further monitoring is required after regular use to determine whether water pooling or retention occurs.
- Flood testing of the shower recess is recommended. This may reveal inadequacies in the waterproofing or shower screens, which could lead to water damage in surrounding areas.

- Floor waste was found to be clear and free of blockages at the time of inspection. Further monitoring is advised after consistent use to identify any drainage issues or buildup requiring cleaning.
- No elevated moisture readings were detected around the tap fittings or behind the shower walls (as viewed from adjacent rooms), suggesting no active plumbing leaks at the time of inspection.
- Sealing of grout and tiles is recommended to prevent moisture buildup and mould growth in damp areas such as showers.
- The condition of grout and sealant appeared to be good.
- The exhaust fan appeared to be operational, which supports moisture control in the bathroom.

- No leaks were observed during flushing. The toilet operated normally, and the toilet pan appeared to be securely fixed to the floor.

- Basin(s) were water tested and inspected, with no leaks or blockages identified in the plumbing or drainage system at the time of inspection.
- Further monitoring is recommended after the basin(s) are placed under regular use to confirm ongoing performance and cleanliness.
- No visible water damage was observed to the vanity cabinetry at the time of inspection.
- Stored items inside the vanity obstructed full visibility during the inspection. It is advised that the area be re-inspected once all obstructions are removed.

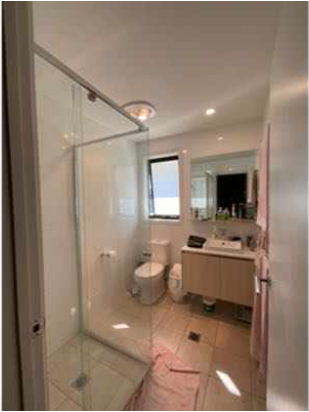
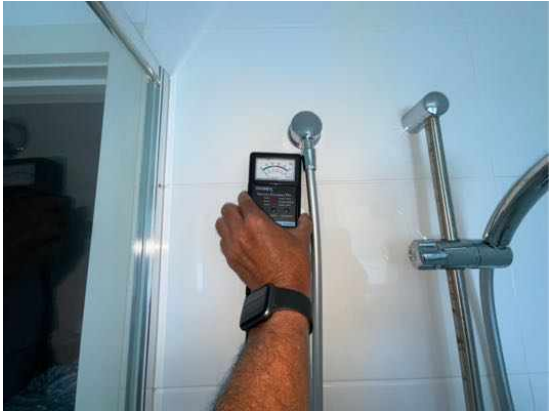
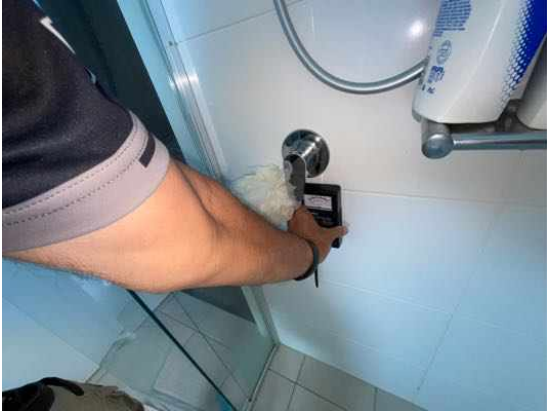
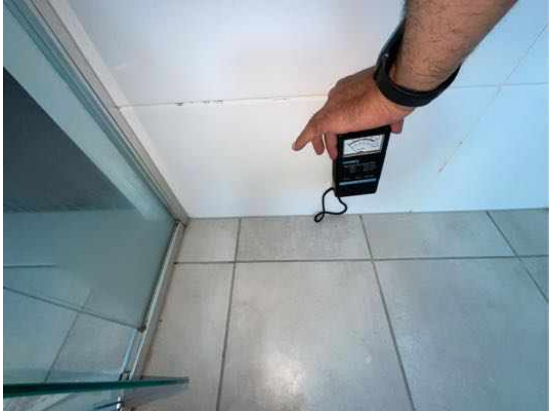
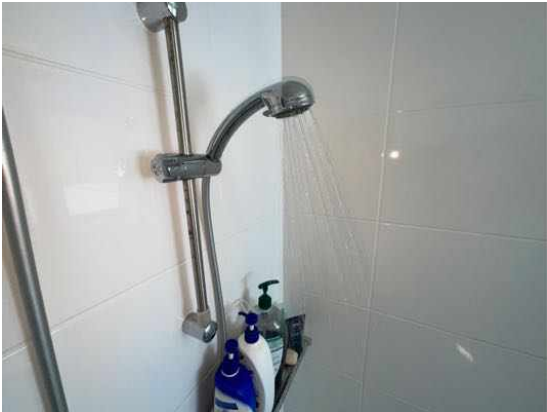
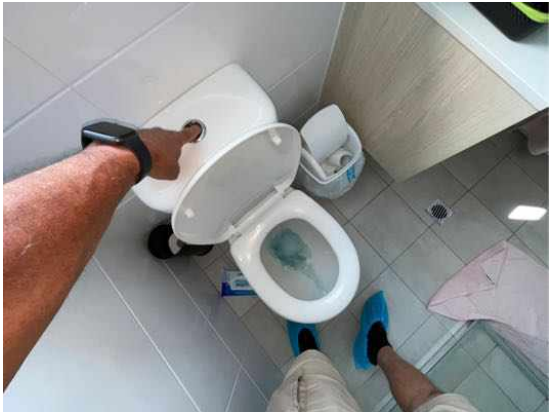
Building: Main Building
 Location: Ensuite
 Finding: Wet Areas - Bathroom(s) - Overall Condition & Recommendations.
 Information: Overall Condition & Recommendations

- Flood testing of the shower recess is recommended. This may reveal inadequacies in the waterproofing or shower screens, which could lead to water damage in surrounding areas.

- Floor waste was found to be clear and free of blockages at the time of inspection. Further monitoring is advised after consistent use to identify any drainage issues or buildup requiring cleaning.

- No elevated moisture readings were detected around the tap fittings or behind the shower walls (as viewed from adjacent rooms), suggesting no active plumbing leaks at the time of inspection.

- Elevated moisture readings were found in the lower shower walls, which is a common occurrence with certain tile types that naturally absorb more moisture. This should be monitored over time.

- Sealing of grout and tiles is recommended to prevent moisture buildup and mould growth in damp areas such as showers.
- The condition of grout and sealant appeared to be good.

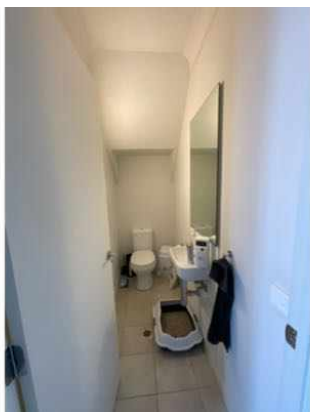
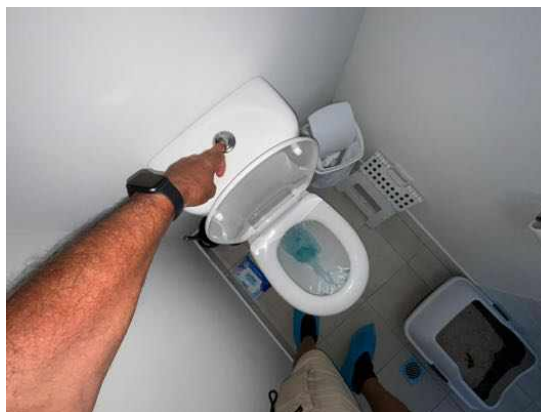
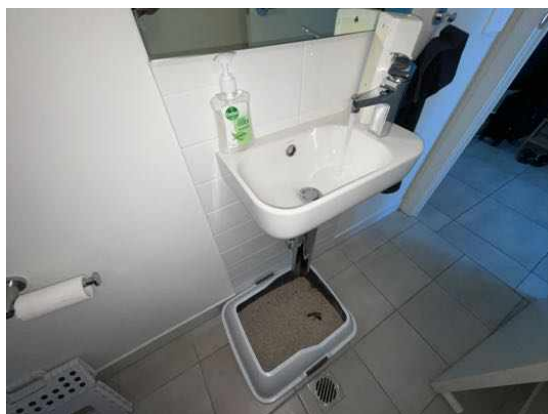
Building: Main Building
Location: Toilet (WC)
Finding: Overall Condition: Toilet & Basin.
Information: TOILET & BASIN ASSESSMENT

- No leaks were observed during the flushing process.
- The toilet operated normally with no signs of malfunction or abnormal water flow.
- The toilet pan was securely fixed to the floor at the time of inspection.

- Sealant around the basin and wall junctions appeared to be in serviceable condition
- Regular maintenance of sealant and grouting in wet areas is essential to prolong the life of surrounding materials and reduce the risk of water damage.

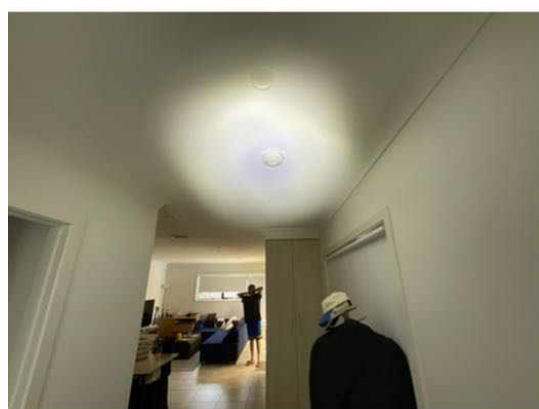
Building: Main Building
Location: All Areas
Finding: Smoke Detectors / Alarms.
Information: Reporting on the presence, type, location, or compliance of smoke detectors or alarms, including hard-wired smoke detection systems and their legislative requirements, is outside the scope of this inspection report.

- All smoke detectors be tested monthly by the homeowner.
- All systems comply with the requirements of AS 3786 and any applicable state-based legislation.
