Building and Timber Pest Inspection Report

Inspection Date: Wed, 28 Jan 2026

Property Address: 18 Park St, Lowood QLD 4311, Australia

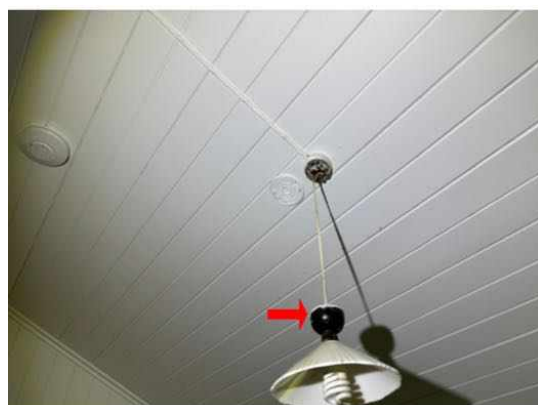
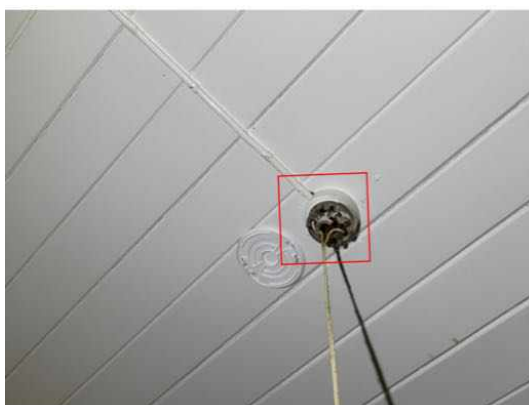
Finding 1.01

Building:	Main Building
Location:	Bedroom
Finding:	Bedroom - light fitting base cover loose
Information:	At the time of the inspection, it was noted that the base cover for the light fitting in the back bedroom on the left side was loose and does not cover the metal fittings that the electrical cables are connected to.

This is a minor safety hazard as there is a risk of an electric shock if the metal fittings are touched when the light is switched on.

A licensed electrician should be engaged to re-install the base cover. This should be done as a matter of urgency.

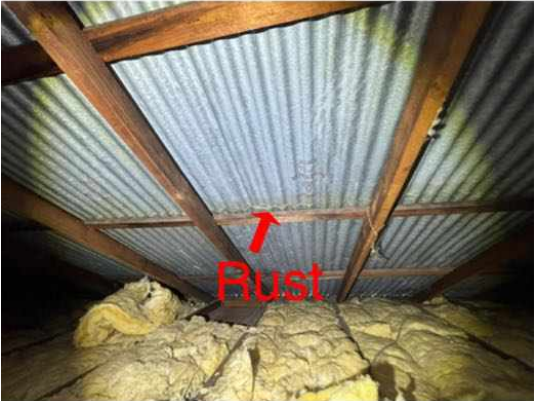
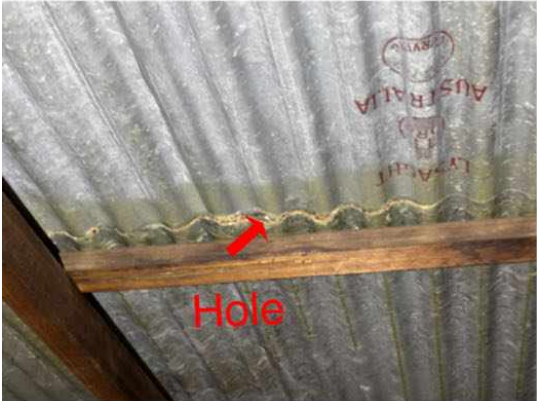
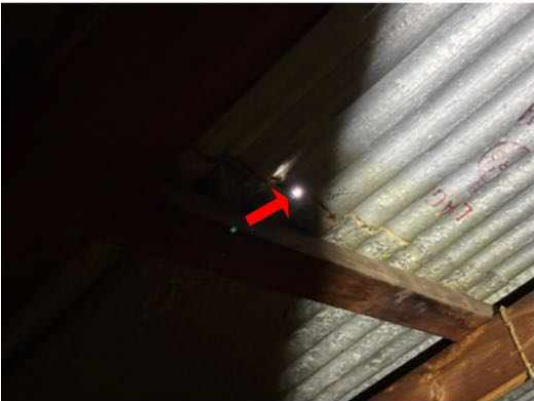
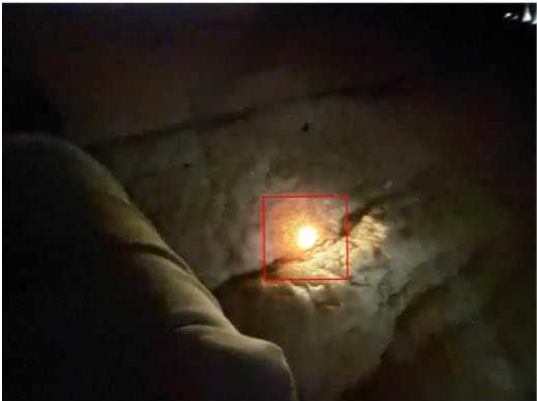
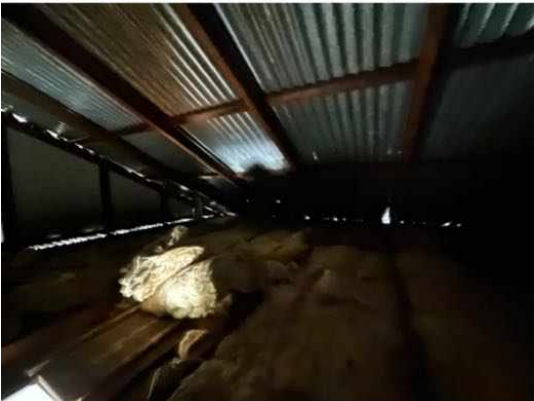
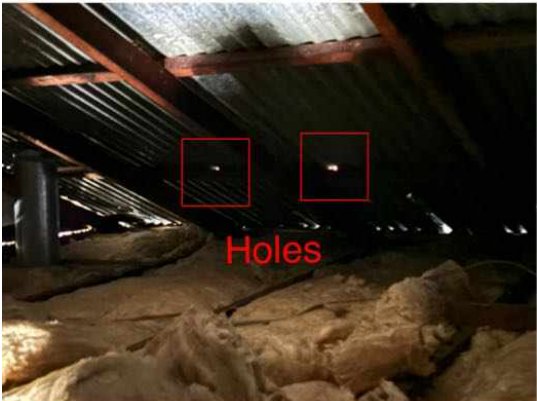
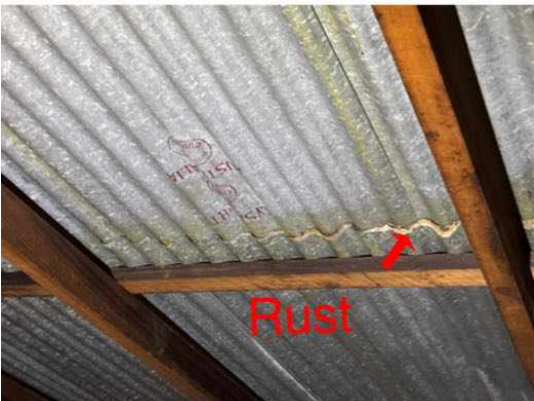
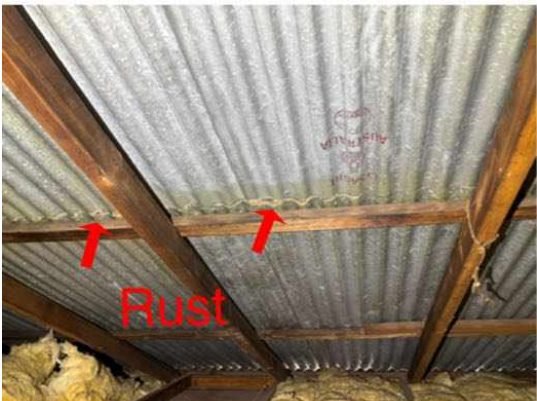
Finding 2.01

Building:	Main Building
Location:	Roof Exterior
Finding:	Metal roof covering - rusted
Information:	At the time of the inspection, it was noted that there was evidence of rust to the horizontal joints in the metal roof sheets. At least three holes can be seen in areas that are rusted. The rust can only be seen from inside the roof cavity due to the fact that the metal roof covering has been painted. There is evidence of extensive hail damage to the exterior of the roof covering.

The metal roof covering has signs of rusting and at least three holes were found in rusted areas. These are potential ingress points for moisture in the roof void. The rust is on the horizontal joins in the metal roof sheets and can only be seen from the roof void as the roof covering has been painted. The metal roof covering has extensive hail damage to it.

A roofing contractor should be engaged to replace the metal roof covering. This

should be done as a matter of urgency.

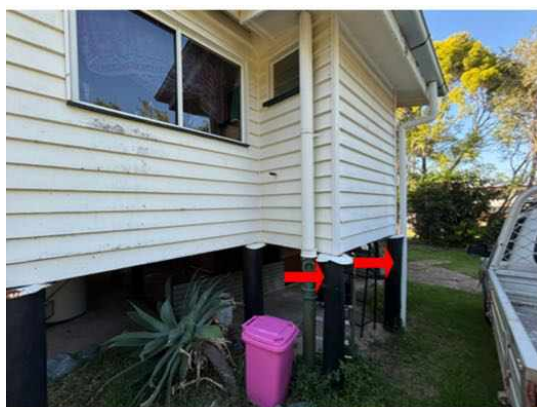
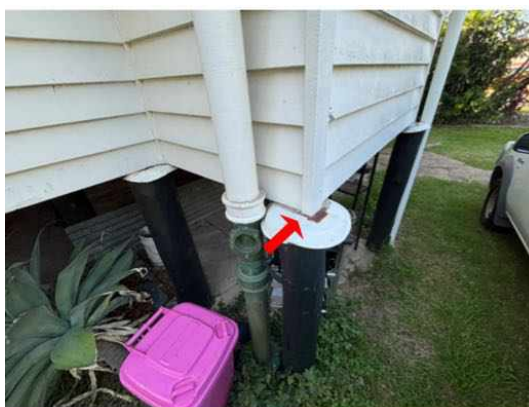
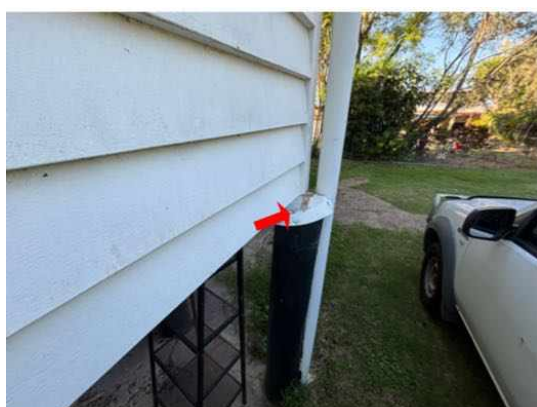
Finding 3.01

Building:	Main Building
Location:	Rear elevation
Finding:	Timber stumps - movement
Information:	At the time of the inspection, it was noted that the two rear timber stumps have moved. This is evidenced by the paint silhouette on the top of the metal ant caps. This may be historic. The client should monitor the timber stumps for any further movement.

A house stumping specialist could be engaged to assess the timber stumps. This can be done at the clients discretion.

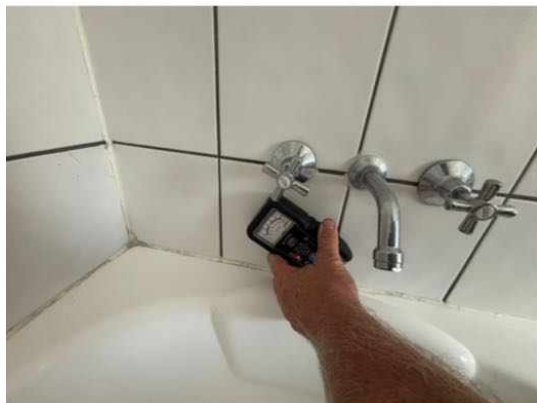
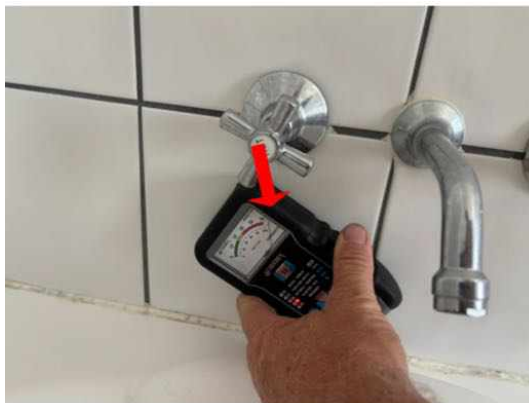
Finding 3.02

Building:	Main Building
Location:	Bathroom
Finding:	Bathroom - elevated moisture reading
Information:	At the time of the inspection, it was noted that an elevated moisture reading was

recorded below the hot tap for the bath tub. There is no evidence in the subfloor area under the bath that indicates a water leak.

The client should monitor the area for any water leaks.

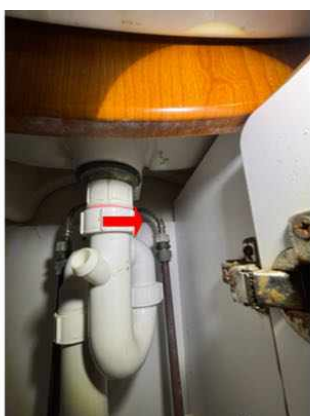
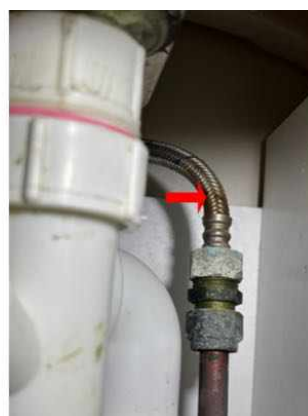
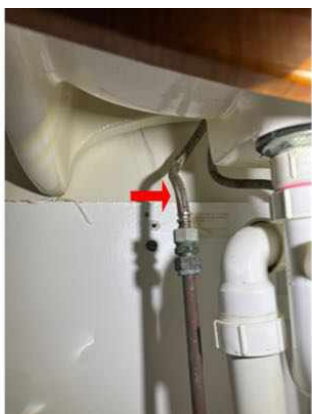
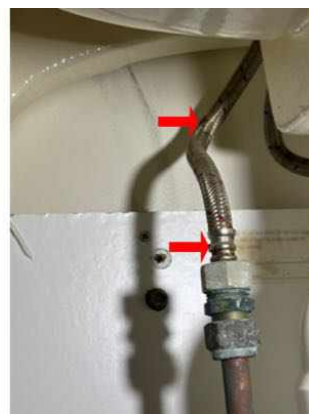
Finding 3.03

Finding: Bathroom - flexible hoses have signs of rust

Information: At the time of the inspection, it was noted that the flexible hoses to the bathroom vanity mixer had signs of rusting. This may be due to the age of the hose. Flexible hoses typically have a 5 - 10 year lifespan. It is recommended that they be changed if they have signs of bulging, fraying, kinking or rust.

A licensed plumber should be engaged to replace both the flexible hoses to the bathroom vanity mixer. This should be done as a matter of urgency.

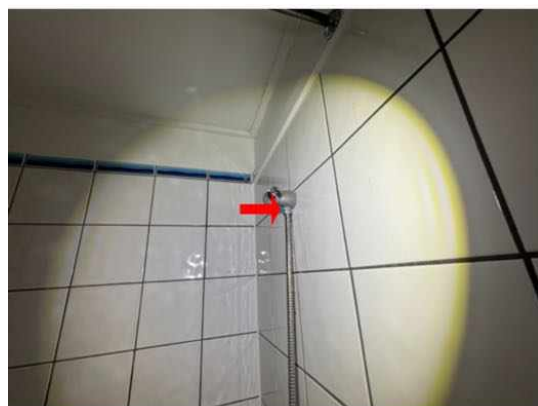
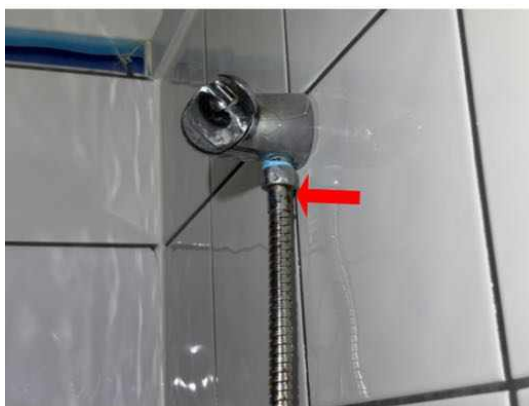
Finding 3.04

Building: Main Building
 Location: Bathroom
 Finding: Bathroom - shower hose leaking
 Information: At the time of the inspection, it was noted that the hose for the shower head was leaking when the taps are turned on. Further deterioration will occur if left unaddressed.

A licensed plumber should be engaged to replace the shower hose. This can be done at the clients discretion.

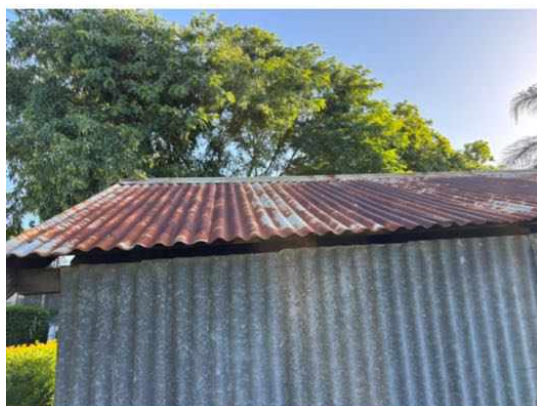
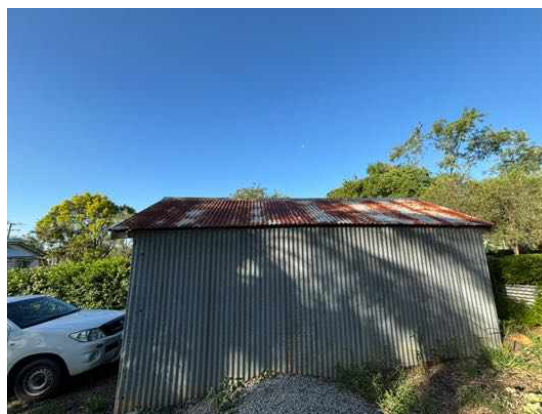
Finding 3.05

Building: Out Building
 Location: Carport
 Finding: Carport - roof covering rusted
 Information: At the time of the inspection, it was noted that the metal roof sheets on the carport at the rear of the property are rusting.

A roofing contractor could be engaged to replace the metal roof sheets. This can be done at the clients discretion.

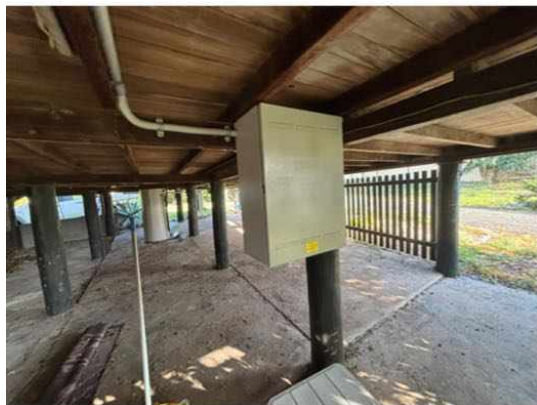
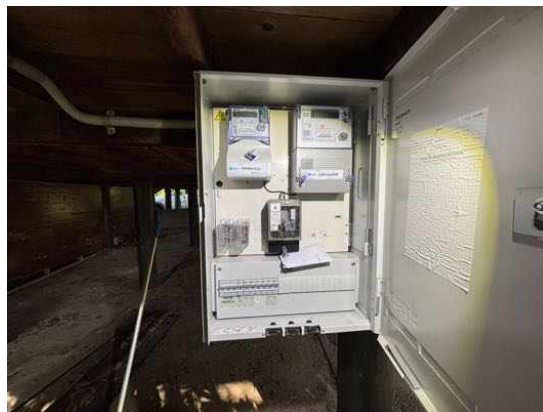
Finding 6.01

Building:	Main Building
Location:	All External Areas
Finding:	Termite Management System - no evidence of a chemical installation
Information:	At the time of the inspection, no evidence of a chemical termite management system was found. There is no durable notice in the meter box.

There are ant caps on top of the timber stumps which are designed to expose concealed termite activity. The metal ant caps do not stop termite activity. The timber stumps have drill holes to the base which indicate that they may have been treated to prevent termites. There is no evidence on site of when this was carried out and should be presumed to be no longer effective.

A durable notice should be placed in the switchboard unit to indicate current termite barriers. At the time of inspection, it appeared as though no termite management system has been installed, with no evidence to suggest preventative works taking place.

The application of a post-construction chemical termite barrier is highly recommended for all properties, particularly if live termite activity has been found on the site previously. Such barriers are highly effective in preventing termite attack on any timber building elements throughout the property.

The client may consider gaining further advice from a pest controller as to the costs and procedures involved with this application. It is recommended that obtaining such advice be a short-term priority.

A termite treatment system and annual termite inspections are important parts of an ongoing termite management plan.

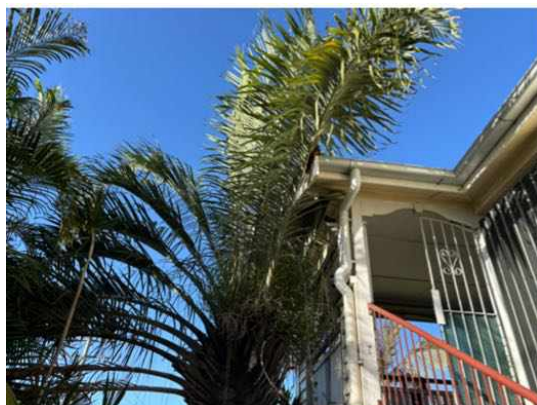
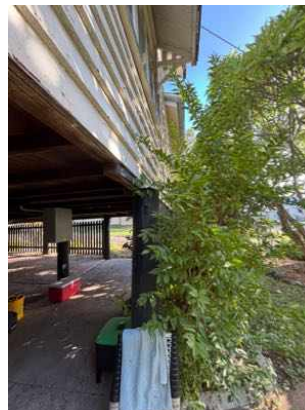
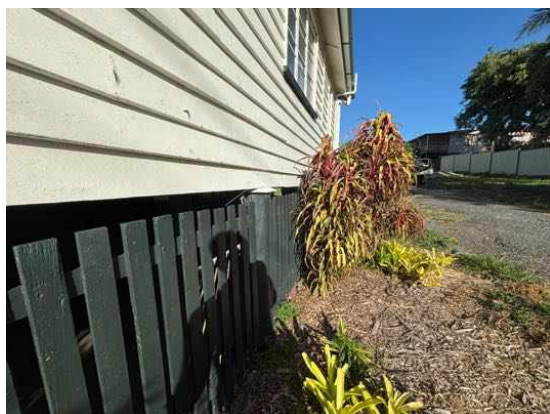
Finding 6.02

Building:	Main Building
Location:	All External Areas
Finding:	Vegetation touching the building
Information:	At the time of the inspection, it was noted that there was vegetation touching the building in several locations. This creates a potential access point for termites to enter the building undetected. This is a conducive condition for termite activity.

The client is to ensure that the vegetation is trimmed back to prevent undetected termite entry to the building and to provide a clear inspection area between the vegetation and the dwelling. This should be done as a matter of urgency.

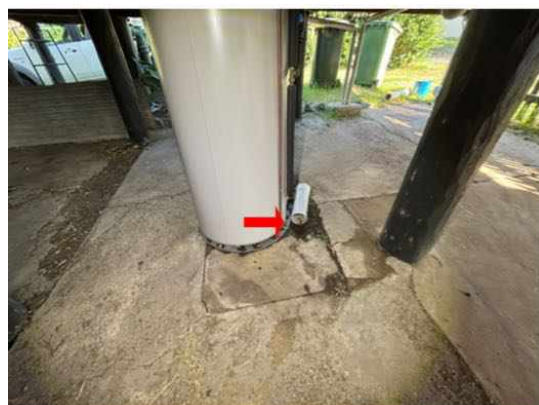
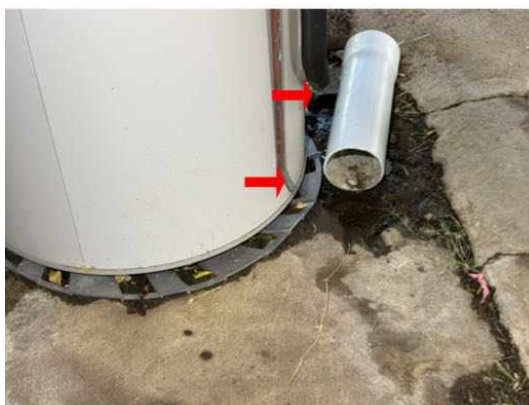
Finding 6.03

Building: Main Building
 Location: Subfloor
 Finding: Hot water tank - not plumbed to stormwater
 Information: At the time of the inspection, it was noted that the overflow for the hot water tank was not plumbed to the storm water system. Moisture is draining into the ground next the hot water unit.

This creates a conducive condition for termite activity. Moisture may also damage the associated building materials.

A licensed plumber should be engaged to plumbing the overflow into the storm water system. This should be done as a matter of urgency.

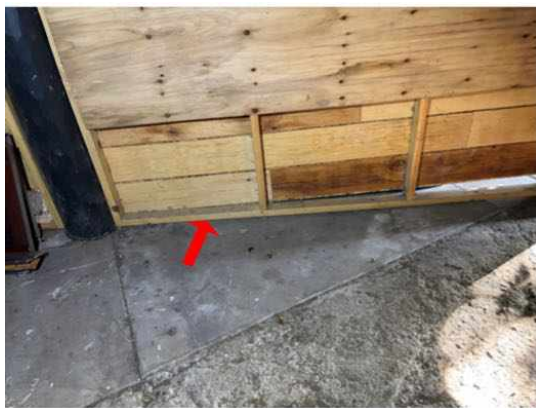
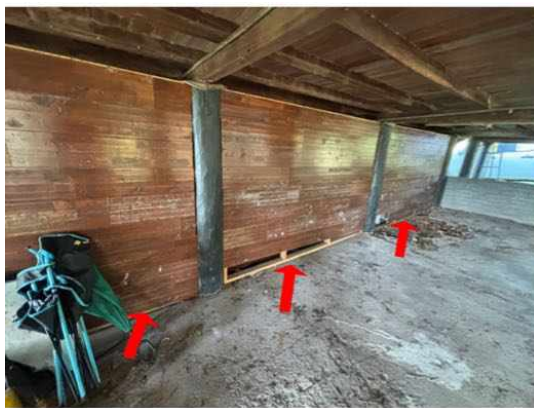
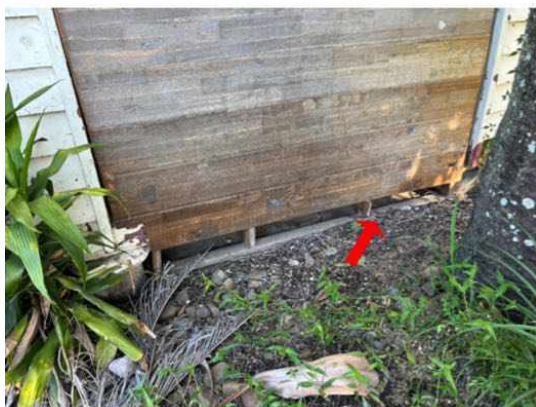
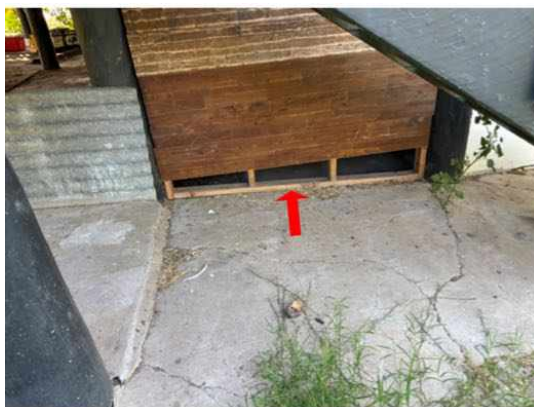
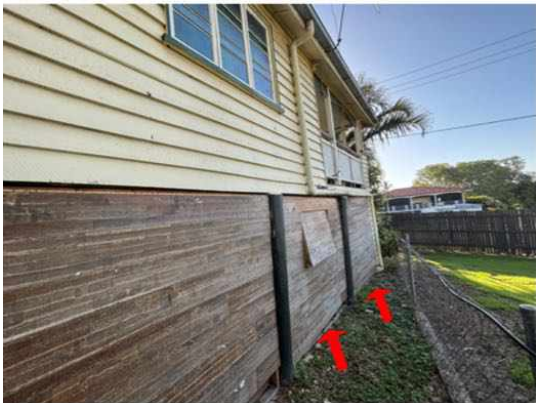
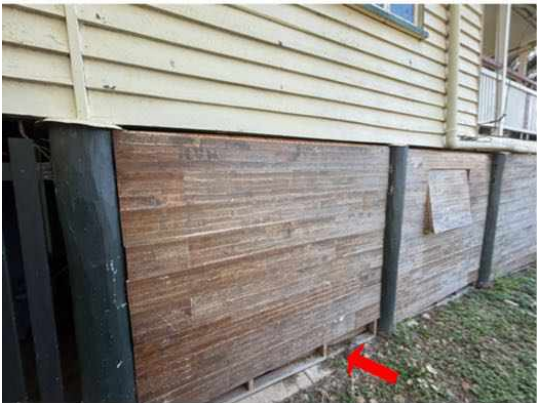
Finding 6.04

Building: Main Building
 Location: Subfloor
 Finding: Building materials in direct ground contact - conducive to termites
 Information: At the time of the inspection, it was noted that there was timber in contact with the ground in several areas of the subfloor area of the dwelling.

Where timber elements are in direct contact with the ground and consequently

moisture or dampness they become conducive to termite activity. Whether timber is used as a building element part of a fencing structure or stored as an unused item they can provide an environment that is attractive to termite infestation.

When met with excessive moisture timber begins to decay and develop wood rot. Any timbers that are in direct contact with external grounds especially if left untreated or non-durable also provide ingress for subterranean termites into that particular element.

The removal of any such materials that may be conducive to termite activity should be removed as soon as possible to minimise the risk of termite attack.

Annual termite inspections should be carried out in order to further protect the dwelling.

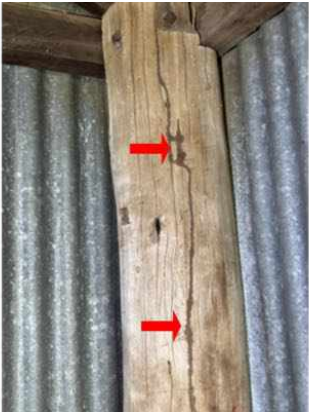
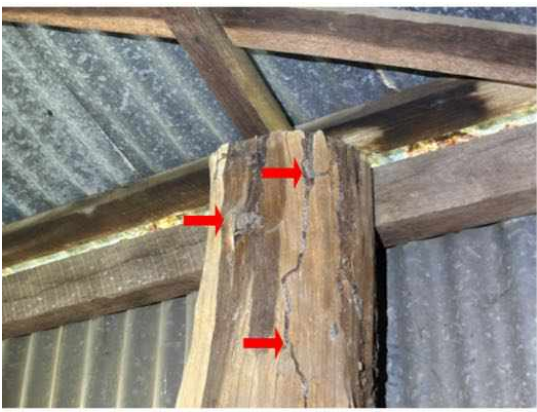
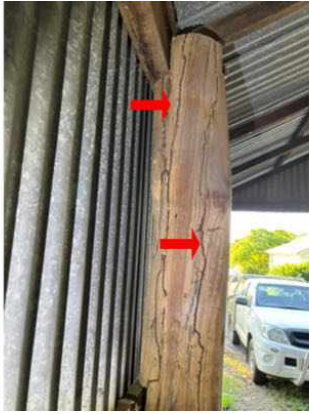
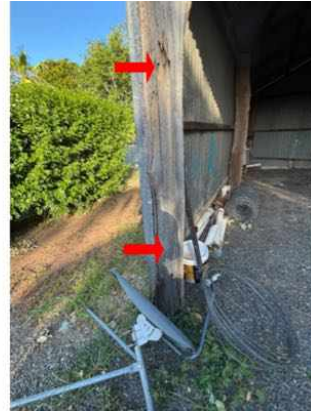
Finding 6.05

Building: Main Building
Location: Subfloor
Finding: Evidence of termite workings / mudding was present at the time of inspection
Information: Evidence was found at the time of inspection to suggest that termite activity was present in the carport. Termite mudding was found in the carport at the rear of the property. These workings appear to have been treated.

The homeowner should comply with instructions and recommendations as per the warranty provided by the pest company and continue to monitor areas which have conditions conducive to termite activity.

Annual pest inspections are also advised in order to identify such workings.

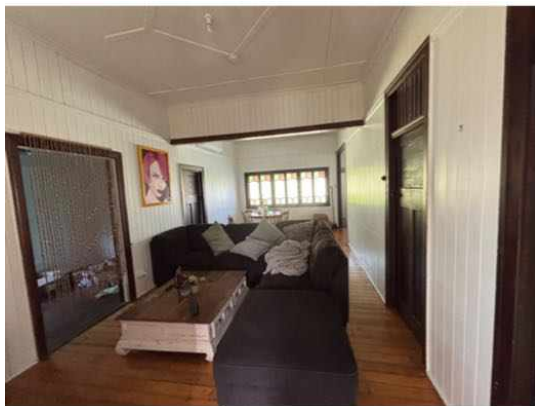
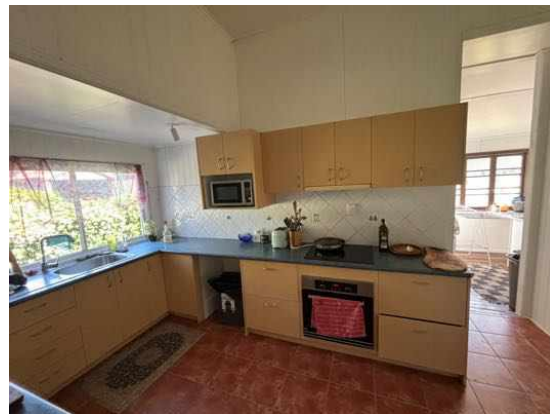
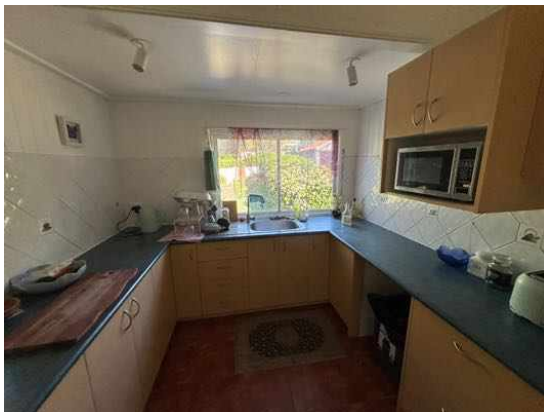
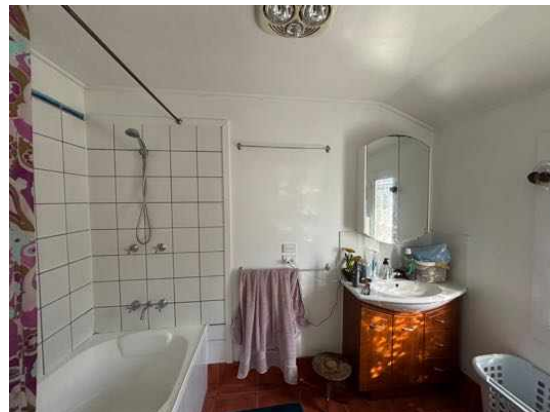
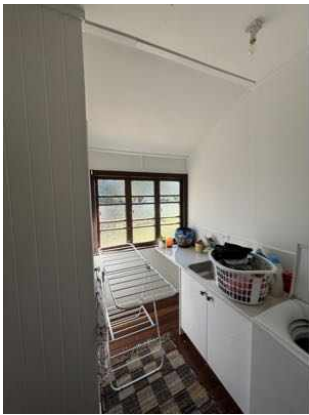
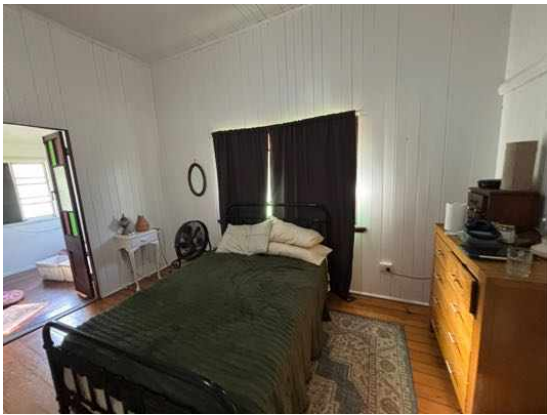
Noted Item

Building: Main Building
Location: All Internal Areas
Finding: Obstructions and Limitations - Internal areas
Information: These photographs are an indication of the obstructions and limitations which impeded full inspection of the property of the internal areas at the time of inspection. These obstructions can hide an array of defects and should be removed to allow full inspection to be carried out. A re-inspection is recommended once the areas are made accessible.

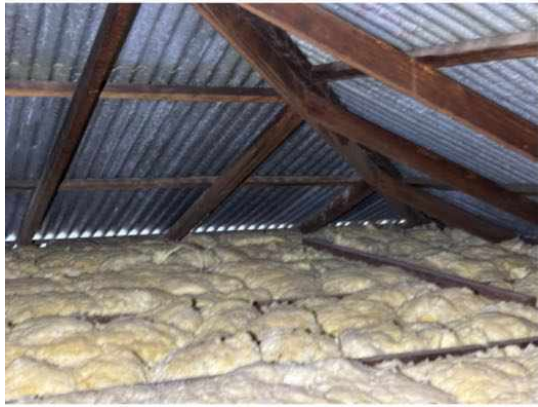
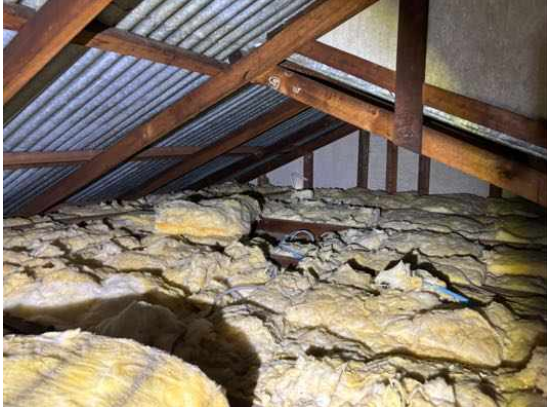
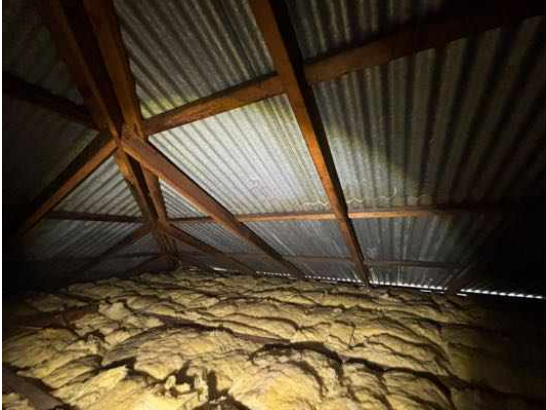
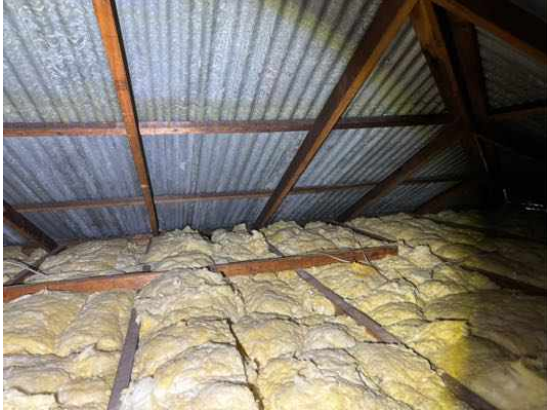
Noted Item

Building: Main Building
Location: Roof Void
Finding: Obstructions and Limitations - Roof cavity
Information: These photographs are an indication of the obstructions and limitations which impeded full inspection of the property of the roof cavity

at the time of inspection. These obstructions can hide an array of defects and should be removed to allow full inspection to be carried out. A re-inspection is recommended once the areas are made accessible.
