# Building and Timber Pest Inspection Report

Inspection Date: Thu, 5 Feb 2026

Property Address: 26/49 Gannon Ave, Manly West QLD 4179,  
Australia

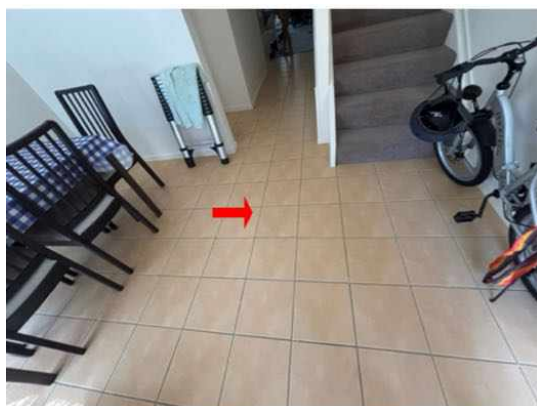
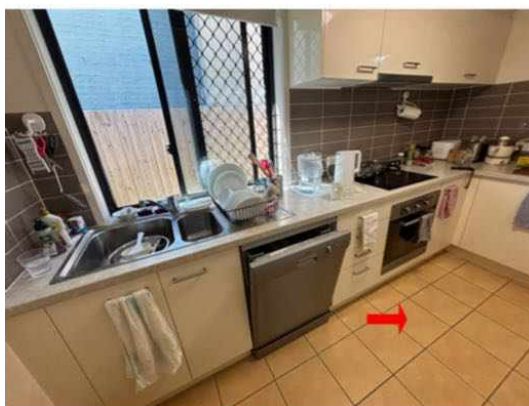
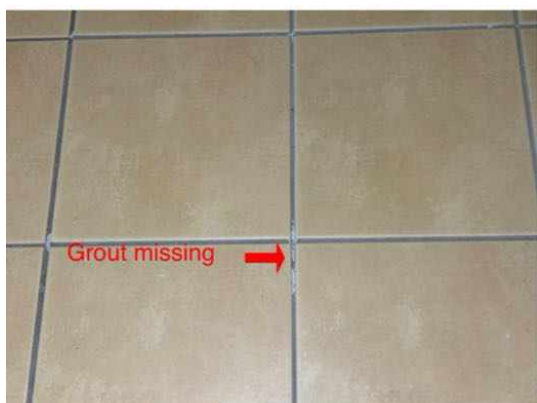
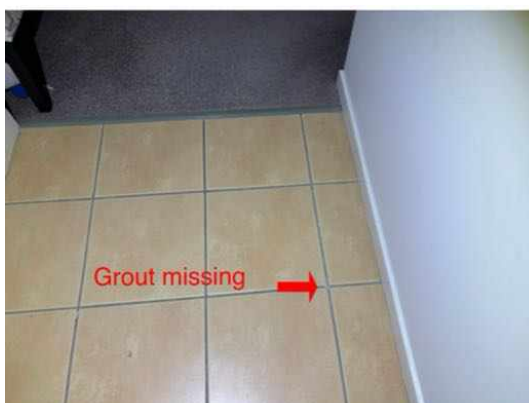
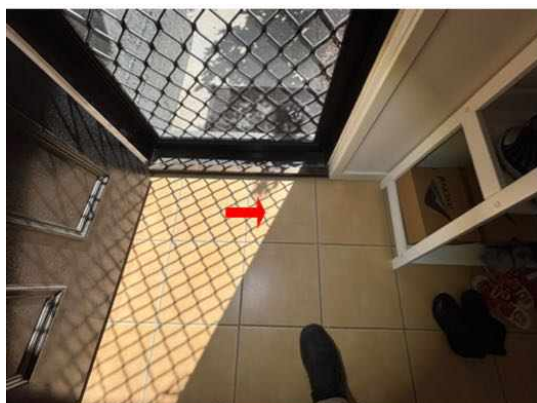
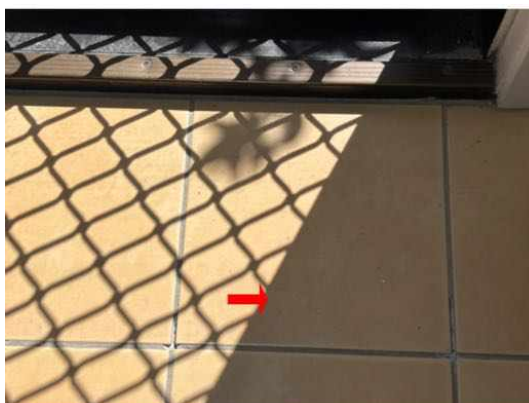
#### Finding 3.01

Finding: Tiles - Drummy

Information: At the time of the inspection, it was noted that the floor tiles from the entry through to the kitchen and hallway were drummy. Small sections of grout were missing. Drummy tiles are easier to crack as evidenced by the tile at the front door.

The term 'drummy' refers to tiles that have become detached from their fixing, despite otherwise being in relatively good condition. Such defects are generally caused by physical or moisture damage to the area. Drummy tiled areas may also be a direct result of poor workmanship during the construction process.

Tiled areas may swell and shrink with changes in air humidity if the area has sustained moisture damage. Any exposure to moisture is capable of causing tiled areas to become drummy and/or cracked over a prolonged period of time. Drummy tiled areas generally require removal and replacement of affected tiles, with adequate sealant and grouting.

Specialist trades are available for these types of services. A registered builder may be required to undertake works if damage is extensive or if secondary building defects have resulted. Otherwise, it is advised that a tiling contractor be appointed to perform works as necessary. Immediate action is recommended to ensure that no further damage is sustained in the affected area.

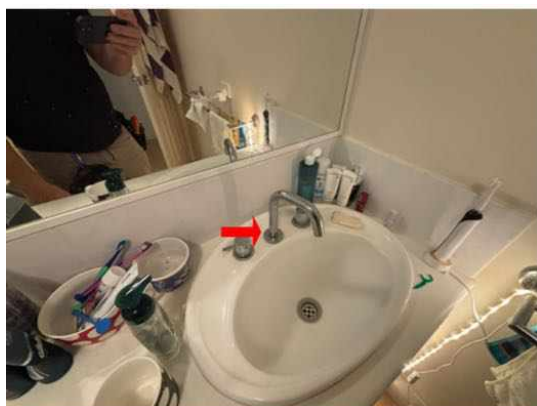
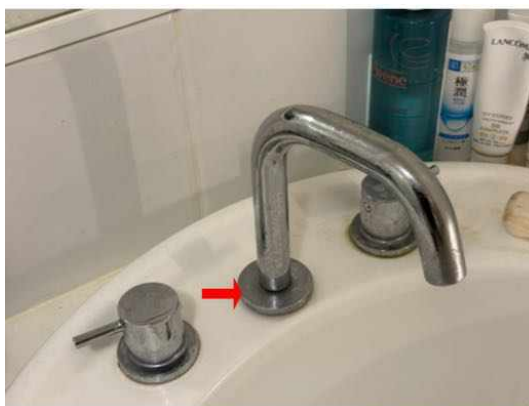
### Finding 3.02

Building: Main Building  
 Location: Downstairs bathroom  
 Finding: Downstairs bathroom - basin spout is loose  
 Information: At the time of the inspection, it was noted that the spout to the vanity basin in the downstairs bathroom was loose. The fastener for the spout may have worked loose. If left unaddressed, the spout may loosen further allowing moisture to enter the cabinet.

A building maintenance professional or licensed plumber should be engaged to re-secure the vanity basin spout. This should be done as a short term priority.

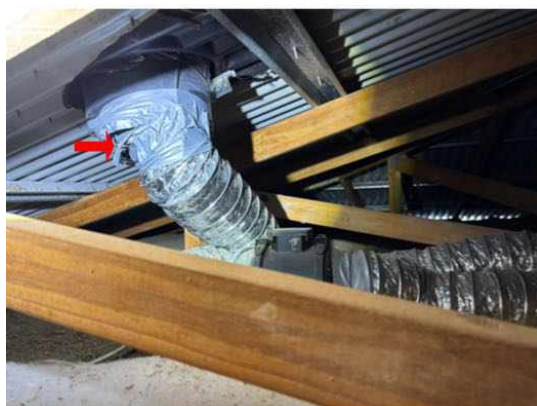
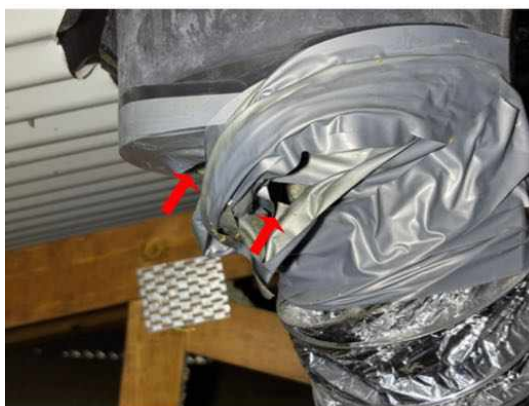
### Finding 3.03

Building:	Main Building
Location:	Roof Void
Finding:	Roof void - flexible ducting loose
Information:	At the time of the inspection, it was noted that the flexible ducting for the downstairs bathroom fan is not securely attached to the roof vent. This allows the bathroom fan to vent into the roof void.

A building maintenance professional could be engaged to re-secure the flexible ducting to the roof vent. This can be done at the clients discretion.

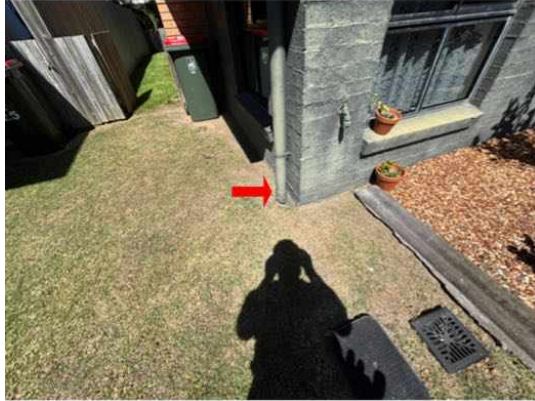
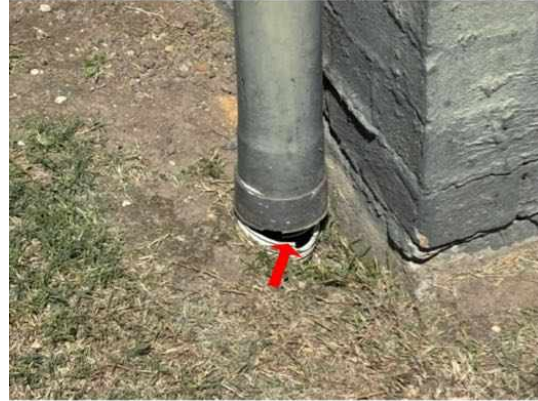
### Finding 3.04

Building:	Main Building
Location:	Front elevation
Finding:	Down pipe - damaged
Information:	At the time of the inspection, it was noted that the bottom section of the down pipe at the front of the dwelling is damaged. This affects the functionality of the down pipe and allows water to escape near the foundation.

Excessive moisture next to the foundations of a building creates a conducive condition for termite activity. Excessive moisture may also cause deterioration of the associated

building materials.

A licensed plumber should be engaged to carry out this repair. This can be done at the clients discretion. The client should inform the body corporate of the damaged down pipe as this may be a body corporate responsibility to repair this damage.

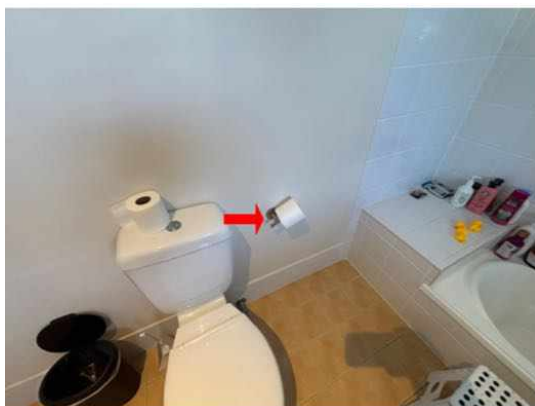
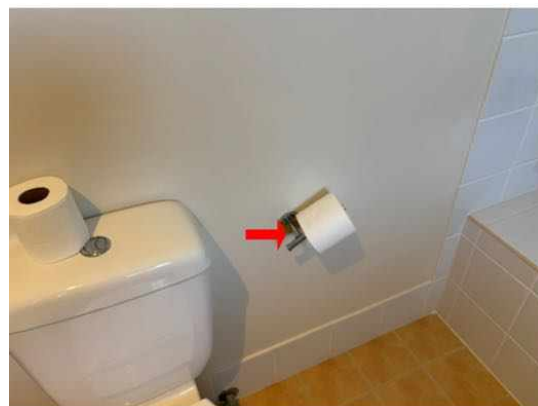
### Finding 3.05

Building: Main Building  
 Location: Upstairs bathroom  
 Finding: Upstairs bathroom - toilet roll holder is broken  
 Information: At the time of the inspection, it was noted that the toilet roll holder in the upstairs bathroom was broken. While not a major operational defect, function can deteriorate if the problem is left unmanaged.

It is advised that the homeowner performs remedial works to replace the toilet roll holder. A building maintenance professional may be required to perform these works. This can be done at the clients discretion.

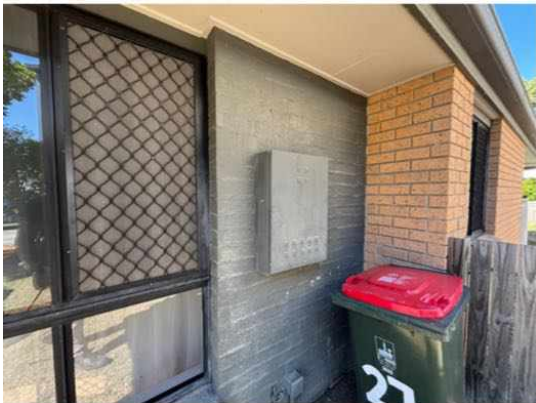
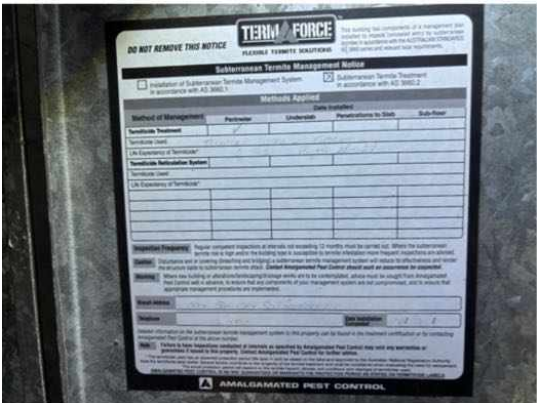
#### Finding 6.01

Building:	Main Building
Location:	All External Areas
Finding:	Termite Management System - no evidence of a current chemical installation
Information:	At the time of the inspection, no evidence of a current chemical termite management system was found. There is a durable notice in the meter box showing a chemical treatment appears to have been carried out on the 18/08/2003 with an expected lifespan of 5 years. If this is the correct date, then this treatment will no longer be effective. The durable notice is worn to such an extent that the date of installation is difficult to determine.

A durable notice should be placed in the switchboard unit to indicate current termite barriers. At the time of inspection, it appeared as though no termite management system has been installed, with no evidence to suggest preventative works taking place.

The client should make enquiries of the body corporate to confirm the extent of the termite management plan for the complex and the individual units, also, are annual termite inspections are being carried out and are up to date. The client should confirm that the body corporate is responsible for termite management.

The application of a post-construction chemical termite barrier is highly recommended for all properties, particularly if live termite activity has been found on the site previously. Such barriers are highly effective in preventing termite attack on any timber building elements throughout the property.

The client may consider gaining further advice from a pest controller as to the costs and procedures involved with this application. It is recommended that obtaining such advice be a short-term priority.

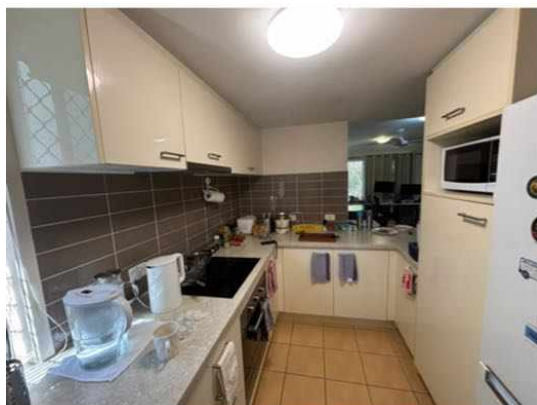
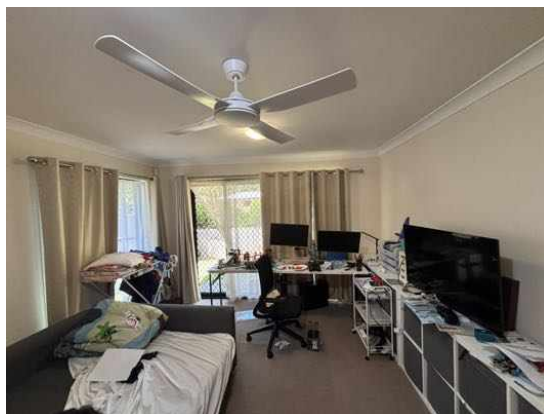
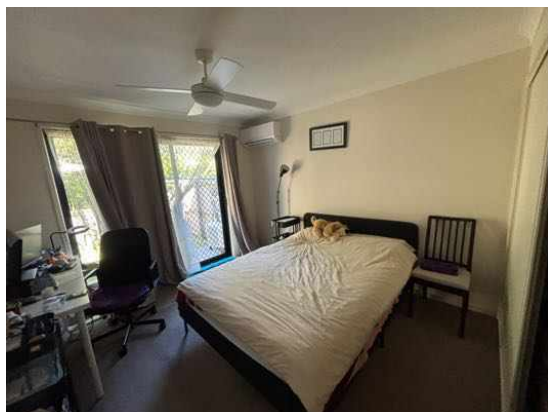
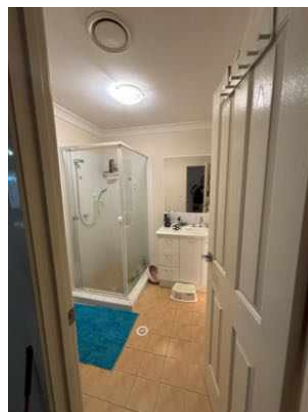
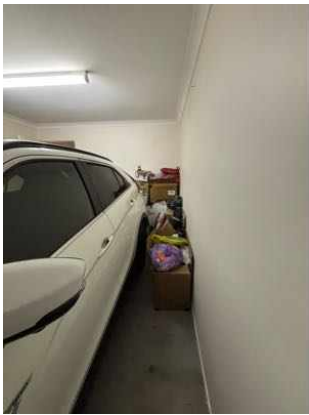
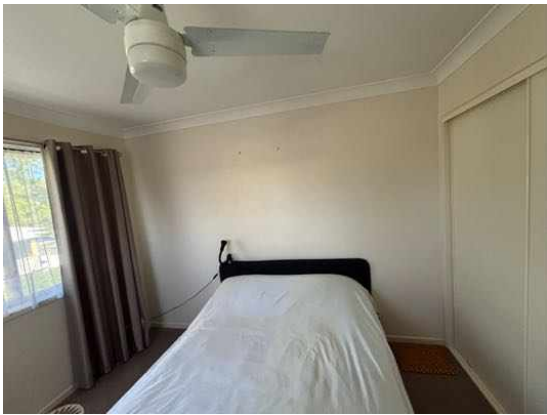
Building: Main Building  
Location: All Internal Areas  
Finding: Obstructions and Limitations - Internal areas  
Information: These photographs are an indication of the obstructions and limitations which impeded full inspection of the property of the internal areas at the time of inspection. These obstructions can hide an array of defects and should be removed to allow full inspection to be carried out. A re-inspection is recommended once the areas are made accessible.

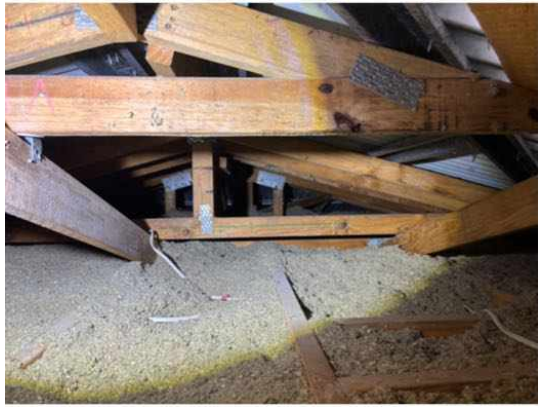
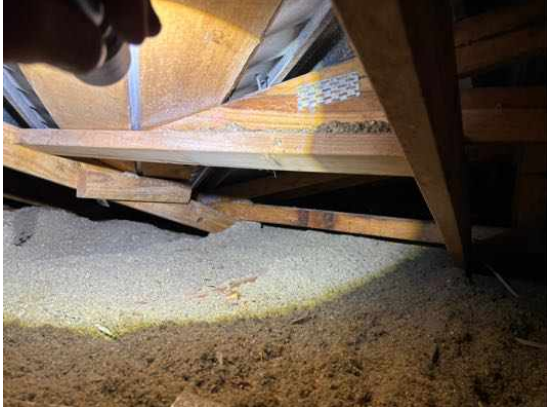
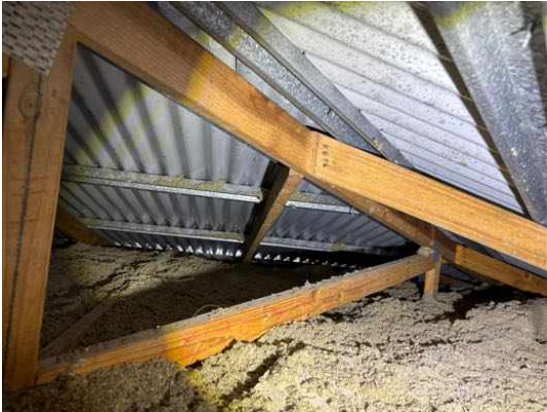
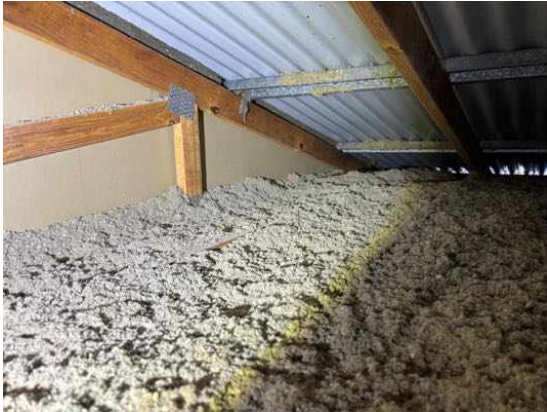
Building: Main Building  
Location: Roof Void  
Finding: Obstructions and Limitations - Roof cavity  
Information: These photographs are an indication of the obstructions and limitations which impeded full inspection of the property of the roof cavity

at the time of inspection. These obstructions can hide an array of defects and should be removed to allow full inspection to be carried out. A re-inspection is recommended once the areas are made accessible.
