Building and Timber Pest Inspection Report

Inspection Date: Fri, 27 Feb 2026

Property Address: 51 Crowley Bvd, Claymore NSW 2559,
Australia

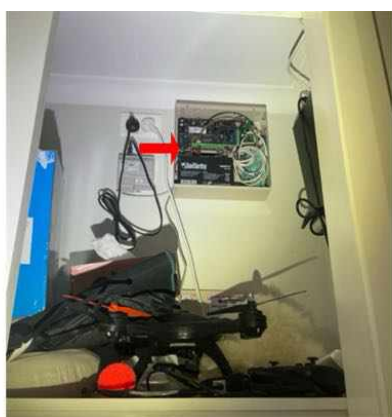
Finding 1.01

Building:	Main Building
Location:	All Internal Areas
Finding:	Electrical wires exposed
Information:	Exposed electrical wiring/panel was identified. Exposed electrical wiring represents a potential safety hazard including for fire and personal contact. Contact a licensed electrician urgently for further inspection investigation and rectification.

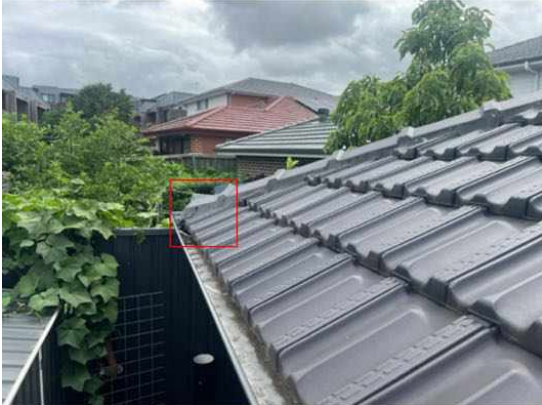
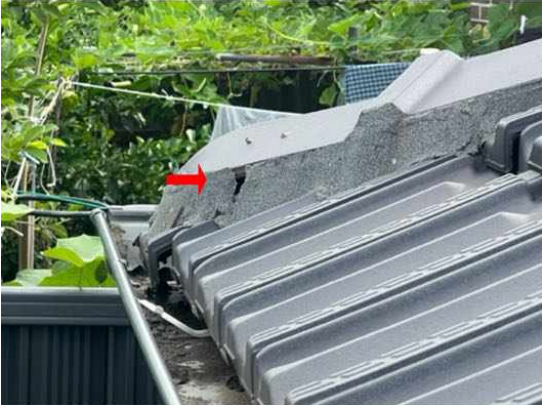
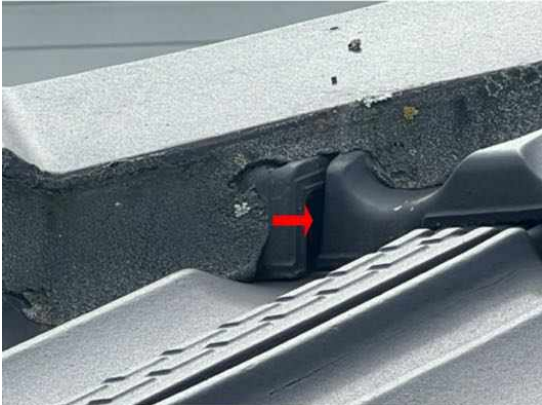
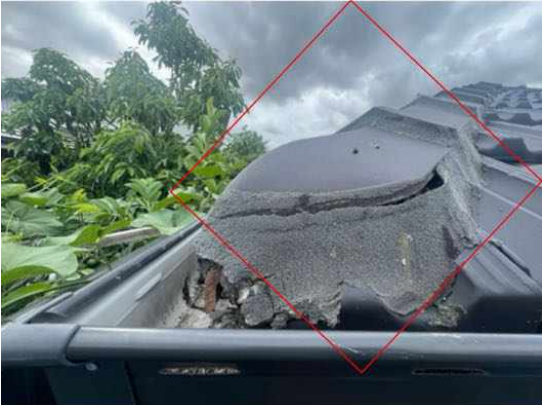
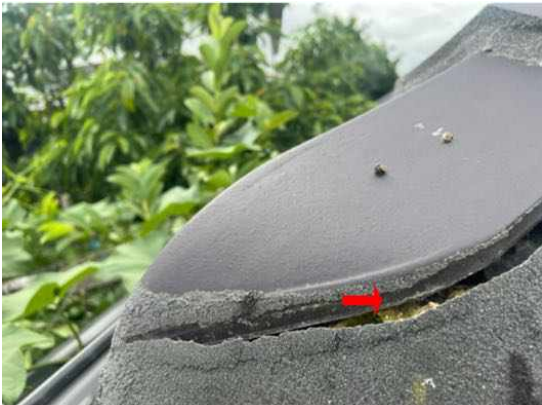
Building:	Main Building
Location:	Roof Exterior
Finding:	Mortar - Deterioration to some areas - Repair recommended
Information:	Mortar, or 'bedding', is the material which fills joins and intersections between tiles and other building elements on the exterior roof covering, such as gable ends, hip capping and valleys. Upon inspection of the exterior roof, it was noted that sections of the mortar show varying levels of deterioration.

Mortar generally deteriorates as a result of frequent exposure to weather conditions over a prolonged period of time. Mortar that is deteriorating may allow water ingress into the roof void, putting associated building elements and roofing structures at risk of water damage. Deteriorated mortar also detracts from the functionality of roof tiles and

Failure to rectify this defect can cause significant water damage.

Mortar deterioration can be attended to by a handy person where areas of deterioration are localised and easily accessible. Otherwise, consultation with a roofing contractor is advised where greater works are required.

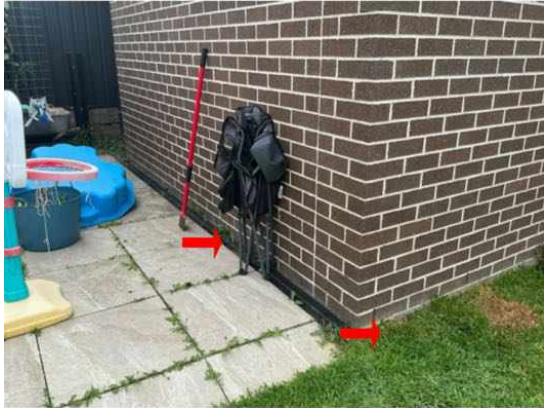
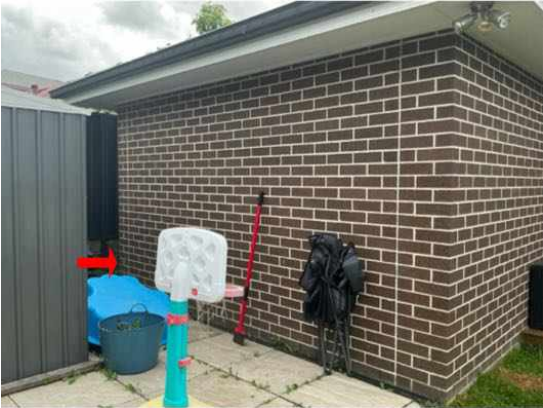
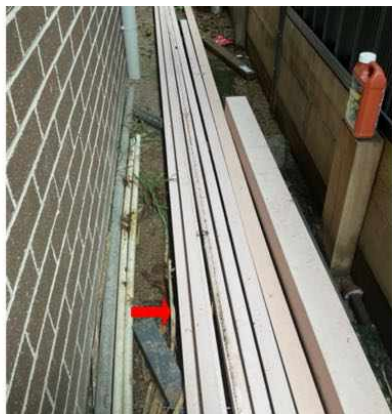
Finding 3.02

Building: Main Building
Location: All External Areas

Finding: Site drainage - Inadequate

Information: The site drainage in this area was found to be inadequate at the time of inspection, creating potential for subsequent water damage to associated building elements.

It is important that water does not lie against the base of walls; surrounding paths and ground levels should be sloped to drain water away from walls. Downpipes should not discharge stormwater onto lower walls or plinths. Stormwater should be carried away by large, regularly cleaned drains. Ground levels may need to be lowered to expose a buried DPC.

Where site drainage is inadequate, installation of an Agricultural (Aggie) Drain may be required. A qualified plumber should be appointed to further inspect the property and perform any remedial works as necessary. Water damage and secondary defects are likely to occur if left unmanaged.

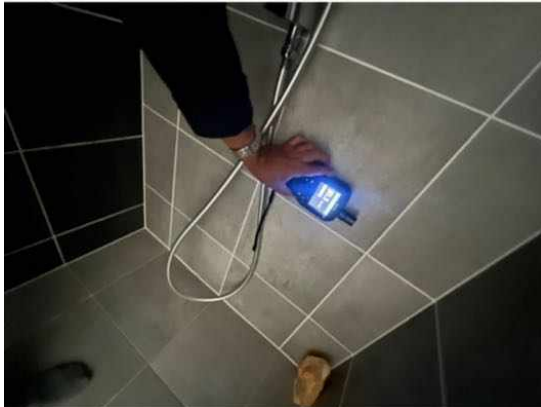
Finding 3.03

Building:	Main Building
Location:	Bathrooms, ensuite
Finding:	Elevated Moisture Bathroom (No visible deterioration noted)
Information:	Elevated moisture levels were detected to tiled surfaces in bathroom/shower areas. Persistent moisture ingress can lead to concealed damage, including timber rot and mould growth.

Elevated moisture readings in tiled wet areas can occur from normal shower use, age/deterioration of waterproofing membranes, plumbing leaks or moisture absorption through grout lines. While no damage was visible, elevated readings may indicate moisture retention behind tiles, which can be a conducive condition for future deterioration if not monitored.

Monitor the area over time for signs of drumming, efflorescence, tile movement, or grout deterioration. If concerns arise, a licensed waterproofing specialist can perform further investigation (e.g., pressure testing, membrane assessment).

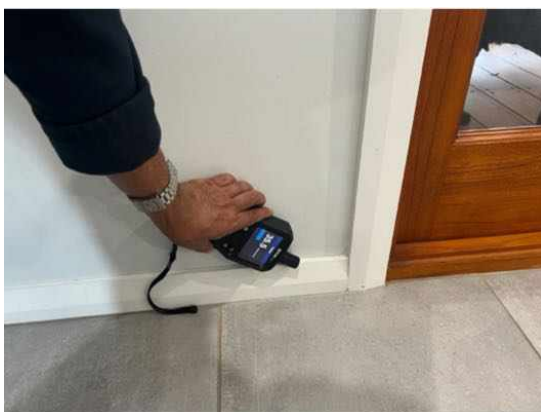
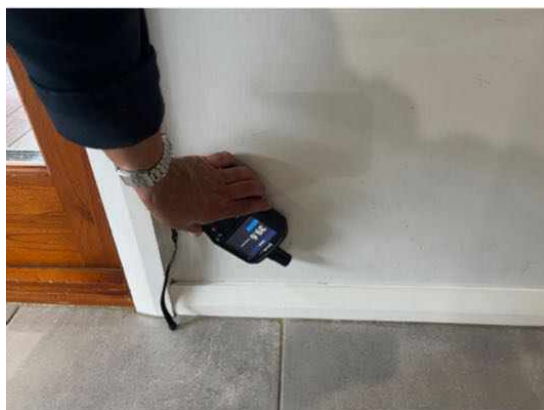
Finding 3.04

Building:	Main Building
Location:	Rear near sliding door and external rear wall
Finding:	Elevated Moisture Detected – No Visual Deterioration Observed
Information:	Moisture readings taken indicated elevated levels above typical thresholds. However, at the time of inspection, no visible signs of water damage, staining, timber decay, or mould growth were identified. While this may be due to recent exposure or concealed moisture, further monitoring is recommended. If concerns persist, a licensed builder or water ingress specialist should be engaged to assess concealed areas and verify the source, especially given the expectations of durability and weatherproofing.

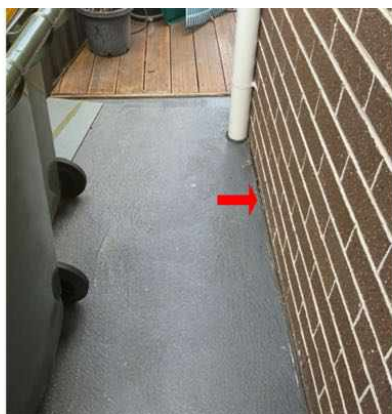
Finding 3.05

Building:	Main Building
Location:	All External Areas
Finding:	Gap Between Concrete and External Wall - to some areas
Information:	Visible gaps were observed between the external masonry wall and adjacent concrete slab at the pathway.

This separation may permit water ingress and contribute to concealed moisture-related damage, pest ingress, or slab movement if left unsealed.

The defect appears consistent with common differential settlement or poor sealant detailing at the slab-to-wall junction. Recommend a licensed contractor seal the gap with an appropriate flexible, UV-stable exterior-grade sealant to prevent moisture entry and pest intrusion.

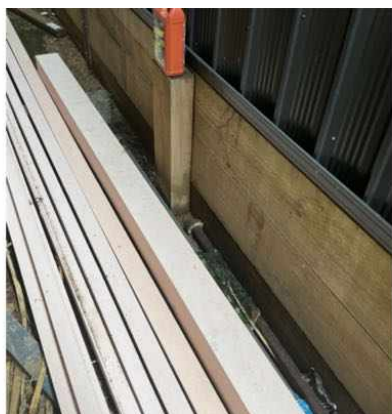
Building:	Main Building
Location:	All External Areas
Finding:	Retaining wall - Defective - (Lower sleepers moisture)
Information:	The retaining wall in this area was found to be defective at the time of inspection. Generally, defective retaining walls are caused by poor original design or material use. However, deteriorated retaining walls may also be a result of substandard construction, poor site drainage or unmanaged stormwater flows.

If left unmanaged, the retaining wall may become a safety hazard if it continues to destabilise. Where retaining walls further rot and decay, an environment is created that is conducive to termite and pest infestation.

Significant repair and replacement should be expected. Where retaining walls are considered structural walls, a structural engineer / surveyor should be consulted regarding required remedial works. Otherwise, a landscaper or retaining wall installer may be appointed to repair or replace the wall, at the discretion of the client.

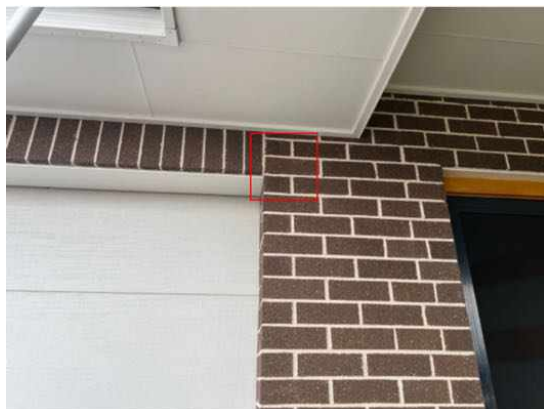
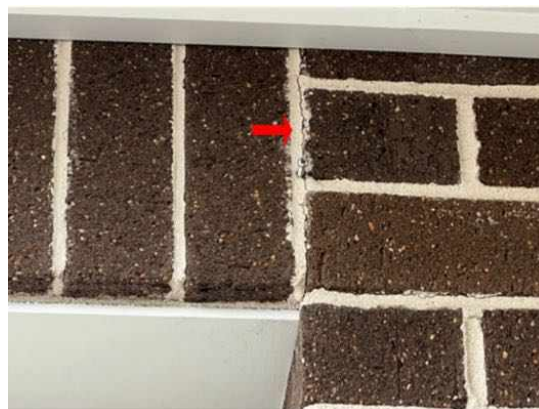
or moisture ingress and secondary damage as a result.

Mortar deterioration can be addressed by a bricklayer where areas of deterioration are localised and easily accessible. Alternatively, appointment of a registered builder is advised, to repoint large areas of decaying mortar. Where secondary structural defects have become evident, consultation with a structural engineer may be required.

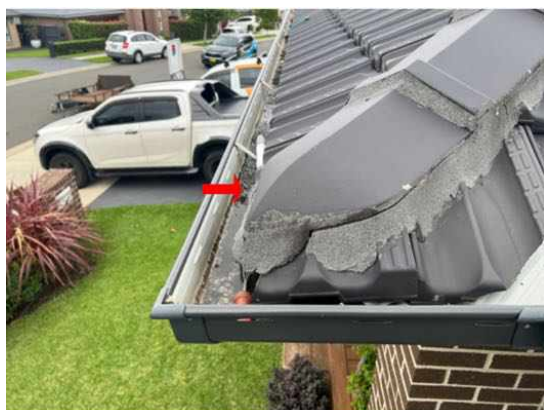
Finding 3.13

Building:	Main Building
Location:	All External Areas
Finding:	Gutters - Water pooling and debris
Information:	Water was found to be pooling in sections of the roof guttering. This is generally a secondary defect caused by blocked or partially blocked gutters. Such blockages and subsequent water pooling are likely to lead to rust and water damage to associated structures if left unattended.

Any areas of guttering that shows evidence of water pooling should be checked for partial or full blockages and any secondary damage that may have occurred as a result. Depending on the extent of the damage, building elements may require repair and/or replacement to ensure adequate roof drainage and function of exterior plumbing system.

A roofing plumber should be appointed as soon as possible to rectify this issue. It is highly advised that all gutters be maintained on a frequent basis to ensure the condition of roof plumbing.

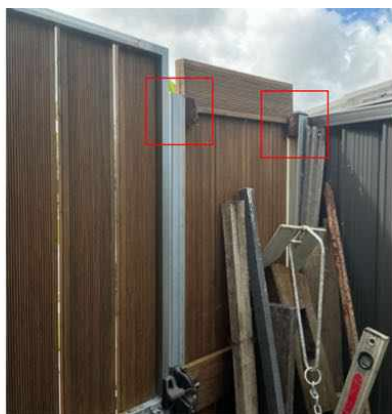
Finding 3.14

Building:	Main Building
Location:	All External Areas - Left Side
Finding:	Building element - Damaged - missing fixings
Information:	Breakage occurs generally when the building materials have either aged and decayed, or as a result of damage (accidental or deliberate).

Repair and/or replacement of broken elements is advised to ensure that additional secondary defects do not arise as a consequence. Such works are necessary, as all building elements play a key role in the operation and function of the overall structure and its performance.

A relevant tradesperson should be appointed to repair or replace the affected building element prior to any subsequent damage being caused.

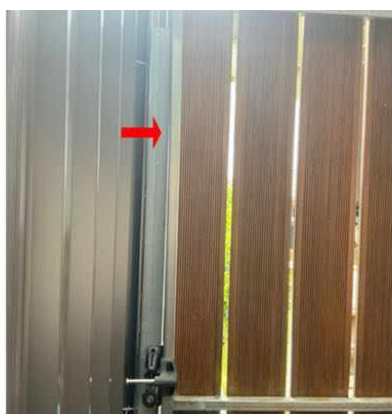
Finding 3.15

Building:	Main Building
Location:	All External Areas
Finding:	Door - Binding/jamming
Information:	Binding and/or jamming of this door is evident during standard operation. This defect inhibits the functionality of the affected door as well as creating potential for secondary defects to associated building elements, such as damage to the floor covering.

For minor causes, a qualified carpenter or general handyperson should be appointed to perform minor rectification works at client discretion.

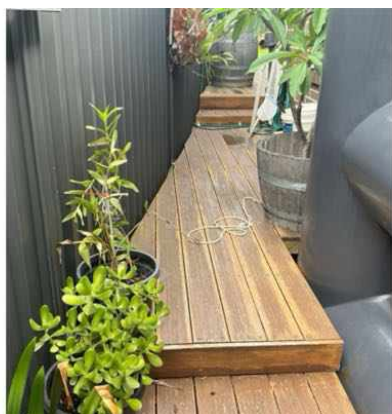
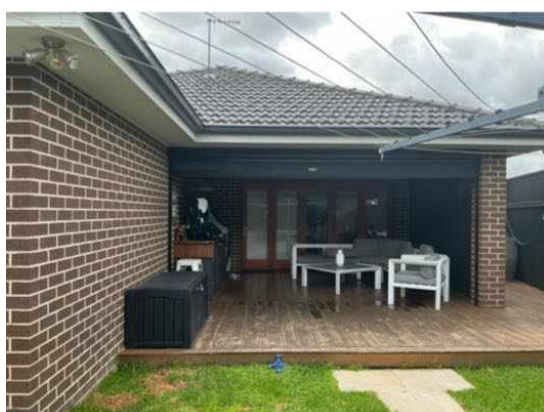
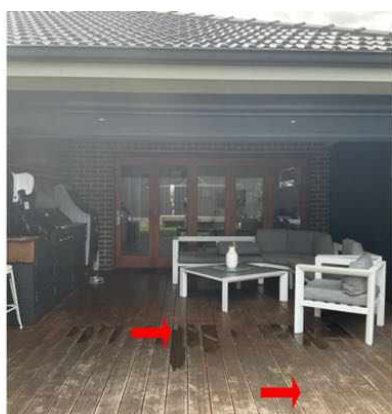
Finding 3.16

Building:	Main Building
-----------	---------------

Location: All External Areas
Finding: Timber deck - General weathering
Information: The external timber decking exhibits general weathering and surface wear consistent with age and exposure. Inspection of the decking boards and substructure was limited due to stored items and restricted access, preventing full assessment of fixings, framing and connections. ongoing maintenance including cleaning, sealing and periodic inspection of concealed structural components is recommended to minimise deterioration and potential decay over time.

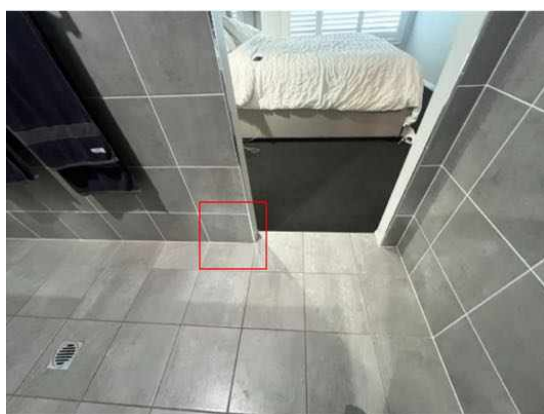
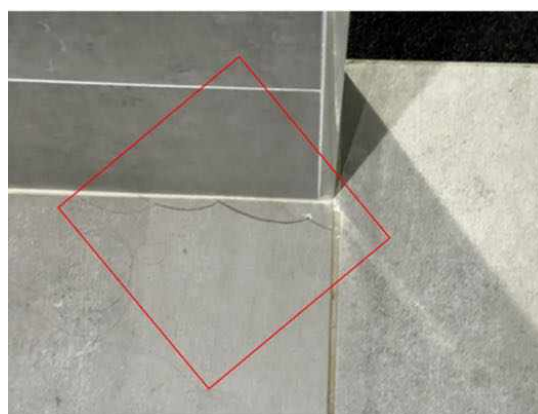
Finding 3.17

If left unmanaged, water penetration to these areas may lead to subsequent water damage, which is likely necessitate repair work to affected building elements.

Where water penetration has led to water damage, appointment of a relevant tradesperson may be required to repair damaged building elements.

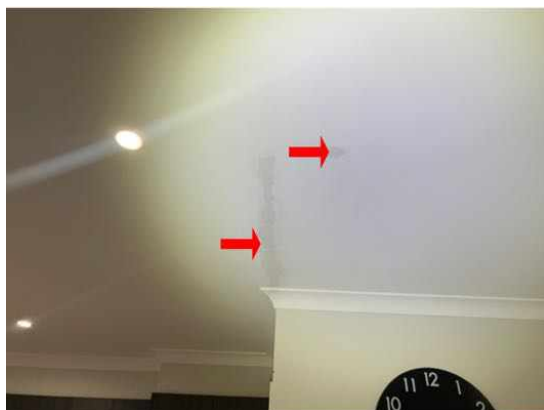
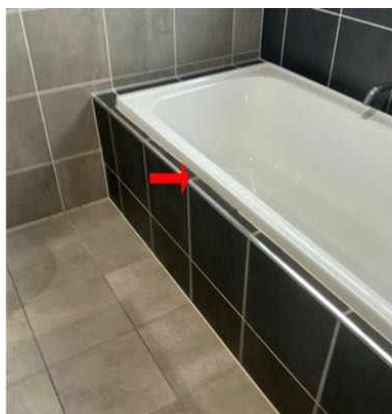
Finding 3.21

Building:	Main Building
Location:	All Internal Areas
Finding:	Sealant and grouting - Missing or degraded to some areas
Information:	It was noted on inspection that sealant or grout is degraded.

A sealant specialist or tiling contractor should be appointed to complete these works as soon as possible

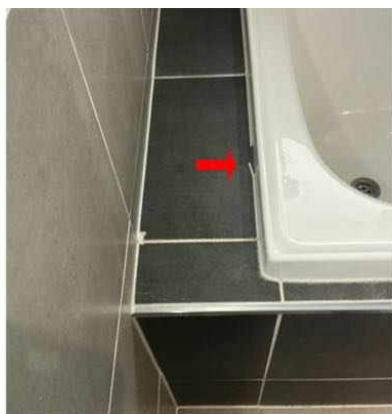
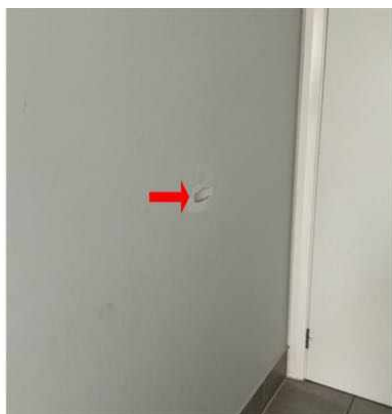
Finding 3.22

Building:	Main Building
Location:	All Internal Areas
Finding:	Building element - Damaged - plaster damaged laundry
Information:	Breakage occurs generally when the building materials have either aged and decayed, or as a result of damage (accidental or deliberate).

A relevant tradesperson should be appointed to repair or replace the affected building element prior to any subsequent damage being caused.

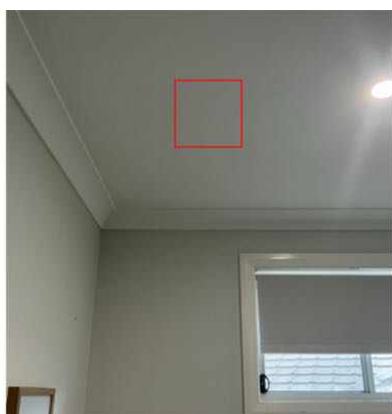
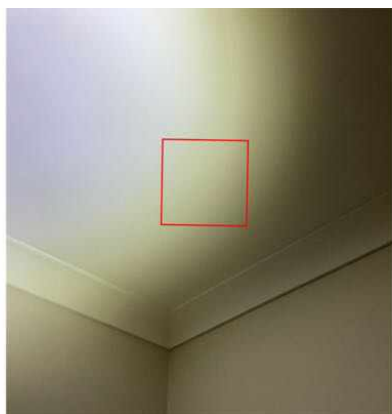
Finding 3.23

Building:	Main Building
Location:	All Internal Areas, Garage
Finding:	Ceiling nails - Popping To some areas
Information:	Numerous popped nails were identified in the internal ceiling at the time of inspection. Nails and screws hold simply by the friction between them and the surface they are applied to. Over time, the nails and screws can back out, which is often a result of general ageing and deterioration of the building structure.

Re-fastening of popped nails will help to maintain the stability of the internal ceiling and associated building elements. Such minor works will also help to improve the appearance of the affected area and secure the ceiling sheets, so as to prevent the onset of ceiling sagging. These works should be performed by a qualified carpenter or plasterer at client discretion.

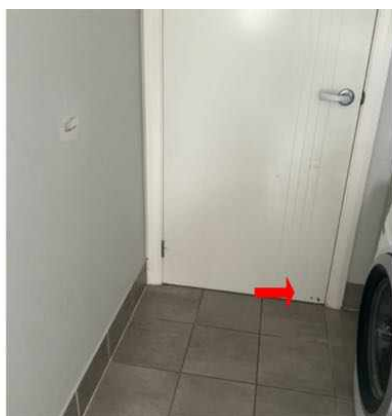
Finding 3.24

Building:	Main Building
Location:	All Internal Areas
Finding:	Door stop - Missing to some areas
Information:	The door stop is missing or is inadequate to stop the door handle from damaging the wall. Although some building elements may seem irrelevant or unnecessary, all building elements play a key role in the operation and function of the overall structure and its performance.

Re-installation or replacement of the door stop is advised as soon as possible to prevent any subsequent damage to the door or associated structures. A general handyman may be appointed to perform these works at client discretion.

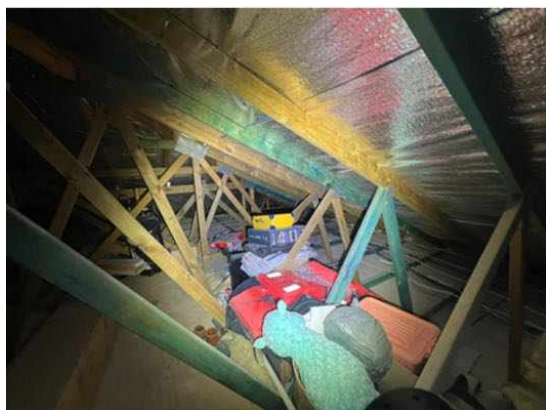
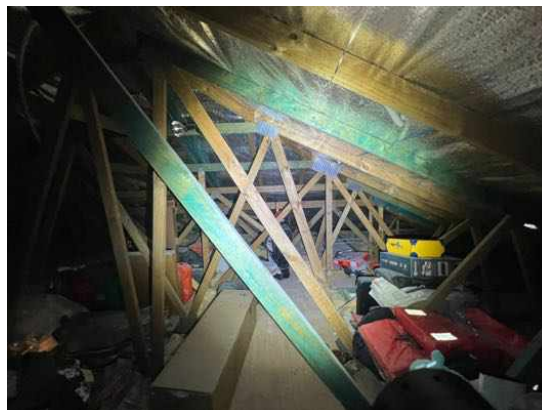
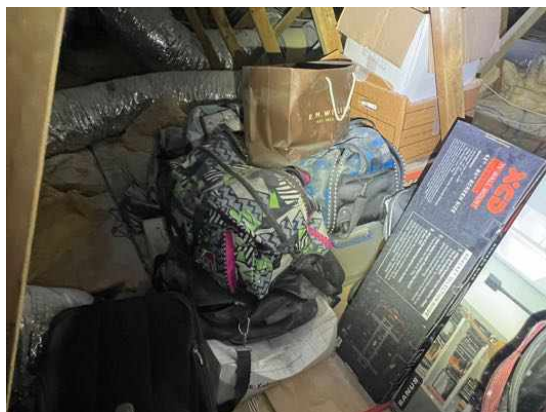
Finding 3.25

Building:	Main Building
Location:	Roof Void
Finding:	Stored Items - Roof Void
Information:	Stored goods were noted in the roof void.. Roof spaces are not designed for storage and excessive weight can damage ceiling structures. All stored items should be removed.

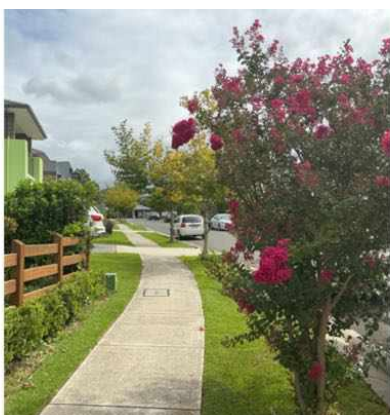
Finding 6.02

Building: Main Building
 Location: All External Areas
 Finding: Trees within 50m
 Information: Trees within 50m of the property can be conducive to termite activity. It is recommended an invasive inspection of all trees with 50m to the property be carried out by a qualified pest control expert.

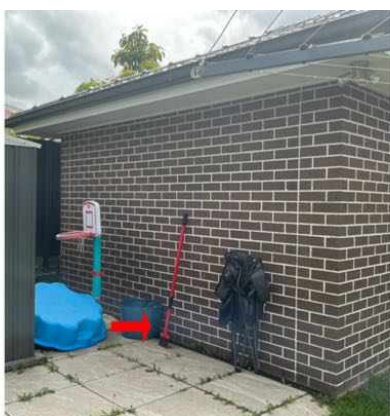
Finding 6.03

Building: Main Building
 Location: All External Areas
 Finding: Slab Edge - Exposure
 Information: An inspection zone of at least 75mm in relation to the exposed slab edge, between the bottom brick and the perimeter pavement, is required. This inspection zone

Where the slab edge cannot be properly inspected, it is highly recommended that termite or timber pest inspections be carried out every 6-12 months to aid protection of the property against infestation.
