Building and Timber Pest Inspection Report

Inspection Date: Sat, 28 Feb 2026

Property Address: 12A Winifred St, Condell Park NSW 2200,
Australia

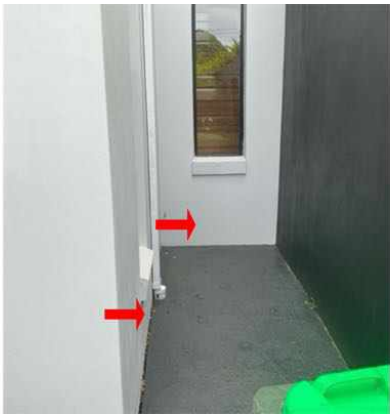
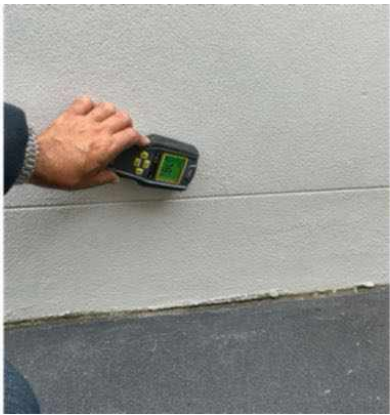
Building:	Main Building
Location:	All External Areas, Garage
Finding:	Damp (Also reference to 3.01 to 3.04)
Information:	Damp (or structural damp) refers to the presence of unwanted moisture in the structure of a building, either as the result of intrusion from outside, or condensation from within the structure. Generally, structural damp is caused by rain penetration, rising damp, and leaks from plumbing pipes.

Unmanaged damp facilitates the formation and development of mould, fungi growth and wood rot, decaying associated building materials and compromising their structural integrity. Damage to finishes is also likely to occur, including lifting, bubbling, peeling and staining of paint, plaster and wallpaper.

Consultation with a qualified plumber is advised immediately to identify the cause of damp and perform remedial works as required. Where excessive mould growth is present, further inspection by a specialist environmental health inspector should also be considered.

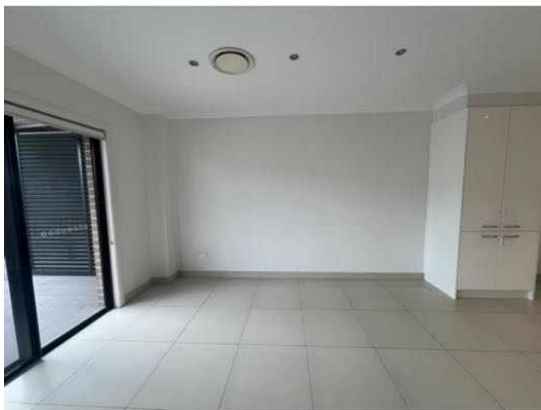
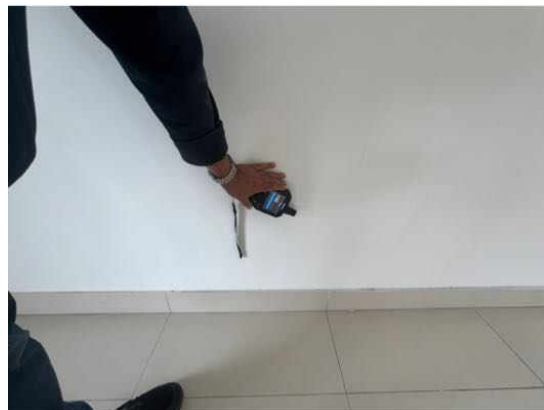
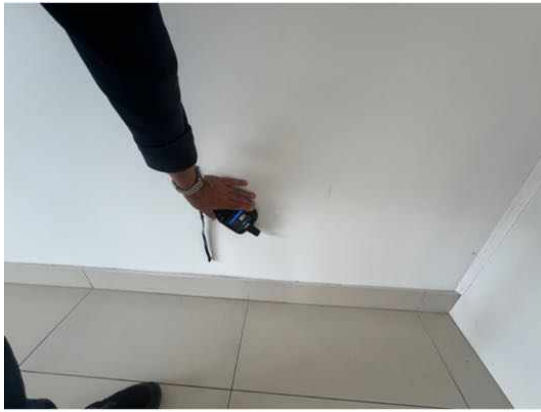
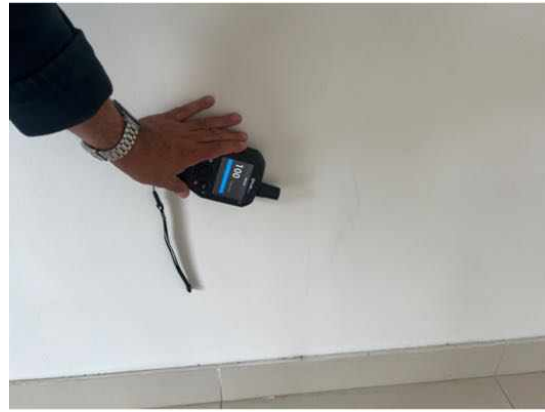
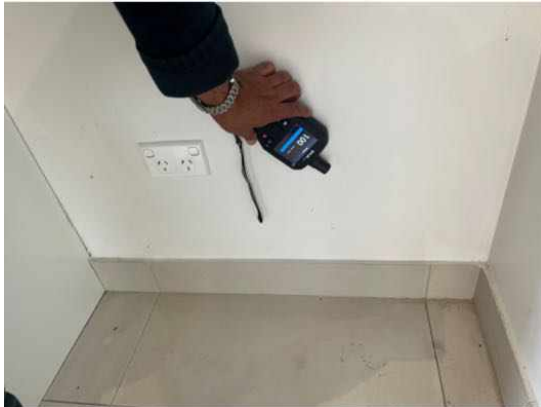
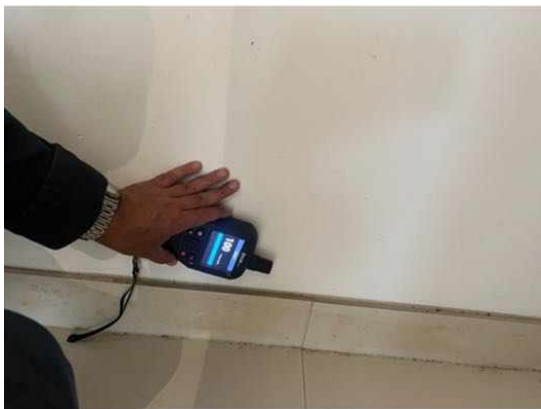
Building:	Main Building
Location:	All Internal Areas - Right external wall
Finding:	Elevated Moisture – Further Investigation Recommended
Information:	Elevated moisture readings were detected in several locations with no visible surface issues, although no significant structural damage was evident at the time of inspection, dampness can contribute to deterioration if left unaddressed. A further investigation by a licensed plumber or waterproofing specialist is recommended to confirm the source and ensure no concealed issues are developing.

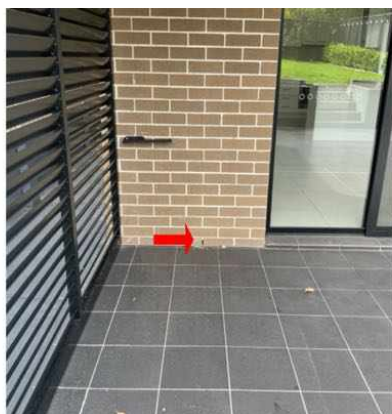
Building:	Main Building
Location:	All External Areas
Finding:	DPC & Weep Holes
Information:	The ground level is nearly flushed or level with no visible step-down or separation from the weep holes or the damp-proof course (DPC). This presents a moisture risk, as AS 2870 and NCC Volume 2 Part 3.1.2 require ground levels or hard surfaces to be at least 75 mm below the DPC or the lowest course of brickwork with weep holes to prevent rising damp or lateral moisture ingress. Monitoring is recommended along with creating a 75 mm clearance or isolation gap along the wall line as required by NCC Vol 2 Part 3.1.2.3 and AS 2870 Clause 5.3.3. Monitor for any signs of rising damp or efflorescence.

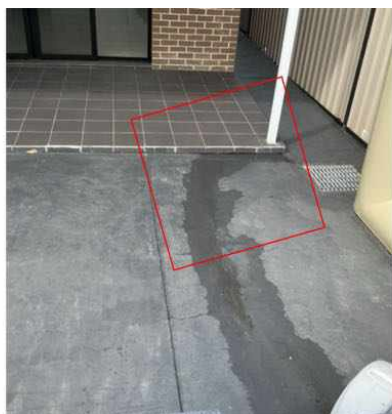
Finding 3.04

Building:	Main Building
Location:	All External Areas
Finding:	Site drainage - Inadequate
Information:	The site drainage in this area was found to be inadequate at the time of inspection, creating potential for subsequent water damage to associated building elements.

Where site drainage is inadequate, installation of an Agricultural (Aggie) Drain may be required. A qualified plumber should be appointed to further inspect the property and perform any remedial works as necessary. Water damage and secondary defects are likely to occur if left unmanaged.

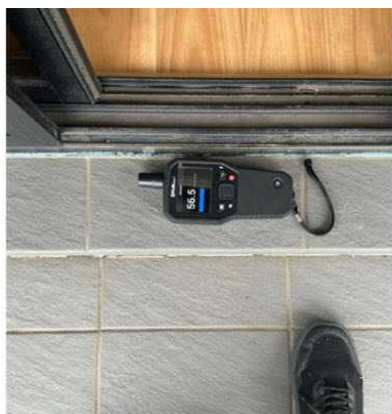
Finding: Balcony – Elevated Moisture to Tiled Floor Area

Information: Slightly elevated moisture readings were detected to the tiled balcony floor with visible efflorescence and discolouration to grout lines indicating prolonged or recurring moisture presence beneath the tile finish. This condition is commonly associated with failed grout or sealant joints, insufficient surface drainage and/or inadequate waterproofing allowing moisture to become trapped within the balcony substrate. While no internal water ingress was evident at the time of inspection, the readings exceed what would be expected under normal dry conditions and warrant further investigation. This issue is considered a minor defect at present, with the potential to escalate if moisture migration continues, and assessment by a suitably qualified waterproofing specialist is recommended.

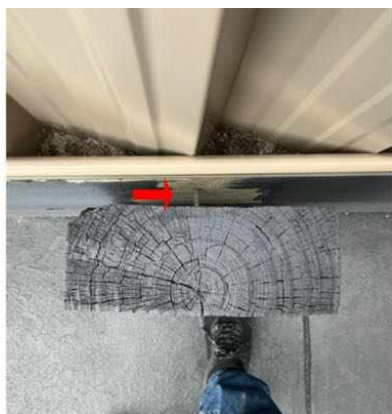
Building:	Main Building
Location:	All External Areas
Finding:	Retaining wall - Defective (posts misaligned, wood rot, drainage provision can't be confirmed)
Information:	The retaining wall in this area was found to be defective at the time of inspection. Generally, defective retaining walls are caused by poor original design or material use. However, deteriorated retaining walls may also be a result of substandard construction, poor site drainage or unmanaged stormwater flows.

If left unmanaged, the retaining wall may become a safety hazard if it continues to destabilise. Where retaining walls further rot and decay, an environment is created that is conducive to termite and pest infestation.

Significant repair and replacement should be expected. Where retaining walls are considered structural walls, a structural engineer / surveyor should be consulted regarding required remedial works. Otherwise, a landscaper or retaining wall installer may be appointed to repair or replace the wall, at the discretion of the client.

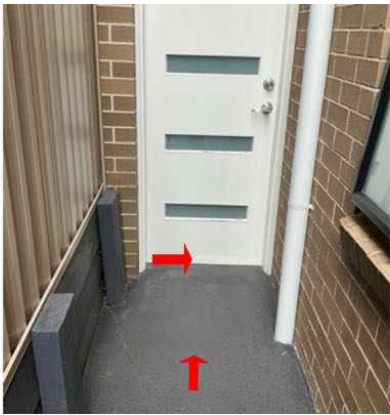
Finding 3.09

Building:	Main Building
Location:	All External Areas - Right side
Finding:	Building element - Damaged - Rear door moisture damaged , (No step down to the entrance possible moisture ingress risk)
Information:	Breakage occurs generally when the building materials have either aged and decayed, or as a result of damage (accidental or deliberate).

Repair and/or replacement of broken elements is advised to ensure that additional secondary defects do not arise as a consequence. Such works are necessary, as all building elements play a key role in the operation and function of the overall structure and its performance.

A relevant tradesperson should be appointed to repair or replace the affected building element prior to any subsequent damage being caused.

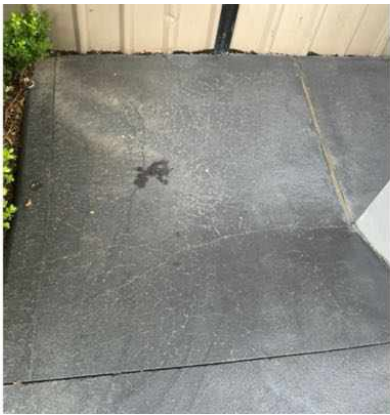
Finding 3.10

Building: Main Building
 Location: All External Areas
 Finding: Cracking - External Concrete Paving Damage Category 3 - Wide Cracks (2mm - 4mm)
 Information: Wide cracks were identified in external concrete paving Wide cracks are significant and are likely to lead to the development of safety hazards and secondary defects if left unmanaged.

General age and expected deterioration of the paved areas is a common cause of this type of cracking. However, expansion and contraction of the slab may also have occurred due to environmental factors. Such factors include variable moisture and weather conditions, the presence of trees and their roots having a settling or lifting

Cracking to this degree may also be due to poor original installation of the concrete. Factors such as poor compaction of the sub surface and/or inadequate reinforcing of the slab may create cracking and other secondary defects. Wide cracks may also have a more significant structural cause, such as subsidence of soils.

Where the crack is located adjacent to structural elements of the building, the advice of a Structural Engineer is advisable before undertaking repairs. Significant repair and likely replacement of the concrete paving is probable.

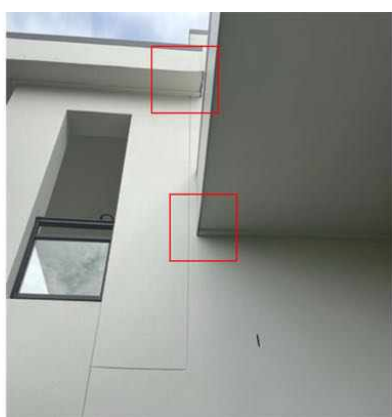
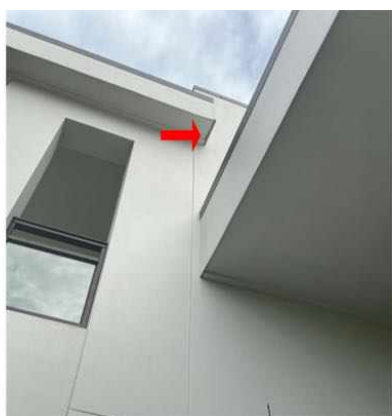
Finding 3.11

Building:	Main Building
Location:	All External Areas
Finding:	Incomplete or substandard works - cladding separating front moisture risk
Information:	The works to this area appear to be incomplete or have been completed to a substandard level.

It is highly recommended that the relevant trades be appointed to complete these works and ensure the safety of the area and the longevity of all associated building elements.

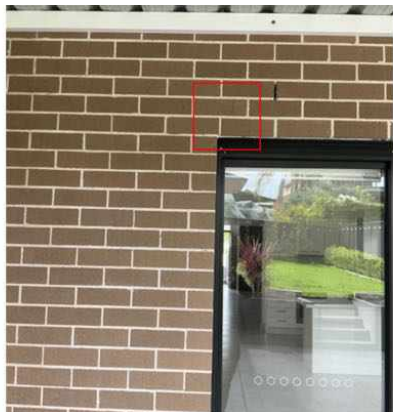
Finding 3.12

Building:	Main Building
Location:	All External Areas - Rear
Finding:	Brickwork - Cracking [Fine]
Information:	Although fine cracks are quite noticeable, they are often only considered to be an appearance defect and usually do not indicate any structural damage. Generally, the cause of a fine crack is indicative of a separation between brickwork and mortar throughout the structure, but single bricks may also show cracks of this nature.

Always contact a building inspector should cracks widen lengthen or become more numerous.

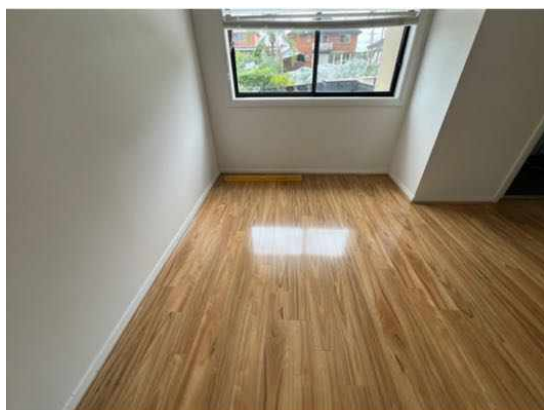
Building:	Main Building
Location:	Second story
Finding:	Uneven Laminate Floor to some areas
Information:	unevenness was observed to sections of the laminate flooring. This condition is typically associated with installation tolerances, minor subfloor irregularities, or natural movement of a floating floor system. While not considered a major defect, the unevenness may present a minor trip hazard and lead to accelerated wear of the flooring if left unrectified. Monitoring and, if required, localised rectification by a flooring contractor is recommended.

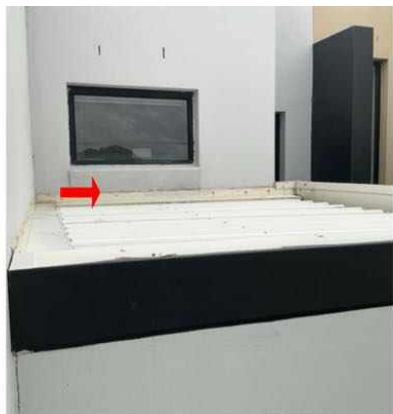
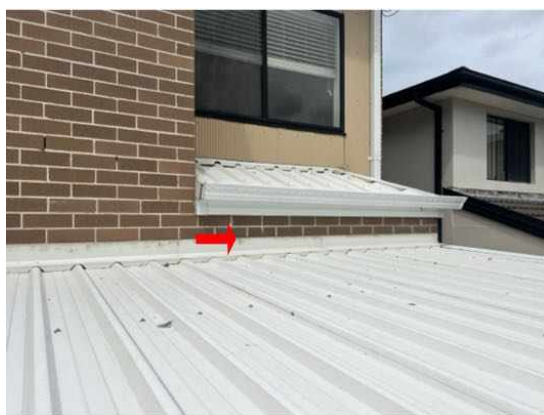
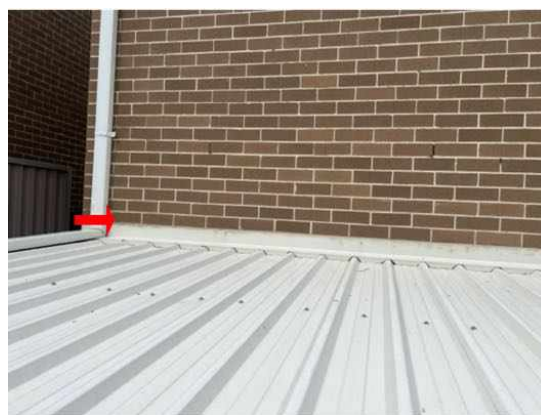
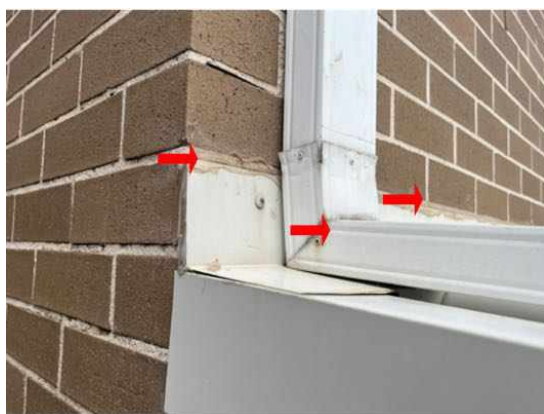
Finding 3.16

Building:	Main Building
Location:	Front , Rear
Finding:	Flashing defective -poor installation
Information:	The metal flashing at the wall junction appears inadequately installed, with visible gaps and lifting and reliance on surface sealant rather than a properly chased and continuous detail. The junction does not appear fully weather-tight, increasing the risk of moisture ingress into the wall cavity or roof structure over time. Defective flashing installation can lead to concealed deterioration if not addressed. Recommend

assessment and rectification by a qualified roofing contractor to ensure compliant and effective weatherproofing.

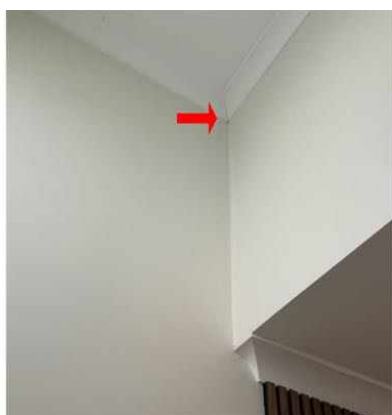
Finding 3.17

Building: Main Building
 Location: All Internal Areas - Front void ,
 Finding: Painted surface - Bubbling
 Information: Sections of paint in this area was found to have bubbled and deteriorated. Paint bubbling is generally an indication of excessive moisture in the area, that is currently hidden by the painted surface.

It is highly advised that the affected paint be cleaned to allow a further, more invasive inspection by a licensed plumber. Failure to act on this defect may necessitate major works in the future.

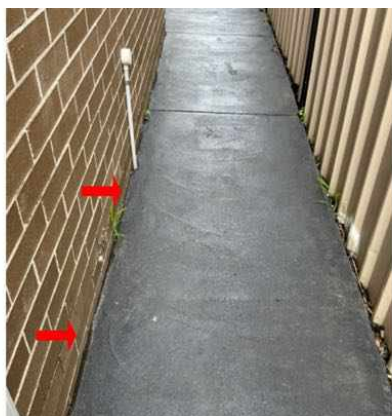
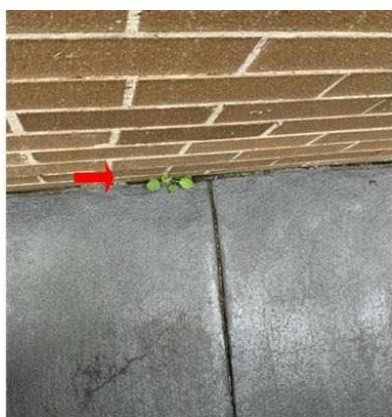
Finding 3.20

Building: Main Building
Location: All External Areas
Finding: Gap Between Concrete and External Wall - to some areas
Information: Visible gaps were observed between the external masonry wall and adjacent concrete slab at the pathway.

with an appropriate flexible, UV-stable exterior-grade sealant to prevent moisture entry and pest intrusion.

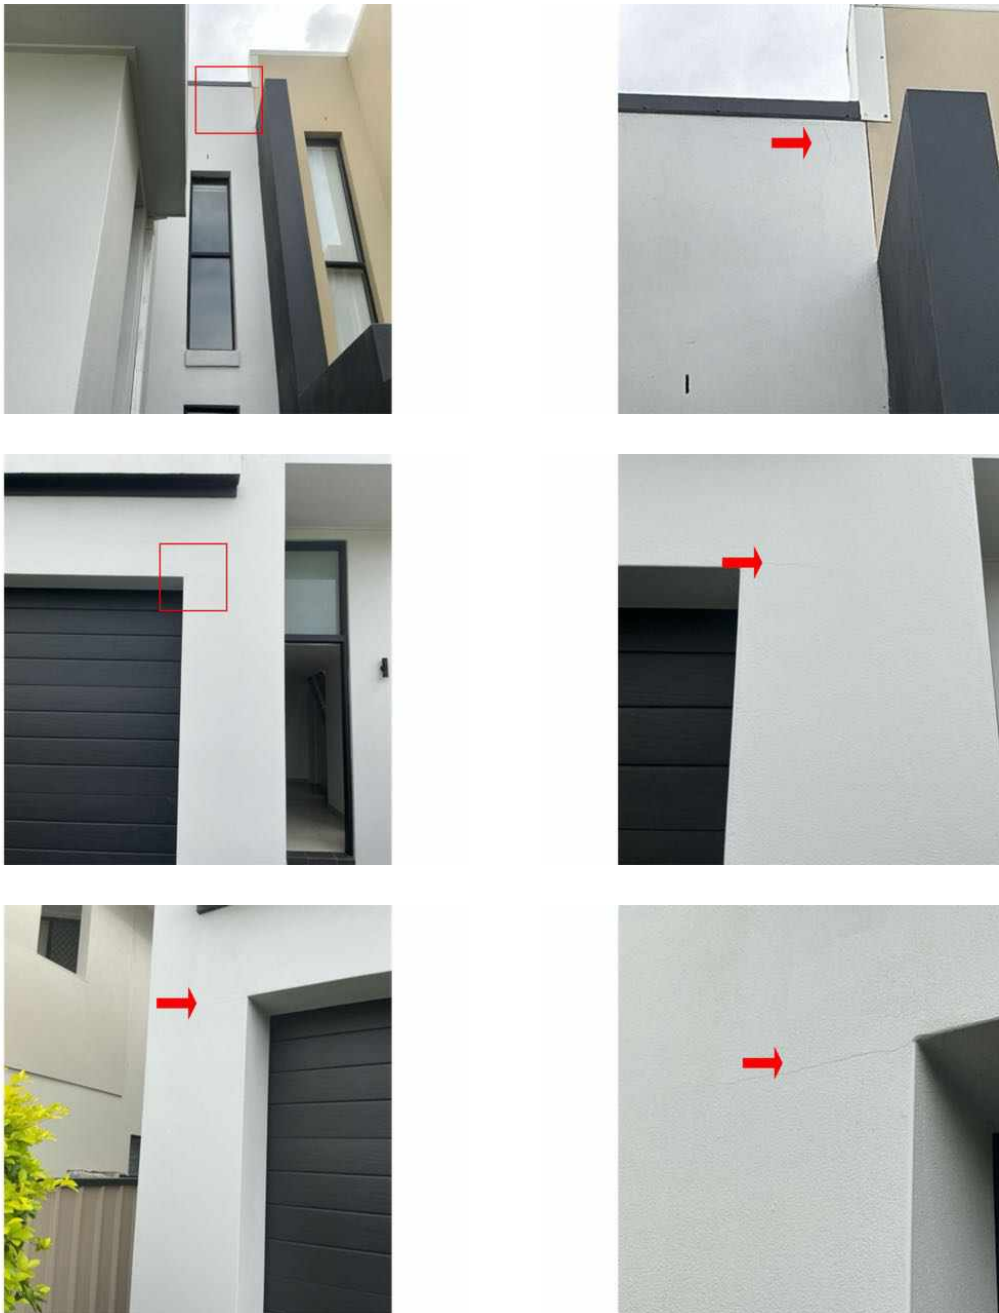
Finding 3.21

Building:	Main Building
Location:	All External Areas
Finding:	Cracks to render - Category 1 to some areas
Information:	It has been observed that cracking to rendered surfaces has occurred. The degree of damage falls within Category 1, described as fine cracks that do not need repair and which are less than 1.0mm in width limit.

Damage of this category is not considered a defect for rectification. Always contact your building inspector should cracks widen, lengthen, or become more numerous.

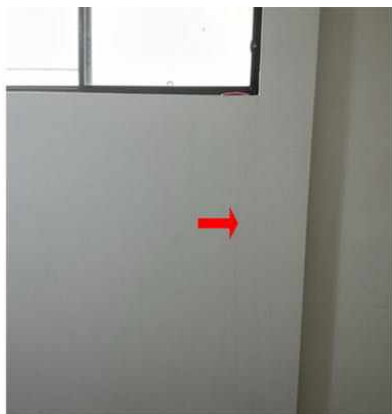
Finding 3.22

Building:	Main Building
Location:	All External Areas
Finding:	Water staining
Information:	Water staining was evident in this area at the time of inspection. Water staining indicates that surfaces have been exposed to excessive moisture over time. The minerals and other elements in the water lead to staining, which may graduate to corrosion and deterioration if left unmanaged.

Conversely, where water staining is old and inactive, affected building materials may be repaired or replaced at client discretion. A qualified carpenter or registered builder may be appointed to perform these works.

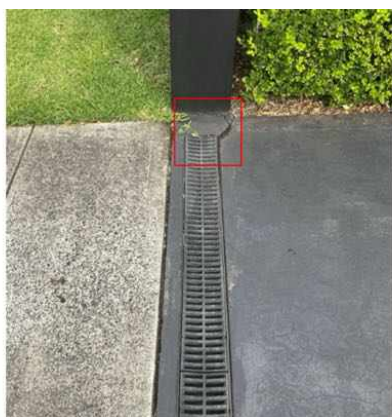
Finding 3.23

Building: Main Building
 Location: Driveway
 Finding: Building element - Damaged - Concrete damaged driveway
 Information: [MUST EDIT]

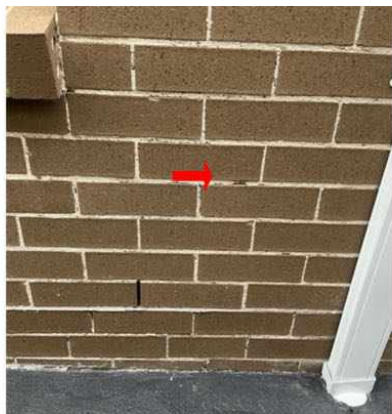
Building: Main Building
Location: All External Areas
Finding: Brickwork - Deteriorated mortar to some areas

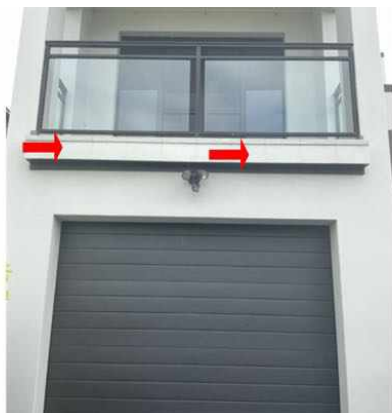
water and may be associated with drainage, overflow, or edge detailing issues. While currently cosmetic, continued moisture exposure may contribute to surface deterioration over time. Further assessment of balcony drainage and waterproofing performance is recommended.

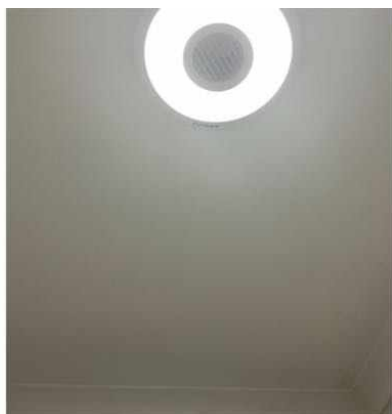
Finding 3.35

Building:	Main Building
Location:	Laundry
Finding:	Water Staining - Humidity or Ventilation
Information:	The ceiling surface shows faint darkened spotting or shadowing, commonly consistent with surface mould or humidity-related staining, often found in bathroom or wet area ceilings with insufficient ventilation. While there is no visible sagging or major water damage, the pattern suggests prolonged moisture exposure, possibly due to steam accumulation or minor condensation issues. According to AS 4349.1-2007 (Appendix C), this would be classified as a minor defect unless further deterioration or active leaks are found. Recommend improving mechanical or natural ventilation, cleaning the surface with mould treatment, and monitoring for recurrence.

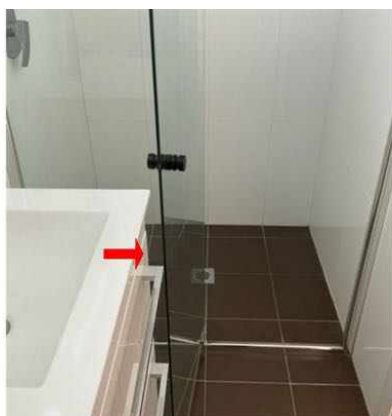
Finding 3.37

Location:	Ensuite
Finding:	Installation - substandard or incomplete - Shower
Information:	The shower screen door appears to be installed in close proximity to the vanity unit or adjacent walls, resulting in limited or no clearance between the glass panel and adjacent cabinetry. The current installation may restrict full door operation and compromise effective water containment within the shower area. Substandard installation can increase the risk of water escaping beyond the wet area, damage to door or cabinets/walls potentially affecting surrounding finishes over time. Adjustment or rectification by a qualified installer is recommended to ensure proper alignment and adequate clearance.
