Building and Timber Pest Inspection Report

Inspection Date: Thu, 22 Jan 2026

Property Address: 352 Alison Rd, Coogee NSW 2034,
Australia

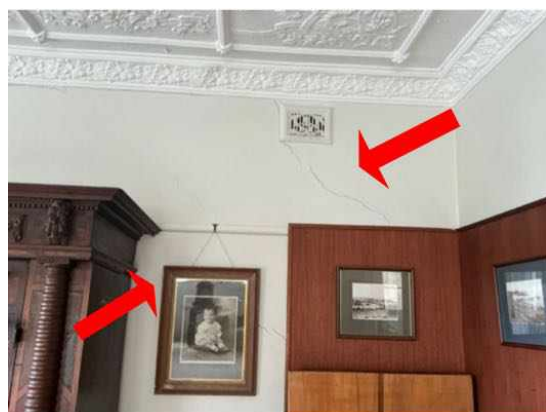
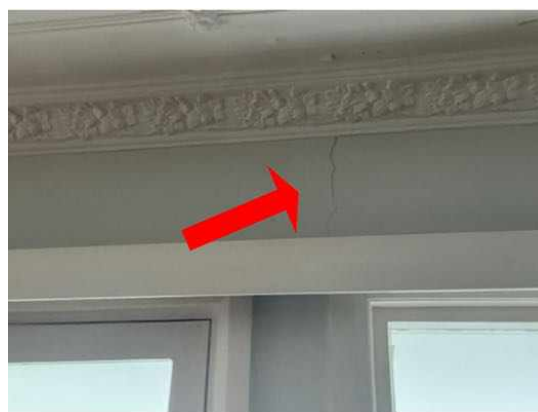
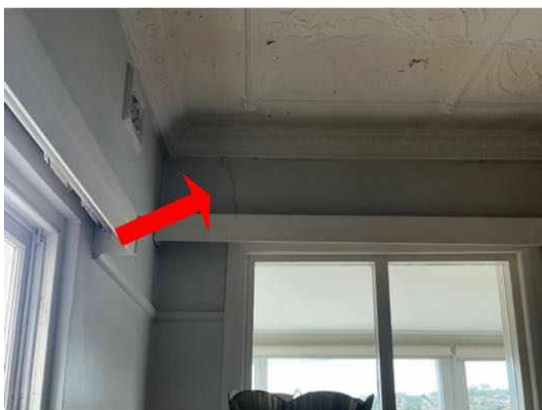
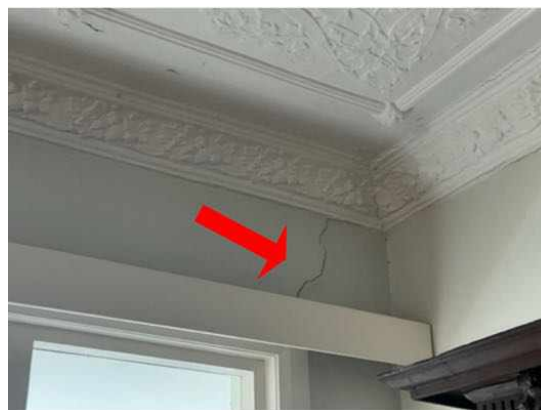
Finding: Cracking to Internal Masonry Walls

Information: Cracking was identified to the internal masonry walls within the lounge room area. The property is of an older style of construction, and the cracking may be associated with movement at the front of the building, where a large retaining wall is located. Given the age of the property and surrounding site conditions, the presence of cracking is not unexpected.

Movement of supporting ground, retaining structures, or differential settlement over time can result in stress being transferred to masonry walls, leading to cracking. While the cracking does not appear unusual for a property of this age, the underlying cause cannot be confirmed as part of a visual inspection.

It is highly recommended that further consultation be undertaken with a suitably qualified structural engineer to assess the cracking, determine the cause, and advise whether repairs or remedial works are required. Ongoing monitoring of the affected areas is also advised.

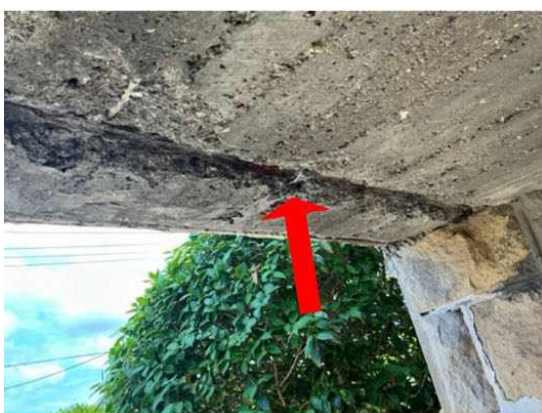
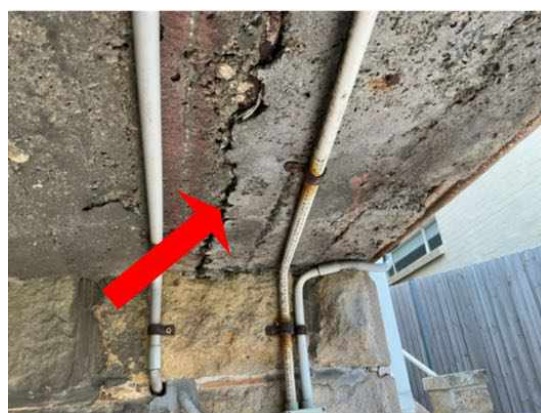
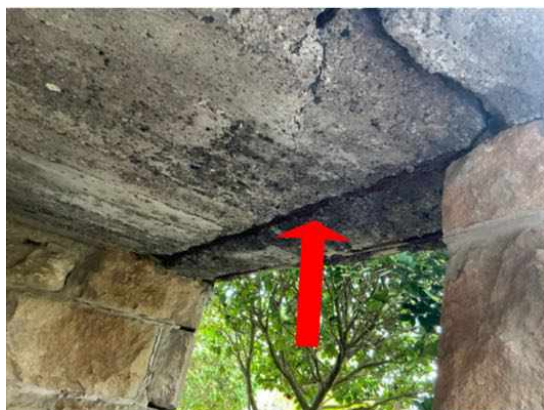
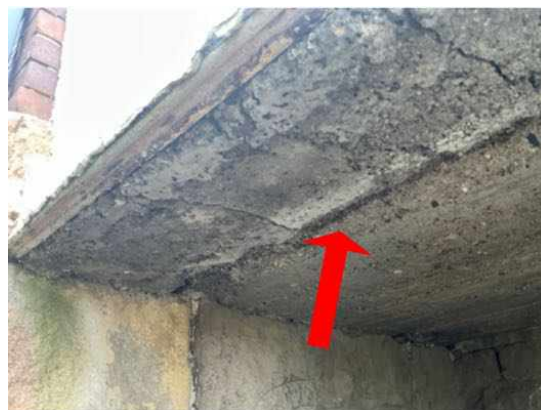
Finding 2.02

Building:	Main Building
Location:	Front Elevation
Finding:	Concrete - Spalling
Information:	Concrete spalling is the common term used to describe a number of factors which cause concrete construction to deteriorate. Generally, water penetration causes the concrete reinforcement to rust and expand, creating stresses on the surrounding concrete and in turn causing it to spall (or break away). Alternatively, if the cement component is too alkaline, reactions with the general atmosphere occurs and star-shaped cracks appear which allow rainwater to penetrate. Concrete spalling may also originate from poor original water proofing.

Left unmanaged, the problem is likely to worsen over time, potentially leading to the development of major structural defects. It is highly recommended that a structural engineer and builder be appointed to provide estimates on the required works.

Repair works will generally involve works, including removal of affected concrete and the treatment or replacement of any exposed steel. Some injection of resins or special mortars may also be possible, however this depends on the size and extent of consequent damage.

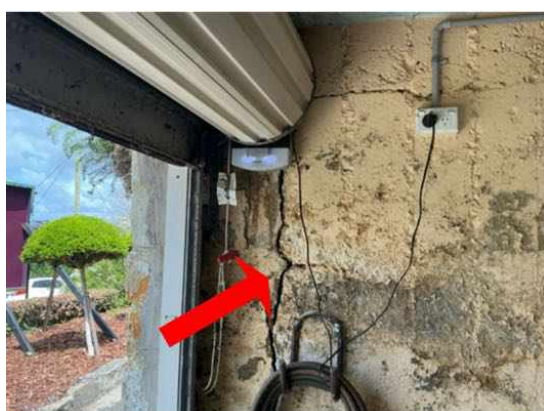
Finding 2.03

Building:	Garage
Location:	Garage
Finding:	Cracking to Internal Garage Retaining Walls
Information:	Significant cracking was identified within the internal garage, which is a subterranean structure. The cracking appears to be concentrated at the junction where the front retaining wall meets the internal garage retaining wall, indicating separation at this interface.

Cracking at retaining wall junctions can be indicative of movement, differential loading, or inadequate connection between adjoining retaining structures. Given the subterranean nature of the garage and the role these walls play in retaining soil and supporting loads, this cracking is considered significant and may worsen over time if not addressed.

It is recommended in the short term that a structural engineer be engaged to further inspect the affected areas to determine the cause and extent of the movement. Based on their advice, appropriate remedial works should be carried out to stabilise the retaining walls and prevent further separation or potential structural and safety issues.

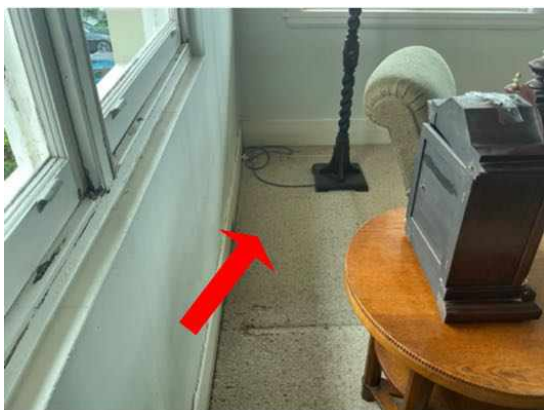
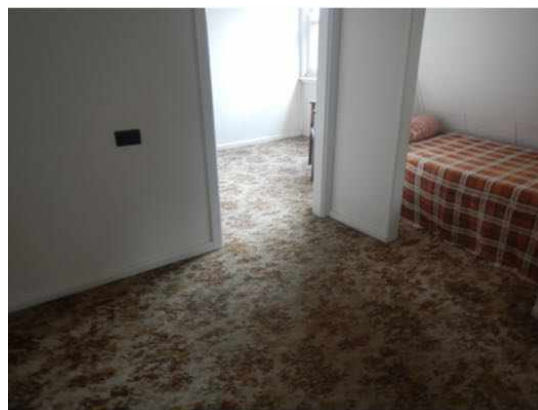
Finding 3.01

Building:	Main Building
Location:	Living Room, upper level bedrooms
Finding:	Uneven Flooring to Living Room and Bedrooms
Information:	Uneven flooring was identified to the front living room and to several upstairs bedrooms. The flooring appears to dip and vary in level in certain areas, which is common in older-style dwellings and may be associated with age-related wear, settlement, or past alterations.

The unevenness may be the result of natural movement of the structure over time, including possible movement of subfloor supports, bearers, joists, or differential settlement of the building. Due to the limitations of a visual inspection, the exact cause of the uneven flooring could not be confirmed.

It is recommended that the affected areas continue to be monitored for any further movement or deterioration. If the unevenness worsens or causes functional or safety concerns, further investigation by a builder or structural engineer is advised to determine the cause and whether repairs are required.

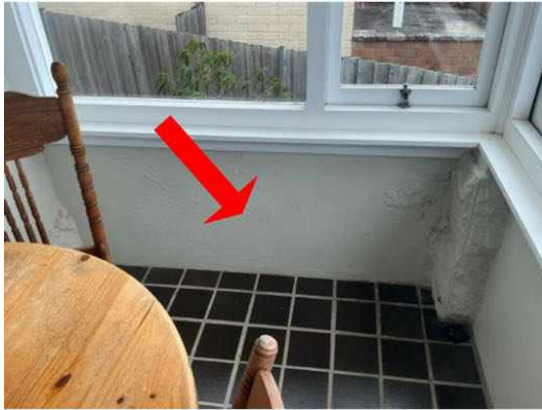
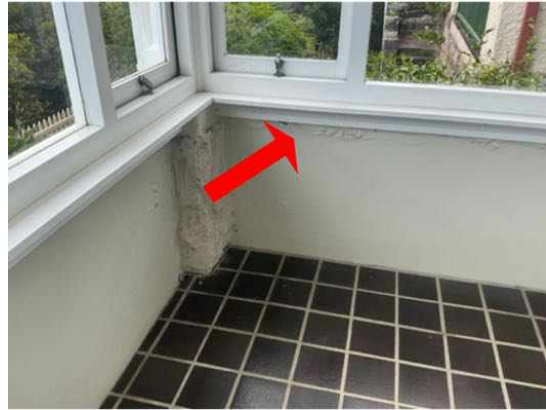
Finding 3.02

Building:	Main Building
Location:	Sunroom
Finding:	Damp Sunroom or Former Balcony
Information:	Rain penetration (also known as penetrating damp) is a common form of dampness that can occur through walls. The walls in the sunroom (which was likely formerly a balcony that has been enclosed) is only likely a double layer of bricks and not cavity construction. Walls with no cavity can allow moisture to be absorbed into the interior of the property. Masonry is an absorbent material, and therefore will slowly draw rainwater or even humidity into the wall. Measures can be taken to prevent the moisture-absorbing from the interior of the wall such as waterproofing barriers or waterproof paint. A damp specialist or builder can be appointed to carry out these works

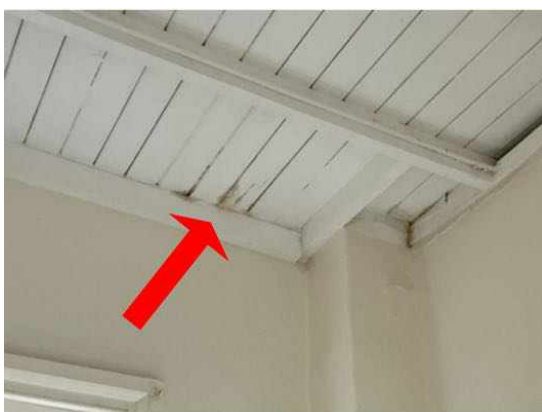
Finding 3.03

Finding: Ceiling - Water stained

Information: Water staining to ceiling linings in this area was evident at the time of inspection. Water staining indicates that surfaces have been exposed to excessive moisture over time.

While mostly an appearance defect, water staining can be indicative of more serious defects such as leak from the roof exterior.

Where water staining is active, a licensed plumber must be consulted to identify the cause of the staining and to provide advice on any reparation works that may be required. Replacement of any damaged structures is advised.

Conversely, where water staining is old and inactive, affected building materials may be repaired or replaced at client discretion.

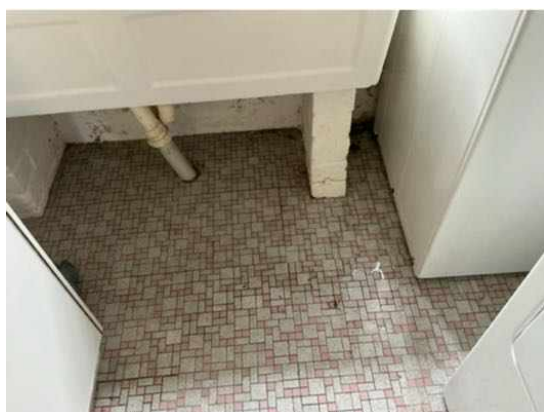
Finding 3.04

Finding: Suspected Leak to Laundry Plumbing
Information: Evidence of water was observed on the floor within the laundry area at the time of inspection. This indicates a suspected leak associated with either the washing machine connections or the laundry tub plumbing.

The presence of water on the floor suggests that pipework, hoses, fittings, or appliance connections may be leaking intermittently or have recently leaked. Ongoing moisture in this area may lead to damage to flooring, joinery, or adjacent building elements if not addressed.

It is recommended in the short term that a licensed plumber be engaged to inspect the laundry plumbing, washing machine connections, and laundry tub to identify the source of the leak and carry out repairs as required. The area should be kept dry and monitored until repairs are completed.

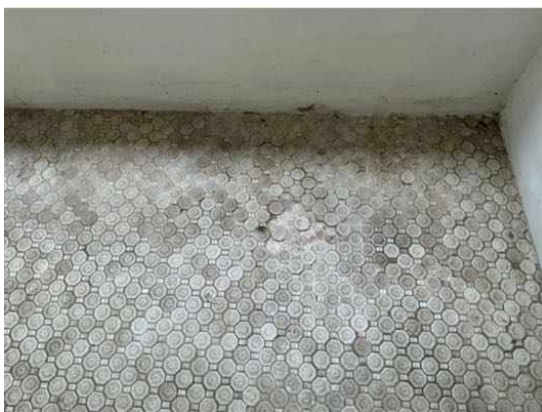
Finding 3.05

Building: Main Building
Location: Sunroom rear
Finding: Tiles - Missing
Information: Tiles were found to be missing in this tiled area. It appears as though broken tiles have been removed and not replaced, or have come loose from their original fixing through general deterioration.

Where tiles are missing may eventually lead to exposure of the waterproof membrane below the tiles, which may deteriorate.

Any tiles that are missing should be replaced by a tiling contractor or general handyman. If left unmanaged over a prolonged period of time, water damage may occur to areas below.

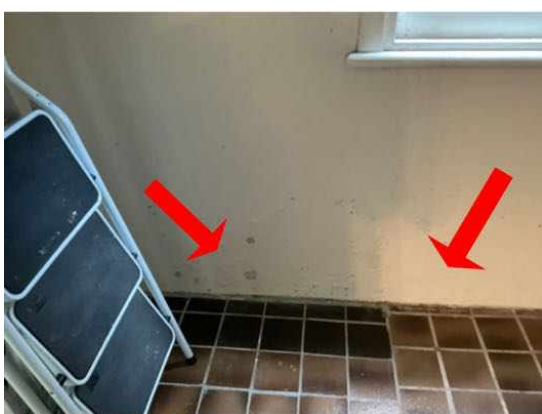
Finding 3.06

Building:	Main Building
Location:	Pantry - Walk In
Finding:	Damp Penetration Full Brick
Information:	Rain penetration (also known as penetrating damp) is a common form of dampness that can occur through walls.

Common cause of this issue is the original construction of the building is full brick construction. With no cavity between the exterior brick wall and the interior brick wall, moisture can penetrate through to the interior wall. Damaged roof plumbing can also attribute to excess moisture in the full brick walls.

The cause of the water penetration should be addressed immediately to prevent internal issues such as damp and mould.

Further consultation with a damp specialist is recommended to advise on methods to prevent moisture getting to internal areas.

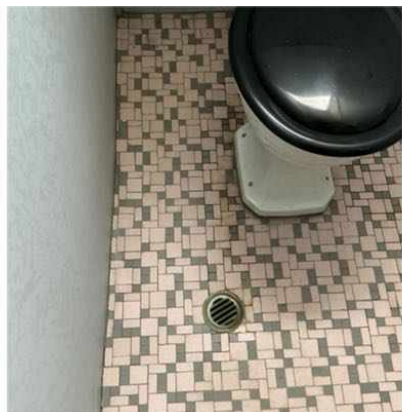
Finding 3.07

Building:	Main Building
Location:	Bathroom 2
Finding:	Toilet - Leaking

Information: At the time of inspection, the toilet showed evidence of leaking during operation.

Although common, internal water leaks can be detrimental to surrounding building elements. Rust, corrosion, decay and water damage are all potential outcomes of a water leak that is left unattended, which are then likely to develop into more serious defects and may necessitate major repair works. Additionally, internal water leaks may significantly increase the water usage within the property.

It is highly advised that internal water leak be addressed by a licensed plumber as soon as possible. Use of the leaking toilet should be minimised until such time.

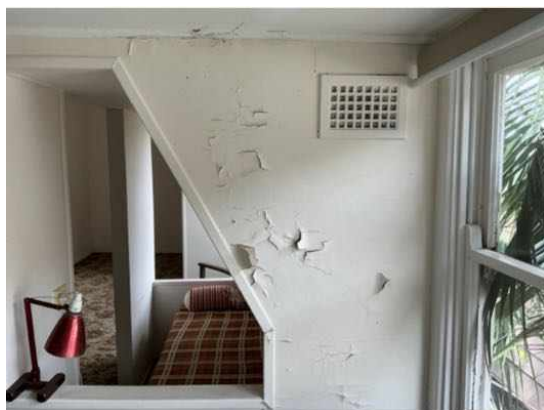
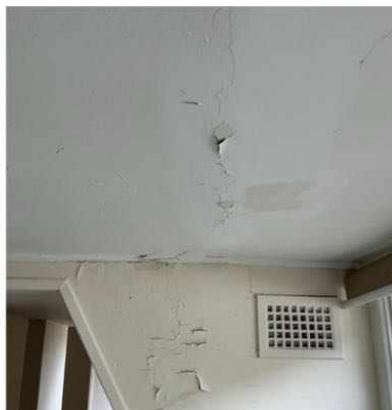
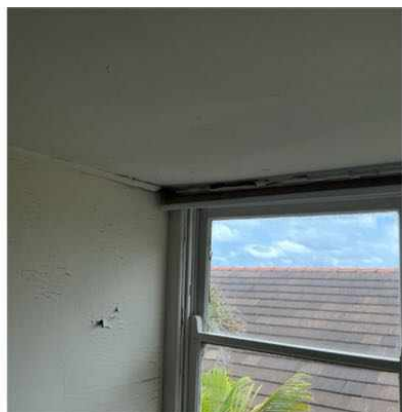
Finding 3.08

Finding: Water Staining to Walls and Ceilings – Top Floor

Information: Water staining was observed to walls and ceilings in areas of the top floor of the property. This staining is indicative of moisture ingress and suggests that water has entered the building fabric at some point.

The staining is likely associated with leaks through the roof covering, roof plumbing, window flashings, or associated building elements. Defective or deteriorated flashings, roof materials, or window seals can allow rainwater to penetrate and track internally, resulting in visible staining to internal finishes.

It is recommended in the short term that a licensed roof plumber and/or builder be engaged to investigate the roof and window areas above the affected locations, identify the source of the water ingress, and carry out repairs as required. The affected internal areas should continue to be monitored for any signs of ongoing moisture or active leaks.

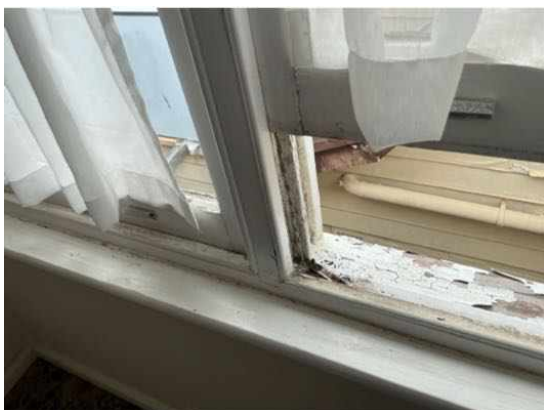
Finding 3.09

Building:	Main Building
Location:	All Areas
Finding:	Windows - Sash balances broken
Information:	<p>The windows throughout the house were not functioning at the time of inspection. It appears that many of the sash balance mechanisms were damaged. Sashes are the moveable panes of windows that primarily slide vertically over each other to expose one half of the window area. Each sash is provided with springs balances and/or compression weather-stripping, which act to hold the window in place in one position.</p> <p>The sash balance mechanism will need replacement to allow the window to function as intended. Such works may be completed by a qualified carpenter or registered builder.</p>

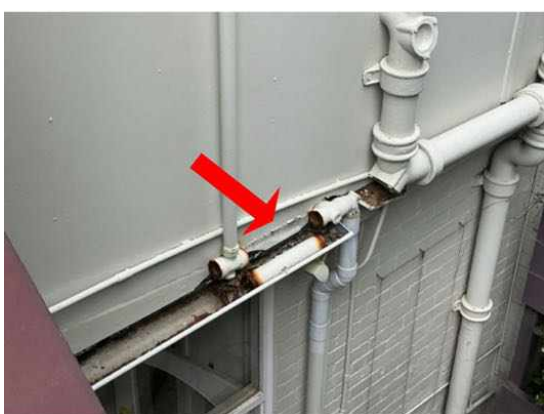
Finding 3.10

Building:	Main Building
Location:	Rear Elevation
Finding:	Building element - Rusted or corroded
Information:	This pipework shows evidence of rusting and corrosion, which is likely to have developed as a result of excessive exposure to moisture and or inadequate coatings.

As surface rust provides no protection to the underlying iron, the deteriorating condition is likely to worsen if not addressed in the short-term future.

Where possible, the use of galvanized (treated) metals or aluminium coated metals aid in rust prevention, as does regular general maintenance. Rust formation can be controlled with coatings, such as paint, that isolate the iron from the environment.

Rusting and corrosion should be managed by ideally removing or limiting the affected surface from exposure to moisture. A plumber may be appointed to replace any building elements that have been severely affected by rust or water damage.

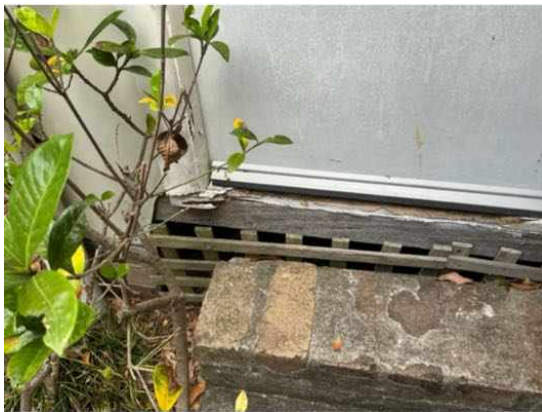
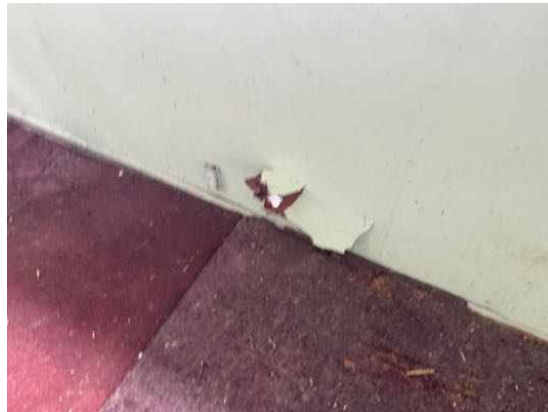
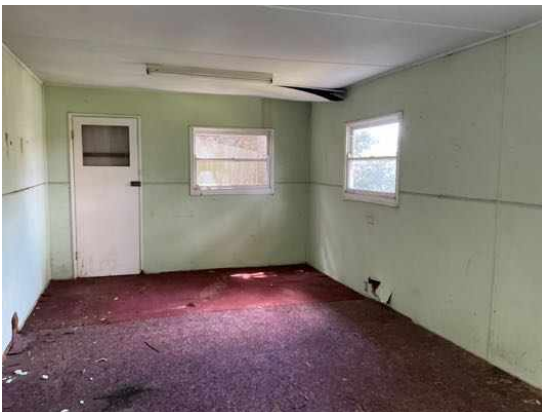
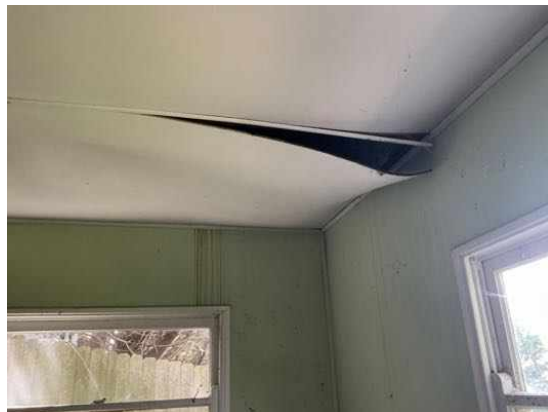
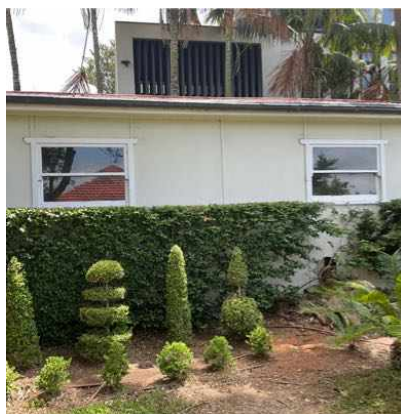
Finding 3.11

Building:	Out Building
Location:	Entry
Finding:	Rear Shed / Studio – Multiple Defects Identified

Information: The rear shed / studio structure was observed to have multiple significant defects. These include evidence of roof leaks, water staining to internal walls and ceilings, and general deterioration of the building fabric. These issues indicate that the structure has been subject to ongoing moisture ingress and has not been adequately maintained.

In addition, the exterior walls are constructed with materials suspected to contain asbestos, and the roof cladding is also suspected asbestos-containing material. Due to these materials, any repair, disturbance, or demolition works present potential health risks if not managed correctly. The combination of water damage, age, and hazardous materials significantly limits the practicality and cost-effectiveness of repair works.

While some repairs may be technically possible, it is considered that the most viable long-term outcome for the rear shed / studio is likely demolition rather than repair. In the short term, further consultation with a licensed builder and a qualified asbestos specialist is strongly recommended to assess the structure, confirm the presence of asbestos, and determine safe and appropriate options for demolition or remediation.

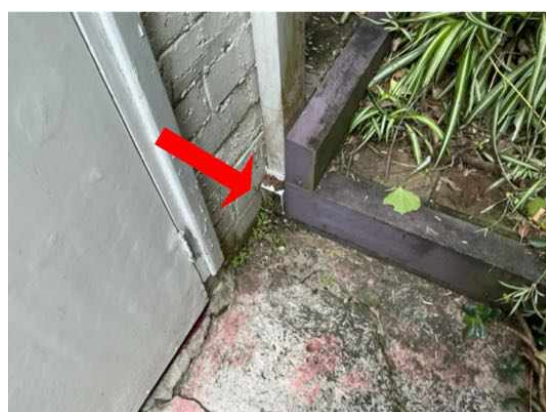
Finding 3.12

Building:	Main Building
Location:	Rear Elevation
Finding:	Stormwater drain - Not connected
Information:	The roof plumbing is not adequately connected to stormwater drainage on the site. This disconnection negatively impacts the functional capacity of the roof plumbing.

Where roof plumbing doesn't drain adequately, the area at the base perimeter can become excessively damp, potentially creating an environment that is susceptible to rust and corrosion of surrounding building elements, as well as attracting termites and other pests. The excess water may even undermine footings of walls and lead to structural issues.

It is highly recommended that a plumber be appointed to further inspect the area and to install adequate drainage equipment where necessary.

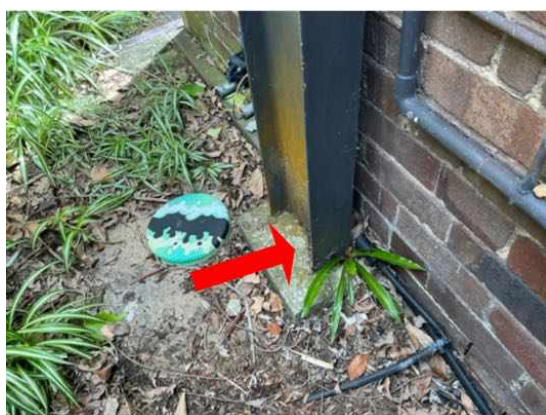
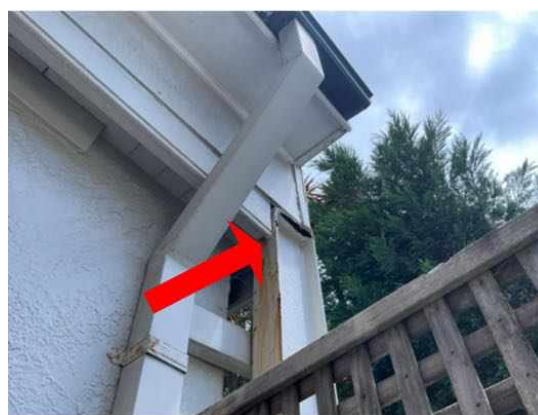
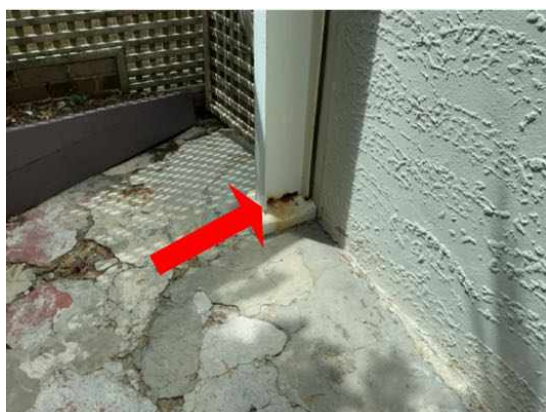
Finding 3.13

Building:	Main Building
Location:	Rear Elevation
Finding:	Rusting to Rear Steel Support Beams
Information:	The rear steel support beams to the property were observed to have areas of surface

rust. This deterioration is indicative of prolonged exposure to moisture and environmental conditions, and if left unmanaged, may progressively worsen over time.

Rusting of steel elements can lead to a reduction in the effective cross-section of the steel, potentially compromising the structural capacity of the beams. While the beams did not appear to be significantly compromised at the time of inspection, ongoing corrosion increases the risk of future structural issues.

It is recommended in the short term that the affected steel beams be further assessed by a builder or suitably qualified tradesperson. Appropriate remedial works may include cleaning back the rust, treating the steel with an anti-corrosion product, and recoating or repairing as required to prevent further deterioration and protect the long-term structural integrity of the beams.

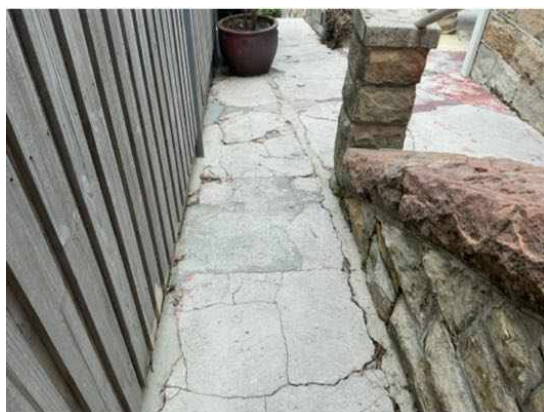
Finding 3.14

Building:	Main Building
Location:	All External Areas
Finding:	Cracking - External Concrete Paving
Information:	Distinct cracks were identified in external concrete paving. Distinct cracks are generally found in older concrete paving, and may also present as a trip hazard as consequence of an uneven or curved surface.

General age and expected deterioration of the paved areas is a common cause of this

type of cracking. However, expansion and contraction of the slab may also have occurred due to environmental factors. Such factors include variable moisture and weather conditions. Cracking to this degree may also be due to poor original installation of the concrete.

Factors such as poor compaction of the sub surface and/or inadequate reinforcing of the slab may create cracking and other secondary defects.

Repairs are likely to be required to prevent further cracking and to reduce hazards associated with cracking, such as tripping. Monitoring of all cracking should be conducted frequently. Always contact a building inspector should cracks widen, lengthen, or become more numerous.

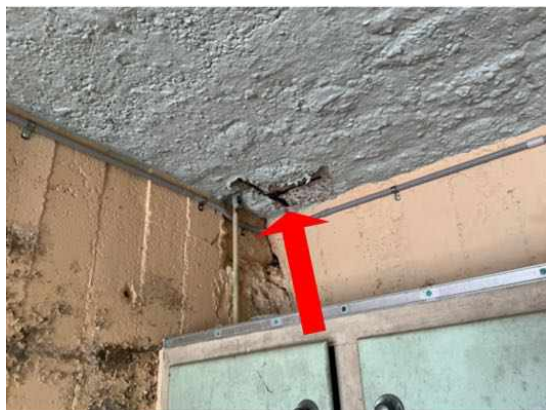
Finding 3.15

Building:	Garage
Location:	Garage
Finding:	Concrete - Spalling
Information:	Concrete spalling is the common term used to describe a number of factors which cause concrete construction to deteriorate. Generally, water penetration causes the concrete reinforcement to rust and expand, creating stresses on the surrounding concrete and in turn causing it to spall (or break away). Alternatively, if the cement component is too alkaline, reactions with the general atmosphere occurs and star-shaped cracks appear which allow rainwater to penetrate. Concrete spalling may also originate from poor original water proofing.

Left unmanaged, the problem is likely to worsen over time, potentially leading to the development of major structural defects.

Repair works will generally involve works, including removal of affected concrete and the treatment or replacement of any exposed steel. Some injection of resins or special mortars may also be possible, however this depends on the size and extent of consequent damage.

A structural engineer should be appointed to provide estimates on the required works.

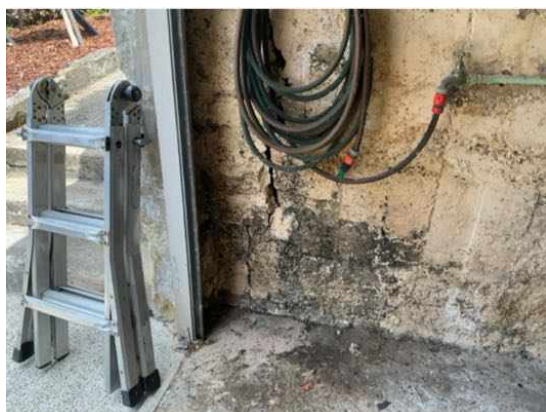
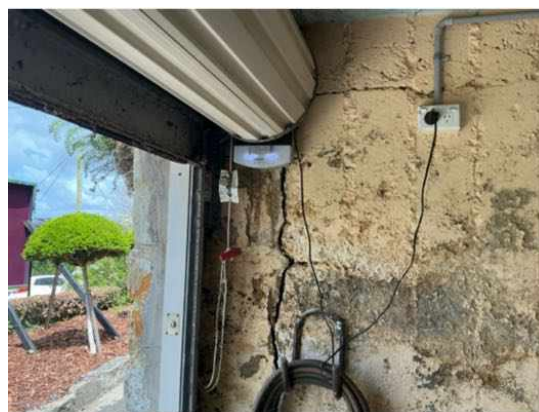
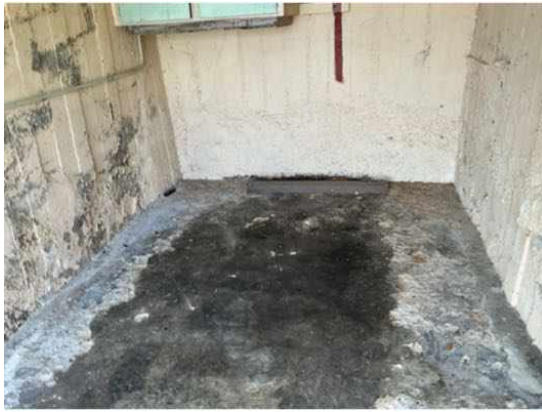
Finding 3.16

Information: Lateral penetrating damp refers to the sideways movement of moisture, predominantly from the surrounding ground, which tends to affect basement walls and other earth-retaining walls. The implications of unmanaged damp range from mould fungi growth, wood rot and decaying building materials, to finishes including lifting, bubbling, peeling and staining of paint, plaster and wallpaper.

Consultation with a damp specialist is advised to address the cause of the damp and to perform remedial works if necessary.

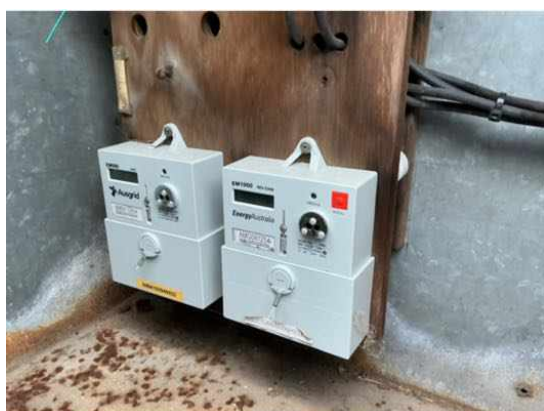
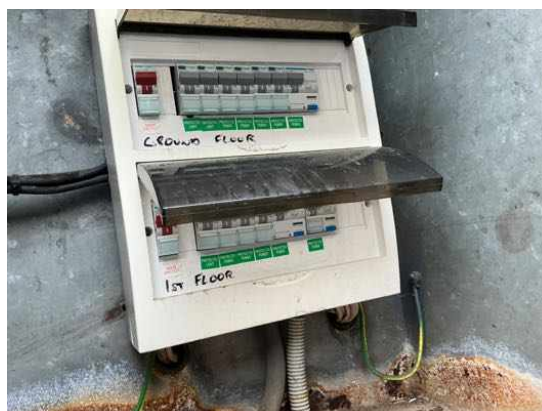
Finding 6.02

Building:	Main Building
Location:	Electrical circuit box
Finding:	Termite Management System No Evidence of Installation
Information:	The application of a post-construction termite barrier is highly recommended for all properties. Such barriers are highly effective in preventing termite attack on any timber building elements throughout the property.

The client may consider gaining further advice from a pest controller as to the costs and procedures involved with this application. It is recommended that obtaining such advice be a short-term priority.

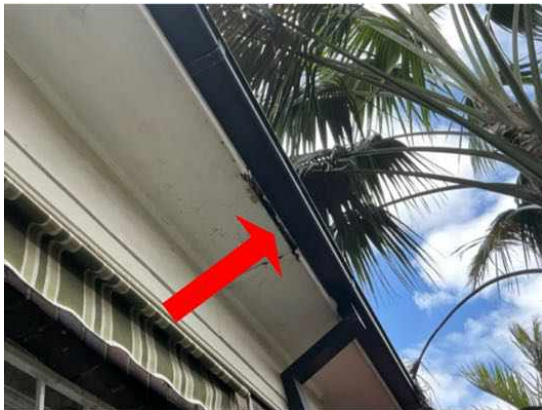
Finding 7.02

Building:	Main Building
Location:	Exterior walls - left side
Finding:	Fascias - Wood rot
Information:	Wood rot was found to be affecting fascias and barges in this area, evidenced by the presence of mould on the surface in some areas. Wood rot, also known as Fungal Decay, occurs when timbers and other cellulose building materials are exposed to damp conditions on an ongoing basis.

A qualified plumber may be appointed to assess the cause of excessive moisture and to provide advice on any remedial works as required. A qualified carpenter or registered builder may also be required to replace affected building materials.

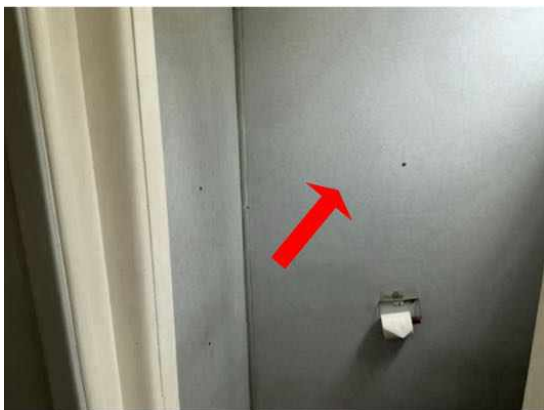
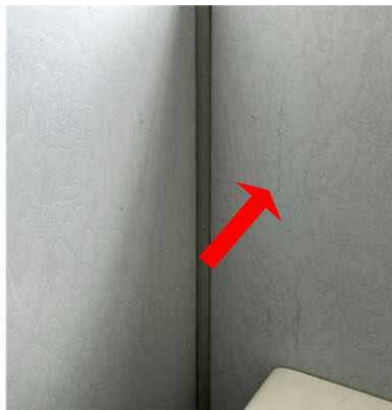
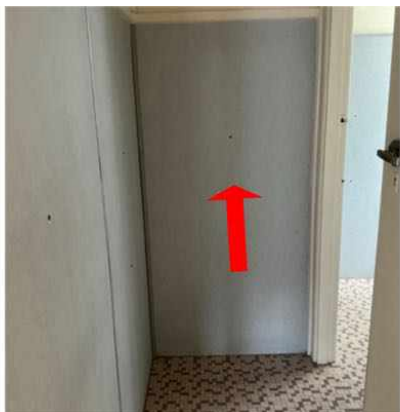
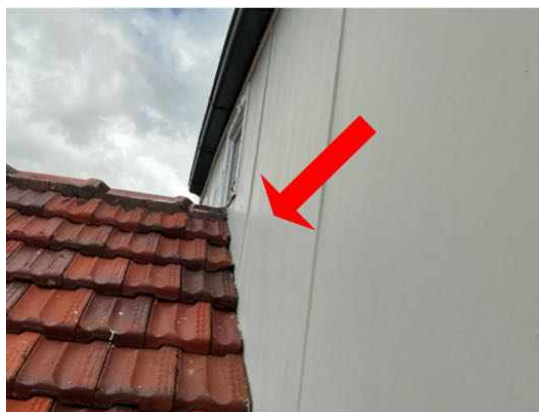
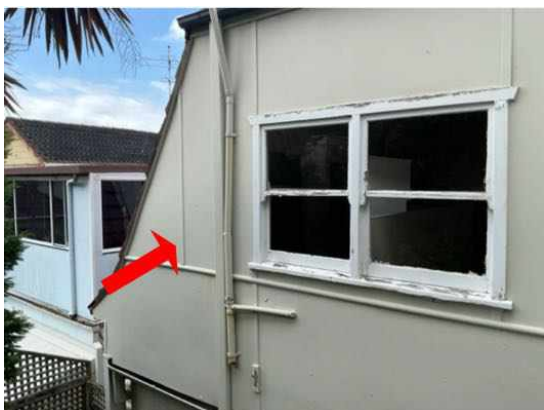
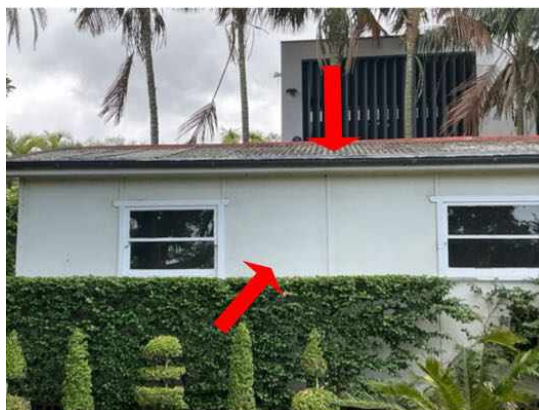
Building:	Main Building
Location:	All Areas
Finding:	Asbestos Containing Material Suspected
Information:	Reporting on Asbestos is outside the Scope of this Report. This suspected defect is highlighted as a caution only. We suspect, based on our experience in the building industry, that there is a higher risk of the identified building elements and other possible areas of the house containing asbestos.

In the interim, the client is advised to act with caution, especially when considering any damage to building materials general wear and tear renovations extensions demolition and general maintenance activities due to the suspected presence of Asbestos.
