Building Inspection Report

Inspection Date: Sat, 28 Feb 2026

Property Address: 1/37 Patty St Mentone VIC 3194

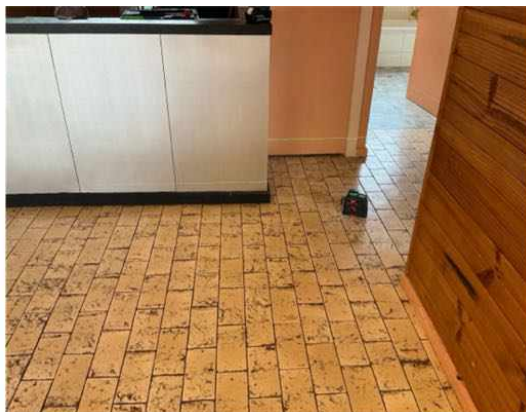
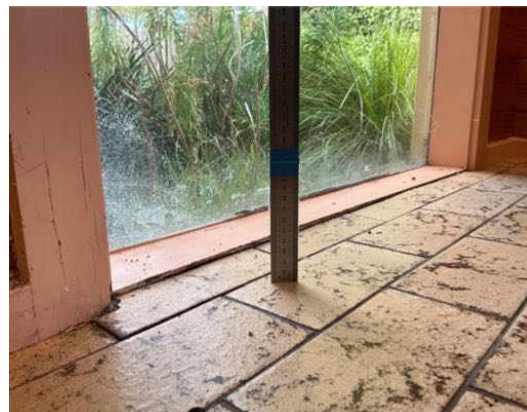
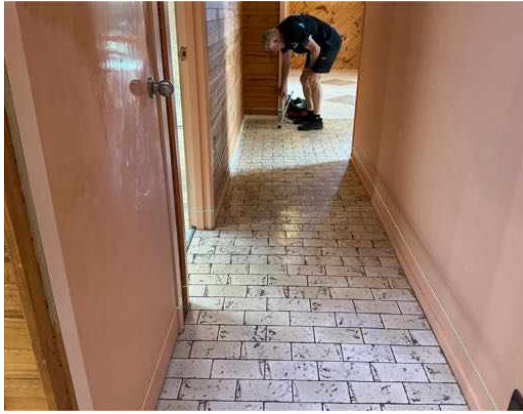
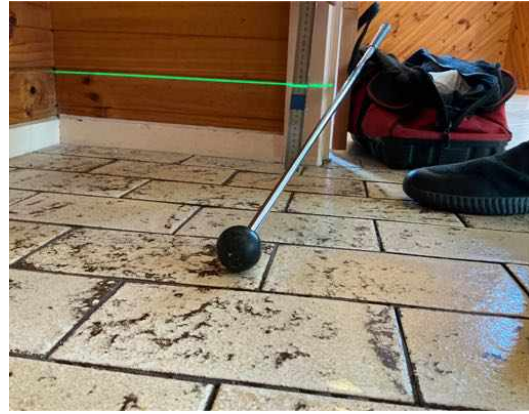
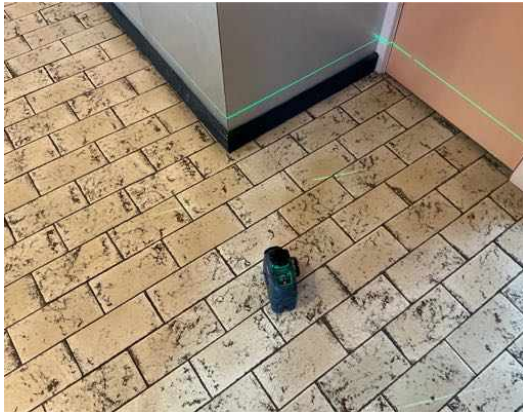
Defects 2.01

Building: Main Building
Location: All Areas
Finding: Floor tiles - Uneven
Information: The tiled flooring area appears to be uneven in this area. While this may indicate a failure of the subfloor structure, it is suspected, in this case, that the area has been subjected to poor tiling workmanship at the time of installation.

Where poor workmanship is the cause of uneven tiling, the tiled surface level is unlikely to decrease further. If unevenness does increase over time, this may indicate issues with the associated flooring structure.

Where uneven tiled flooring appears to be a result of poor tiling work, a tiling contractor should be appointed to re-instate the flooring at the discretion of the client. Where flooring remains uneven, further inspection of the flooring structure may be required.

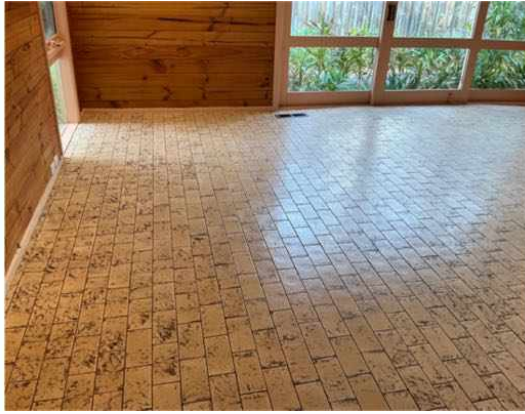
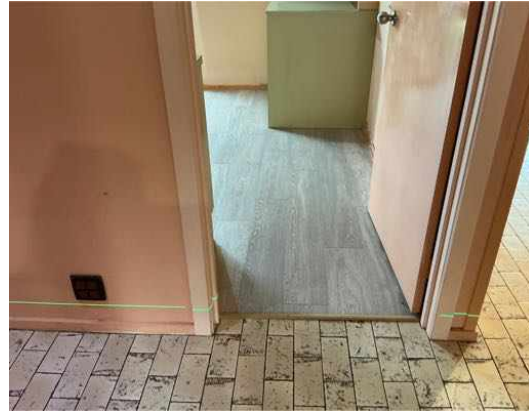
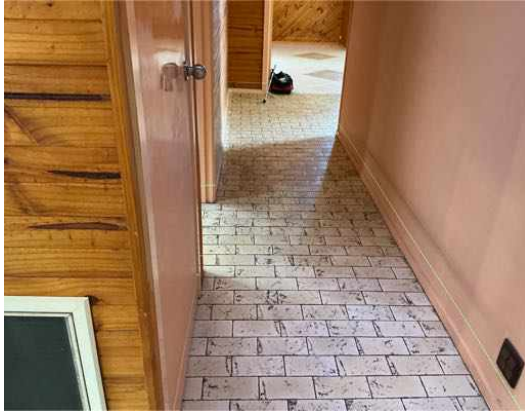
Defects 2.02

Bouncy floors generally indicate that the floorboards or the subfloor structures are coming loose from the joists that they are installed on. Bouncy flooring may also be the result of gaps between flooring and stumps or joist structures, which require packing.

Major defects were the original timber Stumps are still used throughout the subfloor of this building and will need replacement prior to any further works.

The client is advised to seek quotations for required repairs from a Registered Builder specialising in re-stumping. The potential resolution may range from packing gaps in subfloor structures through to replacement of subfloors stumps and refixing of flooring.

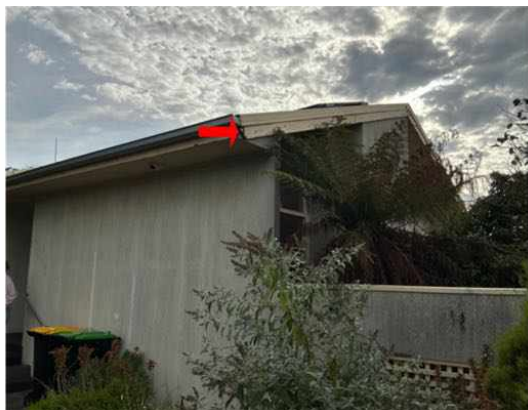
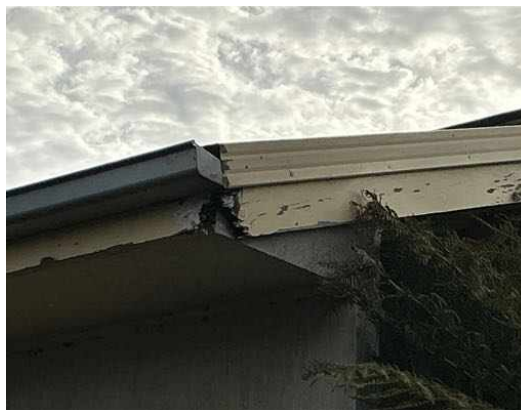
Defects 3.01

Building:	Main Building
Location:	Fascias
Finding:	Fascias - Wood rot
Information:	Wood rot was found to be affecting fascias and barges in this area, evidenced by the presence of mould on the surface in some areas. Wood rot, also known as Fungal Decay, occurs when timbers and other cellulose building materials are exposed to damp conditions on an ongoing basis.

It is likely that this wood rot has developed as a result of faults in the roof plumbing, creating excessive moisture in this areas. Frequent exposure to rain and other weather conditions also make fascias and barges susceptible to accelerated deterioration.

Early intervention and regular maintenance will prolong the useful life of these building elements. Prior to any works being performed, the cause of the moisture that has created the visible wood rot should be identified and addressed in a suitable manner.

It is advised that a roof plumber be appointed to inspect all roof plumbing and subsequently identify the cause of the wood rot. Replacement of affected fascias and barges may then be a necessary step in protecting surrounding building elements from

such deterioration.

A qualified plumber may be appointed to assess the cause of excessive moisture and to provide advice on any remedial works as required. A qualified carpenter or registered builder may also be required to replace affected building materials.

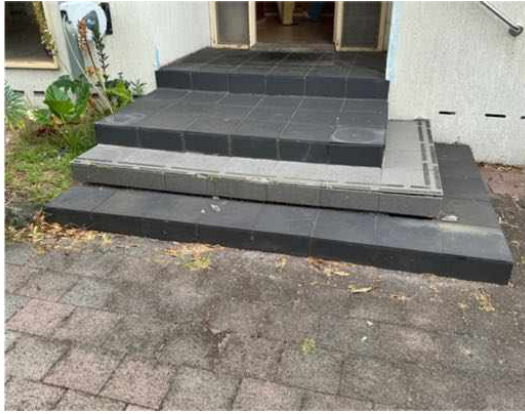
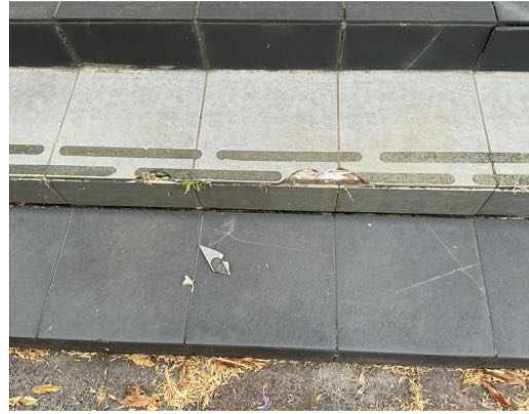
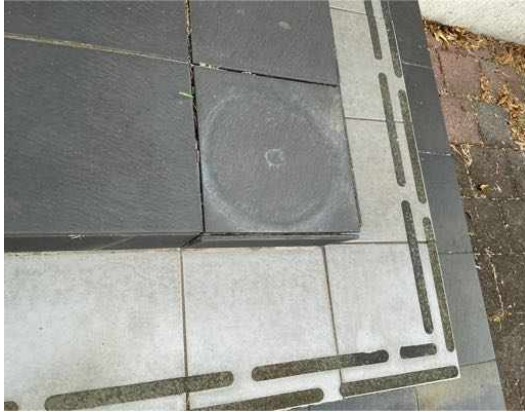
Defects 3.02

Finding: Tiles - Cracked or damaged

Information: Cracking was evident to the tiling in this area at the time of inspection. While the cracking appears to be minor, this area is frequently exposed to water, allowing potential for water penetration into adjoining sections of walls or flooring.

If left unmanaged, water penetration to these areas may lead to subsequent water damage, which is likely necessitate repair work to affected building elements.

A tiling contractor should be appointed to ensure that no further water damage occurs. The re-application of silicone and grouting throughout remaining tile work is also advised, to further protect the area against water penetration.

Where water penetration has led to water damage, appointment of a relevant tradesperson may be required to repair damaged building elements.

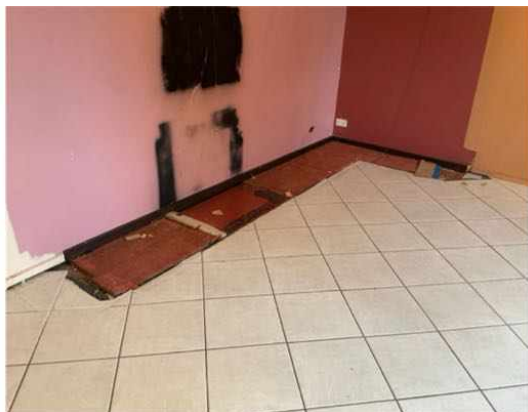
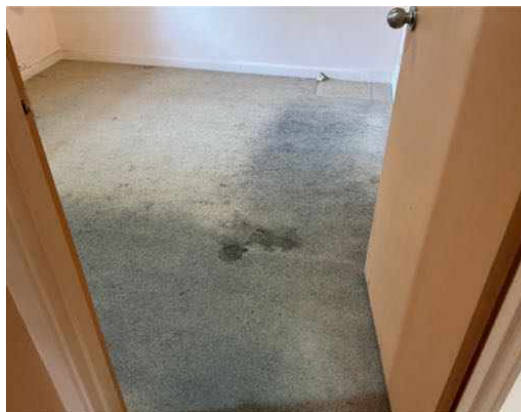
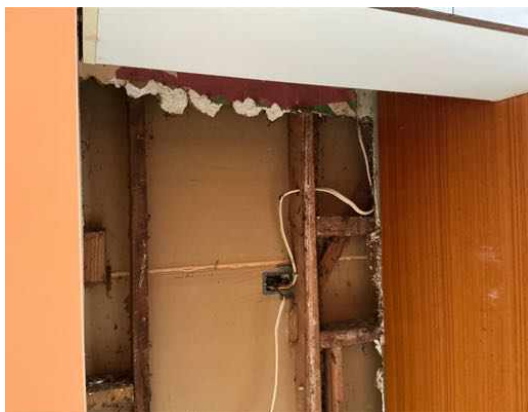
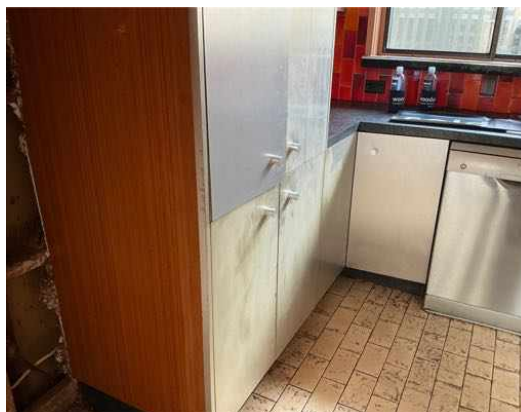
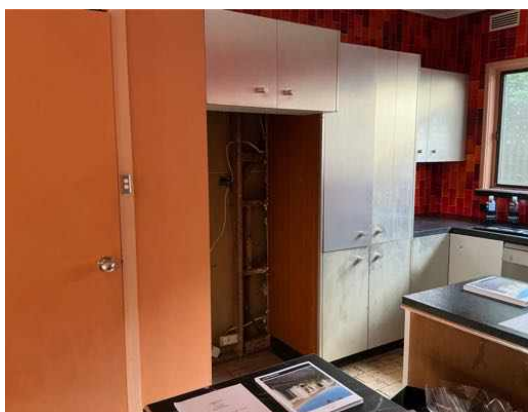
Defects 3.03

Building:	Main Building
Location:	All Areas
Finding:	Deteriorated elements
Information:	It was identified that some items around the home have suffered from environmental effects and wear and tear with replacement required.

Secondary defects are likely if the issue is not addressed.

Elements such as bolts and structural brackets may require the services of a builder where replacement is required other wise a carpenter or handy man can attend to the more general replacement requirements such as loose hinges, door handles, fixtures etc.

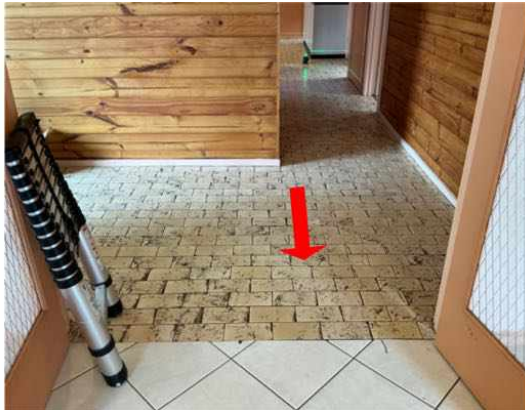
Defects 3.04

Finding: Floor tiles - Cracked and drummy

Information: Cracking in the floor tiles was evident in this area at the time of inspection. It is suspected that this cracking has occurred as a result of the floor being uneven and lacking a solid or suitable foundation for the tiles to be laid on. Settlement in the floor foundations may also have caused movement and resulted in the cracking of tiles in this area.

Cracked tiles throughout the household detract from the overall appearance of the affected areas, as well as creating potential for water penetration to adjoining building

elements. If left unmanaged, water damage may occur as a result of constant water penetration over a prolonged period of time.

While not considered a matter of urgency, replacement of cracked floor tiles is advised as a solution. A tiling contractor or general handyperson may be appointed to perform these works at client discretion. Where cracks become more numerous, consultation with a registered builder specialising in re-stumping may be required.

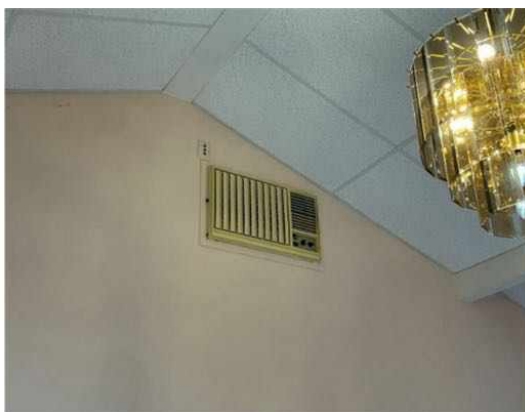
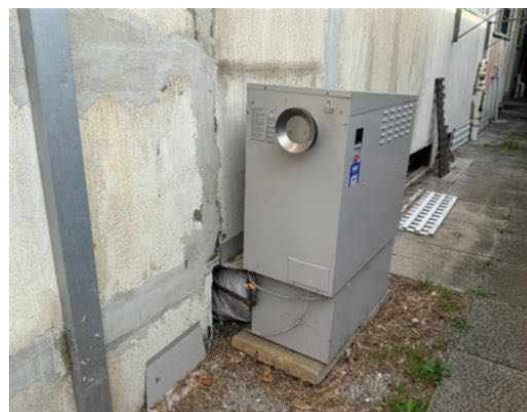
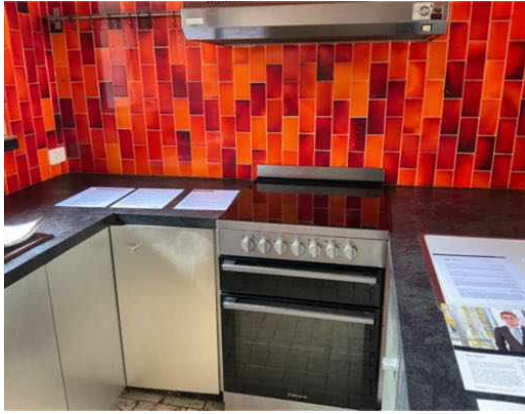
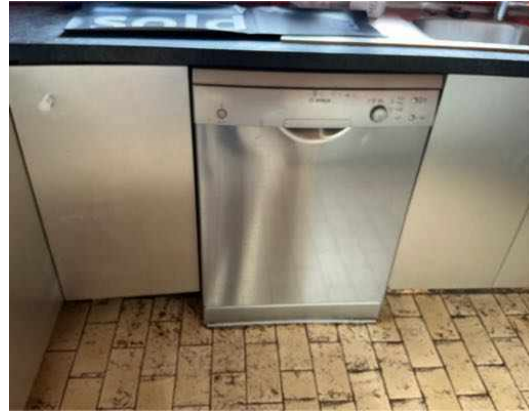
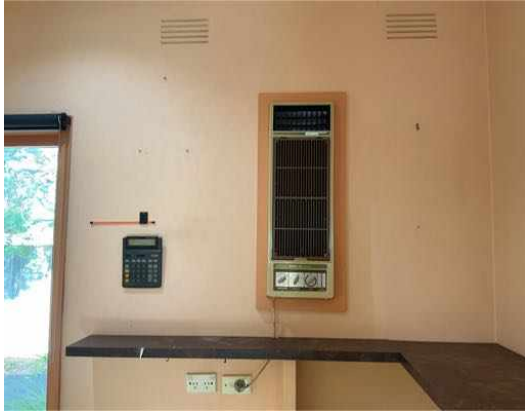
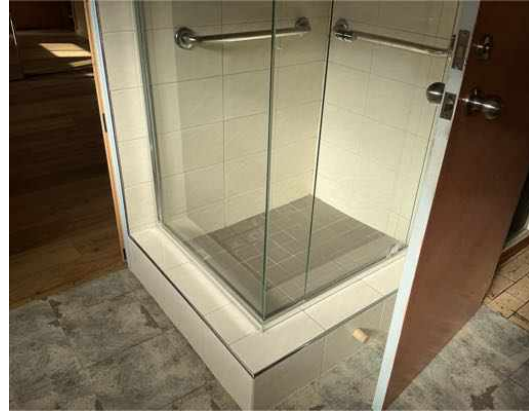
Defects 3.05

Building:	Main Building
Location:	All Areas
Finding:	Warranty - Expired
Information:	Where appliances are beyond their warranty period, the owner should be prepared to meet the cost of replacement or repair of the item at any time. The operation of the appliance can not be guaranteed and further inspection by an appropriately qualified tradesperson may be required.

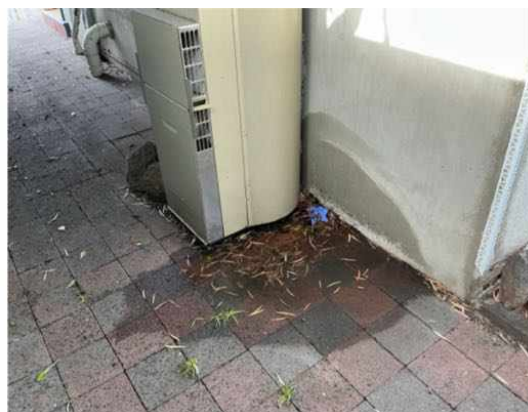
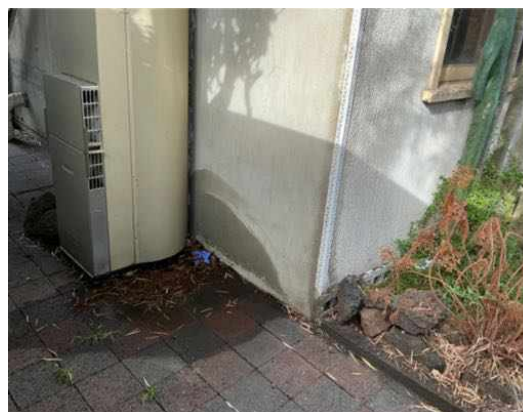
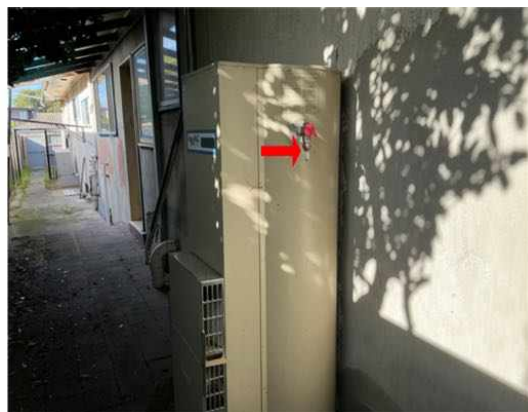
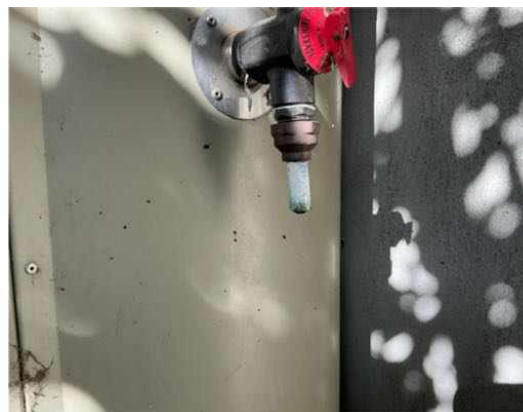
Defects 3.06

Building: Main Building
 Location:
 Finding: HWS Overflow - Not Connected
 Information: The Hot Water System (HWS) overflow was found to be disconnected from storm water drainage and is creating excessive moisture in the surrounding area.

These damp conditions can lead to secondary defects such as rot, rust or corrosion of associated building elements, the formation of fungal decay, or even the creation of potential slip hazards. When coupled with poor site drainage, pooling of water may also attract termite activity to this area.

It is highly recommended that a licensed plumber be appointed to connect the HWS overflow in order to prevent such an environment from being created. These minor works should be carried out as soon as possible.

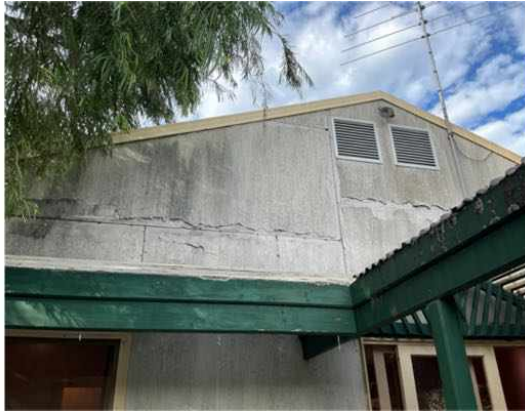
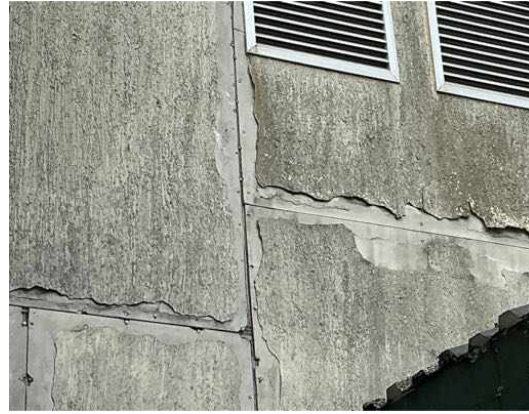
Defects 3.07

Building:	Main Building
Location:	All Areas
Finding:	Render - Drummy
Information:	Drummy rendered areas were identified at the time of inspection. The term 'drummy' refers to render that has become detached from its fixing, despite it still being solid. Such defects are generally caused by physical or moisture damage to the area. Drummy render may also be a direct result of poor workmanship during the construction process.

Render may swell and shrink with changes in air humidity if the area has sustained moisture damage. Any exposure to moisture is capable of causing rendered areas to become drummy and/or cracked over a prolonged period of time. Drummy render generally requires chipping off and re-rendering or painting.

Specialist trades are available for these types of services. A registered builder may be required to undertake works if damage is extensive, or if secondary building defects have resulted. Immediate action is recommended to ensure that no further damage is sustained in the affected area.

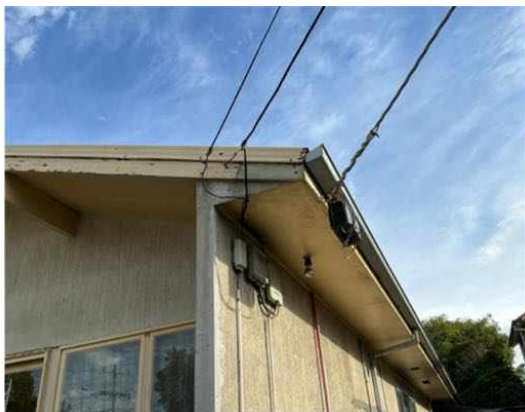
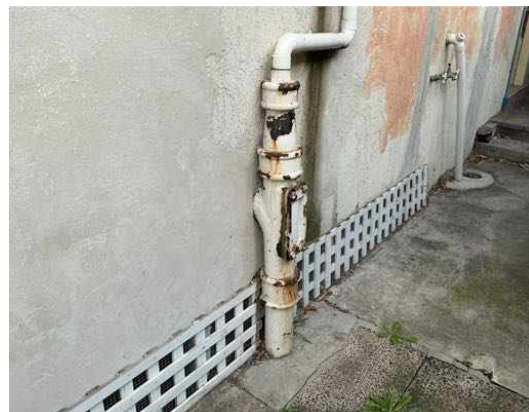
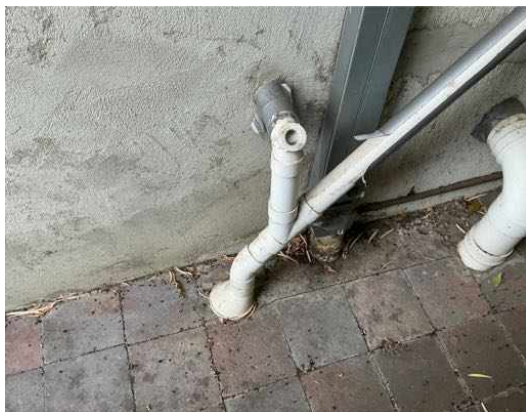
Defects 3.08

Building:	Main Building
Location:	All plumbing fixtures, including roof plumbing
Finding:	Roof plumbing - Rusted or corroded
Information:	The roof plumbing has areas of rust and corrosion. It is suspected that this has been caused by blockages, resulting in pooling or standing water, that have prematurely rusted elements of the roof plumbing.

Rusted roof plumbing will generally develop holes and leaks that can affect other building elements with poor drainage of storm water. Poorly drained roof areas will also lead to damp conditions surrounding the base perimeter of the building which, if left unmanaged, can lead to a range of secondary building defects.

Repair and/or replacement of rusted roof plumbing is highly required in order to reinstate the roof drainage system to a fully operational level. To further maintain these areas, gutters should be cleaned frequently, allowing the avoidance of any partial blockages.

A licensed plumber or specialist roof restoration company should be appointed to undertake these works. It is advised that such works be completed as soon as possible to prevent any further damage and deterioration.

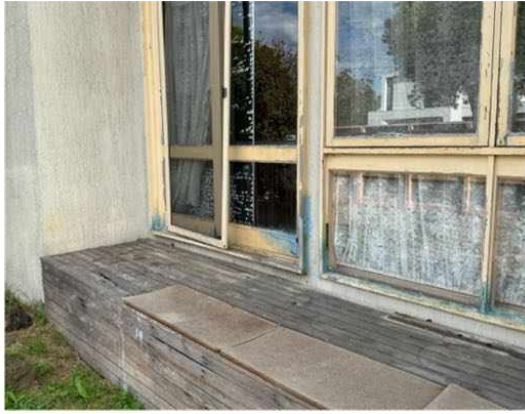
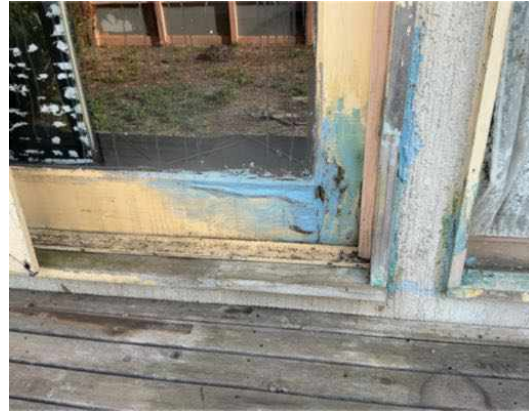
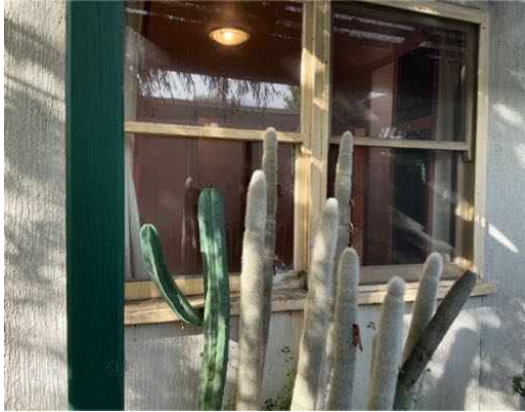
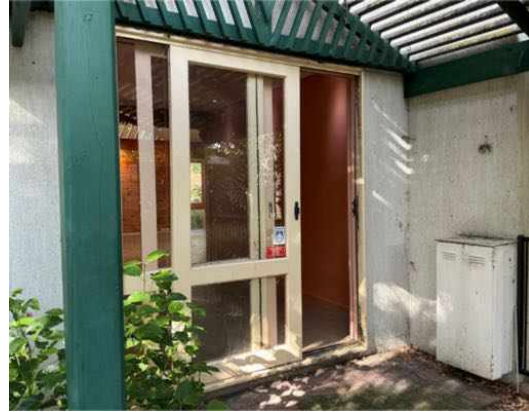
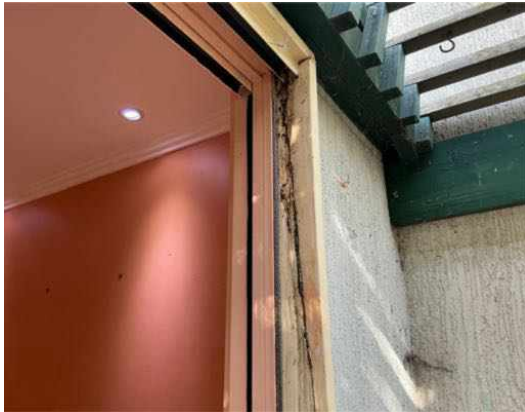
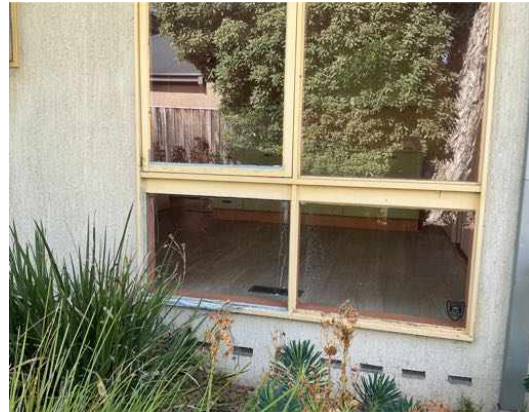
Defects 3.09

Building:	Main Building
Location:	Windows and doors
Finding:	Windows - Wood rot
Information:	Wood rot was found to be affecting external windows. Wood rot, also known as Fungal Decay, occurs when timbers and other cellulose building materials are exposed to damp conditions on an ongoing basis.

It is likely that this wood rot has developed as a result of frequent exposure to rain and other weather conditions. It is suspected that failure to maintain the window frames over a prolonged period has resulted in them deteriorating at an accelerated rate, increasing their susceptibility to the development of wood rot. Leaks in roof plumbing or associated pipework may have also contributed to the formation of the wood rot in this area.

Windows were mostly rotted and most will require replacement.

Early intervention and regular maintenance will prolong the useful life of these building elements. Prior to any works being performed, any associated pipework or roof plumbing should be inspected by a licensed plumber for faults or leaks.

Repair and/or replacement of affected window frames may be a necessary step in protecting surrounding building elements from such deterioration. Remedial works should be performed by a qualified carpenter or registered builder as soon as possible to prevent any further damage.

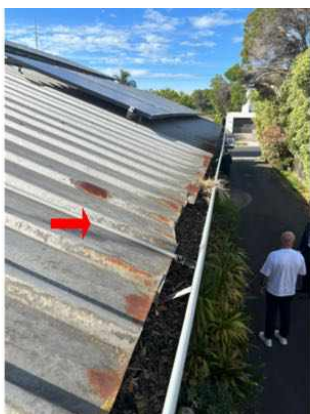
Defects 3.10

Building:	Main Building
Location:	All Areas
Finding:	Roof sheets - Rusted
Information:	Metal roofs generally comprise numerous individual sheets, which join and overlap. These intersections are particularly prone to lift at the edge and consequently rust at these points.

Upon inspection of the exterior roofing structure, evidence of rust to these sections was identified. If left unmanaged, these degrading joins can allow water ingress to the internal roofing structures, potentially leading to secondary damage of building elements. Accelerated deterioration of the roofing sheets and any associated building

elements is also likely to occur.

A roofing contractor should be appointed immediately to assess the damage to the roofing sheets and to perform remedial works as necessary. Works may include replacement of severely affected roofing sheets or minor works such as the application of rust-retardant surface protectors.

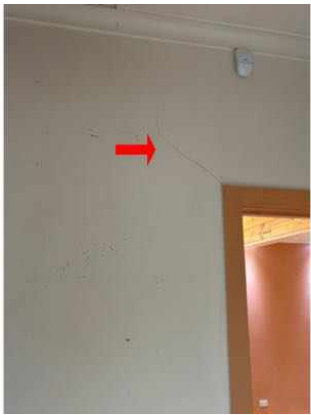
Defects 3.11

Building:	Main Building
Location:	Laundry
Finding:	Brickwork - Cracking noticeable
Information:	There were several cracks and or crack repairs evident to external brickwork.

Noticeable cracks are a common occurrence in external brickwork and are a likely result of age expected building movement, general expansion, and/or contraction of building materials in different weather conditions. Noticeable cracks in brickwork may develop if left unattended, with potential for necessitating major remedial works or replacement of the brickwork.

It is highly advised that a qualified bricklayer be appointed to provide necessary works to cracked brickwork to prevent any further damage. Such works should be conducted as soon as possible.

Always monitor these cracks and contact a building inspector should cracks widen, lengthen, or become more numerous.

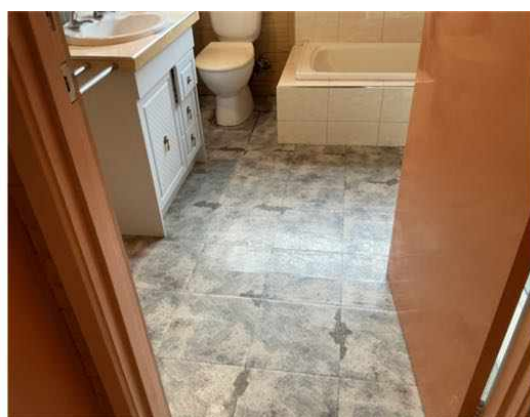
Building: Main Building
 Location: Bathroom
 Finding: Asbestos - Suspected ACM Identified on Site
 Information: Reporting on Asbestos is outside the Scope of this Report. This suspected defect is highlighted as a caution only. We suspect, based on our experience in the building industry, that there is a higher risk of the identified building element containing asbestos.

As Asbestos Reporting is outside the scope of this report, we advise that you consider a separate Asbestos Inspection and Condition Audit, which can include the taking of samples for definitive confirmation of the presence of Asbestos.

In the interim, the client is advised to act with caution, especially when considering any damage to building materials general wear and tear renovations extensions demolition and general maintenance activities due to the suspected presence of Asbestos.

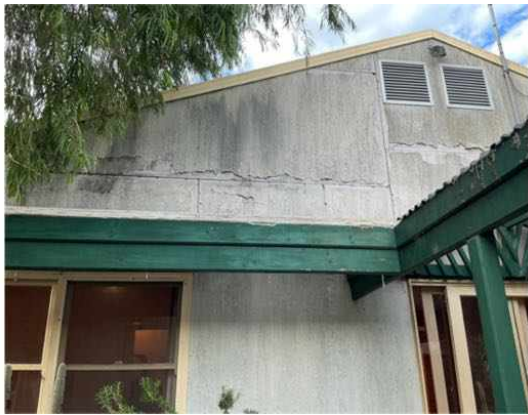
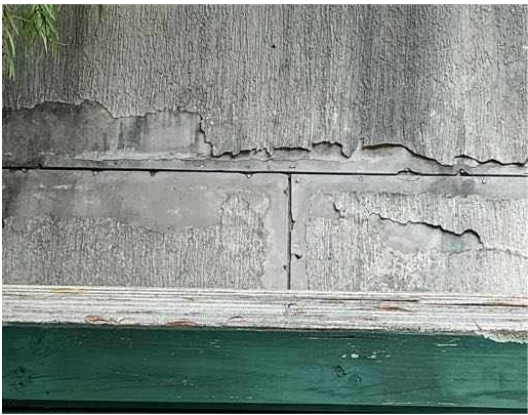
Building: Main Building
 Location: All Areas
 Finding: Asbestos - Suspected ACM Identified on Site
 Information: Reporting on Asbestos is outside the Scope of this Report. This suspected defect is highlighted as a caution only. We suspect, based on our experience in the building industry, that there is a higher risk of the identified building element containing asbestos.

As Asbestos Reporting is outside the scope of this report, we advise that you consider a separate Asbestos Inspection and Condition Audit, which can include the taking of samples for definitive confirmation of the presence of Asbestos.

In the interim, the client is advised to act with caution, especially when considering any damage to building materials general wear and tear renovations extensions demolition and general maintenance activities due to the suspected presence of Asbestos.

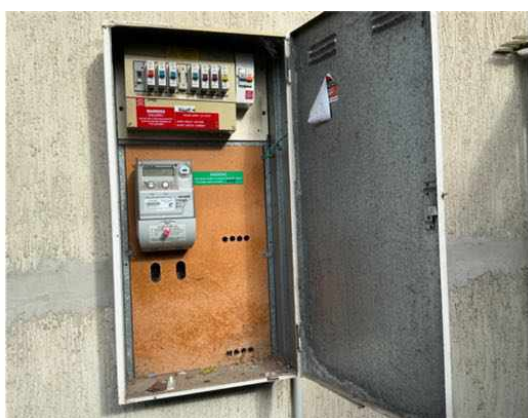
Building: Main Building
 Location: Electrical Switchboard
 Finding: Termite Management System - no evidence of a chemical installation

A durable notice should be placed in the switchboard unit to indicate current termite barriers. At the time of inspection, it appeared as though no termite management system has been installed, with no evidence to suggest preventative works taking place.

Information: The application of a post-construction chemical termite barrier is highly recommended for all properties, particularly if live termite activity has been found on the site previously. Such barriers are highly effective in preventing termite attack on any timber building elements throughout the property.

The client may consider gaining further advice from a pest controller as to the costs and procedures involved with this application. It is recommended that obtaining such advice be a short-term priority.

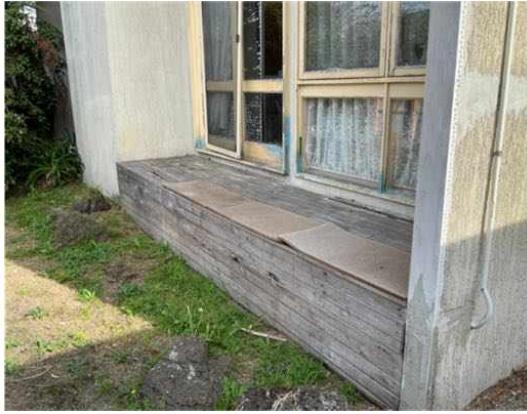
Building: Main Building
Location: Front Elevation
Finding: External Timber Balcony or Deck - Structural Stability
Information: The load capacity of the external balcony or deck could not be verified during the inspection.

External timber structures are also constantly exposed to weather elements and can deteriorate in an accelerated manner, ongoing assessments are required.

It is highly recommended that a Structural Engineer further assess the external timber balcony or deck to inform the client of its load capacity. Regular maintenance inspections by competent practitioners is needed.
