Building and Timber Pest Inspection Report

Inspection Date: Fri, 13 Mar 2026

Property Address: 524/1 Hutchinson Walk, Zetland NSW 2017,
Australia

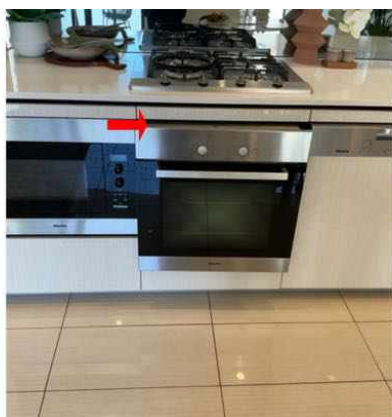
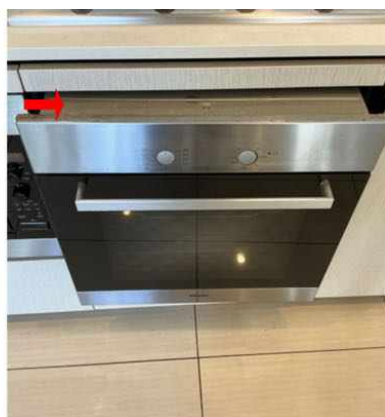
Finding 1.01

Building: Main Building
Location: Kitchen
Finding: Unsecured Oven Installation
Information: The electric oven located beneath the gas cooktop in the kitchen island was found to be unsecured.

During a light pull, the oven moved forward freely, presenting a potential safety hazard, especially if weight is applied to the open door. According to AS 4349.1–2007 Appendix C (C2.2 and C2.3), appliances should be properly installed to prevent movement or dislodgement.

This defect is considered a major safety concern due to the risk of injury or damage. Immediate rectification is recommended by a licensed kitchen installer or qualified tradesperson to properly secure the appliance in accordance with manufacturer installation instructions. Rectification should occur within 24–48 hours to eliminate the risk.

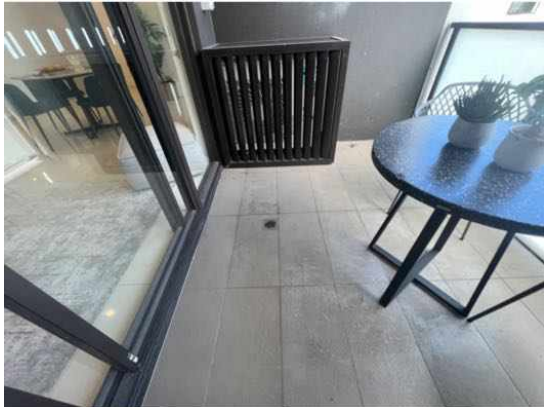
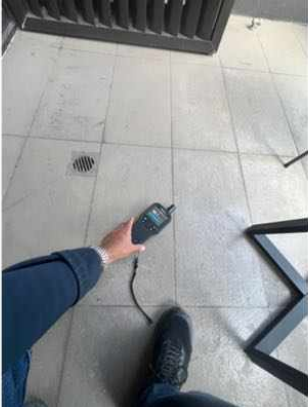
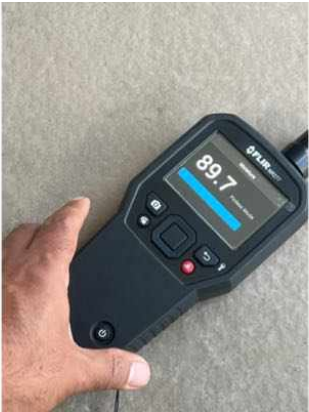
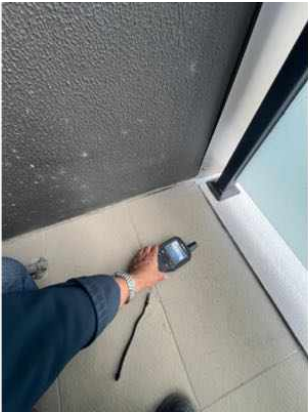
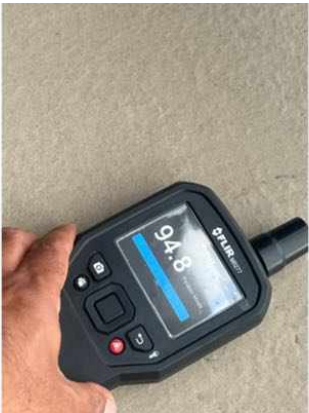
Finding 3.01

Building: Main Building
Location: All Internal Areas

Finding: Elevated Moisture Detected - Strata
Information: Slightly Elevated moisture levels were detected in window frames and bottom of sliding doors frames. The areas should be monitored for and changes to existing conditions e.g damp , paint bubbling of staining. Further invasive investigation by a licensed plumber or waterproofing specialist is recommended to confirm the source and extent of water ingress if condition persists. As this relates to a multi-residential building, the source of water ingress may involve common property, a suitably qualified waterproofing contractor is recommended to determine cause, responsibility, and scope if required.

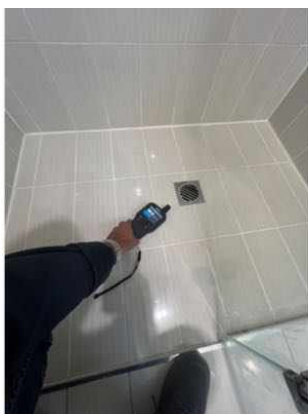
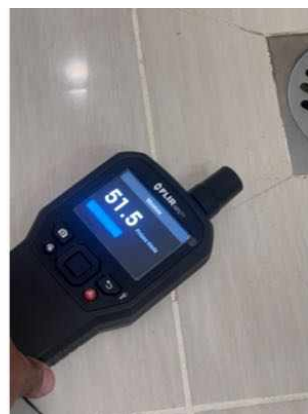
Finding 3.02

Building:	Main Building
Location:	Bathroom
Finding:	Elevated Moisture Bathroom (No visible deterioration noted)
Information:	Slightly Elevated moisture levels were detected to tiled surfaces in bathroom/shower areas. Persistent moisture ingress can lead to concealed damage, including timber rot and mould growth.

Elevated moisture readings in tiled wet areas can occur from normal shower use, age/deterioration of waterproofing membranes, plumbing leaks or moisture absorption through grout lines. While no damage was visible, elevated readings may indicate moisture retention behind tiles, which can be a conducive condition for future deterioration.

Monitor the area over time for signs of drumming, efflorescence, tile movement, or grout deterioration. If concerns arise, a licensed waterproofing specialist can perform further investigation (e.g., pressure testing, membrane assessment).

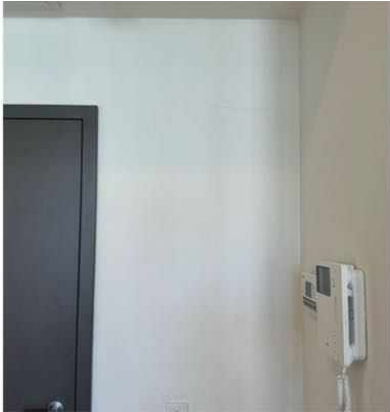
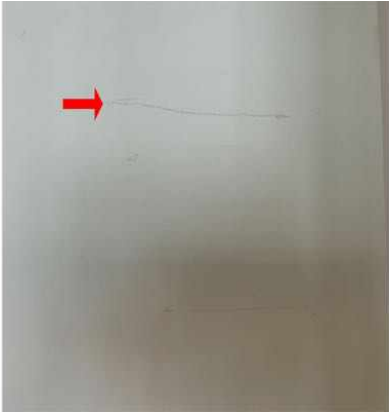
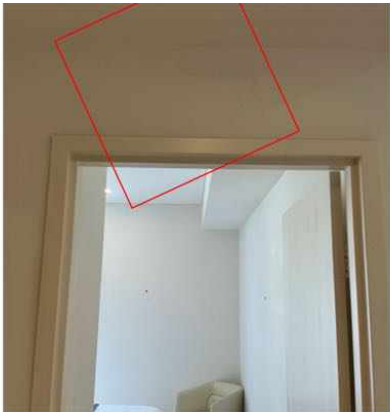
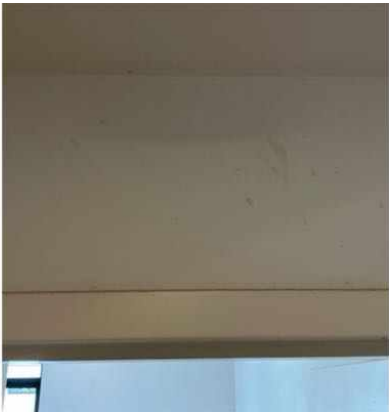
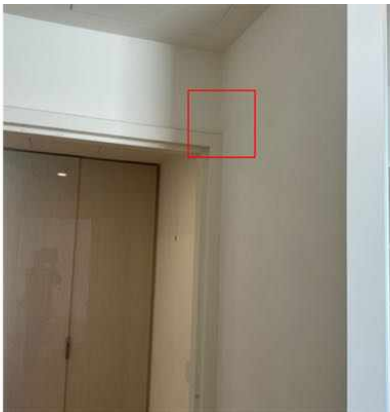
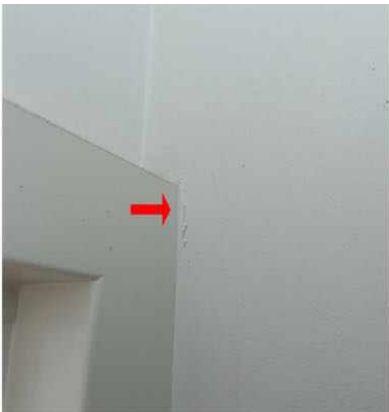
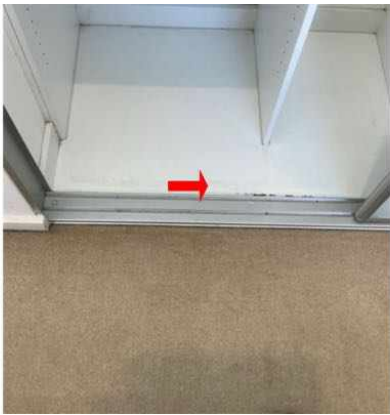
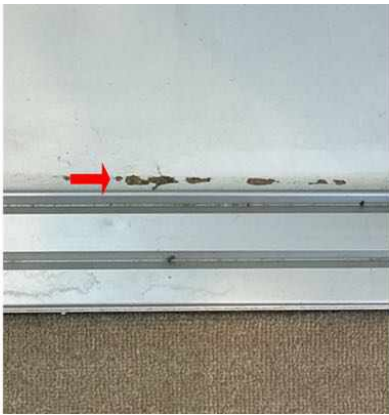
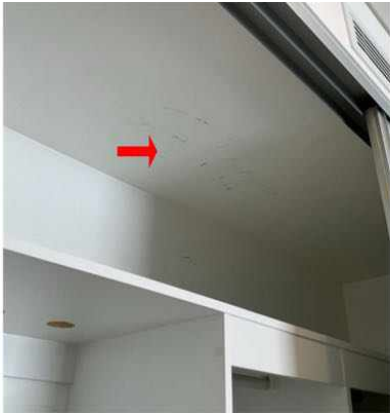
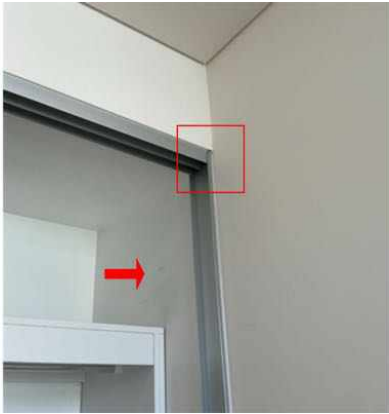
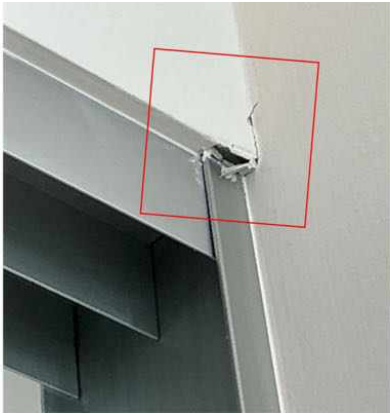
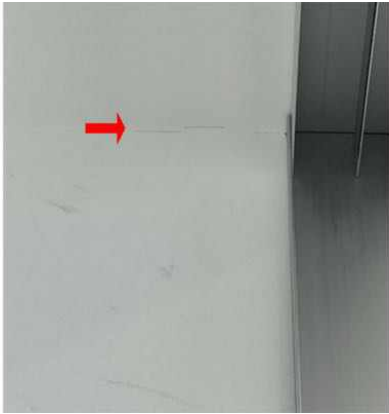
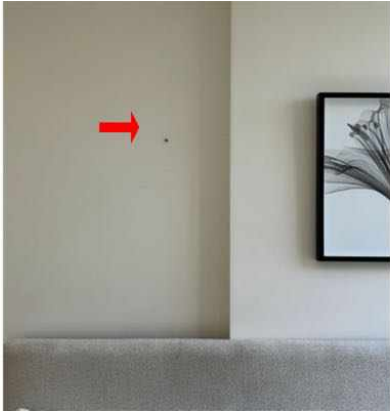
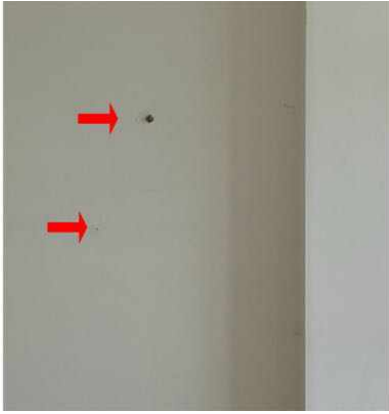
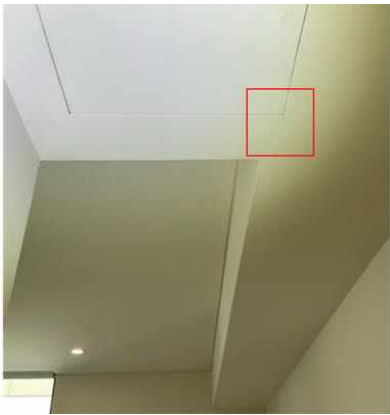
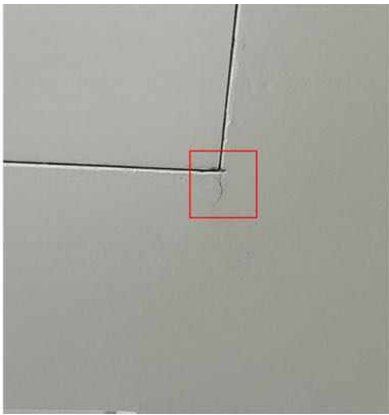
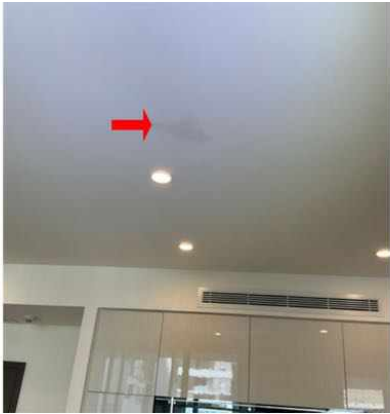
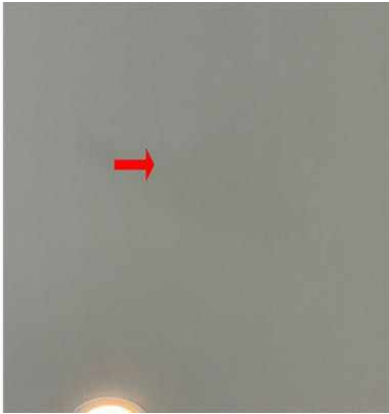
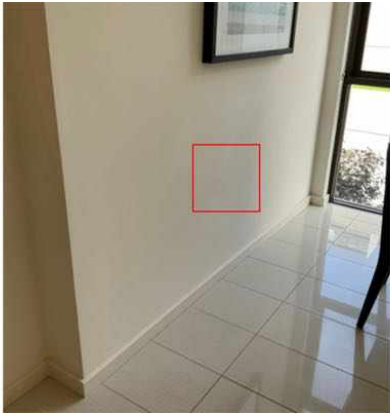
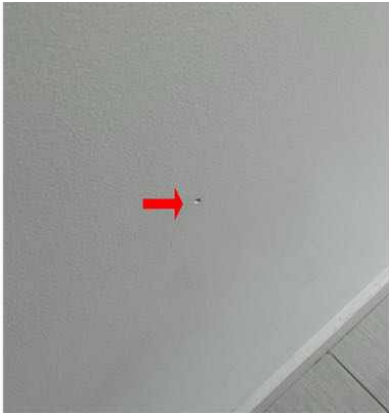
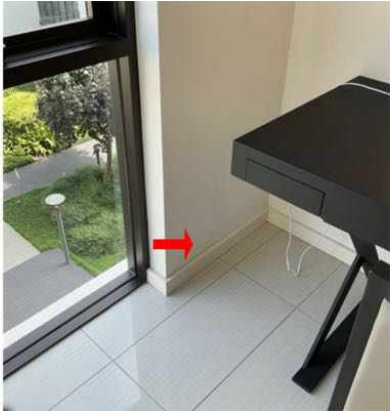
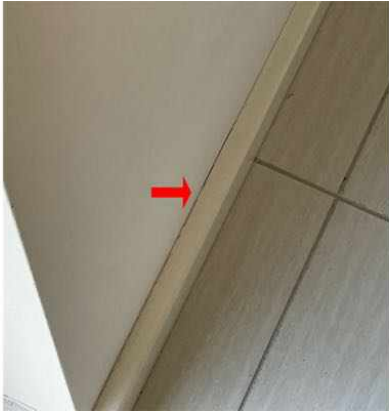
Finding 3.03

Building:	Main Building
Location:	All Internal Areas
Finding:	Paint finish and hairline cracking
Information:	The paint finish in this area was identified as being incomplete at the time of inspection including some hairline minor cracking.

Whilst incomplete or missing paint finish is generally an appearance defect, it can also lead to the development of secondary building defects over time. Incomplete areas of paint finish expose the area to moisture, potentially accelerating the deterioration of underlying building materials.

Incomplete paint finishes should be sanded back, filled, leveled and painted, as applicable. Where inadequate or missing paint protection has led to the deterioration of the associated building element, repair and/or replacement of this building element may be required.

A painting contractor should be appointed as soon as possible to perform necessary works to aid the appearance of the affected area and to ensure the area is protected against further deterioration. Alternatively, the homeowner following manufacturer instructions may perform these works.

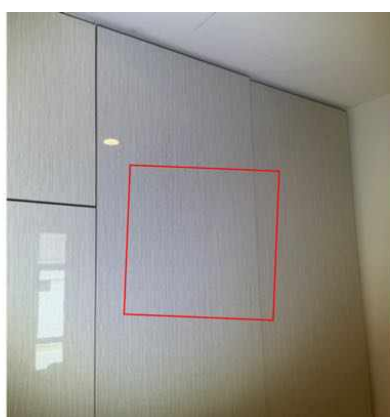
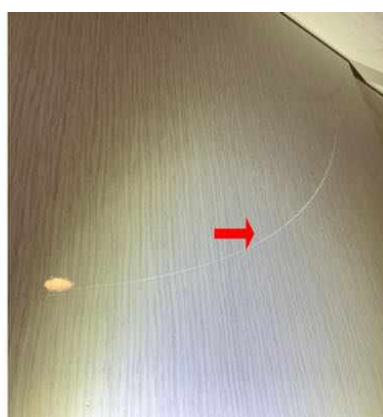
Finding 3.04

Building:	Main Building
Location:	All Internal Areas
Finding:	Building element - Damaged - Scratch to cupboard door
Information:	Breakage occurs generally when the building materials have either aged and decayed, or as a result of damage (accidental or deliberate).

Repair and/or replacement of broken elements is advised to ensure that additional secondary defects do not arise as a consequence. Such works are necessary, as all building elements play a key role in the operation and function of the overall structure and its performance.

A relevant tradesperson should be appointed to repair or replace the affected building element prior to any subsequent damage being caused.

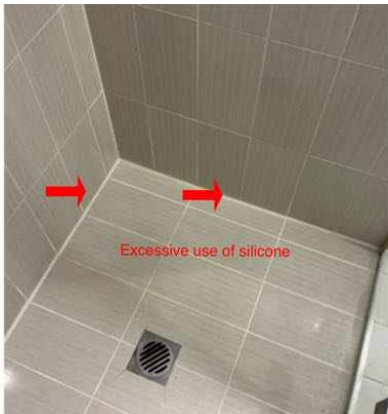
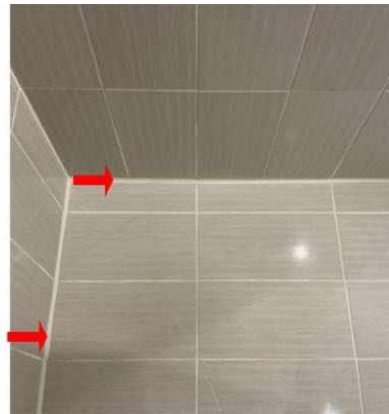
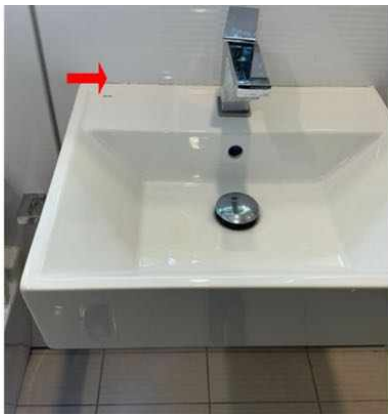
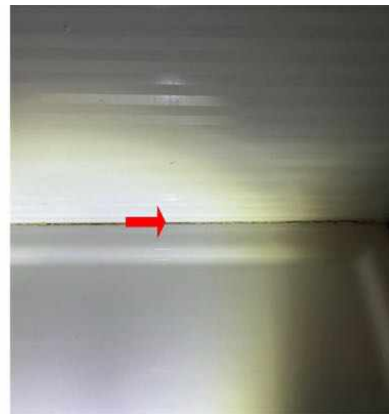
Finding 3.05

Building:	Main Building
Location:	All Internal Areas
Finding:	Sealant and grouting - Missing or degraded
Information:	It was noted on inspection that sealant or grout is degraded.

Different materials and floor areas move at different rates, generally causing cracking to grout or sealant at this point. A flexible sealant is required to allow for expected expansion and contraction, while keeping the joint water tight and protective of all associated building materials.

excessive mould to the sealant and grout require scraping out and replacement where required

Flexible and mould resistant materials should be applied to affected areas to prevent any subsequent water damage that is likely to occur. Regular maintenance and replacement of damage or missing or damaged sealant and grout is highly recommended to the wet areas, as this is a regular wear and tear defect. Sealant and grouting in areas that come into regular contact with water should be maintained for the long term care of your property.

A sealant specialist or tiling contractor should be appointed to complete these works as soon as possible

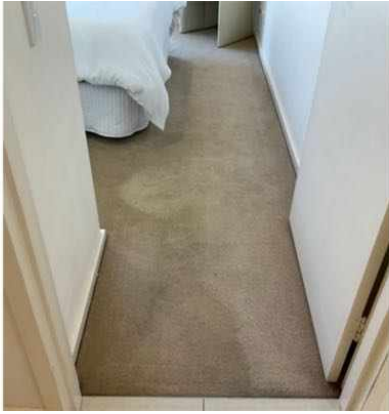
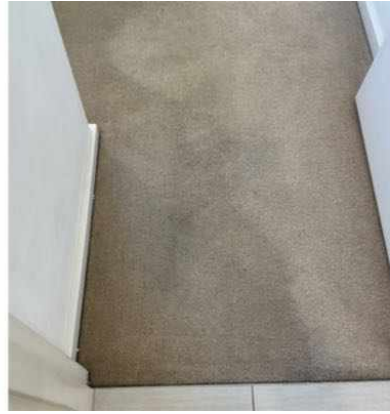
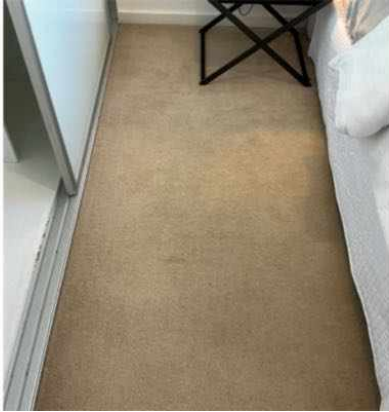
Finding 3.06

Building:	Main Building
Location:	All Internal Areas
Finding:	Carpet - Deteriorated
Information:	The carpet shows visible wear and deterioration, with areas of flattening, shading, and possible staining evident along the traffic path. The condition appears consistent with normal wear from regular foot traffic, resulting in reduced pile resilience and uneven appearance. Replacement or professional cleaning may be considered to improve appearance. This condition is considered a minor defect / maintenance item and does not impact the structural integrity of the dwelling.

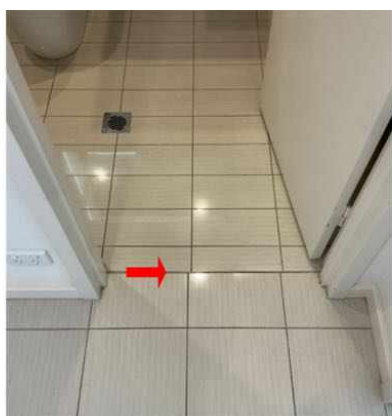
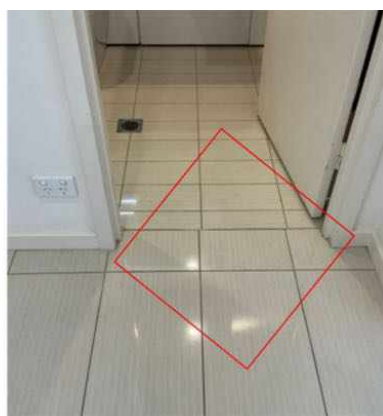
Building: Main Building
 Location: Bathroom
 Finding: Bathroom & external floor threshold
 Information: The bathroom floor is at the same level as the adjoining timber flooring. This configuration is typical in modern apartments and is permitted where compliant waterproofing and floor falls are provided. No evidence of moisture damage was observed at the time of inspection; however, waterproofing performance cannot be confirmed without invasive inspection.

Care should be taken to avoid excessive water migration beyond the bathroom during use.
