Building and Timber Pest Inspection Report

Inspection Date: Thu, 26 Feb 2026

Property Address: 19/346 PENNANT HILLS RD
CARLINGFORD NSW

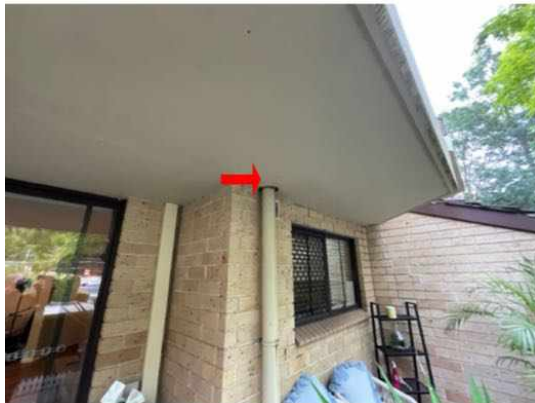
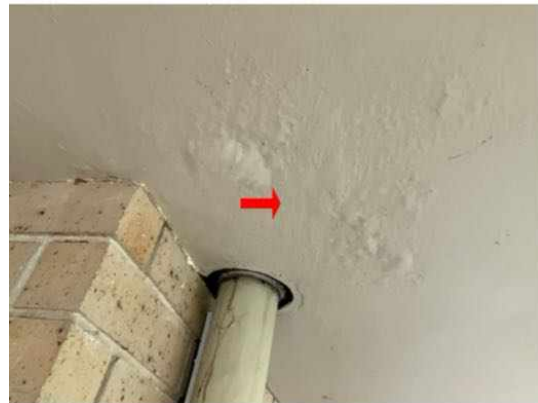
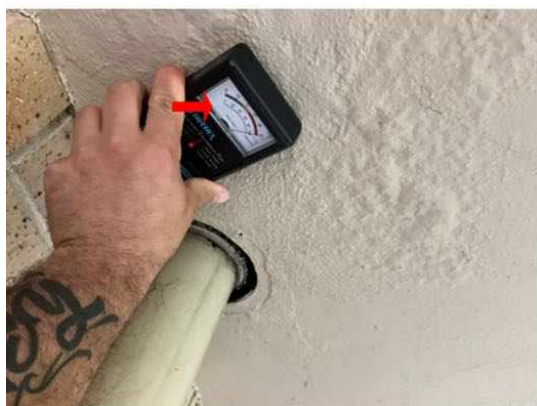
Finding 2.01

Building: Main Building
Location: Balcony
Finding: Water leak suspected - Internal
Information: An internal water leak is suspected in this area at the time of inspection. Internal water leaks can be detrimental to surrounding building elements; their potential causes include damage to plumbing fittings and fixtures, through to water damage and deterioration of associated building elements.

Rust, corrosion, decay and water damage are potential outcomes where a minor water leak is left unattended. More serious defects may also result, such as electrical hazards, or water damage to structural building elements.

An internal water leak is suspected around the pipe penetration in the balcony. A licensed plumber must be appointed immediately for repairs.

In extreme cases, structural damage may develop due to a prolonged water leak. It is highly advised that internal water leaks be addressed by a licensed plumber as a matter of relative urgency.

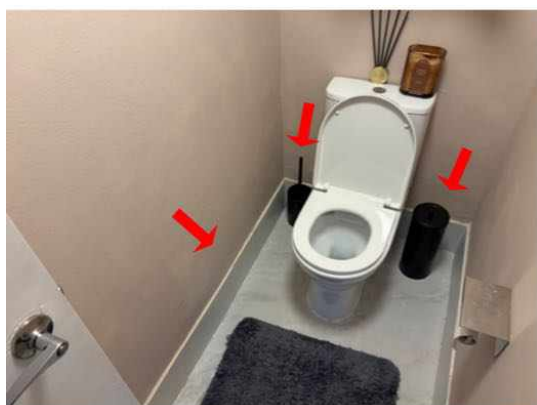
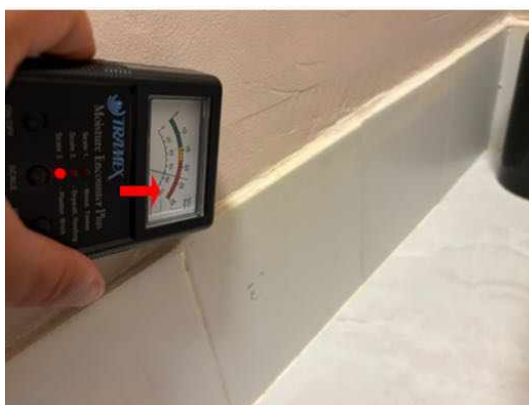
Finding 2.02

Building:	Main Building
Location:	Toilet (WC)
Finding:	Evidence of excessive moisture was present at the time of inspection
Information:	Excess moisture was identified in this area at the time of inspection. Furthermore evidence of surface repair was noted.

Excessive moisture can attract termites and produce conditions that promote termite attack, fungal growth and wood decay. Excessive moisture is generally caused by deteriorated, inadequate or missing roof drainage, leaking plumbing pipes or fixtures, poorly plumbed HWS overflows or condenser units and poor site drainage. It is highly recommended that all plumbing and drainage fixtures and fittings be maintained regularly in order to prevent excessive moisture being present in the external / internal property.

Excess moisture was identified to the toilet with patch repair to the surfaces. A licensed plumber must be appointed urgently for further assessment. Alternatively a bathroom specialist must be appointed for assessment as there maybe an active water leak from the shower area.

A licensed plumber must be appointed urgently for further assessment. Alternatively a bathroom specialist maybe appointed as there maybe an active water leak from the shower area.

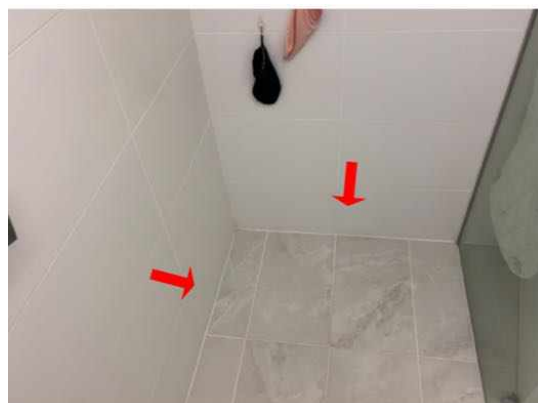
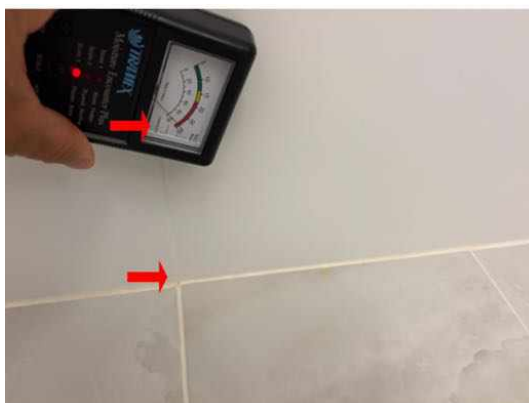
Finding 3.01

Building:	Main Building
Location:	Bathroom
Finding:	Shower damp - Sealant and grout
Information:	Damp is evident to the lower 400mm of wall to the shower alcove. This defect is quite common, and is suspected to have been caused by moisture permeating or leaching through the grouting and sealant in this area, which shows evidence of deterioration. Leaking pipes within the wall is also a possible cause however this seems unlikely in this instance as there is no moisture build up around the taps or transferring to the other side of the wall. There appears to be no sealant around the tap spindles which may be a small contributing factor.

Damp (or structural damp) refers to the presence of unwanted moisture in the structure of a building, either as the result of intrusion from outside, or condensation from within the structure. In the shower area, internal water leaks, degraded materials or other sources of excessive moisture are generally the cause of damp.

Unmanaged damp in the shower recess is likely to facilitate the formation and development of mould and fungi growth, decaying associated building materials and compromising their structural integrity of associated elements. It is important to address damp conditions, as the World Health Organisation notes that excess moisture leads - on almost all indoor materials - to growth of microbes such as moulds, fungi and bacteria, which subsequently emit spores and other matter into the indoor air. Exposure to these contaminants is associated with a wide range of respiratory and other health-related problems. Damp conditions also create a conducive environment for termite infestation.

Consultation with a bathroom sealant specialist is advised immediately to identify the cause of damp and to perform remedial works as required.

Always ensure that sealant and grout is in good condition to prevent any moisture issues occurring in the future.

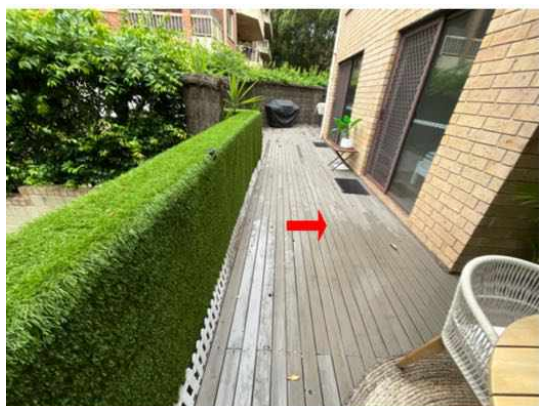
Finding 6.02

Building: Main Building
 Location: Fencing & Landscaping
 Finding: Building materials in direct ground contact - conducive to termites
 Information: Where timber elements are in direct contact with the ground and consequently moisture or dampness they become conducive to termite activity. Whether timber is used as a building element part of a fencing structure or stored as an unused item they can provide an environment that is attractive to termite infestation.

When met with excessive moisture timber begins to decay and develop wood rot. Any timbers that are in direct contact with external grounds especially if left untreated or non-durable also provide ingress for subterranean termites into that particular element.

The removal of any such materials that may be conducive to termite activity should be removed as soon as possible to minimise the risk of termite attack.

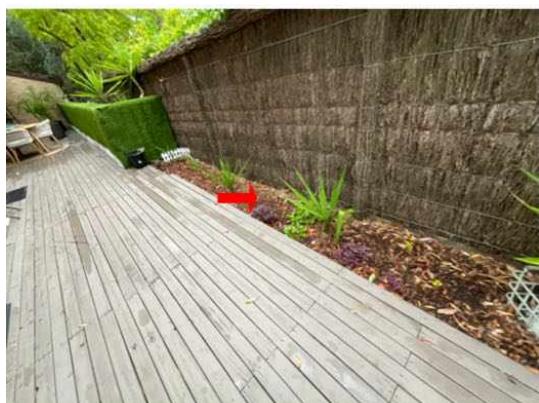
Finding 6.03

Building:	Main Building
Location:	Garden beds
Finding:	Garden Beds - Conditions Conducive to Termites
Information:	Garden beds were found to be evident in the garden area. These garden beds can include untreated timber, and with a combination of moisture from watering hosing can make conditions conducive to termite activity and termite ingress.

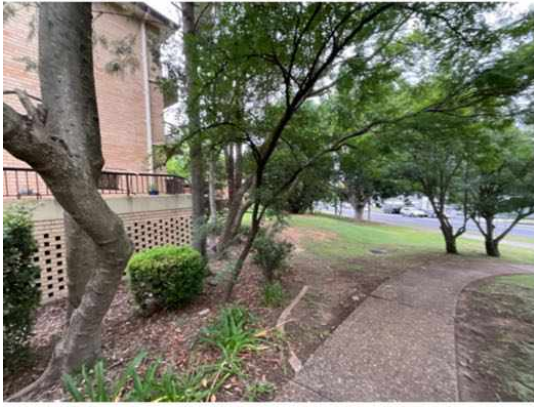
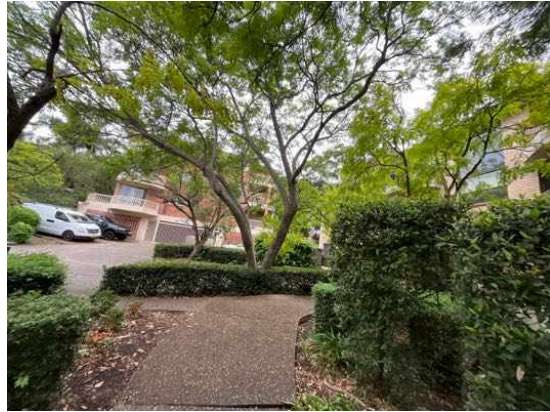
Finding 6.04

Building:	Main Building
Location:	Yard
Finding:	Surrounding bushland- Conducive to termite activity
Information:	Home and or building is situated in a high risk area for termite activity, due to close proximity to surrounding bushland. Surrounding bushland - Conducive

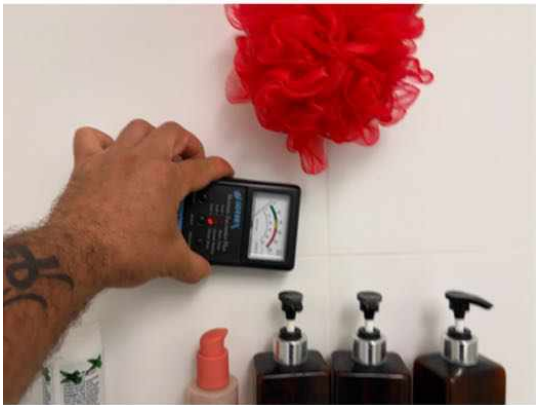
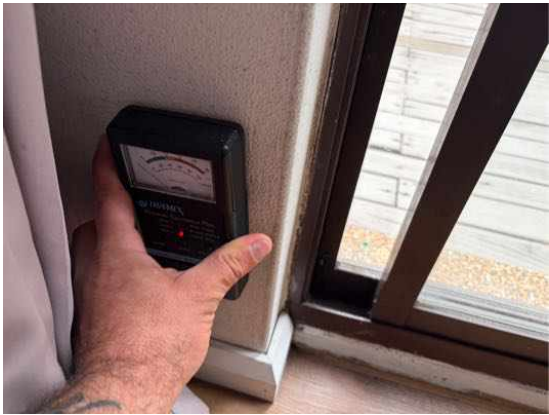
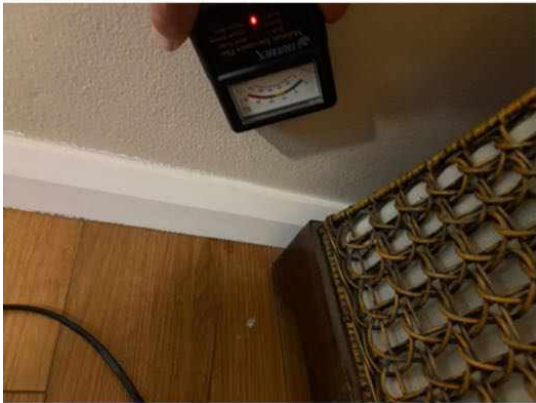
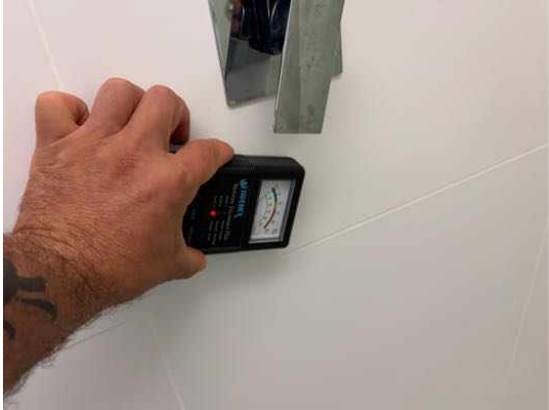
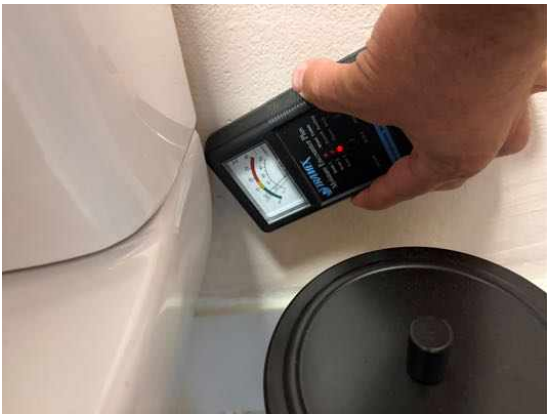
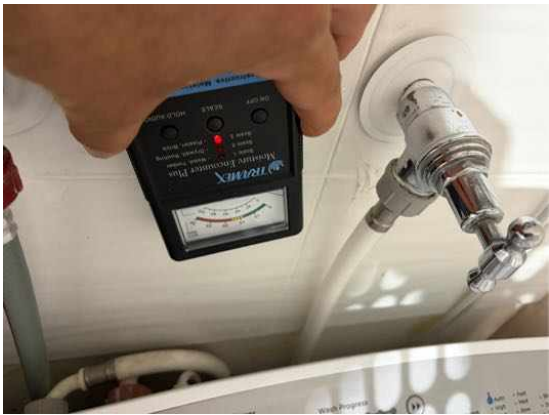
Building: Main Building
Location: All Areas
Finding: Moisture metre
Information: During the inspection the property was checked for moisture using a moisture metre.

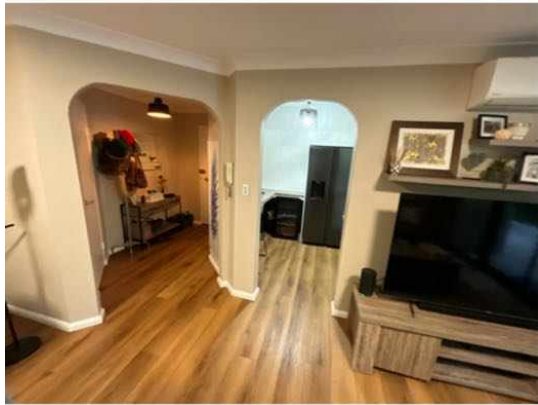
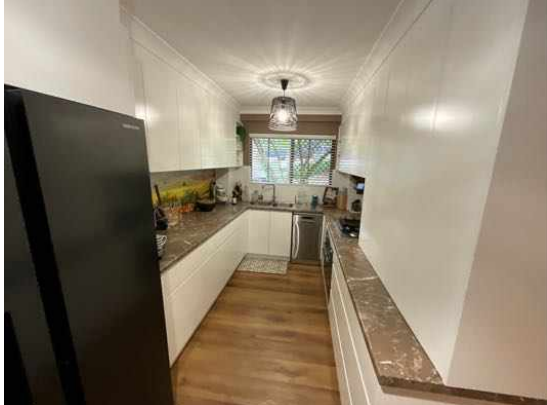
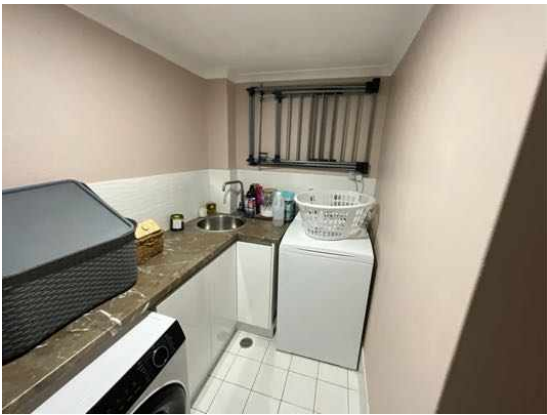
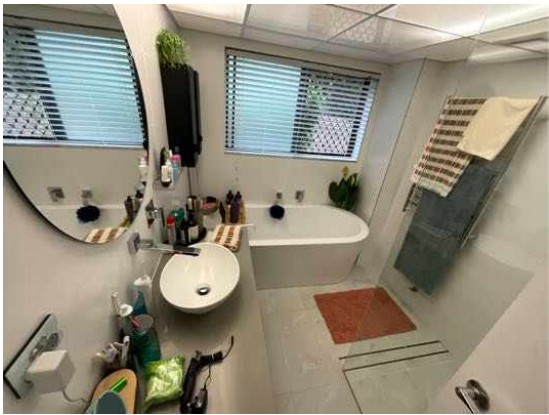
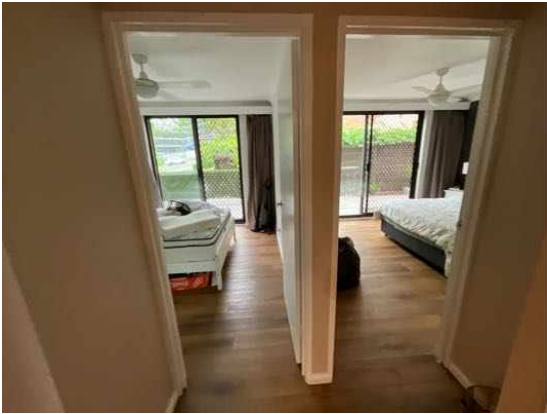
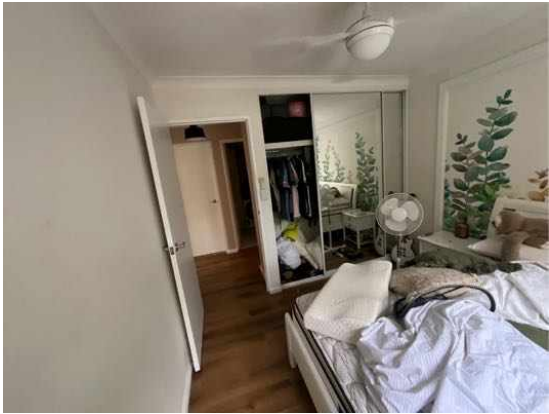
These photographs are an indication of the obstructions and limitations which impeded full inspection of the property at the time of inspection. These obstructions can hide an array of defects and should be removed to allow full inspection to be carried out. A re-inspection is recommended once the areas are made accessible.
