# Building and Timber Pest Inspection Report

Inspection Date: Wed, 25 Feb 2026

Property Address: 6 Gill Ave, Liverpool NSW 2170, Australia

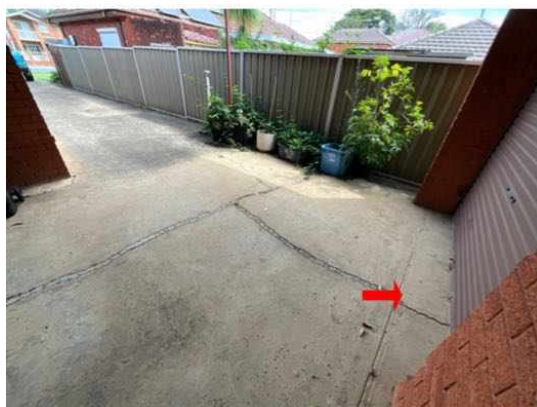
Building:	Main Building
Location:	Garage
Finding:	Crack in concrete slab - Category 4
Information:	A crack coded as Category 4 was identified in the slab. A Category 4 crack is described as a crack that appears as a gap in the slab, with disturbing curvature or change in level affecting the slab.

The approximate width of the crack or gap is 4mm-10mm or a change in offset of greater than 25mm when a 3m straight edge is placed over the defect.

Category 4 cracking to slabs exceeds allowable Standards and Tolerances, and are therefore considered as major defects that require rectification.

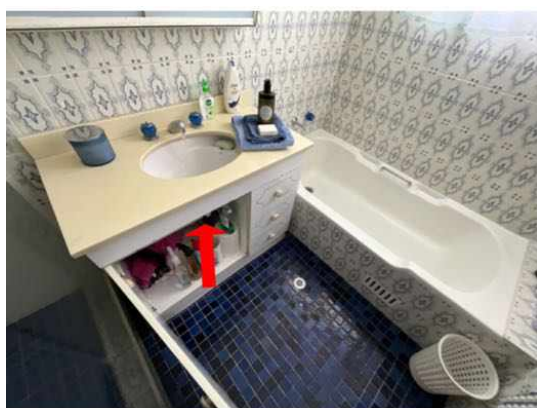
### Finding 3.01

Building:	Main Building
Location:	Bathroom
Finding:	Water leak - Active

Information: Generally, water leaks occur when a particular area of the property is not weather or water tight. As the surrounding area was found to be damp at the time of inspection, the leak is considered ongoing and hence requires urgent action.

Regardless of the location, even minor leaks that are left unmanaged can lead to serious damage of associated building elements and result in the need for replacement of building materials. Mould and other hazards such as electrical hazards may also arise if the leak is left to develop.

It is highly advised that the cause of the leak be identified and resolved immediately by a licensed plumber to prevent any further damage. Depending on the extent of the damage previously sustained, repair and/or replacement of any affected building materials may be required.

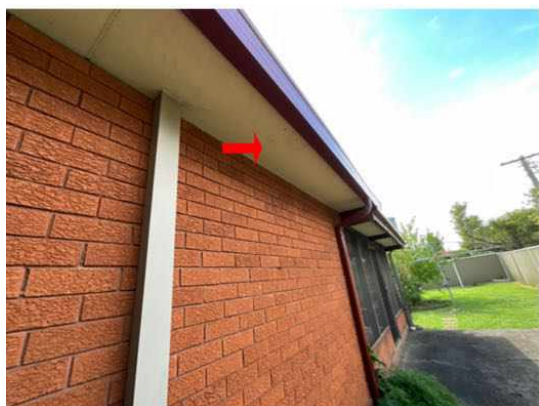
### Finding 3.02

Building: Main Building  
 Location: Multiple areas  
 Finding: Eaves/Roof plumbing -- water damages  
 Information: Water damage is generally an indication of excessive moisture being present, usually via a leak. It is suspected that gutter blockages causing stormwater to backflow into the eaves causing water damages. This is additionally conducive to termite activity due to the damp conditions.

Where water damage is evident, the primary requirement is to identify and rectify the source of the leak. Gutters must be kept clear of any blockages moving forward. A roofing plumber should be appointed for further assessment if the problem persists.

Once the leak is repaired, consultation with relevant tradespeople, including carpenters, plasterers and painters, is advised.

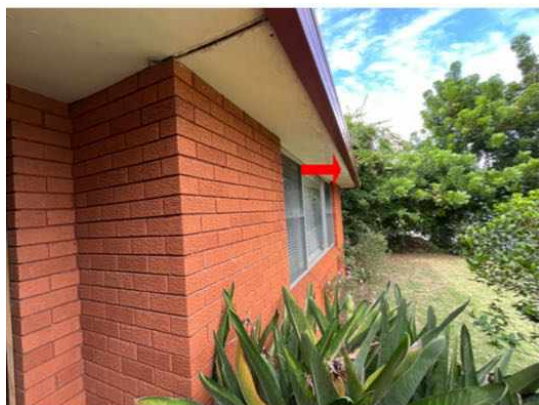
### Finding 3.03

Building: Main Building  
 Location: Front Elevation  
 Finding: Eaves - Sagging  
 Information: Sagging to the eaves was evident in this area at the time of inspection. This type of defect is generally consistent with older properties, where the eave sheeting has worn over time.

Eaves are important in preventing water ingress to associated walls by promoting adequate water run-off from roofing structures. Their secondary function is to prevent shelter to adjoining structures from excessive moisture and hence prevent water damage to these areas.

Sagging eaves are susceptible to the attraction of excessive moisture, and are therefore considered non-functional. This defect also detracts from the overall appearance and condition of the roofing structure and any associated structures.

A roofing plumber or general handyman is recommended to perform rectification works as soon as possible. Subsequent water damage is likely to result over time if left unattended.

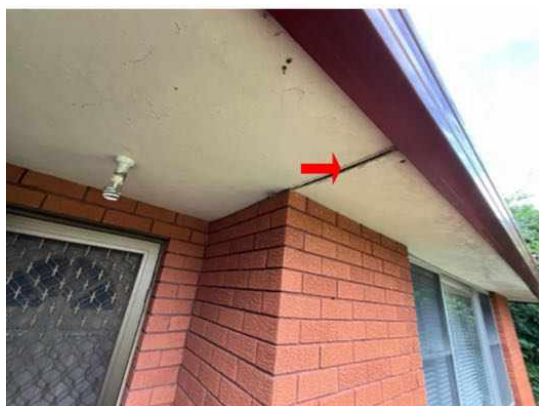
### Finding 3.04

Building:	Main Building
Location:	Multiple areas
Finding:	Beads - Damaged
Information:	Beading acts (like cornice or skirtings) to cover the intersection or joins of building materials. It was noted at the time of inspection that beading in this area has deteriorated. This deterioration is suspected to have been caused by general ageing and frequent exposure to weather, which is expected in a building of this age and condition.

Beading is important in weatherproofing the surrounding building elements and preventing pest ingress. Furthermore, beading works to protect the joins of building materials, which are more susceptible to deterioration and decay.

Repair or replacement of the beading is advised to ensure the protection and longevity of any associated building elements. Such works may be performed by a general handyperson or qualified carpenter.

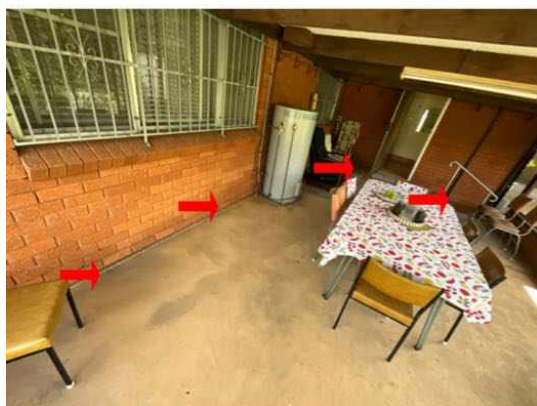
### Finding 3.05

Building:	Main Building
Location:	Alfresco
Finding:	Air vents - Blocked or inadequate
Information:	It was noted at the time of inspection that the subfloor area lacks adequate ventilation. The cause of this inadequate ventilation is the state of the air vents to the subfloor area. Where air vents are insufficient in number or are blocked, either fully or partially, subfloor ventilation is decreased.

A well ventilated subfloor aids in maintaining dry conditions, preventing secondary damage such as wood rot and pest activity, as well as preventing the development of mould/fungi and mildew (which can lead to major respiratory issues or safety hazards for occupants, particularly the elderly, the very young and those with existing illnesses).

All air vents should be cleared of blockages to promote adequate air flow to the area. Where ventilation is still insufficient, retrospective installation of air vents may be required. Appointment of a registered builder may be required to perform these works as necessary.

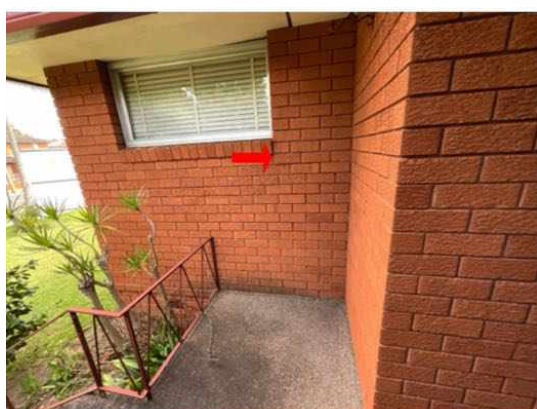
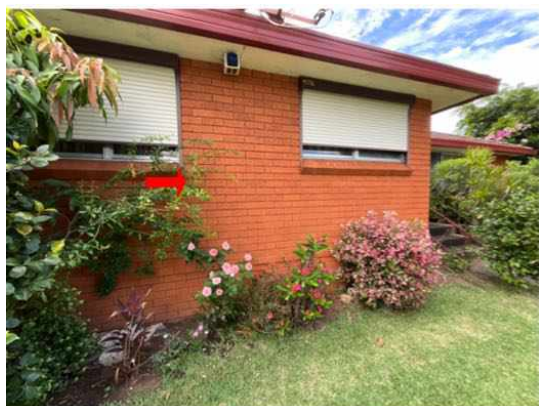
### Finding 3.06

Building:	Main Building
Location:	Multiple areas
Finding:	Brickwork - Step cracking
Information:	Step cracking was identified to the brickwork in this area at the time of inspection. Step cracking, which is similar to other forms of cracking, has a variety of possible causes. However, the most common is the subsidence of adjacent footings.

Step cracking is a relatively common defect, and is most likely to occur adjacent to windows, doors and other openings. Mortar failure in the gaps between affected bricks indicates the stresses and tensions affecting the wall.

Minor step cracking can be used as a warning sign to address factors causing stress to the wall, which can include the effect of surrounding trees, water leaks, soil erosion, or even the presence of reactive soils in the surrounding area. The degree of damage falls within Category 1, described as fine cracks, which are less than 1.0mm in width limit, and that do not need repair.

Damage of this category is not considered a defect for rectification. Always contact your building inspector should cracks widen, lengthen, or become more numerous.

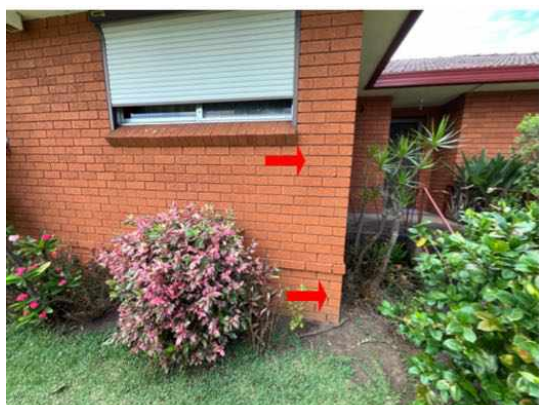
### Finding 3.07

Building:	Main Building
Location:	Multiple areas
Finding:	Brickwork - Cracking [Fine]
Information:	Although fine cracks are quite noticeable, they are often only considered to be an appearance defect and usually do not indicate any structural damage. Generally, the cause of a fine crack is indicative of a separation between brickwork and mortar throughout the structure, but single bricks may also show cracks of this nature.

Cracking of this nature can generally be repaired with minor filling and should be conducted by a qualified bricklayer.

Always contact a building inspector should cracks widen lengthen or become more numerous.

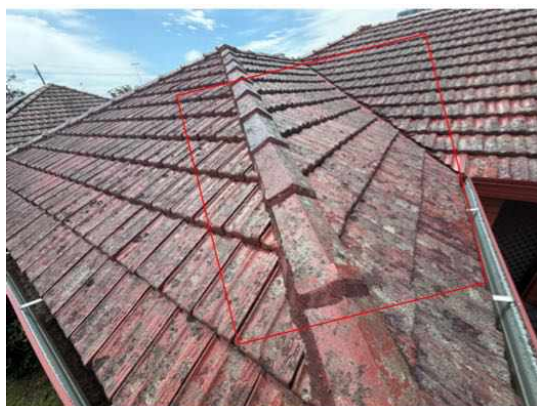
Where left unmanaged, deteriorating roof tiles are likely to lead to a number of secondary defects, including minor water leaks and weather exposure to internal roofing structures.

Consultation with a licensed roofing contractor is highly advised to gain advice on cost of remedial works that may be required in the short to medium term. Remedial works are likely to increase the longevity of the exterior roofing structure.

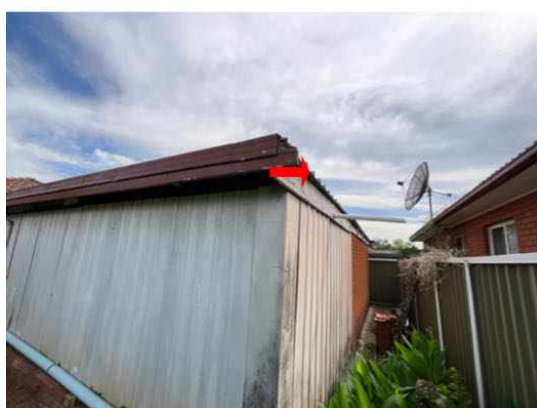
Excessive moisture creates an environment which accelerates the deterioration of building elements in the area, as well as being conducive to termite and pest infestation. Such an environment is likely to necessitate repair and/or replacement of building elements, which are prone to sustaining wood rot, rust or corrosion.

A roofing plumber should be appointed as soon as possible to install relevant roof plumbing materials. Depending on the extent of the damage, repair and/or replacement of damaged building elements may be required.

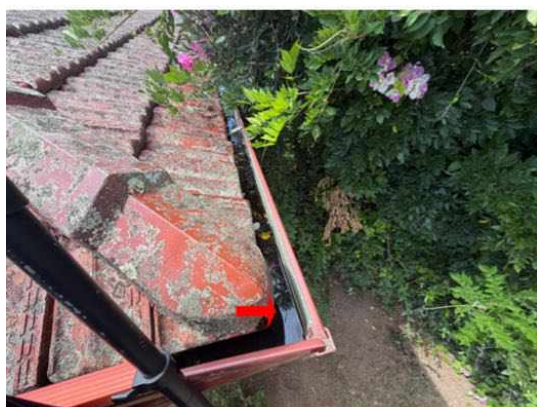
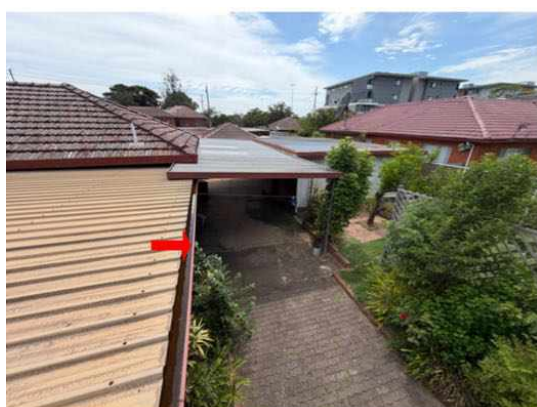
### Finding 3.16

Building:	Main Building
Location:	Gutters

Any areas of guttering that shows evidence of water pooling should be checked for partial or full blockages or otherwise appropriate fall to the downpipe must be applied accordingly. Any secondary damage that may have occurred as a result must be rectified. Depending on the extent of the damage, building elements may require repair and/or replacement to ensure adequate roof drainage and function of exterior plumbing system.

A roofing plumber must be appointed as soon as possible if inadequate fall to downpipe is deemed to be the cause. It is highly advised that all gutters be maintained on a frequent basis to ensure the condition of roof plumbing.

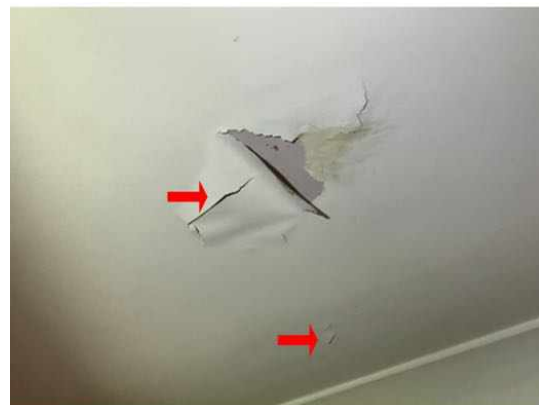
Inadequate surface preparation can also cause these failures, especially when paint is applied to bare wood or a very porous surface without first applying a primer.

A qualified painter should be appointed to rectify the problem.

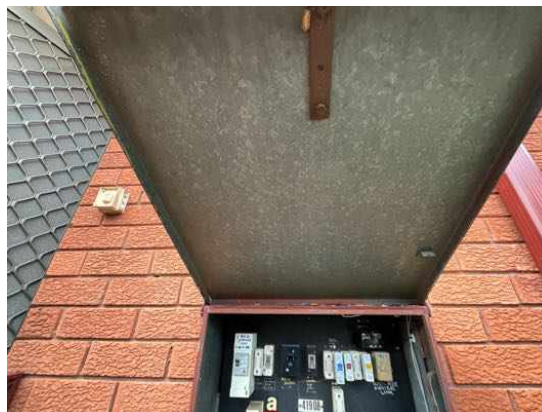
A durable notice should be placed in the switchboard unit to indicate current termite barriers. At the time of inspection, it appeared as though no termite management system has been installed, with no evidence to suggest preventative works taking place.

The client may consider gaining further advice from a pest controller as to the costs and procedures involved with this application. It is recommended that obtaining such advice be a short-term priority.

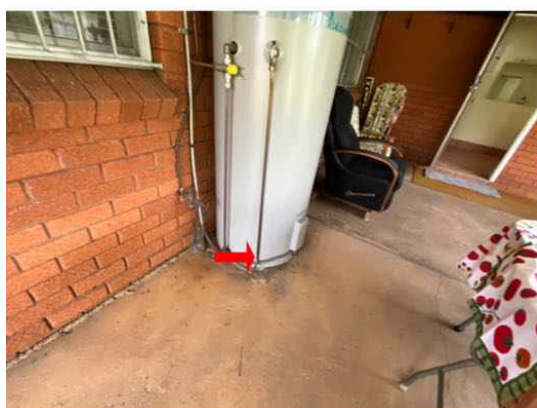
### Finding 6.03

Building: Main Building  
 Location: Yard - Side  
 Finding: Overflow - Not plumbed for drainage  
 Information: The overflow is not plumbed or connected to suitable drainage, which can result in the surrounding area becoming excessively damp.

These damp conditions can lead to secondary defects such as rot, rust or corrosion of associated building elements, the formation of fungal decay, or even the creation of potential slip hazards. When coupled with poor site drainage, pooling of water may also attract termite activity to this area.

It is highly recommended that a licensed plumber be appointed to install adequate drainage to the overflow. These works will ensure that the area remains dry and free of any secondary defects.

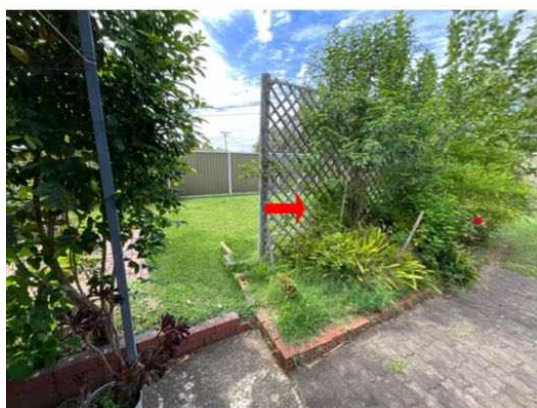
### Finding 6.04

Building: Main Building  
 Location: Fencing & Landscaping  
 Finding: Building materials in direct ground contact - conducive to termites

When met with excessive moisture timber begins to decay and develop wood rot. Any timbers that are in direct contact with external grounds especially if left untreated or non-durable also provide ingress for subterranean termites into that particular element.

The removal of any such materials that may be conducive to termite activity should be removed as soon as possible to minimise the risk of termite attack.

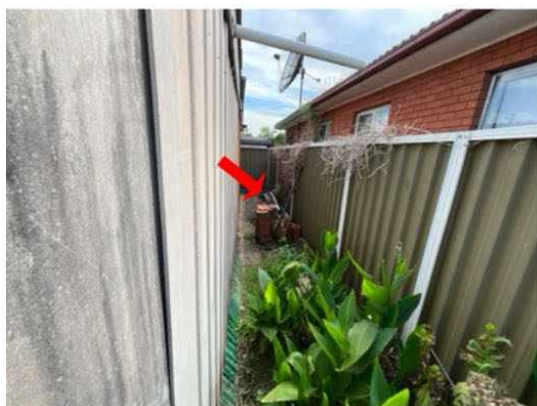
### Finding 6.05

Building: Main Building

It is highly recommended that any stored timbers be immediately removed from areas in which they may attract any termite / timber pest attack. Minimisation of risk / prevention of termite attack is far more adequate than dealing with the presence of termite activity.

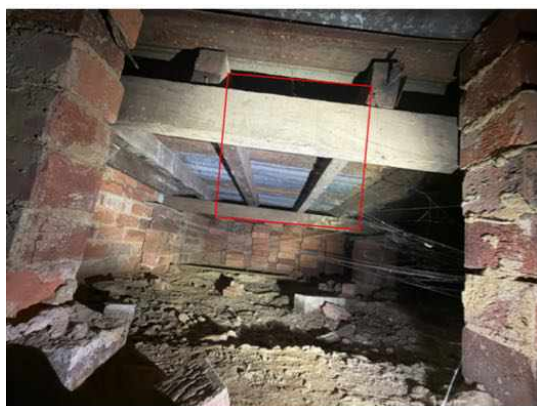
### Finding 6.06

Building:	Main Building
Location:	Subfloor
Finding:	Formwork timbers - left in situ
Information:	Formwork timber appears to have been left on site and in situ after concrete construction. Formwork timber is used to support and shape the concrete while pouring during the construction process. Leaving formwork timbers in the subfloor space or around the exterior of the property increases the risk of termite activity being present. As they are likely to come into contact with weather conditions or excessive moisture wood rot is likely to develop on timbers that are not treated. It is highly recommended that any formwork timbers be immediately removed from areas in which they may attract any termite/timber pest attack. Minimisation of risk/prevention of termite attack is far more adequate than dealing with the presence of termite activity.

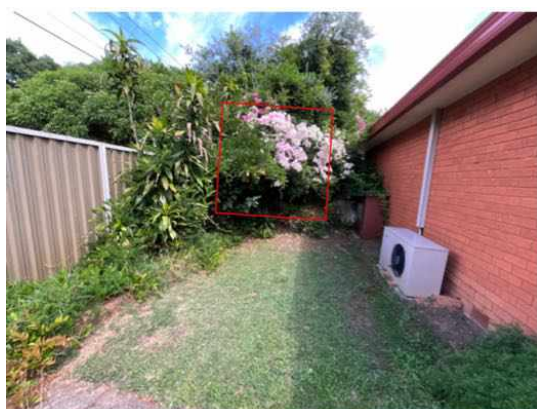
### Finding 6.07

Building:	Main Building
Location:	
Finding:	Surrounding bushland - Conductive
Information:	Home and or building is situated in a high risk area for termite activity, due to close proximity to surrounding bushland.

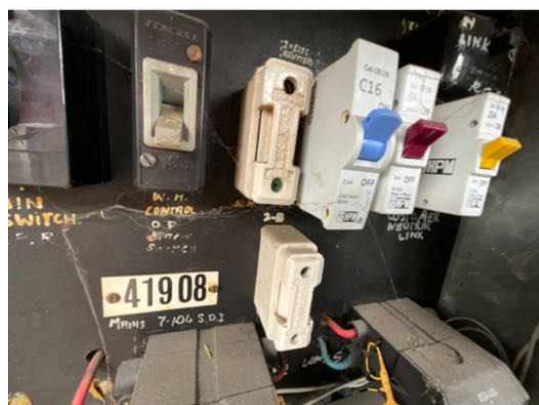
While this on its own on is not considered a defect it is noted for the clients consideration that a switchboard upgrade may be required in the short to mid term to improve the functionality of the electrical system. A licensed electrician could be appointed to provide quotation for the works at the client's discretion which may in turn expose other required works to bring the system up to a compliant state.
