Building and Timber Pest Inspection Report

Inspection Date: Mon, 23 Feb 2026

Property Address: 152 Clovelly Rd Randwick, NSW, Australia

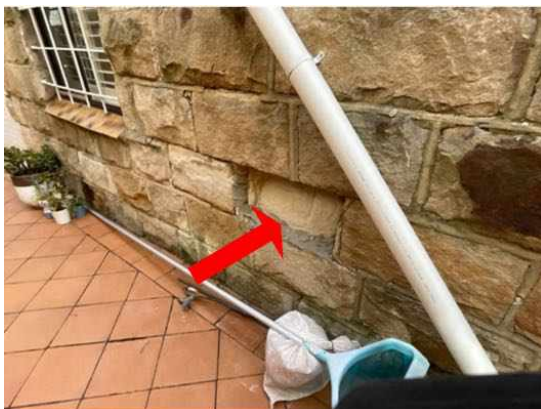
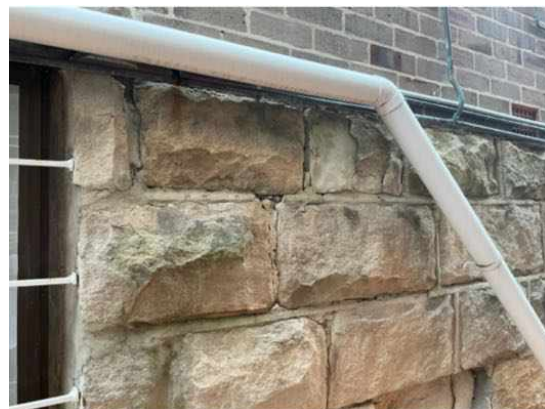
Finding 3.01

Building:	Main Building
Location:	Exterior walls - left side
Finding:	Sandstone deterioration
Information:	Deterioration was evident to sections of the sandstone in this area at the time of inspection. Commonly referred to as stone corrosion or erosion, the blocks are aged and likely to have been affected by a variety of factors, including weather exposure, damage, salt-based deterioration, and more. Overtime, these factors can affect the blocks, causing them to become brittle and appear corroded or eroded. If left unmanaged, potential implications include further deterioration of the building materials, the development of secondary defects, and potential development of structural instability of the wall. Consultation with a stone mason is recommended and repairs should be carried out at their advise.

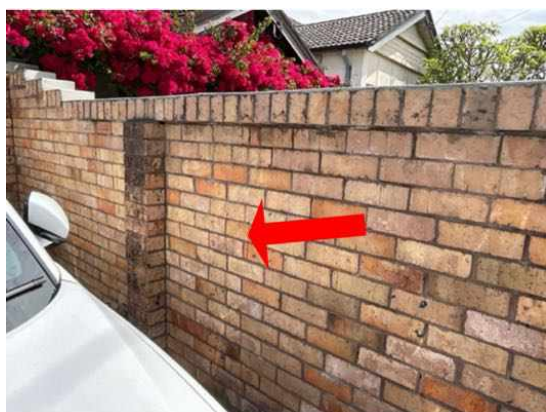
Finding 3.02

Building:	Main Building
Location:	Yard - Front
Finding:	Sandstone Deterioration and Mortar Joint Cracking
Information:	Deterioration to sandstone masonry was observed on an exterior wall, along with

spine cracking to sections of the sandstone mortar joints. The deterioration appears consistent with weathering and age-related decay of the stone and mortar.

At the time of inspection, there was no indication that the observed deterioration is causing structural instability. The wall appears to be generally stable; however, ongoing weather exposure may lead to further surface erosion and widening of mortar cracks over time.

It is recommended that a suitably qualified stonemason or builder be consulted to assess the condition of the sandstone and mortar joints. Localised repointing and minor repairs may be required to prevent further deterioration and maintain the integrity of the wall.

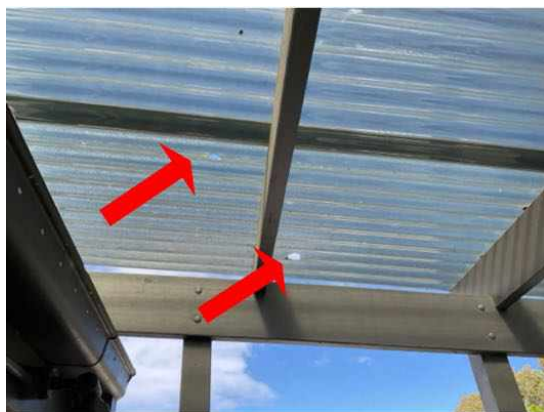
Finding 3.03

Building:	Main Building
Location:	Pergola
Finding:	Surface - Holes
Information:	Holes in surfaces are generally indicative of impact damage, whether accidental or deliberate, or a failing of the surface material.

Where holes are apparent in the surface of a building material, the surface is no longer sealed against water penetration or further impact damage, which may lead to additional damage to the surrounding surface.

Repair or replacement of the affected building element is recommended as soon as possible to ensure that any secondary defects are minimised. A qualified carpenter or general handyperson should be appointed to perform these works.

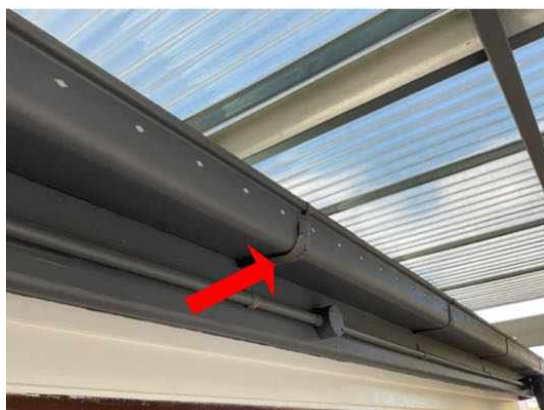
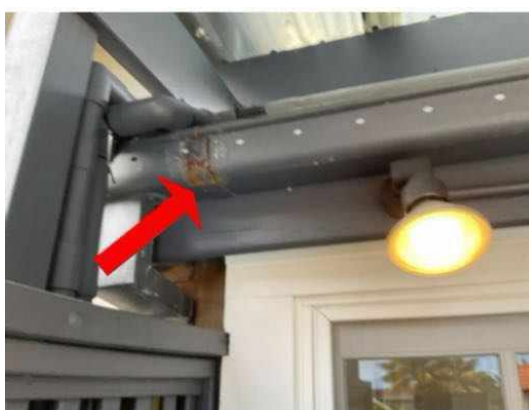
Finding 3.04

Building:	Main Building
Location:	Pergola
Finding:	Roof plumbing clips rusted
Information:	The roof plumbing clips show evidence of rusting and corrosion, which is likely to have developed of inadequate coatings.

As surface rust provides no protection to the underlying iron, the deteriorating condition is likely to worsen if not addressed in the short-term future. Without management, the clips will continue to rust and may cause issues with the associated guttering.

A roof plumber may be appointed to replace any clips that have been severely affected by rust to prevent future issues.

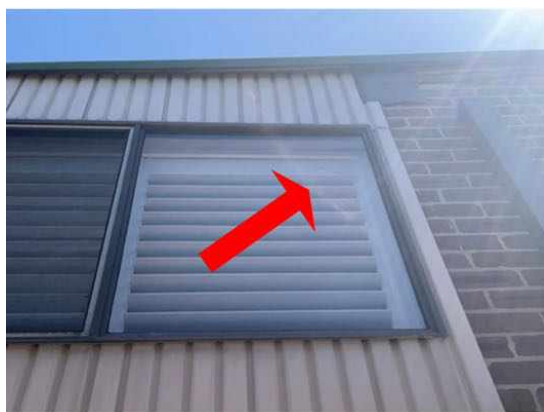
Finding 3.05

Building:	Main Building
Location:	Exterior walls - left side
Finding:	Window - Cracked
Information:	Cracks were identified in the window in this area. Cracking in windows is generally the result of impact damage, and is likely to develop further when left unmanaged.

A qualified glazier is required to repair the window as soon as possible.

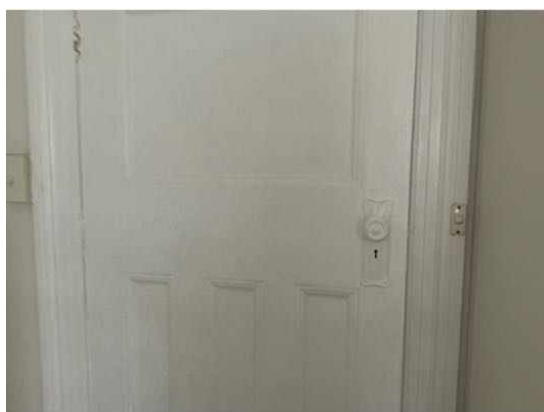
Finding 3.06

Building: Main Building
Location: Bedroom 2
Finding: Door - Binding/jamming
Information: Binding and/or jamming of this door is evident during standard operation. This defect inhibits the functionality of the affected door as well as creating potential for secondary defects to associated building elements, such as damage to the floor covering.

A door that binds to flooring or to the associated door frame may have several causes, ranging from minor defects, such as poor installation of the door or deteriorated hinges.

A qualified carpenter or general handyperson should be appointed to perform minor rectification works at client discretion.

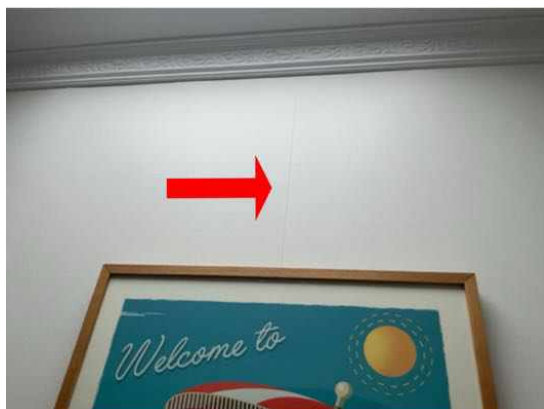
Finding 3.07

Building: Main Building
Location: Study
Finding: Cracking - Damage Category 0 - Hairline (less than 1mm)

Information: Hairline cracks are very minor in nature and generally are only ever an appearance defect. While such cracking may be noticeable in some cases, it is quite common and does not indicate any structural damage.

Cracking of this nature can generally be repaired with minor sanding, filling and/or repainting. Such works should be performed by a qualified painter or a general handyman.

Monitoring of all cracking should be conducted frequently. Always contact a building inspector should cracks widen, lengthen, or become more numerous.

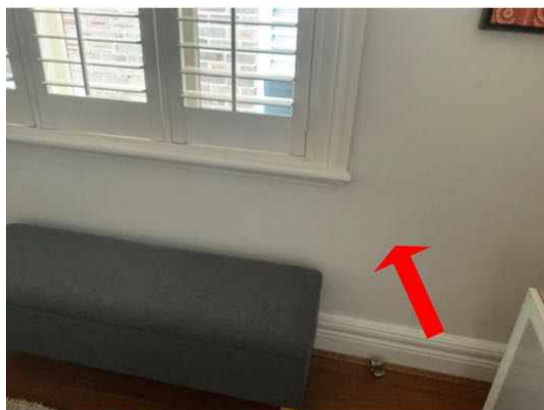
Finding 3.08

Building: Main Building
 Location: Lounge Room
 Finding: Damp - Moisture penetration wall
 Information: Damp readings were taken in this area at the time of inspection. Damp penetration is a common form of dampness that can occur through walls, roofs or openings.

Common causes include faulty or missing flashing or bridging of cavities. Moisture penetration can also occur when water tracks over cavities or by tracking across wall ties.

The cause of the damp can be further inspected by a plumber or damp specialist to determine the cause of the damp and advise if repairs are required.

Trades responsible for such repairs may include builders or damp specialists.

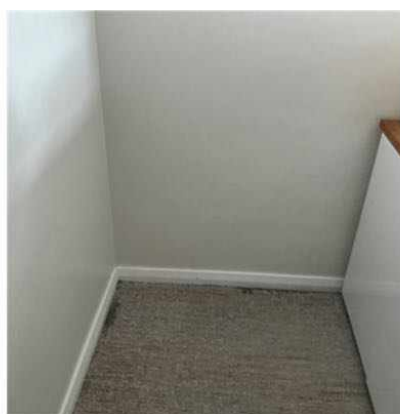
Finding 3.09

Building:	Main Building
Location:	Study lower
Finding:	Damp Internal
Information:	Damp readings were taken in these areas at the time of inspection. Damp (or structural damp) refers to the presence of unwanted moisture in the structure of a building. Generally, structural damp such as this is caused by moisture penetration from the exterior wall through to the interior wall, or rising damp from the base of the footing to the internal areas.

Unmanaged damp facilitates the formation and development of mould, fungi growth and wood rot, decaying associated building materials. Damage to finishes is also likely to occur, including lifting, bubbling, peeling and staining of paint, plaster and wallpaper.

The first step in addressing damp is to diagnose the cause of the damp. Further consultation with a damp specialist is advised to identify the cause of damp and perform remedial works as required.

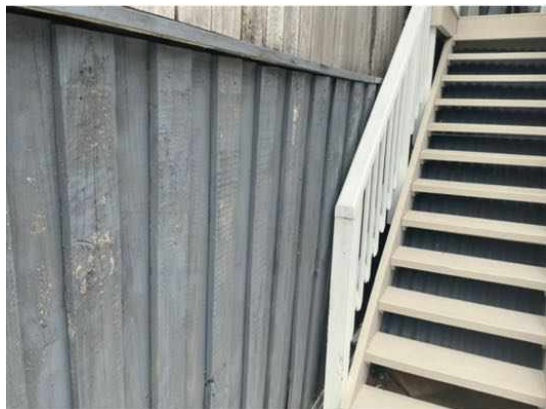
Finding 3.10

Building:	Main Building
Location:	Yard - Back

Finding:	Fence leaning
Information:	The fence at the side of the property appears to have a slight lean. The causes of this defect could be movement of the footing, poor installation of the wall and footing or insufficient improper preparation of foundations during construction. To find out if the wall will move any more or or if it will cause any more secondary defect or structural issues a builder or engineer should be consulted. Repairs can be carried out by a bricklayer if required.

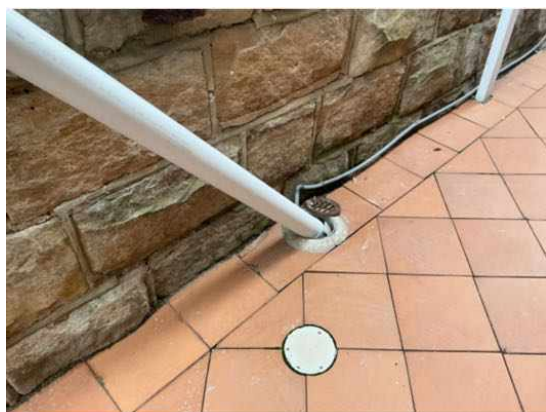
Finding 3.11

Building:	Main Building
Location:	Exterior walls - left side
Finding:	Storm water running into sewer.
Information:	The storm water is connected directly to the sewer pipe work in this area.

This defect is creates excess stress on the sewage system and this practice can lead to fines from sydney water.

It is recommended that a plumber be appointed immediatly to remove the downpipe from the sewer and connect it to the storm water or make arrangements to off load the water at an appropriate source.

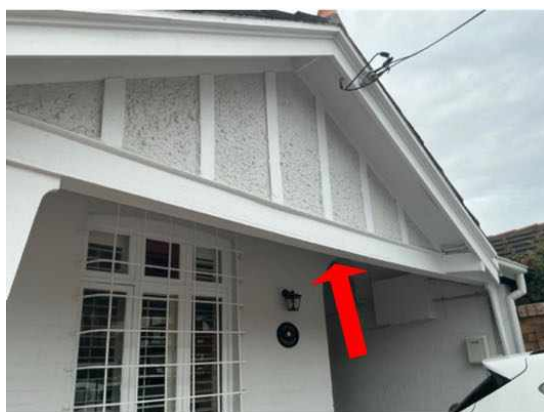
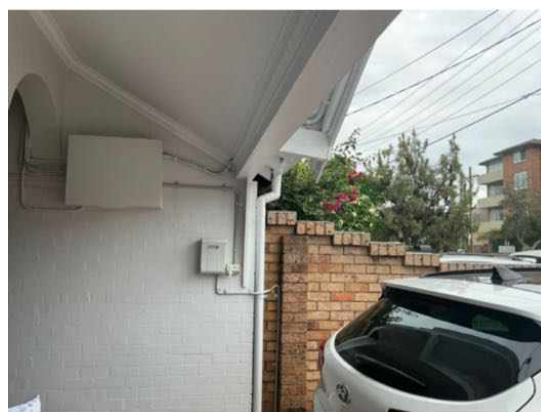
Finding 3.12

Building: Main Building
 Location: Front Elevation
 Finding: Sagging Beam to Front Gable Structure
 Information: A slight sag was observed to the lower beam of the front gable structure. The deflection may be associated with the removal of a previous support post or alteration to the original structural configuration.

No significant cracking or distortion was noted to the masonry or cladding above this area at the time of inspection. However, the visible sag indicates some degree of structural movement or reduced support to the beam.

It is recommended that a qualified builder assess the gable structure to determine whether additional support, reinforcement, or reinstatement of a post is required to prevent further deflection or future structural issues. Continued monitoring of the area is advised.

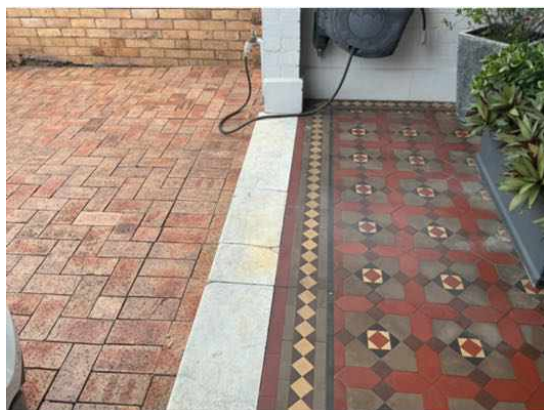
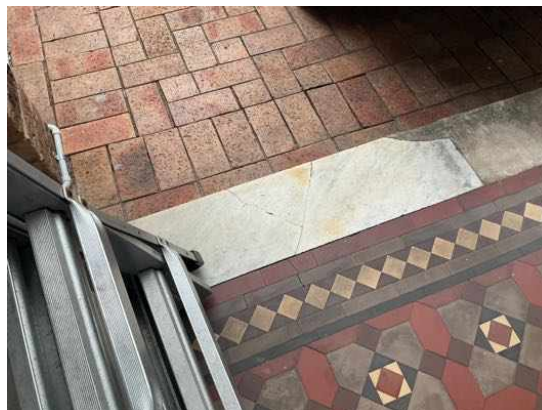
Finding 3.13

Building: Main Building
 Location: Yard - Front
 Finding: Terrazzo cracked
 Information: Cracking in to the entry step was evident at the time of inspection. It is suspected that this cracking has occurred as a result of the floor being uneven and lacking a solid or suitable foundation for the tiles to be laid on or from general wear and tear over the life span of the property.

Cracked building elements throughout the household detract from the overall appearance of the affected areas, however, this is not likely to cause secondary defects and is generally considered an appearance defect.

While not considered a matter of urgency, replacement of cracked is advised as a solution. A tiling contractor may be appointed to perform these works at client discretion.

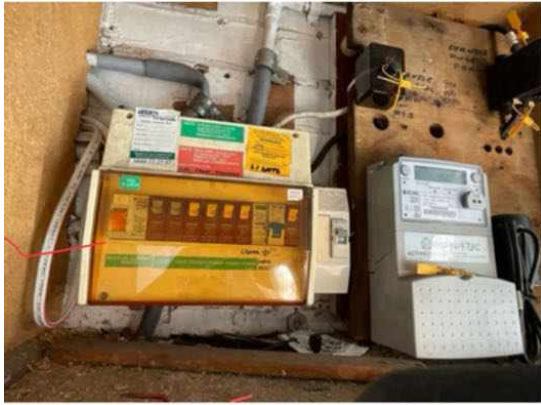
Building:	Main Building
Location:	Electrical circuit box
Finding:	Termite Management System No Evidence of Installation
Information:	The application of a post-construction termite barrier is highly recommended for all properties. Such barriers are highly effective in preventing termite attack on any timber building elements throughout the property.

A durable notice should be placed in the switchboard unit to indicate current termite barriers. At the time of inspection, it appeared as though no termite management system has been installed, with no evidence to suggest preventative works taking place.

The client may consider gaining further advice from a pest controller as to the costs and procedures involved with this application. It is recommended that obtaining such advice be a short-term priority.

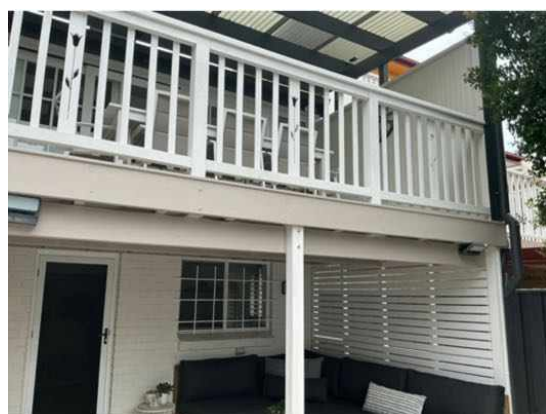
Building:	Main Building
Location:	Balcony
Finding:	Note on Timber Balconies and Suspended Timber Structures
Information:	The load capacity of timber balconies and other suspended external timber structures has not been verified as part of this inspection.

It is recommended that any suspended timber external structure be assessed and certified by a structural engineer to ensure it is not overloaded and remains safe for use.

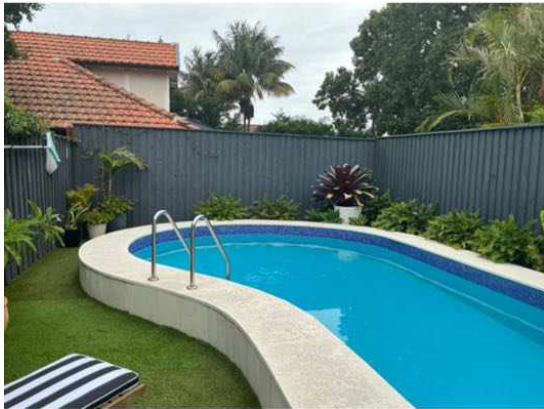
Building: Main Building
 Location: Yard - Back
 Finding: Pool on property.
 Information: This property has a pool. Pools are not in the scope of inspection on building inspections as cannot be inspected sufficiently. Further Inspection by a pool specialist always recommended to determine the condition of the pool is advised to gain further insight.
