Building Inspection Report

Inspection Date: Mon, 30 Mar 2026

Property Address: 43 Sanctuary Way, Beaconsfield VIC 3807,
Australia

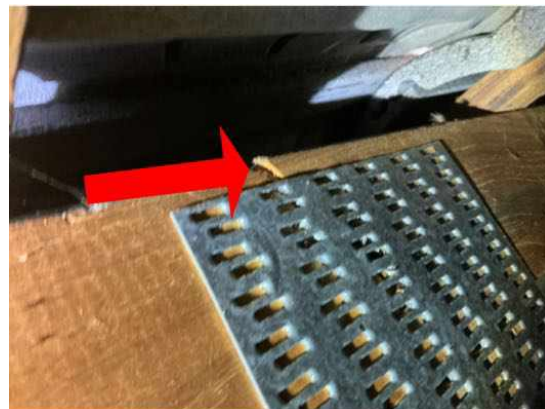
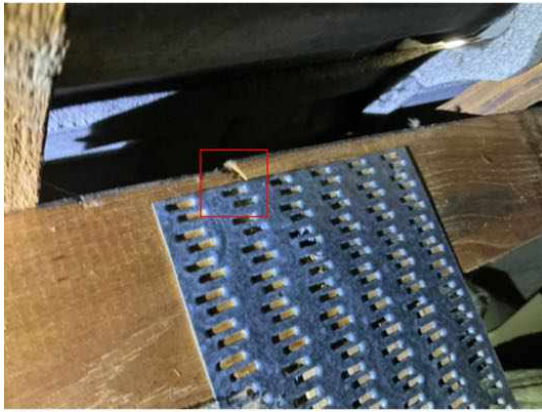
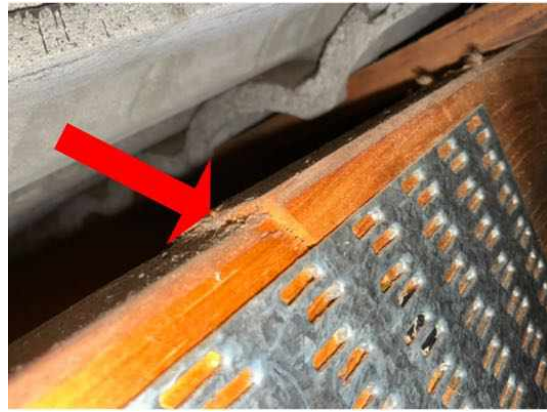
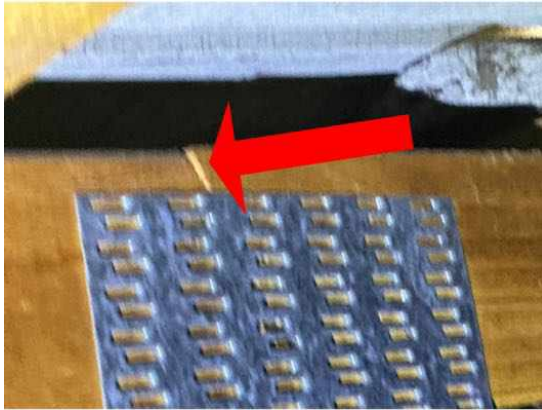
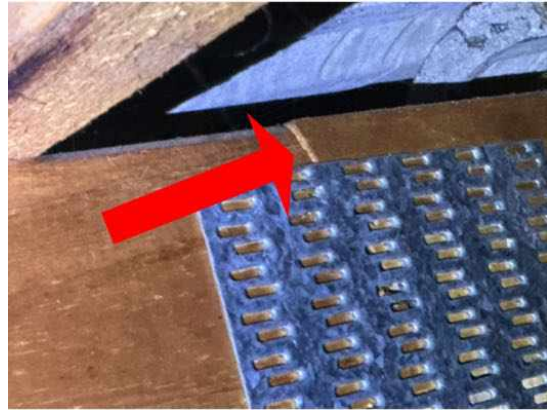
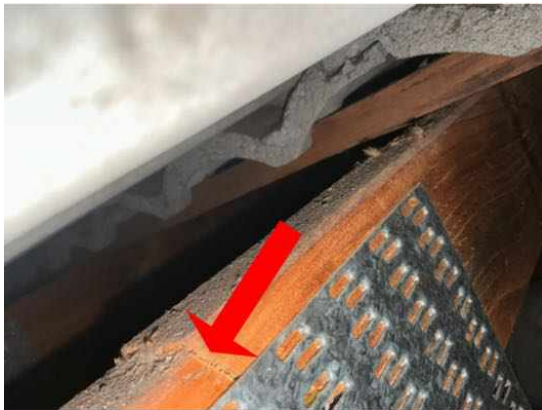
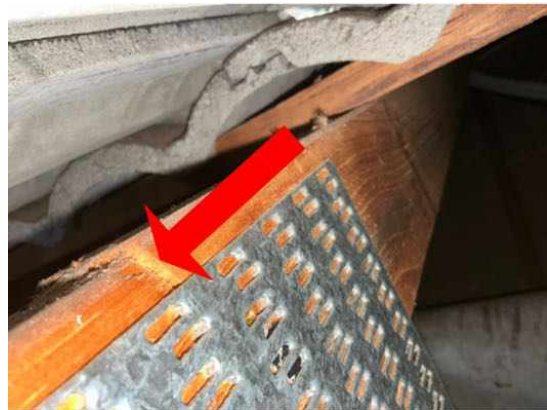
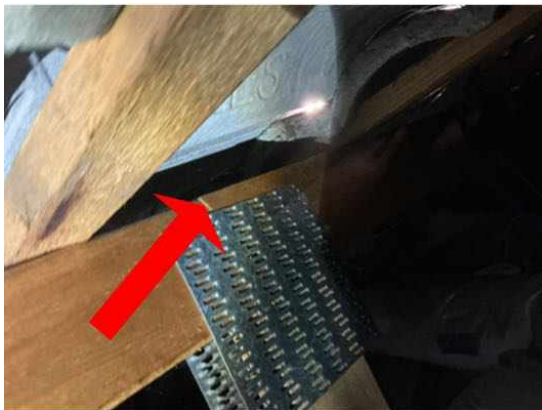
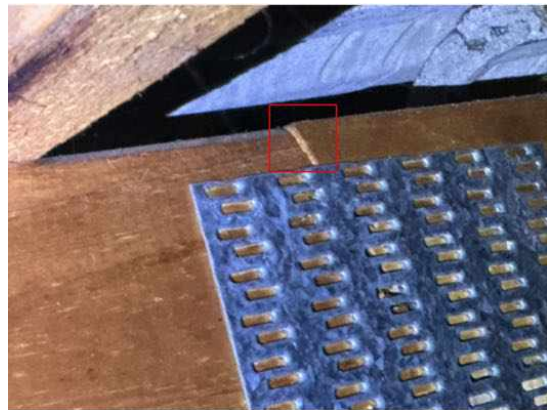
Defects 3.01

A longitudinal split was observed to a rafter within the roof space, located adjacent to a metal gang nail plate connection. The split appears localised and is consistent with timber shrinkage or stress at the connection point.

While no significant deformation was noted at the time of inspection, splitting at a structural connection may affect the integrity of the member if it progresses.

It is recommended that a registered builder be engaged without delay to assess the extent of the damage and replace the affected rafter as required to ensure the structural adequacy of the roof framing.

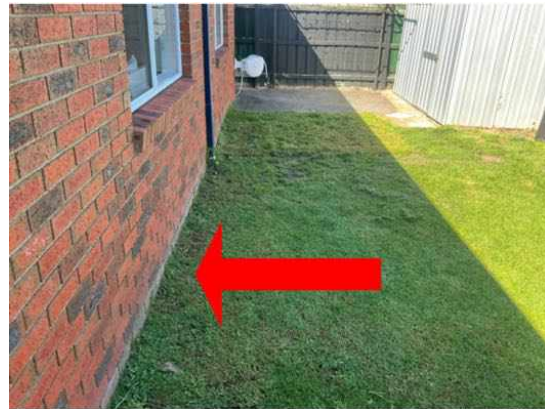
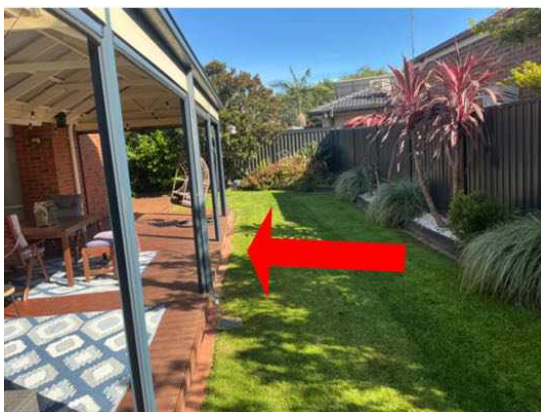
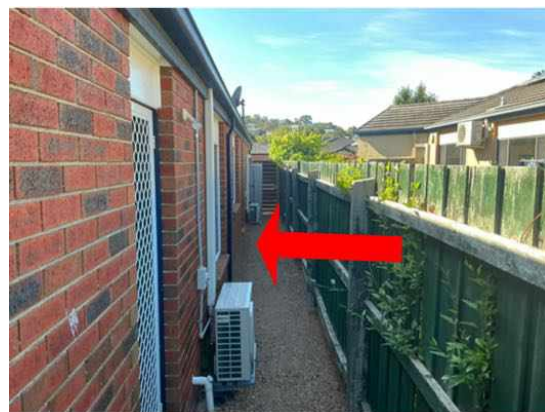
Defects 3.02

Building: Main Building
 Location: All External Areas
 Finding: Site drainage - Inadequate
 Information: The site drainage in all yards was found to be inadequate at the time of inspection, creating potential for subsequent water damage to associated building elements.

It is important that water does not lie against the base of walls; surrounding paths and ground levels should be sloped to drain water away from walls. Downpipes should not discharge stormwater onto lower walls or plinths. Stormwater should be carried away by large, regularly cleaned drains. Ground levels may need to be lowered to expose a buried DPC.

Where site drainage is inadequate, installation of an Agricultural (Aggie) Drain may be required. A qualified plumber should be appointed to further inspect the property and perform any remedial works as necessary. Water damage and secondary defects are likely to occur if left unmanaged.

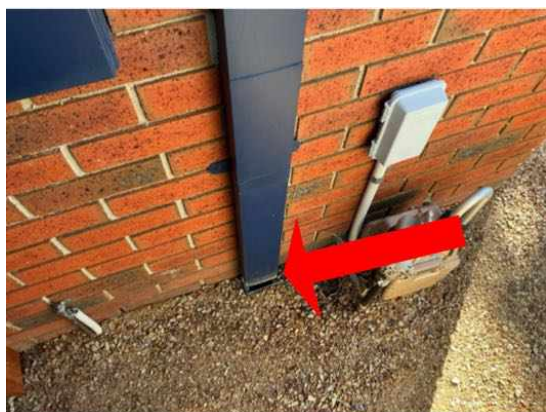
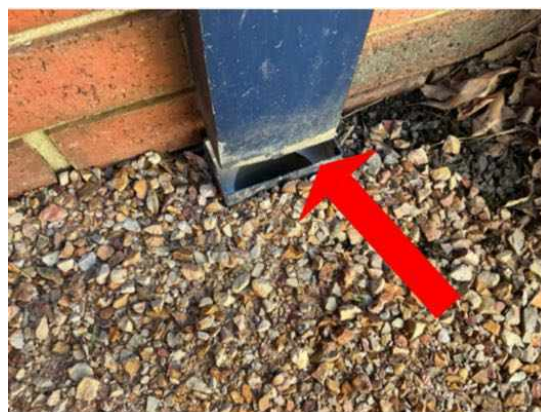
Defects 3.03

Building: Main Building
 Location: Exterior walls - left side
 Finding: Stormwater Drainage – Detached Downpipe (LHS)
 Information:

The left-hand side (LHS) downpipe was observed to be detached from the stormwater connection at the base. As a result, roof water is not being properly directed into the drainage system.

This condition may lead to uncontrolled discharge of water at the base of the structure, increasing the risk of soil saturation, foundation movement, and potential moisture ingress into adjacent building elements.

It is recommended that a licensed plumber be engaged to reconnect the downpipe to the stormwater system and ensure proper discharge in accordance with drainage requirements.

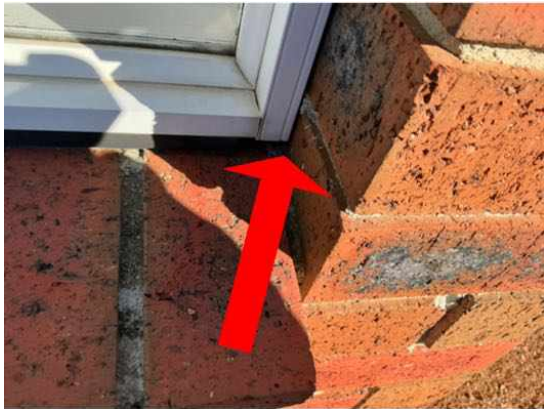
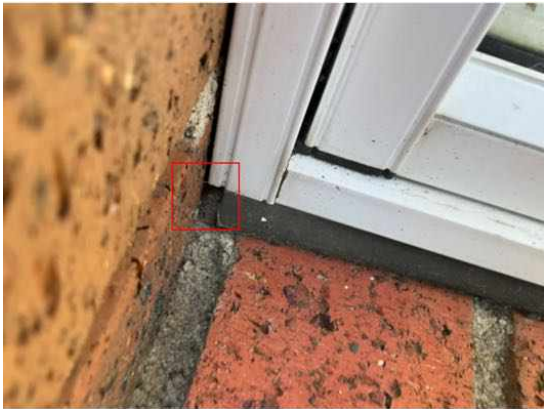
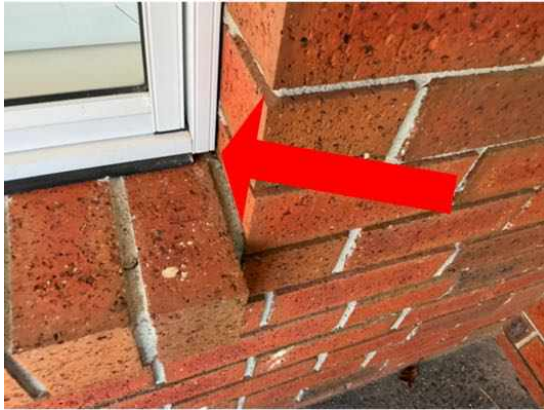
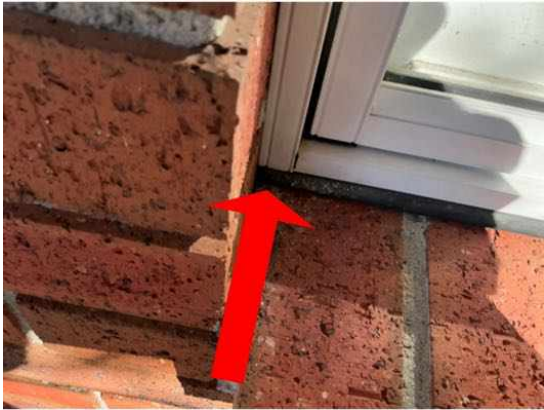
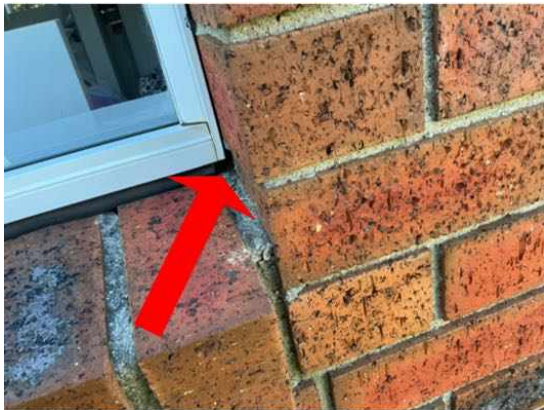
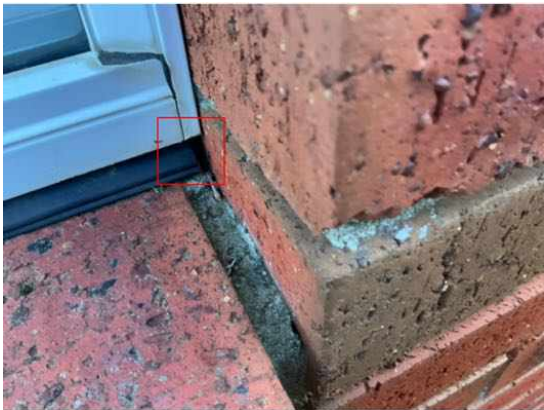
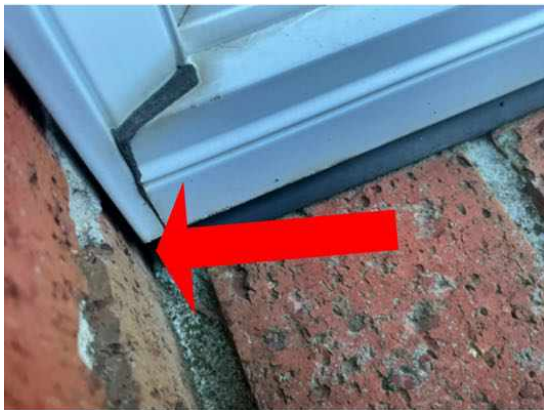
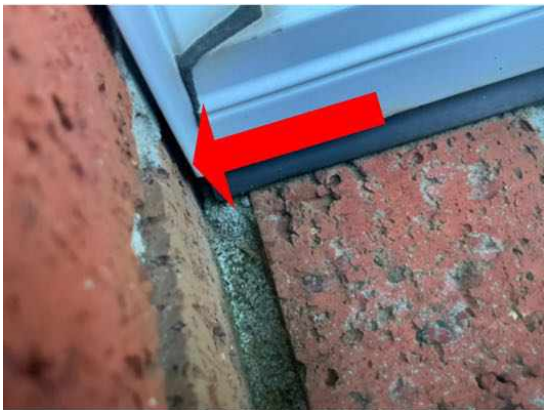
Defects 3.04

Building:	Main Building
Location:	All External Areas
Finding:	Window seals - deteriorated
Information:	The window seals have deteriorated and are in a generally poor condition. Due to frequent exposure to weather conditions and subsequent moisture, deterioration of window seals is expected in a property of this condition and age.

Where window seals have deteriorated, the window is no longer weather-tight; rain penetration and subsequent water damage is therefore likely to ensue. Insulation of the area against external weather conditions will also be compromised.

It is recommended that all deteriorated window seals be replaced by a general handyman or sealant expert to prevent any further damage and to restore the window to a fully functional level.

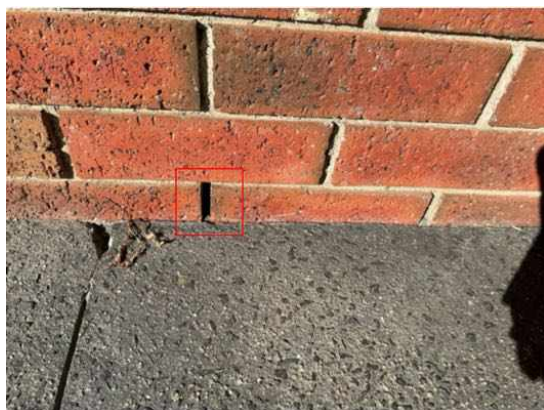
Defects 3.05

Building: Main Building
Location: All External Areas
Finding: Insufficient Clearance to External Weep Holes
Information: Inspection revealed that the external weep holes around the base of the external walls have insufficient clearance, with landscaping materials such as soil positioned directly beneath or against them. Weep holes are essential for allowing moisture within the wall cavity to escape and for enabling ventilation of the internal wall space.

When weep holes are obstructed or have inadequate clearance, their function is compromised. This can result in moisture being trapped within the wall cavity, leading to potential structural deterioration, rising damp, or even termite ingress—especially in timber-framed dwellings.

It is recommended that the landscaping be adjusted to ensure a minimum vertical clearance of at least 75mm below the lowest part of the weephole. This will allow for proper drainage and ventilation and help protect the structural integrity of the property.

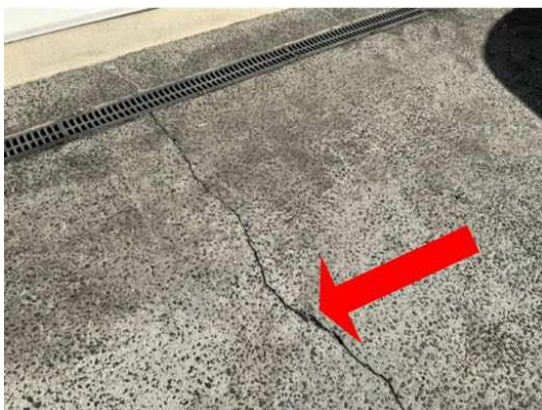
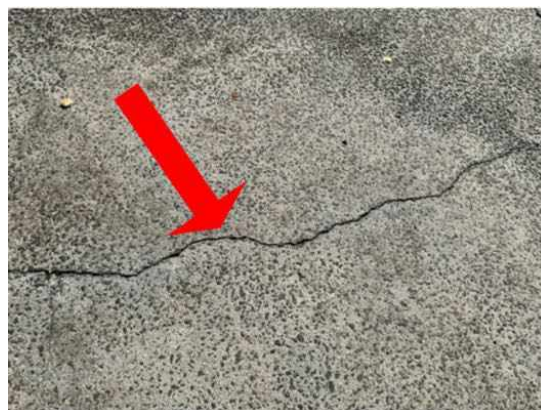
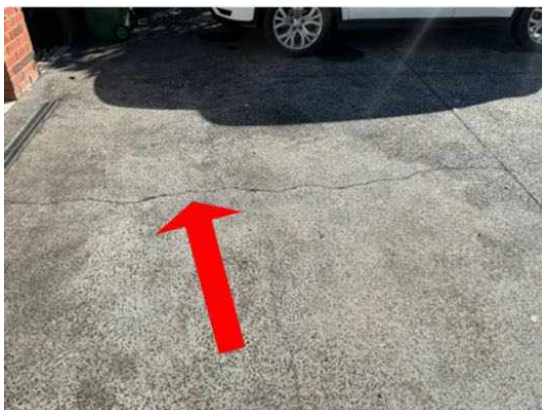
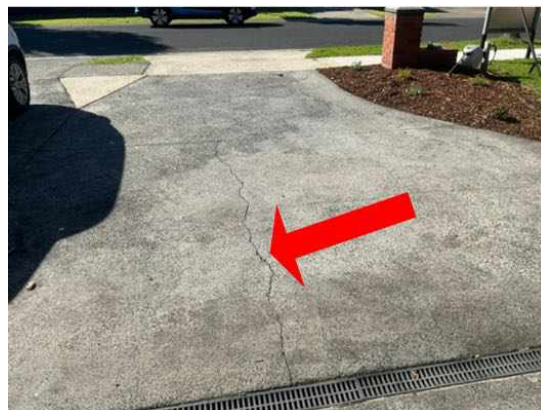
Defects 3.06

Building:	Main Building
Location:	Driveway
Finding:	Cracking - External Concrete Driveway - Damage Category 3 - Wide Cracks (2mm - 4mm)
Information:	Wide cracks were identified in external concrete driveway. Wide cracks are significant and are likely to lead to the development of safety hazards and secondary defects if left unmanaged.

General age and expected deterioration of the paved areas is a common cause of this type of cracking. However, expansion and contraction of the slab may also have occurred due to environmental factors. Such factors include variable moisture and weather conditions, the presence of trees and their roots having a settling or lifting affect on the soil, or the effect of load bearing, e.g. heavy vehicles over a sustained period of time.

Cracking to this degree may also be due to poor original installation of the concrete. Factors such as poor compaction of the sub surface and/or inadequate reinforcing of the slab may create cracking and other secondary defects. Wide cracks may also have a more significant structural cause, such as subsidence of soils.

Where the crack is located adjacent to structural elements of the building, the advice of a Structural Engineer is advisable before undertaking repairs. Significant repair and likely replacement of the concrete paving is probable.

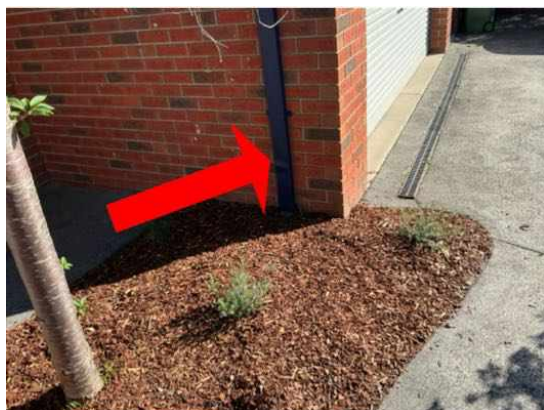
Defects 3.07

Building: Main Building
 Location: Exterior walls - front
 Finding: Stormwater Drainage – Dented Downpipe (Front LHS of Garage)
 Information:

One of the downpipes located on the front elevation at the left-hand side (LHS) of the garage wall was observed to be dented. No significant damage or leakage was noted at the time of inspection.

This condition is considered minor and primarily cosmetic; however, deformation of the downpipe may slightly restrict water flow if severe or worsen over time.

Rectification can be carried out at the client's discretion. If required, a licensed plumber can assess and repair or replace the affected section to ensure optimal performance and appearance.

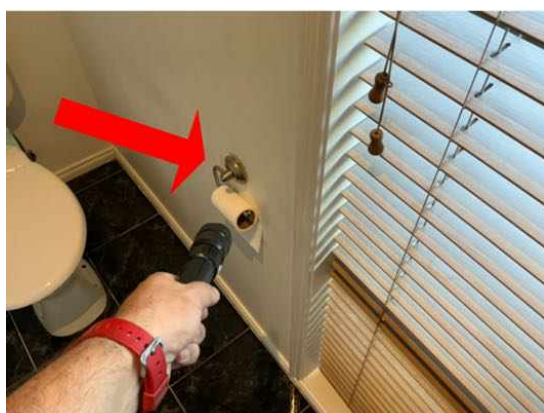
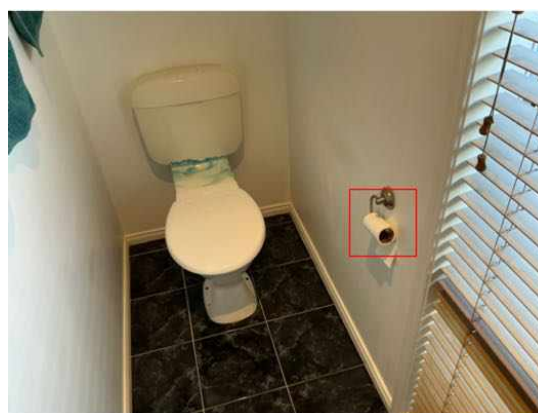
Defects 3.08

Building:	Main Building
Location:	Ensuite
Finding:	Toilet roll holder - Loose
Information:	The toilet roll holder was found to be loose at the time of inspection. While not a major operational defect, function can deteriorate if the problem is left unmanaged.

It is advised that the homeowner performs remedial works to re-attach the toilet roll holder to its original fixing. A general handyperson may be required to perform these works.

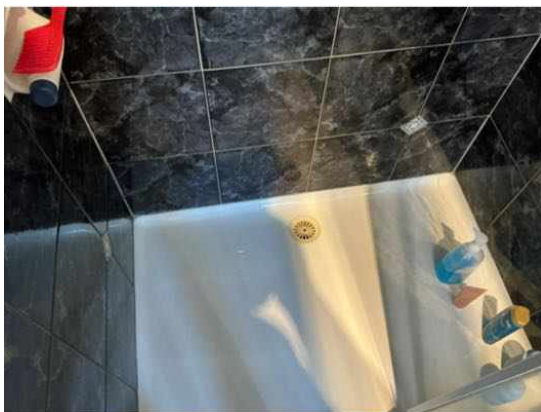
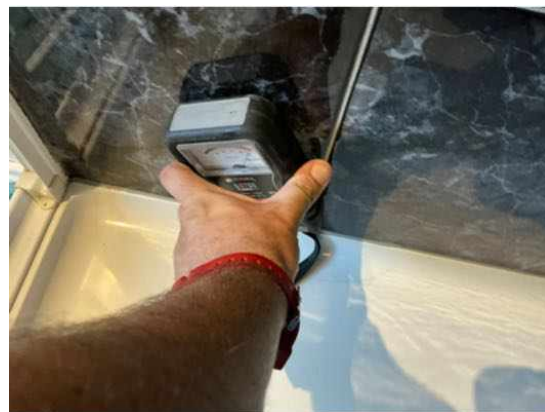
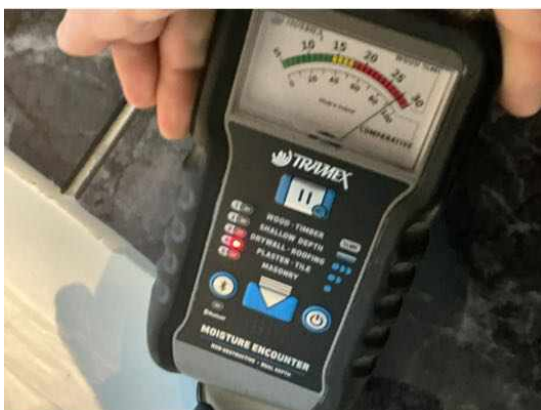
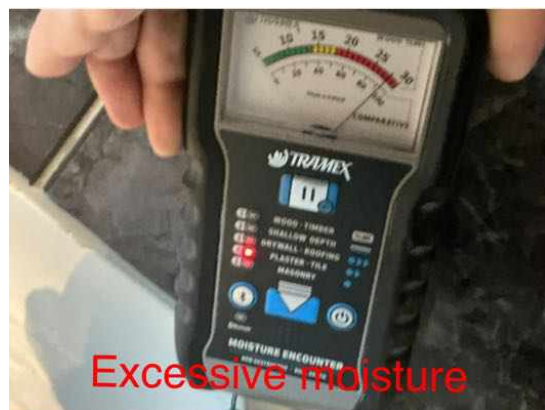
Defects 3.09

Building:	Main Building
Location:	Ensuite
Finding:	Shower - Damp
Information:	Damp is evident to the lower 300mm of wall to the shower alcove. This defect is quite common, and is suspected to have been caused by moisture permeating through the grouting in this area, which shows evidence of deterioration. Leaking pipes within the adjoining wall is also a possible cause.

Damp (or structural damp) refers to the presence of unwanted moisture in the

structure of a building, either as the result of intrusion from outside, or condensation from within the structure. In the shower area, internal water leaks or other sources of excessive moisture are generally the cause of damp.

Unmanaged damp in the shower recess is likely to facilitate the formation and development of mould and fungi growth, decaying associated building materials and compromising their structural integrity. It is important to address damp conditions, as the World Health Organisation notes that excess moisture leads - on almost all indoor materials - to growth of microbes such as moulds, fungi and bacteria, which subsequently emit spores and other matter into the indoor air. Exposure to these contaminants is associated with a wide range of respiratory and other health-related problems.

Consultation with a qualified plumber or bathroom specialist is advised immediately to identify the cause of damp and to perform remedial works as required. Where excessive mould growth is present, further inspection by a specialist environmental health inspector should also be considered.

Always ensure that sealant and grout is in good condition to prevent any moisture issues occurring in the future.

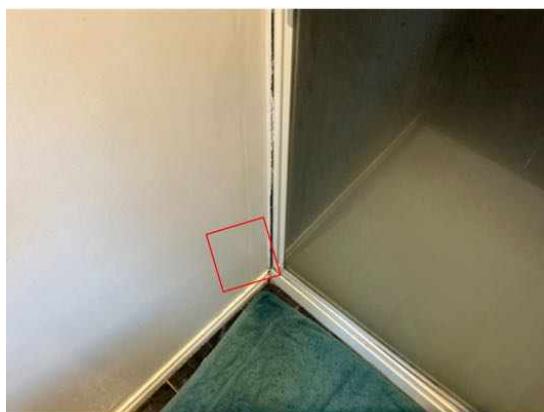
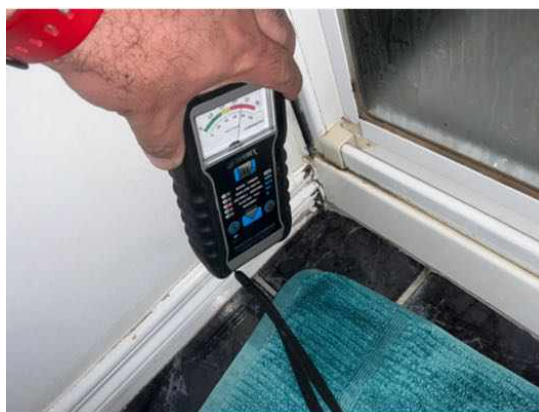
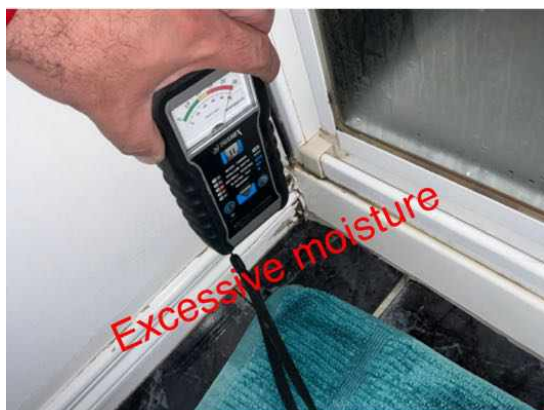
Defects 3.10

Location: Ensuite
 Finding: Elevated Moisture Readings to Adjacent Wall
 Information:

Elevated moisture readings were detected to the plaster wall adjacent to the shower, and the skirting board in this area shows signs of moisture-related deterioration.

This condition may be associated with minor water ingress, potentially from shower usage or localised sealing issues. At the time of inspection, no extensive damage was evident; however, ongoing moisture exposure may lead to further deterioration if not addressed.

It is recommended that a licensed plumber be engaged to inspect the shower area and confirm the source of moisture. Any defective seals or joints should be rectified, and the affected skirting board replaced if required. Ongoing monitoring is advised following repairs.

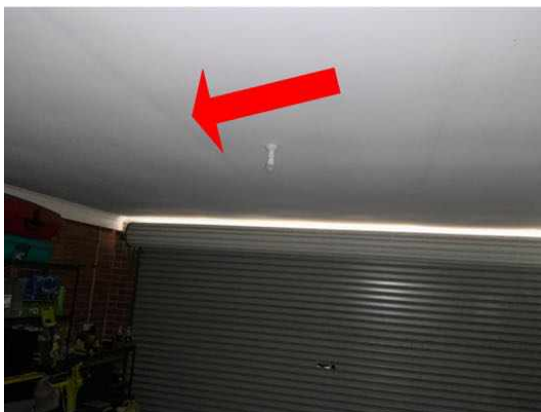
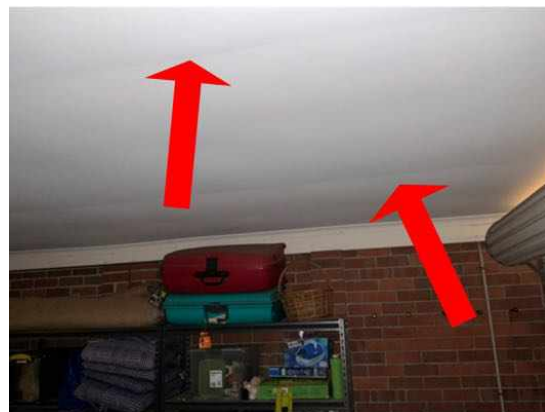
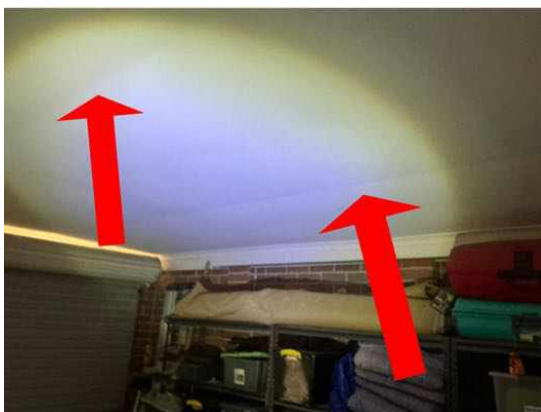
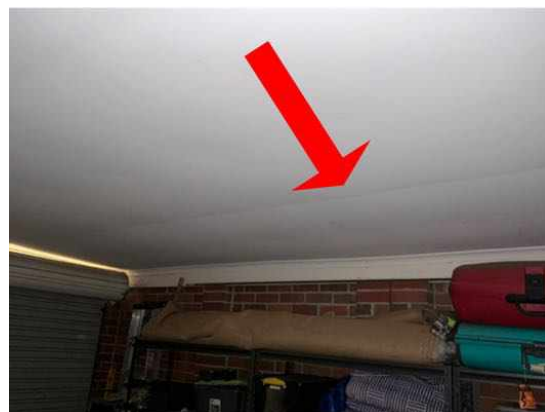
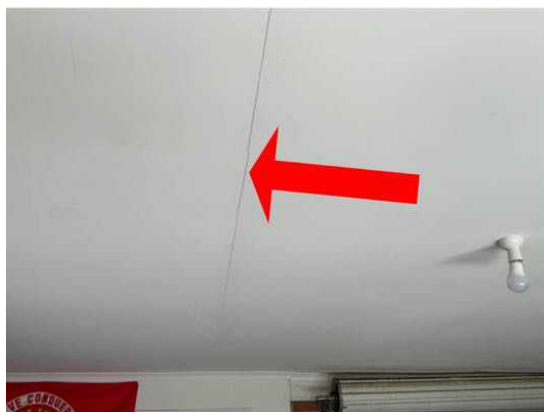
Defects 3.11

Building: Main Building
 Location: Garage
 Finding: Ceiling sagging - Garage
 Information: Sections of the ceiling were found to be sagging at the time of inspection. Sagging to the fixed ceiling structure generally indicates that the building materials have swollen,

due to contact with water, or that fixings (e.g. nails or glue) have become loose and require reattachment. This is a very common defect in carports due to their lack of insulation and or their susceptibility to moisture. Condensation builds up in the roof and rests on the plasterboard softening it somewhat which makes it more likely to sag and release from its fixing points.

Where minor sagging is evident, comparatively minor works, such as re-gluing of ceiling sheets, may be required. Such works may be performed by relevant tradespeople, such as plasterers and painters. Where excessive moisture has caused the roofing structure to swell and sag, the source of the water leak should primarily be identified prior to any remedial works being performed.

While damage is minimal at this stage a licensed plasterboard contractor should be appointed to repair the ceiling. Insulating the area could be considered by the client once repaired.

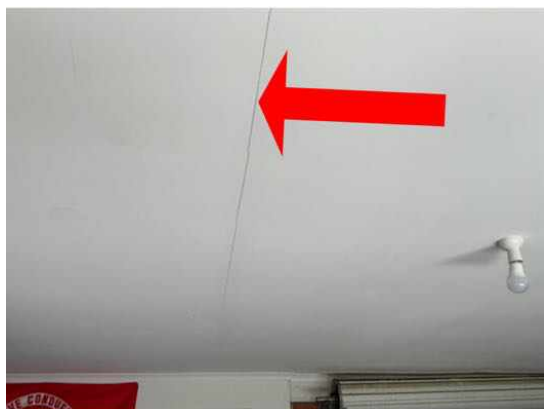
Defects 3.12

Building:	Main Building
Location:	Garage
Finding:	Cracking - Damage Category 2 - Noticeable - Garage ceiling
Information:	Noticeable cracks are a common occurrence as a result of many primary defects. Such causes may include age, general wear and tear, expected building movement, general expansion/contraction of building materials in different weather conditions, and/or minor failings in the installation or application of building materials.

Noticeable cracks may result in minor sticking or jamming of associated doors and windows, which require easement. However, noticeable cracks are easily filled and repaired. A plasterer can be consulted to install an expansion joint at this point to allow for this movement during different weather conditions.

Monitoring of all cracking should be conducted frequently. Always contact a building inspector should cracks widen, lengthen, or become more numerous. Additionally, your building inspector should also be contacted if associated building elements such as doors and windows become more difficult to operate over time.

Relevant tradespeople, such as carpenters, painters and plasterers, should be appointed to perform remedial works, as deemed necessary.

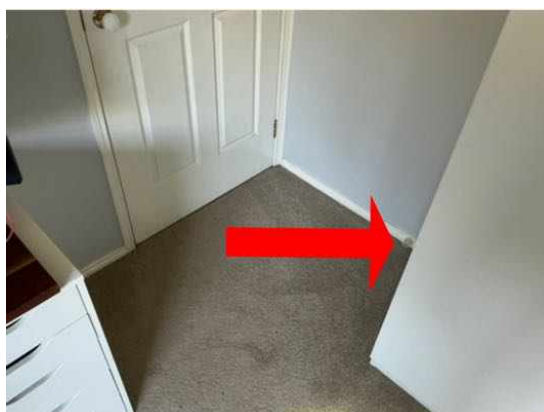
Defects 3.13

Building:	Main Building
Location:	Bedroom 2
Finding:	Door stop - Missing
Information:	The door stop is missing or is inadequate to stop the door handle from damaging the wall. Although some building elements may seem irrelevant or unnecessary, all building elements play a key role in the operation and function of the overall structure and its performance.

Re-installation or replacement of the door stop is advised as soon as possible to prevent any subsequent damage to the door or associated structures. A general handyman may be appointed to perform these works at client discretion.

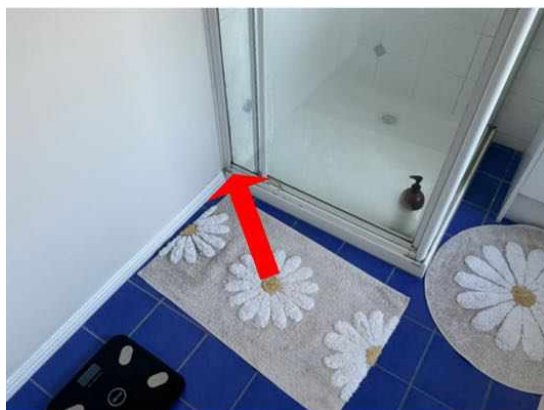
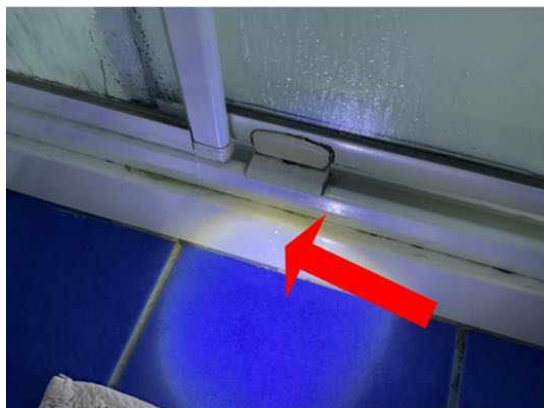
Defects 3.14

Building:	Main Building
Location:	Bathroom 2
Finding:	Shower screen - Leaking
Information:	Leaking was evident to the 2nd bathroom's shower screen at the time of inspection. It is suspected that the leaking has occurred as a result of deteriorated or missing caulking to the shower or general ageing of the building elements.

Leaking from the shower where left unattended, is likely to lead to water damage to adjoining flooring and walls. Such damage can lead to water damage and necessitate extensive remedial works being required. Active water leaks may also create an environment that is susceptible to the formation and development of mould.

Appointment of a caulking contractor is required to repair or replace the caulking to the shower area. Such works should be performed as soon as possible to ensure that no further damage occurs.

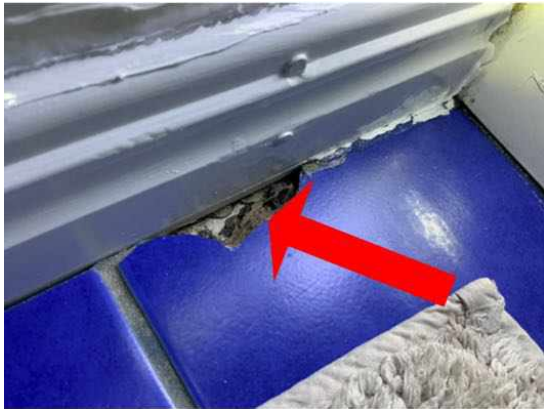
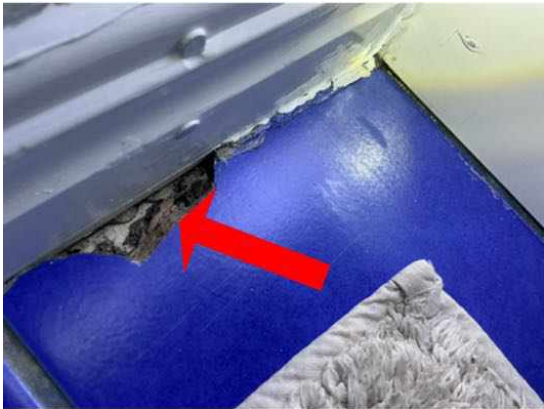
Defects 3.15

Building:	Main Building
Location:	Bathroom 2
Finding:	Floor tiles - Cracked
Information:	Cracking in the floor tiles was evident in 2nd bathroom at the time of inspection. It is suspected that this cracking has occurred as a result of the floor being uneven and lacking a solid or suitable foundation for the tiles to be laid on. Settlement in the floor foundations may also have caused movement and resulted in the cracking of tiles in this area.

Cracked tiles throughout the household detract from the overall appearance of the affected areas, as well as creating potential for water penetration to adjoining building elements. If left unmanaged, water damage may occur as a result of constant water penetration over a prolonged period of time.

While not considered a matter of urgency, replacement of cracked floor tiles is advised as a solution. A tiling contractor or general handyperson may be appointed to perform these works at client discretion. Where cracks become more numerous, consultation with a registered builder specialising in re-stumping may be required.

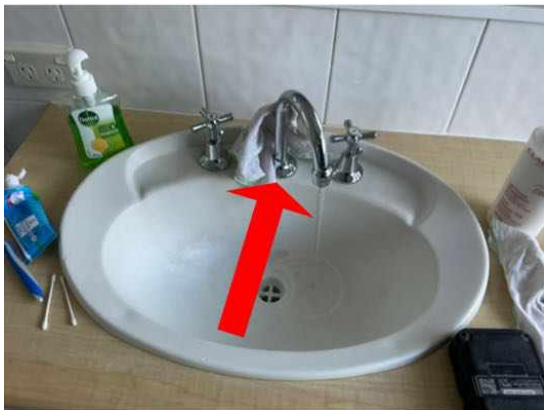
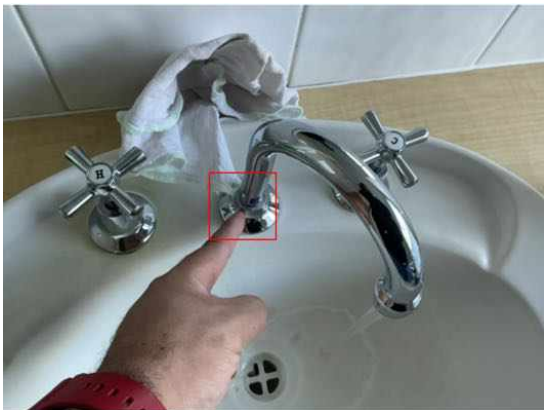
Defects 3.16

Building: Main Building
 Location: Bathroom 2
 Finding: Vanity Tap - Loose
 Information: The ink tap in the 2nd bathroom has deteriorated with age, and is consequently loose. This tap being loose creates potential for water leaks and subsequent water damage to the surrounding area.

Where taps or spouts are loose, a qualified plumber should be appointed to re-fix the plumbing fitting.

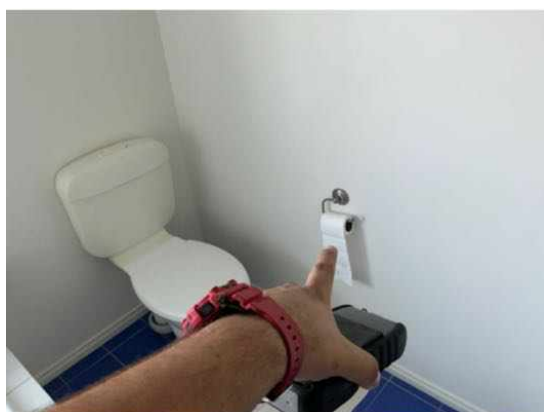
Defects 3.17

Building:	Main Building
Location:	Bathroom 2
Finding:	Toilet roll holder - Loose
Information:	The toilet roll holder was found to be loose at the time of inspection. While not a major operational defect, function can deteriorate if the problem is left unmanaged.

It is advised that the homeowner performs remedial works to re-attach the toilet roll holder to its original fixing. A general handyperson may be required to perform these works.

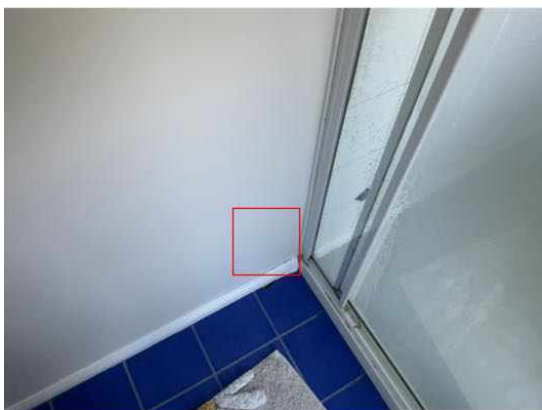
Defects 3.18

Building:	Main Building
Location:	Bathroom 2
Finding:	Excessive Moisture Detected in Plaster Wall Adjacent to Shower
Information:	During the inspection, elevated moisture levels were recorded in the plaster wall on the left-hand side of the shower using a moisture meter. Excessive moisture in this area can create conditions that promote termite infestations, fungal growth, and wood decay.

The moisture buildup may be caused by deteriorated or inadequate waterproofing, leaking plumbing pipes, or poor drainage around the shower area. It is highly recommended that a licensed plumber or builder investigates the source of the moisture and ensures that all plumbing and drainage fixtures are functioning properly to prevent further damage to the internal property. Regular maintenance of these systems is essential to prevent excessive moisture and associated risks.

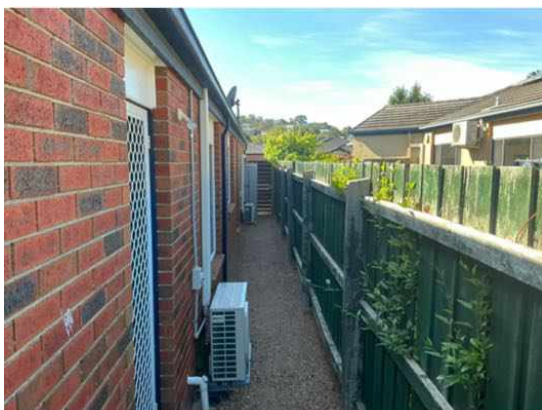
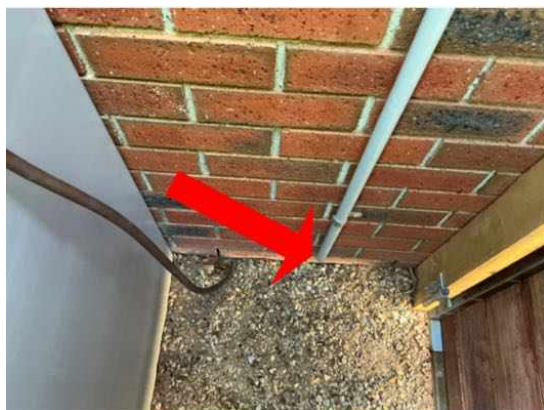
Defects 3.19

Building:	Main Building
Location:	Yard - Side
Finding:	AC Overflows - Not plumbed to suitable drainage
Information:	Upon inspection, it was found that the AC overflow is not plumbed or connected to suitable drainage. This could lead to the surrounding area becoming excessively damp, which in turn may cause secondary defects such as rot, rust, corrosion of associated building elements, and the formation of fungal decay. In addition, prolonged damp conditions could create potential slip hazards. Poor site drainage may exacerbate the issue, potentially attracting termite activity to the area.

We recommend that a licensed plumber be appointed to properly plumb the AC overflow and connect it to suitable drainage. This will help ensure that the area remains dry and free from secondary defects.

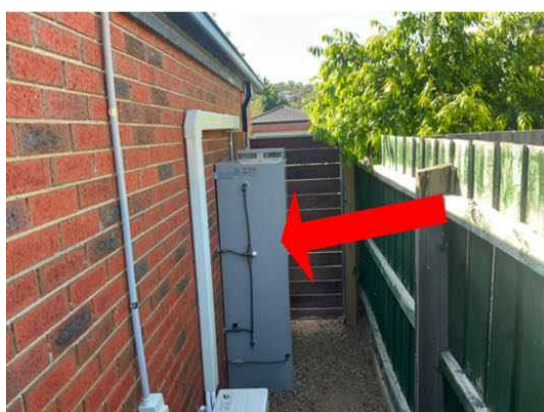
Defects 3.20

Building:	Main Building
Location:	Yard - Side
Finding:	HWS Overflow - Not Connected
Information:	The Hot Water System (HWS) overflow was found to be disconnected from storm water drainage and is creating excessive moisture in the surrounding area.

These damp conditions can lead to secondary defects such as rot, rust or corrosion of associated building elements, the formation of fungal decay, or even the creation of potential slip hazards. When coupled with poor site drainage, pooling of water may also attract termite activity to this area.

It is highly recommended that a licensed plumber be appointed to connect the HWS overflow in order to prevent such an environment from being created. These minor works should be carried out as soon as possible.

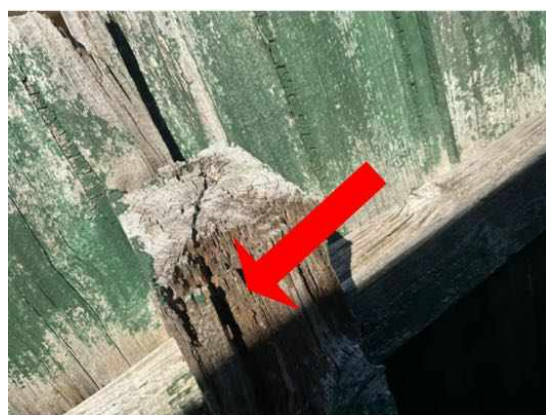
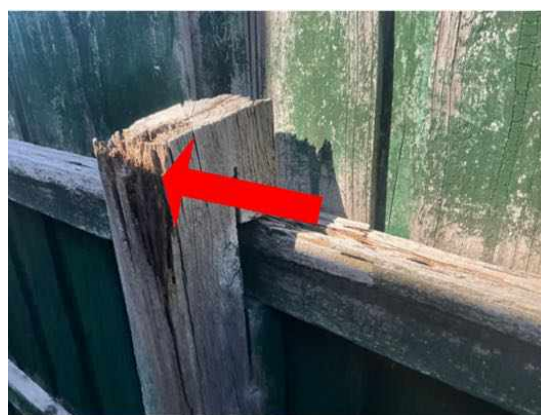
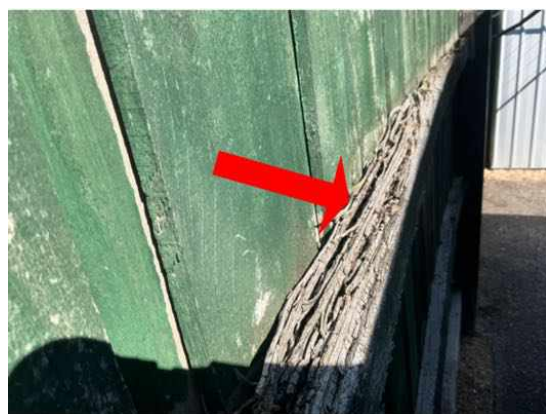
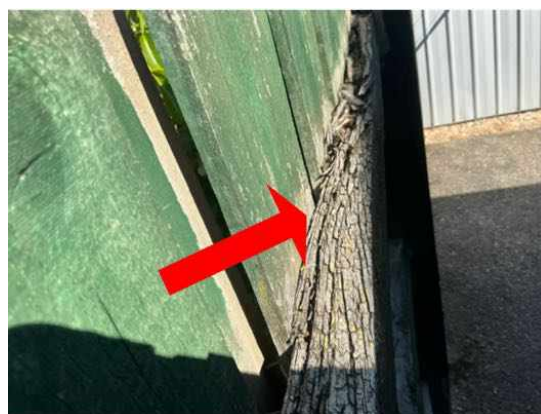
Defects 3.21

Building:	Main Building
Location:	Fencing
Finding:	Fencing - Deteriorated and wood rot
Information:	It was noted at the time of inspection that sections of the fencing throughout the

property have deteriorated, exhibiting signs of wood rot, which is a form of fungal decay. Fungal decay occurs when wood is exposed to moisture over time, allowing fungi to break down the wood fibers, leading to structural weakness. This deterioration is typically caused by age, wear, and prolonged exposure to weather conditions. Inadequate installation or maintenance may also contribute to the issue.

If left unattended, the extent of the damage is likely to worsen, further compromising the integrity of the fencing. While repair of several elements of the fencing may be required, complete replacement should also be considered by the client.

It is recommended that a licensed fencing contractor be appointed to assess the condition of the fencing, provide further advice, and perform necessary rectification works. Addressing this issue promptly will help prevent further deterioration and ensure the safety and stability of the fencing.

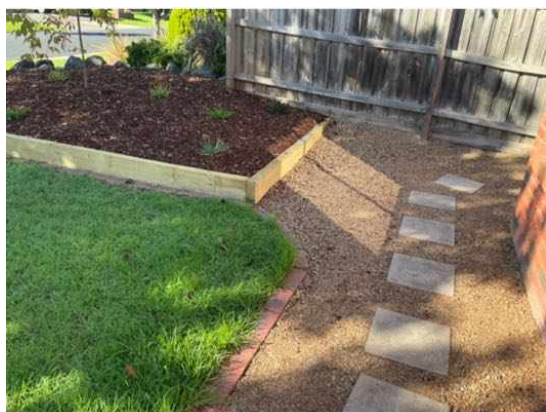
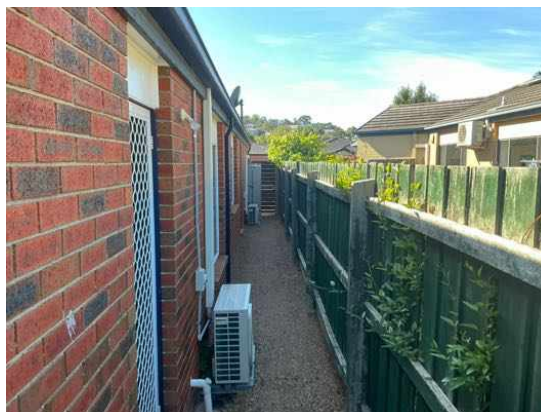
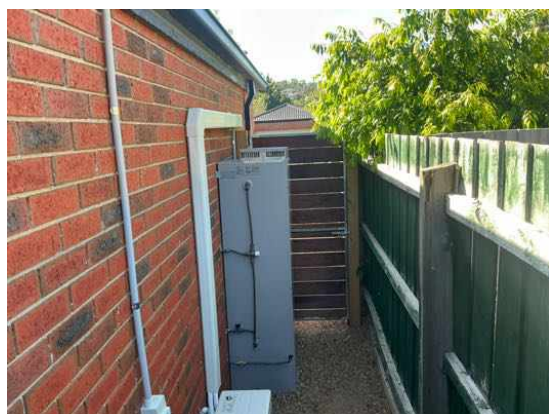
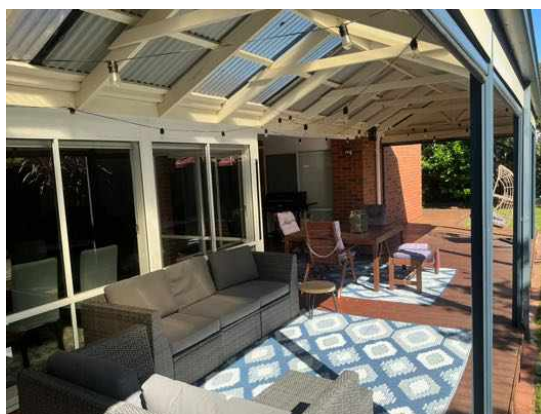
Noted Item

Building: Main Building
 Location: All External Areas
 Finding: Obstructions and Limitations - Exterior
 Information: These photographs are an indication of the obstructions and limitations which impeded the inspection of the external areas of the property at the time of inspection. These obstructions can hide an array of defects and should be removed to allow full inspection to be carried out. A re-inspection is recommended once the areas are made accessible.

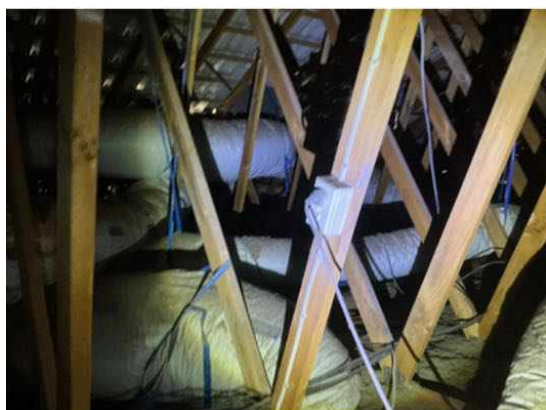
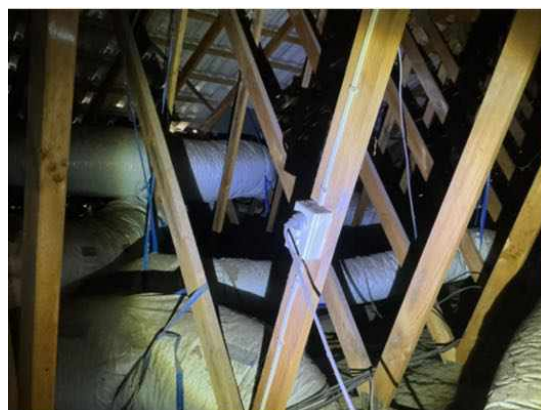
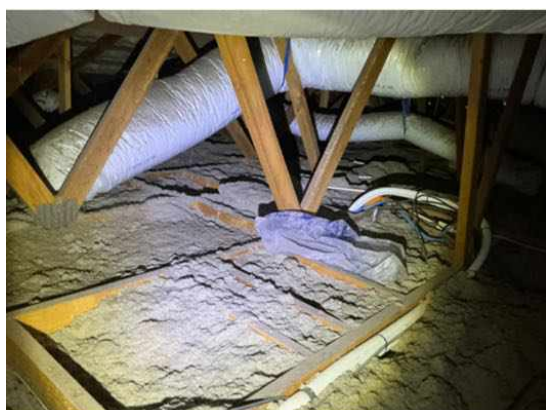
Noted Item

Building: Main Building
 Location: Roof Void
 Finding: Obstructions and Limitations - roof cavity
 Information: These photographs are an indication of the obstructions and limitations which impeded the inspection of the roof cavity area of the property at the time of inspection.

These obstructions can conceal an array of defects including structural deficiencies, moisture ingress, insulation concerns, timber pest activity and non-compliant building alterations. Although reasonable attempts were made to access and inspect the roof cavity to the extent safely possible, inspection coverage was limited due to the restricted entry conditions.

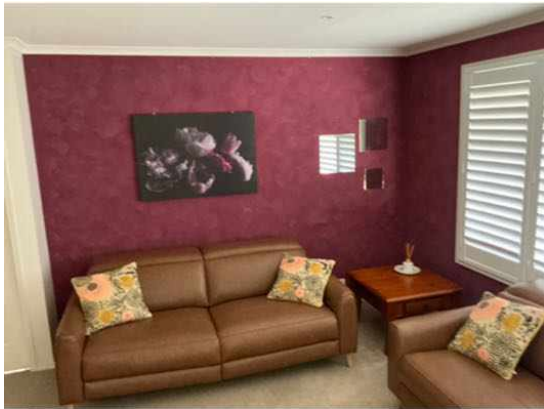
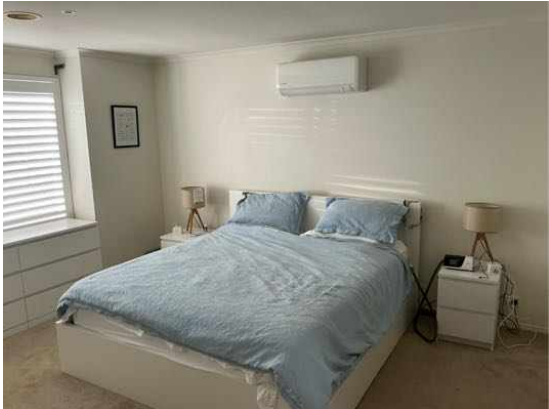
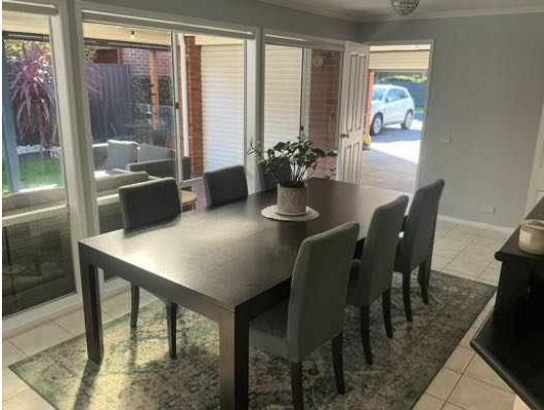
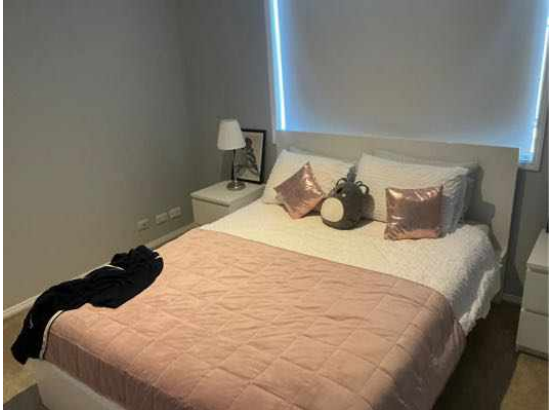
Noted Item

Building:	Main Building
Location:	All Internal Areas
Finding:	Obstructions and Limitations - Interior
Information:	These photographs are an indication of the obstructions and limitations which impeded the inspection of the internal areas of the property at the time of inspection. These obstructions can hide an array of defects and should be removed to allow full inspection to be carried out. A re-inspection is recommended once the areas are made accessible.
