Building and Timber Pest Inspection Report

Inspection Date: Thu, 19 Feb 2026

Property Address: 16 Dundas St, Wangaratta VIC 3677,
Australia

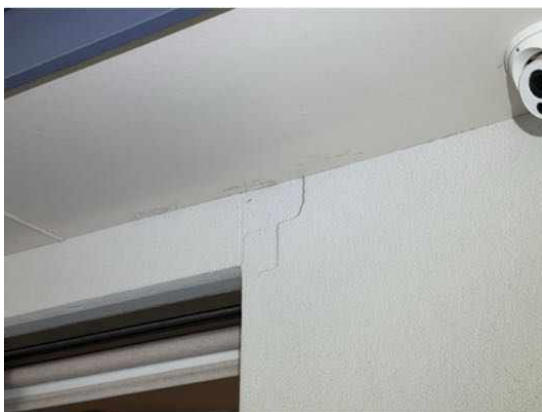
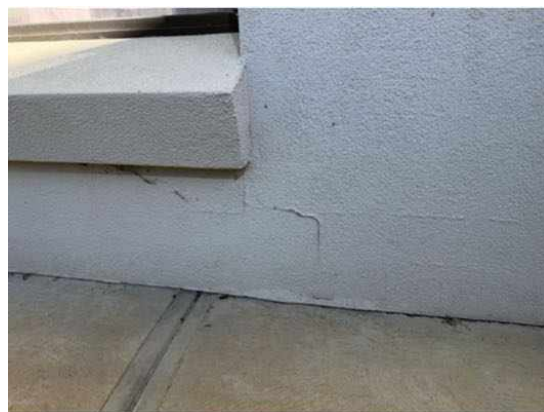
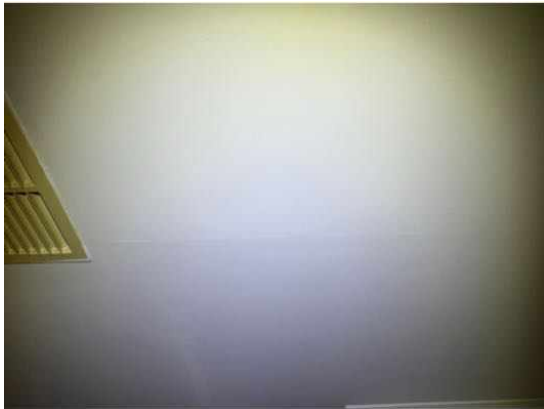
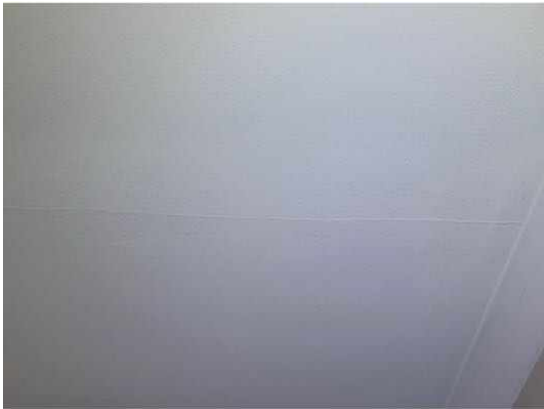
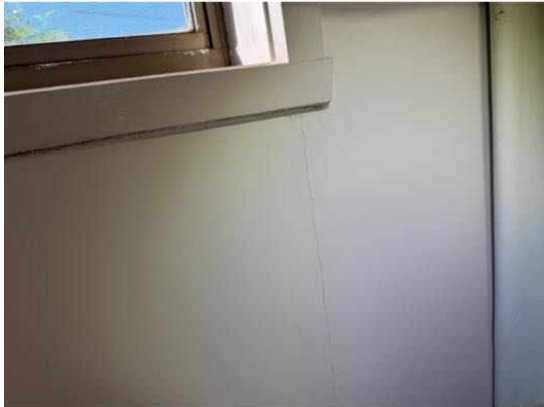
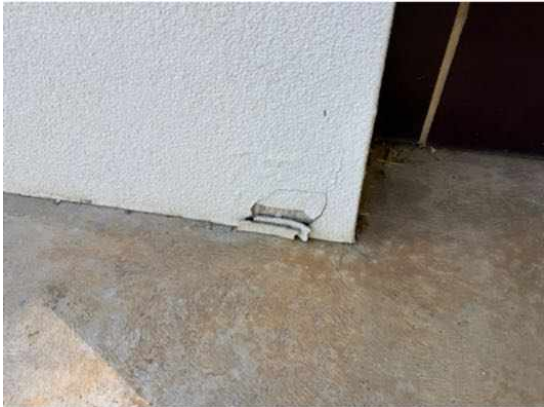
Finding 3.01

Building:	Main Building
Location:	Brickwork, Plaster
Finding:	Cracking - External & Internal
Information:	Cracking was identified to some areas of the brickwork and internal wall linings at the time of inspection. Cracking has a variety of possible causes, however, the most common is general movement of adjacent footings and/or expansion / contraction of building materials.

Cracking is a relatively common defect, and is most likely to occur adjacent to windows, doors and other openings.

The client should monitor the cracking. Should the cracking lengthen, widen or become more numerous, the client should consult with a structural engineer promptly to provide further advice.

All areas of internal and external cracking should be closely monitored to identify any further movement. Should cracking lengthen, widen, or become more numerous, a structural engineer should be engaged, for further evaluation.

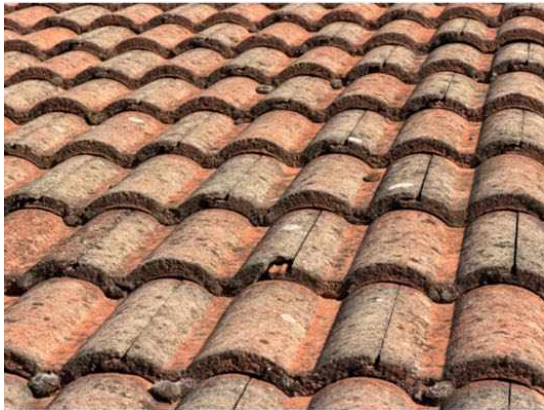
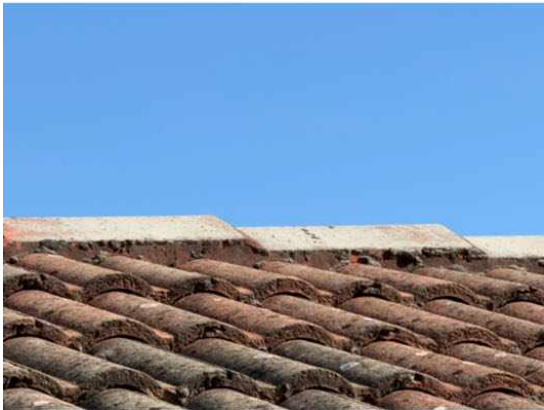
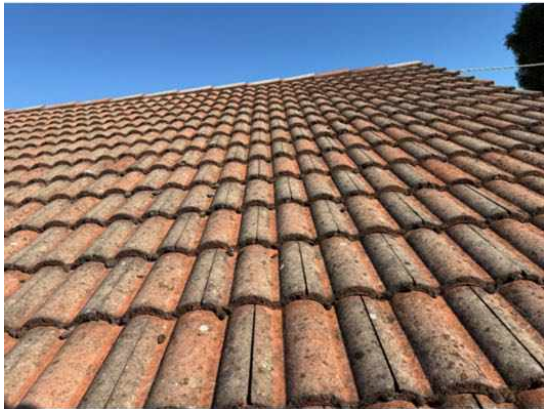
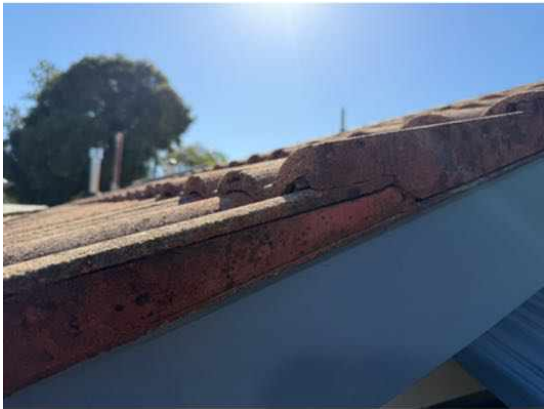
Finding 3.02

Building: Main Building
 Location: Roof Exterior
 Finding: Roof Exterior - Weathered, Cracking
 Information: Areas of general weathering & cracking/chipping of the roof exterior were noted. While weathering of the tiles is consistent with the age of the property, maintenance works are advised, to ensure the longevity of the roof exterior.

Recommend consulting with a licensed roofing contractor in the short term, to provide further advice on maintenance works required.

General weathering and cracking was identified to the roof exterior. Recommend consulting with a licensed roofing contractor at clients discretion, to provide further advice regarding future maintenance works needed.

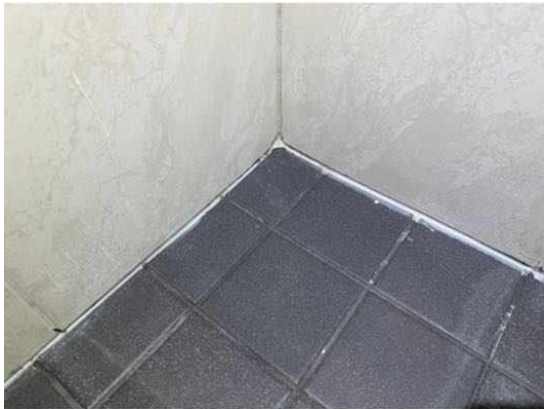
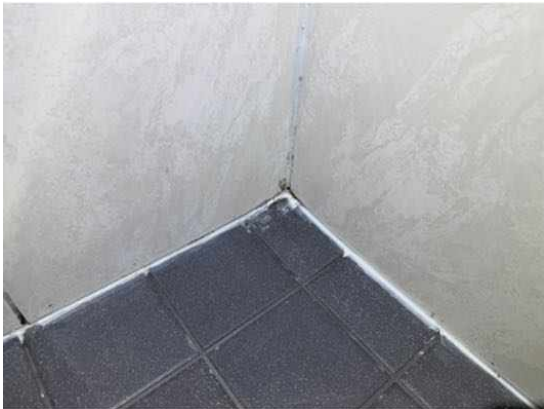
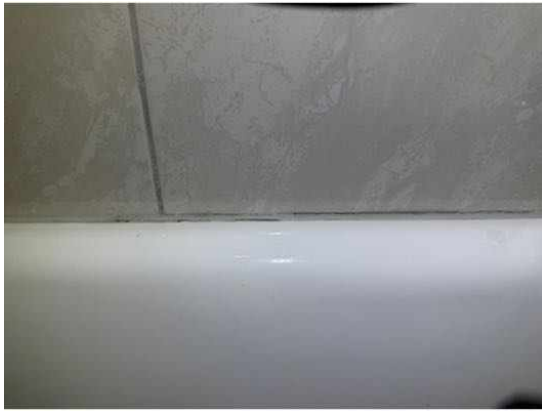
Finding 3.03

Building: Main Building
Location: Tiled Areas, Shower
Finding: Sealant and grouting - deteriorated or missing
Information: It appears that the sealant and grout is not present or has deteriorated, in some tiled areas.

Sealant and grouting in areas that come into regular contact with water should be maintained for the long term care of your property.

A sealant specialist or tiling contractor should be appointed to complete these minor works, to prevent the potential development of secondary building defects overtime.

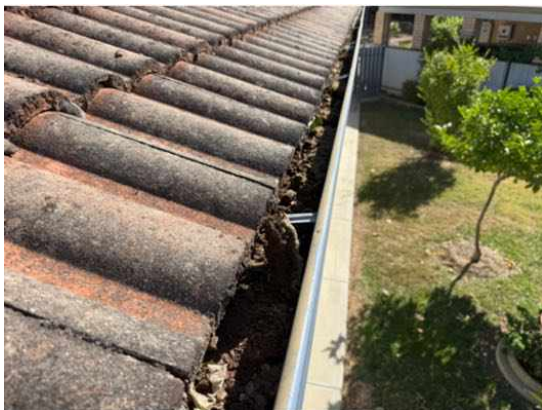
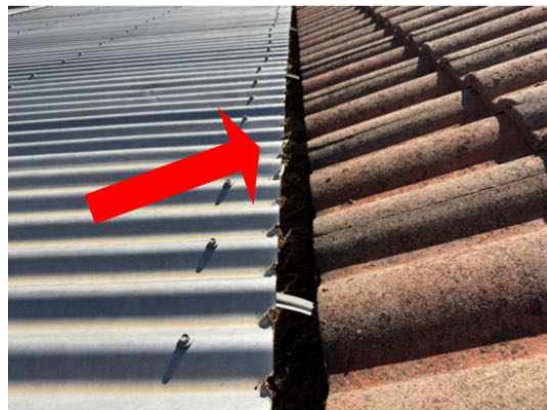
Finding 3.04

Building: Main Building

Location: Gutters

Finding: Debris in Gutters

Information: It appears that there is some debris in the gutters. Accumulation of debris can lead to blockages of the gutters & water overflows, if neglected.

Recommend engaging a general handyman to remove all debris from the gutters promptly to prevent overflows & blockages.

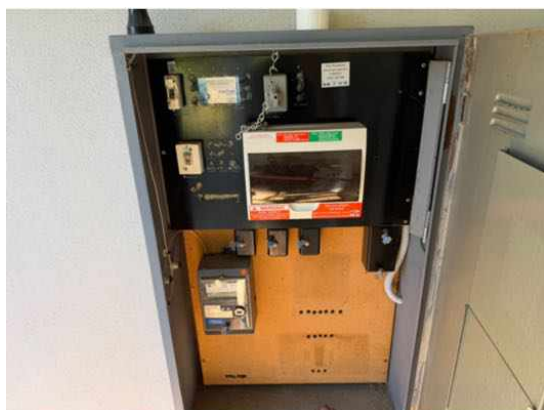
Finding 6.01

Building: Main Building
Location: Switchboard
Finding: Termite Management System - no evidence of a chemical installation
Information: The application of a termite barrier is recommended, as it appears no termite management system has been installed, with no evidence or durable notice to suggest works taking place. Generally, a durable notice is placed in the meter box to indicate current termite barriers.

Such barriers are highly effective in preventing termite attack on the building and therefore should be installed.

Recommend seeking further advice from a licensed pest controller.

Installation of a termite barrier is recommended as there was no evidence of installation of a previous termite management system. 12 monthly termite inspections, conducted by a qualified termite inspector are also advised. Recommend engaging a licensed pest controller, to provide further advice.

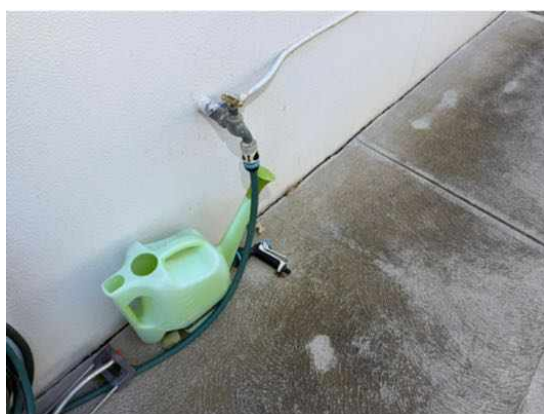
Finding 6.02

Building: Main Building
Location: Tap
Finding: Potential Water pooling - against property
Information: Potential areas of water pooling around the perimeter of the property were identified. Where insufficient drainage of taps are present, water pooling is likely to occur, and can create areas conducive to timber pests. Recommend consulting with a licensed plumber to provide further advice.

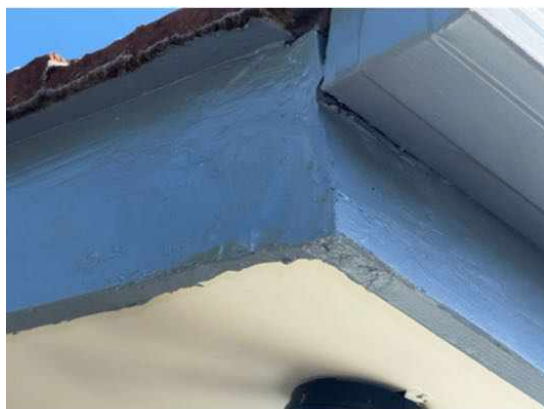
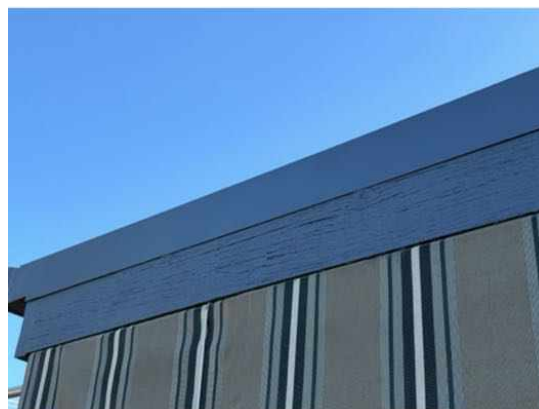
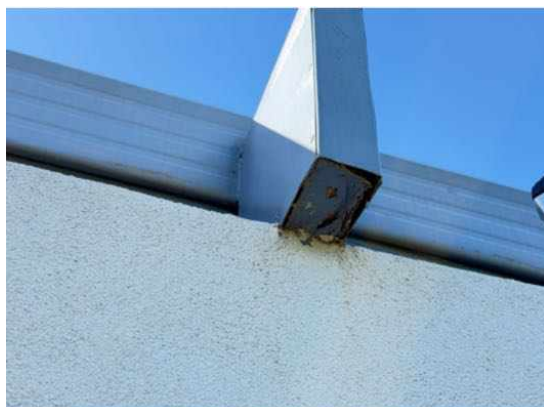
Finding 7.01

Building:	Main Building
Location:	Carport Beams, Fascias
Finding:	Fungal decay & weathering
Information:	Areas of fungal decay (wood rot) were identified at but not limited to the fence, carport beams & fascias. For areas of fungal decay, it is advised that the client monitor these areas. Should further deterioration occur, a licensed carpenter can be engaged at clients discretion to provide maintenance works.

For areas of general weathering, it is advised the client engage a licensed painter to apply protective sealant or coating to areas of weathered external timbers.

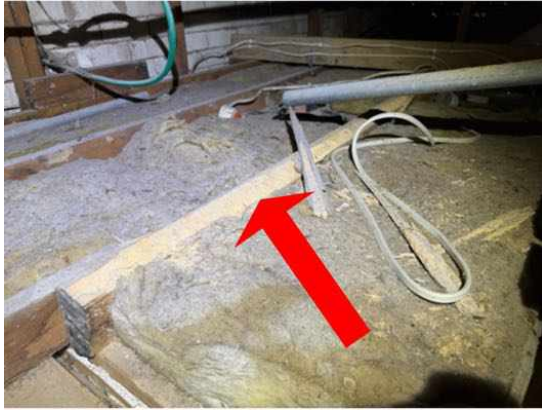
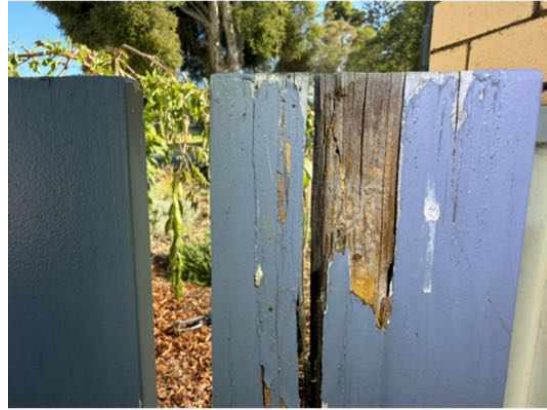
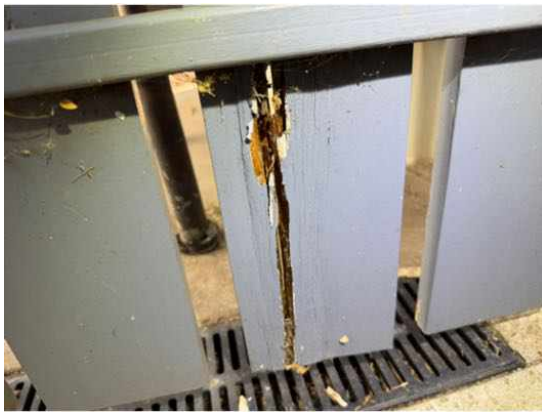
Finding 8.01

Building:	Main Building
Location:	Roof Void, Fence
Finding:	Evidence of wood borer damage identified (powder-post)

Information: Evidence of previous Lyctus Borer (powder-post beetle) damage was identified in the roof void at but not limited to the edge of a timber batten and to the front fence. Wood borer damage is generally considered superficial damage to the affected timber. As no live wood borer activity was identified treatment is not required.

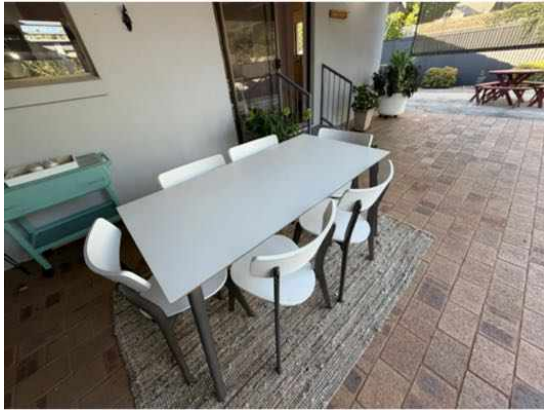
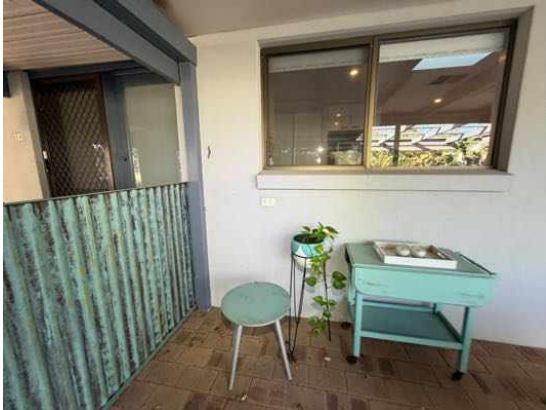
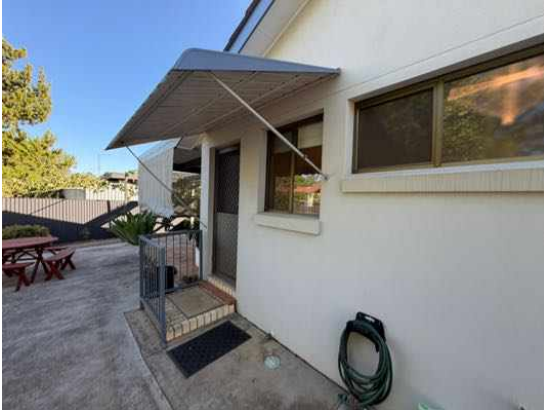
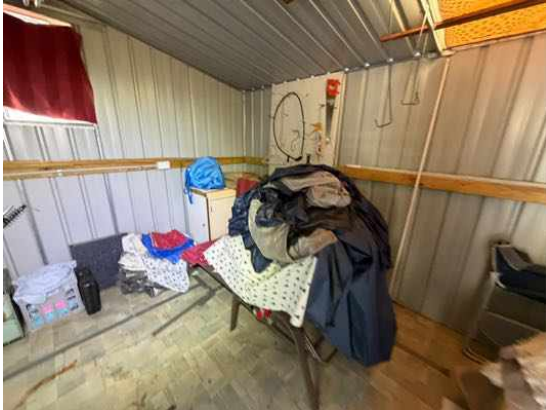
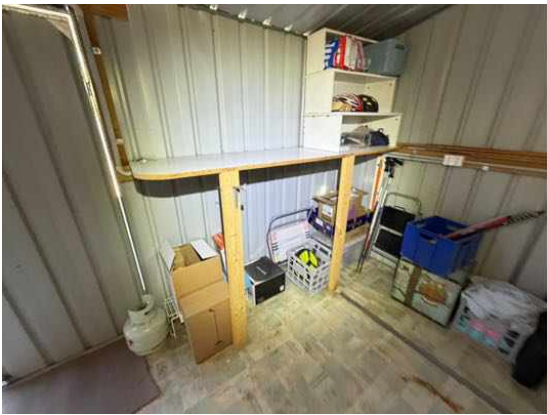
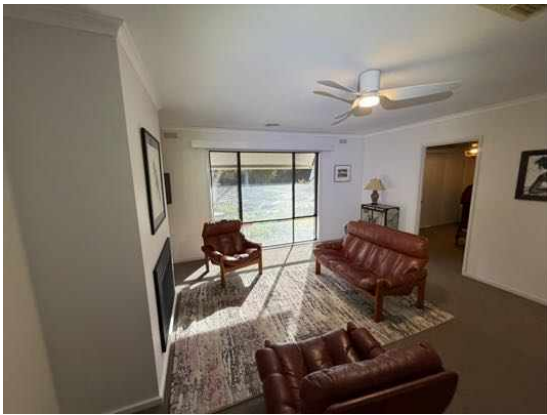
Building: Main Building
Location: All Areas
Finding: Additional Photos - Obstructions and Limitations
Information: These photographs are an indication of the obstructions and limitations which impeded full inspection of the property at the time of inspection. These obstructions can hide an array of defects and should be removed to allow full inspection to be carried out. A re-inspection is recommended once the areas are made accessible.

Several limitations and obstructions impeded the inspection and, if feasible, should be removed, and a further inspection should be performed. The roof void was unable to be fully inspected due to low clearance, ductwork and obstructions. Indicative images below depict some of the obstructions encountered.

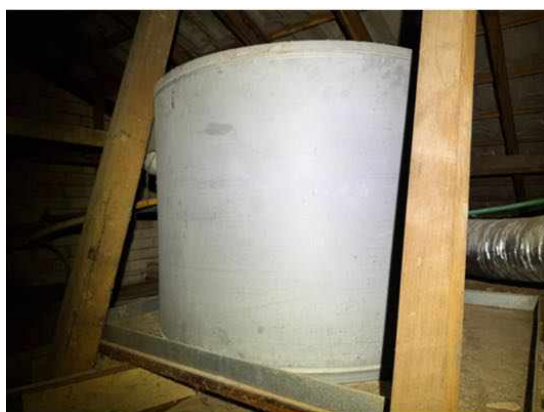
Building: Main Building
 Location: Roof Void
 Finding: Gravity-Fed HWS - Disconnected
 Information: A disconnected gravity-fed hot water system (HWS) remains in the roof void.

Despite this plumbing system being unused, it may contain residual water. If neglected, rust of the system overtime, may lead to residual water leaking.

Recommend that the client either monitor the condition of the system or get the system drained by a licensed plumber to prevent any potential future leaks.

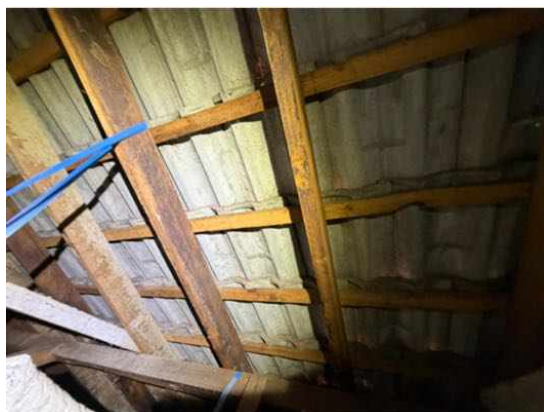
Building: Main Building
 Location: Roof Void
 Finding: Sarking - Not Present
 Information: It is noted for your information that sarking has not been installed on the roof, a common finding in buildings of a similar age. Sarking is a laminated aluminium foil applied to the interior of the roof covering, assists in insulating the property and acting as a vapour-barrier to the roof void.

The client can consult with a licensed roofing contractor at their discretion, to provide further advice.

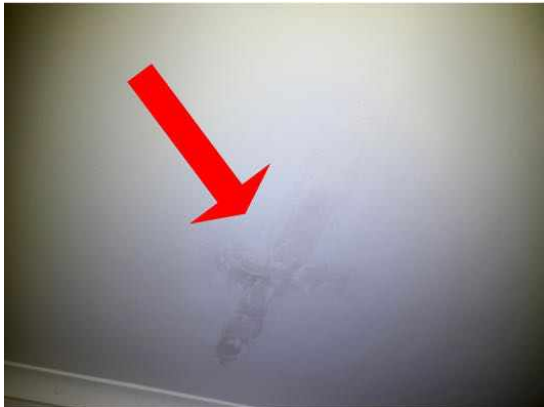
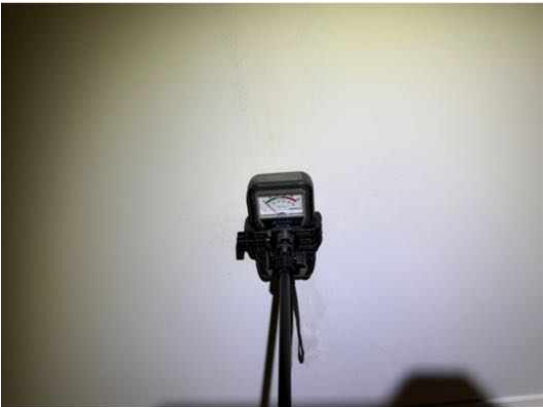
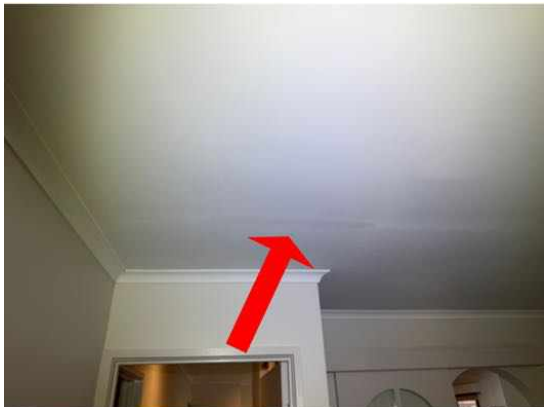
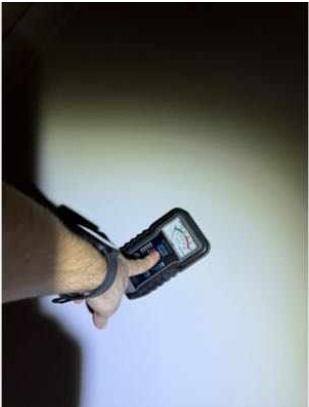
Building: Main Building
Location: Lounge room, Front bedroom/Study
Finding: Ceiling Marks
Information: It appears that some marks were identified at, but not limited to the front bedroom/study and lounge room ceiling. No high moisture was evident in these areas at the time of inspection. It is recommended that the client monitor these areas.
