# Building and Timber Pest Inspection Report

Inspection Date: Fri, 27 Mar 2026

Property Address: 90 Carlisle St, Ingleburn NSW 2565,  
Australia

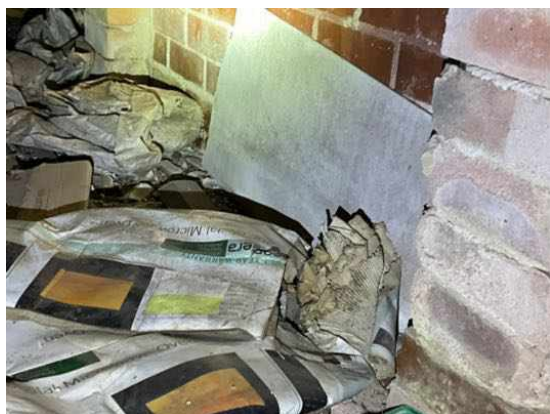
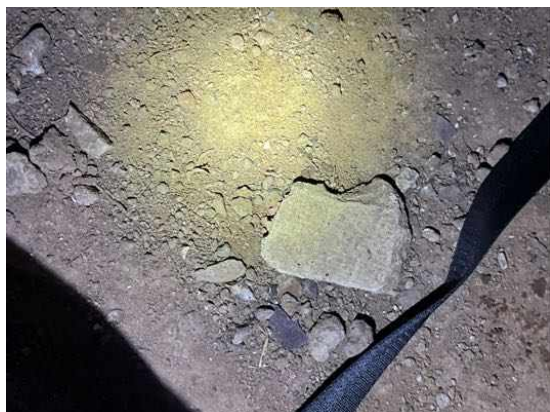
Building:	Main Building
Location:	All Areas
Finding:	Asbestos - Suspected ACM Identified on Site
Information:	Reporting on Asbestos is outside the Scope of this Report. This suspected defect is highlighted as a caution only. We suspect, based on our experience in the building industry, that there is a higher risk of the identified building element containing asbestos.

As Asbestos Reporting is outside the scope of this report, we advise that you consider a separate Asbestos Inspection and Condition Audit, which can include the taking of samples for definitive confirmation of the presence of Asbestos.

In the interim, the client is advised to act with caution, especially when considering any damage to building materials general wear and tear renovations extensions demolition and general maintenance activities due to the suspected presence of Asbestos.

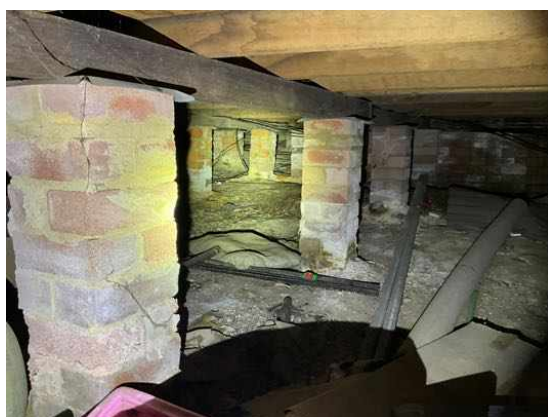
## Finding 1.02

Building:	Main Building
Location:	Subfloor
Finding:	Mould - Present
Information:	Mold growth is present throughout the property, primarily due to inadequate ventilation. Poor airflow and moisture accumulation within the house have created ideal conditions for mold to thrive.

- **Health Hazards**: Mold growth can pose serious health risks to occupants, particularly those with allergies, asthma, or other respiratory conditions. Prolonged exposure to mold spores can cause respiratory issues, skin irritation, and other allergic reactions.
- **Structural Damage**: Mold can degrade building materials over time, leading to rot and weakening of the structural components such as timber, drywall, and insulation, which can result in costly repairs.
- **Decreased Property Value**: The presence of mold can significantly reduce the value of the property, as it indicates underlying moisture and ventilation issues that need addressing.

A licensed mold remediation specialist should be engaged to remove the mold and treat affected areas. In addition, a ventilation expert or builder should assess and improve the house's ventilation system, possibly installing exhaust fans, vents, or mechanical ventilation systems to ensure adequate airflow and prevent future mold growth.

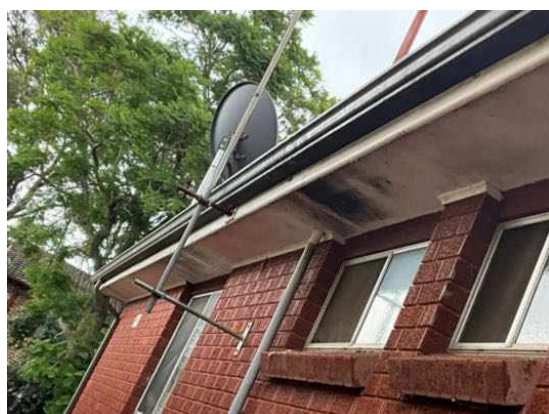
### Finding 2.01

Building:	Main Building
Location:	All Areas
Finding:	Eaves - water Stained
Information:	Water stains are present on eaves, indicating a potential water leak or seepage issue.

Prolonged water exposure can lead to structural damage, mold growth, and compromise the aesthetic appeal of the affected area. Additionally, it may indicate underlying issues that, if unaddressed, can escalate and result in more extensive damage.

A qualified plumber or water damage restoration specialist should investigate and address the source of the water stains. Repairing leaks, improving waterproofing, and, if necessary, restoring the affected surfaces are crucial to preventing further damage and maintaining the integrity of the space.

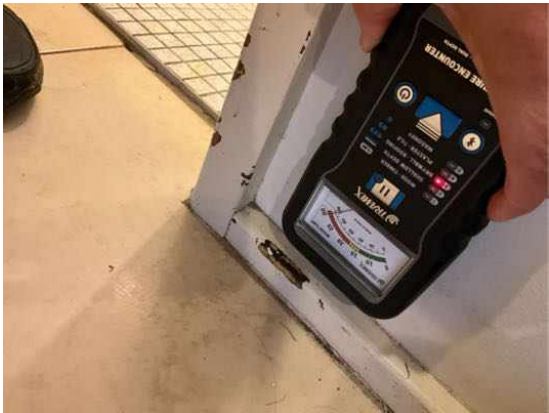
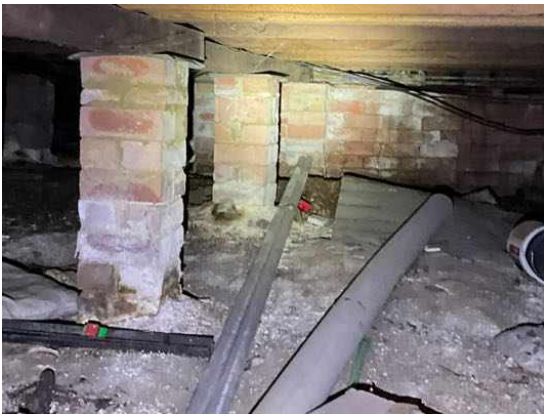
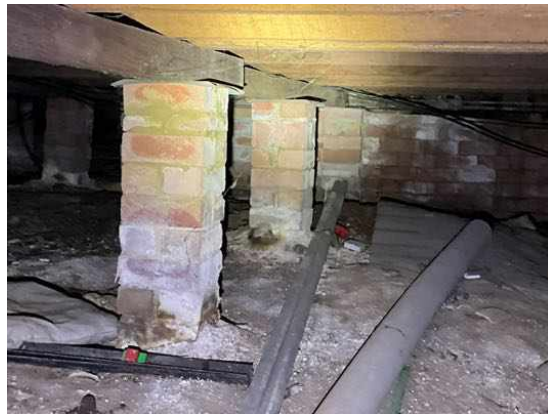
### Finding 2.05

Building:	Main Building
Location:	All Areas
Finding:	Damp - Rising
Information:	Rising damp describes the upward movement of water in low sections of building elements (e.g. walls) by capillary action - the movement of water through porous materials such as bricks, sandstone or mortar.

Rising damp is generally managed by the installation of a damp proof course during construction. A Damp Proof Course (DPC) is an impermeable barrier at the base of the wall above ground level. However, many 19th Century buildings have no damp course installed, or the materials have failed. The DPC may have been omitted as a consequence of poor workmanship, or it may have been bridged where materials built up against the side of the house allow moisture ingress above the DPC level.

The first step in addressing rising damp is to diagnose the cause. The identified cause should be addressed first before addressing the appearance and other defects which have resulted from the rising damp. If the original cause is not resolved, further cases of damp are likely to ensue, resulting in secondary defects.

Consultation with a qualified plumber is advised immediately to identify the cause of the damp and perform remedial works as required.

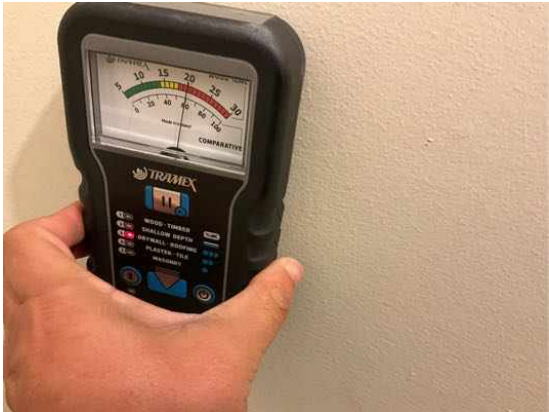
## Finding 2.06

Building:	Main Building
Location:	Toilet (WC)
Finding:	Evidence of excessive moisture - Drywall
Information:	Excessive moisture is present at the time of , indicating a potential water leakage issue within the wall.

The prolonged presence of moisture can lead to mold growth, deteriorate the structure, and create an environment conducive to health hazards. Additionally, it may compromise the adhesive holding the tiles, leading to their detachment.

A licensed plumber or a qualified contractor specializing in water damage remediation

should investigate the source of the moisture, fix any leaks, and address the damage. Additionally, replacing affected tiles and ensuring proper waterproofing are crucial to preventing future issues.

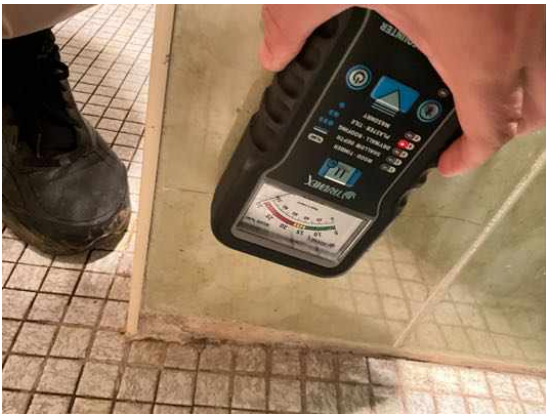
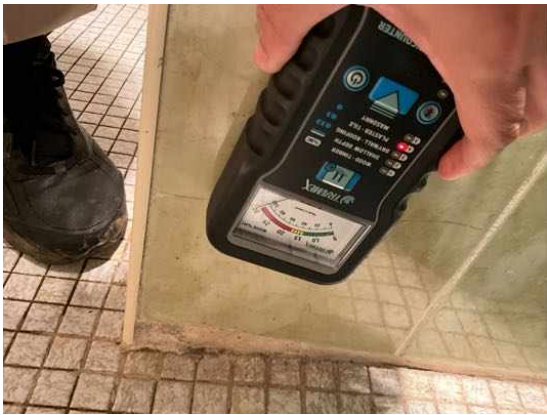
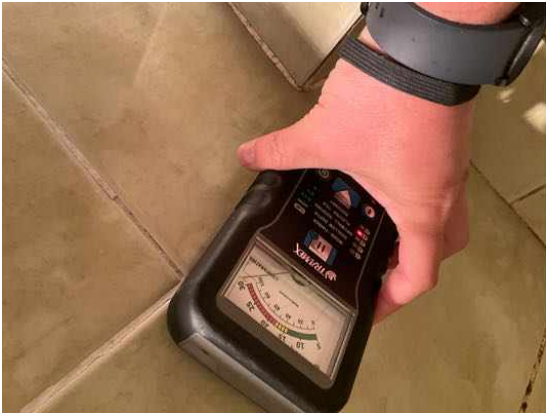
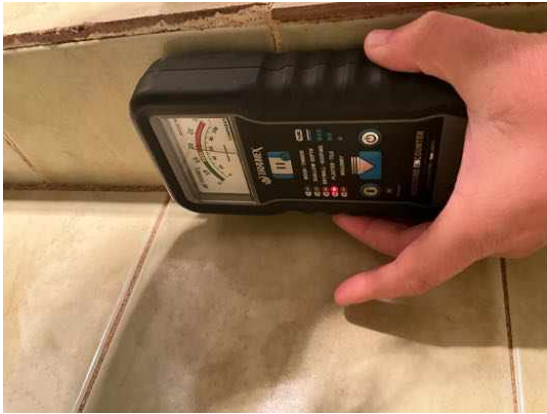
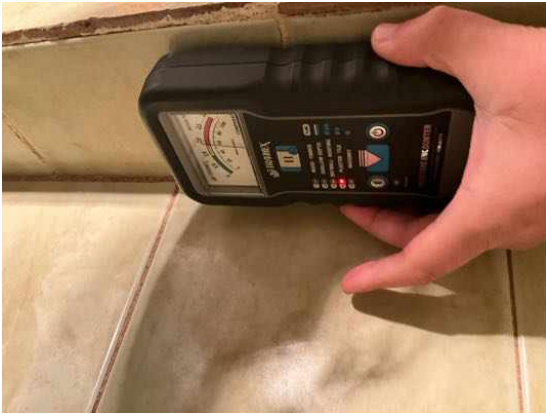
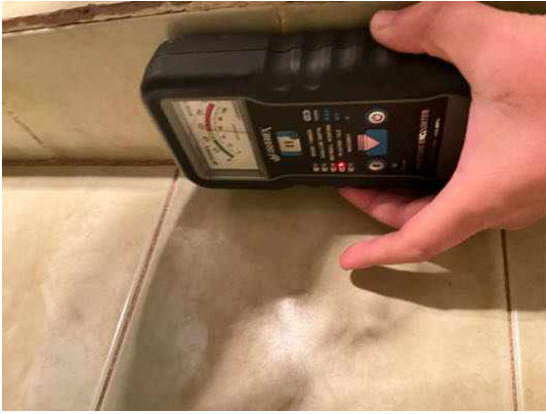
**Finding 2.07**

Building: Main Building  
 Location: Bathroom  
 Finding: Evidence of excessive moisture was present at the time of inspection  
 Information: Excessive moisture is present behind the bathroom tiles, indicating a potential water leakage issue within the wall.

The prolonged presence of moisture can lead to mold growth, deteriorate the structure, and create an environment conducive to health hazards. Additionally, it may compromise the adhesive holding the tiles, leading to their detachment.

A licensed plumber or a qualified contractor specializing in water damage remediation should investigate the source of the moisture, fix any leaks, and address the damage. Additionally, replacing affected tiles and ensuring proper waterproofing are crucial to preventing future issues.

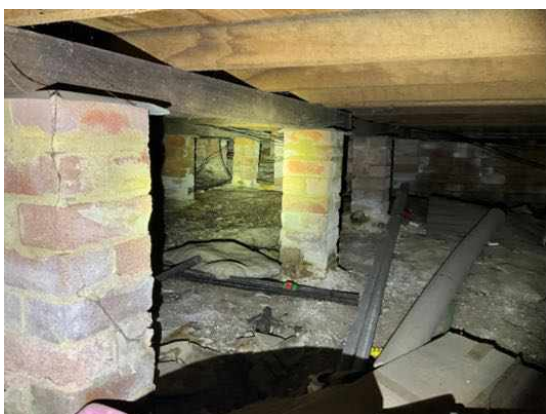
Finding: Subfloor - Site drainage - Inadequate

Information: The site exhibits poor drainage under the subfloor, leading to several critical issues. Water accumulates and does not properly drain away from the subfloor area, creating a hazardous condition.

2. Risk of subfloor structural damage due to prolonged moisture exposure.
3. Potential for mold and mildew growth, compromising indoor air quality and a potential of Termite attack.
4. Safety hazard for occupants due to slippery surfaces and potential electrical hazards.

The poor site drainage under the subfloor poses a significant safety risk to the occupants, as it can lead to structural damage and health hazards.

This issue requires immediate attention and rectification. A licensed and experienced plumber or licensed builder specialising in drainage and foundation work should be engaged to assess the problem and implement necessary drainage solutions, such as improved grading, installation of drainage systems, and moisture barrier enhancements. Regular maintenance and inspections should also be scheduled to prevent future occurrences. Water damage and secondary defects are likely to occur if left unmanaged.

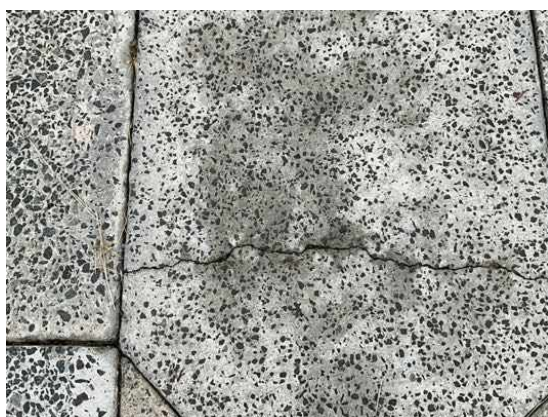
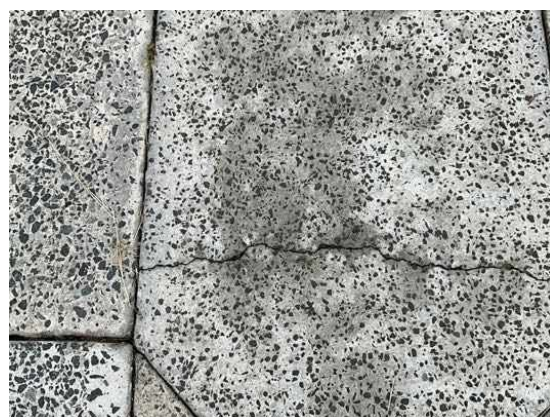
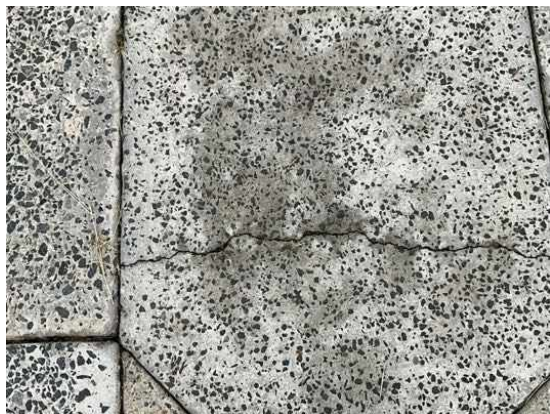
Building:	Main Building
Location:	All Areas
Finding:	Noticeable Cracking in Concrete Slab
Information:	Noticeable cracking has been observed in the concrete slab, failing to meet the required construction and quality standards.

- Cracks are visible on the surface and may extend through the depth of the slab.
- Evidence of improper curing or inadequate reinforcement leading to cracking.

The presence of noticeable cracks in the concrete slab can result in:

- Compromised structural integrity of the slab, potentially leading to failure under load.

- Water ingress through cracks, causing corrosion of reinforcement and further weakening the structure.
- Potential trip hazards and aesthetic issues, reducing the overall value and safety of the property.
- Increased maintenance and repair costs due to ongoing deterioration.

- A structural engineer should be engaged to assess the extent of the cracking and recommend appropriate repair methods.
- A licensed contractor or concrete repair specialist should carry out the recommended repairs under the guidance of the structural engineer.

A detailed inspection should be conducted post-repair to confirm compliance with the required standards and to ensure that the structural integrity of the concrete slab has been restored.

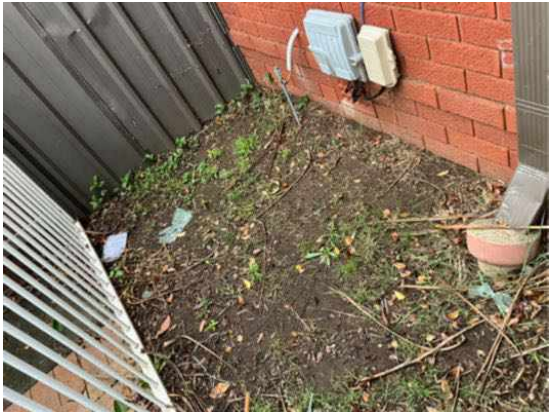
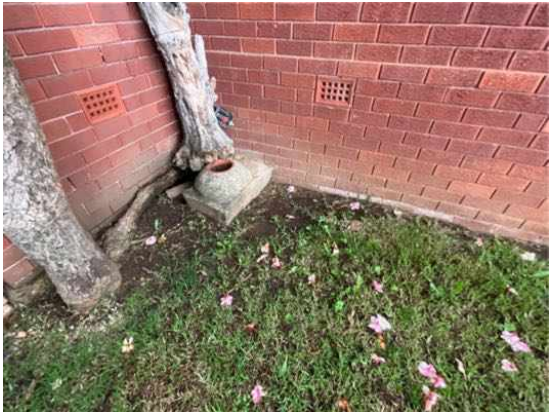
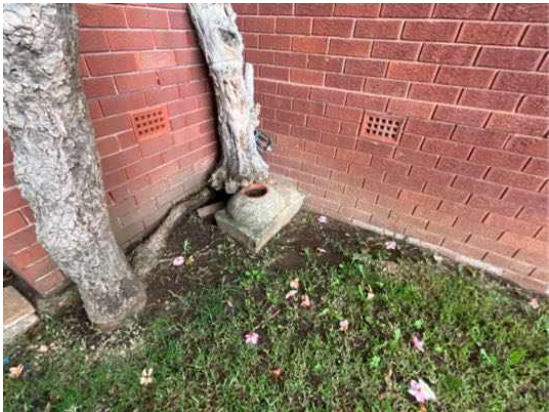
### Finding 3.02

Building:	Main Building
Location:	All Areas
Finding:	Perimeter - Insufficient Fall
Information:	The perimeter ground levels were found to have an inadequate slope away from the adjoining building structure, creating potential for water pooling in this area.

Perimeter is required to fall from the building by a minimum of 25mm in the first metre and bare ground should fall away from the house by 50mm in the first meter. This standard ensures that excessive moisture does not pool around the base of building structures, which creates potential for water and structural damage, as well as making the area susceptible to termite and timber pest activity.

Where ground levels do not have adequate fall, a licensed paving contractor should be appointed to install or remove and re-level pavement.

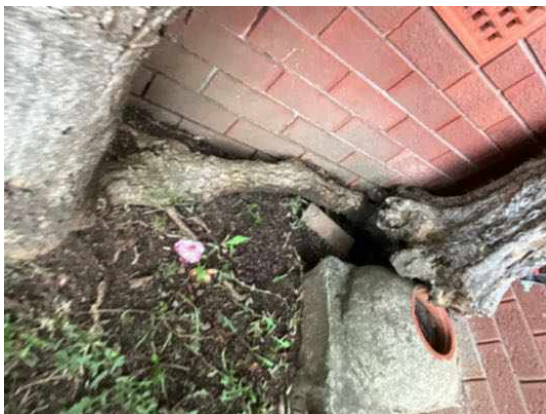
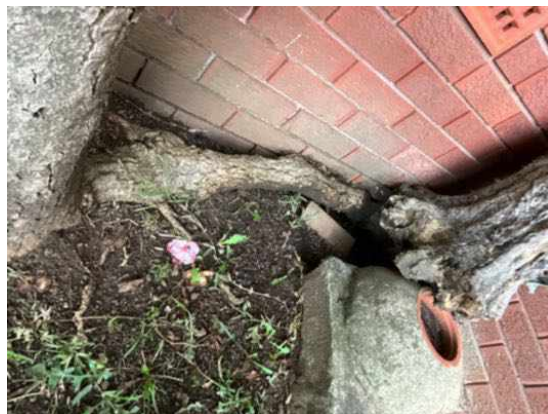
**Finding 3.03**

Building: Main Building  
Location: Yard - Back  
Finding: Tree Roots Adjacent to Structure  
Information: Tree roots were observed encroaching beneath and in close proximity to the building structure and footings. This condition has the potential to cause future structural movement, displacement of footings, cracking to masonry elements, and possible damage to underground services as the roots continue to grow and expand.  
Risk:  
Ongoing root growth may lead to differential movement, cracking of brickwork, and

disturbance of foundations, which can result in costly structural repairs if left unmanaged.

It is recommended that a qualified arborist be engaged to assess the tree and root system, and to provide advice on appropriate management such as root pruning, installation of root barriers, or tree removal if required. Further assessment by a structural engineer may be necessary where structural impact is identified.

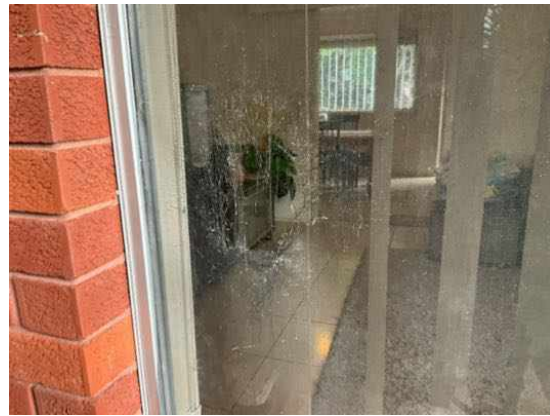
### Finding 3.04

Building:	Main Building
Location:	Front Elevation
Finding:	Damaged insect grill
Information:	The insect grill is damaged , compromising its ability to prevent insects from entering the designated area.

Increased likelihood of insect infiltration, potentially leading to hygiene issues and discomfort for occupants.

A qualified maintenance technician or facilities management team should address the broken insect grill promptly to restore its functionality and prevent the associated risks.

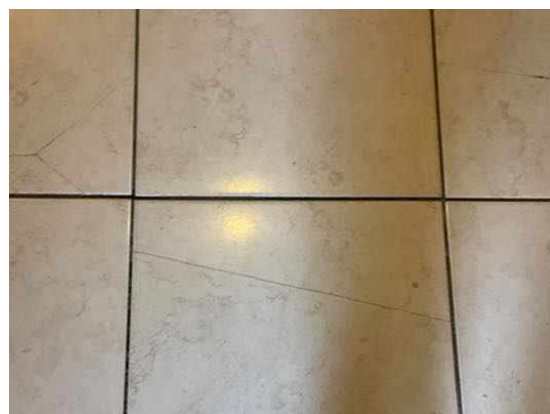
### Finding 3.05

Building: Main Building  
 Location: All Areas  
 Finding: Floor Tile crack  
 Information: A floor tile has a visible crack on the surface.

The damaged tile presents a trip hazard, may lead to cuts if stepped on barefoot, and can allow moisture ingress into the substrate, which may cause further deterioration or loosening of adjacent tiles. It also affects the overall appearance of the floor.

A licensed tiler should be engaged to remove the damaged tile and install a matching replacement. If spare tiles are unavailable, additional remedial work may be required to blend the repair with surrounding finishes.

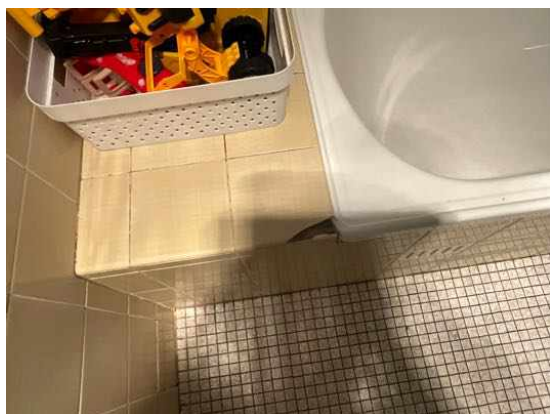
### Finding 3.06

Finding: Tiles - Cracked or damaged

Information: Cracking was evident to the tiling in this area at the time of inspection. While the cracking appears to be minor, this area is frequently exposed to water, allowing potential for water penetration into adjoining sections of walls or flooring.

If left unmanaged, water penetration to these areas may lead to subsequent water damage, which is likely necessitate repair work to affected building elements.

A tiling contractor should be appointed to ensure that no further water damage

Where water penetration has led to water damage, appointment of a relevant tradesperson may be required to repair damaged building elements.

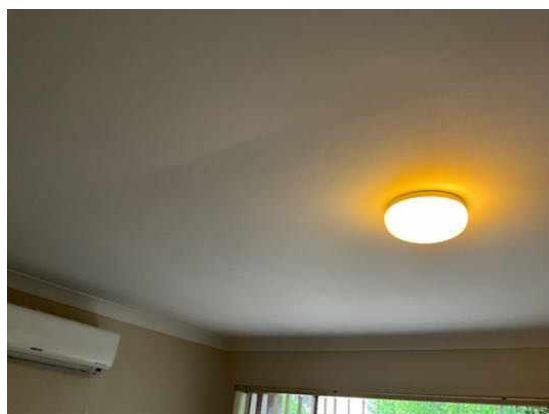
### Finding 3.07

Building:	Main Building
Location:	Living Room
Finding:	Sagging Ceiling Lining
Information:	The ceiling lining exhibits visible sagging/deformation, which is indicative of potential failure of the fixing system and/or deterioration of the plasterboard. This condition may be associated with inadequate fixing, moisture ingress, or age-related material fatigue. The defect is considered significant as it may compromise the structural integrity of the ceiling lining.

- Risk of sudden collapse of the ceiling lining, posing a safety hazard to occupants
- Potential presence of underlying issues such as roof leaks or moisture damage
- Progressive deterioration if not addressed in a timely manner

It is recommended that a licensed builder or qualified plasterer be engaged to assess and rectify the issue. Further investigation may be required to identify any underlying causes (e.g. roof leaks), and repairs should be carried out in accordance with relevant Australian Standards.

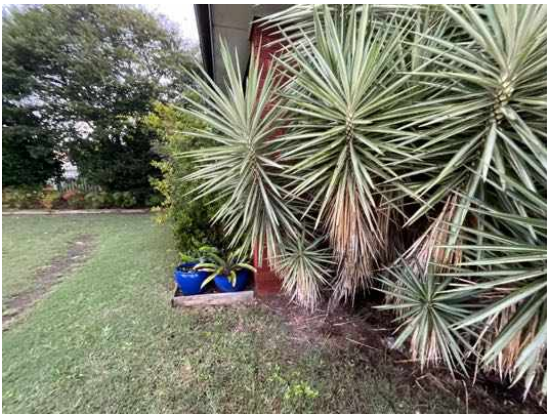
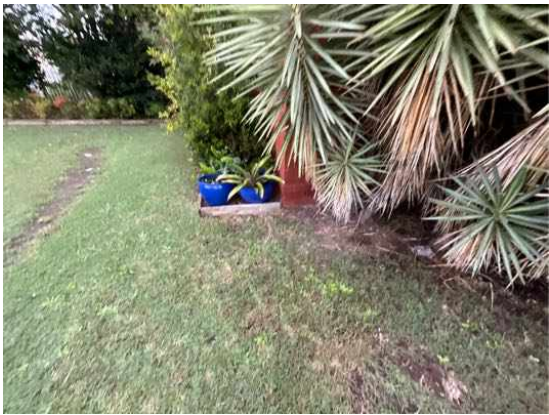
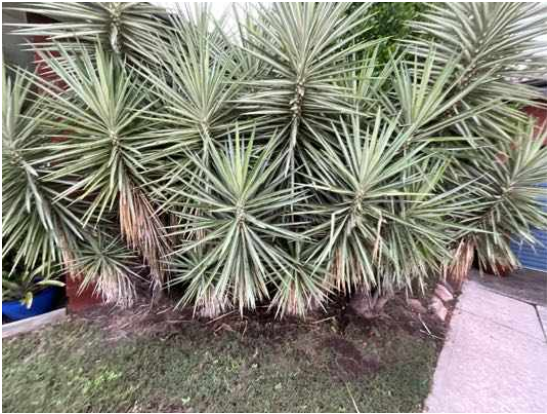
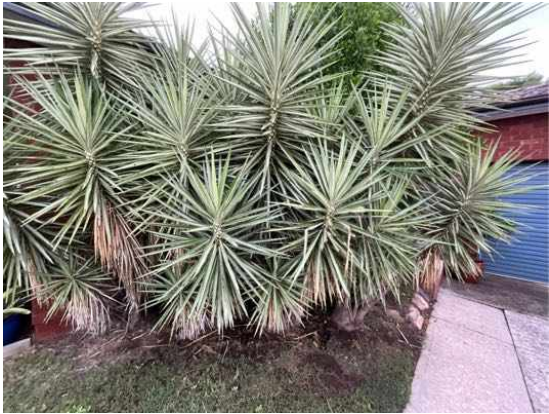
Building:	Main Building
Location:	All Areas
Finding:	Dense vegetation around a property can increase the risk of termite infestation
Information:	The presence of dense vegetation around a property can increase the risk of termite infestation, as it provides a conducive environment for them. To address this, consider maintaining a clear space between the vegetation and your home. If you suspect a termite issue, it's advisable to consult with a licensed pest control professional for inspection and treatment.

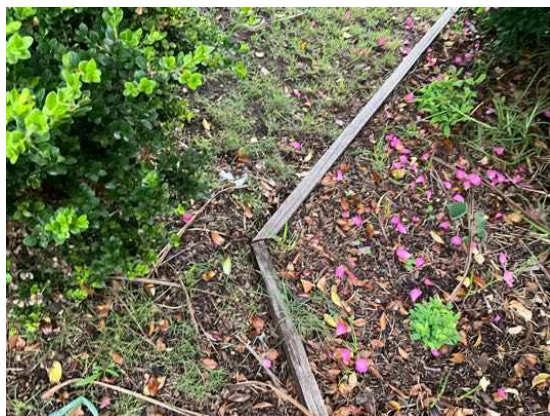
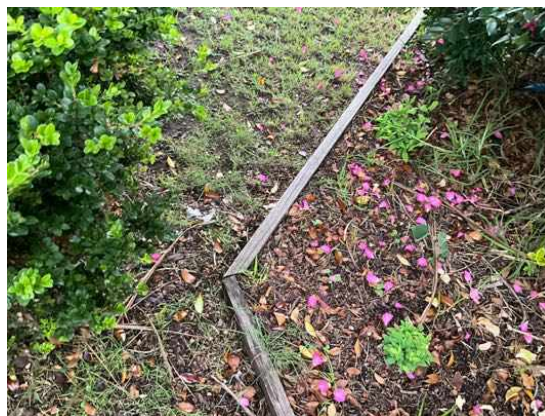
**Finding 6.03**

Building: Main Building  
Location: All Areas  
Finding: Timber on ground / conducive conditions to termite damage  
Information: Timber on the ground is indeed conducive to termite damage. Termites are known to thrive in moist environments, and wood in contact with soil or moisture is more susceptible to infestation.

To prevent this, it's important to keep timber elevated and away from direct ground contact. Regular inspections and proper termite control measures are also essential to protect your wooden structures from termite damage.

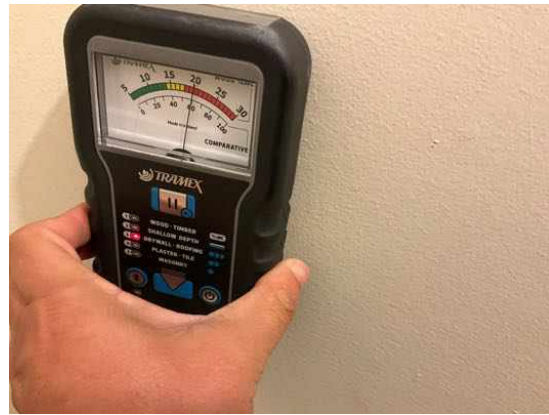
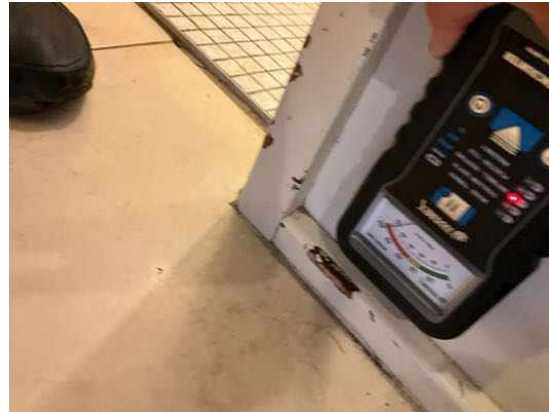
### Finding 6.04

Building:	Main Building
Location:	All Areas
Finding:	Excessive moisture - Conducive to Timber pest
Information:	Excessive moisture can attract termites and produce conditions that promote fungal growth and wood decay.

Excessive moisture is generally caused by deteriorated inadequate or missing roof drainage leaking plumbing pipes or fixtures poorly plumbed HWS overflows or condenser units and poor site drainage.

Prior to any remedial works being performed a qualified plumber should be appointed to further inspect the property and to identify the cause of the excessive moisture. Works to remove affected building elements may then be necessary and should be performed by an appropriate tradesperson.

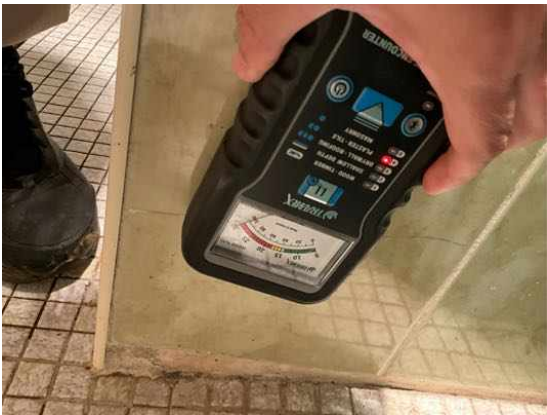
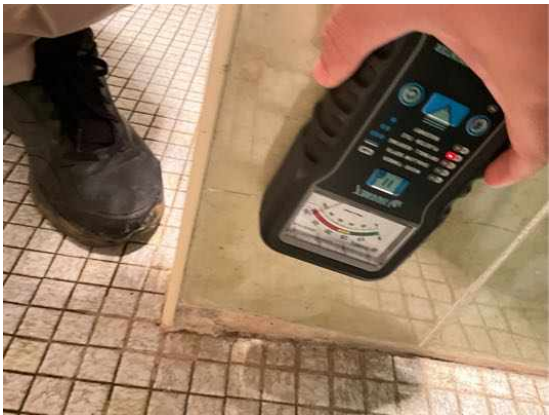
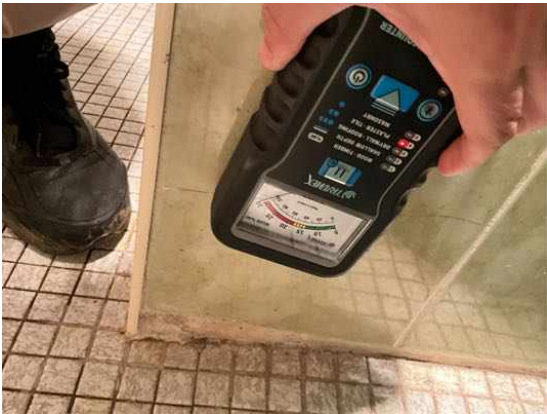
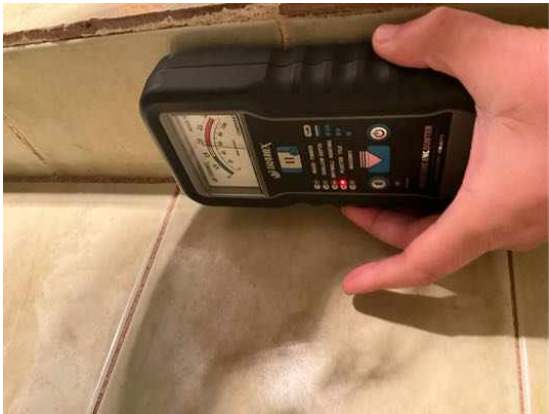
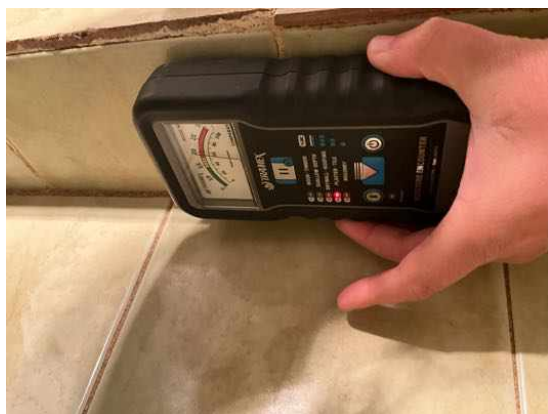
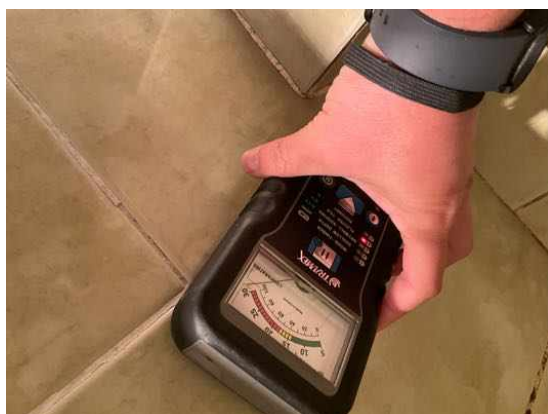
### Finding 6.05

Building:	Main Building
Location:	Bathroom
Finding:	Excessive moisture - Conducive to Timber pest
Information:	Excessive moisture can attract termites and produce conditions that promote fungal growth and wood decay.

Excessive moisture is generally caused by deteriorated inadequate or missing roof drainage leaking plumbing pipes or fixtures poorly plumbed HWS overflows or condenser units and poor site drainage.

Prior to any remedial works being performed a qualified plumber should be appointed to further inspect the property and to identify the cause of the excessive moisture. Works to remove affected building elements may then be necessary and should be performed by an appropriate tradesperson.

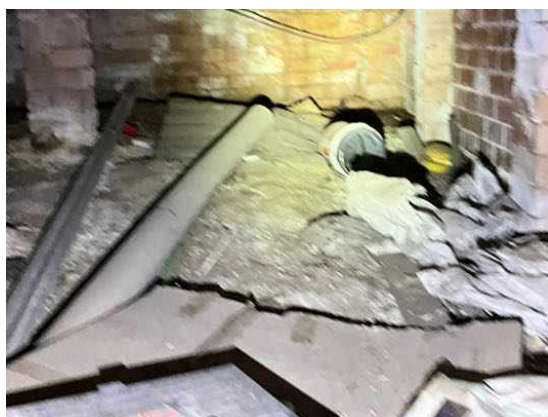
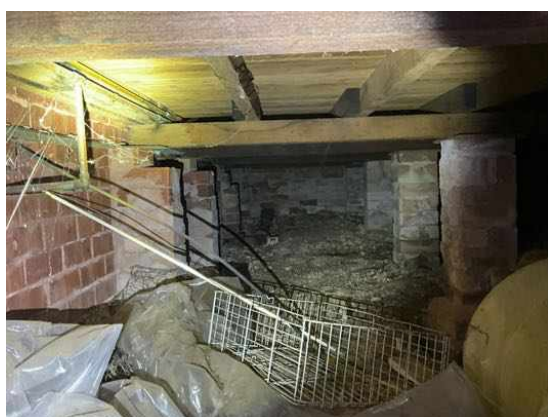
### Finding 6.06

Building:	Main Building
Location:	Subfloor
Finding:	Subfloor - poor ventilation, inadequate site drainage, water stains
Information:	The subfloor lacks adequate ventilation, suffers from inadequate site drainage, exhibits water stains, creating conducive conditions for timber pests such as termites.

Risk: The combination of poor ventilation, inadequate drainage, water stains significantly increases the risk of timber pest infestations. Termites are attracted to moist environments and can thrive in subfloors with high humidity levels and water damage. The lack of proper ventilation and drainage exacerbates moisture retention, providing an ideal habitat for timber pests to establish colonies and cause extensive damage to the subfloor structure. Additionally, water stains indicate previous or ongoing moisture issues, which further attract timber pests and contribute to the deterioration of timber materials.

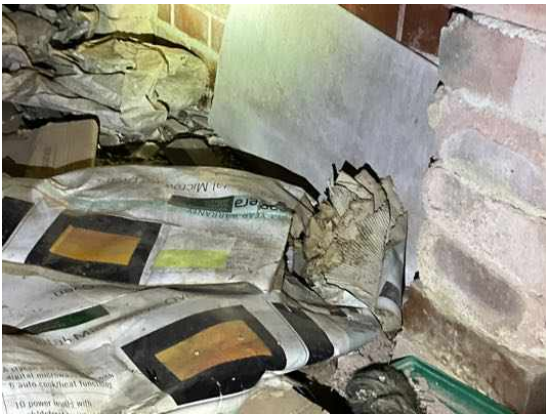
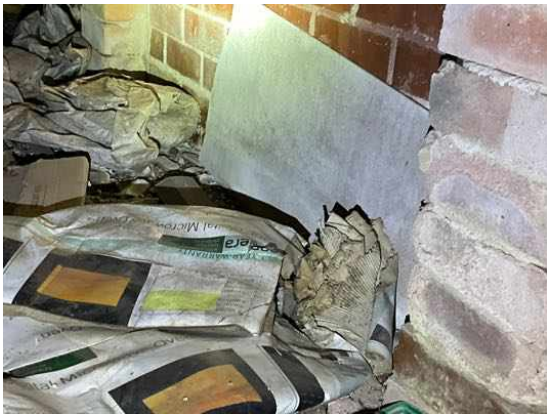
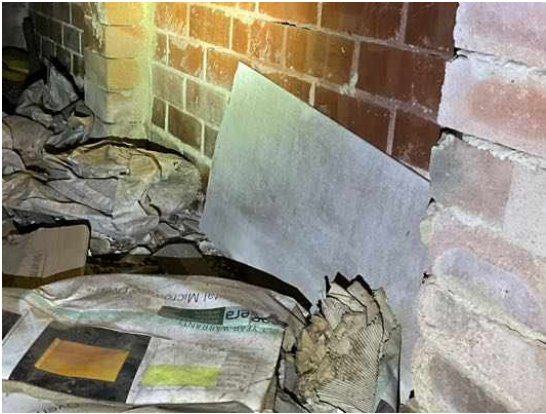
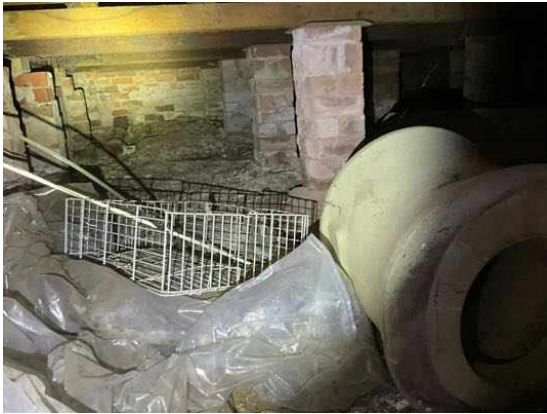
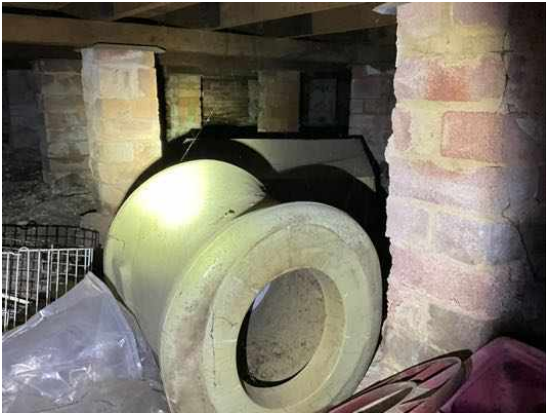
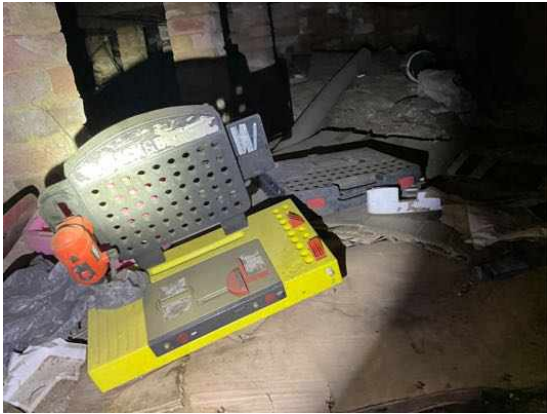
**Noted Item**

Building: Main Building  
Location: All Areas  
Finding: Additional Photos - Obstructions and Limitations  
Information: These photographs are an indication of the obstructions and limitations which impeded full inspection of the property at the time of inspection. These obstructions can hide an array of defects and should be removed to allow full inspection to be carried out. A re-inspection is recommended once the areas are made accessible.
