Building and Timber Pest Inspection Report

Inspection Date: Wed, 11 Mar 2026

Property Address: 144/2 Melody Ct, Warana QLD 4575,
Australia

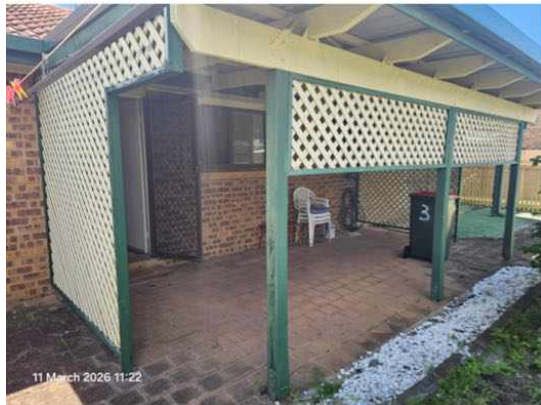
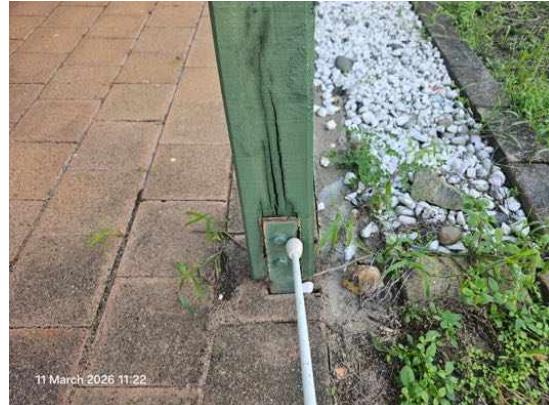
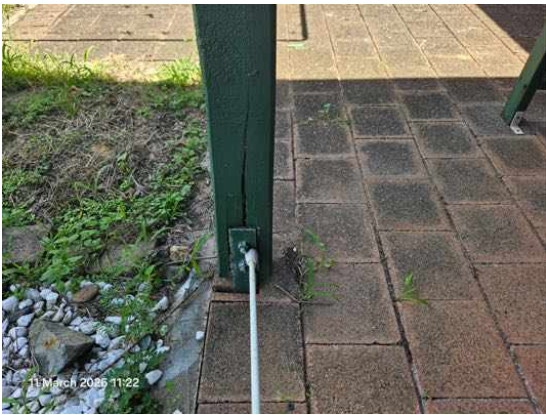
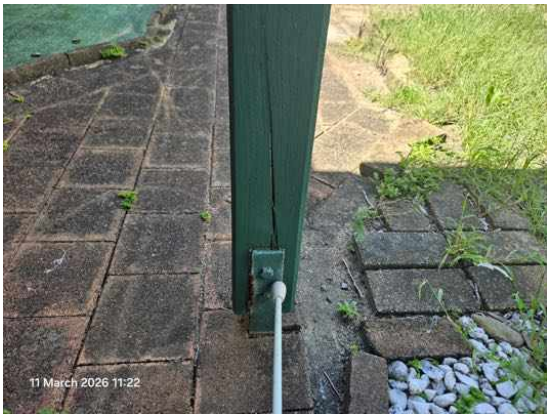
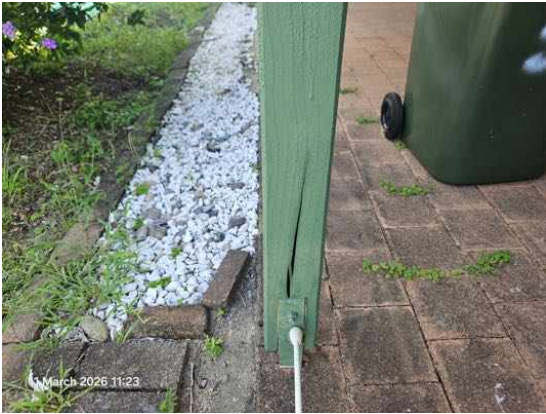
Finding 3.01

Information: On the day of inspection the rear pergola was inspected and it was noted that two of the posts are splitting at the base. Being at the base of the posts, these splits, which are approximately 300mm in length, will compromise the bolted fixings ability to secure the posts in position. These have the potential to become a major defect if not rectified immediately.

It advise that a licensed builder or licensed carpenter be engaged to replace the posts with new timbers.

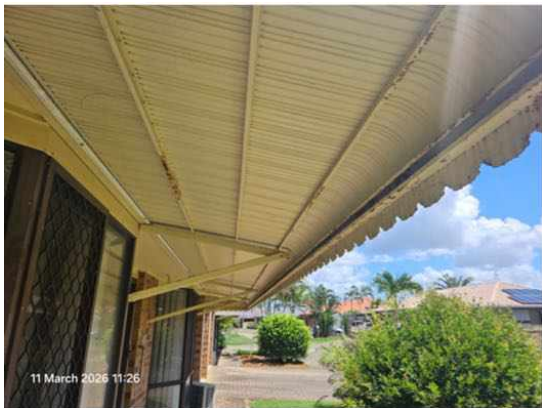
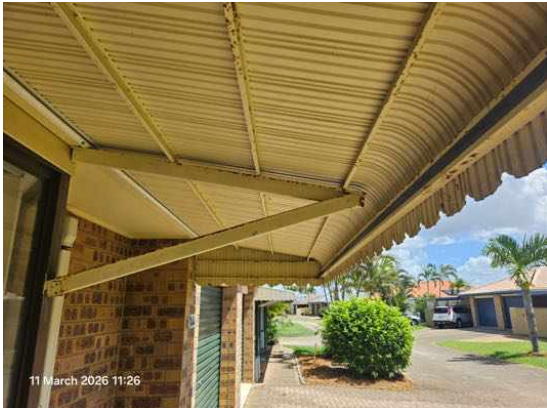
Finding 3.02

Building: Main Building
Location: Front elevation
Finding: Awning - rust present.
Information: On the day of inspection it was noted that the steel frame of the front awning had surface rust developing. The surface coating / paint has deteriorated and the base metal is exposed.

It is advised that an application of a suitable moisture resistant protective coating and a rust treatment method be implemented or engaging a suitably qualified handy person to replace the item could be a solution.

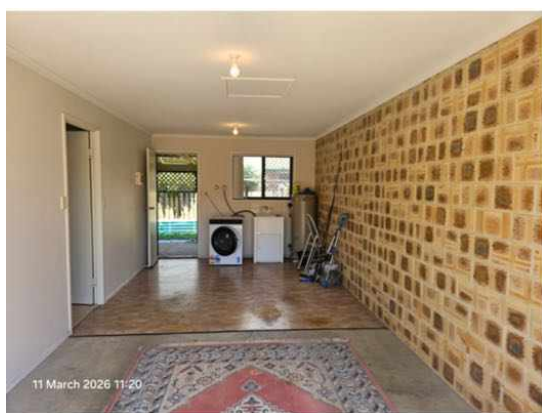
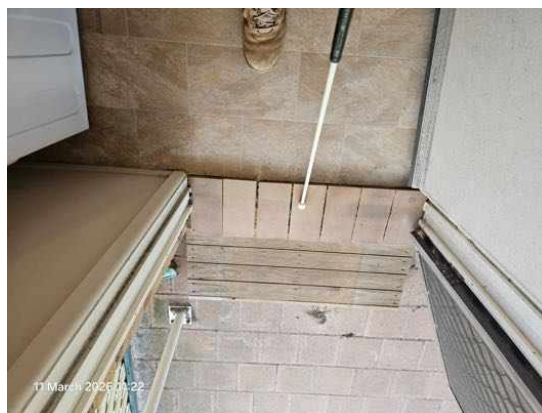
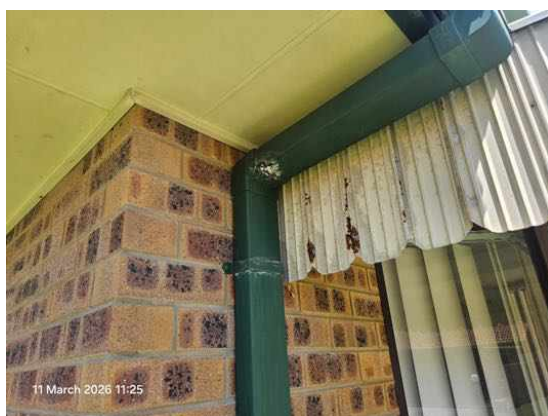
Finding 3.03

Building: Main Building
 Location: As shown
 Finding: Miscellaneous minor defects
 Information: Below are listed the miscellaneous minor defects identified on the day of inspection.

1. Downpipes require sealing at the joints.
2. Rear door sill tiles are loose and require re-gluing and grouting.

These minor defects should be attended to in the short term to prevent further deterioration.

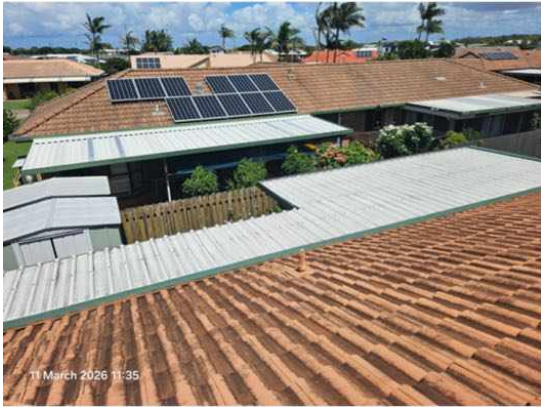
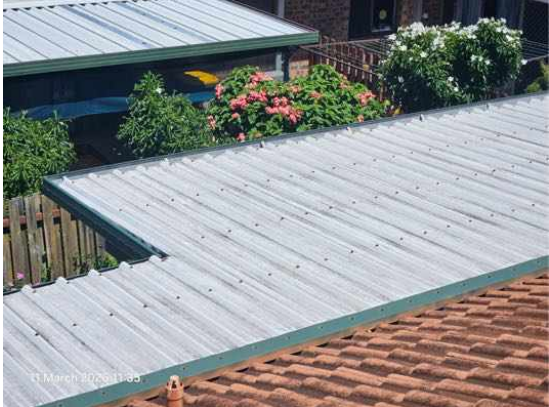
Finding 3.04

Building: Main Building
 Location: Pergola
 Finding: Roof screws - rusting
 Information: It was noted during inspection, that throughout the roof surface of the pergola, the majority of roof screws are showing signs of rust at varying degrees ranging from minor to moderate.

The pergola roof condition is noted as a minor defect ; however it should be made a priority to maintain the surface condition and prevent possible leaks and further deterioration.

This should be monitored over time, and should the condition worsen, consider replacement of the screws. As roof screws deteriorate they can have an effect on the adjoining roof materials.

A roofing plumber could be appointed at the clients discretion to replace the screws in question.

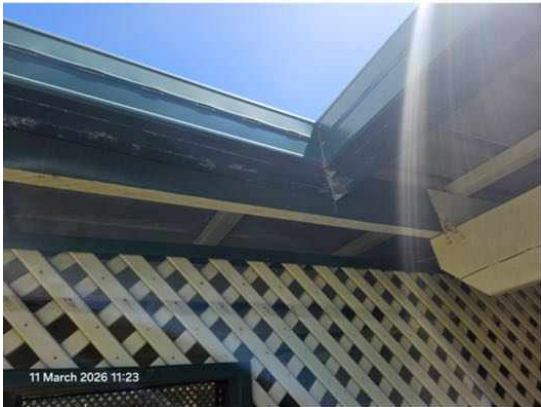
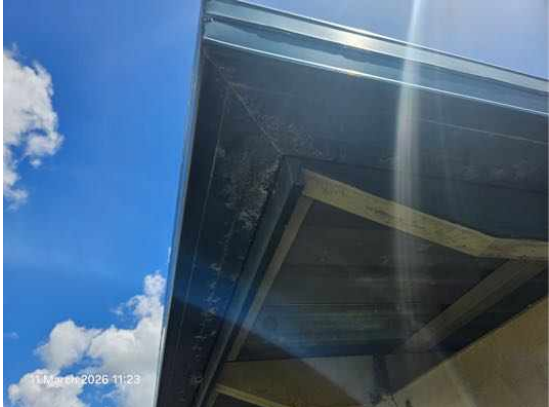
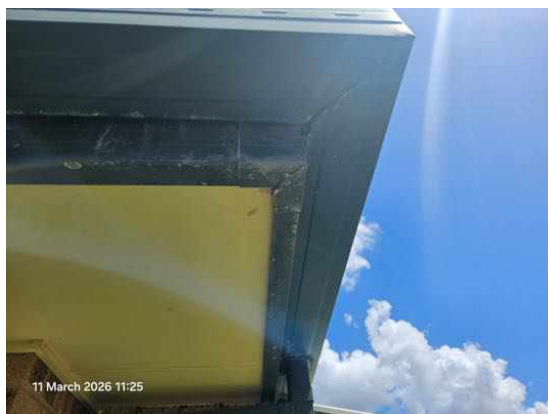
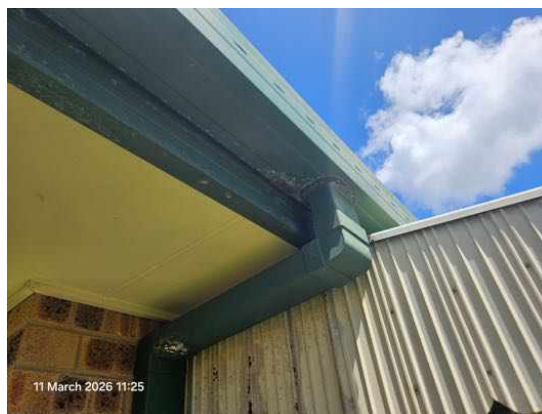
Finding 3.05

Building: Main Building
 Location: All External Areas
 Finding: Fascia & gutter general defects
 Information: The fascia has areas of surface rust to the external corners, surfaces and connections of the downpipes. Resealing the gutter joints internally and treating and repainting of the metal surfaces should be carried out. The end cap of the rear fascia as shown in the photos, will require replacement.

Any resealing should be done with polyurethane as silicone does not permit painting.

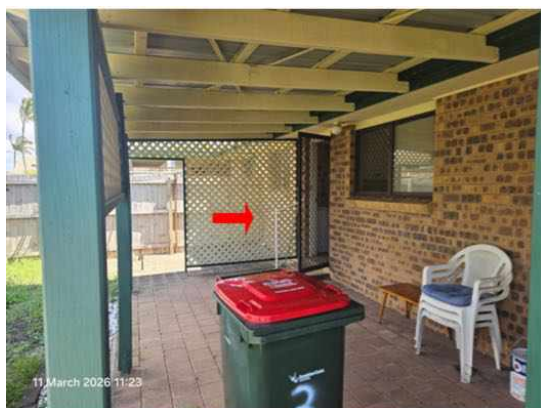
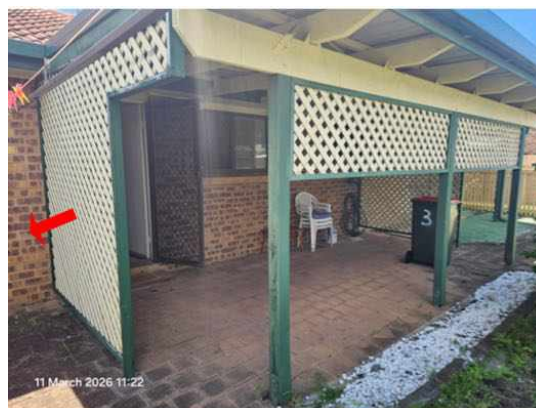
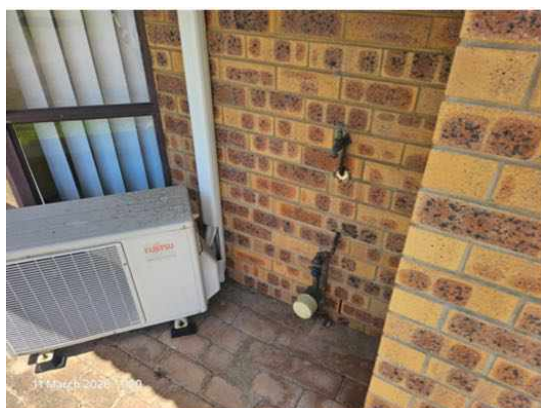
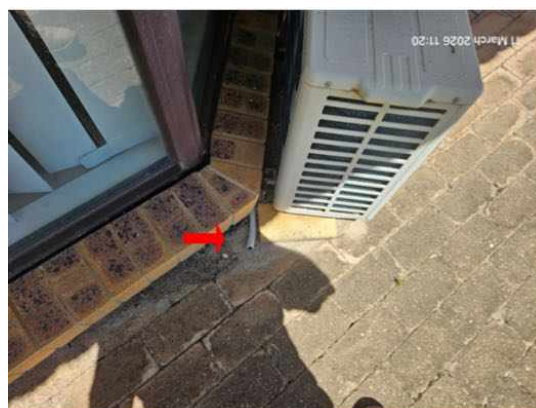
Building:	Main Building
Location:	As shown
Finding:	Air Conditioner and HWS - Disconnected overflow
Information:	The air conditioner and HWS overflows were found to be disconnected from storm water / sewer drainage and could create excessive moisture in the surrounding area. Such leaking creates an environment which is conducive to an array of defects, including water damage to associated building elements and the attraction of termite or timber pest infestation.

It is recommended that a licensed plumber be appointed to connect the overflows in order to prevent such an environment from being created.

These minor works should be carried out as soon as possible.

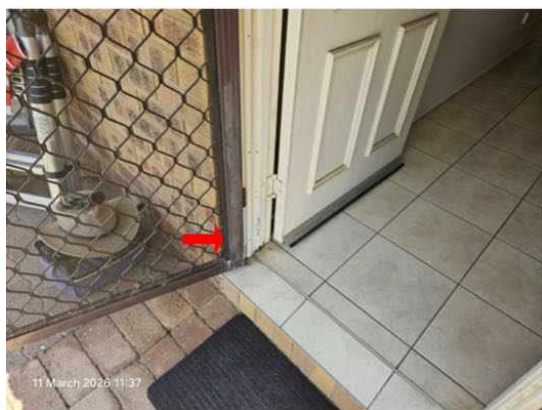
Finding 6.02

Building:	Main Building
Location:	Front entry
Finding:	Wood rot / fungal decay
Information:	The timber door jamb of the front entry shows evidence of wood rot in the end sections of the timber.

Wood rot, also known as Fungal Decay, occurs when timbers and other cellulose building materials are exposed to damp conditions on an ongoing basis. This could be the result of exposure to weathering over a prolonged period of time, or the attraction of excessive moisture from other abutting building materials.

Early intervention and regular maintenance, particularly of exterior timbers, will prolong the useful life of these building elements. Prior to any works being performed, the cause of the moisture that has created the visible wood rot should be identified and addressed in a suitable manner. Replacement of affected timbers may then be a necessary step in protecting surrounding building elements from such deterioration.

A licensed carpenter or licensed builder should be consulted to advise on a solution for the affected building materials.

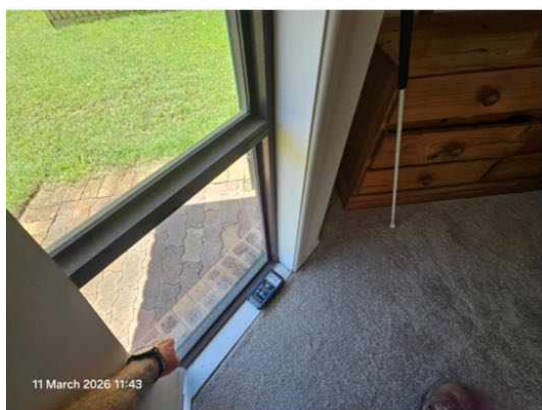
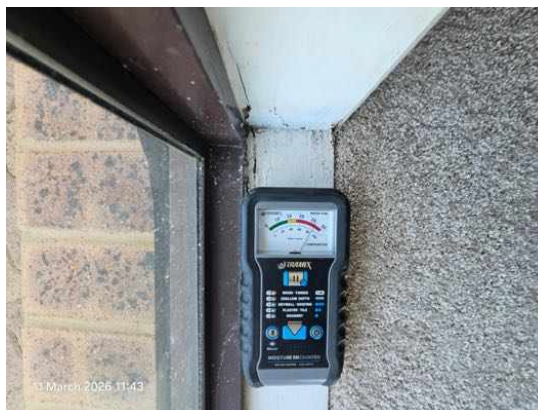
Finding 6.03

Finding: Wood rot / fungal decay

Information: The timber reveal and architrave of the bay window in bedroom1 show evidence of wood rot in sections of the timber. It is possible that water is entering the wall cavity via a hole in the external brick window sill. This should be sealed. If painting externally is planned consider using a polyurethane sealant instead of silicone.

Wood rot, also known as Fungal Decay, occurs when timbers and other cellulose building materials are exposed to damp conditions on an ongoing basis. This could be the result of exposure to weathering over a prolonged period of time, or the attraction of excessive moisture from other abutting building materials.

The bay window sills / reveals exhibited minor elevated moisture readings. This could be due to external sill sealing and / or window gasket deterioration. Having these assessed and sealed accordingly will assist in reducing any further moisture.

Early intervention and regular maintenance, particularly of exterior timbers, will prolong the useful life of these building elements. Prior to any works being performed, the cause of the moisture that has created the visible wood rot should be identified and addressed in a suitable manner. Replacement of affected timbers may then be a necessary step in protecting surrounding building elements from such deterioration.

A licensed carpenter or licensed builder should be consulted to advise on a solution for the affected building materials.

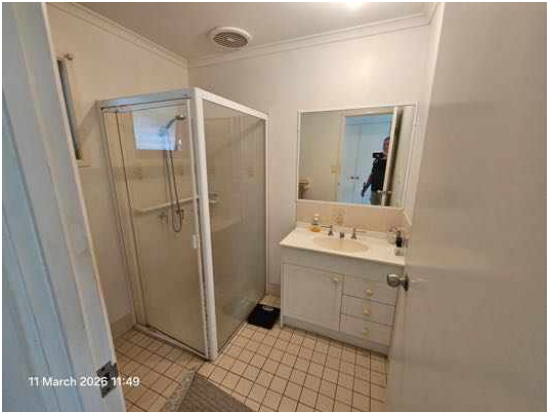
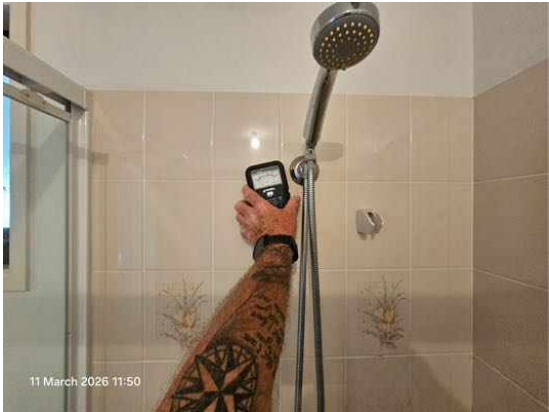
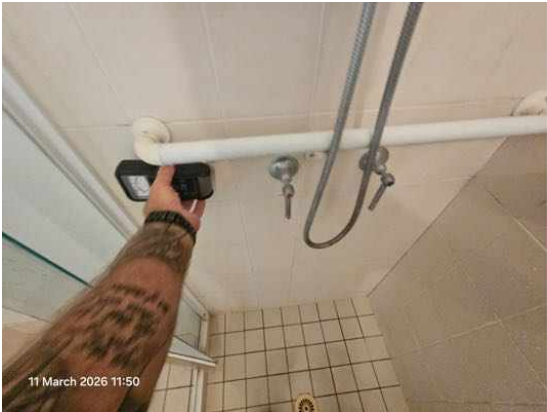
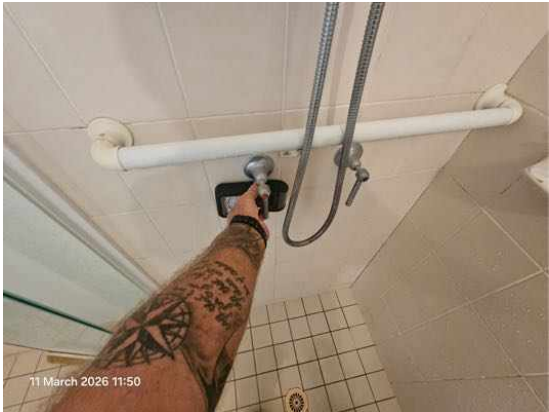
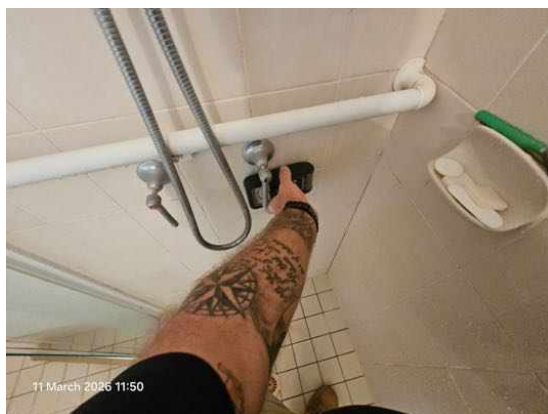
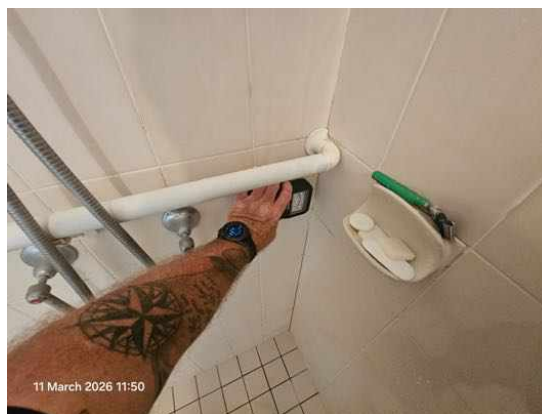
Building: Main Building
Location: Bathroom
Finding: No moisture detected in bathroom
Information: On the day of inspection the shower in the bathroom was measured for moisture using a "Tramex" moisture meter. During this inspection no moisture was detected in these areas and the tiled / sheeted surfaces appear to be in fair condition. The grout and sealant will require renewal.

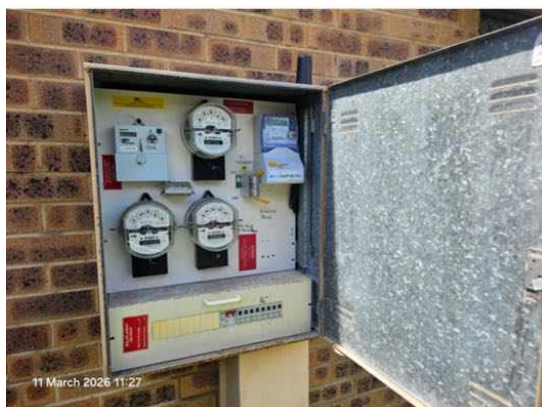
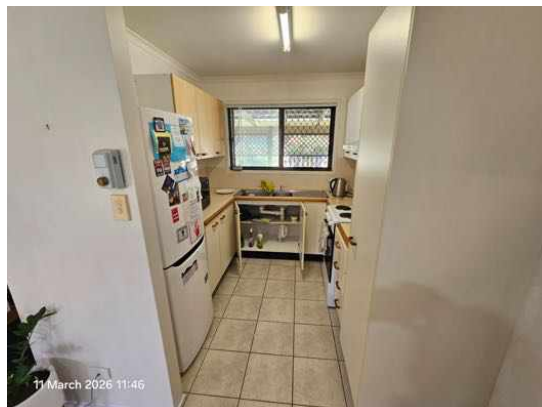
Building: Main Building
 Location: Meter box, kitchen cupboard
 Finding: Durable pest inspection notice - not assessable
 Information: On the day of inspection it was noted that the durable pest inspection / treatment notice was missing, not visible or out of date. These notices / stickers are to verify the timber pest inspection dates, the inspector, the currency and type of timber pest system / barrier in place or being used in and around the property.

It cannot be determined if an annual inspection programme is in place. Discuss the properties system with the vendor / agent and obtain copies of relevant documents if available. A programme will be required for 12 months from this inspection.

It is recommend that the inspector of the day or a licensed timber pest controller be contacted to assess the properties needs and provide costings for an annual inspection programme.
