## Building Inspection Report

Inspection Date: Thu, 12 Mar 2026

Property Address: 16 Cyprus St, Lalor VIC 3075, Australia

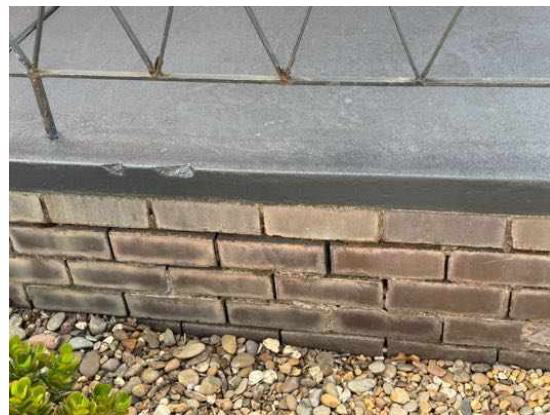
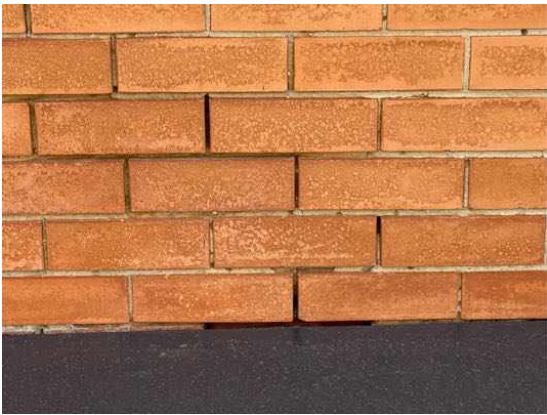
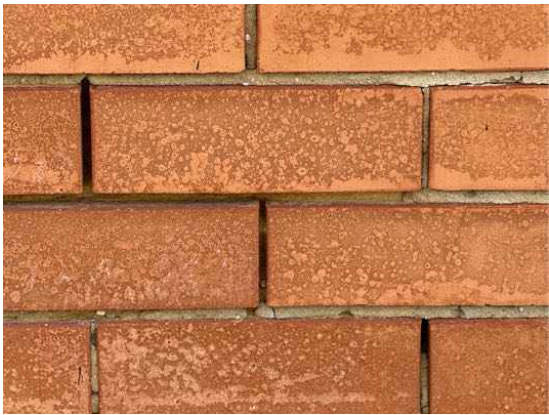
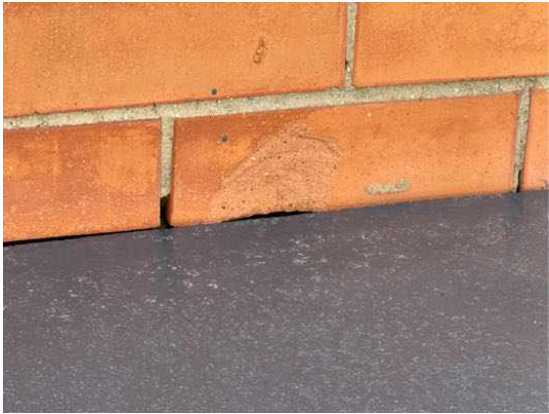
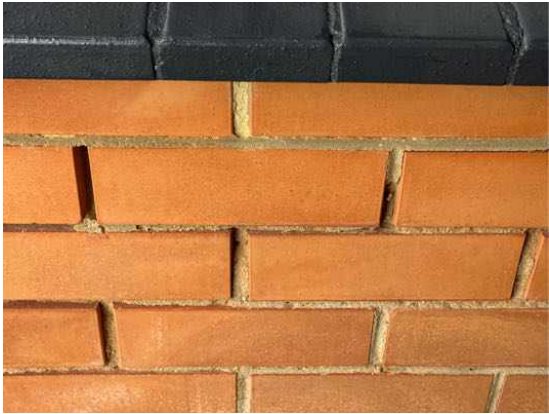
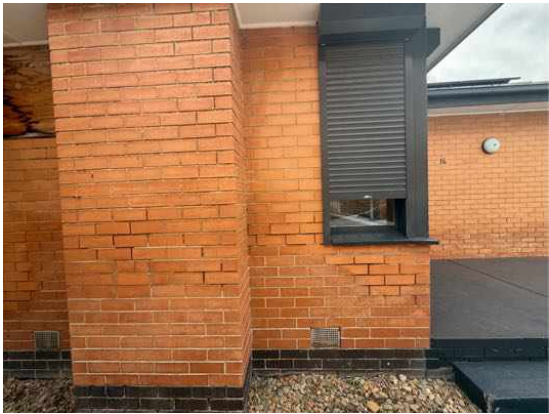
#### Defects 2.01

Building:	Building 1
Location:	All Areas > All Areas
Finding:	Brickwork mortar missing - gaps, holes and voids
Information:	At the time of the inspection the exterior brickwork showed numerous / a lot of areas where mortar has been dislodged or missing. The numerous gaps, holes or voids that have been left in the exterior brickwork are considered to be excessive. All exterior brickwork walls will require extensive repair to rectify these areas, they are required to be fully filled in and patched to prevent the further damage and deterioration from exposure and exterior weather conditions.

The damage and deterioration in brickwork is suspected to be a result of poor filling of the mortar beds and perpendes during the brickwork installation and construction or poor trade practices. When gaps, holes and voids are filled or patched the tradespersons must ensure mortar colour and consistency are as near as possible to match the existing mortar and remains the same as the original installation of brickwork mortar.

These types of defects should be rectified before any further weathering can occur and will prevent gaps, holes and voids from enlarging or deteriorating further. These

type of defects would allow water and moisture, insect, pests, vermin to ingress into wall cavities that will overtime create secondary defects and damage as a result.

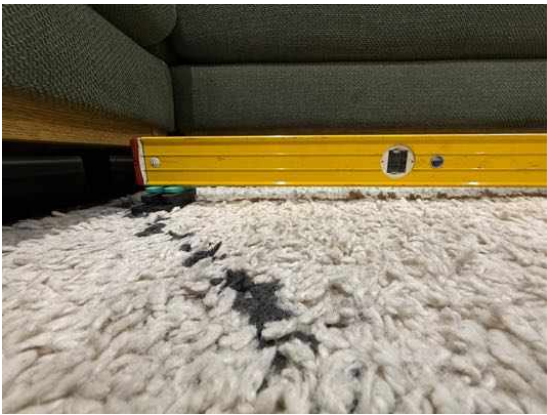
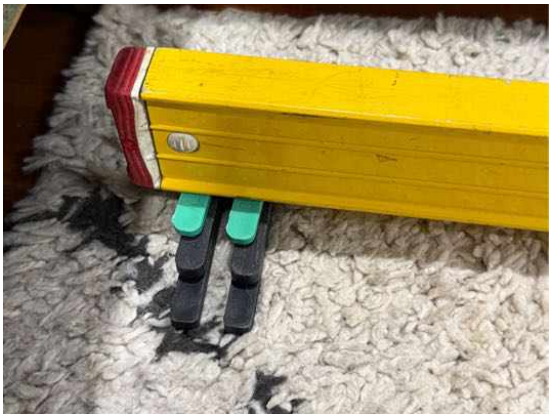
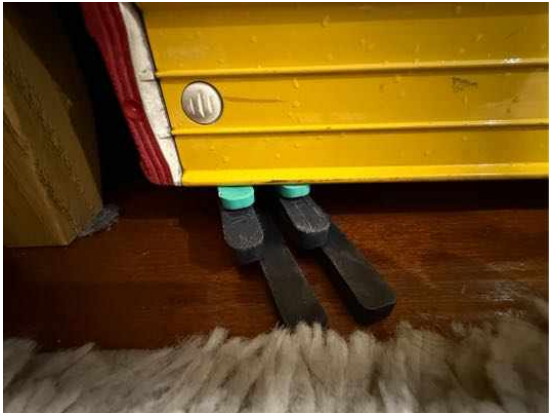
### Defects 3.01

Building:	Building 1
Location:	All Areas > All Areas
Finding:	Floor levels
Information:	The internal flooring in some areas throughout the home were observed to be showing signs of being out of level and uneven. Uneven and out of level floors with a property of this age is considered in most cases to be mostly normal however some areas were considered to be excessive. The uneven and out of level floors in a home is

Floor levels can have complex and varying causes, which will influence the required remedial works. Remedial may be necessary and the client should begin by consulting a registered builder who has expertise in re-stumping to determine the required scope of works that may be deemed necessary. This may include some form of underpinning to some areas, at the same time as addressing the underlying cause of the uneven and out of level floors. Client may also consider consultation with a geotechnical engineer to understand what and how the surrounding soil is reacting to surrounding moisture.

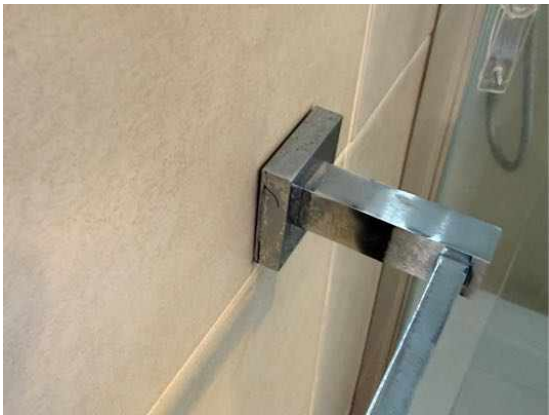
**Defects 3.02**

Building: Building 1  
Location: Bathroom > All Areas  
Finding: Bathroom towel rail loose  
Information: Bathroom towel rail was observed to be loose and may require maintenance to make good, this occurs generally due to substandard installation and or poor workmanship. A qualified carpenter should be appointed to repair or replace the affected towel rail, this type of defect is at the clients discretion.

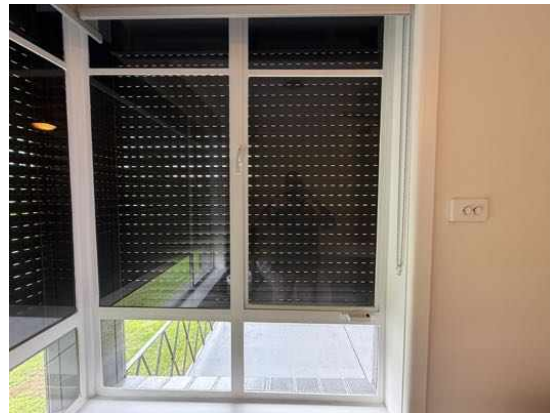
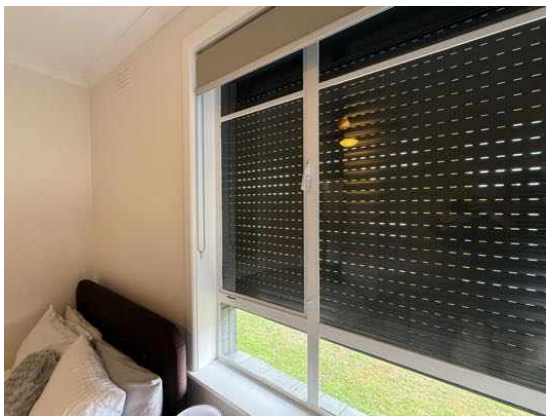
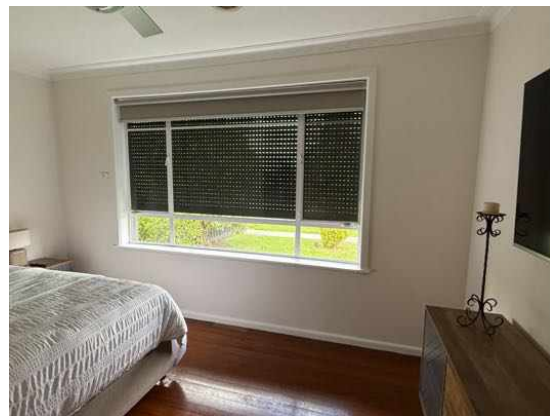
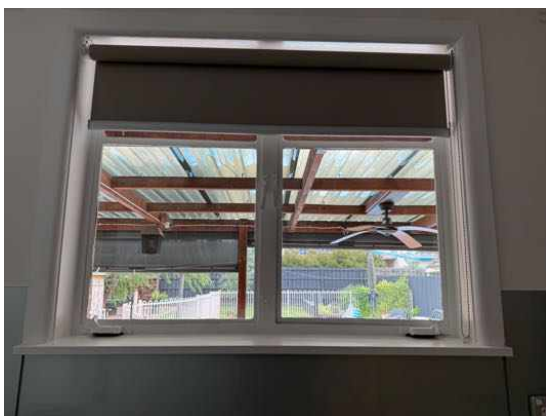
### Defects 3.04

Building:	Building 1
Location:	All Areas > All Areas
Finding:	Flyscreens
Information:	Numerous flyscreens were found to be missing to the windows throughout the home at the time of inspection. Whether the flyscreens have not been installed or have been removed for maintenance and or painting purposes, this missing building element detracts from the operational state of the window.

Where not replaced, missing flyscreens allow pest and insect ingress into the adjoining room/s. It is advised that all missing building elements be installed or

replaced in order to ensure the full function of all building structures.

A qualified carpenter may be appointed to replace flyscreens at the discretion of the client.

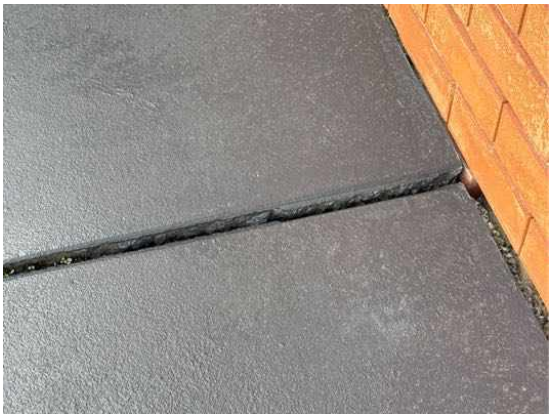
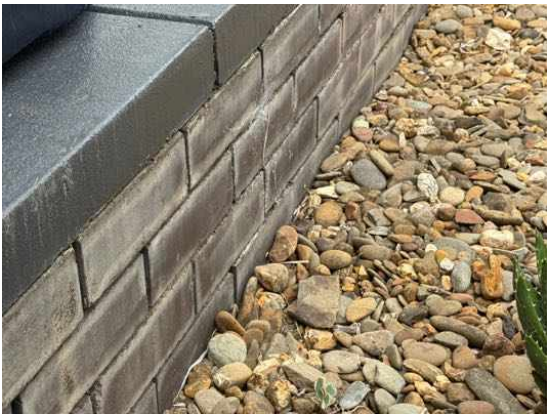
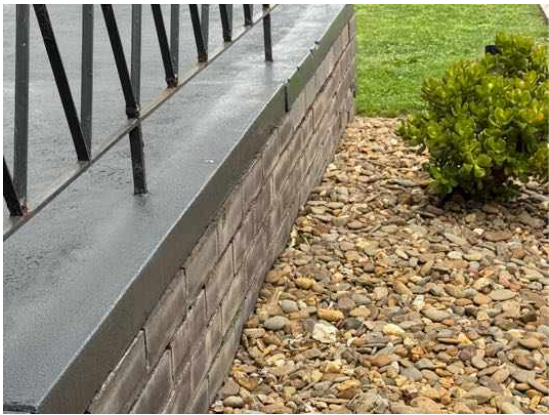
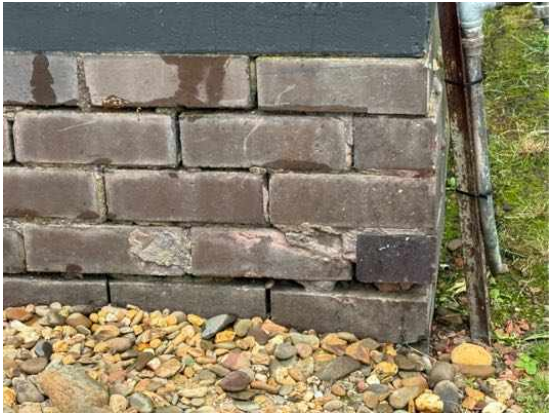
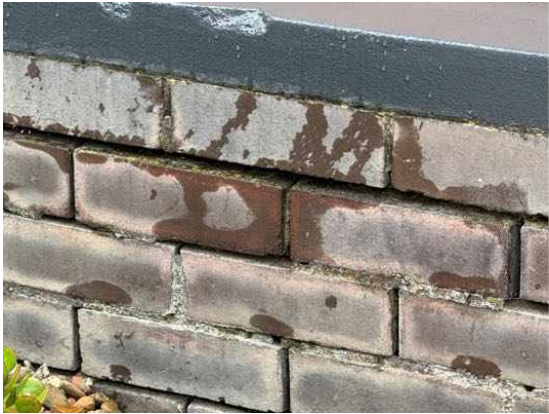
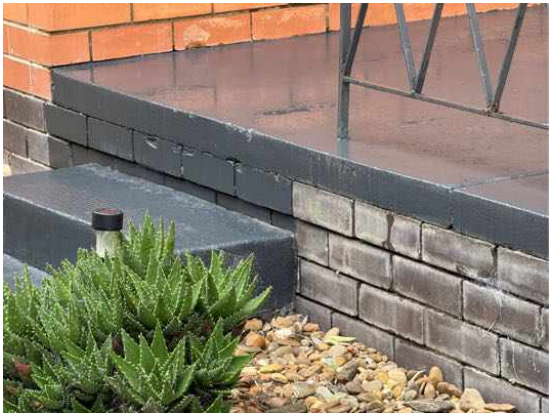
### Defects 3.05

Building: Building 1  
Location: All Areas > All Areas  
Finding: Brickwork - cracks and movement  
Information: At the time of the inspection numerous cracks and movement were observed throughout the exterior brickwork of the home. There was some areas of unevenness

and out of level floor areas in the home and this is likely to indicate some subsidence and movement in the foundations and the associated building structures in the property. Structural issues are generally the underlying cause of such brickwork movement and cracking. It is suspected that this damage has been created due to movement and general subsidence of associated foundations as well as normal age and deterioration. The brickwork cracks and movement may develop further over time with the potential for necessitating some remedial works or even in extreme cases replacement of the brickwork.

Noticeable brickwork cracks and movement are a common occurrence in external brickwork and are a likely result of some building movement, general expansion, and/or contraction in some building elements in different weather conditions. The client is recommended to appoint a structural engineer to inspect the structural integrity of these areas and affected brickwork, to assess the safety of the associated structures. Where remedial work is deemed to necessary or required the engineer can also nominate a scope of works required for rectification or even the prevention of further damage and deterioration. Always contact a Registered builder and or Structural engineer should cracks widen lengthen or become more numerous, even after any repair works have been completed.

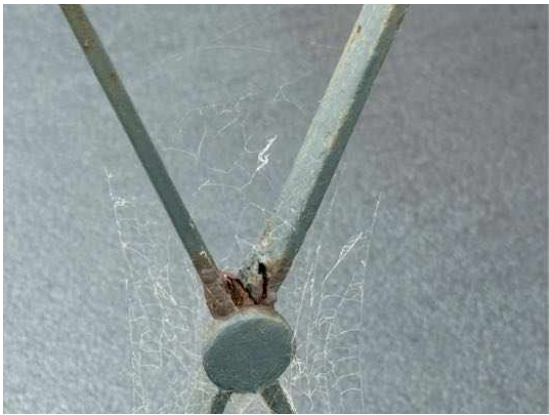
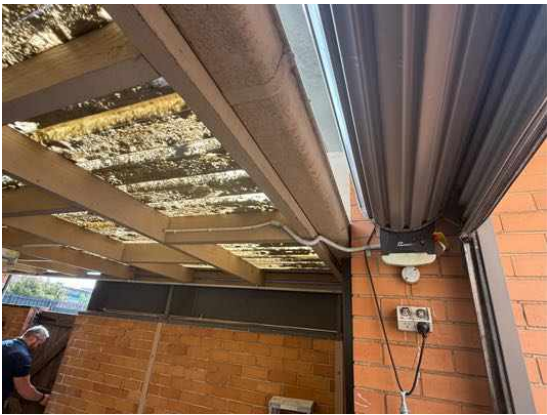
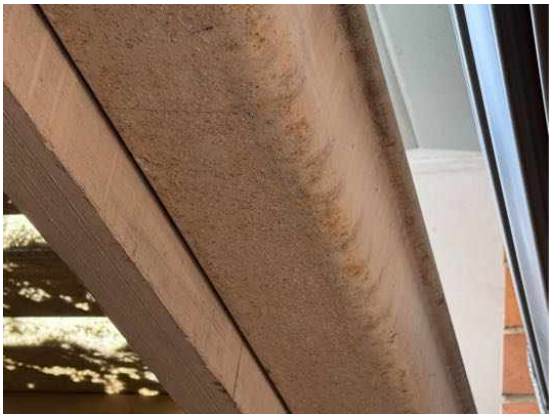
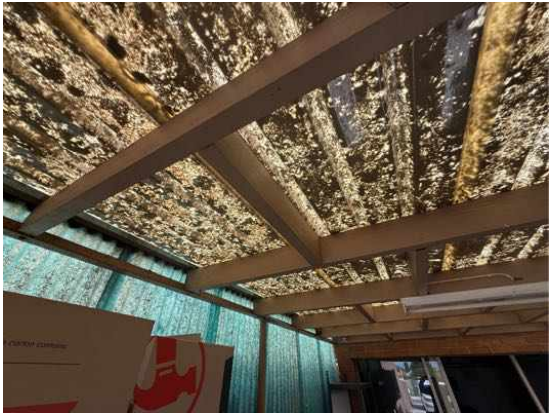
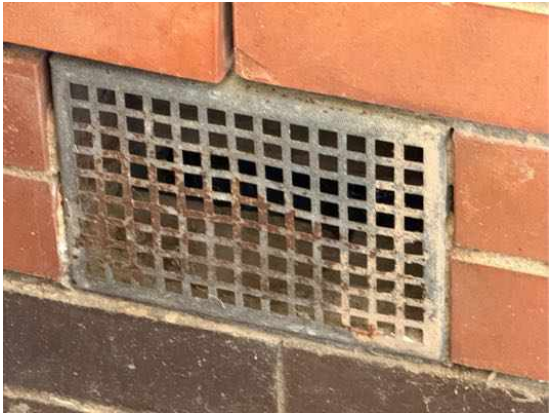
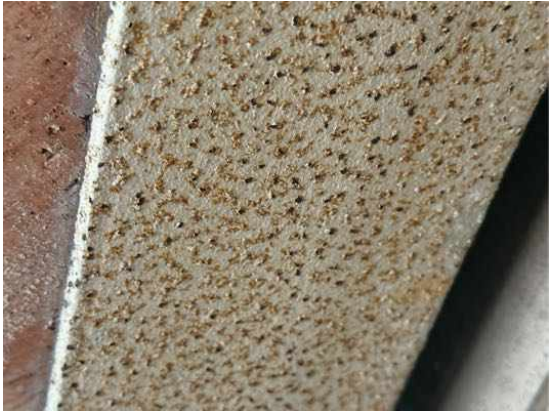
### Defects 3.06

Building:	Building 1
Location:	All Areas > All Areas
Finding:	Building element - Rusted or corroded
Information:	Some exterior building elements and materials that show evidence of rusting and corrosion, has likely developed as a result of excessive exposure to moisture, harsh weather conditions and or inadequate coatings. A surface that is found to be rusted provides no protection to the underlying iron, the deteriorating condition is likely to worsen if not addressed and left unmanaged, it is therefore recommended that the relevant tradespersons remove as much rust as possible, clean and re-paint these areas.

Where possible, the use of galvanized (treated) metals or aluminium coated metals aid in rust prevention, as does regular general maintenance. Rust formation can be controlled with coatings, such as paint, that isolate the iron from the environment. Rusting and corrosion should be managed by ideally removing or limiting the affected surface from exposure to moisture and harsh weather conditions. A qualified painter or other relevant tradespersons may be appointed to paint affected areas and a qualified carpenter to replace any building elements that have been severely affected by rust or water damage.

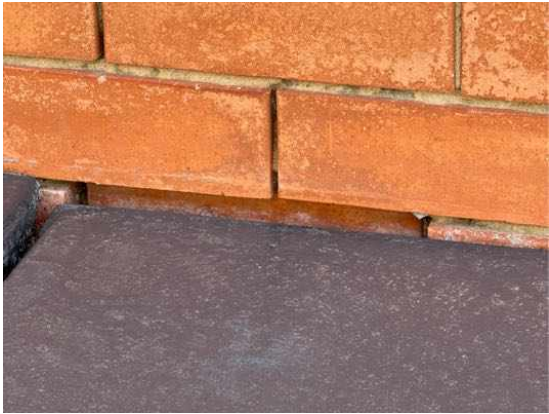
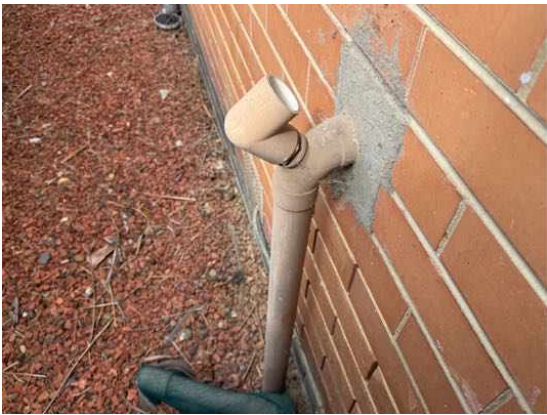
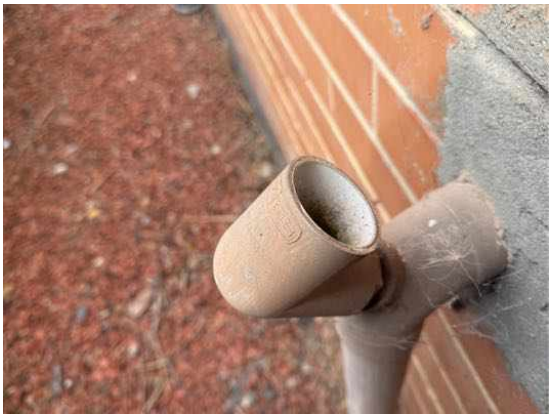
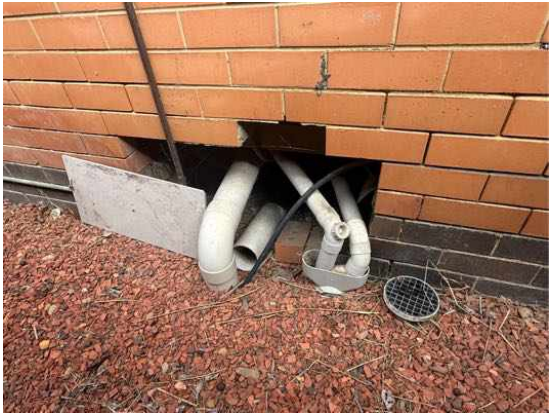
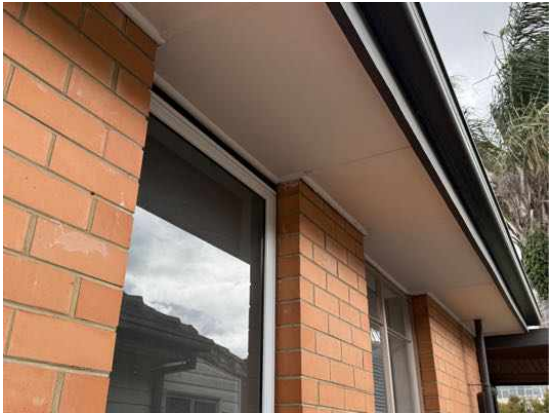
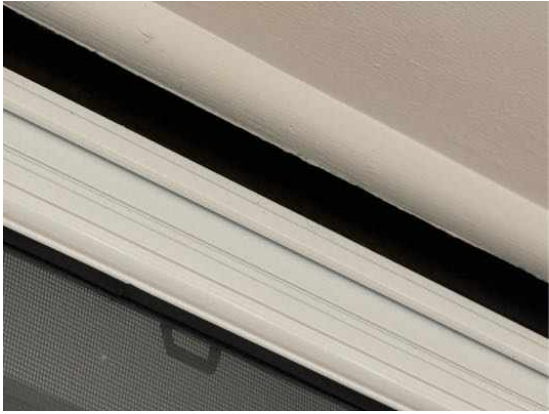
### Defects 3.07

Building: Building 1  
 Location: All Areas > All Areas  
 Finding: Subfloor door and other holes in the exterior walls  
 Information: The subfloor door was observed to be missing and no subfloor door installed. Other holes in the exterior walls or open areas like the subfloor door should be rectified and adequately filled or trimmed to prevent the ingress of unwanted pests and vermin. A window around on the back right hand side of the home has not been finished with a trim of flashing.

Gaps and holes around the home makes the area susceptible to spiders, insect and vermin ingress to the internal areas bringing disease and unhealthy environments As

such, associated internal building elements are likely to deteriorate without the adequate protection a home needs. Further secondary defects are suspected to occur if these areas are left unmanaged. All holes, gaps or cracks should be adequately covered, filled, flashed by a suitable building material, sealant or trimmings as soon as possible to prevent any inevitable future deterioration and secondary damage. Such works should be completed in the short term future by the relevant tradespersons.

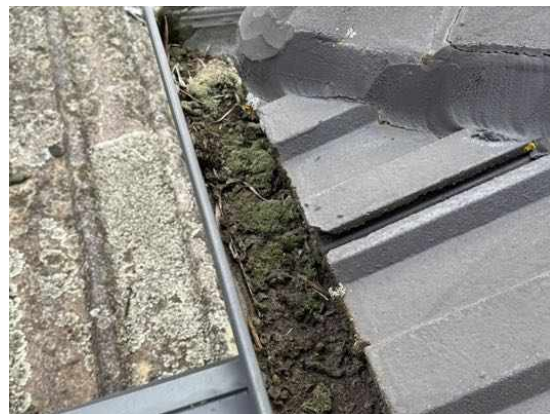
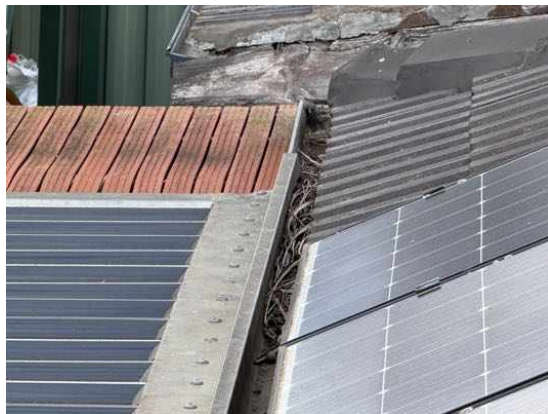
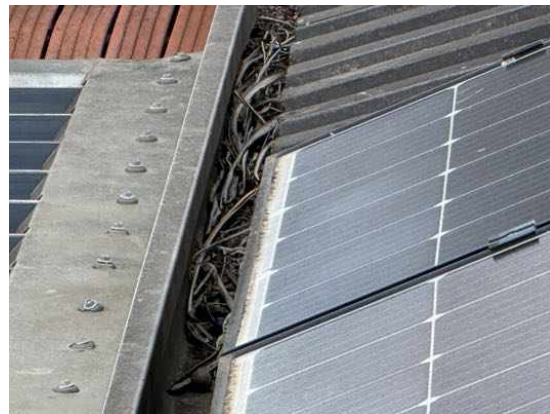
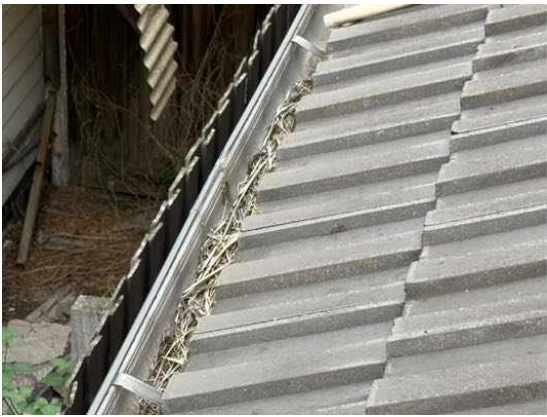
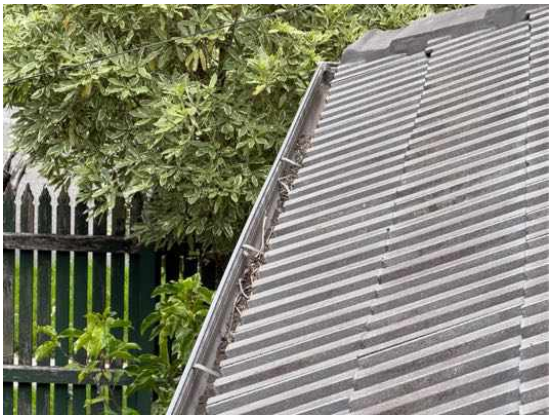
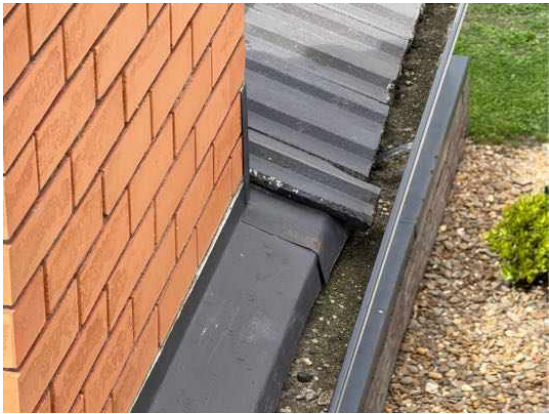
### Defects 3.09

Blocked gutters are likely to lead to high levels of moisture in the affected areas. Such moisture will not only cause rust and decay of the associated building materials, but can also provide conditions that are conducive to termite and timber pest activity. Blockages in gutters should therefore be removed immediately to ensure dry conditions are maintained.

It is recommended that blocked gutters be cleaned and leaf matter and debris be removed by a relevant tradespersons as a priority.

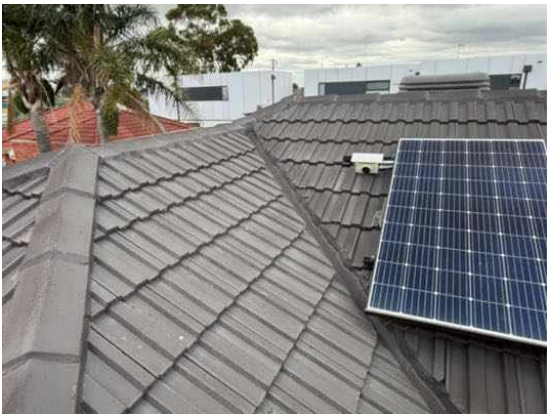
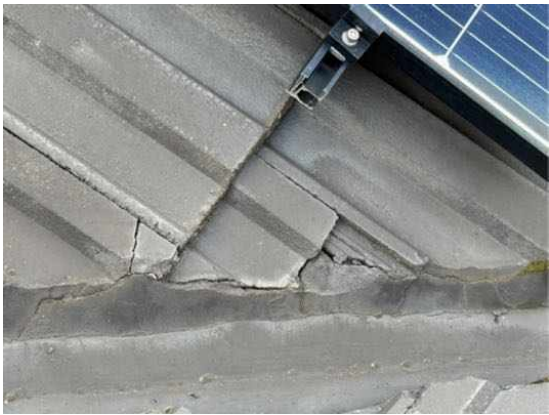
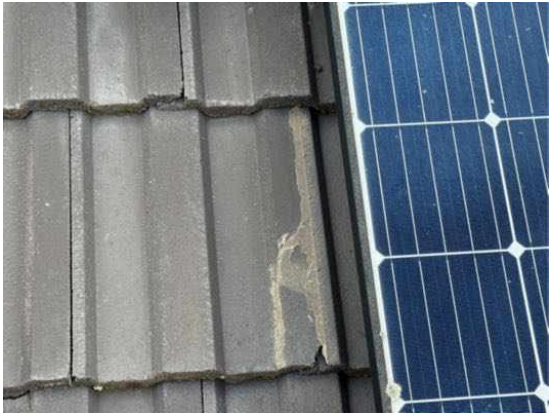
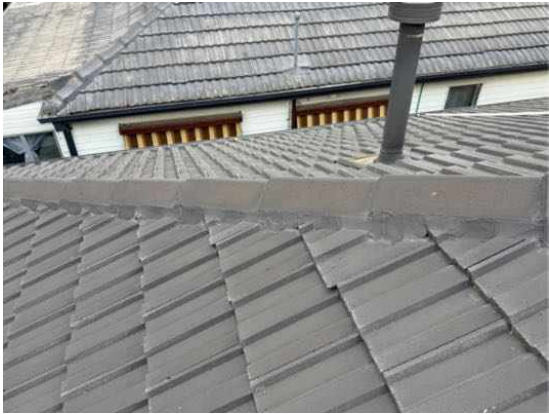
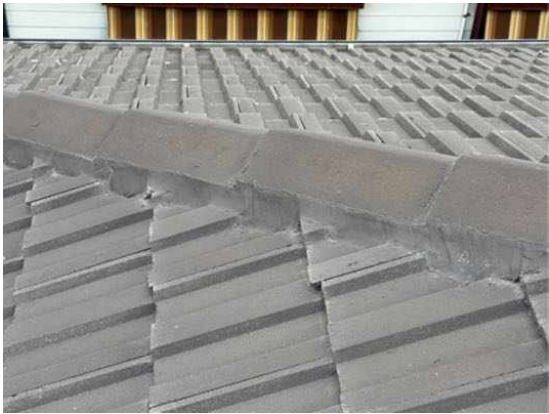
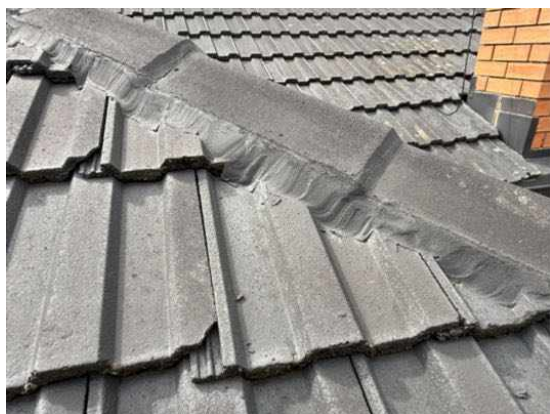
### Defects 3.10

Building:	Building 1
Location:	All Areas > All Areas
Finding:	Roof tiles - broken, chipped, dislodged or show some slippage
Information:	Upon inspection of the roof tiles, it was observed that numerous roof tiles slipped down or have been dislodged from their original positions and have not been repositioned before the roof restoration was completed. Numerous roof tiles may slip over time due to a number of minor causes, including not placed correctly upon installation, not stuck down on the top of valley irons, flashings, roof tile chips and breakages, failings in the adjoining battens, or fixings that may have failed.

In this case I suspect that tiles have just slipped or dislodged from they original positions overtime, these roof tiles when readjusted should receive some form of fixing to fix them down. Either by a good adhesive or a good quality silicon sealant. Roof tiles that have moved from their original position may allow water penetration into the roof void, exposing roofing structures to excessive moisture. This creates an environment that is conducive to water damage and accelerated deterioration of all associated building elements below these areas.

Replacement of broken, loose or missing roofing tiles is also highly recommended immediately or in the short term future to prevent the development of any secondary defects overtime if left unmanaged. A roofing plumber or roof tiler should be appointed to complete such works as deemed to be necessary.

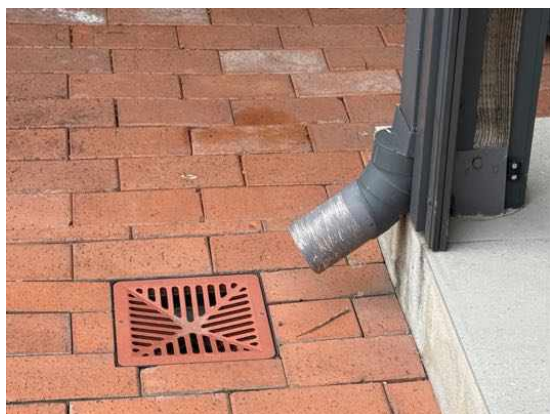
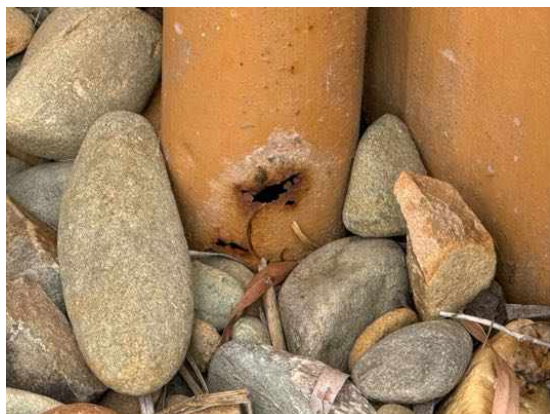
### Defects 3.11

Building:	Building 1
Location:	All Areas > All Areas
Finding:	Down-pipe on the rear pergola is not properly connected to stormwater
Information:	It was observed at the time of inspection that the rear pergola down-pipe was observed to be emptying onto the rear paved area. The down-pipe was situated over the top of a stormwater - sump or pit, it should be either connected properly to the stormwater drainage system or fully inserted down into stormwater sump or pit so as to prevent any splashes. Where down-pipes sit above the pit, these surrounding areas are always susceptible to excessive splashing and moisture, rust, corrosion, termite and pest.

The down-pipe on the outside of the teen retreat was observed to be rusted and corroded showing a small rusted hole. If these down-pipes are not rectified or left unmanaged, moisture, wood rot, rust and corrosion is likely to lead to further damage and deterioration to the adjoining building elements and surrounding areas. This also makes these areas more susceptible to termite and pest activity. It is recommended that client appoint and seek advice and consultation with a licensed plumber to gain advice and rectify affected areas in the short term future.

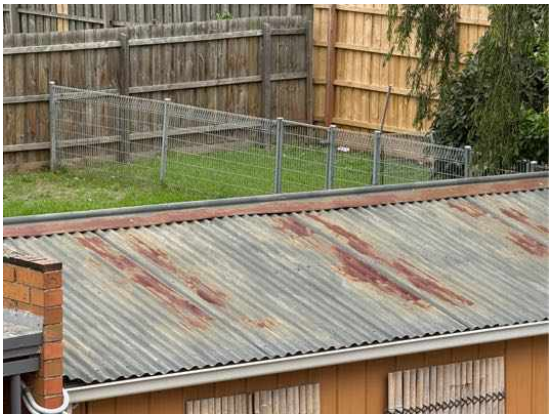
### Defects 3.12

Building:	Building 1
Location:	All Areas > All Areas
Finding:	Teen retreat roofing iron - rusted and corroding
Information:	Garage / teen retreat roofing iron and flashings were observed to be showing signs of excessive rust and corrosion from exposure to exterior weather conditions, inadequate coatings. As these types of surfaces rust they provide no protection to the underlying iron, the deteriorating condition is likely to worsen if not addressed in the short-term future.

Where possible, the use of galvanized (treated) metals or aluminium coated metals aid in rust prevention, as does regular general maintenance. Rust formation can be usually controlled with coatings, such as paint, that isolate the iron from the environment however these areas appeared to be past repair or painting. Rusting and corrosion should be managed by ideally removing the affected areas or limiting the affected surface from exposure weather conditions or to excessive moisture. A qualified roof plumber should be appointed to provide remedial work to the affected areas of rust, corrosion or water damage.

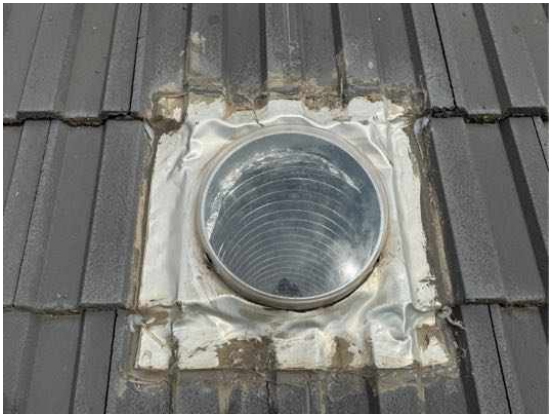
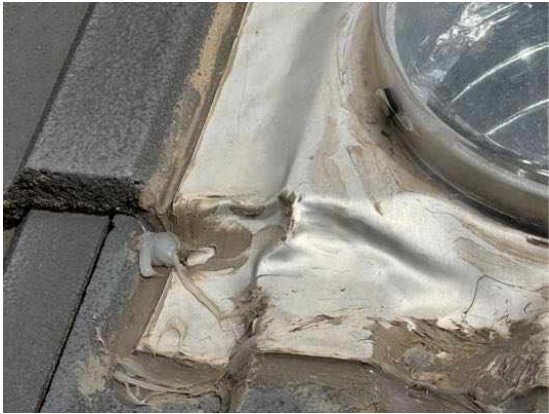
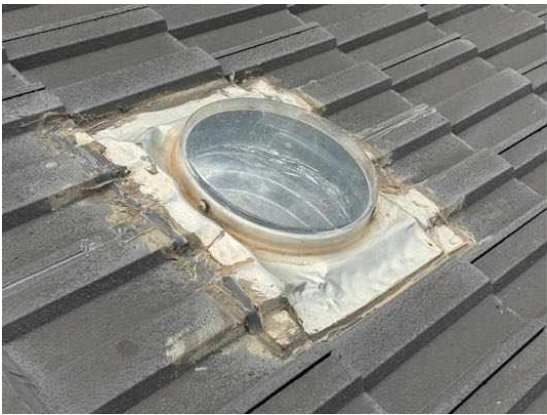
**Defects 3.13**

Building: Building 1  
Location: All Areas > All Areas  
Finding: Roof flashing - non-standard  
Information: The roof flashing that has been installed to this roof skylight is not the correct flashing that should be used and not considered to be adequate and fit for purpose as a skylight flashing. This type of flashing is normally used as a bottom timber window flashing. However the flashing does appear to be working at the time of the inspection and may be ok for a short time, however if left as is and unmanaged this type of flashing is suspected not excepted to keep the roof water-tight or weatherproof.

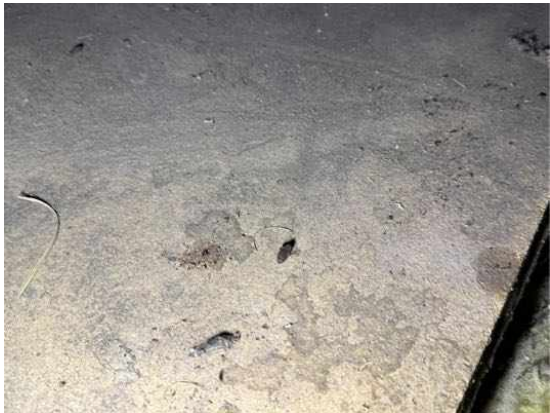
**Defects 3.14**

Building: Building 1  
Location: All Areas > All Areas  
Finding: Evidence of Vermin in the roof space  
Information: Evidence of pests or rodents were present in the roof space at time of inspection. Pests such as possums, insects, spiders and rodents can cause issues ranging from smells and stains through to physical damage to wiring and other important building elements in the roof void. A licensed pest controller should be appointed to free the roof void of any pests and to install deterrents or seal access points to ensure that rodents can not enter the roof space as easily.
