Building and Timber Pest Inspection Report

Inspection Date: Fri, 13 Feb 2026

Property Address: 66 Chad Terrace, Glenroy NSW 2640,
Australia

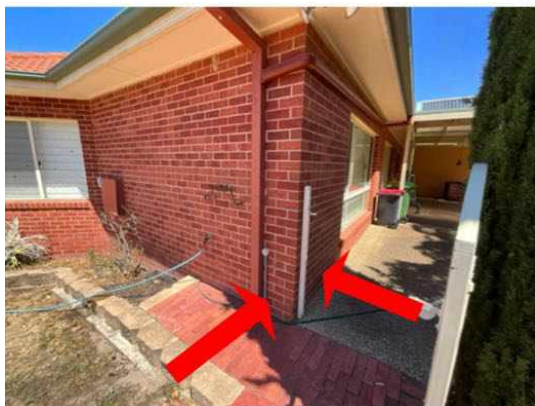
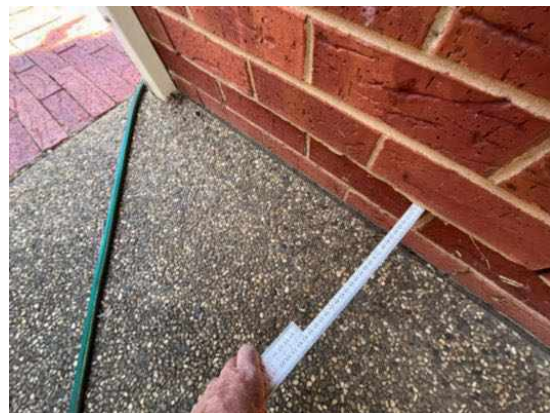
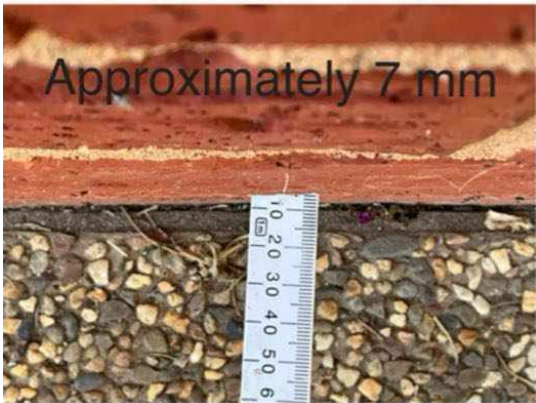
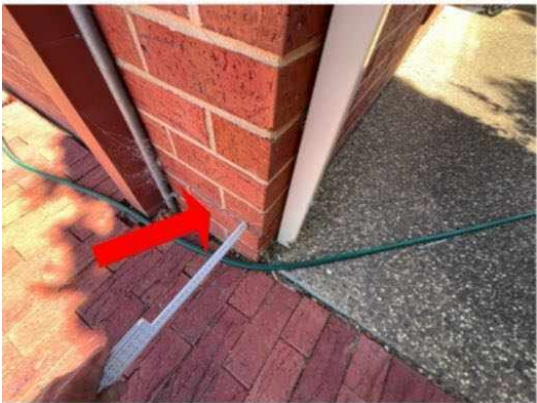
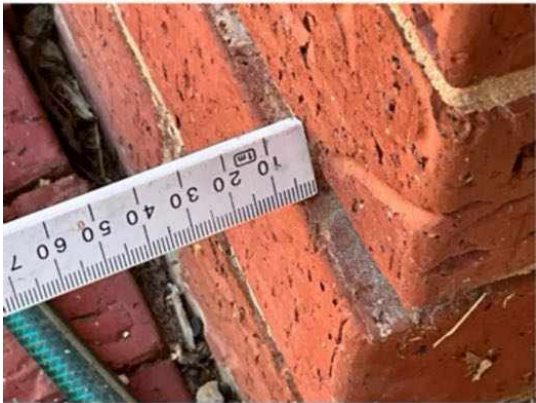
Finding 3.01

Building: Building 1
Location: Living Room
Finding: Brickwork - cracking/ movement
Information: cracking was identified to the brickwork in this area at the time of inspection. Step cracking, which is similar to other forms of cracking, has a variety of possible causes. However, the most common is the subsidence of adjacent footings.

Step cracking is a relatively common defect, and is most likely to occur adjacent to windows, doors and other openings. Mortar failure in the gaps between affected bricks indicates the stresses and tensions affecting the wall.

Minor step cracking can be used as a warning sign to address factors causing stress to the wall, which can include the effect of surrounding trees, water leaks, soil erosion, or even the presence of reactive soils in the surrounding area.

If cracking becomes extensive or severe, the client is advised to consult a structural engineer.

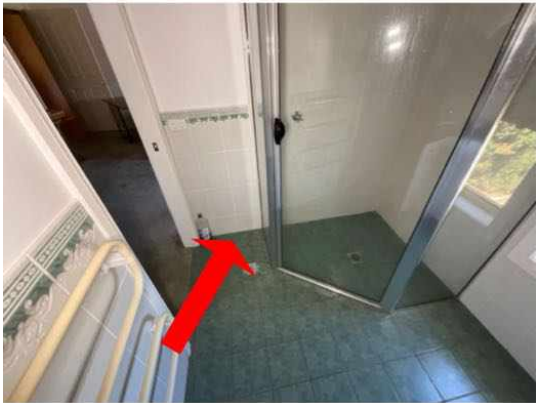
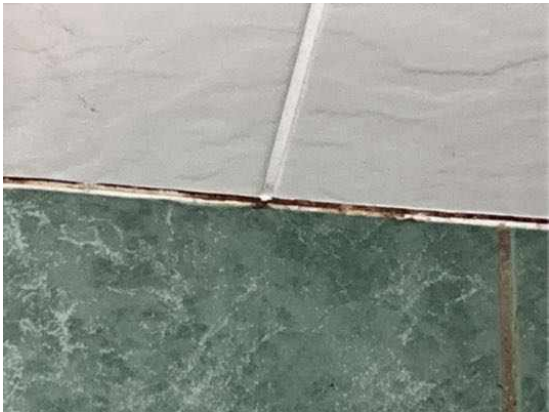
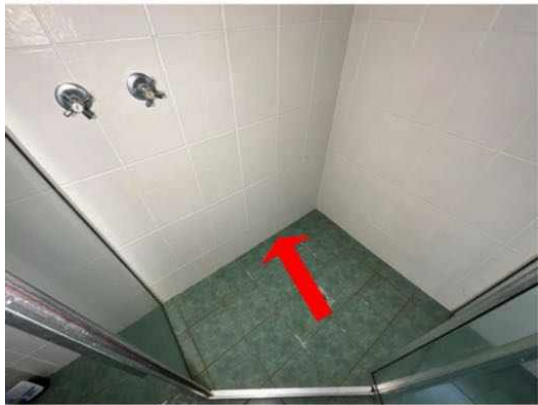
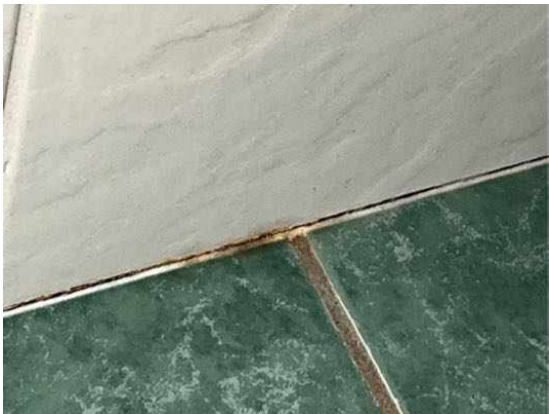
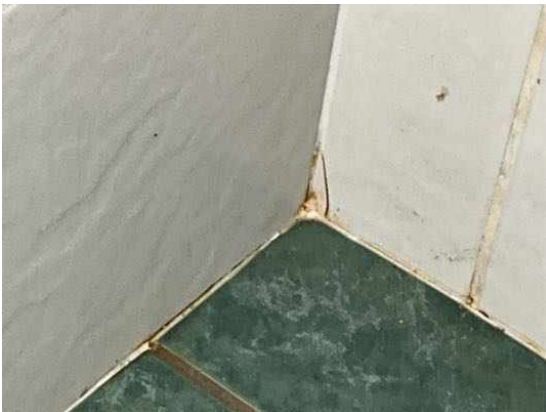
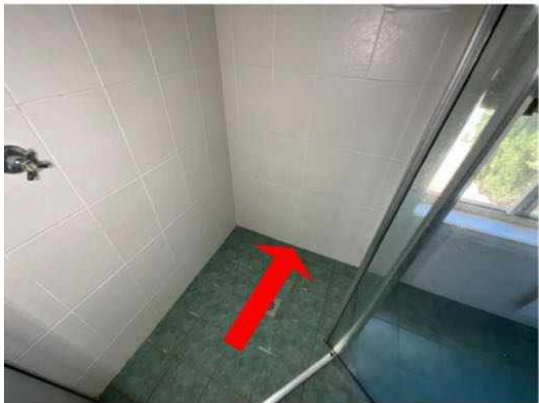
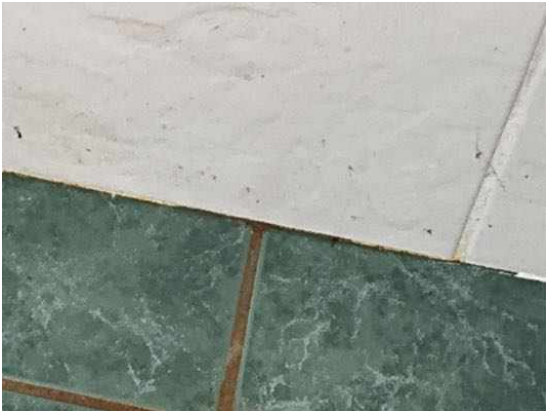
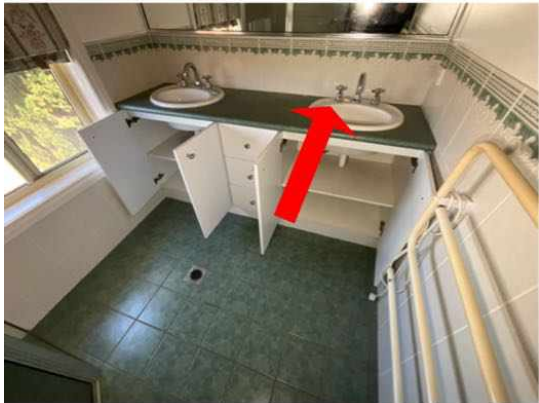
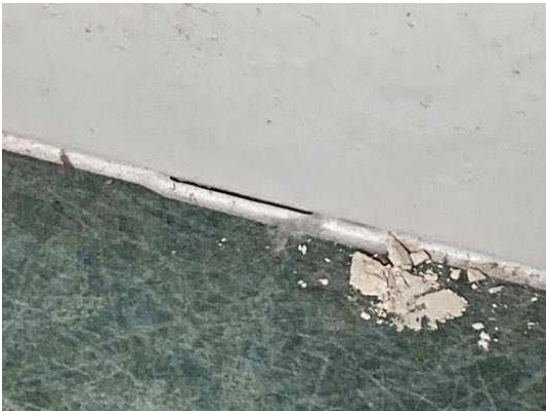
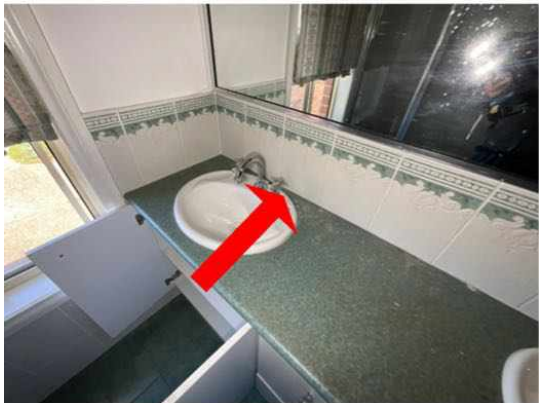
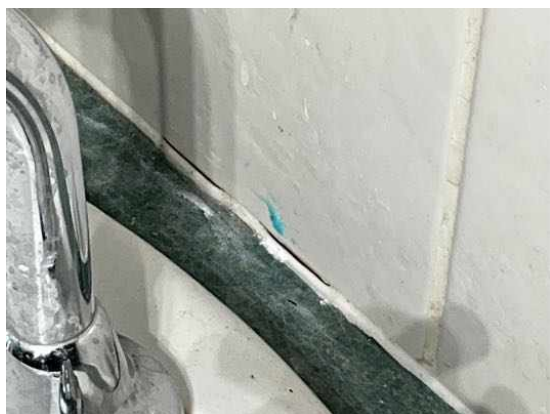
Finding 3.02

Building: Building 1
 Location: Ensuite
 Finding: Inadequate sealant or Grout
 Information: This area has a lack of effective Sealant or Grout. This is allowing the ingress of water to the structure inside the wall.

The presence of water encourages Termite attack, Mould and Fungal Decay.

A Tiler or General Handy person must be contacted as soon as possible to effect repairs and prevent further deterioration.

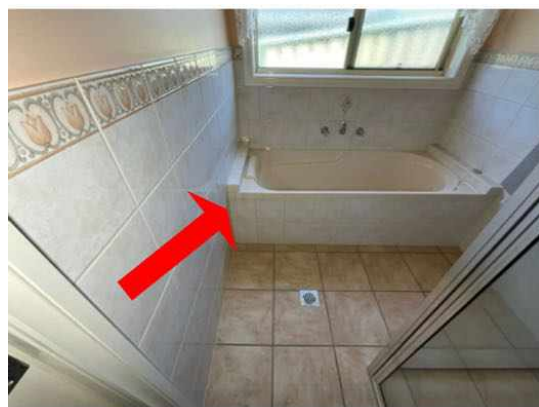
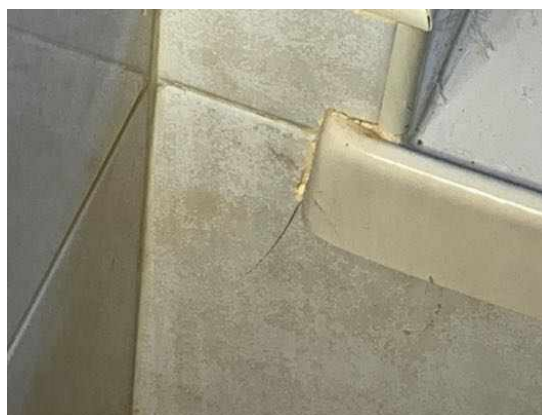
Finding 3.03

Building:	Building 1
Location:	Bathroom
Finding:	Wall Tiles- Cracked
Information:	Cracked tiles within the household detract from the overall appearance of the affected areas, as well as creating potential for water penetration to adjoining building elements. If left unmanaged, water damage may occur as a result of constant water penetration over a prolonged period of time.

While not considered a matter of urgency, replacement of tiles is advised as a solution. A Tiling Contractor may be appointed to perform these works at client discretion.

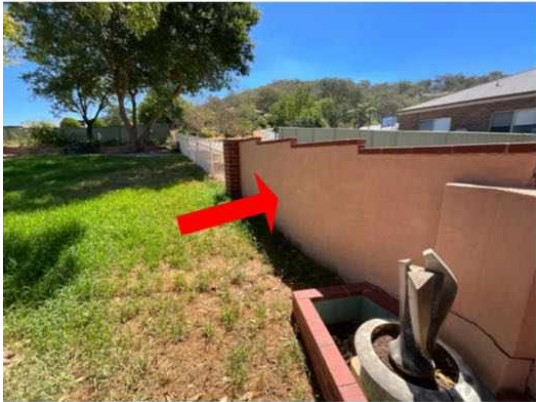
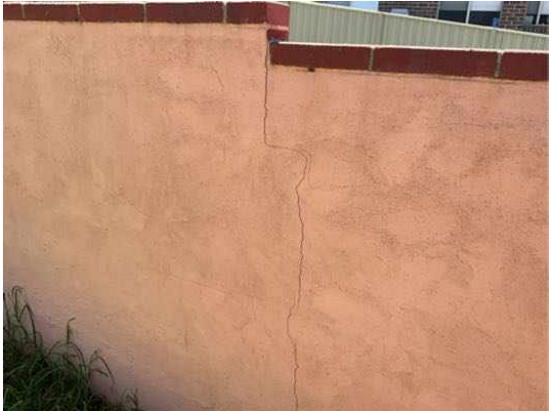
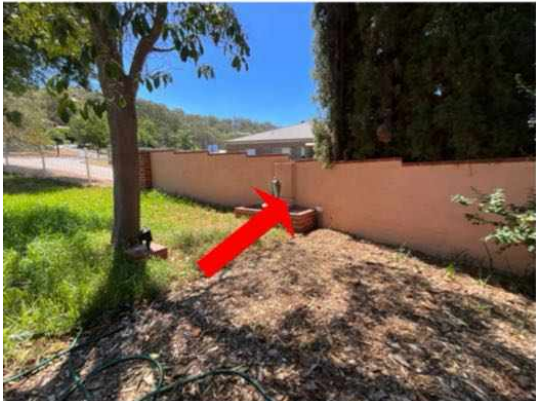
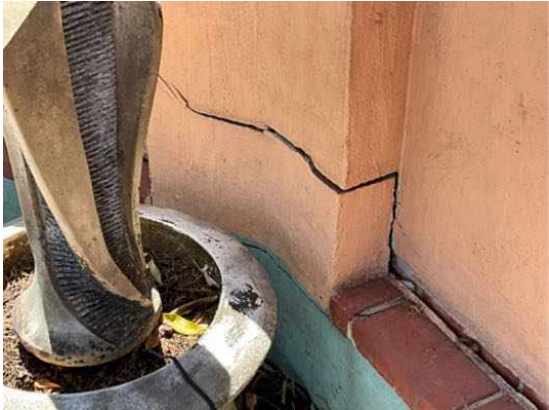
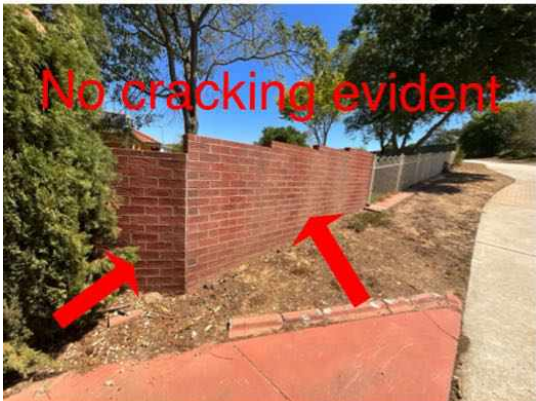
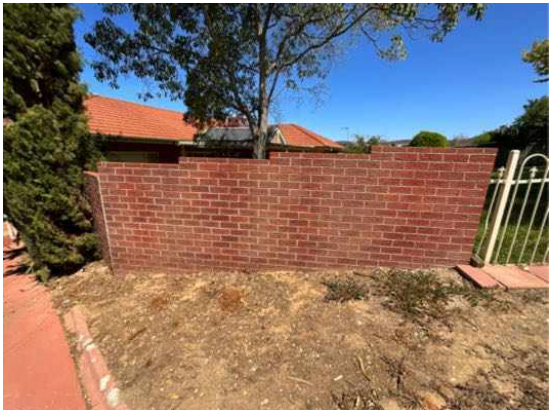
Finding 3.04

Building:	Building 1
Location:	Garden wall
Finding:	Cracks to External Render
Information:	It has been observed that cracking to external rendered surfaces has occurred.

The extent of cracking would suggest that this is a Minor defect.

Monitoring for 12 months is recommended. If cracking increases in size or number, contact a Registered Builder to make all needed repairs and avoid further deterioration.

Always contact your building inspector should any cracks widen, lengthen, or become more numerous.

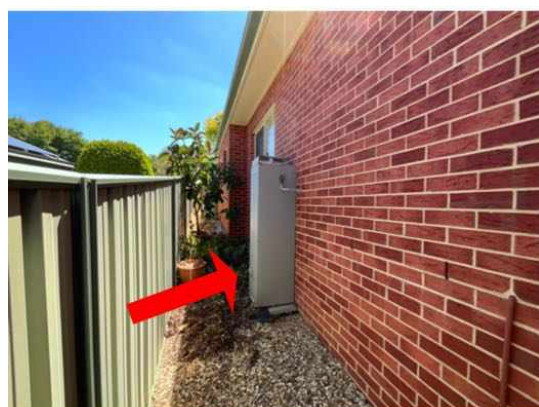
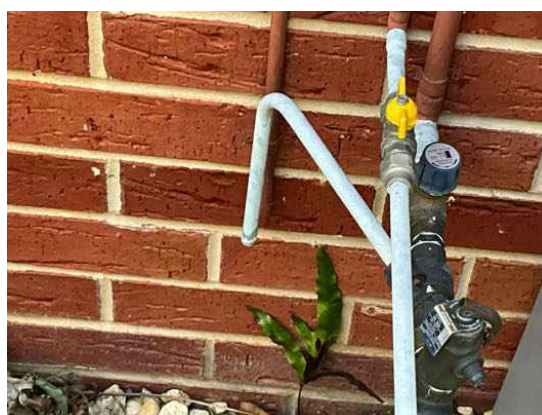
Finding 6.01

Building: Building 1
 Location: Yard - Side
 Finding: HWS Overflow - Not Connected
 Information: The Hot Water System (HWS) overflow was found to be disconnected from storm water drainage and is creating excessive moisture in the surrounding area.

These damp conditions can lead to secondary defects such as rot, rust or corrosion of associated building elements, the formation of fungal decay, or even the creation of potential slip hazards. When coupled with poor site drainage, pooling of water may also attract termite activity to this area.

It is highly recommended that a licensed plumber be appointed to connect the HWS overflow in order to prevent such an environment from being created. These minor works should be carried out as soon as possible.

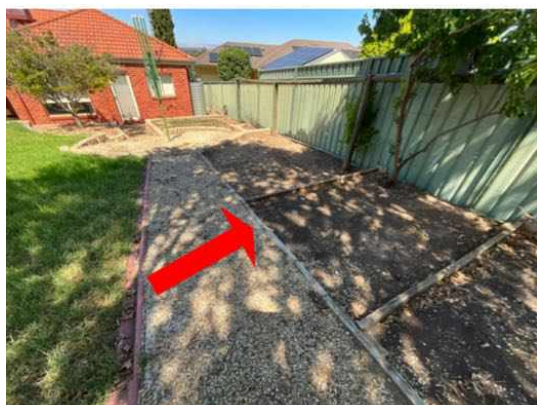
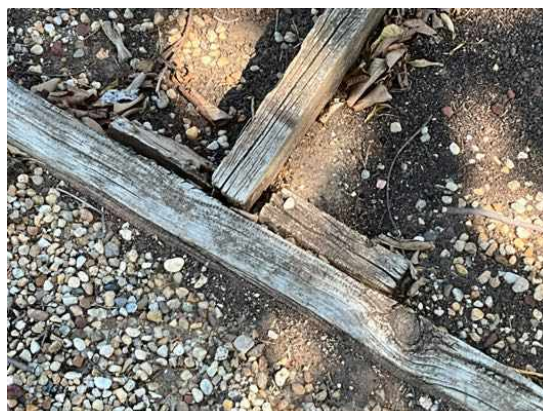
Finding 6.02

Building: Building 1
 Location: Yard - Back
 Finding: Untreated or non-durable timbers in a hazardous environment
 Information: To reduce the risk of timber pest attack it is essential that timber used in a hazardous environment (e.g. in direct contact with the ground or frequently exposed to damp conditions) is of sufficient durability and/or is adequately preservative treated.

Untreated timbers in direct contact with the ground are likely to develop severe wood rot and/or fungal decay if left unattended creating attraction for subterranean termites to infest the timbers from surrounding areas.

If untreated or non-durable timbers are found to be in a hazardous environment it is highly advised that replacement of these building elements be performed as soon as possible to aid the protection of the property against termite / timber pest attack.

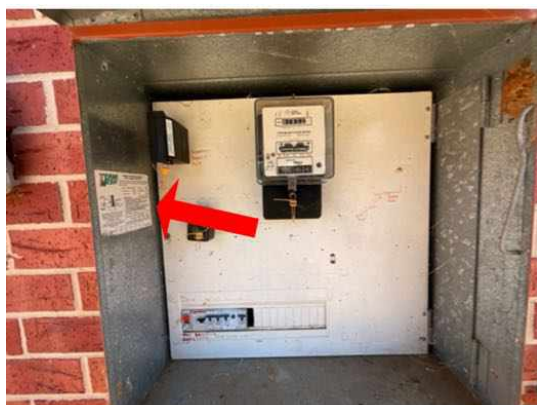
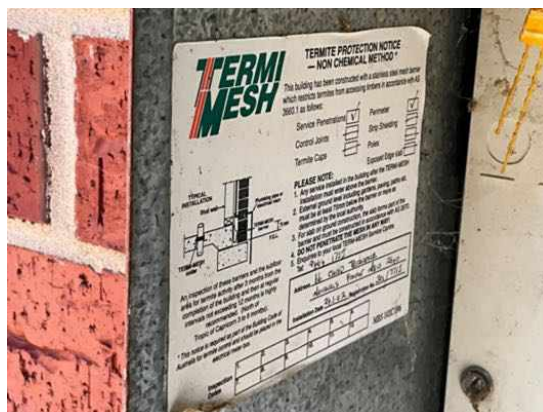
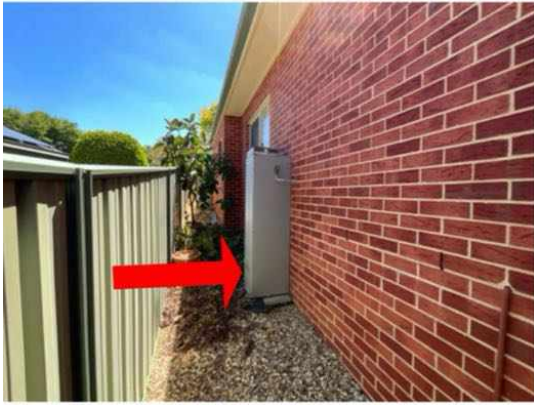
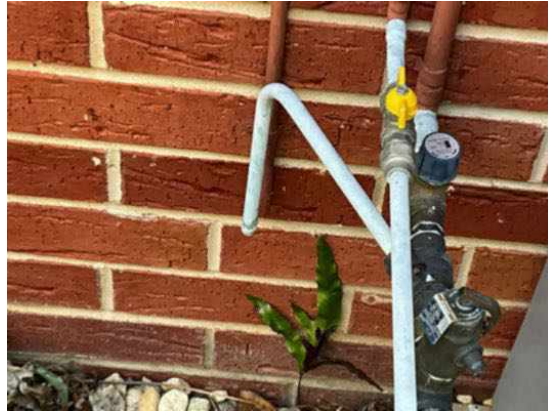
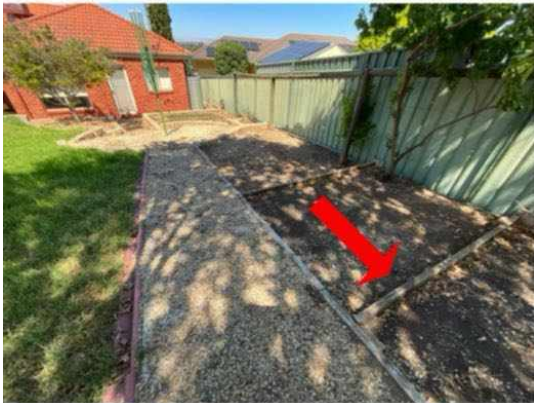
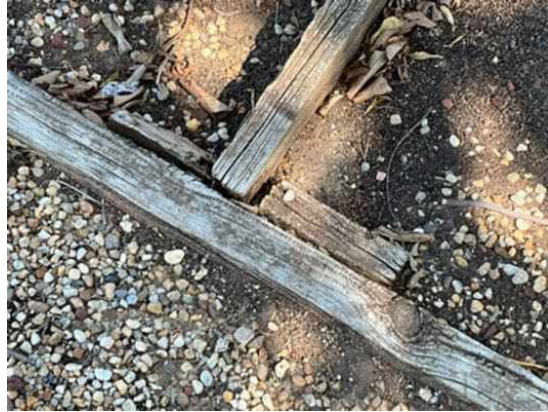
Finding 6.03

Building: Building 1
 Location: All External Areas
 Finding: Termite Management System - no evidence of a chemical installation
 Information: The application of a post-construction chemical termite barrier is highly recommended for all properties, particularly if live termite activity has been found on the site previously. Such barriers are highly effective in preventing termite attack on any timber building elements throughout the property.

A durable notice should be placed in the switchboard unit to indicate current termite barriers. At the time of inspection, it appeared as though no termite management system has been installed, with no evidence to suggest preventative works taking place.

The client may consider gaining further advice from a pest controller as to the costs and procedures involved with this application. It is recommended that obtaining such advice be a short-term priority.

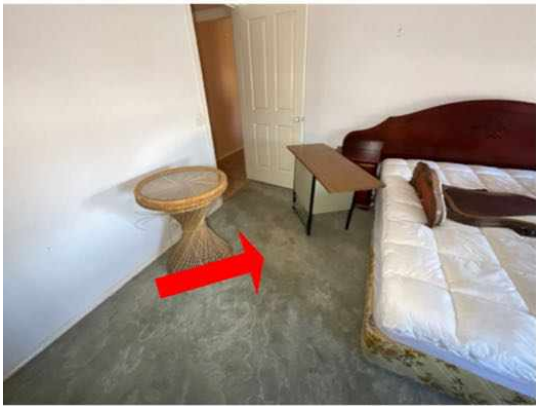
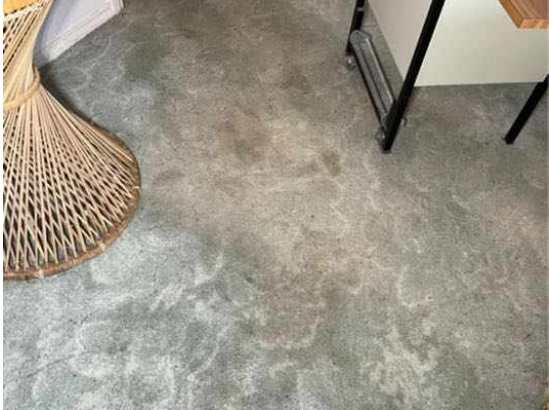
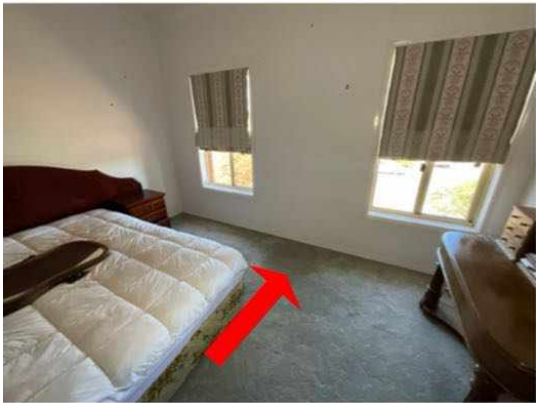
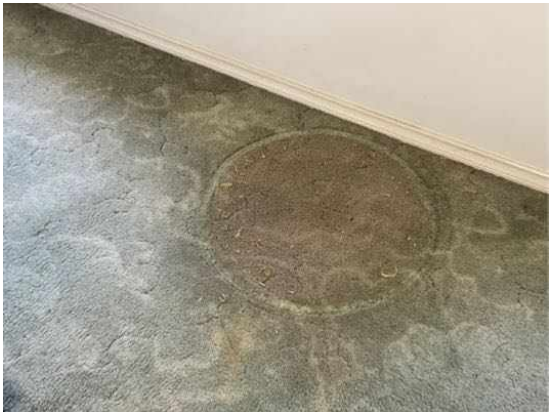
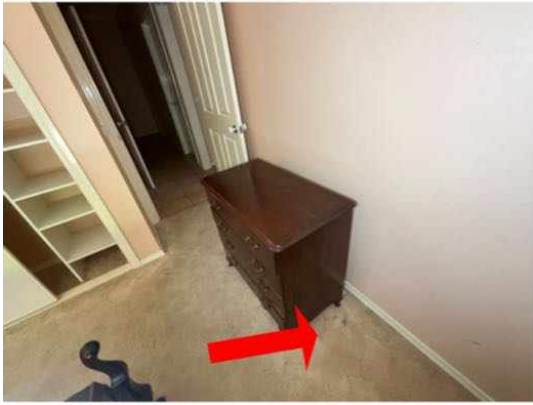
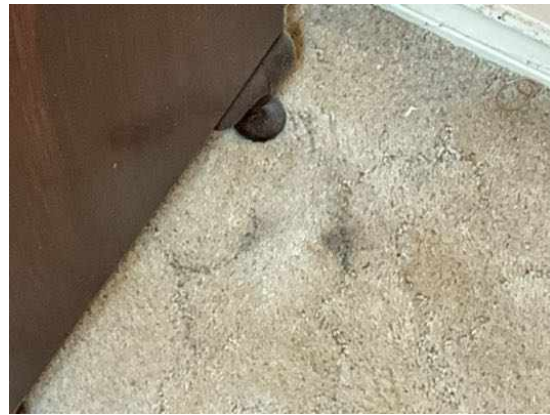
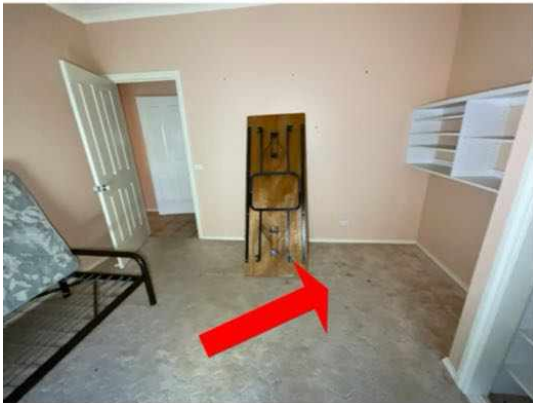
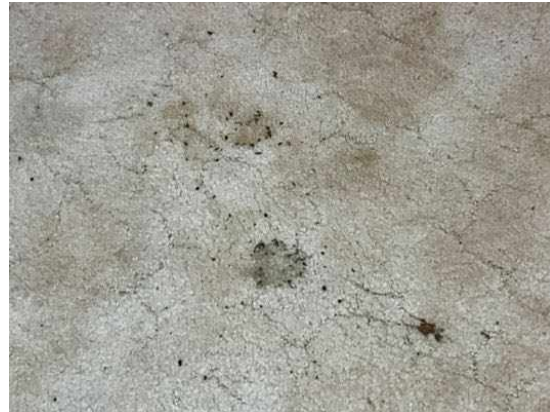
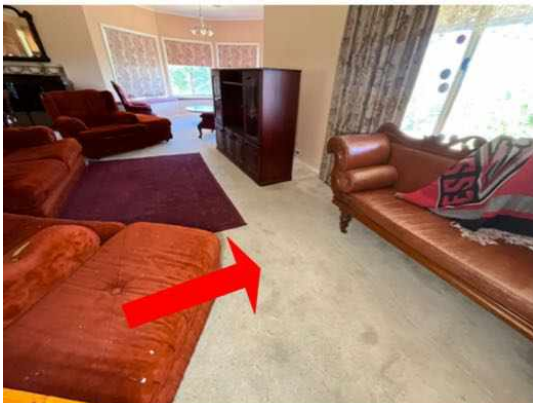
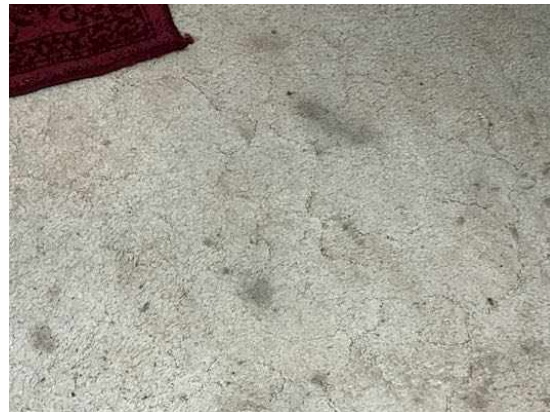
Noted Item

Building: Building 1
Location: All Internal Areas
Finding: Carpet- Staining
Information: The carpet shows signs of staining or soiling. Several areas show marks.

A carpet cleaning company should be consulted at the discretion of the client, to apply all appropriate methods to improve the carpet condition.

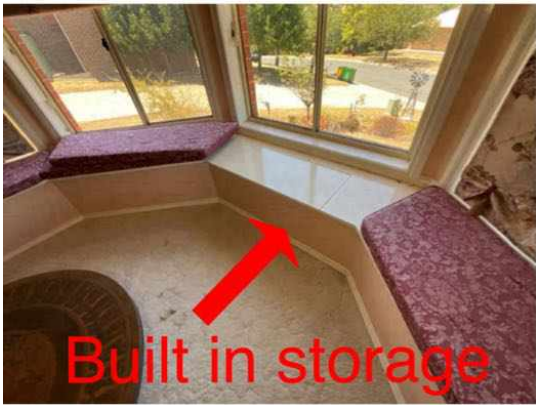
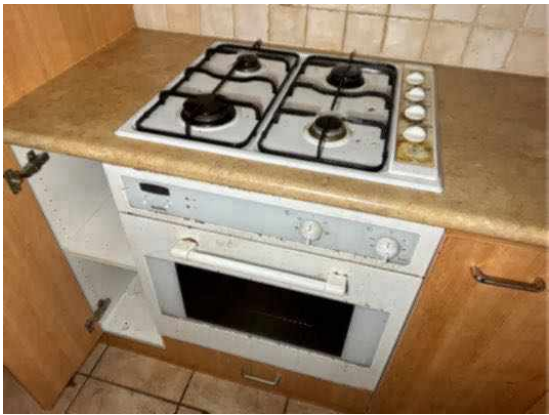
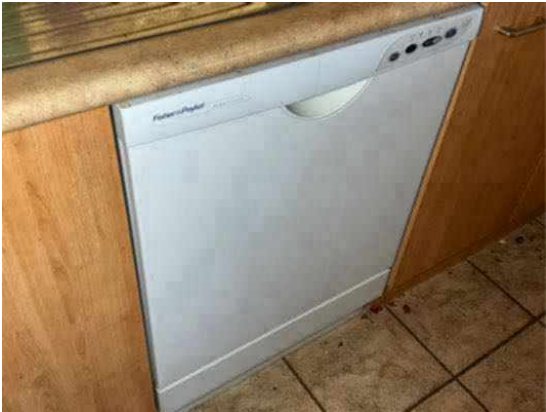
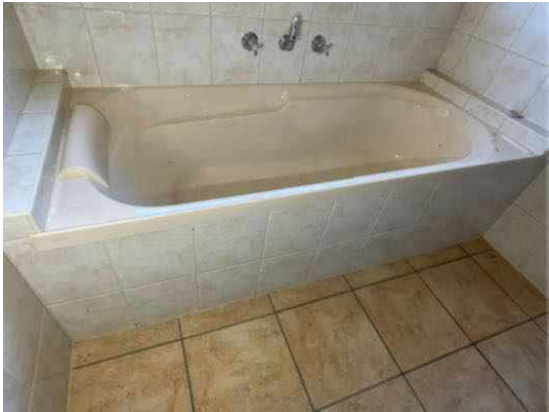
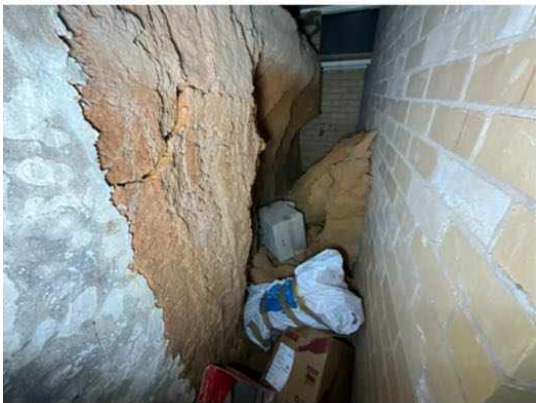
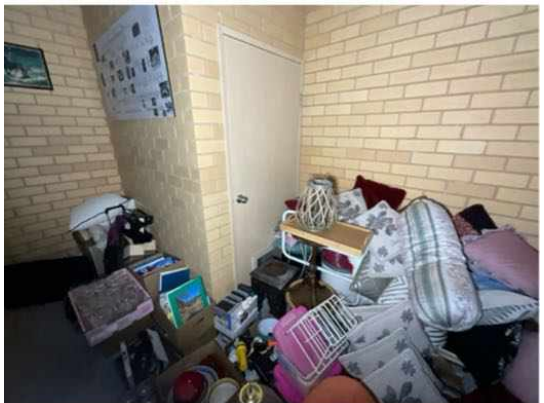
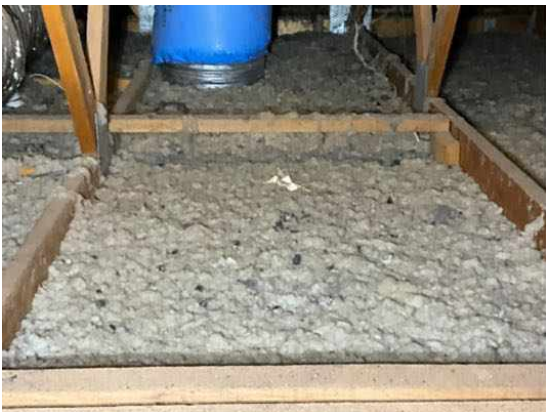
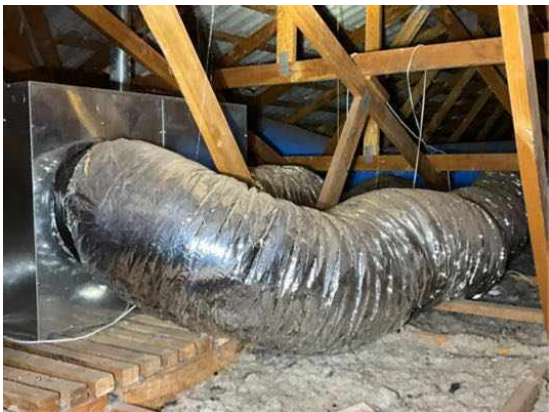
Noted Item

Building:	Building 1
Location:	All Areas
Finding:	Additional Photos - Obstructions and Limitations
Information:	These photographs are an indication of the obstructions and limitations which impeded full inspection of the property at the time of inspection. These obstructions can hide an array of defects and should be removed to allow full inspection to be carried out. A re-inspection is recommended once the areas are made accessible.
