Building and Timber Pest Inspection Report

Inspection Date: Fri, 13 Feb 2026

Property Address: 69 Rennie St, Thornbury VIC 3071, Australia

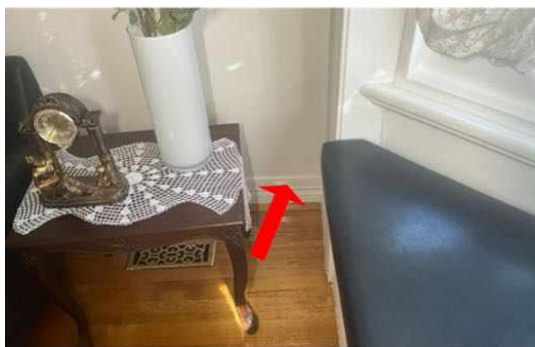
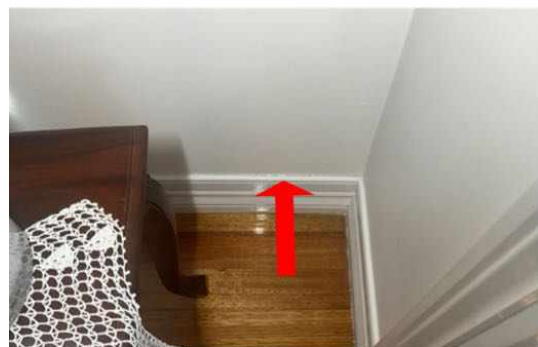
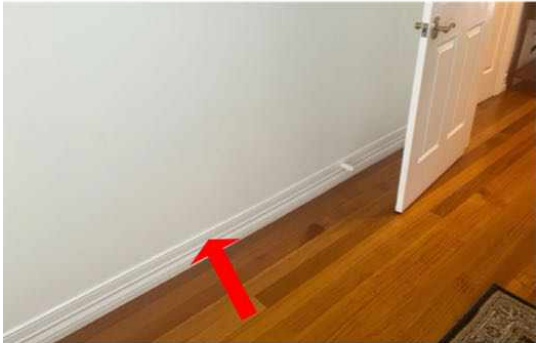
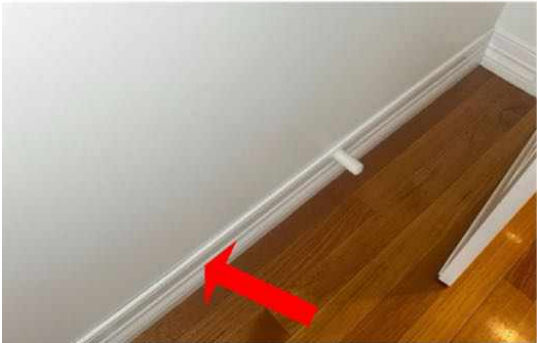
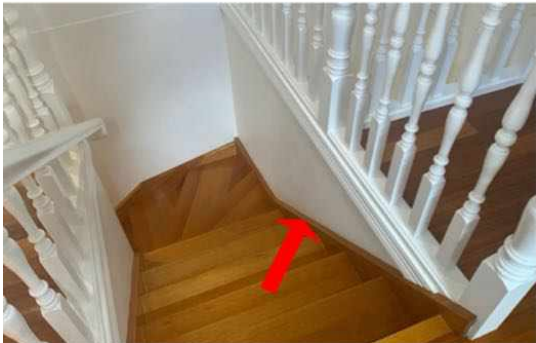
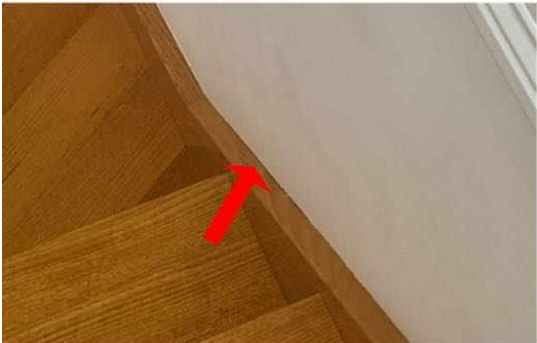
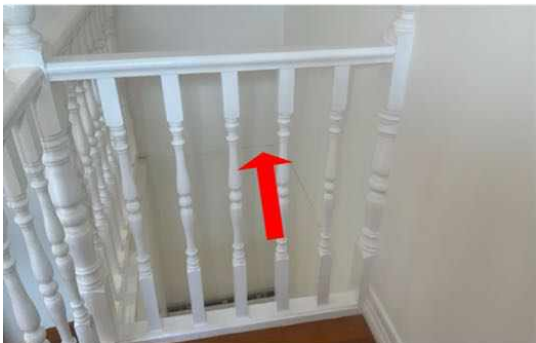
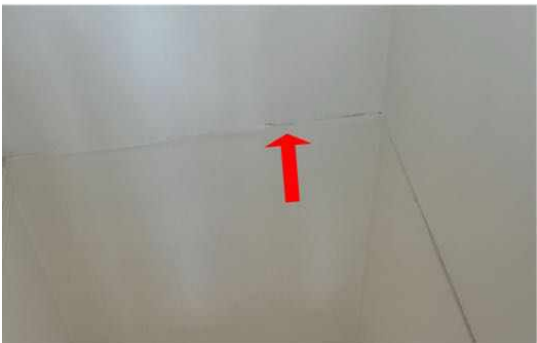
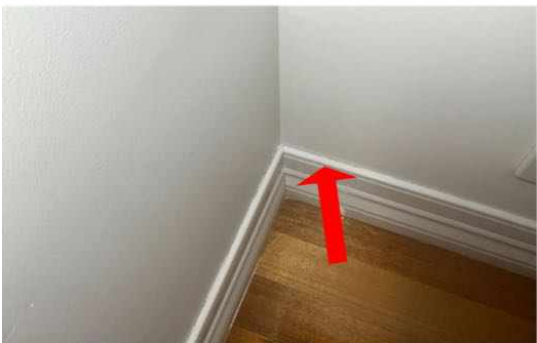
Finding: Cracking - fine

Information: Some fine cracking was noted throughout the property.

Although fine cracks are quite noticeable, they are often only considered to be an appearance defect, and usually do not indicate any structural damage. Generally, the cause of a fine crack is indicative of a separation between building materials and finishes (e.g. paint, plaster, etc.) along joins.

Cracking of this nature can generally be repaired with minor sanding, filling and/or repainting. Such works should be performed by a qualified painter or a general handyman.

Monitoring of all cracking should be conducted frequently. Always contact a building inspector should cracks widen, lengthen, or become more numerous.

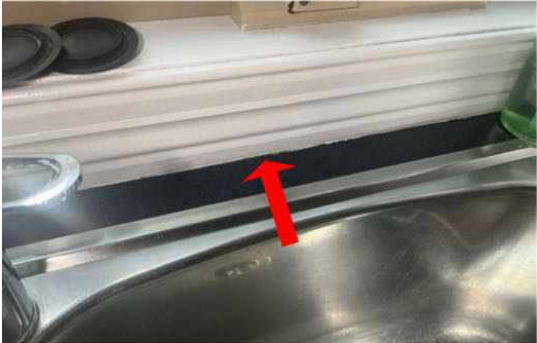
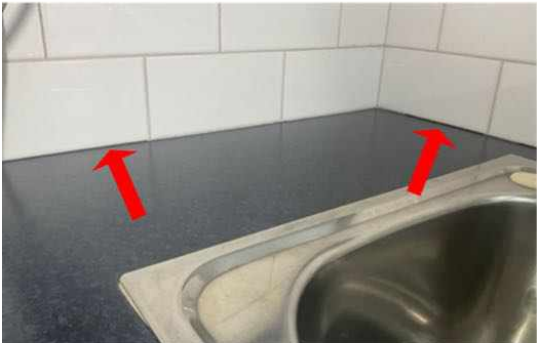
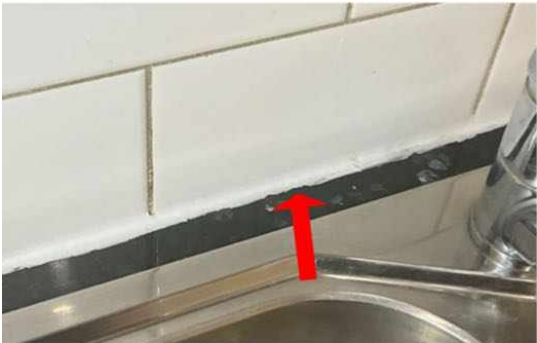
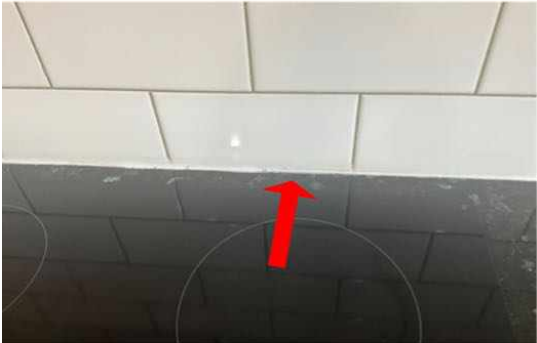
Finding 3.02

Building:
Location: All Areas
Finding: Sealant - Missing or degraded
Information: Sealant is missing or degraded in this area. Sealant is used to protect gaps and crevices in building materials to ensure that they are water-tight and prevent water penetration to the associated structures.

Where sealant is missing or degraded , a tiling contractor should be appointed immediately to re-apply any silicone where necessary. Failure to do so may lead to water damage to the surrounding area.

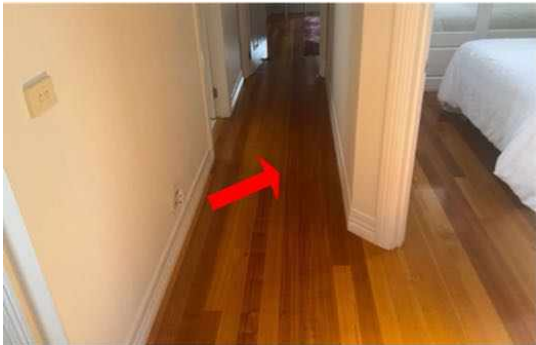
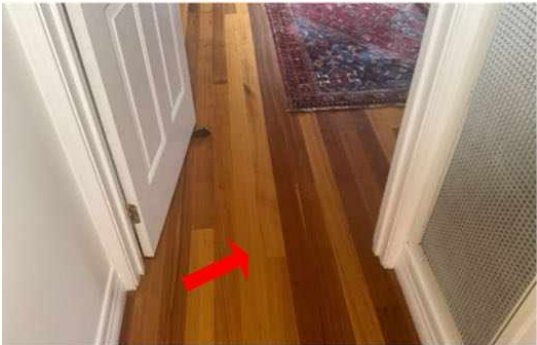
Finding 3.03

Building:
Location: All Areas
Finding: Floor - creaking slightly in some areas
Information: The internal flooring in these areas were creaking slightly when walked upon at the time of inspection.

Creaking floors generally indicate that the floorboards or the subfloor structures are coming loose from the supporting structure that they are installed on.

The areas should be monitored for any changes or unevenness. Should this occur, consultation with a registered builder should be undertaken to determine the cause . The potential resolution may involve regluing and screwing the floor down through to replacement of subfloor support structures.

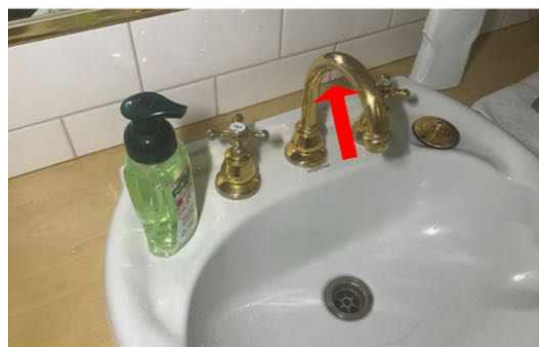
Finding 3.04

Finding: Grout and sealant - Missing or degraded within the bathroom area

Information: It was noted on inspection that grout or sealant is degraded to areas within the bathroom.

Different materials move at different rates, generally causing cracking to grout at this point. Build up of moisture in the bathroom can also cause grout and sealants to degrade and become mouldy.

Any damaged or degraded materials should be scraped out and flexible and mould resistant materials should be applied to affected areas to prevent any subsequent water damage that may occur. Regular maintenance and replacement of damaged or missing grout/ sealant is highly recommended to the wet areas, as this is a regular wear and tear defect. Both grout and sealant in areas that come into regular contact with water should be maintained for the long term care of your property.

A bathroom specialist or tiling contractor should be appointed to complete these works as soon as possible.

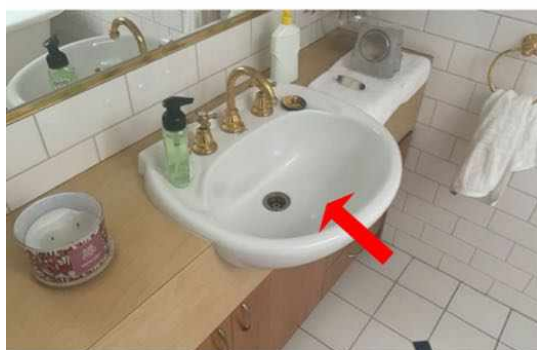
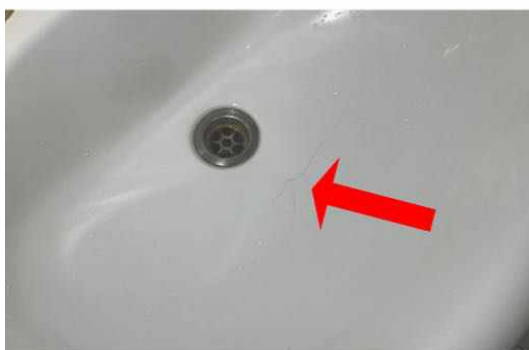
Finding 3.05

Finding: Crack to vanity basin

Information: At the time of inspection it was noted that there was a crack to the vanity basin in the main bathroom.

It is suspected that this may have occurred as a result of impact damage. No leaking was noted through the cracking when the tap was run.

The crack should be monitored for any further changes. Should the crack increase in size, a bathroom specialist may be engaged to inspect the area and repair or replace the basin as required.

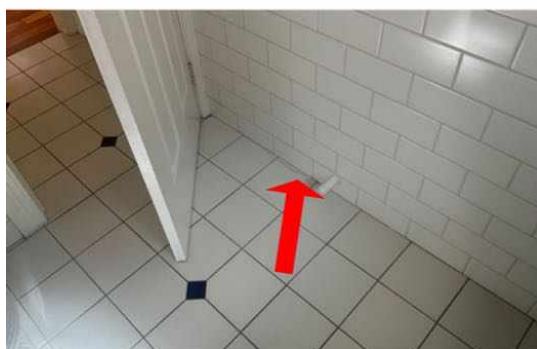
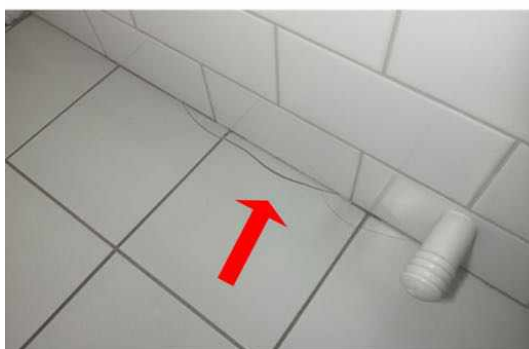
Finding 3.06

Finding: Floor tiles - Cracked

Information: Cracking in the floor tiles was evident in this area at the time of inspection. It is suspected that this cracking has occurred as a result of the floor lacking a solid or

suitable foundation for the tiles to be laid on, movement due to settlement of the floor foundations or impact damage.

Cracked tiles throughout the household detract from the overall appearance of the affected areas, as well as creating potential for water penetration underneath the tiles causing them to become drummy.

While not considered a matter of urgency, replacement of cracked floor tiles is advised as a solution. A tiling contractor or general handyman may be appointed to perform these works at client discretion.

Where cracks become more numerous, consultation with a registered builder specialising in re-stumping may be required.

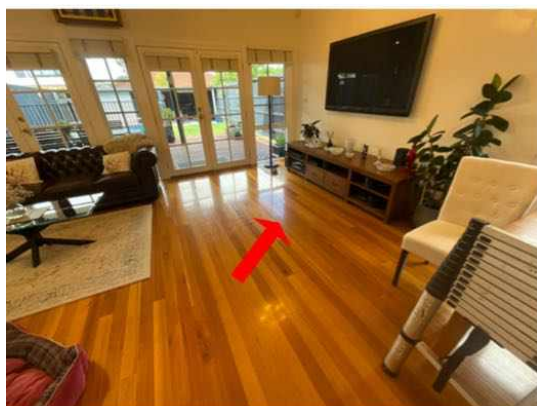
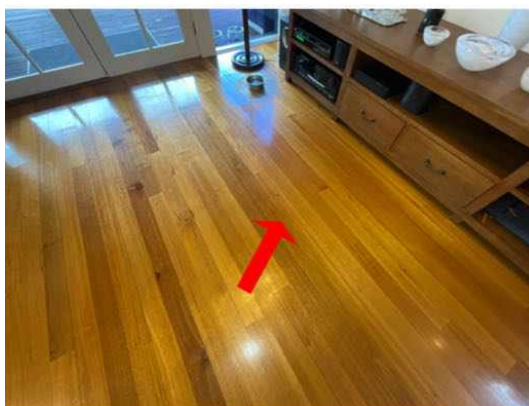
Bouncy floors generally indicate that the floorboards or the subfloor structures are coming loose from the joists that they are installed on. Bouncy flooring may also be the result of gaps between flooring and stumps or joist structures, which require packing.

It is recommended the flooring be monitored over a period of time for any changes such as increased bouncing or the floor becoming out of level.

Where necessary, the client would then be advised to seek quotations for required repairs from a Registered Builder specialising in re-stumping. The potential resolution may range from packing gaps in subfloor structures through to replacement of subfloors stumps and refixing of flooring.

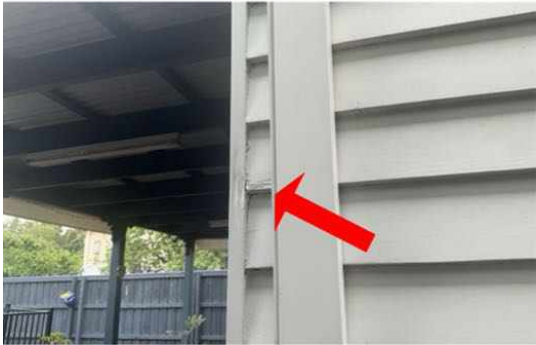
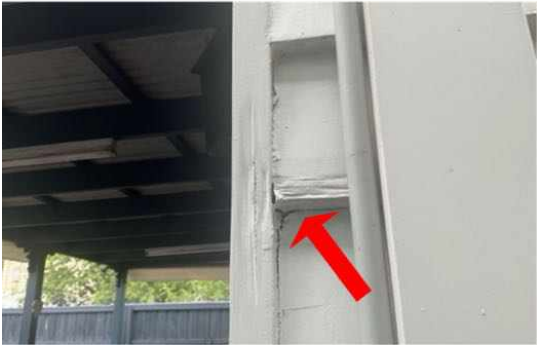
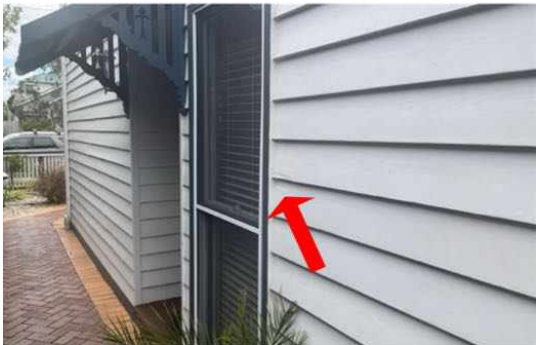
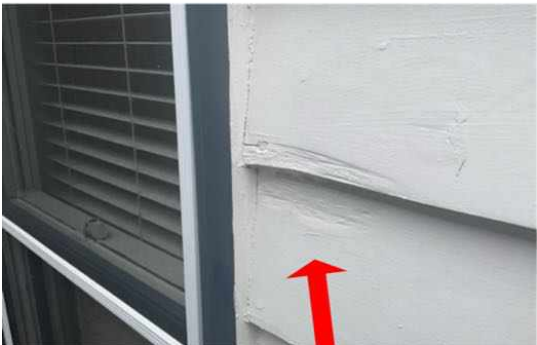
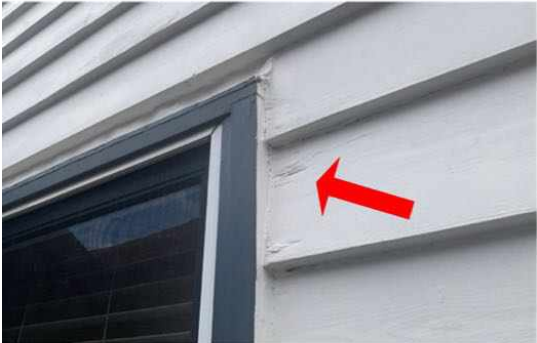
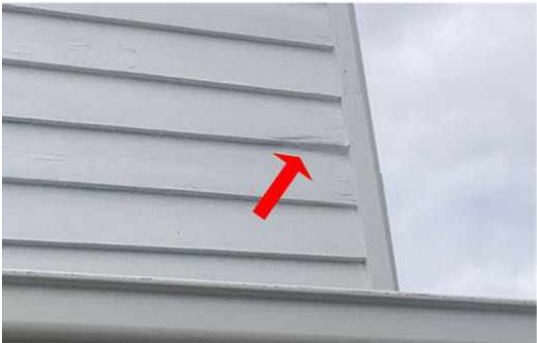
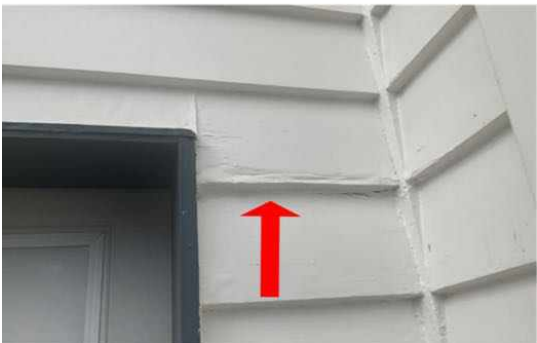
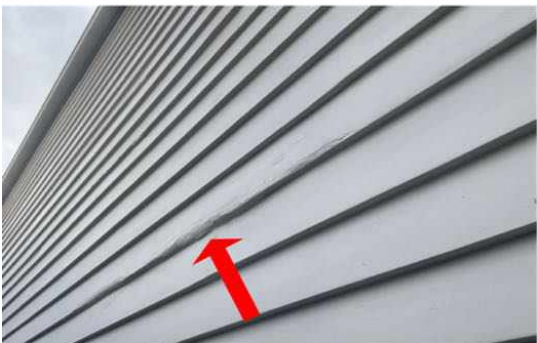
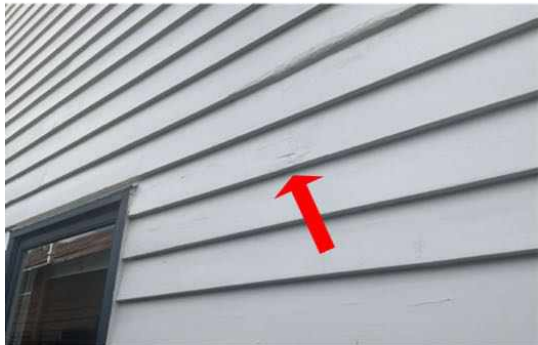
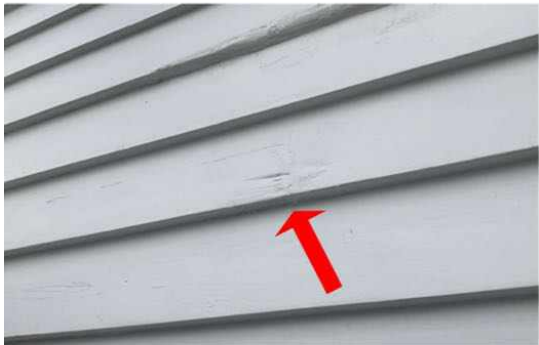
Finding 3.09

Building:
Location: All External Areas
Finding: Weatherboards - Rotting
Information: Some of the external weatherboards show signs of fungal decay (wood rot) in several sections. This wood rot is suspected to have developed over a prolonged period of time due to frequent weather exposure, which is expected in a property of this age and condition

Weatherboards are sealed and protected by paint and other sealants. When these sealants deteriorate over time, they allow water penetration to the weatherboards, causing wood rot. If left unmanaged, the wood rot is likely to develop further, possibly necessitating major repair or replacement works in the long-term future.

To maintain the condition of the external wall cladding, any severely affected weatherboards should be substituted as soon as possible with pre-treated replacements. Where weatherboards have rotted due to excessive moisture other than rain penetration, the cause of the moisture should be identified immediately by a licensed plumber. A qualified carpenter should be appointed to repair and replace rotting weatherboards.

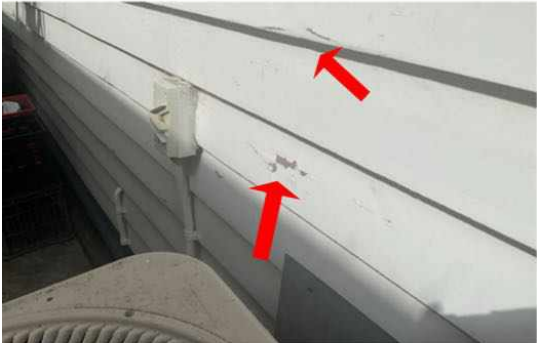
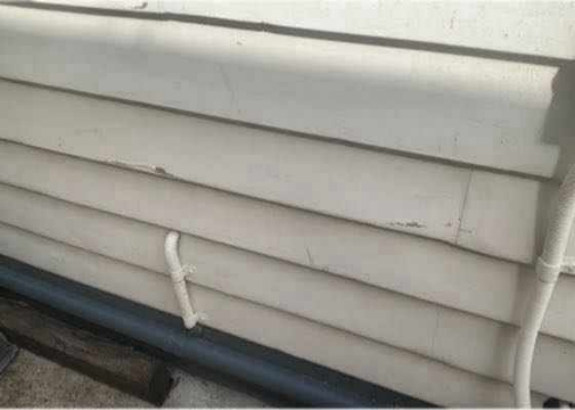
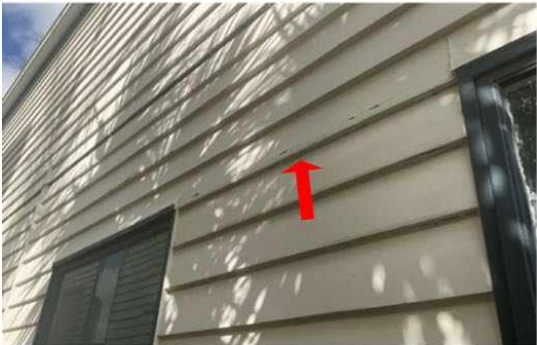
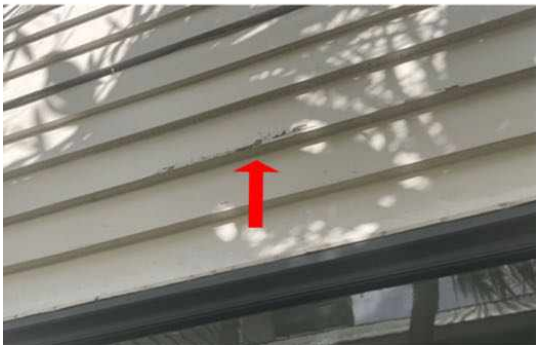
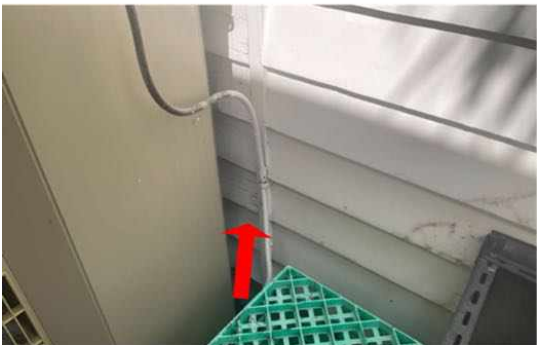
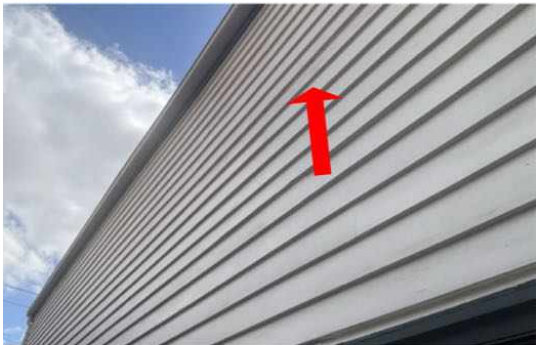
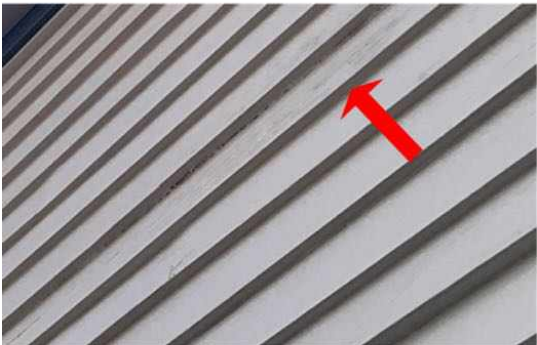
Finding 3.10

Building:
Location: All External Areas
Finding: Timber - exposed to weather
Information: External timbers that are frequently exposed to harsh weather conditions require adequate protection in order to maintain their condition. Where timbers have not been painted or treated adequately, general deterioration is likely to occur at an accelerated rate.

If left unattended, replacement of these timbers is likely to be necessary in the short-term future.

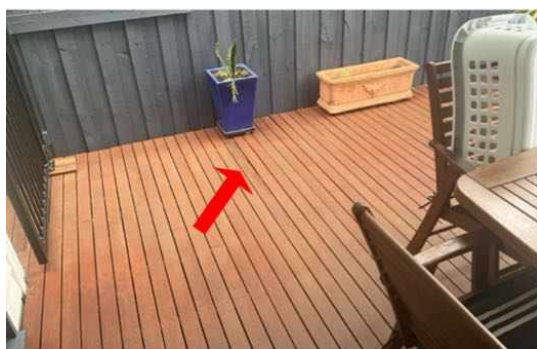
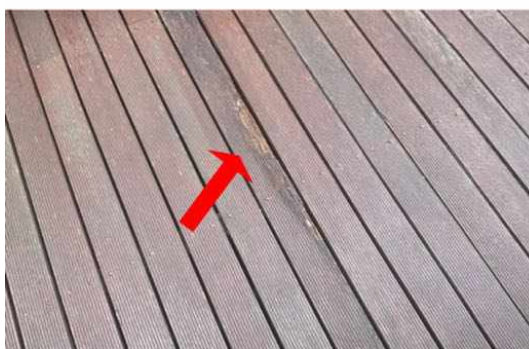
Finding 3.11

Building:
 Location: Deck
 Finding: Damage to decking board
 Information: At the time of inspection there appeared to be some damage to the decking boards on the rear deck.

It appeared that this damage may have been caused by excessive moisture sitting on the board over time.

This area should be monitored and if necessary the board should be replaced and any secondary damage dealt with.

A qualified carpenter or decking specialist should be engaged to perform this task.

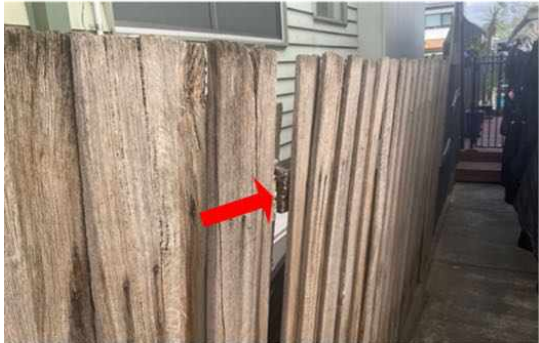
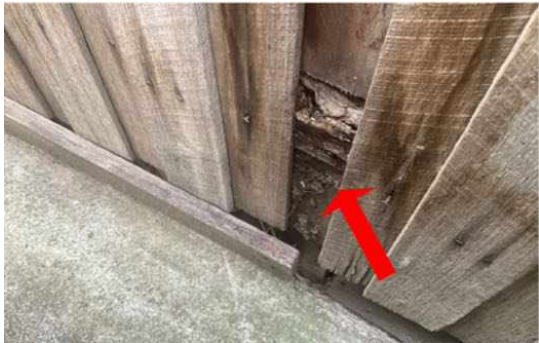
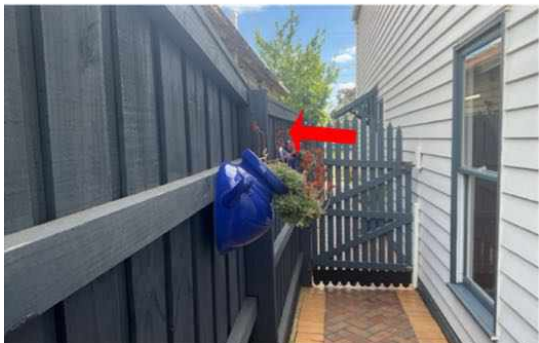
Finding 3.12

Building:
 Location: Yard - Back
 Finding: Fencing - leaning with some areas of deterioration
 Information: It was noted at the time of inspection that sections of the side fencing either side of the property were leaning slightly. Some areas of deterioration were also noted.

Typically fencing deteriorates due to age and or wear, rot and or rust which is generally expected for a structure of this age, due to prolonged exposure to weather conditions. Sometimes inadequate installation or maintenance can be to blame.

Should further damage occur, repair of several elements of the fencing may be required. Replacement may also be a consideration.

A licensed fencing contractor should be appointed to provide further advice and perform rectification works as necessary.

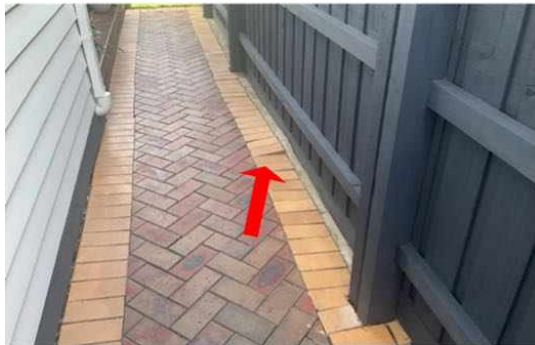
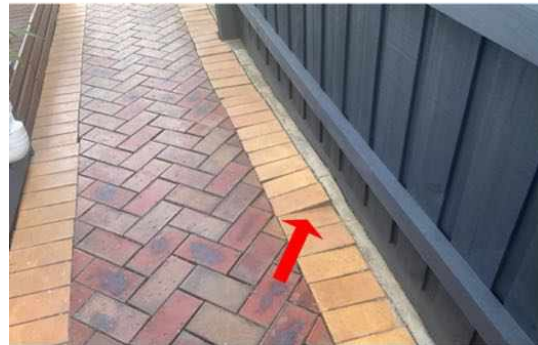
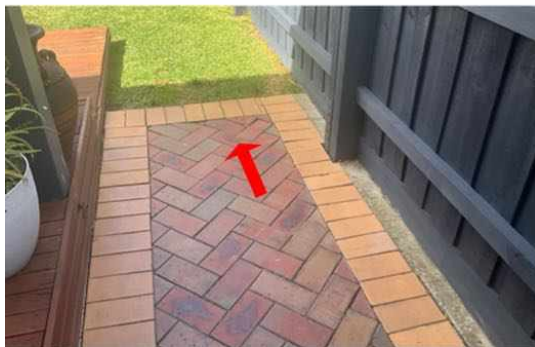
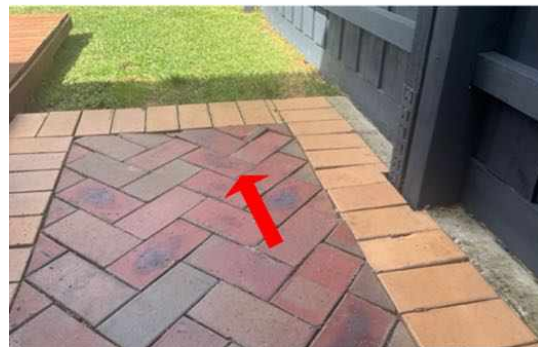
Finding 3.13

Building: Yard - Back
 Location: Paving - Uneven with some lifting and subsidence noted I n some areas
 Finding: Sections of the external paved area on the right hand side of the property are uneven with some lifting and subsidence noted in some areas. It appears as though the area may have been subject to poor installation, or that paving sections have shifted due to movements in the foundation of the property.
 Information:

Where paving becomes very uneven it may create a trip hazard.

Monitoring of the area is recommended . Should pavers become further uneven, re-

paving of the area would be required to remedy this situation.

Further consultation with a specialist landscaper would then be advised.

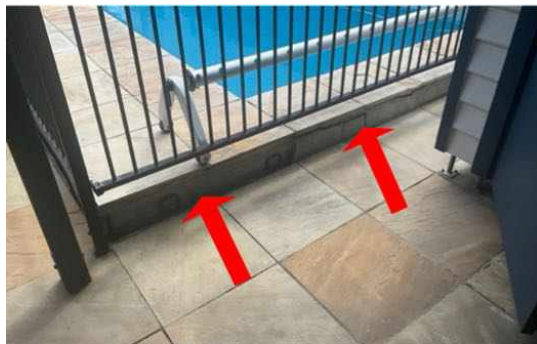
Finding 3.14

Building:	
Location:	Pool Area
Finding:	Render missing and cracked
Information:	Cracked and missing render was noted in this area at the time of inspection.

This type of damage is often consistent with general dilapidation of the property, and may continue to develop if left unmaintained.

Whilst minor in nature, repairs should be conducted to prevent water ingress behind the remaining render and subsequent further damage.

A suitably qualified renderer should be engaged to perform this task.

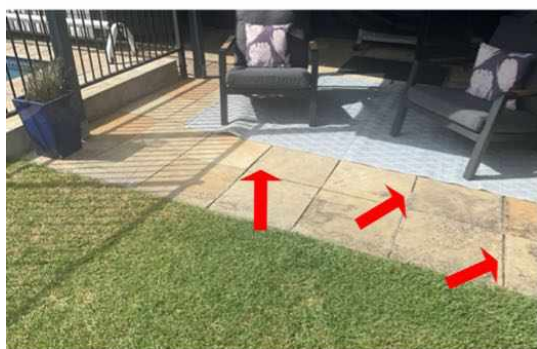
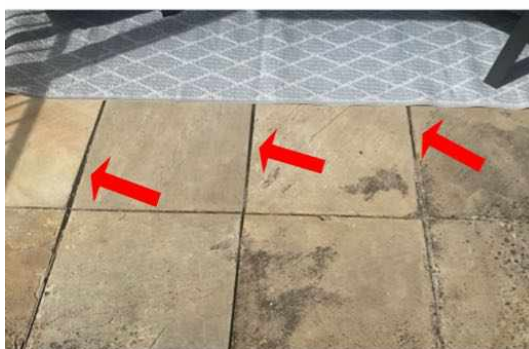
Finding: Exterior Grouting - Missing or damaged

Information: It was noted on inspection that grout is degraded to the joints between the paving in the rear patio area.

It is suspected this has just developed over time due to possible shifting of the pavers caused by simple ground movement.

The damaged / missing grout should be scraped out and a flexible sealant applied where necessary.

A competent handyman or landscaper may be appointed to complete these works.

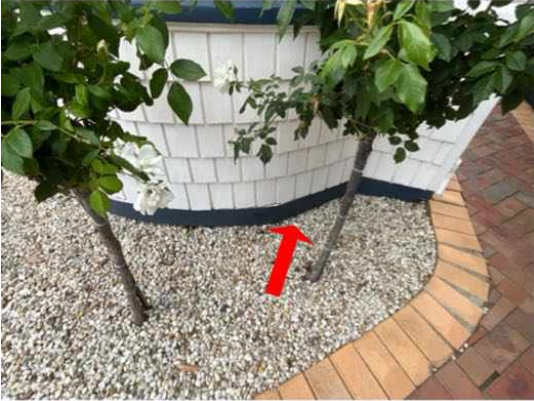
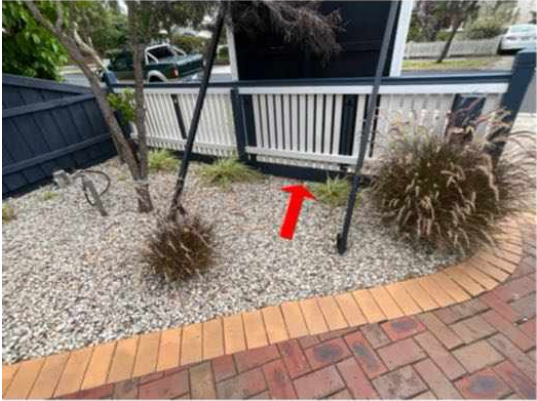
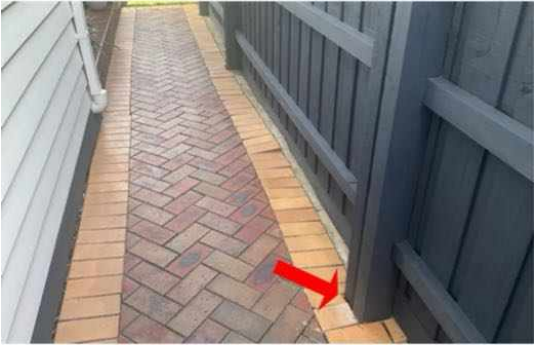
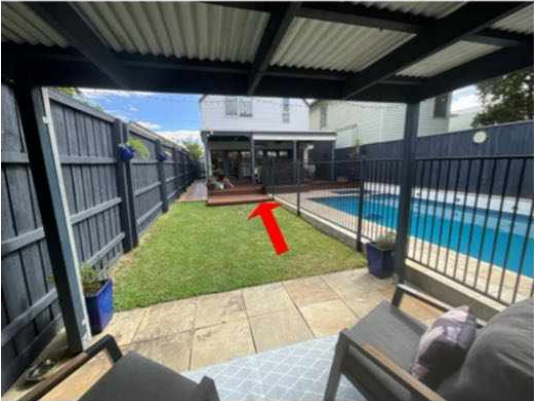
Building:
 Location: All External Areas
 Finding: Building materials in direct ground contact - conducive to termites
 Information: Where timber elements are in direct contact with the ground and consequently moisture or dampness, they become conducive to termite activity. Whether timber is used as a building element, part of a fencing structure or stored as an unused item, they can provide an environment that is attractive to termite infestation.

When met with excessive moisture, timber begins to decay and develop wood rot. Any timbers that are in direct contact with external grounds especially if left untreated or non-durable also provide ingress for subterranean termites into that particular

element.

Where possible, the removal of any such materials that may be conducive to termite activity should be carried out as soon as possible to minimise the risk of termite attack. Where not possible or practical, regular monitoring of timber elements is recommended. Replacement of any damaged materials should be carried out where necessary.

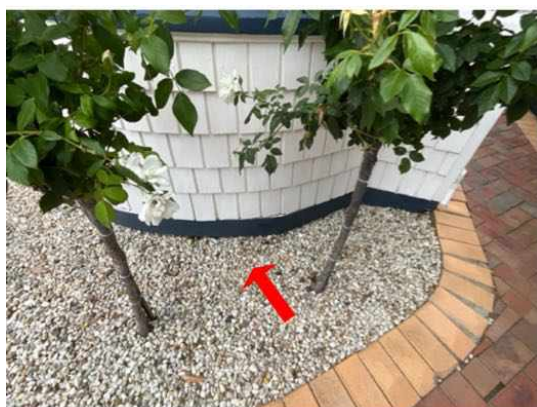
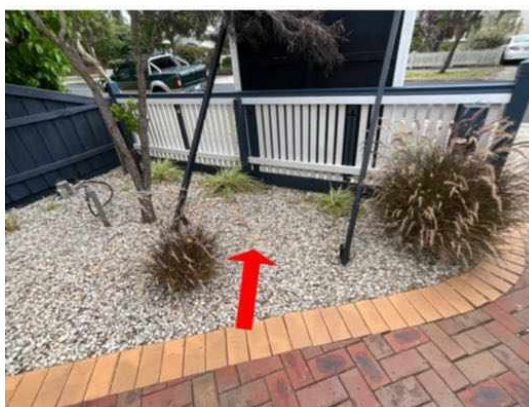
Finding 6.02

Finding: Garden Beds - Conditions Conducive to Termites

Information: Garden beds were found to be evident around and against the property. These garden beds can include untreated timber, and with a combination of moisture from rainfall and hosing, can make conditions conducive to termite activity and termite ingress.

The removal and replanting of species that do not provide "cover" or cutting back of existing vegetation will assist greatly in preventing this from occurring.

Where removal of any such materials that may be conducive to termite activity is not possible or practical regular monitoring of the areas should be carried out to minimize the risk of potential termite attack.

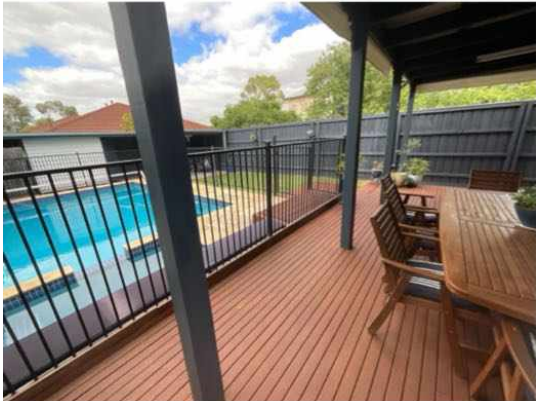
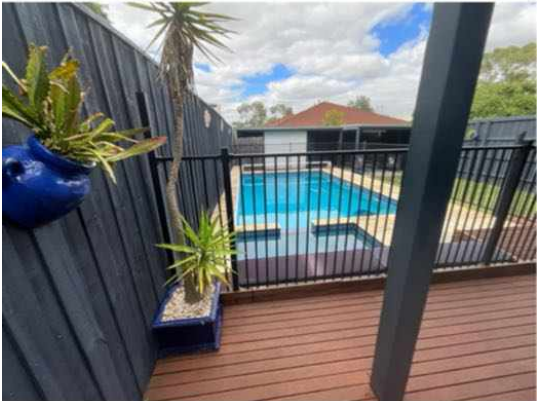
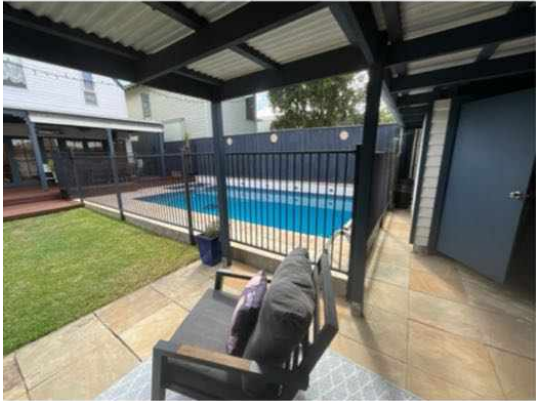
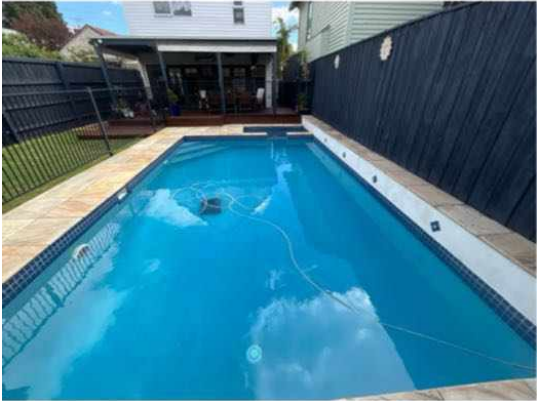
Building:
Location: Pool Area
Finding: Pool , equipment and fencing
Information: Please note that this inspection does not cover pool, equipment or fencing.

It is highly advised that a pool specialist be appointed to inspect the pool and associated equipment and provide advice on compliance and any rectification works that may be required.

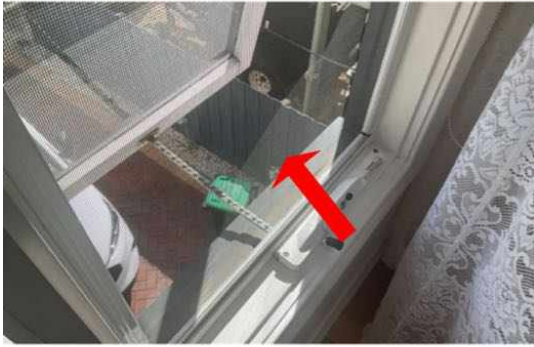
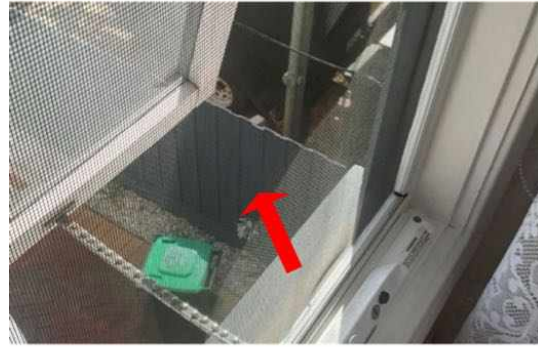
Information: It was noted on inspection that the windows to the second storey of the property are suspected to open wider than current standards for safety regulations allow.

Second storey windows should be limited to 125mm openings so as to prevent falling hazards.

This item is noted as an information item only, however caution should be taken around this window especially when young children are present.

There are a number of retro fit limiters that could be applied to the window should the owner wish to do so.

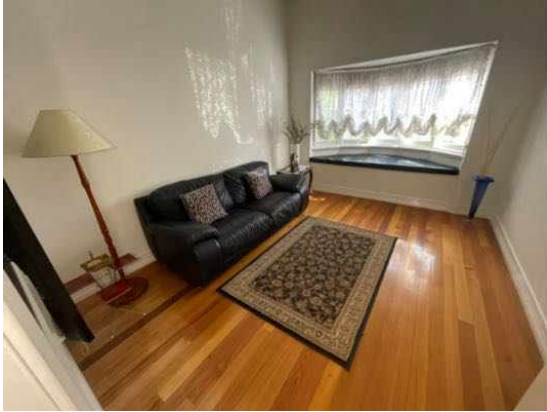
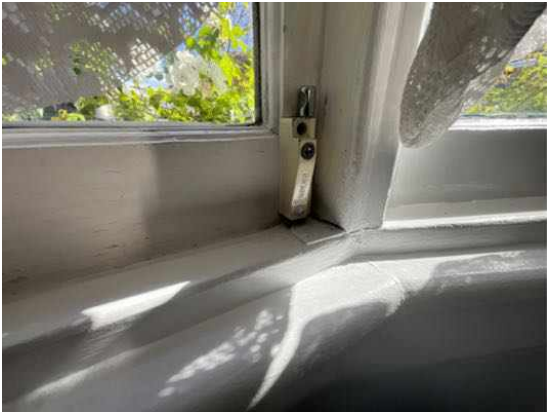
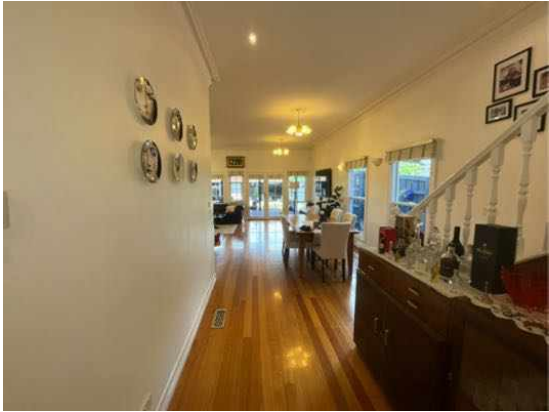
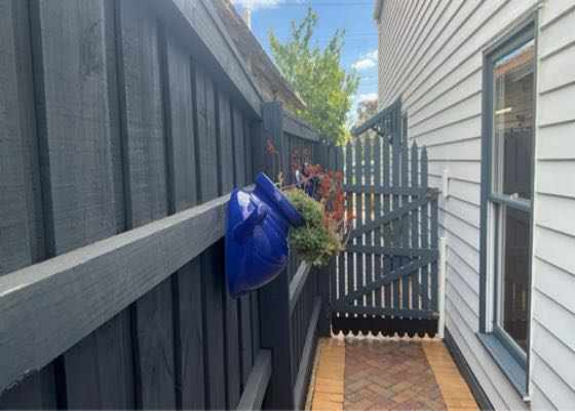
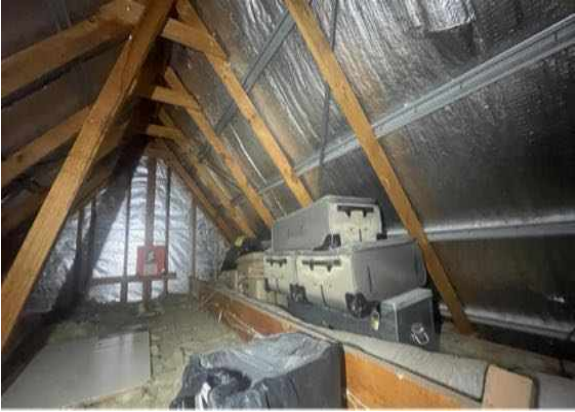
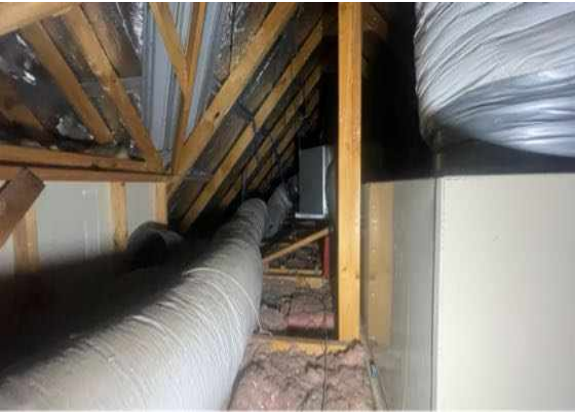
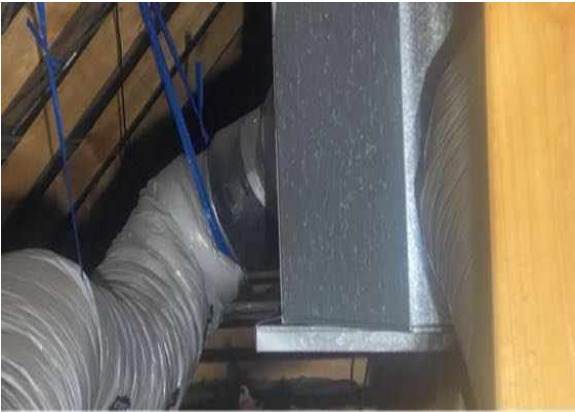
Finding: Additional Photos - Obstructions and Limitations

Information: These photographs are an indication of the obstructions and limitations which impeded full inspection of the property at the time of inspection. These obstructions can hide an array of defects and should be removed to allow full inspection to be carried out. A re-inspection is recommended once the areas are made accessible.
