Building and Timber Pest Inspection Report

Inspection Date: Thu, 5 Feb 2026

Property Address: 17 Fernyhough St, Rouse Hill NSW 2155,
Australia

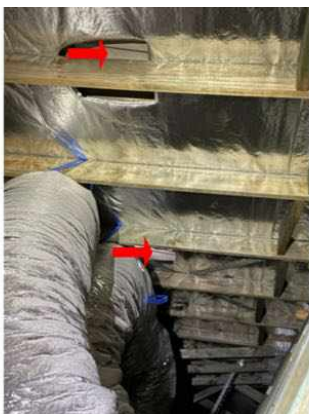
Finding 3.01

Building: Main Building
Location: Roof Void
Finding: Sarking - Damaged
Information: Sarking, a laminated aluminium foil applied to the interior of the roof covering, assists in insulating the property and acting as a vapour-barrier to the roof void and, subsequently, to the household.

Where sarking is damaged, both insulation and moisture protection of the property are inhibited. This creates a loss of energy and thus negatively impacts the energy efficiency of the property, allowing potential for moisture ingress from condensation or leaking roof tiles.

It is important to repair any holes or damaged sections of sarking to ensure that the building material is fully functional. A registered builder or qualified carpenter should be consulted to provide further advice on this defect and to perform rectification works at client discretion.

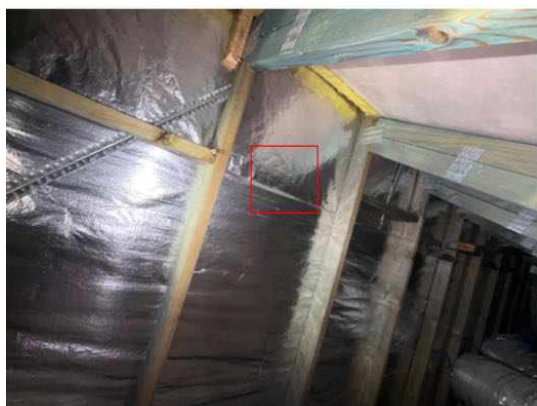
Finding 3.02

Location: Roof Void
 Finding: Roof nogging - Missing
 Information: Upon inspection of the roof void it was noted that one roof nogging was missing.

Roof noggings are required to provide lateral support and stability to the roof framing. The absence of this component may reduce the structural integrity of the roof, potentially leading to movement, vibration, or long-term damage to roofing materials.

It is recommended that a licensed builder or carpenter install the missing nogging in accordance with relevant Australian Standards and manufacturer specifications to ensure adequate structural support and compliance.

- Replace missing nogging to the roof structure
- Ensure wet area sealant and grouting is in serviceable condition

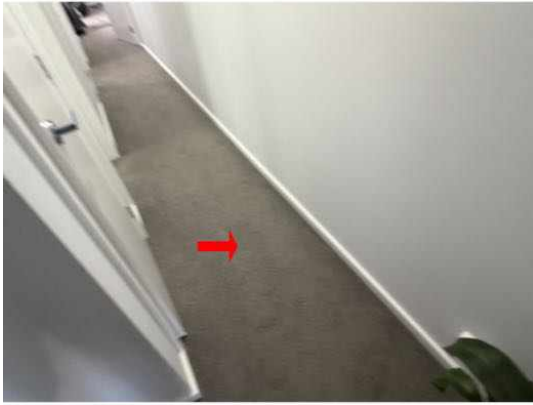
Finding 3.03

Building: Main Building
 Location: Upstairs
 Finding: Floors - Squeaky
 Information: The internal flooring in this area was identified as being squeaky at the time of inspection. This generally presents as a discernible change in level as they are walked across.

Although structural defects such as settlement could also be possible, however squeaky floors generally indicate that nails are coming loose from the joists that they are installed on, which is generally cosmetic rather than structural.

The client should appoint a licensed carpenter to undertake repairs.

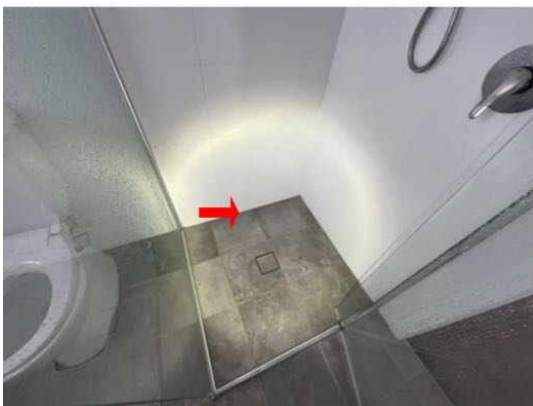
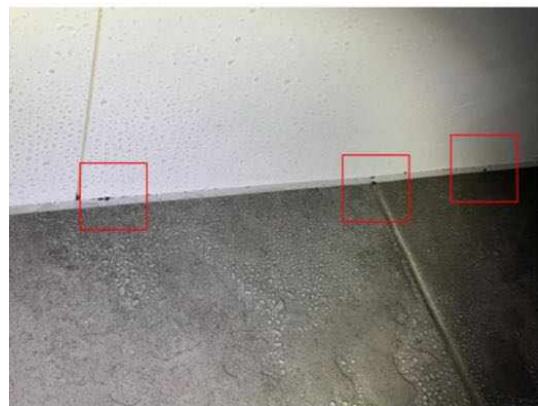
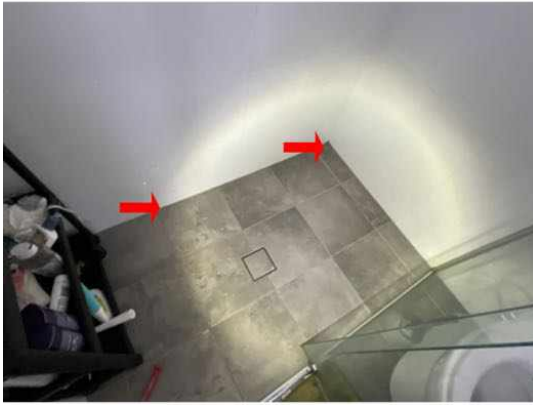
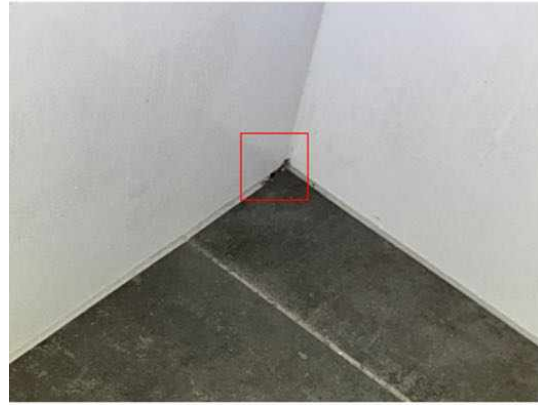
Finding 3.04

Finding: Sealant and grouting - Mould

Information: There appears to be excessive mould to the sealant and grout which will likely require scraping out and replacement. Flexible and mould resistant materials should be applied to affected areas to prevent any subsequent water damage that is likely to occur. Regular maintenance and replacement of damage or missing or damaged sealant and grout is highly recommended to the wet areas, as this is a regular wear and tear defect. Sealant and grouting in areas that come into regular contact with water should be maintained for the long term care of your property. A sealant specialist or tiling contractor should be appointed to complete these works as soon as possible.

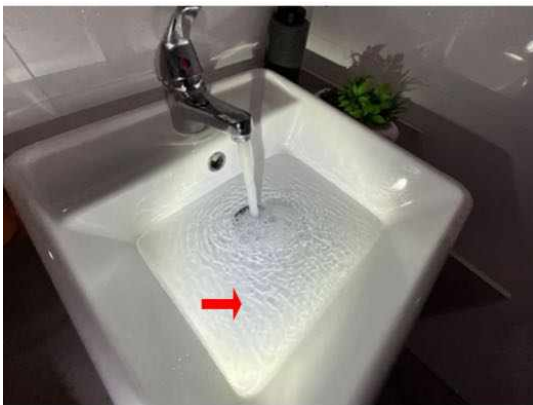
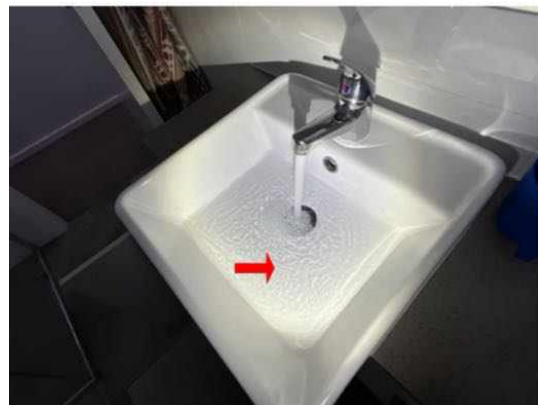
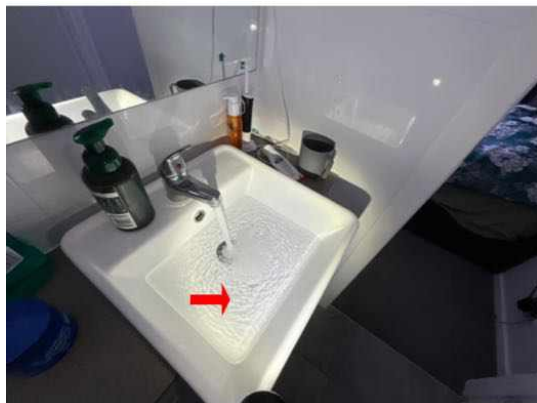
Finding 3.05

Building: Main Building
 Location: All Areas
 Finding: Sink/basin - slow draining
 Information:

The sink/basin drain appeared to be partially blocked at the time of inspection. Blockages here are usually caused by hair and other debris. If left unmanaged, a lack of general maintenance may lead to the development of more significant defects, such as water damage to surrounding building materials.

A licensed plumber should be appointed to remove the blockage at the client discretion.

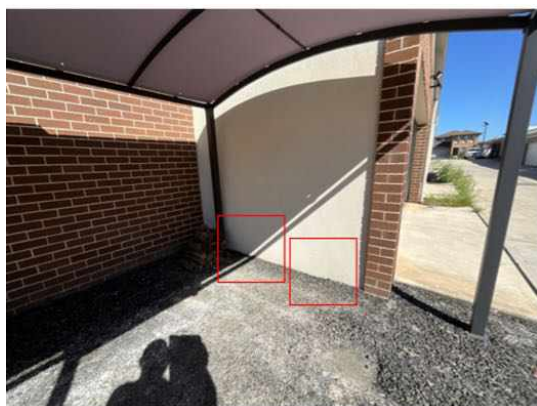
Finding 6.01

Building:	Main Building
Location:	Garage
Finding:	Bridging of termite barrier
Information:	Bridging of termite barriers occurs when termites bridge (usually by building a mud tunnel) a termite barrier or inspection zone or where termites have a passage allowing them to bridge the barrier.

Generally this takes the form of finished ground levels external paving or concrete being retrospectively installed above the damp course level the adjacent internal floor level or weep and ventilation holes.

Where bridging has occurred full inspection is prevented and termites may enter a property in a concealed or undetectable manner.

- Remove bridging to the termite physical barrier behind the garage
- Regular inspections every 12 months

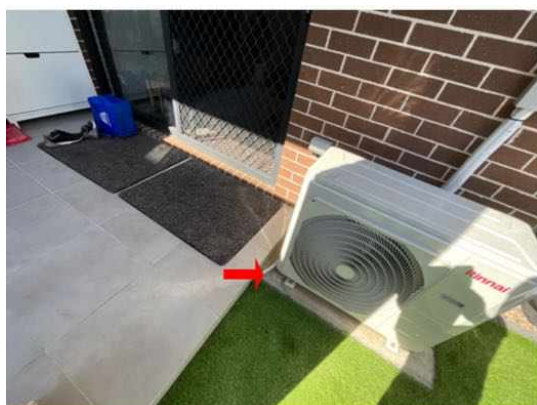
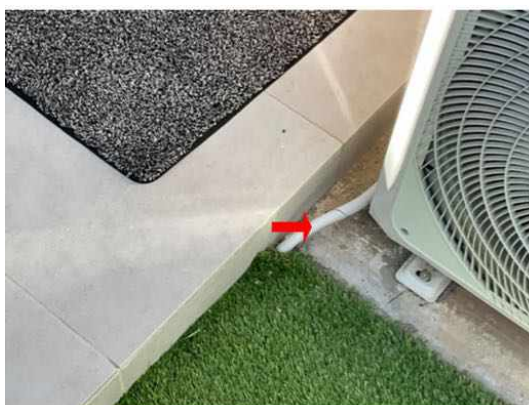
Finding 6.02

Building:	Main Building
Location:	Alfresco
Finding:	Overflow - Not plumbed for drainage
Information:	The overflow is not plumbed or connected to suitable drainage, which can result in the surrounding area becoming excessively damp.

These damp conditions can lead to secondary defects such as rot, rust or corrosion of associated building elements, the formation of fungal decay, or even the creation of potential slip hazards. When coupled with poor site drainage, pooling of water may also attract termite activity to this area.

It is highly recommended that a licensed plumber be appointed to install adequate drainage to the overflow. These works will ensure that the area remains dry and free of any secondary defects.

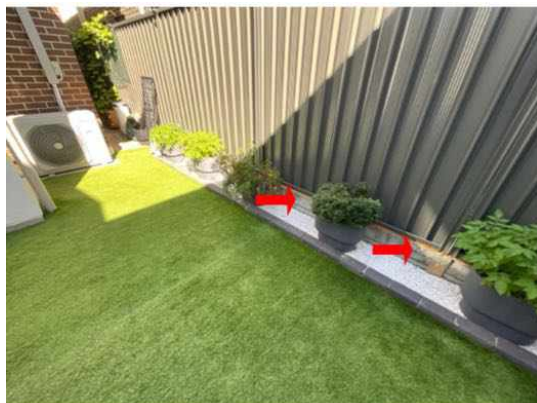
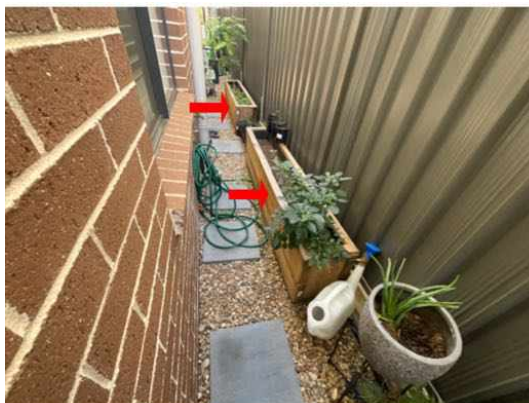
Finding 6.03

Building:	Main Building
Location:	Fencing & Landscaping
Finding:	Building materials in direct ground contact - conducive to termites
Information:	Where timber elements are in direct contact with the ground and consequently

moisture or dampness they become conducive to termite activity. Whether timber is used as a building element part of a fencing structure or stored as an unused item they can provide an environment that is attractive to termite infestation.

When met with excessive moisture timber begins to decay and develop wood rot. Any timbers that are in direct contact with external grounds especially if left untreated or non-durable also provide ingress for subterranean termites into that particular element.

The removal of any such materials that may be conducive to termite activity should be removed as soon as possible to minimise the risk of termite attack.

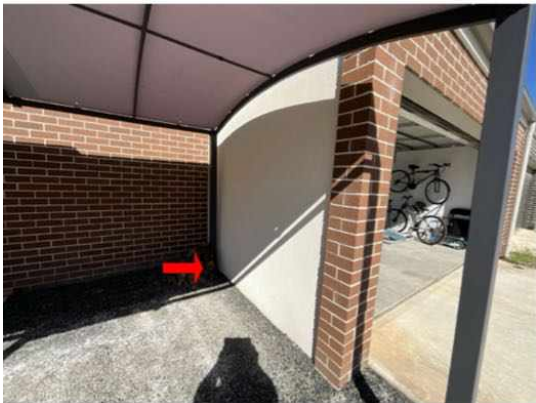
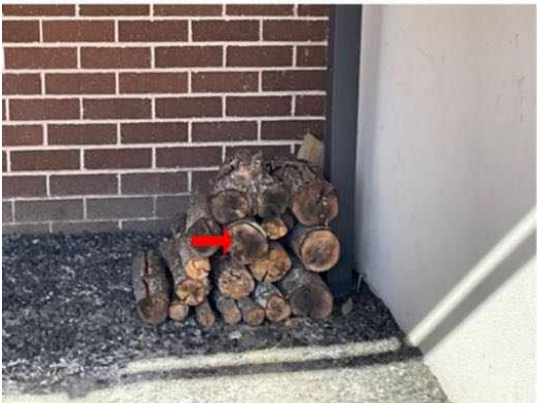
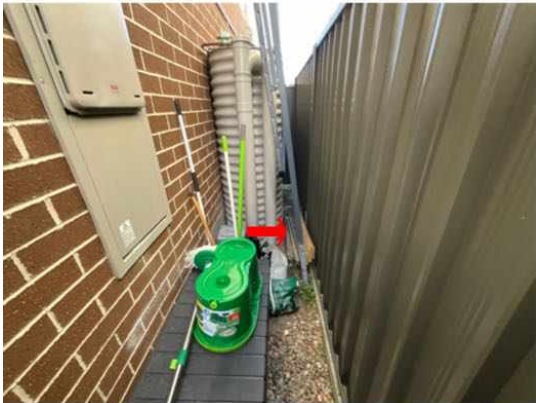
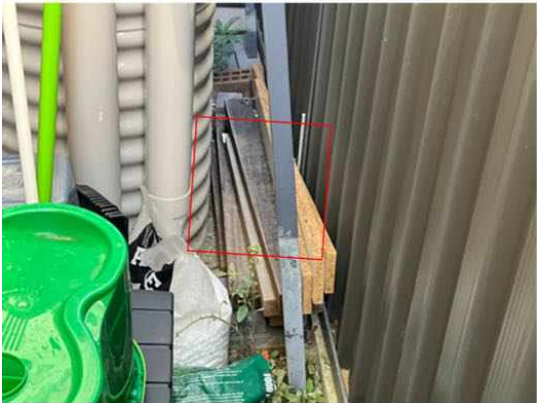
Finding 6.04

Building:	Main Building
Location:	Multiple areas
Finding:	Stored timbers - subfloor space or external area
Information:	The storing of timbers in the subfloor space or around the external property increases the risk of termite activity being present. As they are likely to come into contact with weather conditions or excessive moisture wood rot is likely to develop on timbers that are not treated.

It is highly recommended that any stored timbers be immediately removed from areas in which they may attract any termite / timber pest attack. Minimisation of risk / prevention of termite attack is far more adequate than dealing with the presence of termite activity.

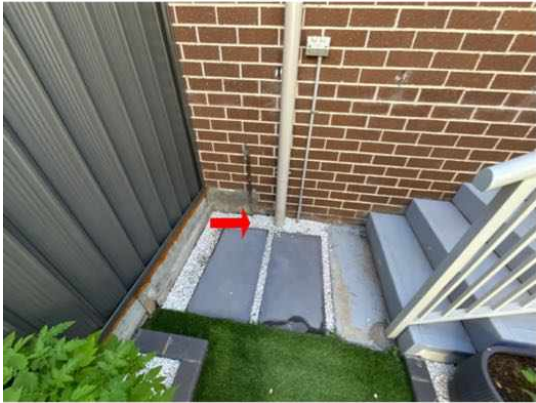
Finding 6.05

Building: Main Building
Location: External tap
Finding: Tap - No drain
Information: The external tap in this area was noted to have no drain at the time of inspection.

This keeps the surrounding surfaces damp while using the tap, which becomes conducive to termite activity.

A licensed plumber must be appointed to ensure an appropriate drain is installed.
