Building and Timber Pest Inspection Report

Inspection Date: Mon, 16 Mar 2026

Property Address: 272 Lane Cove Rd, North Ryde NSW 2113,
Australia

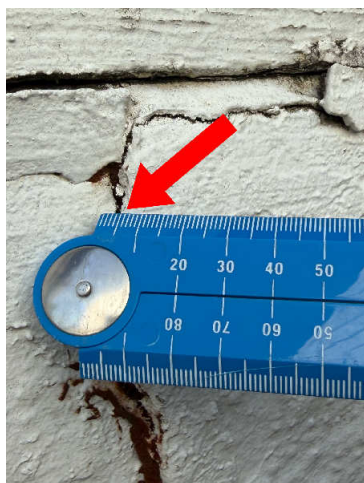
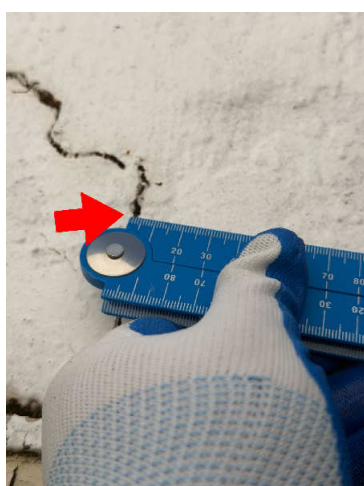
Finding: Brickwork - Cracking [Extensive repairs required]

Major cracking is evident to the brickwork in this area. When managing this degree of cracking, major extensive repair work is generally required. Such work is likely to involve replacement of sections of affected brickwork.

Structural issues are generally the underlying cause of such cracking. It is suspected that this damage has been created due to movement of key structural elements or general subsidence of associated footings.

A structural engineer and bricklayer should be appointed immediately to inspect the structural integrity of the affected brickwork and to assess the safety of the associated structures. The engineer can also nominate a scope of works required for rectification.

Always contact a building inspector or engineer should cracks widen lengthen or become more numerous, even after repair works have been completed.

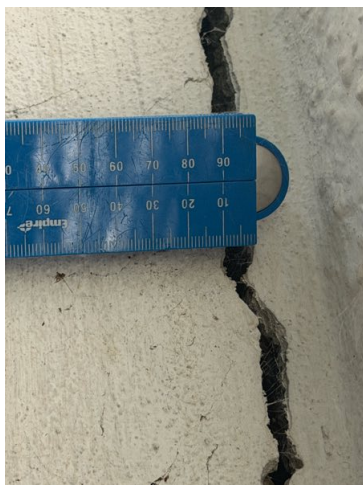
Finding 2.02

Information: A vertical separation approximately 10 mm wide was observed at the junction between the side wall and the main external wall. The rendered joint has opened and the render has separated along the interface of the two adjoining wall sections.

The separation appears consistent with differential movement between adjoining wall structures and failure of the rendered joint. The opening may allow moisture penetration and pest entry if left unsealed.

A qualified structural engineer should inspect the affected area and clean and repair the joint using a suitable flexible sealant or expansion joint system, followed by patching and repainting of the render to maintain weatherproofing and accommodate ongoing movement.

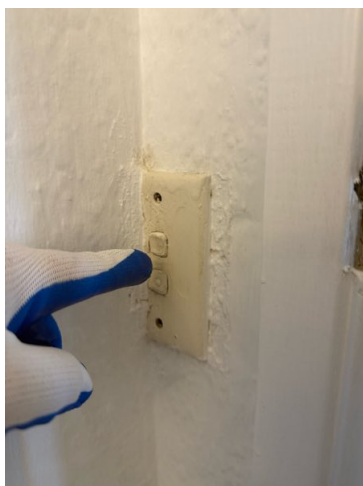
Finding 3.01

Finding: Toggle - Damaged

Information: The toggle on the light switch is visibly damaged, with signs of wear or deformation around its edges. The cover plate is also aged and discoloured, showing yellowing around the screws and surface staining.

Engage a licensed electrician to replace the damaged switch and cover plate. Ensure the internal wiring is checked for safety and functionality. Upgrade to a modern fitting to ensure compliance with current regulations and enhance safety.

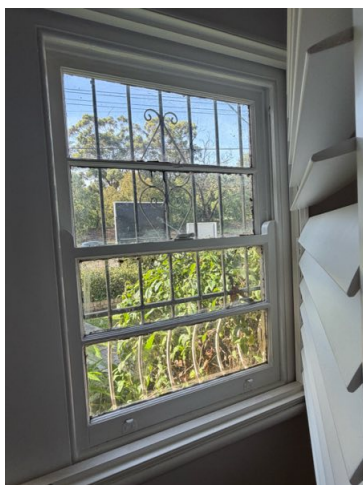
Finding 3.02

Information: Several windows throughout the property were jammed and difficult to operate at the time of the inspection. Windows provide ventilation to the adjoining area and should be at a fully operational level to ensure user comfort. Restricted function of the window may also pose as a potential safety hazard if required for emergency egress from the building.

Generally, factors such as general age of the building element and a lack of maintenance are the usual causes for this type of defect.

Replacement of window hardware or frame may be required, as well as minor repairs and cleaning. A registered builder or general handy person will be required to repair the affected windows.

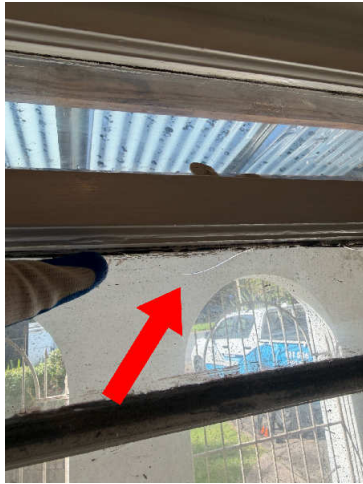
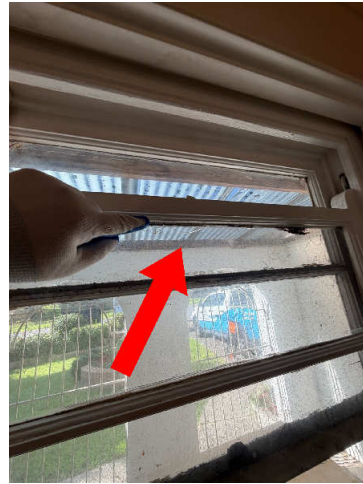
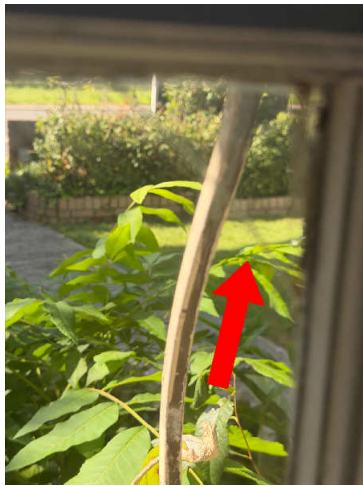
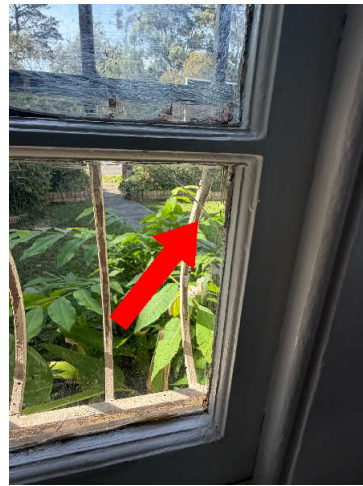
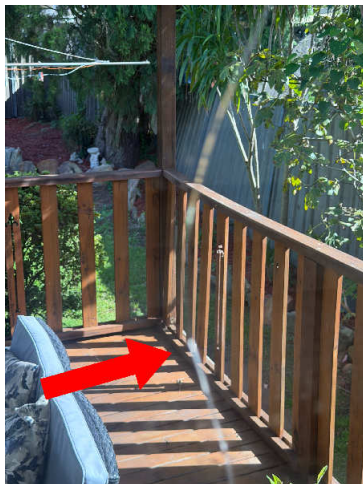
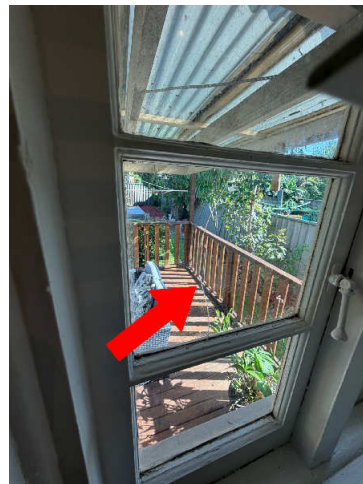
Finding 3.03

Finding: Window Glass - Cracked

Information: It was noted the window glass is cracked during the time of the inspection.

The crack may affect the transparency and clarity of the glass, distorting the view through the window. Furthermore, if the crack compromises the window's structural integrity, it can potentially compromise its ability to retain heat, maintain insulation, or withstand external pressures.

It is important to address a cracked window glass promptly to prevent further damage, potential safety hazards, and energy loss. Seeking professional assistance or replacing the damaged glass altogether is recommended to restore the window's functionality and aesthetics while ensuring the overall safety and security of the premises.

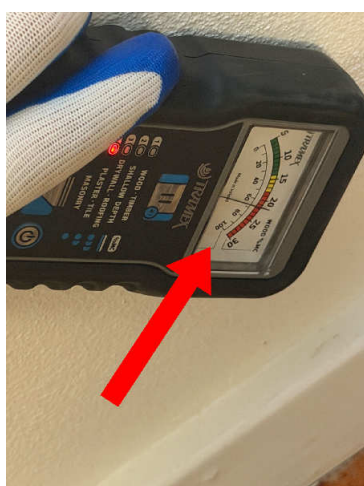
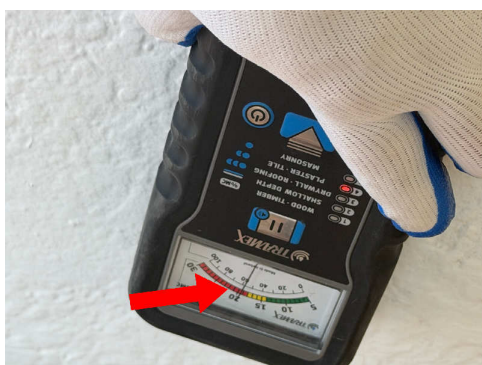
Finding 3.04

Information: Damp (or structural damp) refers to the presence of unwanted moisture in the structure of a building, either as the result of intrusion from outside, or condensation from within the structure. Generally, structural damp is caused by rain penetration, rising damp, and leaks from plumbing pipes.

Unmanaged damp facilitates the formation and development of mould, fungi growth and wood rot, decaying associated building materials and compromising their structural integrity. Damage to finishes is also likely to occur, including lifting, bubbling, peeling and staining of paint, plaster and wallpaper.

The first step in addressing damp is to diagnose the cause. The identified cause should be addressed first prior to repairing the appearance and other defects which have resulted from the rising damp. If the original cause is not resolved, further cases of damp are likely to ensue, resulting in secondary defects.

Consultation with a qualified plumber is advised immediately to identify the cause of damp and perform remedial works as required. Where excessive mould growth is present, further inspection by a specialist environmental health inspector should also be considered.

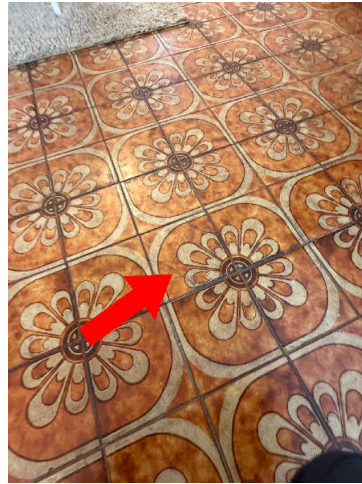
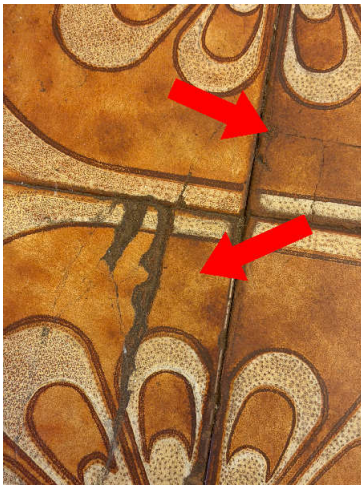
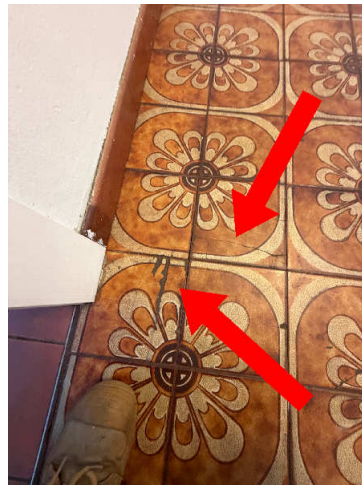
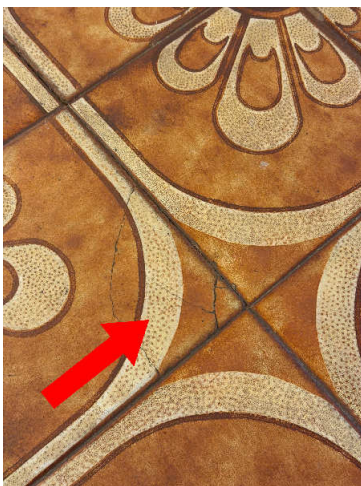
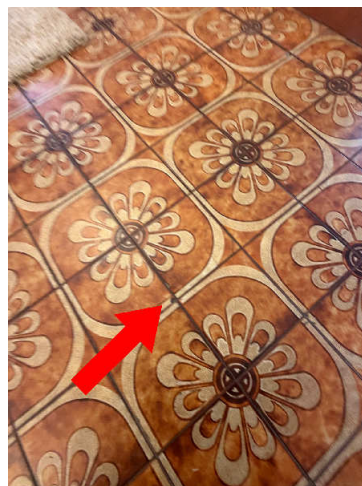
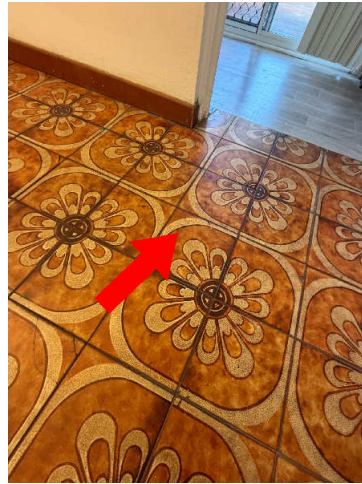
Finding 3.05

Finding: Cracked floor tiles

Information: Cracking in the floor tiles was evident in this area at the time of inspection. It is suspected that this cracking has occurred as a result of minor settlement or shrinkage of the slab.

Cracked tiles throughout the household detract from the overall appearance of the affected areas however it is unlikely to create or lead to any secondary defects.

While not considered a matter of urgency, replacement of cracked floor tiles is recommended at the clients discretion. A tiling contractor may be appointed to perform these works. Where cracks become more numerous, contact a licensed building inspector for further investigation.

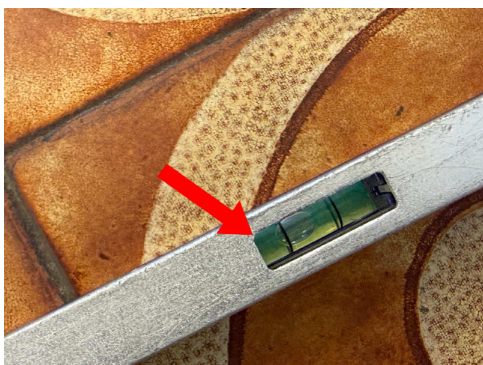
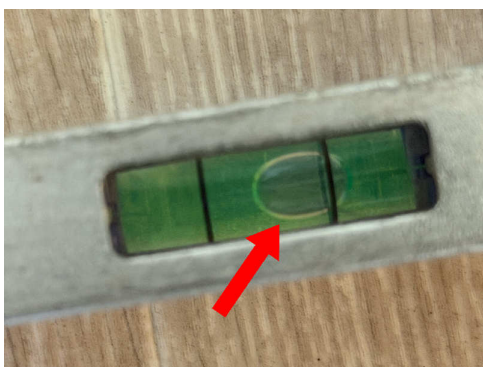
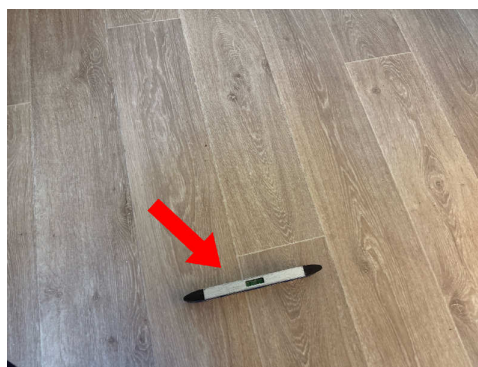
Finding 3.06

Building: Main Building
Location: All Internal Areas
Finding: Flooring - Uneven

The internal flooring in this area is out of level and uneven. Uneven flooring is likely to indicate minor defects such as expected movement of the foundations of the property, but may also indicate subsidence of the associated subfloor stumps.

It is advised that the flooring be closely monitored to identify any further movement. Where flooring remains relatively unchanged for an extended period of time (i.e. several months), it is likely that this defect has been caused by expected movement of the foundations of the property.

However, where flooring is uneven further, potentially invasive inspection of the subfloor structures and stumps in this area is required. In this case, works to repair are likely to be required, and would be carried out by a registered builder specialising in re-stumping.

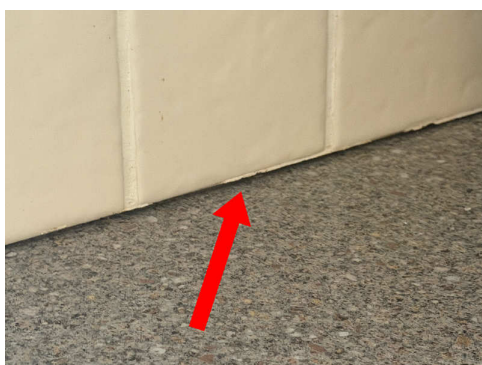
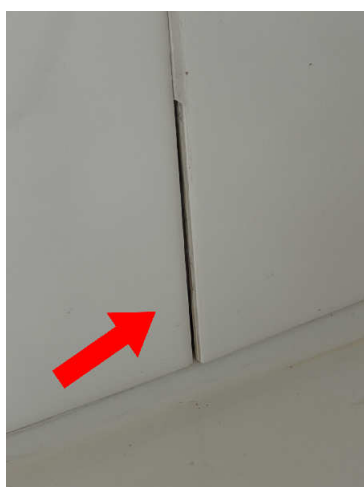
Finding: Sealant and grouting - Missing or damaged

It was noted on inspection that sealant or grout is degraded in multiple locations of the property.

Different materials and floor areas move at different rates, generally causing cracking to grout or sealant at this point. A flexible sealant is required to allow for expected expansion and contraction, while keeping the joint water tight and protective of all associated building materials.

Flexible and mould resistant materials should be applied to affected areas to prevent any subsequent water damage that is likely to occur. Regular maintenance and replacement of damage or missing or damaged sealant and grout is highly recommended to the wet areas, as this is a regular wear and tear defect. Sealant and grouting in areas that come into regular contact with water should be maintained for the long term care of your property.

A sealant specialist or tiling contractor should be appointed to complete these works as soon as possible

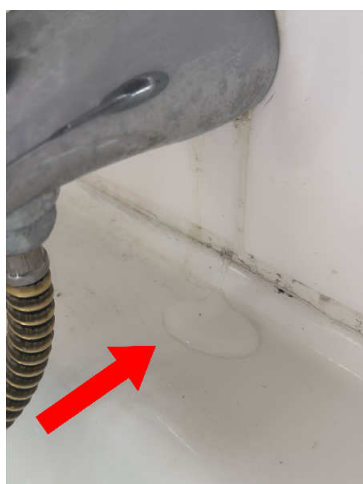
Finding: Spout - Leaking

Information: The Spout in this area was found to be leaking at the time of inspection. This is a common defect that is consistent with general ageing of the building element. However, it may be indicative of substandard plumbing workmanship if the tap is relatively new.

While this defect only seems minor, if left unmanaged, it is likely to result in the development of rust, water damage and/or extensive water usage.

It is advised that a handyman or licensed plumber be appointed to perform remedial works on the affected tap. Such works should be performed prior to the development of secondary defects to ensure adequate functionality of all associated building elements.

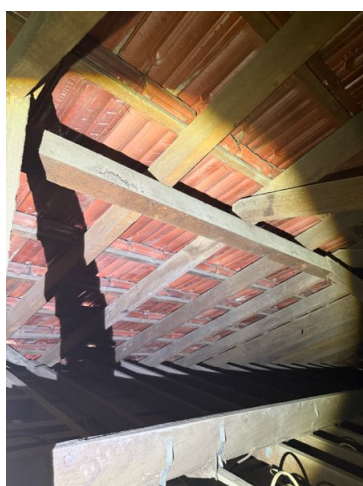
Finding 3.12

Finding: Sarking - Missing

Information: Sarking is missing under the roof sheeting. Sarking acts as an insulator that helps with noise reduction and protects against water penetration. Sarking plays a key role in the operation and function of the overall roofing structure and its performance.

Although not a requirement at the time of construction, replacement of any missing building element is advisable (although this can be quite expensive to do after the time of construction). Where sarking is missing, regular inspections of the roof tiles for cracking and potential moisture penetration is required.

Sarking may be retrospectively fitted by a registered builder at the discretion of the client.

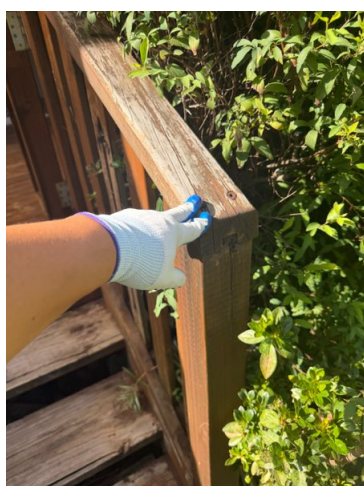
Information: The handrail, a crucial safety feature designed to provide support and stability, has been insecurely installed, raising significant safety concerns. The attachment of the handrail to the supporting structure is compromised, compromising its ability to bear weight and fulfill its intended function. This condition poses a serious risk to individuals relying on the handrail for support, especially on stairs or elevated areas.

Engage the services of a qualified contractor or structural engineer to assess the overall condition and provide recommendations for repair or replacement.

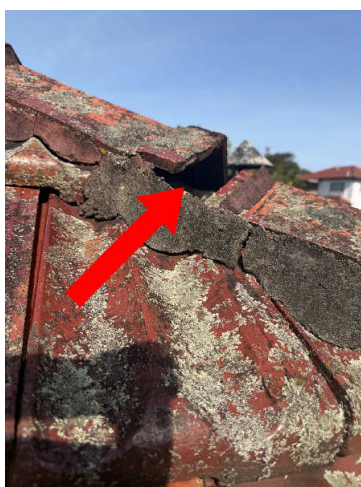
Finding: Roof tiles - Ridge tiles broken

Information: Upon inspection of the exterior roof, it was noted that several ridge tiles have been broken. Ridge tiles are the uppermost capping tile at the apex of a roof, and are important in promoting adequate roof drainage.

Ridge tiles, as per any other tile, can become brittle and break as a consequence of age and frequent exposure to weather conditions. Broken tiles of any type may result in water ingress, creating potential for moisture damage to ceiling linings and other associated building elements.

Prior to secondary damage being sustained, it is important to replace any broken tiles. Consultation with a roofing restoration company is advised as soon as possible.

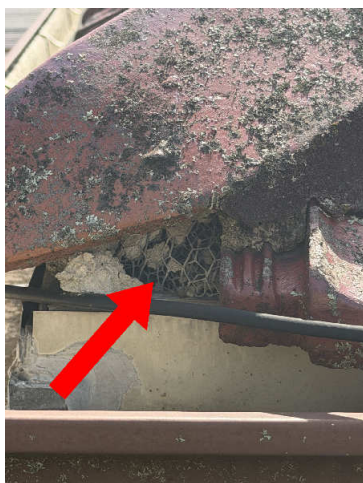
If left to further deteriorate, broken and brittle roof tiles are likely to lead to water penetration via the roof into the ceiling space, causing secondary damage to ceiling linings, insulation and roof structures. Broken roof tiles are also likely to detract from the effectiveness of the roof drainage system, creating potential for secondary damage to the exterior roof covering and roof plumbing.

Replacement of broken tiles is required and should be performed by a roofing contractor as soon as possible.

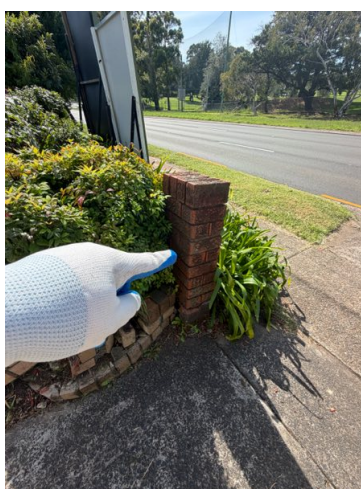
Finding 3.22

Building: Main Building
Location: Yard - Front
Finding: Brick Bouondary Wall - out of plumb

The leaning condition indicates movement and loss of stability of the masonry pier, which may be associated with foundation movement, impact damage, or deterioration of the supporting brickwork. Continued movement may result in collapse of the pier or adjoining brickwork, posing a potential safety hazard.

A qualified builder or bricklayer should assess the affected wall and surrounding brickwork. Repairs may involve realignment, reconstruction, or replacement of the pier and affected wall section, including rectification of the supporting footing as necessary to restore stability.

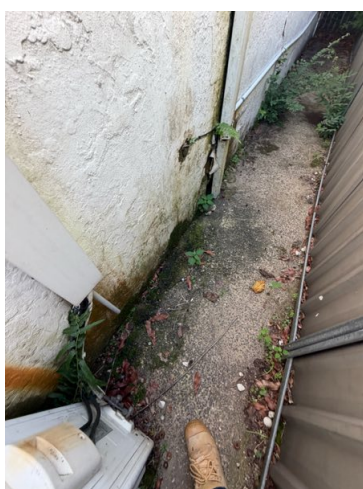
Finding 6.01

If left unattended damp or wet conditions may have many consequences including the development of fungal decay and/or wood rot as well as providing an environment that may be conducive to termite or timber pest attack.

A qualified plumber should be appointed immediately to identify the cause of the excessive moisture in order to prevent further damage. The water leak should be resolved prior to any repairs of the damaged area which may require localised replacement of building materials and refinishing..

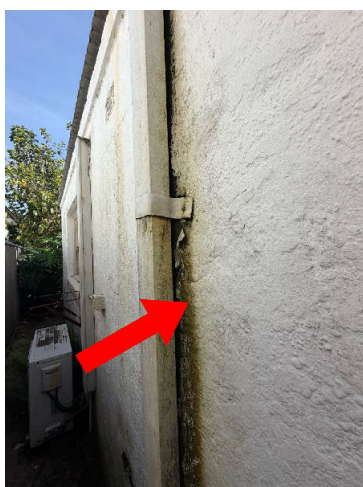
Such leaking creates an environment which is conducive to an array of defects, including water damage to associated building elements and the attraction of termite or timber pest infestation.

It is highly recommended that a licensed plumber be appointed to connect the overflow in order to prevent such an environment from being created. These minor works should be carried out as soon as possible.

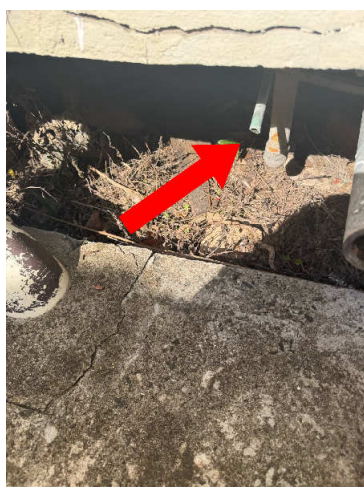
Finding 6.04

These damp conditions can lead to secondary defects such as rot, rust or corrosion of associated building elements, the formation of fungal decay, or even the creation of potential slip hazards. When coupled with poor site drainage, pooling of water may also attract termite activity to this area.

It is highly recommended that a licensed plumber be appointed to connect the HWS overflow in order to prevent such an environment from being created. These minor works should be carried out as soon as possible.

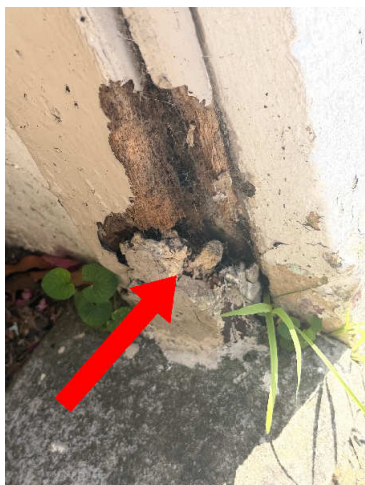
Finding 7.01

Early intervention and regular maintenance, particularly of exterior timbers, will prolong the useful life of these building elements. Prior to any works being performed, the cause of the moisture that has created the visible wood rot should be identified and addressed in a suitable manner. Replacement of affected timbers may then be a necessary step in protecting surrounding building elements from such deterioration.

A qualified plumber may be appointed to assess the cause of excessive moisture and to provide advice on any remedial works as required. A qualified carpenter or registered builder may also be required to replace affected building materials.

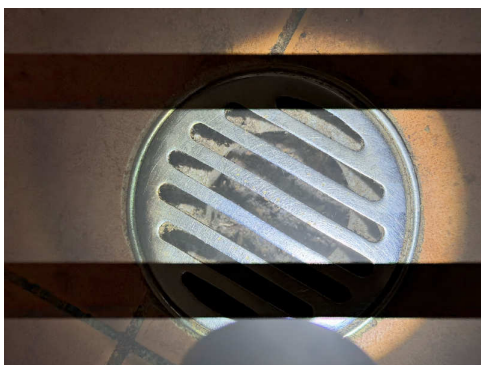
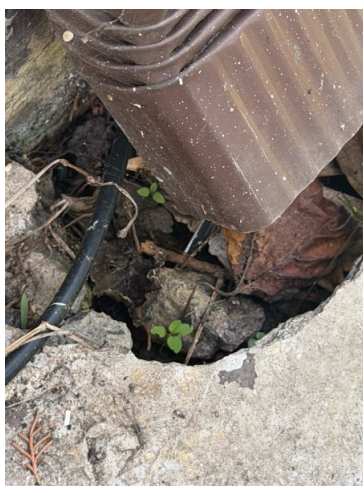
Information: The inspection has revealed the presence of rubbish in the drainage system, raising concerns about a potential blockage.

It is important to note that the drainage inspection is outside the scope of this report. Given the severity of the suspected blockage and to ensure a thorough assessment, engaging a licensed plumber with expertise in drainage systems is strongly advised.

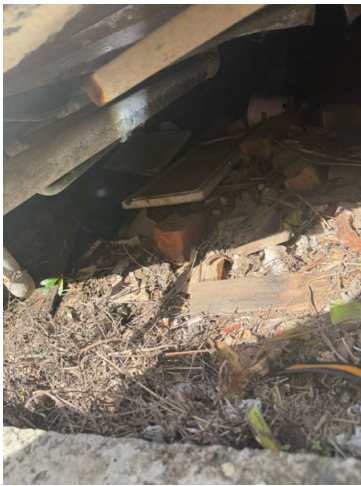
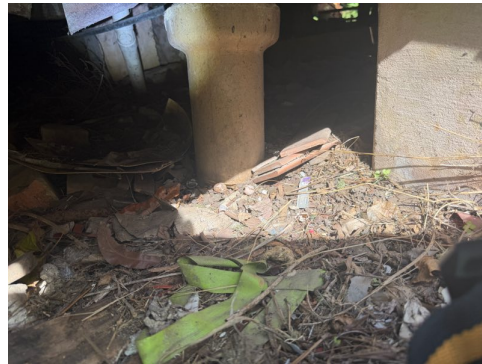
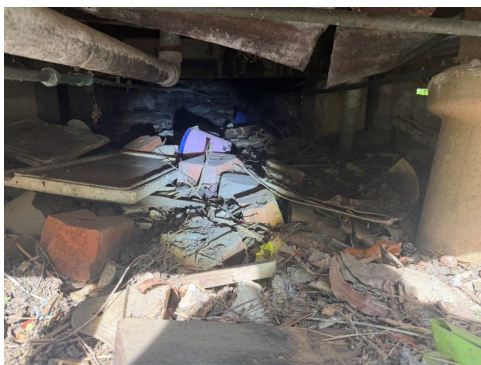
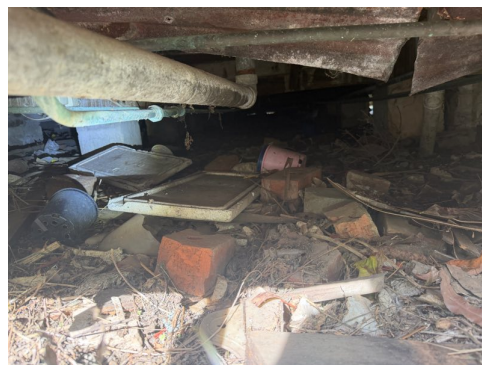
Finding: Lack of Access to Subfloor

Information: The additional photos indicate during the time of the inspection there were Lack of Access to subfloor due to obstruction and entry point smaller than 400mm*600mm.
